Pentraeth, Abersoch

Archaeological Watching Brief

Prosiect Rhif / Project No. G2386

Adroddiad Rhif / Report No.1284

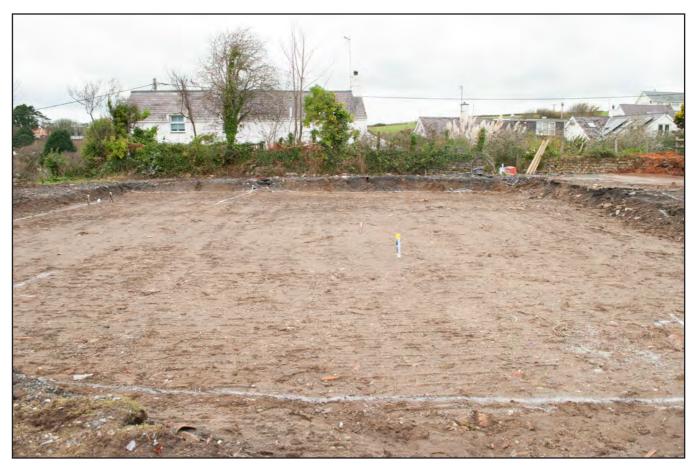
Plate 01: Photograph of site looking North after site demolition and prior to ground reduction. 1x1m Scale.

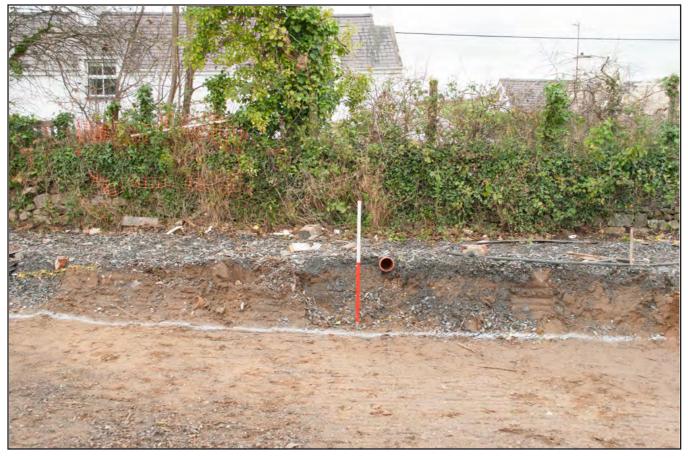
Plate 02: South facing section, edge at rear of house. 1x1m Scale.

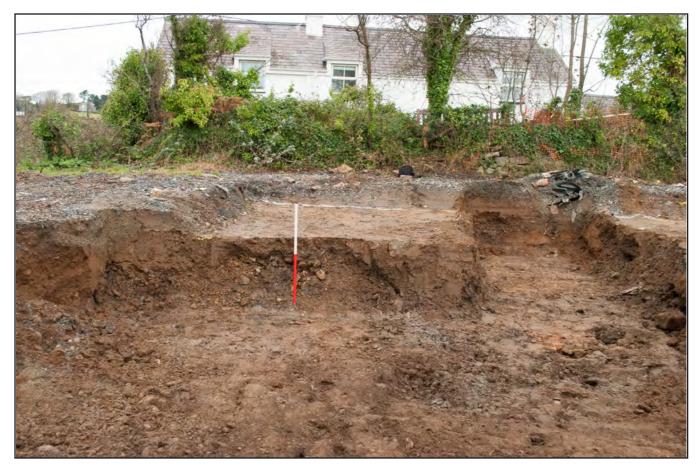
Plate 04: South facing section of foundation excavation. 1x1m Scale.

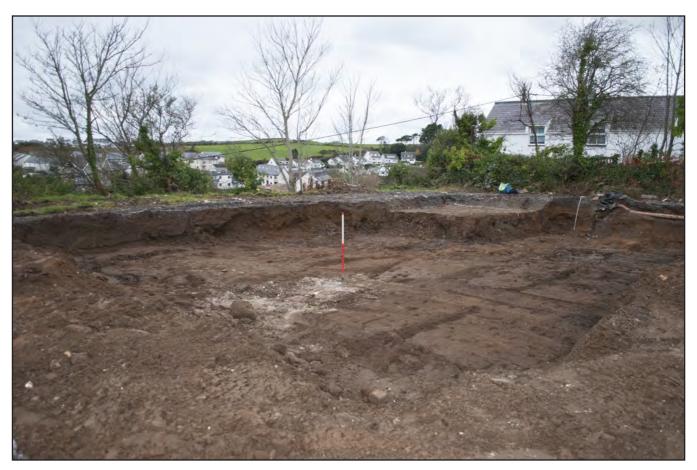
Plate 05: General view of building footprint on reduction of levels. View from Northeast. 1x1m Scale.

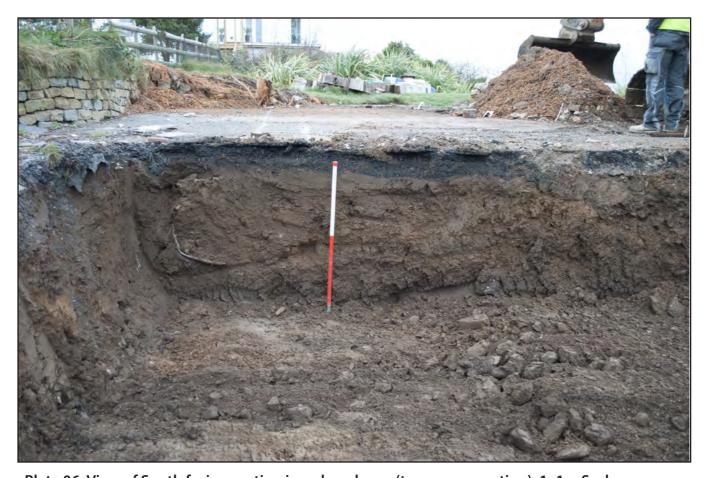
Plate 06: View of South facing section in reduced area (temporary section). 1x1m Scale.

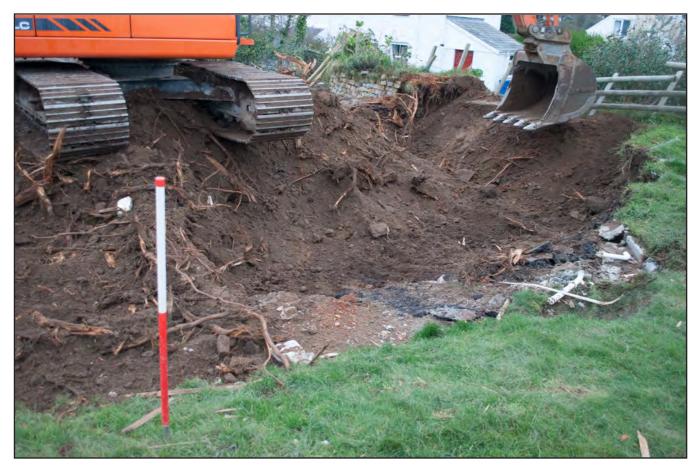
Plate 07: Photograph of disturbance caused by tree bole at North end of site. 1x1m Scale.

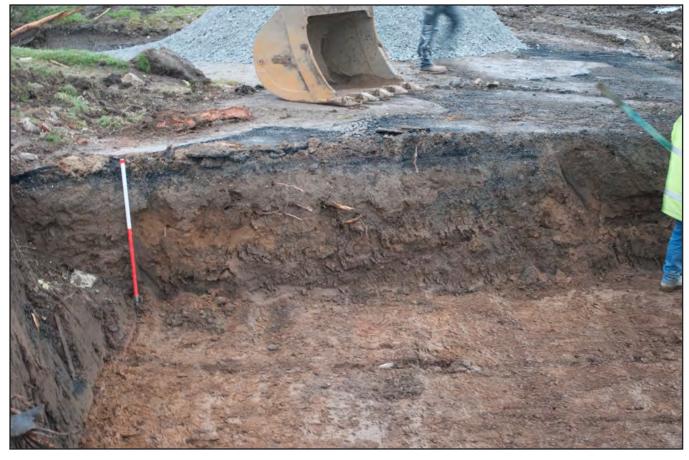
In the northern garage extension area, below a tarmacadam layer 0.05m thick, a mid orangey brown sandy silt former garden soil (106), 0.35m thick, was observed, overlying the orange silty sand layer (101). This suggests that the area to the north, previously

Plate 08: West facing section of garage extension during excavation. 1x1m Scale.

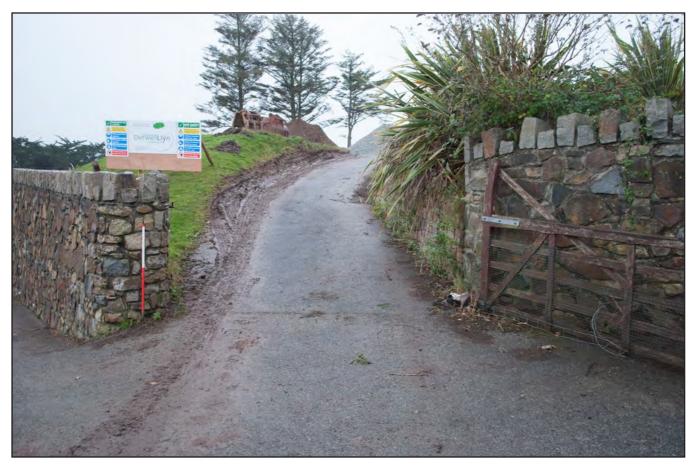
As a result of an assessment of the ground conditions, the excavation of trench foundations was abandoned in favour of ground reduction over the entire house plot and garage area (Figures 02, 03), which resulted in a 229m² area being reduced. The reduction was carried out to a depth of up to 1.3m below the current ground surface (Plates 01-04, 12-15). A proposal to remove the gate pier in order to widen access up the driveway to the site was subsequently abandoned (Plate 10).

Plate 10: View from South of access driveway and roadside gate pier (possibly to be removed). 1x1m Scale.

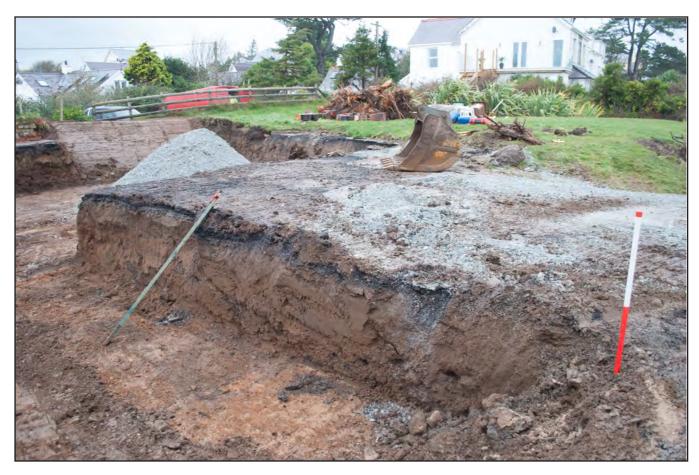
Plate 12: Oblique view of Eastern portion of ground reduction, showing South facing section. 1x1m Scale.

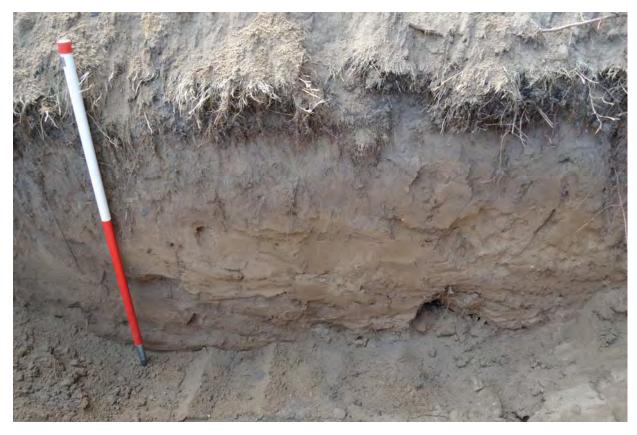
The results of the trial trenching revealed a number of successive sand deposits sloping down gradually from the southwest to the northeast (Plate 2). The upper compact sand and gravel layer (102) may represent a levelling/ foundation layer that was placed on top of the lower sand deposits prior to the construction of the current property located on the site. Post-medieval white ware pottery was uncovered (not retained) from above the layer above (101), along with the remains a dog which had been buried by the previous owners. The lower sand deposits may represent the main construction material of the medieval motte, however no dating evidence was uncovered from these layers.

Plate 02: South Facing Section of Trench 1.

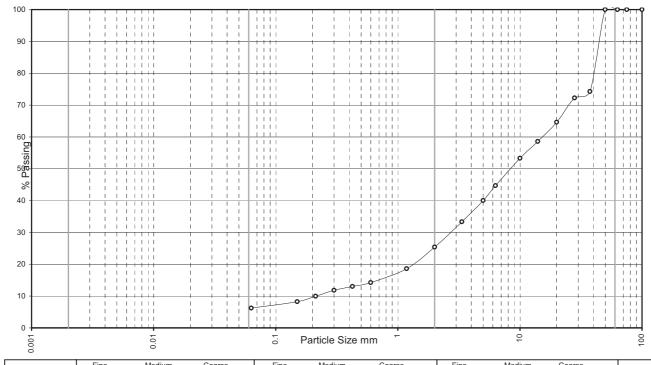
Borehole No BH01 Sample B 1 Depth: 1.20 m

Particle Size Distribution BS1377 :1990 Part 2
Test 9.2 Wet Sieving, 9.4 Sedimentation - Pipette Method

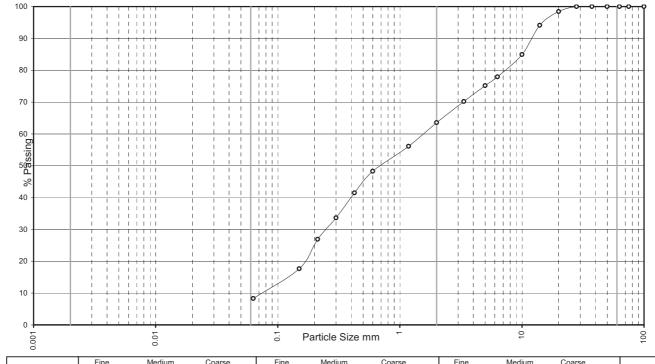
Borehole No BH01 Sample B 6 Depth: 6.20 m

Particle Size Distribution BS1377 :1990 Part 2
Test 9.2 Wet Sieving, 9.4 Sedimentation - Pipette Method

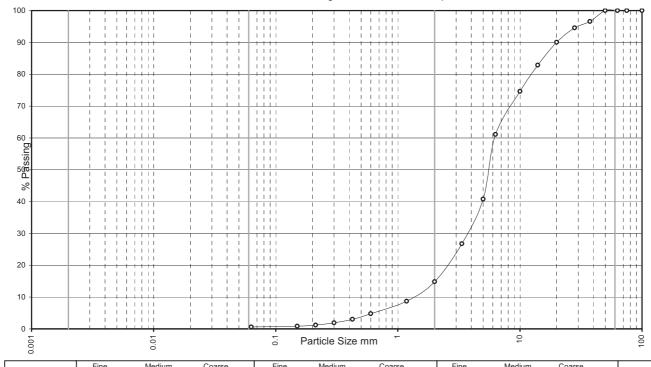
BoreholeNo BH01 **Sample** B 11 **Depth**:11.20 m

Particle Size Distribution BS1377 :1990 Part 2
Test 9.2 Wet Sieving, 9.4 Sedimentation - Pipette Method

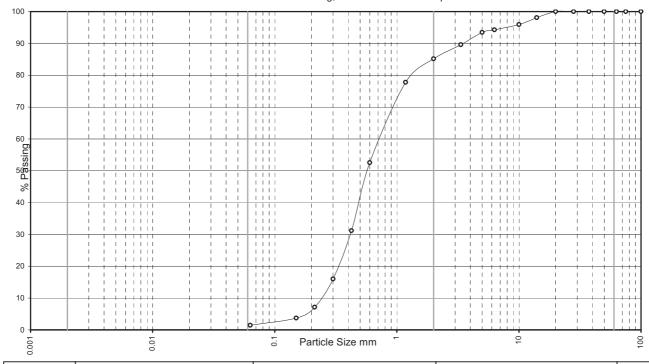
BoreholeNo BH01A **Sample** B 12 **Depth**:12.20 m

Particle Size Distribution BS1377 :1990 Part 2
Test 9.2 Wet Sieving, 9.4 Sedimentation - Pipette Method

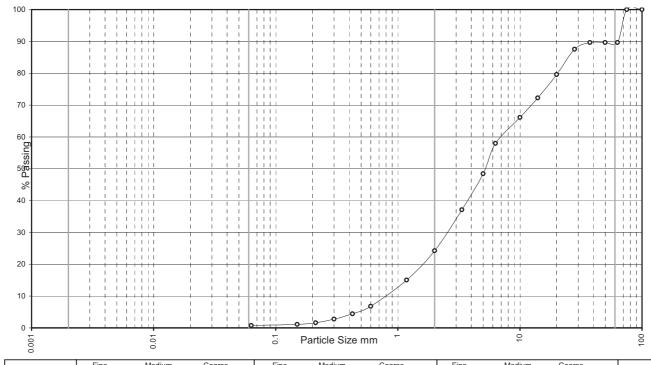
Borehole No BH02 Sample B 7 Depth: 7.20 m

Particle Size Distribution BS1377 :1990 Part 2
Test 9.2 Wet Sieving, 9.4 Sedimentation - Pipette Method

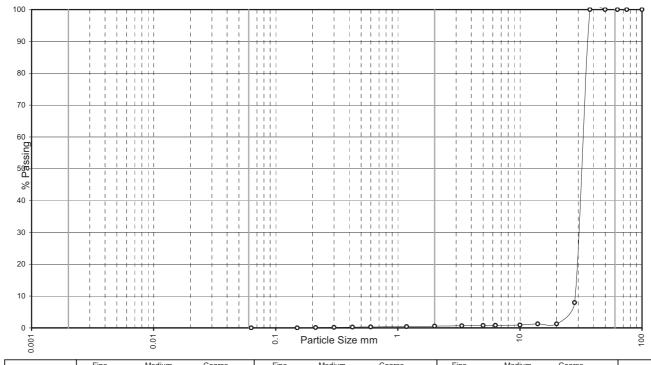
Borehole No BH02 Sample B 12 Depth: 12.20 m

Particle Size Distribution BS1377 :1990 Part 2
Test 9.2 Wet Sieving, 9.4 Sedimentation - Pipette Method
