St. Engan's Parish Church Llanengan, Gwynedd

Archaeological Watching Brief

Project No. G2294

Report No. 1091

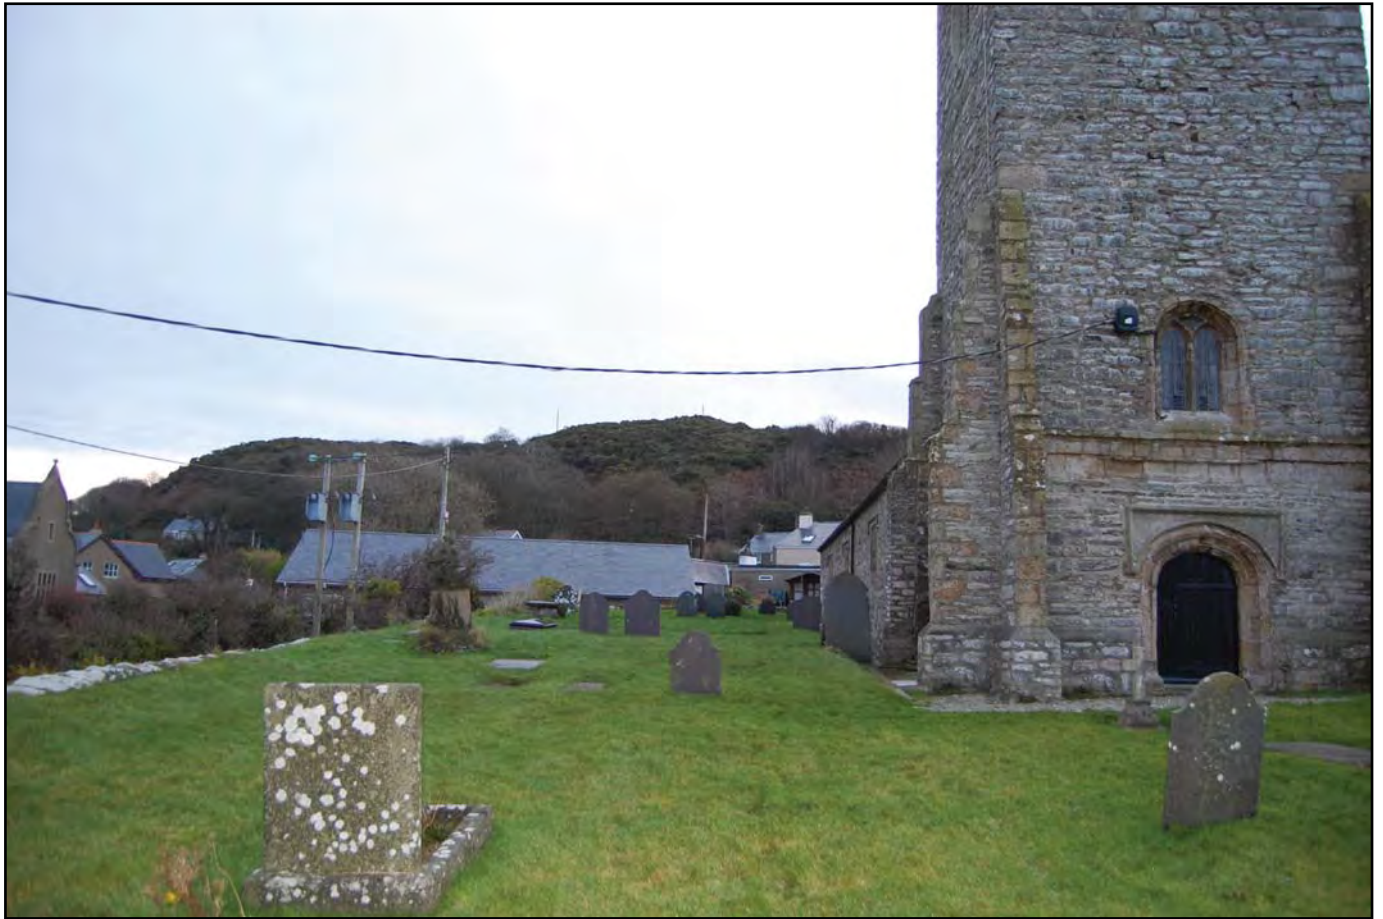
Plate 01 - View east of the churchyard of the parish church of St. Engan - the light grey patch of concrete visible by the base of the church tower marks the exit point of the electrical cable and ducting from the church.

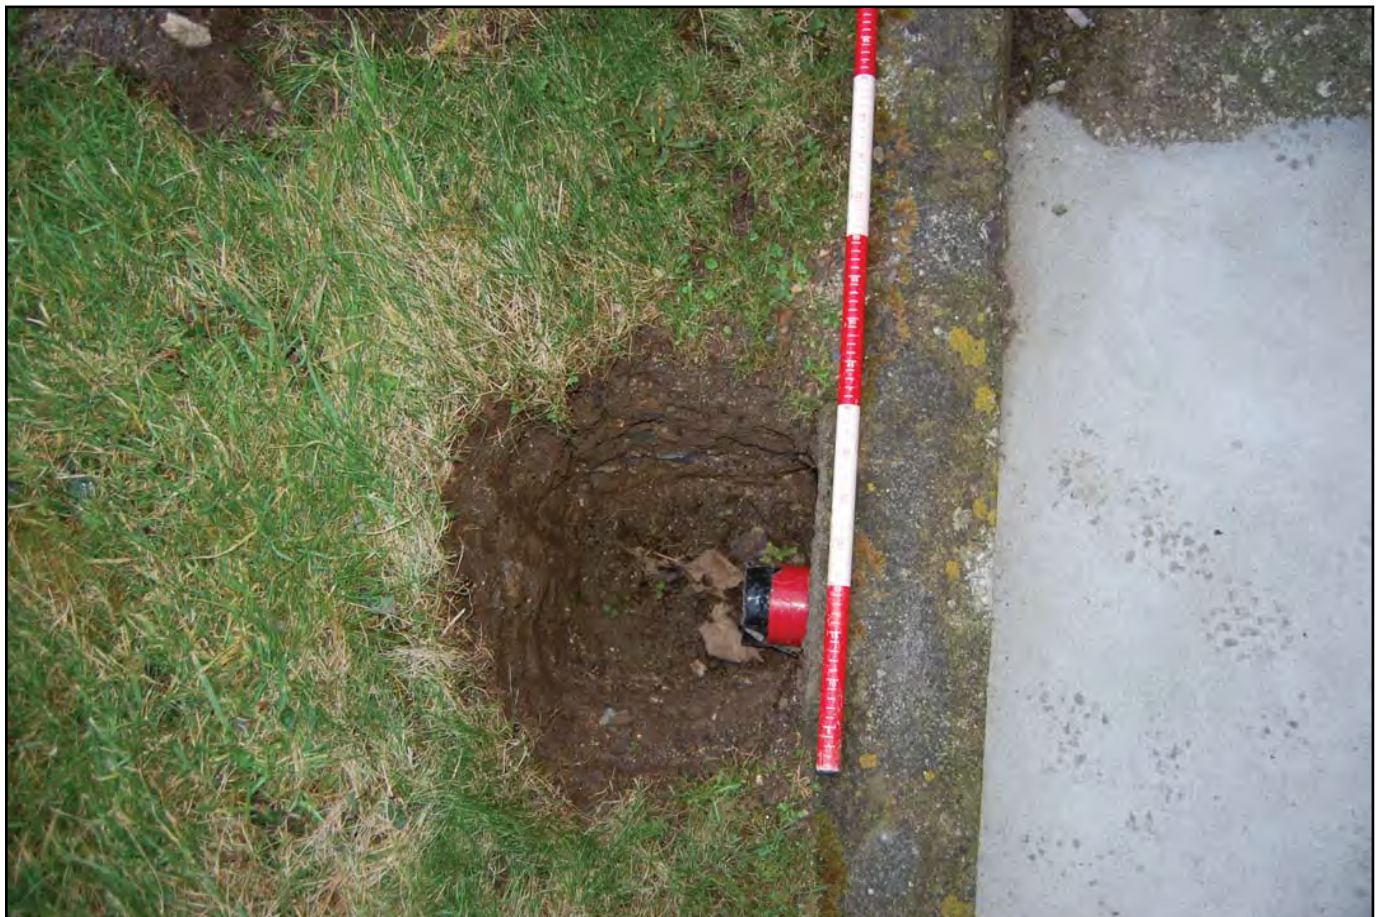
A pit 0.40m x 0.40m x 0.37m (min. depth southern side) and 0.55m (max. depth northern side) had already been excavated by *Derwen Llŷn Ltd.* prior to GAT arrival on site in order to facilitate the positioning of the 0.10m electrical cable ducting from inside the church tower to the churchyard (**Plate 02 & Figure 01**). The pit was 0.66m east of the western buttress on the north face of the church tower and 0.60m from the north face of the church tower. This pit was recorded as **TP01** and would subsequently be extended on the western side to become **TR01**.

Plate 02 - TP01 as excavated by Derwen Llŷn Ltd. Electrical cable ducting visible in bottom of pit.

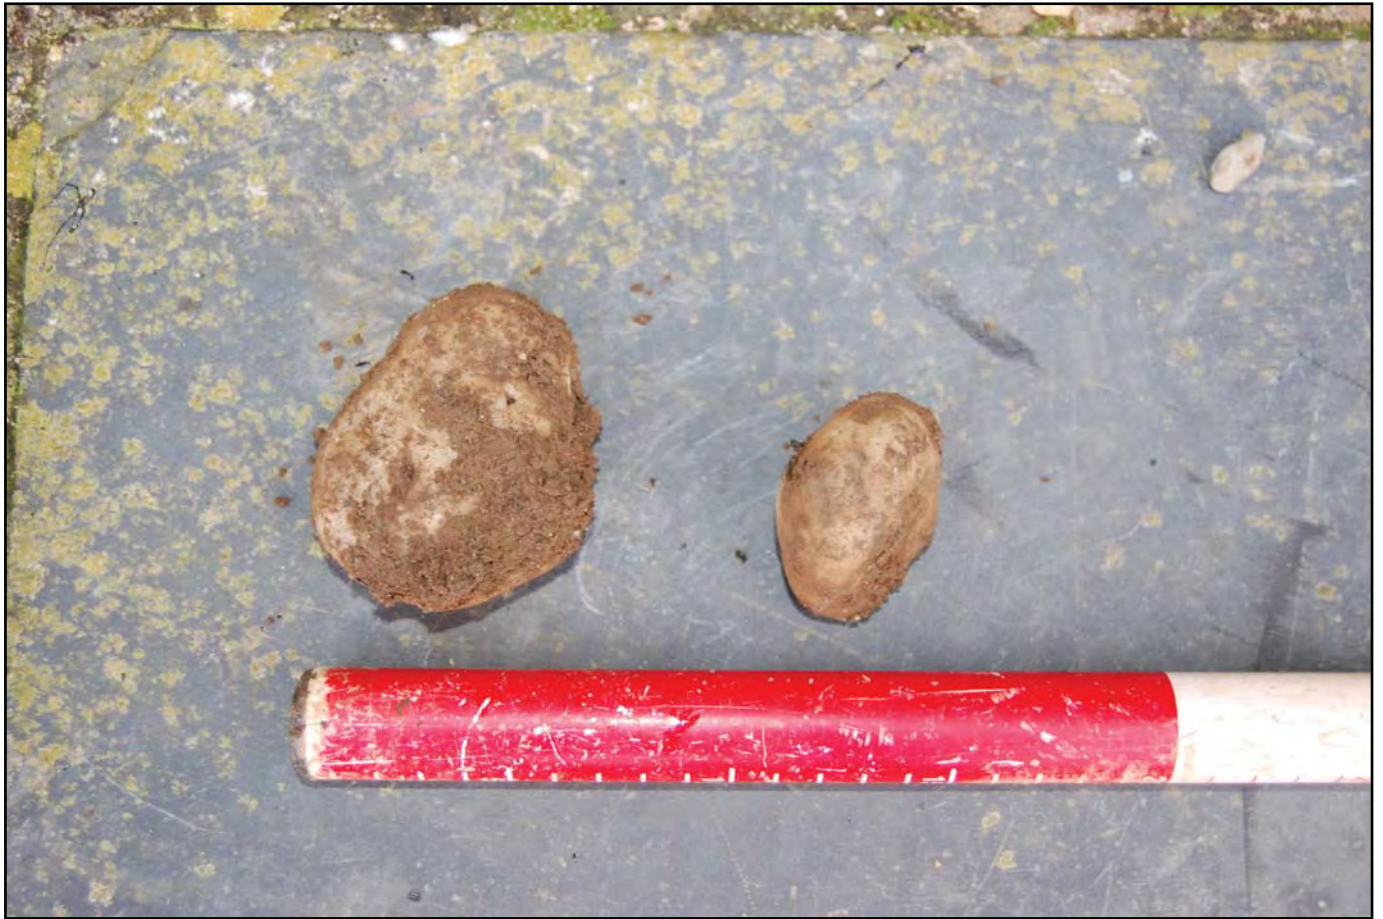
The finding of two rounded white quartz pebbles from the churchyard adds to the total number of this type of find recorded from putatively early church sites. The burial of quartz pebbles within graves was recorded during the excavation of a burial at Tywyn y Capel, Treaddur Bay, Anglesey (Davidson 2009, 191). An excavation at Capel Maelog, Powys (Britnell 1990, 36) also revealed a pre-church grave marked with quartz pebbles. The use of quartz pebbles in a burial context has a much wider geographical distribution, and examples have been excavated at Kellington Church, North Yorkshire, England (Daniell 1998: 165) and Illaunloughan, Co. Kerry http://heritagecouncil.ie/unpublished_excavations/section12.html#Illaunloughan and Iniscealtra, Co. Clare, both in Ireland http://heritagecouncil.ie/unpublished_excavations/section12.html#Iniscealtra

Plate 03 - Two Quartz pebbles (70mm and 40mm maximum dimensions respectively) recovered from TR01.

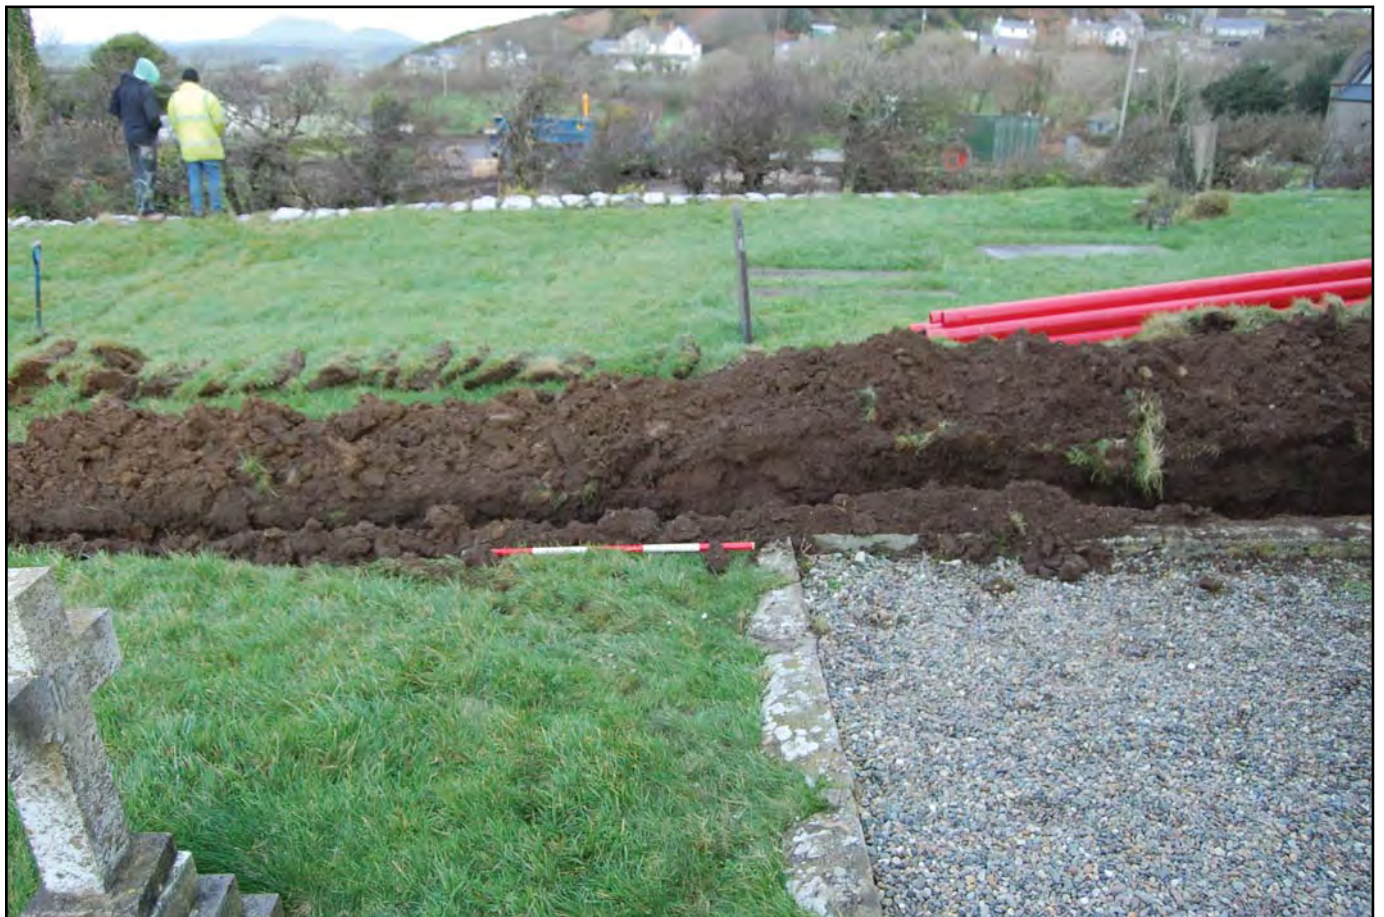
The subsoil from approximately 3.50m to the western end of **TR01** was a light brown very clean unweathered clay. No finds or features were recorded (**Plate 04**). In the base of the trench 1.20m from the west wall of the church tower was a large stone 0.50m in length and at least 0.20m wide. The stone was partially buried under the concrete kerbing which surrounds the church at this point (**Plate 05**). No attempt was made to remove the stone or record its thickness. In the base of the trench 1.60m from the concrete kerbing surrounding the church on the northern side the top of a ceramic drainage pipe was uncovered running on an almost identical alignment as **TR01** (**Plate 06**). A length of 1.80m of the top of the pipe was visible before the western end of **TR01**.

Plate 04 - View north across TR01 showing the difference between the topsoil and subsoil of the western and eastern ends of the trench.

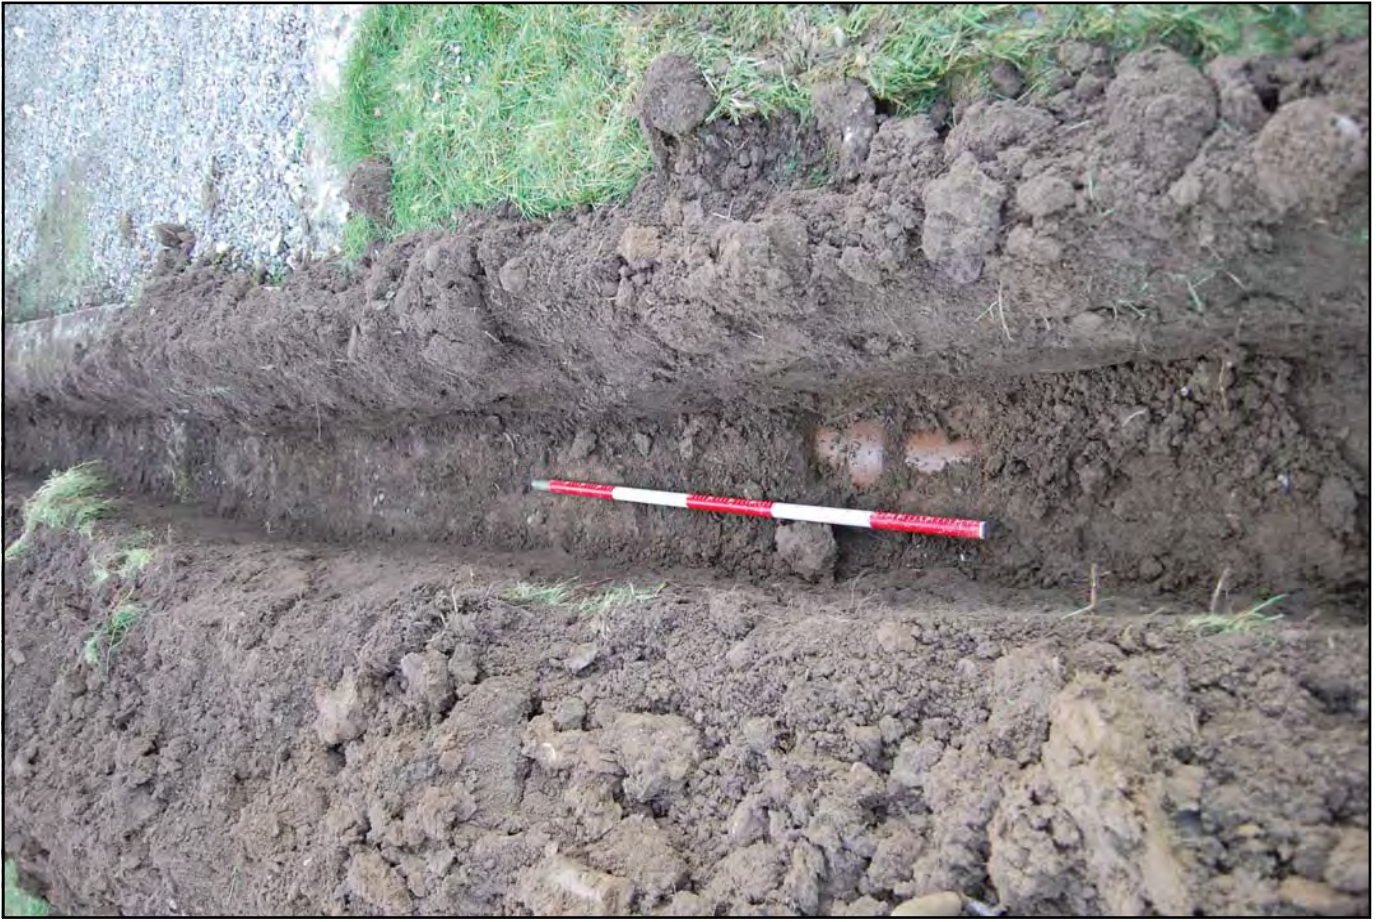
Plate 06 - View east along TR01 with one of the ceramic drainage pipe collars visible to the right of the scale.

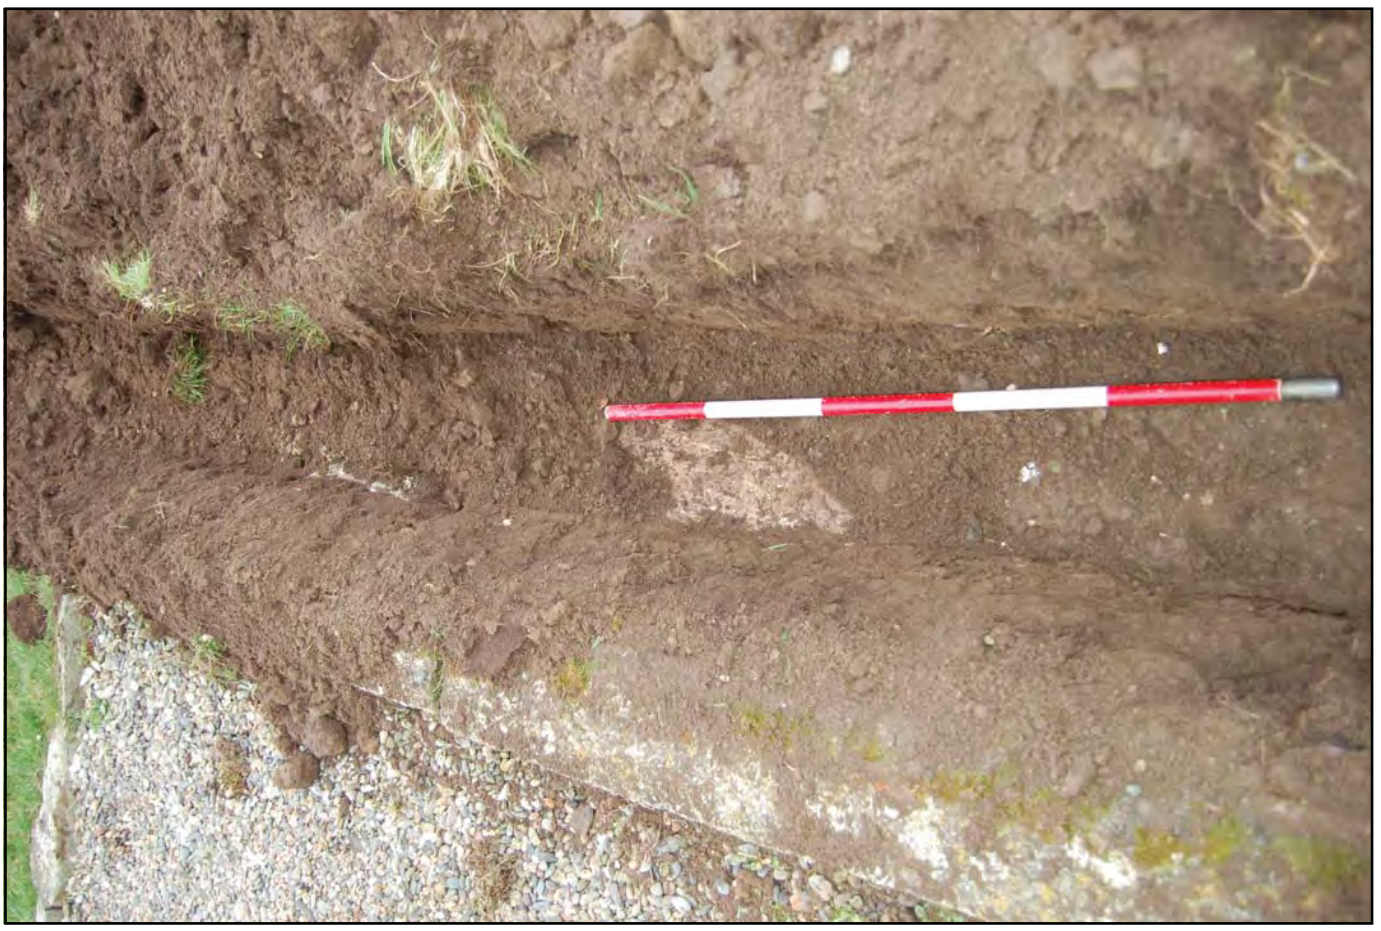
Plate 05 - Large stone (0.50m x >0.20m) visible in the bottom of TR01 - the southern edge of the stone lies directly under the concrete kerbing.

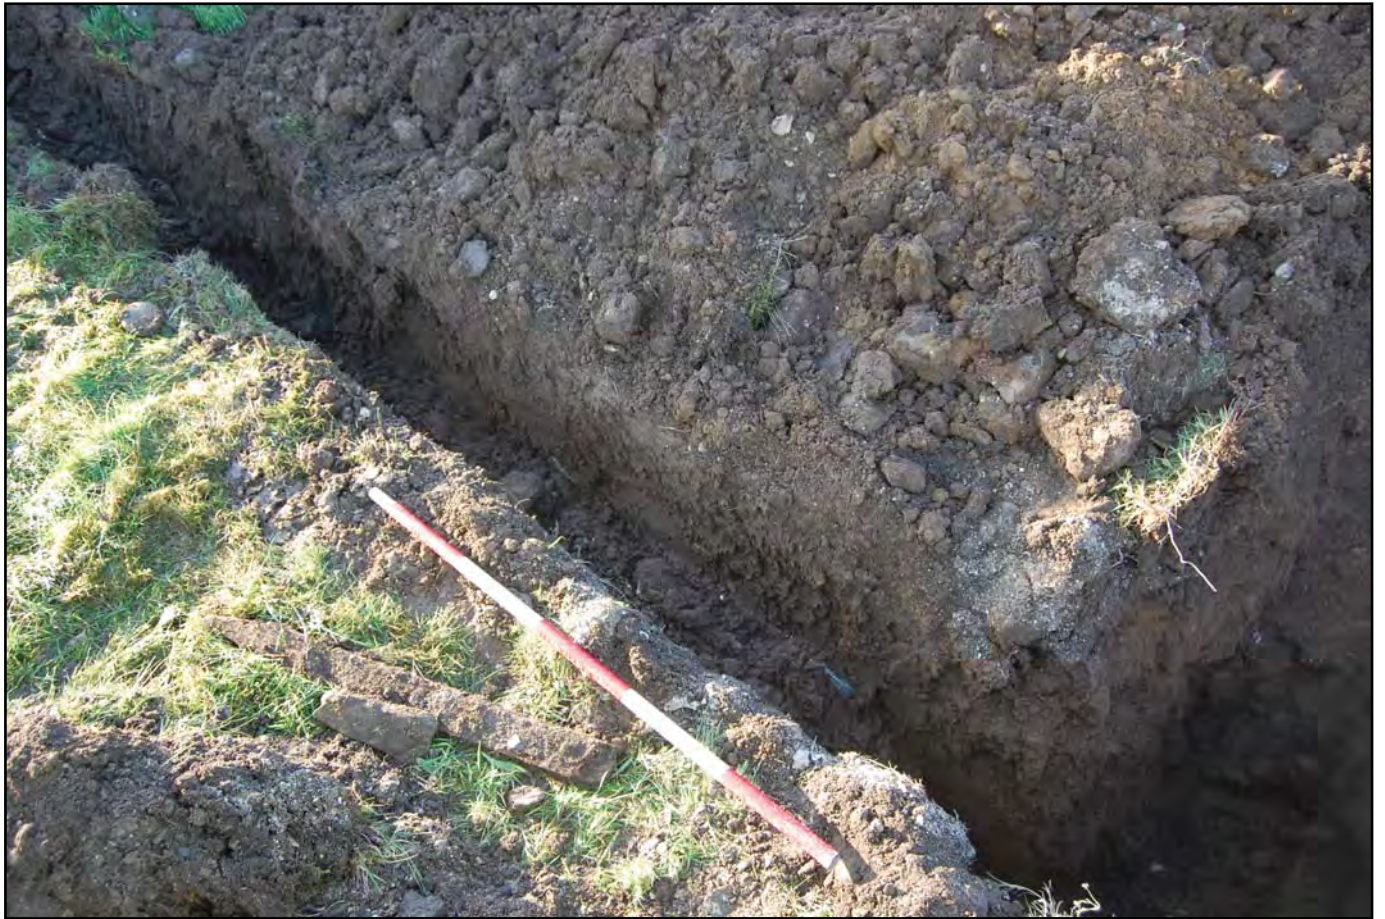
From the western end of **TR02** to a distance of approximately 1.00m from the north wall of the churchyard the topsoil was of a very similar character to that found in the western end of **TR01**, being a heavy clay silt containing very few inclusions. Depth of the topsoil was 0.35m deep. No finds or features were recorded (**Plate 07**).

Plate 07 - View south along TR02 with broadened section to the right of the image.

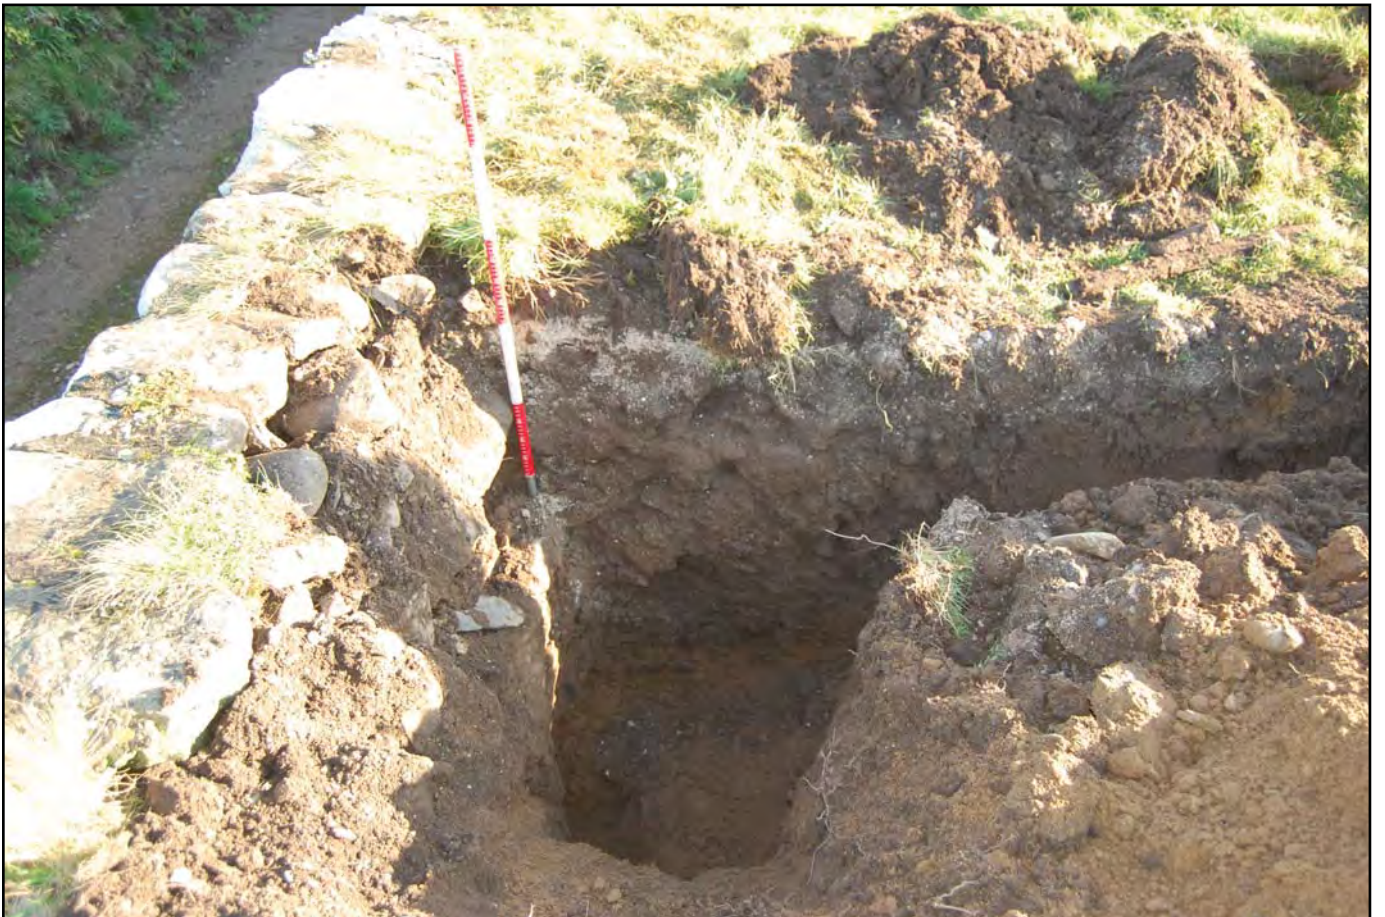
Approximately 1.00m from the north wall of the churchyard the character of the topsoil changed to become similar in character to that in the eastern end of **TR01**, becoming more friable and containing sub-angular inclusions up to 20mm in size. Depth of topsoil varied between 0.05m 1m away from the wall and 0.65m where the topsoil met the inside face of the churchyard wall. A light grey deposit which consisted of lime (calcium oxide) and mortar fragments 1.00m long and between 0.05m and 0.15m thick lay immediately below the turf and extended down to the base of the topsoil as fragments within the soil matrix (**Plate 08**).

Plate 08 - View east of topsoil against south face of north wall of the churchyard - note the mortar spread within the topsoil.

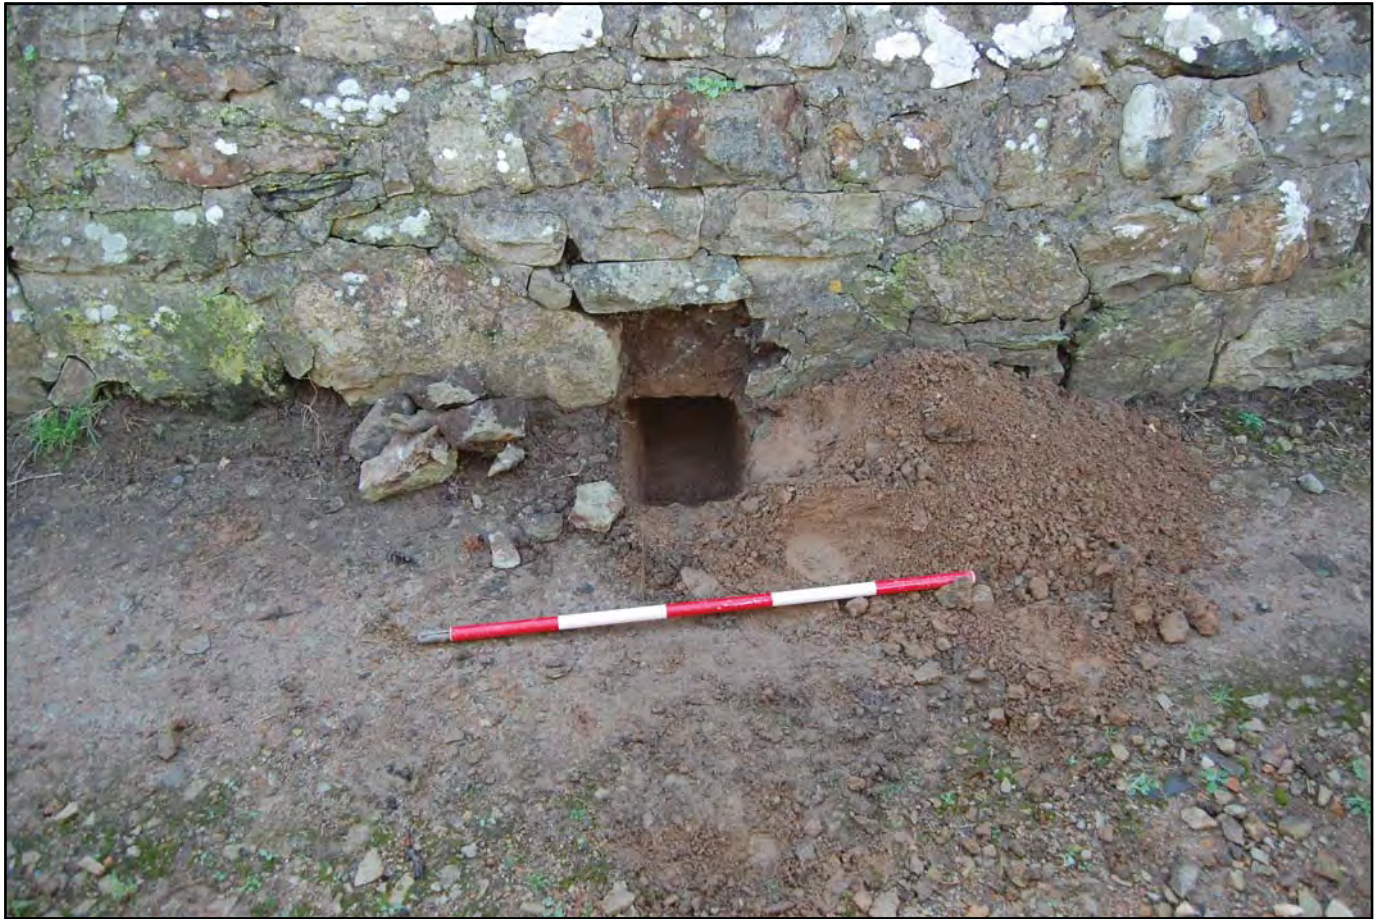
A section of the inside (south) face of the north wall of the churchyard was uncovered during the excavation of **TR02**. Safe access to the base of the trench was not possible and a photograph record was made from the trench side. An area 1.60m by 0.55m by 1.30m was opened against the base of the wall in order to allow a *Derwen Llŷn Ltd.* groundworker to excavate a slot 0.20m wide and 0.30m deep under the base of the wall (**Plate 09**).

Plate 09 - View south of external face of north wall of the churchyard - the exit of the electrical cable ducting is visible as the slot in the centre of the image.

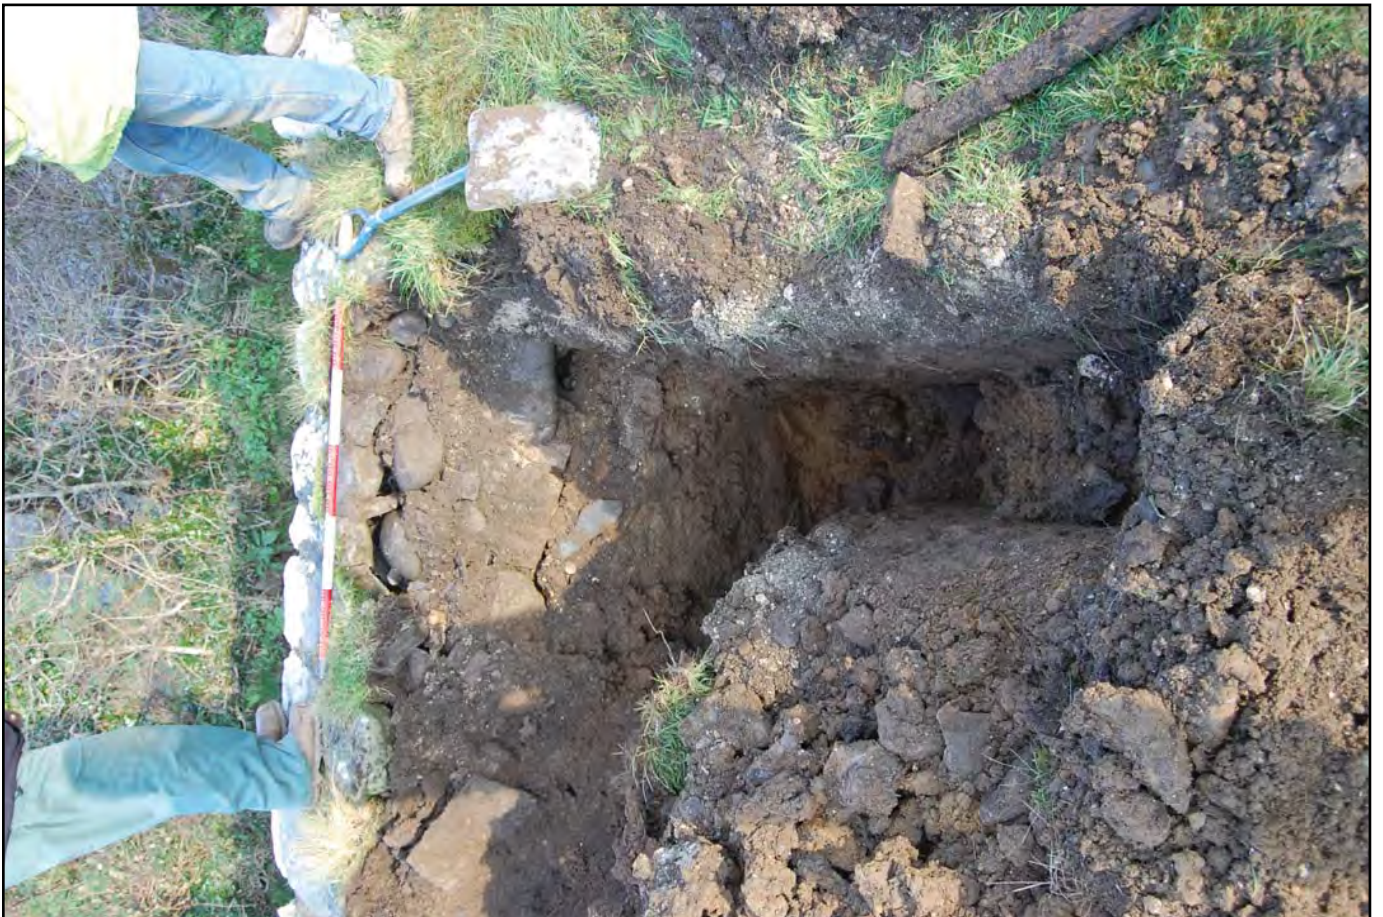
The lower 0.90m of the wall was constructed 0.75m wide, and above this was constructed 0.50m wide with capstones averaging 0.40m long and 0.30m wide. The wall was constructed of rough courses on both the inside and outside faces, with the outside face being mortar bonded. Above 0.90m on the inner face was comprised of much more irregular courses and

these were not mortar bonded (**Plate 10**). Following construction of the lower courses of the wall, the narrower width upper courses were constructed and topsoil was then embanked against the inner face of the wall to a maximum depth of 0.65m.

Plate 10 - View north of inside of north wall of the churchyard.

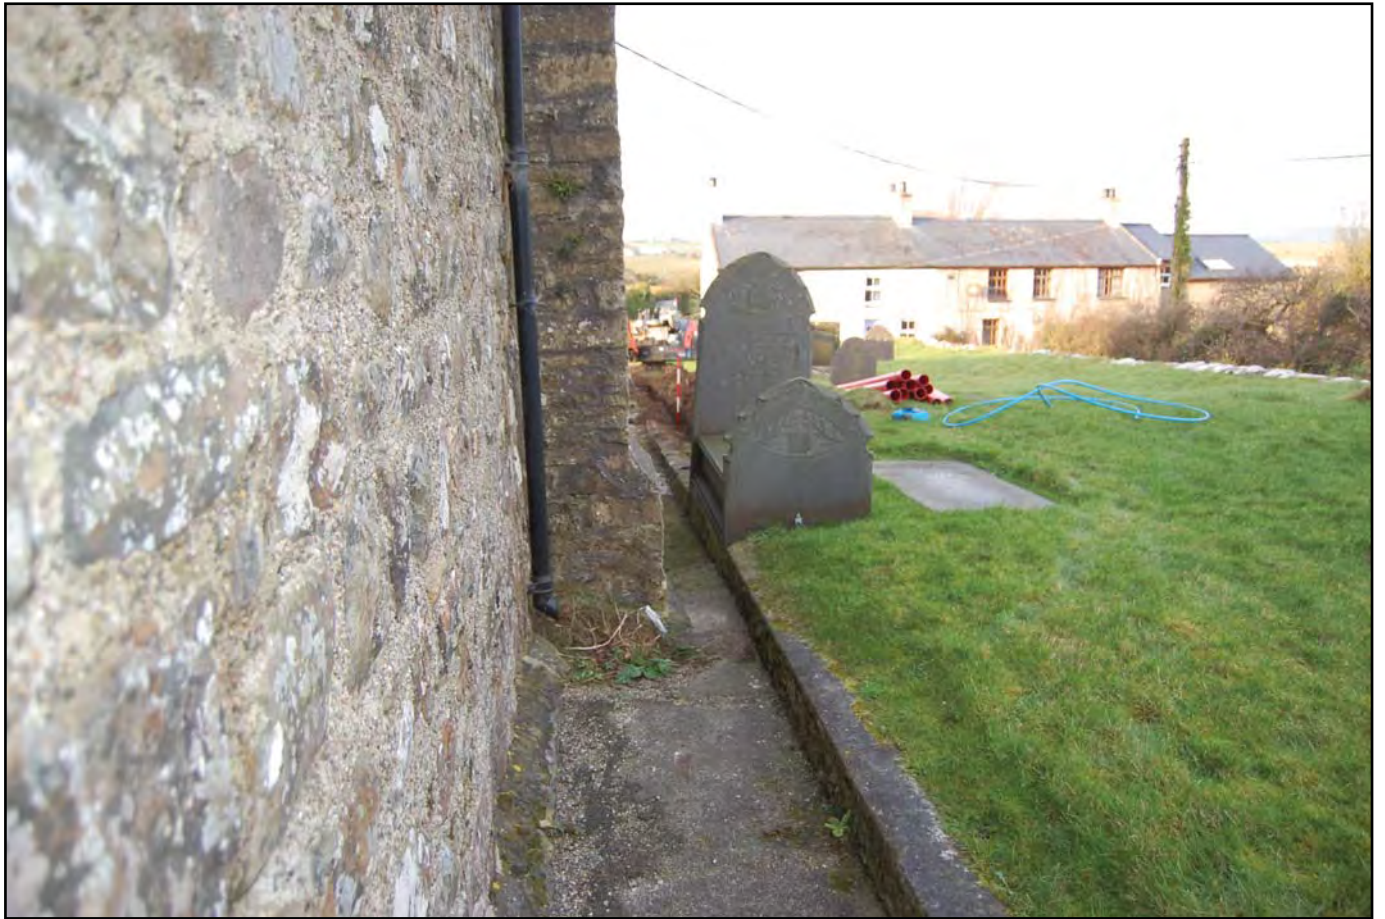
The ceramic drainage pipe revealed in the base to **TR01** appears to connect to the drainpipe, guttering and associated drain visible on the north side of the nave (**Plate 11**). The 3rd edition Ordnance Survey map of 1918 (**Figure 04**) shows a path of some description has been added around the church after the production of the 2nd edition Ordnance Survey map of 1900. The drainpipes and guttering may well have been installed between these dates, even though the faculty applied for in 1911 to carry out repairs was refused. The large stone revealed in the base of **TR01** appears to mark where the ceramic drainage pipe emerges from underneath the concrete kerbing constructed around the north side of the church.

Plate 11 - View west along north wall of the parish church - the downpipe is above the drain alongside the church, with the scale marking the position of the large stone in the bottom of TR01

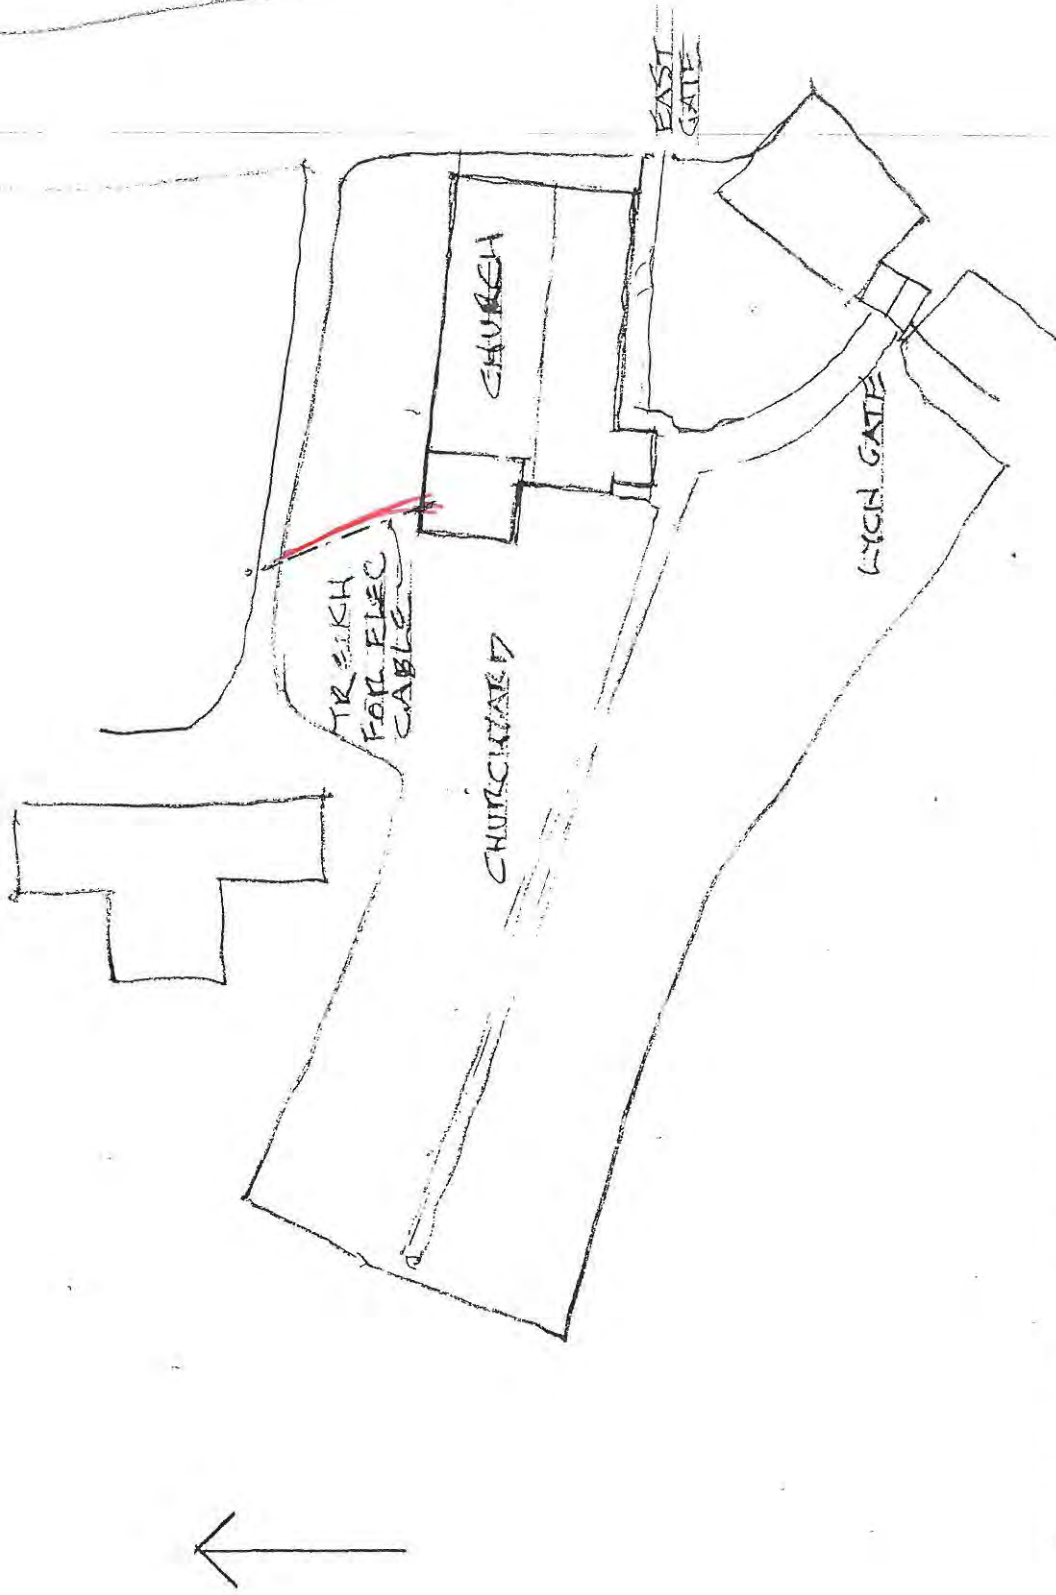
FIGURE 01 – Reproduction of Client Drawing No. RCJ/LJ 01

The scheme consists of the excavation of a trench for an electrical cable approximately 25m in length, 600mm deep and 300mm wide between the north wall of the church tower and the northern wall of the churchyard. The proposed methodology is to utilise a toothless bucket to carry out the excavation.

ST ENGAN'S CHURCH, LLANENGAN
SITE LAYOUT
N/S
