## Wooden Casement Windows

Plas Coch  
Llanedwen

GAT Project No. 1973  
prepared by  
David Longley  
August 2009

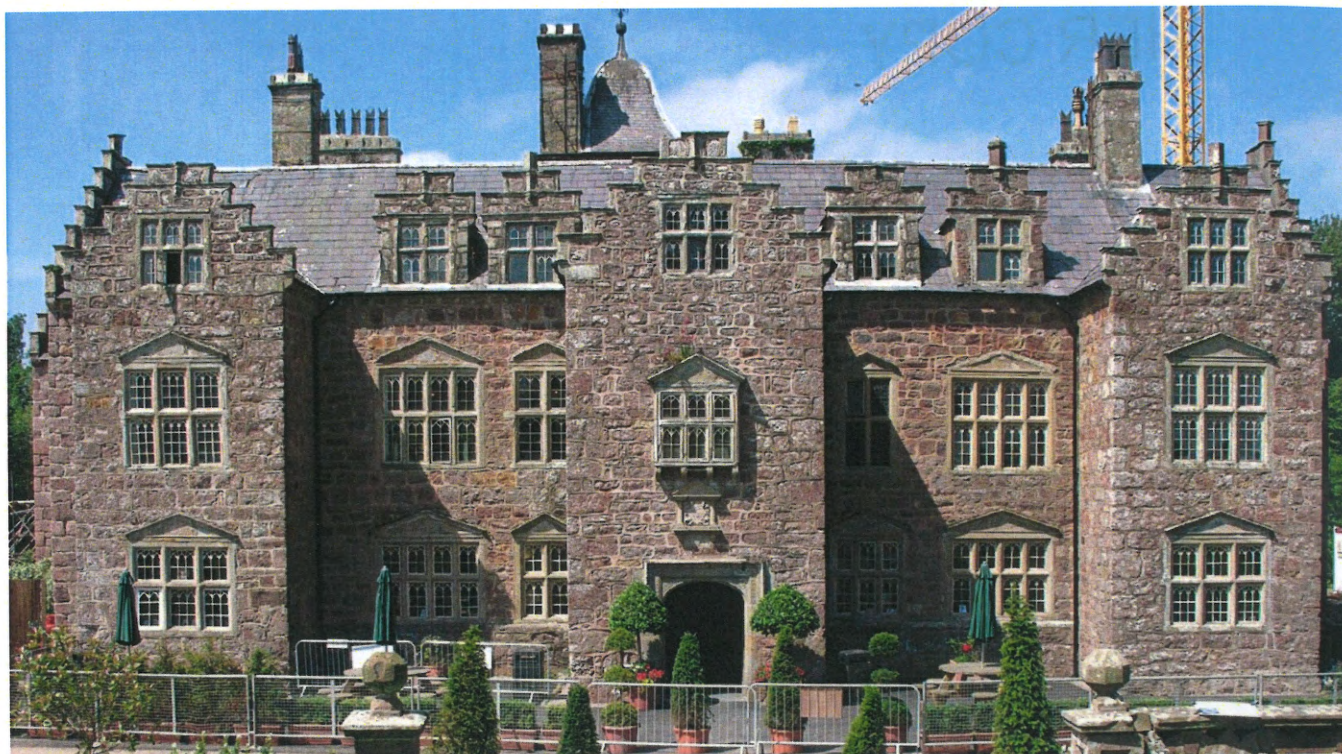
south-east wing

main wall between  
south-east wing and porch

porch

main wall between  
north-east wing and porch

north-east wing

The eastern facade comprises the eastern wall of the main house and three projecting wings. The south-eastern wing, the central wing (which houses the porch) and the intermediate range are all part of the 16th century house. The northern wing and the bay immediately to the south of it are part of the early nineteenth century additions.

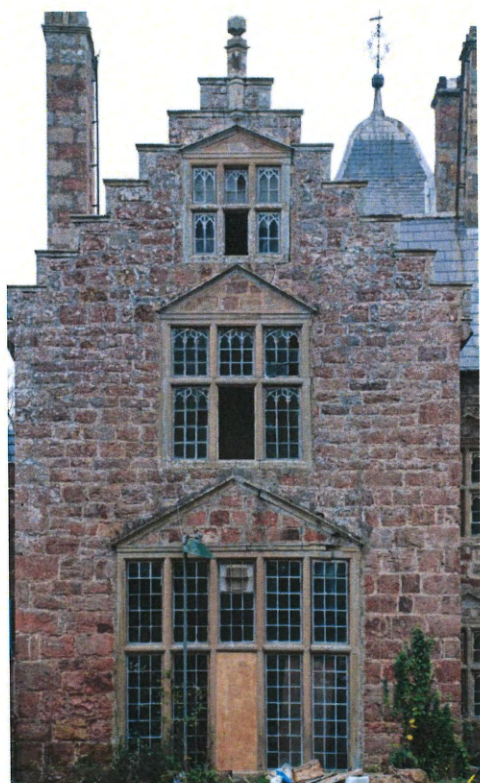
The dining room extension, two storeys  
and an attic.

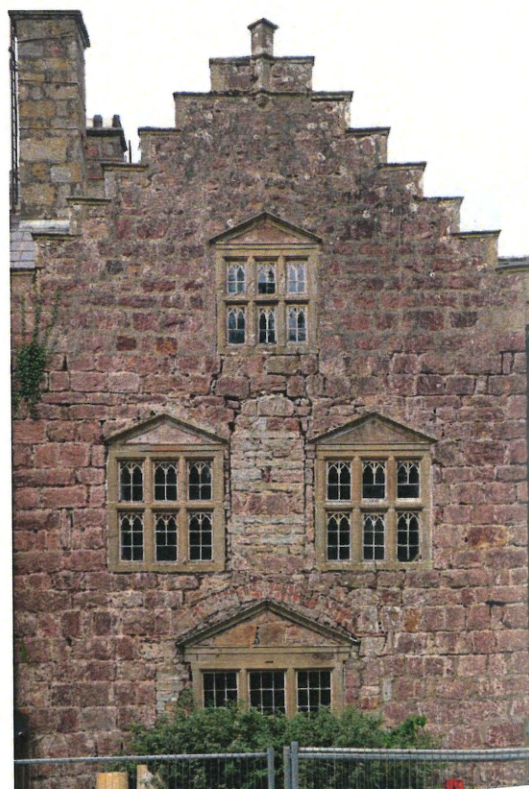
The southern gable of the main house

The southern face comprises the gable end of the main eastern block (to the right) a recessed corridor between that and an early Victorian dining room extension to the left.

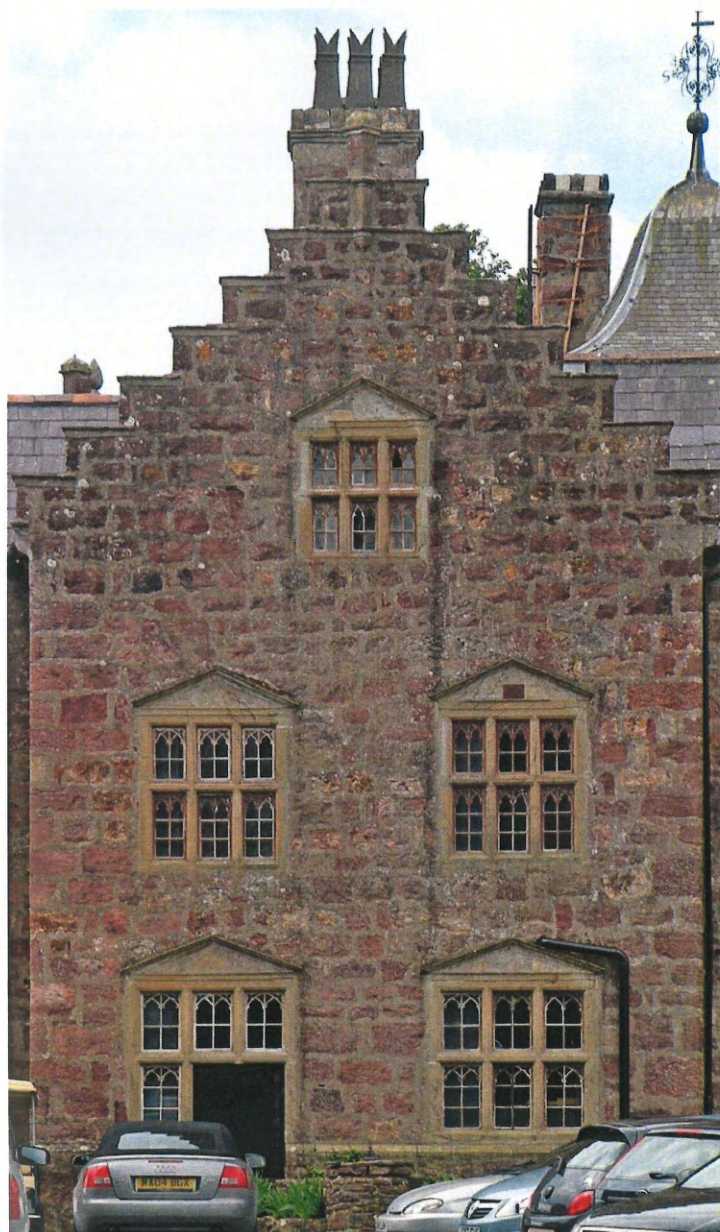
This block is part of the early nineteenth century extension, with two storeys and an attic and cellars below,

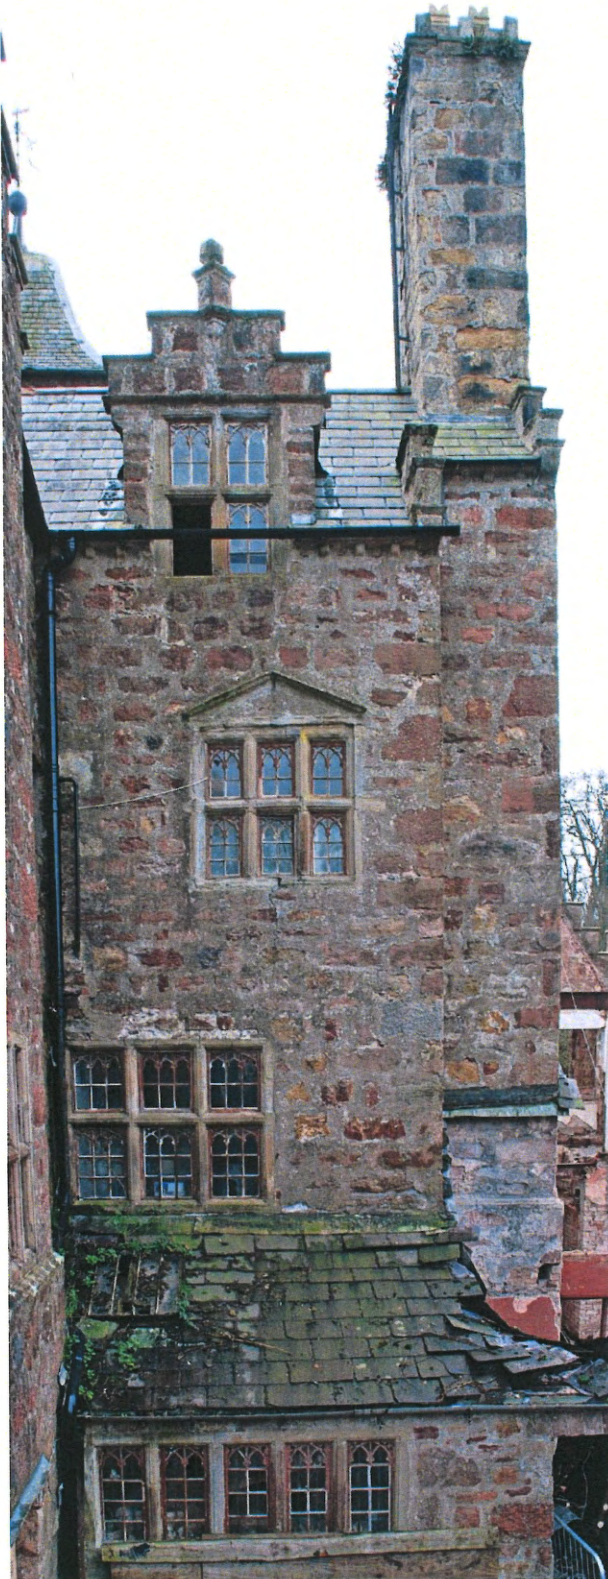
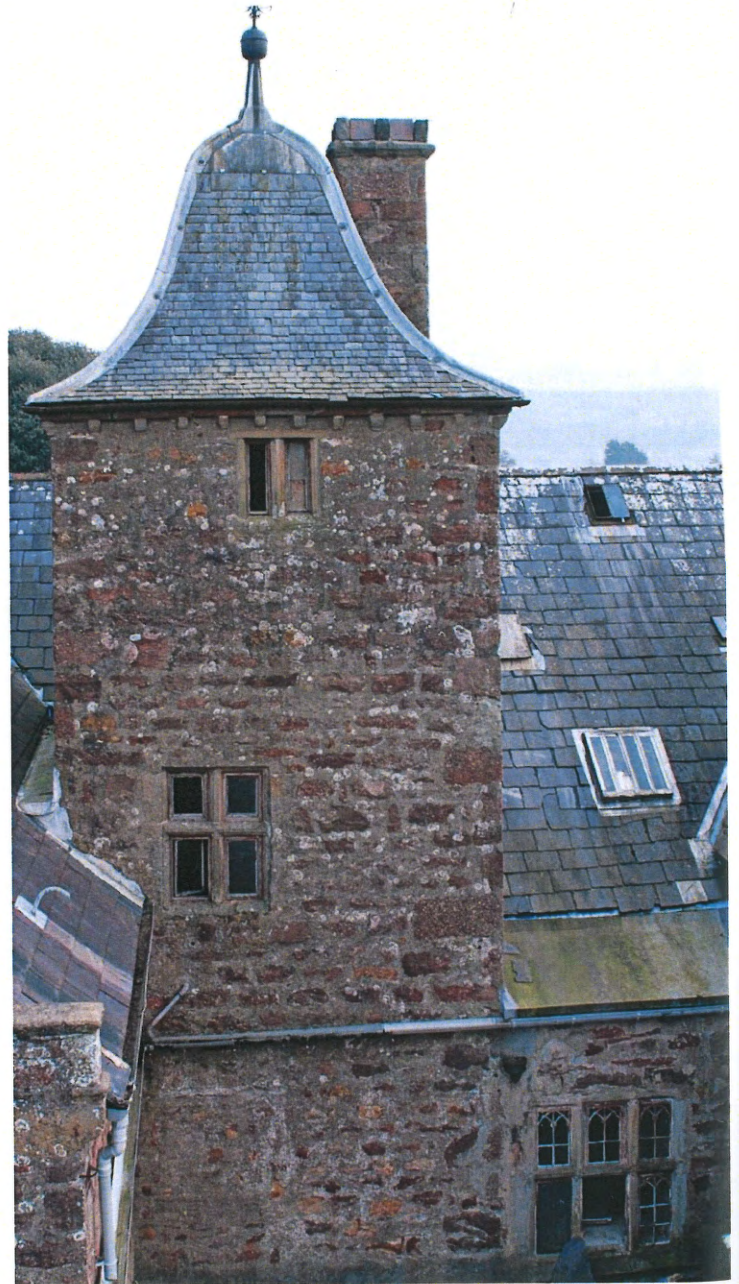
This wing extends perpendicular to the main axis of the house and was built around 1600, on two full storeys, and a basement and attic.

The corridor at basement level communicates with the western extension.

The tower is built against, and around, a chimney stack against the west wall and must, originally, have accommodated a staircase. The adjacent corridor at first floor level communicates with the first floor of the early nineteenth century dining room wing.

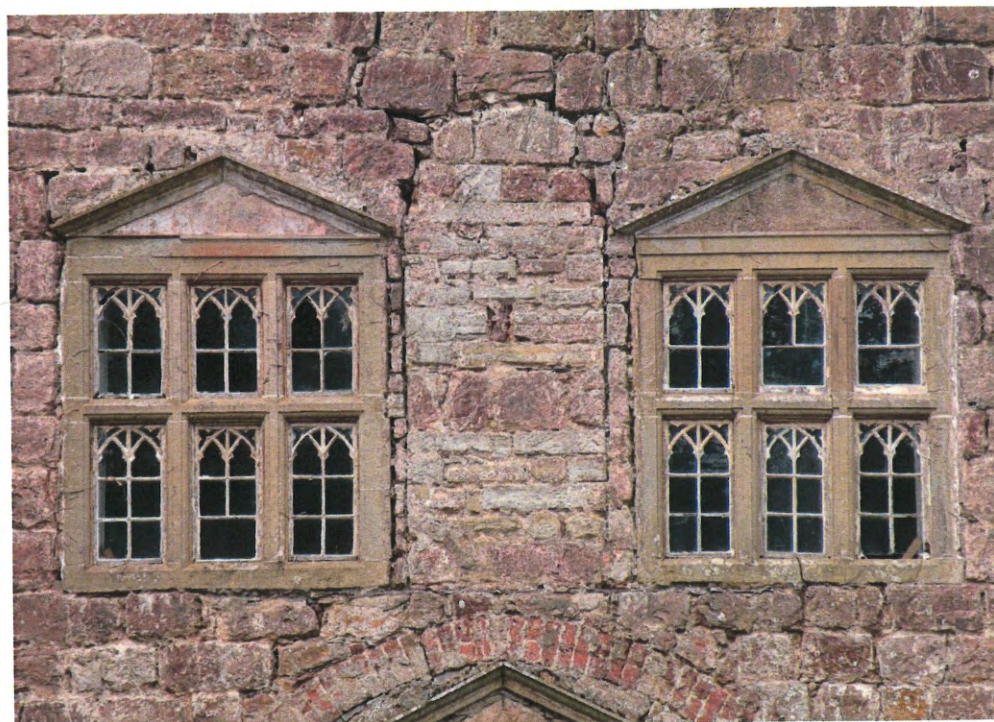
South Gable: first floor

**There are two windows on the first floor, south gable, both early 19th century replacements for earlier, original windows. Both windows are of six lights, separated by stone mullions and transomes (3 over 2 rows). Both windows accommodate Gothic-pointed-and-cusped wooden casements and glazing bars. Type 1**

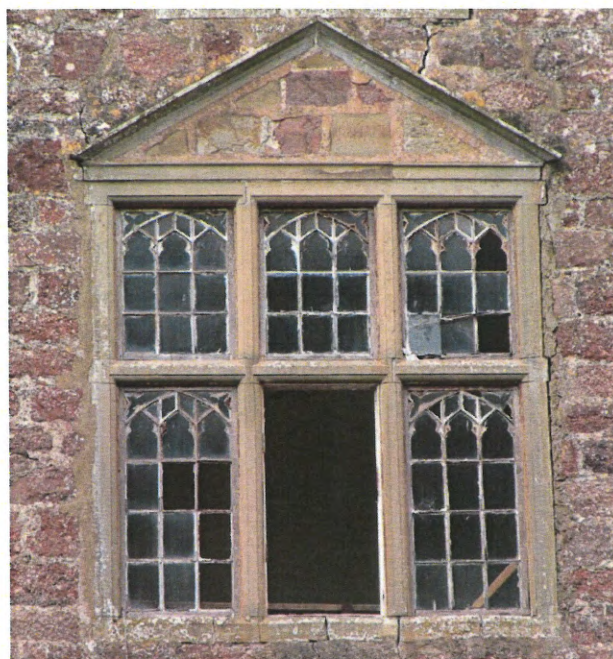
Attic

Six light window with four panes in each casement. **Type 1**

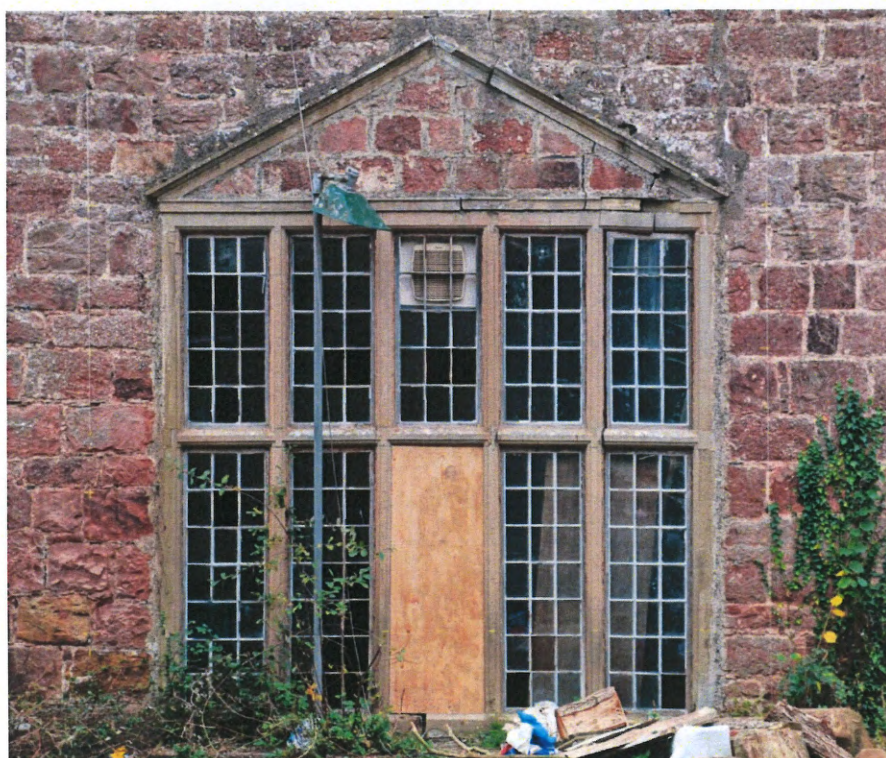
Dining Room

This window of early 19th century date, as all on the southern face, displays the same classical styling as that on the south gable. This window is exceptionally large, divided into 10 lights (5 over 2 rows) by mullions and transomes. The openings accommodate wooden frames, housing small, plain, rectangular panes. In the upper register there are 15 panes in each frame (3 over 5 rows down) and in the lower register, 21 panes in each frame 3 over 7 rows. The central frame of the lower register was designed to open. **Type 5.**

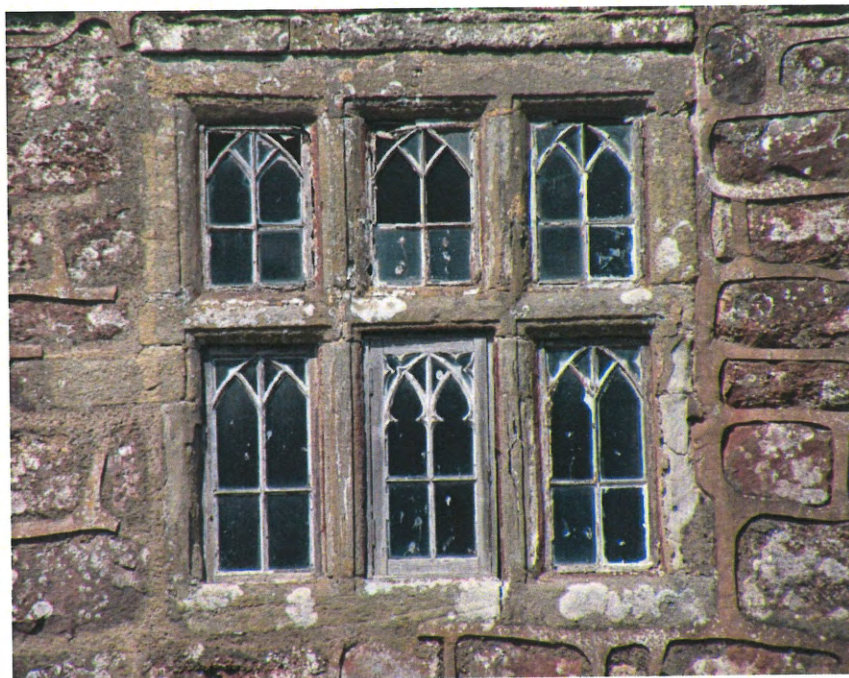
South-east wing, attic

Six-light stone mullion and transomed window. All of the casements are of four panes, with accommodation for varying sizes of openings. **Type 1. (Drawings of central casement in lower register).**

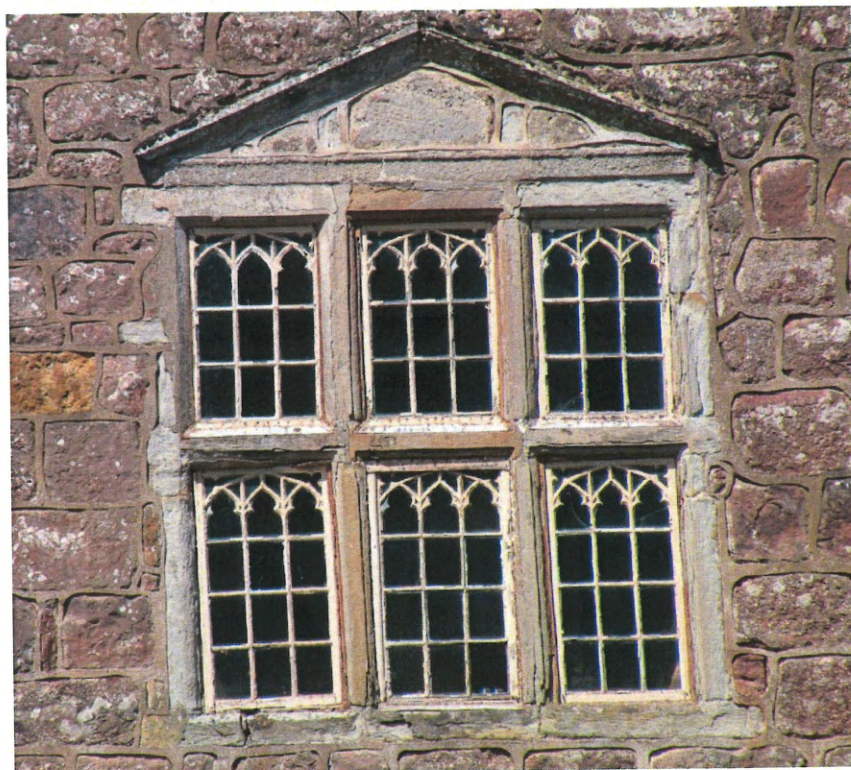
South-east wing, first floor

This original window has six lights and carries twelve-pane casements (3 across by 4 down) in the lower register. The upper register carries nine-pane casements. **Type 2. (Drawings of upper and lower register)**

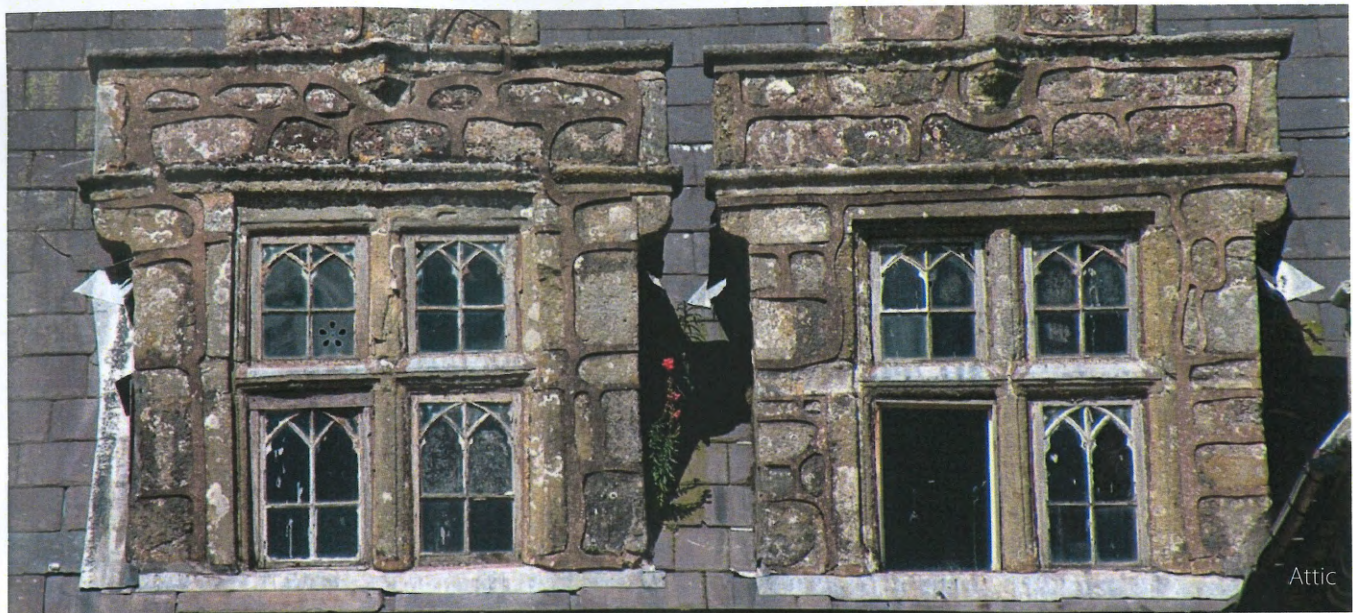
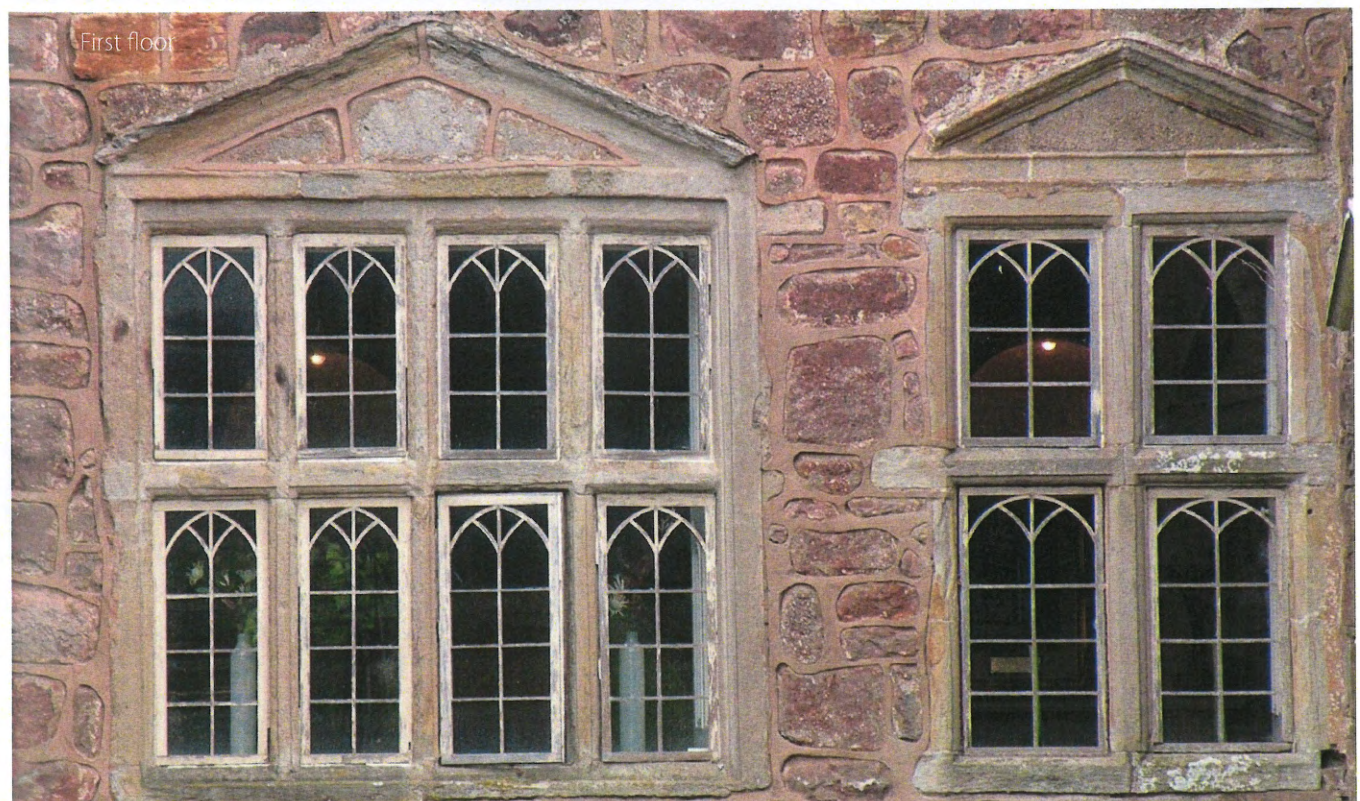
Each of two dormers are of four lights. The casements on the eastern attic are of four panes, with accommodation for varying sizes of openings. **Type 1**

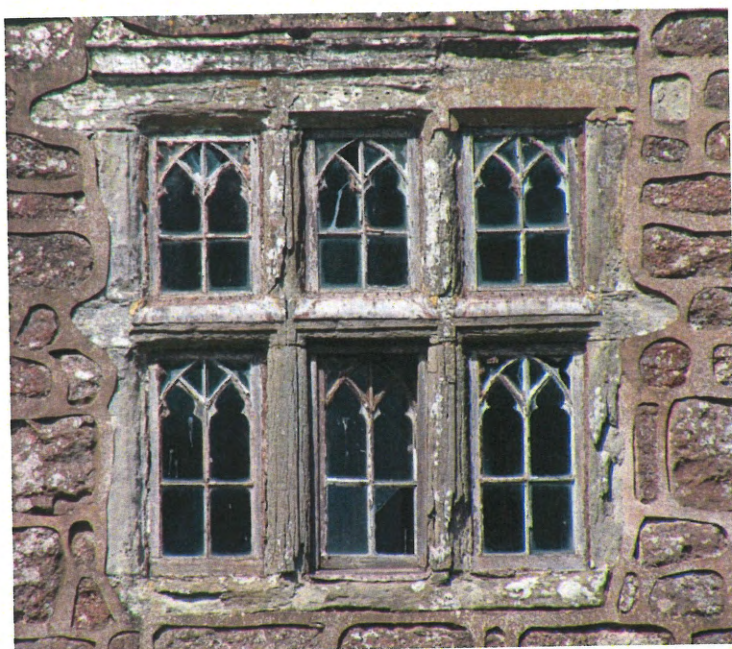
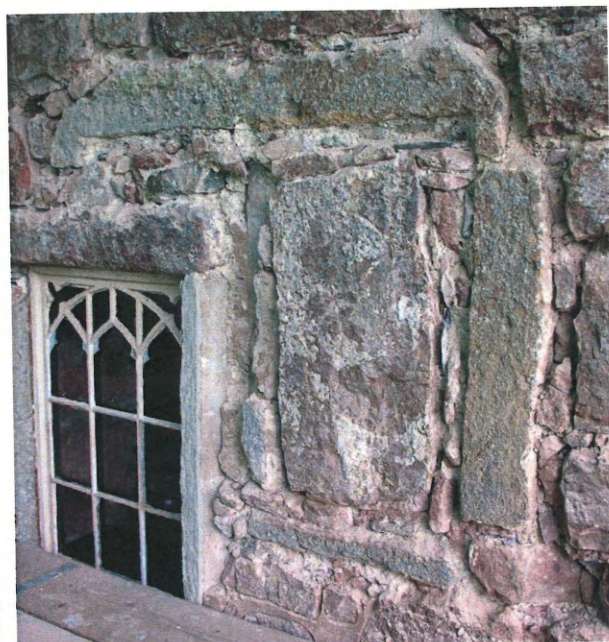
1. Porch attic
2. Ground floor insertion
3. First floor oriel

There are windows at ground floor level at either side of the porch. The present windows of Type 2 style are modern insertions, offset into earlier blocked openings.

This oriel window is an important survival. The wooden casements, however, are a modern replacement of the twentieth century. The oriel is of six lights. The modern casements have four panes each. **Type 4.**

Attic wing window of six-lights, each of four panes, with accommodation for varying sizes of openings. **Type 1**

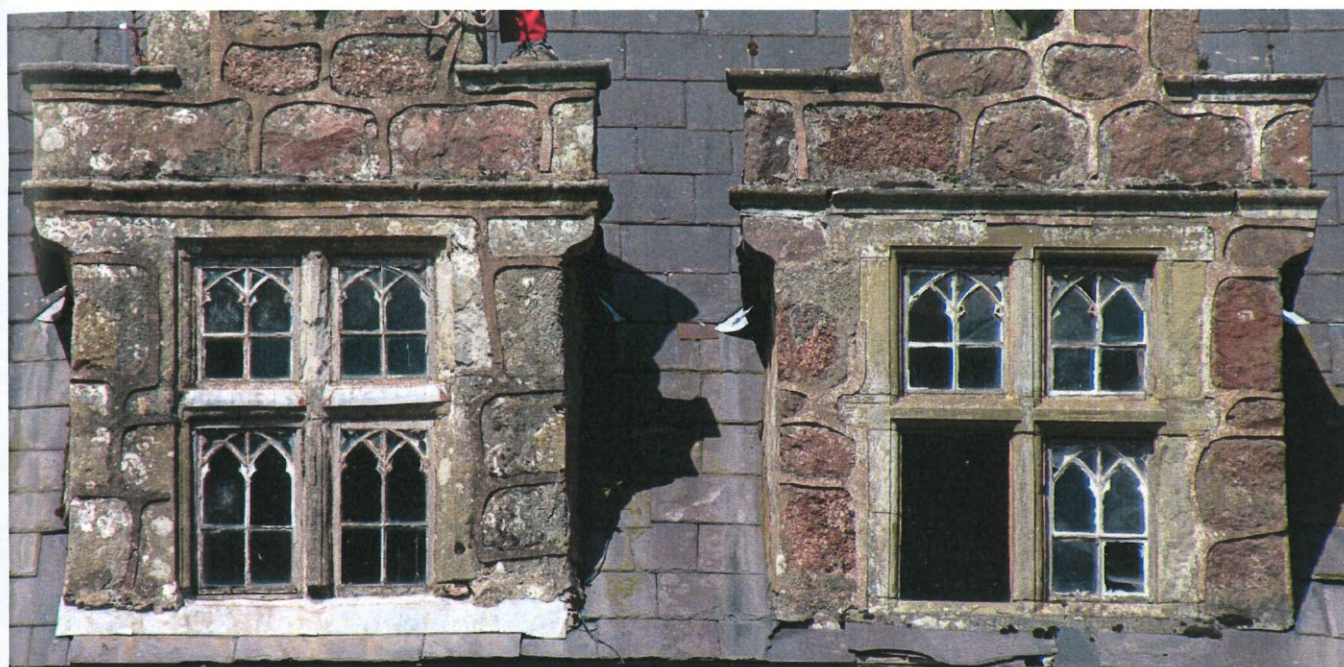
Attic dormers

Each of two dormers are of four lights. The northernmost of the two dormers is of the early nineteenth century. The casements are of four panes, with accommodation for varying sizes of openings. **Type 1. (Drawing of dormer 3 casement, upper register)**

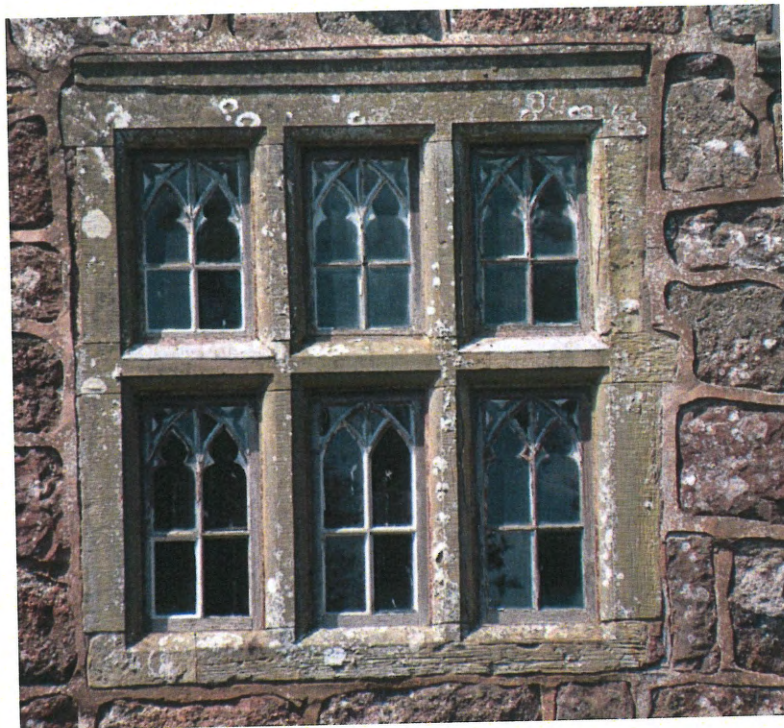
Attic

Six-light stone mullion and transomed window. All of the casements are of four panes, with accommodation for varying sizes of openings. **Type 1.**

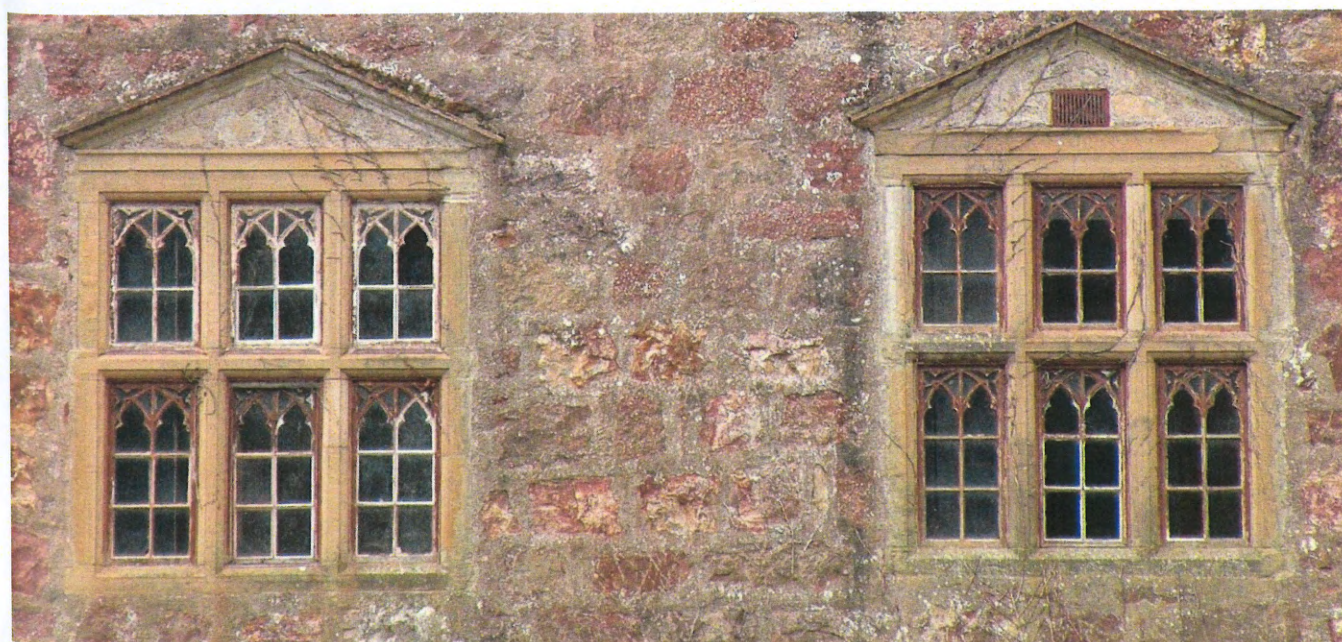
There are two six-light windows on the ground floor. The northernmost of the two has been modified with the removal of two openings in its lower register to accommodate a door. Otherwise the two ground floor windows, the two first floor, six-light windows and the attic six-light window, all carry four-pane casements. **Type 1.**

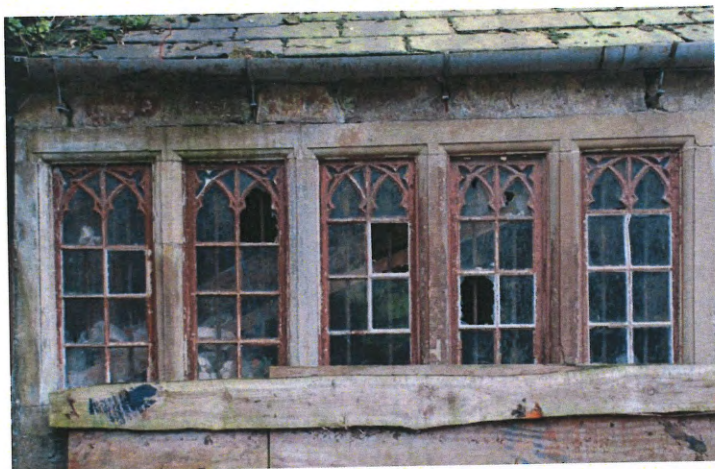
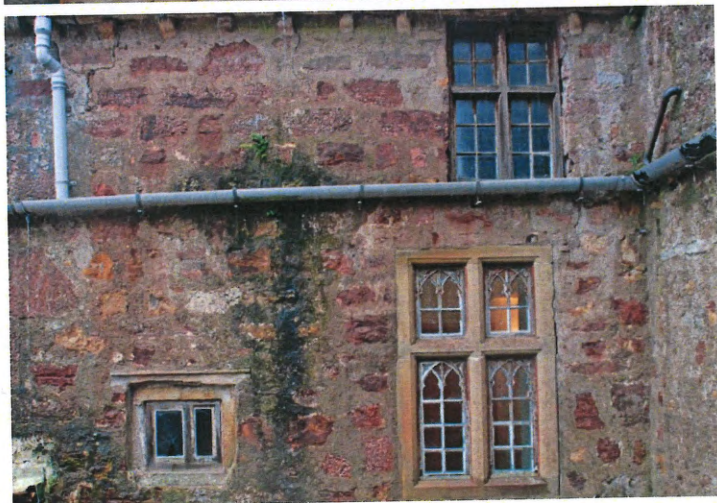
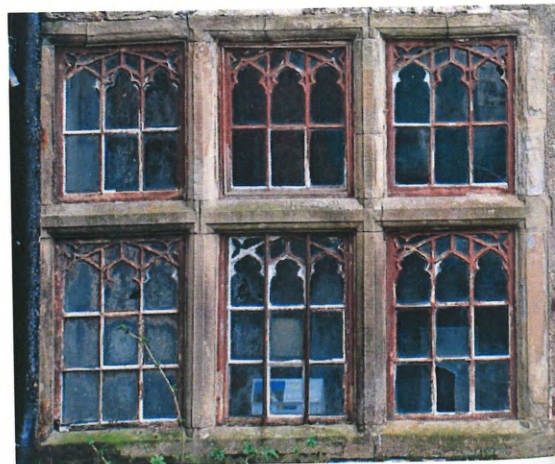
1. cellar corridor
2. ground floor
3. kitchen wing, south

Corridor at cellar level from main house to western extension: the corridor is lit by a stone mullion and transomed window of five-lights in a horizontal row, carrying eight-pane casements (two panes across, four rows down). A similar, single-light window of eight panes is set at the western end of the corridor. (All type 1)

At ground floor level there is a large stone mullion and transomed window of six lights accommodating wooden casements of nine panes in the lower register and six panes in the upper register. Type 2

At first floor level there is a small square original opening of stone jambs, sill and lintel, surmounted by a horizontal drip mould. It is occupied by two glazed frames, one, side hinged, narrower than the other. (Type 6).

Also on the first floor there is a nineteenth century stone mullion and transomed window of four lights. The lower register accommodates casements of eight panes, the upper register of four panes. (Type 1).

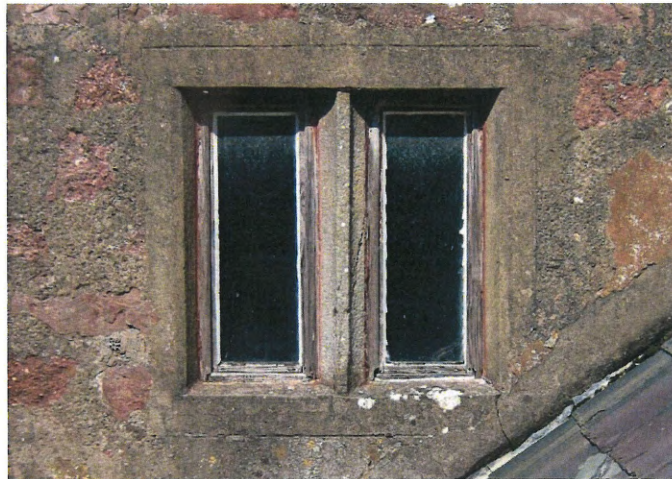
south tower

The tower windows are original. There is a recessed, stone mullion and transomed four-light window at the level of the main house attic and, under the eaves of the tower, two-light, stone mullioned windows at north, west and south sides. These are now occupied by plain, rectangular, side hinged wooden casements (**Type 6**)

There is a first-floor corridor to the south of the tower. This is lit by a six-light stone mullion and transomed window, now occupied by **type 1** casements (six panes, lower register, four panes, upper register).
