**ABERFFRAW WATCHING BRIEF**  
**BRITISH GAS WALES**

**ABERFFRAW WATCHING BRIEF - BRITISH GAS WALES**

**GWYNEDD ARCHAEOLOGICAL TRUST 1992**

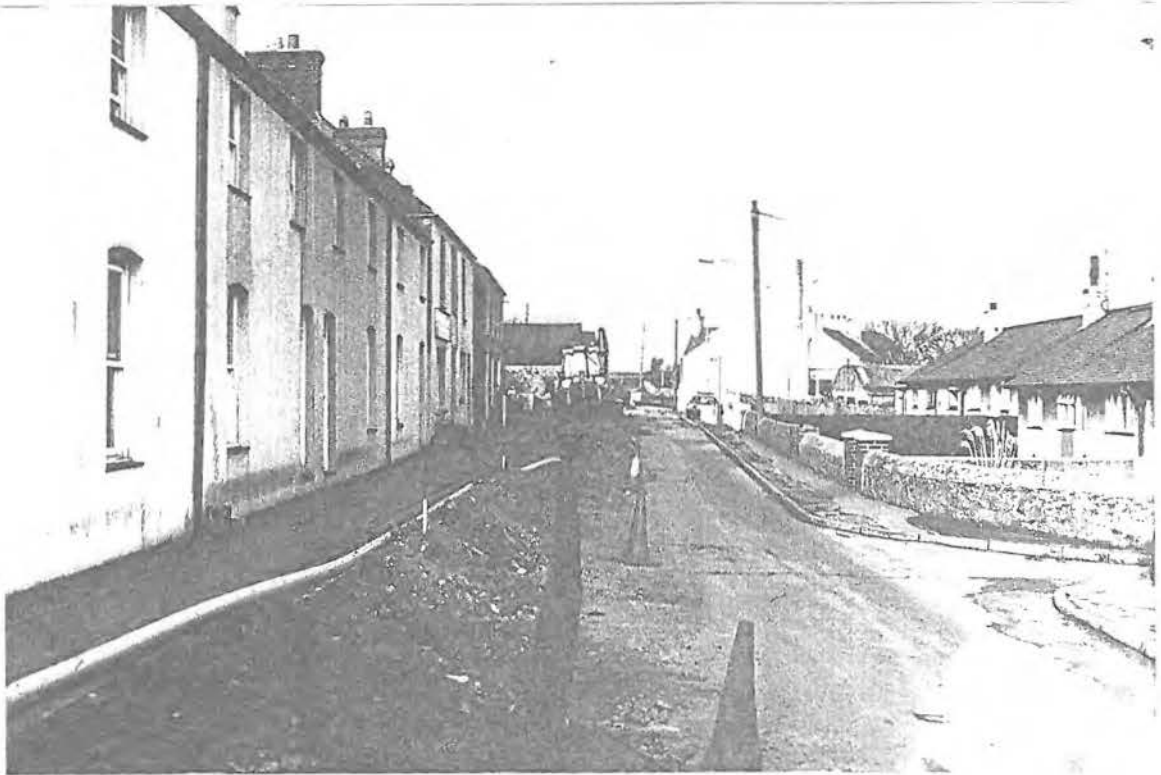
Plate 1. Trench 1: View from east

Trench 1 was excavated from the police station, southwards along Llewelyn Street to Bodorgan Square. (plate 1 and 2).

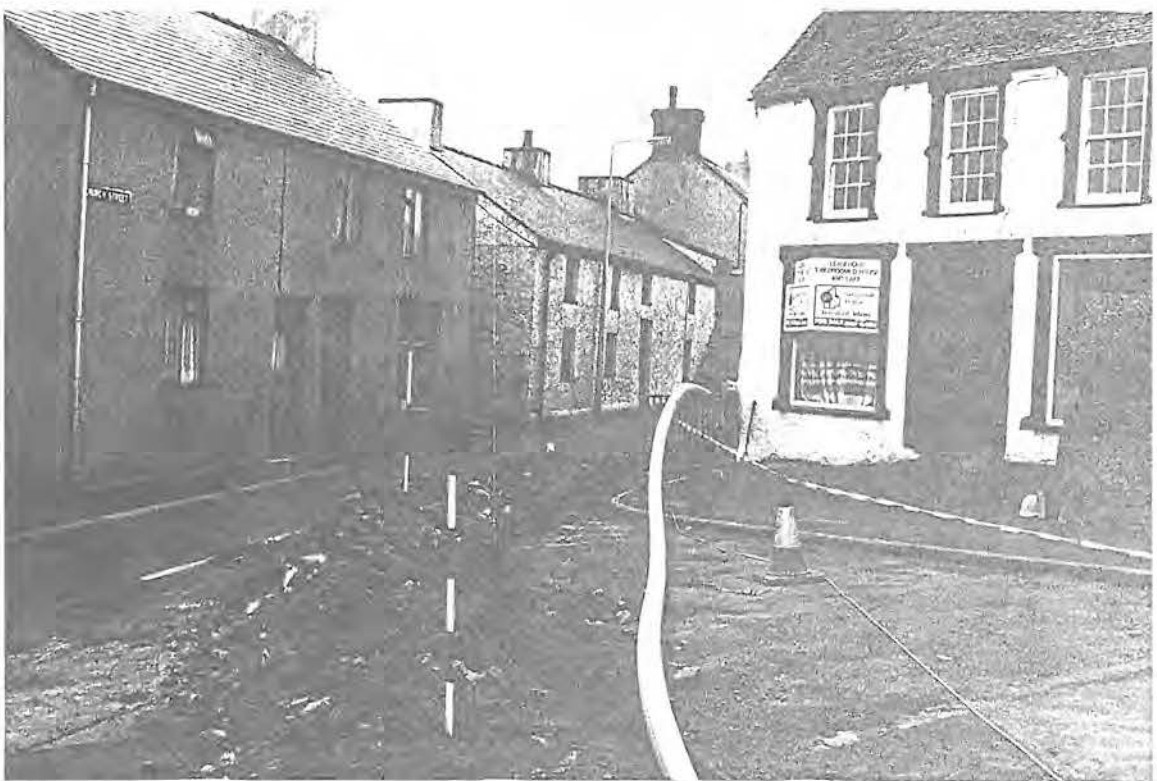
Plate 4. Trench 3: View from north

Street. (plate 4 and 5). A possible feature was noticed at the south west corner of Bodorgan Square, (D2), (plate 6), approximately 3m wide. Beneath 0.07m thick of tarmac (001) and 0.12m of grey rubble fill (002) for the tarmac, a distinct 0.10m thick lens of yellow sand was found, (007.) The sand contained a large percentage of small stones / gravel, and overlaid an inconsistent layer of stone free, middle brown sand, (008.) On the south west side all layers were butted up against a 0.60m thick of shattered bedrock / rubble, (009), which probably extended deeper than the bottom of the trench. Beneath (008), the trench was filled down to the base of the trench by (006) natural. D2 was recorded and photographed.
