REPORT ON THE ARCHAEOLOGICAL ASSESSMENT AT THE CROSVILLE BUS DEPOT, BEACH ROAD, BANGOR.

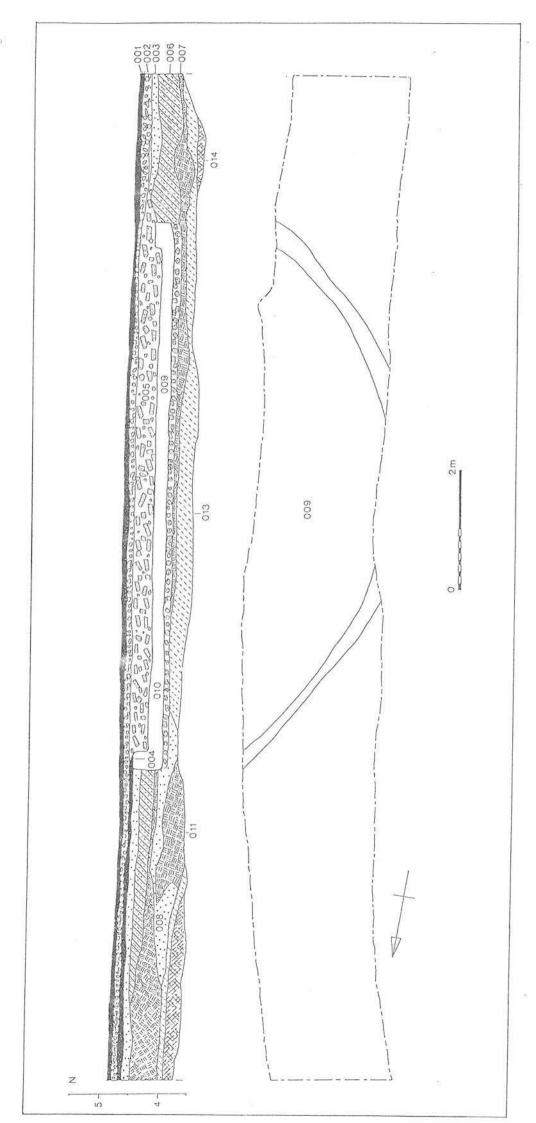
Fig. 3. Section and plan of trench A.

A trench 17m in length and 2m wide was excavated by machine to a depth of 1-1.5m in the southern corner of the bus park to the rear of the depot. The removal of the tarmacadam revealed a circular concrete structure (009) of unknown purpose, with a further area of tarmacadam to the north associated with it. Beneath these features were successive levellings of clay and clinker. The clinker (003, 008), which contained nineteenth century pottery, possibly originated from the iron foundry situated on Beach Road at the end of the last century. The trenches were excavated down to the clay subsoil, which contained no features of archaeological interest.

Trenches A and B contained no features of archaeological significance. The area appeared to have had waste material from the iron foundry in Beach Road spread upon it and covered over with either clay or soil in the nineteenth century. There are no records as to the function of the concrete circle in trench A although it could have been the base for a fixed crane, possibly dating from World War II when munitions were stored on the site.

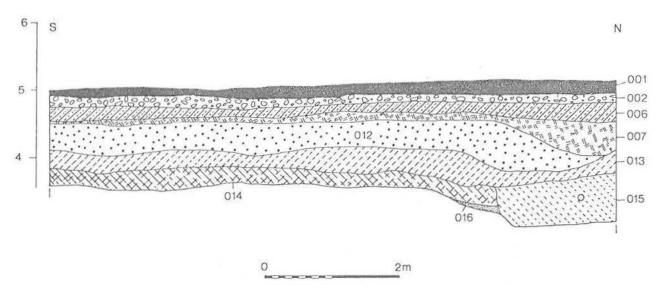
Fig. 4. Section of trench B.

A trench 9m in length and 2m wide was excavated by machine to a depth of 1.5-2m at the rear of the bus park, 20m north-west of trench A. The removal of the tarmacadam surface revealed a

layer of clay above a layer of clinker. The clinker (012) disappeared at the northern end of the trench and contained sherds of nineteenth century pottery, being similar to the clinker layers in trench A. A deposit of silty clay lay beneath the clinker, sealing a drainage trench (015). The drain within this trench was constructed from half-round sections of pottery pipe lying on flat roof slates and probably dates to the nineteenth century. This drainage trench also cut through sandy gravel (016) which lay beneath the natural clay.

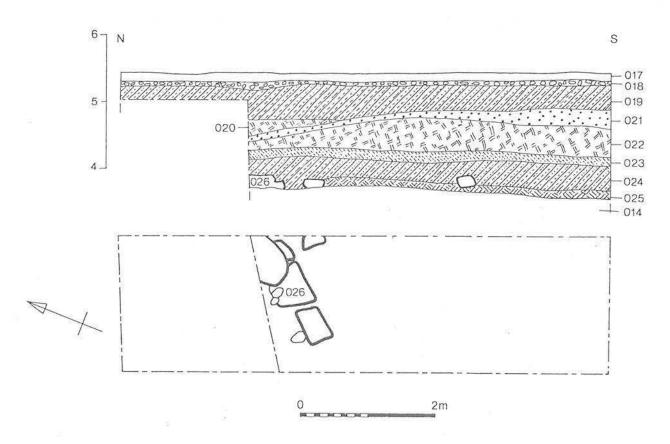
Fig. 5. Section and plan of trench C.

A trench 8m in length and 2m wide was excavated by machine to a depth of 2m within the northeast side of the bus depot. The concrete was cut through using a diamond disc cutter and then broken up by machine. A 2m length at the northern end of the trench was only excavated to a depth of 0.4m due to a leakage of diesel from a pump situated 1m from the trench (Plate 3). This was to prevent diesel from flooding the remainder of the trench. This trench was the most significant archaeologically. It contained similar levelling layers of clay and clinker to those recorded in trenches A and B (Plate 4). Beneath these, at the northern end of the trench, an alignment of large flat stones was discovered (026) (Plates 5 and 6). The stones were approximately 100mm thick and the largest was 0.6m in length and 0.6m wide. These stones were set on the natural clay surface (014) and did not appear to have had a construction trench dug for them. Only one stone of the second course was present and this was set back 0.1m from the face of the lower stone course. Behind these stones were a number of large rounded beach stones which may have made up the core of a wall faced with the flat slabs, the lower course of which made a plinth to support the upper courses. Unfortunately, due to the diesel spillage, any indication as to the wall's width could not be determined. The top of the wall as revealed lay 1.5m below the surface of the concrete. The horizon of clayey silt (024) which lay above the wall contained a large quantity of roofing slate. A whole example matches in thickness the fragment found by Hughes in 1898/9 and probably dates to the mid-thirteenth century.

The only significant archaeological feature recorded was the wall footing in trench C. Although it is impossible to date this wall with any precision, its proximity to the friary buildings and the existence of roofing slates similar to those found in 1898/9 would support a date within the latter half of the thirteenth century. The wall appears to have been too insubstantial to have supported any significant load but given its distance from the friary itself and its sympathetic alignment with Afon Adda it may have been the precinct wall of the friary. In which case a major portion of the area of proposed development must lie within the friary precinct, although it is impossible to state how far to the north, west and south the precinct extended as no return wall was observed in trenches A and B.
