REPORT ON THE PRE-RECLAMATION
ARCHAEOLOGICAL SURVEY AND EXCAVATIONS OF
THE VALE OF CONWAY MINE COMPLEX, LLANRWST

**REPORT ON THE PRE-RECLAMATION
ARCHAEOLOGICAL SURVEY AND EXCAVATIONS OF
THE VALE OF CONWAY MINE COMPLEX, LLANRWST**

by P.T.Muckle

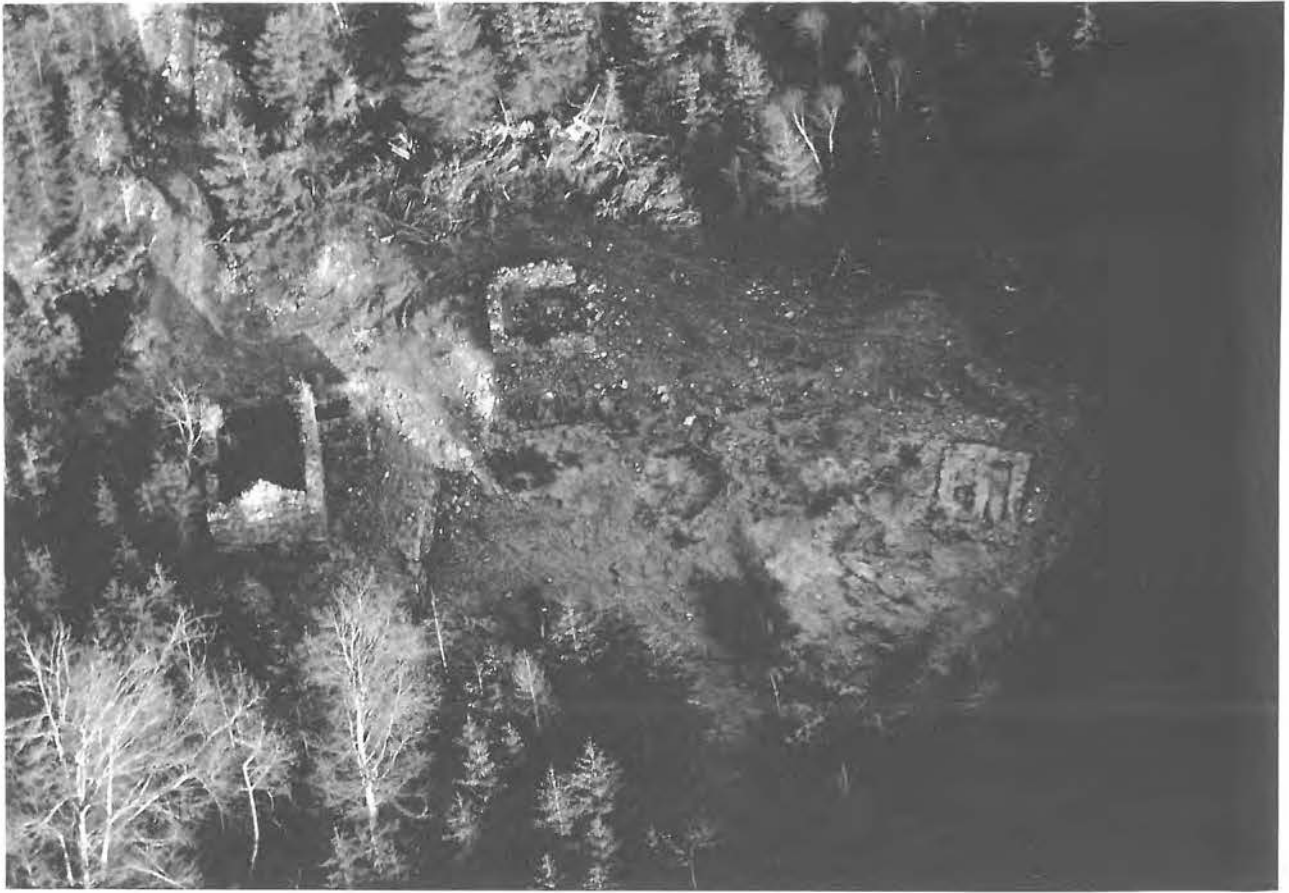
Plate 1. Aerial photograph showing the mill complex before reclamation.
North is at the top of the photograph.

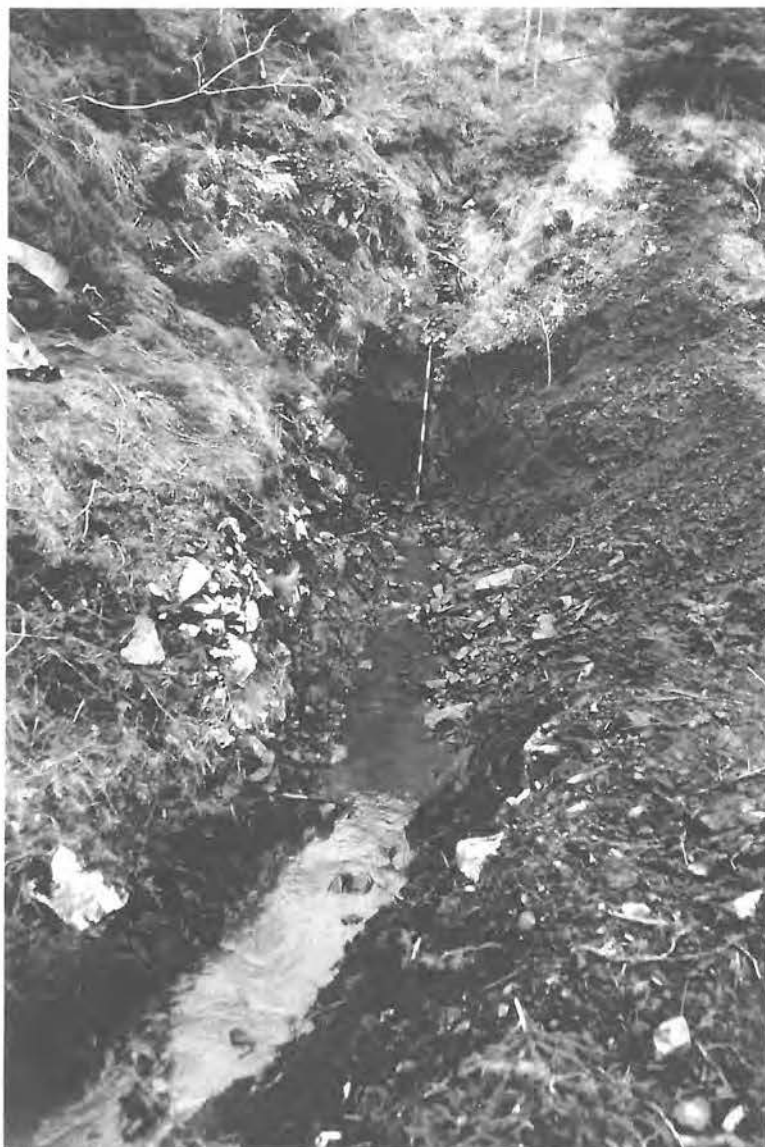
Plate 3. Adit E26 from the south after the wall had been numbered and dismantled, and the adit entrance cleared of rubble prior to treatment (GAT 1059/92/03/15, scale 2m).

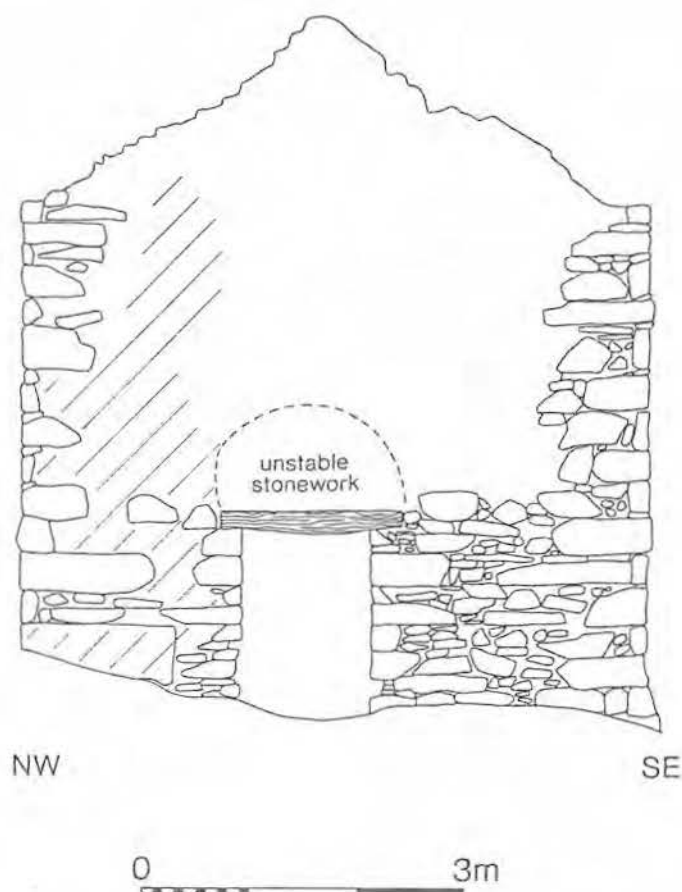
Fig. 11 Crusher house - south-west facing external elevation

The south-west facing external wall contains the lower entrance to the crusher, where crushed ore was barrowed out onto the dressing floor (Fig. 11). The wall is similar in construction to the south-east wall with stressed quoins of large dressed stone and a lower course of large squared stones up to the height of the door lintel. The door is slightly off-centre and is 1.2m (4ft) wide and 1.9m (6ft 3in) high, above which are three very badly decayed timber lintels resting on dressed quoin stones, which have now been replaced. The wall immediately above the lintel had not been rendered and appears extremely unstable. Above this stonework and extending to the top corners of the wall the stones are small and irregular in shape and are not regularly coursed, apart from occasional two-stone strings of longer, flatter stones to tie in the ones below. The western third of the wall has been rendered more or less from bottom to top with a coarse grey render incorporating sandy tailings. There is far less rendering than on the south-east wall and the wall appears less stable as a result.

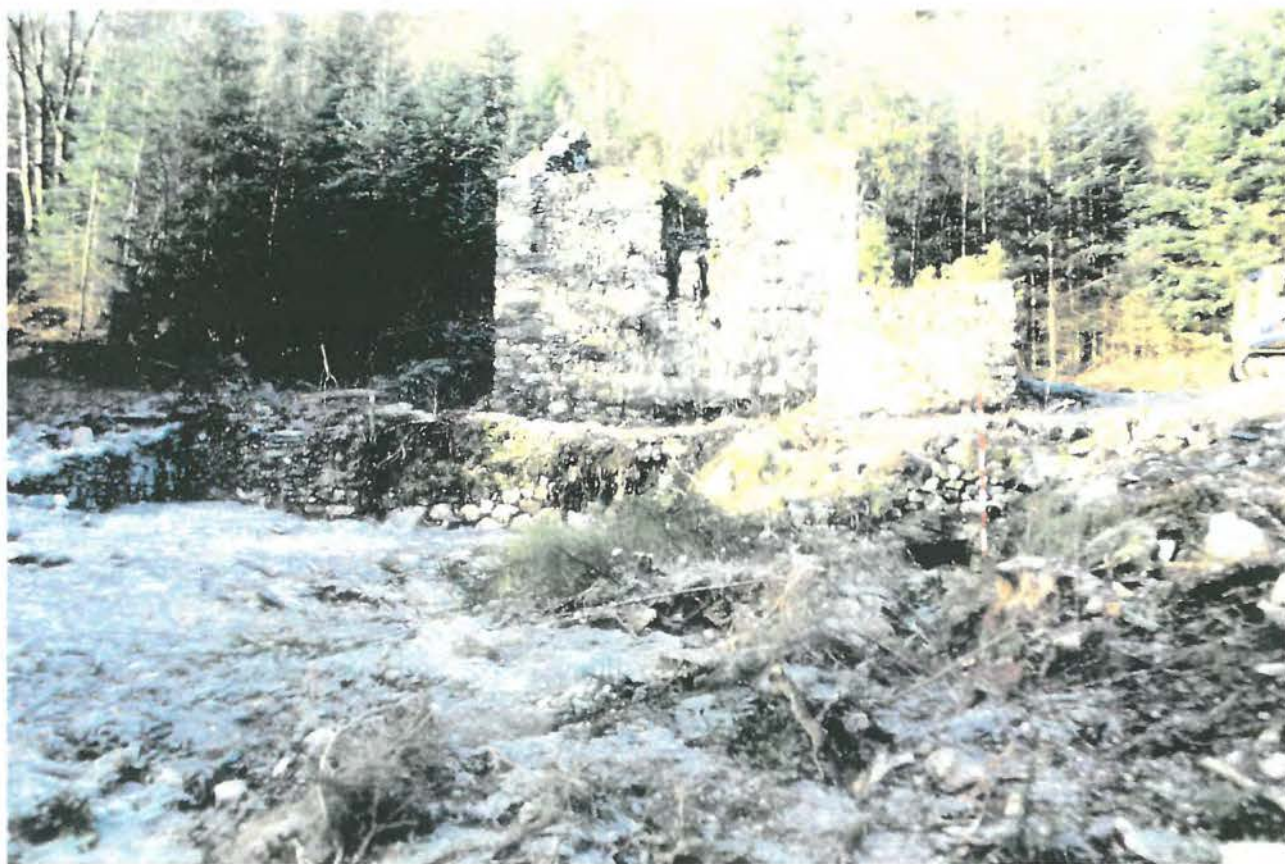
Plate 5 The crusher house and wheelpit before reclamation

The early photograph of the crusher (Plate 4) shows that originally the building was rendered, although apparently with a weak mortar that had largely crumbled due to weathering over the years (Plate 5). This was true of many of the structures; there was often little or no mortar visible in the joints between the stones but at the base of most walls a deposit of weathered mortar could be found. Plate 6 shows the interior gable wall of the crusher house during reclamation. Firstly, loose material was cleaned out between the stones to provide a key for the mortar, as can be seen in the bottom left hand side of the photograph. The wall was then pointed using a generous amount of mortar, as visible in the centre of the photograph. Finally, the mortar was rendered by throwing on local dark grey tailings sand (top and right of photograph).

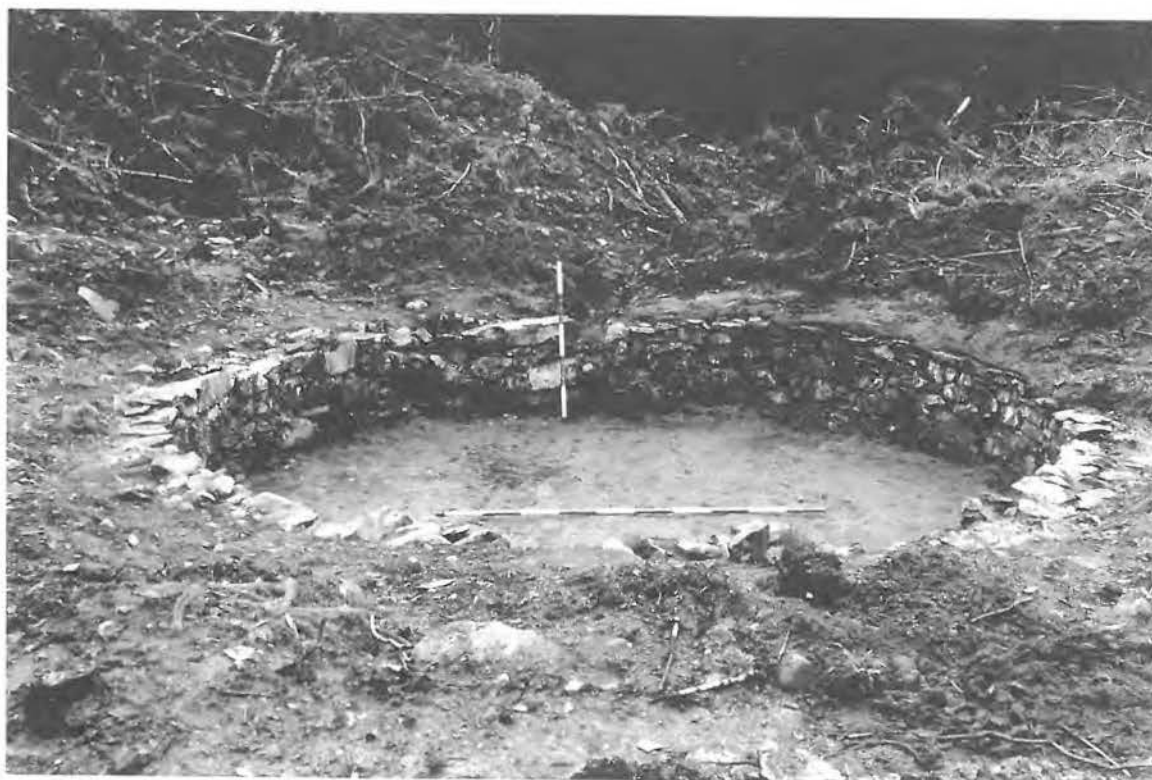
Plate 7. The buddle pit from the west after (GAT 1059/05/03, scales 2m and 1m)

The entire buddle was excavated to natural, producing no finds other than some wall tumble in the west quadrant of the pit (Plate 7).

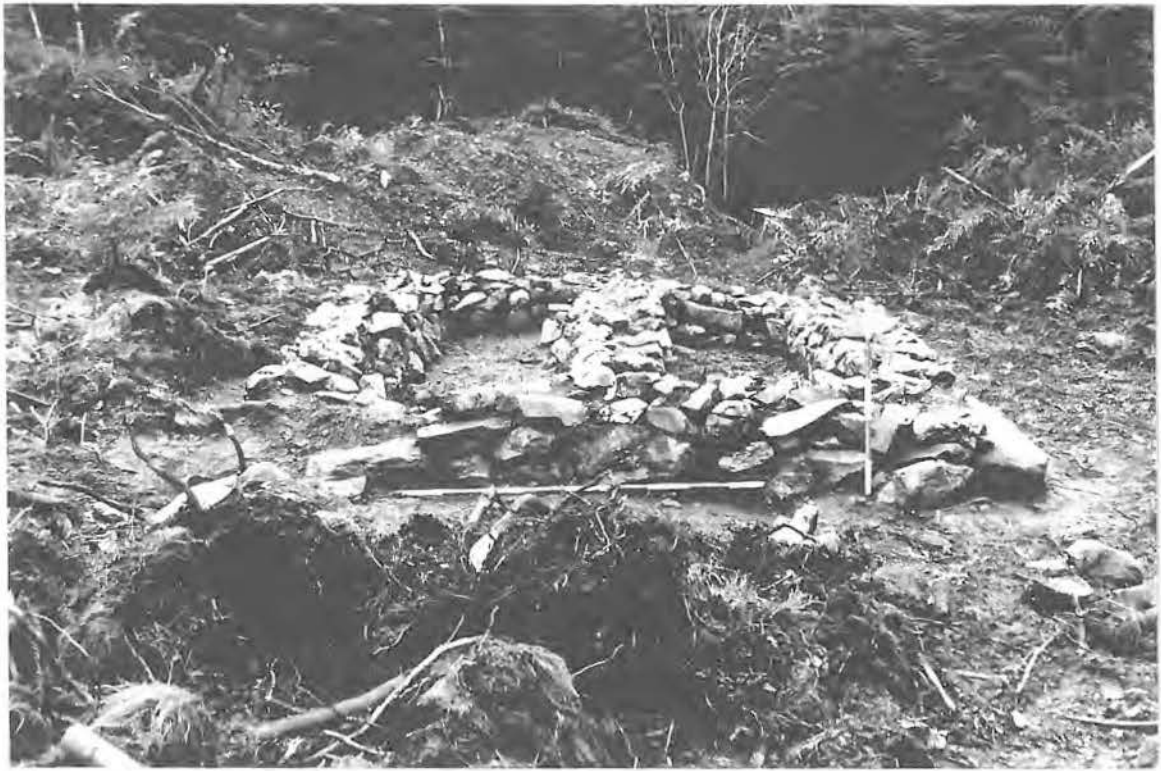
Plate 8. The settling tanks after clearance

The settling tanks are in the most south-easterly and lowest part of the mill complex, and probably acted as traps for mineral particles to stop the pollution of the water system, a factor that was largely ignored at the later workings of Parc and Hafna. The settling tanks were fed from the buddle pit, although the exact line of the drain from the buddle cannot be traced because of damage by forestry machines in the 1970's. There are no obvious inlets or outlets to the tanks, which suggests that the tanks were launder fed from the buddle and the sludge was brought in over the tank walls. Before clearance the tanks were heavily vegetated including the remains of a large tree stump in the western half with roots 0.3m diameter growing through the walls of the tank. The tree was removed by chainsaw and machine without causing any damage to the structure (Plate 8.). Beneath the vegetation was a layer of dark grey humic sandy soil 0.2m (8in) thick, similar to that found in the buddle, sitting on top of orange brown natural. The tanks were not emptied because of the highly toxic nature of their contents.

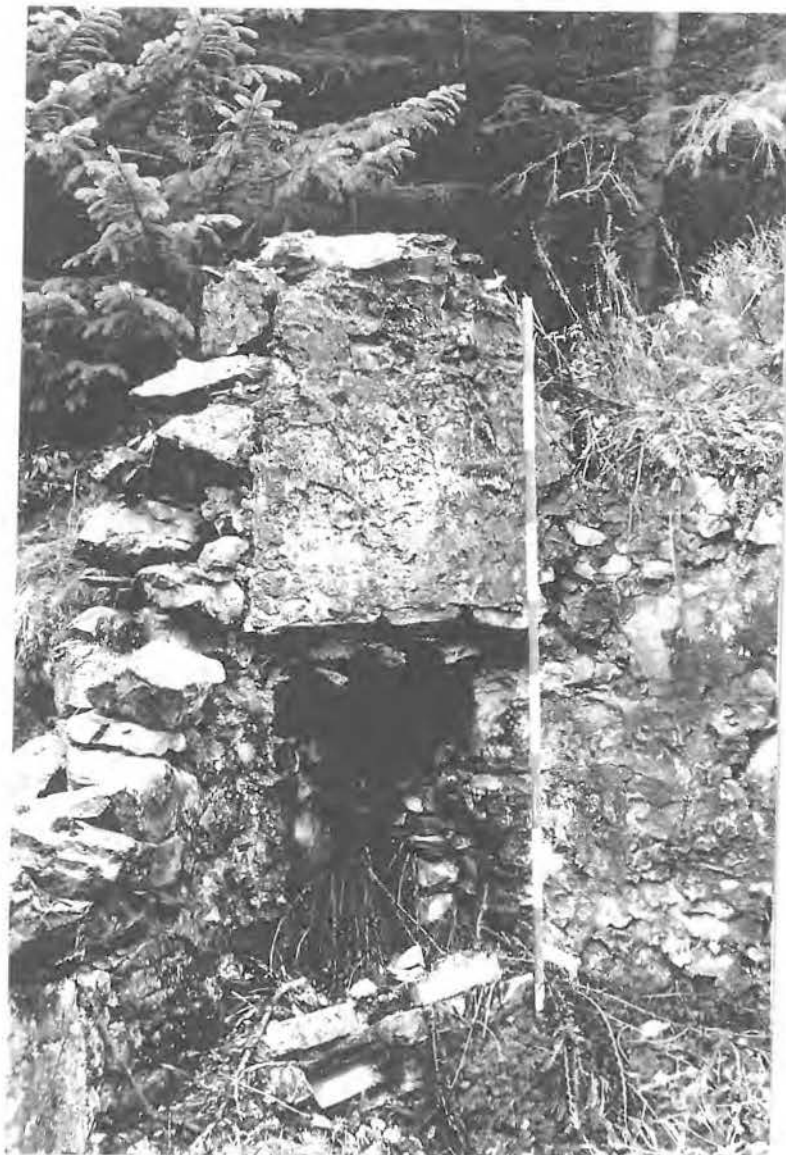
Plate 9. The hearth and flue in the cottage annexe
