CONWY SEWERAGE AND
SEWAGE DISPOSAL SCHEME
INVESTIGATIONS IN CASTLE SQUARE

by A. Gruffydd
illustrations by H.F. Riley
for Gwynedd Archaeological Trust 1992

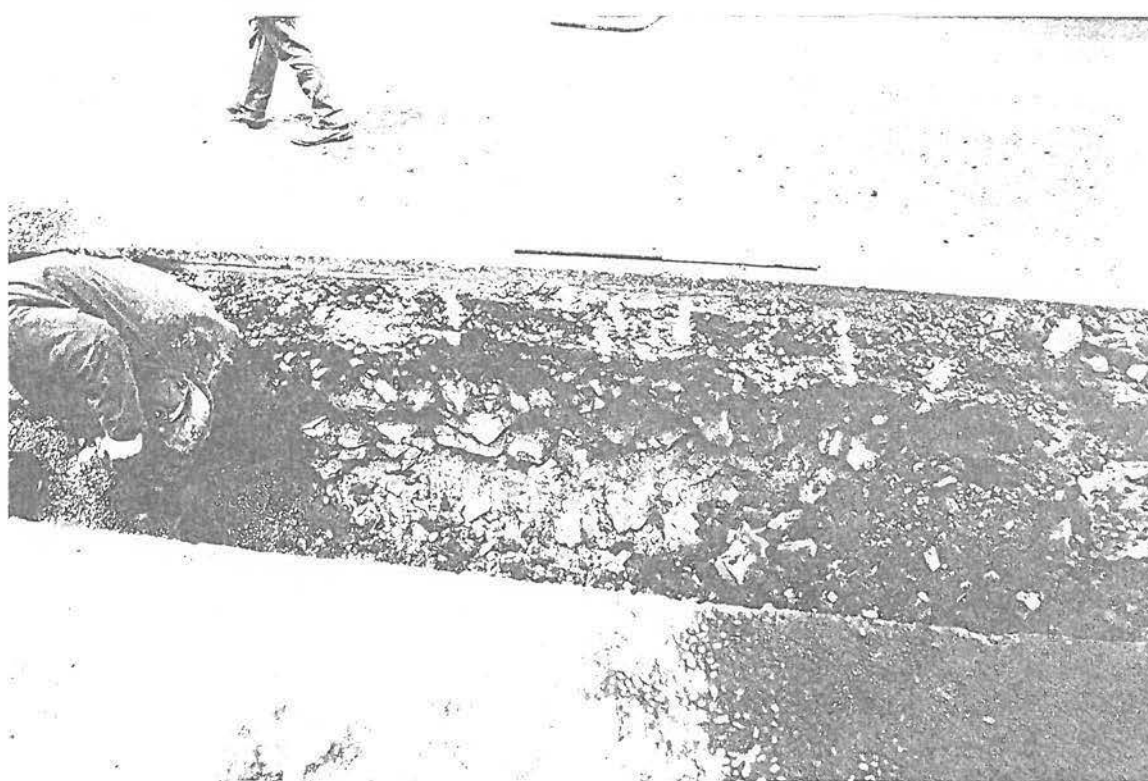
Plate 4. View Of Town Wall Foundations (south facing)

While the trench was being extended eastwards towards Conwy Bridge however, traces of the town wall (which had also been reduced to enable the construction of the modern road) again leading from the north face of the castle, could be seen in the section (Plate 4). The wall was represented by a 2m wide cut in the section and consisted of heavily disturbed angular rocks / boulders. The foundation trench for the town wall was at least 1m deep and extended below the base of the trench.
