# **GWYNEDD ARCHAEOLOGICAL TRUST**

**Seion Chapel, Conwy**

**Watching brief and archaeological response at  
Seion Chapel, Conwy, Gwynedd**

Report No ~~45~~ 45

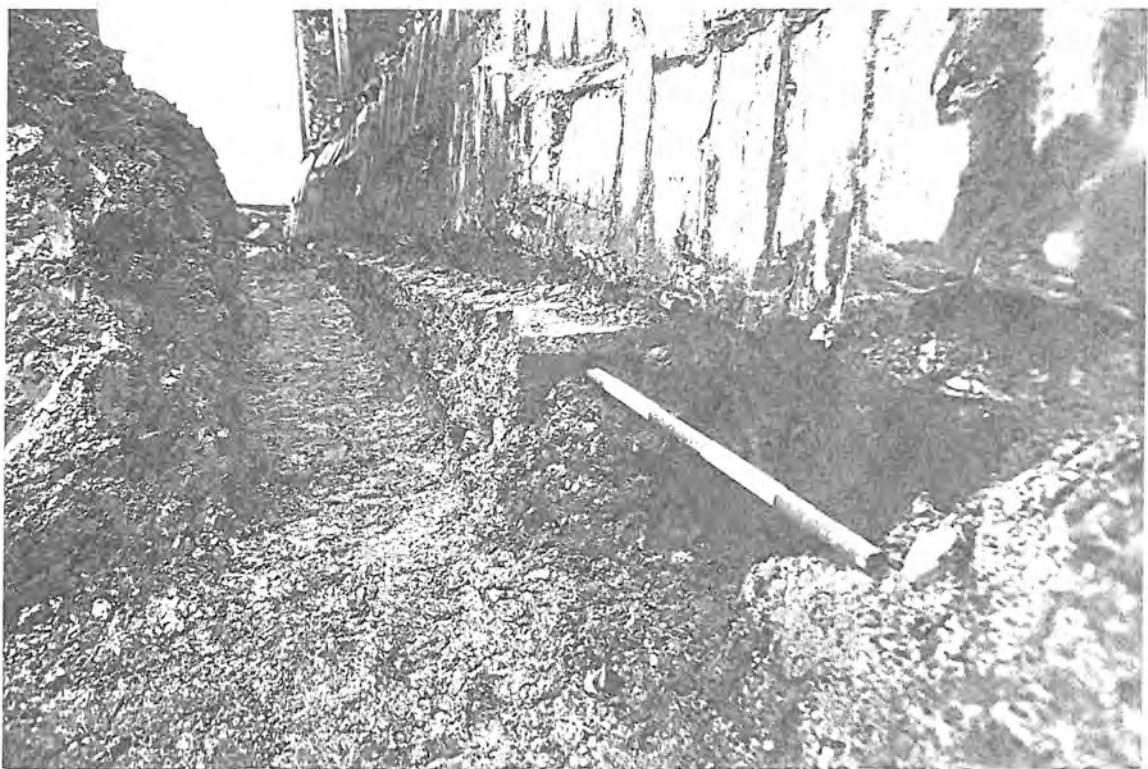
Conway, Seion Chapel. Contractors trench showing location of pit 001.

A pit (context 001) had been dug against the northern wall of Plas Mawr, measuring approximately 1.0m across and 0.5m deep. The items recovered from the pit included one small piece of post-medieval/19th century window glass, (Finds No. 008) a 0.50 x 0.40 m piece of copper alloy with two small circular perforations, (Finds No. 006) one piece of bone, (finds no 007) and a small amount of shell and slate. The pit (Fig 5 ) appears to have been dug against the foundation course of Plas Mawr, however on stratigraphic grounds it could equally have been an earlier feature disturbed by the foundations of the house.
