CONWY WEST SEWAGE DISPOSAL
& QUAY PIPELINES - 1993

ARCHAEOLOGICAL MONITORING
AND RECORDING

REPORT NO. 73

Gwynedd Archaeological Trust Report No. 73

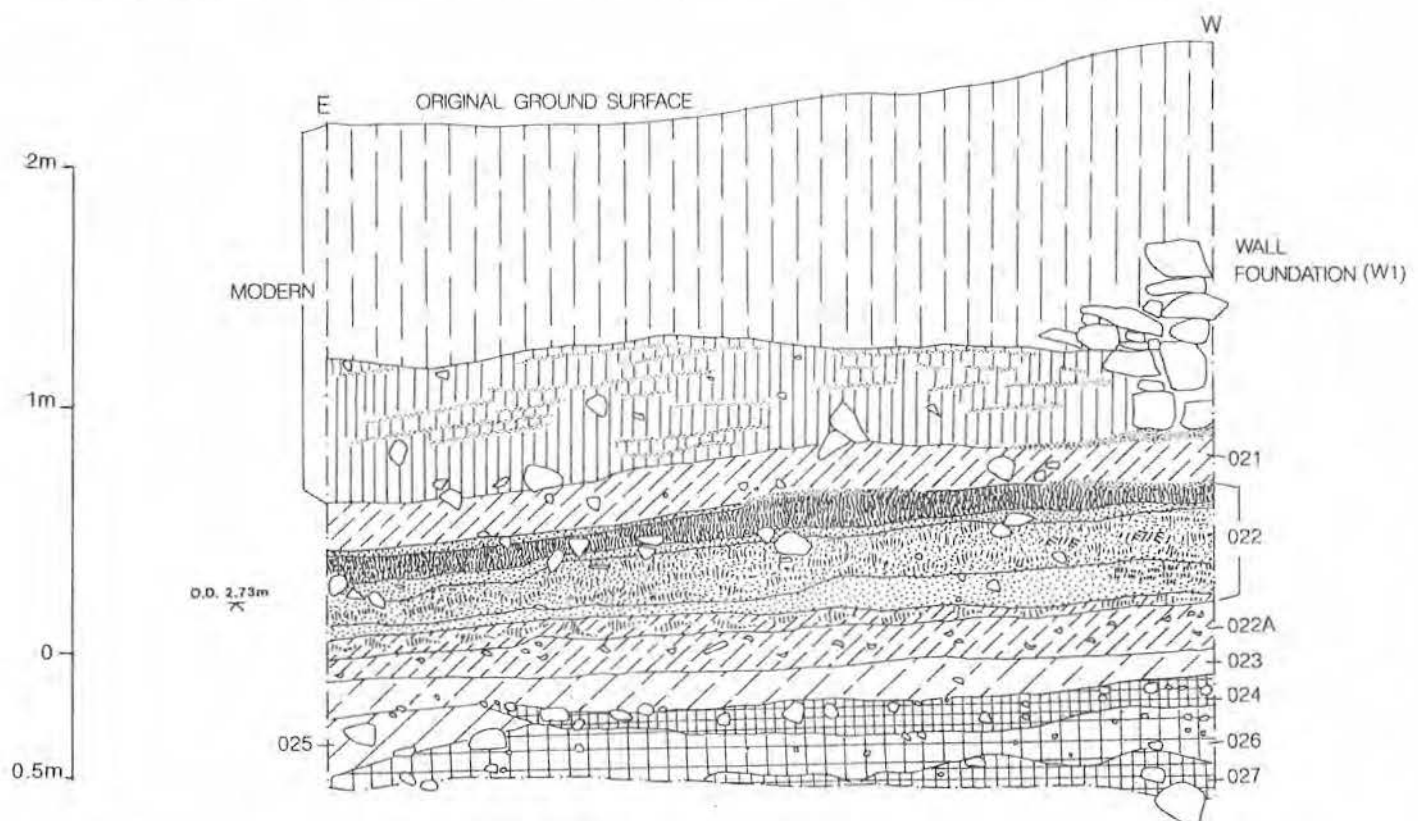
Fig. 5 Trench D north facing section

A further evaluation trench was excavated on the north side of the town wall on the site of the proposed reception pit (see figs. 3 and 5). The trench was excavated by machine to the level of natural geology at a depth of 3.0m below ground level under the supervision of GAT. No features of archaeological origin were present. The stratigraphic sequence recorded during the operation was of a very similar nature to that recorded on the south side of the town wall in trench A.

The natural geology proved to be a glacial deposit of bright orange highly cemented fragmented stone and small pebbles (027). This was overlain by a discoloured layer of the same context up to 0.20m thick (026). A band of smooth pinkish brown clay (025) partially overlay this layer at the eastern extent of the recorded section, also apparently glacial in origin. Partially overlying this and generally present across the trench was a 0.20m thick layer of rounded pebbles set in a blue-grey clay (024). This probably represents a primary water laid deposit and contained no inclusions of organic or cultural material. Overlying this was a further 0.20m deposit of sticky grey clay (023) which included a moderate amount of marine shell debris. A large amount of shell was present in the overlying layer of grey silty clay which also contained occasional slate fragments (022a). The remaining stratigraphy rising to recent demolition deposits was made up of alternating deposits of grey river silts and organic peaty layers of preserved wood chippings (022). Much cultural and marine material was present throughout the sequence including bone (animal), shell debris, and occasional 18th - 19th century pottery sherds, although markedly less than that observed in trench A. Overlying 022 was up to 1.5m of various layers of mixed clay deposits containing much waste material such as brick, slate, and timber pieces representing modern dumping and makeup. The earliest was 021, a layer of grey silty clay mixed with sub-angular stones, brick and slate debris.

Wall foundations observed in plan during the removal of the boatyard building foundations were present in the north facing section of trench D. The foundation courses of dry-stone irregular masonry appeared to be constructed directly on context 021. No construction cut was visible within the trench for this feature (see fig.5) and it appeared that the later layers had been dumped against or over these foundations.

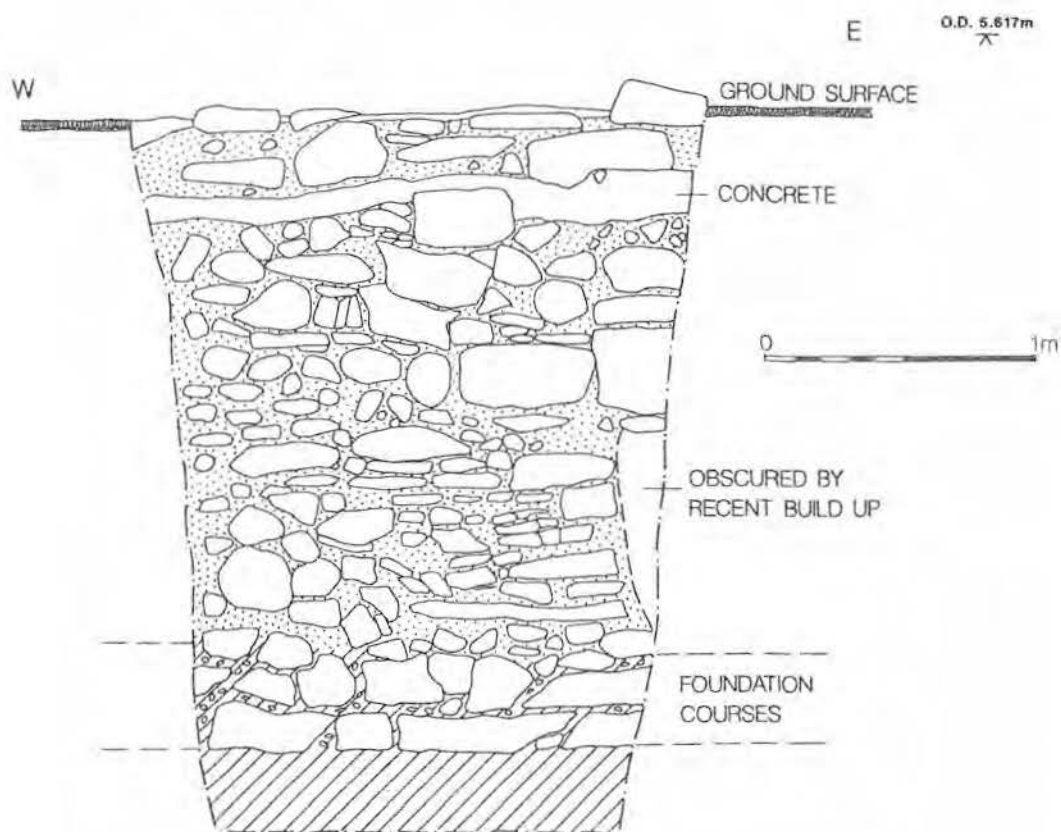
Fig. 6 Test Pit A, south facing section

This was located on the south side of the town wall 11.2m from Lower Gate street arch and right up against the town wall (see fig. 3). The pit measuring 2.1m in length and 2.0m wide was designed to record the foundations of the town wall and their underlying geology in preparation for a possible deviation of the route of the main storage/pumping pipe.

The pit was excavated to a total depth of 2.65m and, following the installation of adequate trench shoring, the foundation and elevation of the town wall was recorded with scaled field drawing (see fig. 6) and black and white and colour photography.

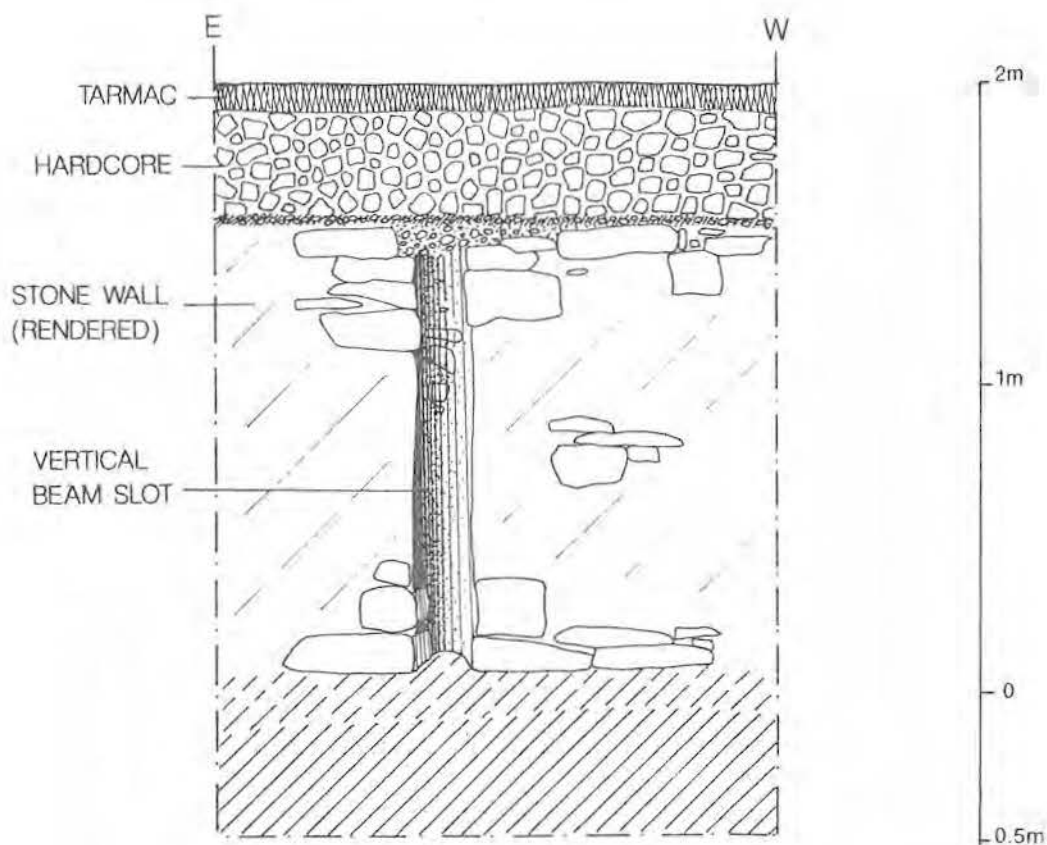
Fig. 7 Test Pit A, north facing diagrammatic section

A well preserved stone-built wall was located in the north facing section of the test pit. The wall was a maximum height of 1.40m with its base constructed at a depth of 1.90m from the present ground surface on a 0.20m deposit of grey silty clay. An interesting feature of the wall was the location of a vertical beam slot 0.20m wide and 0.15m deep running the entire height of the wall.

Documentary investigation following the discovery of these remains indicates a small structure was located at this point on the 1898 O.S 1:2500 edition map (see Fig. 3), although the function of the feature remains unknown at the present time.

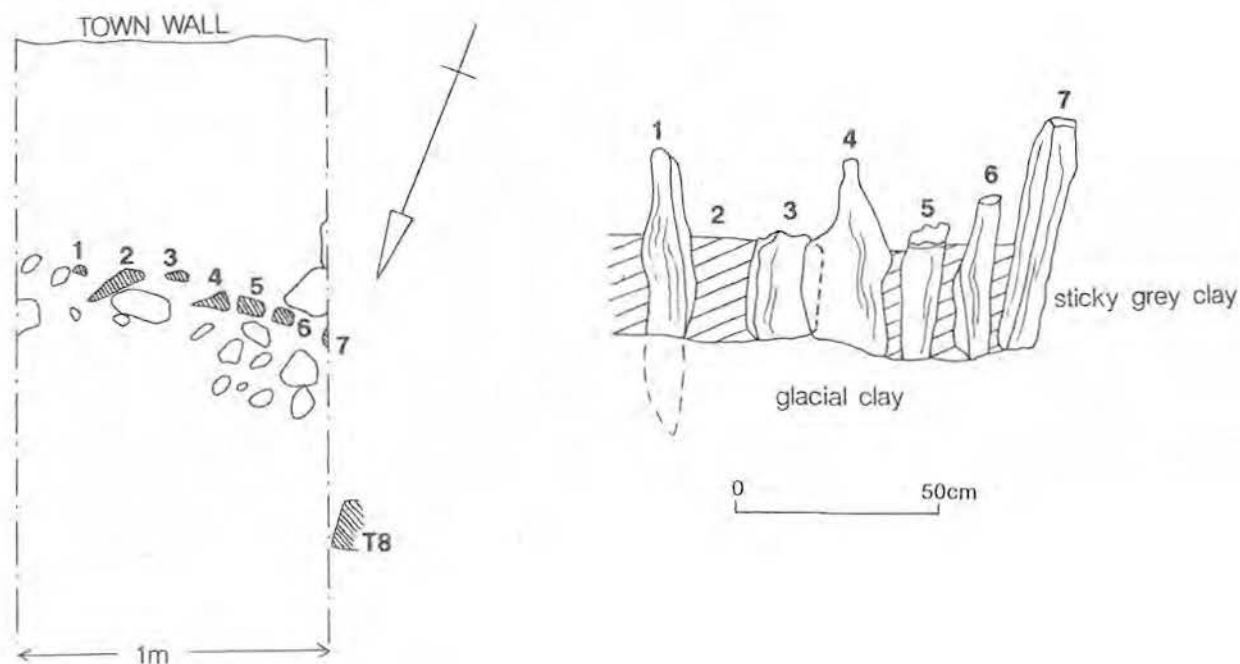
Fig. 8 Test pit B, diagrammatic plan and elevation

A test pit 2m x 2m was located on the north side of the town wall 13m from the Lowergate street arch and up against the town wall to permit Welsh Water's consultant engineers to record the nature and depth of the town wall and its underlying geology. Since its location was within the area outlined for archaeological watching brief for the removal of the boatyard buildings, the work was observed by GAT and a record made of identified features (see fig. 8 and plate 1).

The test pit was excavated to a maximum depth of 3.0m. At a depth of 2.5m from the ground surface a line of timber stakes was observed running approximately parallel to the town wall and approximately 1.0m to the north. Excavation and removal of the feature was carried out by GAT following agreement with the contractors on site to allow a brief delay in the work.

Seven individual timber stakes closely spaced and set firmly into a deposit of sticky grey clay were sealed by 0.90m thick deposit of grey silty clay alternating with thin lenses of organic peaty material. Some of the timbers seemed to exhibit evidence of extensive wear to the upper half suggesting that whatever their original form or function they had remained exposed for some considerable time prior to the deposition of the sealing layer. Six of the stakes were recovered and examples will be subjected to dendrochronological examination in the hope of securing a date for the timber.

Perhaps the earliest and most significant discovery was that of a line of well preserved stakes set closely together and forming a linear timber feature near to and approximately parallel to the line of the town wall 2.5m below the present surface and sealed by deposits provisionally dated from pottery evidence as laid down as early as the 16th century. Dendrochronological results are awaited on recovered samples in the hope of attaining an accurate date for the feature. It is noted with considerable interest that the stratigraphic location of the feature bears a resemblance to that of the discovery of timbers of a 16th century fish weir investigated by GAT on the opposite foreshore in 1988. It is hoped that positive results from the analysis of the stakes can be included in a report on the subsequent stages of the project.

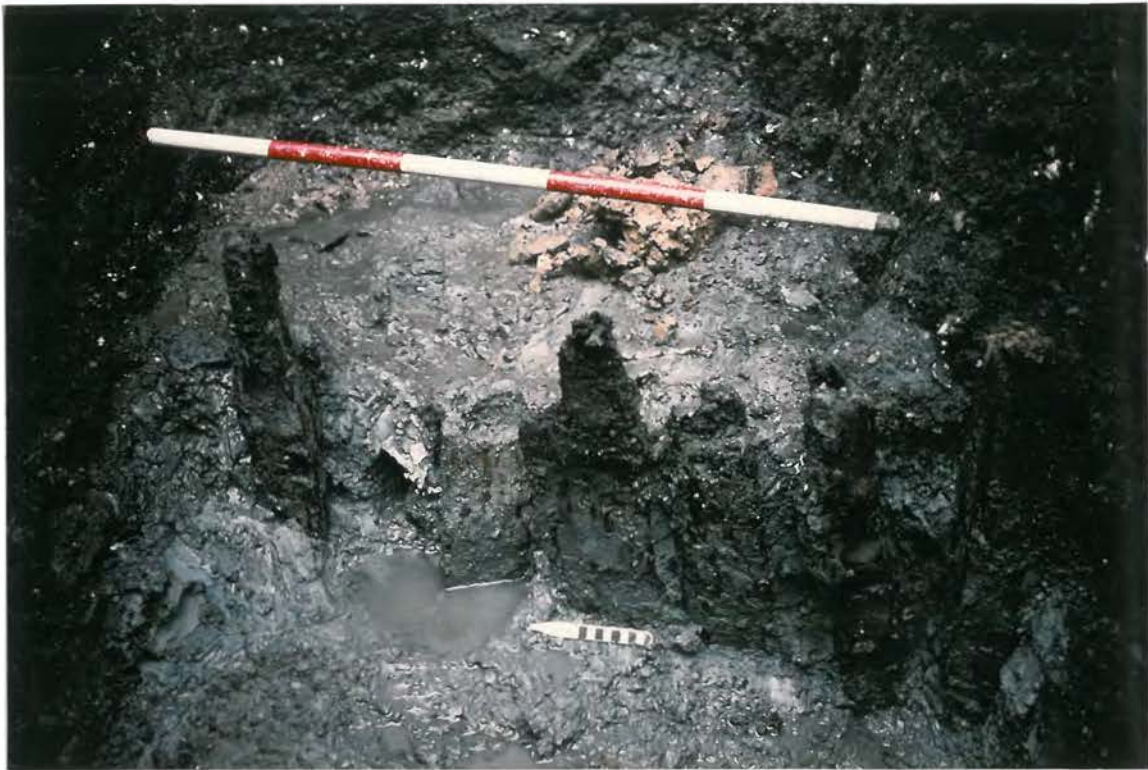
Plate 1 Test pit B - Area 2 Detail of stake line.

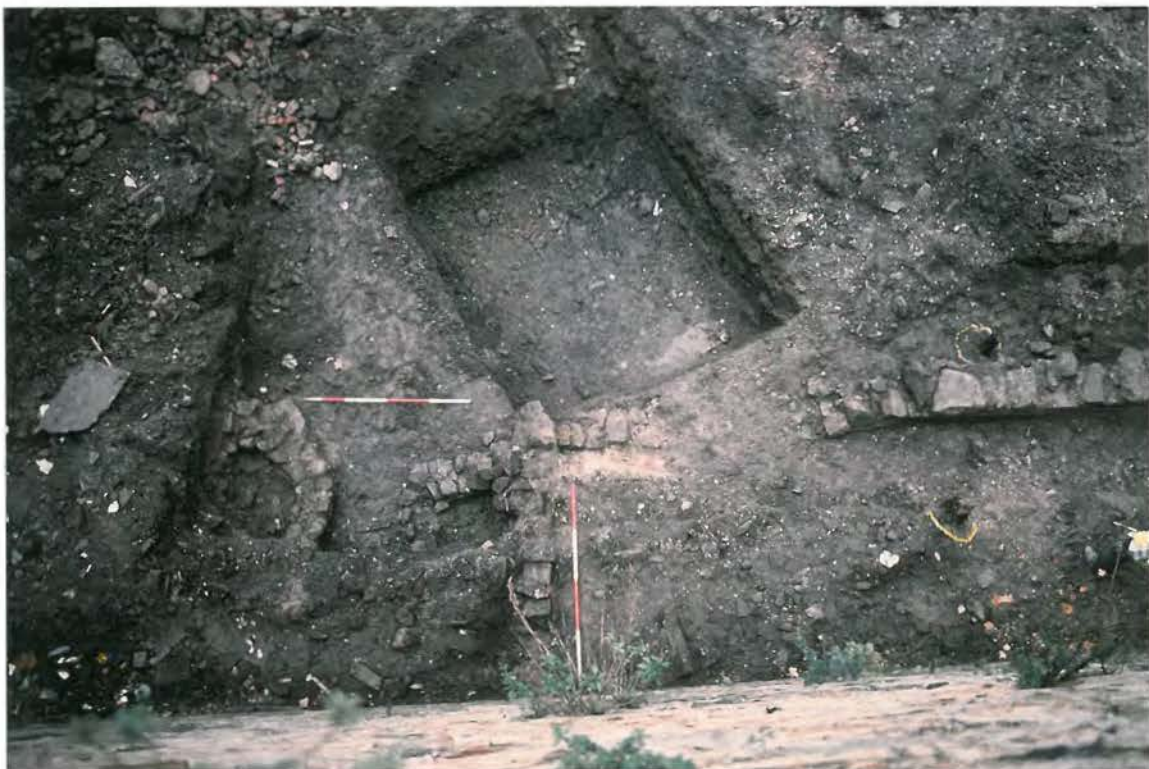
Following the clearance of the boatyard building remains at ground level a tracked Hymac fitted with 3 foot scraper bucket was used under the supervision of GAT to carefully remove c.0.50m of the recent rubble overburden within Area 1 (see fig. 3). Once the location of features had been established during this operation the remains were rapidly hand-cleaned to provide adequate definition for the recording of their position and constructional detail (see plate 2.)

Plate 2 Area 2 Structures 1 and 2 and Trench D. Site of former boatyard.
