Proposed Nuclear Power Station Wylfa, Ynys Môn

Archaeological Evaluation: Trial Trenching

Project No. G2096

Report No. 1015

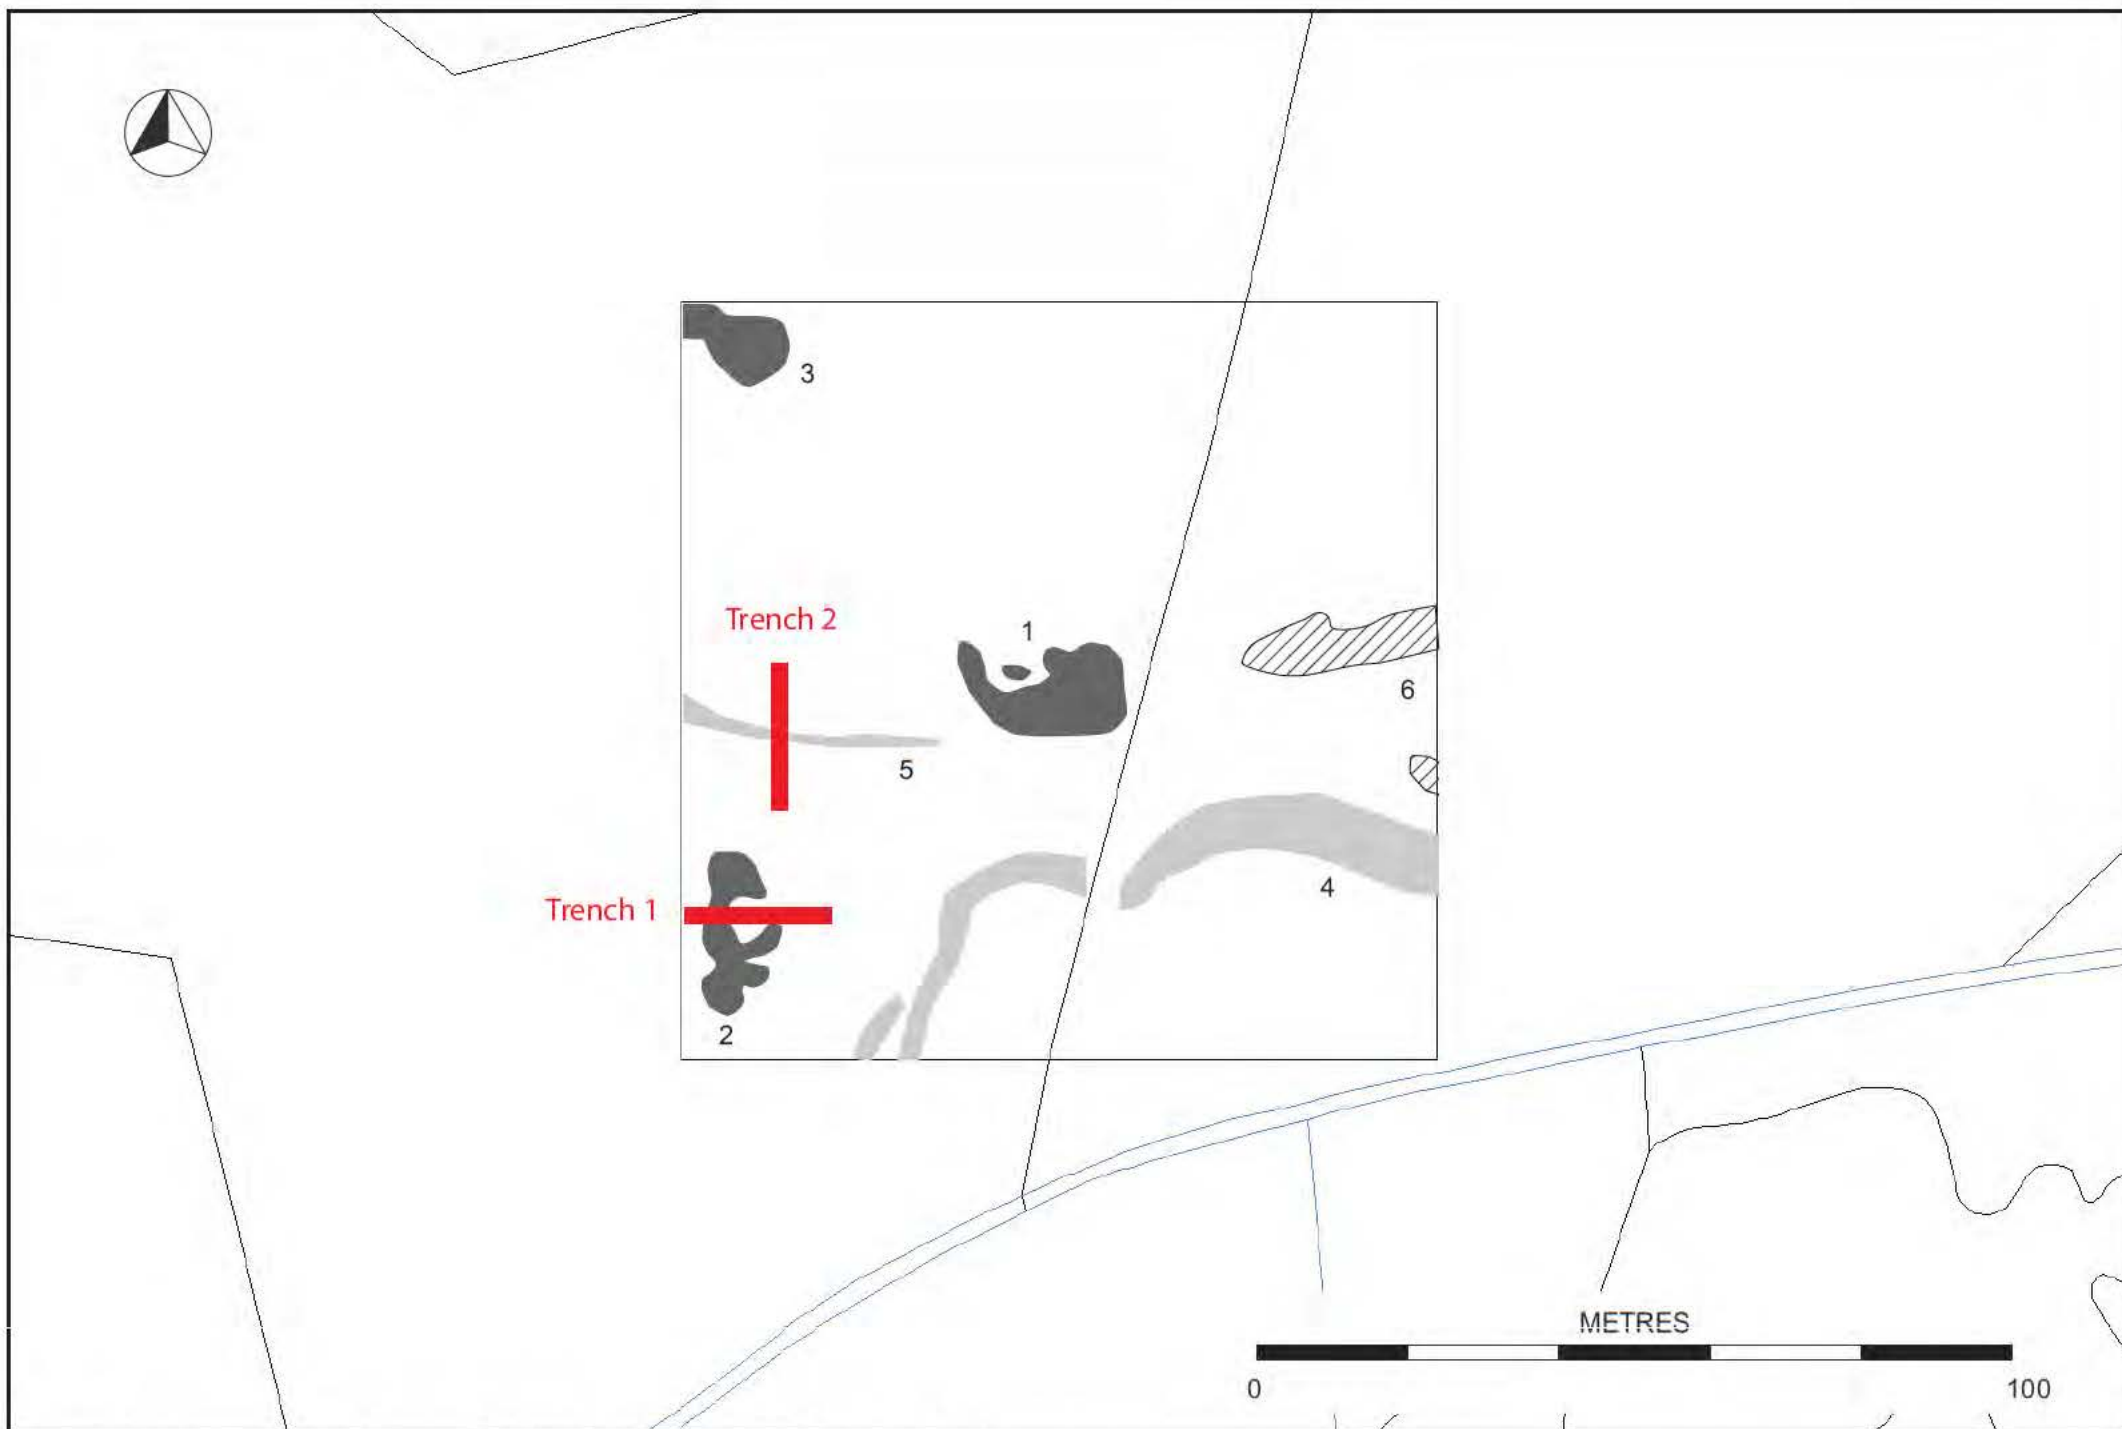
Figure 2 - Zone 1: Location of Gwynedd Archaeological Trust (GAT) Trenches 1 and 2.

Note: feature numbers refer to anomalies identified during the GAT targeted magnetometer survey completed in September 2011 (GAT Report 987).

- Location: Zone 1 (figures 01 & 02; plates 01 to 04)
- Size: 19.40m x 2.20m x 0.55m Orientation E-W
- Description: Trench 01 was positioned across GAT geophysical survey Feature 2 (suspected burnt mound).

- No evidence for a burnt mound was identified. The localised root burning may have created the thermoremnance signal interpreted as a possible burnt mound.

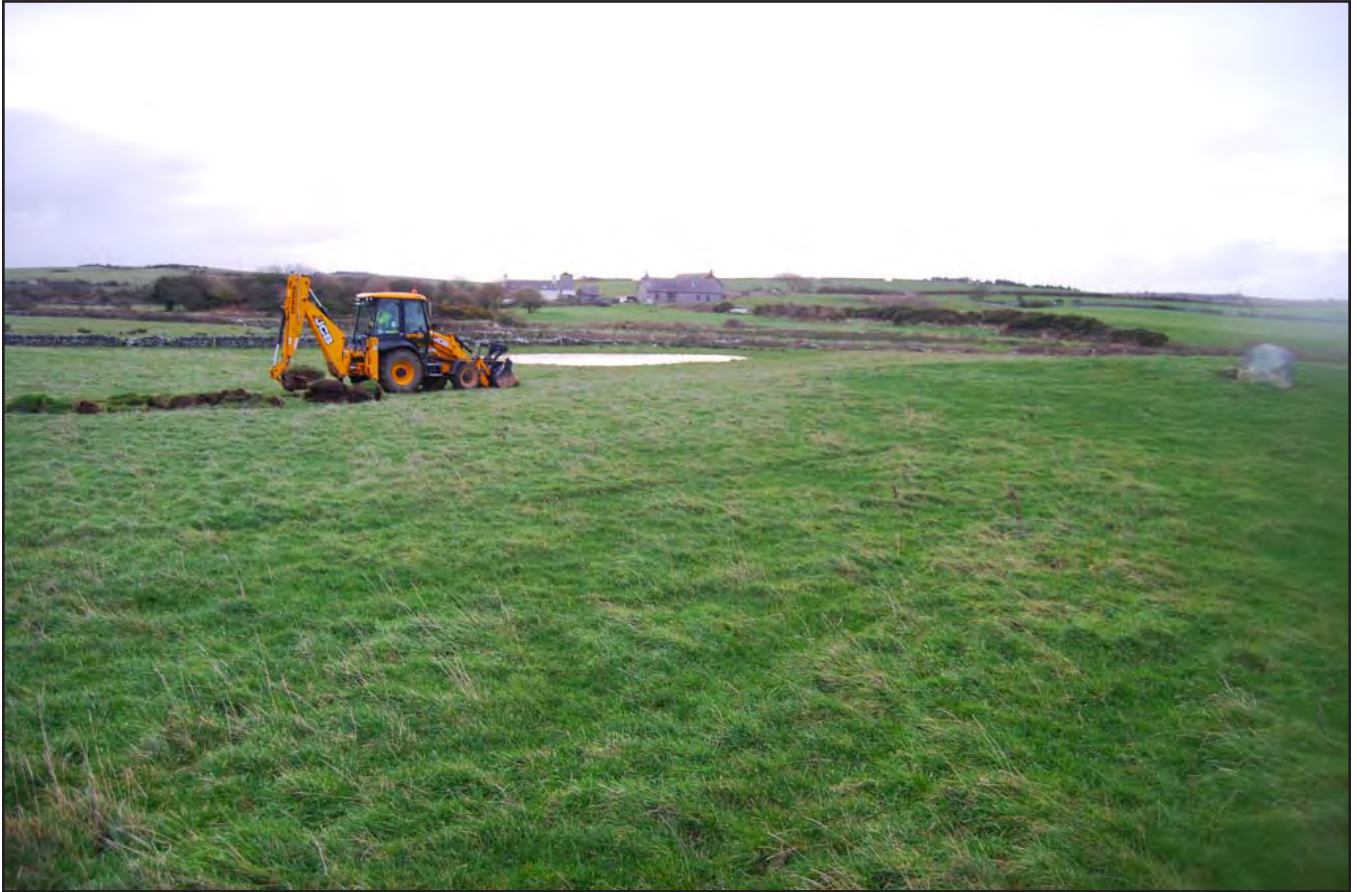
Plate 01: General shot of Zone 01 and the location for Trenches 1 and 2

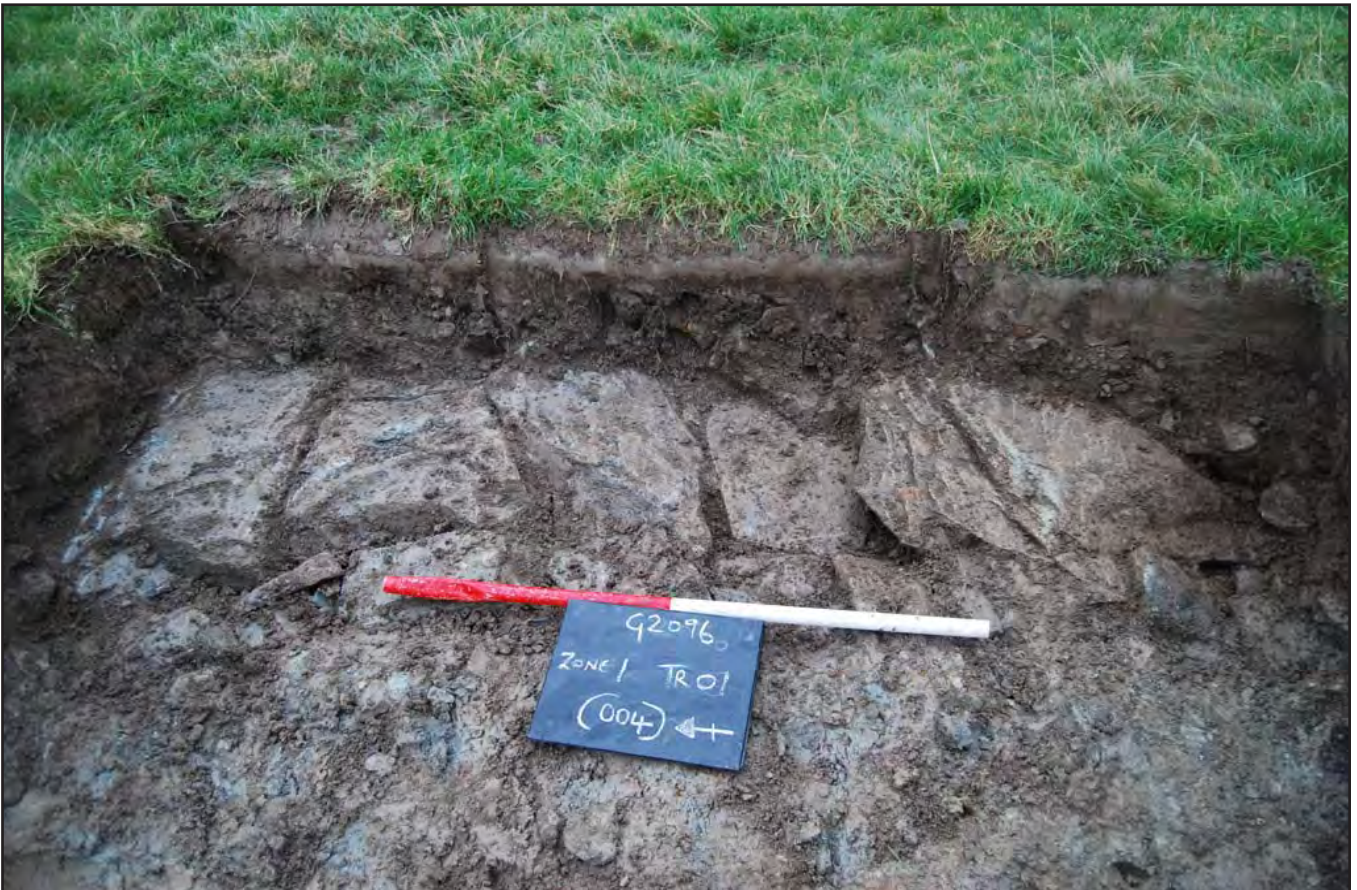
Plate 02: Large field drain/culvert in Trench 1, viewed from the west

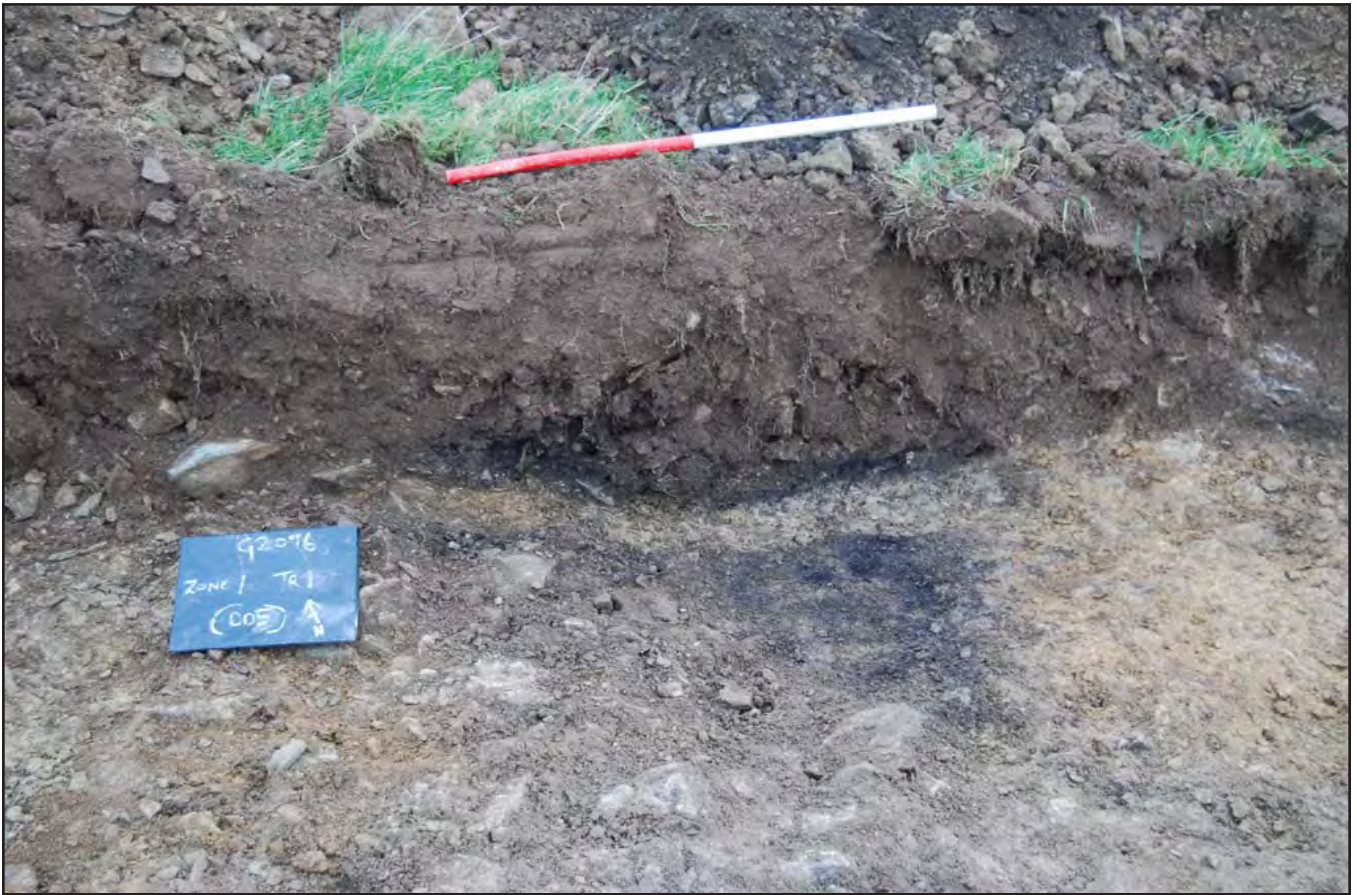
Plate 03: Possible field boundary in Trench 1, with evidence of root burning in feature

- Two features were identified with the confines of the trench:
 1. A field boundary (GAT Report **987** Feature 5): characterised as a very shallow former field boundary with a N-S orientation across the trench. A small section on the northern side was excavated to test the profile. The fill was very similar to the subsoil above in composition, but had more root present as well as evidence of root burning. The width of the field boundary was 0.85m, with a depth of 0.08m, and probably dates to the 18thC or 19thC. *This is most likely a field boundary extant on the 25" First Edition Ordnance Survey map of the area* (Figure 7)

- Evidence for root burning was also identified within the trench at the subsoil horizon. This burning may have created a thermoremnance signal during the magnetometer geophysical survey

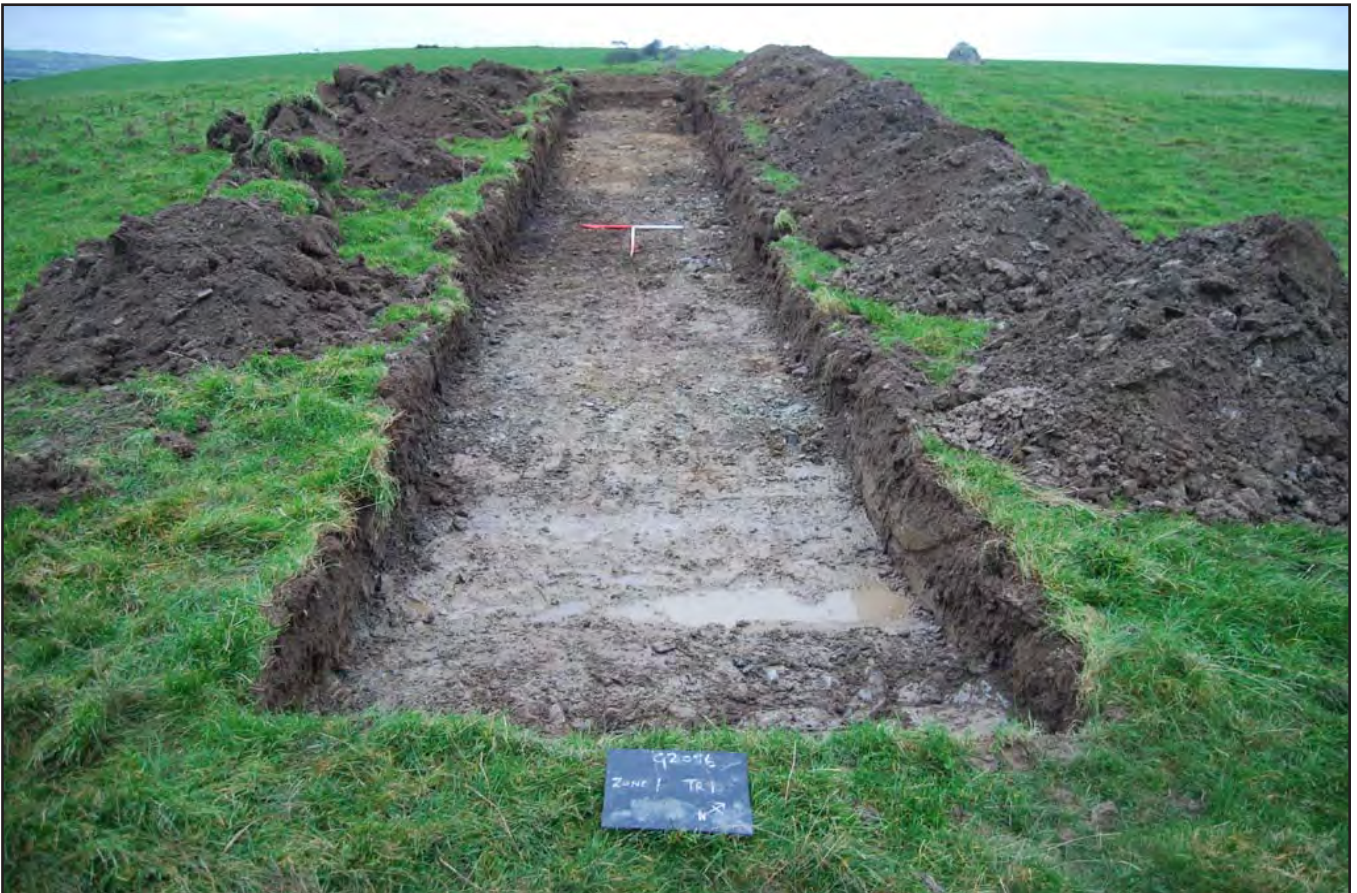
Plate 04: Post excavation view of Trench 1, with field drain in foreground and boundary scales

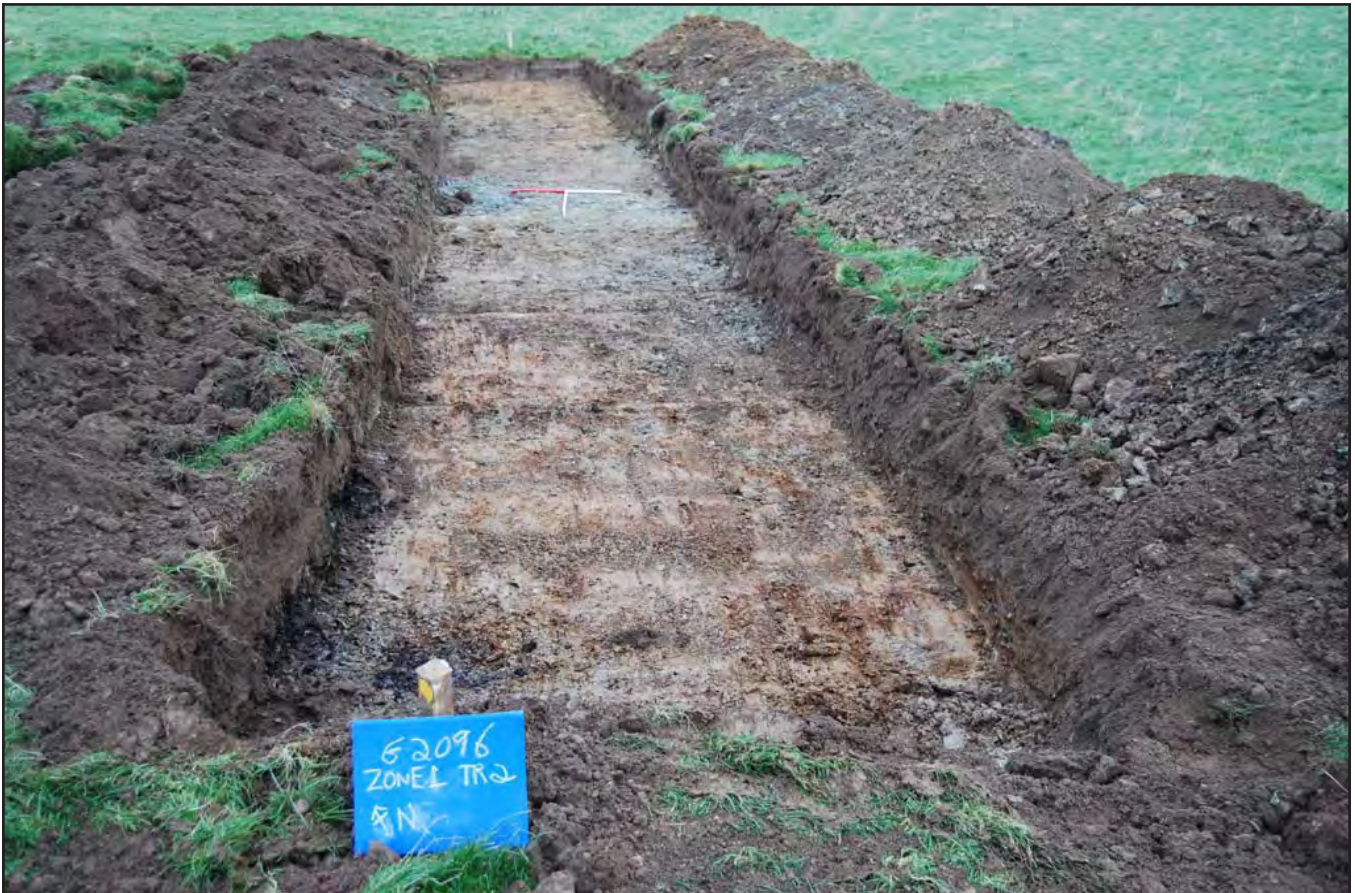
Plate 05: Post-excavation shot of Trench 2, viewed from the southwest with the field boundary at the location of the scales (cf. Plate 06 for a close up shot of the field boundary).

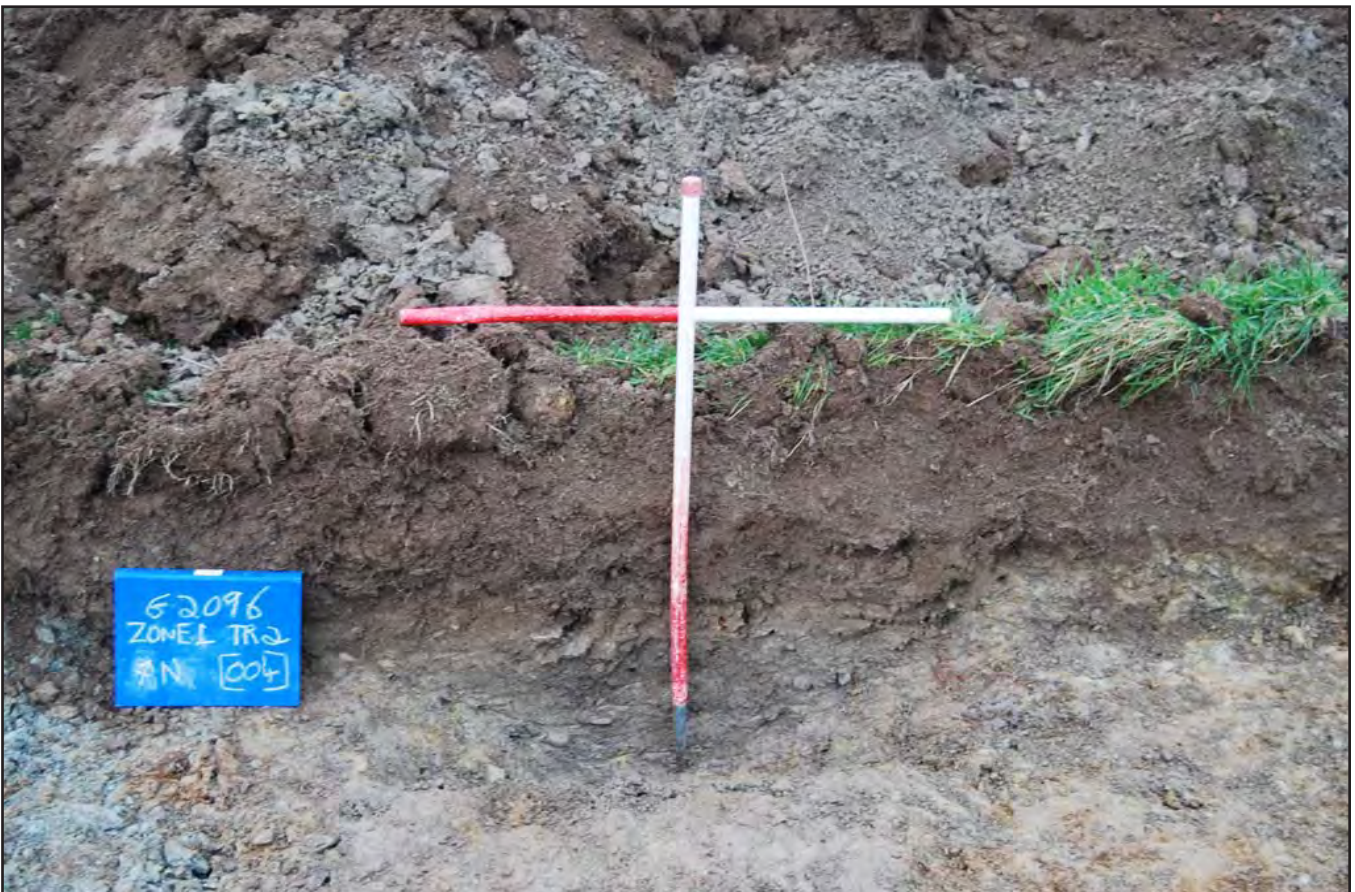
Plate 06: East-facing section of the shallow field boundary in Trench 2 (cf. Plate 05 for general view of the feature within the trench)

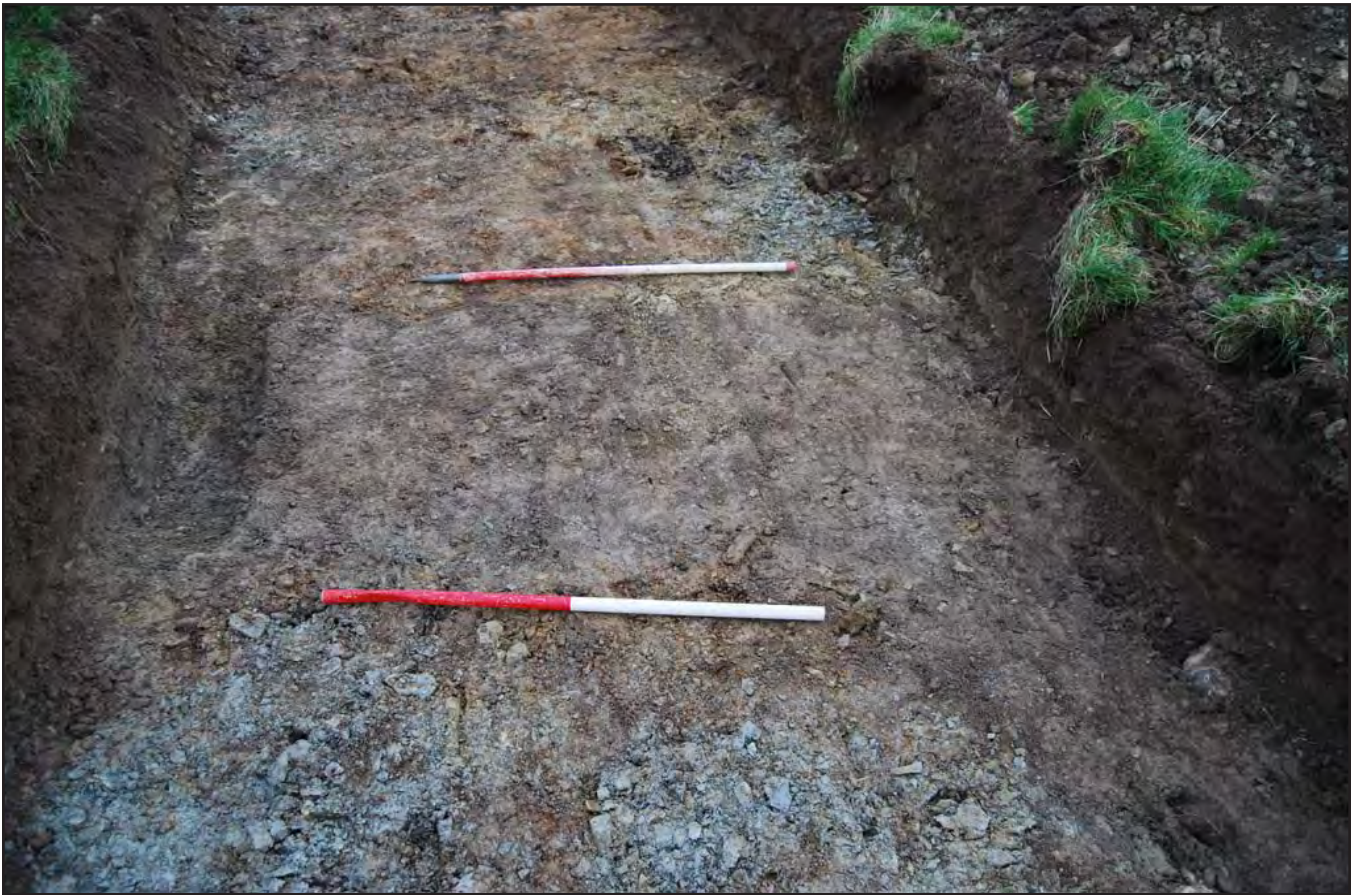
Plate 07: South-facing view of field boundary in Trench 02, sectioned on the left side

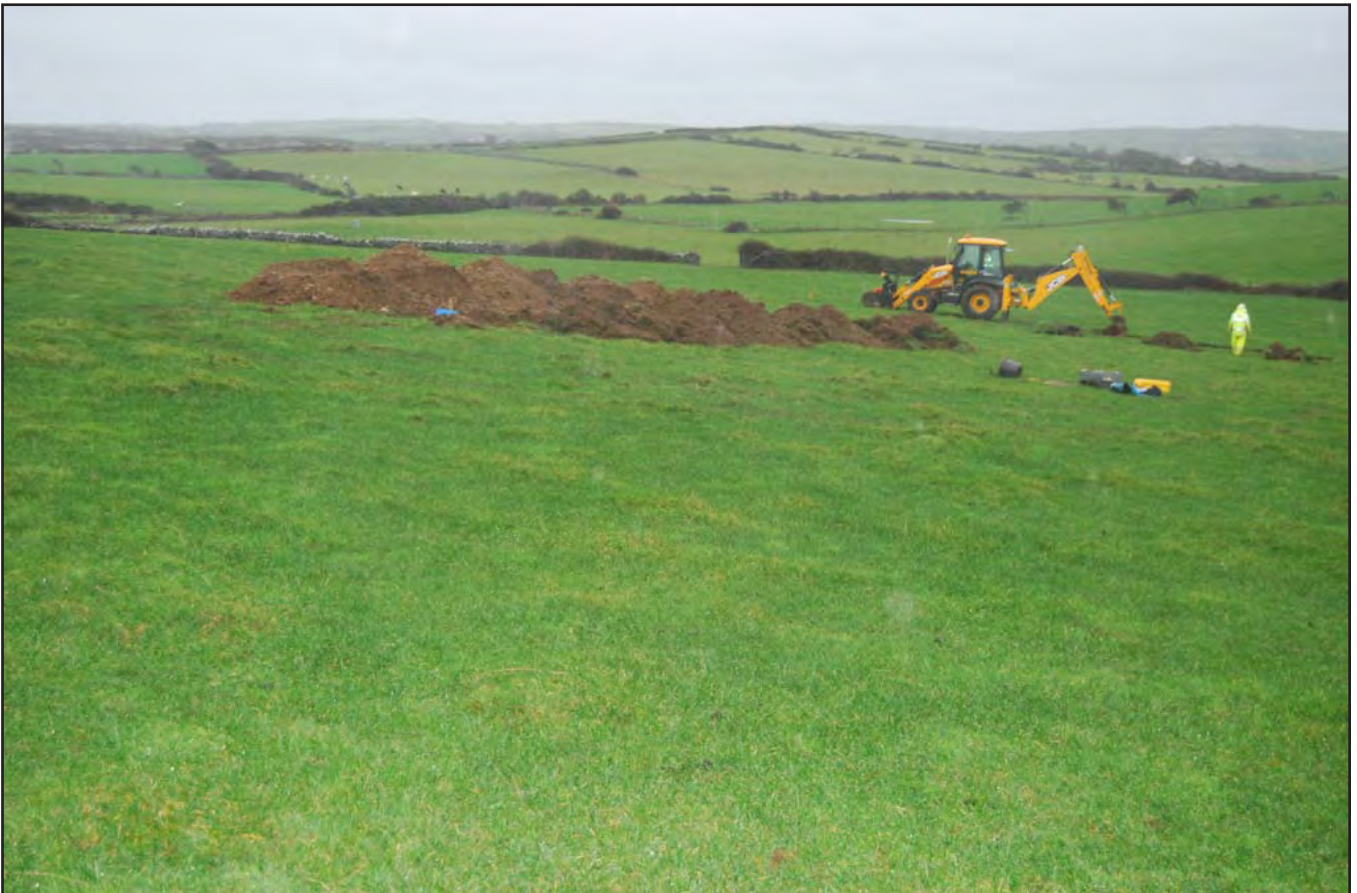
Plate 08: General shot of the trenching in Zone 02: Trench 4 is located in the foreground, with Trench 3 in the background (the JCB is positioned within Trench 3)

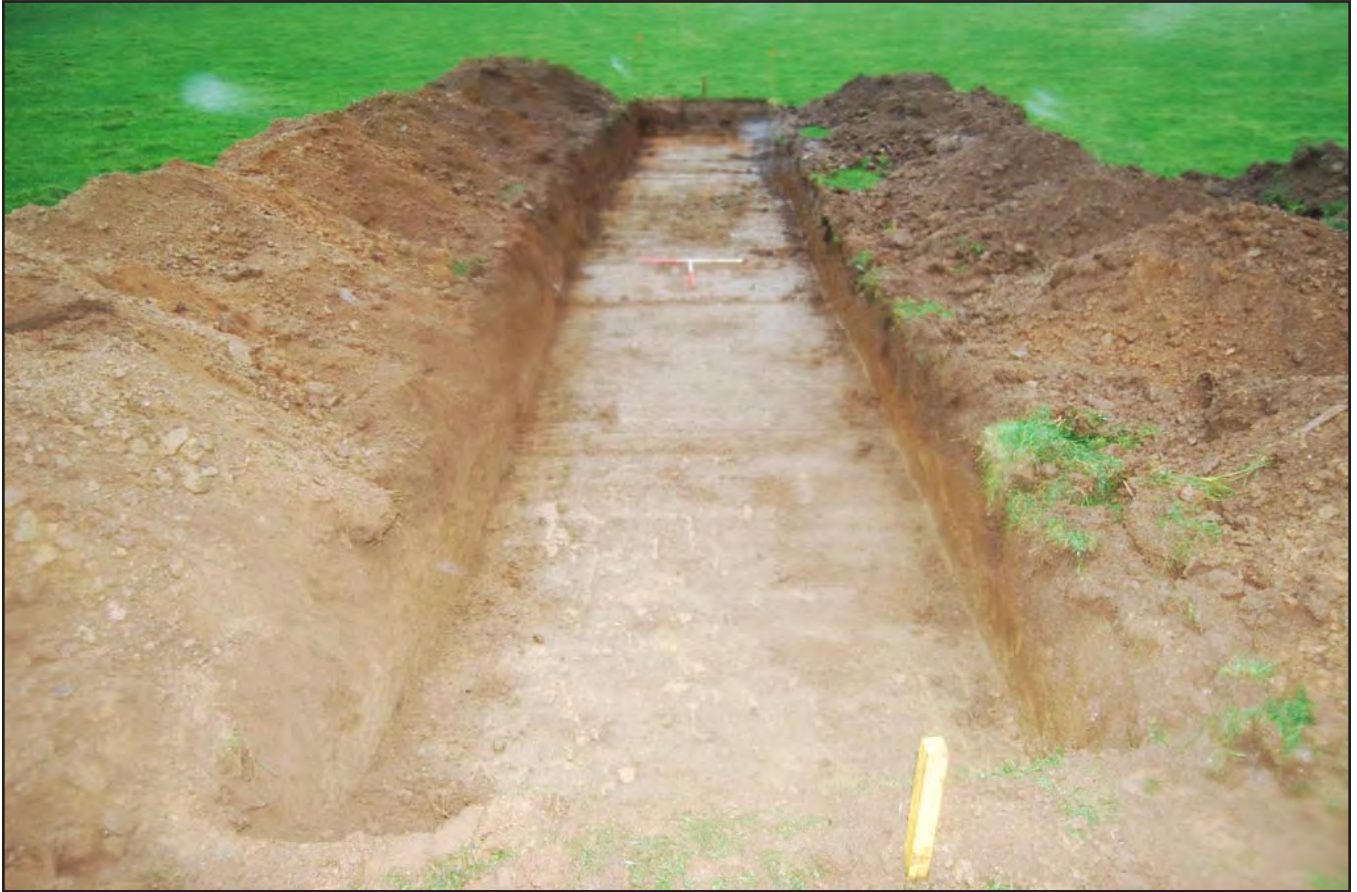
Plate 09: Post-excavation shot of Trench 3 from the north-west

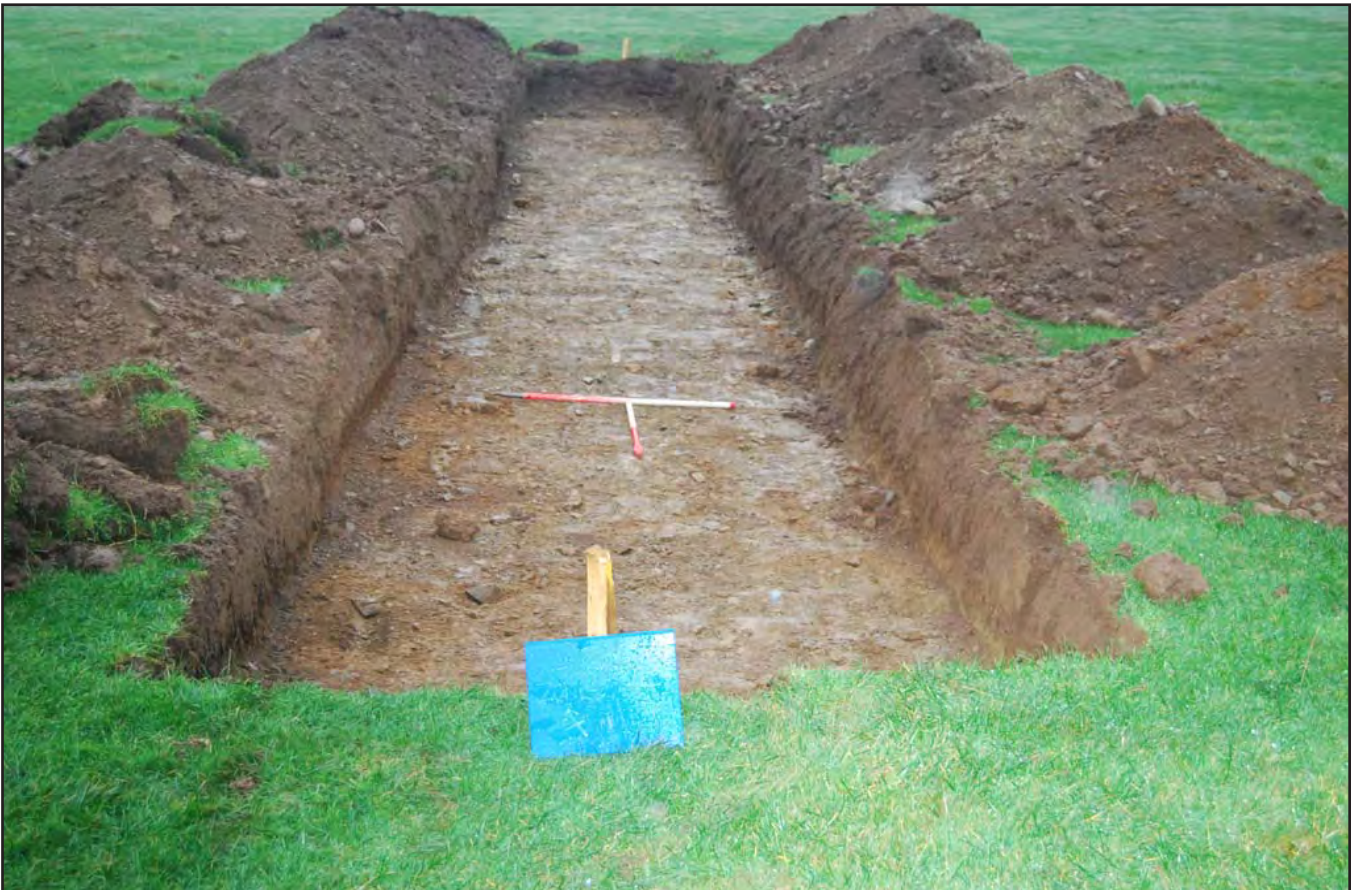
Plate 10: Post-excavation shot of Trench 4 from the north-east in Zone 02

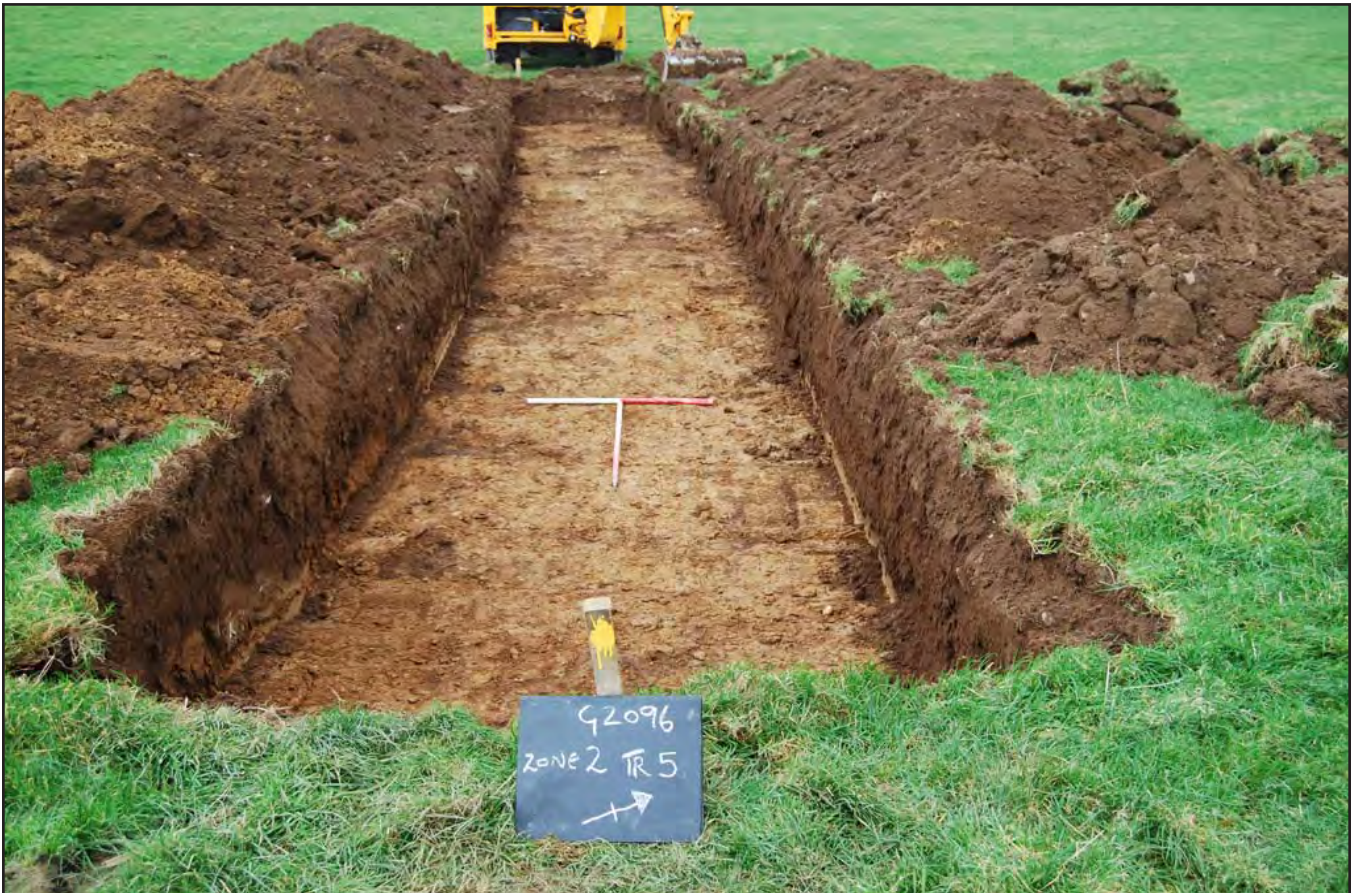
Plate 11: Post-excavation shot of Trench 5 in Zone 03; no archaeological features found

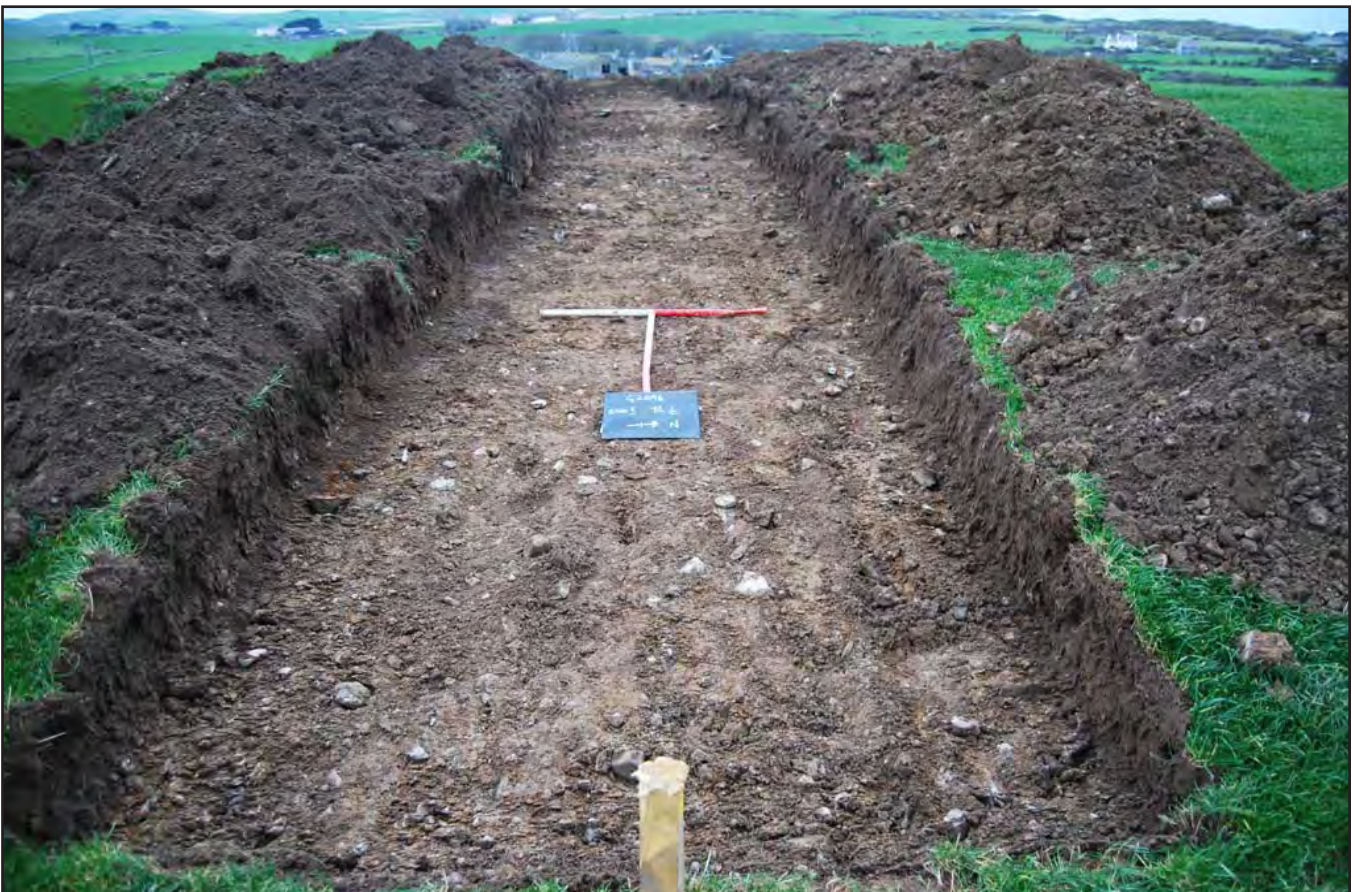
Plate 12: Post-excavation shot of Trench 6 in Zone 03; no archaeological features found

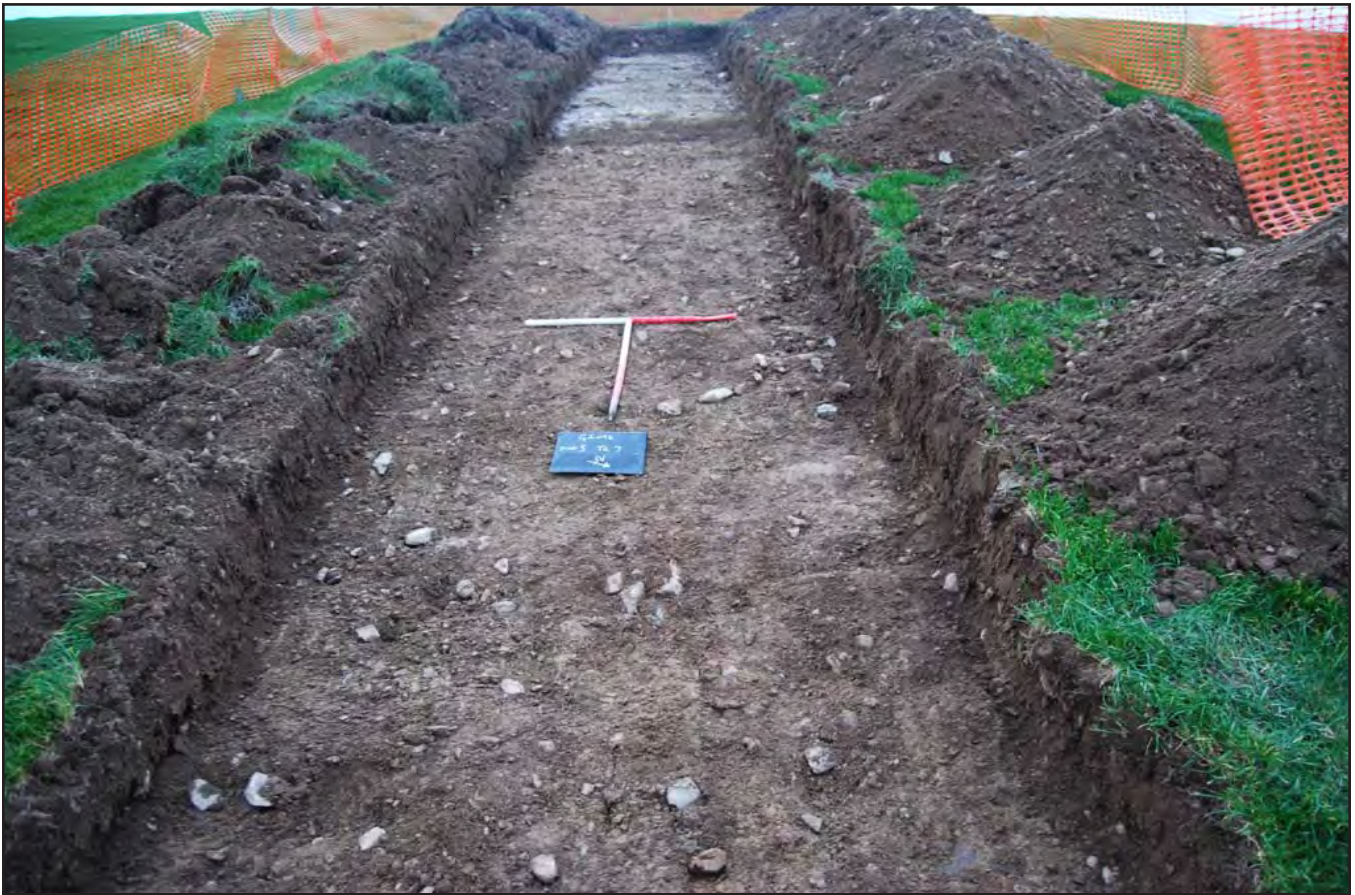
Plate 13: Post-excavation shot of Trench 7; the field boundary ditch identified was located towards the western end of the trench (cf. Plate 14 for a detailed shot of the feature).

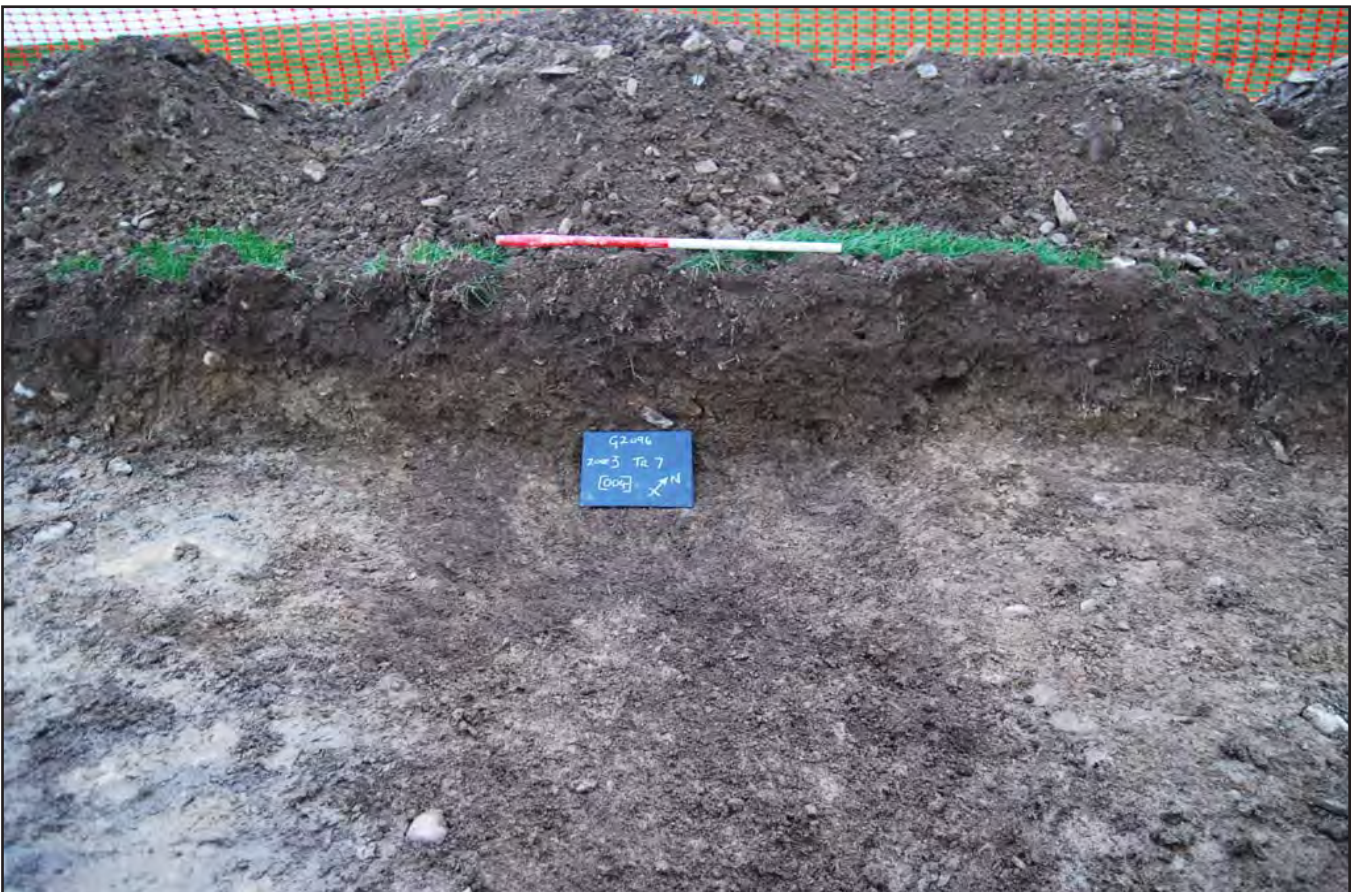
Plate 14: Trench 7 - southeast facing section of the shallow field boundary

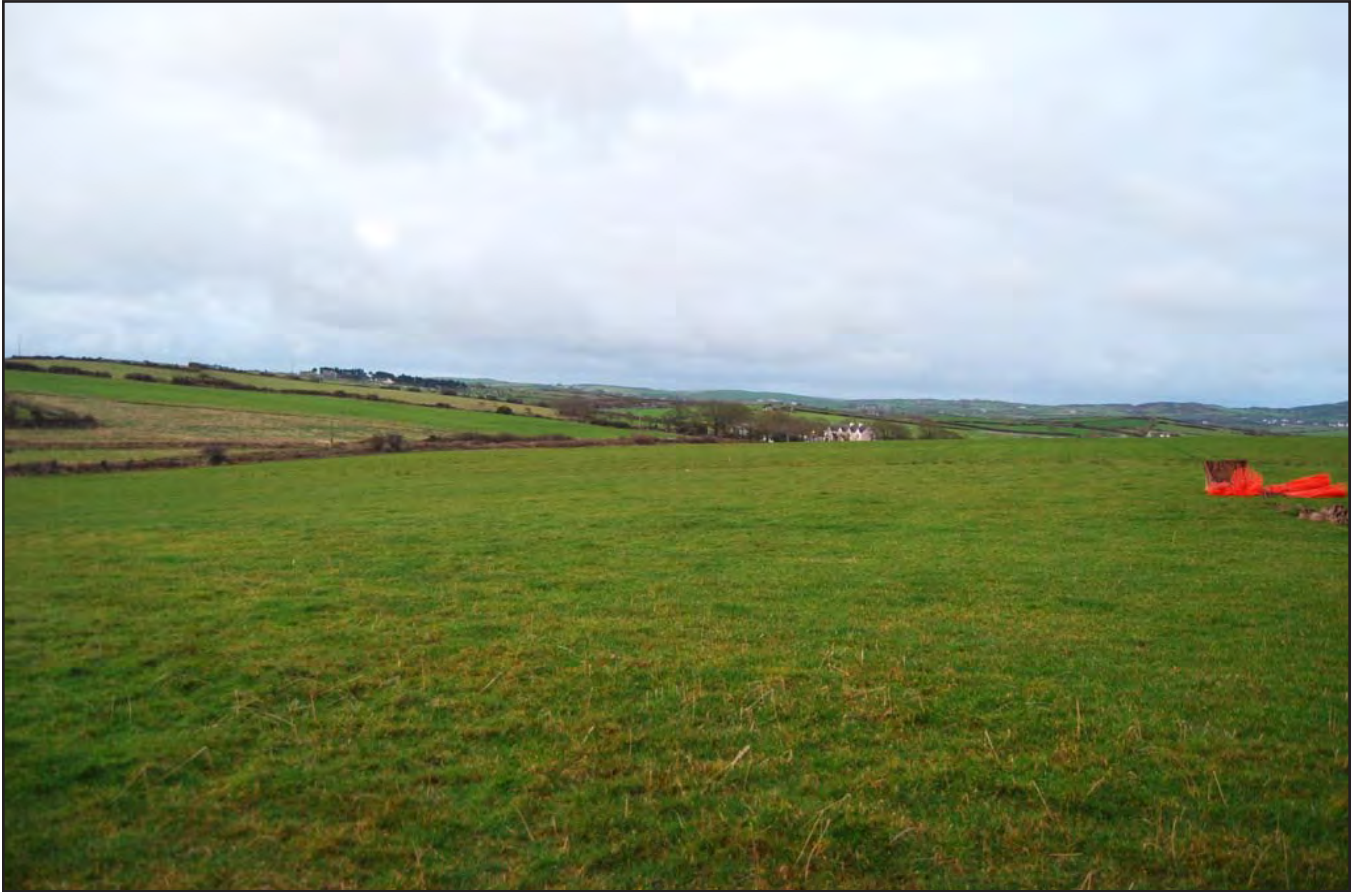
Plate 15: Pre-excavation location shot for Trench 8 within Zone 04

- Location: Zone 4 (figures 01 & 05; plates 15 to 17)
- Size: 20.0m x 2.0m x 0.31m Orientation: NE-SW
- Description: Trench 08 was positioned across GAT geophysical survey Feature 24 (possible burnt mound).

- There were two parallel and modern ditches running in a NW-SE direction across this trench that were interpreted as a former hedge-bank and ditch that can be also be seen on the surface. The targeted feature (GAT Report **987** Feature 24) was a possible shallow tree bole, which contained some manganese and light root burning, irregular in shape and 0.10m deep, possibly associated with the former field boundary (the former field boundary can be seen on the 25" First Edition Ordnance Survey map of the area; cf. Figure 07).
