Proposed Nuclear Power Station Wylfa, Ynys Môn

Archaeological Evaluation: Trial Trenching

Project No. G2096

Report No. 1015

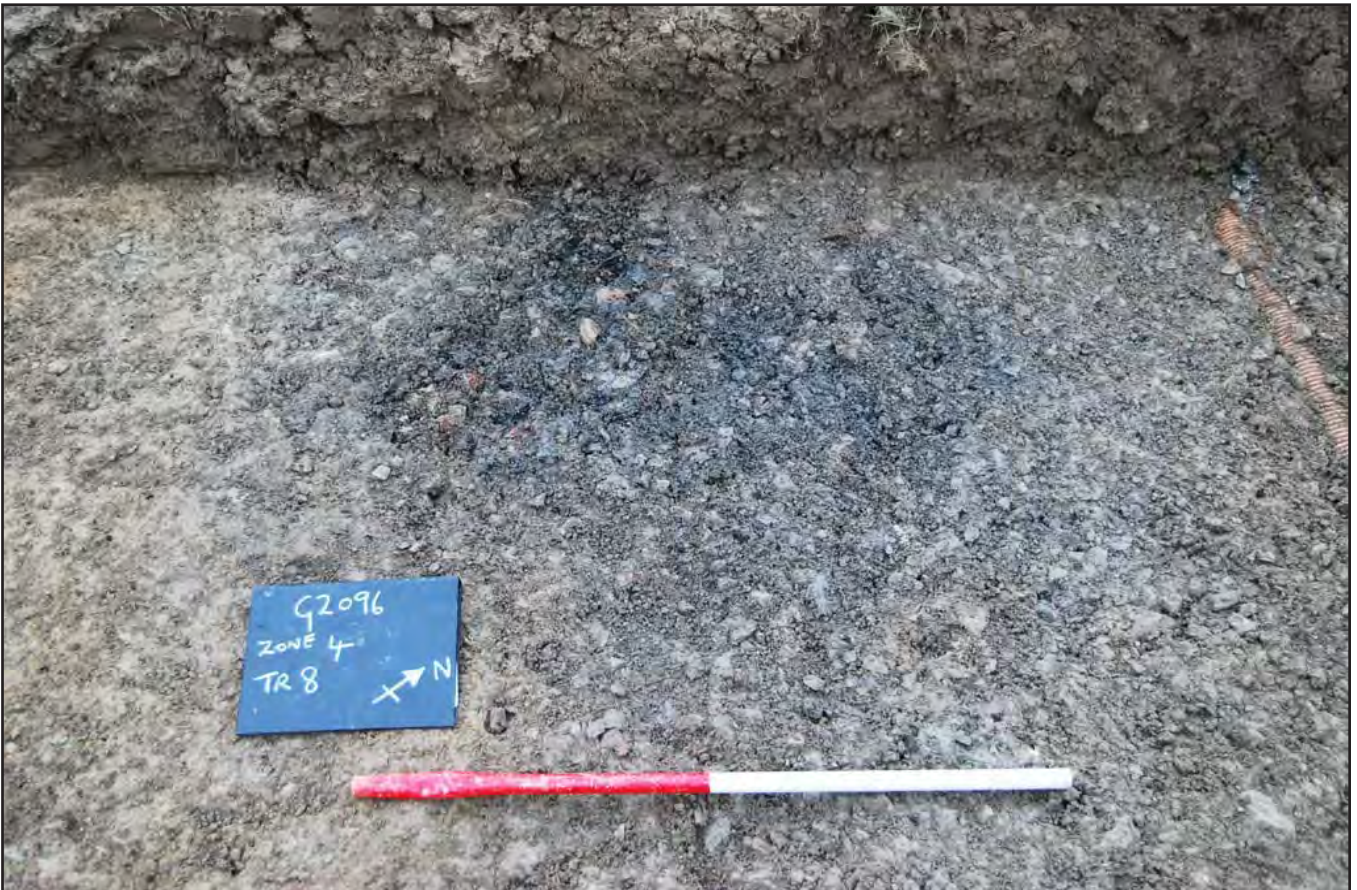
Plate 16: Trench 8 - Detail of irregular shaped hollow containing burnt root and manganese. This feature was interpreted in the GAT geophysical survey of Zone 04 as a possible burnt mound (GAT Report 987: Feature 24). The results from the trenching confirmed that it was in fact evidence for root clearance

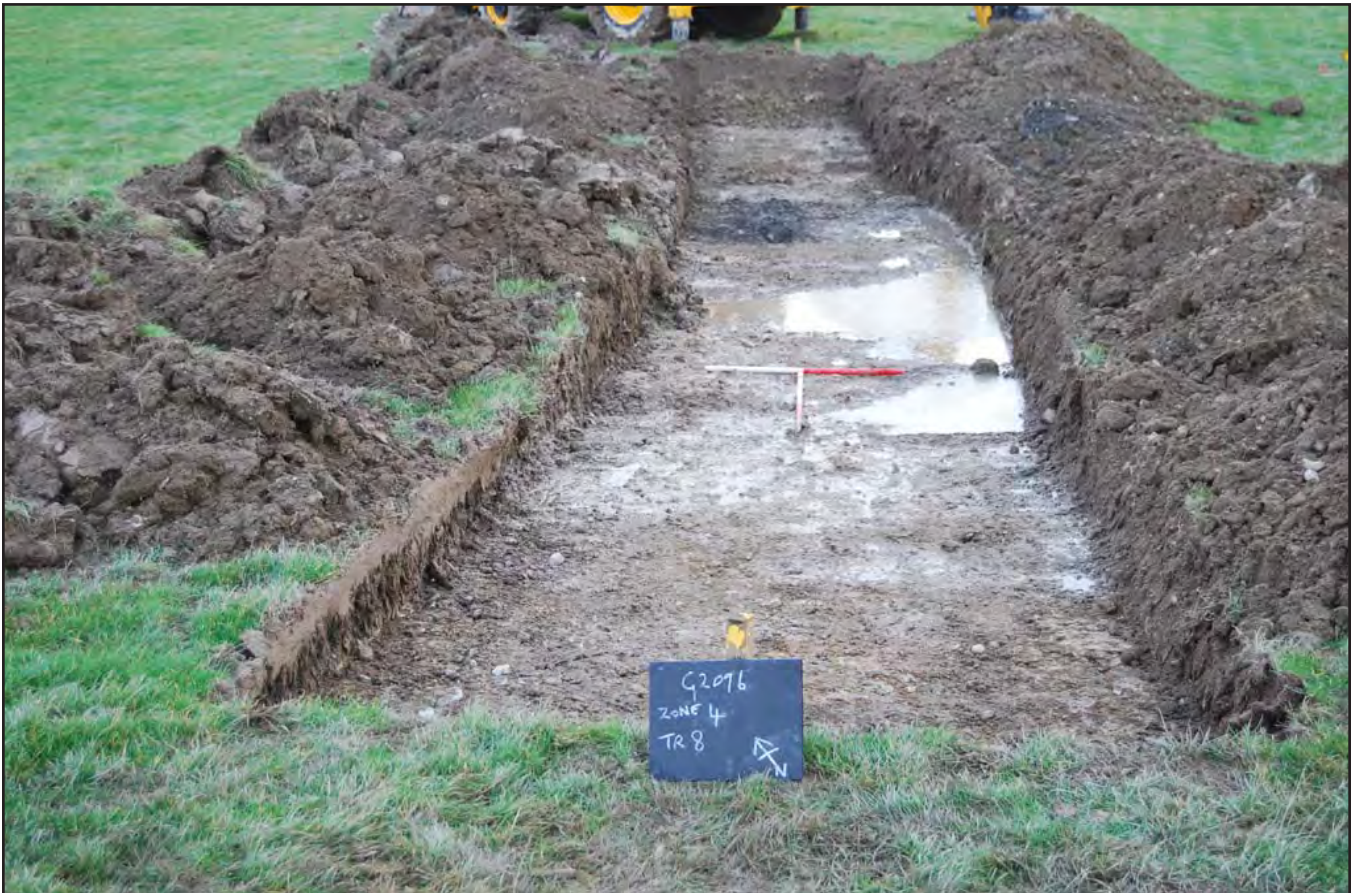
Plate 17: Pre-excavation shot of Trench 8 from the southwest, area of root burning/manganese clearly visible towards the southern end of the trench (cf. Plate 16 for a detailed image). This feature was initially thought to be a possible burnt mound, based on a geophysical anomaly (GAT Report 987/Feature 24). Trench 8 confirmed the feature was not of prehistoric origin

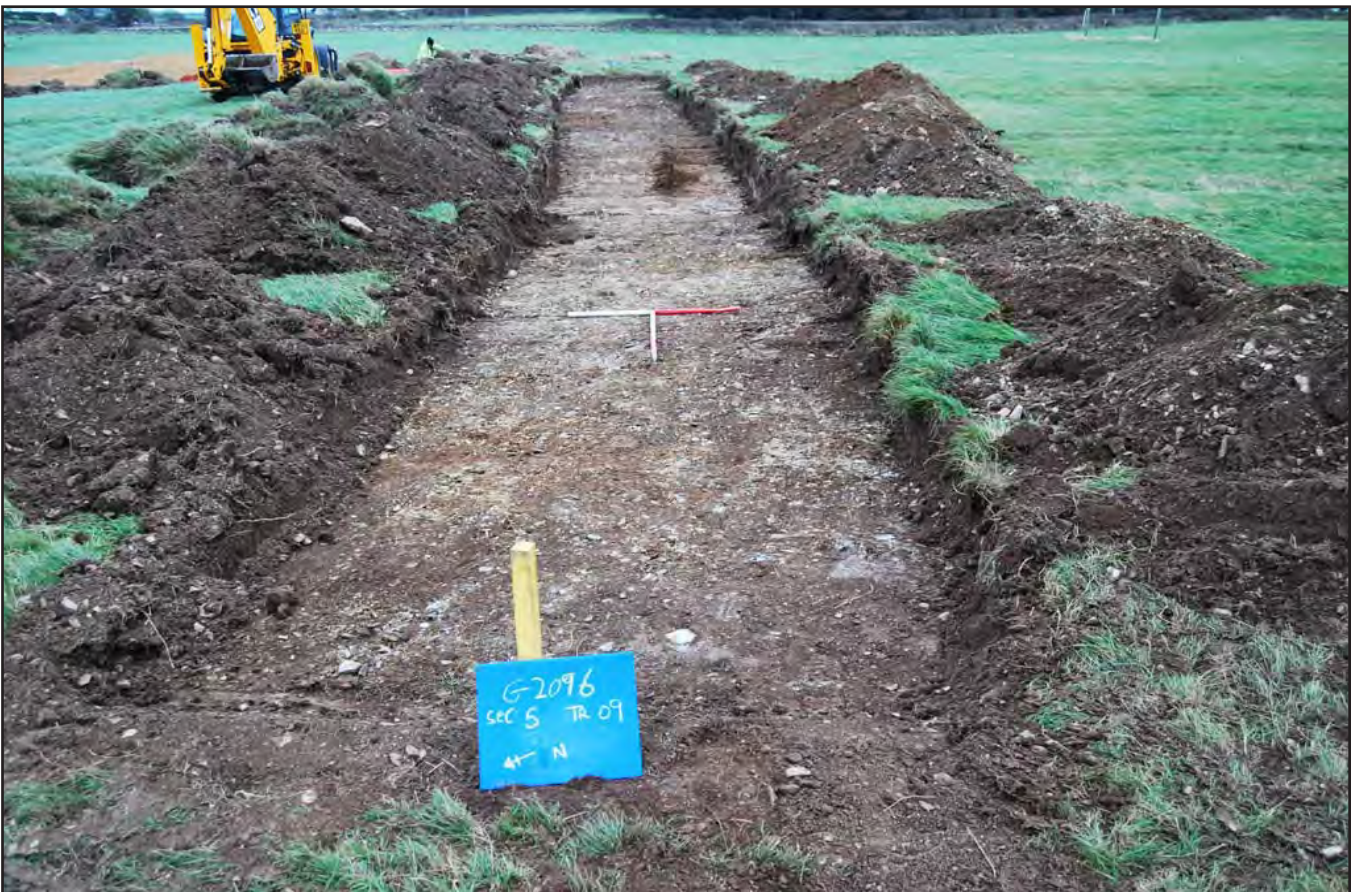
Plate 18: Post-excavation shot of Trench 9 in Zone 05. Shallow bedrock (shale) was extant in the western end of the trench (foreground of image).

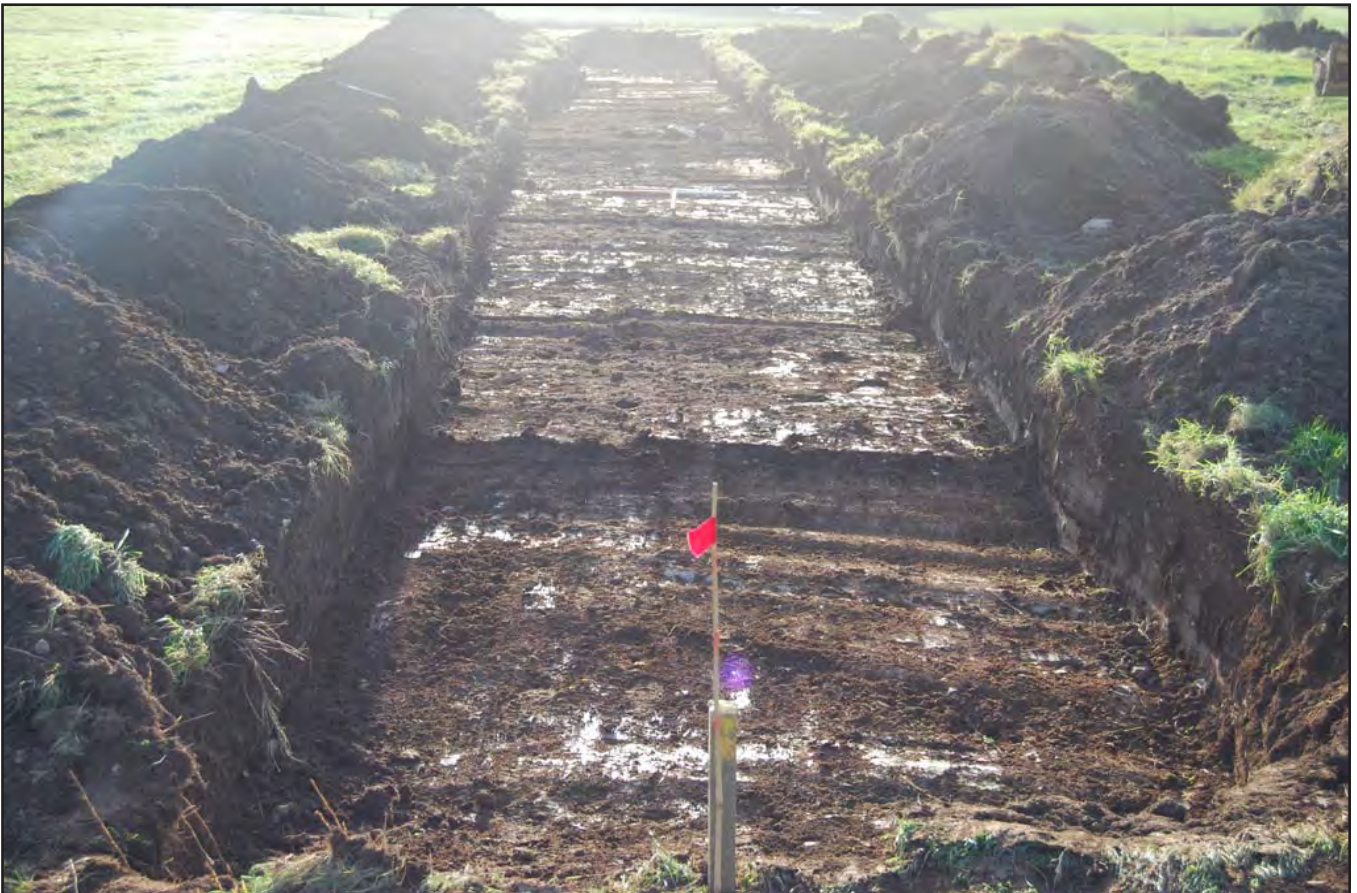
Plate 19: General pre-excitation shot of Zone 05, and location for Trench 10

- Location: Zone 5 (figures 01, 06 & 08; plates 19 to 24)
- Size: 31.0m x 2.20m x 0.60m Orientation: NNE-SSW
- Description: Trench 10 was positioned across GAT geophysical survey Features 33 (linear anomaly possibly former boundary or drainage)

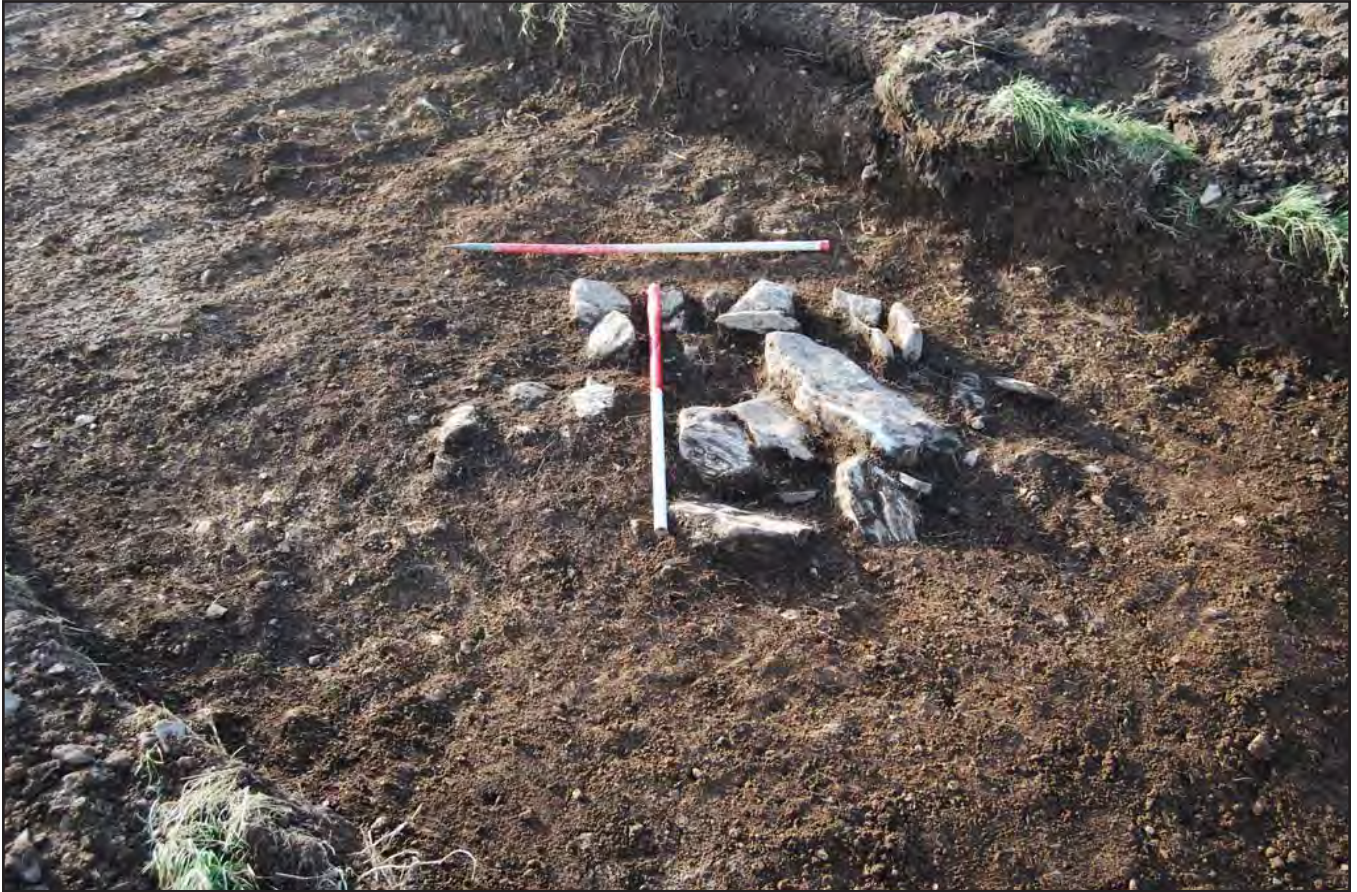
Plate 21: Pre-excavation shot of pit [Context10004] in Trench 10; viewed from the east.

2. Pit fill (Context 10005): The fill of the pit was a dark brown silty clay with occasional flecks of charcoal and contained very large amounts of medium to large sub-rounded stones, some of which had been placed on their sides and others laid flat (Figure 08). No artefactual evidence for the dating or use of the pit was found, it could possibly be the remains of a grave or a backfilled storage pit.

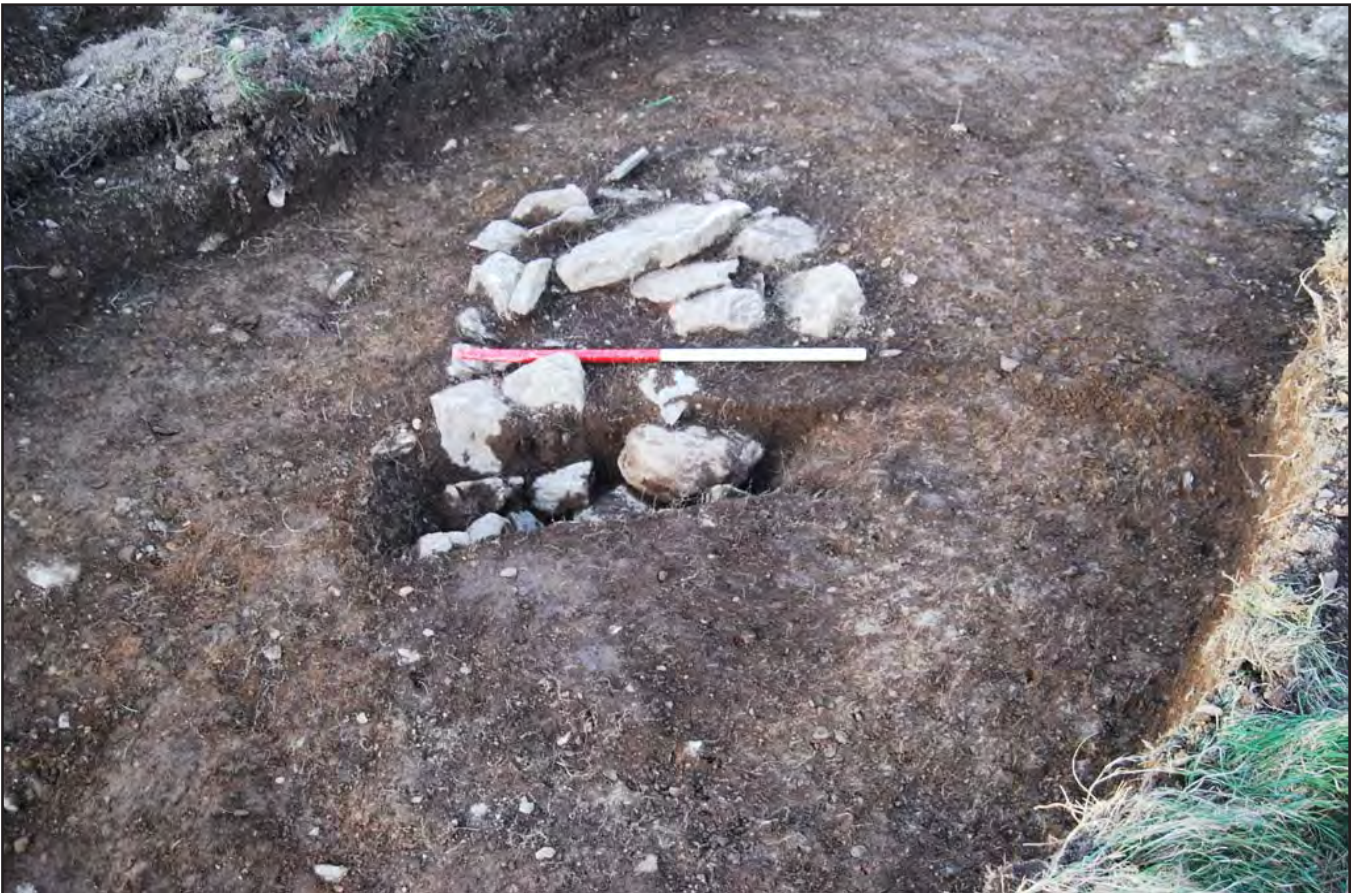
Plate 22: View of pit [Context10004] in Trench 10 from the southeast during excavation

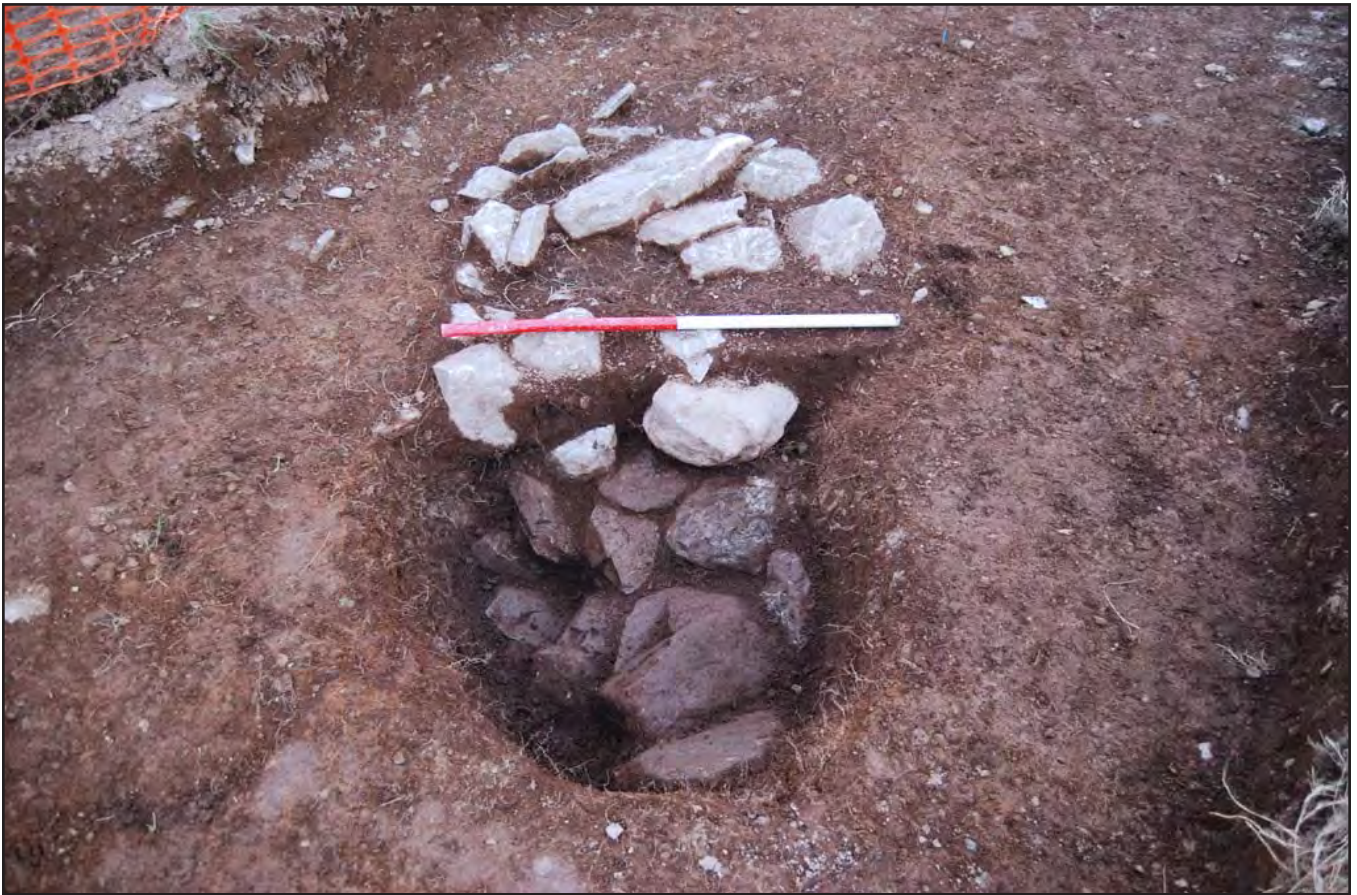
Plate 23: View of pit [Context10004] in Trench10 from the southeast during excavation and partial removal of stone fill (Context 10005).

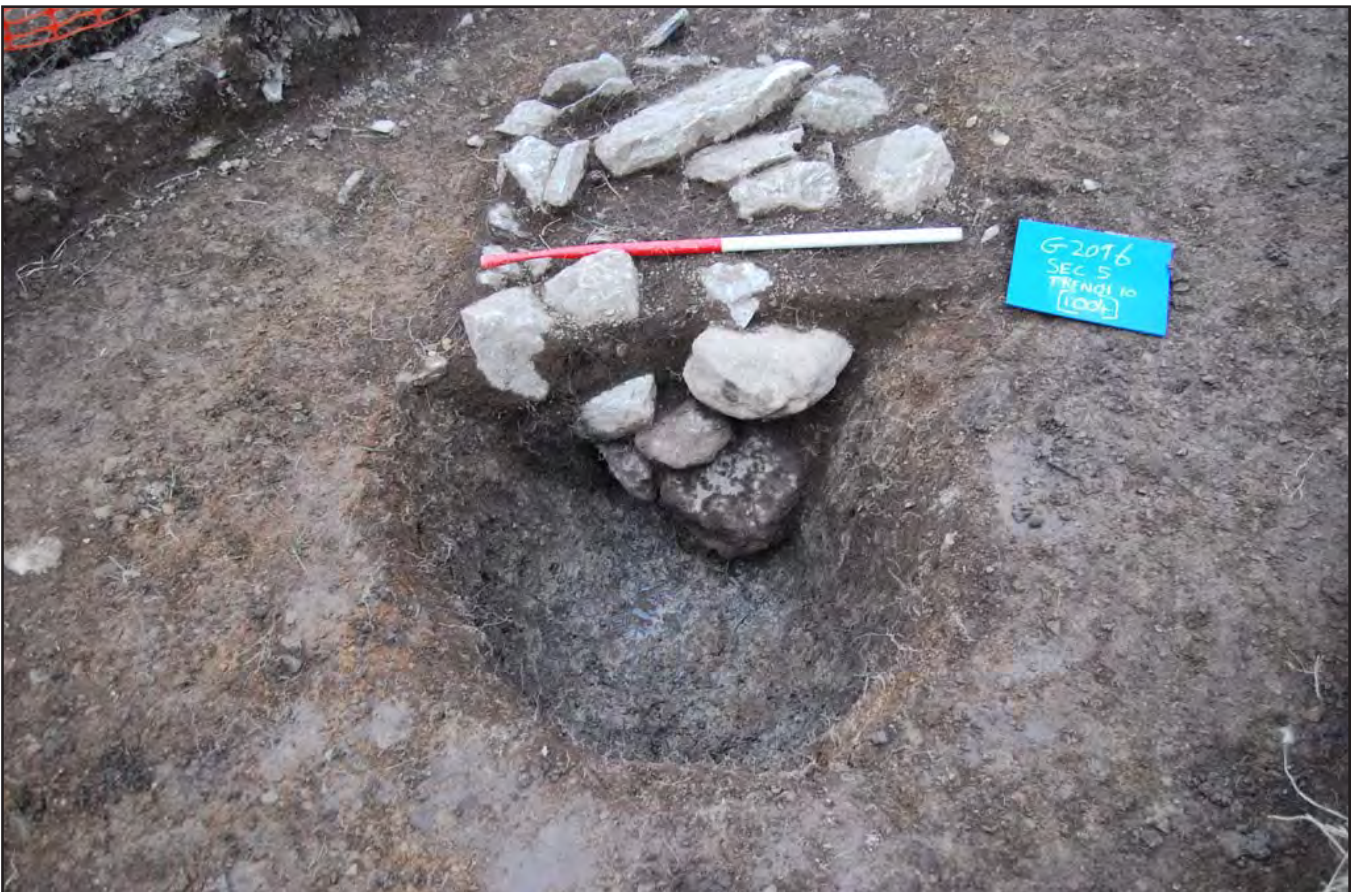
Plate 24: View of pit [Context10004] in Trench10 during the excavation and removal of stone fill (Context 10005) from the southeastern portion of the pit.
