# Proposed Nuclear Power Station Wylfa, Anglesey

Archaeological Evaluation:  
Geophysical Survey, Interim Report

Project No. G2096

Report No. 1019

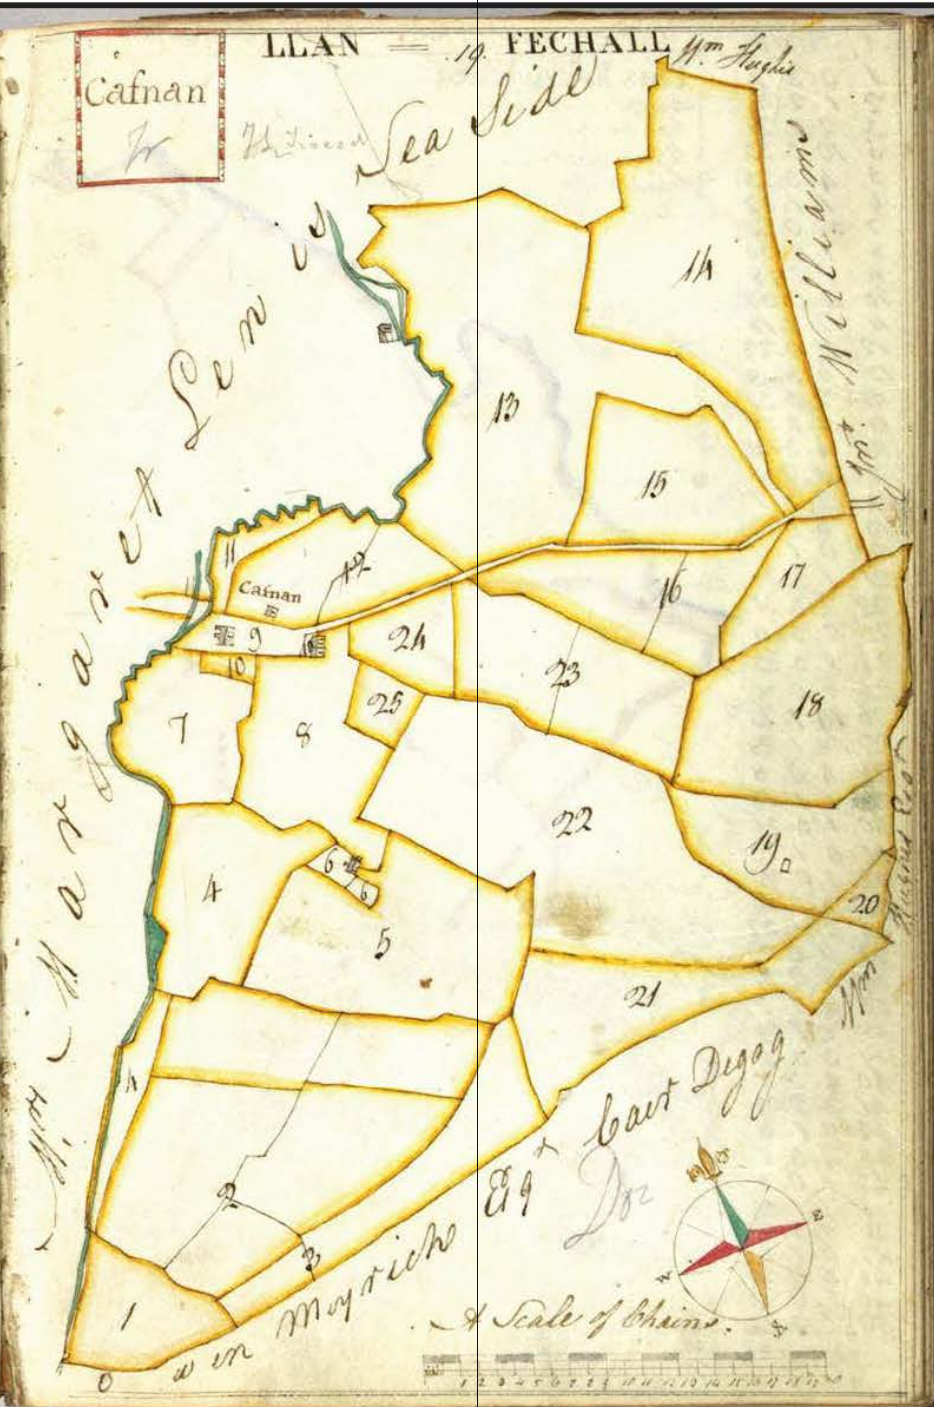
Fields & Names.	Anable	Pasture	Meadow
Cafnan	4 R.P.	4 R.P.	4 R.P.
1		3. 1. 27	
2	20. 2. 6		
3			4. 2. 17
4		7. 1. 0	
5	9. 2. 19		
6	0. 2. 13		
7			4. 1. 8
8		5. 2. 36	
9		2. 3. 9	
10	0. 2. 7		
11			0. 2. 1
12	4. 2. 10		
13		17. 3. 31	
14	14. 3. 17		
15	6. 0. 34		
16	5. 2. 19		
17	2. 3. 12		
18	10. 1. 22		
19	5. 2. 7		
20			0. 3. 1
21			7. 2. 10
22	16. 3. 30		
23	7. 0. 33		
24	1. 3. 30		
25	1. 0. 22		
	108. 2. 1	37. 0. 23	17. 2. 37
	163. 1. 21	Total

The agricultural landscape of dispersed settlement preserves elements that have evolved over centuries, in particular the patterns of roads, footpaths and farm boundaries. This is illustrated by the map evidence and is pertinent to the geophysical surveys. A Carreglwyd and Berw estate survey from c.1780 (Fig 2) shows a series of small fields to the west of Wylfa. This was soon superseded and much of the present field system was in place by the time the first Ordnance Survey manuscript was produced in the 1820s (Fig. 3). There is little remaining earthwork evidence of the former field system and it appears that most early surface features were removed during the land improvements associated with the establishment of the modern field system. There have been few changes since the Ordnance Survey County Series maps of 1889 and 1924. Figures 4 and 5 show the 1889 edition, the 1924 is not included as it is almost identical. It should be noted that some surviving features such as the current road, some boundaries and Cafnan house can be recognised on the early estate survey. Comparison to recent maps indicates that the estate survey is semi-diagrammatic and not an accurate scaled map.

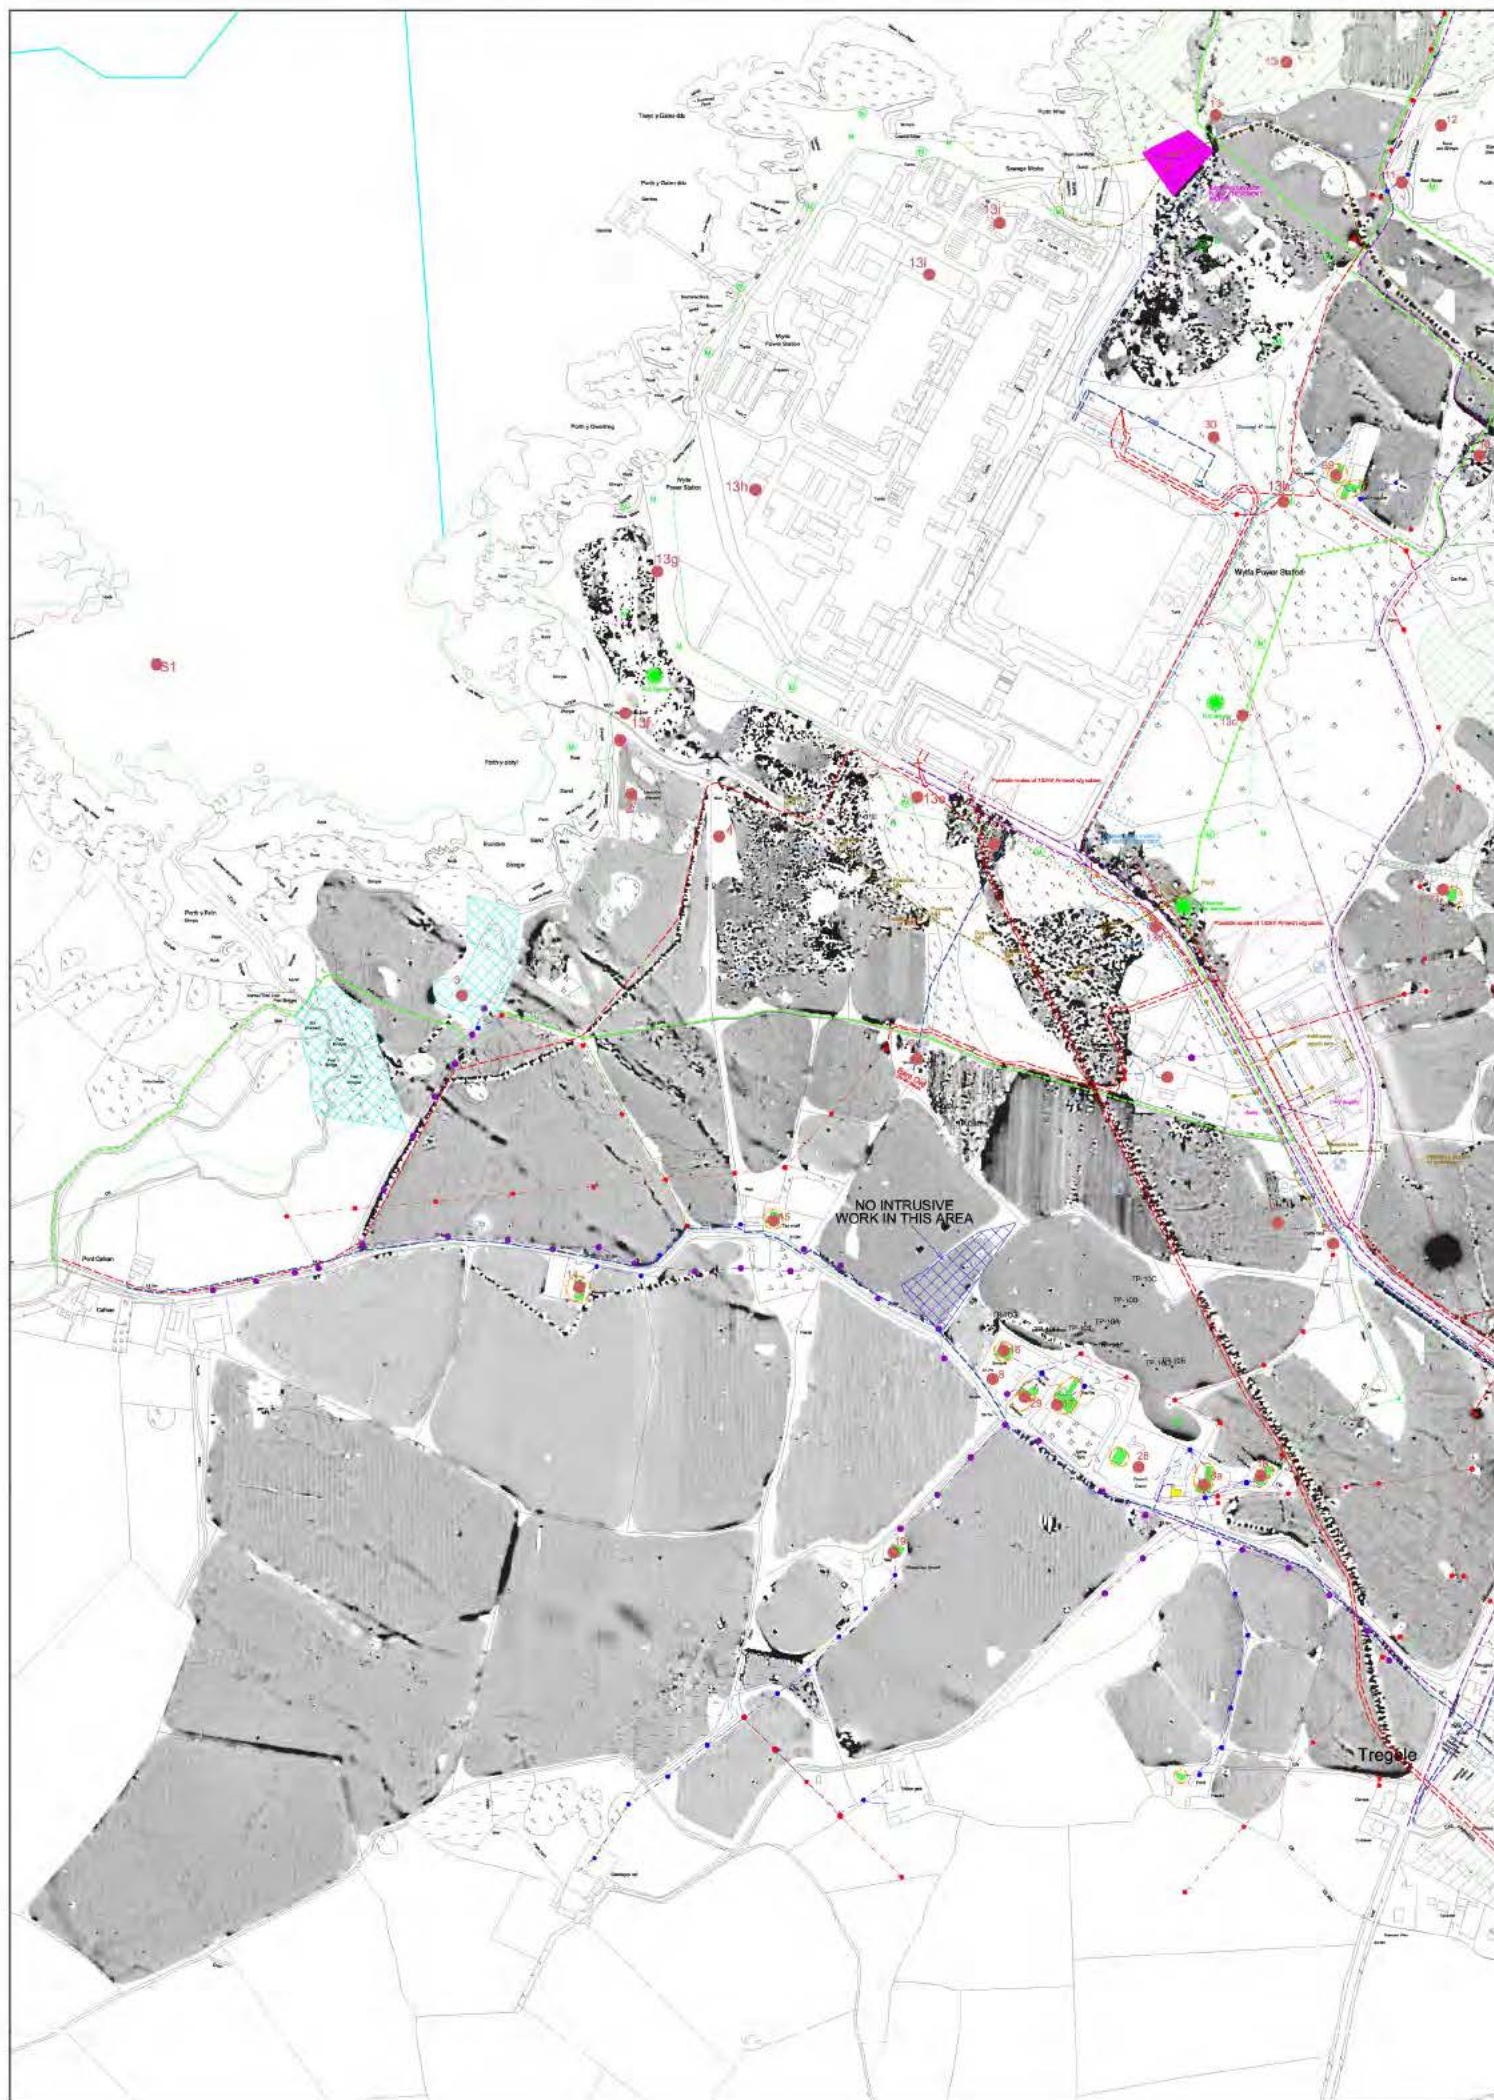
A geophysical survey of the current development zone was carried out by Fugro Aperio Ltd for Horizon Nuclear Power (Fig.6). This was carried out as part of an initial multiplatform survey/ground investigation programme of works. GAT monitored all relevant intrusive investigation works (inc. test pitting and trenching), and also provided an archaeological interpretation of the results of the Vertical Magnetic Dipole (VMD) component of the multiplatform survey. It should be noted that a further area of survey located to the south of the present area is still to be completed and will be presented in an updated version of this report.

The VMD survey used a pair of Caesium vapour magnetometers with a 1m traverse interval on a **GEEP** (Geophysical Exploration Equipment Platform) multiplatform survey sled towed by an all-terrain-vehicle. The survey results were presented to GAT as a grey-scale plot clipped to  $\pm 15\text{nT}$ . An interpretation plan and table of non-ferrous and non-geological magnetic gradient anomalies was produced (Fig. 6). Two further area of survey are currently awaiting completion and will be incorporated into a revised version of this report.
