# Dickie's Boatyard, Bangor

## Archaeological Assessment

Project No. G2259

Report No. 1049

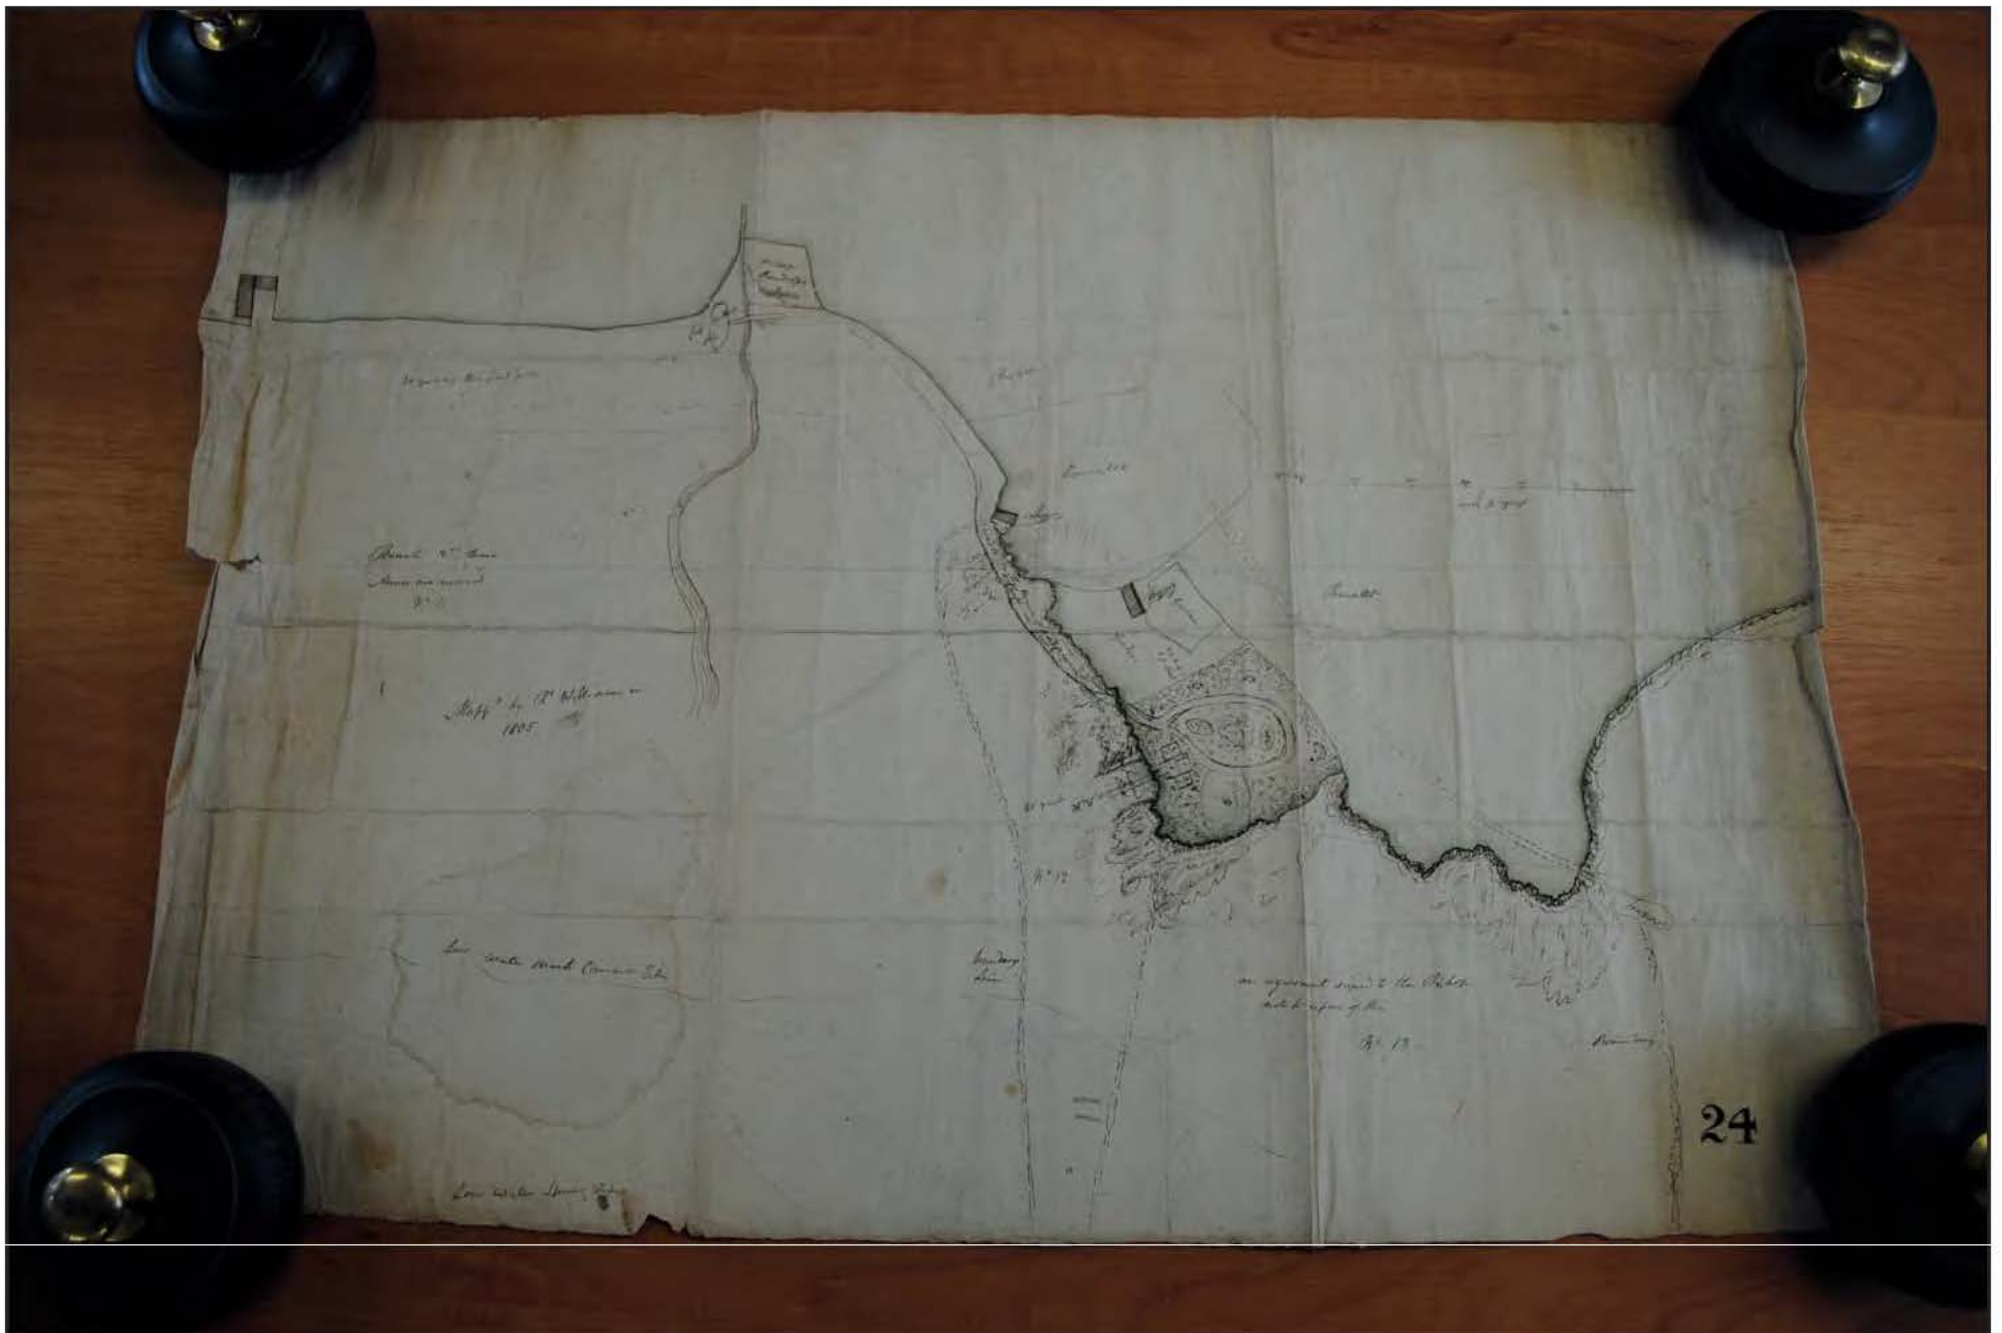
Figure 02 - Reproduction of Penrhyn Estate Map 206 #24 from 1805. The map is orientated from the sea looking at the coast. Garth headland is towards the centre of the image and the development zone is located to the left. The ship yard was established at the development site in 1836, from land leased to Edward Ellis by the Penrhyn Estate

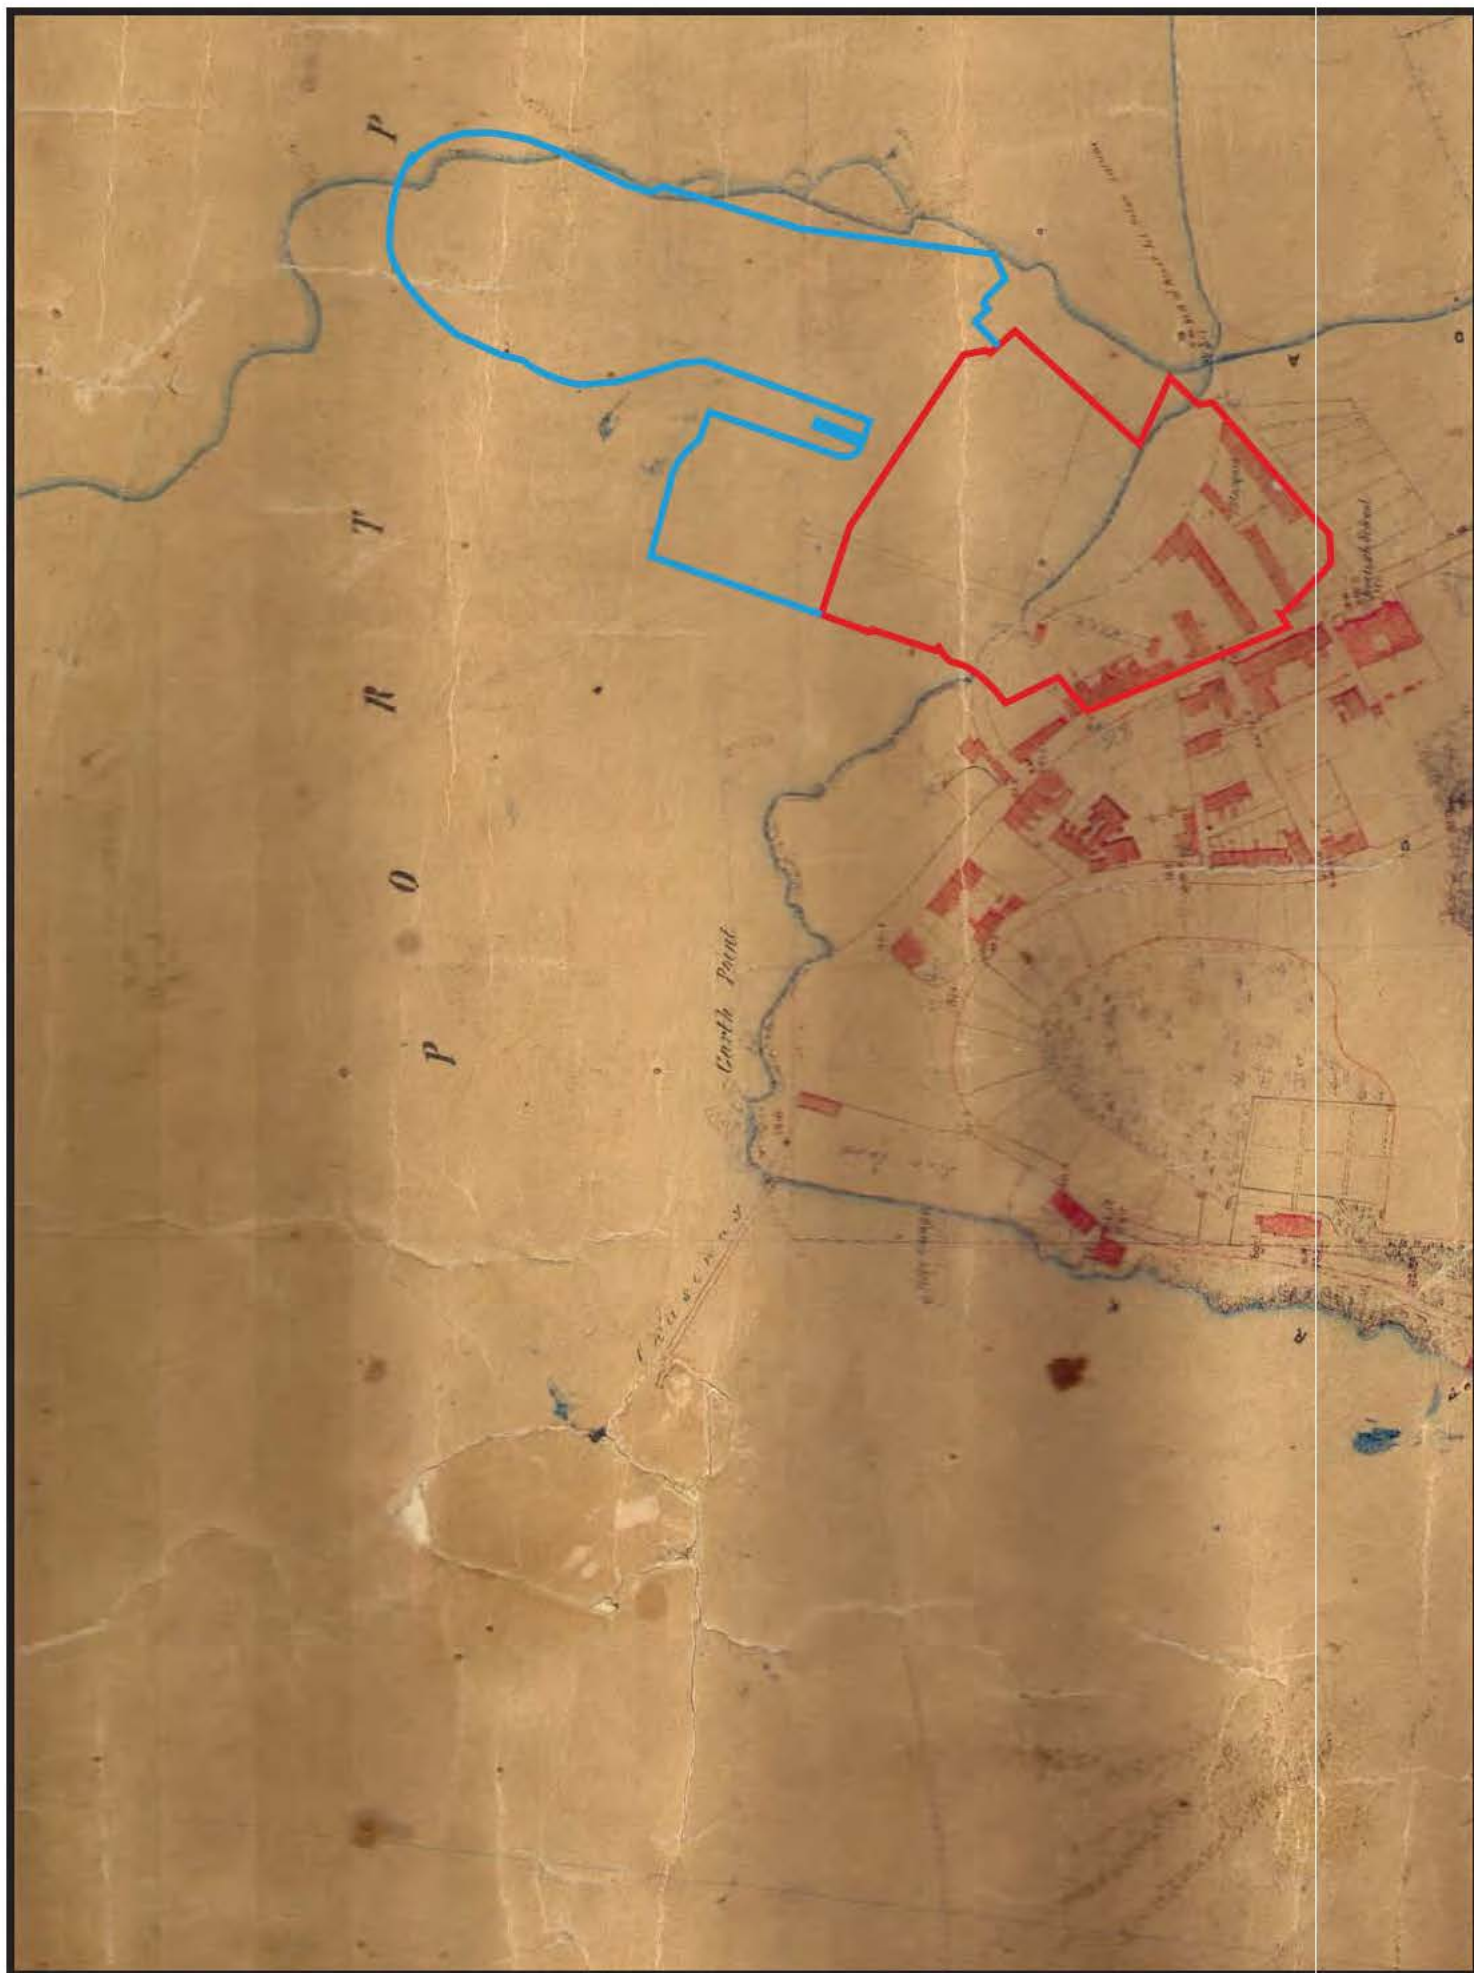
Figure 04 Detail from Captain Edward Johnson's map of Bangor 1854 (GAS XM/Maps/2754): the development zone is highlighted in red and blue; the red zone is the location for the proposed apartments and next stage watching brief. The Edward Ellis ship building yard with associated properties and slipway are visible within the red outlined area. The southern of the yard also includes Garth Slate Works established by 1849. The evolution of the yard infrastructure is visible on the First to Third Edition 25" Ordnance Survey Maps of the area (published 1890, 1900 and 1914, reproduced as Figures 6 to 8). NOT TO SCALE

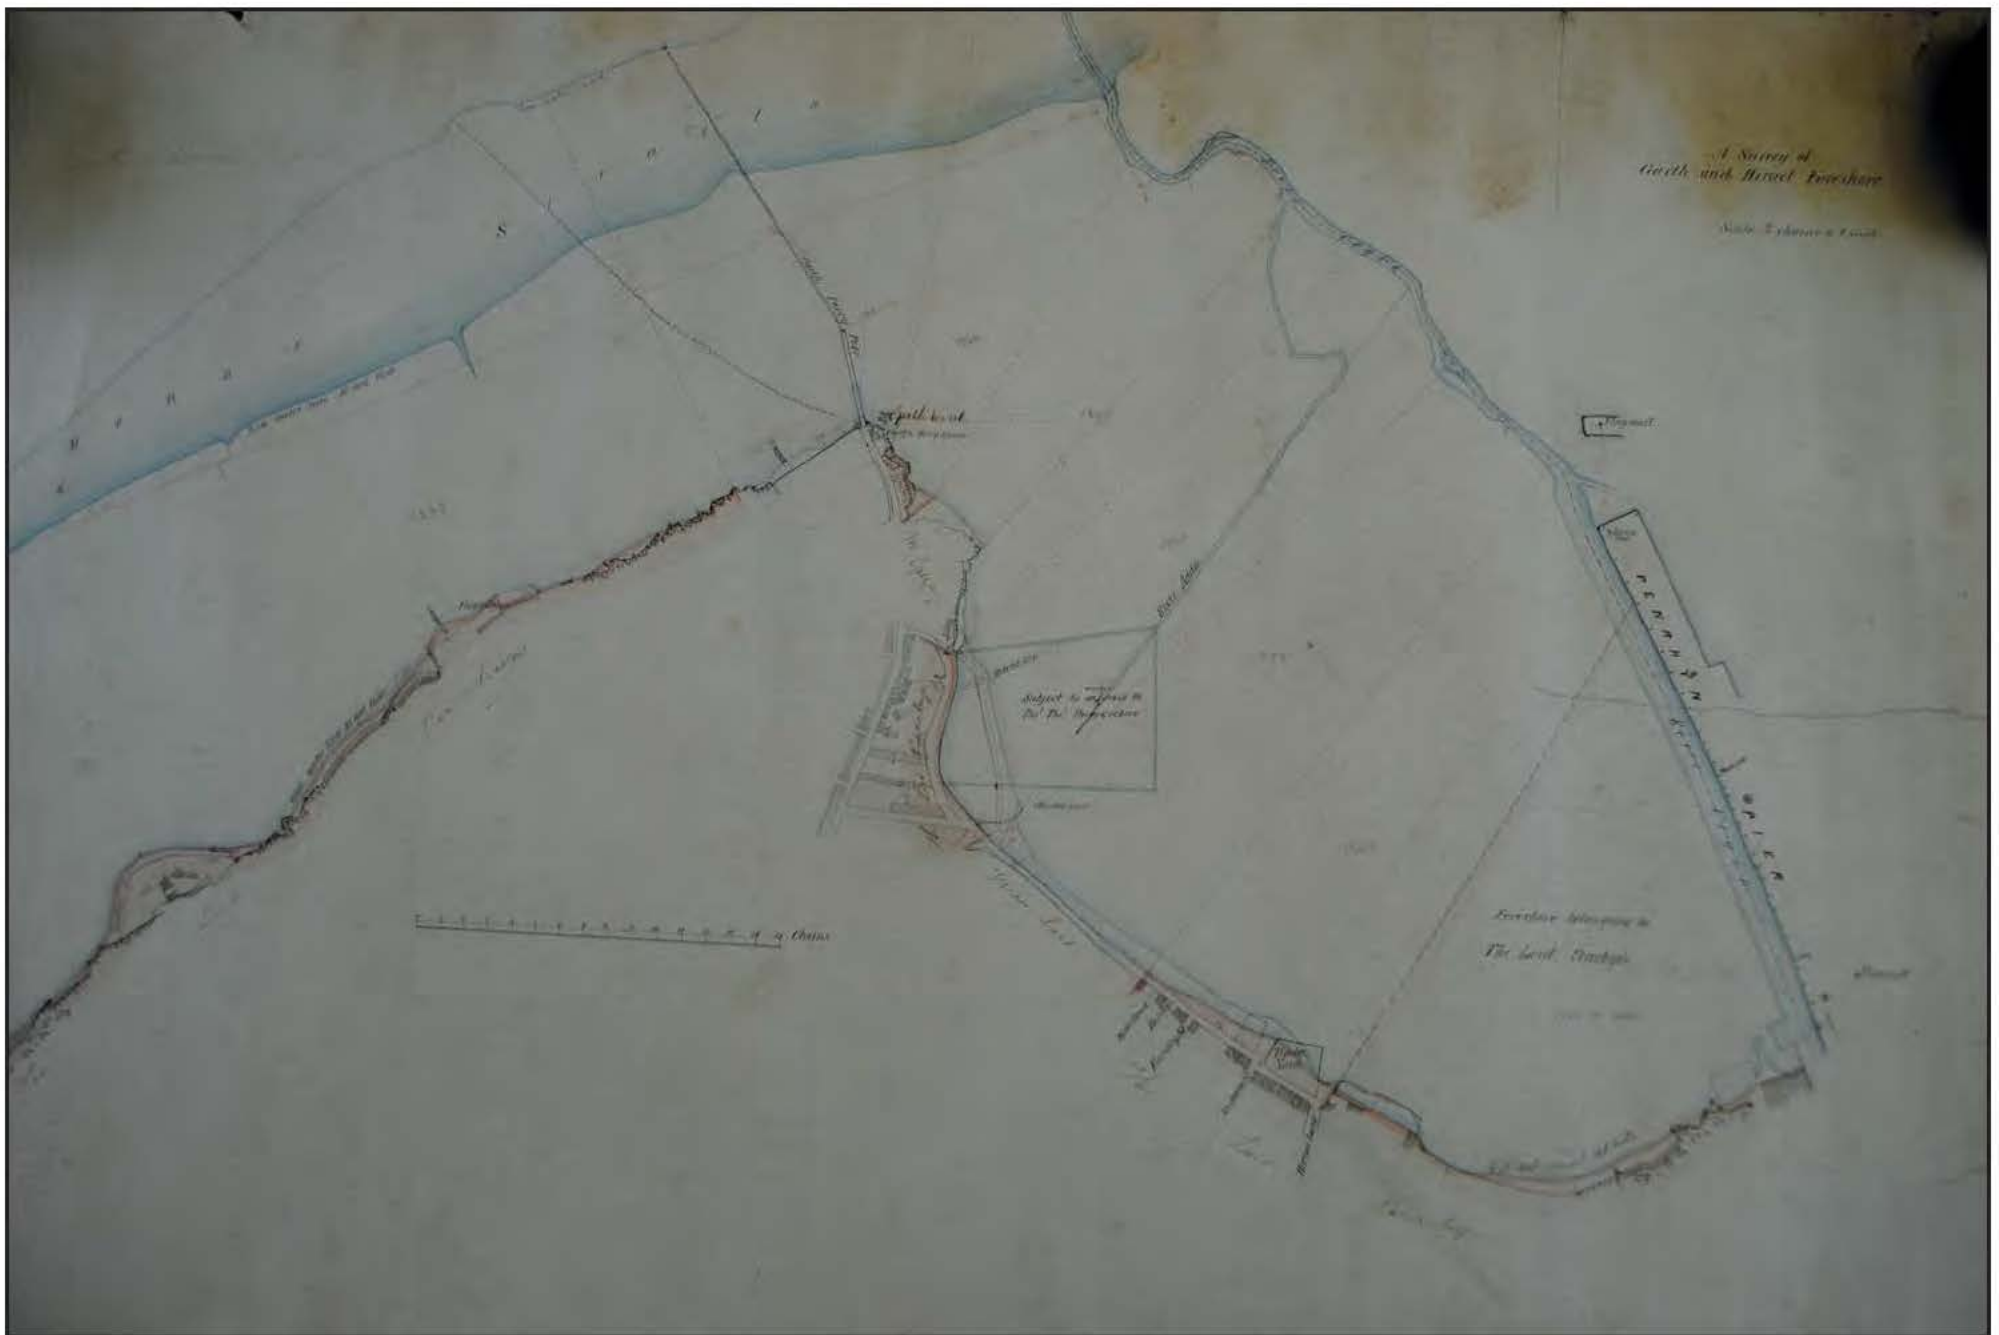
Figure 05 - Reproduction of Penrhyn Estate Map 206 #23 published in February 1867, detailing properties and land leased by the Penrhyn Estate to Edward Ellis, ship builder at the location of the proposed development (centre of image). The ship building works were established in 1836 and the slipway associated with it is clearly visible. The Garth slate works were established on these premises in 1849, at the southern end of the site, along what became Beach Road. The rest of the site remained as a ship builders and eventually became Dickie's boatyard. The majority of the Slate Works along Beach Road were demolished in 1935.

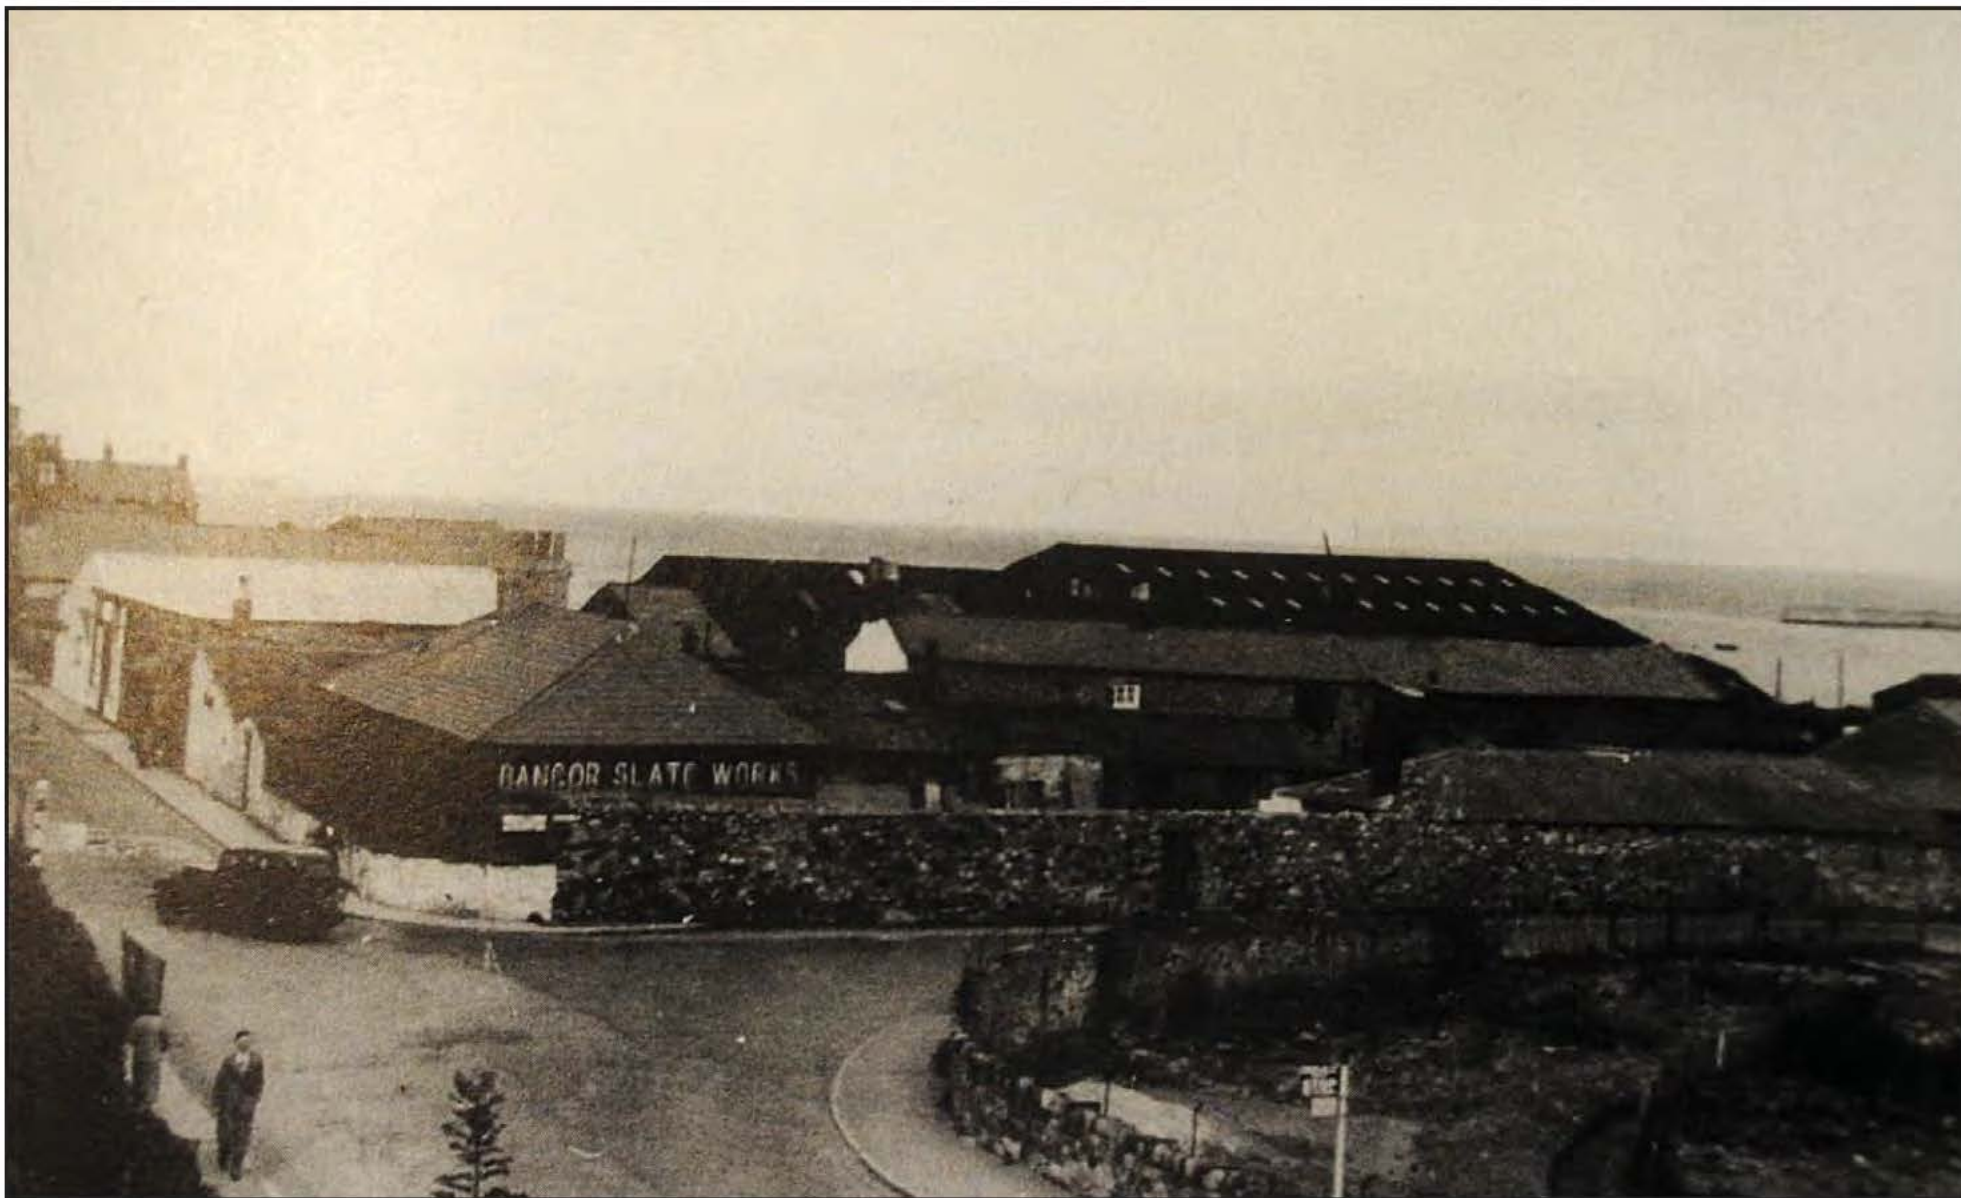
Figure 09 - Reproduction of a photograph of the junction of Beach Road and Garth Road in the early 1930's. A building marked "Bangor Slate Works" can clearly be seen in the foreground on the junction behind a boundary wall. A single storey building also against the boundary wall at the right end of the image was also part of the slate works. These buildings were demolished along with the boundary wall to accommodate improvements to Beach Road in 1935. In the background are buildings associated with the shipbuilding industry extant on the property since 1836. These buildings became part of "Dickie's Boatyard", the last business extant on the site prior to demolition in 2011. (Image reproduced from Cowell, J. 1994. Bangor: A Pictorial History: 60 (Llangefni))

The original boundary wall extant on Figures 02 to 09 fronting Beach Road was demolished in 1935, along with the slate works buildings on the junction with Garth Road (cf. Figure 09). The current boundary wall (Plates 01, 02, 03 and 05) is built from irregular shaped stone; small planting areas are extant on the corner at the junction with Garth Road (Plate 05). The upstanding stone-built wall along the southeastern boundary of the site (Plate 01, 18 and 19) that until 2011 separated *Dickie's Boatyard* from the *Texaco* garage, appears to be on historic mapping from at least 1867 (Figure 05) and is visible on the First to Third Edition 25" Ordnance Survey Maps of the area (1890, 1900 and 1914 respectively; Figures 06, 07 and 08). The wall detail on Plate 19 shows a standing height of 1.80m on the development side (stands taller on the *Texaco* side) and a construct of irregular shaped stone that includes evident repair work including brick fragments and cement capping. A slate buttress is attached and this may be an addition to accommodate the construction of the garage forecourt on the other side; the buttress providing structural support within the development site.

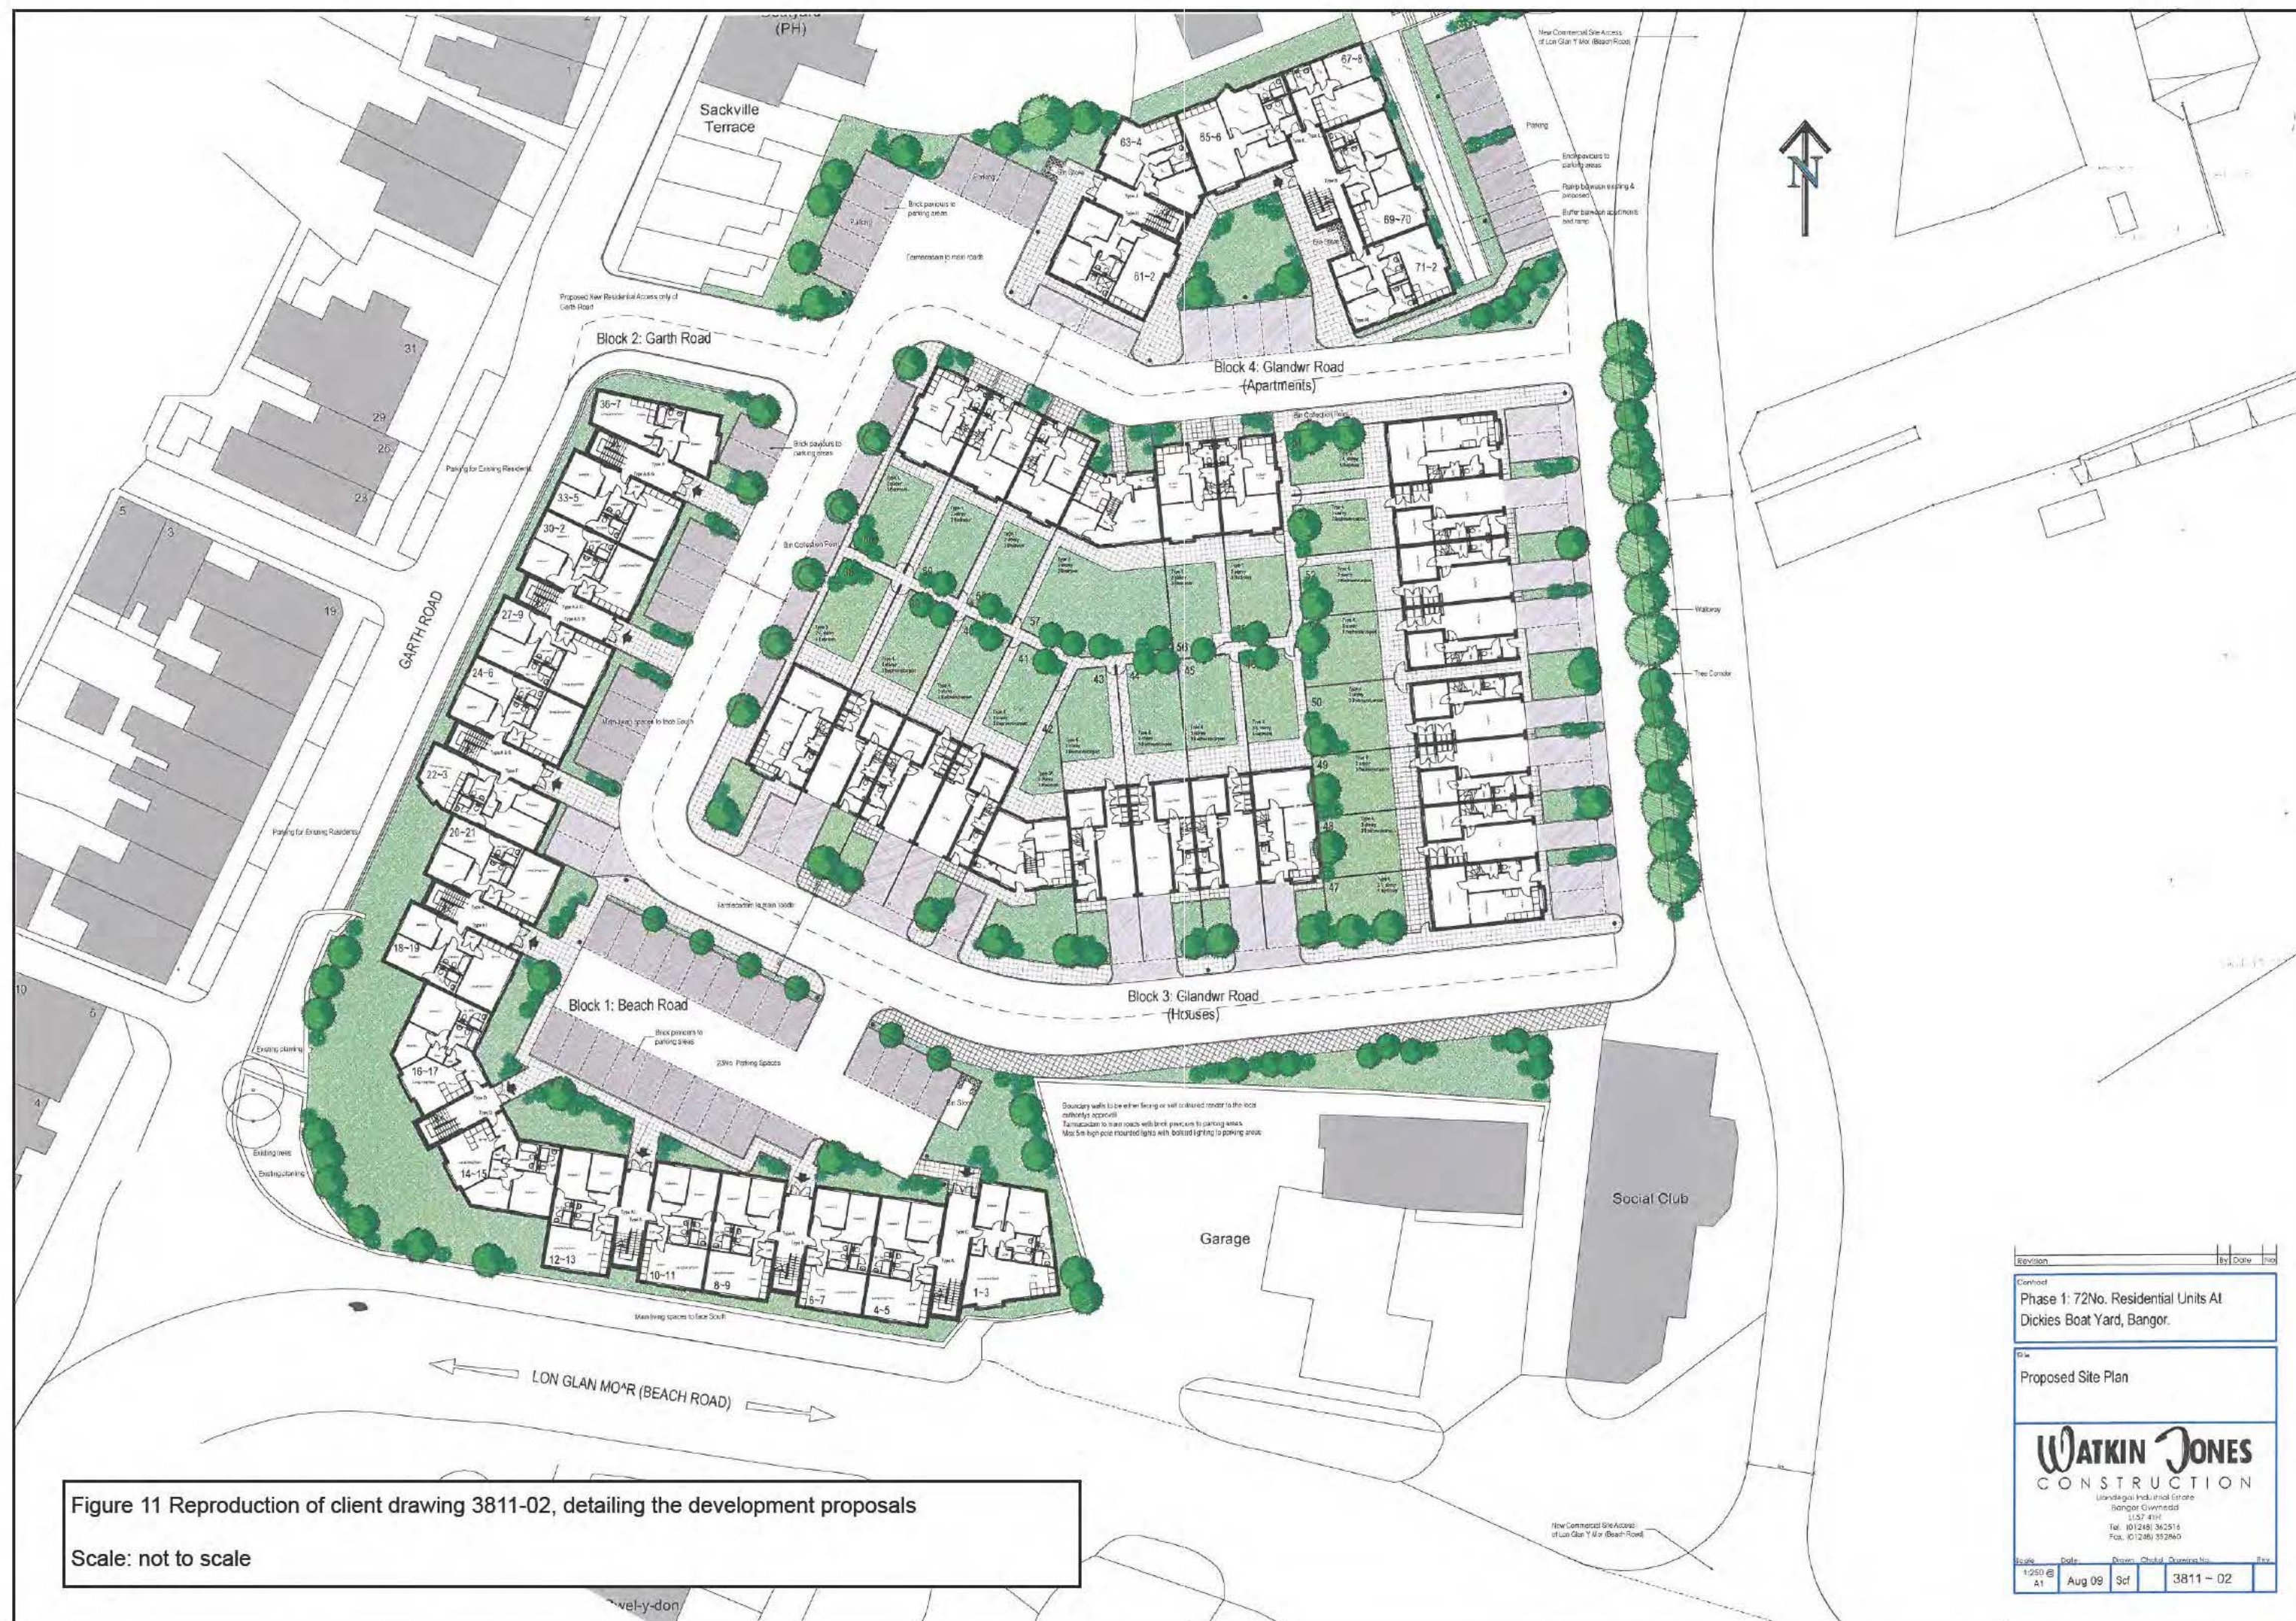
Figure 11 Reproduction of client drawing 3811-02, detailing the development proposals

It is recommended that an opportunity is taken to record the partly demolished red brick structure along Garth Road (Plates 20 to 22) during further demolition and during construction of the access point, as well as any foundation level activity associated with the former structures along Garth Road and within the complex grouping of structures located at the western end of the site on the Ordnance Survey historic mapping (Figures 06 to 08). It is also recommended the watching brief examines the foundation level structural material identified during the walkover (plate 06) that appears to represent a former structure evident on historic mapping; this will be at the location between Blocks 1 and 3, detailed on **Watkin Jones Homes** Drawing No. 3811-02 *Proposed Site Plan* (Figure 11).

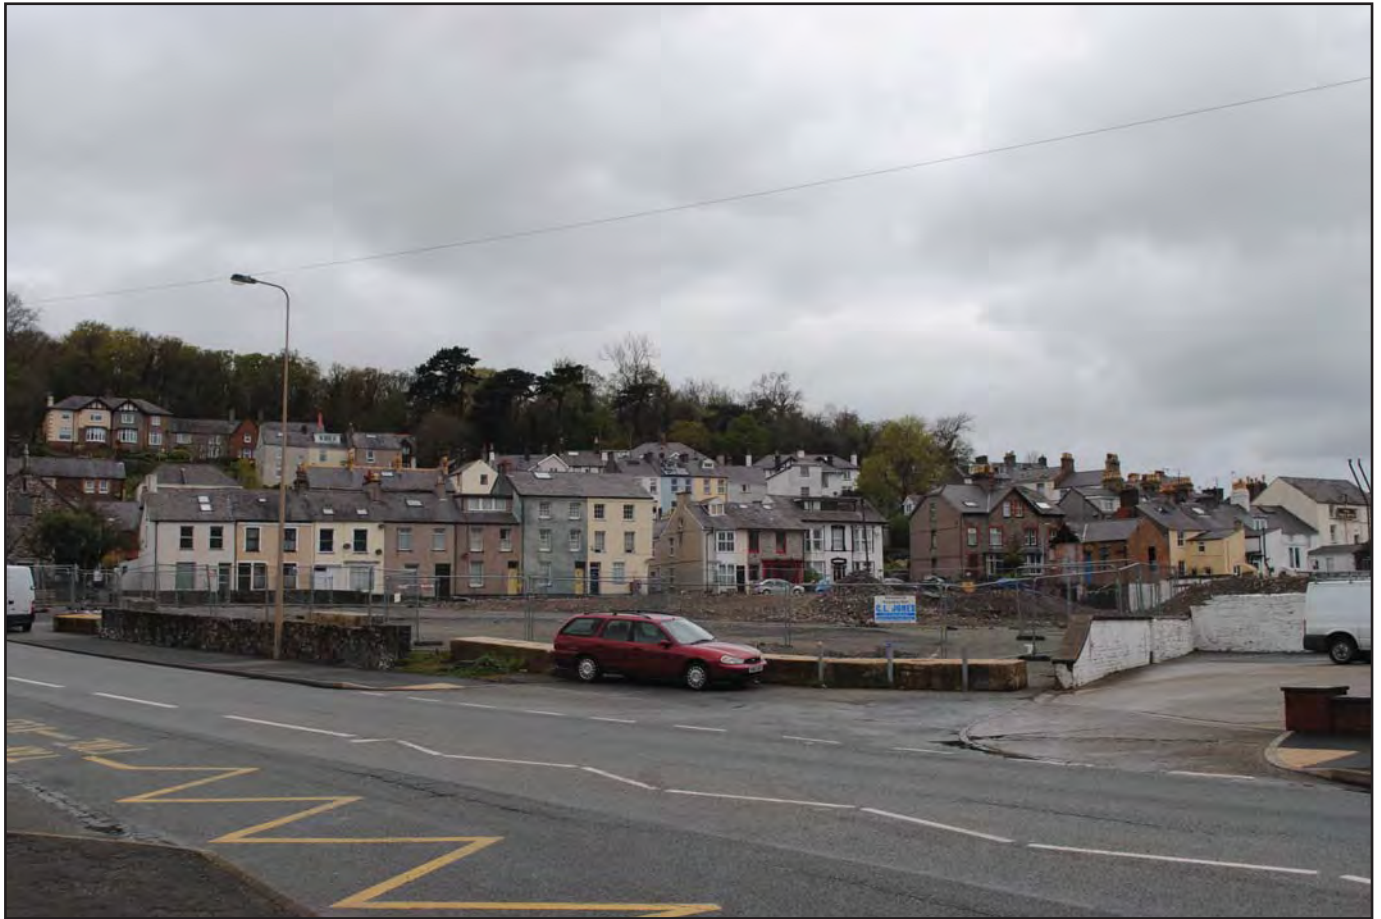
**Plate 01 - View northeast of development area, looking from Beach Road. Note the demolition rubble at the centre of the area. The former boundary wall was built post-1933 after the widening of Beach Road. The original boundary wall was demolished ahead of the road widening.**

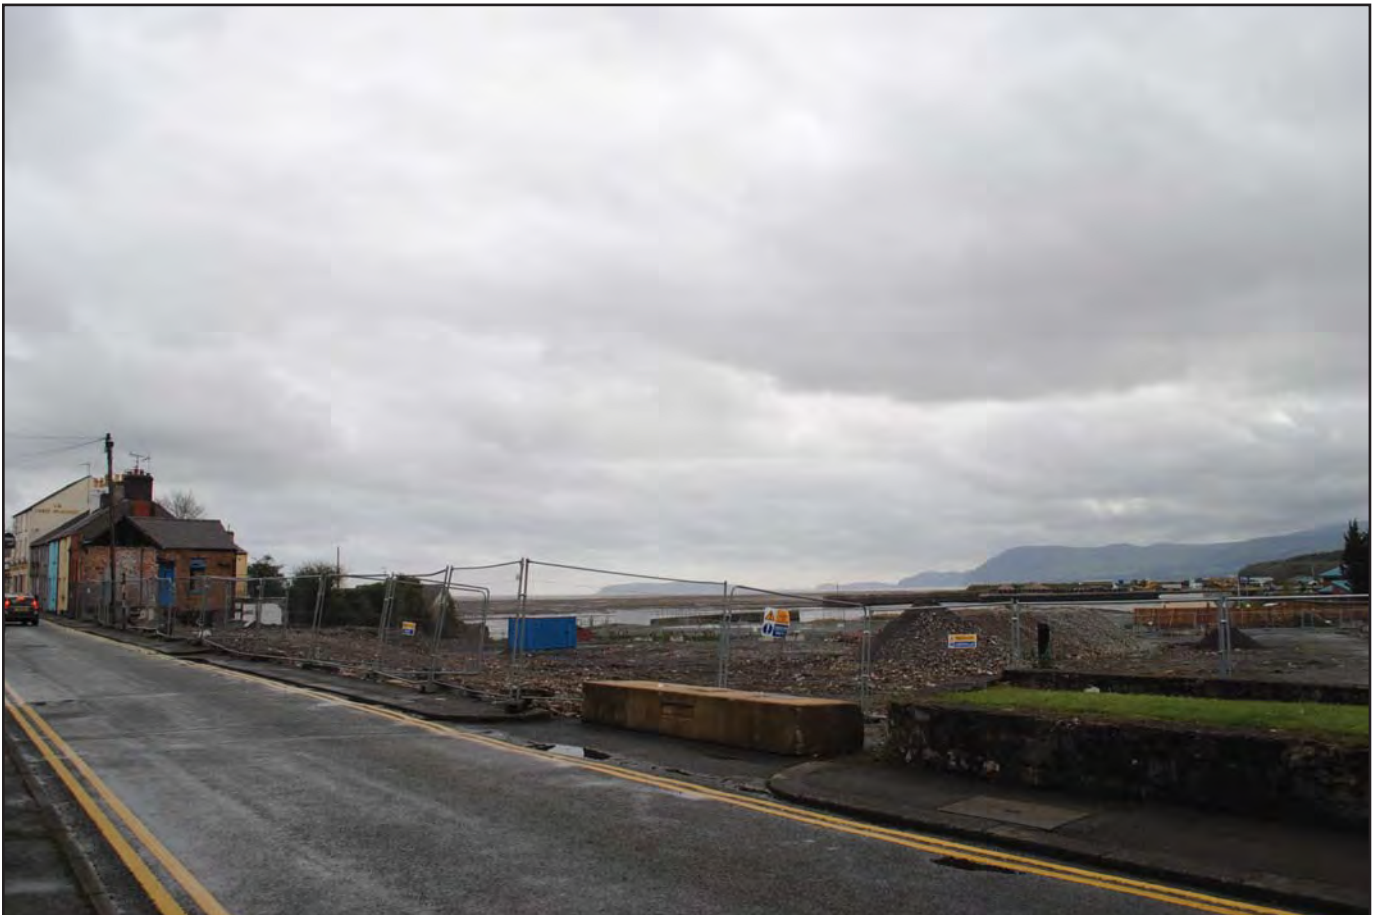
**Plate 02 - View northeast of development area, looking from Garth Road. Note the blocked entrance and the demolition rubble, representing former Dickie's Boatyard buildings. Note upstanding red-brick building at left of image: this has been partly demolished ahead of works.**

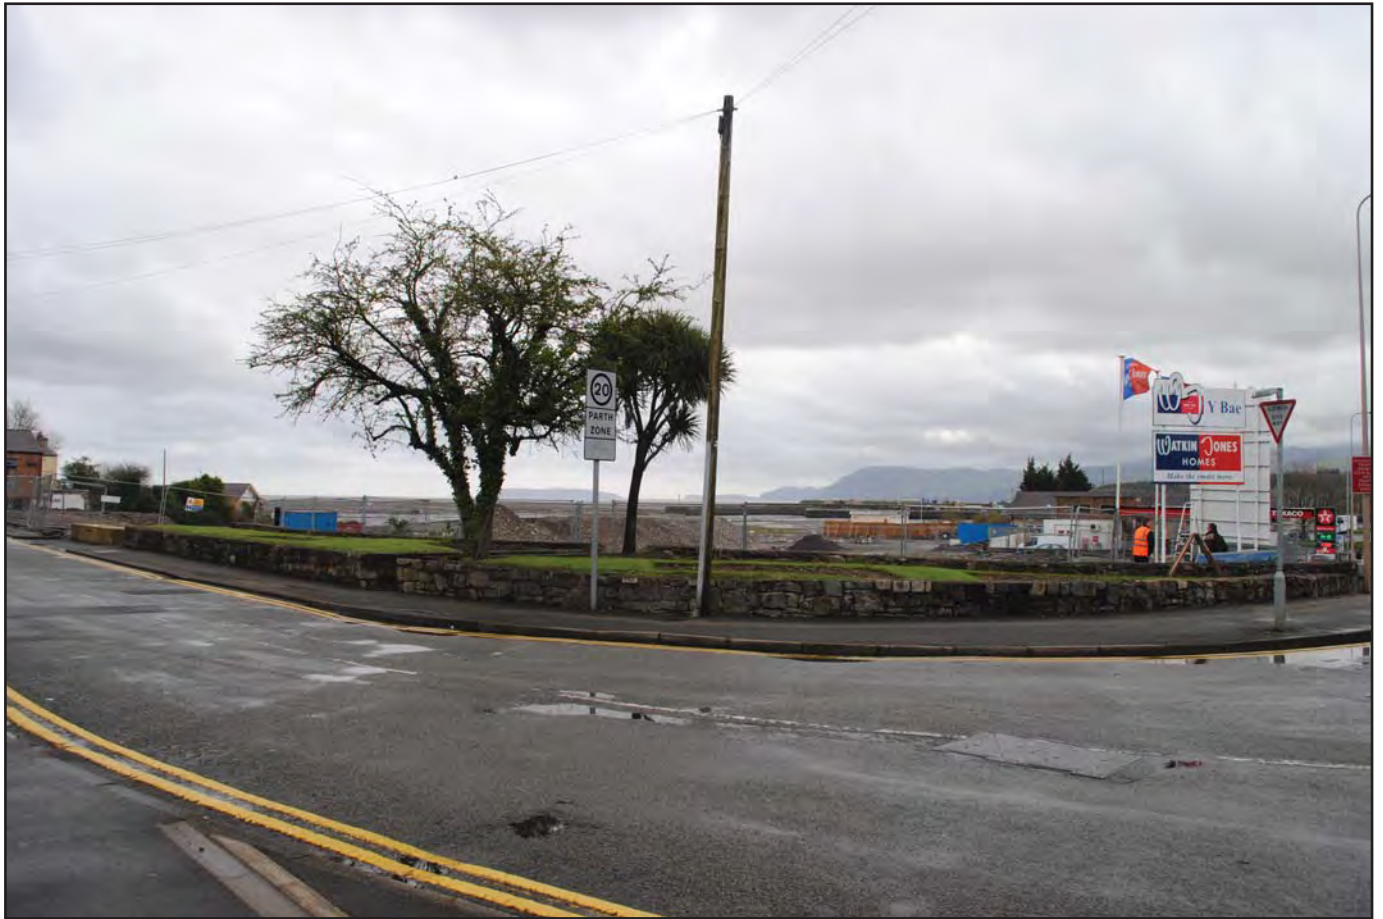
**Plate 03 - View northeast of development area, looking from the junction of Garth Road and Beach Road. Note the raised wall and planting: this was built post-1933 after the widening of Beach Road. The original boundary wall was demolished ahead of the road widening.**

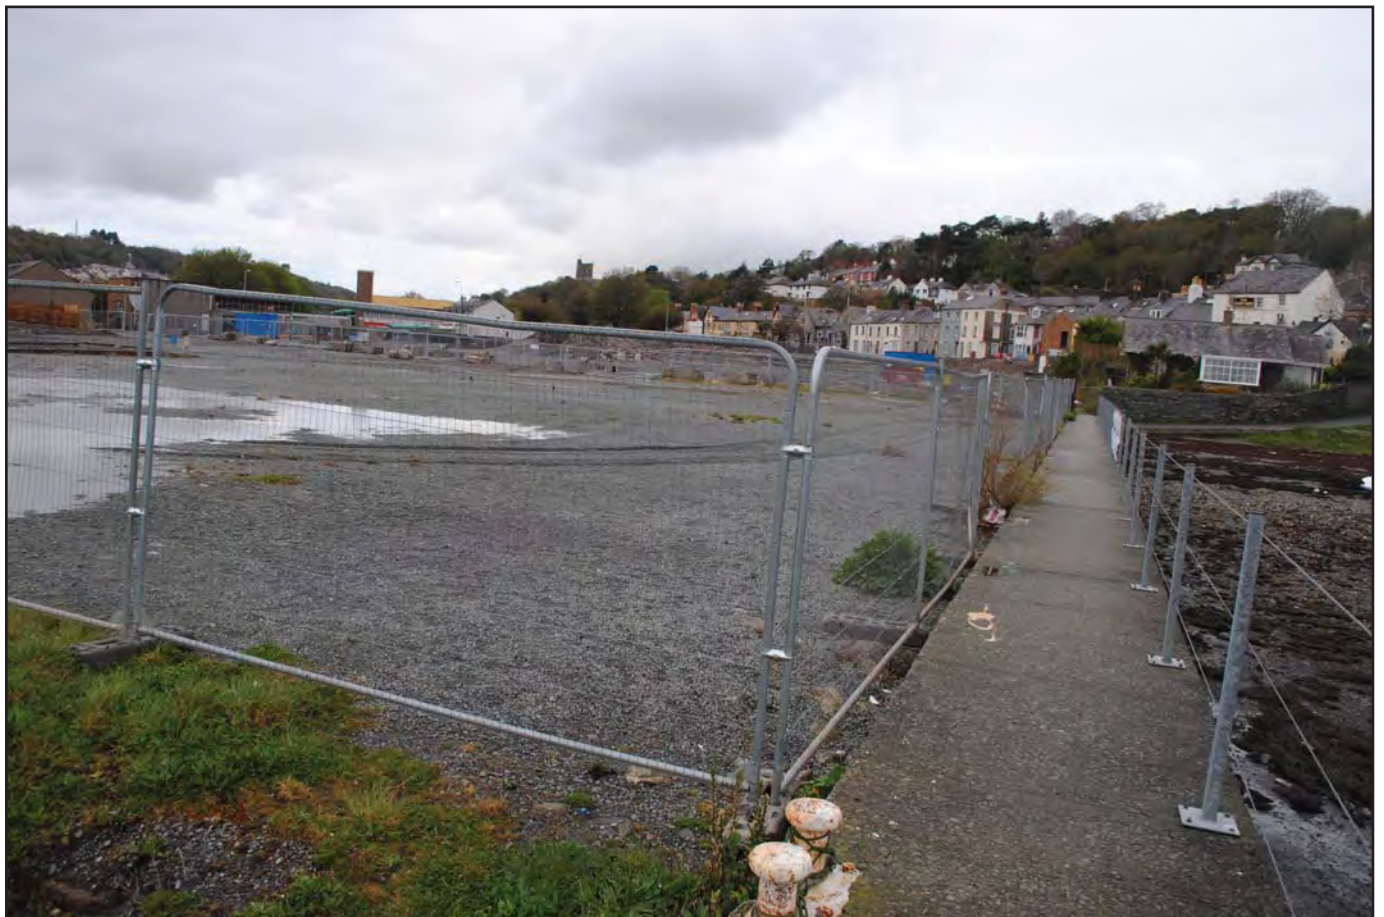
**Plate 04 - View southwest of development area, looking from the jetty walkway towards the former boatyard. The jetty/boatyard replaced the former mid-nineteenth century slipway and "Lewis Pier" (post-1890)**

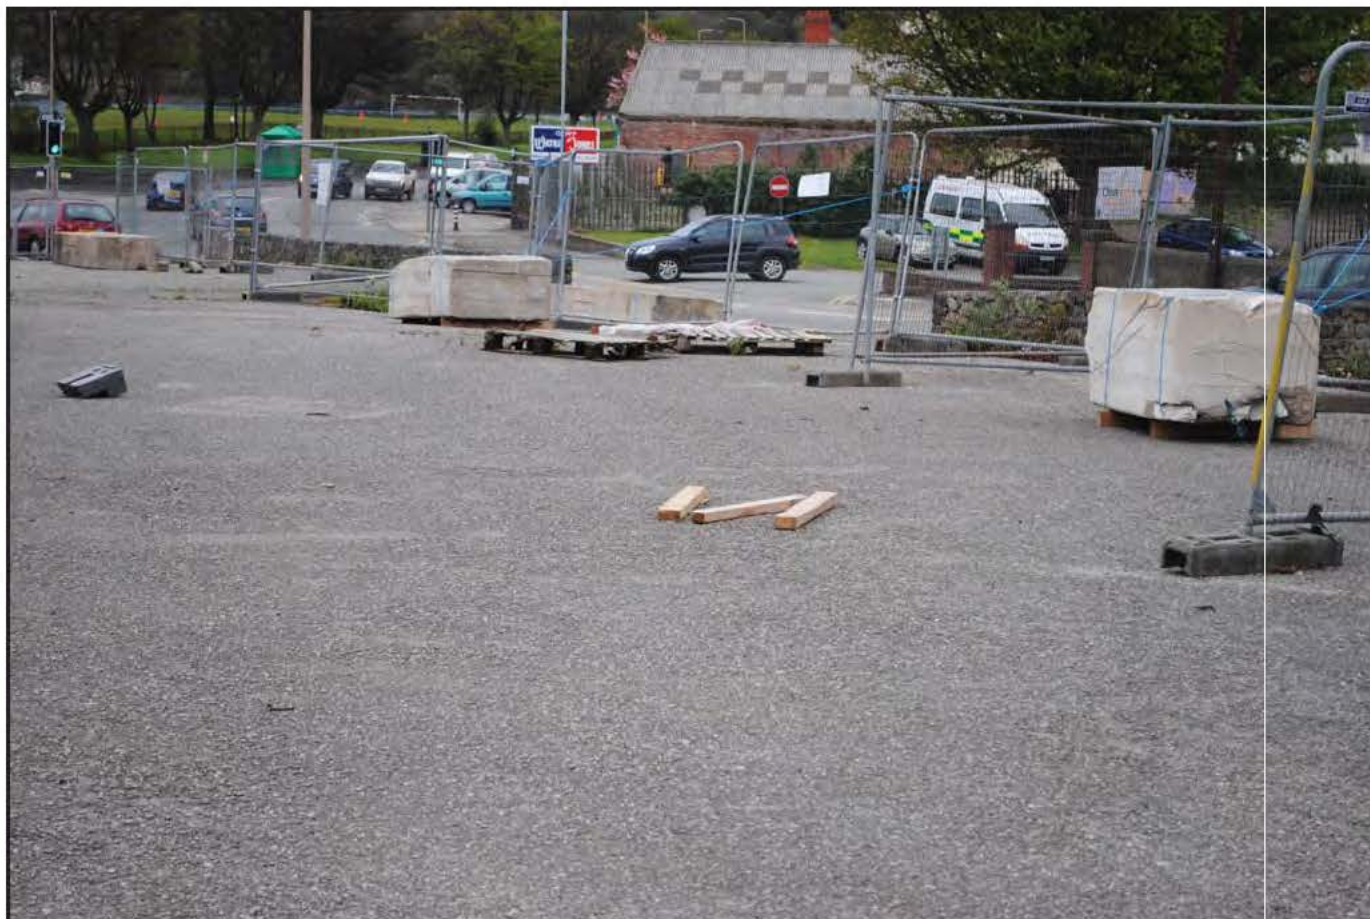
Plate 05 - View southeast from within development area detailing extant hardcore surface and existing boundary walls and entrance.
