# Dickie's Boatyard, Bangor

## Archaeological Assessment

Project No. G2259

Report No. 1049

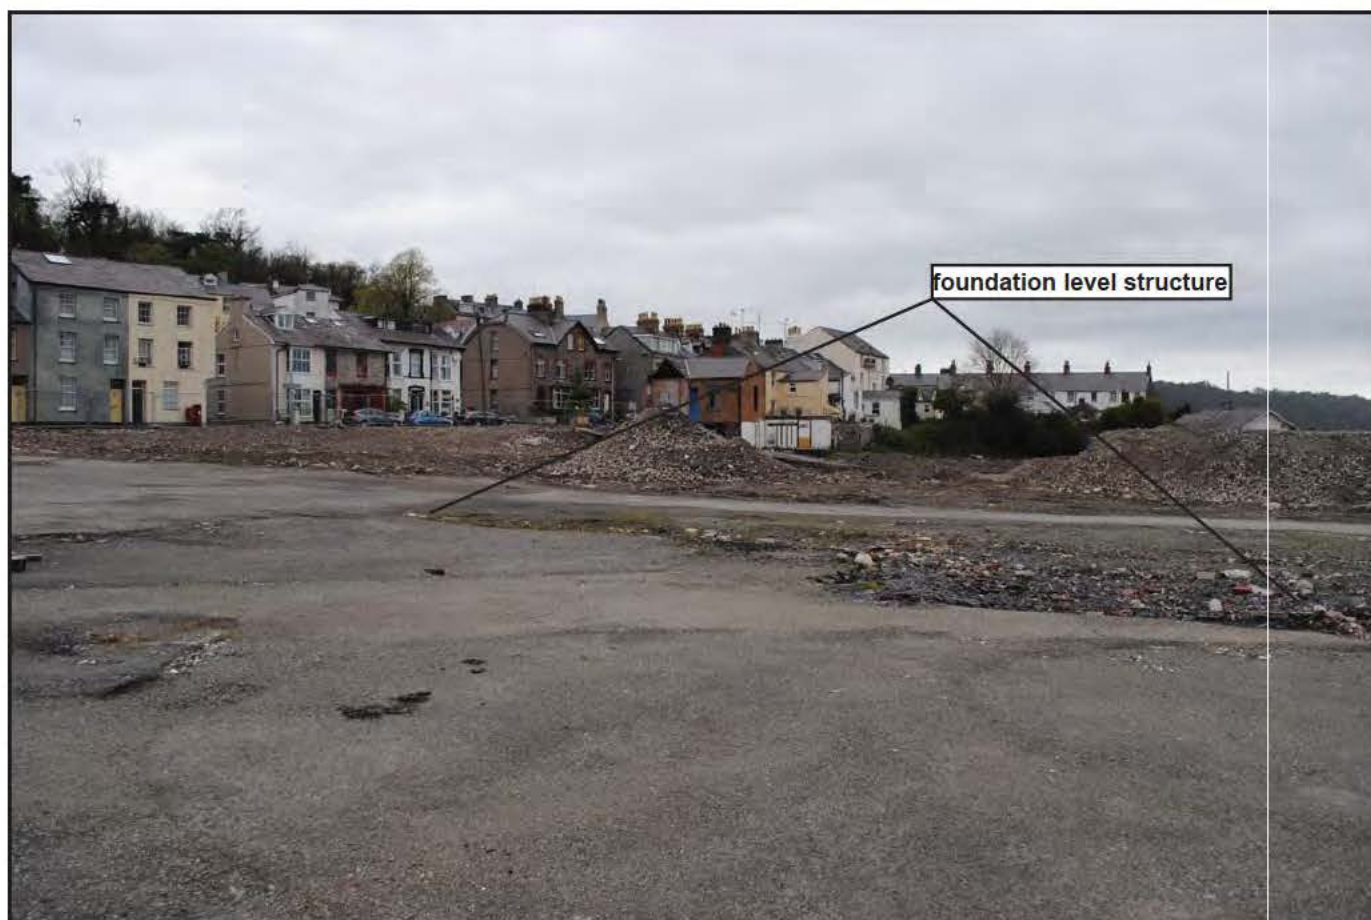
Plate 06 - View north from within development area, detailing demolition rubble from Dickie's Boatyard. Note also a foundation level structure towards centre of image, which may represent a former slate works building visible on the First to Third Edition 25" Ordnance Survey Maps

Based on the results of the walkover survey in this area and the historical mapping and pre-demolition images, it is recommended that the watching brief stage should allow an opportunity to examine the red-brick structure further during demolition as well as any evidence for foundation level activity associated with the complex of former buildings facing Garth Road and where the former slip way start point was located.

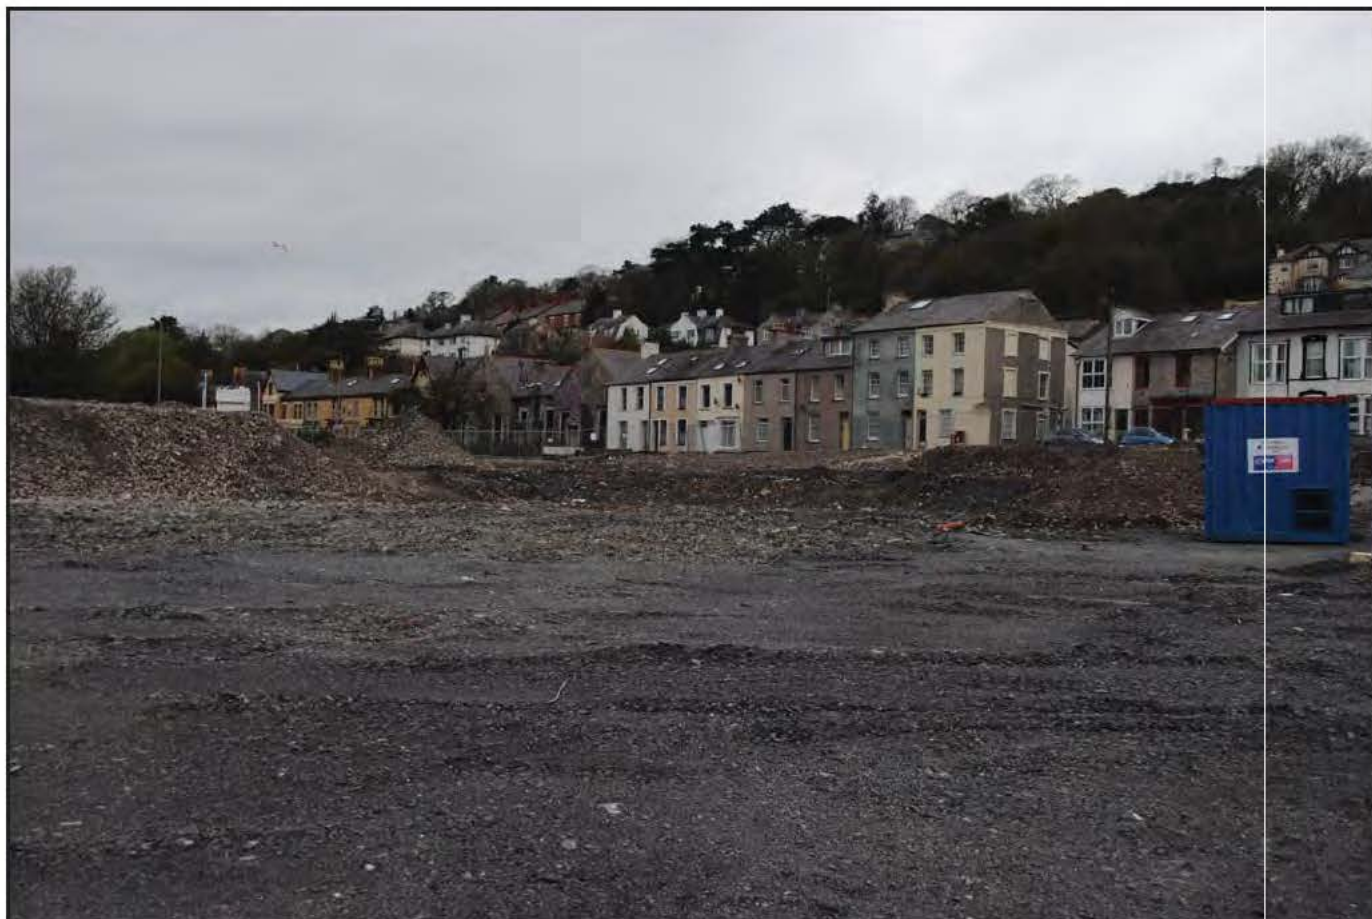
Plate 07 - View southwest from within development area detailing demolition rubble and extant levelled surface. Garth Road is visible in the background

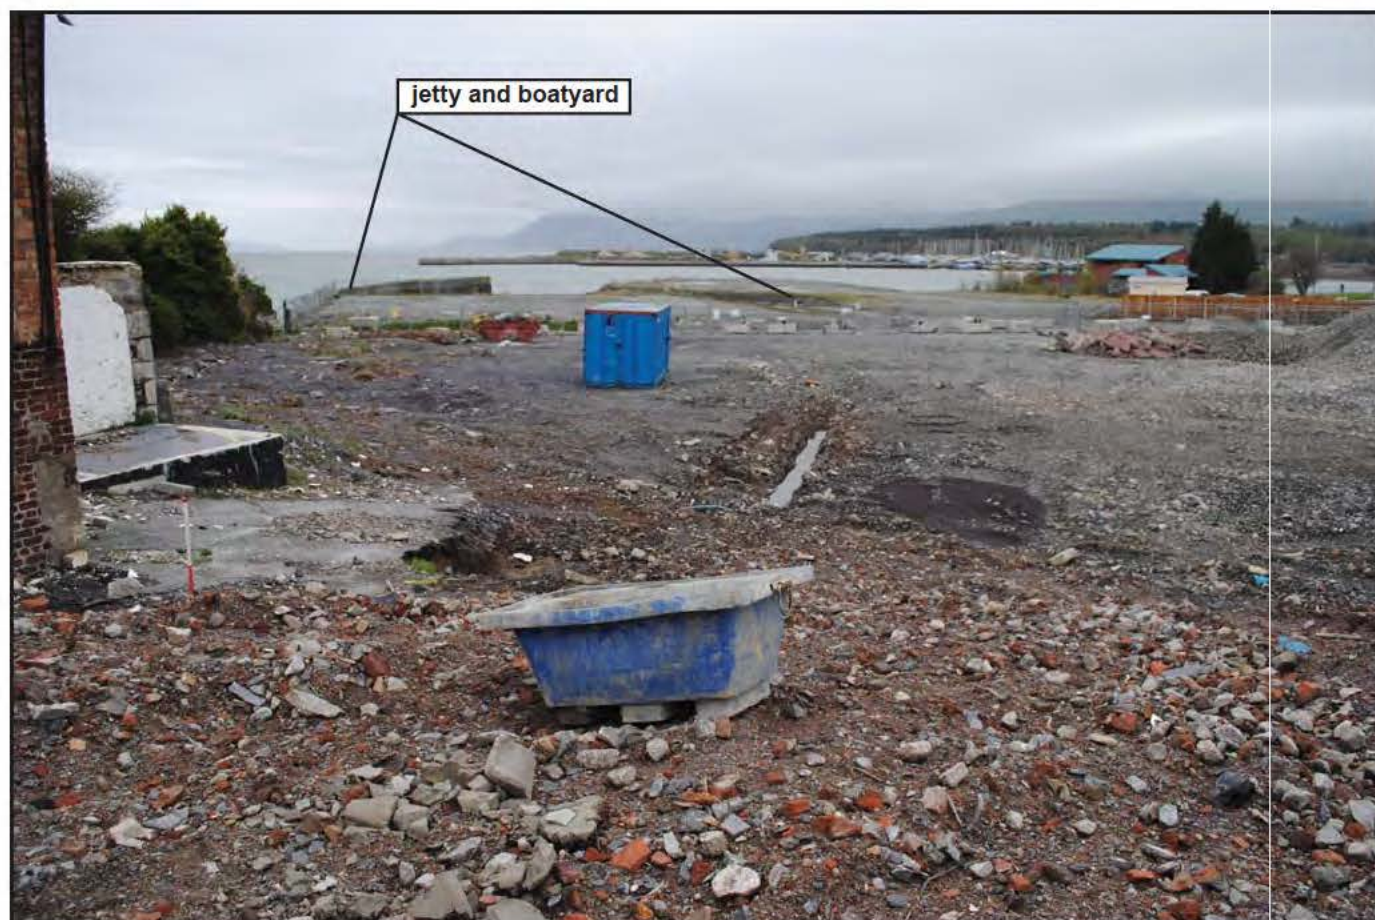
Plate 08 - View east from within development area, detailing demolition rubble from former Slate Yard/subsequently Dickie's Boatyard buildings. Note the upstanding reb-brick building at left of image and jetty/boatyard in the background. The jetty/boatyard replaced an earlier slipway and pier.

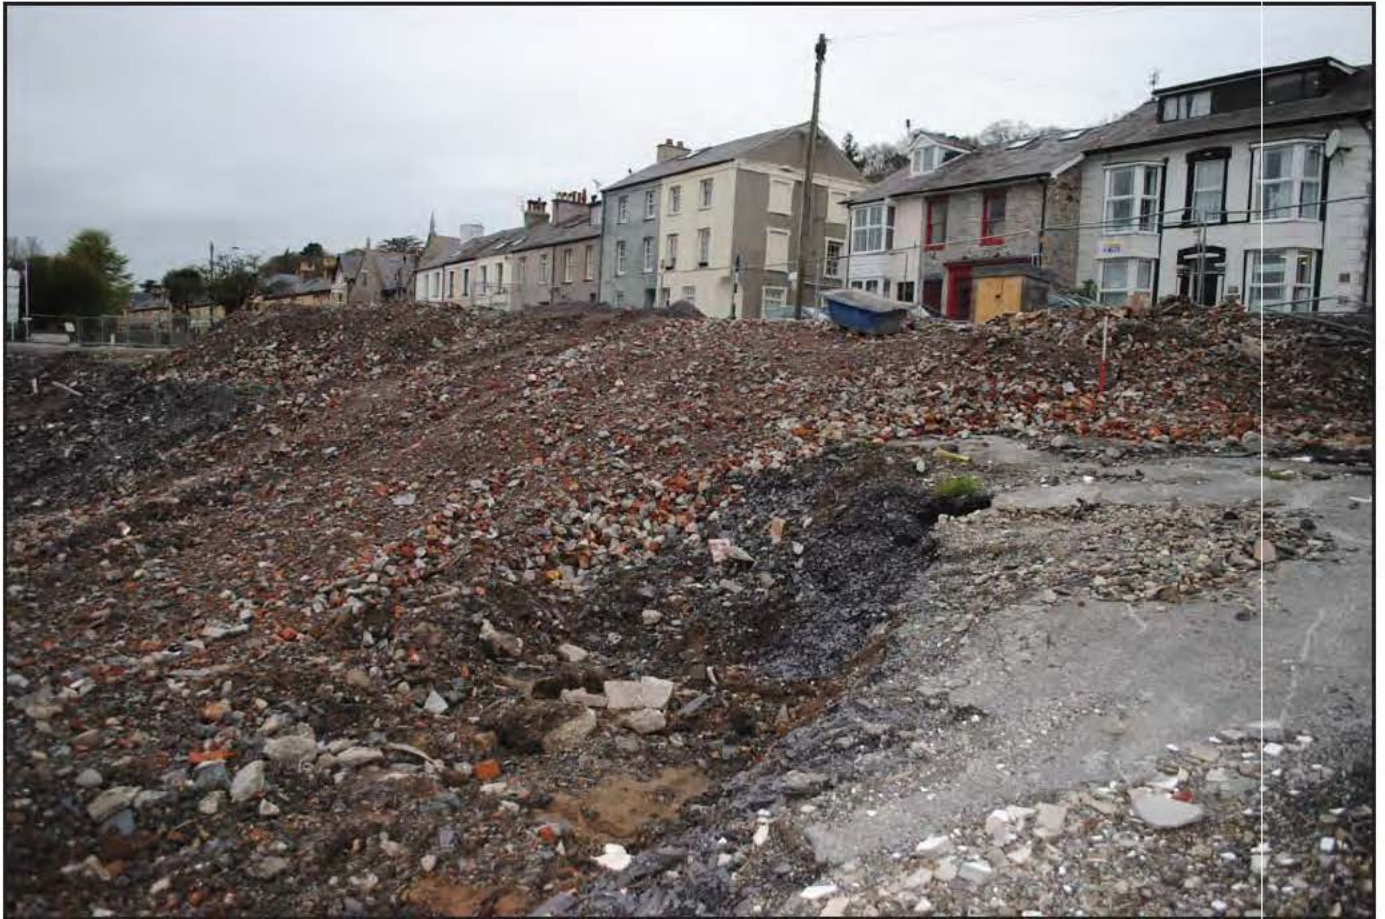
**Plate 09 - View southwest from within development area detailing demolition rubble and extant levelled surface. Garth Road is visible in the background**

As evident from Plates 02, 07, 09, 21 and 22, there was no continuous boundary wall along Garth Road and, until 2011, a series of buildings were located here that fronted onto Garth Road; these buildings were associated with the shipbuilding industry and not the slate works. The historic mapping from 1867 to 1914 (Figures 05 to 08) shows the extent of the properties along this road; Figure 09 details a series of irregular sized commercial structures separated by gated access points and low level boundary walls. These were still partly in use by *Dickie's Boatyard*, as evident in Figure 01.

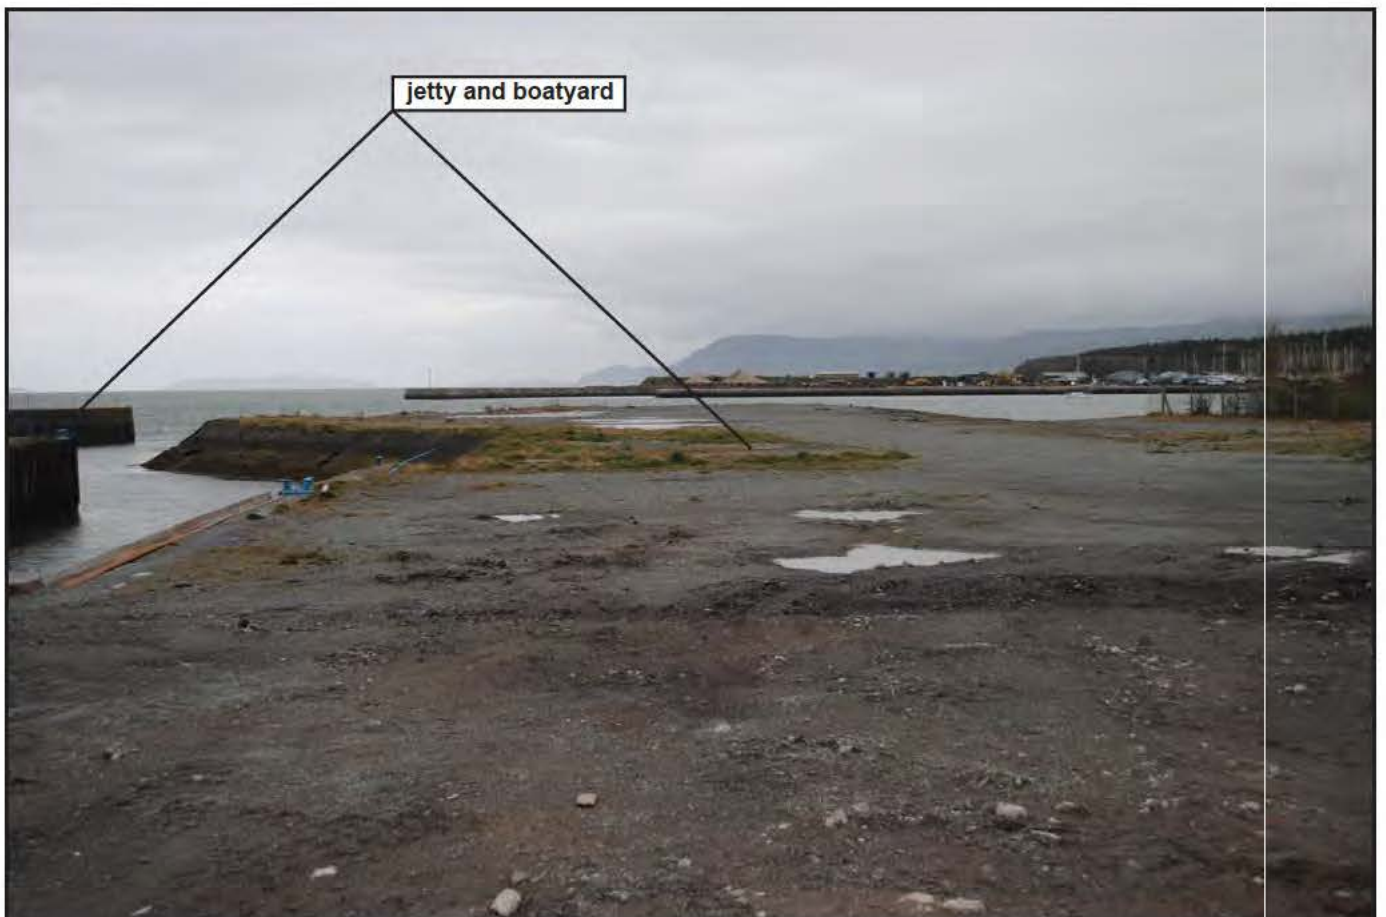
**Plate 10 - View east from within development area, detailing jetty/boatyard area.**  
**Note: this area is not being developed at this stage but the image indicates the extent of twentieth century development of Dickies' as the jetty/boatyard replaced the existing slipway and "Lewis' Pier" extant on late nineteenth/early twentieth century historic mapping**

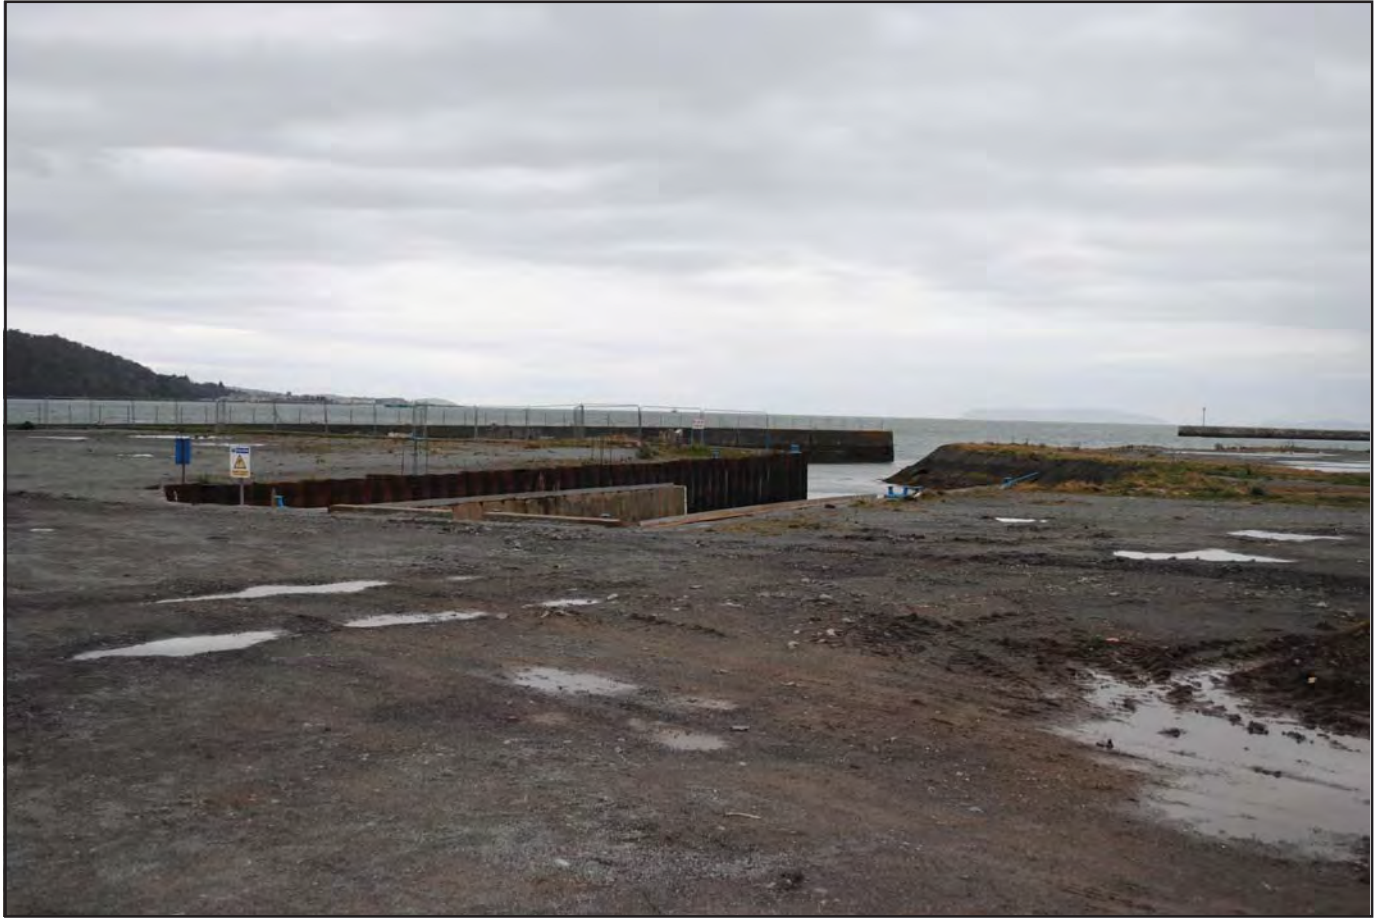
Plate 11 - View northwest detailing jetty/boatyard/dock area. Note the concrete built dock in the centre, the sheet piled boatyard to the left and the made ground forming the boatyard on the right. Note: this area is not being developed at this stage but the image indicates the extent of twentieth century development of Dickies' as the jetty/boatyard replaced the existing slipway and "Lewis' Pier" (via the dock and sheet piled yard) that were extant on late nineteenth/early twentieth century historic mapping

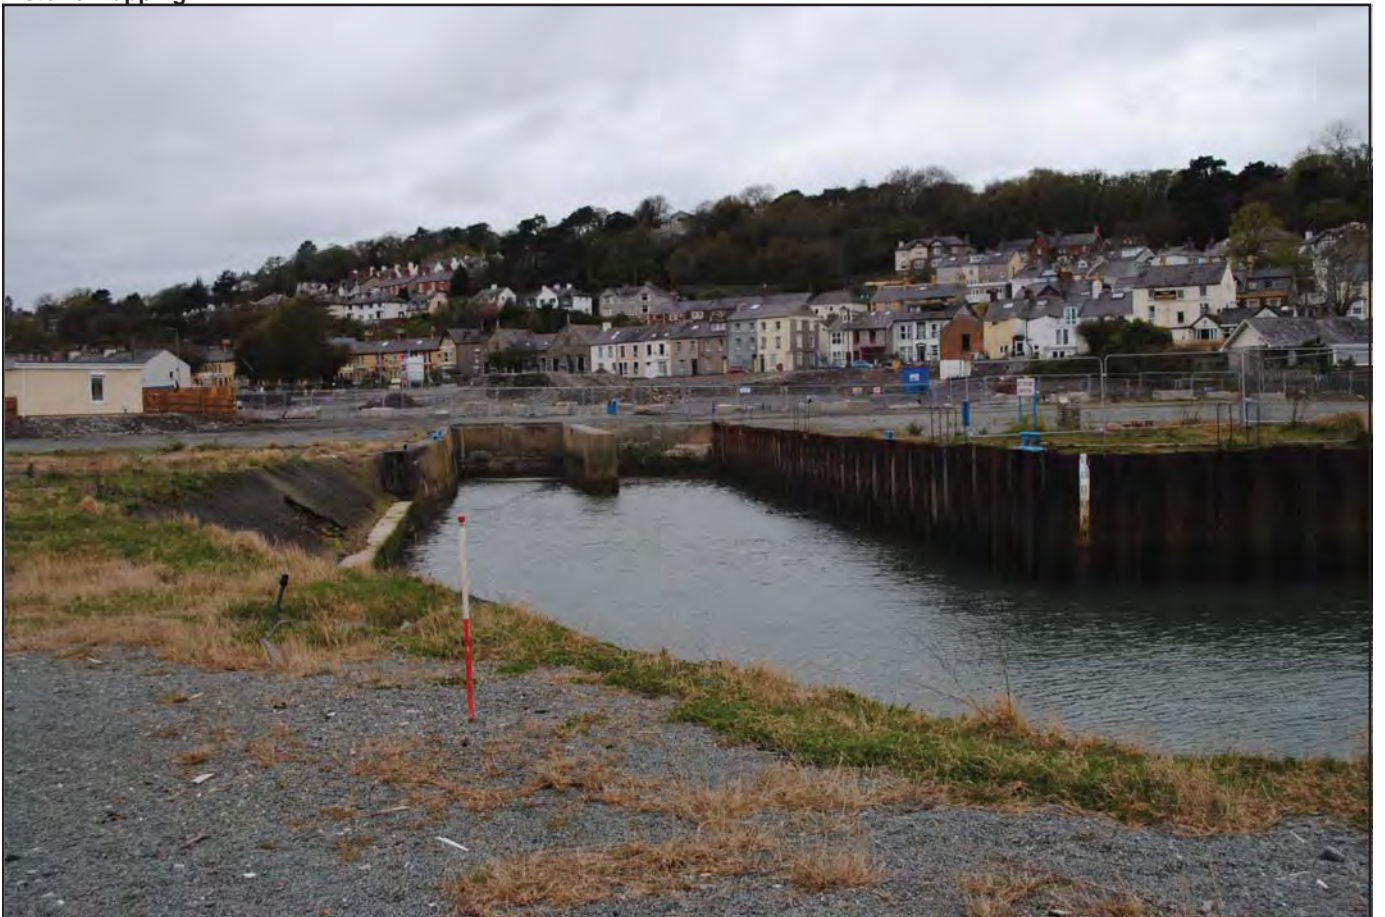
Plate 12 - View southwest detailing boatyard/dock area. Note the concrete built dock in the centre, the sheet piled boatyard to the right and the made ground forming the boatyard on the right. Note: this area is not being developed at this stage but the image indicates the extent of twentieth century development of Dickies' as the jetty/boatyard replaced the existing slipway and "Lewis' Pier" (via the dock and sheet piled yard) that were extant on late nineteenth/early twentieth century historic mapping

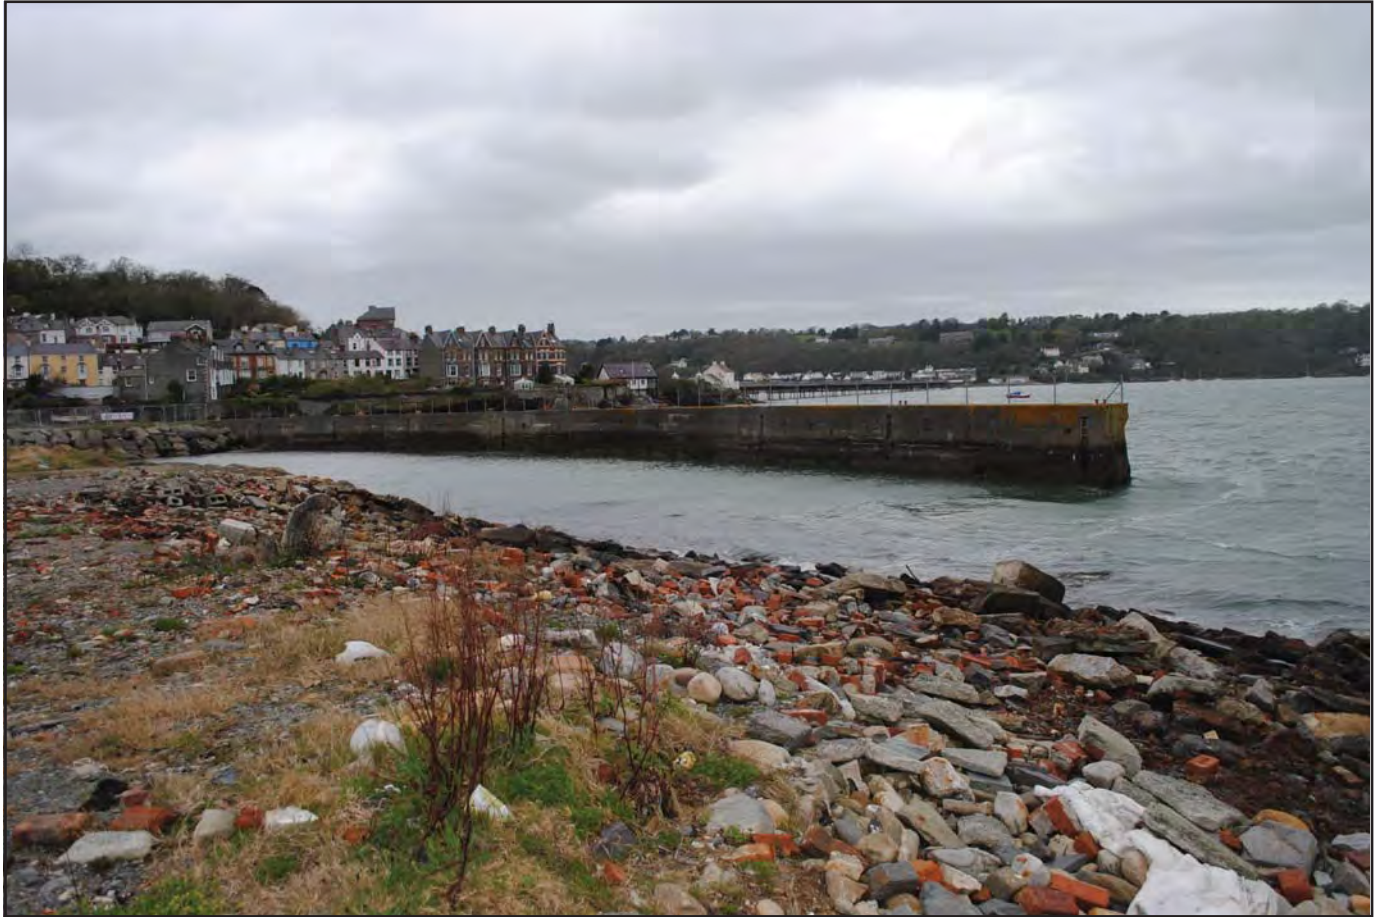
The modern jetty, which replaced the slipway, was constructed from cast concrete and extended 89.0m into the sea (Plates 13, 16 and 17); the average width was 2.0m. The portion of the yard/dock attached to the jetty (cf. Figure 01), was roughly square in shape and measured 45.0m in width and 44.0m in length. The surface was a hardcore deposit (Plate 17), with the seaward side built with sheet piling (Plate 12). It was not possible to determine the construction material used to build the yard. A concrete dock separated this yard from a larger yard to the south (Plate 12). This dock measured 15.0m in width and was constructed from cast concrete; a 16.0m long and 2.0m wide mooring projected into the sea. The larger, southern yard measured 58.0m in width and extended 85.0m into the sea (Plate 10). The surface was constructed from hardcore and it appears to have been constructed from deposited demolition material as evident in Plate 13.

Plate 13 - View west of the jetty from the sheet piled boatyard area. Note: this area is not being developed at this stage but the image indicates the extent of twentieth century development of Dickies' as the jetty/boatyard replaced the existing slipway and "Lewis' Pier" (via the dock and sheet piled boatyard) that were extant on late nineteenth/early twentieth century historic mapping

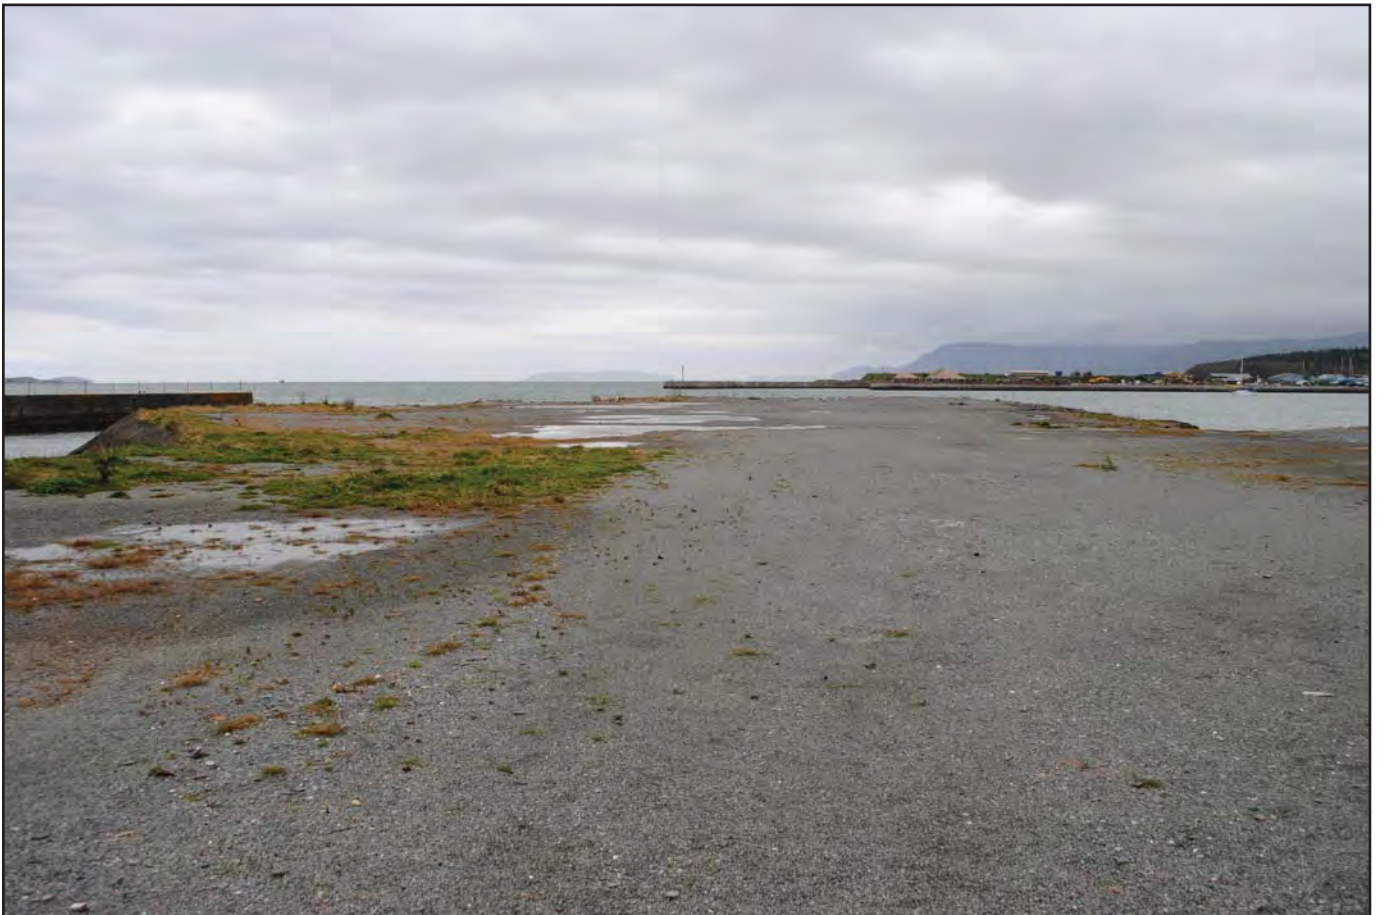
Plate 14 - View northeast of boatyard area. Note: this area is not being developed at this stage but the image indicates the extent of twentieth century development of Dickies' as the boatyard replaced the existing "Lewis' Pier" extant on 1900 and 1914 25" Ordnance Survey Maps of the area.

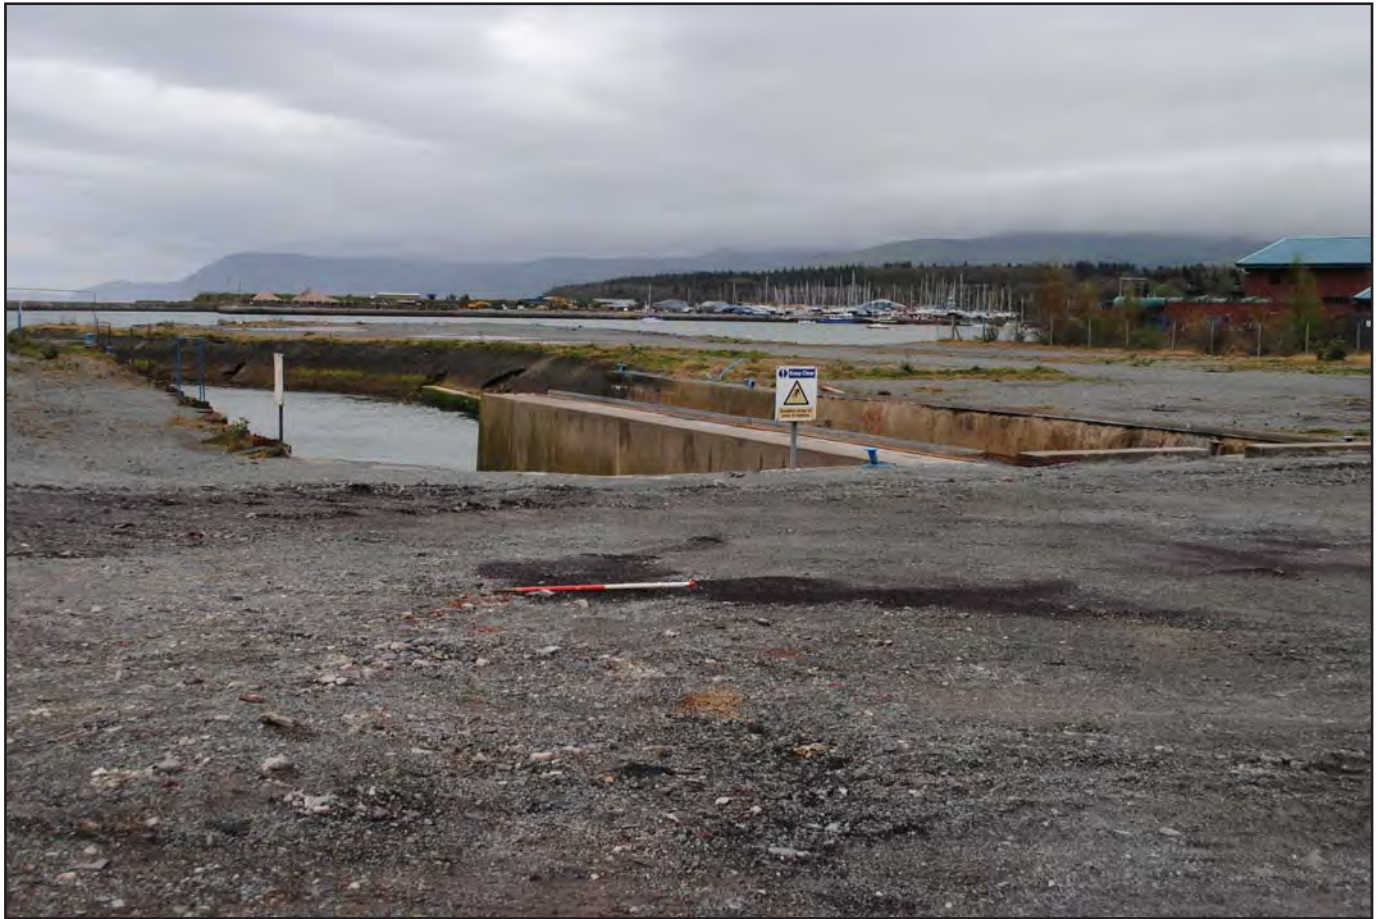
**Plate 15 - View east of the boatyards located either side of the concrete dock.**

**Note:** this area is not being developed at this stage but the image indicates the extent of twentieth century development of Dickies' as the boatyards replaced the existing slipway and "Lewis' Pier" that were extant on late nineteenth/early twentieth century historic mapping

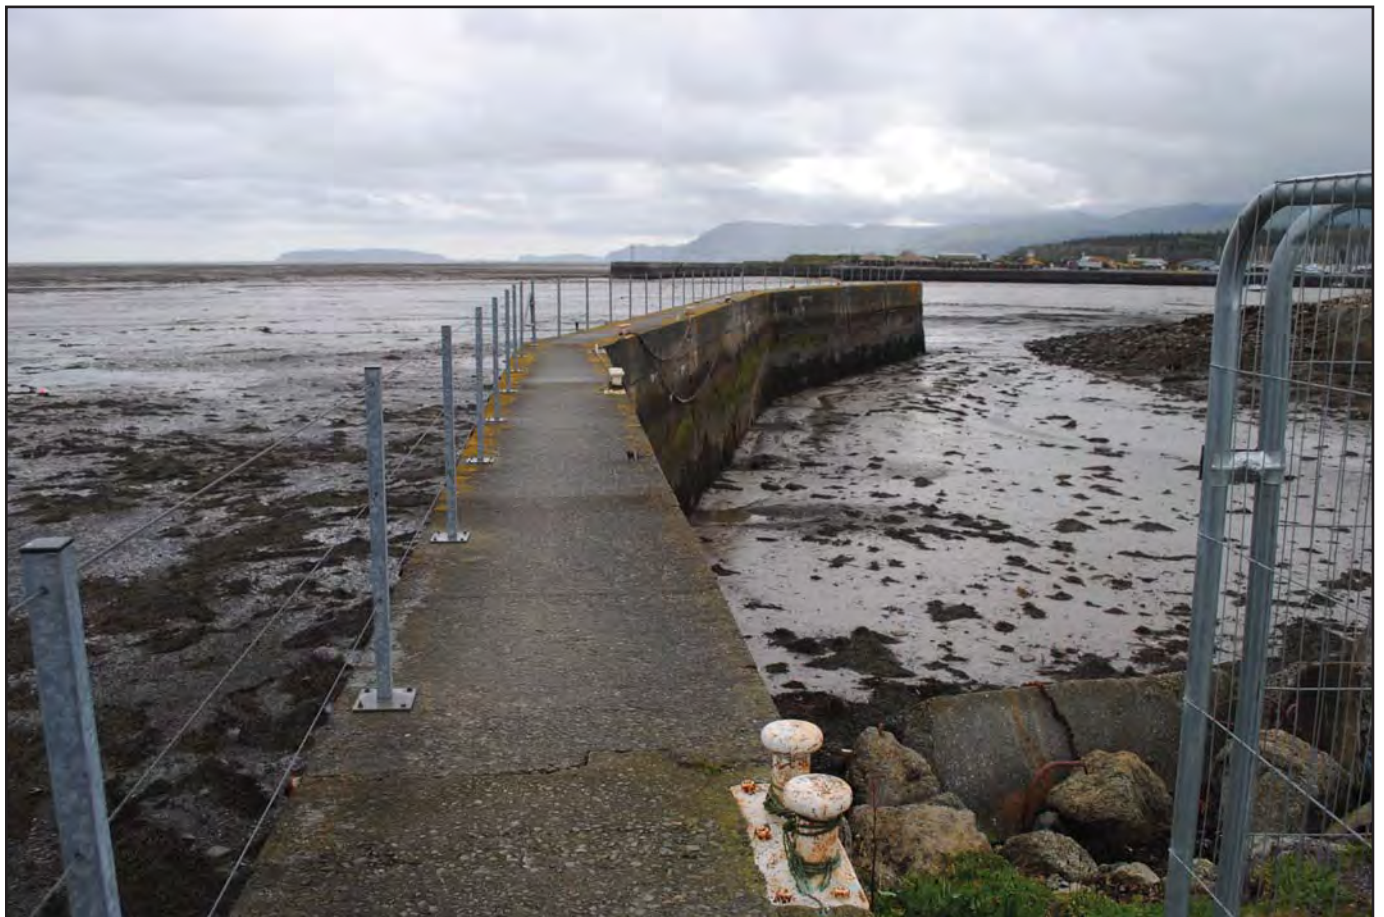
**Plate 16 - View along the twentieth century jetty. The jetty is built from concrete; note the moorings in the foreground.**

**Note:** this area is not being developed at this stage but the image indicates the extent of twentieth century development of Dickies' within the slate works.

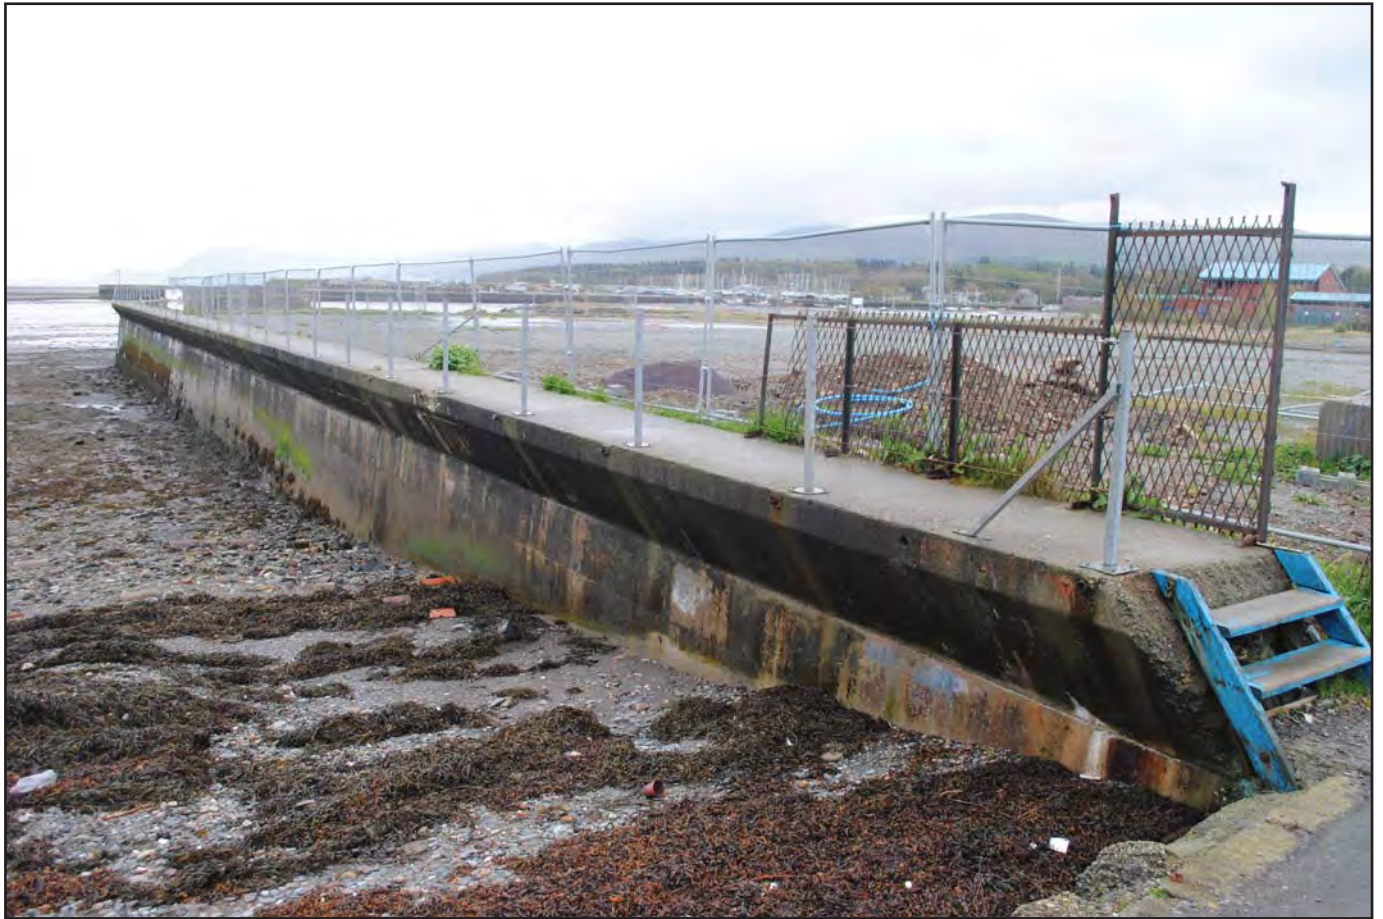
Plate 17 - View along the side of jetty/boatyard detailing concrete construction.  
 Note: this area is not being developed at this stage but the image indicates the extent of twentieth century development of Dickies' within the former slate yard.

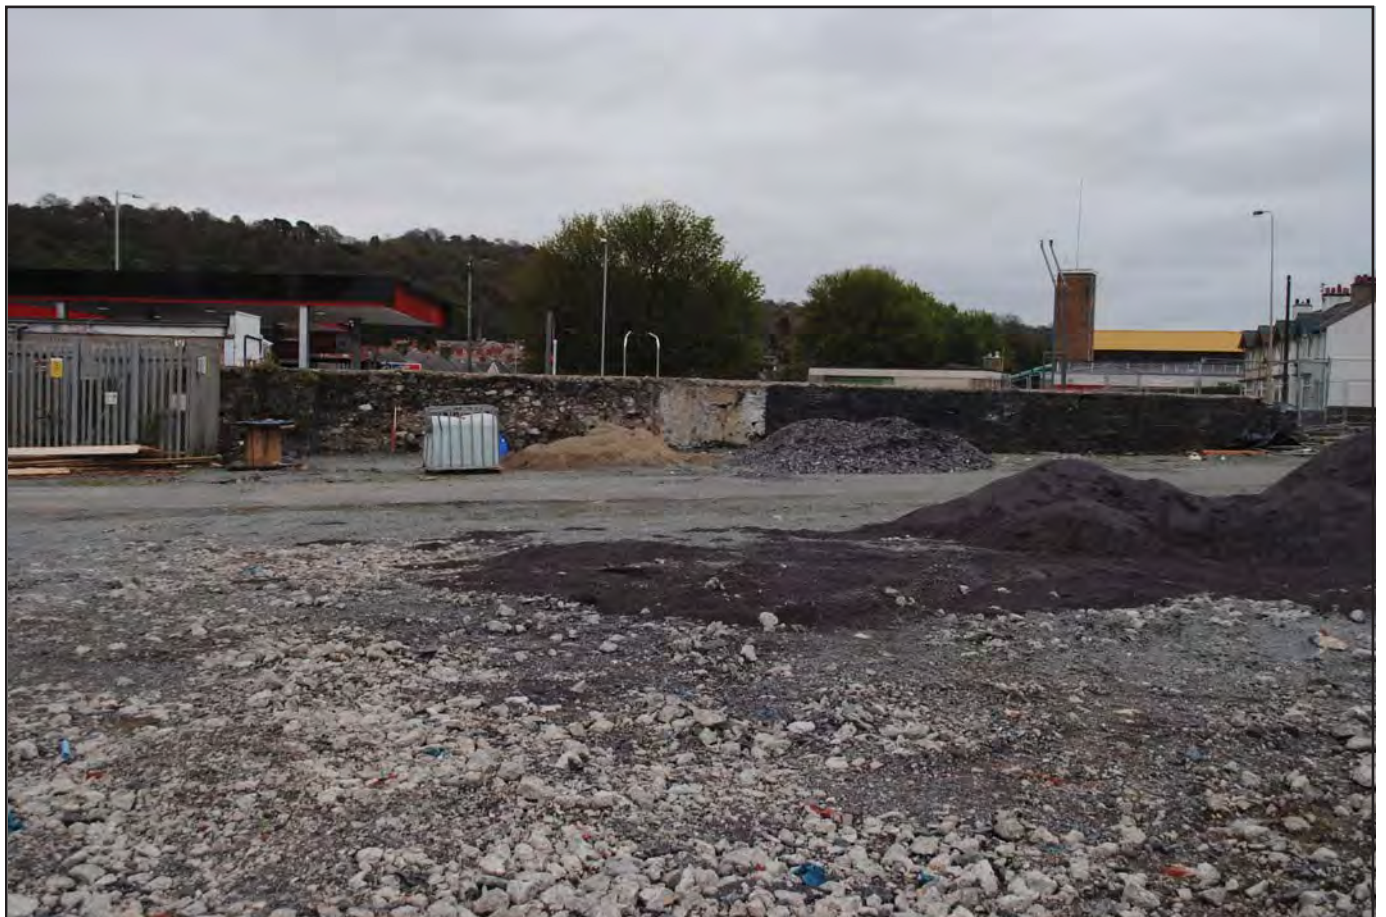
Plate 18 - View south from within the development area of former boundary wall. An electricity substation is visible to the left. It is currently unclear from client drawing 3811-02 if this will be demolished or rendered.

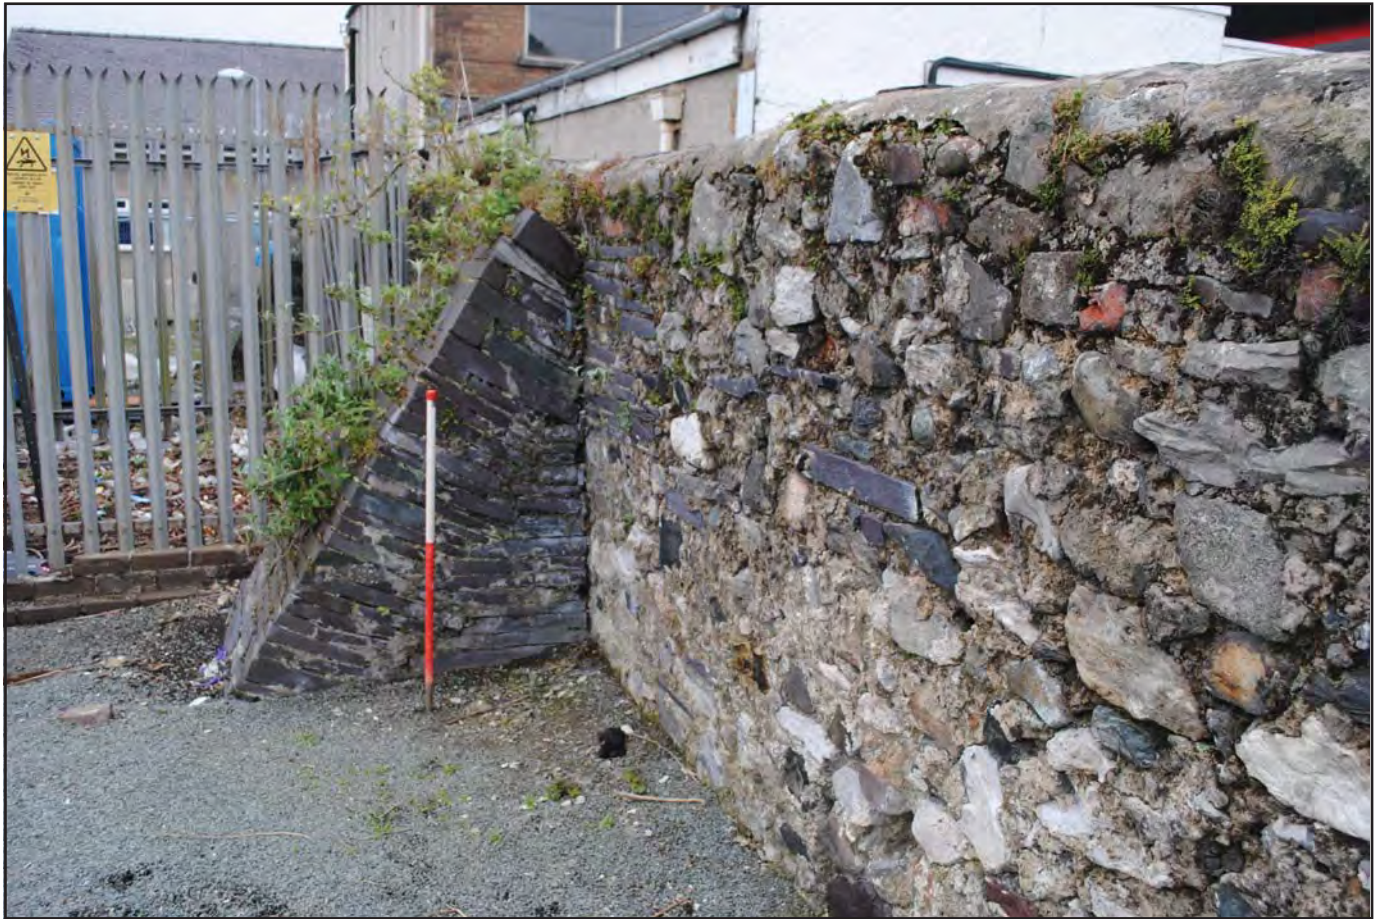
Plate 19 - Detailed view of boundary wall from Plate 18: note the slate buttress.  
Note: It is currently unclear from client drawing 3811-02 if this will be demolished or rendered.

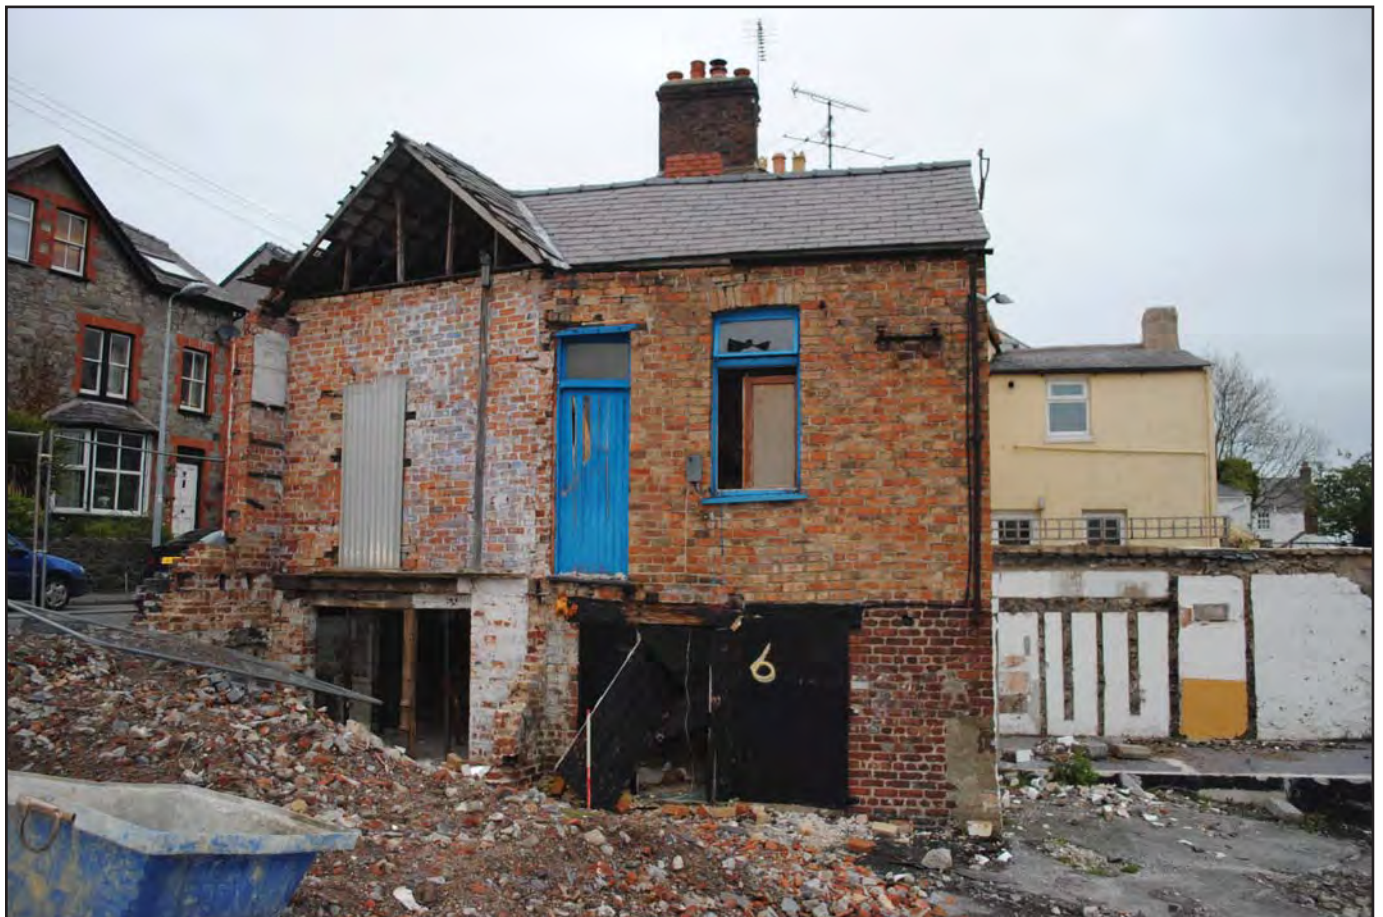
Plate 20 - View of southwest facing elevation of former building associated with the Garth Slate works and subsequently Dickies Boatyard. It appears on client drawing 3811-02 that this building will be demolished to accommodate a new access point off Garth Road.

It is recommended that an opportunity is taken to record the partly demolished red brick structure along Garth Road (Plates 20 to 22) during further demolition and during construction of the access point, as well as any foundation level activity associated with the former structures along Garth Road and within the complex grouping of structures located at the western end of the site on the Ordnance Survey historic mapping (Figures 06 to 08). It is also recommended the watching brief examines the foundation level structural material identified during the walkover (plate 06) that appears to represent a former structure evident on historic mapping; this will be at the location between Blocks 1 and 3, detailed on **Watkin Jones Homes** Drawing No. 3811-02 *Proposed Site Plan* (Figure 11).

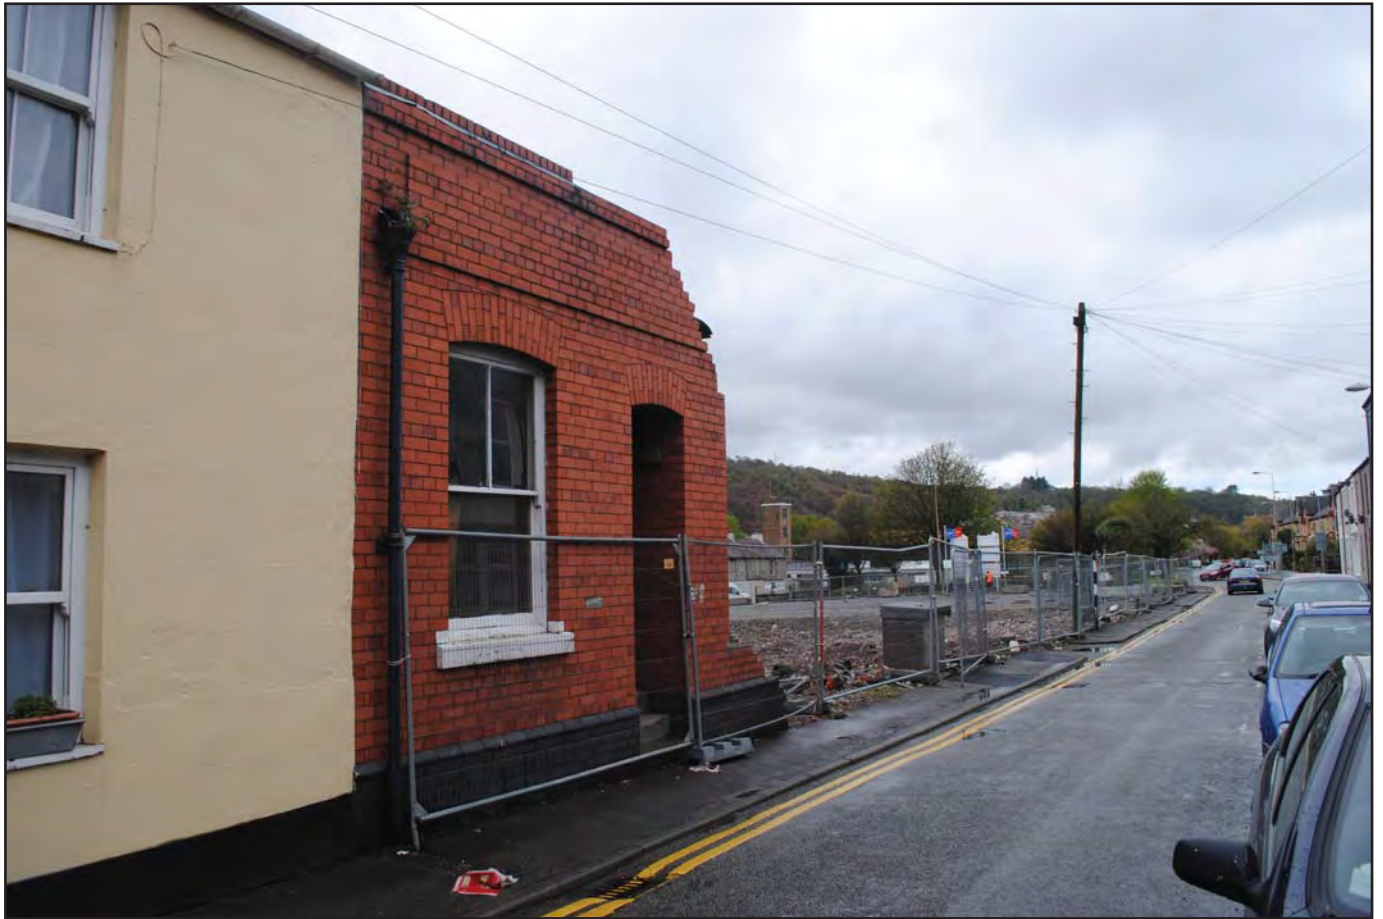
Plate 21 - View of west facing elevation of former building associated with the Garth Slate works and subsequently Dickies Boatyard. It appears on client drawing 3811-02 that this building will be demolished to accommodate a new access point off Garth Road.
