# Dickie's Boatyard, Bangor

## Archaeological Assessment

Project No. G2259

Report No. 1049

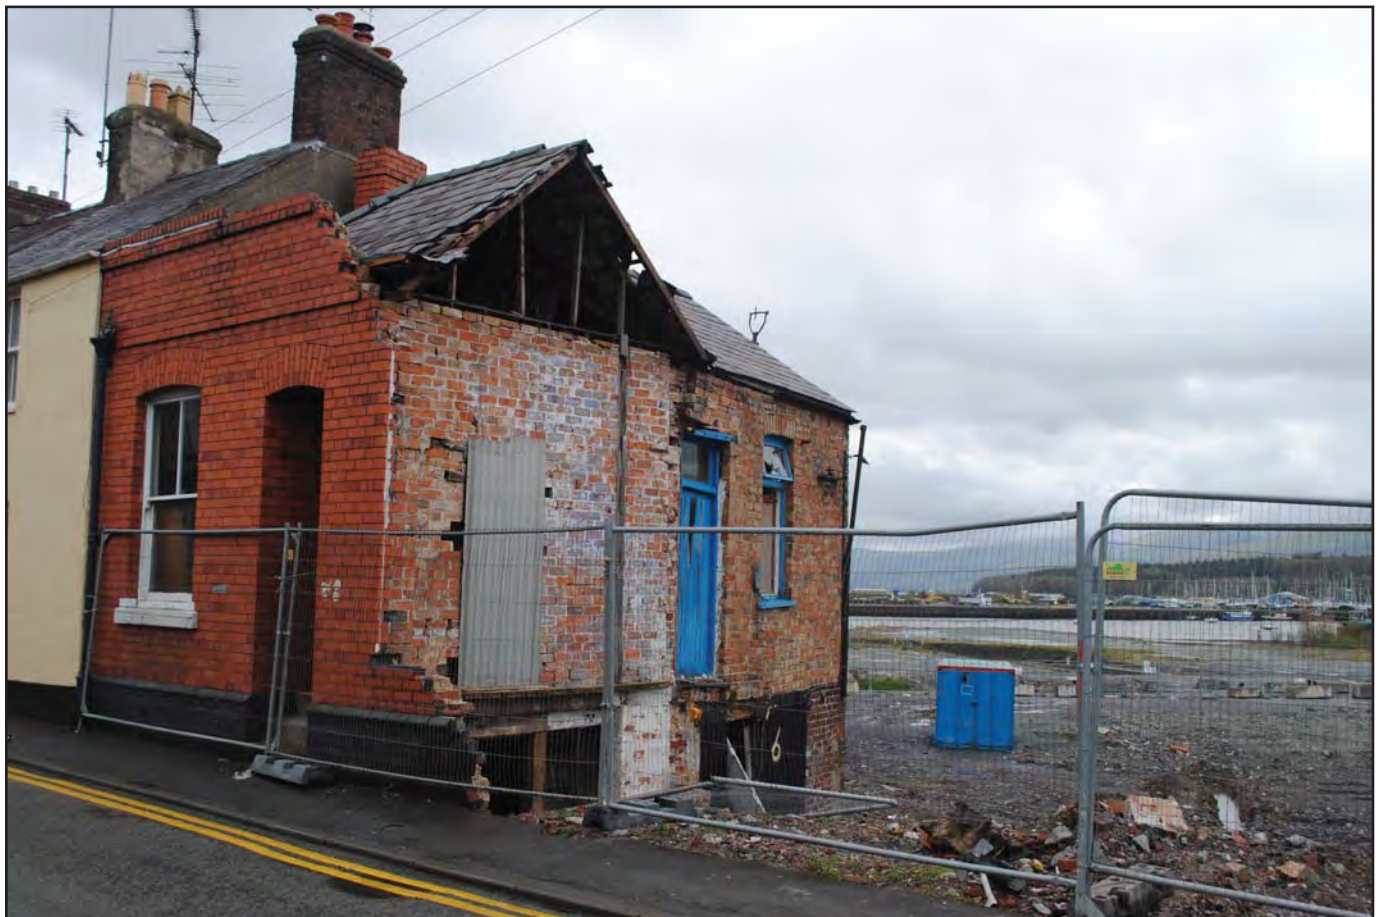
Plate 22 - View of southwest facing elevation of former building associated with the Garth Slate works and subsequently Dickies Boatyard. It appears on client drawing 3811-02 that this building will be demolished to accommodate a new access point off Garth Road.

It is recommended that an opportunity is taken to record the partly demolished red brick structure along Garth Road (Plates 20 to 22) during further demolition and during construction of the access point, as well as any foundation level activity associated with the former structures along Garth Road and within the complex grouping of structures located at the western end of the site on the Ordnance Survey historic mapping (Figures 06 to 08). It is also recommended the watching brief examines the foundation level structural material identified during the walkover (plate 06) that appears to represent a former structure evident on historic mapping; this will be at the location between Blocks 1 and 3, detailed on **Watkin Jones Homes** Drawing No. 3811-02 *Proposed Site Plan* (Figure 11).

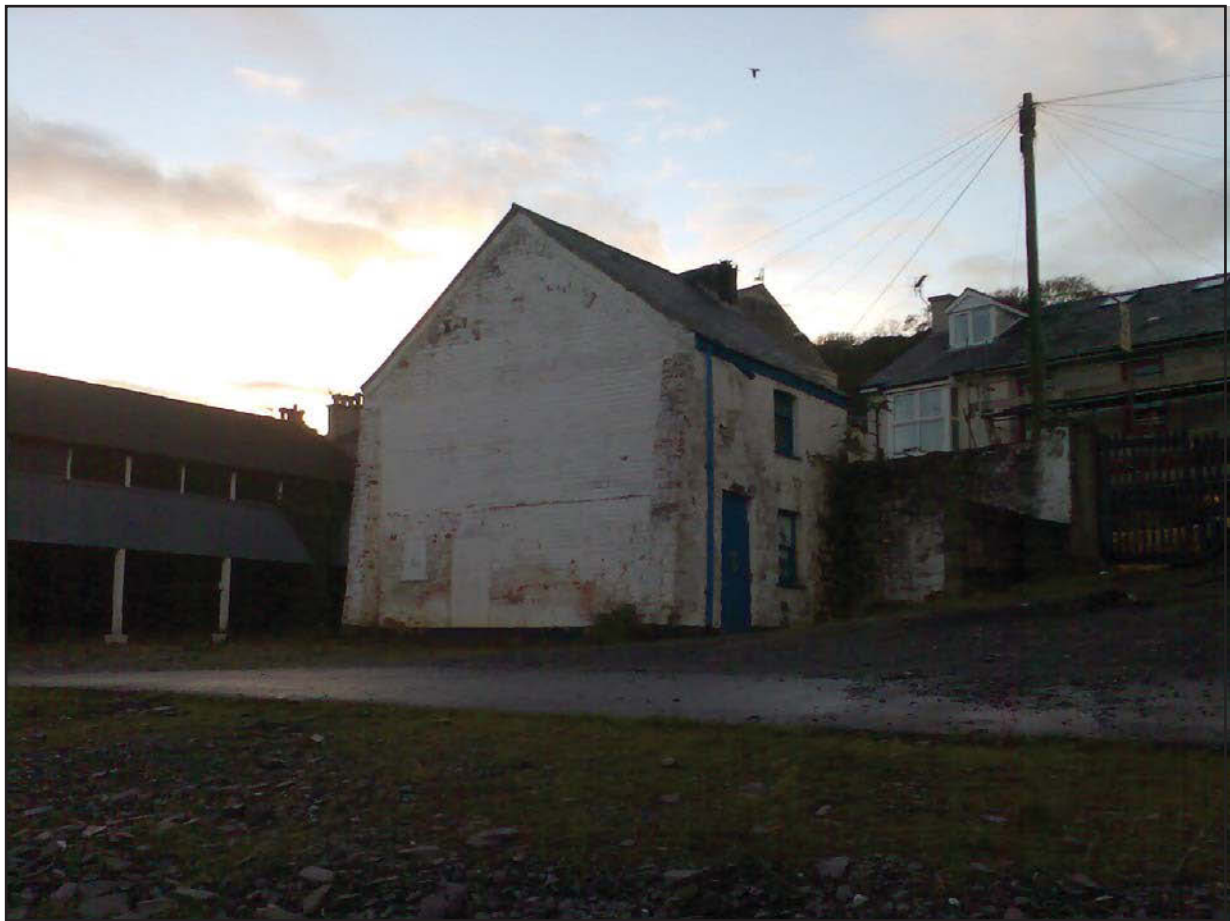
Plate 29 - Rear view of the Dickie's Boatyard structure/former shipbuilding yard structure fronting Garth Road. This structure was demolished in 2011. The historic mapping details a complex grouping of structures at this location (Figures 06 to 08) including the slipway. A buttress has been added to the building, probably after the demolition of an attached structure. A blocked door and window are evident at ground level. Gated access from Garth Road is also visible at the right side of the image. (Source: Watkin Jones Homes)

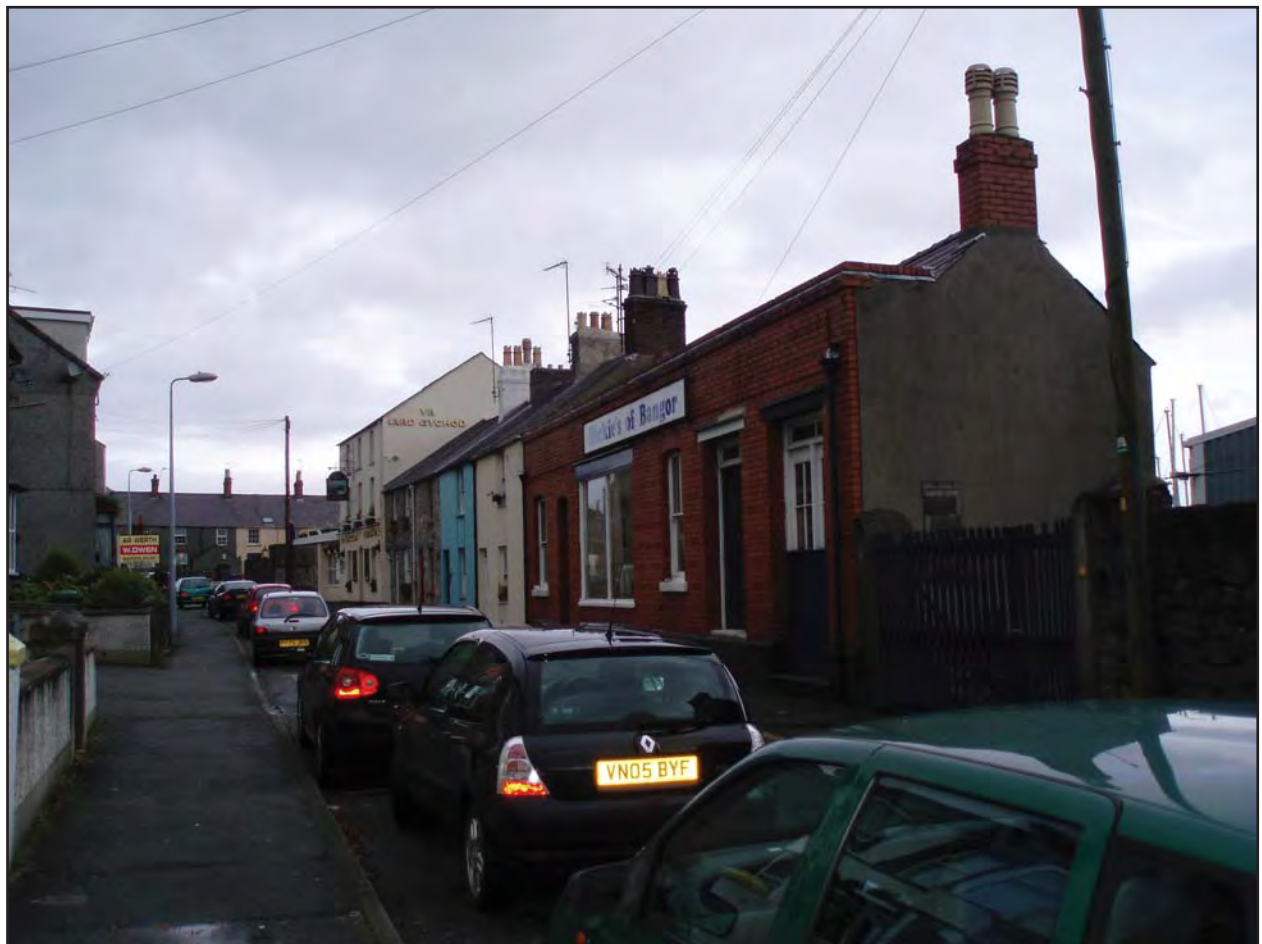
Plate 30 - View north along Garth Road of the Dickie's Boatyard structure/former shipbuilding yard structure fronting Garth Road. The majority of this elevation was demolished in 2011 (part of the structure is still upstanding as of May 2012; cf. Plates 20 to 22). A former shop window, two access doors and a sash window are visible along with a gated access to the yard. A blocked window is visible on the gable end. (Source: Watkin Jones Homes)

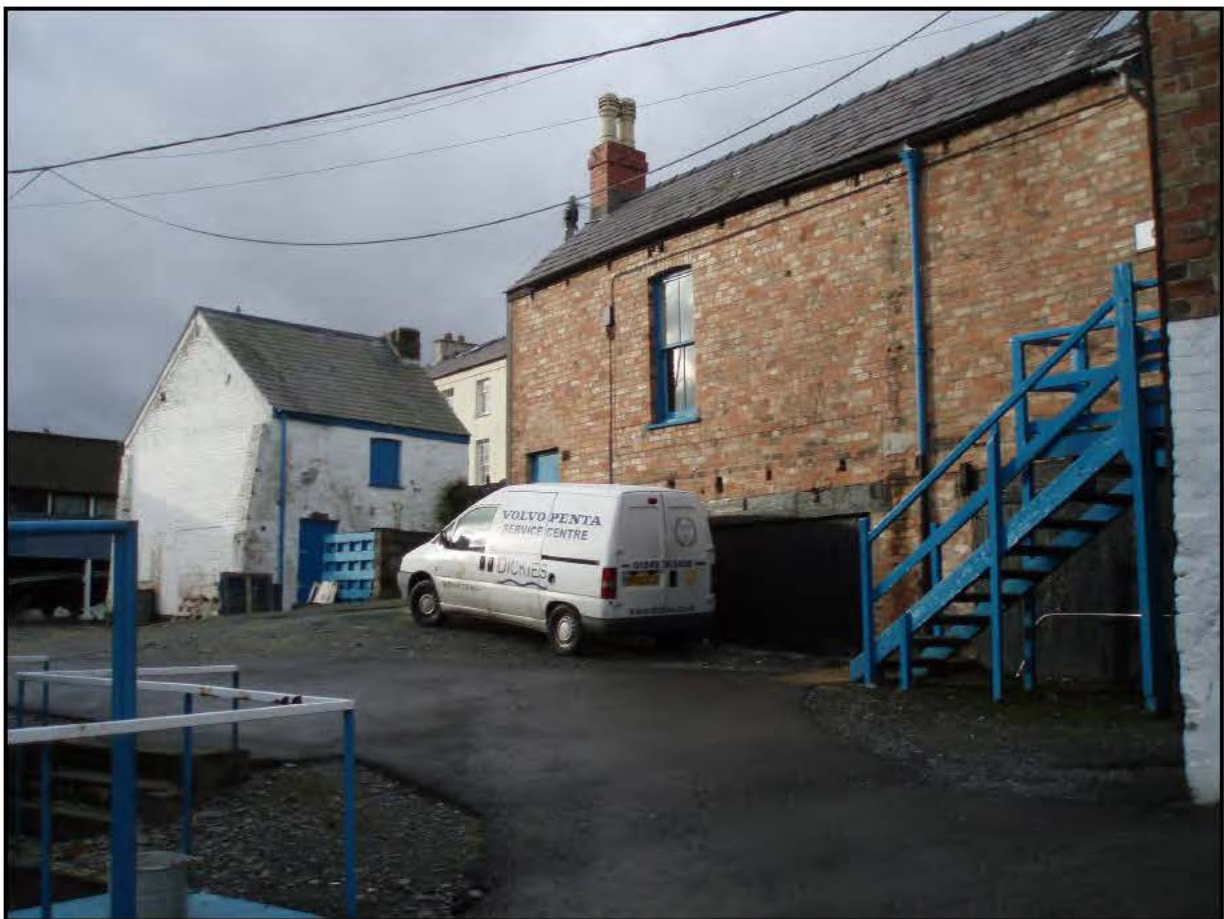
Plate 27 - Rear view of the Dickie's Boatyard structure/former shipbuilding yard structure fronting Garth Road. This elevation was demolished in 2011 (part of the structure is still upstanding as of May 2012). A series of holes or sockets are visible just below roof level as well as above a large wooden lintel. The historic mapping details a complex grouping of structures at this location (Figures 06 to 08) including the slipway. A buttress has also been added to the whitewashed building at the left of image, probably after the demolition of an attached structure; again the map evidence suggests a building associated with the slipway was located there. (Source: Watkin Jones Homes)

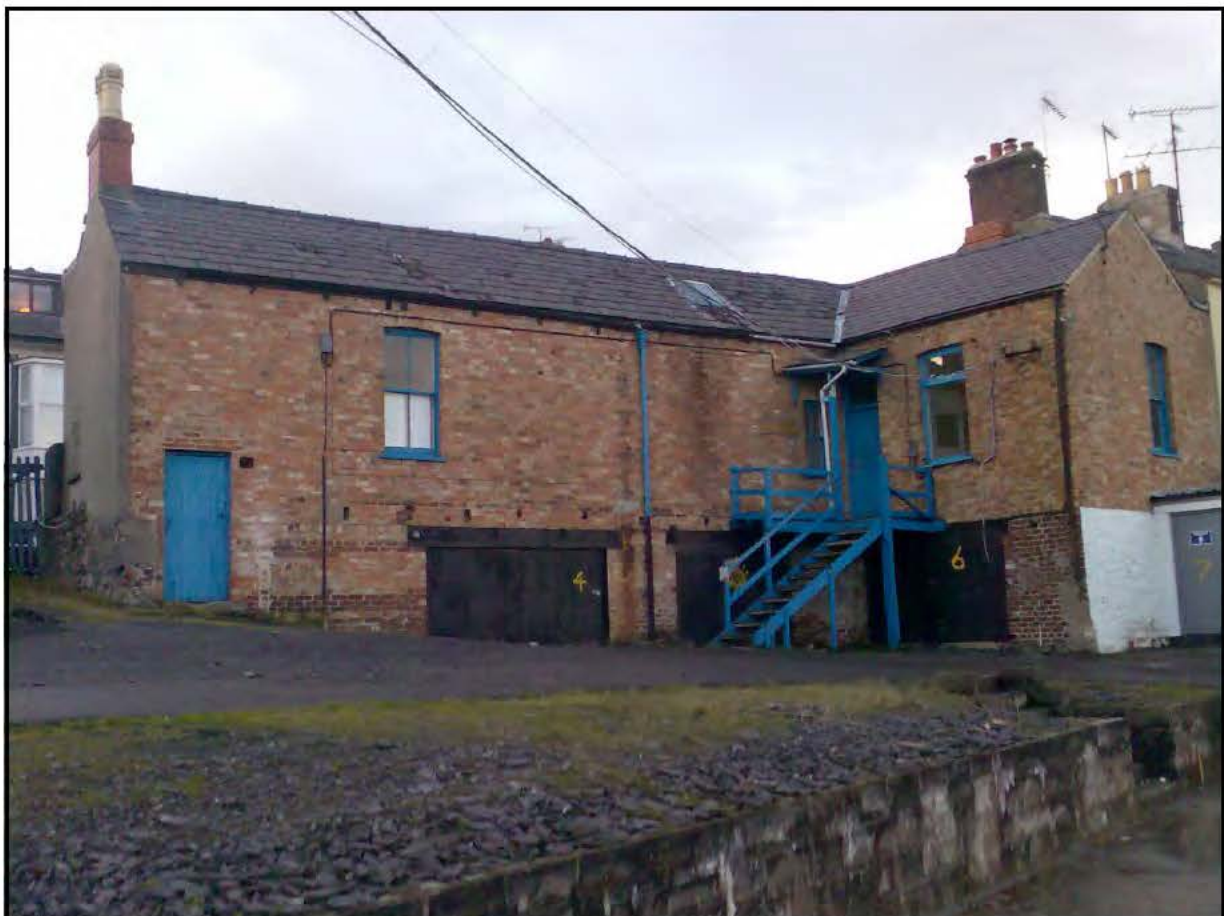
Plate 28 - Rear view of the Dickie's Boatyard structure/former shipbuilding yard structure fronting Garth Road. This elevation was demolished in 2011 (part of the structure is still upstanding as of May 2012; cf. Plates 20 to 22). A series of holes or sockets are visible just below roof level as well as above a large wooden lintel. The historic mapping details a complex grouping of structures at this location (Figures 06 to 08) including the slipway. The large doors below the lintels imply that workshops were located at this level. (Source: Watkin Jones Homes)

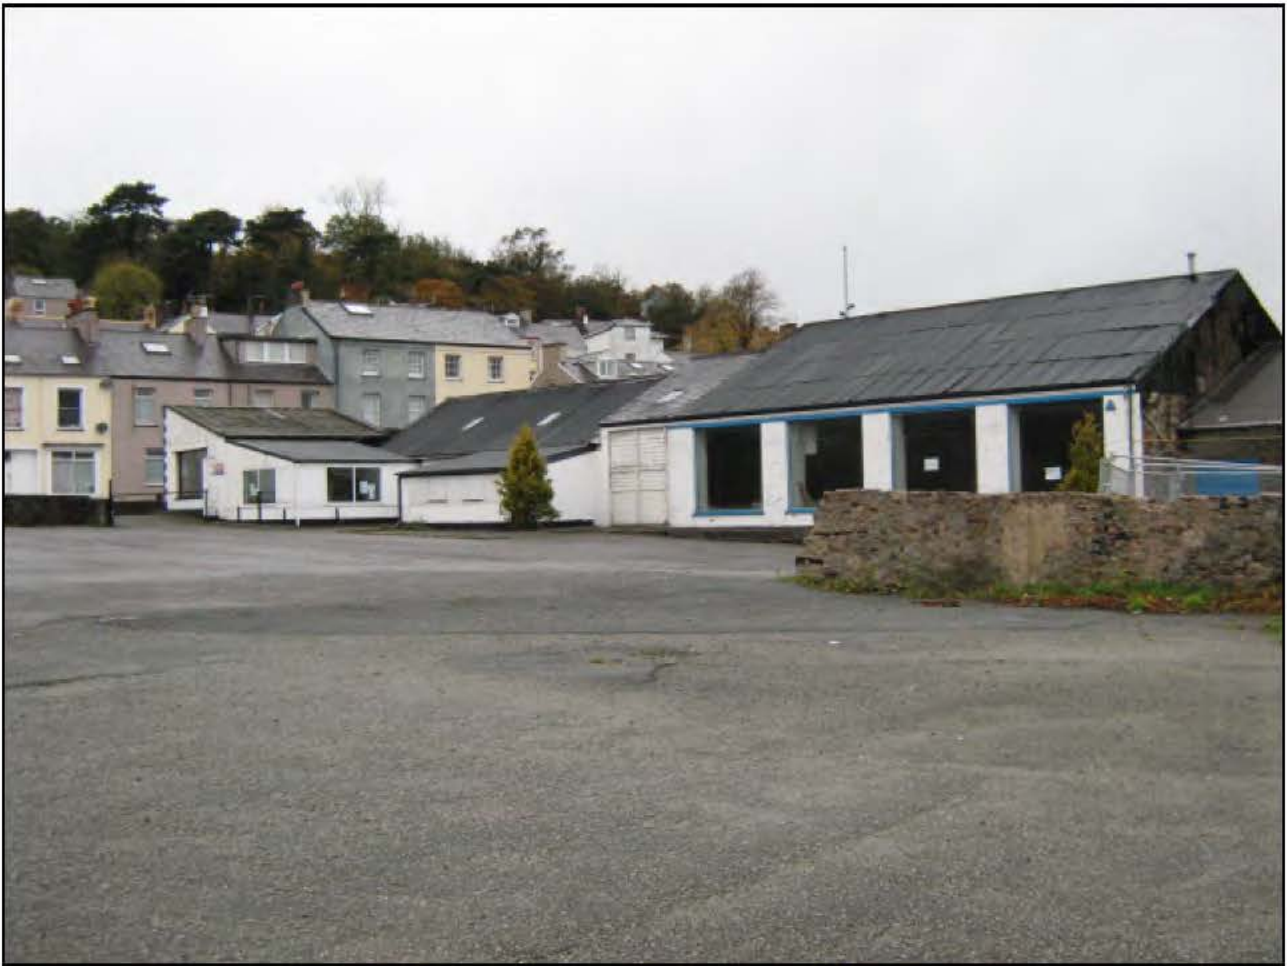
**Plate 25 - View of northwest of the development site prior to the demolition of Dickie's Boatyard. The structure in the centre of the image appears to correspond with a structure at that location on Figure 09, albeit modernised to accommodate large windows. (Source: Watkin Jones Homes)**

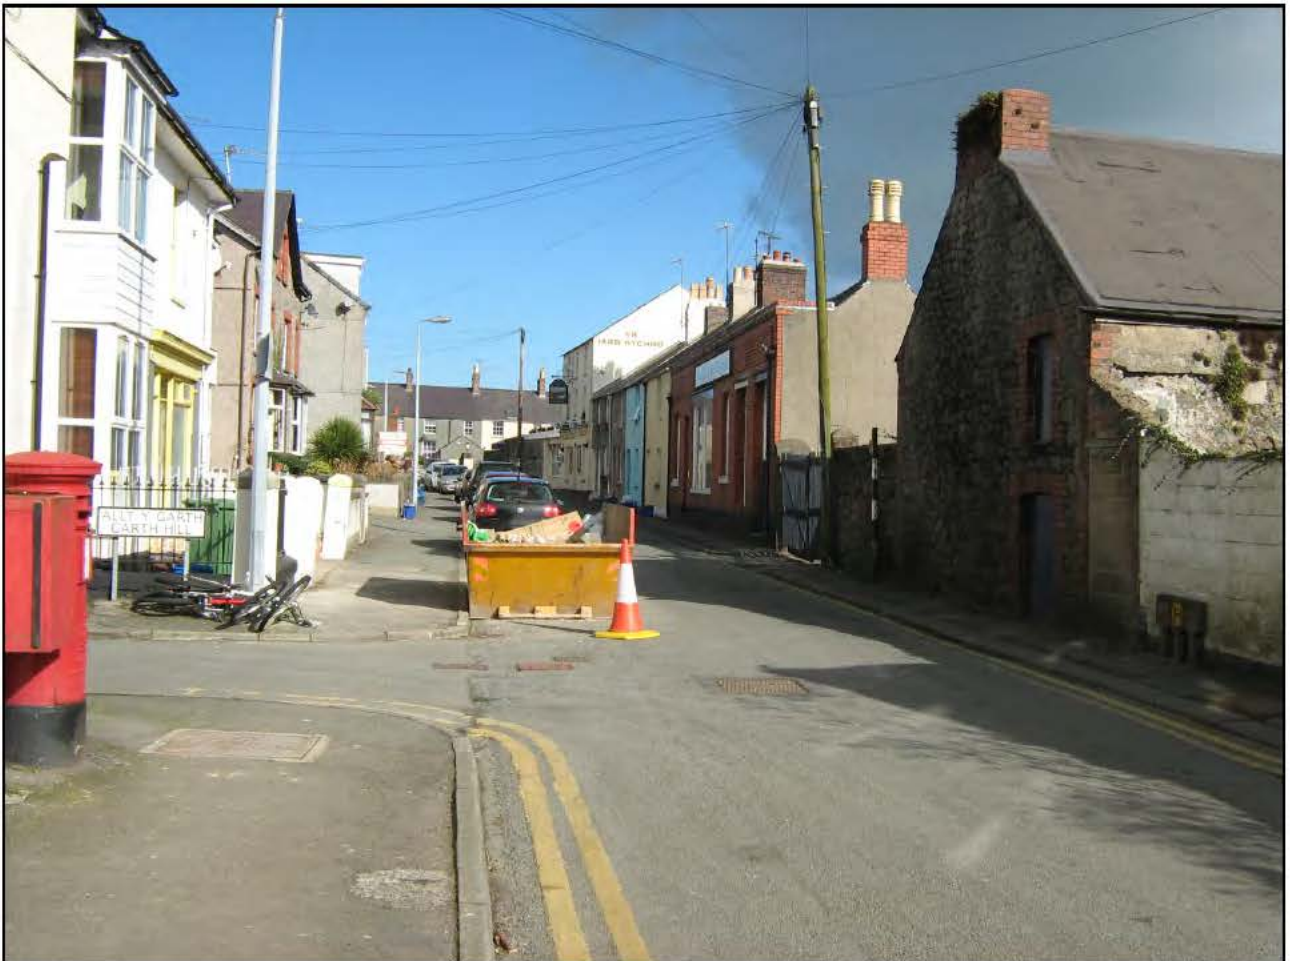
**Plate 26 - View north detailing the former properties along Garth Road prior to demolition in 2011 that formerly belonged to the ship building yard (cf Figure 06) and subsequently Dickie's Boatyard. The red brick building was still partly upstanding during the GAT walkover (cf. Plates 20 to 22). Note the stone-built structure in the foreground with the blocked ground and first floor windows; the remnants of a lean-to structure tie-in is visible on the south facing elevation of the building. (Source: Watkin Jones)**

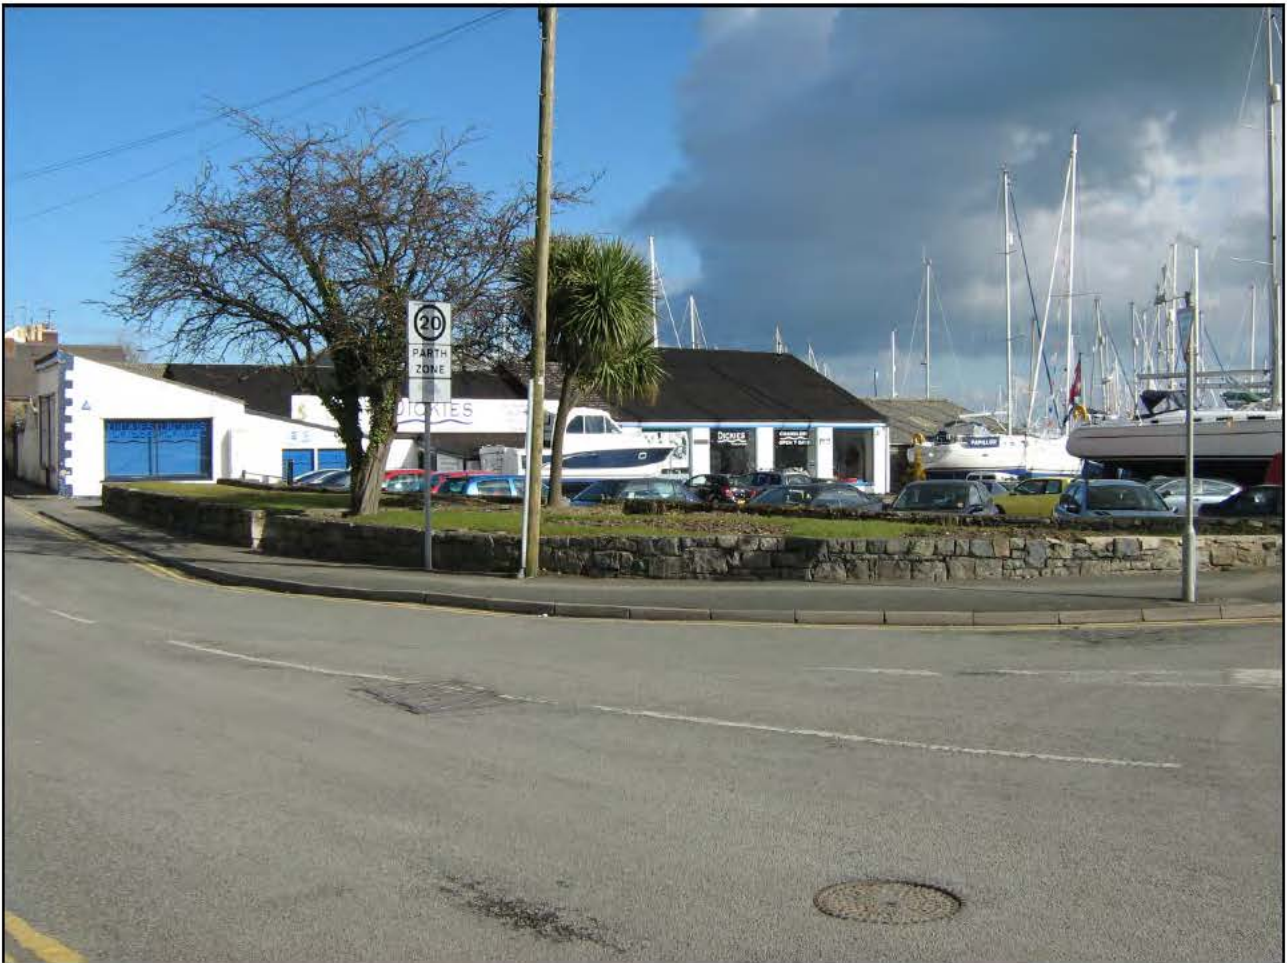
**Plate 23 - View of northeast of the development site prior to the demolition of Dickie's Boatyard in 2011.**  
The white washed property on the left of the image appears to correspond with a structure at that location on Figure 09.  
Source: Watkin Jones Homes.

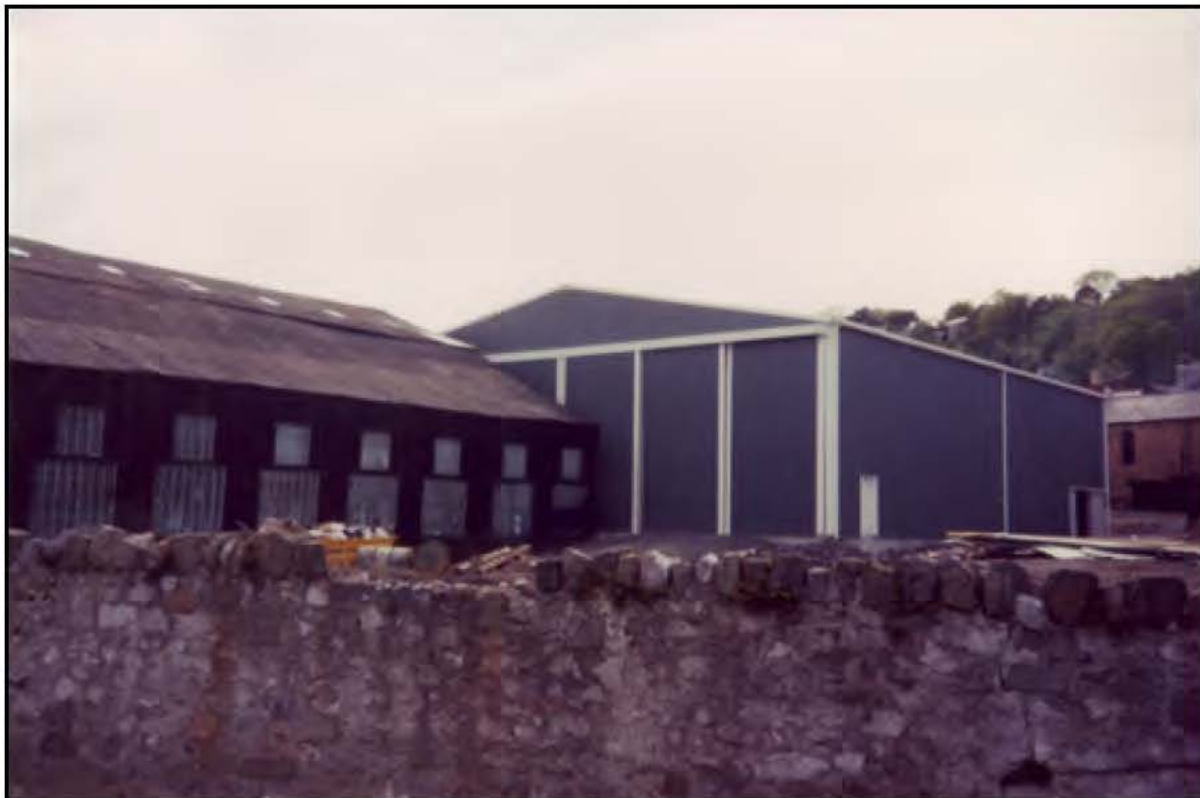
Plate 31 - A reproduction of a photograph taken in 1978 of Dickie's Boatyard prior to the demolition of a boatyard shed. The photograph appears to have been taken from Glan Dwr Road, which ran along the eastern boundary of the site. A former boundary wall is visible in the foreground and the red brick office building along Gareth Road can be seen in the background. The modern pre-fabricated shed remained until the demolition of the Dickie's site in 2011; the older boatyard shed, based on the information in Plate 32, was built from timber with corrugated roofing. The boatyard shed is not visible on the 1914 Ordnance Survey map of the area, but is visible in a photograph from the early 1930s (reproduced as Figure 09) and it is likely to have been constructed in the early twentieth century (Source: Bangor Civic Society; ref. BCS00038)

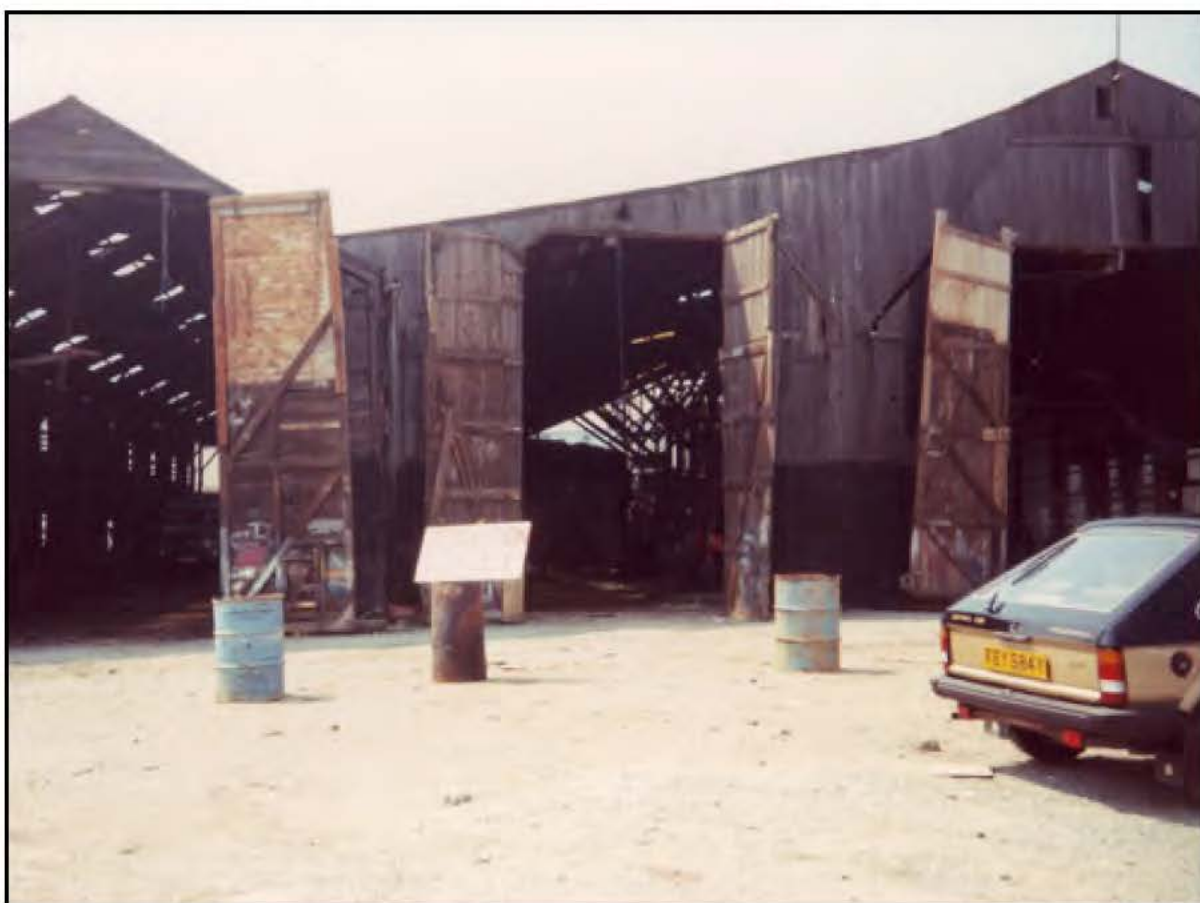
Plate 32 - A reproduction of a photograph taken in 1978 of Dickie's Boatyard prior to the demolition of a boatyard shed. The image is contemporary with Plate 31 and is a view from the south looking the entrance points. Some of the timber framing is visible within the middle entrance and it is also apparent that the shed was expanded in phases as the middle of part of the building appears to have been added to the structures on the left and the right of the image, conjoining them. The boatyard shed is not visible on the 1914 Ordnance Survey map of the area, but is visible in a photograph from the early 1930s (reproduced as Figure 09) and it is likely to have been constructed in the early twentieth century (Source: Bangor Civic Society; ref. BCS00039)
