Garndolbenmaen Water Mains Renewal Scheme, North Wales

Archaeological Watching Brief

Project No. G2263

Report No. 1056

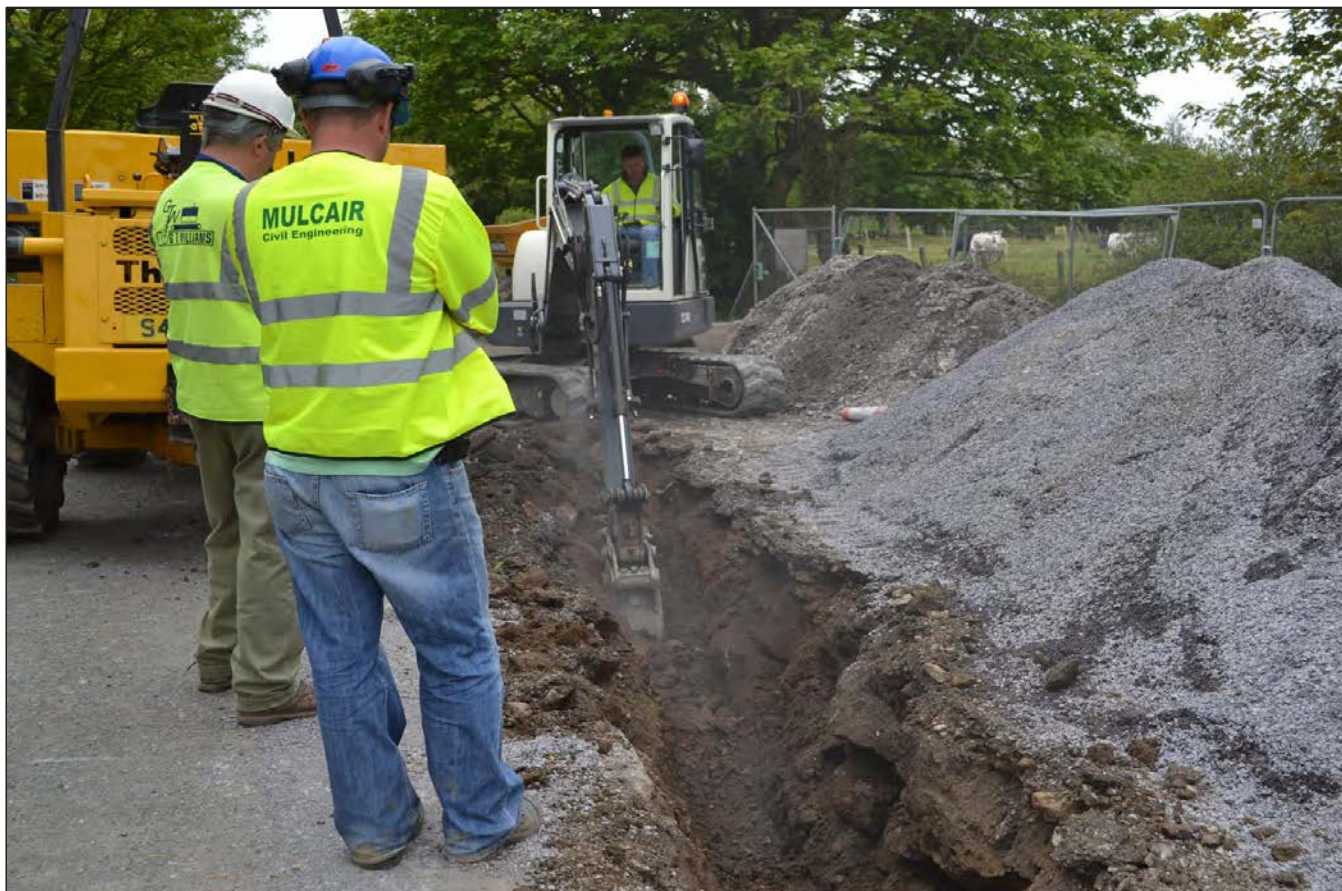
Plate 01: Excavation of pipe trench, section C. View from the SSE.

The majority of the route was on the verge of the road and the route ran as an open cut trench from the south east from the A487 heading roughly north west with a dog leg at the north end to the water connection point. The length of the open cut pipe trench observed by the archaeologist was approximately 450m long (plate 01).

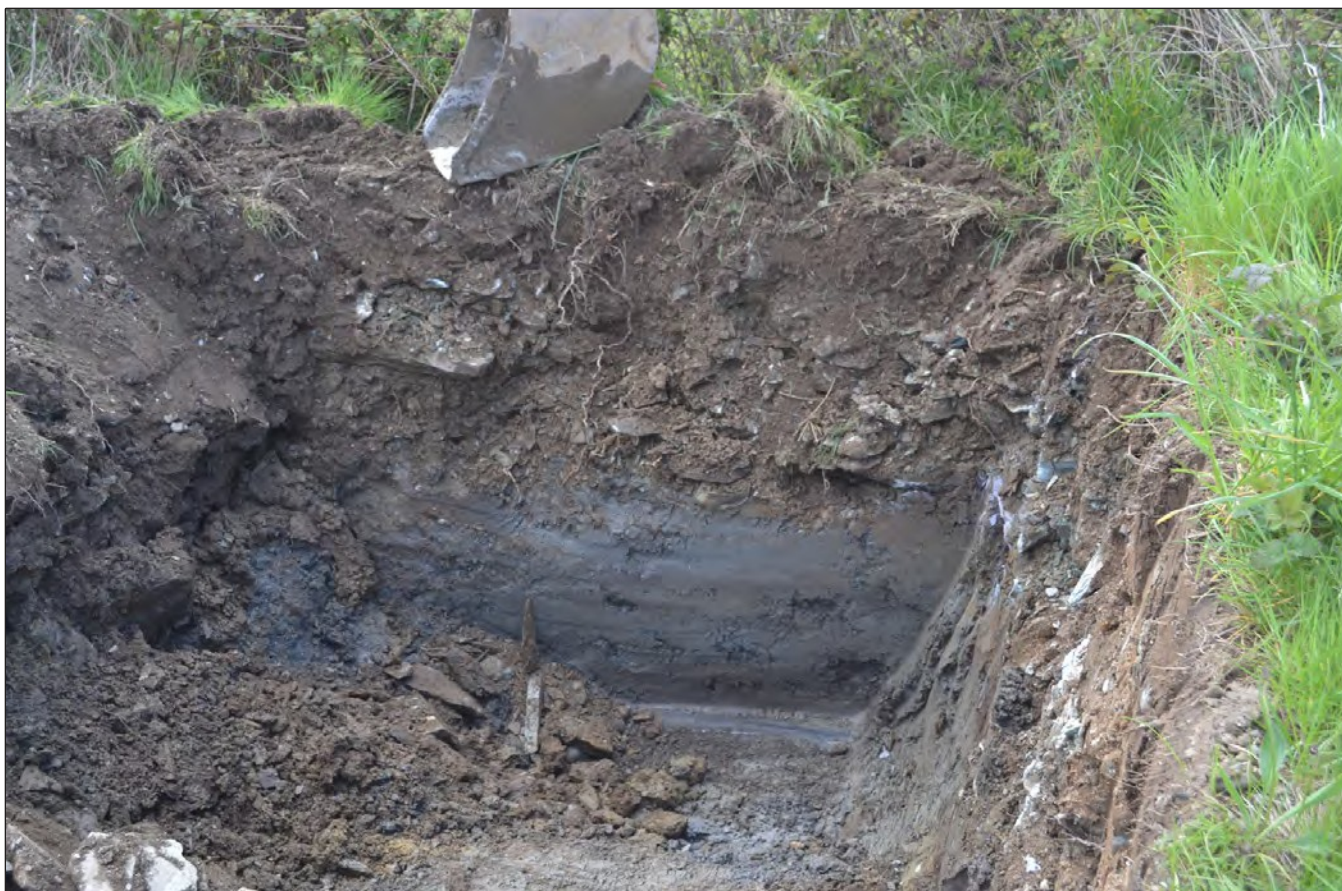
Plate 02: Trial hole 01 on the verge of the A487, shows material for the built up ground for the existing A487 road. The ground drops dramatically to the S. View from the N.

Trial hole 01 was excavated on the southern side of the A487 on the verge opposite the A4857 T junction. A trial hole had already been dug and backfilled due to failure to locate the pipe. The hole was approximately 2m deep and approximately 2.5m square. There were mixed deposits on the south east and south west sides of the trial hole due to the previous attempt to locate the pipe. The area was heavily disturbed due to the ground being made up from when the road was built and also due to the recent road improvement along this stretch of the A487. The topsoil was clay silt mid grey brown with very occasional small stones and numerous roots and measured 0.15m. There was no ploughsoil as below the topsoil was a build up of mixed deposits consisting of light orange grey silts and merges into a hardcore of various sizes of grey blue angular slate and schist from small to large in a grey gritty silt matrix and areas of small to large sub-rounded cobbles and broken boulders. The pipe was located 2m down within the hardcore layer (plate 02).

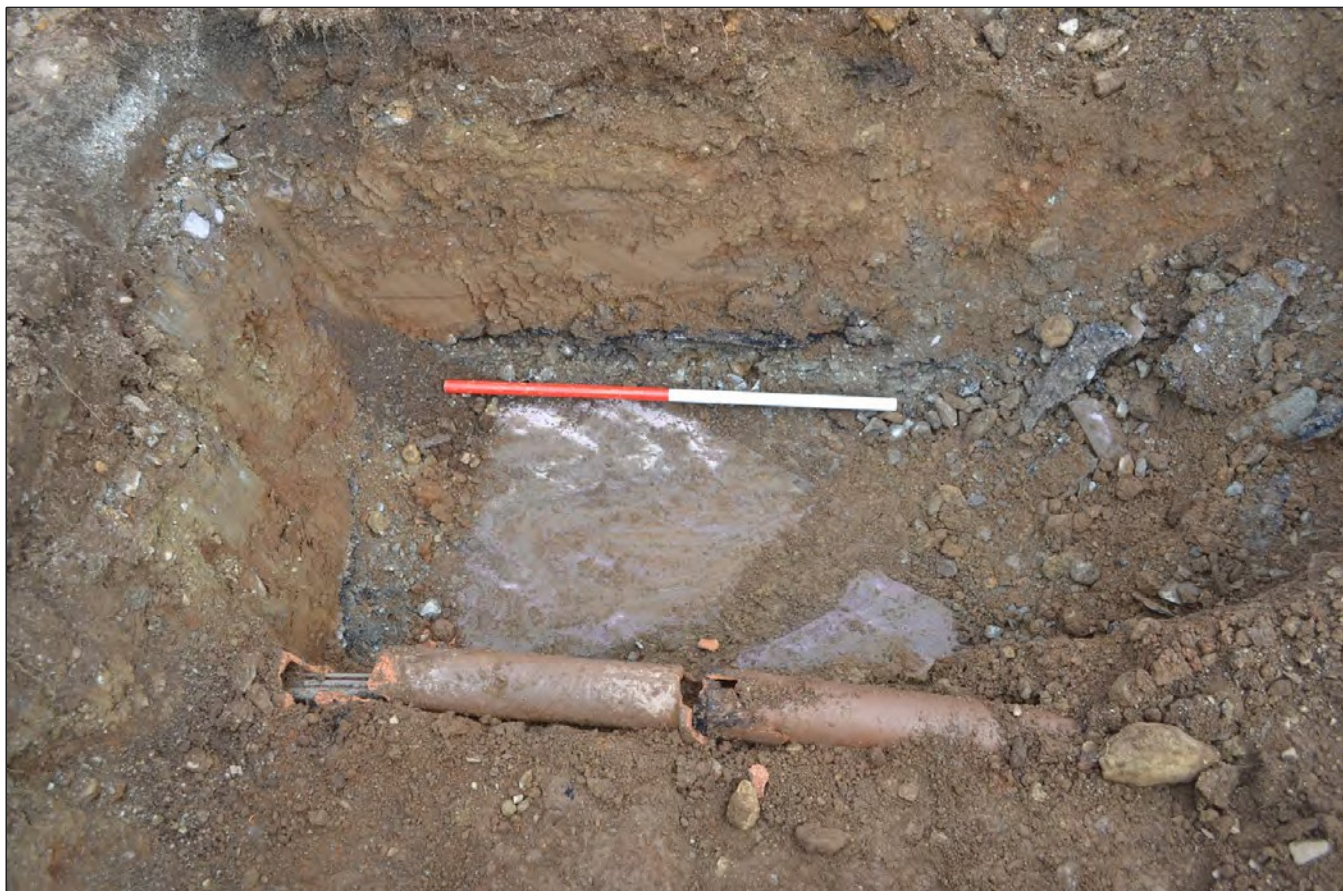
Plate 03: Trial hole 02. Shows purple slate capped culvert and band of Tarnacadam with a sub-base of crushed slate above it, in section, part of the old road.. View from the SW.

Trial hole 02 was excavated on the grassy area by the T junction on the north side of the A487 on the opposite side of the road to the Telephone Exchange. The topsoil was friable dark grey brown sand silt with the ploughsoil being a mix of dark orange brown sand silt with hardcore like crushed angular blue stones. Below this was a silt deposit consisting of a mixed mid brown orange clay sit with yellow patches. A 0.03m thick layer of Tarmacadam with a base of hardcore sat below the silt layer. Under the Tarmacadam and hardcore were large flat purple slate slabs, this was measured at 0.90m below the surface. They were thought to be caps stones to a culvert and ran in a NNW-SSE direction, heading towards and inspection chamber by the existing road. It was decided that the new pipe would not interfere with the culvert but run atop of it (plate 03).

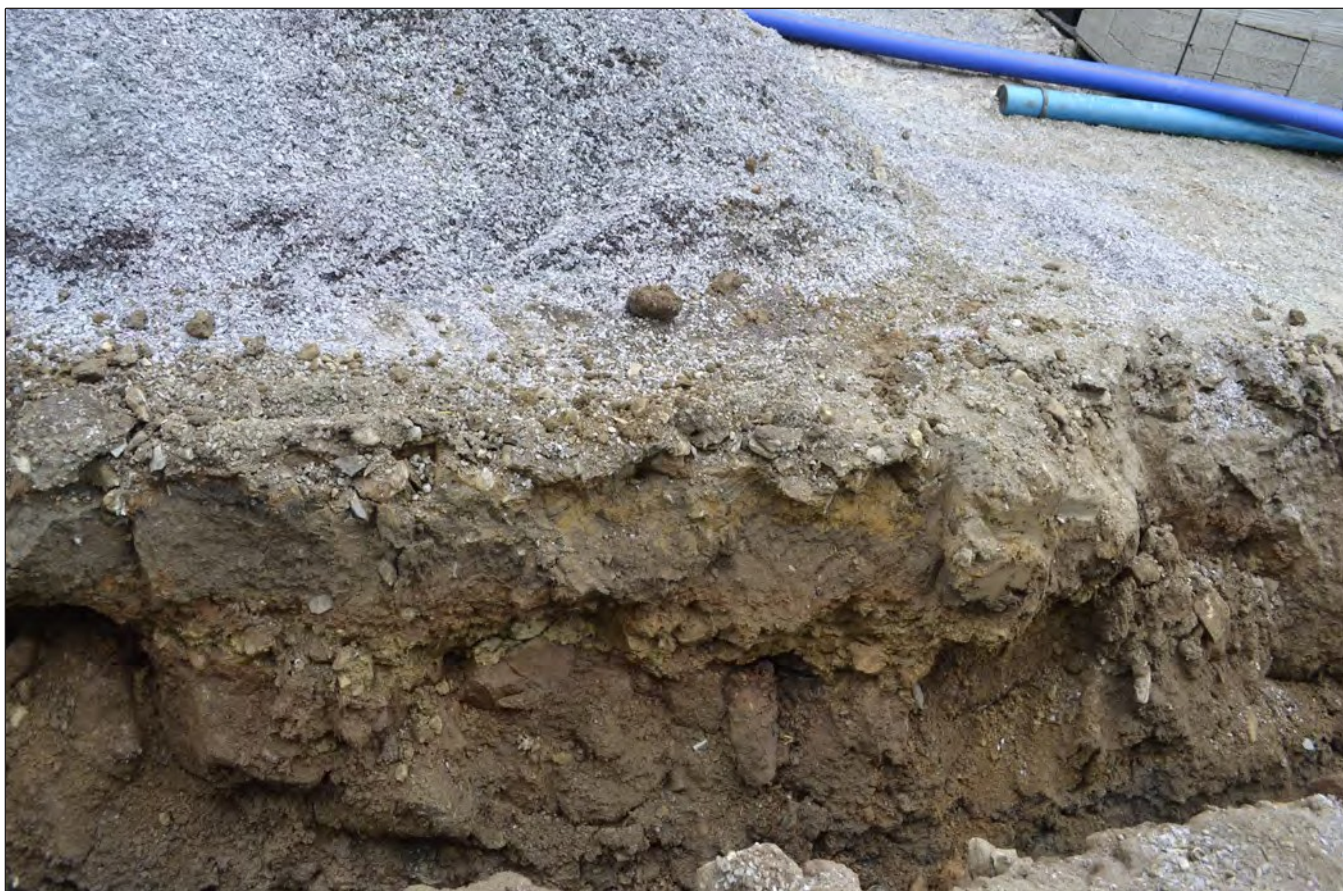
Plate 04: Section C, showing disturbed, mixed and built up material. View from the W.

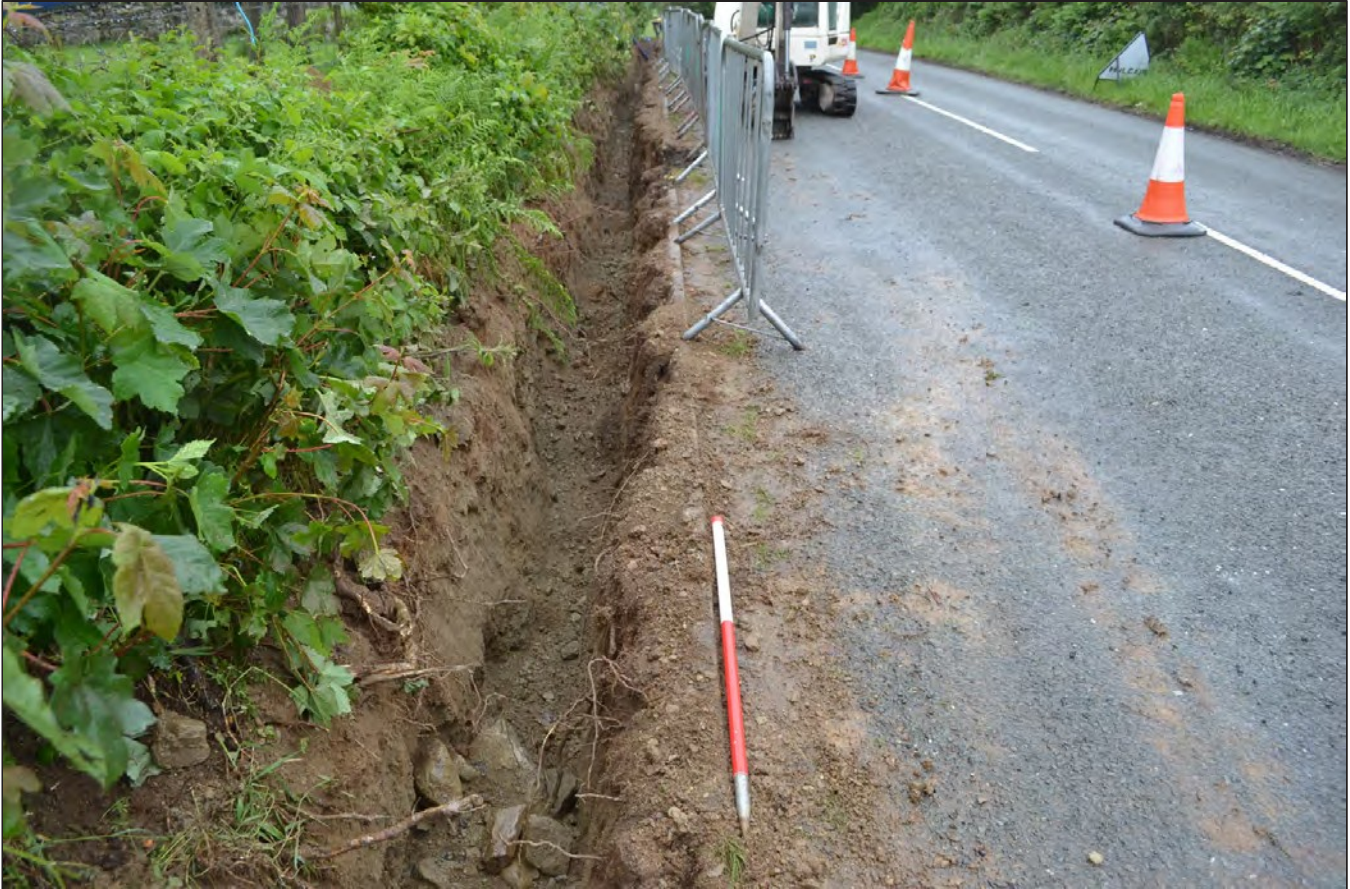
Plate 05: Section I. Showing grey yellow silty and stony hillwash. View from the NW

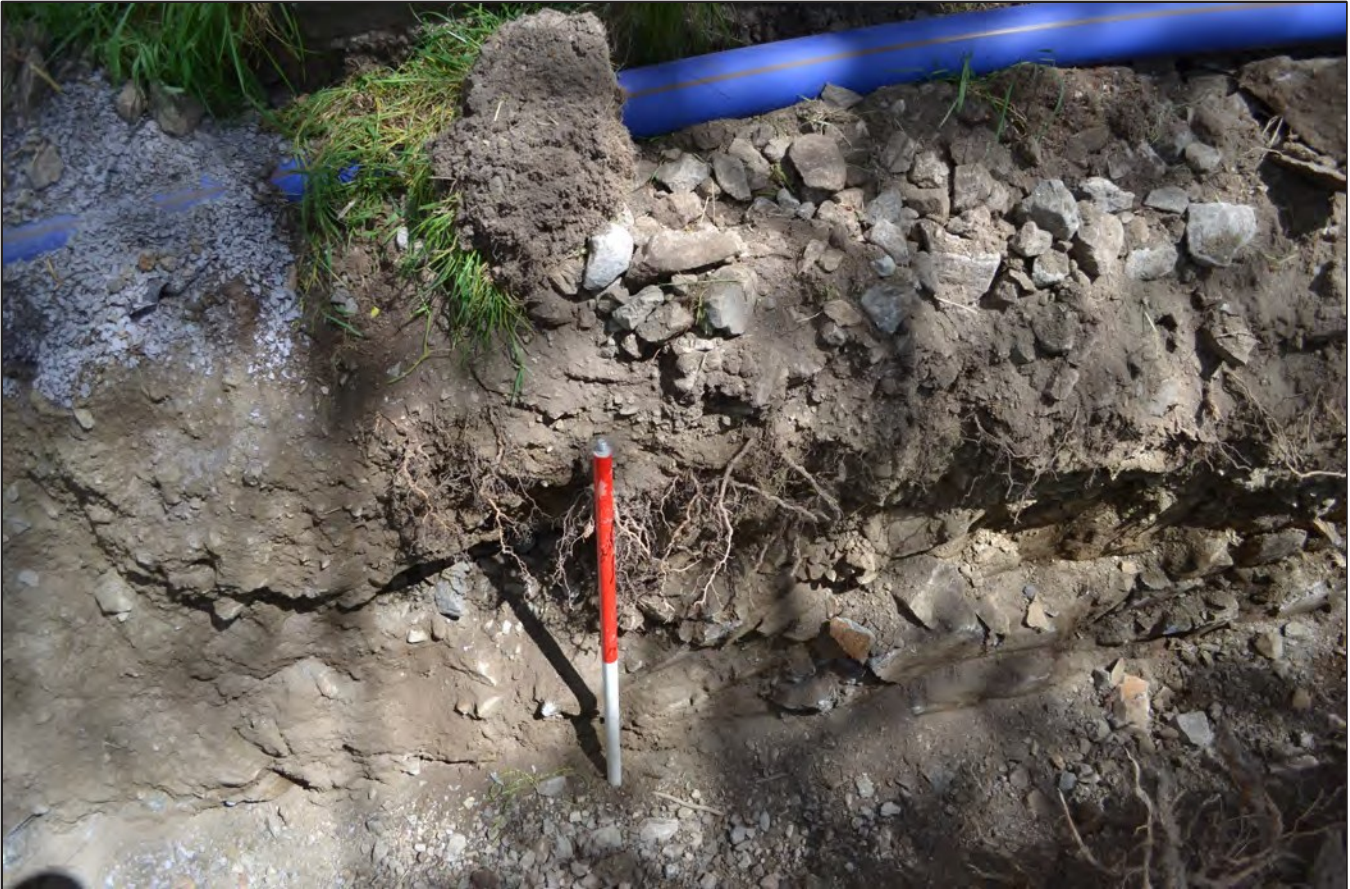
Plate 06: Section G. showing bedrock at the base of the trench. View from the SW.

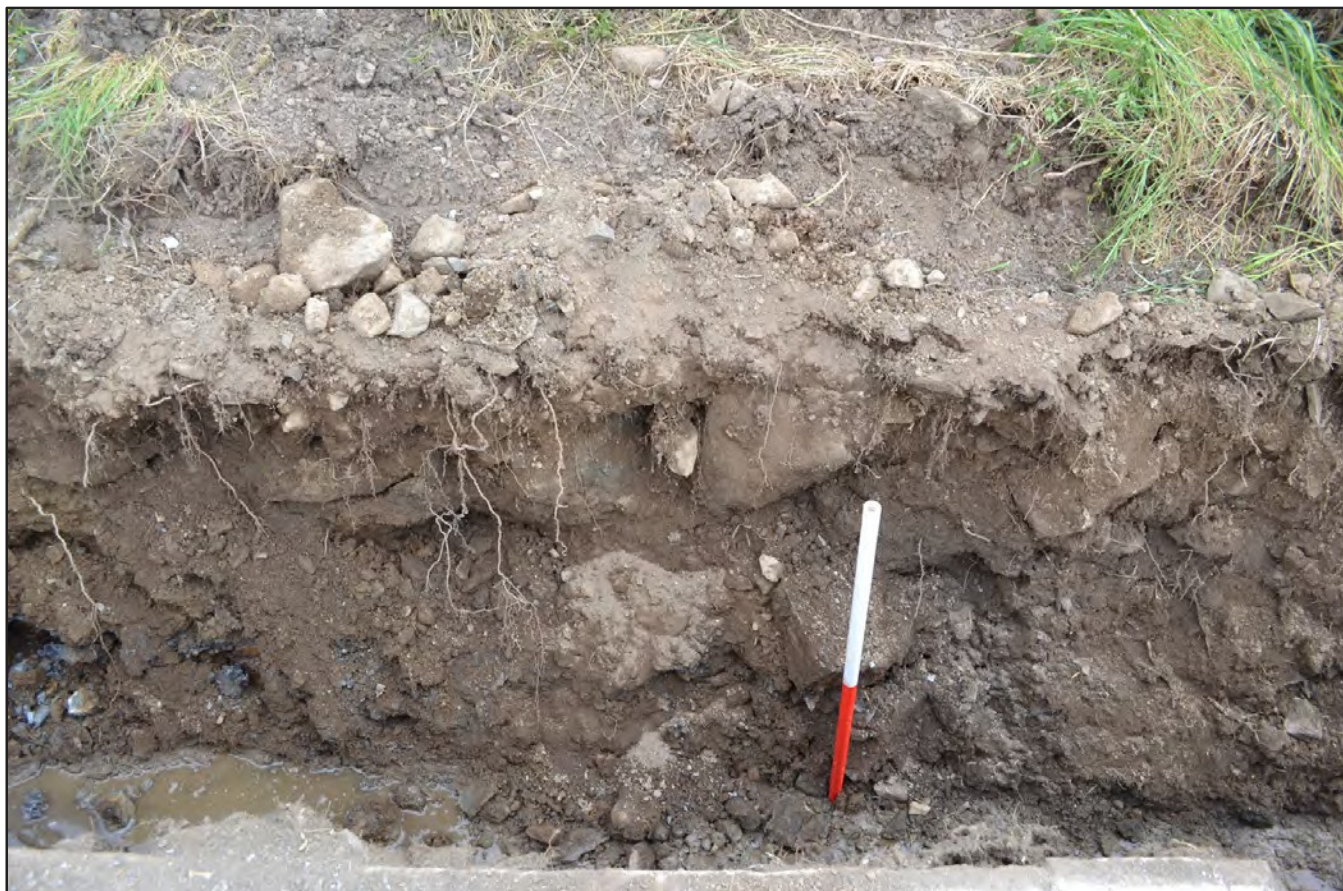
Plate 07: Stones in section C, possible part of an old boundary which followed the route of the original road. The pre-existing Tarmacadam road can be seen starting tho the N of the stones. View from the W.

The only feature that occurred was in section C, within its ploughsoil was a collection of sub-angular and sub-rounded boulders which may have been an old buried boundary, a photographic record and sketch drawing with detailed notes were taken, (plate 07). To the north of this 1.00m below the surface was a layer of Tarmacadam and above this looked to be modern built up ground including large boulders, broken red brick and other debris as well as mixed redeposited natural (plate 08). A 0.10m thick layer of Tarmacadam was also seen in southern half of section E 0.50m below the surface, it also had a crushed slate sub-base immediately below it (plate 09).

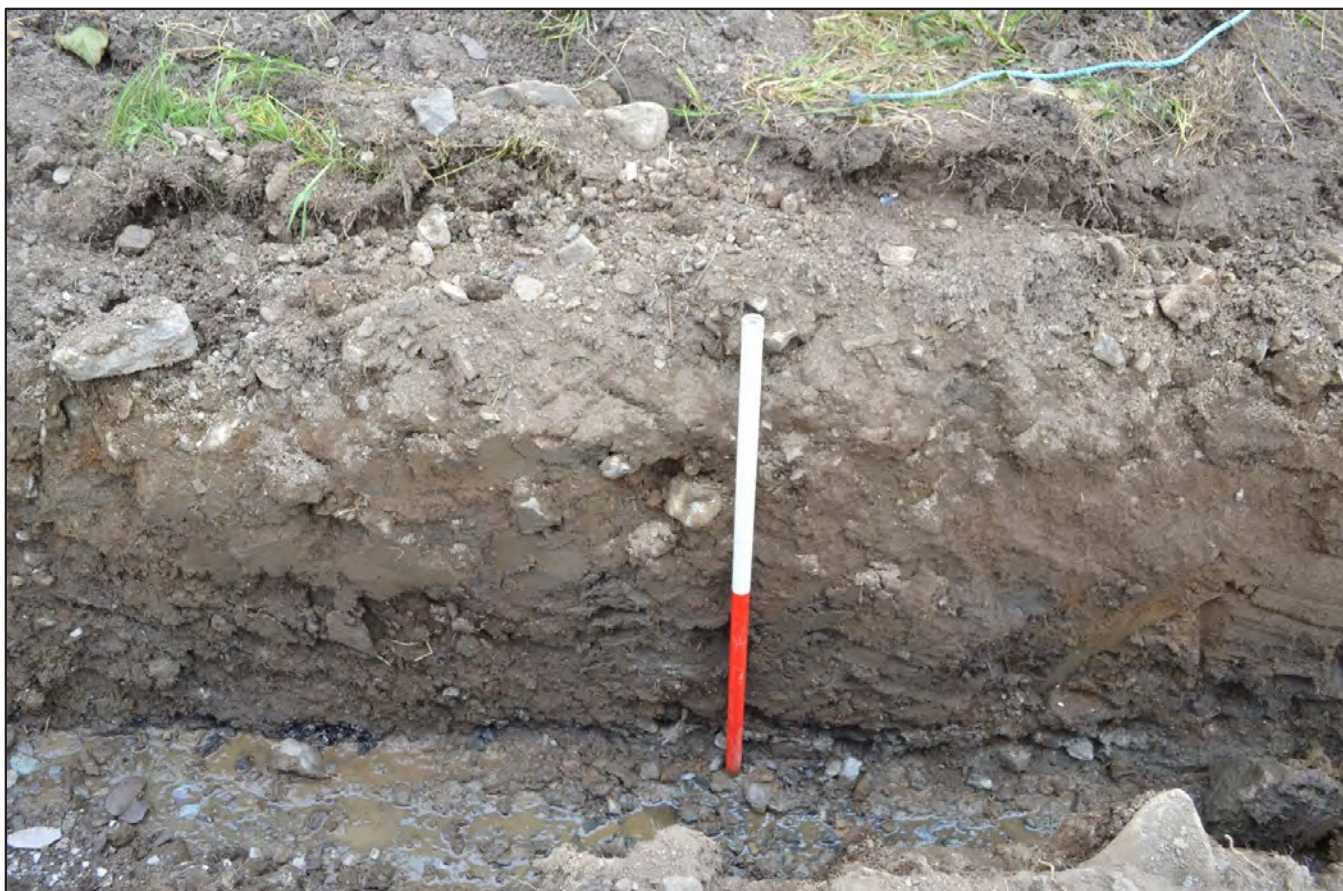
Plate 08: Northern end of section C, showing the pre-existing road indicated by a Tarmacadam layer with crushed slate sub-base layer. View from the W.

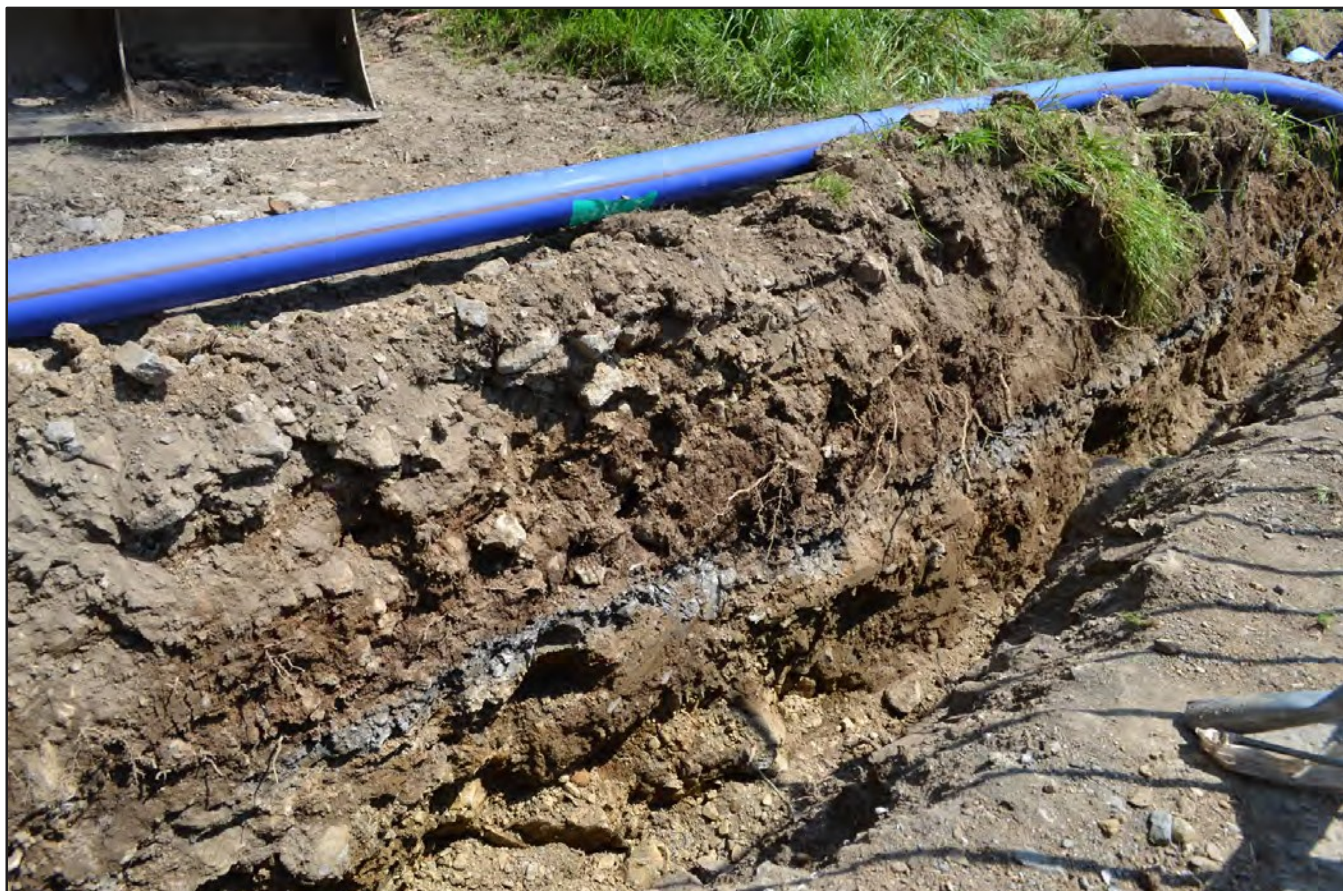
Plate 09: Section E with the old road surface of Tarmacadam and crushed slate sub-base layer running along section at a depth of 0.50m. View from the SW.

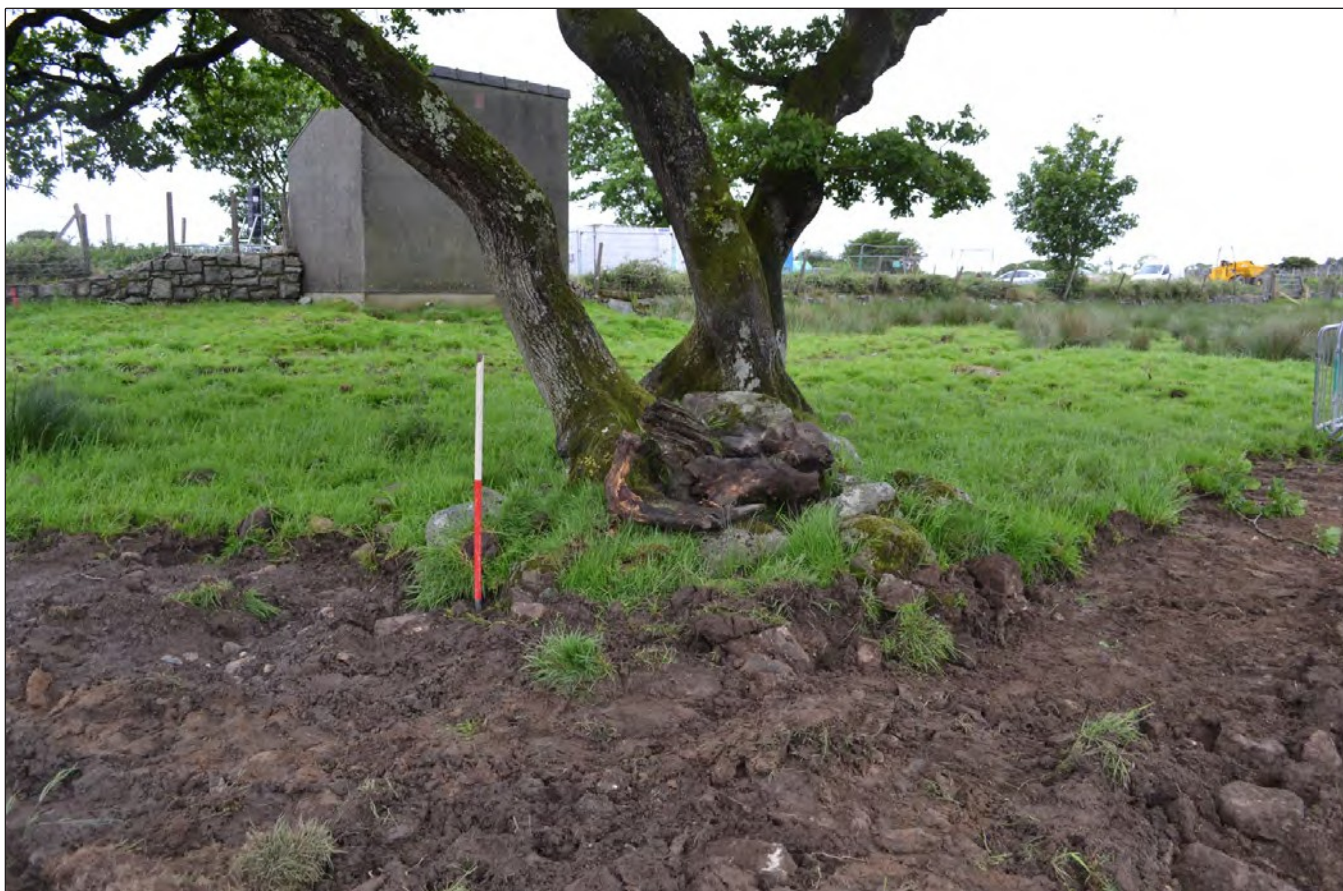
Plate 10: Earth and stone boundary breached, with mature trees growing within it, at the northern end of the scheme, section L. View from the SE.

Only one boundary was breached within this scheme and it was at the most northern and final section (section L) just by where the new pipe was connected to the existing main. This boundary was of earth and stone construction with mature trees growing atop/within it. It measures 2.70m wide and 0.60m high and ran roughly NE-SW. The stones were large sub-rounded cobbles and small boulders within a firm dark orange brown clay silt (plate 10 and 11).

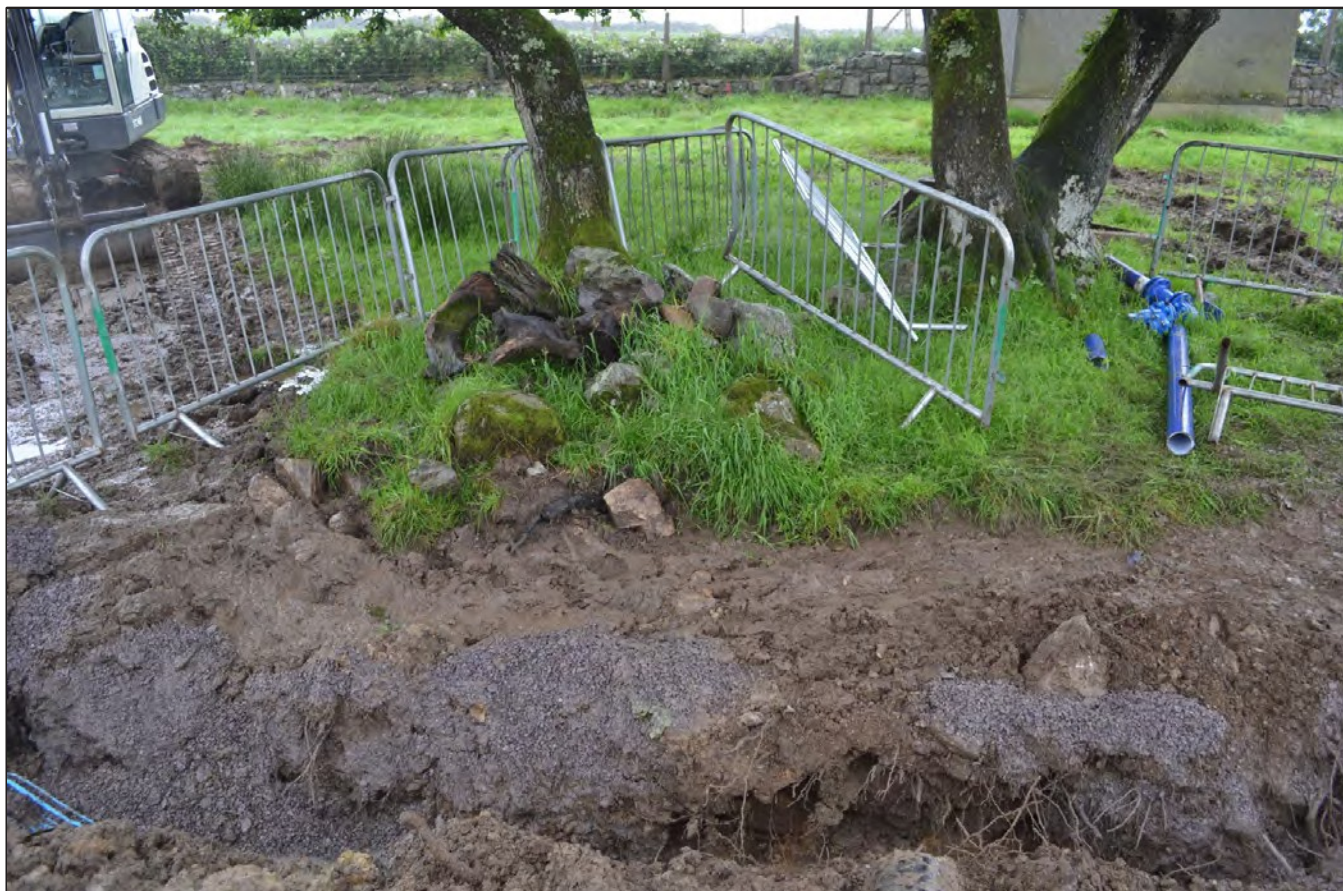
Plate 11: Earth and stone boundary truncated by pipe trench, no features , buried soil or cut below the surface boundary. Section L. View from the ESE.

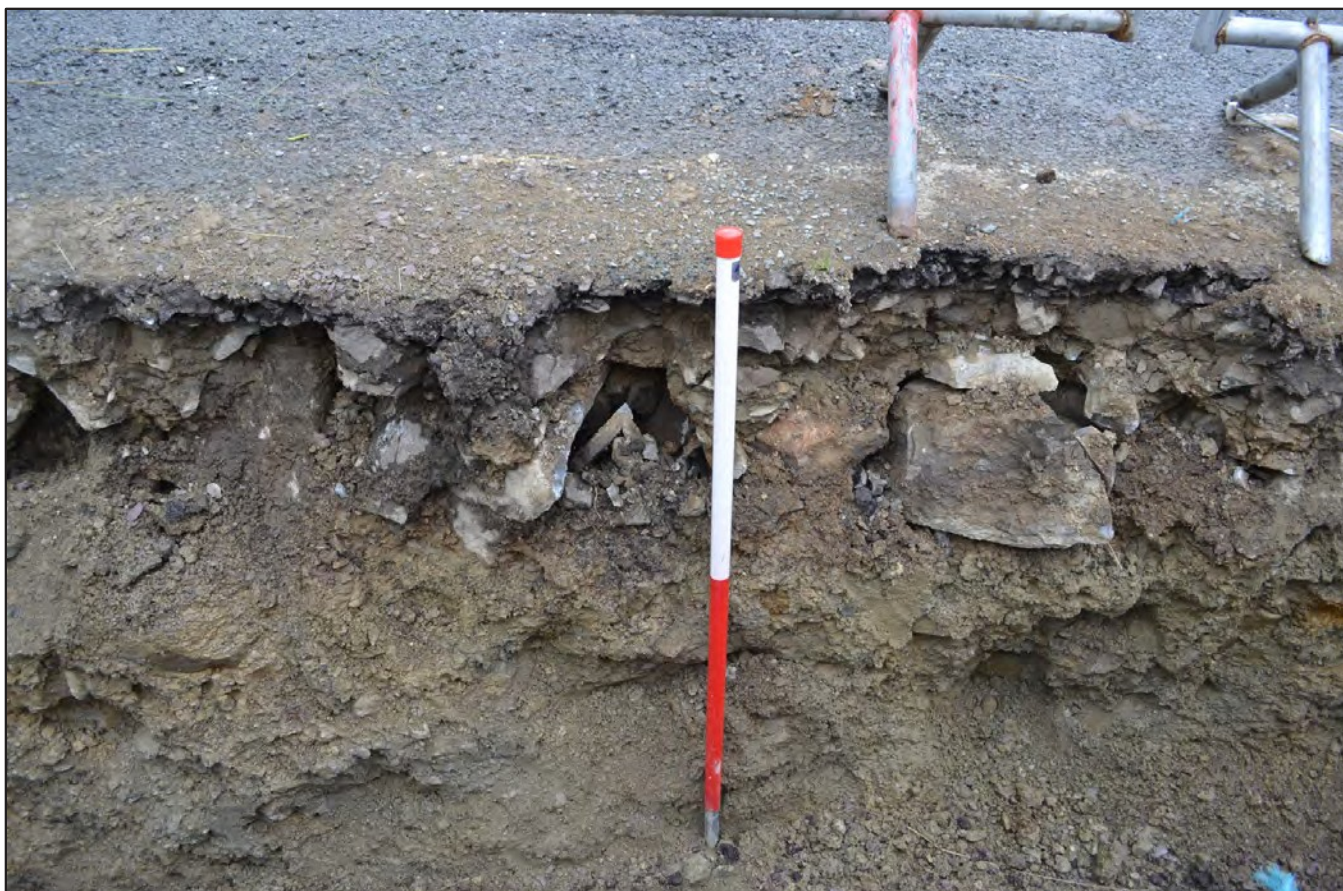
Plate 12: Section K, road side section showing disturbance and built up material below the existing road. View from the NE.

The pre-existing Tarmacadam road was between 1.00m and 0.50m below the current road which explains the disturbed material encountered throughout the scheme, due to the close proximity to the existing road a lot of the deposits encountered may be areas of made up ground for the current road (plate 12).
