HIDDEN HOUSE, BEAUMARIS, ANGLESEY

Archaeological Building Record (Level 2) v2.0

Project No. G2205

Report No. 1072

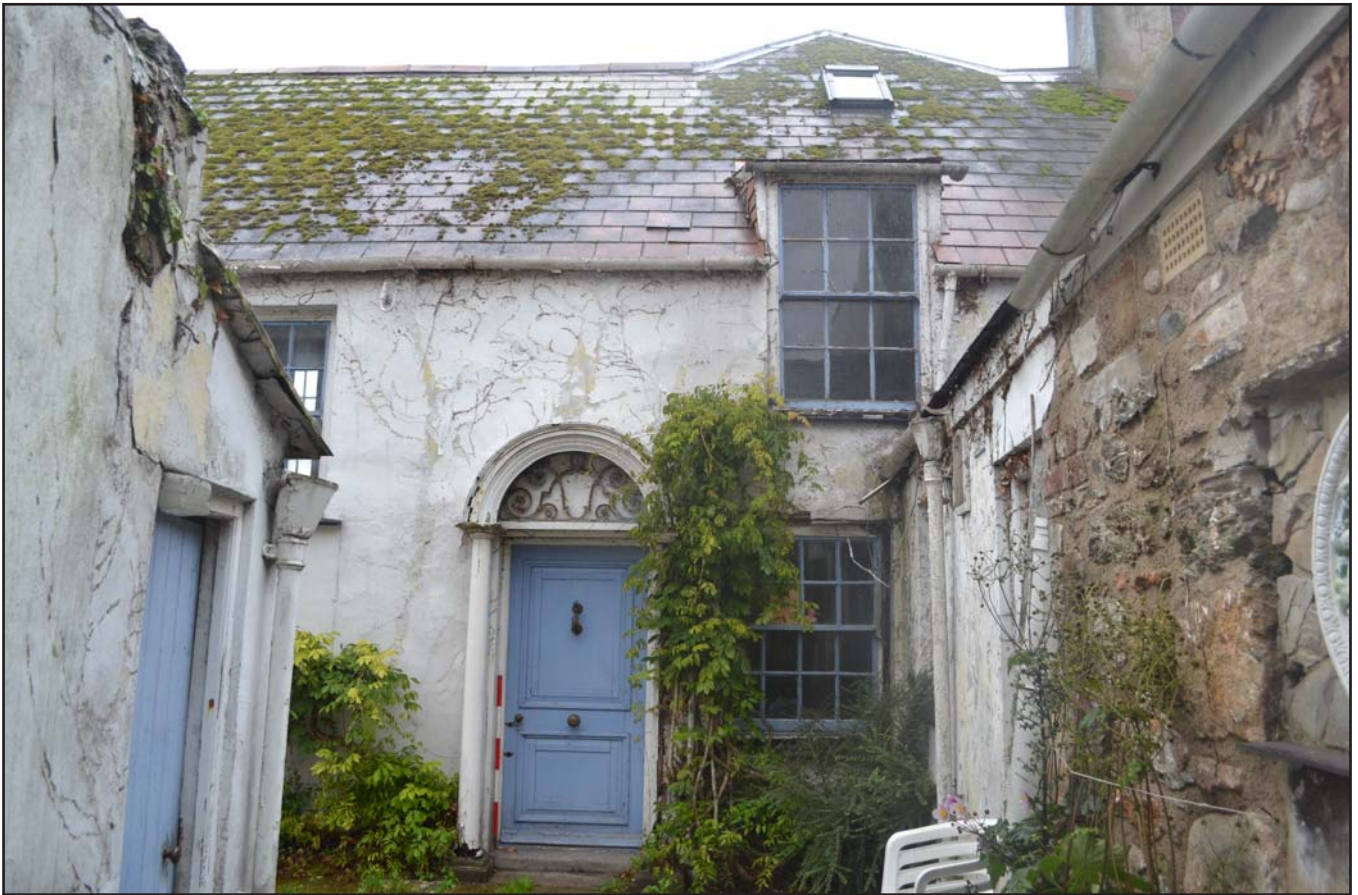
During initial visits all of the external elevations were rendered. The main entrance is offset to the east of the principal range in order to line up with the access off Castle Street, it, itself is a rather fancy round arched doorway with timber columns, the easternmost of which is missing, carrying the deeply moulded arched hood (plates 1 and 2). Over the door there is a blank fanlight, possibly in cast iron. Such fanlights became popular during the 18th century in double pile houses with long central entrance halls, being both decorative externally the fanlight provided additional lighting to the hallway. At Hidden House the fanlight is clearly a later addition, no doubt mimicking the grander styles and houses of the period as it is purely decorative having been added to the external face of the wall. By the early 19th century it was common for fanlights to incorporate a central lantern glazed as an integral part of the design, the example at Hidden House appears to be following this design, suggesting a possible date. The popularity of fanlights waned from the 1840s onwards but may have persisted in more provincial areas, such as Beaumaris. The door itself is a timber two panelled door, apparently with chamfered stops rather than moulded. Although rather difficult to date, it too appears to be late 18th, but is more likely to be early to mid-19th century in date.

The windows on the principal elevation are a mix of 12 and 16 light sash windows. The exposed sash boxes and rather large glazing bars would suggest an early date for the windows, however it is likely that the sashes were inserted into existing openings and the rubble walls prevented the box from being recessed. The lights themselves also vary in size between windows, again making accurate dating difficult.

Plate 01: Southeast external elevation, 1.0m scale.

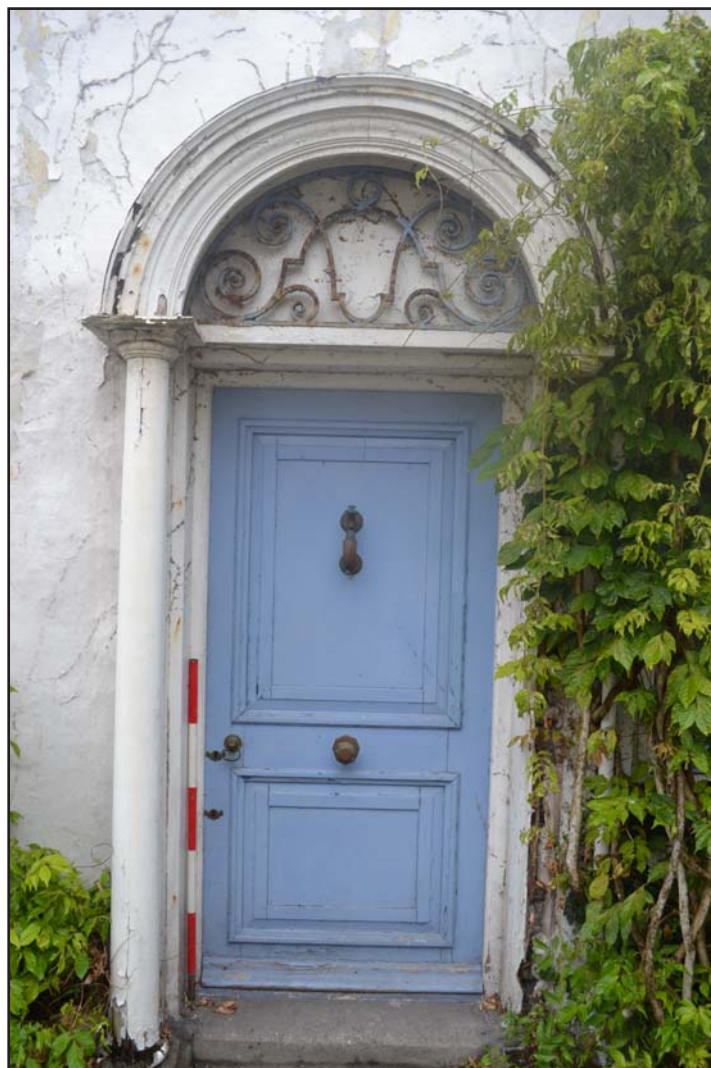
Plate 02: Southeast external elevation, main entrance, 1.0m scale.

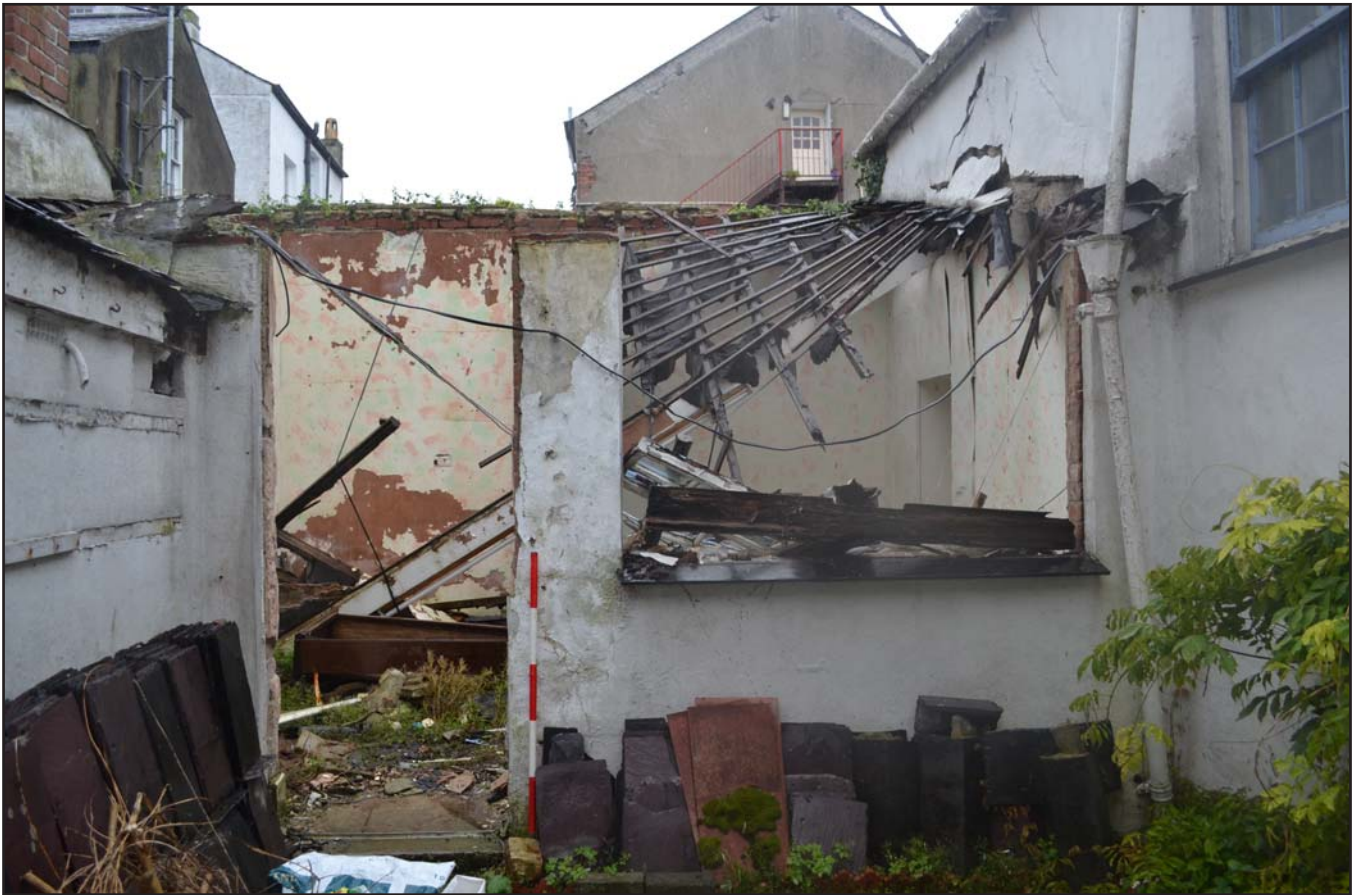
Attached to the principal elevation of Hidden House is a brick built lean-to structure against the garden wall of the property located to the west, referred to as an old 'shop' (plate 3). The mono-pitch roof has mostly collapsed and only the northern most end has some sawn wooden rafters and joists still attached, although these are ready to fall. The roof was of slate, many of which now lay stacked against the eastern elevation. The western elevation is formed by the garden wall of the adjacent property, the northern elevation is of the external wall of the southern elevation of Hidden house, and the southern elevation is the northern external elevation of The Pet Owners Store. The western elevation (shop front) has been constructed from red brick bonded by mortar, with the external face rendered and painted white. There is an opening for a door and large window in the shop front elevation but these are now missing.

The internal walls are plastered and painted white and the floor is of stone flags, although very little is visible due to the collapse of the roof structure into the building.

Plate 03: Northeast external elevation of collapsed shop, 1.0m scale.

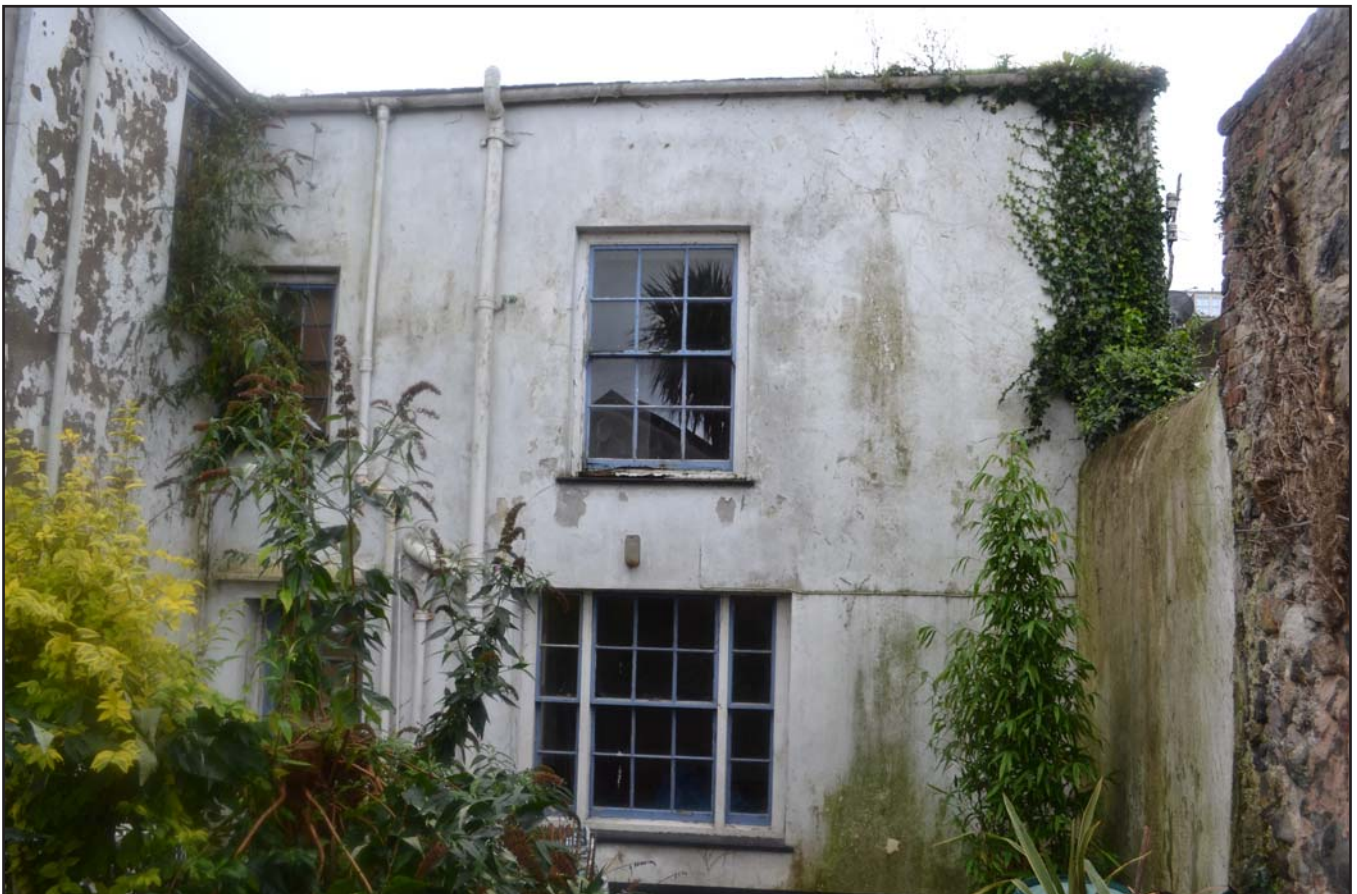
The rear elevations of Hidden House follow a similar pattern to the principal elevation, with a single doorway adjacent to the angle between the two ranges, the door itself is a recent replacement. The windows mirror those recorded on the front elevation, but this time includes a triple sash in the westernmost room (dining room) suggesting that this may have originally been a room of some status (plate 4).

Plate 04: Northwest external elevation.

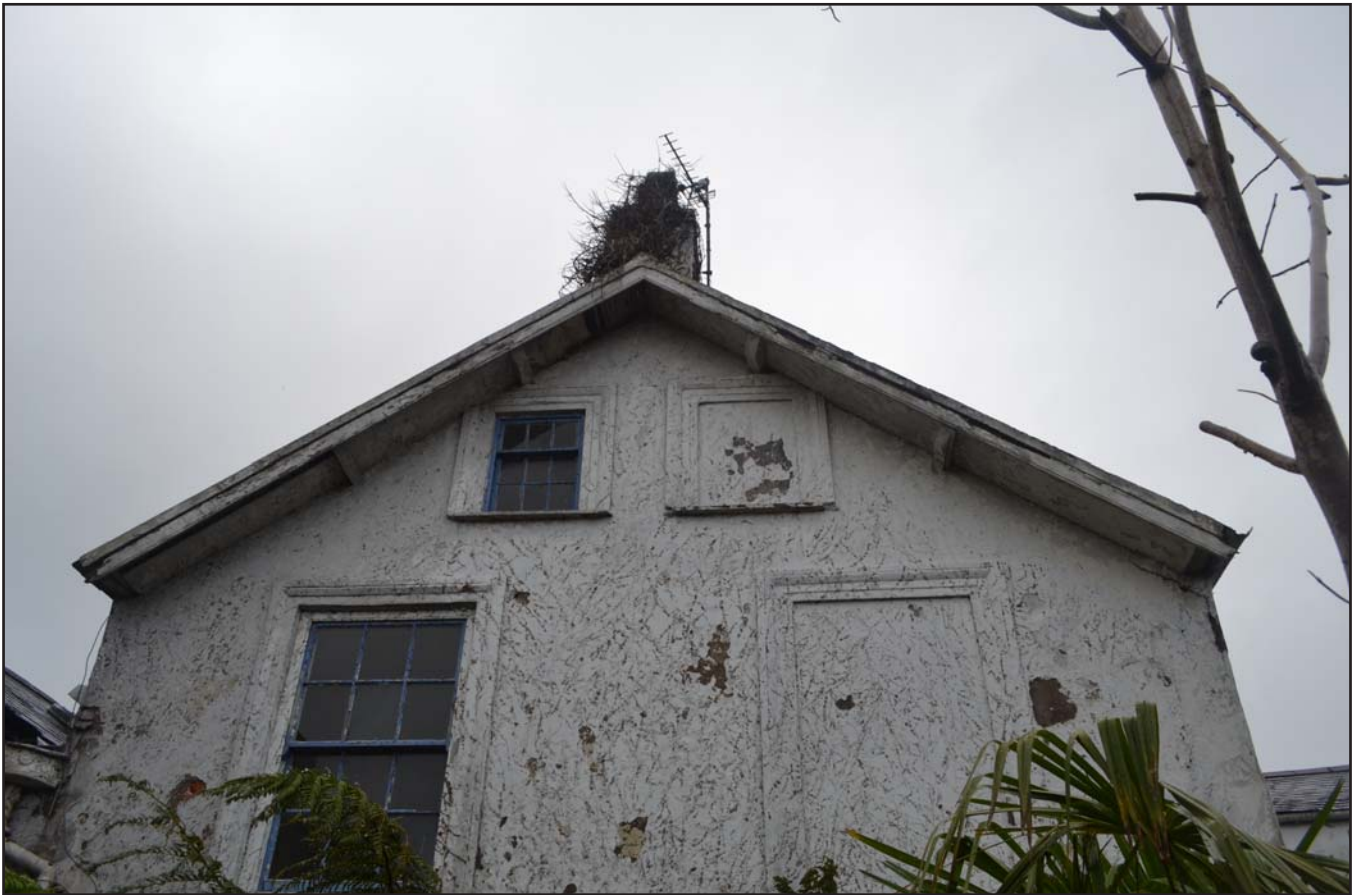
The most striking feature of the rear elevation is the gable of the north south range (plates 5 and 6). To the left are three sash windows matching those seen in the rest of the building. Mirroring these are three blank windows, creating a symmetrical gable. All of the windows have architrave surrounds, the simplicity of these architraves are difficult to date, but they are likely to be contemporary with the cast iron rain-hopper on this elevation which is inscribed with the year 1834 (plate 8).

Plate 05: Northwest external elevation, first floor.

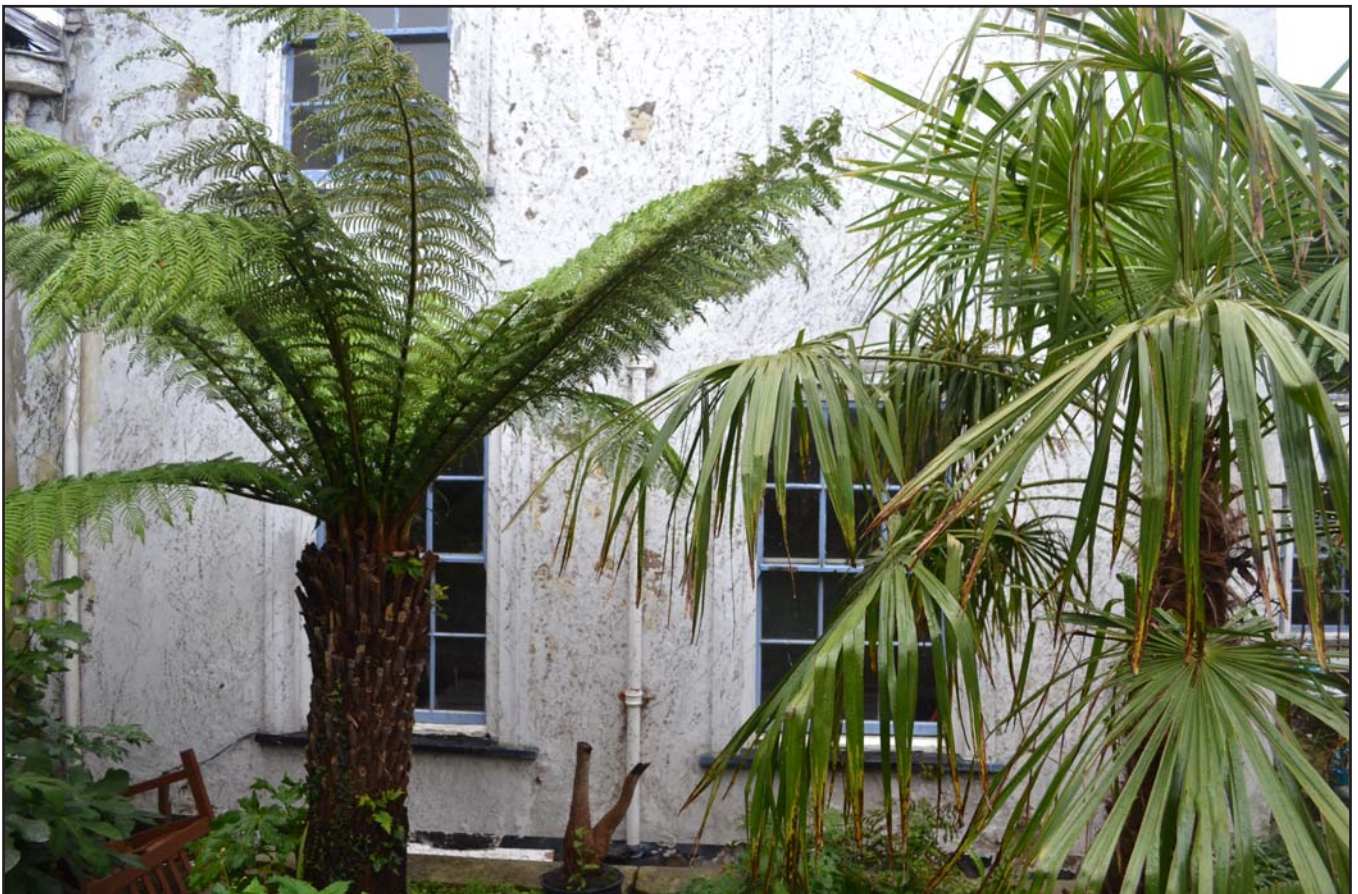
Plate 06: Northwest external elevation, ground floor.

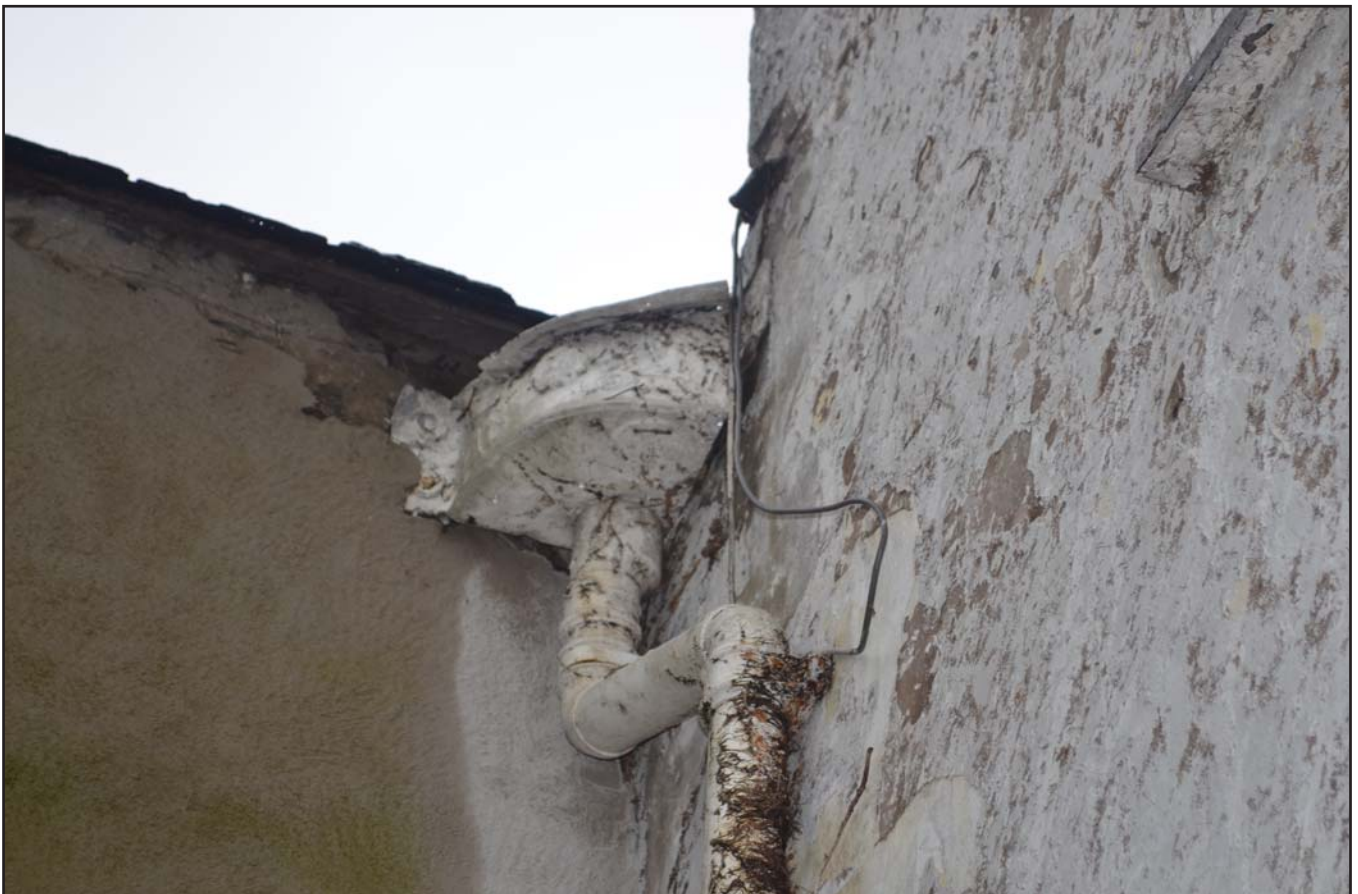
Plate 08: Rain hopper on the northwest external elevation, showing the date 1834.

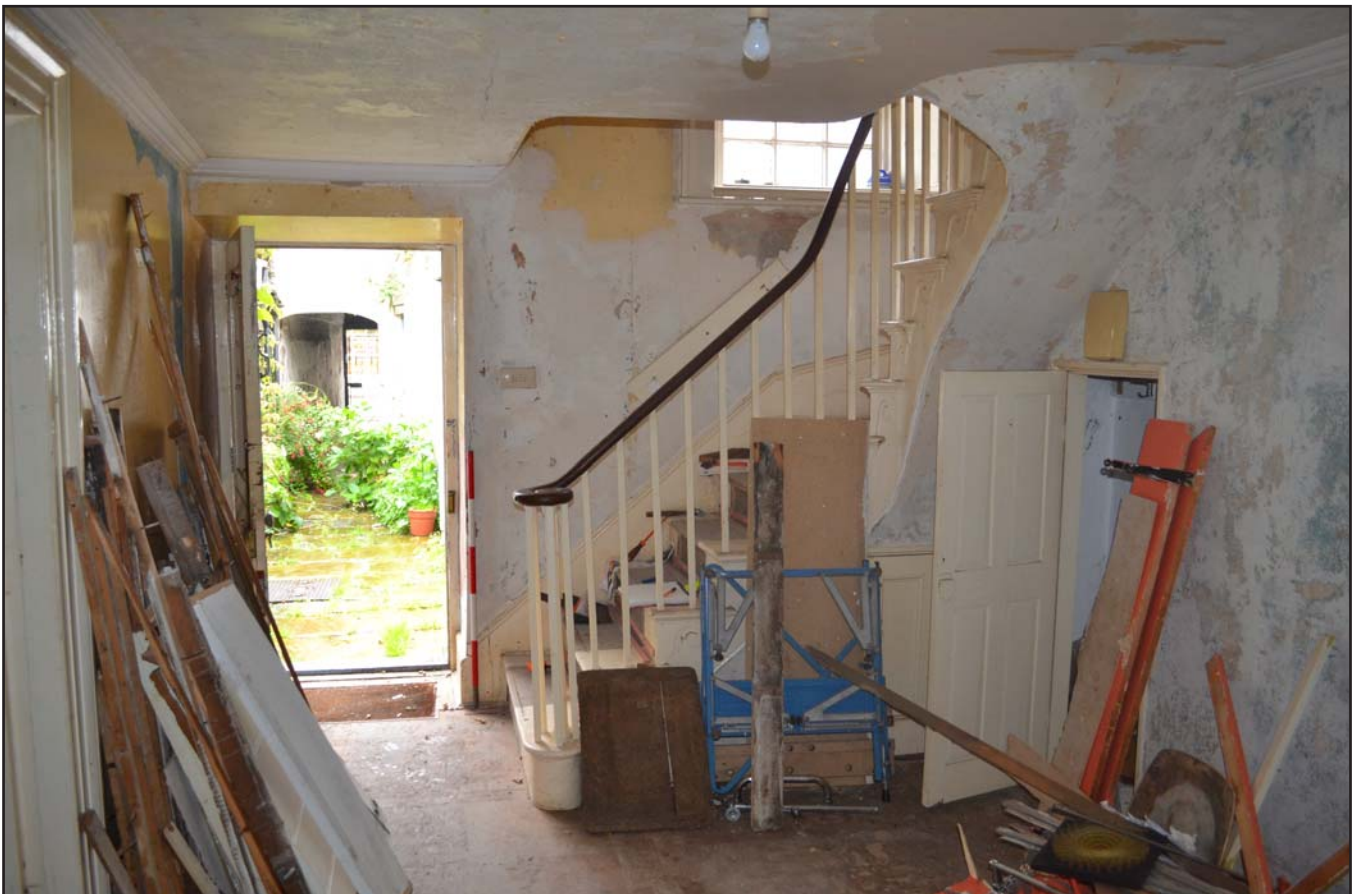
In the south-western corner is an ornate straight flight with winder staircase, with mahogany handrail, curtain step, decorated open-string, and stick balusters. The lower part of the wall has a white-painted moulded wooden skirting-board, above a dark-stained wood panel floor.

Plate 10: Hallway from the northwest showing staircase, 1.0m scale.

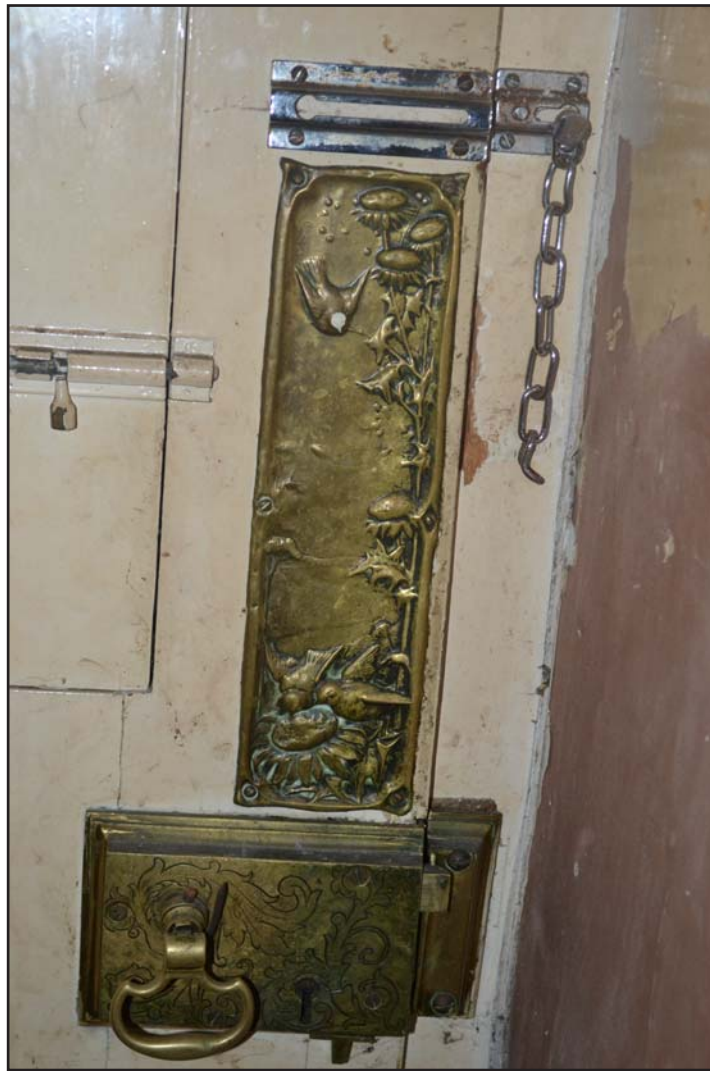
On the southeast wall the internal face of the main entrance is painted white. The door is of a thick panelled hard-wood with hinged opening upper panel (stable door) and an ornate brass lock case incorporating lock, latch and handle in one unit. It is etched with acanthus leaves, and a brass door-plate with moulded pigeon and sunflower motif is located above. The north-eastern and south-western elevations have internal doors framed with white-painted, wood moulded door frames with white-painted, six-panelled wooden doors with brass locks and handles. The north-western elevation has a doorway into the rear garden, although the door frame has been removed. The door is wooden and painted white and would have originally had six-panels although these have now been boarded up. The door has a brass lock and handle of the same style as the internal door fixtures.

Plate 11: Main entrance ornate lockplate.

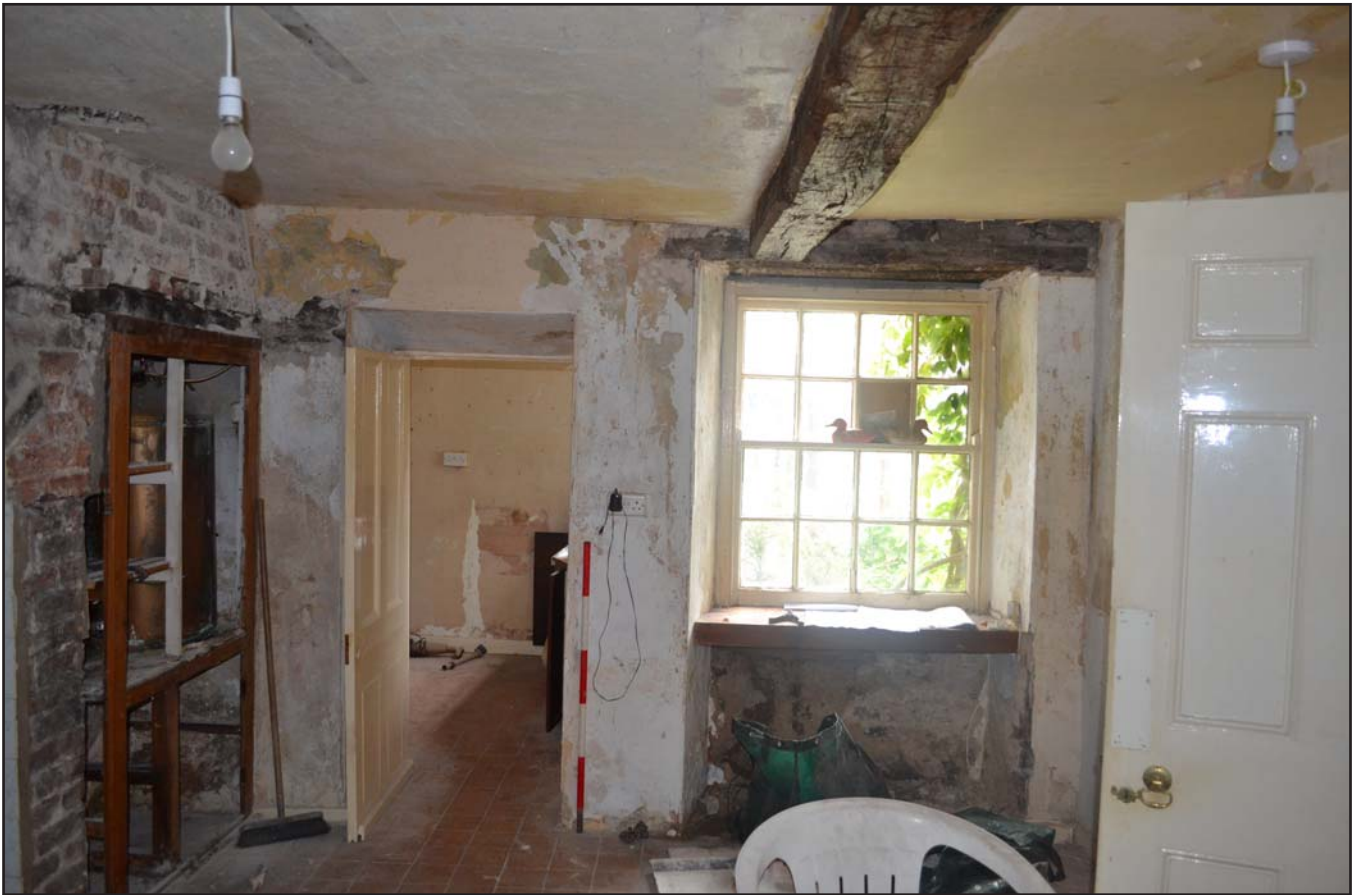
Plate 15: Kitchen from the northwest showing beam, 1.0m scale.

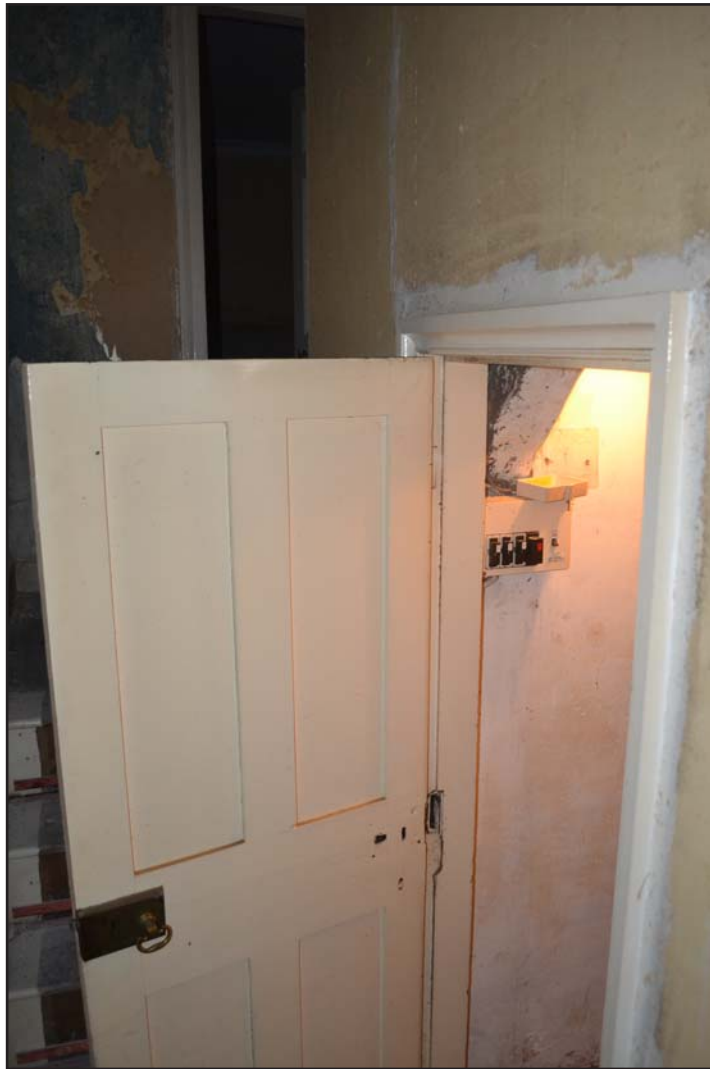
The ceiling is plastered and has the remnants of a yellow-orange coloured paper. The base of a white-painted roof truss can be seen on the south-eastern wall which continues through the ceiling and into the roof space. There are doors in the southwest, northwest, and northeast walls which lead into bedroom 1, the bathroom, and bedroom 2 respectively. All three doors are hung in large, white-painted, wooden moulded frames with thick six-panel hard-wood doors with brass handles. A twelve-pane, white-painted, wooden bay sash window with moulded surround and wooden sill is located in the main stairwell in the southeast elevation.

Plate 17: Landing cupboard showing original truss.

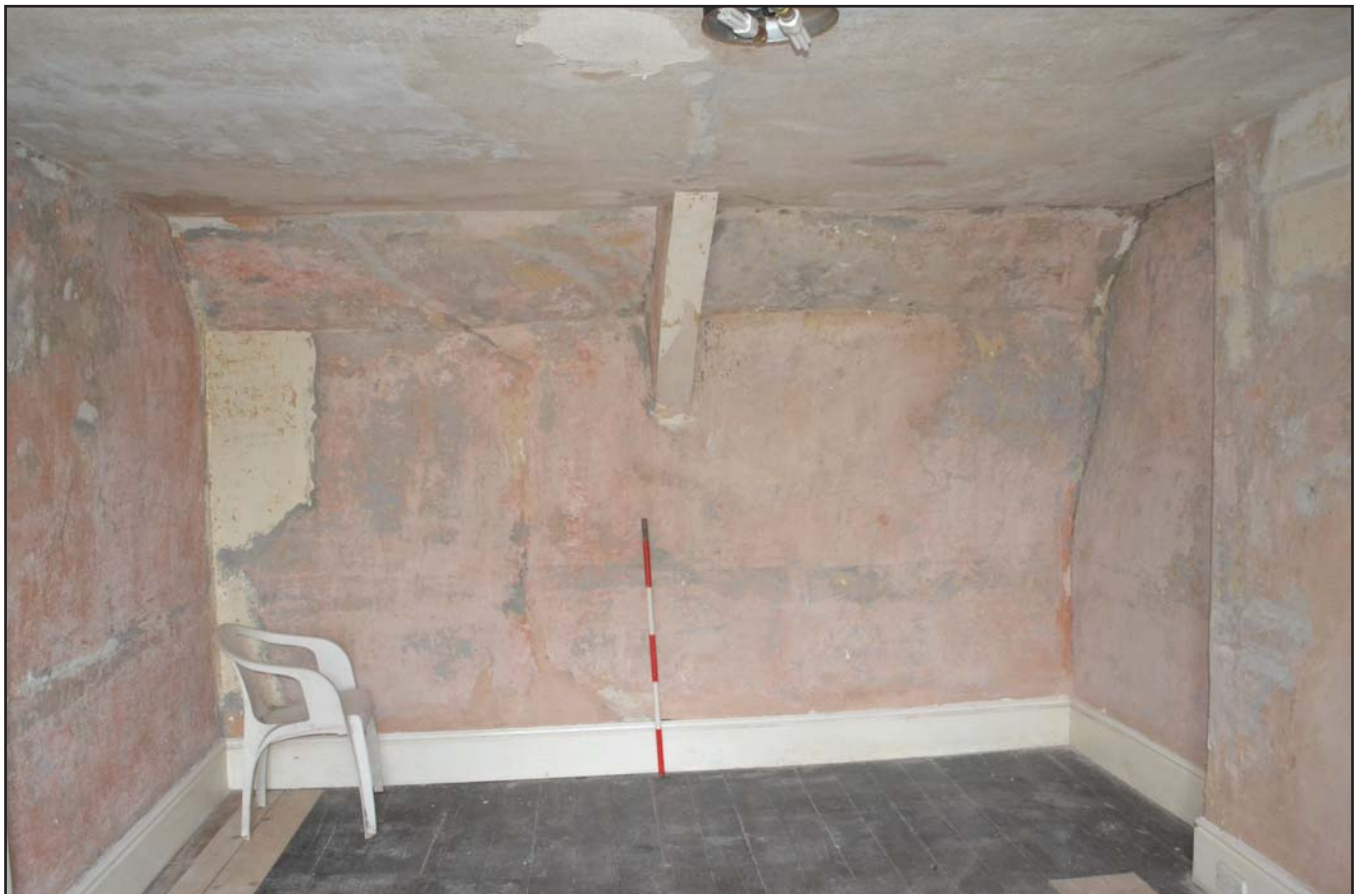
Plate 18: Bedroom 1 from the northwest showing base of truss, 1.0m scale.

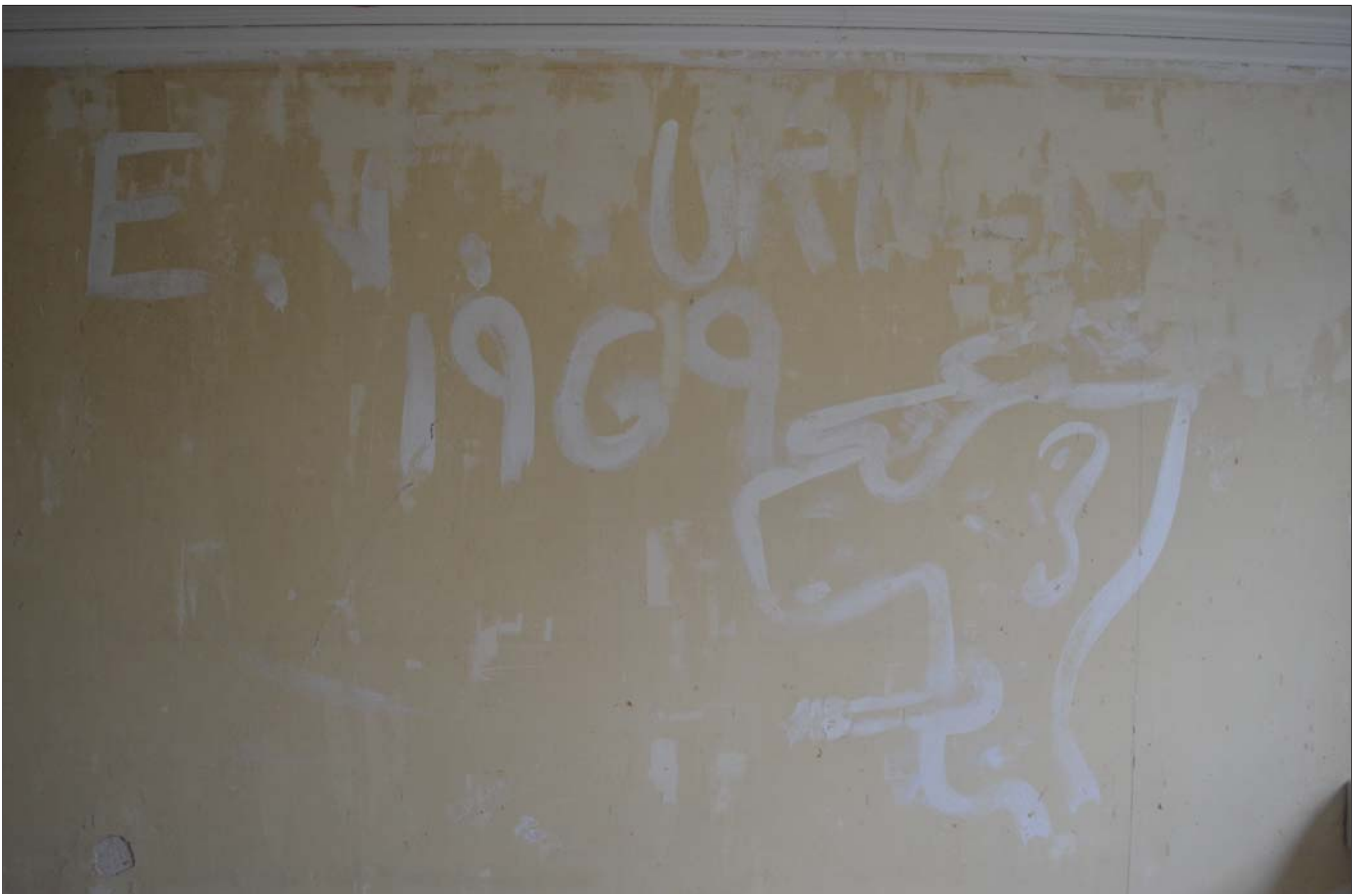
This bedroom is accessed from the southwest via the upstairs landing. The room is rectangular in shape and measures 2.0m in width by 3.3m in length and orientated on a northwest to southeast axis. The ceiling is plastered and painted white, with a moulded and white-painted cornice. The walls are plastered and painted yellow, with evidence that wall paper had previously been removed. On the southwest wall is some graffiti depicting a face in profile with 'E.J. Turner 1969' written alongside.

Plate 20: Bedroom 4 graffiti from the northeast.

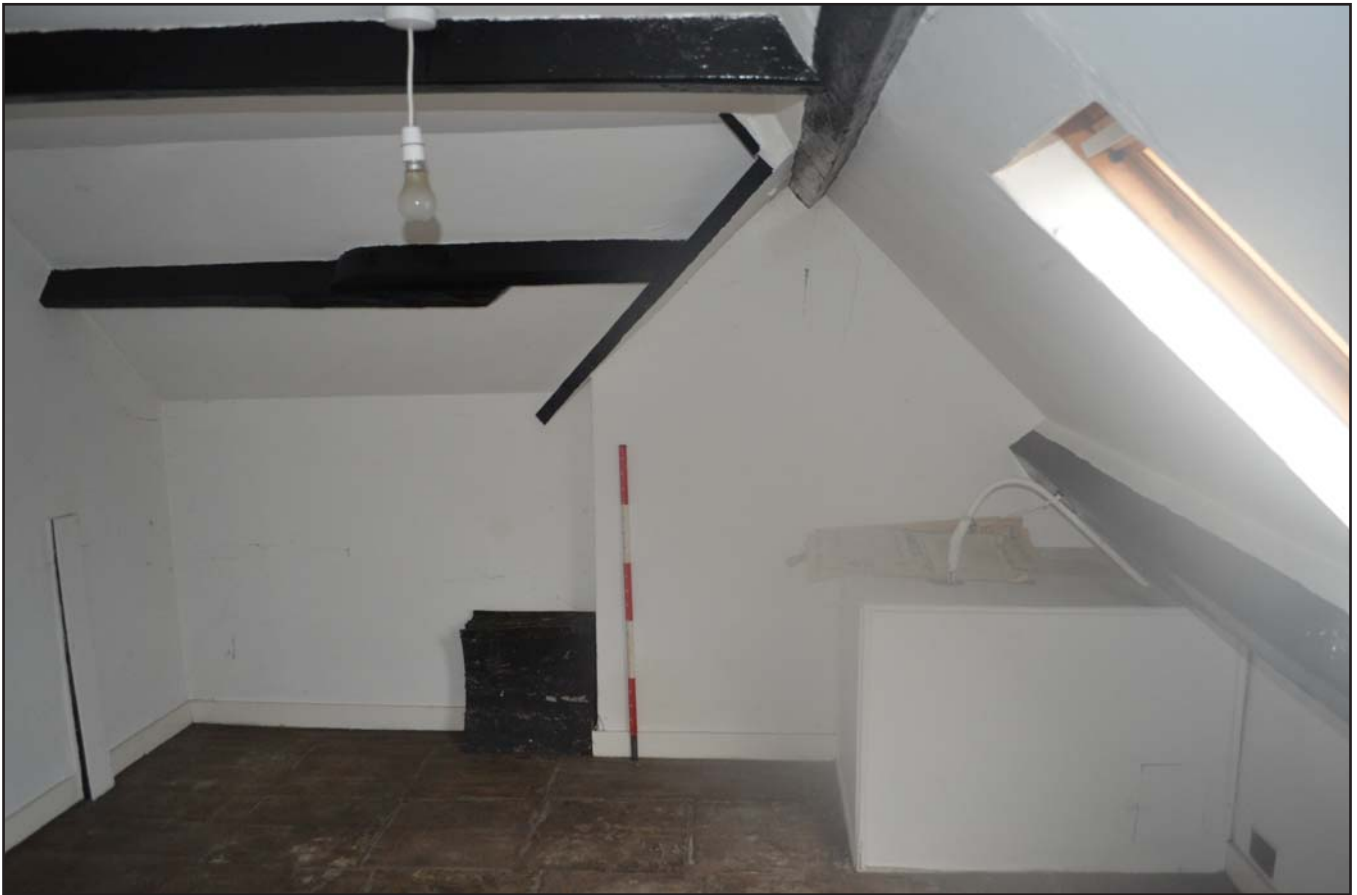
This bedroom is accessed from the west via a stairwell which leads down to the first floor landing. The room is set in the eaves and is square in shape measuring 2.3m square. The ceiling is plastered and painted white with a roof light inserted in the southeast roof pitch. The original and steeper roof pitch can be seen in the northeast elevation, and it is clear that the building has been widened to the northwest. A twisted, dark-stained purlin runs from northeast to southwest and continues into the roof space to the southwest. The purlin appears to have twisted due to the apparent removal of a roof truss, most likely to accommodate an extra bedroom.

Plate 21: Bedroom 5 from the southwest showing original roof pitch, 1.0m scale.

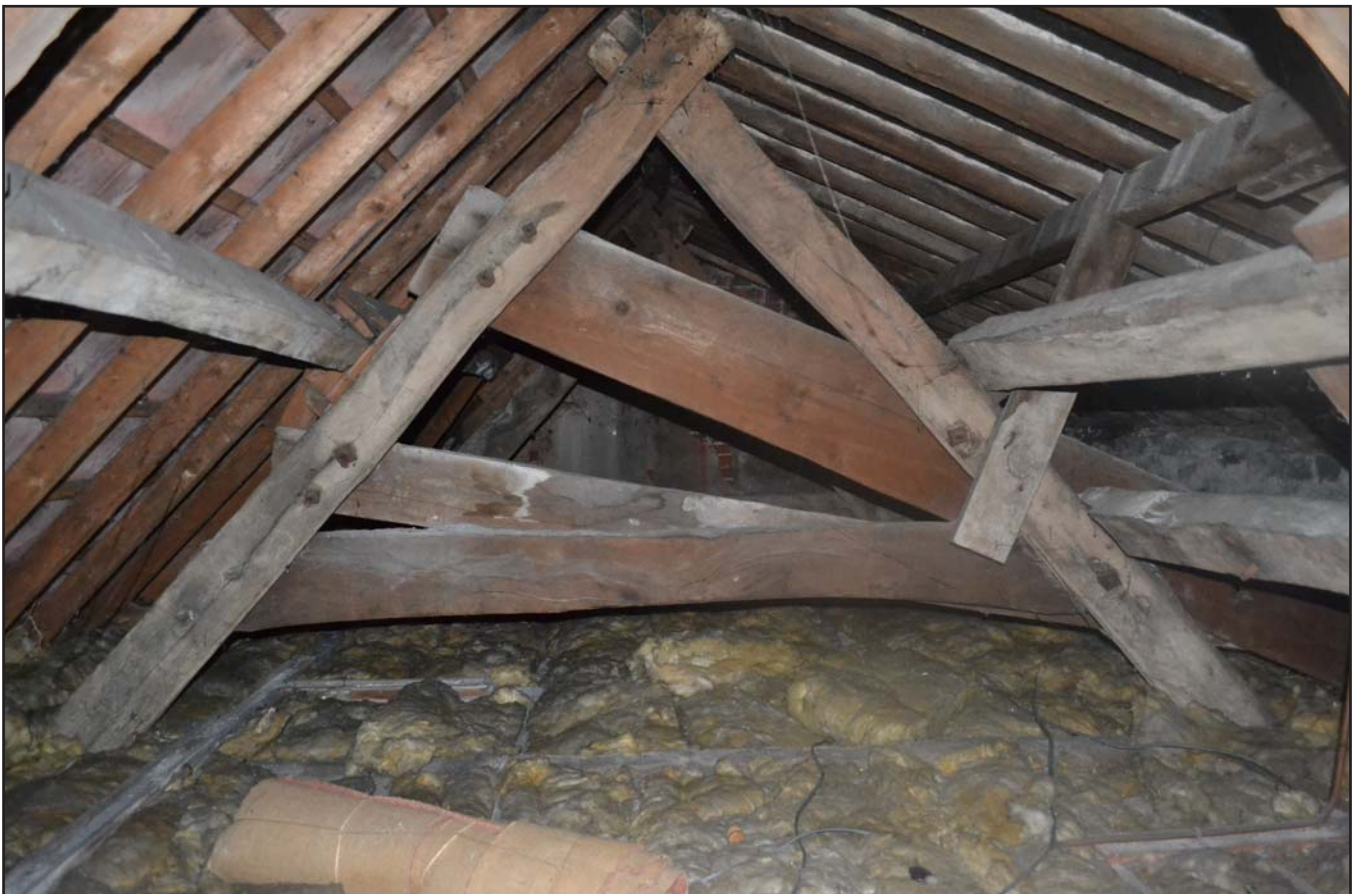
The roof structure of Hidden House consists of two separate elements. The north-south bay has a simple open truss roof with raking struts carrying two purlins. All the timber is softwood deal and the simple bead moulding on the purlins suggest a mid to late 19th century

date. The only significant feature of the roof is the unusual collar immediately below the bridled apex. The collar is adze finished suggesting that it may be a salvaged piece of hardwood re-used as a collar. The collar is an unusual design in an unusual location, its exact purpose is unclear, but it may have been added as additional strengthening taking the load of the ridge piece. The poor finish on the principal rafter suggests that it has been sawn back *in-situ* removing the ridge piece and to some extent removing some of the integrity of the truss.

Plate 22: Roof Void from the northeast showing truss and raised roof pitch.

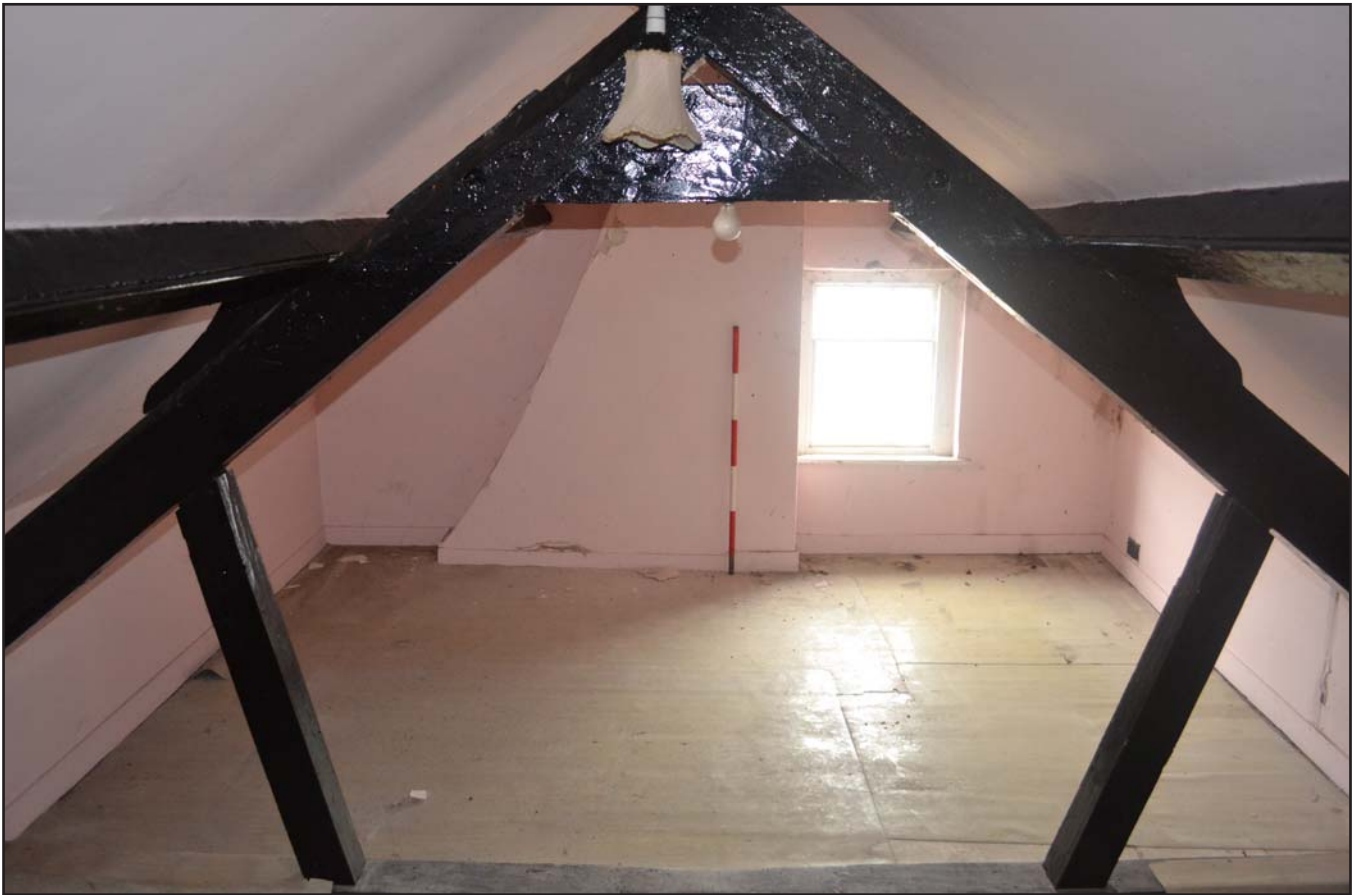
Plate 23: Bedroom 6 from the southeast showing truss, 1.0m scale.

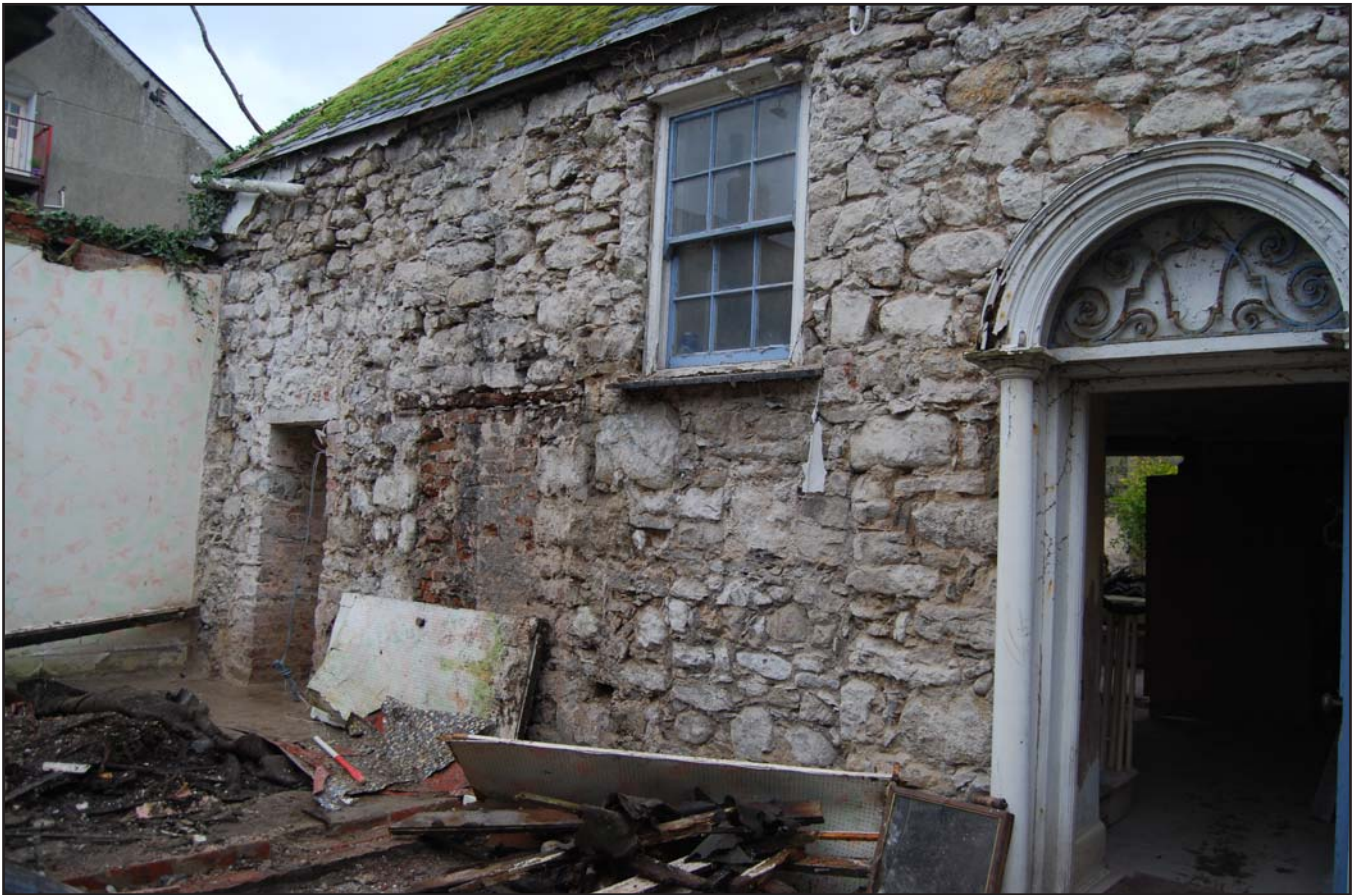
The removal of the render on the principal elevation revealed a number of blocked openings and evidence of at least one inserted doorway, the westernmost. Although difficult to establish with any certainty, the central first floor window may also be a later insertion as there appears to be a very slight change in the stonework to the east of the window. The use of inserted brickwork below an adjacent window means it is difficult to establish whether the existing door is original, however it does seem to follow the general arrangement of the other openings, and is likely, therefore to be original.

The general arrangement of the groundfloor openings, both blocked and open has the appearance of stabling, with three stalls, the westernmost being slightly larger. It is likely, given the buildings location and its relatively small original footprint that Hidden House was built as stabling, possibly for the adjacent Bull Inn.

fact gateways into a private yard or garden to the northwest of Hidden House, perhaps being a continuation of what is now the rear garden. Two other blocked doorways were observed in the southeast elevation of the house, both of which predate the 'shop' and are thus earlier than the 1829 map. The earlier doorway blocked with stone may have been one of the original entrances into the building, and its centralised position suggests it may even predate the current main entrance. The blocked doorway certainly led into the area which is now occupied by the staircase and thus clearly predates it, although the original location of the staircase, if indeed there was a first floor, is currently unknown. Moreover, the general arrangement of the groundfloor openings, both blocked and open has the appearance of stabling, with three stalls, the westernmost being slightly larger. It is possible therefore, given the buildings location and its relatively small original footprint, that Hidden House was originally built as stabling, possibly for the adjacent Bull Inn.

Plate 25: Southeast elevation from the east showing two blocked entrances, 1.0m scale.

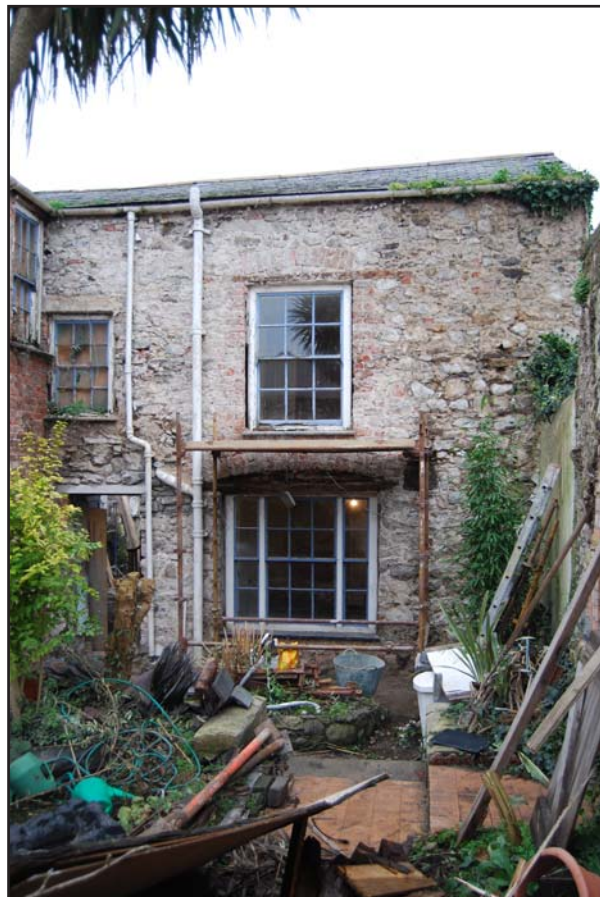
The rear of the property has clearly been significantly altered, with the removal and replacement of the first floor window using a smaller sash window, and the addition of a large brick-built extension, which if the rain water hopper is correct, was added in 1834. This may well have coincided with the switch of the principal elevation from the northwest to the southeast.

Plate 26: Removal of render on the northwest elevation showing replaced first floor window.
