HIDDEN HOUSE, BEAUMARIS, ANGLESEY

Archaeological Building Record (Level 2) v2.0

Project No. G2205

Report No. 1072

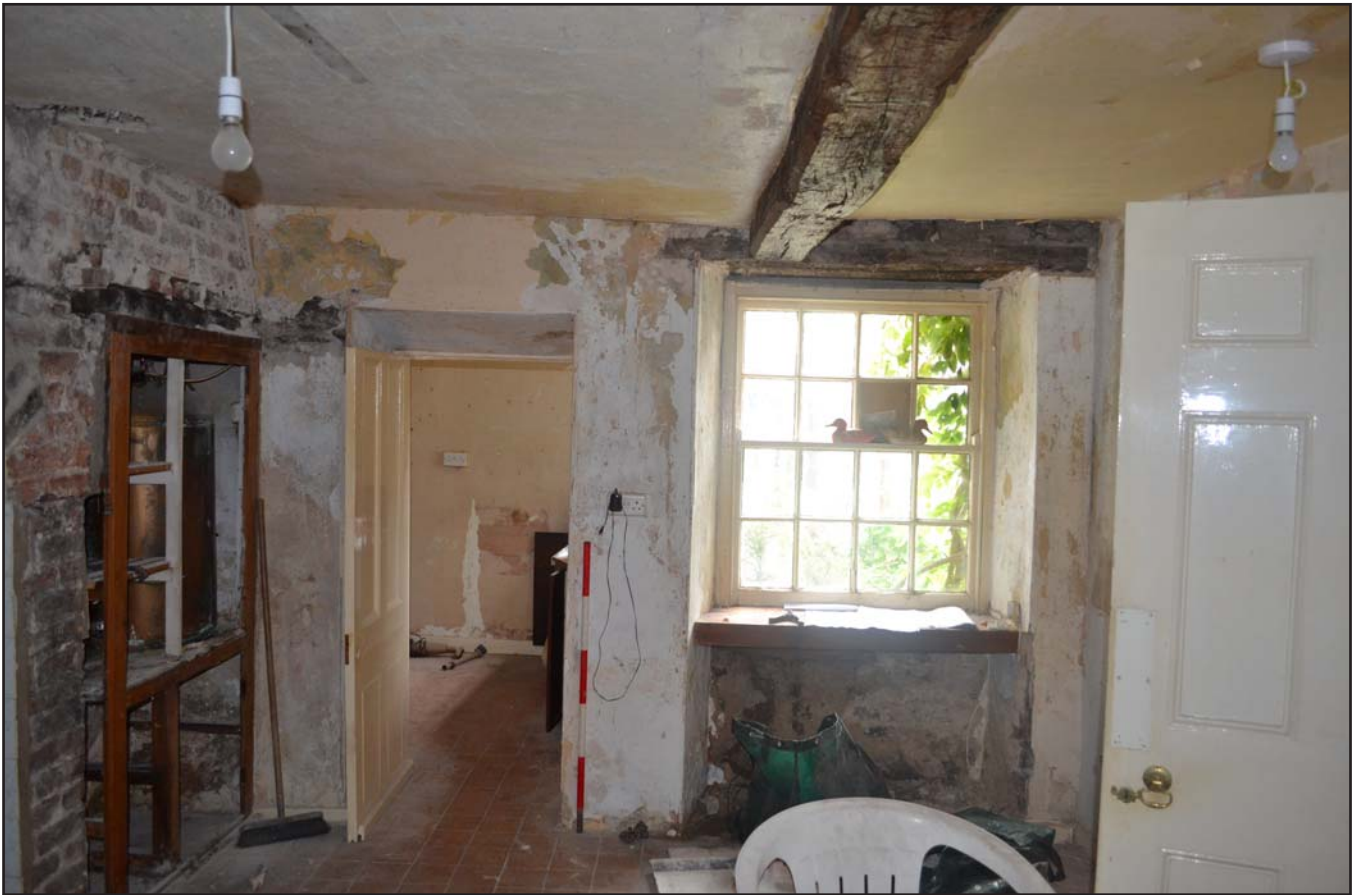
Plate 27: Kitchen showing roof beam from the northwest, 1.0m scale.

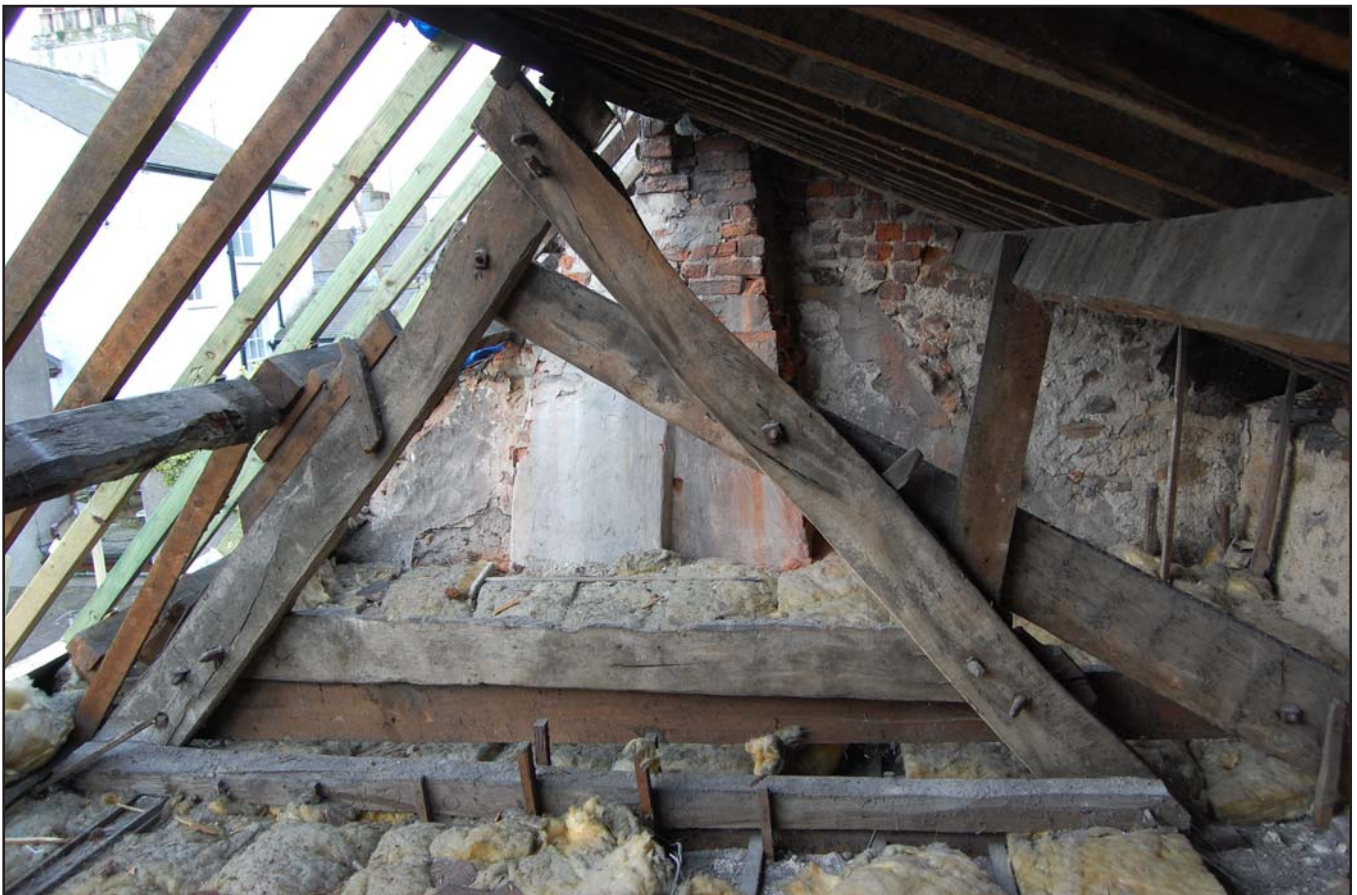
Plate 28: Exposed roof trusses showing roof extension from the northeast.

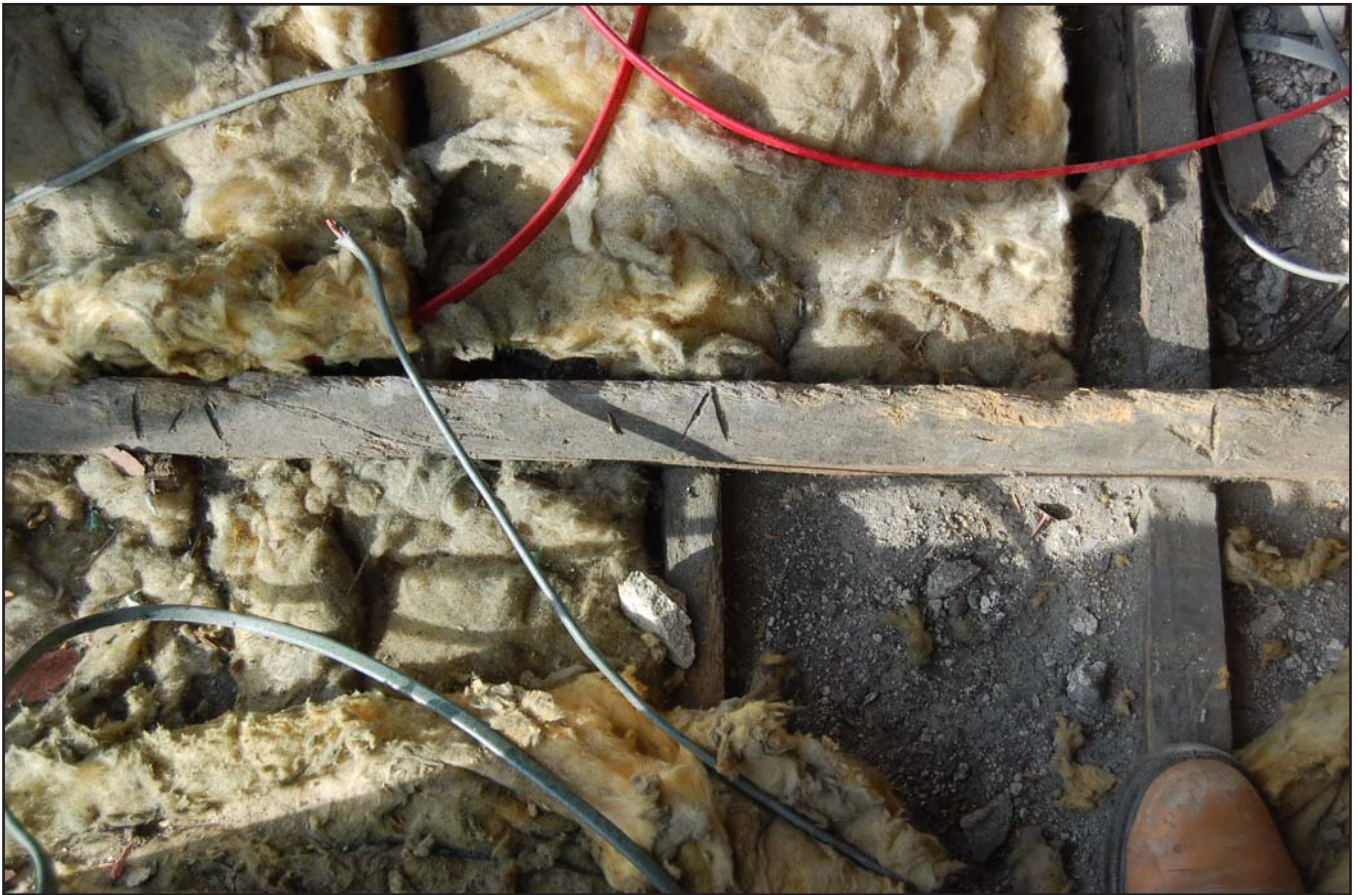
Plate 29: Ceiling joists carpenter mark, from the southeast

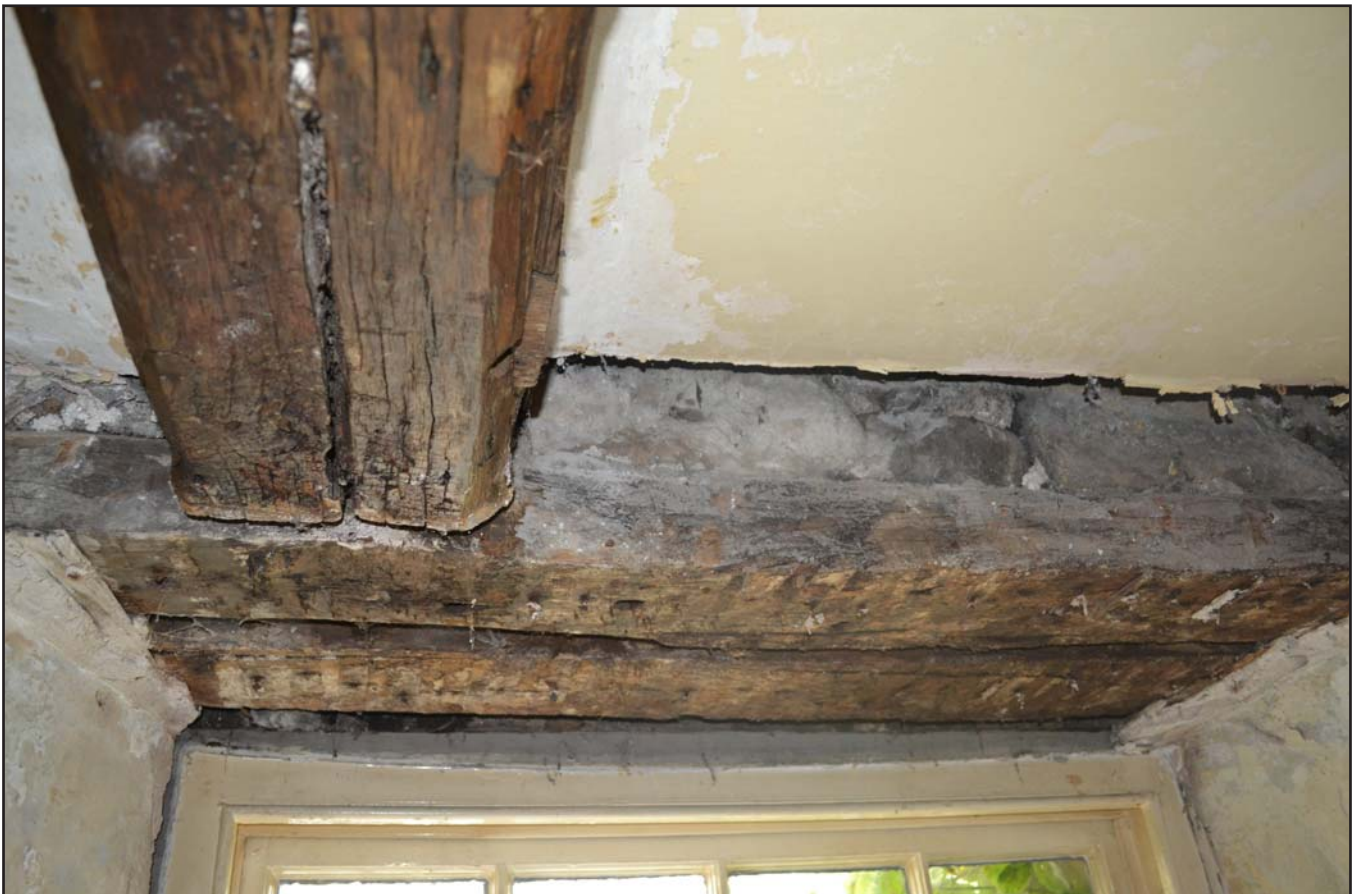
Plate 30: Roughly hewn beam with chamfers and stops in the kitchen, from the northwest

- It is recommended that if any further substantial renovation work occurs at Hidden House (in areas currently unobserved) then an archaeological watching brief is maintained.
- It is recommended that if any renovation/refurbishment work is proposed in the stable block of the Bull Inn then an archaeological watching brief is maintained.
- It is recommended that the Dating Old Welsh Houses Group are informed of the roughly hewn beam in the kitchen with view to obtaining possible dates via dendrochronology.
