Former Watch Office RAF Llandwrog, Caernarfon

Archaeological Building Record: Level 2

Project No. G2286

Report No. 1079

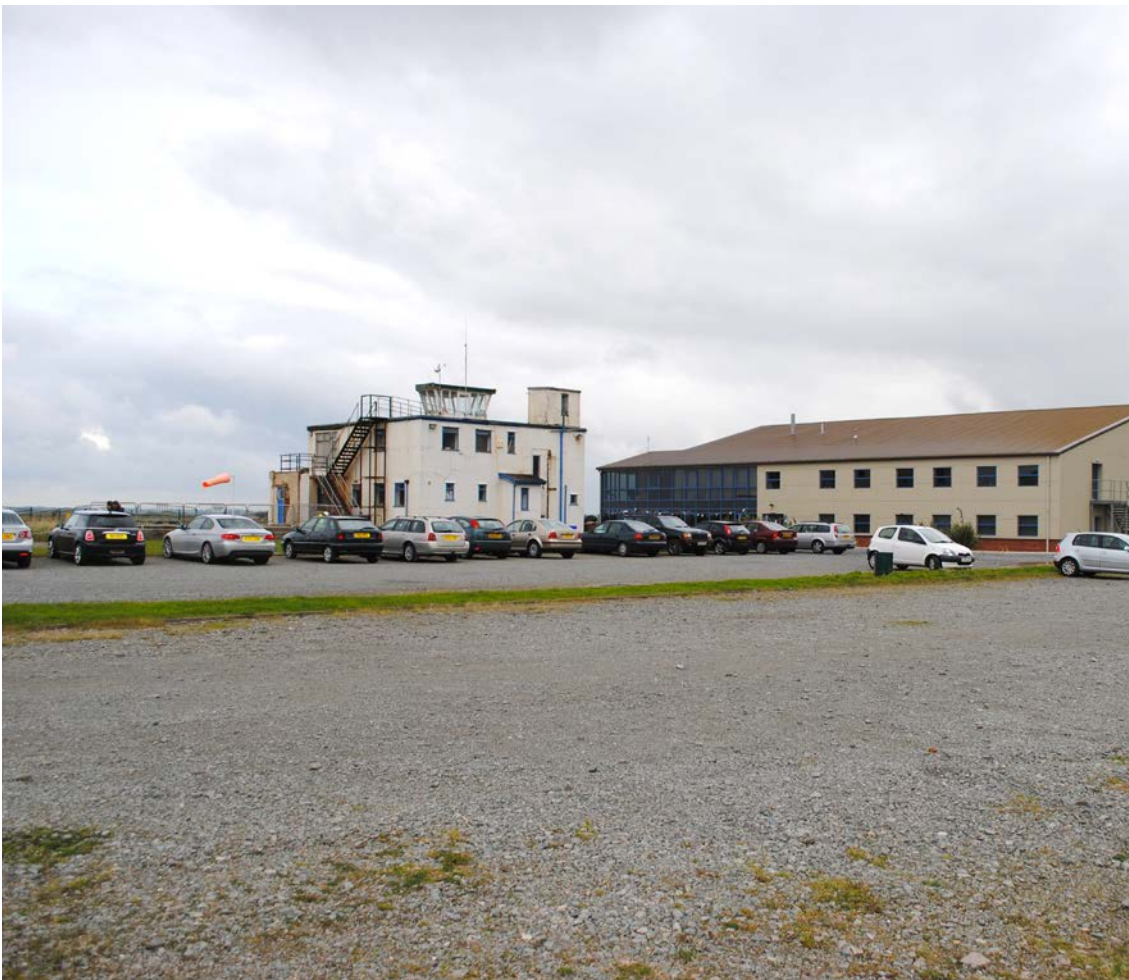
Left:
Plate 02 -
View of watch
office from the
south west.
Modern airport
building to the
right

The former RAF Llandwrog Watch Office is a 10.4m square building, 4.3m high (**Figure 03**). It is of brick and concrete construction, and of two storeys in height. Its main first floor viewing windows look north over the airfield. A small porch faces south, with a small tower on the south east corner of the roof. The roof is constructed of concrete, with a bitumenised surface covering. A glass and wood viewing turret has been added on the north east corner of the roof to aid aircraft observation. The main wall surfaces of the building have been rendered, having formerly been exposed brickwork and concrete during wartime (**Plate 02**).

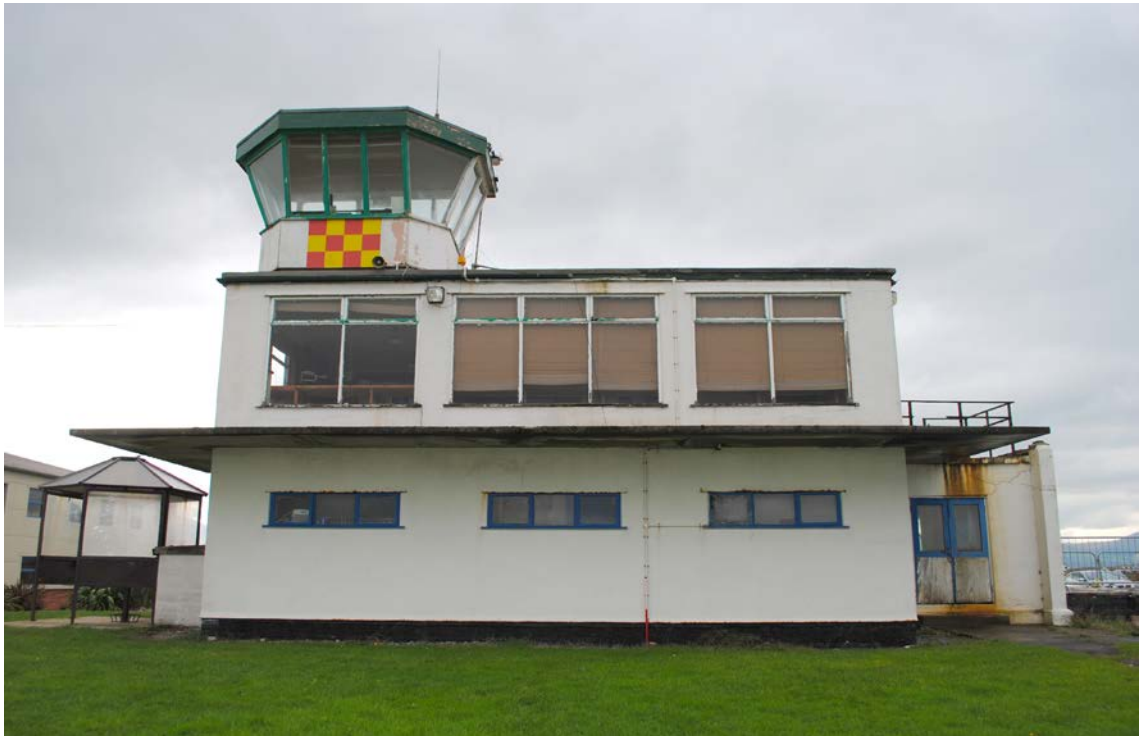
Right:
Plate 03 -
View of northern
elevation of
watch office

The north elevation contains three narrow casement windows at ground floor level, measuring 1.8m by 0.6m each in size. About 0.6m above these windows is a concrete apron, about 0.2m thick, which extends out about 1.5m from the control tower wall, acting as the base of a former balcony (**Plate 03**, see page 08).

The first floor is taken up with three large casement windows, giving a view over the airfield. At ground floor level, three courses of brickwork are visible, above which the building is fully rendered.

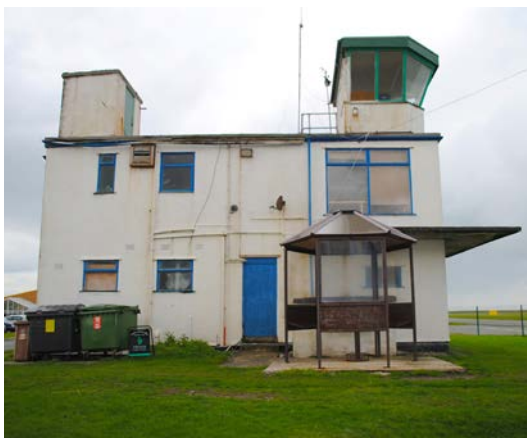
Right:
Plate 04 -
View of eastern
elevation of
watch office,
partly obscured
by modern
shelter

On the eastern elevation a central door at ground floor level gives access to the building, with two windows (1m by 0.5m) to the south of it and a smaller one to the north (**Plate 04**).

The concrete apron/former balcony continues from the north elevation and extends for approximately 3.5m along this elevation, with a large casement viewing window above. Two windows are located at first floor level to the south.

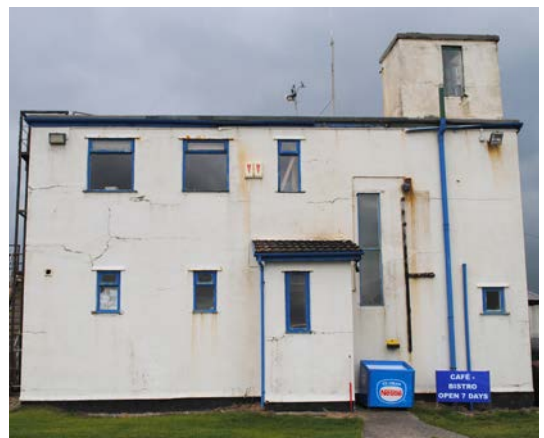
Far right:
Plate 05 -
View of south-
ern elevation
of watch office,
with ground
floor porch

A central porch protects the entrance to the building on the south side, and there are three ground floor windows. A tall two light window lights the stair well to the east of the entrance, covering both ground and first floors. Three windows light the first floor, two wide and one narrow (**Plate 05**).

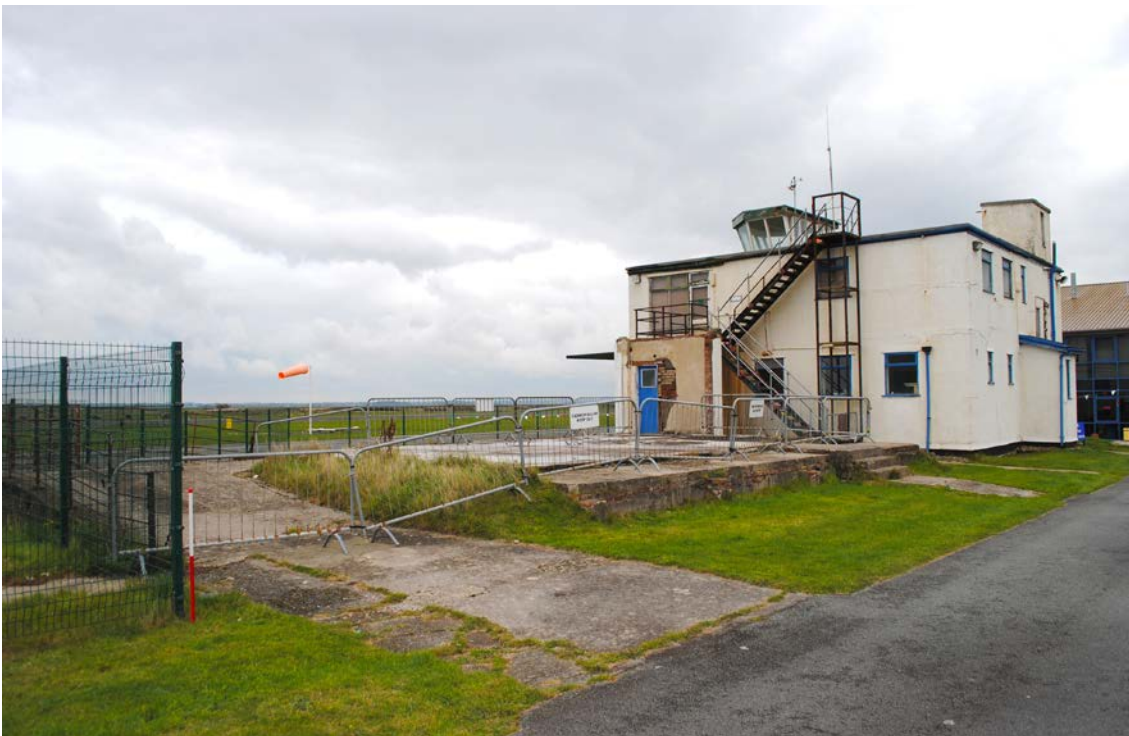
Left:
Plate 06 -
View of western
elevation of
watch office,
taken from the
south west, with
the concrete
pad of a former
RAF building

The western elevation has three similar windows (1.2m by 0.95m each in size) at ground floor level, a single similar one at first floor level, and a large observation window to the north west, subsequently converted to form an access from the stairway. The stair was built over a supporting extension to the west in the 1960s, which contains a door and north and south facing small windows. The purpose of this extension is not clear, but it supports the metal stairs leading

to the observation tower on the roof added in the 1960s. Adjacent to the west is the concrete platform of a former wartime building. This would appear to have once been fully detached (Plates 06 - 08).

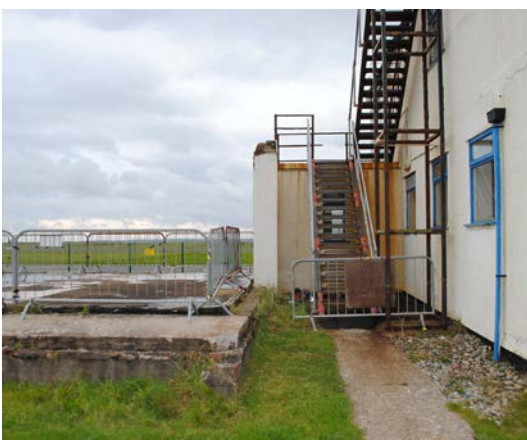
Left:
Plate 08 -
View of western
elevation of
watch office

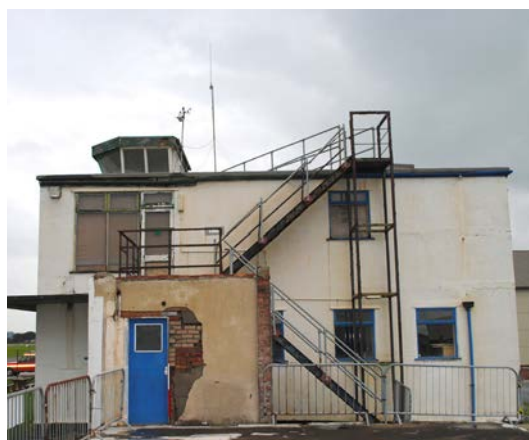
Far left:
Plate 07 -
View of
extension and
roof access
stairs on
western side of
the watch office

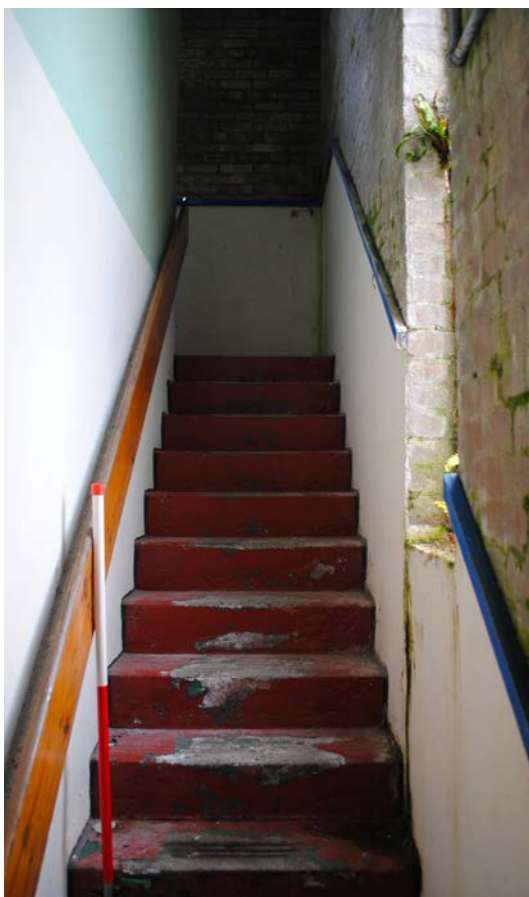
Right:
Plate 09 -
View looking
up the stairs
leading to the
first floor, taken
from the west

The stairwell is entered directly from the south entrance, and extends to the full height of the building. There are 13 concrete treads (each 0.25m by 0.17m high). A single window 2.5m high and 0.5m wide crossing both ground and 1st floor level lights the stair well on the south side. The well is 5.2m high, the full height of the building and extends to a depth of 5.2m. The wall is rendered to handrail level and is exposed brick above. It is rendered on the north side (**Plate 09**).

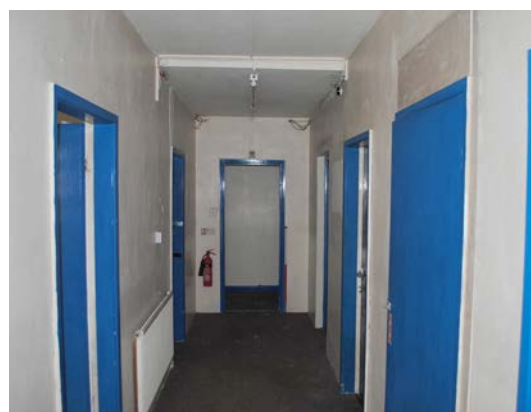
Far right:
Plate 10 -
View down
hallway, taken
from the south

The hall extends northwards of the stair well, with rooms 3-8 accessed off it. It is without distinguishing features, and all surfaces are rendered. Some modification to the wall around cupboard (4) can be seen, suggesting that this was the original entrance to the room(s) to the east of the hall, and the adjacent WC room doors are later additions. The room is 6.2m long on 1.7m wide, and the height is 2.6m, which is the height of all ground floor rooms (**Plate 10**).

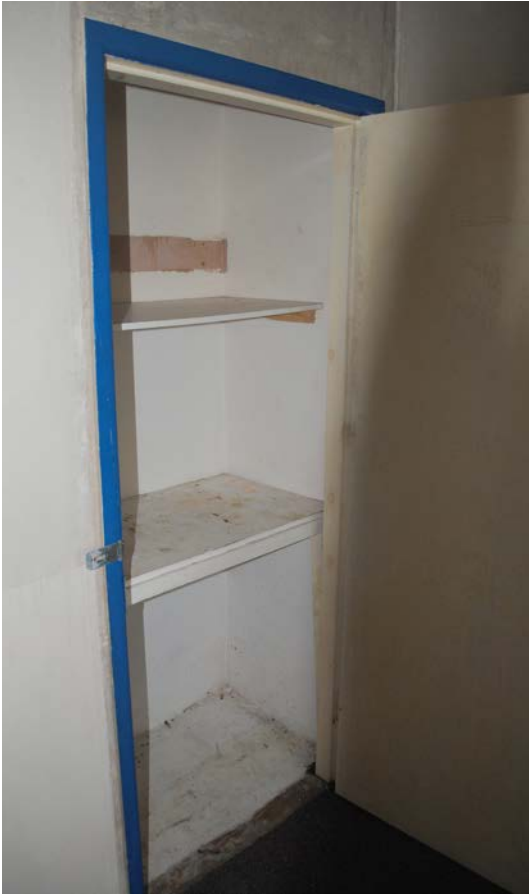
Far left:
Plate 12 -
View of
cupboard,
taken from the
south west

A two shelf cupboard, created from recent changes to the walling between the Ladies WC (3) & Gents WC (6). It has no other distinguishing features. The cupboard is 1.36m by 0.79m (**Plate 12**).

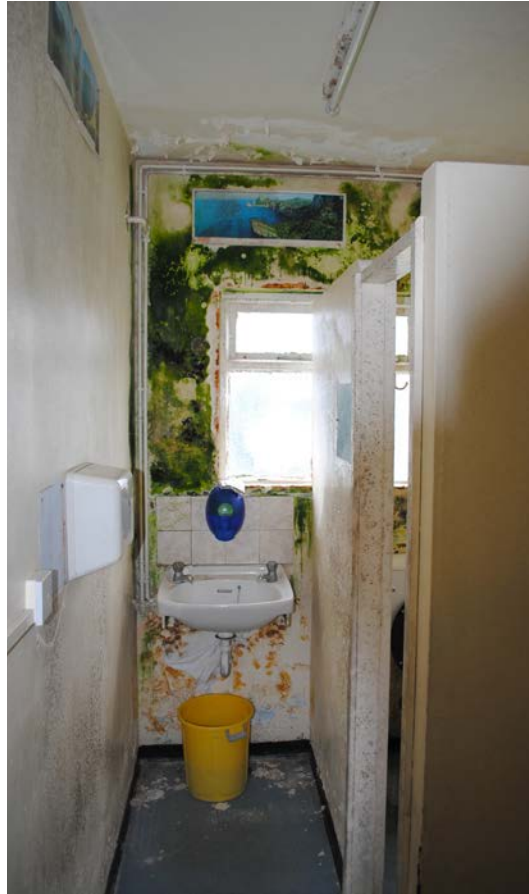
Left:
Plate 15 -
View of gents
WC, taken
from the west.
Later inserted
cubicle to
the right.

A gents WC, with the urinal within an alcove equivalent and a mirror image of that seen in the Ladies WC (3), created as part of post war conversions to the building. There is a window on the east side wall partially obscured by the modern cubicle wall. All the internal fittings are of modern date and without great significance. The room is 3.6m by 1.65m (Plate 15).

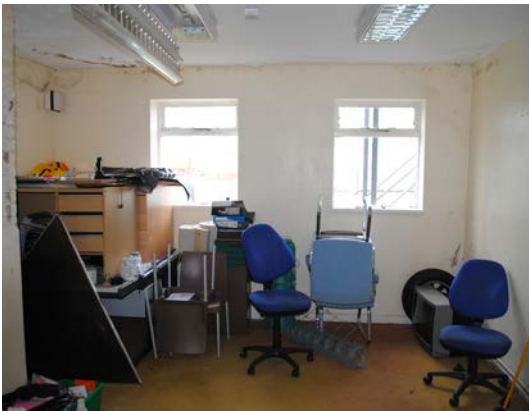
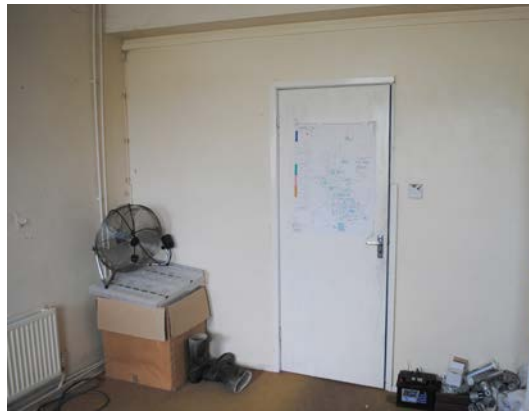
Far left:
Plate 13 -
View of office,
taken from the
east

Left:
Plate 14 -
View of office,
taken from the
south west

A former office room accessed off the west side of the hall (2). It has two casement windows on the west side of the building, and two smaller casement windows on the south. One of the latter, 2.4m by 1.2m, is within a brick cupboard area in the south-east corner of the room, with a door 0.9m wide giving access to this. It is one course of brickwork thick. The room is 4.6m by 4.3m (Plates 13 & 14).

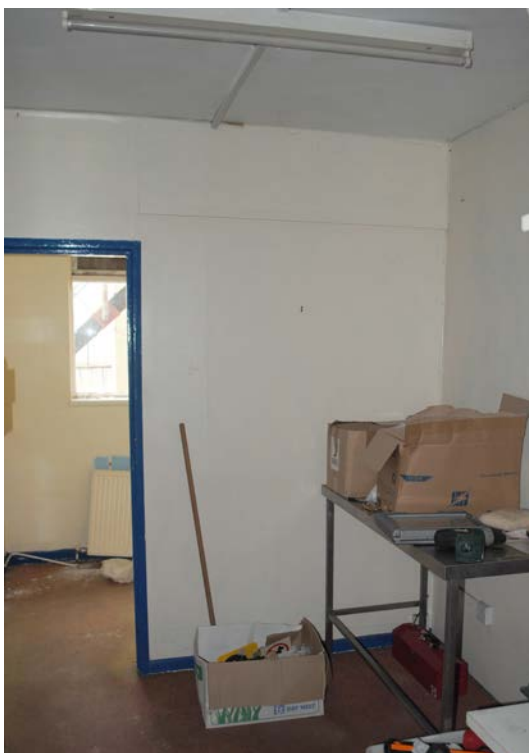
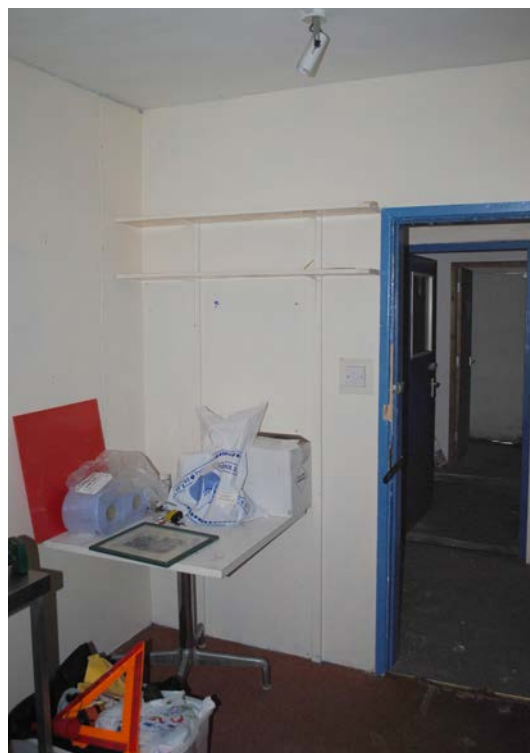
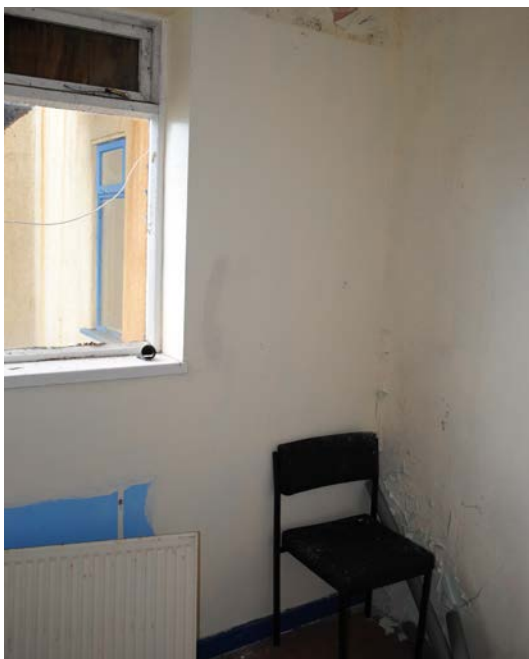
Right:
Plate 16 -
View from the
east into parti-
tioned office

Far right:
Plate 17 -
View from the
west looking
into room 7A

Right:
Plate 18 -
View of room
7A, taken from
the east

An office room, with a single casement window on the west side of the building, subsequently divided in half by a partition wall (creating rooms 7a and 7b), with a doorway within it to the south of the partition. This means that it is only the inner of the two rooms that is lit. The rooms are plastered and boarded, and no features of interest were noted. The room, prior to partitioning, was 4.8m by 2.35m (**Plates 16 - 18**)

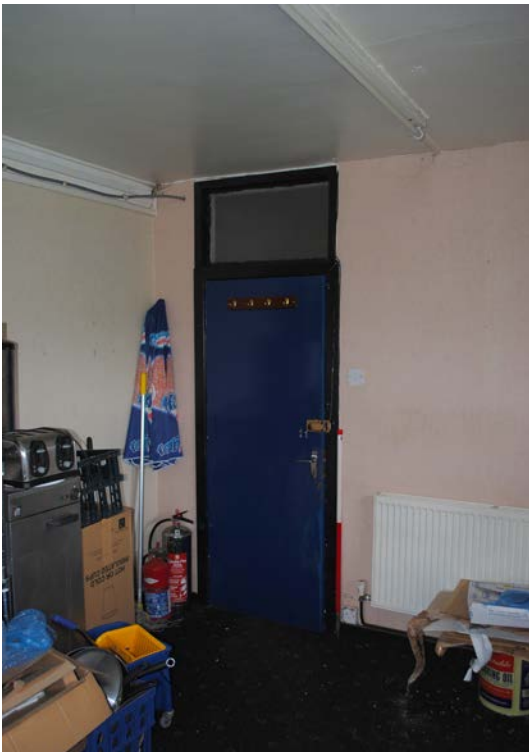
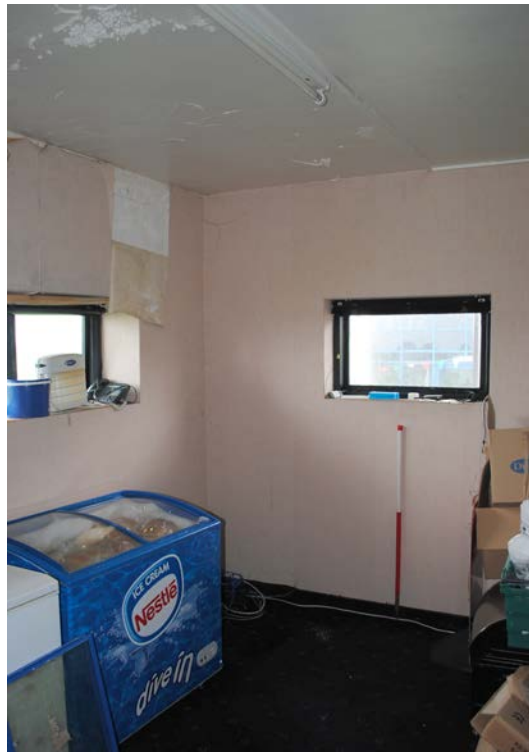
Left:
Plate 22 -
View of office
room 10, from
the west

Far left:
Plate 23 -
View of office
room 10, from
the east

This room was created out of the former long east-west ground floor room on the north side of the building. It has two narrow windows (1.95m by 0.6m) on the north side of the room, and two (0.98m by 0.6m) on the east side wall. The width of the room (3.28m) seems to represent the original width of the wartime long room. The room is currently used for storage and no other features of interest were noted. The room is 4.1m long (**Plate 22 & 23**).

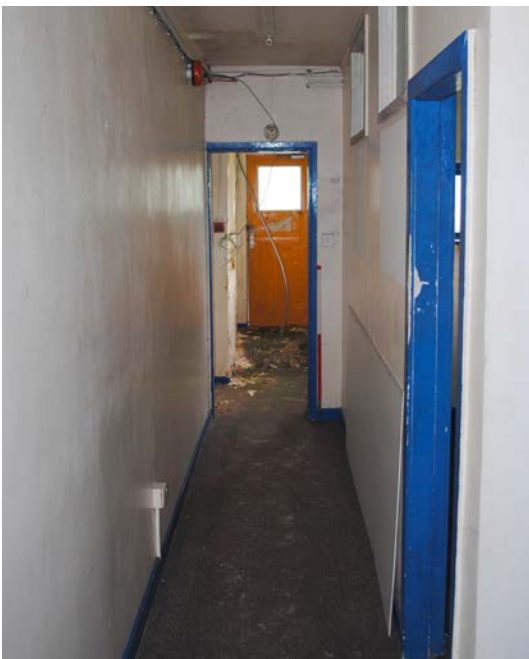
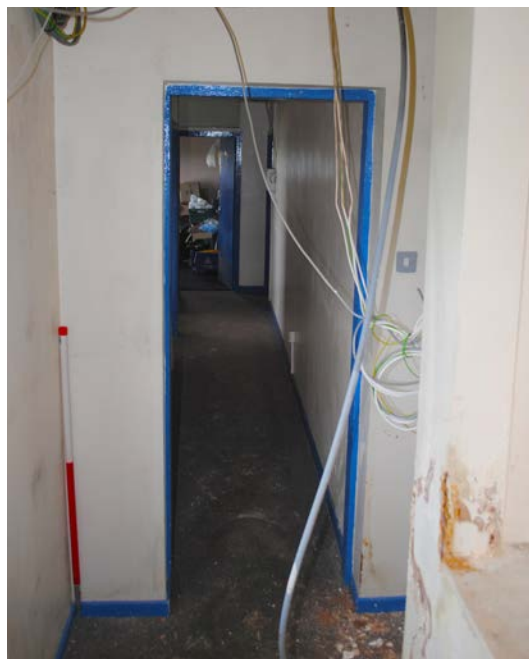
Left:
Plate 21 -
View down
corridor, taken
from the west

Far left:
Plate 20 -
View down
corridor, taken
from the east

A corridor runs east-west, accessed at its eastern end from the hall (2). Its wartime state appears to have originally been a wider, long east-west room running along the entire north side of the building. It was subsequently divided up with partitions on the north and east side, creating a number of new offices and rooms (10-12). The walls on the north and east side of the corridor are modern stud partition walls. The room is currently 6.05m long and 1.2m wide (**Plates 20 & 21**).

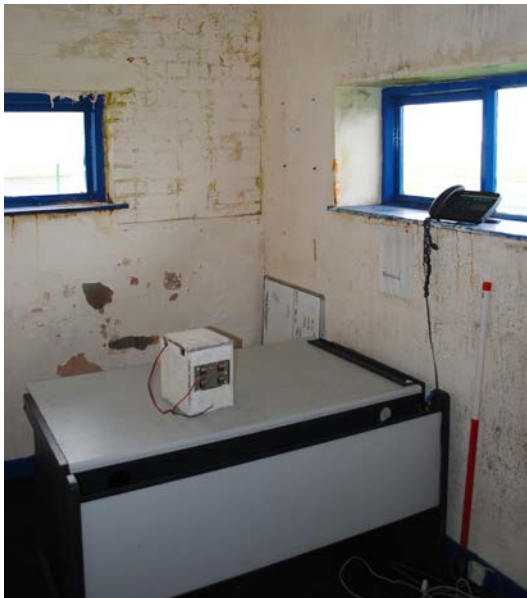
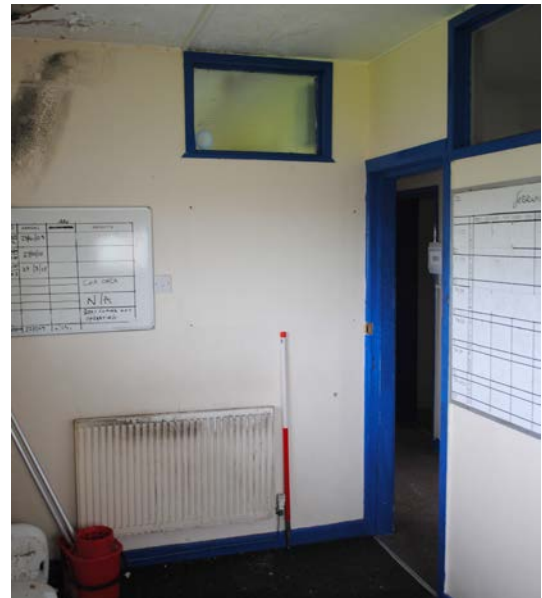
Right:
Plate 25 -
View of office
room 12, taken
from the east

Far right:
Plate 26 -
View of office
room 12, taken
from the west

A room divided by modern partitions to the west of room (11), enclosed by a modern partition to the south & east, with the door to the east of the south partition, and three window lights in the partitions. A single window (2.2m by 0.6m) lights the room to the north and one (1.1m by 0.6m) in the original wall to the west of the room. There were no other features of note (Plates 25 & 26).

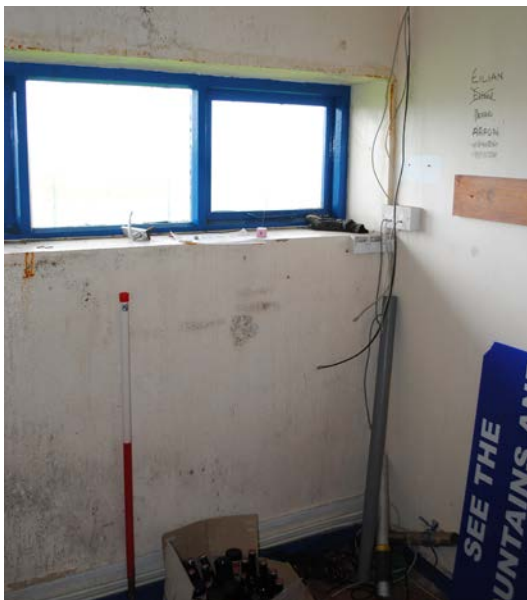
Right:
Plate 24 -
View of store
room 11, taken
from the south

A room divided off by modern partition walls to the south and west, with one long narrow window (2m by 0.6m) runs along the entire north wall of the room. Otherwise there are no features of interest. The room is 2m by 1.97m (Plate 24).

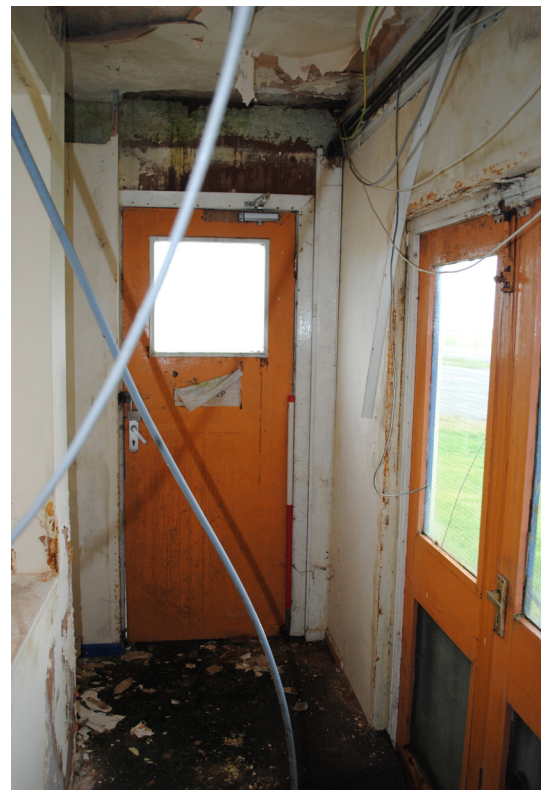
Far right:
Plate 27 -
View of
extension
room 13, taken
from the east

An irregularly shaped extension was added to the west of the building in 1968. It supports the stairs leading to the observation tower on the roof (21). Internally, a pair of doors is located to the north, a single door to the west, and a window to the south. This latter window forms part of a strange hatch like structure. A doorway leads into this area from the western end of the corridor (9), which would appear to be an original feature. The room is 3.4m long and 1.76m wide (Plate 27).

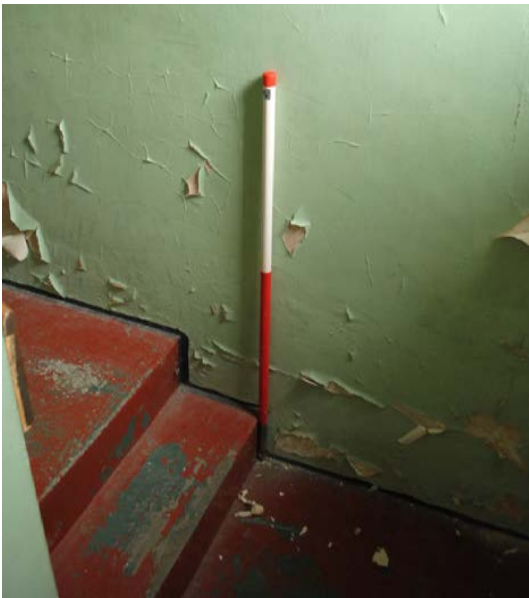
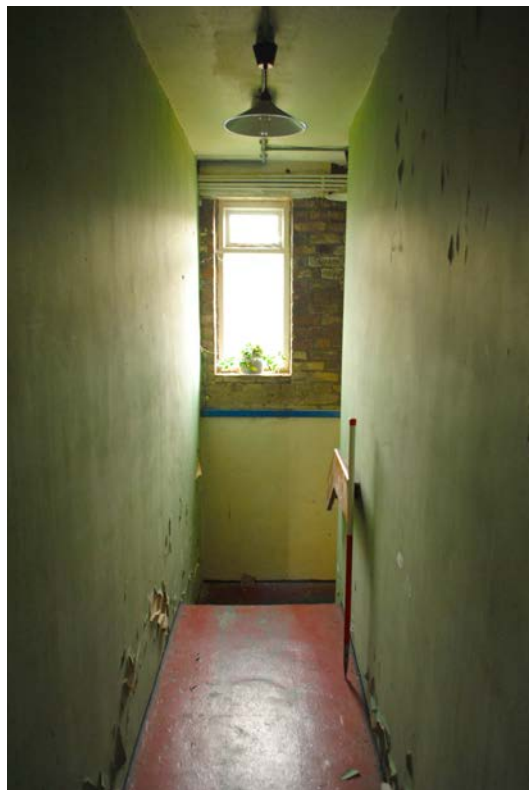
Far left:
Plate 29 -
View of land-
ing steps, taken
from the north;
scale 1x1m

Far left:
Plate 28 -
View looking
down stairs
from landing
room 14, taken
from the east

A very small half landing where the stairs turn 180°. It is lit by a single casement window in the east wall (0.84m by 0.5m). The east wall is exposed brick above the wooden handrail level and plastered below. The landing is 1.9m by 0.85m, and the height is 2.96m to the ceiling (**Plates 28 & 29**).

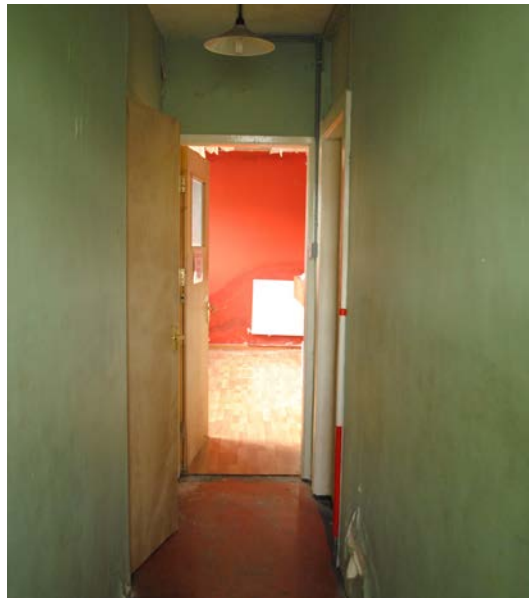
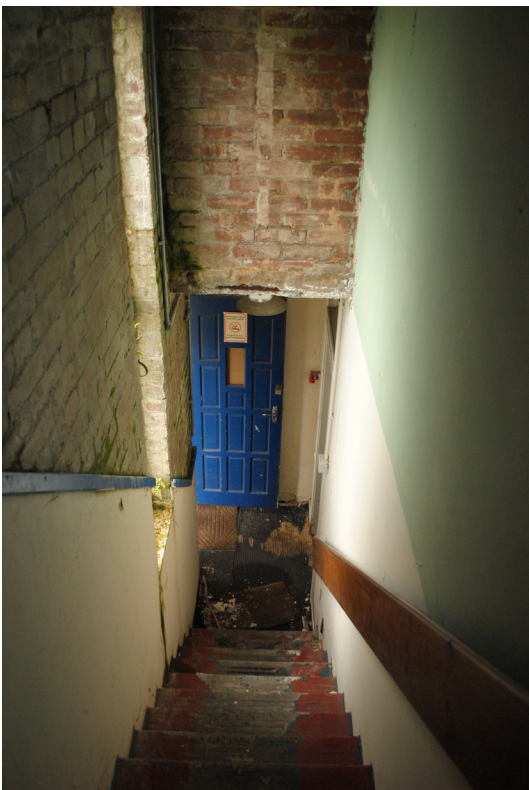
Left:
Plate 30 -
View along hall
room 15, taken
from the east

Left:
Plate 31 -
View along hall
room 15, taken
from the west

The upper landing of the stairs after the return heading westwards, enters (17) at its western end. It has a door into the kitchen on its north side (19), and to a small cupboard to the south (16). There is a small teak handrail on the southern side for the two steps beyond the half-landing (14). The hallway was 5.5m long and 0.9m wide. All rooms on the first floor are 2.6m high, indicating that both storeys are of the same height (**Plates 30 & 31**).

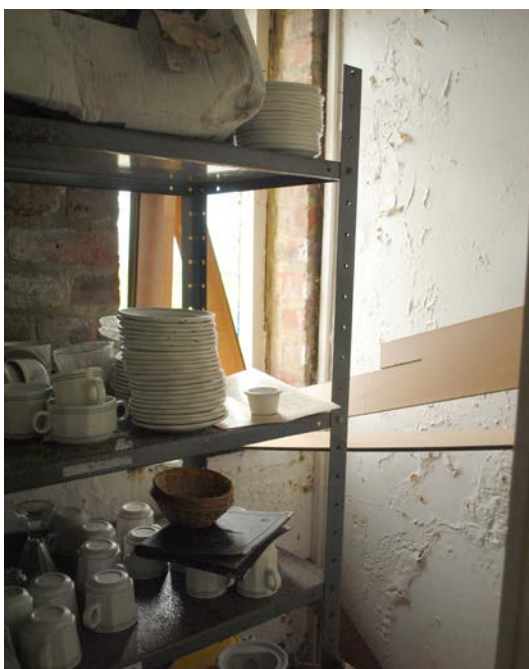
Right:
Plate 32 -
View looking
into cupboard
16, taken from
the south

A very small cupboard is located in the space above the stairs to the south of the hall (15), with a modern door and frame. A small window, 0.7m wide, lights the cupboard on the southern side. The brickwork of the wall, concrete window lintel and concrete roof are undecorated within the cupboard, indicating the wartime utilitarian appearance of the wider building. The cupboard is 1.3m by 1.07m (Plate 32).

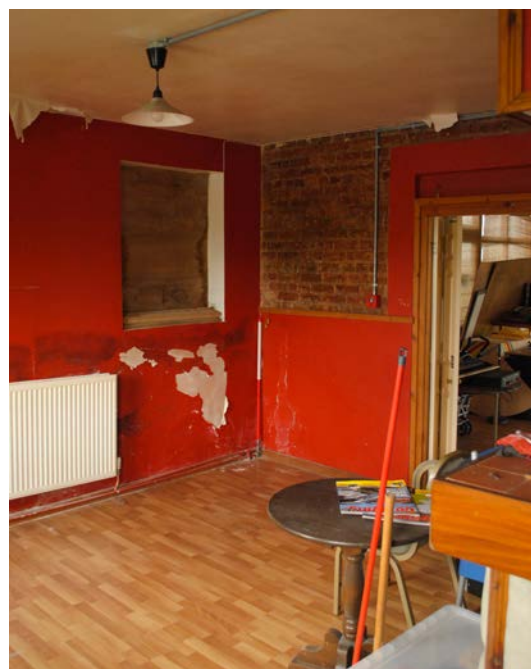
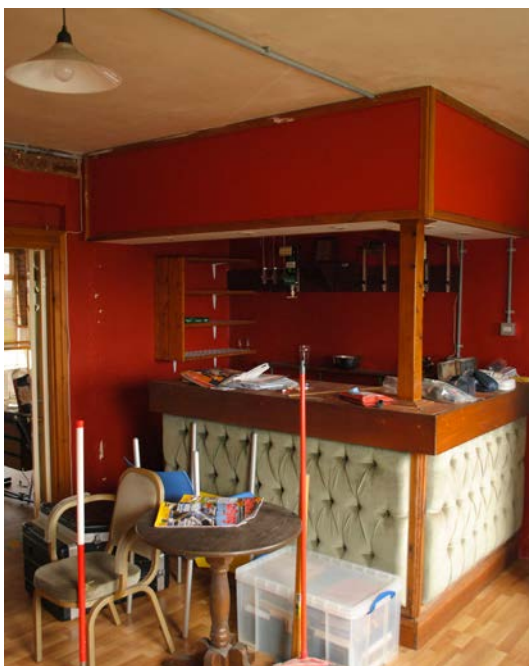
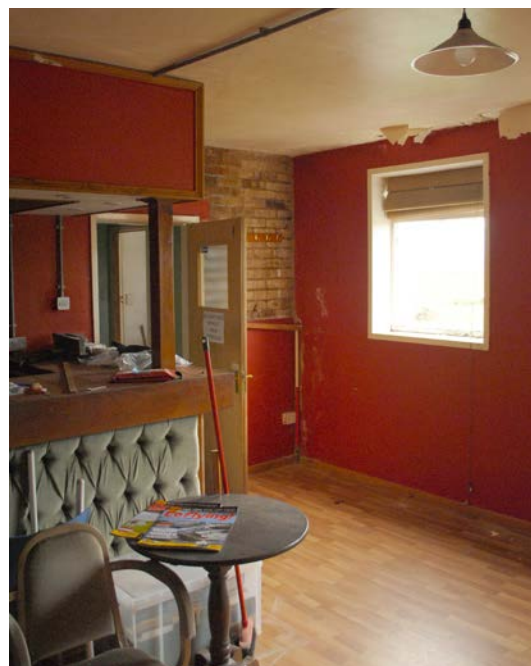
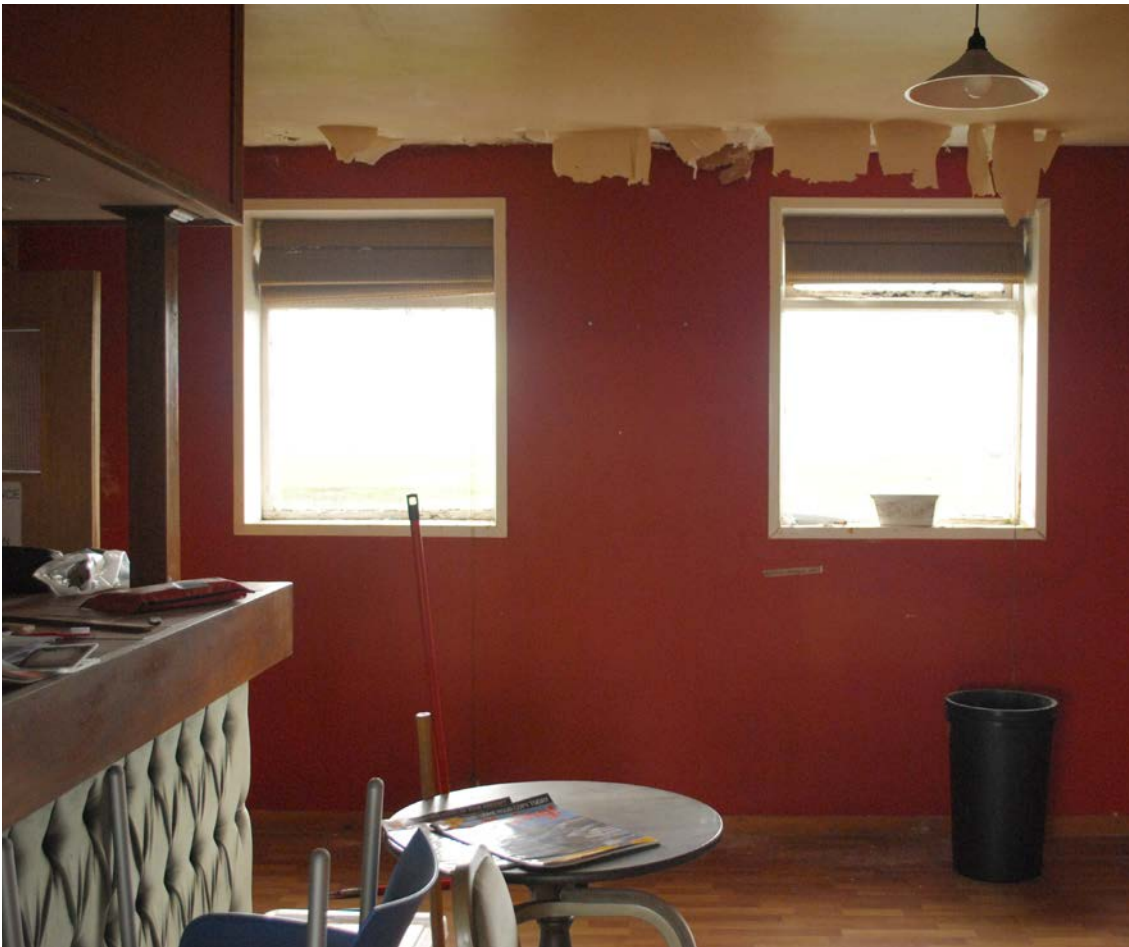
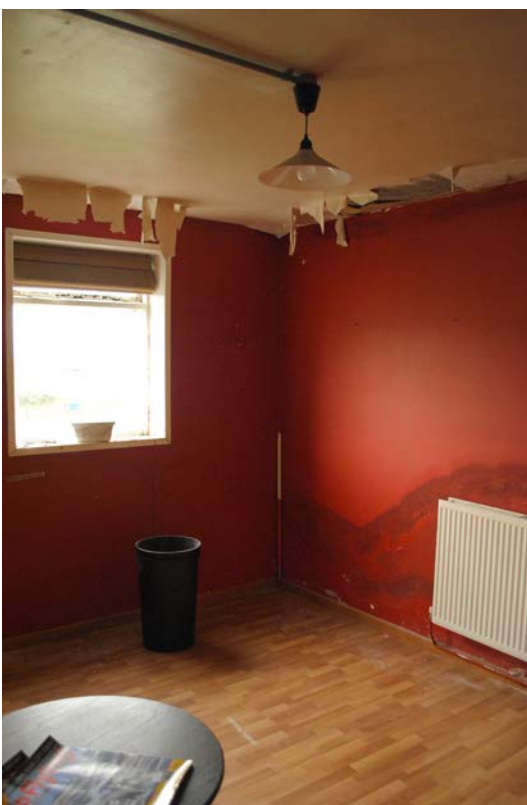
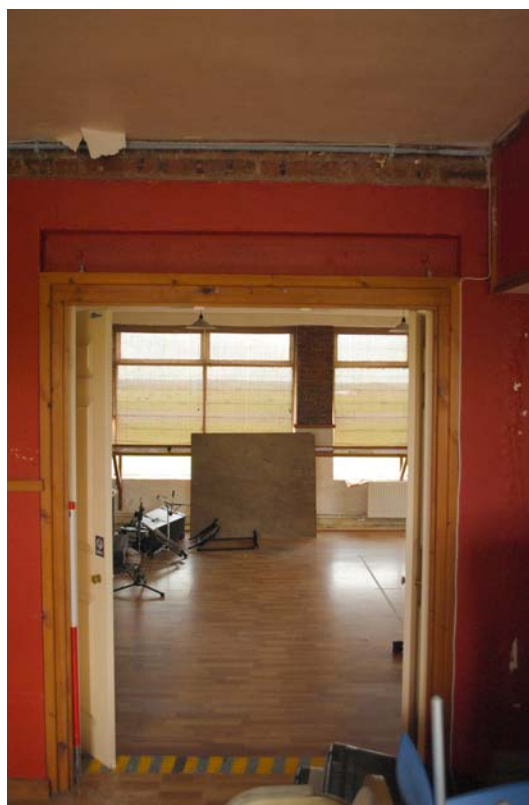
Far right:
Plate 33 -
View of bar
room 17, taken
from the north

Right:
Plate 34 -
View of modern
bar structure in-
serted into bar
room 17, taken
from the west

Far right:
Plate 35 -
View of modern
bar structure in-
serted into bar
room 17, taken
from the south

Left:
Plate 36 -
View of internal
face of south
wall of bar room
17, taken from
the north

Left:
Plate 38 -
View of sliding
door into watch
office room 18,
showing recent
RSJ support-
ing beam, taken
from the south

Far left:
Plate 37 -
View from the
north east of
bar room 17

The room has two casement windows in the south wall (1.8m x 1.3m) and one in the west wall. The north wall of the room appears to be part of the original build, & some of the brickwork is exposed. A wide opening (1.6m x 2m) has been cut into it to provide access to the main Watch Office Room (18), with a rolled steel joist (RSJ) lintel inserted for support, as it is a load bearing wall. A bar area has been inserted into this room in recent times. The room is 4.93m long and 4.4m wide (Plates 33 - 38).

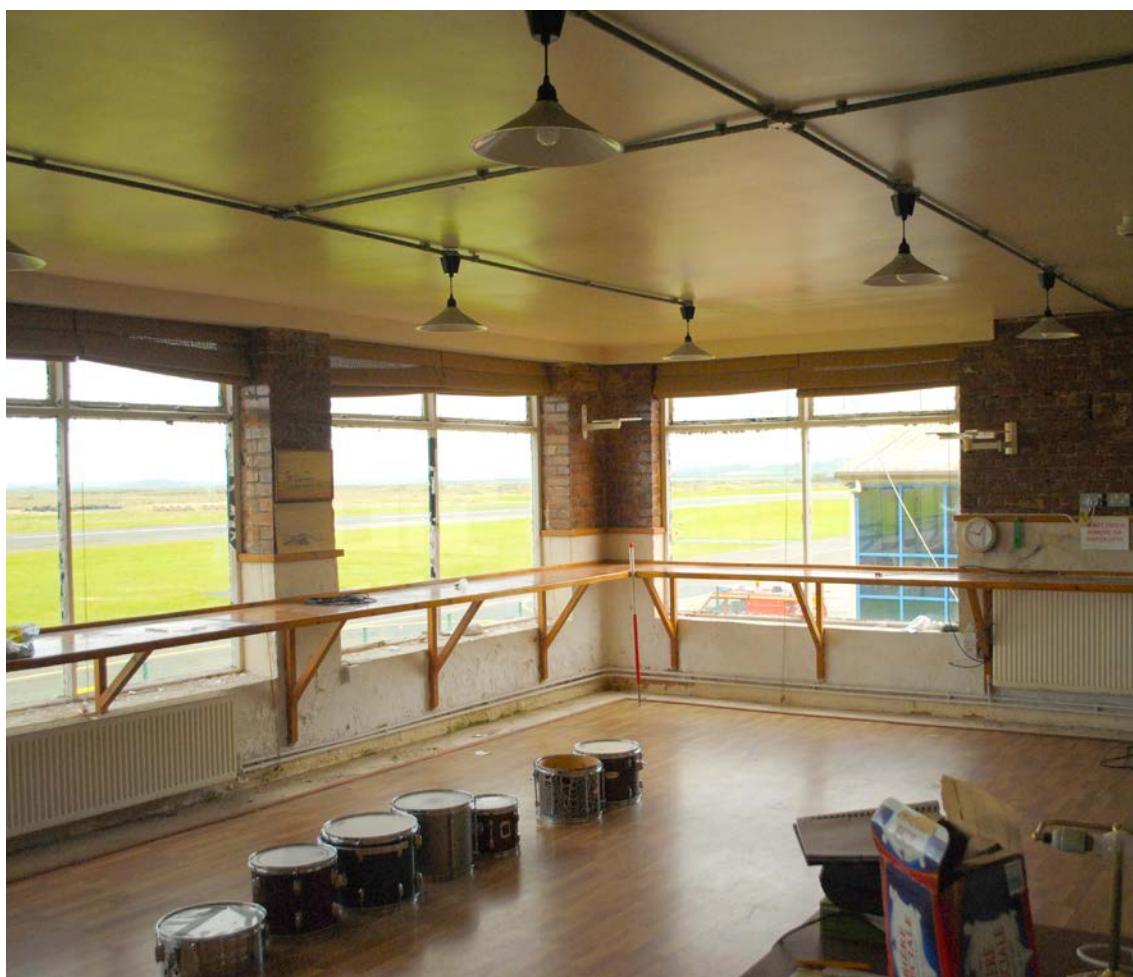
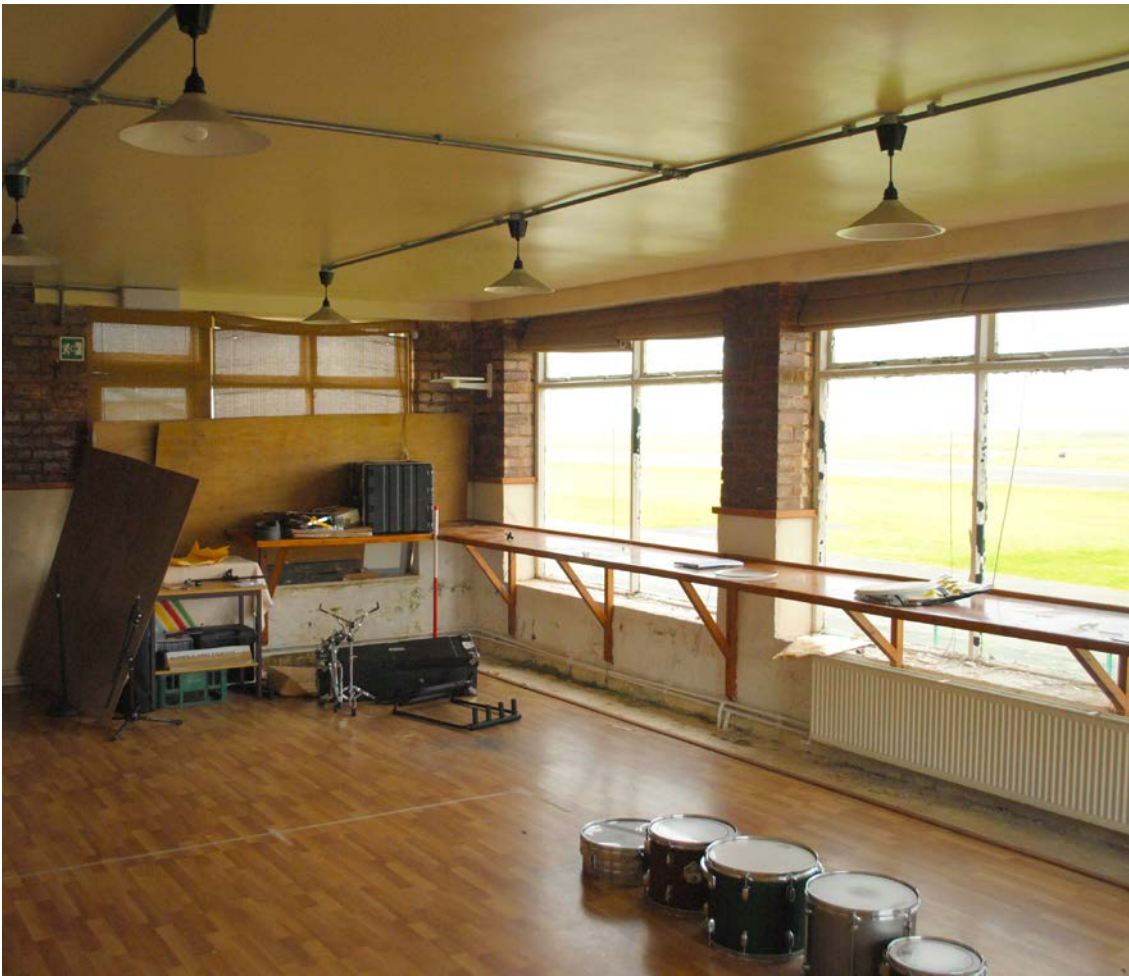
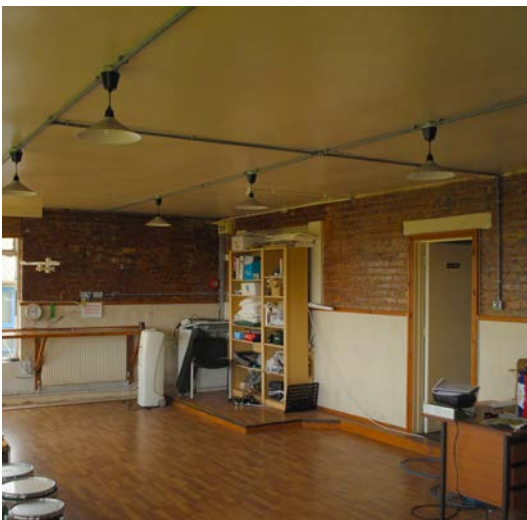
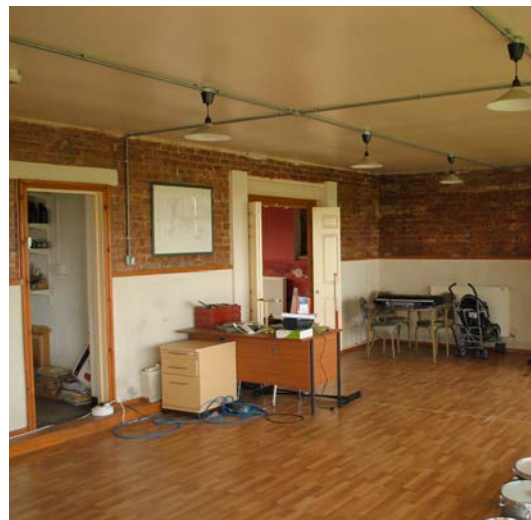
Right:
Plate 39 -
View of main
watch office
observation
room 18,
taken from the
south west

Right:
Plate 40 -
View of watch
office room
18, taken from
the west

Far right:
Plate 43 -
View of watch
office room
18, taken from
the east

Left:
Plate 42 -
View of main
watch office
observation
room 18,
taken from the
north east

Left:
Plate 44 -
View of watch
office 18, with
sliding door
entrance to
bar 17. Taken
from the east
north east

Far left:
Plate 41 -
View of watch
office 18 show-
ing entrance
into kitchen
19 (original
doorway)
and modern
serving hatch.
Taken from the
north west

The main Watch Office room, covering northern half of the 1st floor of the building, has in recent times been used as a room for entertainments. The original brickwork is exposed above dado level (1.3m) around the room. Three large observation window openings fill the length of the north side of the room with two brick

intervening pillars at one third intervals. Two observation windows of similar size are located at the north ends of the east and west sides of this room. An original doorway leads into the modern kitchen (19) on the south side. The south wall has been punctured by two openings; one from the bar area in (17) has already been

discussed. Another, now hidden by modern cupboards, would appear to be a serving hatch from the kitchen (19). This recent change to the building is supported with an RSJ lintel (2.6m by 1.1m). The room is 10.04m by 5.8m wide (Plates 39 - 44).

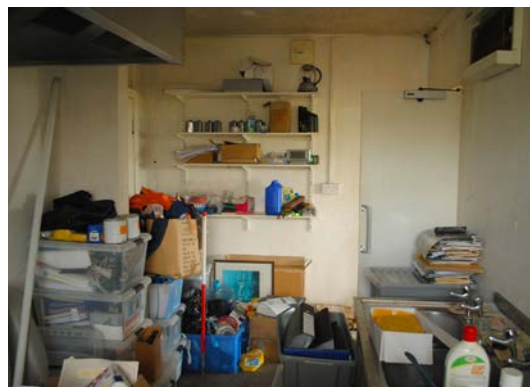
Plate 45 -
View of modern fitted kitchen room 19, taken from the south west

Plate 46 -
View of kitchen room 19, taken from the north east

A modern fitted kitchen is located between the hallway (15) and Watch Office (18), and is currently accessed from an original door in the south wall off (18), and also from the hallway north wall. There is a casement window in the east wall of the room. The wall to the west,

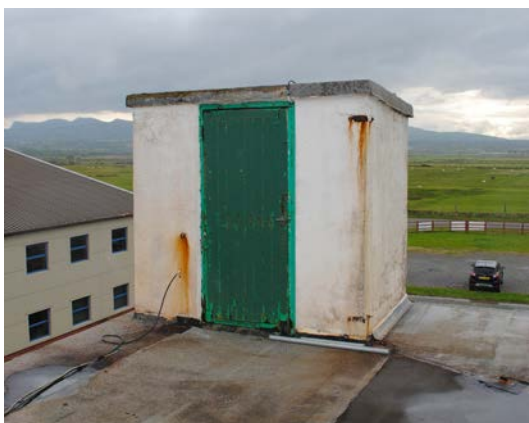
Plate 47 -
View of small enclosed tower room 20 on south east corner of roof, taken from the north west

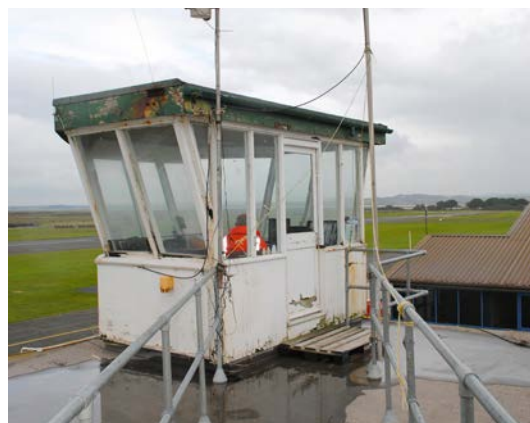
Plate 48 -
View of observation tower on the north east corner, taken from the west
