Water Mains Renewal Scheme, Talwrn to Pentraeth, Isle of Anglesey

Archaeological Watching Brief

Project No. G2271

Report No. 1095

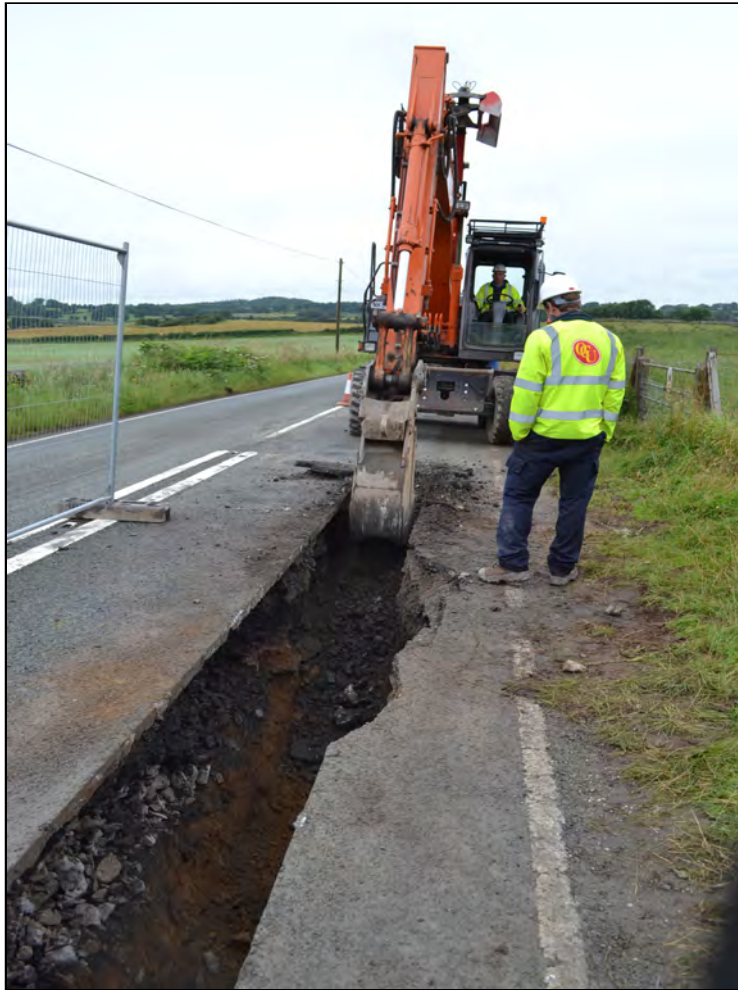
Plate 01: Chainage (CH) 200-300, intensive watching brief using a mechanical excavator. View from the east.

The watching brief was completed between the 30th of July and the 5th of October 2012. The watching brief monitored excavation by a tracked mechanical excavator (plate 01) using a narrow toothless bucket (0.60m wide) for the intensive watching brief at CH 200-300. Spoil was removed from the road using a small dumper truck. A tracked automatic trenching machine (plate 02) was used for the majority of the rest of the works which unloaded the spoil into a large stationary truck behind it, however the tracked excavator was sometimes utilised when the trencher broke down (this became a common occurrence).

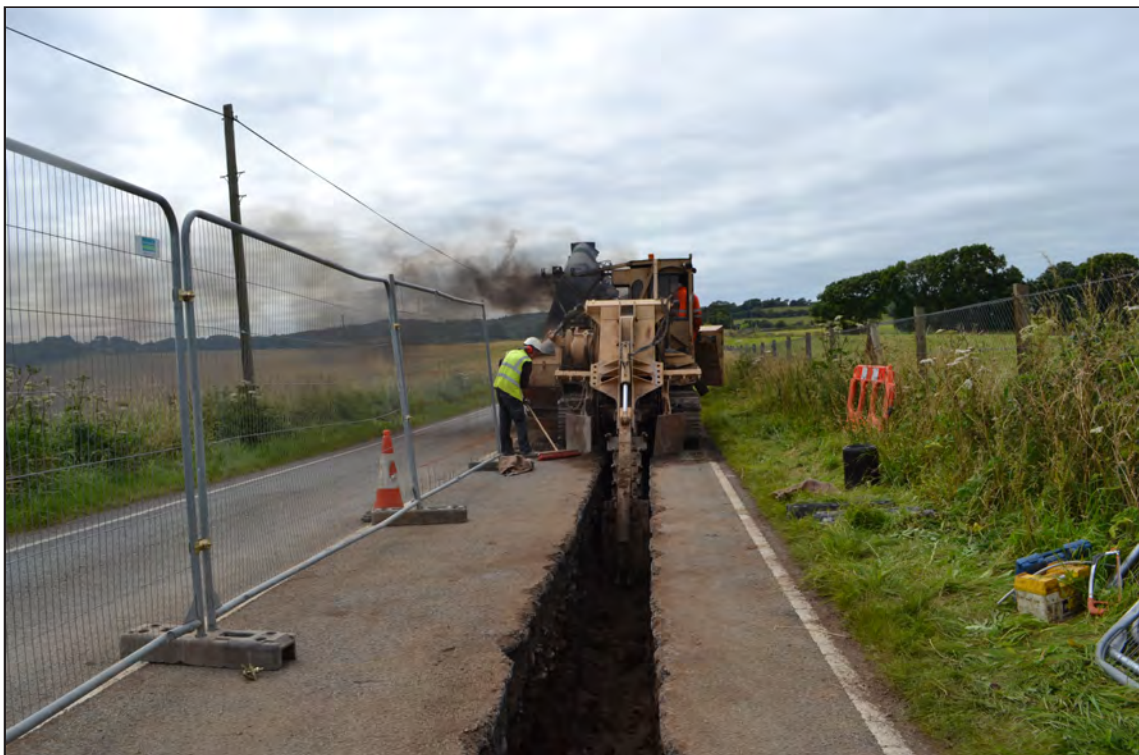
Plate 02: CH 400-500, partial watching brief. Trenching machine in use. View from the east.

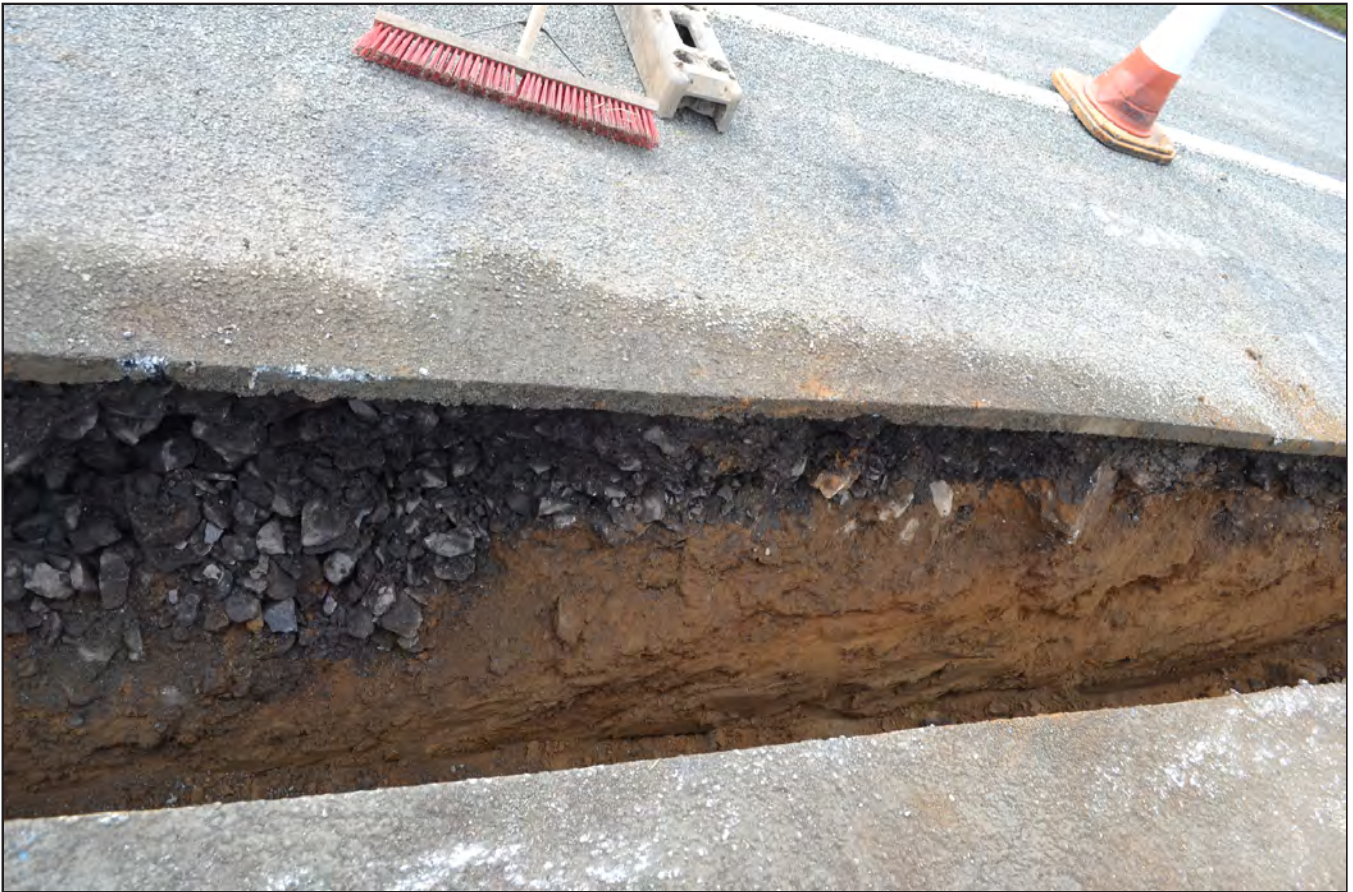
Plate 03: CH 180-200 showing rise in the silt sand natural. View from the north east.

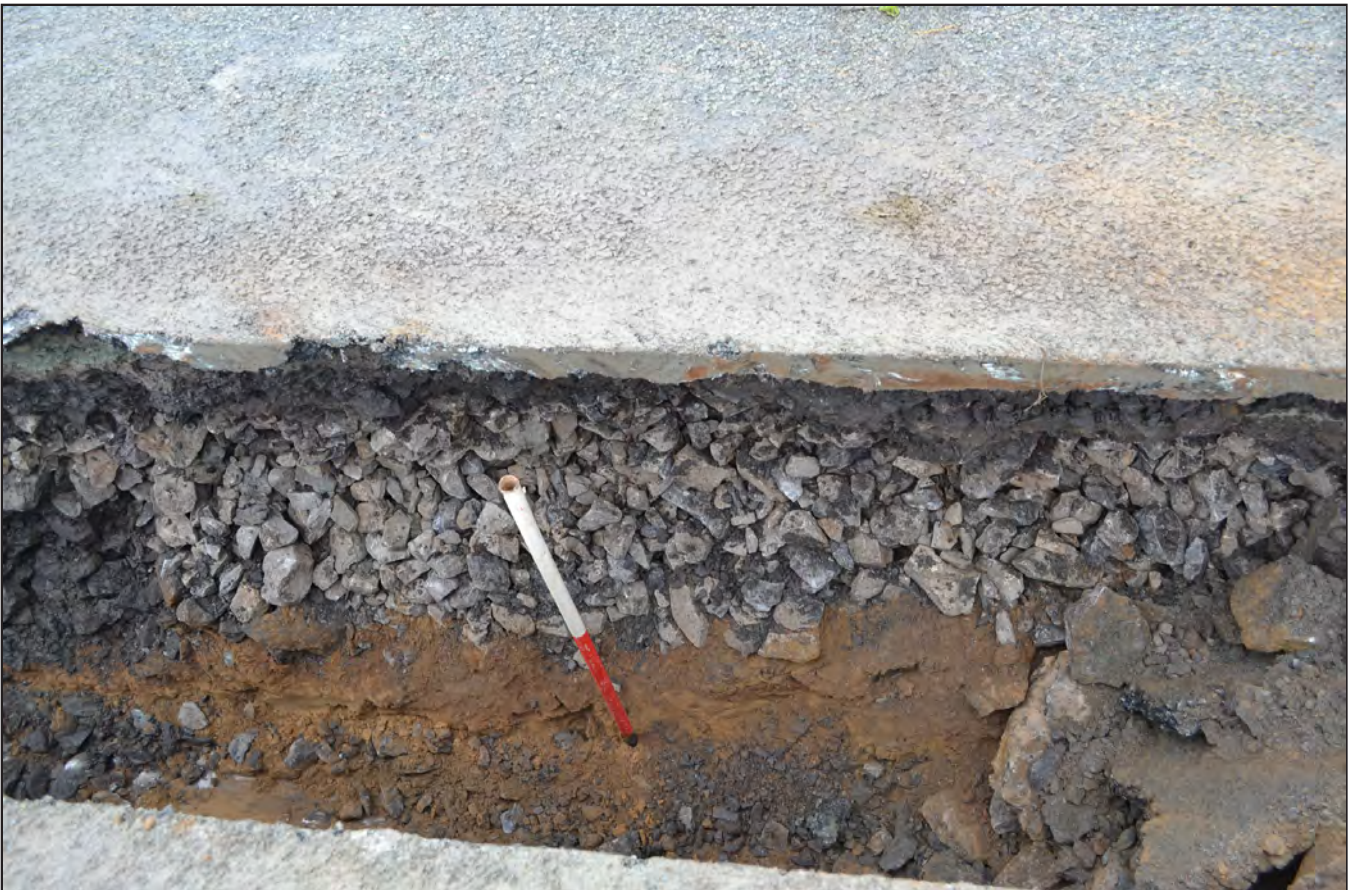
of colluvium or build up ground to the upper level of the colluvium deposit.
CH 200-300 (plate 04)	100m	0.60m	1.30m	Intensive watching brief near Ty'n-y-pwll Barrow (PRN 4356). 0-0.08m was a Tarmacadam road surface. 0.08m-0.78m was a deposit of built up material or mostly hardcore, angular small and medium stones. 0.78m-1.30m was a deposit of yellow orange silt sand colluvium.
CH 300-400	100m	0.65m	1.30m	0-0.08m was Tarmacadam road surface. 0.08m-0.28m was a deposit of angular and sub angular pebbles in a light grey silt clay. 0.28m-0.98m angular and sub angular cobbles in a yellow orange sand silt. 0.98m-1.30m yellow orange silt sand and very few stone.
CH 400-500	100m	0.65m	1.30m	0-0.08m was Tarmacadam road surface. 0.08m-0.28m was a deposit of angular and sub angular pebbles in a light grey silt clay. 0.28m-0.98m angular and sub angular cobbles in a yellow orange sand silt. 0.98m-1.30m yellow orange silt sand and very few stone.

Plate 04: CH 200-300. Section close to Tumulus (PRN 4356) showing material to 'make up' ground for the existing road. View from the north.

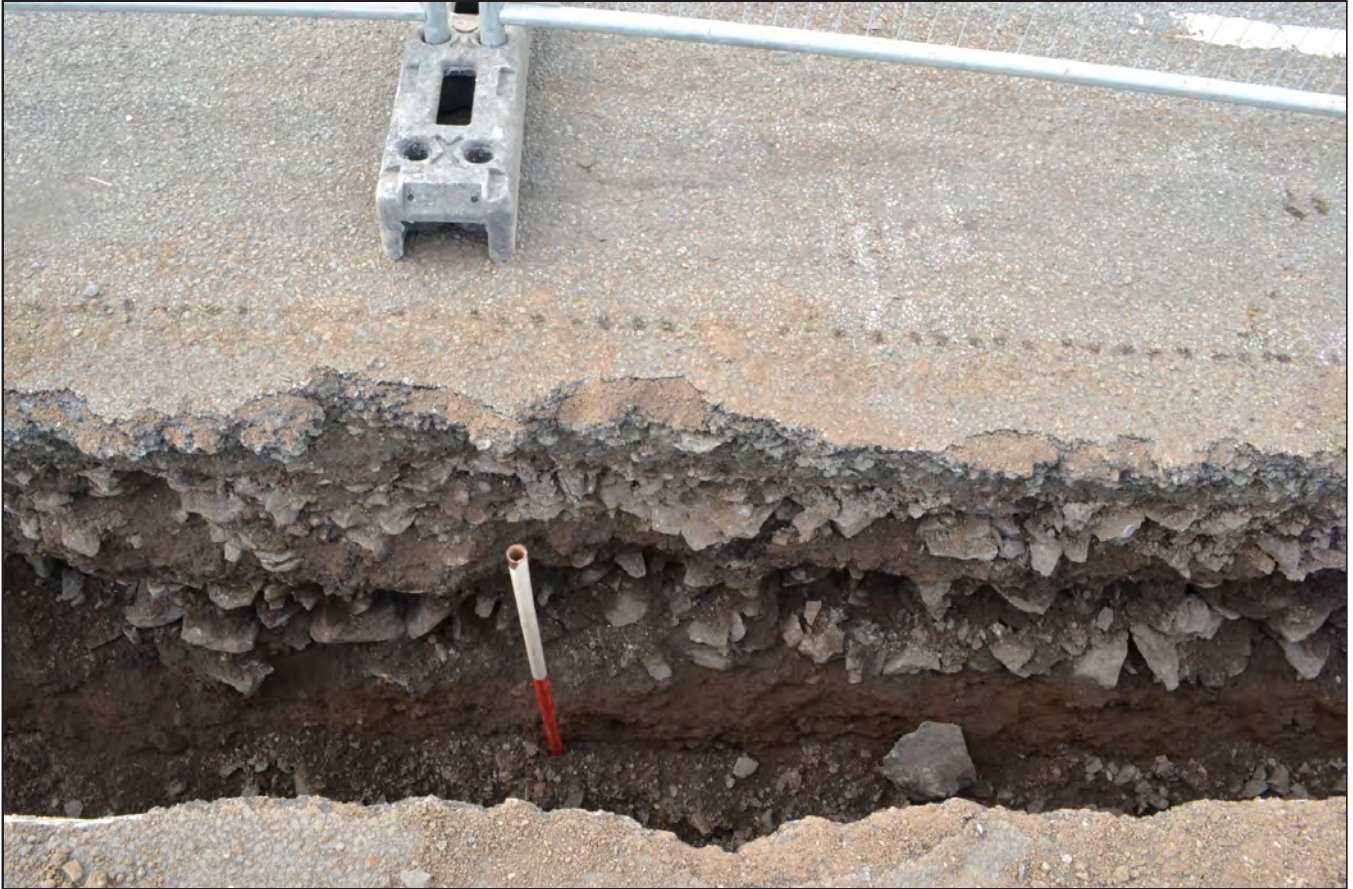
Plate 05: CH 800-700. Section showing built up layers of rubble and road material, 'made up' ground for the existing road. View from the north.

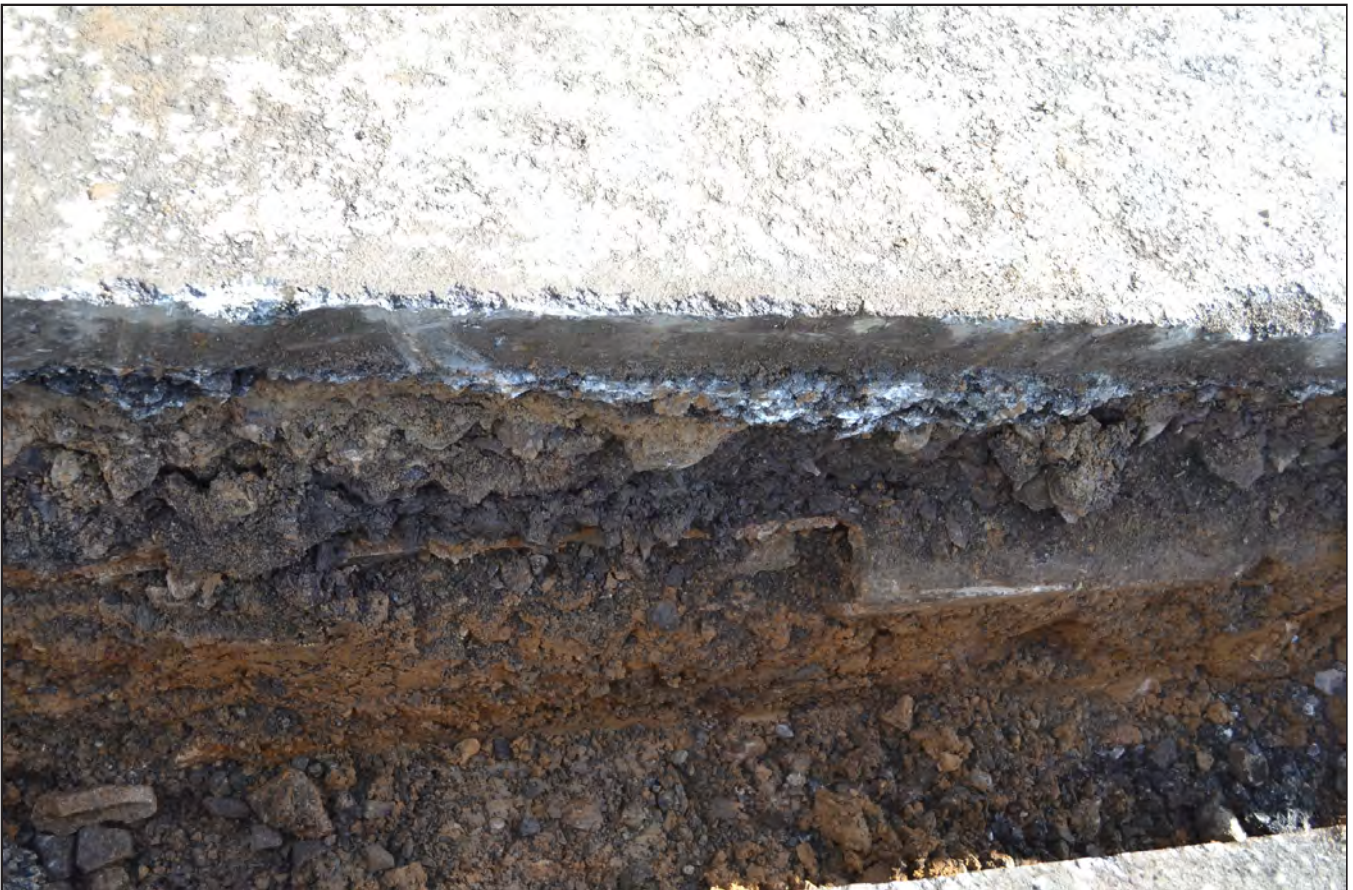
stones.
CH 1600-1650	50.0m	0.60m	1.30m	0-0.20m Concrete upper layer. 0.20m-0.30m Tarmacadam and hardcore, possible previous road surface to the concrete. 0.30m-0.50m Road build up rubble. 0.50m-0.60m Hardcore. 0.60m-1.30m Natural sands and silts.
CH 1775-1850 (plate 06)	75.0m	0.60m	1.30m	0-0.20m Concrete upper layer 0.20m-0.40m Tarmacadam, possible previous road surface to the concrete. 0.40m-0.80m Mixed road rubble of angular and sub angular stones, small to medium, in a grey yellow silt clay. 0.80m-1.00m Mixed redeposited natural containing an old, dead, concrete pipe. 1.00m-1.30m Natural, orange yellow clay sand silt with occasional sub rounded small to medium stones.
CH 2000-2100	100m	0.60m	1.30m	0-0.30m Tarmacadam road surface. 0.30m-0.80m Hard deposit of medium to large angular and sub angular stones in mid yellow brown sand silt. 0.80m-1.30m Friable and loose sand silt mixed deposit of mid yellow brown with very few stone inclusions. 0.90-1.30m Mixed deposit of angular small stones in a hard yellow clay (fill of field drain cut). Within this deposit was broken pieces of dead field drain pipe.

There were no new features encountered and all of the sections recorded within the trench showed, to various degrees, disturbed deposits below the Tarmacadam road surface layer which was the made up ground to build the existing B5109 road. Below this built up material was the natural geology. There were 2 sections that had modern disused water pipe disturbance, between CH 1775-1850 and CH 2000-2100.

Plate 06: CH 1775-1850 showing disused pipe and disturbed ground underneath the existing road. View from the northwest.
