Garnfadryn Pumping Station Water Renewal

Archaeological Watching Brief

Project No. G2290

Report No. 1104

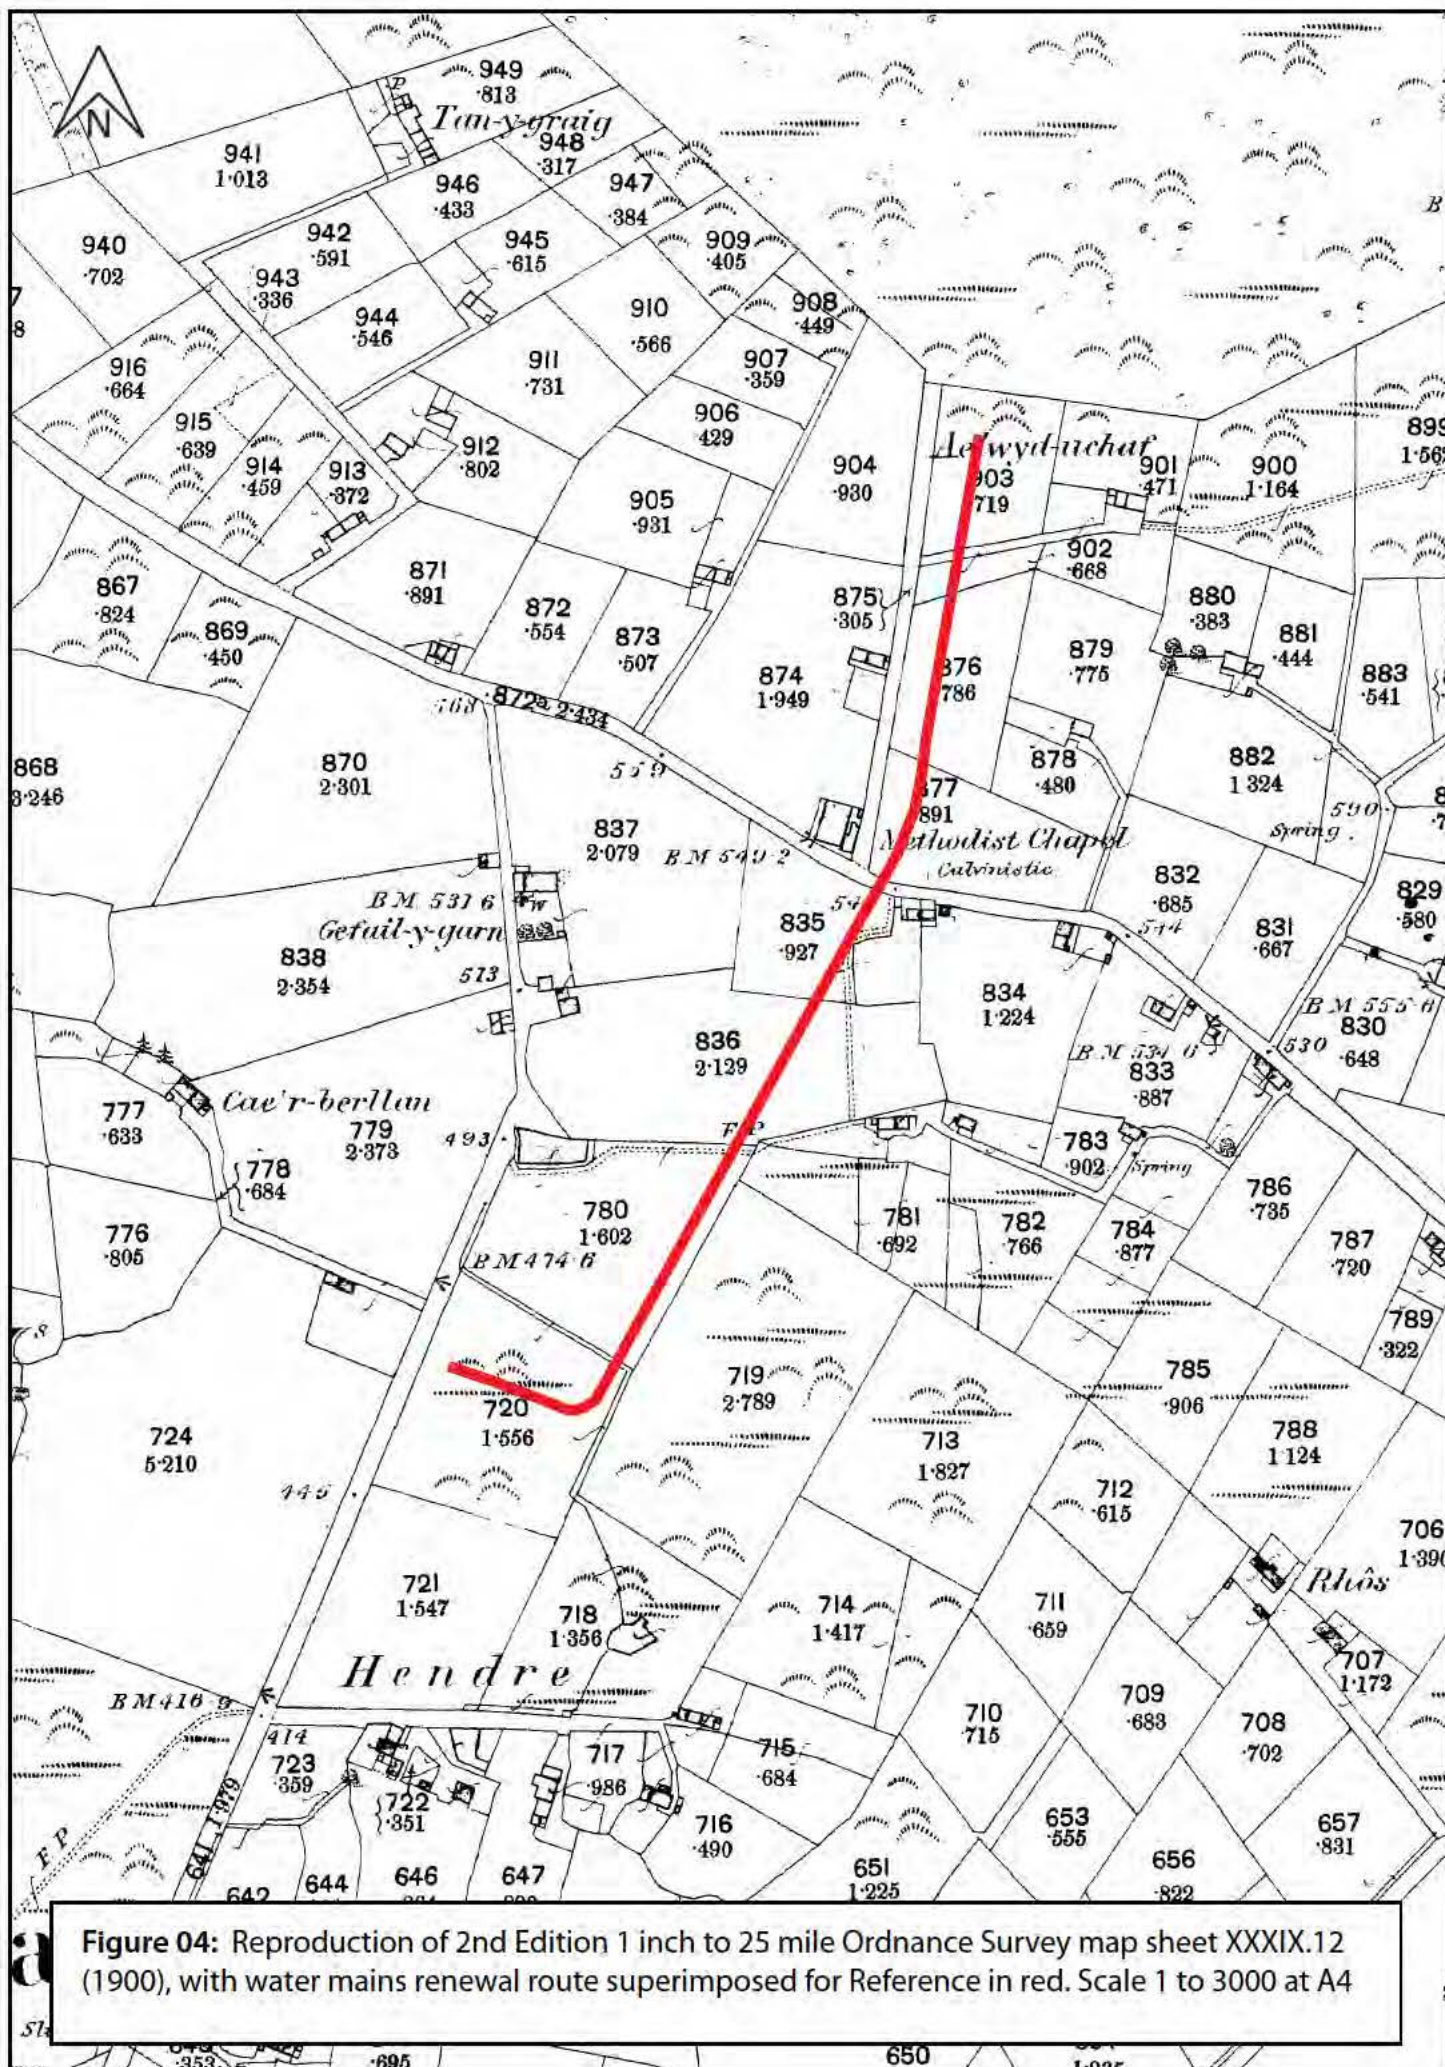
Figure 04: Reproduction of 2nd Edition 1 inch to 25 mile Ordnance Survey map sheet XXXIX.12 (1900), with water mains renewal route superimposed for Reference in red. Scale 1 to 3000 at A4

An examination of the First to Third Edition 25" to 1 Mile Ordnance Survey maps of the area (Caernarvonshire Series Sheet XXXIX.12 1989, 1900, 1919) reveals that the field systems have remained unchanged, while the local road was improved in the twentieth century (Figures 03, 04, 05).

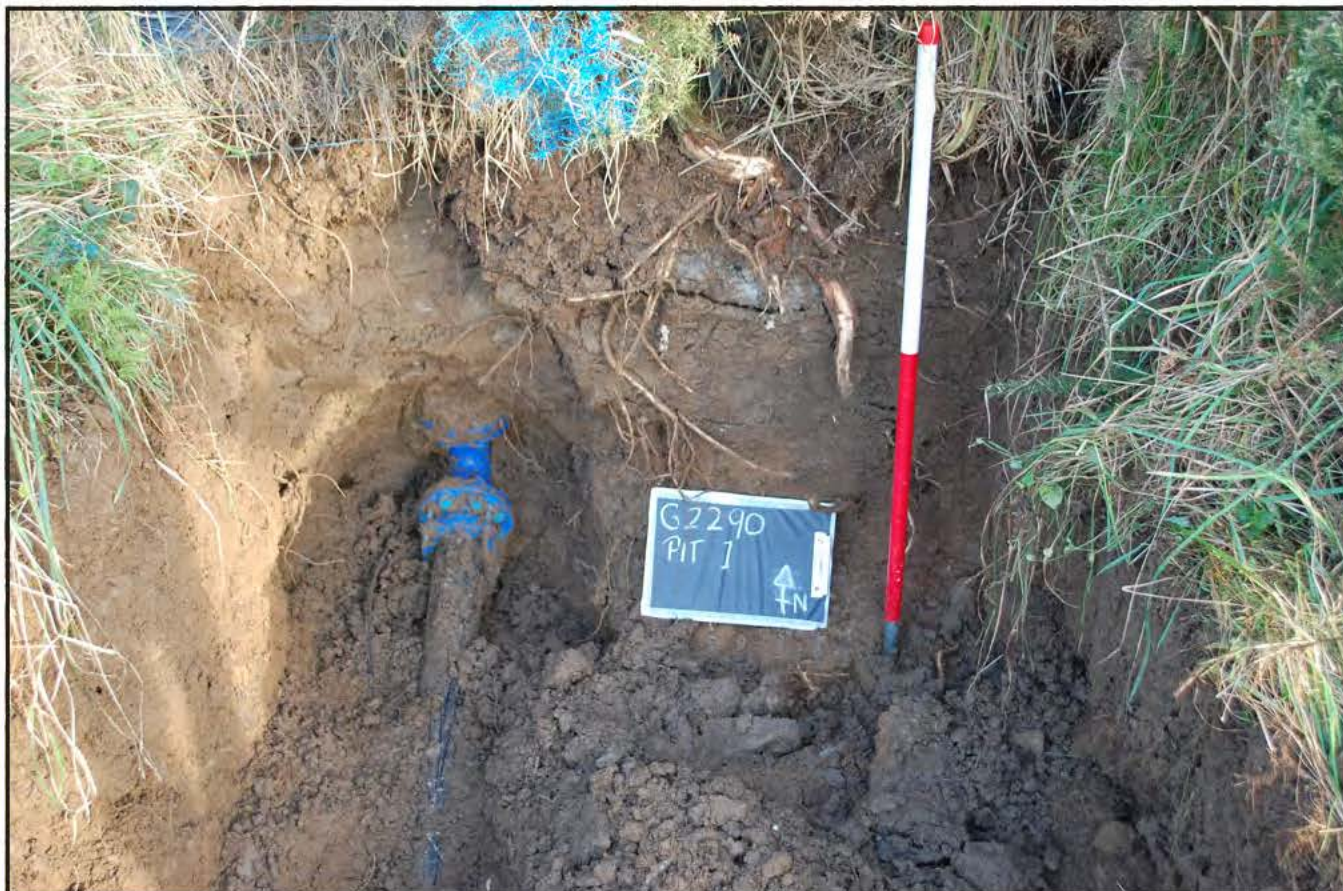
Plate 1: Field 1/pit 1 - south facing section detailing topsoil, subsoil, 1960' water main and valve.
Scale = 1 metre.

Size: 1.5m long x 1m wide x 0.8m deep

LR Pit 1 was situated 3.5m from the west field boundary and immediately below the northern fence and hedge boundary in ground sloping steeply to the south in order to locate the valve and the original main which were visible at the base of the pit.

The topsoil was mid brown clay silt, with frequent roots, small, medium and large sub-angular stones. Depth = 0.5m

The subsoil was orange brown clay, and the original main was visible in the bottom of the LR Pit. Depth = 0.3m

No archaeological activity was identified within the confines of the LR pit.

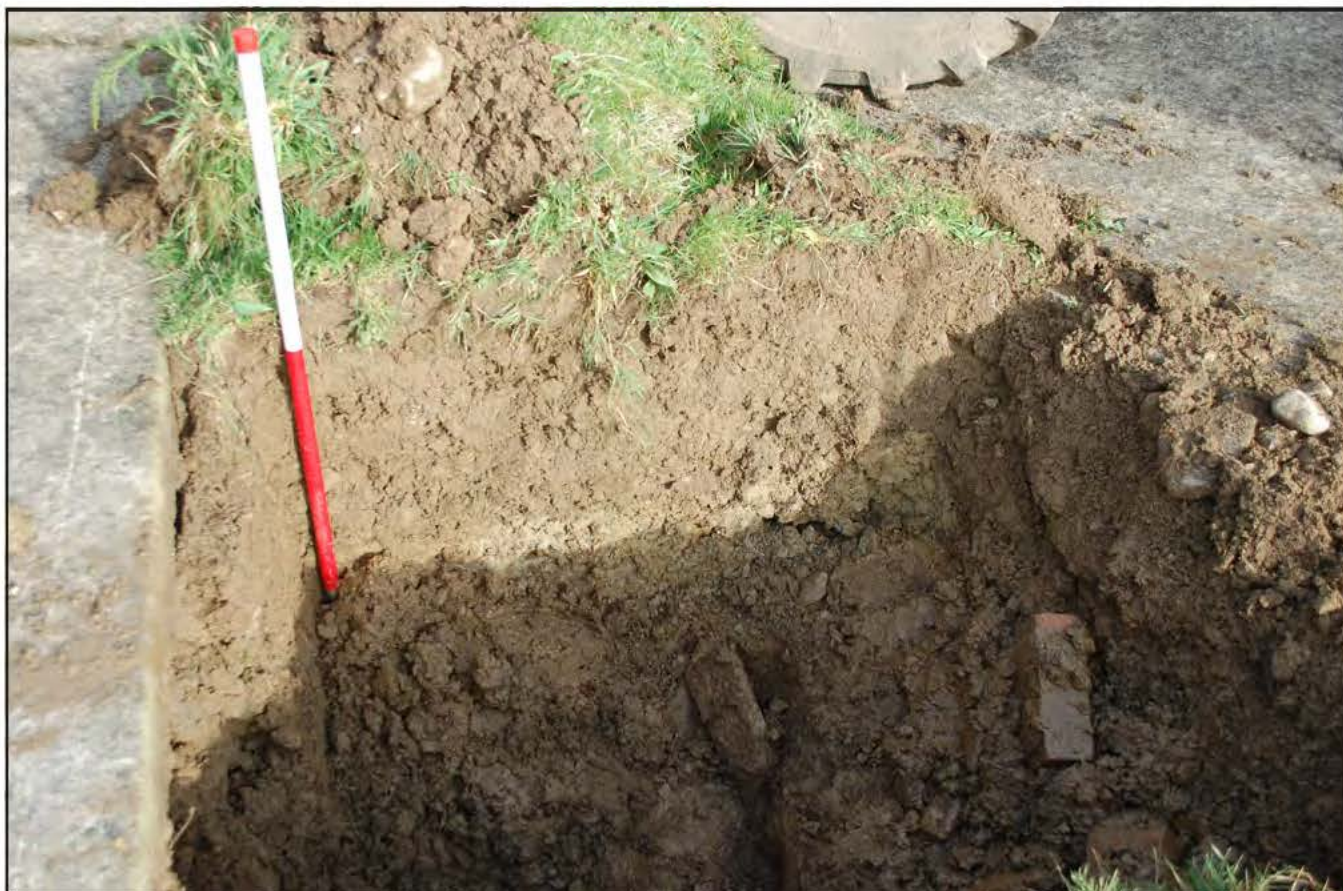
Plate 2: southern reservoir compound/pit 2 - south facing section detailing topsoil and disturbed subsoil with building debris. Scale = 1 metre.

LR Pit 2 was excavated to locate the valve situated to the E of the pump house between two manhole covers. The ground had previously been disturbed to install the valve, and pieces of brick and concrete were visible in the spoil and in the pit as it was excavated.

The topsoil was light medium brown clay silt with grit and gravel inclusions. Depth approximately 0.3m

The natural was light grey clay with grit and gravel inclusions, this deposit also contained building debris probably associated with the construction of the reservoir. Depth = 0.7m

No archaeological activity was identified within the confines of the LR pit.

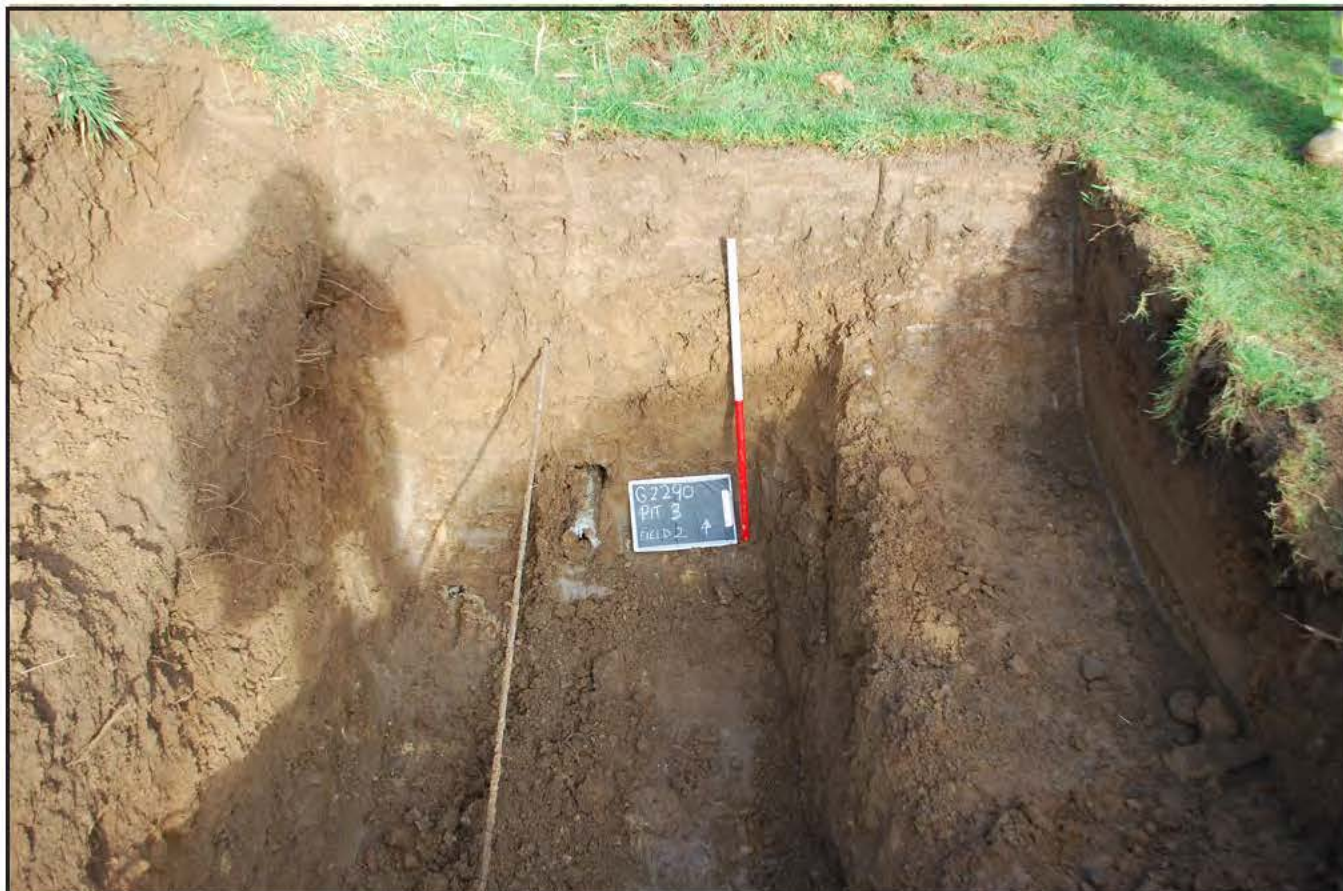
Plate 3: Pit 3/Field 2 - South facing section, detailing topsoil, subsoil, natural and existing 1960's main. Scale = 1 metre.

The topsoil was medium brown clay silt with grit and gravel inclusions and small and medium sub-angular stones. Depth = 0.3m

The subsoil was light brown clay silt with grit and gravel inclusions and small and medium sub-angular stones. Depth 0.3m

The natural was medium orange brown clay. Depth = 0.6m

The 1960's main was visible at the base of the pit with a telecommunications cable (now defunct). The cable followed the route of the original main.

No archaeological activity was identified within the confines of the LR pit.

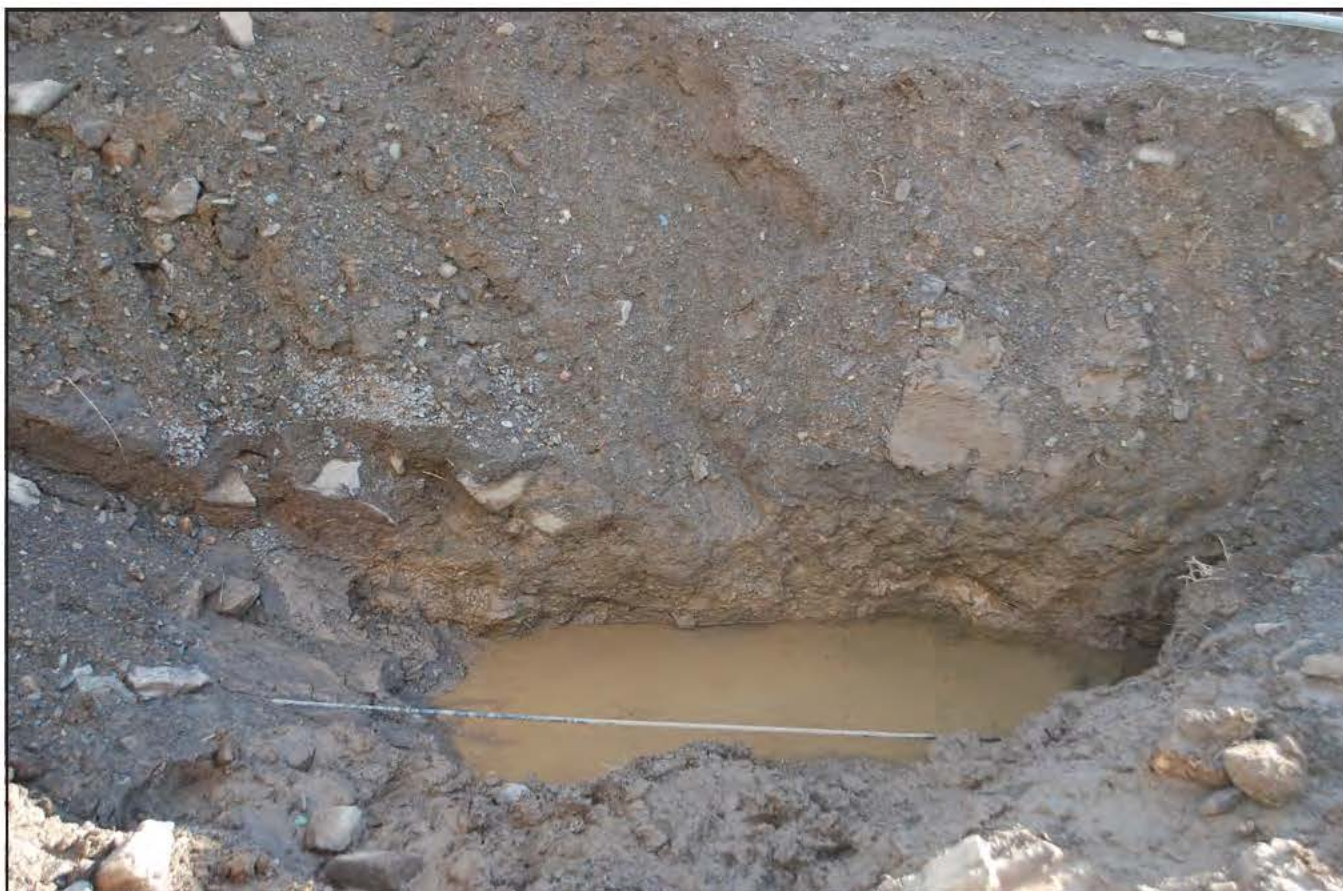
Plate 4: Pit 4/Field 3 - West facing section, detailing limit of excavation and water ingress. Visible in section is extensive overburden associated with a local residential build. Beneath the overburden is existing topsoil and subsoil. Scale = 1 metre

This LR Pit was situated to the east of the lane to Garnfadryn Hill and north of the local road in the south western corner of the plot. It was in the grounds of Cynefin house which had been renovated recently. The LR pit was located beneath a large spoil heap generated by the building work which had to be removed before the LR pit could be excavated. The deposits were covered by a significant amount of overburden, and appeared to be very disturbed, added to which heavy rainfall meant the whole area was very wet and muddy. The groundwork was completed between visits by the archaeologist and the pit was waterlogged when it was recorded.

The topsoil was dark brown clay silt with small, medium and large sub-angular stones.

The subsoil was light orange clay with small and medium sub-angular stones.

No archaeological activity was identified within the confines of the LR pit, although the depth of the LR pit did not exceed the subsoil horizon.

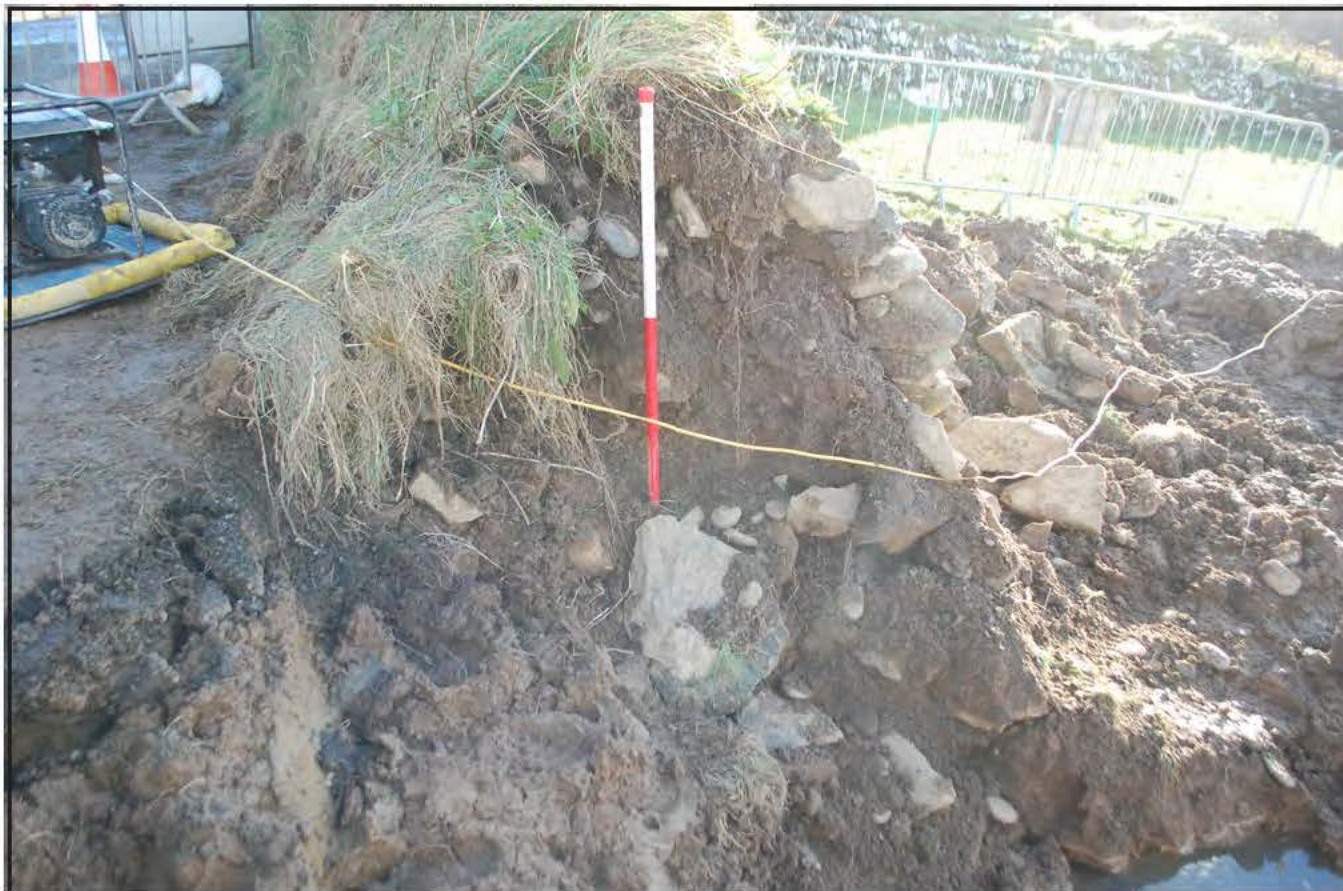
Plate 5: Breakthrough of wall at Northern end of Field 4 showing West facing section. The wall forms a boundary with the local road which is visible on the far left of the picture. Scale = 1 metre.

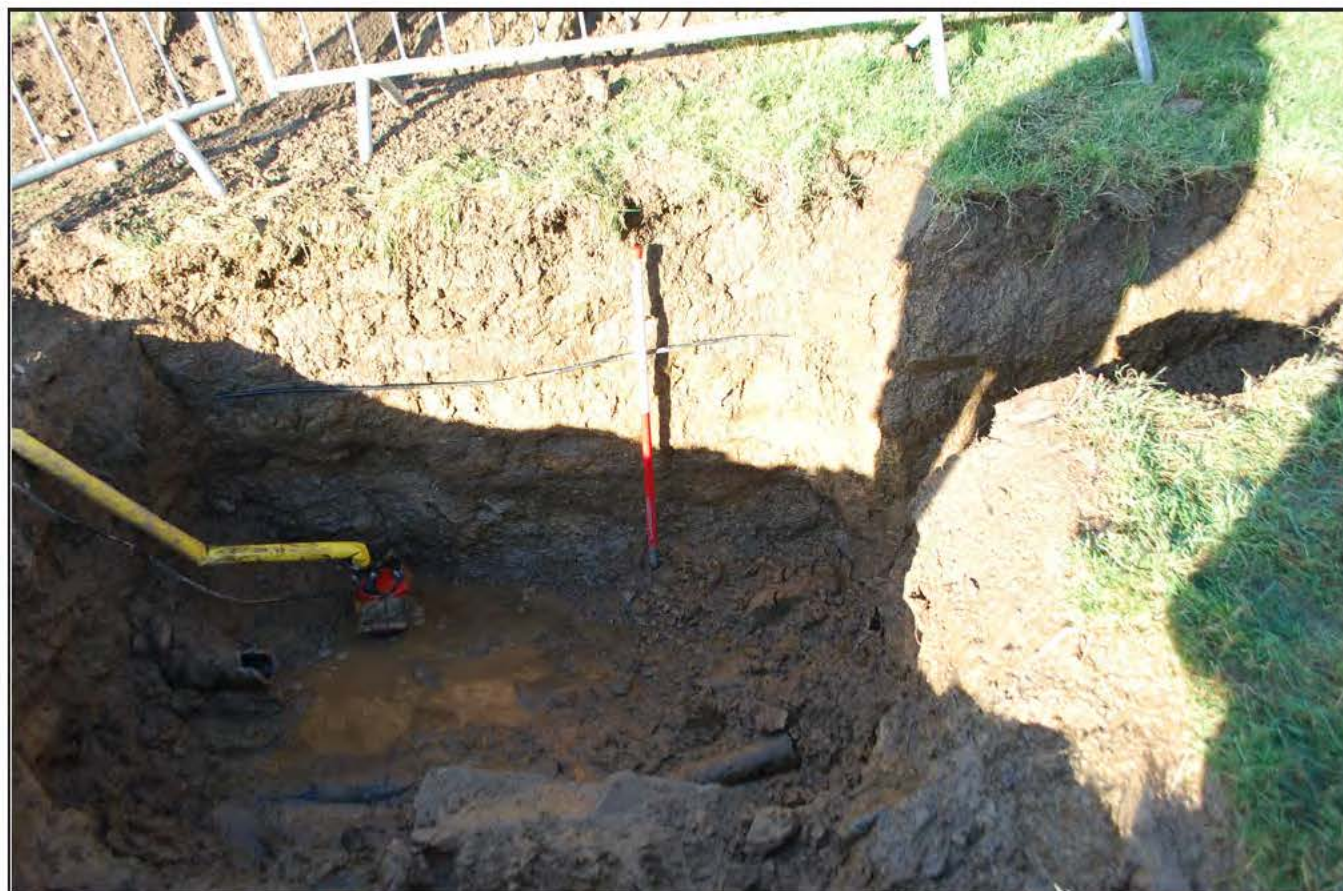
Plate 6: Pit 5/Field 4 - East facing section, detailing topsoil, subsoil and 1960's water main. The pit was waterlogged and a submersible pump is visible at the bottom of the pit. Scale = 1 metre.

LR Pit 5 was situated to the south of the local road, approximately 8m south of the northern boundary. The field sloped gently to the south, levelling off at the southern end. The 1960's main was visible in the bottom of the pit.

The topsoil was medium brown clay silt with small pebbles and occasional small sub-angular stones. Depth = between 0.3m and 0.5m.

The subsoil was orange clay with grit and gravel, small and medium sub-angular stones. Depth = 0.25m.

The natural was pale orange-yellow clay with grit and gravel inclusions. Depth = 0.75m.

No archaeological activity was identified within the confines of the LR pit.

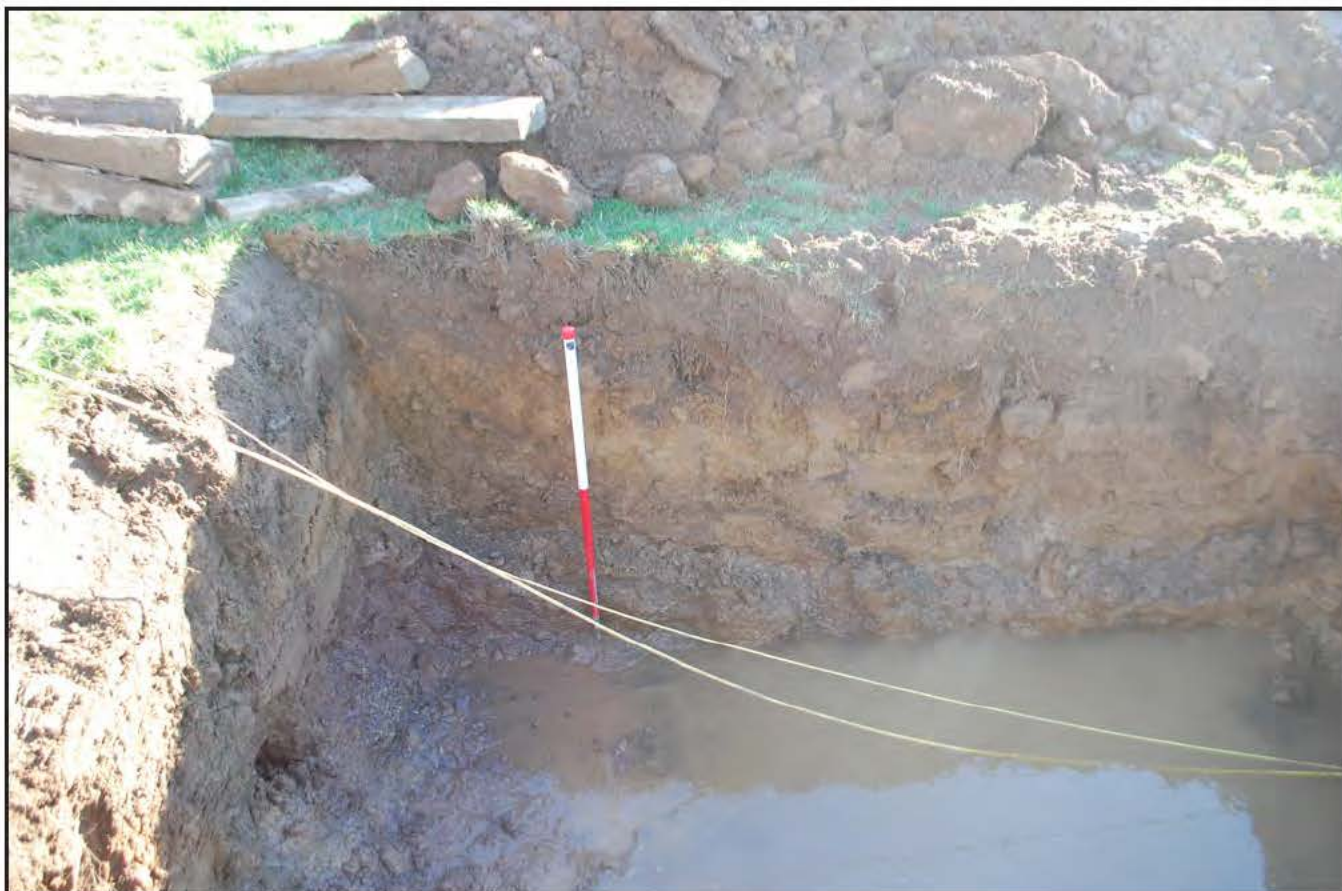
Plate 7: Pit 6/Field 5 - West facing section detailing topsoil, subsoil and disturbed ground associated with 1960's water main which is visible on the left of the picture. The base of the pit is waterlogged. Scale = 1 metre.

LR Pit 6 was situated at the southern end of the field, approximately 3m to the north of a ditch and bank which formed the field boundary.

The topsoil was medium brown clay silt with small and medium sub-angular stones. Depth = 0.2m

The subsoil was orange clay with small, medium and large sub-angular stones, with occasional boulders. Depth = 0.2m

The natural was light orange brown clay. Depth = 0.9m

No archaeological activity was identified within the confines of the LR pit.

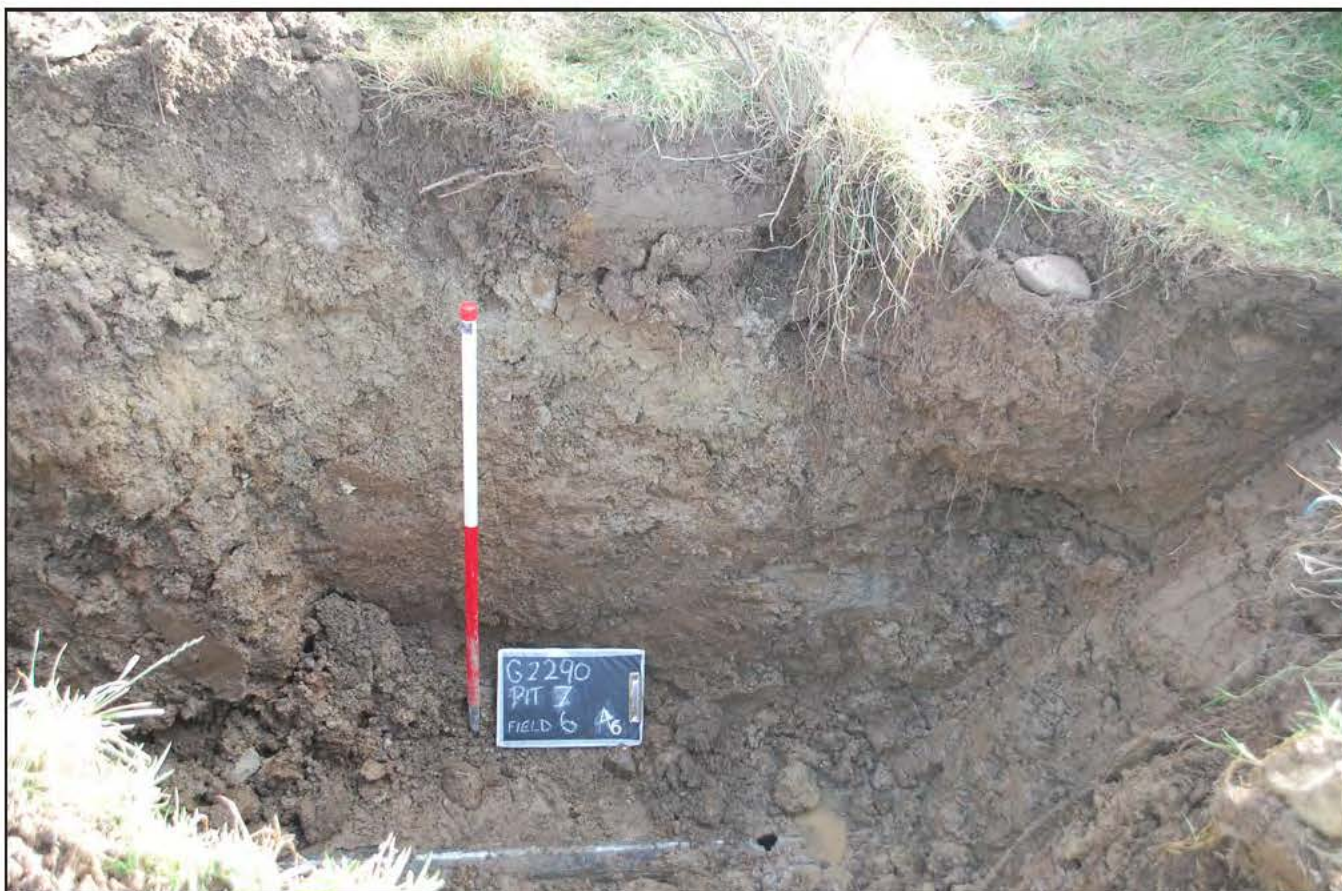
Plate 8: Pit 7/Field 6 - north west facing section, detailing topsoil, disturbed subsoil and natural deposits, and 1960's water main visible in the bottom of the pit. Scale = 1 metre. Board should read Field 6

The LR Pit was situated approximately 2m to the north of the southern boundary, which was a ditch and bank, and approximately 10m west of the eastern boundary. A narrow trench (2m x 0.5m wide) was excavated in northeast/southwest direction to locate the original main, and once the main was located, the trench was extended to the north.

The subsurface deposits were very mixed and the subsoil and natural appeared to have been disturbed, this could be associated with the installation of the 1960's main.

The subsoil was reddish brown clay silt with small sub-angular stones. Depth = 0.3m

The natural was light grey clay with grit, gravel and small sub-angular stones. Depth 0.5m

The 1960's main was visible at the base of the pit. The field was very wet with reeds and rough grasses.

No archaeological activity was identified within the confines of the LR pit.

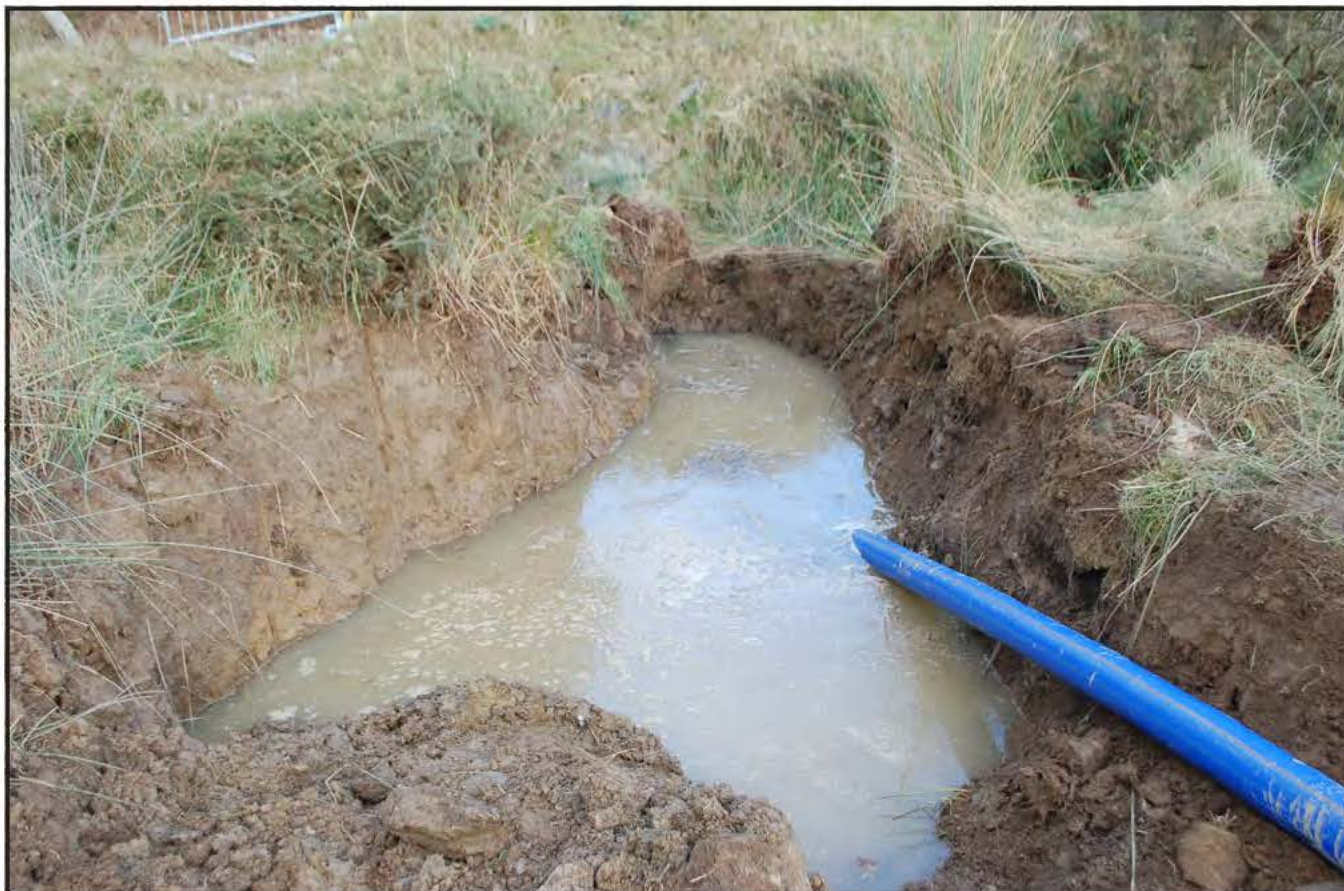
Plate 9: Pit 8/Field 7 - detailing topsoil, subsoil and ingress of water. The pit is located immediately to the south of a drainage ditch in a very wet field. The new main is visible on the right of the picture. View from the South.

LR Pit 8 was excavated to locate the bend in the original main which turned forty five degrees to the west. The LR Pit was situated close to the ditch and bank separating fields 6 and 7, and the bottom of the trench was waterlogged, being 1.5m deep to go under the ditch. The LR Pit was irregularly shaped.

The topsoil was medium brown clay silt with frequent small stones.

The natural was pale yellowy grey clay to the west, and medium grey brown possibly re-deposited material to the eastern side of the trench.

No archaeological activity was identified within the confines of the LR pit.

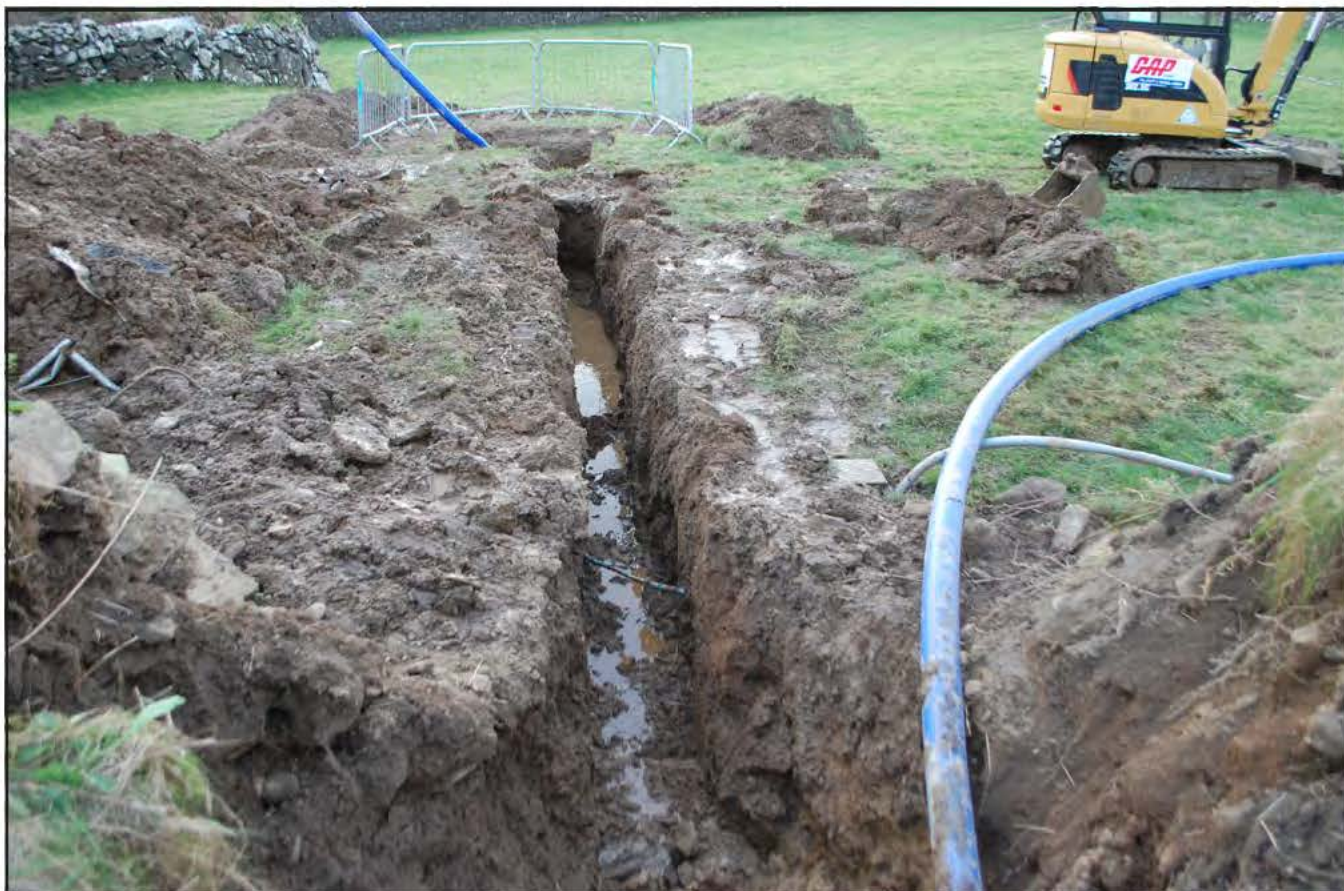
Plate 10: Open cut trench A/Field 4 - view to the South and Pit 5 from the Northern boundary wall. A domestic service pipe can be seen crossing the trench which is waterlogged at the base.

Approximately 10m of open cut trench was excavated from the northern boundary wall in a southerly direction to connect a length of new pipe to a valve at the road and the pipe in LR Pit 5. A service pipe for a domestic supply crossed the trench from the north east in a south westerly direction. The trench was 0.5m wide and 1m deep and was aligned N/S.

The topsoil was light greyish brown with small and medium sub-angular stones.

The natural was orange brown clay, and the trench was waterlogged at the bottom.

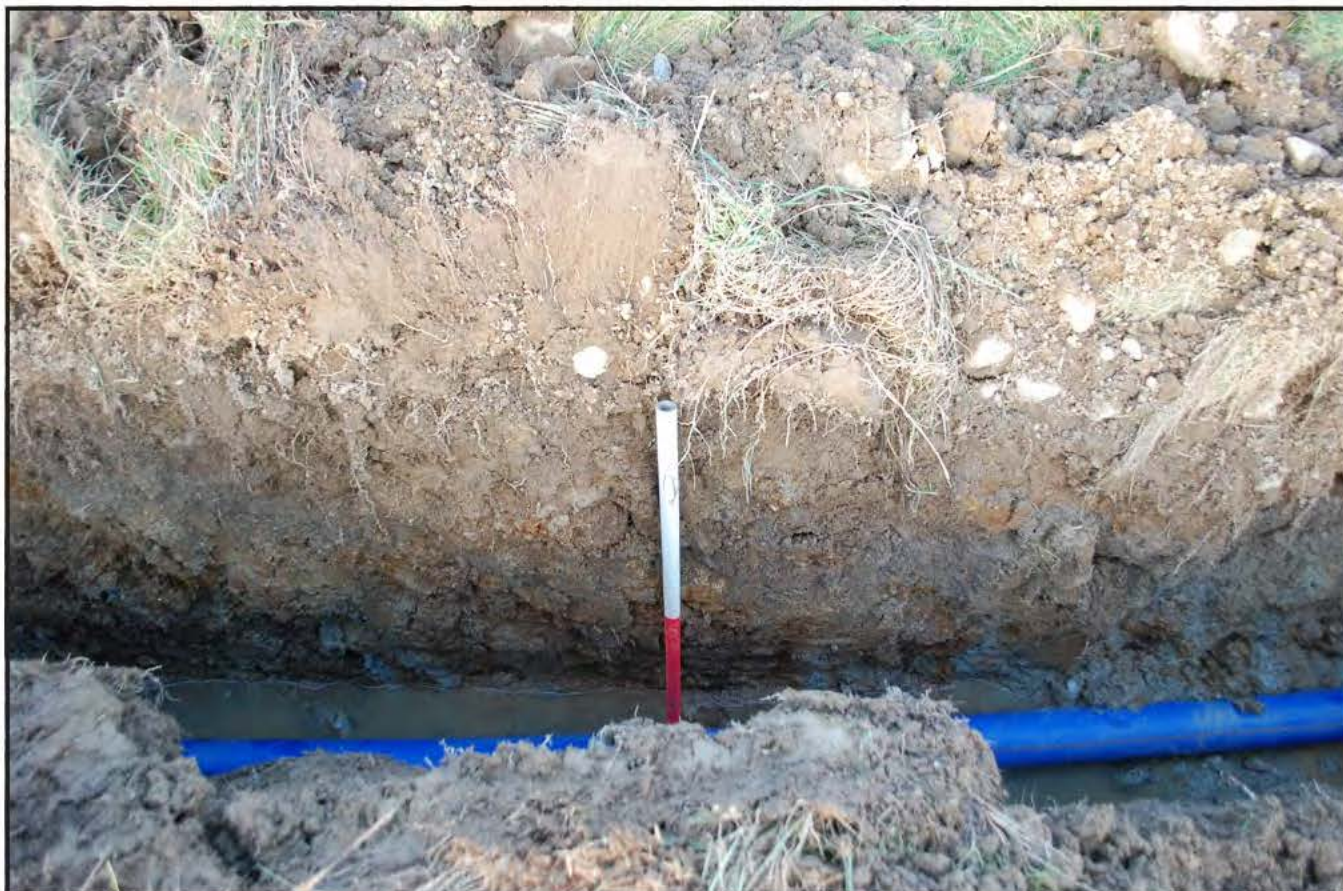
Plate 11: Open cut trench B/Field 7 - South facing section detailing topsoil, subsoil, the new pipe can be seen in the base of the trench which was waterlogged. Scale = 1 metre.

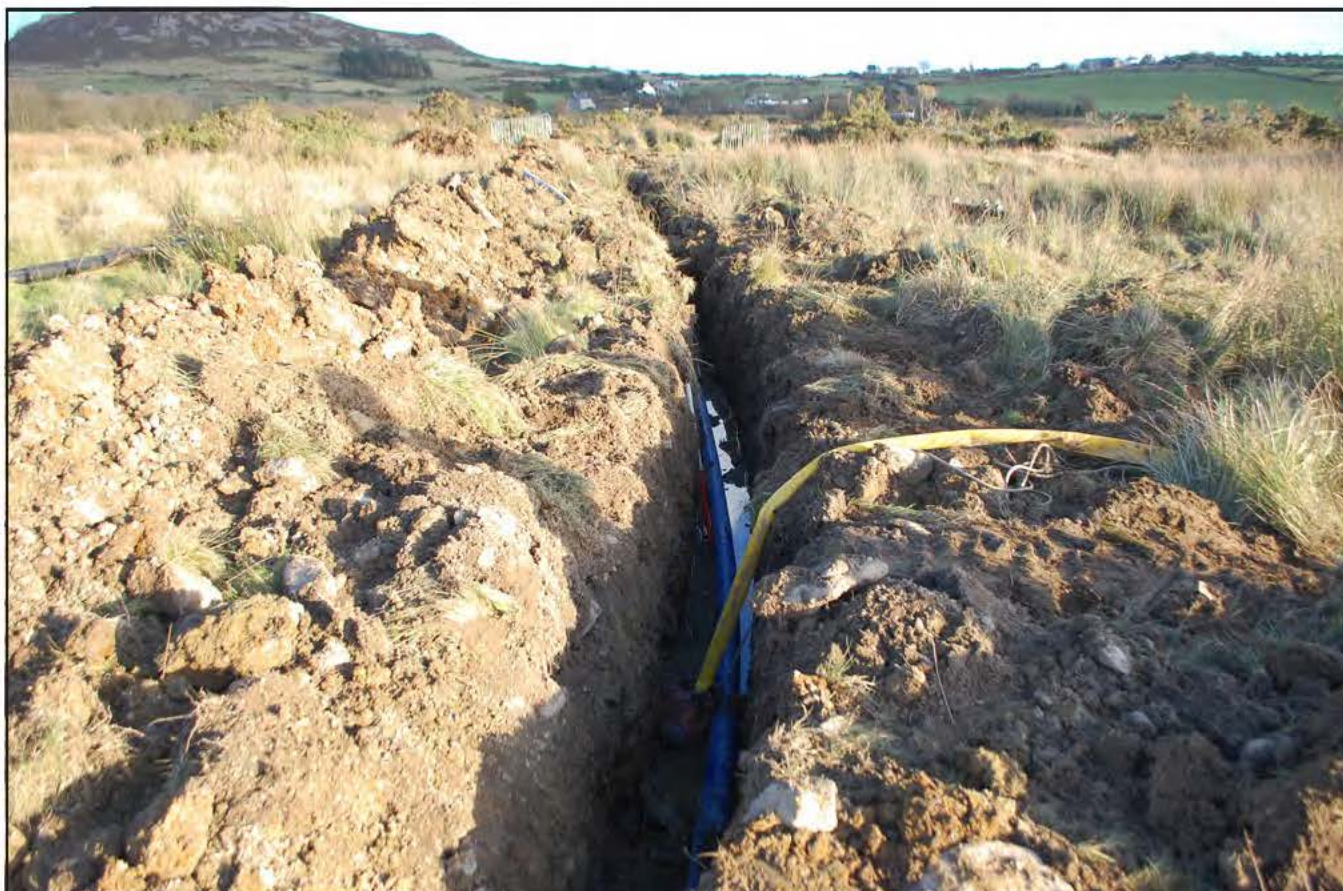
Plate 12: Open cut trench B/Field 7 - view to the East North East showing new pipe in the bottom of the trench. The trench had been waterlogged and was pumped out with a submersible pump which can be seen in the foreground alongside the pipe. The trench was approximately 40 metres long, 0.5 metres wide, and between 1 metre and 1.2 metres deep. Scale = 1 metre.
