Low Head Pipeline Replacement Project, Dolgarrog,

Archaeological Survey and Recording Report

Project No. G2158

Report No. 1114

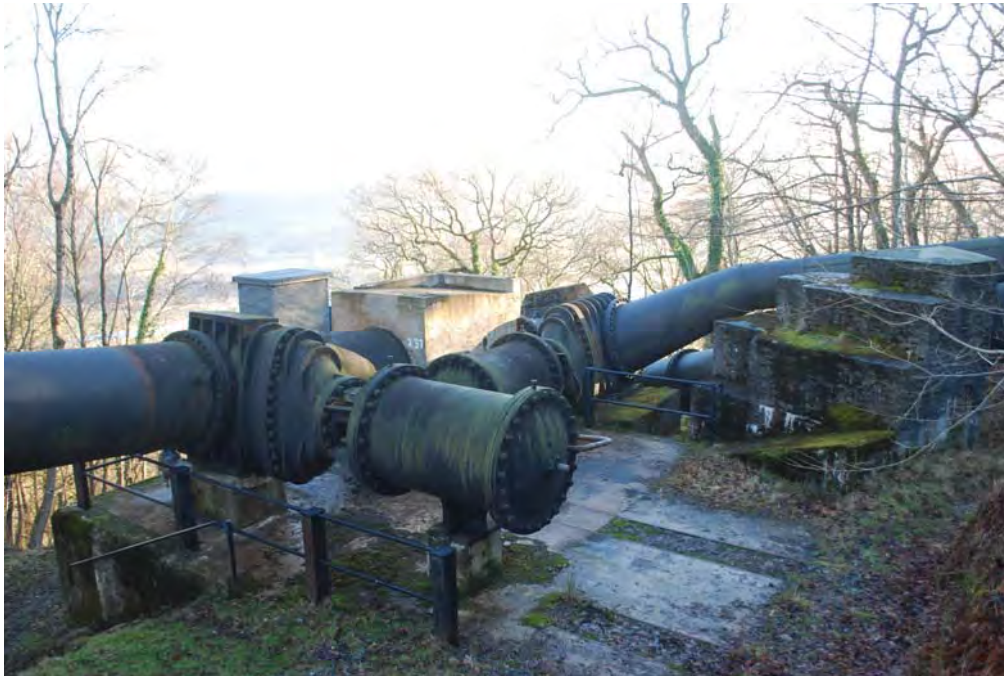
The junction of pipes and valve house known as Marble Arch, after an iron gantry footbridge over the incline. The original Marble Arch had to be demolished as it was unsafe, with this arch being built at some point after 1925.

Plate 01: PRN 16321 - Marble Arch Pipe Junction, View From SW

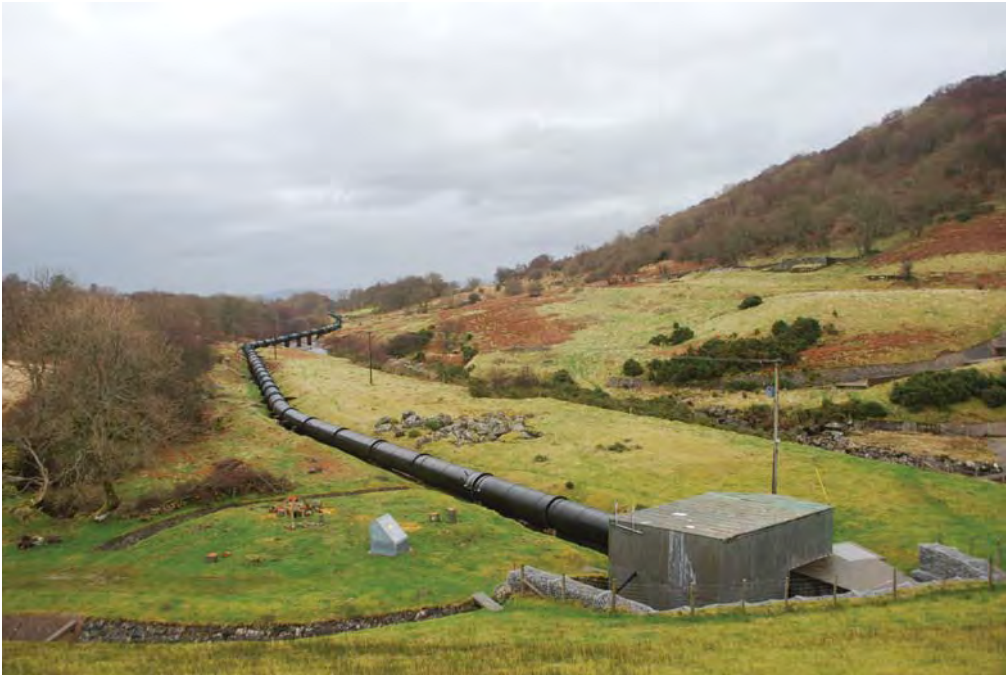
A riveted and welded six foot pipe running from Coedty Reservoir to its junction with other pipes at Marble Arch, and thence down to the power station at the aluminium works. It was built on concrete piers and a plinth, and was completed in 1924. However, there were problems with the pipe and it failed under test and caused flooding in a village. The pipe was damaged in the flood of November 1925 and rebuilt by March 1927. There are numerous points along the pipe where water is leaking from it.

Plate 03: PRN 31890 and 31907 - Llyn Coedty Valve House and Pipe, View From SW

The majority of the features associated with the current pipeline will be removed, replaced, or modified during the works. However these have been fully recorded and no further work is recommended on these features.

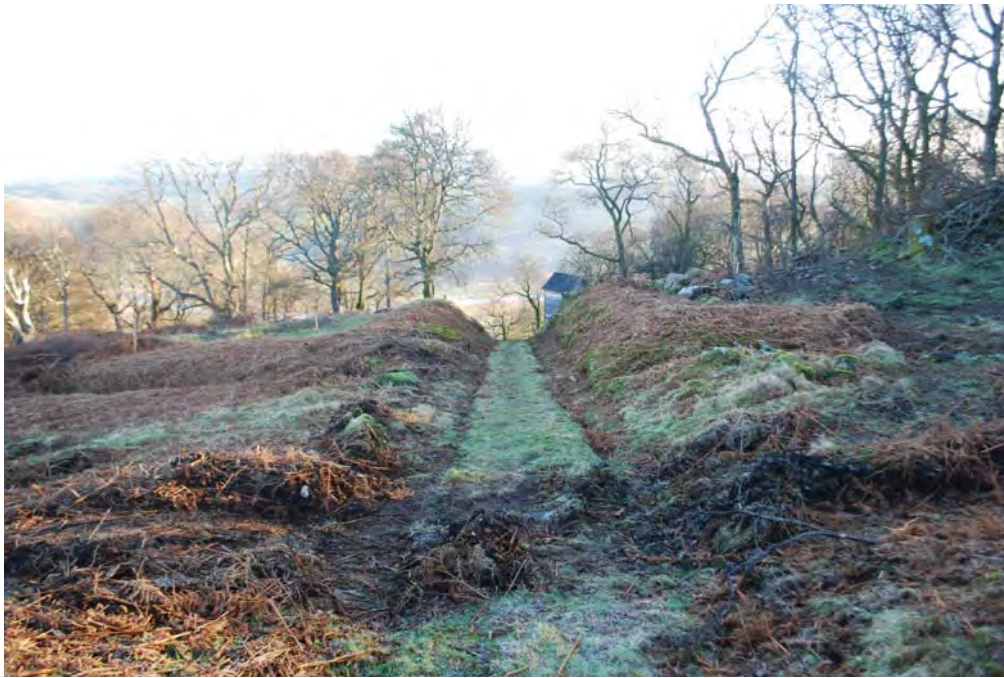
Plate 02: PRN 16322 - Quarry Incline, View from WSW

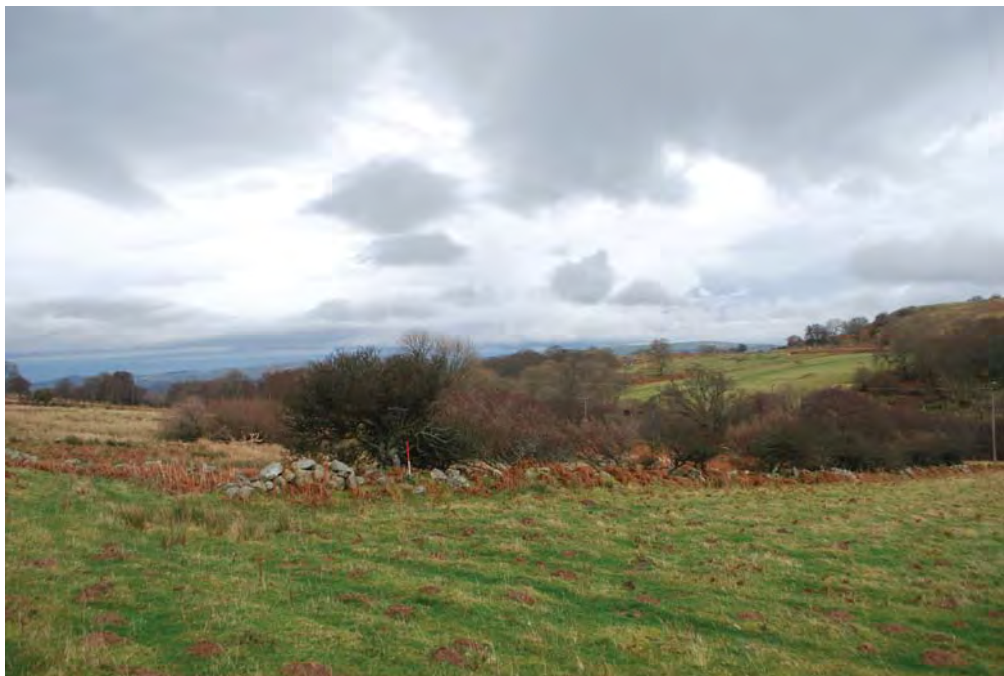
- **PRN 31900 (NGR SH75696709): Drystone wall** – 19th Century well-built drystone wall, surviving up to six courses high, of loose rounded boulders. The wall is up to 1m high in places. Its character appears to be of 19th century date, and built on a regular straight alignment. It probably forms a later sub division of some of the wandering wall systems. Large plant access requires removal of wall. Detailed recording prior to this event followed by an archaeological watching brief during breaching.

Plate 08: PRN 31900 - Field Boundary, View From SW

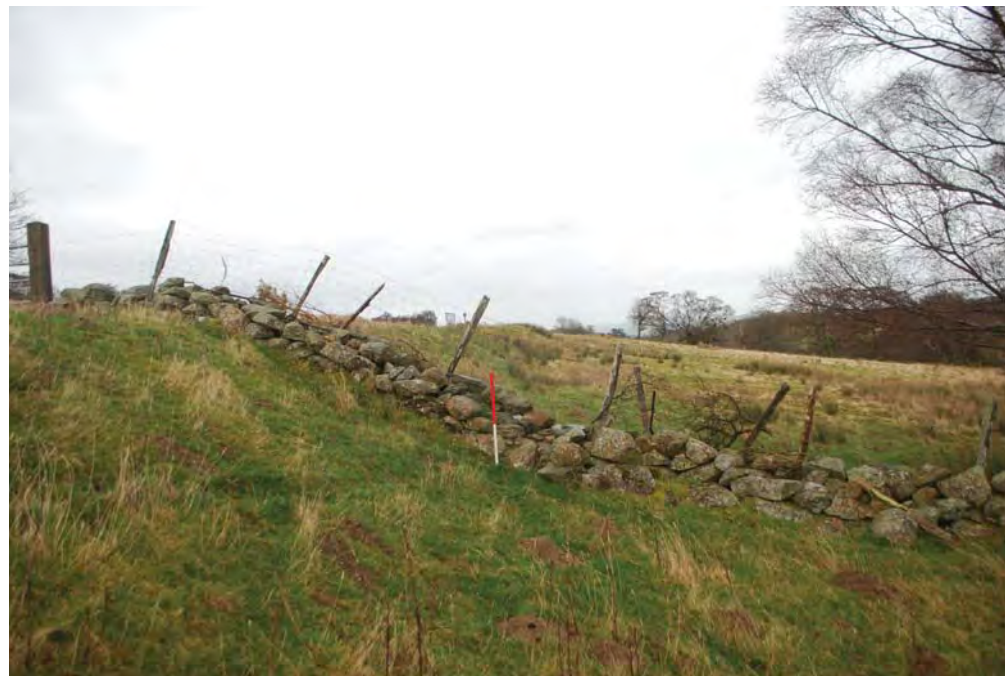
- **PRN 31905 (NGR SH75576690C): Drystone wall** - Late medieval/early post medieval wall Probably rebuilt and straightened at NW end but probably part of the older field system. A well-built drystone wall of loose rounded boulders. The wall is up to 1m high in places. Its character appears to be of 19th century date, but its south-eastern end was far from straight as shown on the 1889 map. It is probable that the wall has been rebuilt and straightened but was originally part of the wandering wall system around Ffrith-Ddu. The south-eastern end of this wall may have to be removed. . Detailed recording prior to this event followed by an archaeological watching brief during breaching.

Plate 10: PRN 31905 - Field Boundary, View From SW

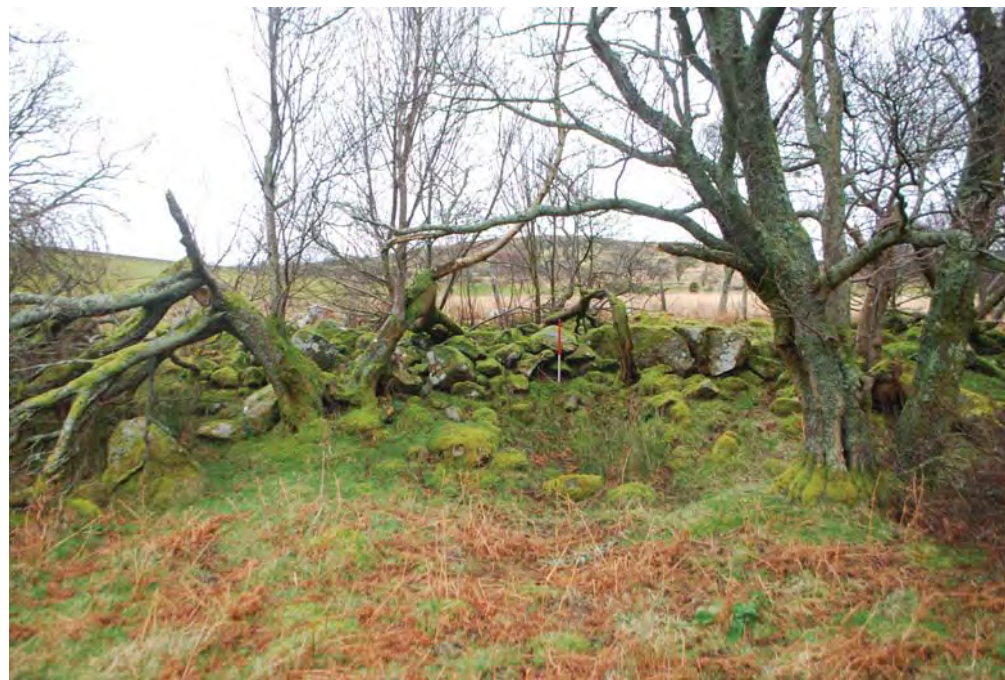
- **PRN 31908 (NGR SH75606678 C): Drystone wall** - Late medieval/early post medieval well-built drystone wall of loose rounded boulders, although now very collapsed. The wall is up to 0.5m high in places. Trees grow along its length. Detailed on the 1889 map as a line of trees, so the wall must have been out of use by then. Detailed recording prior to groundworks followed by an archaeological watching brief during breaching.

Late medieval/ Early Post-medieval drystone wall in very poor condition with trees growing along its length. Constructed of loose rounded boulders, on average two courses high, and aligned roughly NE-SW. A small stretch of wall survives in better condition, with a maximum height of 1m, towards the SW end. Makes use of natural stone outcrops where possible. Detailed on the 1889 map as a line of trees, so the wall must have been out of use by then.

Plate 11: PRN 31908 - Field Boundary, View From SE

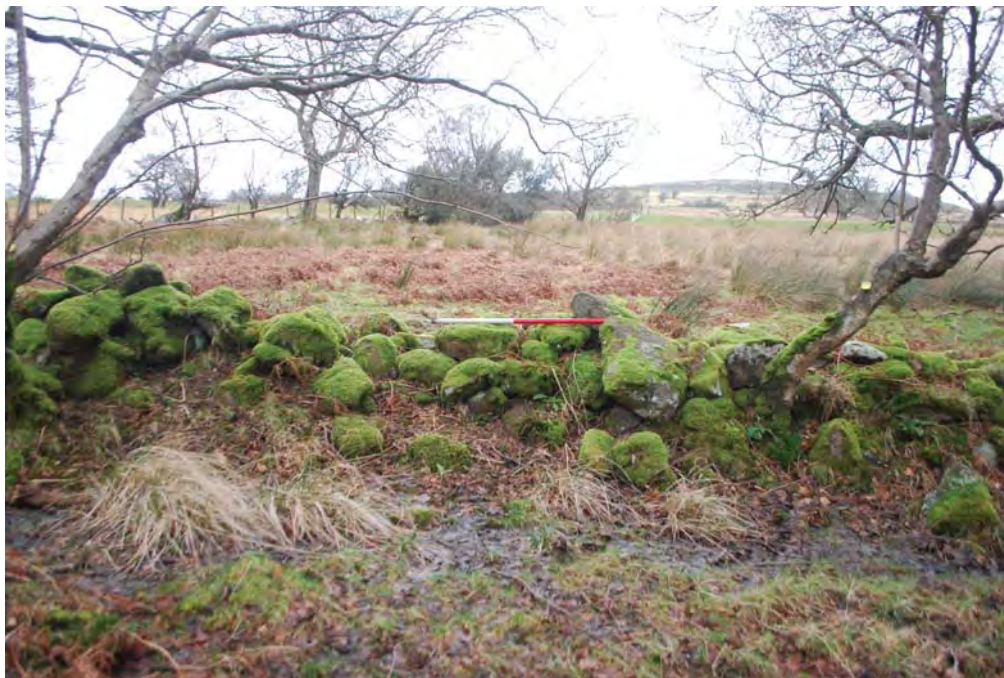
- **PRN 31909 (NGR SH75646690): Drystone walls south of Ffrith Ddu House** - Late medieval/early post medieval well-built drystone wall of loose rounded boulders. The wall is up to 1m high in places. Associated with other less well preserved walls forming small rectangular fields. These walls wander slightly and are probably of pre-19th century date. Detailed recording including survey. Watching brief including recording of section.

Late medieval/ Early Post-medieval drystone walls south of Ffrith Ddu farmhouse. Surviving up to three courses high (0.75m), and approximately 1m wide. Constructed from loose sub-rounded boulders. There is some tumble associated with the wall on the SE side. At its NE end the wall is in significantly better condition, with ten courses (1.5m) surviving. There is an entranceway towards the NE end where a path is shown on the 1st Edition OS Map of 1889. It runs perpendicular to boundary wall PRN 31905 but is not built into it. It is associated with a number of other, less well preserved walls, forming small rectangular fields with entranceways around the remains of the Ffrith Ddu farmhouse. These walls wander slightly and are probably of a pre-19th century date.

Plate 12: PRN 31909 - Field Boundary, View From SE

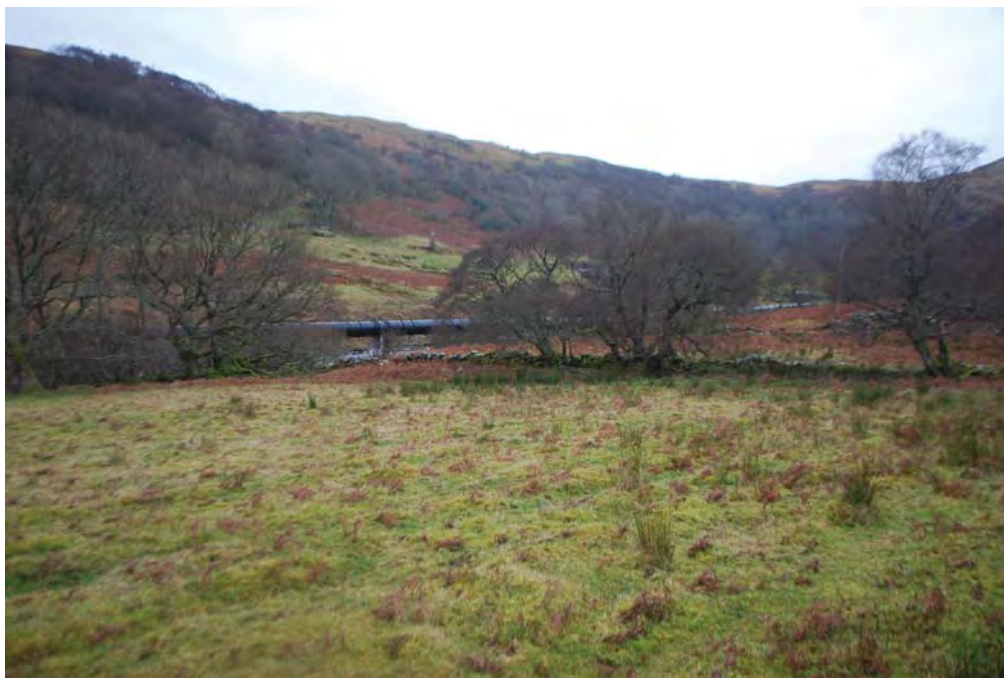
- **PRN 31910 (NGR SH75726697): Drystone wall with possible inscribed stone** - Late medieval/early post medieval much collapsed drystone wall, probably associated with Ffrith Ddu farmhouse. It included a rough boulder, about 1.3m high and 0.4m wide, inscribed with a possible Latin Cross orientated slightly north-north-west to south-south-east. The stone is broken along its western side. The SE end of this wall may have to be removed. Detailed recording, watching brief

Late medieval/ Early Post-medieval drystone wall, probably associated with the Ffrith Ddu farmhouse. The wall is orientated NW-SE and survives up to four courses (1m) high, with an approximate width of 1m. It is constructed for sub-rounded and angular boulders, and slopes downhill to the SE where it is in a very ruinous state. A rough boulder, about 1.3m high and 0.4m wide, inscribed with a possible Latin Cross orientated slightly NNW-SSE, was located within the wall. The stone is broken along its western side. At its NW end it is abutted by boundary wall PRN 31900. Originally shown as continuing further to the NW on the 1889 1st Edition OS map, there is no evidence of this on the ground today.

Plate 13: PRN 31910 - Field Boundary, View from N

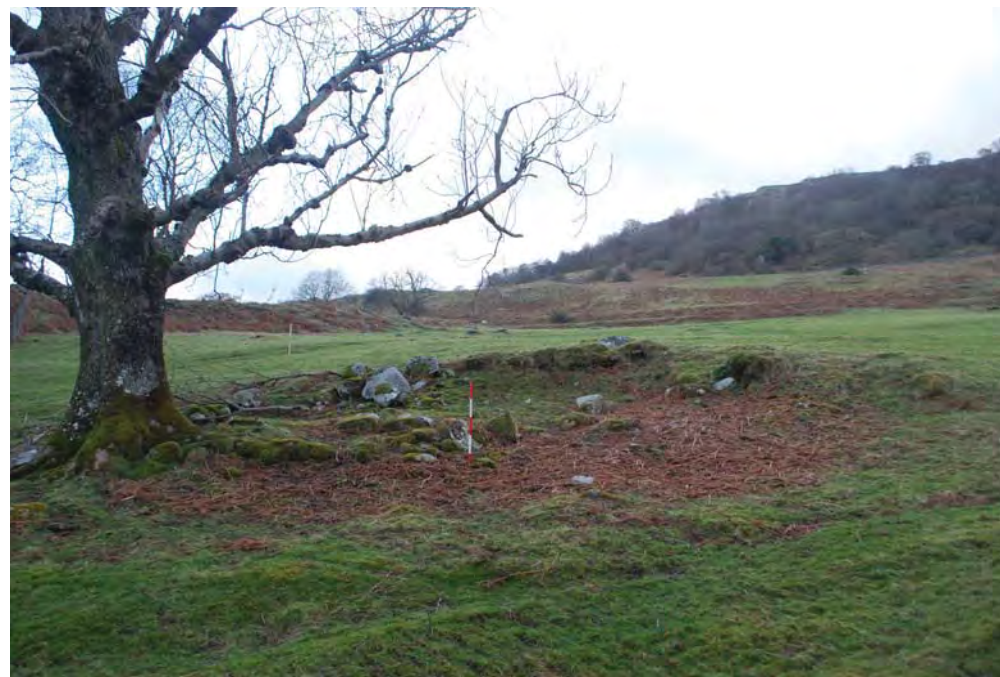
- **PRN 31918 (NGR SH75976716):** Stone structure/long hut - late medieval/early post medieval. Small rectangular stone built structure orientated north-east south-west, measuring c8.5m x 4.7m externally (plate 7). It is built of rough coursed angular shale slabs, and smaller stones forming walls about 0.7m wide. The SE wall is best preserved as it is terraced into the slope and it stands c.1m high, the SW wall is also fairly well preserved but the other two walls survive only at foundation level. The NW wall has a line of facing stones surviving at foundation level. The interior is full of rubble. The building runs along the slope rather than perpendicular to it and has no other characteristics of medieval long huts. Its preservation also suggests an early post medieval rather than a medieval date. It was probably the house associated with a small farmstead including the adjacent enclosure. *The fencing should be very clear as the whole field is to be used for access.*

Small rectangular stone built structure orientated NE-SW and measuring approximately 8.5m x 4.7m externally. It is built with a mix of rough coursed angular shale slabs and smaller stones, forming walls approximately 0.7m wide. The SE and SW walls are the best preserved, with the former terraced into the slope and standing roughly 1m high. The other two walls survive only at foundation level, with the NE wall having a line of facing stones surviving. The interior is full of rubble. The building runs along the slope rather than perpendicular to it, but has no other characteristics of a medieval long hut. Its preservation suggests an Early Post-medieval, rather than a medieval date. It was probably the house associated with a small farmstead including the adjacent enclosure (PRN 31929) to the NE, and it is located directly in line with a possible entranceway (PRN 31919) into that enclosure. Although the enclosure is shown on the maps there is no hint of a building here on the 1788 map.

Plate 16: PRN 31918 - Remains of Long Hut, View From NW

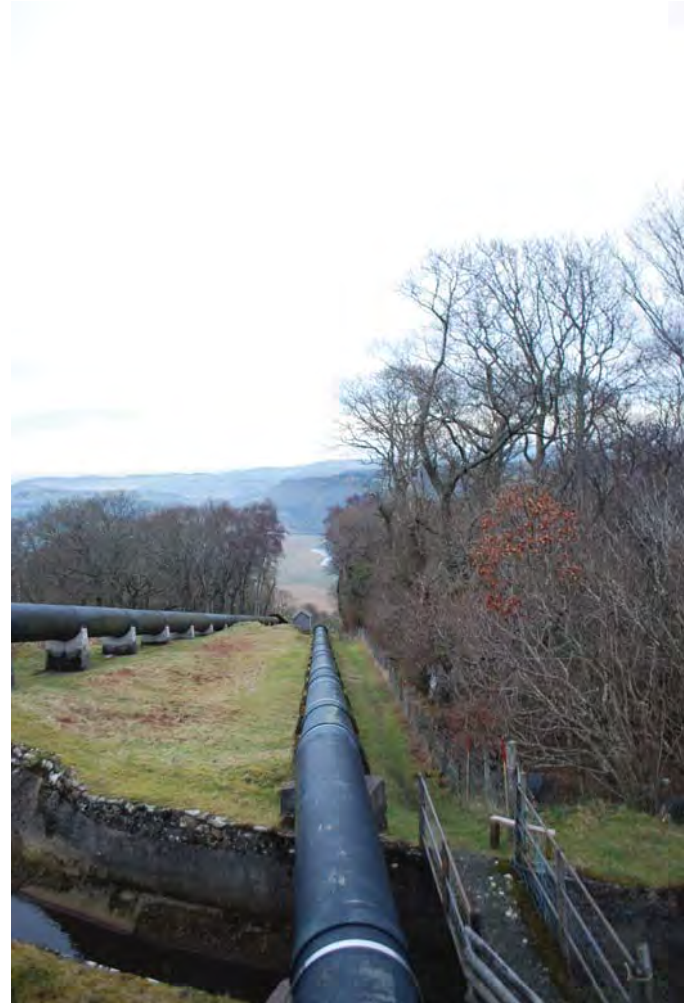
- **PRN 31934 (NGR SH76476704): incline and water pipe** - Part of water catchment system for hydro-power station built for the aluminium works between 1907 and 1911, an incline taking water in a pipe from the upper leat to the power station. The incline is shown on 1913 map, although it does not indicate the pipe. The pipe was made redundant when the pipeline from Llyn Cowlyd was constructed in 1936 and 1937 (*ibid.*: 40), but is still used as part of the surge protection for the Coedty system. This pipe is to be entirely removed and replaced, and will possibly be mounded over and partially buried. The impacted area indicated on ES Chapter 6 Figure 6.3 (reproduced in Appendix IV), will be surveyed; a detailed record will also be completed.

Plate 24: PRN 31934 - Incline and Water Pipe, View From SW

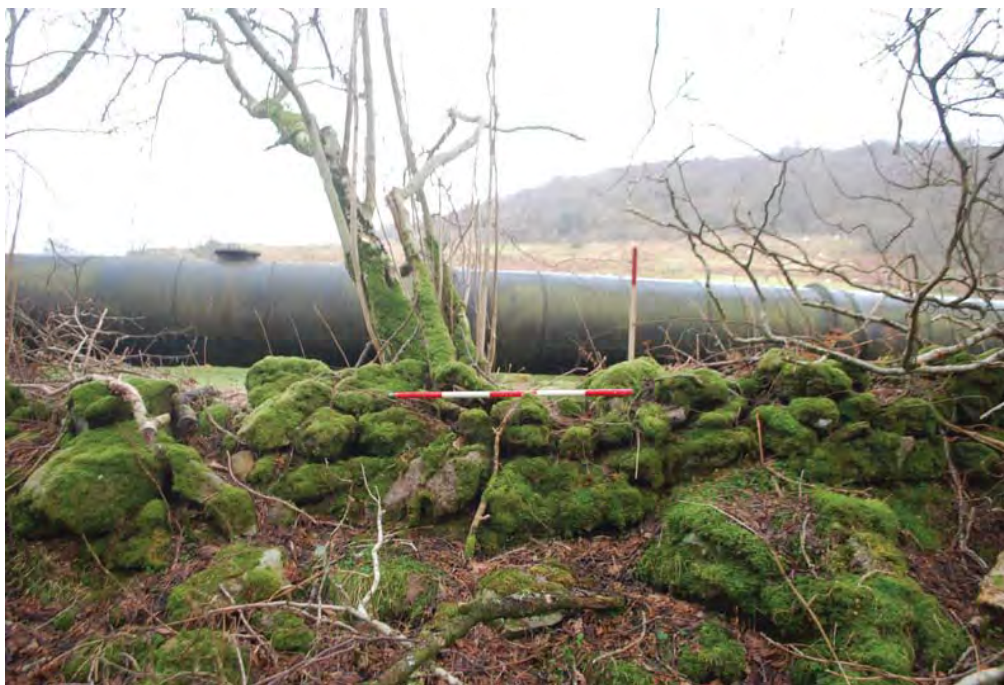
- **PRN 31959 (SH75926716 C): Field wall/revetment** - Late medieval/early post medieval field boundary wall running along top of natural escarpment. Revetment of rounded boulders c1m high facing NW. The ground to SE is level with the top of the wall. A line of hazel and ash grows along the wall indicating a former hedge. Many of the hazel are old coppices and some trunks are bent showing where they were once laid. Wall is fairly close to the existing pipeline so care must be taken that the wall is not damaged when the pipe is dismantled.

Plate 36: PRN 31959 - Field Boundary, View From NW

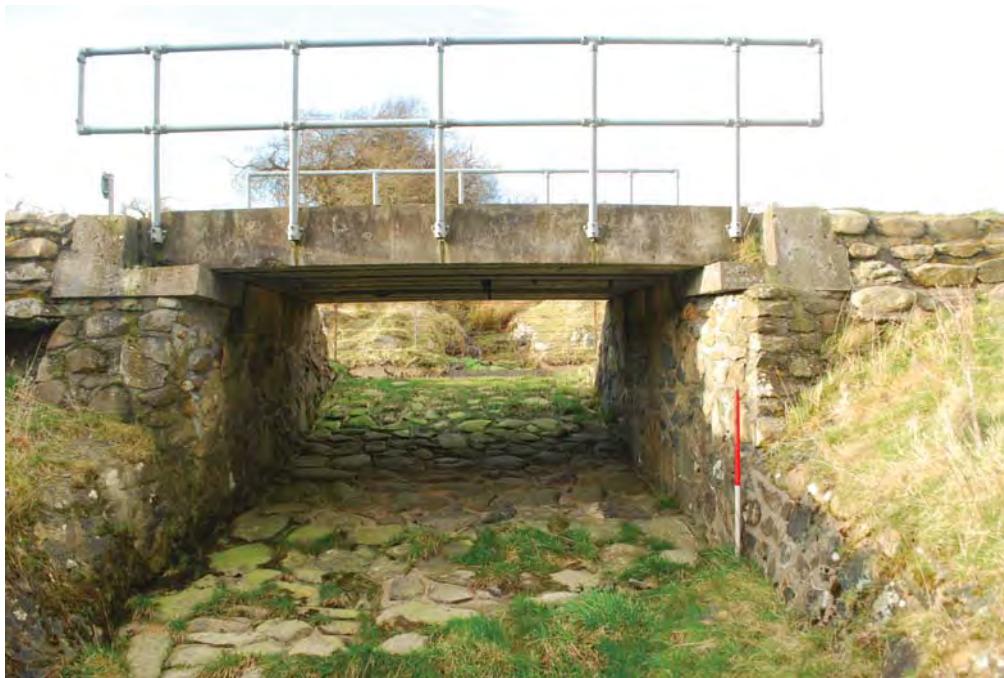
Plate 44: PRN 31974 - Channel for Stream Passing Under Leat, View From SE

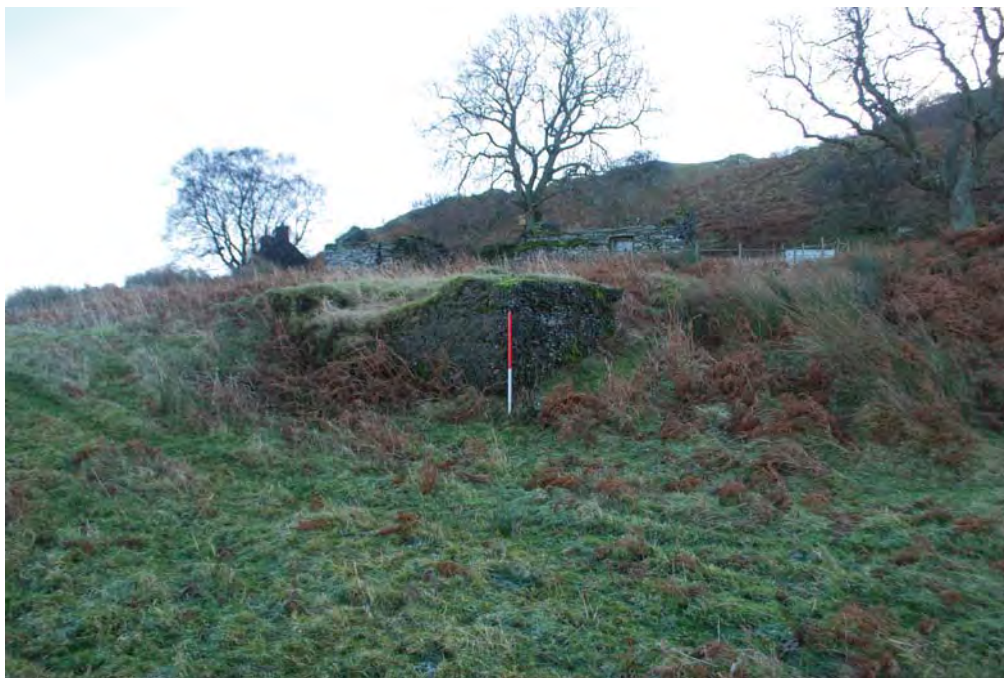
Plate 60: PRN 36386 - Concrete Platform, View From NW
