# Arfordir Coastal Heritage

## Progress Report 2012-13

Project No. G2072

Report No. 1120

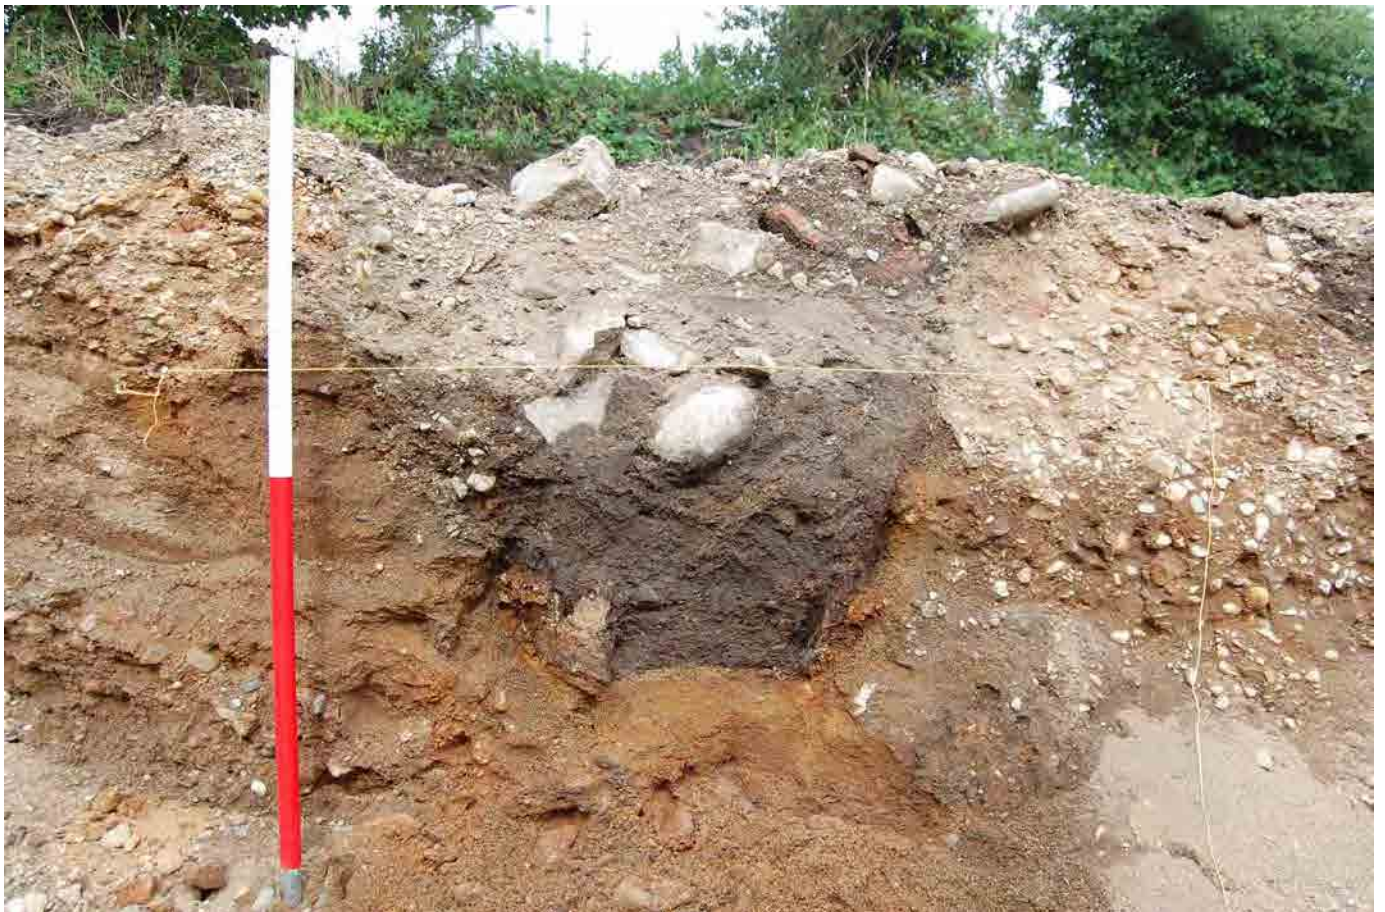
Plate 2 Nefyn: the base of a wooden barrel (PRN 31728)

Upon initial investigation the feature was clearly visible in a south facing section and appeared to be roughly 'v' shaped in profile. Further cleaning showed that the feature was in fact a pit, the base of which had been lined using part of a wooden barrel with ferrous hoops (PRN 31728) (plate 2).

The wooden barrel which had been placed at the base of the pit was tight against the side of the cut and had been partially cut away during the excavation. A number of staves and fragments of the hoops were visible on both sides of the cut. No base to the barrel could be seen nor was there any staining suggesting that one had ever been present.

The purpose of the barrel within the pit is not instantly clear. Given Nefyn's former herring fishing industry it is possible that the pit was used for smoking fish, a buried barrel was traditionally used when preparing Arbroath Smokies, however the lack of charcoal and decline of the herring industry by 1918 may discount this theory. The fact that the barrel did not have a base suggests it was not designed to hold water, but rather to help drain it by keeping the pit clear. The waterlogged deposits also suggest it might have been a sump or cess-pit, though if this was the case, only the lowest deposit is retained from this use.

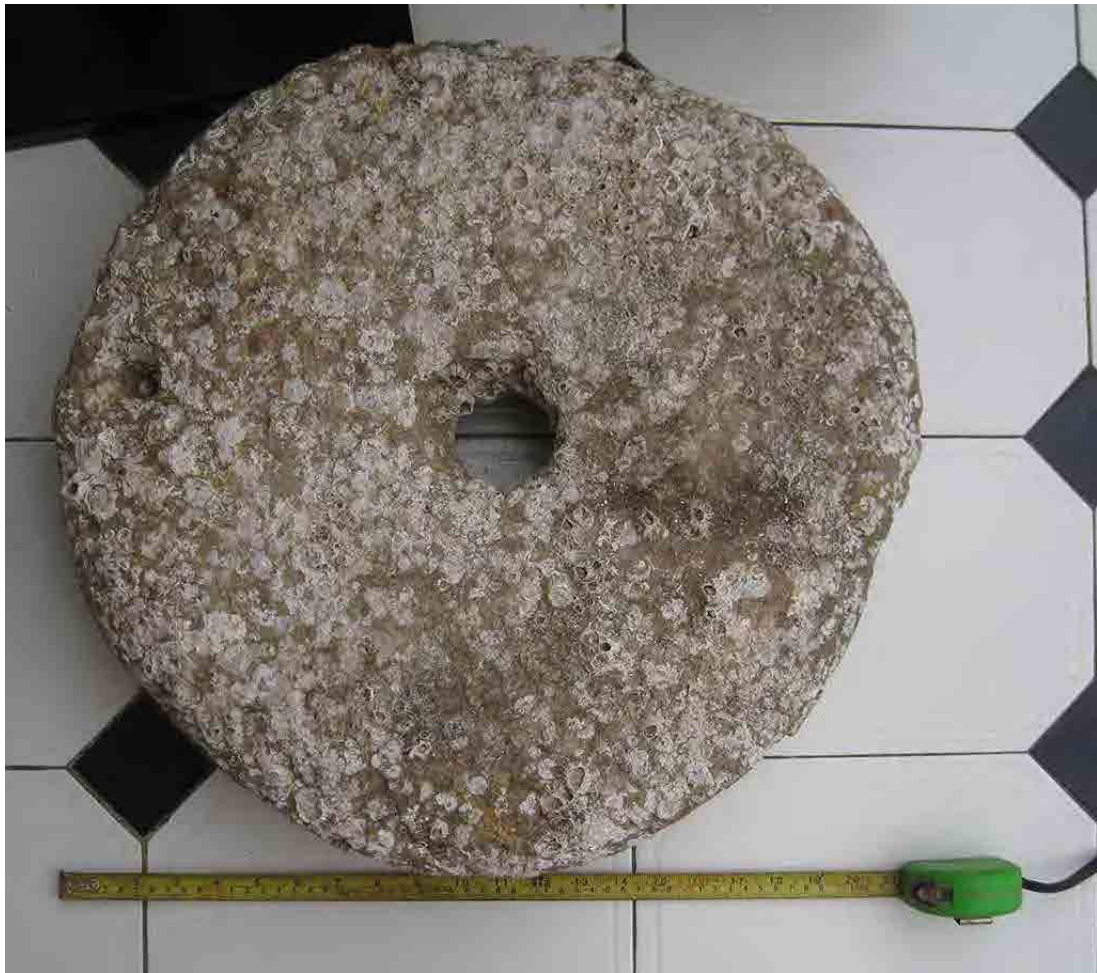
Plate 3: Mill stone re-used as anchor (No. 4)

4. Large circular stone approximately 50cm diameter and 10cm thick. Weight approximately 45Kg. There is a central hole 8cm diameter, and a smaller hole close to the side 3cm diameter. One side flat, though not obviously dressed (but covered with barnacles, so difficult to see). The other side convex. Weight approximately 50Kg. Interpreted as a mill stone with hole at one side for turning handle. May not have been used. Possibly reused as stone anchor (plate 3).

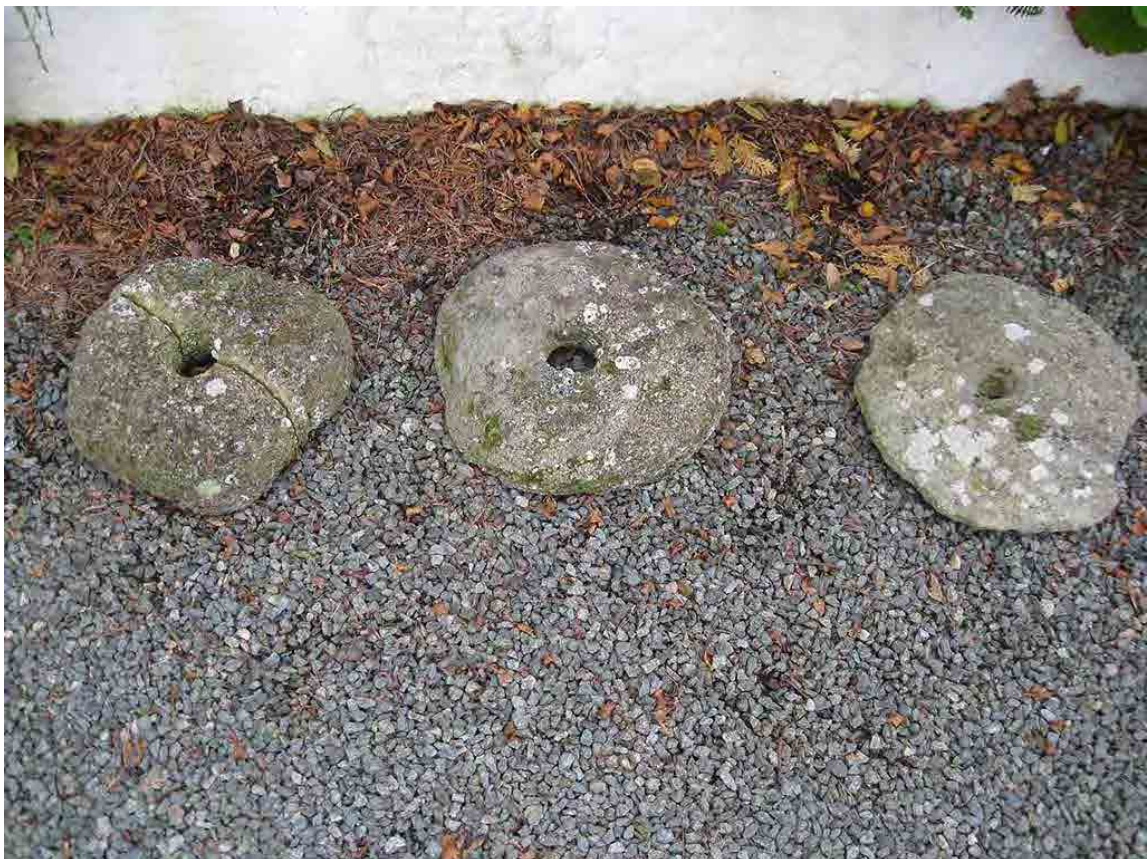
Plate 4: Mill stones re-used as anchors (No's 1-3)

Items held by Mr David McCreadie of Dulas, Anglesey (plate 4)

1. Circular stone with flattened sides approximately 30cm diameter and 10cm thick. Central circular hole approximately 7cm diameter. Stone broken down centre into two parts. One side dressed and slightly worn, other side not dressed. Interpreted as mill stone, possibly reused as anchor.

2. Circular stone with broken flattened sides approximately 40cm diameter and 10cm thick. Central circular hole approximately 7cm diameter. One side dressed and partly worn smooth, other side not dressed. Stone bears resemblance to Anglesey millstone grit. Interpreted as mill stone, possibly reused as anchor.

3. Rough circular disk approximately 30cm diameter and up to 6cm thick. Surfaces not dressed on either side. Small central hole 3cm diameter. No evidence for either side having been dressed. Interpreted as possible anchor stone.

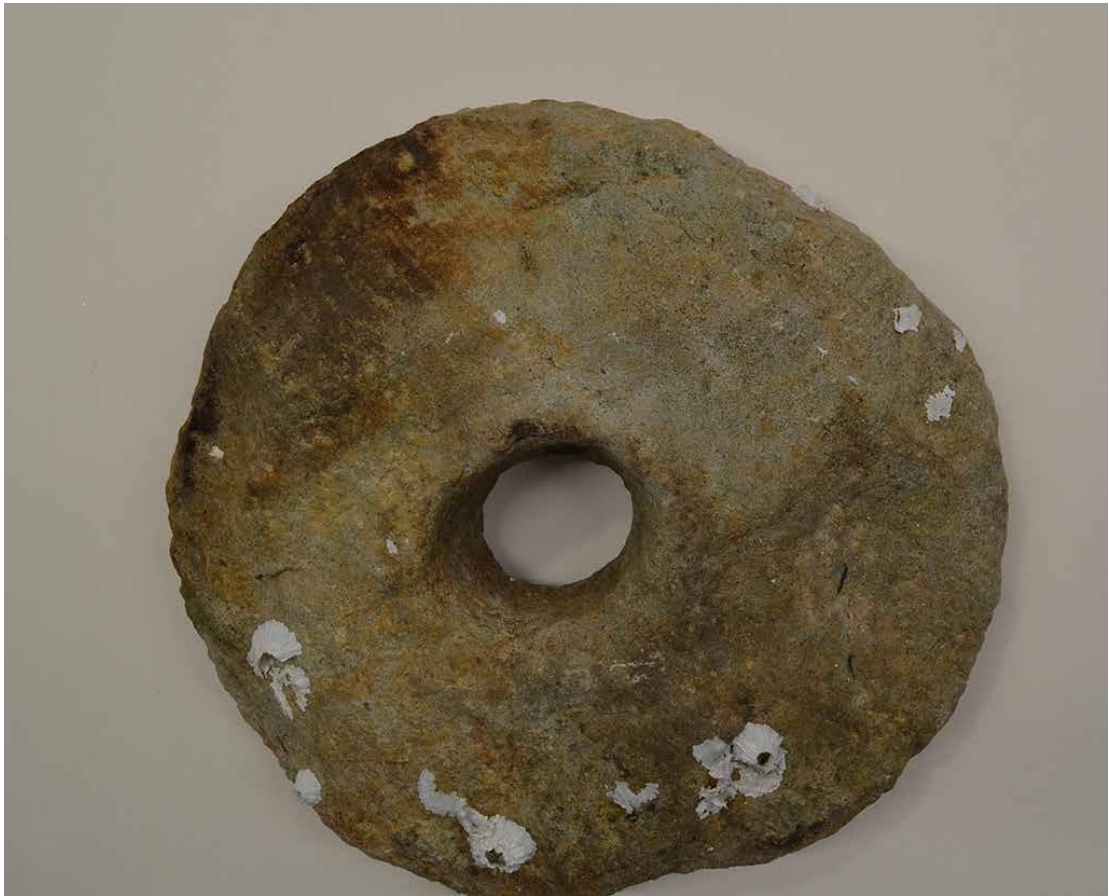
Plate 5: Millstone reused as anchor (No.8)

- 8 A millstone measuring 33cm diameter and between 5cm and 7cm thick. Central hole approximately 6cm diameter, widening to an uneven oval hole 7cm x 9cm in the upper surface. Concave dressed grinding face worn smooth in places and convex (undressed) upper surface. Weight 9.72Kg. Interpreted as former upper millstone possibly reused as stone anchor. Petrology: characteristic of the basal Carboniferous in Anglesey. Composed of fine-grained angular quartz and common jasper. Accession No. 25/210.5 (plate 5)

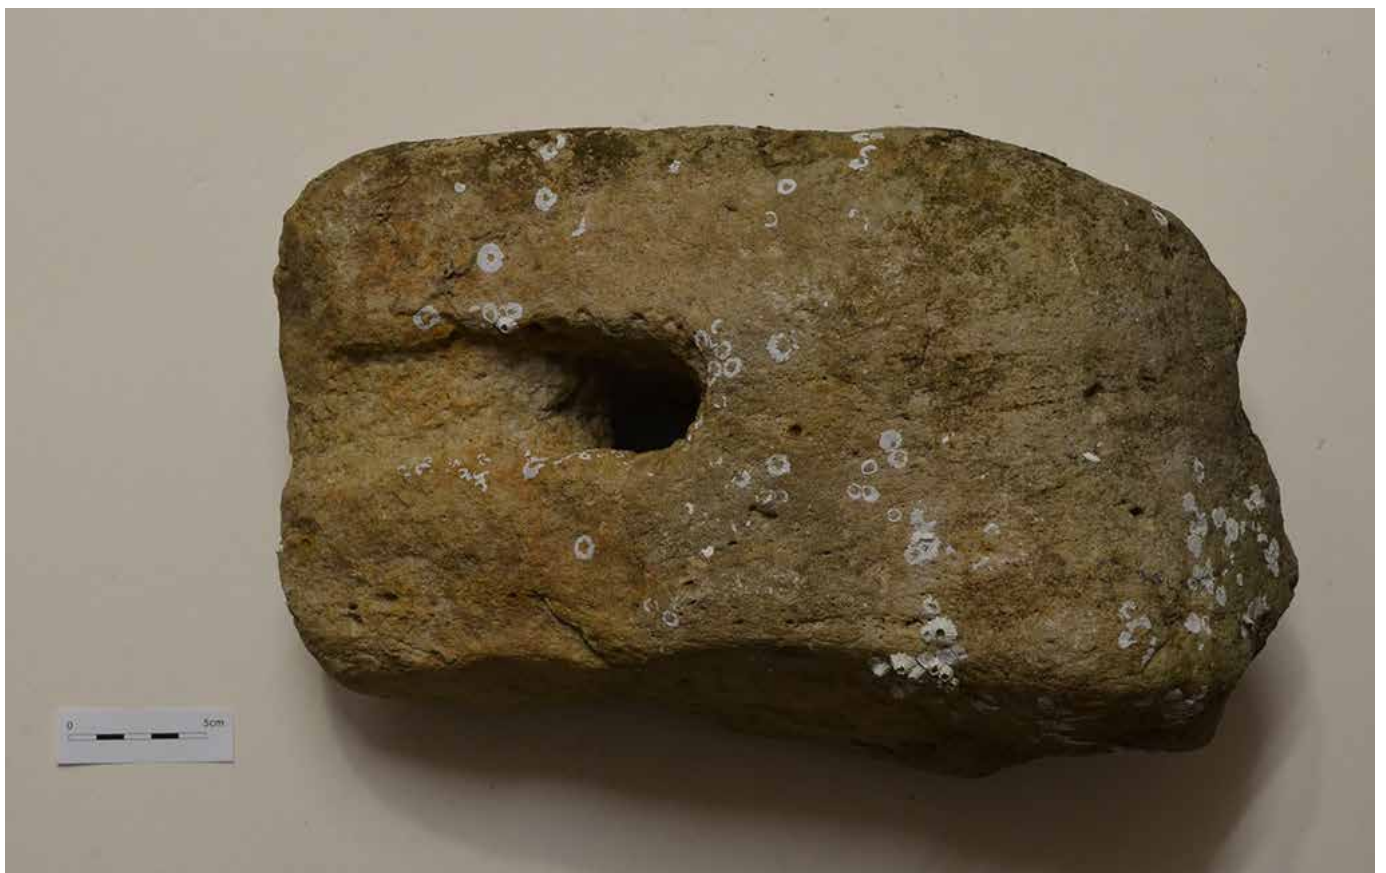
Plate 6: Stone anchor (No. 5)

- 5 Roughly rectangular block of stone approximately 34cm x 18.5cm. Slightly wedge shaped varying from 10cm to 15cm towards base of stone. Neither end is flat, but both are roughly angled. Elongated 5cm x 4cm hole through stone 11cm from top. A wide shallow groove runs from the hole to the top of the stone (approximately 5cm wide, 5mm deep). Weight 14.26Kg. Interpreted as anchor stone. Petrology: quartz sandstone with rare jasper, grey clasts and black shiny magnetite/ilmenite; probably of Anglesey origin. Accession No. 25/210.3 (plate 6)

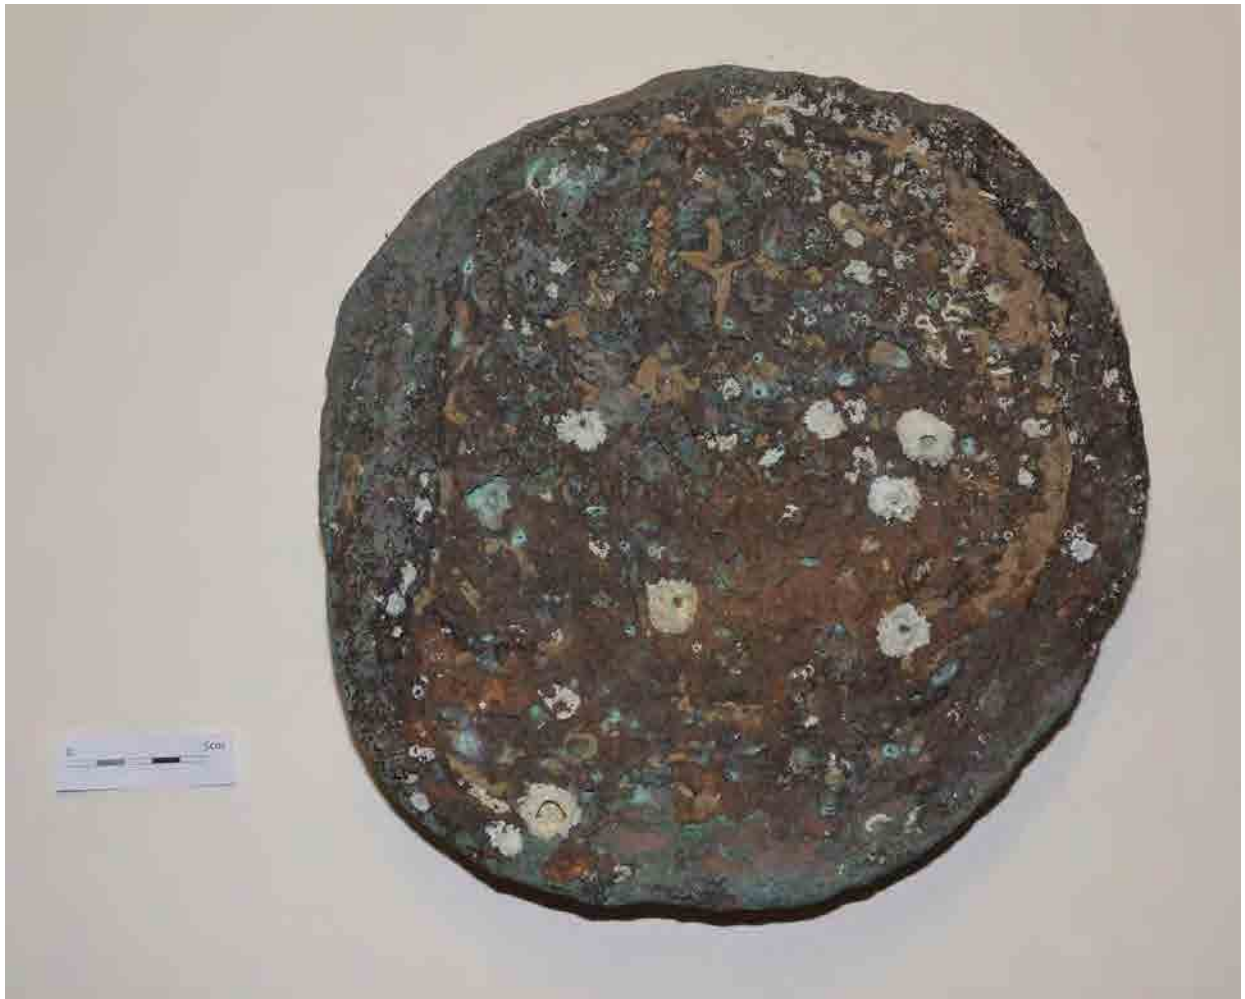
Plate 7: Roman copper ingot (No. 10)

- 10 Roughly circular copper ingot approximately 28cm in diameter and weighing 18.3Kg. The upper surface has a rim approximately 3cm wide, and the rest of the surface is flat and sunk a couple of mm below the rim. The lower side is relatively flat, and curves up at the edges towards the rim (plate 7).

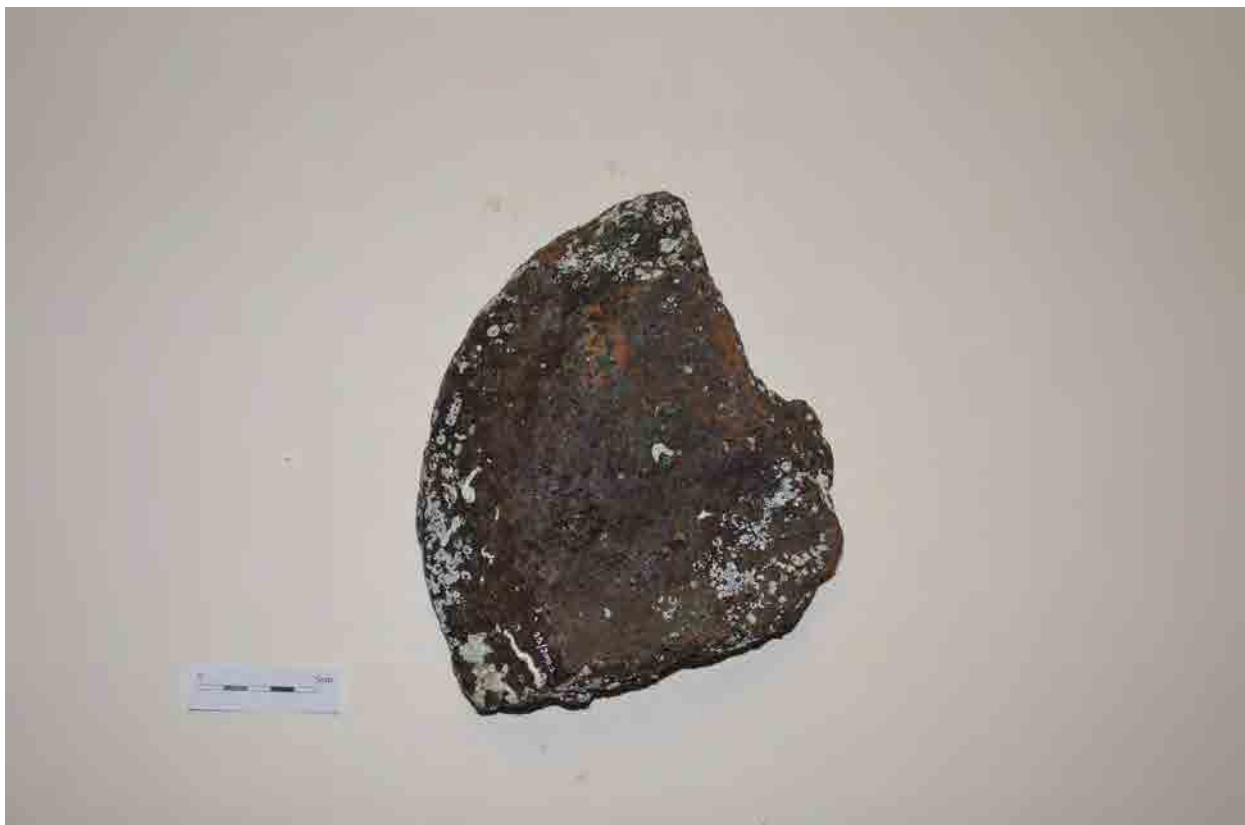
Plate 8: Segment of Roman copper ingot (No. 11)

- 11 Segment of a circular copper ingot 5.36Kg in weight. The circumference of the rim is between 20cm and 25cm long, and the other two side 20cm and 15cm long. The method of manufacture appears the same as the complete ingot, with a protruding rim on the upper surface (plate 8).

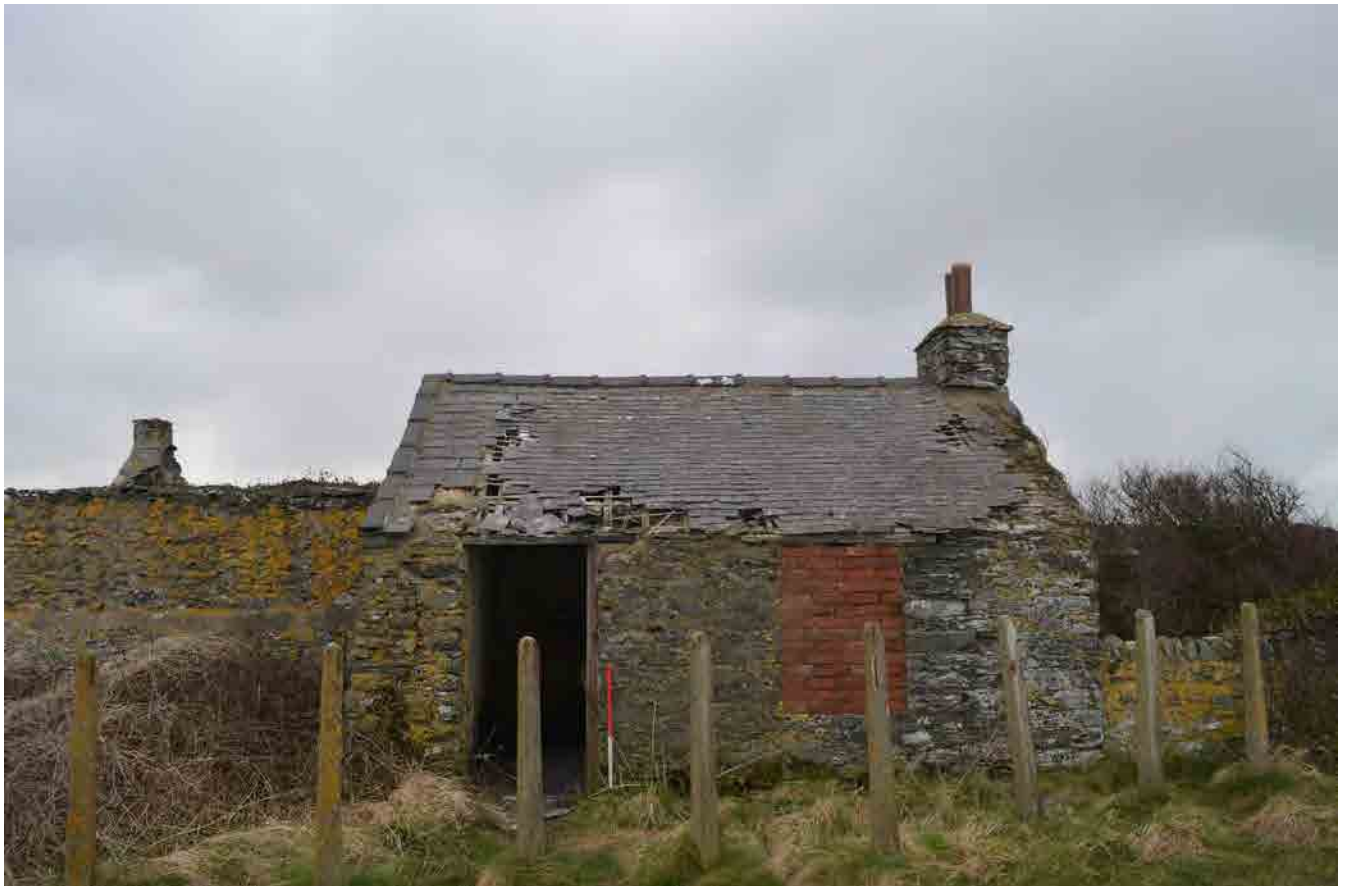
Plate 9: Storws building A weigh house/office (PRN 31916)

At the northern limit of the property is a small rectangular, single storey structure, interpreted as a weigh house and office. This building backs onto the coal yard, and incorporates the high enclosure wall into its construction. The remains of weigh-scales lie outside the west gable. The 1900 OS map shows a second building (B) attached to the east gable of the weigh-house/office, but that building has been taken down and the stone removed. The building is orientated on an east-west axis and faces north, looking out across the shingle of Cemlyn bay. The roof is double pitched and clad in slate, with the eaves extending lower on the northern side than on the southern side. The roof features ceramic ridge tiles and has ceramic coping slabs at the eastern gable. A small rectangular, rubble built chimney extends up from the western gable; this is topped by cement flaunching and two small, circular, ceramic chimney pots. The roof survives in poor repair with holes showing on either side. The walls are rubble built using lime mortar and show patches of render, particularly at the eastern gable.

Sole access to the structure is via a doorway located on the eastern side of the northern elevation. The opening features a wooden lintel positioned directly below the eaves; remnants of a wooden frame survive, but the door itself is absent. A second doorway located on the far southern side of the eastern gable has been entirely blocked up using stone, although the wooden lintel remains visible. The interior was formerly lit by two windows, a large rectangular one in the northern elevation and a smaller one on the far southern side of the western gable; both have been entirely blocked up with red brick.

The interior of the building consists of a single room, open to the roof. The roof structure consists of a narrow ridge beam, flanked by a single purlin on either side and supported by a small central collar beam truss. The truss features a mortise and tenon joint at the top and the collar beam is fastened in place using metal bolts. The spaces between the rafters show remnants of plaster and the timbers have been whitewashed. The walls have been roughly rendered, and show remnants of orange paint in places.

A small fireplace is located just north of centre in the western elevation; this has a substantial stone lintel and red bricks in the hearth. To the south of the fireplace is a small blocked window, this has been blocked up leaving an alcove on the internal side with a wooden sill and lintel. A matching alcove is set in the eastern gable opposite, in what was formerly a doorway. The northern window has also been blocked up, leaving an alcove, however here remnants of a three light wooden window casement remain in the opening.

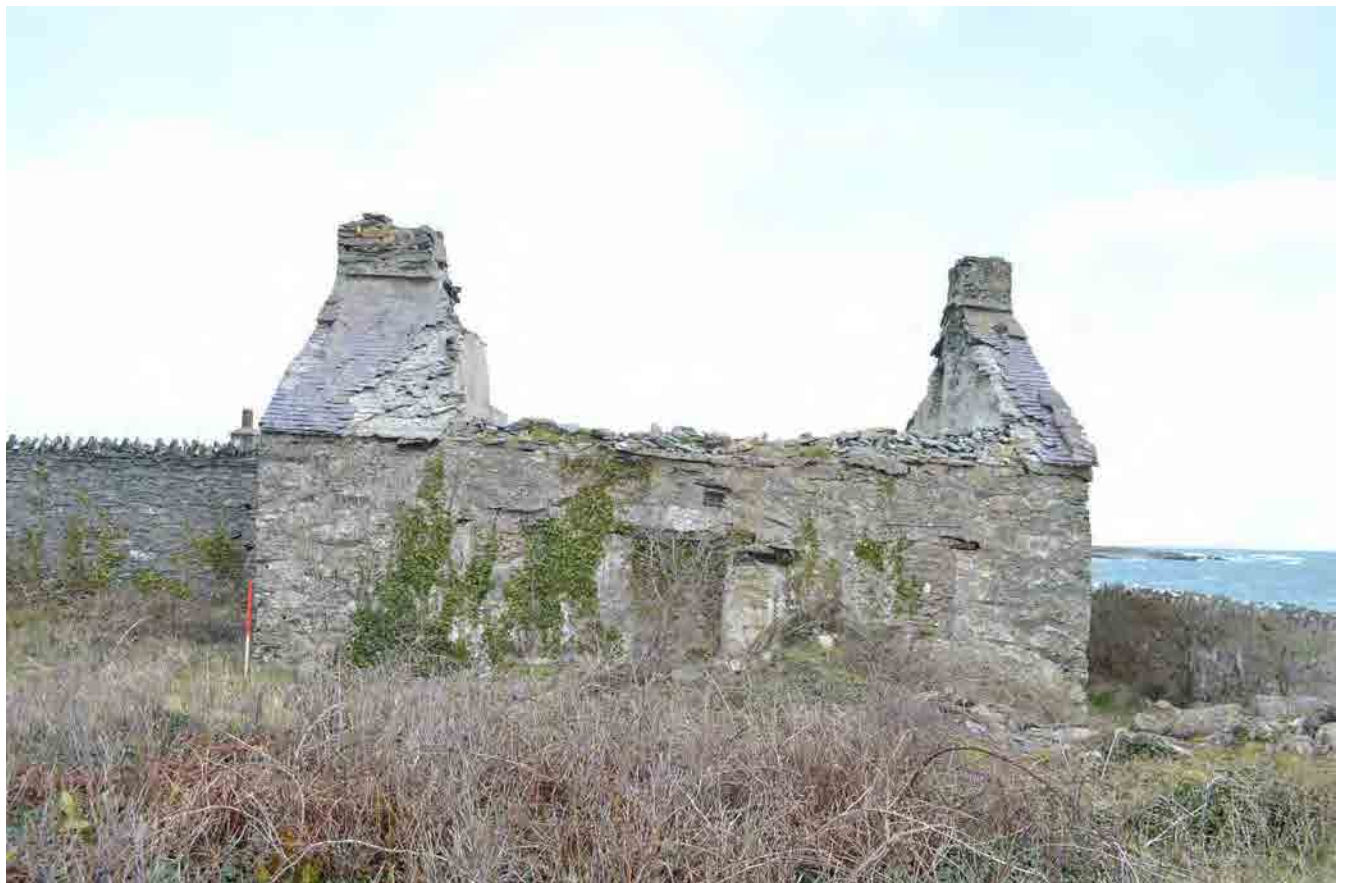
Plate 10: Storws building D cottage (PRN 31916)

The cottage is located on the southern side of the coal yard, on the eastern edge and again appears to incorporate the high enclosure wall into its construction. The principal elevation faces south, looking towards the main storehouse. The cottage is derelict and all openings have been blocked up with stone, making the interior inaccessible. Remnants of a small structure stand at the eastern gable, set back from the main frontage, most likely a privy.

The cottage is partially derelict and survives in poor repair. The double pitched roof has entirely collapsed, though some slates survive at either gable, along with some irregular stone coping slabs. The western gable wall is very thick and features remnants of a large square chimney at the top. The eastern gable is less substantial and features a smaller chimney. The walls of the cottage are rubble built bonded with lime mortar, and partly rendered. Ivy is beginning to obscure the main face.

The southern elevation features a central door flanked by a fairly small window on either side, all of these opening have been entirely blocked up using stone, though a wooden lintel above the door remains visible. Two further blocked doorways are located on the southern side of the eastern and western gables, again displaying wooden lintels. A small window in the northern elevation has been blocked up using brick whilst a fourth set high in the eastern gable remains open.

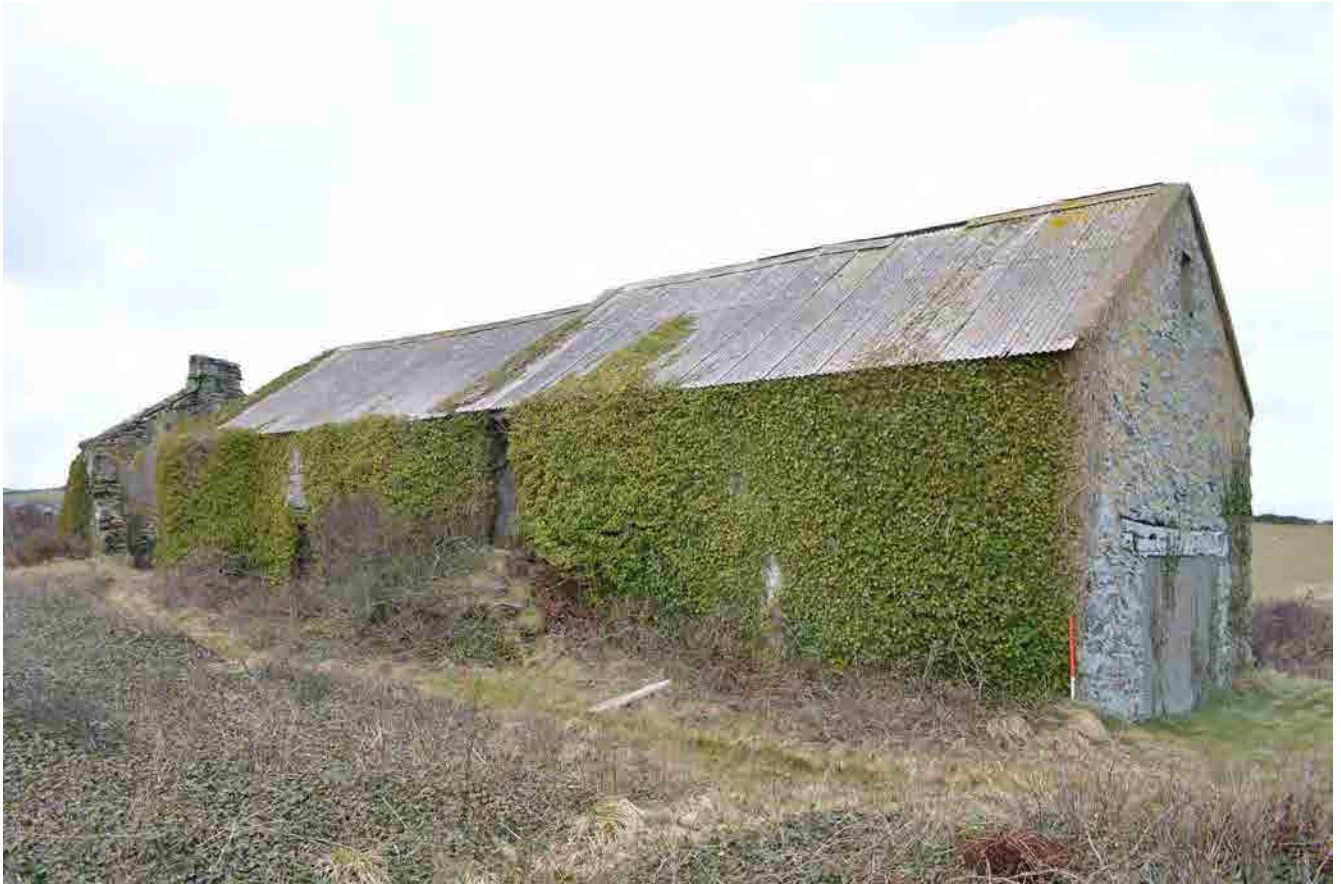
Plate 11: Storws buildings E and F storehouses (PRN 31917)

The northern storehouse is a two storey structure which has undergone significant alteration in recent times. The structure is rectangular in plan and is orientated on a northeast/southwest axis; the roof is double pitched and has been replaced recently using corrugated asbestos panelling. The northern gable features a wide double doorway which has been entirely blocked up and rendered over. A substantial lintel, apparently made from recycled timber (it features numerous peg holes) remains visible above the blocked opening. A small rectangular window remains open at the top of the gable; however no frame or casement is present.

Access to the first floor is gained via a doorway at the south end of the east wall; this doorway is reached via a low external stone staircase. The doorway is set immediately below the eaves; it

features a wooden lintel and a ledged and braced wooden door. The western elevation is almost entirely obscured by ivy, however two small shuttered windows are set at ground floor level and two small square air vents are set at first floor level.

The southern storehouse appears to be of a separate phase to the northern one, the rooflines being slightly different, however the masonry is entirely obscured by ivy, making it difficult to confirm. The structures are similar in style and roughly match each other in dimensions. This structure is again rectangular in plan and is orientated on a northeast/southwest axis; the roof is double pitched and has been replaced recently using corrugated asbestos sheeting. The eastern elevation functions as the principal frontage of this building, facing out to the coast. Access is via a central doorway at ground floor level. The opening features a wooden lintel and door frame, but no door is present. The doorway is flanked by two small rectangular windows, the southern window has been blocked up using stone, but the northern window features an early wooden shutter. The western elevation features a matching pair of windows, both retaining early wooden shutters.

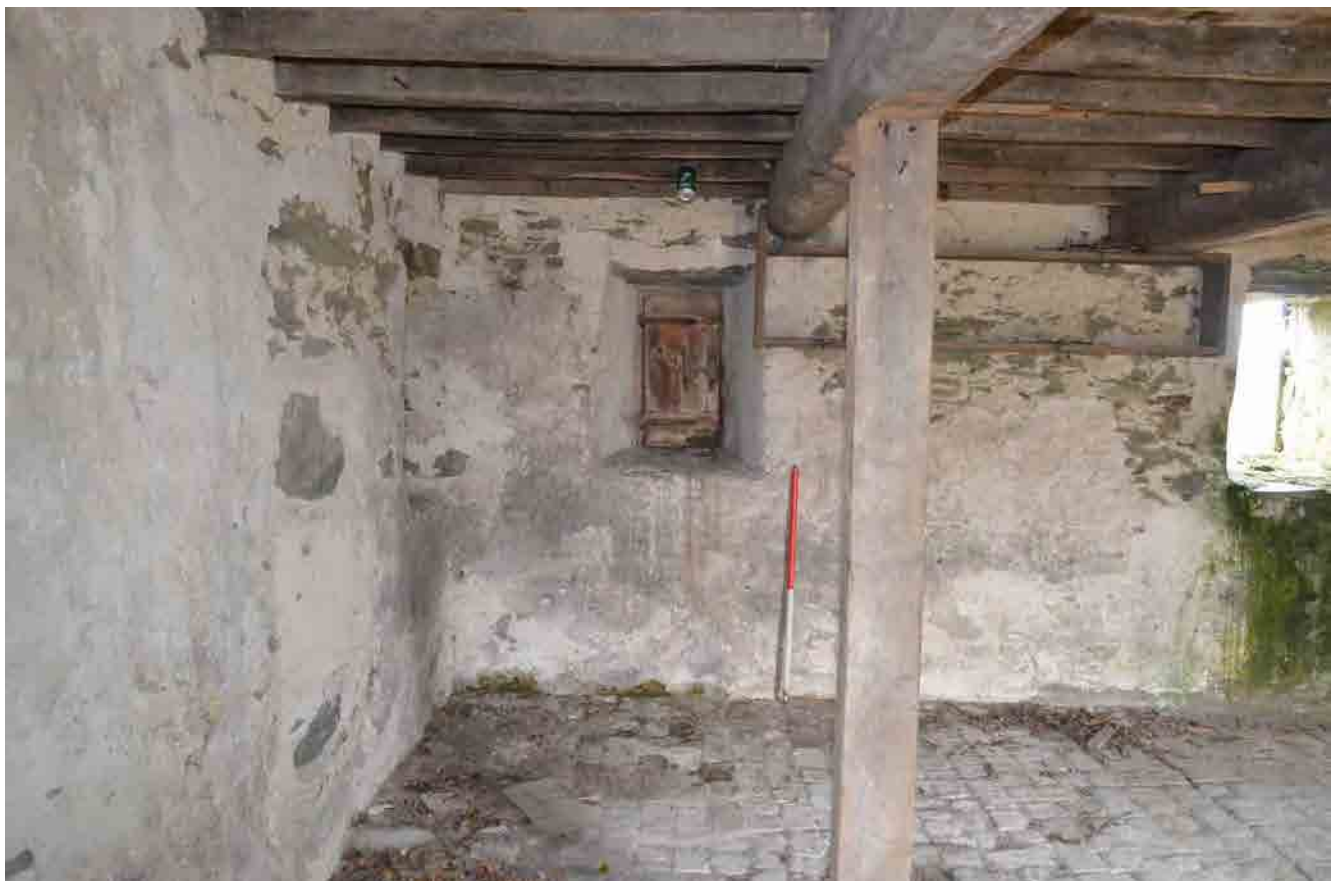
Plate 12: Storws interior of building F (PRN 31917)

The ground floor of the southern storehouse consists of a single, fairly well lit room, not internally linked to the rest of the range. The ceiling features substantial joists supported in places by upright posts. Set into the floor boards of the room above are a number of small hatches, which do not appear original. The walls are roughly rendered and the floor is a mixture of irregular stone slabs and red bricks. Wooden shelving is set against the western wall. There is a small alcove, possibly a blocked window, set on the far west side of the southern wall. The first floor of this structure is accessed via an internal door in the southern wall of the adjacent loft. The space consists of a single room, open to the roof; it features no direct sources of light, and is therefore likely, especially given the strong supports to the floor, to have been used for grain storage.
