# DOLBENMAEN WATER TREATMENT WORKS

## Archaeological Evaluation Report

Project No. G2293

Report No. 1123

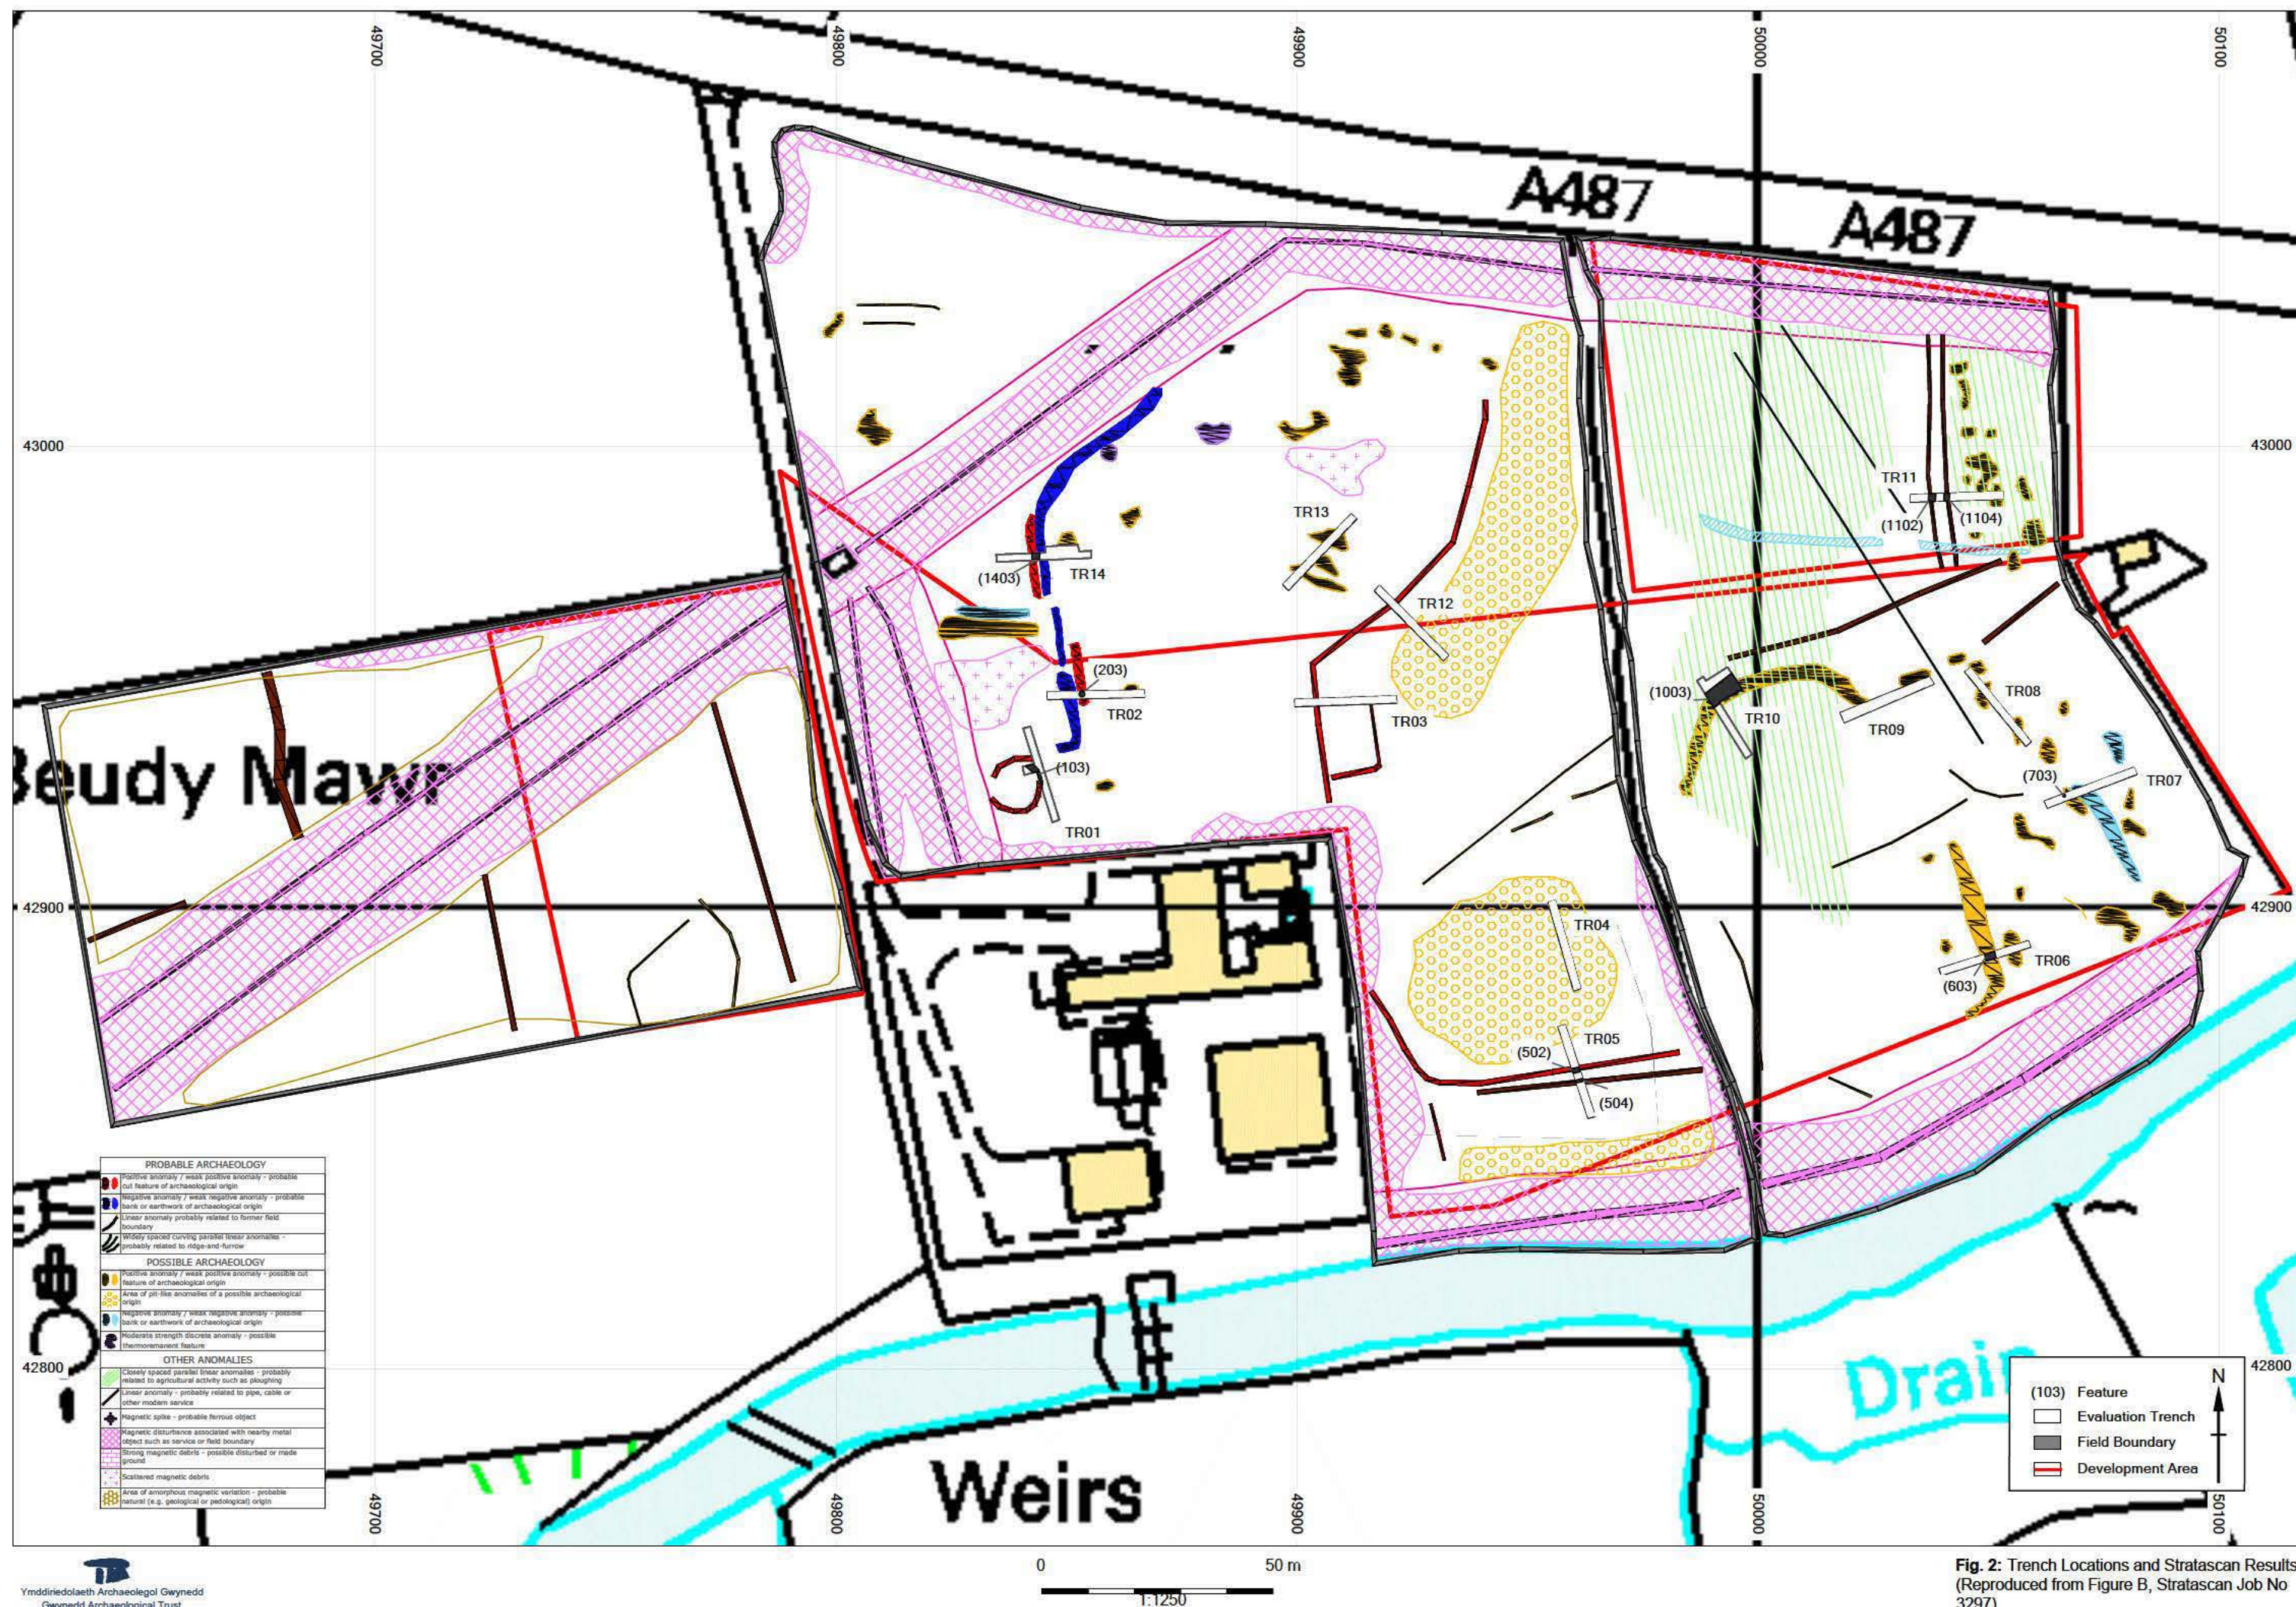
Fig. 2: Trench Locations and Stratascan Results  
 (Reproduced from Figure B, Stratascan Job No 3297)

The trenches locations were based on information received from the preliminary Stratascan results and targeted specific anomalies (see below), and located by digital survey (Figure 2).

A total of fourteen trenches were excavated down to the natural geology during the archaeological evaluation of the site (Figure 2). All the trenches measured 20m by 2m, except for Trenches 01, 10, and 14 where extensions were excavated so as to aid understanding of the features encountered. A dark greyish brown sandy silt topsoil ranging from 0.15m to 0.6m in depth was located within all the trenches. Within trenches 01-03, 06-07, and 12, this sealed a brownish grey sandy silt subsoil, between 0.2m and 0.3m thick. No subsoil was revealed in the remaining trenches, with the topsoil directly overlying the natural geology which alternated between a light reddish brown sandy clay, bedrock, and gravel. Full details of the topsoil, subsoils and natural geology can be seen in Appendix II. All features uncovered were cut into the natural geology and sealed by the topsoil or subsoil unless stated otherwise.

Two possible platforms were also uncovered during the evaluation (**603** and **1002**), both of which are located on ground that is visibly sloping down, to the east and southeast respectively. Platform **603** is not as well defined as Platform **1002** and it is possible that this represents a natural sloping of the ground rather than a manmade platform. The results of the geophysical survey suggest that this feature runs for approximately 40m before turning to the southwest and continuing for a further 9m (Figure 2), which is at least partially visible as a slope on the surface of the field.
