A5 Cymro Gate Retaining Wall, Cymro Gate, Gwynedd

Archaeological Assessment

Project No. G2321

Report No. 1137

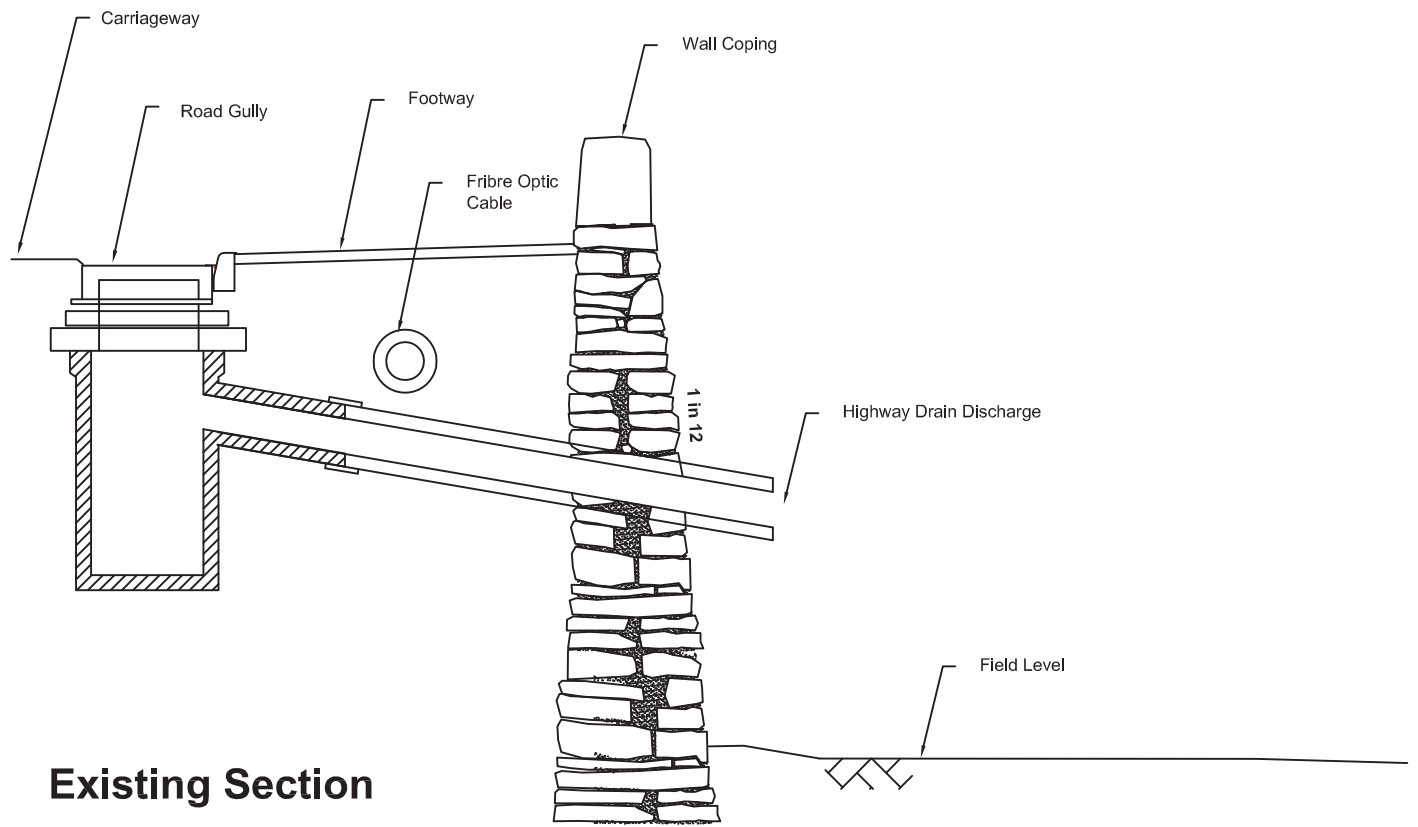
A5 Cymru Gate Retaining Walls Typical Section Before & After

Figure 06: Reproduction of Client Drawing S204/SKE

YGC drawings S/206/DT 001 (Draft) and S204/SK E indicate that the proposed retaining wall will replace the existing wall and this will remove existing structural phasing for the current retaining wall and raise the current height of the wall. The proposed retaining wall will measure 1000mm in height and 535mm in width.

These works involve the placement of an earth embankment behind the northern side of these structures to provide lateral support. The work will extend 10 metres beyond the A5 trunk road on its northern side and will require ground clearance and a scrape back of existing topsoil (down to 300mm), the import of new embankment with a rock-based substrate and the reinstatement of topsoil. The existing retaining wall will be replaced, along with the footpath and drainage system. The proposed works are detailed on scheme drawings S/206/DT 001 (Draft) and S204/SK E (Figures 05 and 06 respectively).

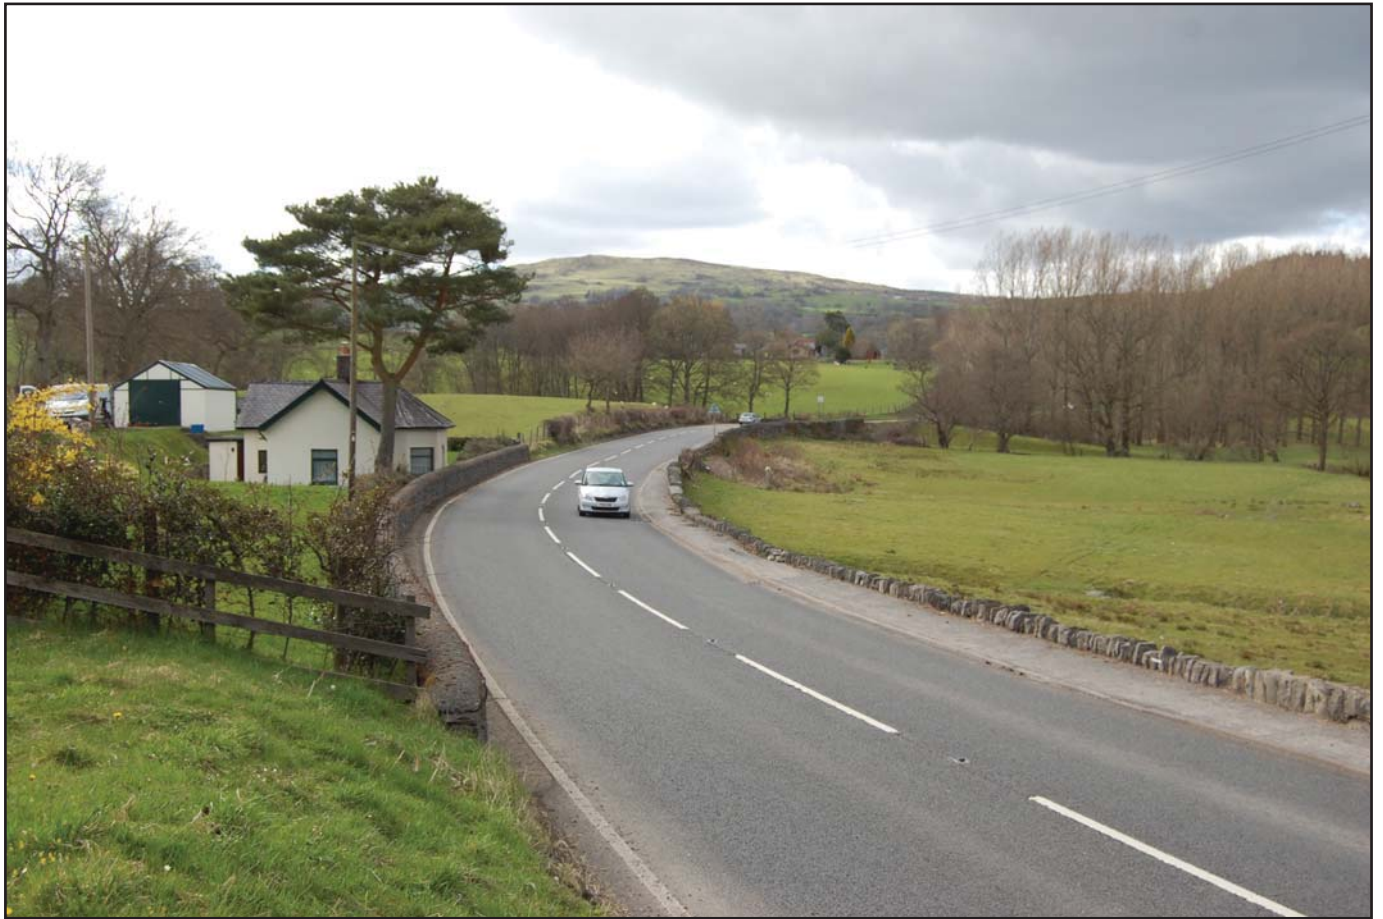
Plate 01 - View of the proposed works location from Chainage 330 westwards towards Chainage 560. The retaining wall to be replaced is on the right hand side of the image. Cymro Gate Tollhouse is in the centre left of the image.

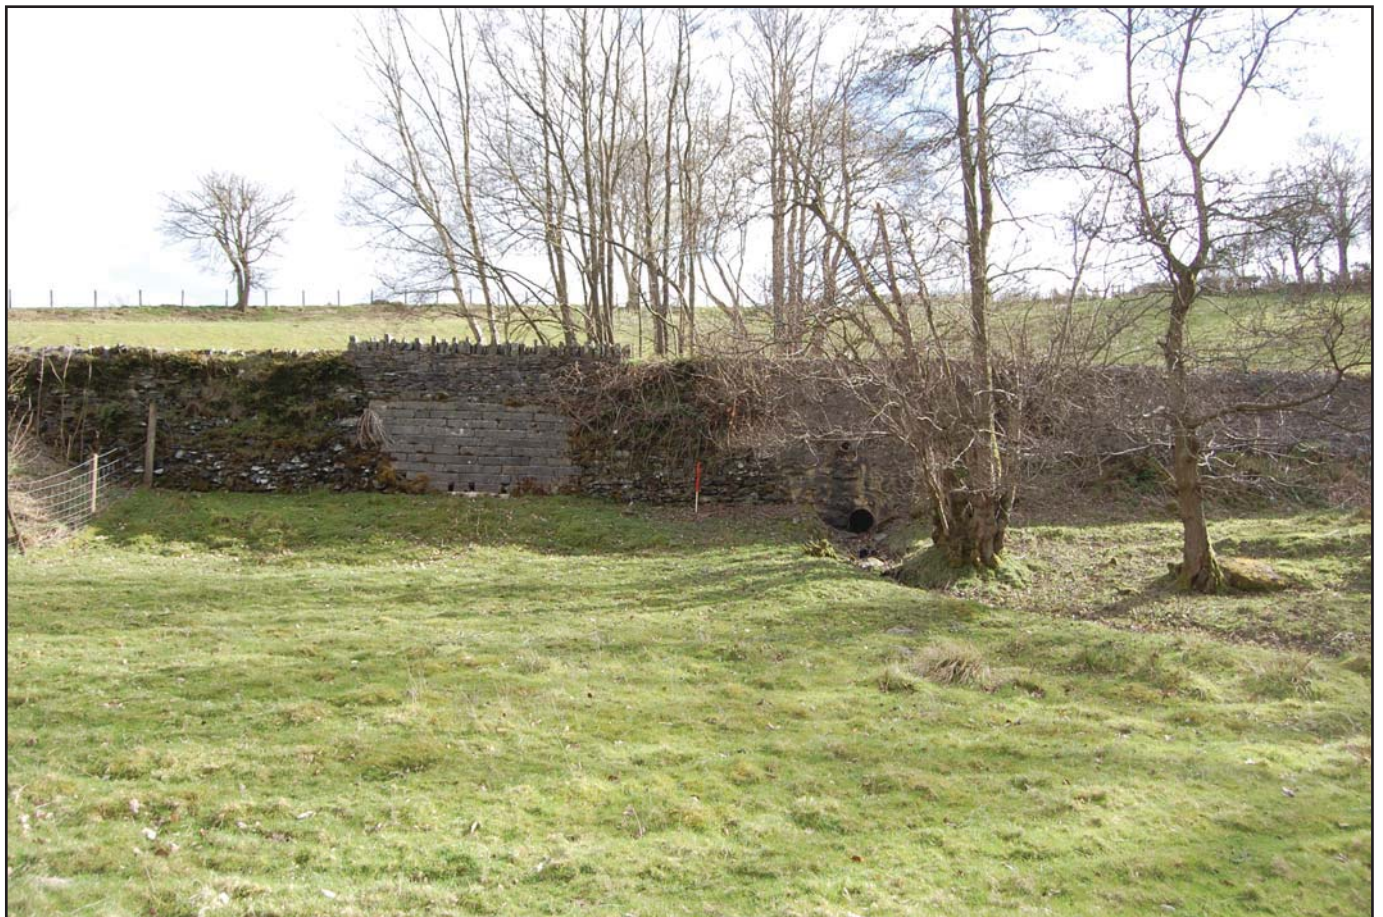
Plate 02 - The north face of the retaining wall at Chainage 140 showing different phases of repair identified during the archaeological assessment. Visible to the right of the ranging pole is the current road surface water drainage scheme at this point.

Recommendations for further assessment: *Detailed Recording of the existing retaining wall prior to main works.*

Recommendations for mitigatory measures: *Watching Brief during main works. Sympathetic design of the replacement structure.*

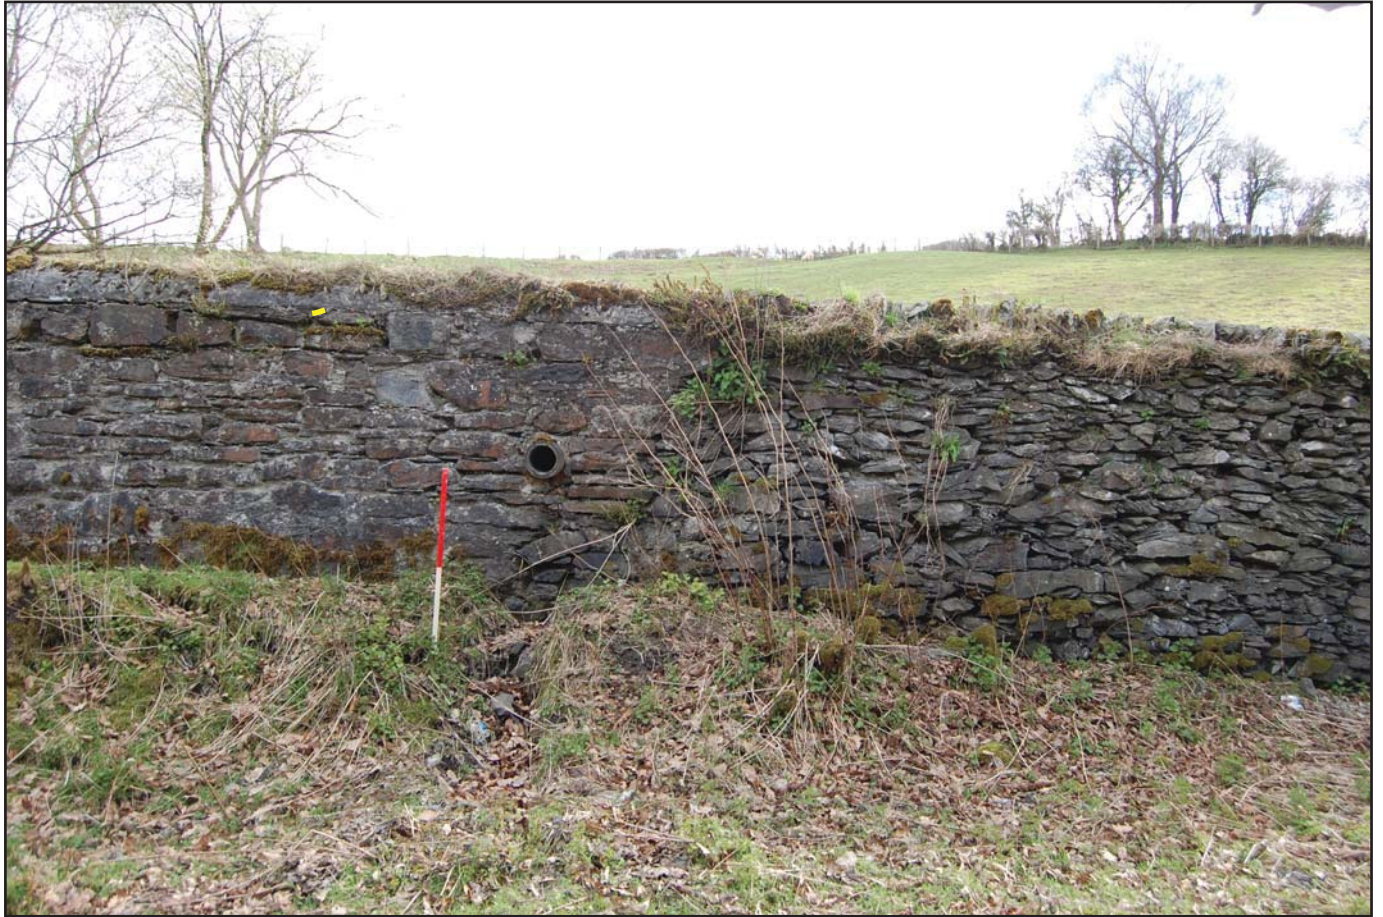
Plate 03 - The north face of the retaining wall at Chainage 160 showing the different phases of repair identified during the archaeological assesment. Visible to the right of the ranging pole is the current road surface water drainage scheme at this point.

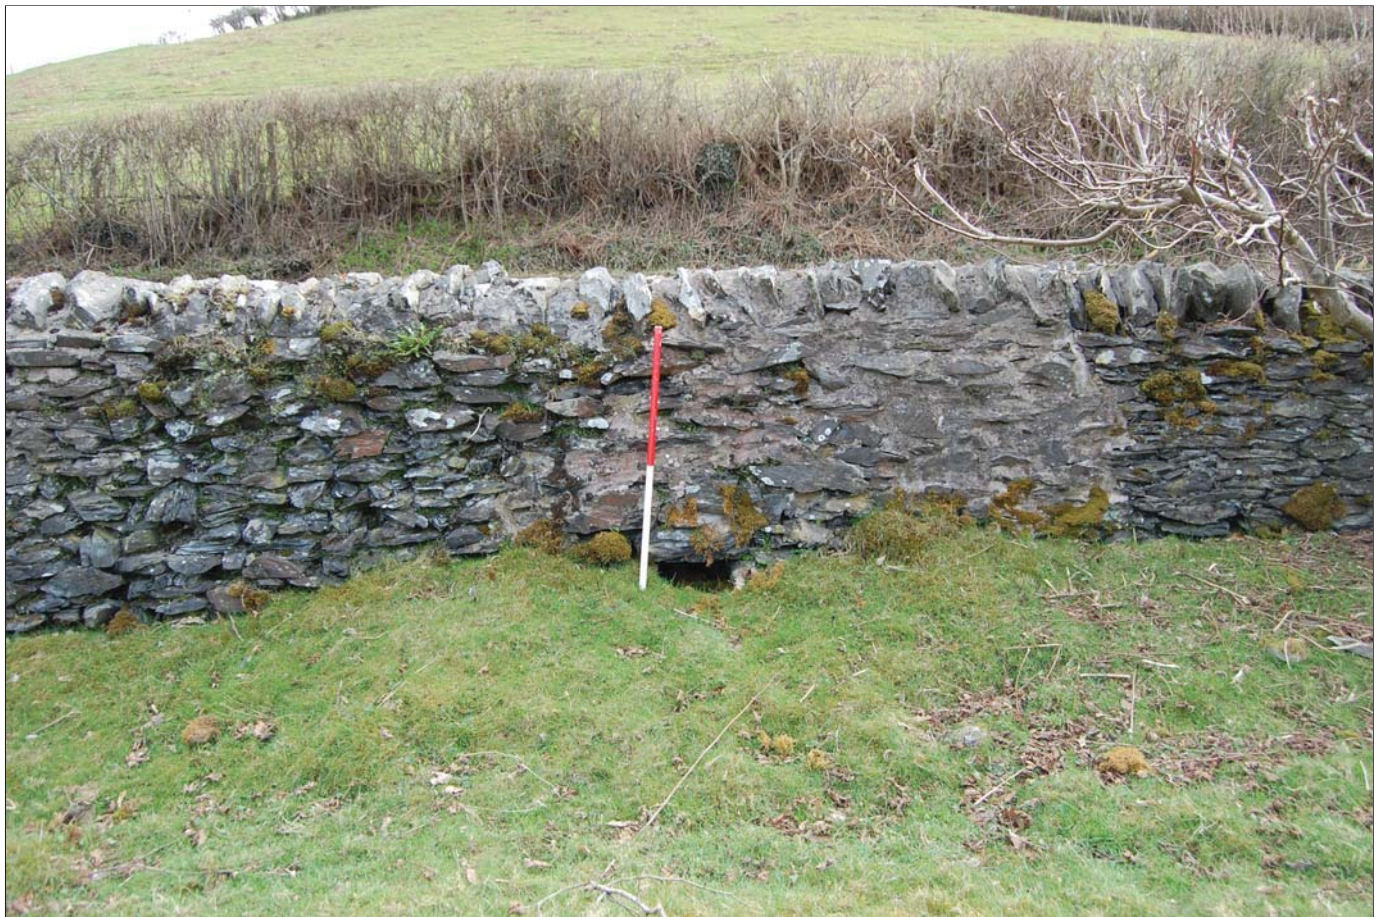
Plate 04 - The north face of the retaining wall at Chainage 170 showing the different phases of repair identified during the archaeological assessment. Visible to the right of the ranging pole is the current road surface water drainage scheme at this point, and appears to be an original Telford specification drain.

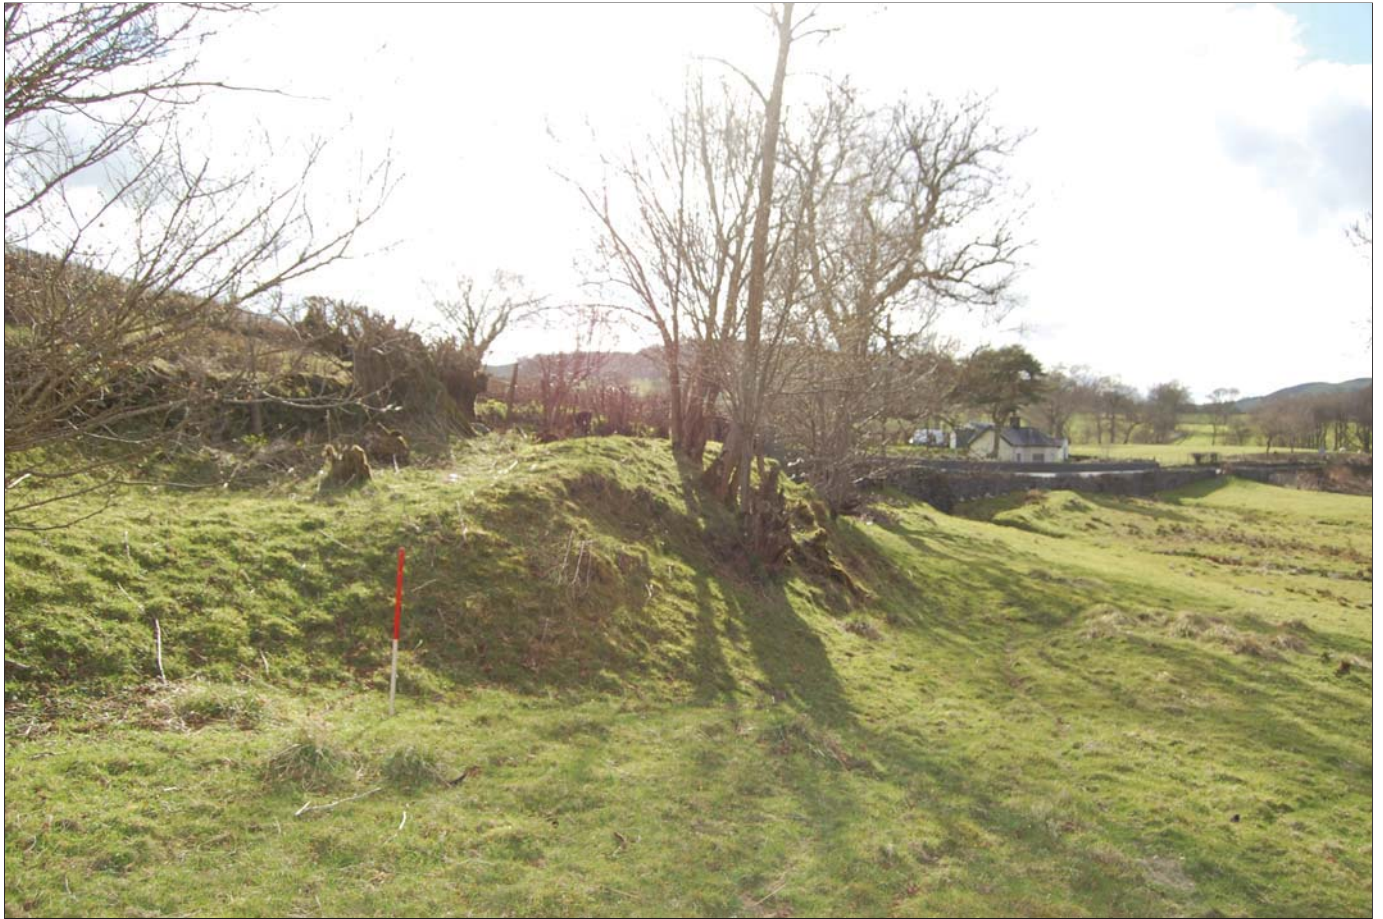
Plate 05 - Road embankment constructed against the face of the retaining wall at Chainage 290. Not indicated on Scheme Drawing S/206/DT 001 (DRAFT) as an embankment.

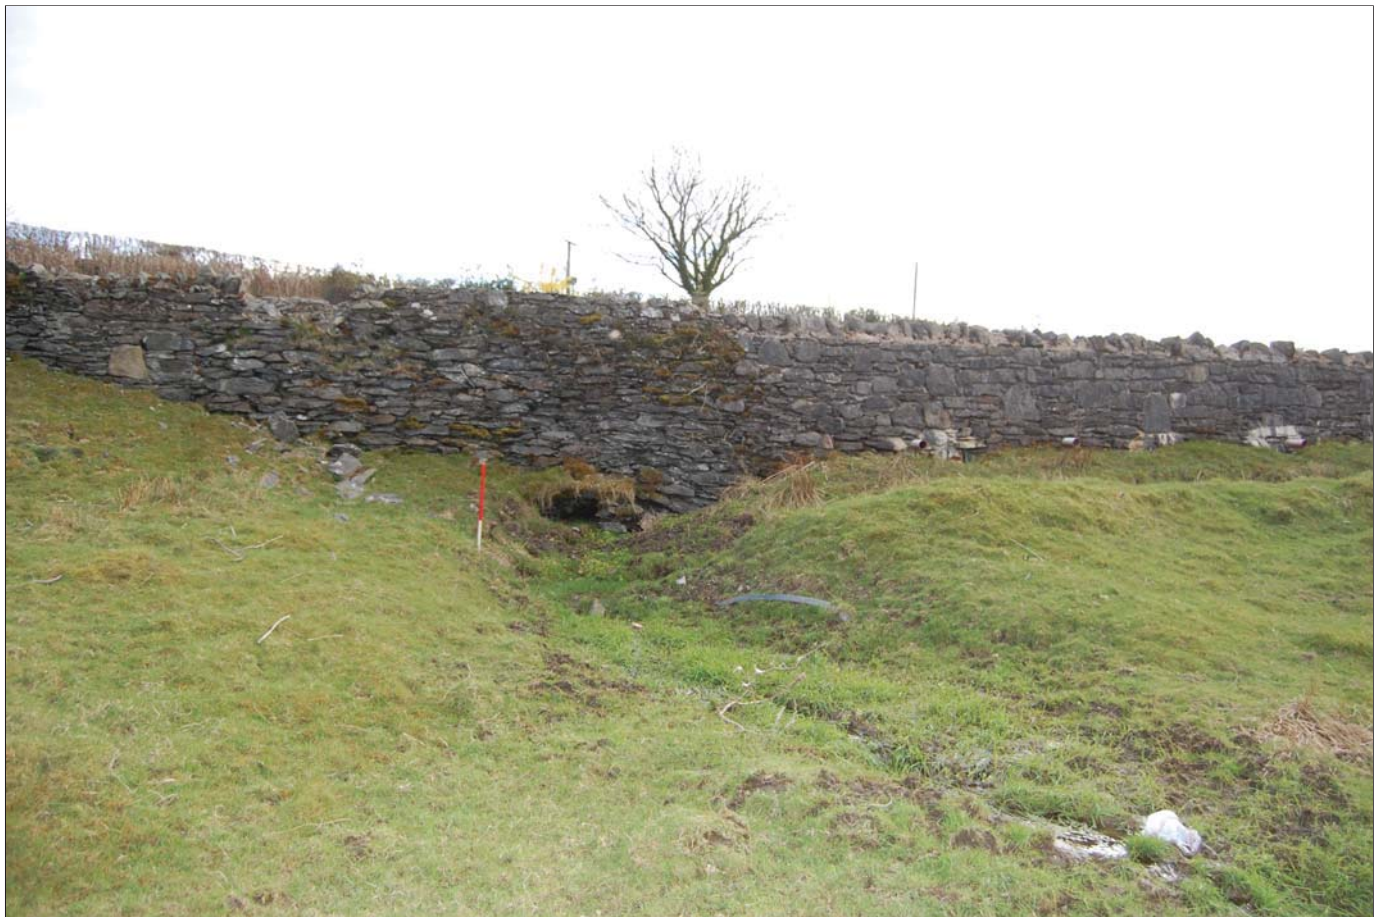
Plate 06 - The north face of the retaining wall at Chainage 350 showing the different phases of repair identified during the archaeological assessment. Visible to the right of the ranging pole is the current road surface water drainage scheme at this point, and appears to be an original Telford specification drain fed into by modern drainage.

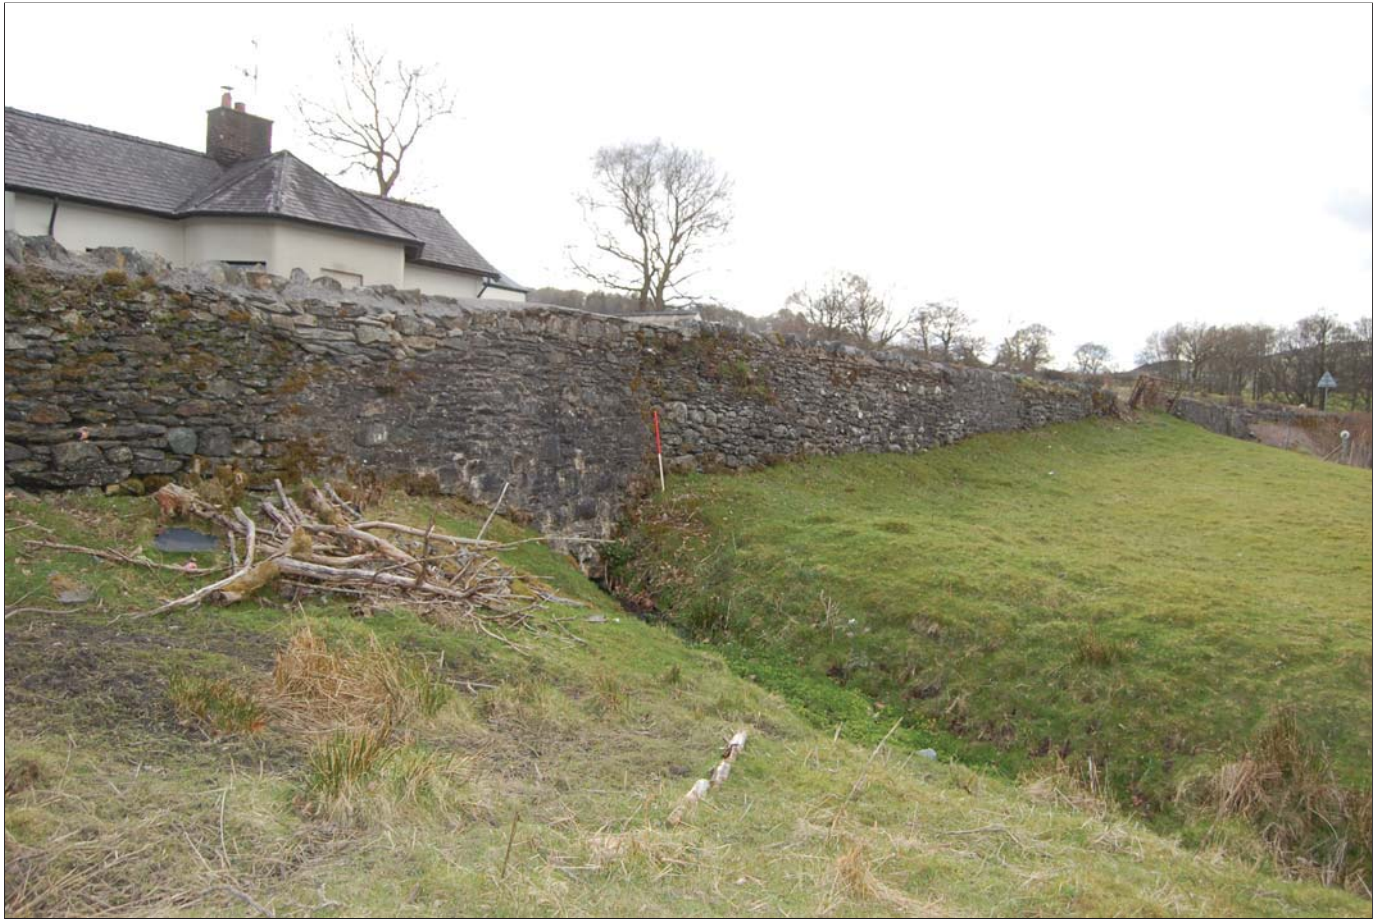
Plate 07 - The north face of the retaining wall at Chainage 400 showing different phases of repair identified during the archaeological assessment. Visible to the left of the ranging pole is the current road surface water drainage scheme at this point.

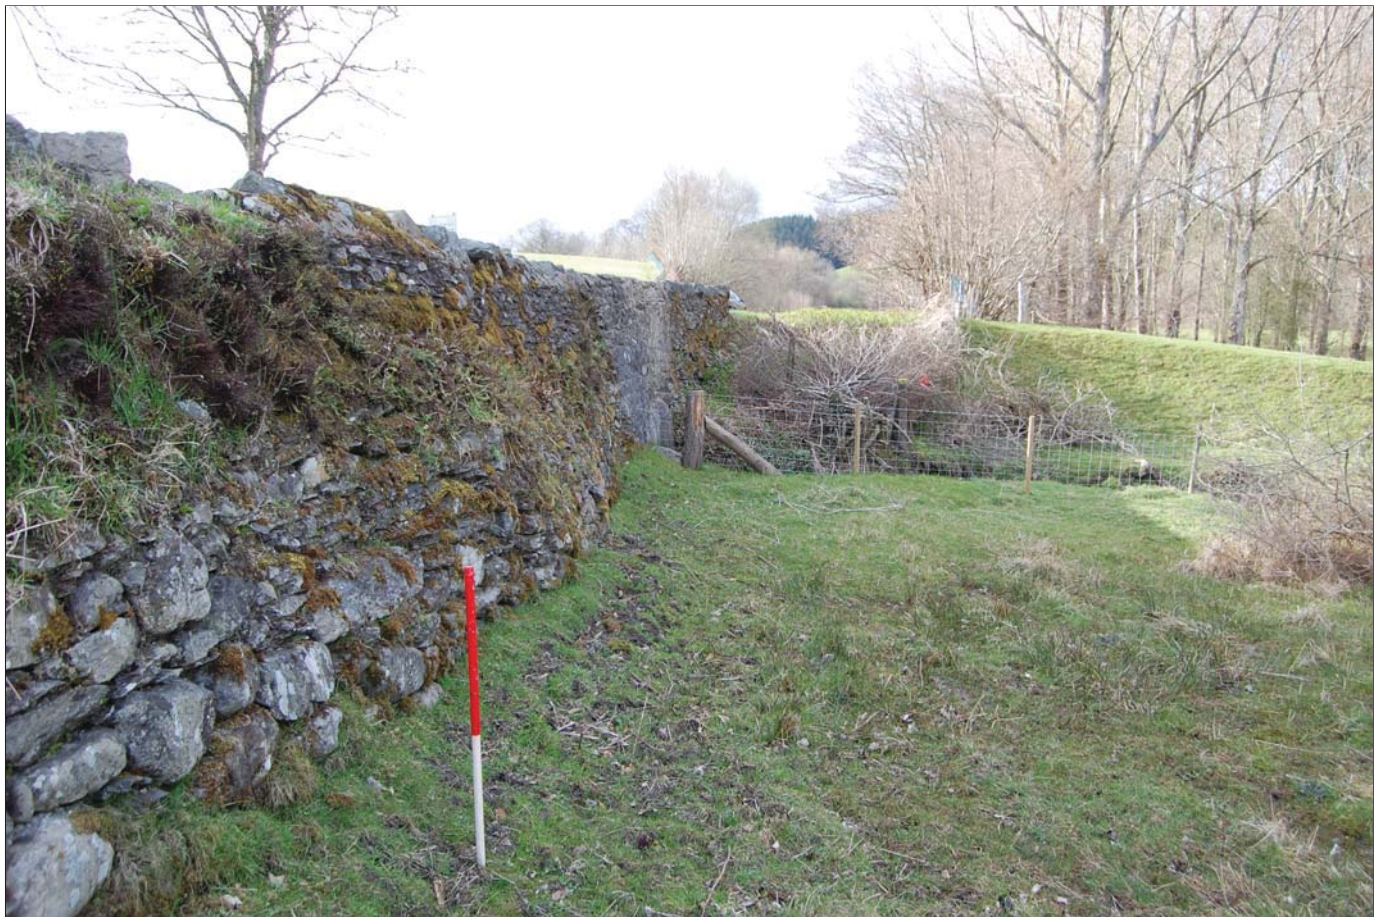
Plate 08 - The north face of the retaining wall at Chainage 530 showing different phases of repair identified during the archaeological assessment. In the centre of the image at Chainage 550 is the culvert under the A5(T) carrying Nant Heulog from south to north to discharge into the Afon Alwen.

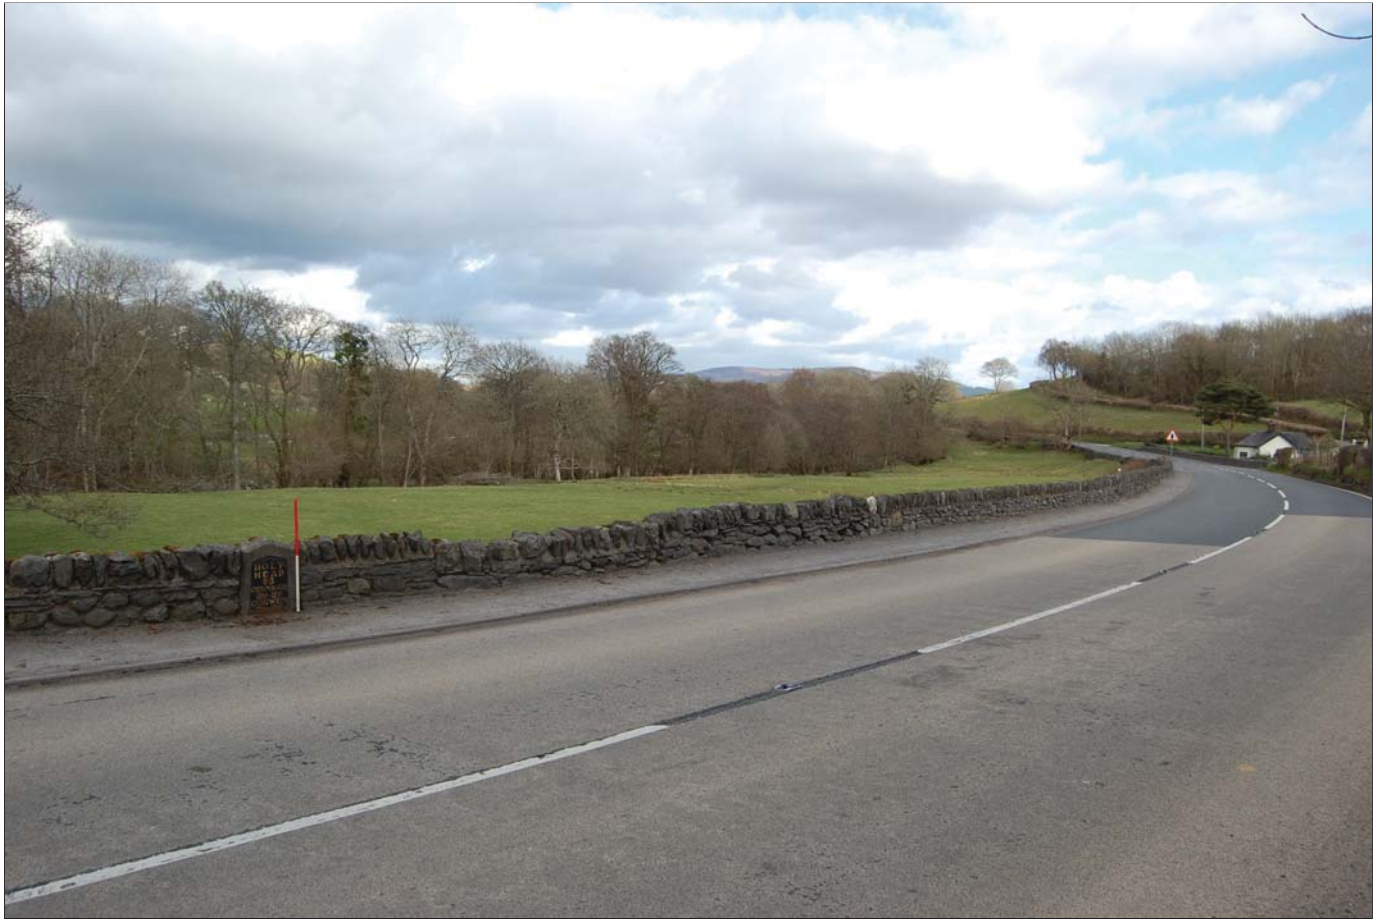
A standard Telford milestone in its original location is now incorporated into the current retaining wall. The milestone specification issued by Thomas Telford for the London – Holyhead road called for a pillar of Limestone from Red Wharf Bay, Anglesey which was 2.1m in height, of which 0.61m were to be buried as a foundation (Quartermaine *et. al.* 2003: 37-38). The text on the plate on the milestone reads: HOLY-HEAD 63 CERNIOGE 9M-2F CORWEN 3M-6F.

The milestone currently stands 0.65m tall, suggesting it has not been raised up as the road surface has been subsequently re-laid. The milestone would not have originally been incorporated into the retaining wall, suggesting the retaining wall has been realigned at least once since its original construction. It is recommended that the milestone is not subsumed by the proposed works and that appropriately maintained in line with the milestone restoration programme (LUAU 2000)

Plate 09 - London to Holyhead road Milestone 63 in its original location at Chainage 520. The Milestone has now been subsumed by an additional 0.84 metres since its placement. Different phases of wall replacement and repair are visible to the left and right of the Milestone.

A watching brief is recommended during main works to monitor against any direct or indirect scheme impact.

Recommendations for further assessment: Detailed Recording prior to main works.

Recommendations for mitigatory measures: Watching Brief during main works/retention in situ.

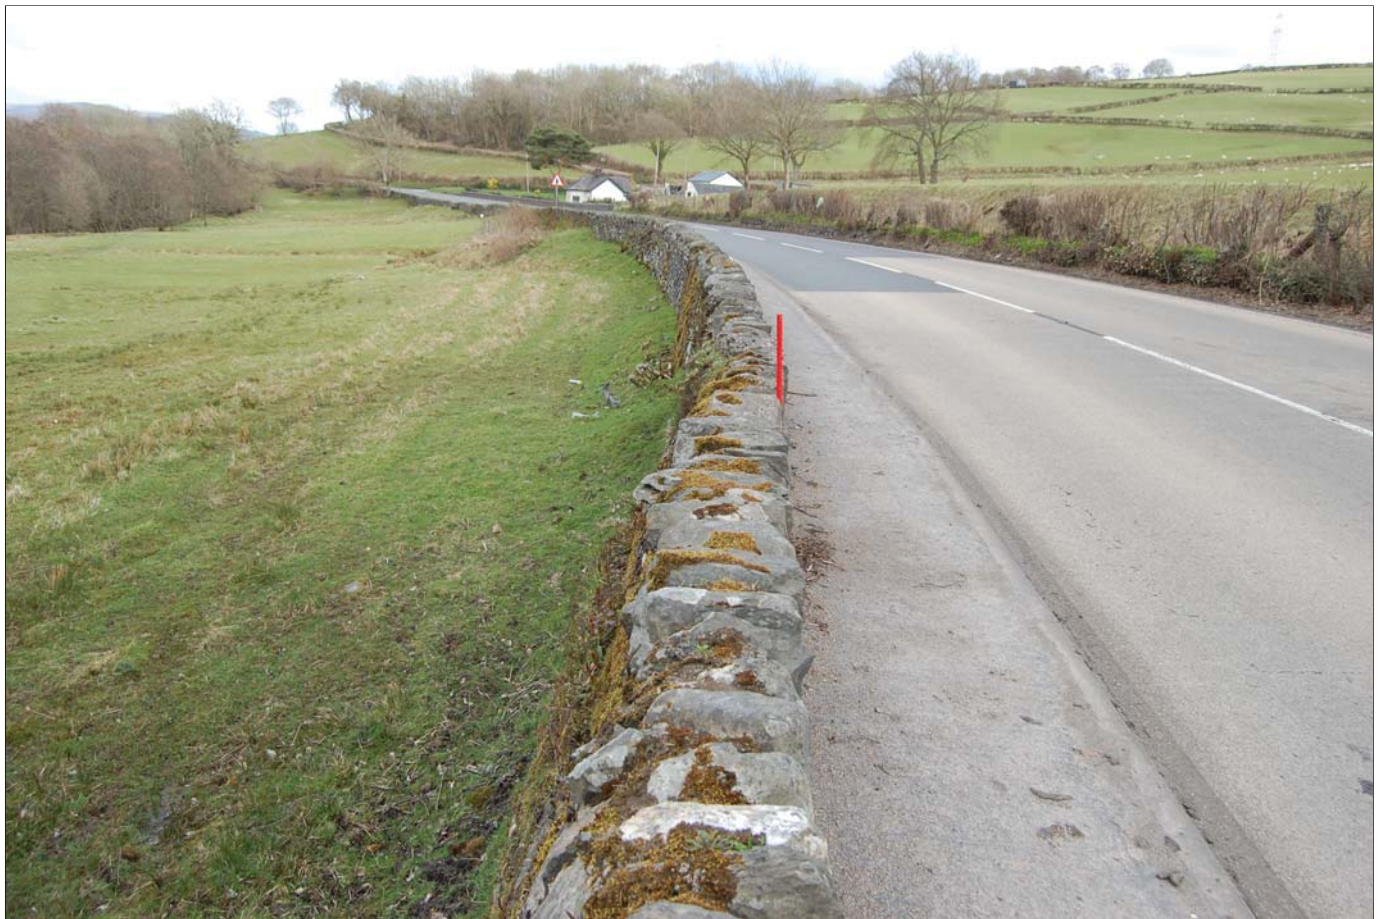
Plate 10 - London to Holyhead road Milestone 63 in its original location at Chainage 520. The ranging pole is in the same location as Plate 09. The original embankment can be seen to the left of the wall.

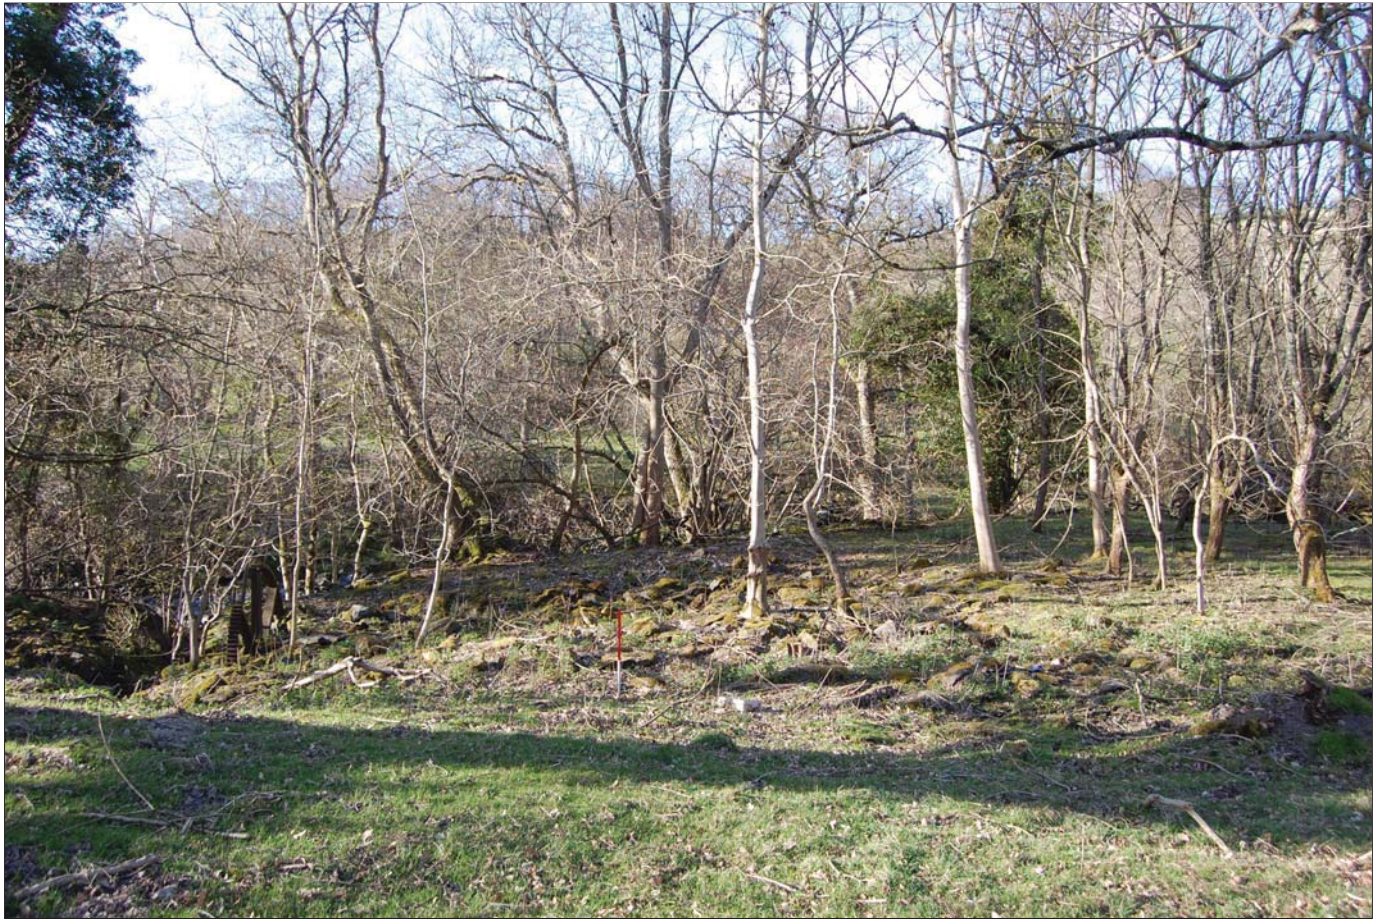
The Glanalwen Saw Mill (NPRN 40911; **SJ02504397**) was built during the mid-nineteenth century by the Rûg Estate as a saw mill and was in use until at least the mid-twentieth century. The is now demolished, although some of the mill machinery, mill race, outbuildings and mill weir all survive in good condition between 1m and 20m south of the proposed scheme. The mill was recorded by the RCAHMW prior to demolition.

Substantial concrete foundations survive of the latest phase of the Glanalwen saw mill: these appear to include a ramped loading platform and storage facility that were part of the timber yard visible on the 2nd Edition 25" County Series Ordnance Survey map of the area (Denbighshire Series Sheet XI.2).

Plate 11 - Location of Glanalwen Saw Mill immediately north of the Afon Alwen. The Mill wheel pit and associated machinery drive wheel can be seen to the left of the image.

As it appears that they cannot be avoided to accommodate the scheme, it is recommended that these features are recorded in advance of the works and all scheme groundworks at this location are subsequently monitored to allow additional recording of subsurface remains, particularly foundations.

Recommendations for further assessment: Detailed Recording prior to main works.

Recommendations for mitigatory measures: Watching Brief during main works/additional recording.

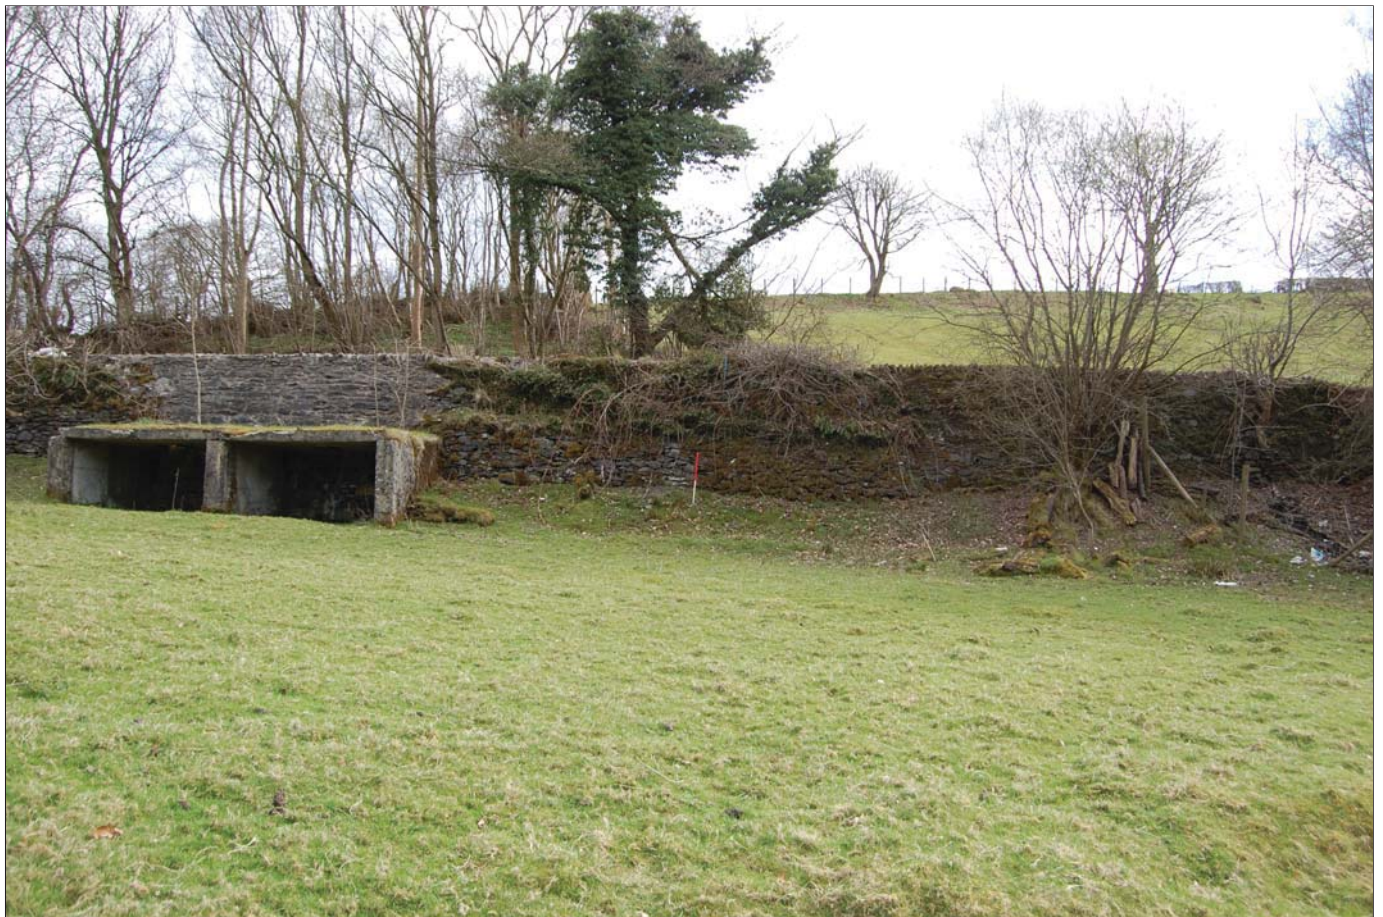
Plate 12 - The north face of the retaining wall at Chainage 120 showing different phases of repair identified during the archaeological assessment. The open fronted concrete structure is recorded on Scheme Drawing S/206/DT 001 (DRAFT) as 'Concrete pump house'.

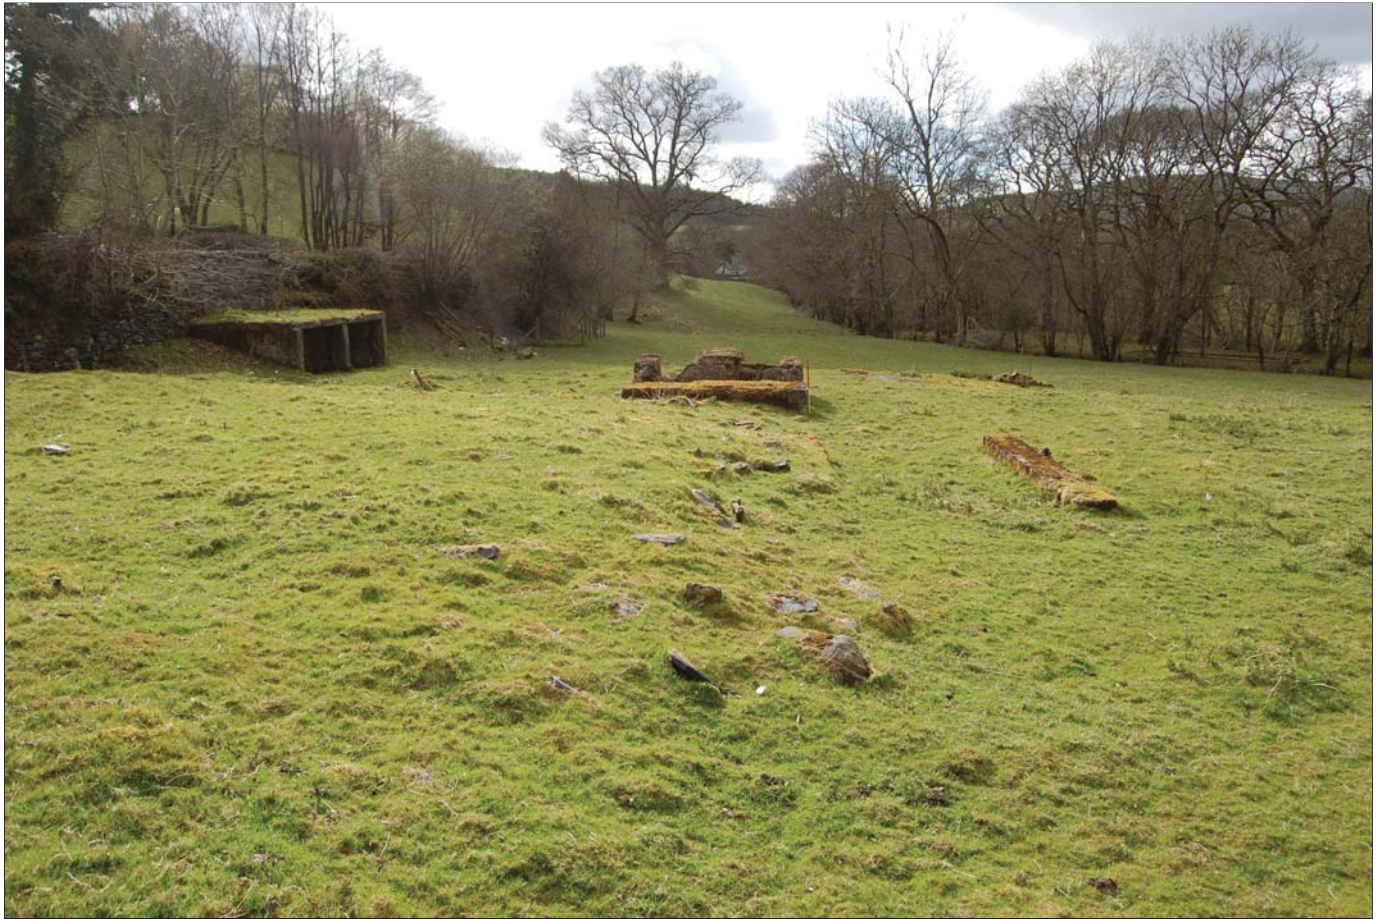
Plate 13 - View westwards of the Post-Medieval structures to the north of the retaining wall between Chainage 70 and Chainage 120.

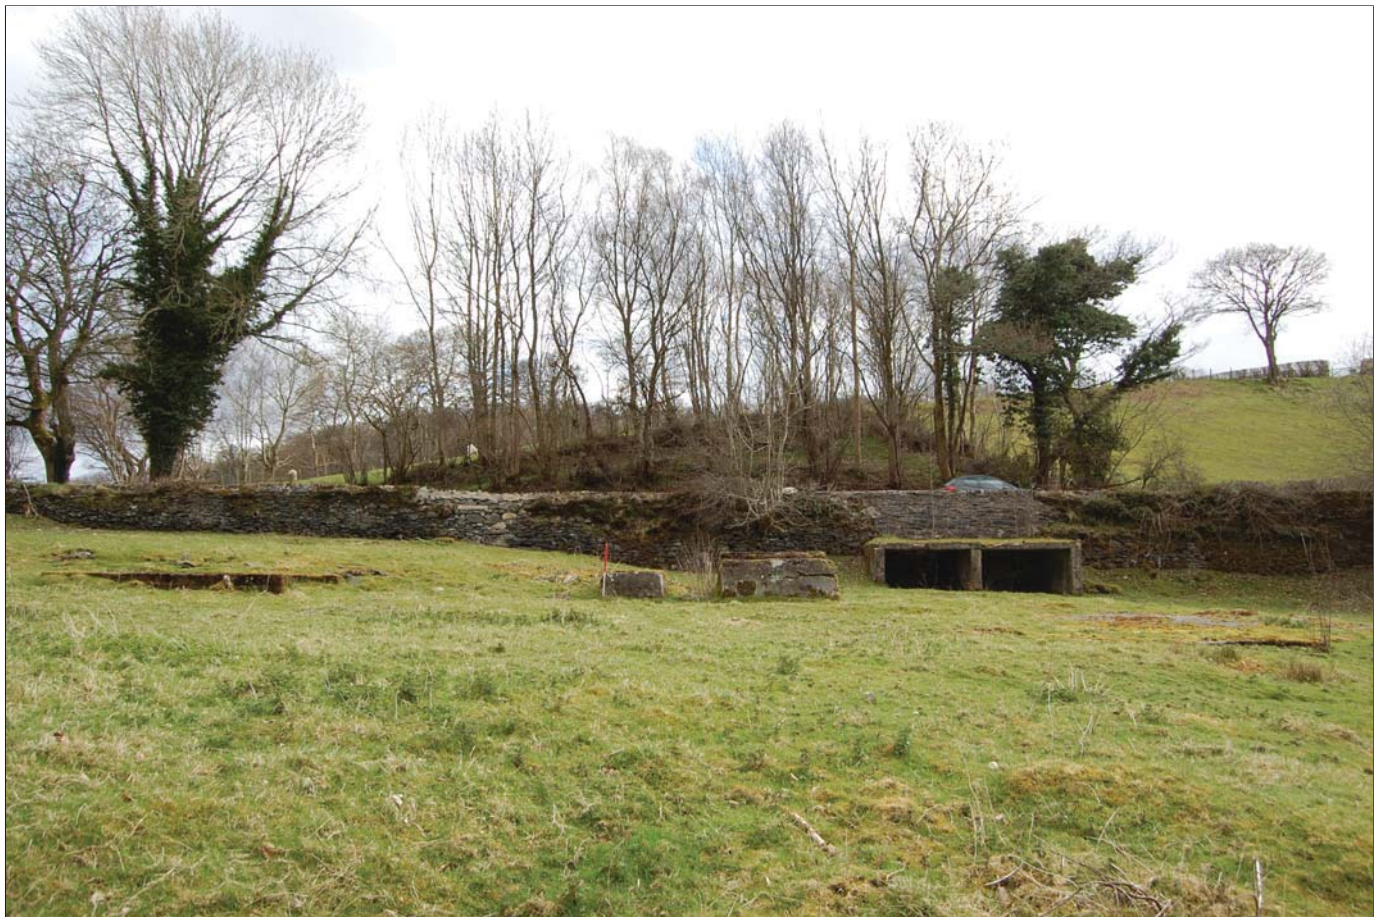
Plate 14 - View southwards of the Post-Medieval structures to the north of the retaining wall between Chainage 70 and Chainage 120.

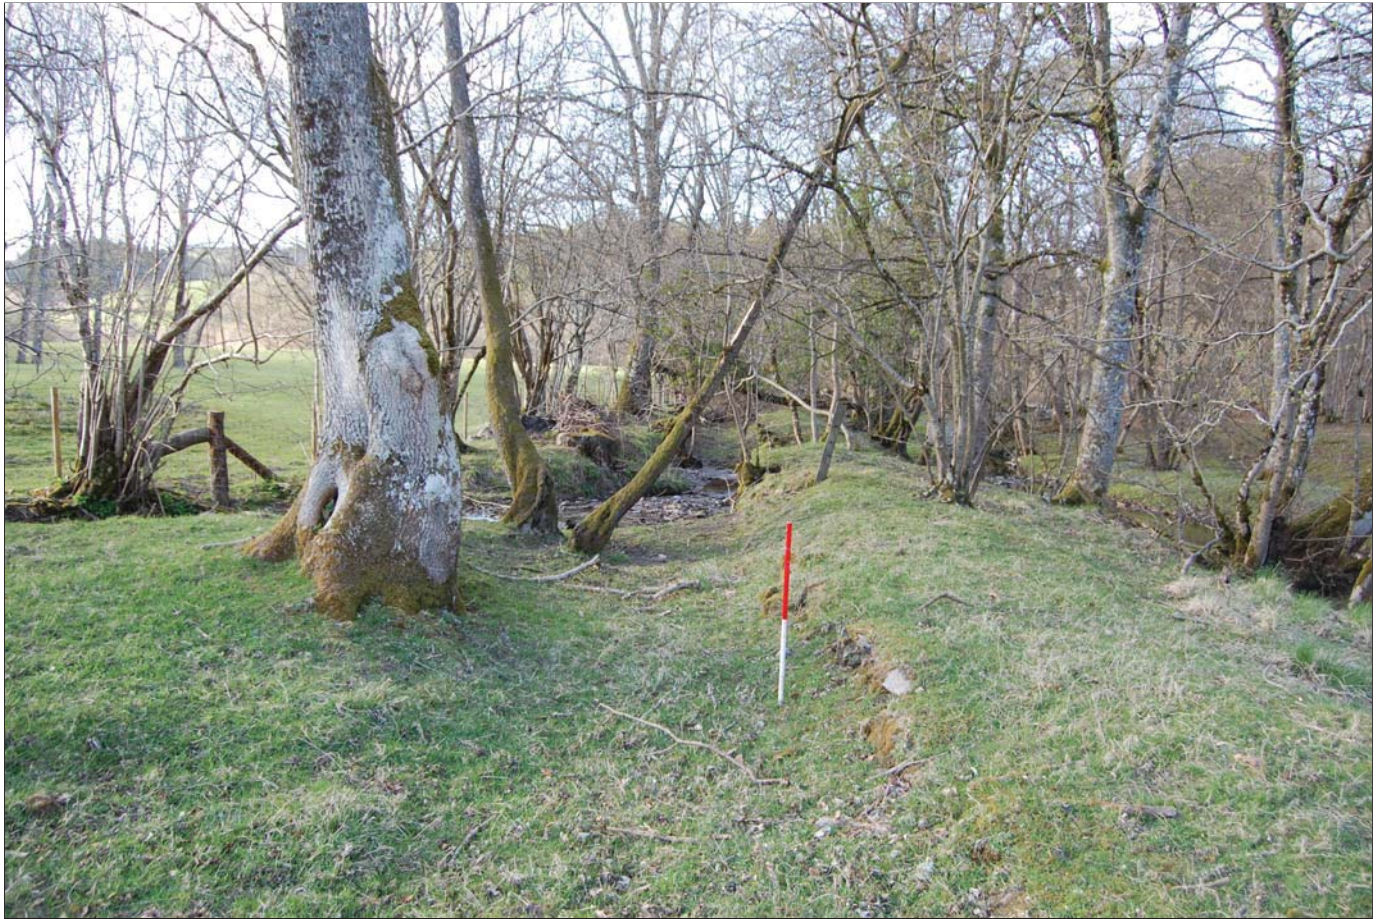
The 493m long mill race which fed the Glanalwen saw mill (Feature 3) survives relatively intact from NGR SJ02484397 to SJ02174415. Constructed as a lined channel, it has been broken through by a series of water channels diverting water off the A5. The drain hole to allow the water to be diverted back into the Afon Alwen for maintenance of the race and the mill still survives.

Plate 15 - View westwards of the Glanalwen Saw Mill Mill Race to the east of its take off point from the Afon Alwen. The remains of the inner stone facing of the Mill Race can be seen to the right of the ranging pole. Nant Heulog is visible entering centre left of the image to drain into the Afon Alwen and also formerly into the Mill Race.

It appears from YGC drawing S/206/DT 001 (Draft) that the feature will not be directly impacted by the embankment. It is recommended that indirect impact from groundworks traffic and material storage is avoided and that this is monitored as part of the general archaeological watching brief mitigation programme.

Recommendations for further assessment: None

Recommendations for mitigatory measures: Avoidance/Watching Brief during main works in the area.
