A5 Cymro Gate Retaining Wall, Cymro Gate, Gwynedd

Archaeological Assessment

Project No. G2321

Report No. 1137

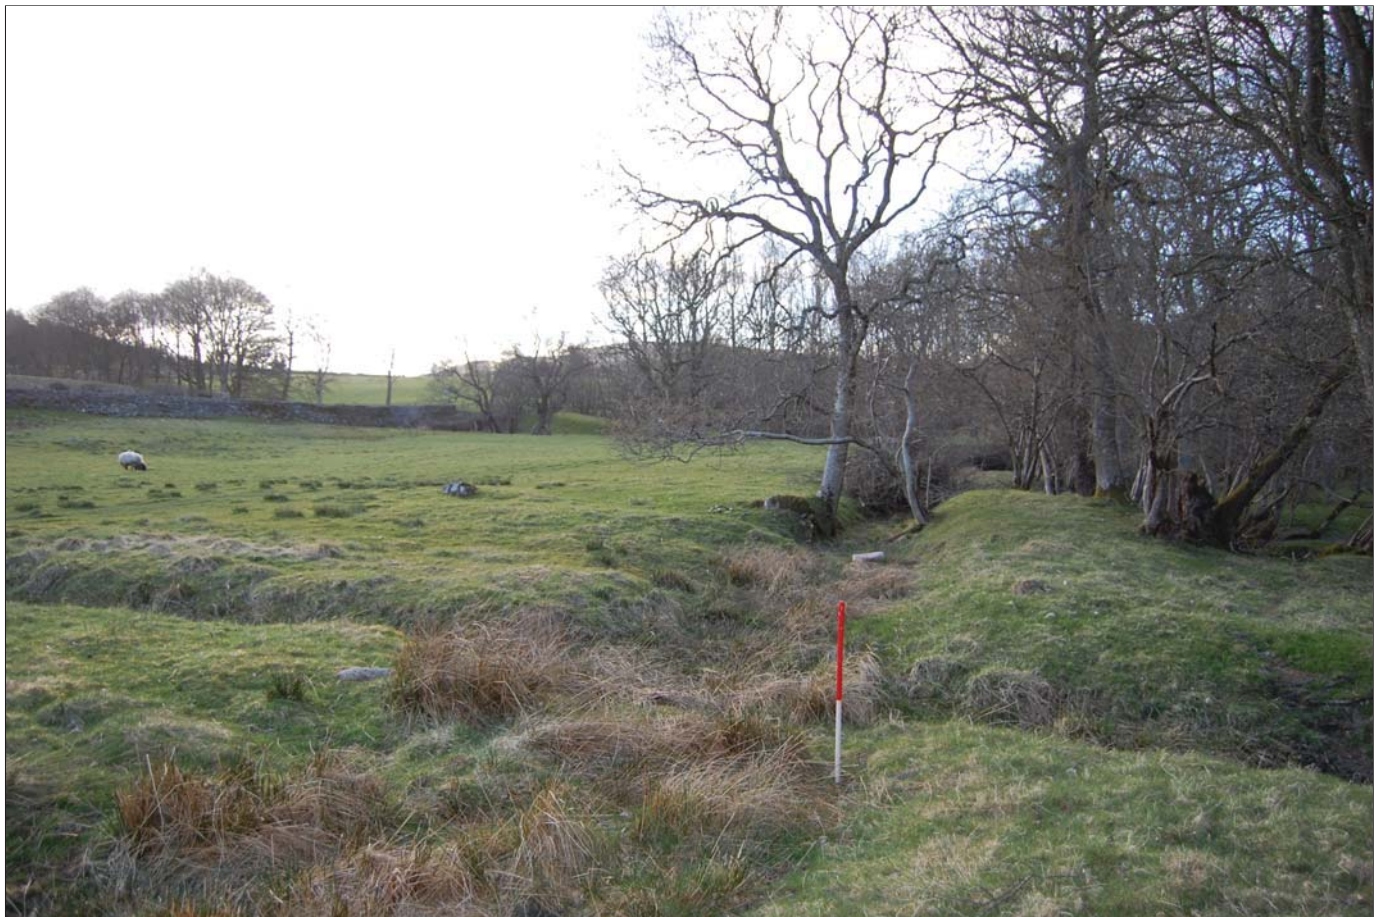
The 493m long mill race which fed the Glanalwen saw mill (Feature 3) survives relatively intact from NGR SJ02484397 to SJ02174415. Constructed as a lined channel, it has been broken through by a series of water channels diverting water off the A5. The drain hole to allow the water to be diverted back into the Afon Alwen for maintenance of the race and the mill still survives.

Plate 16 - View westwards of Glanalwen Saw Mill Mill Race. The Mill Race has been cut by a road surface water drainage channel which runs from Chainage 450.

It appears from YGC drawing S/206/DT 001 (Draft) that the feature will not be directly impacted by the embankment. It is recommended that indirect impact from groundworks traffic and material storage is avoided and that this is monitored as part of the general archaeological watching brief mitigation programme.

Recommendations for mitigatory measures: Avoidance/Watching Brief during main works in the area.

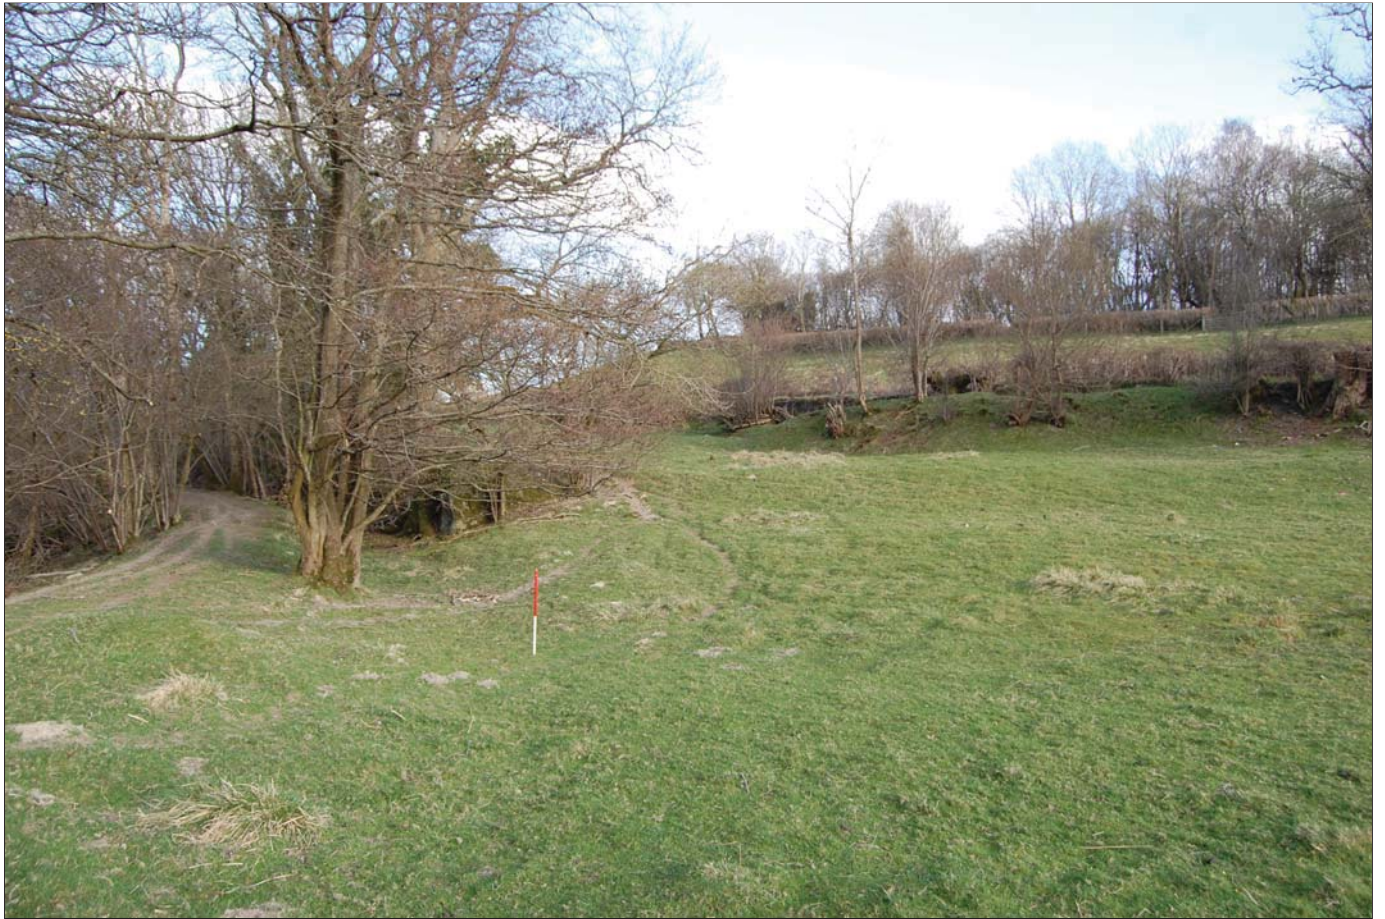
Plate 17 - Former line of the Glanalwen Saw Mill Mill Race looking eastwards at approximately Chainage 230. The ranging pole marks the approximate line of the northern edge of the Mill Race.

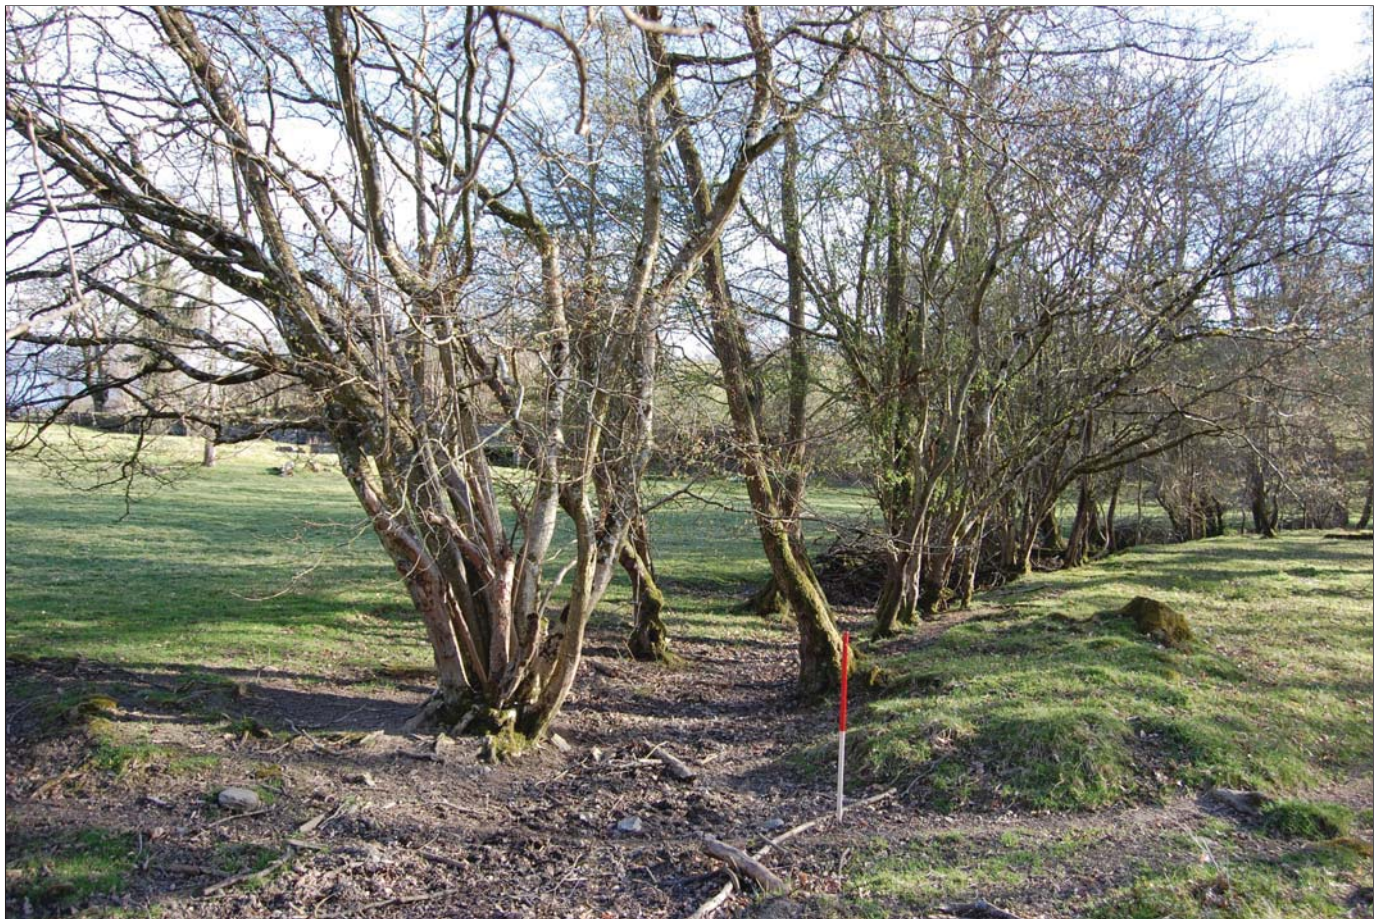
Plate 18 - Former line of the Glanalwen Saw Mill Mill Race. The Glanalwen Saw Mill Wheel Pit is immediately behind the photographer.
