Porth-Yr-Aur Promenade Ground Investigation Works, Caernarfon

Archaeological Watching Brief

Project No. G2340

Report No. 1140

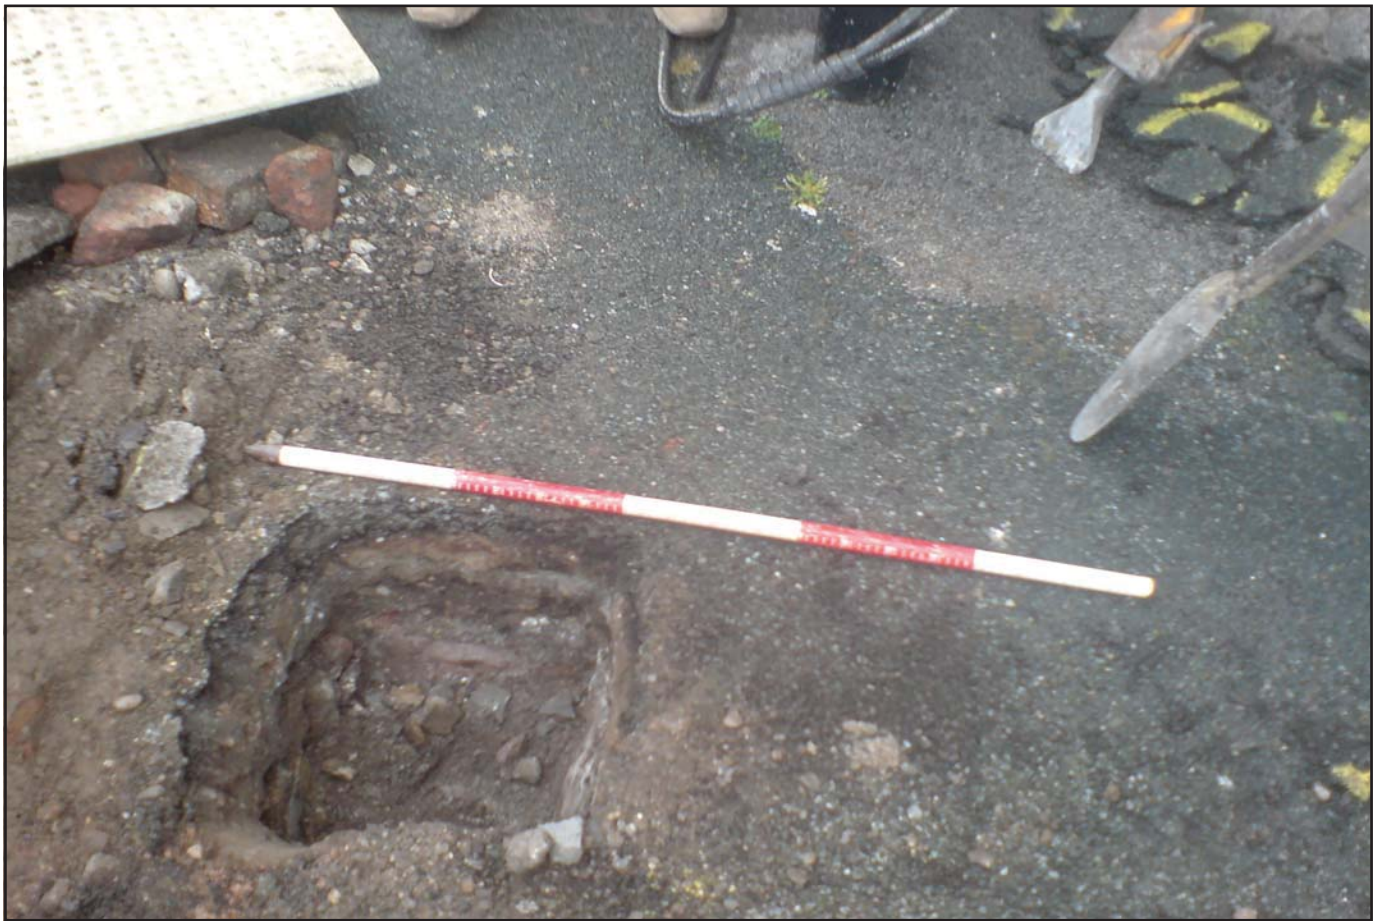
Plate 01 - Test pit measuring 0.50m x 0.50m opened in the planned location of BH1 (SH4766062853)

In order to prove ground conditions in this location a test pit measuring 0.50m x 0.50m was opened in the planned location of **BH1** (Plate 01).

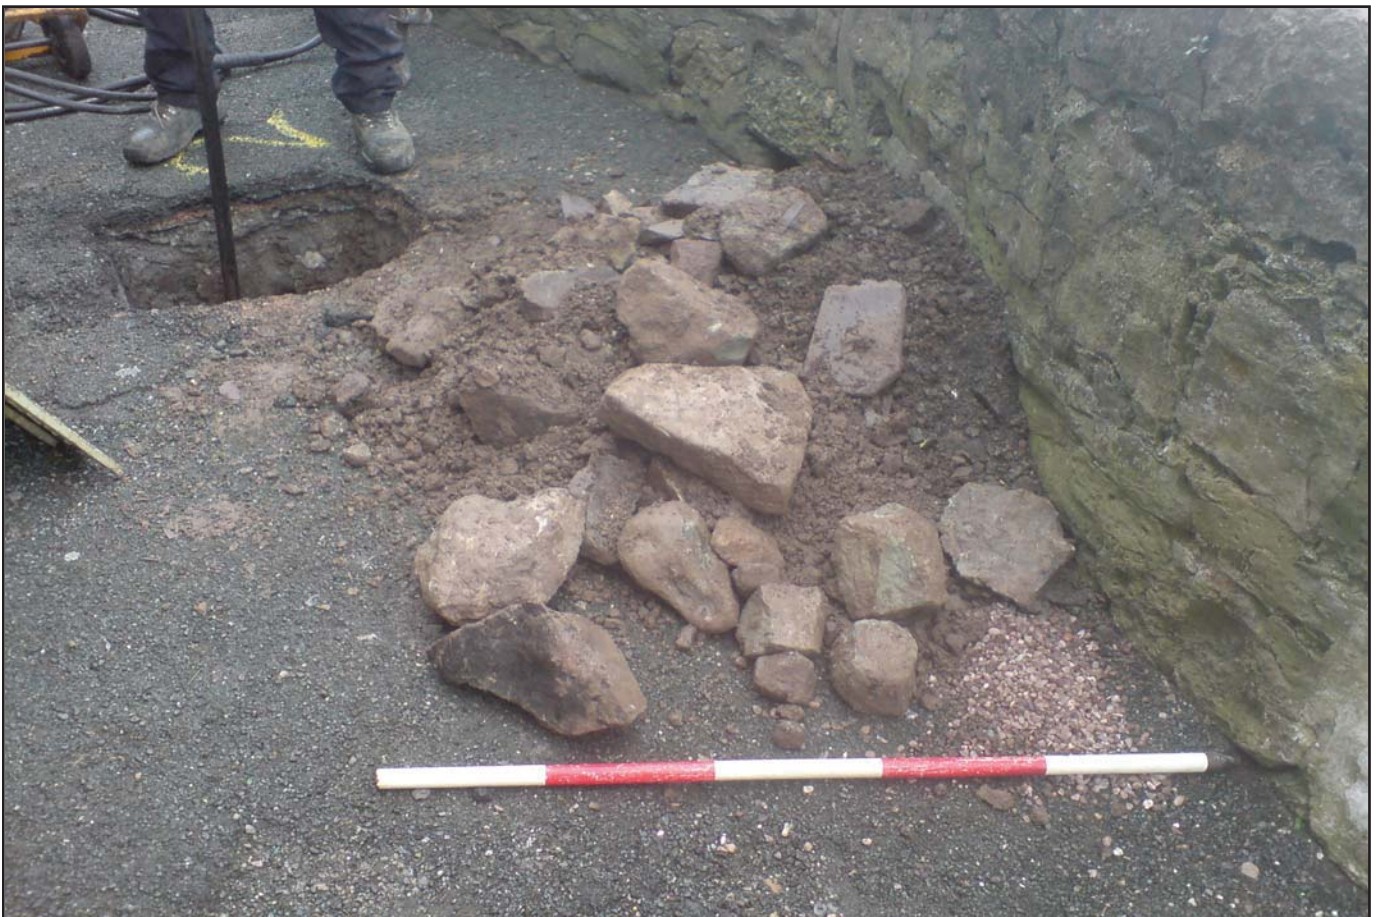
The upper layer of **BH2** was a low quality mid grey tarmac which was a maximum depth of 0.05m. Below this was a layer which consisted of angular stones up to 0.40m (l) x 0.30m (w) x 0.10m (d), broken roofing slates and mortar fragments. This layer continued to 0.70m when the maximum workable depth of the pit was reached.

Plate 02 - Test pit measuring 0.50m x 0.50m opening the planned location of BH2 (SH4766762852)

In order to prove ground conditions in this location a test pit measuring 0.50m x 0.50m was opened in the planned location of **BH2** (Plate 02).

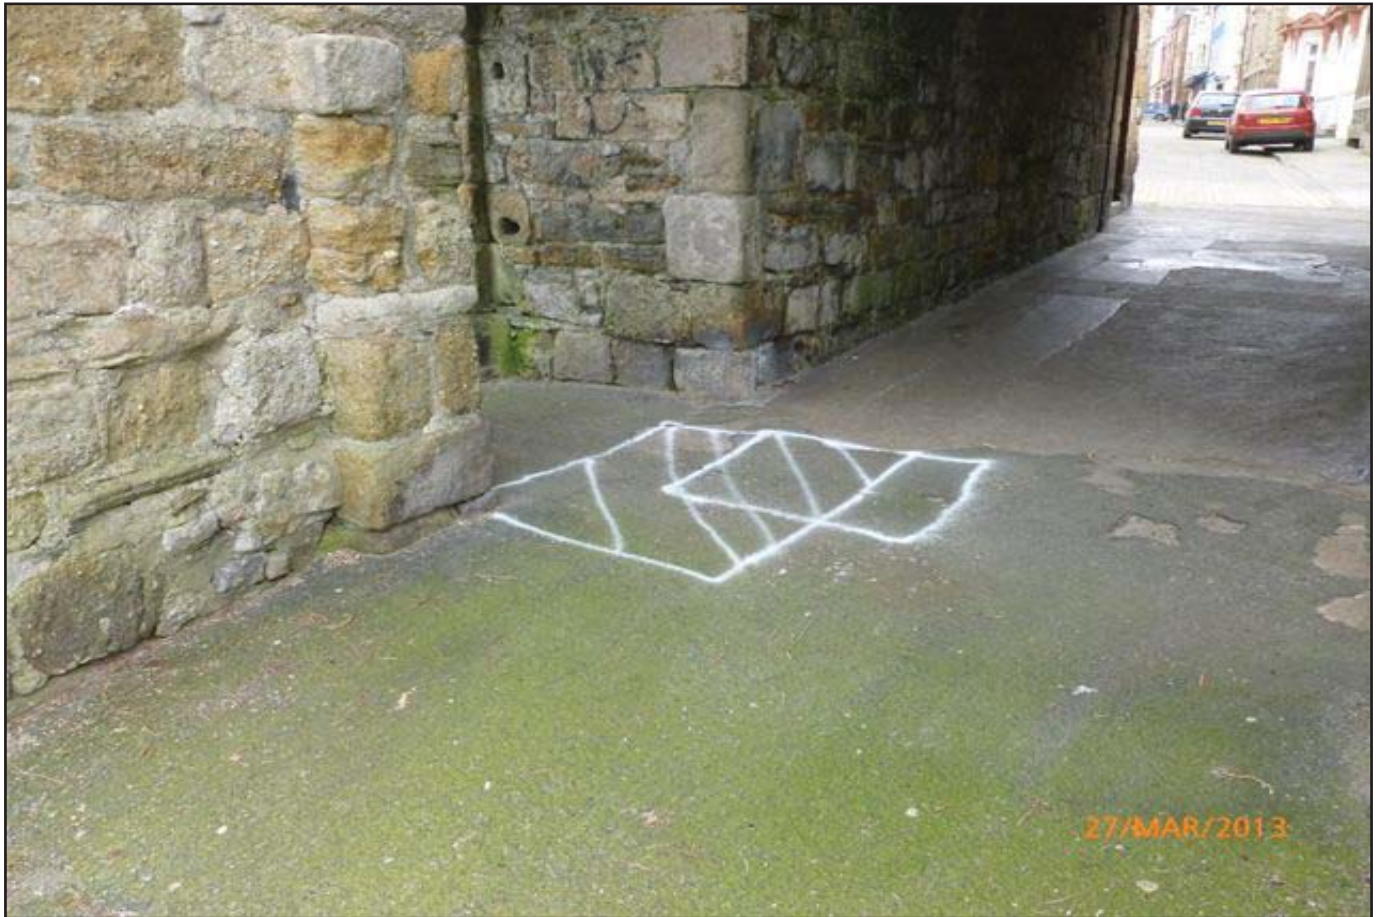
Plate 03: Planned location of TP1 within the Barbican of Porth Yr Aur (SH4766462849).
Image Courtesy of Jenny Emmett, Gwynedd Archaeological Planning Services

In order to locate a surface water drain, Test Pit **TP1** was opened within the Barbican of Porth yr Aur. The position was revised from that originally planned in the GI design and a smaller area was opened (Plate 03 original marked position / Plate 04 revised and excavated position). The pit was positioned to incorporate the northern eastern inner corner of the Barbican. The revised position was recorded by YGC but not provided to GAT by the date of the production of this report. The tarmac surface was broken with a jack hammer and excavated by hand.

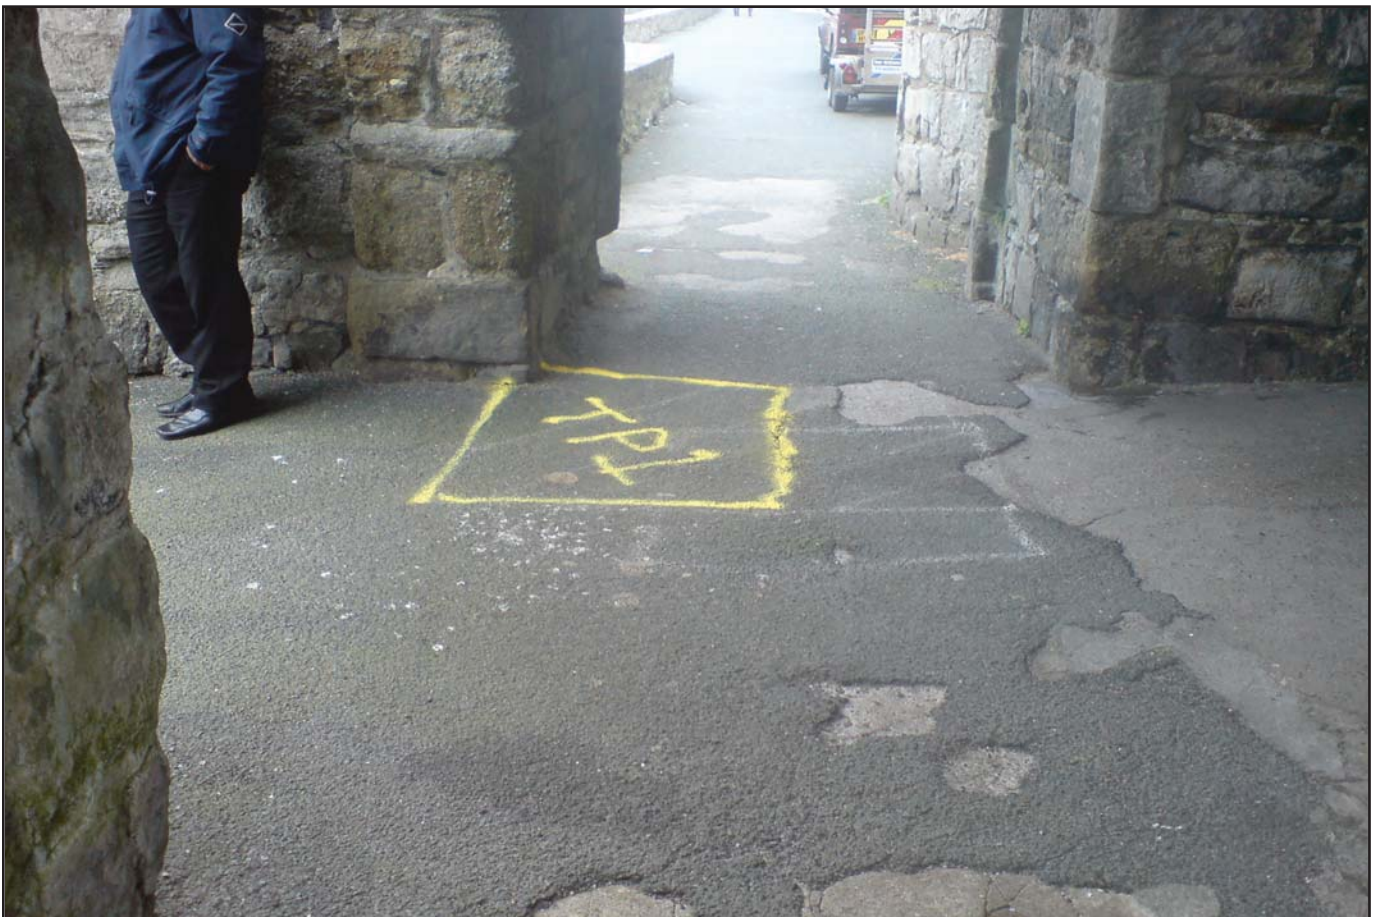
Plate 04: Actual location of TP1 within the Barbican of Porth Yr Aur.

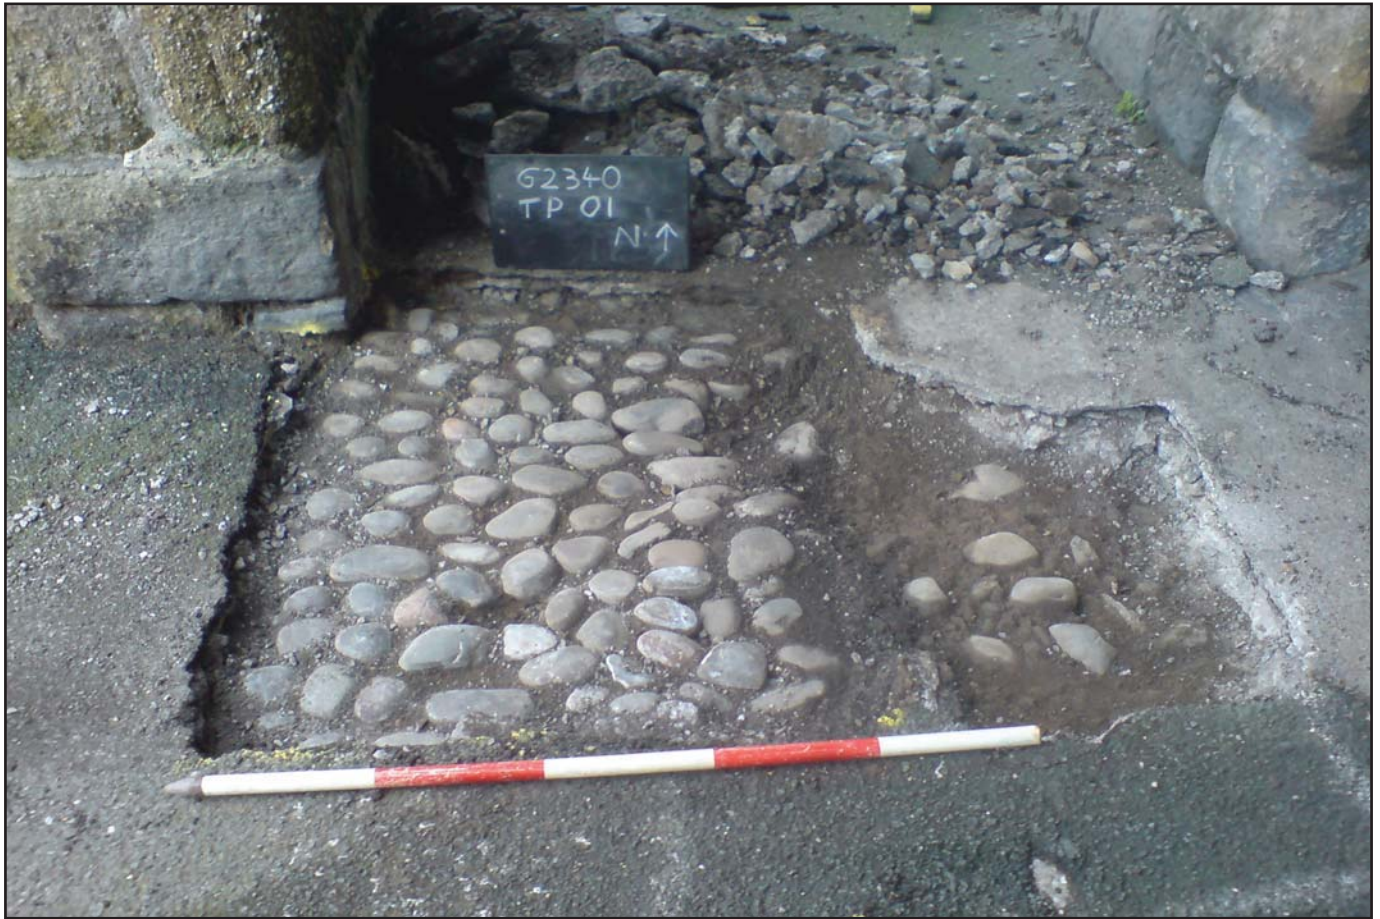
TP1 revealed a well preserved cobbled surface immediately below the tarmac which was left intact. In the south east corner of **TP1** a vertical steel bar, similar to those used in reinforcement works was revealed and appeared to be in situ.

The Cobbled Surface found in **TP1** is not visible on any of the photographs examined during the research for this report. The most likely date for their laying is during the renewal and repair of Porth-Yr-Aur in the 1870s, as they would have aided the east- west surface water drainage of High Street. The holes in the promenade wall to the north west and south west of Porth-Yr-Aur would have allowed this water to run into the sea. The very disturbed and patched area which extends from inside the central passage of Porth-Yr-Aur to the Promenade wall suggests that the drainage exiting the town, of both surface and subsurface water has caused repeated problems at this point, as visible by the steel reinforcement bar uncovered in the south east corner of **TP1**.

Plate 05: Intact cobbled surface uncovered immediately below the tarmac in TP1 within the Barbican of Porth Yr Aur.

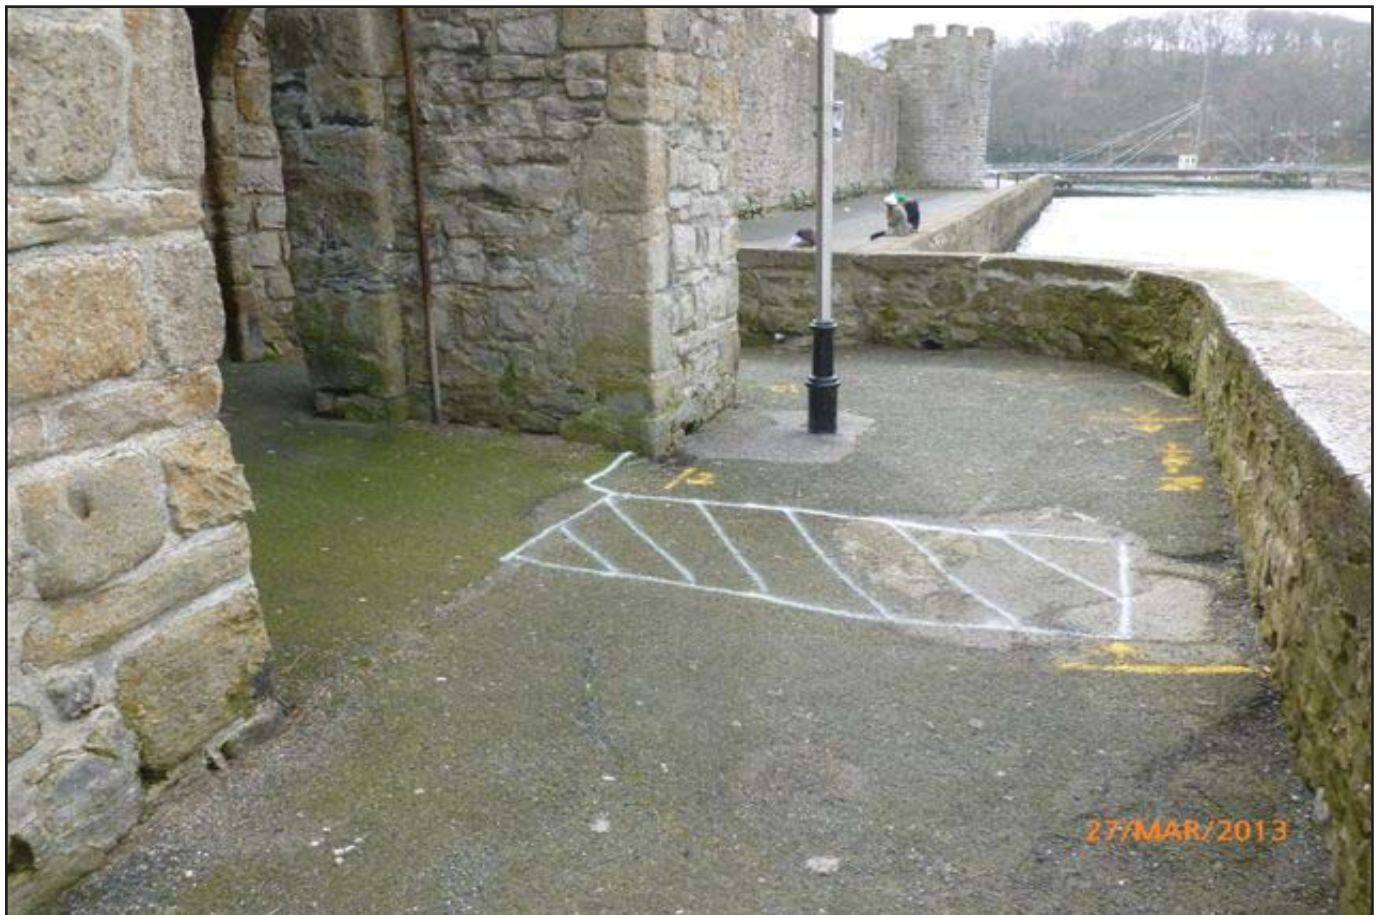
Plate 06: South western Drain Hole in wall of Promenade close to the Barbican of Porth Yr Aur
Image Courtesy of Jenny Emmett, Gwynedd Archaeological Planning Services

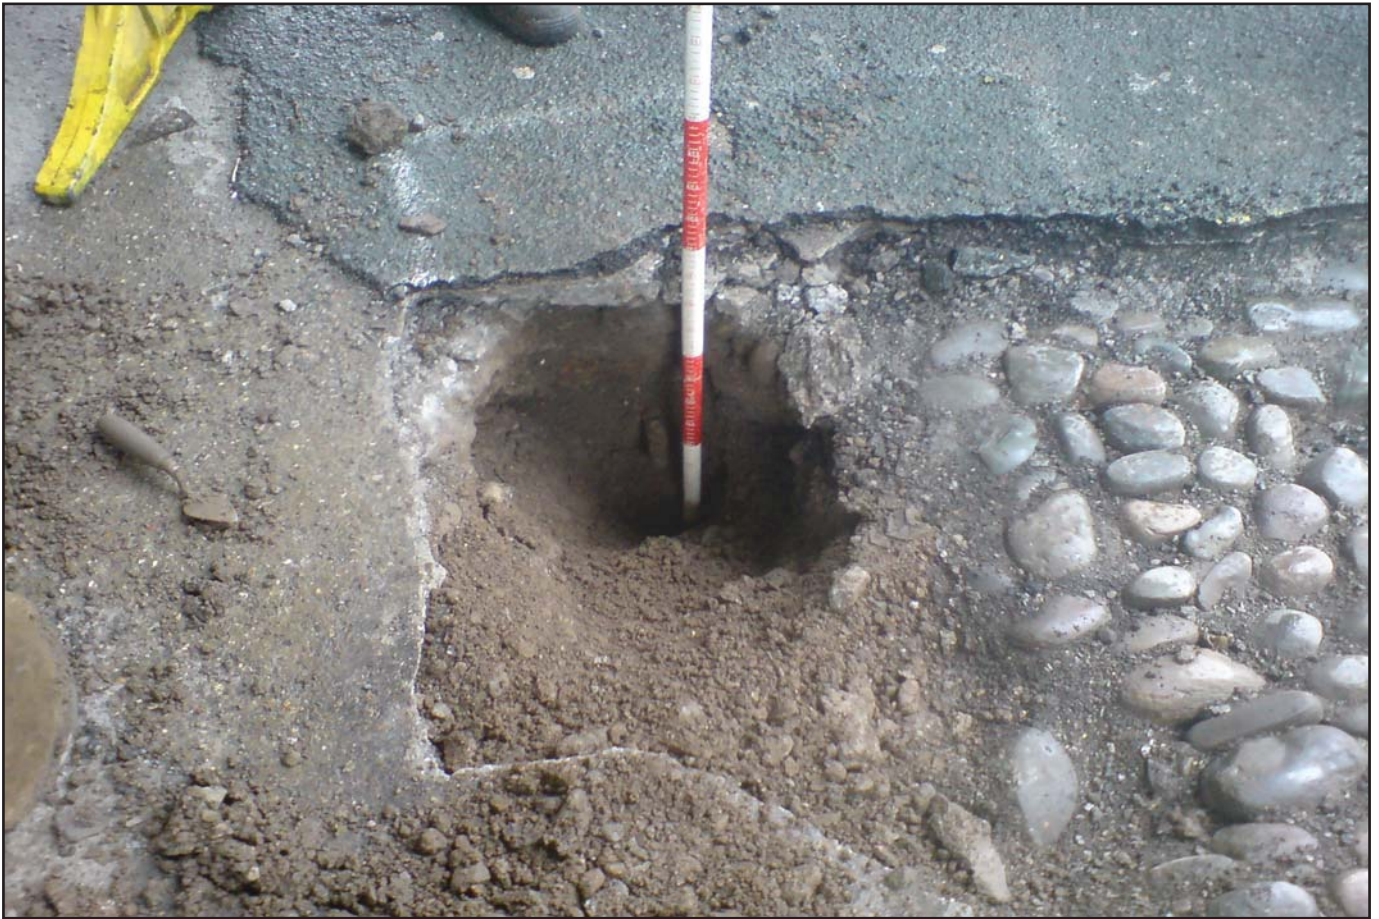
The steel reinforcement bar uncovered in the south east corner of **TP1** and the very disturbed and patched area which extends from inside the central passage of Porth-Yr-Aur to the Promenade wall suggests that the drainage exiting the town, of both surface and subsurface water has caused repeated problems at this point.

Plate 07: Test Pit opened in south eastern corner of TP1. The steel reinforcing bar is visible in the base of the test pit.

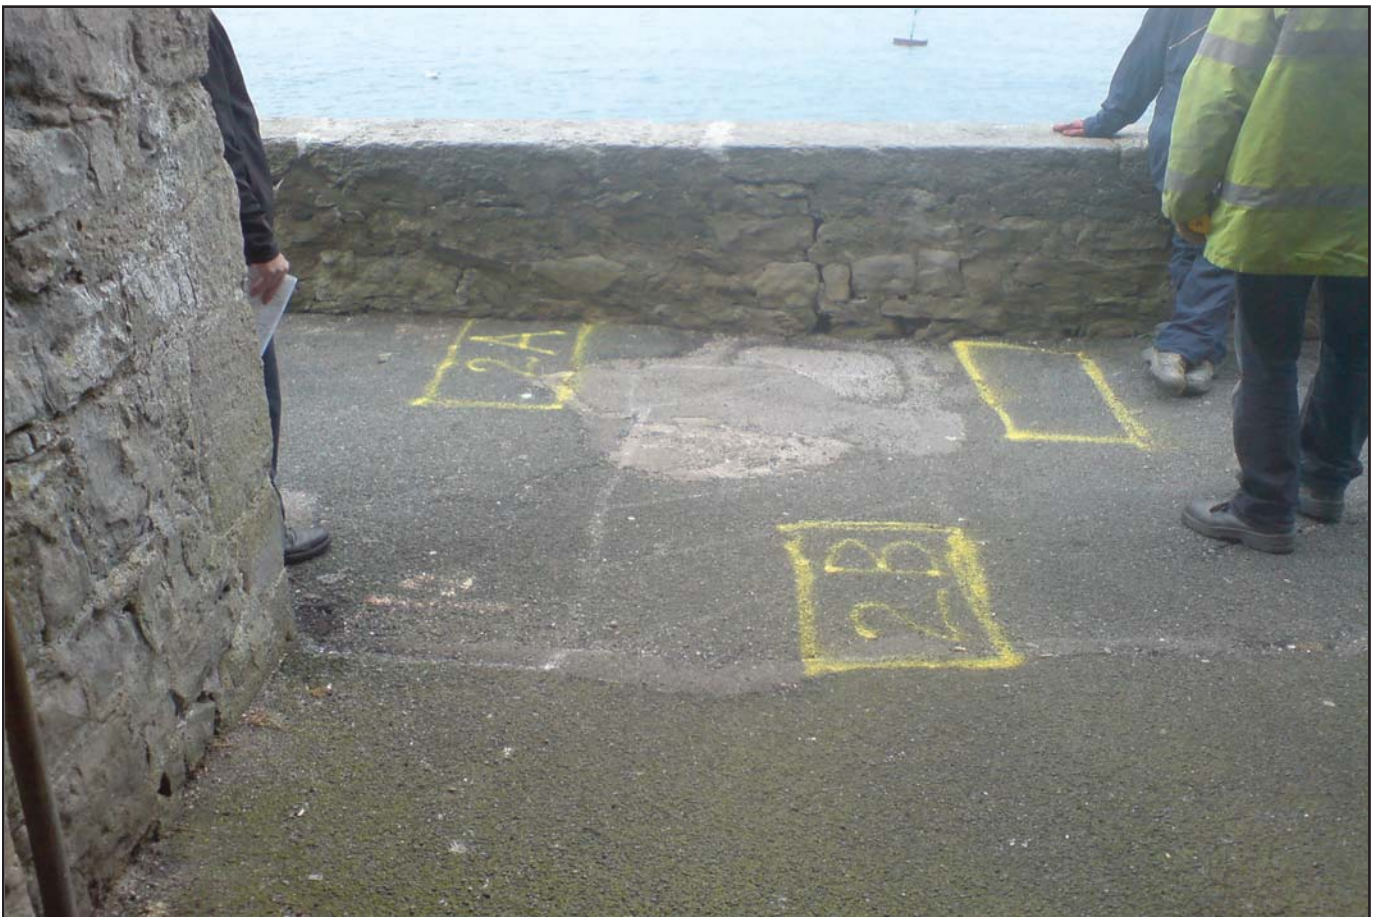
Plate 08: Revised locations of TP2A and TP2B. The proposed location of TP2 is visible as the white sprayed outline on the Tarmac (SH4766462852)

In order to locate an unknown service, Test Pit **TP2A** was opened against the promenade wall. The position was revised from that originally planned in the GI design and **TP2A** and **TP2B** replaced the original, larger proposed TP2 (Plate 08). The revised position was recorded by YGC but not provided to GAT by the date of the production of this report. The tarmac surface was broken with a jack hammer and excavated by hand (Plate 09).

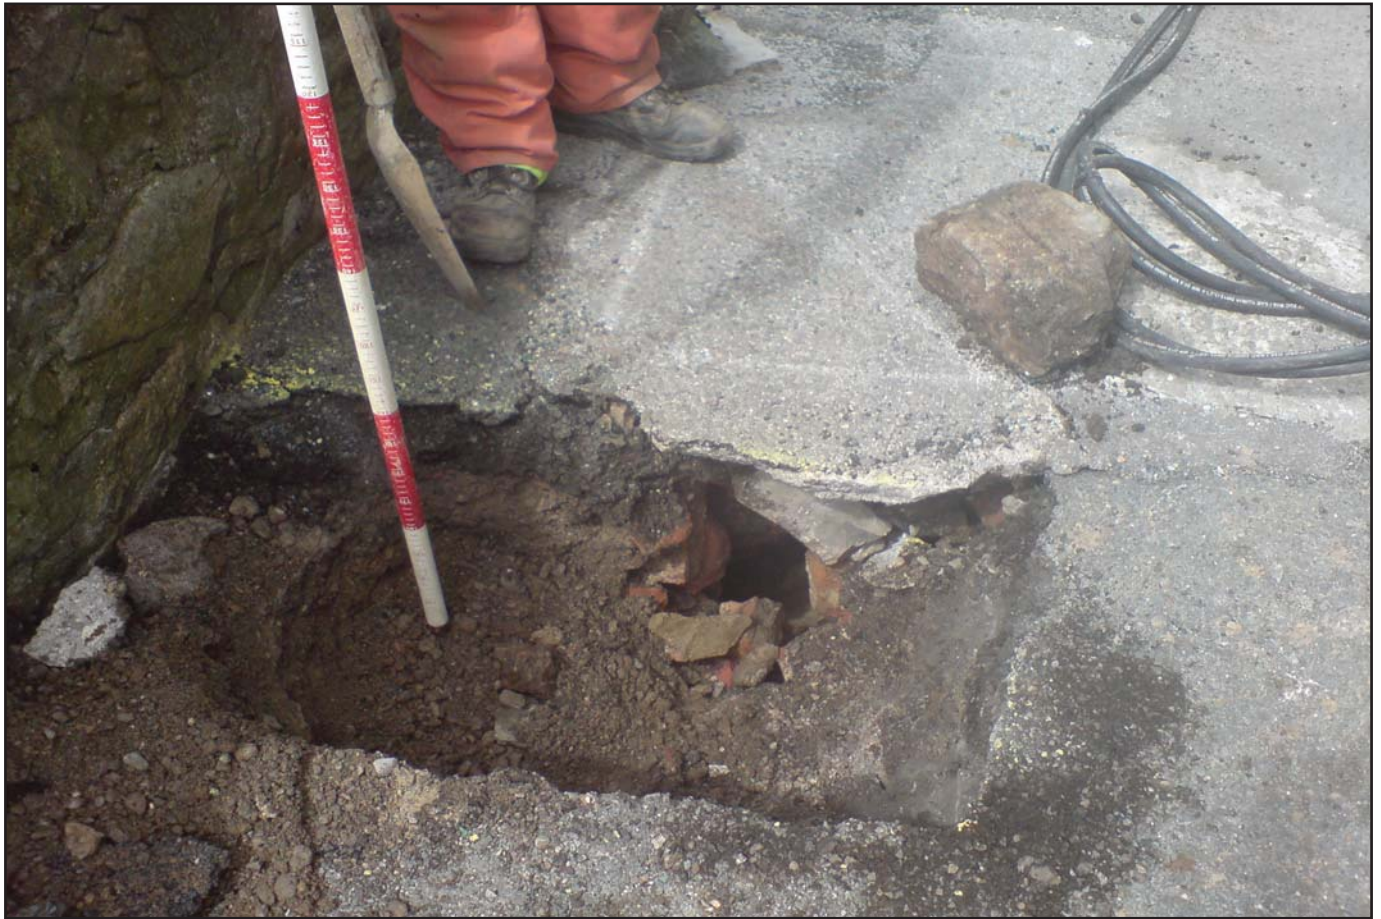
TP2A revealed similar material composition as **TP2B, BH1** and **BH2**, with the north east corner of the pit opening into a void at least 1.00m square and containing a loose fill of broken bricks partly bound by a concrete layer.

The upper layer of **TP2A** was a low quality mid grey tarmac which was a maximum depth of 0.05m thick. Below this was a dark grey to black tarmac 0.10m thick. Immediately below this in the western and southern area of the pit was a layer of mixed backfill containing low quality broken bricks of both light and dark (vitreous) shades of orange, broken pieces of a hard cement (smaller than 0.10m x 0.10m x 0.05m) and pieces of a thin, flexible black tarmac (smaller than 0.05m x 0.05m x 0.02m) .

The north eastern quarter of the pit opened via a hole approximately 0.15m square into a void. The void was examined with a torch and revealed that previous attempts had been made to fill it with broken bricks, broken pieces of a hard cement and a poured or pumped concrete layer, depth of which is was difficult to ascertain but was at least 0.10m. The minimum depth of the void from the visual inspection appeared to be 0.50m in depth, with a minimum length and width of 1.00m. **TP2A** reached a maximum depth of 0.80m.

Plate 09: TP2A open in Porth Yr Aur Promenade showing the upper layers of the made ground behind the Promenade Wall and the opening of the void which extends northwards

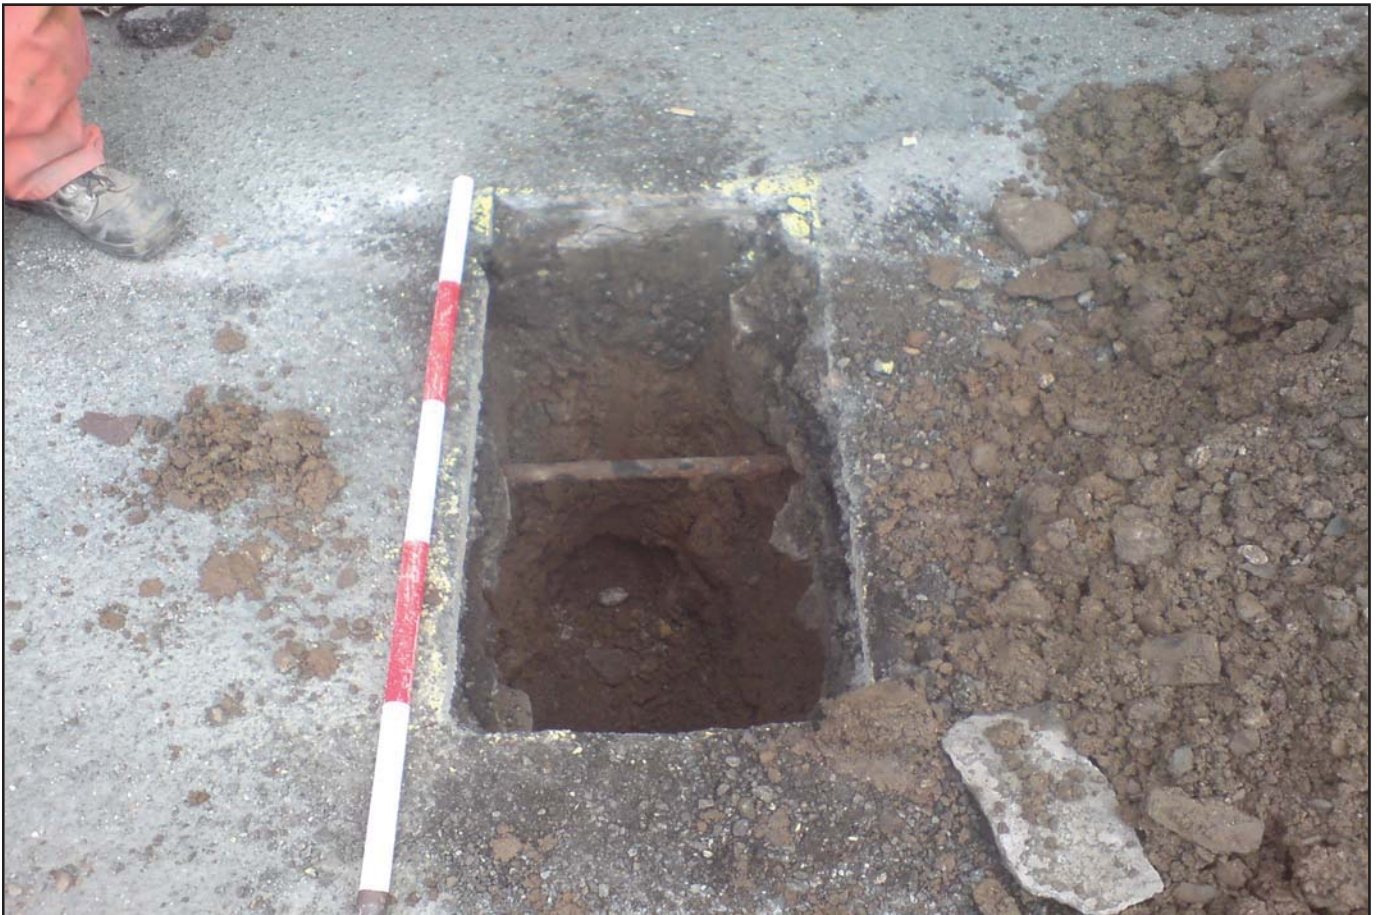
The upper layer of **TP2B** was a low quality mid grey tarmac which was a maximum depth of 0.05m thick. Below this was a dark grey to black tarmac 0.10m thick. The layer beneath consisted of a dark brown sandy clay, fragments of a hard cement with angular inclusion and stones up to 0.05m x 0.05m x 0.03m. Two large worked pieces of stone were recovered from this fill. The service which the GI works wished to locate was found running north-south at a depth of 0.40m. At 0.90m a mortar spread was identified and sample taken for further study. **TP2B** reached a maximum depth of 0.90m.

Plate 10: TP2B open in Porth Yr Aur Promenade showing the location of the service running north-south across the Pit

In order to locate an unknown service, Test Pit **TP2B** was opened on the western edge of the Barbican of Porth Yr Aur. The position was revised from that originally planned in the GI design and TP2A and TP2B replaced the original, larger proposed TP2 (Plate 08). The revised position was recorded by YGC but not provided to GAT by the date of the production of this report. The tarmac surface was broken with a jack hammer and excavated by hand (Plate10).

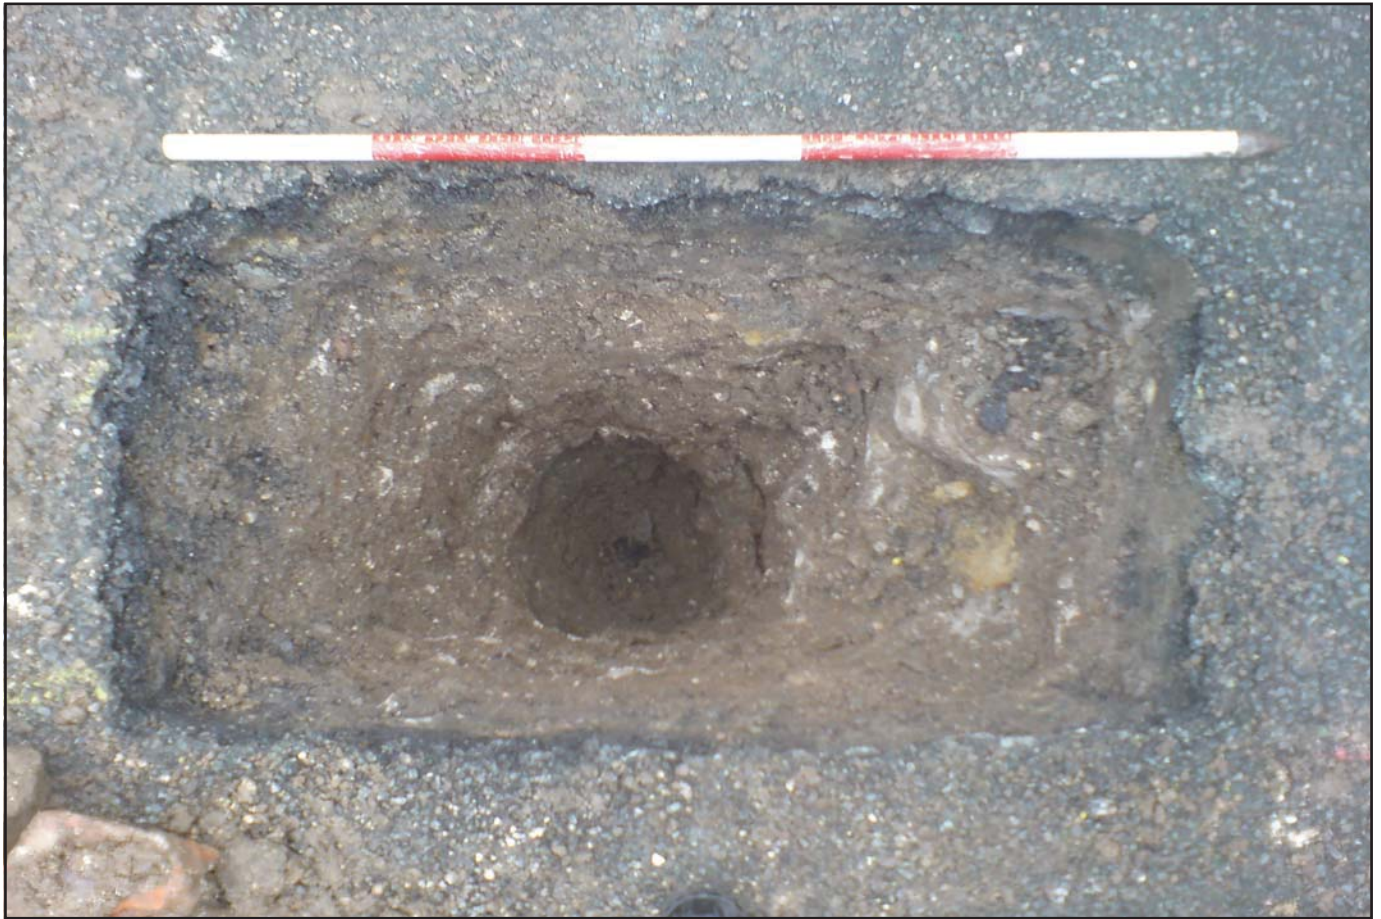
TP3 revealed the composition of the made ground used to infill behind the promenade wall.

The upper layer of **TP3** was a dark grey tarmac which was a maximum depth of 0.10m thick. Below this was made ground consisting of a dark brown clay sand binding together thin purple slate fragments, broken light orange bricks, coarse and angular gravel and mortar fragments. **TP3** reached a maximum depth of 1.43m.

Plate 11: TP3 open in Porth Yr Aur Promenade showing the upper layers of the made ground behind the Promenade Wall

In order to prove ground conditions, Test Pit **TP3** was opened in the surface of the promenade. The position was revised from that originally planned in the GI design and the revised position subsequently recorded by YGC but not provided to GAT by the date of the production of this report (Plate 11). The tarmac surface was broken with a jack hammer and excavated by hand.

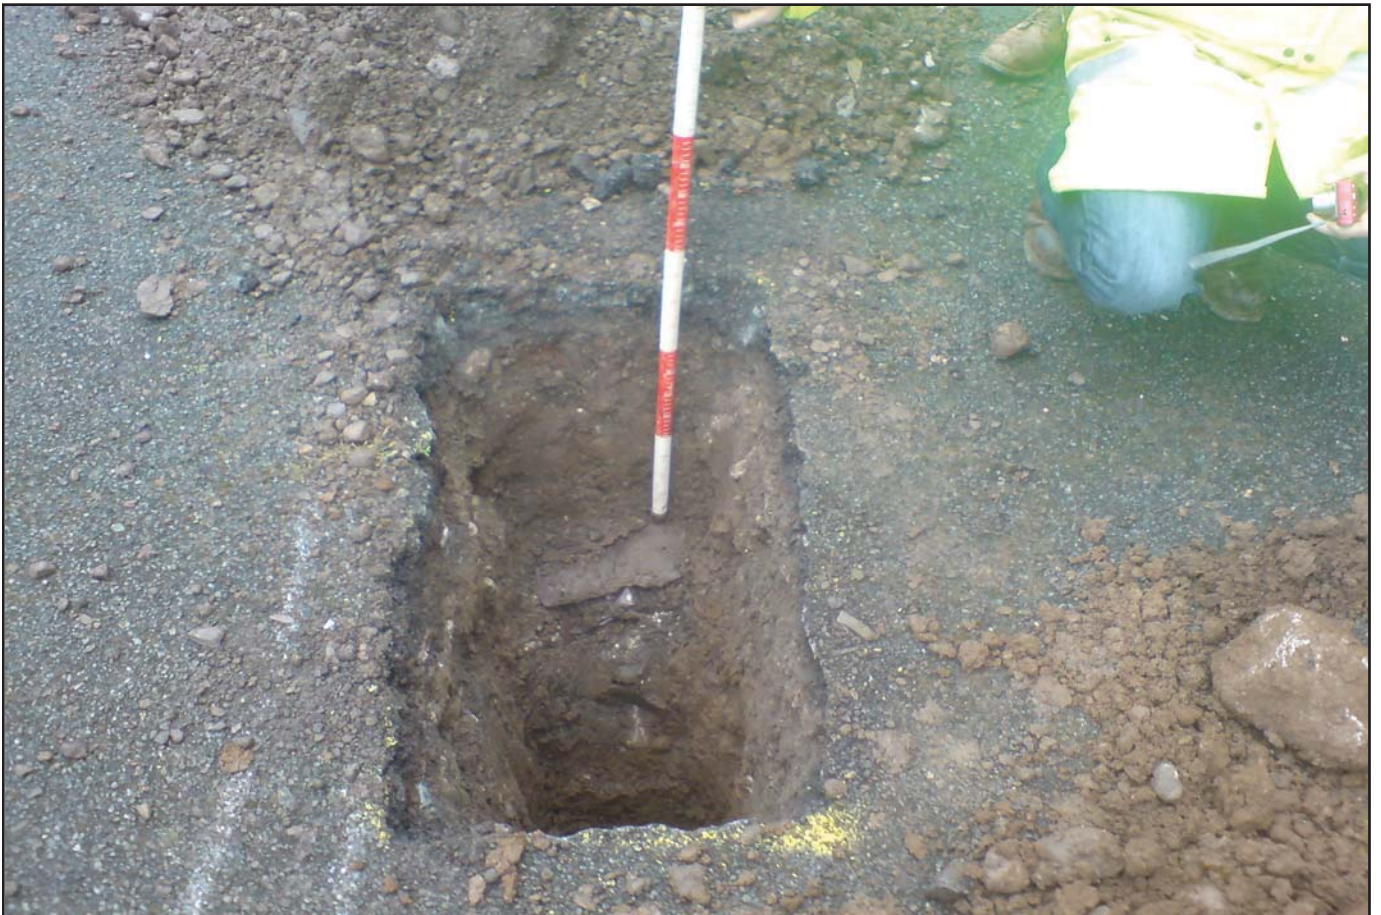
TP4 revealed a slate capped drain running east-west from within the opening of an archway, the voussoirs of which are visible at the base of the town wall. The infill was similar to that encountered in **TP3**.

Only the most recent layers of the construction of the Promenade were encountered in **TP3** and **TP4**. The thin purple slates used for capping the drain found in **TP4** are most likely to have come from the Penrhyn Quarry and aid in part in dating the drain to post 1800, when these beds were being exploited.

Plate 12: TP4 open in Porth Yr Aur Promenade showing the upper layers of the made ground behind the Promenade Wall and the slate capped drain running east-west

In order to prove ground conditions, Test Pit **TP4** was opened in the surface of the promenade. The position was revised from that originally planned in the GI design and the revised position recorded by YGC but not provided to GAT by the date of the production of

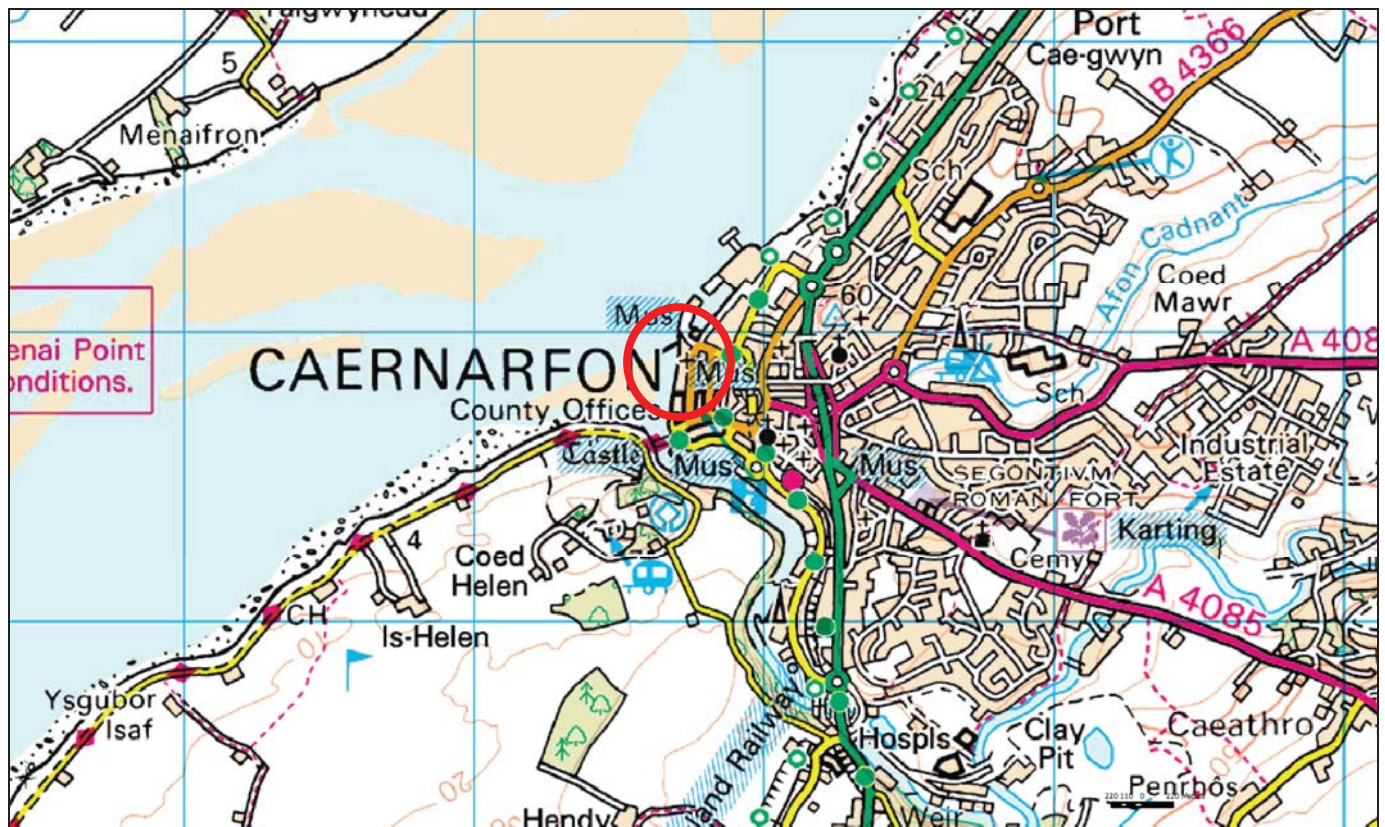
Figure 1. Site Location

A ground investigation is required to provide geotechnical information for the repair of the Porth-Yr-Aur promenade structure in Caernarfon, Gwynedd. A site location drawing is given below.

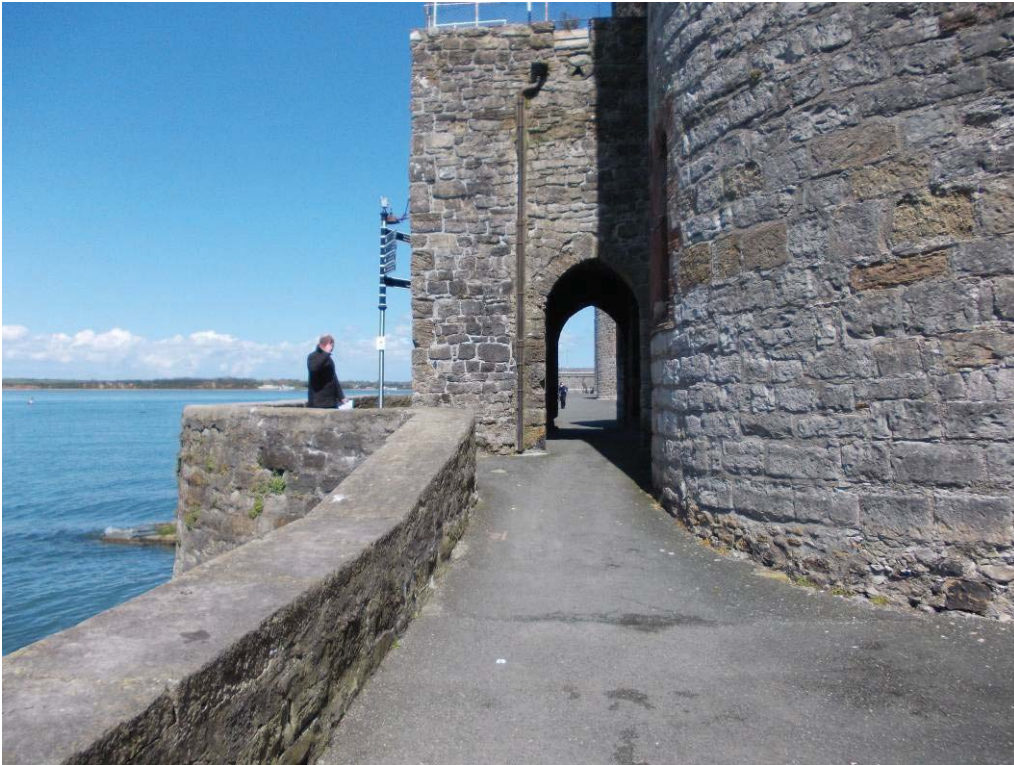
Promenade looking east towards the portico. BH1, BH2 and TP2 are located on the seaward side of the tower, TP1 is located in the archway beneath.

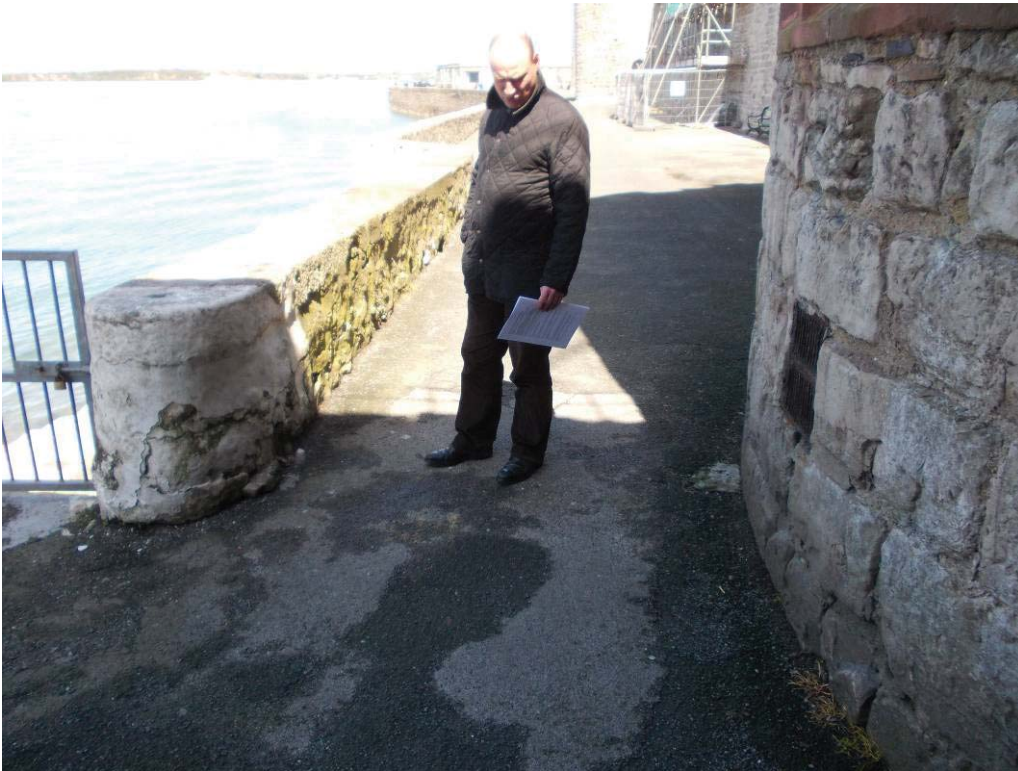
Eastern side of the portico looking east showing narrow access.

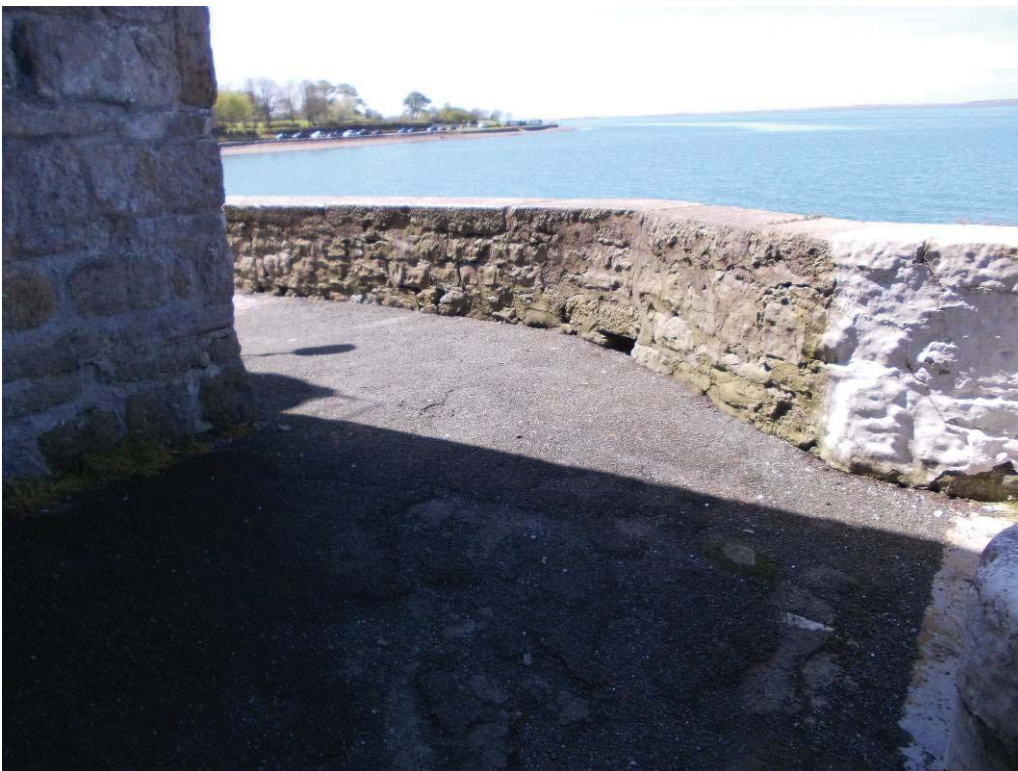
Eastern side of the portico looking north west. Area of BH2.

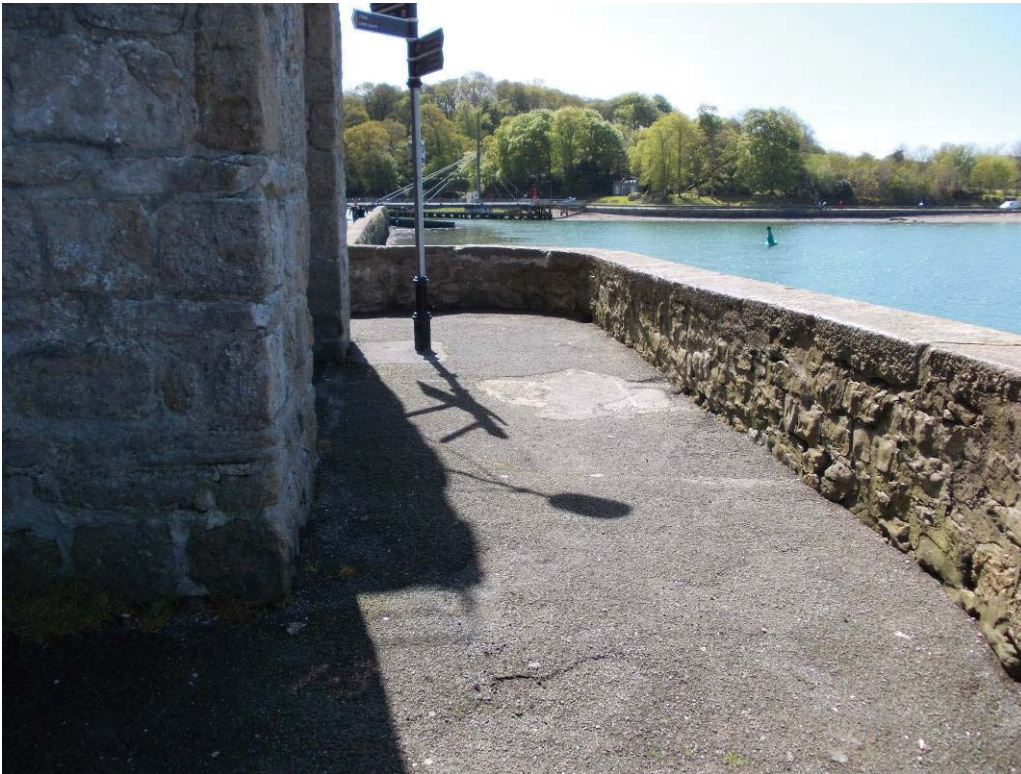
Seaward side of the portico looking west. BH2 is located to the foreground, BH1 to the background, TP2 to is between the boreholes.

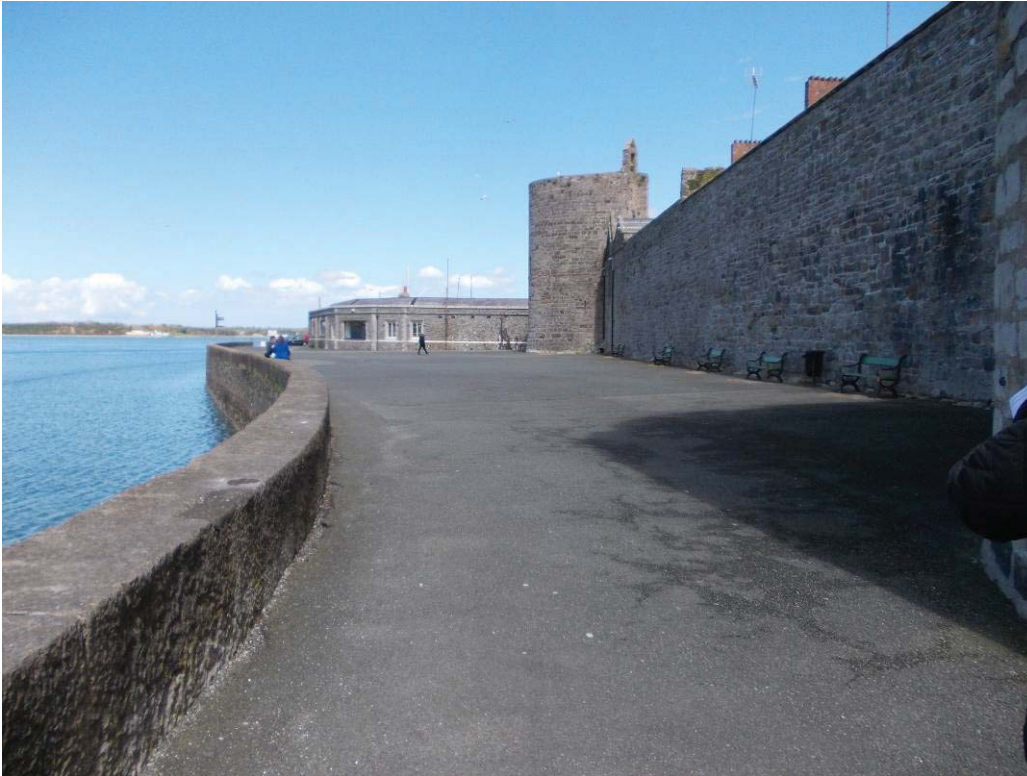
Looking east along promenade. Area of BH3, BH4, TP3, TP4, P3, P4 and P5
