Porth-Yr-Aur Promenade Ground Investigation Works, Caernarfon

Archaeological Watching Brief

Project No. G2340

Report No. 1140

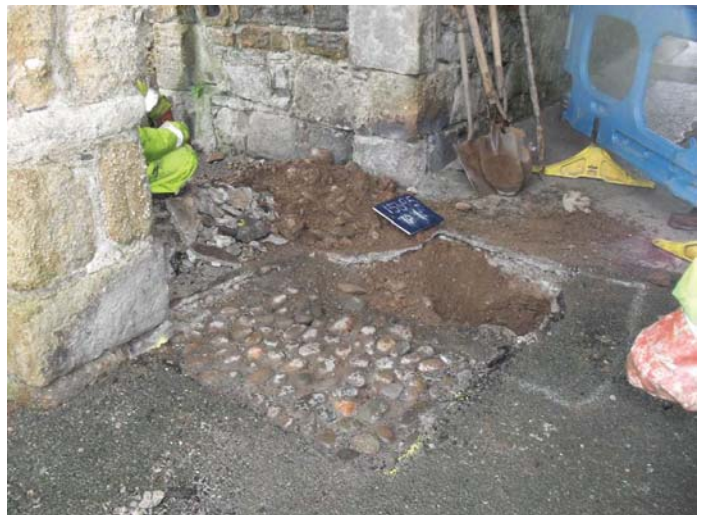
Section View

COMMENTS: Old cobbled surface discovered geologist sketched/logged surface pit dug alongside and stopped at 0.6m

Depth From To		Soil Group	Soil Description
①	G.L	0.05	FILL	Tarmac surfacing
②	0.05	0.15	FILL	Concrete
③	0.15	0.30	FILL	Dark brown slightly clayey gravelly SAND. Gravel is fine to coarse angular to rounded and of mixed lithologies.
④	0.30	0.60	FILL	Dark brown slightly clayey gravelly SAND. Gravel is fine to coarse angular to rounded and of mixed lithologies.

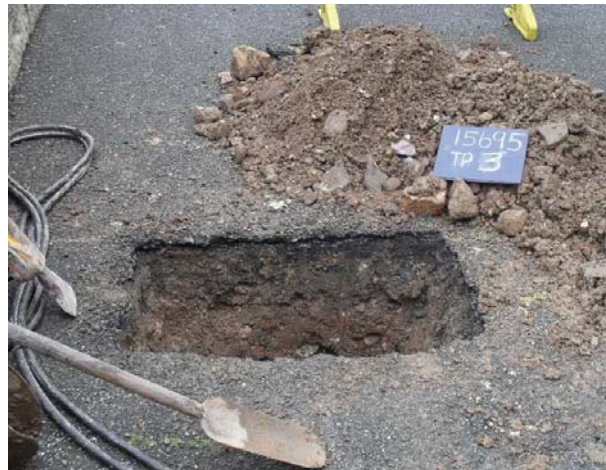
LOCATION: PORTH YR AUR CAERNARFON

COMMENTS: Client also logged photos and stopped pit at 1.43m

Depth From To		Soil Group	Soil Description
①	G.L	0.07	FILL	Tarmac surfacing
②	0.07	1.43	FILL	MADE GROUND (Dark brown slightly clayey SAND. Gravel is fine to coarse angular to rounded and of mixed lithologies. Brick and mortar fragments of increasing size with increasing depth.)
