# Ynys Enlli Coastal Erosion Survey

Project No.: G2318

Report No.: 1176

Prepared for: Cadw and the Bardsey Island Trust

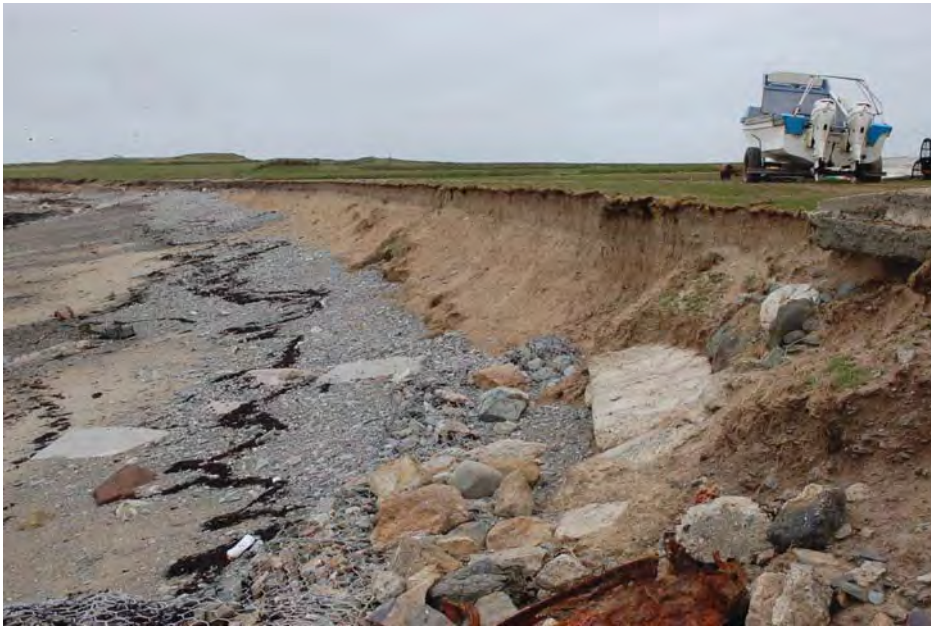
Plate 1. Erosion at eastern end of Henllwyn,  
view from E

While most of the shore of Ynys Enlli is very rocky and erosion is relatively slight it was clear that active erosion was occurring along part of the west coast just north of Porth Solfach, around that bay and around the head of the bay of Henllwyn. The tops of erosion faces were surveyed and this was compared to earlier maps (figures 2 and 3). The 1918 25 inch map is sufficiently accurate to allow a direct comparison with the present survey and this shows that erosion has been most severe in Henllwyn where the coast has receded by up to about 8m since 1918. Coastal defences have been built to try and halt the erosion but these are now largely washed away (plates 1 and 2). The erosion in Porth Solfach has been slightly less at a maximum of about 7m, despite this bay being on the west coast and open to the worst storms.

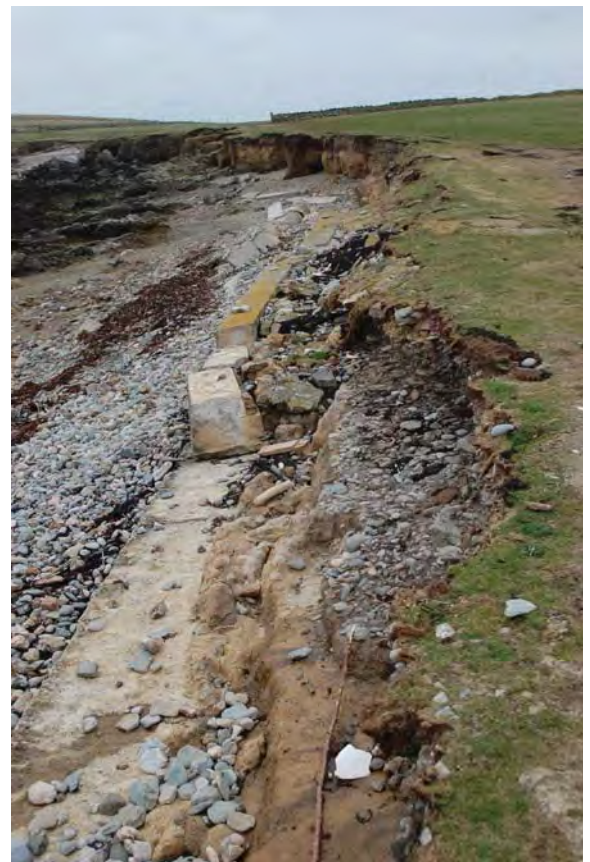
Plate 2. Collapsed sea defences at Henllwyn,  
view from E

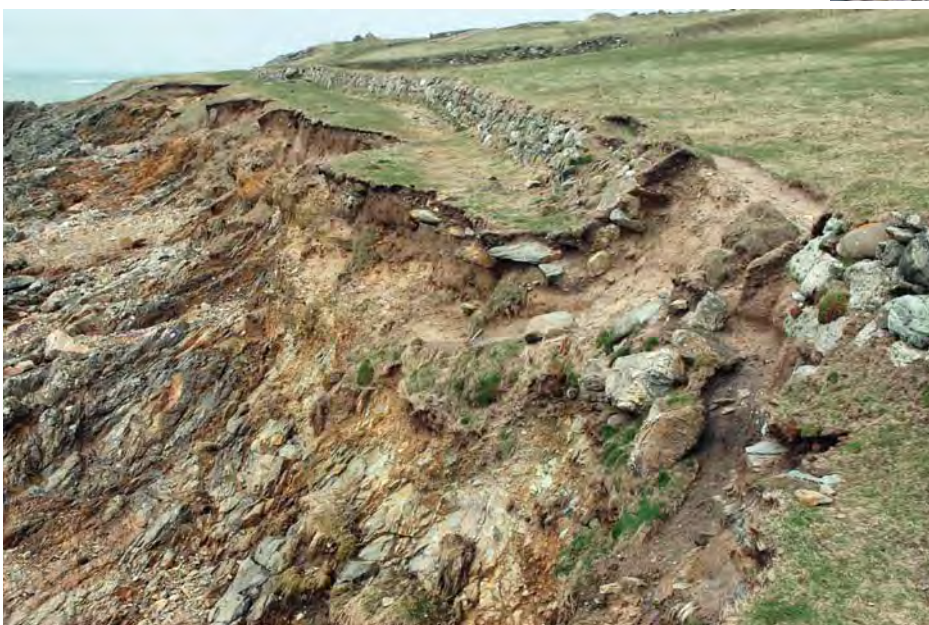
Erosion also appears quite dramatic up the west coast of the island just north of Porth Solfach. Here parts of a track (PRN 38270) running along the coast have been eaten away by the sea, which has also in places breached the field bank on the landward side of the track (plate 3). The 1918 map shows a loss of up to about 8m in this area (figure 2). However erosion is probably slower than it appears. Hope Jones (1988, 15), whose book was based on work done in 1984 and 1985, mentions that the track was eroded “almost across its width in places”. This suggests that there is not much more erosion now than in the early 1980s. The erosion is focussed on areas of weakness, in the case of the track these are culverts running under it, which have enabled the erosion to extend inland. Between culverts erosion is much less dramatic. A similar process has also happened at Henllwyn where a track (PRN 16855) to the lighthouse also runs along the shore edge and has culverts running under it. The 1918 map shows the line of the track slightly further south, but as the coast eroded it has been moved to its present position. The track surface is consolidated by a layer of gravel overlying the earlier soil. It is not clear whether the well-built culverts that outcrop in the coastal section were built specifically to take drainage under the road or whether the full lengths of the drainage channels are stone-lined like the visible culverts (plate 4).

Plate 3. Erosion on west coast of Ynys Enlli  
just north of Porth Solfach,  
view from S

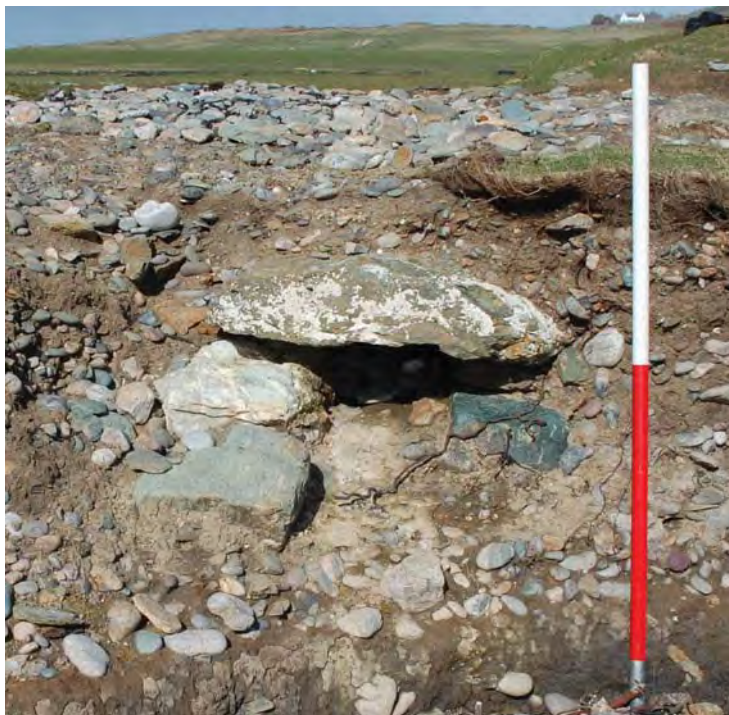
Plate 4. Culvert under the track at Henllwyn, view from S

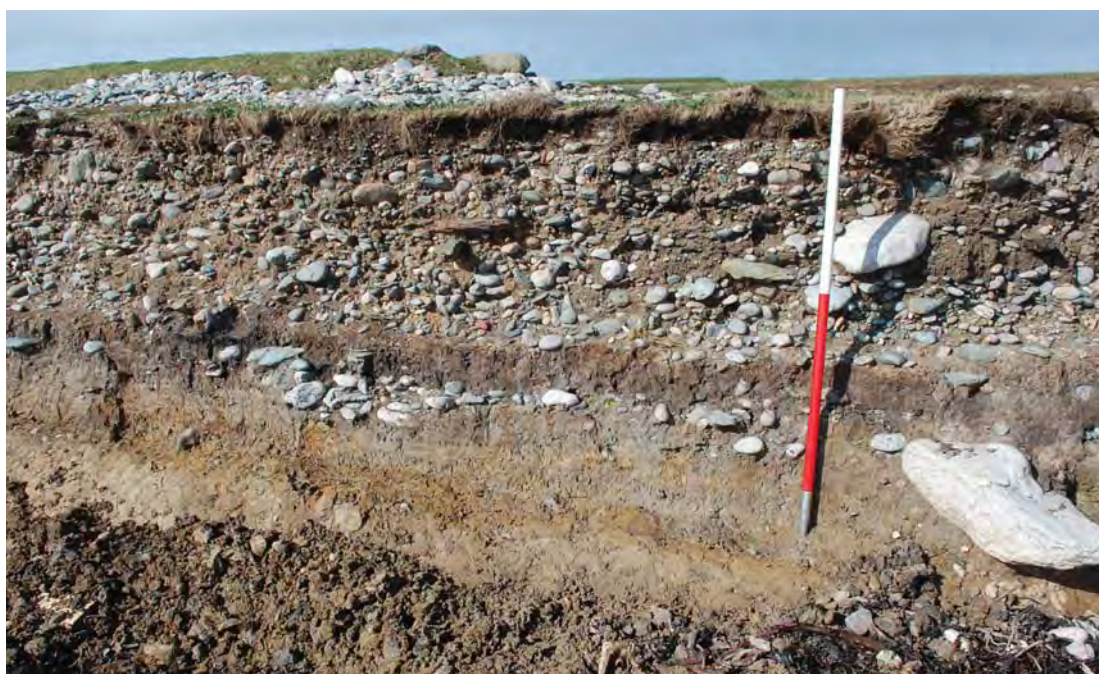
In the current survey few archaeological features or deposits were seen in the erosion faces but some buried soils were noted. In Henllwyn a layer of buried soil (PRN 38677) runs for about 58m from SH 11434 21080 to SH 11491 21095. This layer was recorded at SH 11442 21080 as section 4 (figure 3, plate 5). This is a dark grey loamy clay mottled with iron staining. The layer is about 0.15m thick and in places outcrops as a shelf at the base of the erosion face. The layer contains only a few stones and a patch of charcoal was noted on its surface

where it was drawn in section, but no other cultural material was identified. The stones and gravel of a storm beach overlie this layer at the head of the bay but under the buried soil there is also a layer of stones and gravel that appears to be an earlier storm beach.

Plate 5. Section 4 showing buried soil and pebbles of a storm beach underneath at Henllwyn, view from SE

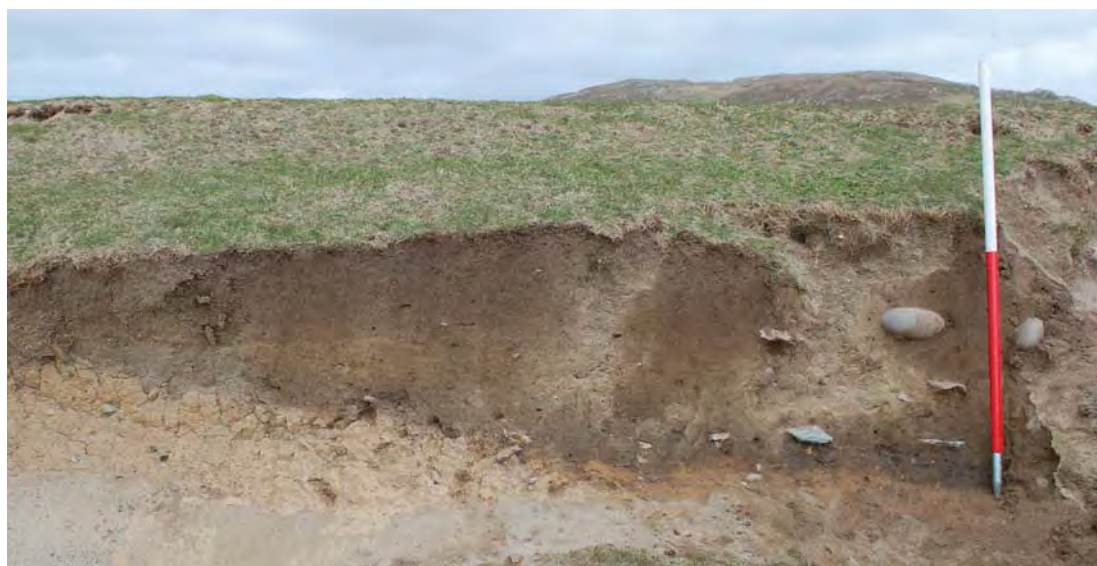
A buried soil has previously been noted at the access to Porth Solfach beach (PRN 16822). This was still visible and was also recorded at SH 11496 21230 as section 3 (figure 2, plate 6). This buried soil is up to 0.12m thick and is a dark grey sandy clay with occasional stones. Some animal bone was found eroding out of the buried soil at this location. The bone was from cattle and included pieces of tibia from a rear leg but also a carpal from a front leg (Sian James, GAT, pers. comm.).

Plate 6. Section 3 showing buried soil containing animal bone at Porth Solfach, view from S

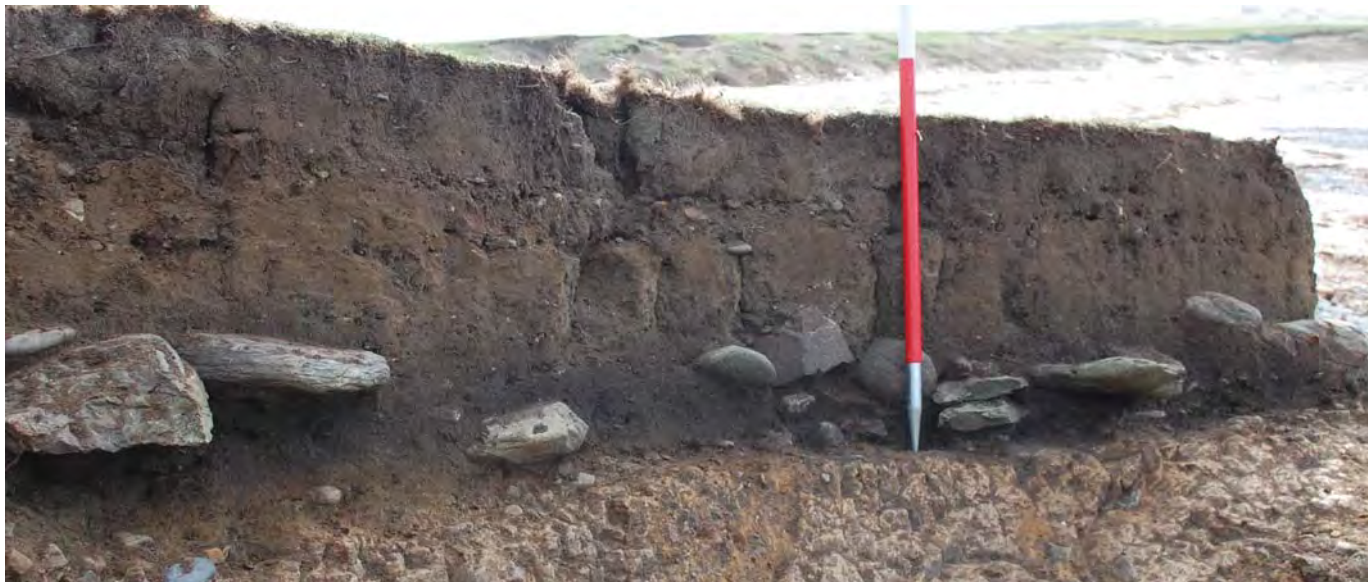
Just north of Porth Solfach a dark layer was seen in the cliff section at SH 11492 21284 (PRN 38294). This was recorded as section 2 (figure 2, plate 7). This layer was a very dark brown in colour and composed of a loamy sand. It contained some charcoal and had a layer of stones along its upper interface. These stones were fairly large, many were flat, and some were burnt. While they did not appear to be part of a structure they may have slipped from one located further inland. Layers of stones were seen in erosion sections at several places and these were clearly stones thrown up by storms (plate 8). However the stones seen in section 2 were larger, not accompanied by gravel, and seem likely to be related to archaeological activity. No artefacts or bones were found at this location.

Plate 7. Section 2 showing dark layer with flat stones along the top, view from N

The dark layer and stones recorded in section 2 (PRN 38294) appeared most likely to be directly related to an archaeological site. This location is under considerable threat of further erosion and would be a high priority for further investigation by excavation before the site is lost.

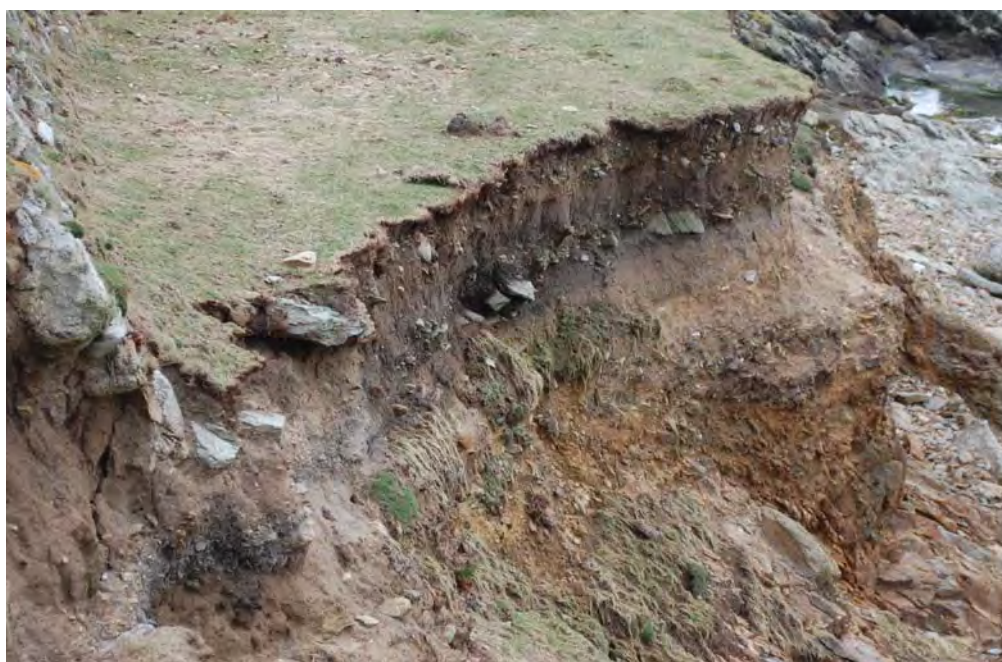
Plate 8. Layer of stones in eroded section, probably storm debris

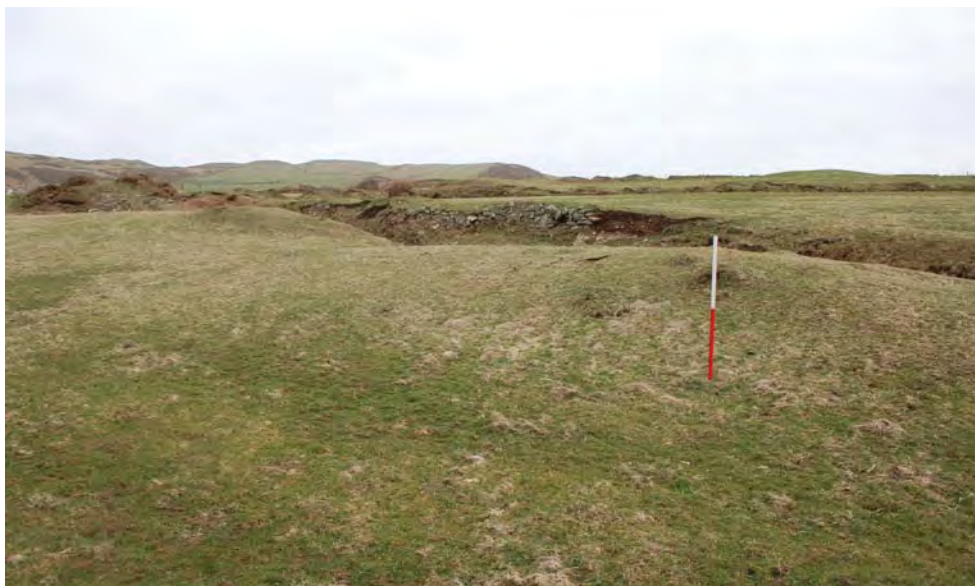
Plate 10. Mounds PRN 39570 and 39571, view from NW

In the area between Porth Solfach and Henllwyn there are occasional low mounds and knolls within the otherwise level landscape. One of these is listed on the HER (PRN 16821, figure 3) but it appears fairly natural in character and others to the north of Porth Solfach have some bedrock outcropping (figure 2). It seems likely that most of these mounds are caused by outcropping bedrock covered by glacial till. However while surveying the coastal erosion it was noticed that there was burnt stone incorporated in a clawdd just north of Porth Solfach. The burnt stone is typical of that found in burnt mounds. Burnt mounds are sites where water was heated using hot stones and they are generally of Bronze Age date, although they can be both slightly earlier and considerably later. Where not reduced by ploughing they can appear as low mounds, often roughly horseshoe-shaped. The burnt stone in the clawdd had clearly originated from elsewhere, probably nearby, and there were four low mounds in the immediate vicinity, arranged in a line immediately adjacent to the only significant stream on the island (figure 4, plate 10). As the availability of water is critical for the use of burnt mounds this location supported the possibility that these mounds were indeed burnt mounds. Turf was removed from a very small square about 0.4m by 0.4m on the top of each mound. Immediately below the turf on the largest three mounds there were angular red-coloured burnt stones, generally in pieces no more than 0.1m long. Quartz was quite common amongst these heat-shattered pieces. Charcoal would be expected in a burnt mound but none was seen, however this may be due to only the surface being inspected and charcoal could have been washed down into the body of the mounds. A flint blade (plate 11) was also recovered from the eastern mound (PRN 39569). The western-most mound had small broken stone but this was sub-rounded rather than angular, comprised only the local rock type and no quartz with no evidence of burning. This mound was much smaller than the others and had bedrock visibly outcropping. After photographing the deposits the turf was immediately put back in place.

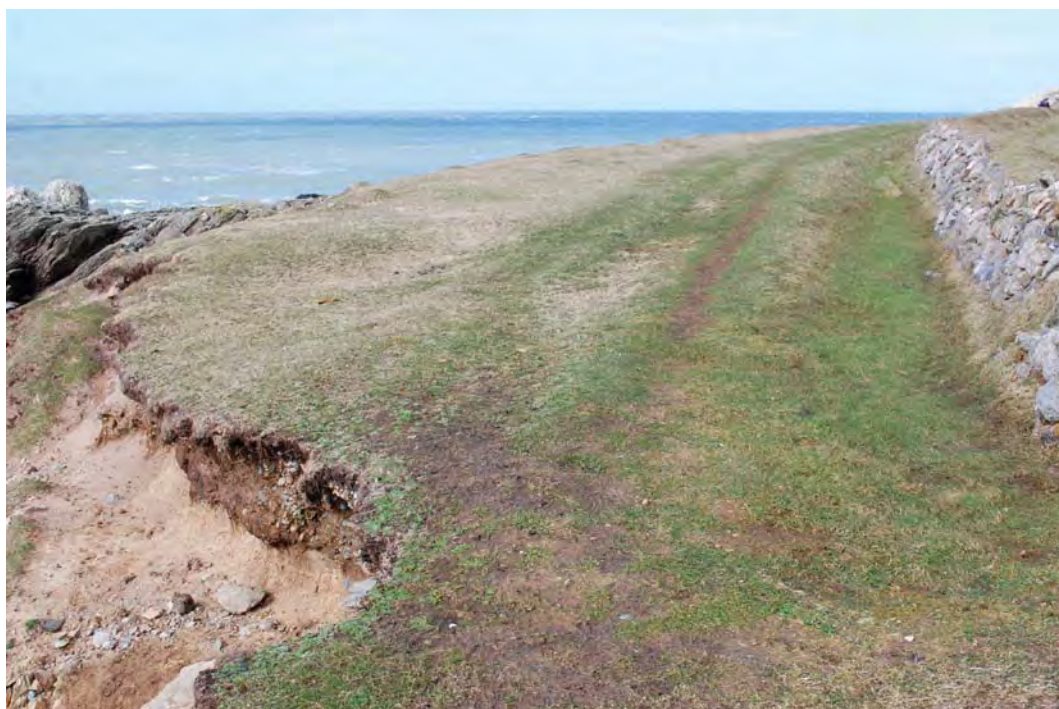
Lockley (1938, 122) describes a track along the west coast of the island that was specifically constructed to aid the collection of seaweed for use as a fertiliser on the fields. This track (PRN 38270, figure 2, plate 12) is still clearly visible, although grassed over and runs from SH 11470 21634 south to Porth Solfach, where it originally must have run down onto the beach at SH 11493 21278. Erosion has now caused a drop of about 1m at the end of the track, which at some time has been blocked off with a now collapsed stone wall. The cross wall is shown in the 1889 25 inch map, but the track was still used when Lockley was on the island in the 1934, so presumably it could still be used to obtain seaweed from the west coast even if it no longer provided access to Porth Solfach beach. Where the track originally ran down to the beach it is visible as a fairly clear hollow-way up to 0.5m deep (figure 4, plate 13). The 1918 map shows this track and shows it ending at SH 11470 21634, although the track starts again further north and it seems likely that it was originally continuous up the west coast.

Plate 11. Track on west coast (PRN 38270), view from S

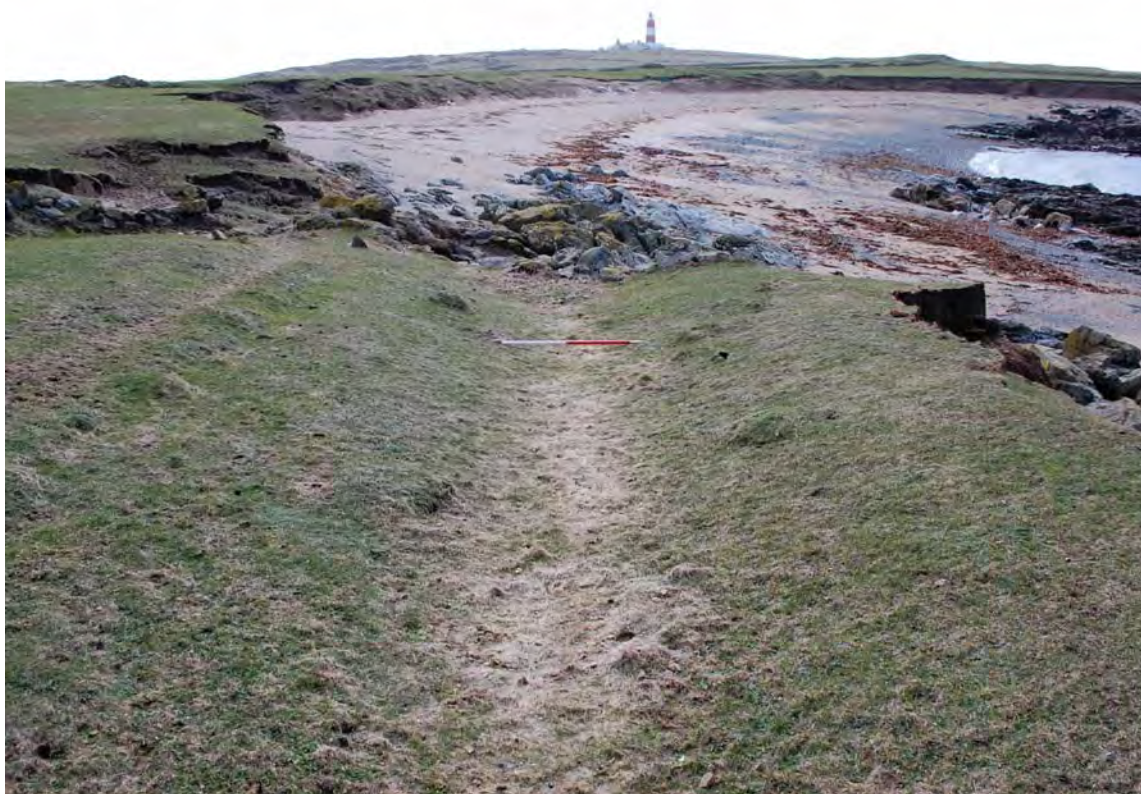
Plate 13. Track (PRN 38270) where it entered Porth Solfach, view from N

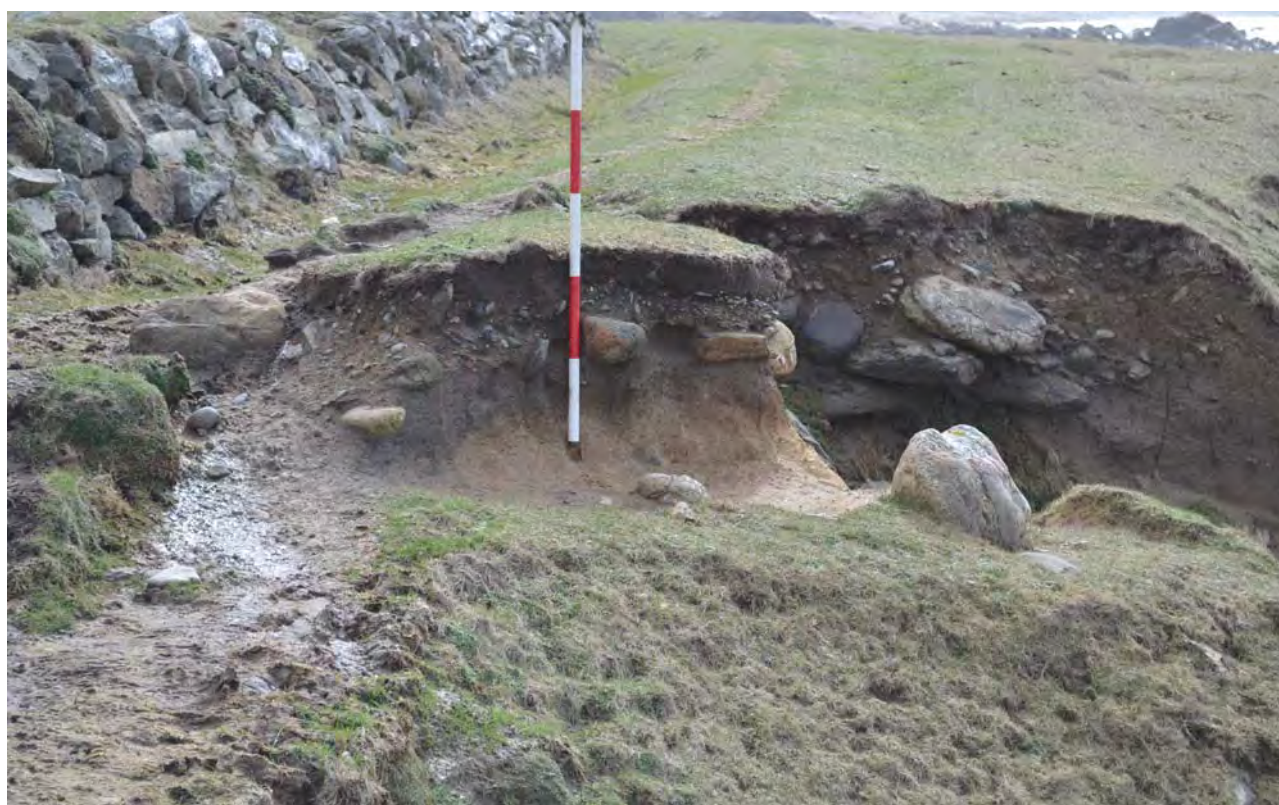
Inspection of the erosion faces on the west coast showed that the western track (PRN 38270) was well-made. The gravel used to for its surface was in many places built-up over a layer of flat stones to provide a foundation and culverts took drains under the track (plate 14). These well-built tracks must have been constructed by the Newborough estate but the 1840 1 inch Ordnance Survey map (reproduced in Arnold 1994, figure 9) shows an earlier track running on a similar line up the west coast before turning inland past Carreg Fawr to Carreg Bach. No evidence of this earlier track was seen in the eroding sections.

Plate 14. Track (PRN 38270) with erosion face showing construction, view from N
