Capel Geifr, Capel Carmel, Aberdaron Water Main Renewal Scheme

Archaeological Watching Brief

Project No. G2376

Report No. 1187

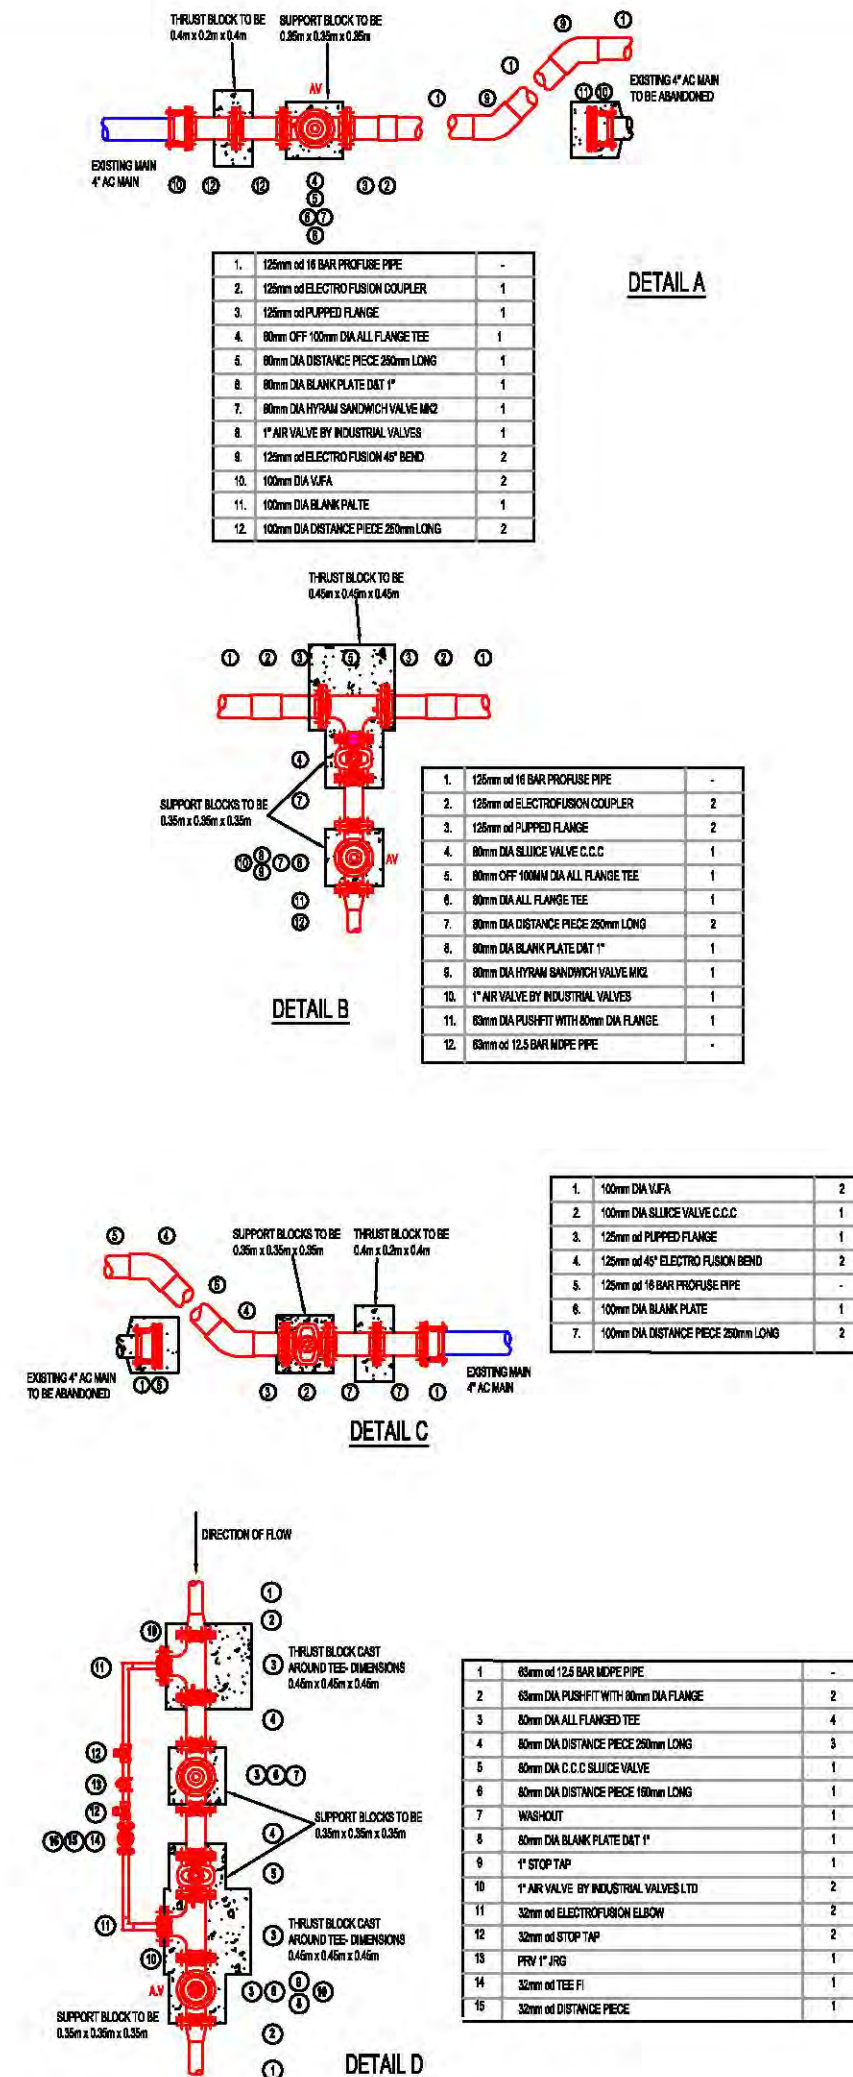
Figure 1

According to *Dwr Cymru* Drawings NP2900416-101 and NP2900416-102 the scheme was to include directional drilling (red line on the scheme drawings, pipebursting (new wider pipe sent through the older narrower pipe; coloured pink on the scheme drawings) and open cutting (a dashed red line on the scheme drawings). Based on feedback from *O'Connor Utilities Limited* who are working on the scheme, the directional drilling will be replaced by open cutting due to wet ground and the open cutting sections marked on the plan will be replaced by directional drilling; the pipebursting at the eastern end of the scheme will be retained. Based on this feedback, the scheme will now involve:

Reproduction of Dwr Cymru Drawing NP2900416-101

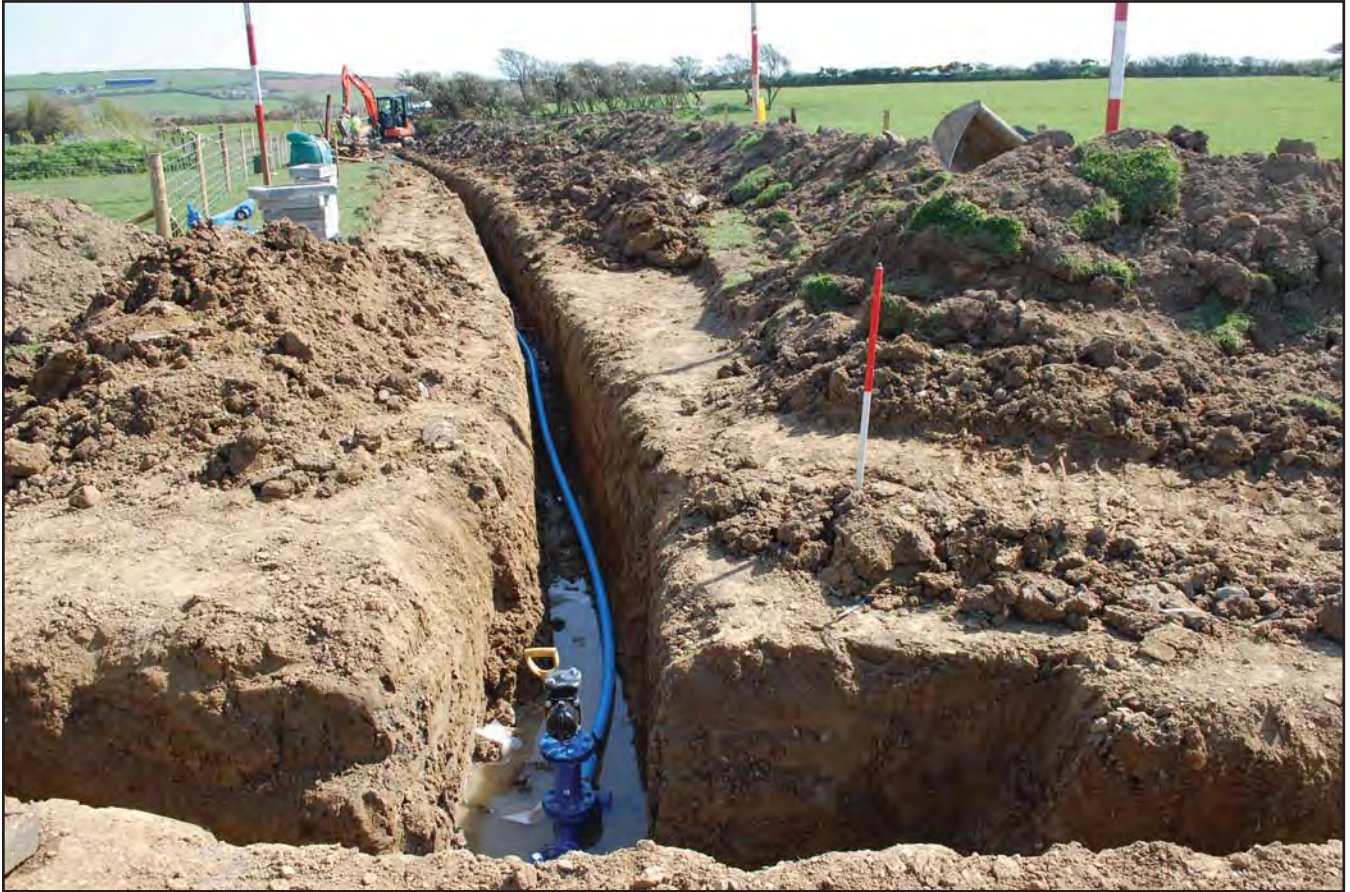
A 'T' shaped area of pipe trench, 150m in length, average of 0.70m wide and 0.90m in depth. The stratigraphy along this section was uniform throughout with 0.20m of dark orange brown silt clay topsoil with occasional small to medium sub-rounded and sub-angular stones. The topsoil sat directly on a glacial horizon of mid orange brown clay with rare sub-rounded stone inclusions which measured 0.70m deep to the base of the pipe trench. No archaeological activity was identified within the confines of the trench.

Plate 01: Section A of the opencut trenching. View from the N.

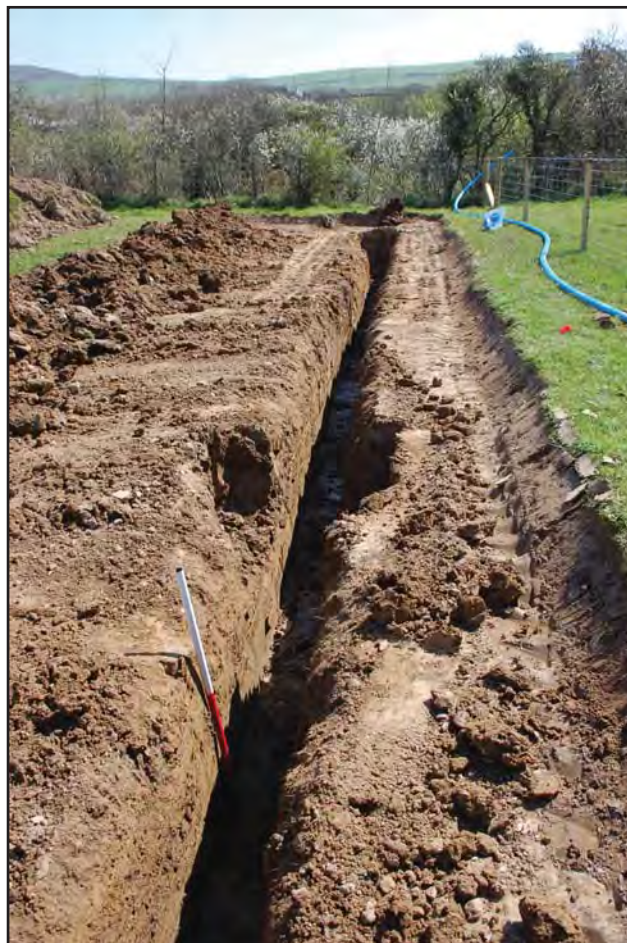
A 16m length of open cut pipe trench measuring 0.70m wide and 0.80m in depth. The stratigraphy along this section was uniform throughout with 0.20m of dark orange brown silt clay topsoil with occasional small to medium sub-rounded and sub-angular stones. The topsoil sat directly on a glacial horizon of mid orange brown clay with rare sub-rounded stone inclusions which measured 0.60m deep to the base of the pipe trench. No archaeological activity was identified within the confines of the trench.

Plate 02: Section B of the opencut trenching. View from the NW

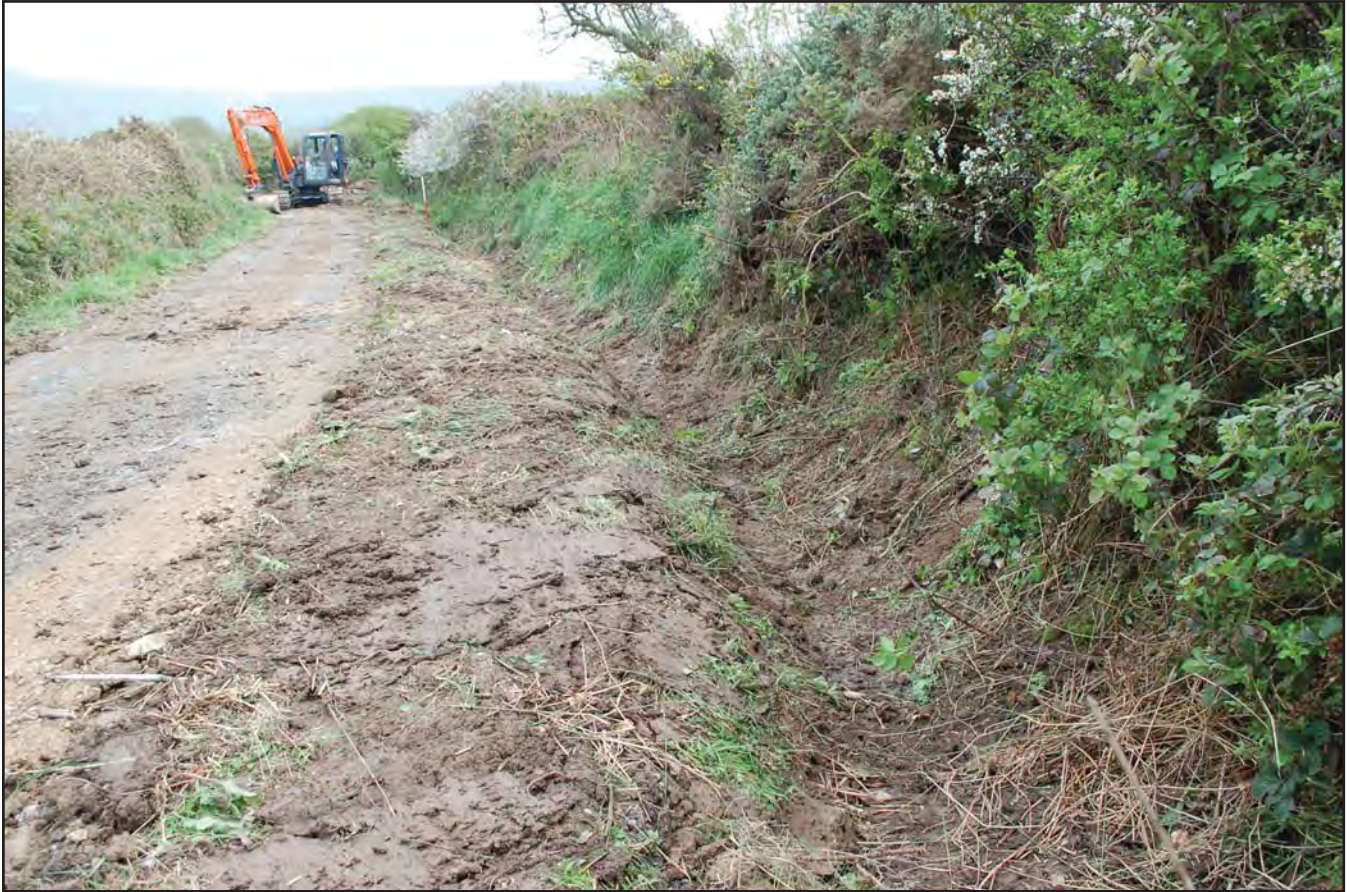
Approximately 30m length of trench was excavated, partially dug into the verge of the trackway. The trench also cut the trackway and measured 0.78m deep and 0.70m wide, an old field drain running east to west cut across the trench at the southern end. The trench cut through a thin layer of hardcore standing laid for the trackway, 0.06m in depth, with the glacial horizon directly below this. The glacial horizon was a deposit of mid brown yellow clay with rare medium sub-angular stone inclusions. No archaeological activity was identified within the confines of the trench.

Plate 03: Section C of the opencut trenching, showing the verge cleared along the track ready for the new pipe. View from the NW

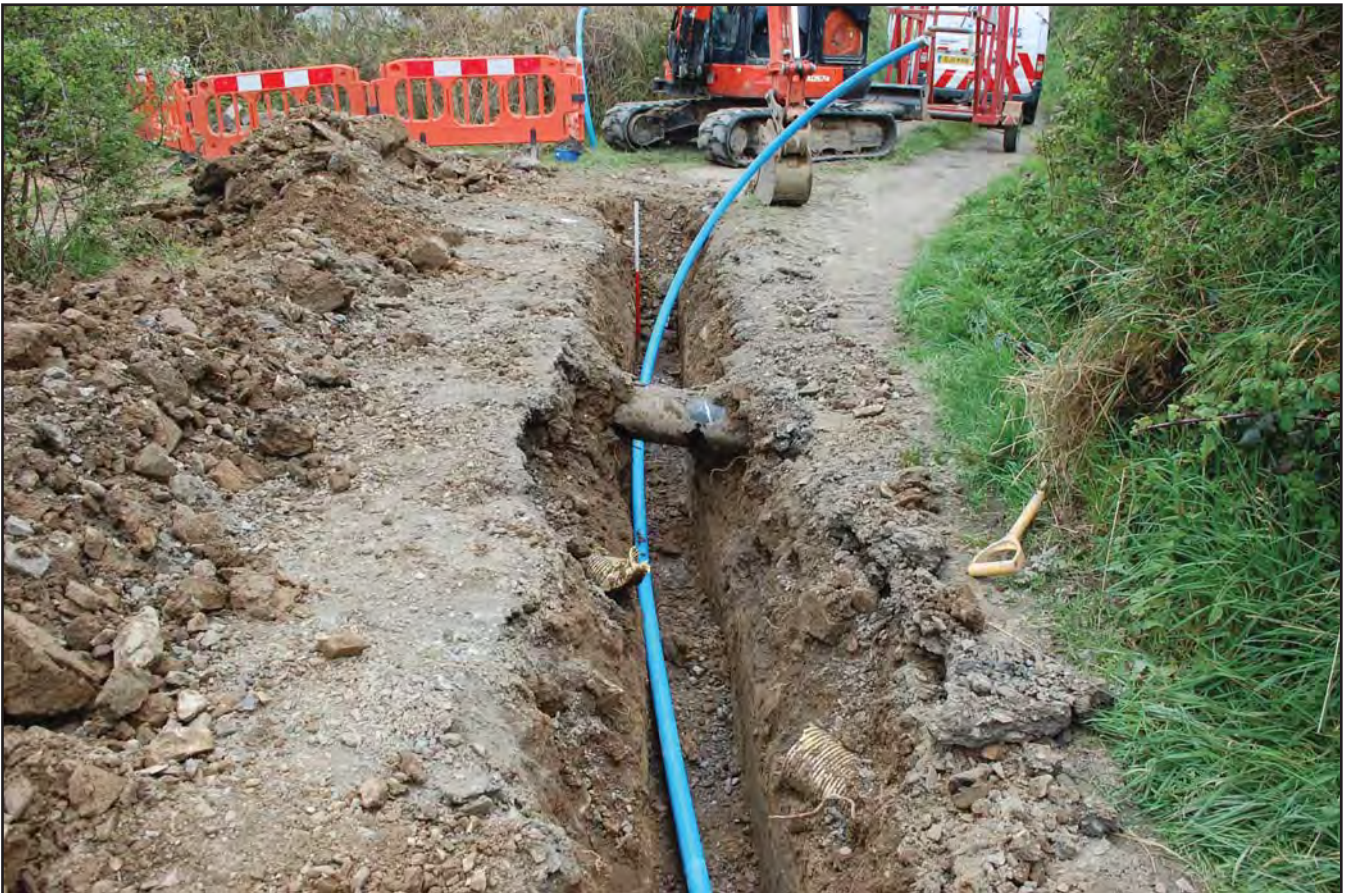
Plate 04: Section C with trench showing field drain cutting across it. View from the NE.

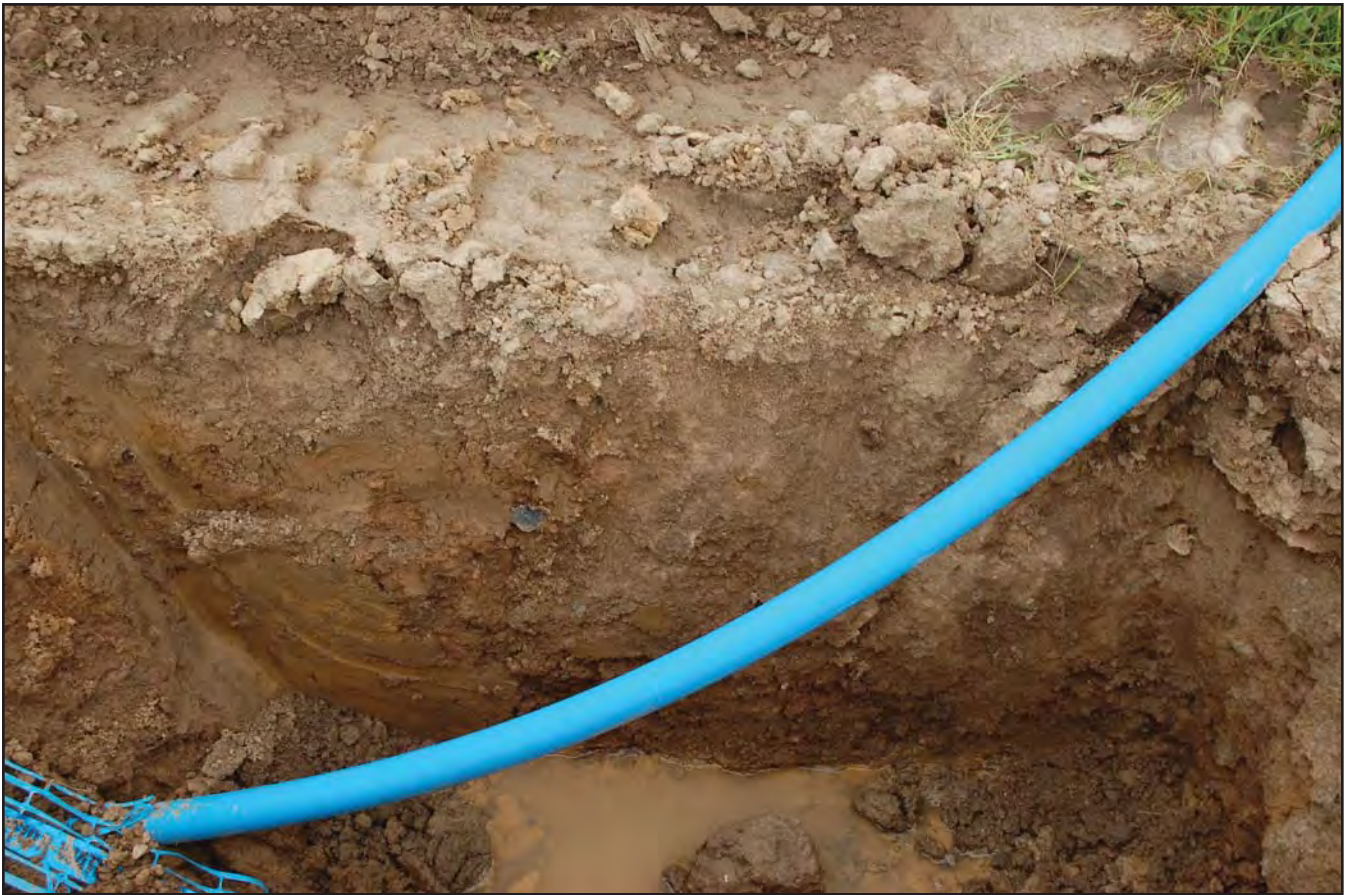
A length of 5m of trench, measuring 0.70m wide and 0.90m in depth. The topsoil was a dark orange brown silt clay measuring 0.10m deep and was directly on the glacial horizon, which was mid brown yellow clay. No archaeological activity was identified within the confines of the trench.

Plate 05: Section D of the opencut trenching. View from the SSW.

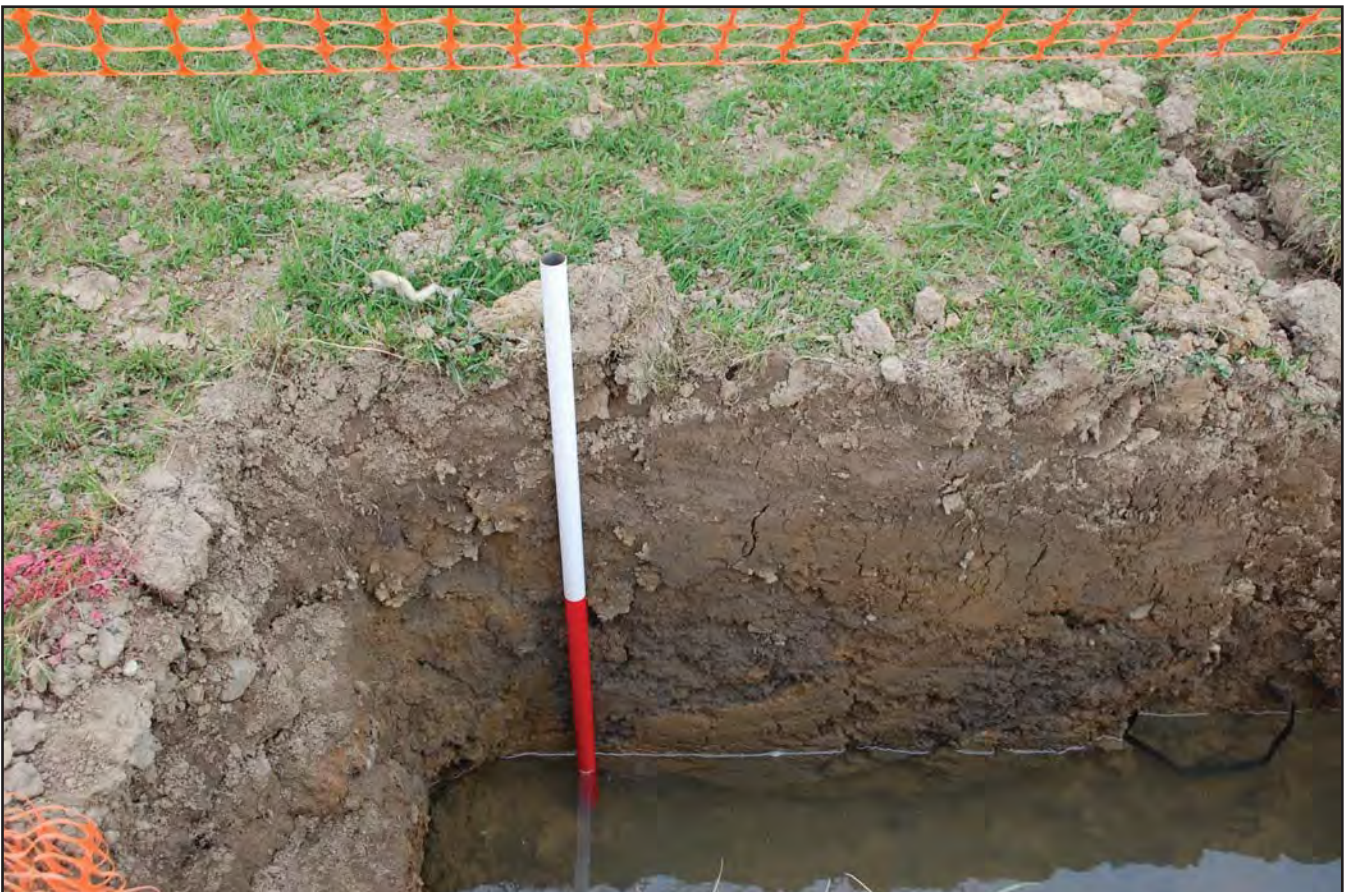
This pit measured 2.0m in length 0.70m wide and 1.0m deep and ran WNW-ESE. The topsoil was mid yellow brown clay above glacial horizon of mid brown yellow silt clay, with occasional sub-angular stone inclusions. No archaeological activity was identified within the confines of the pit.

Plate 06: Pit 01 showing clay glacial horizon. View from the SW.

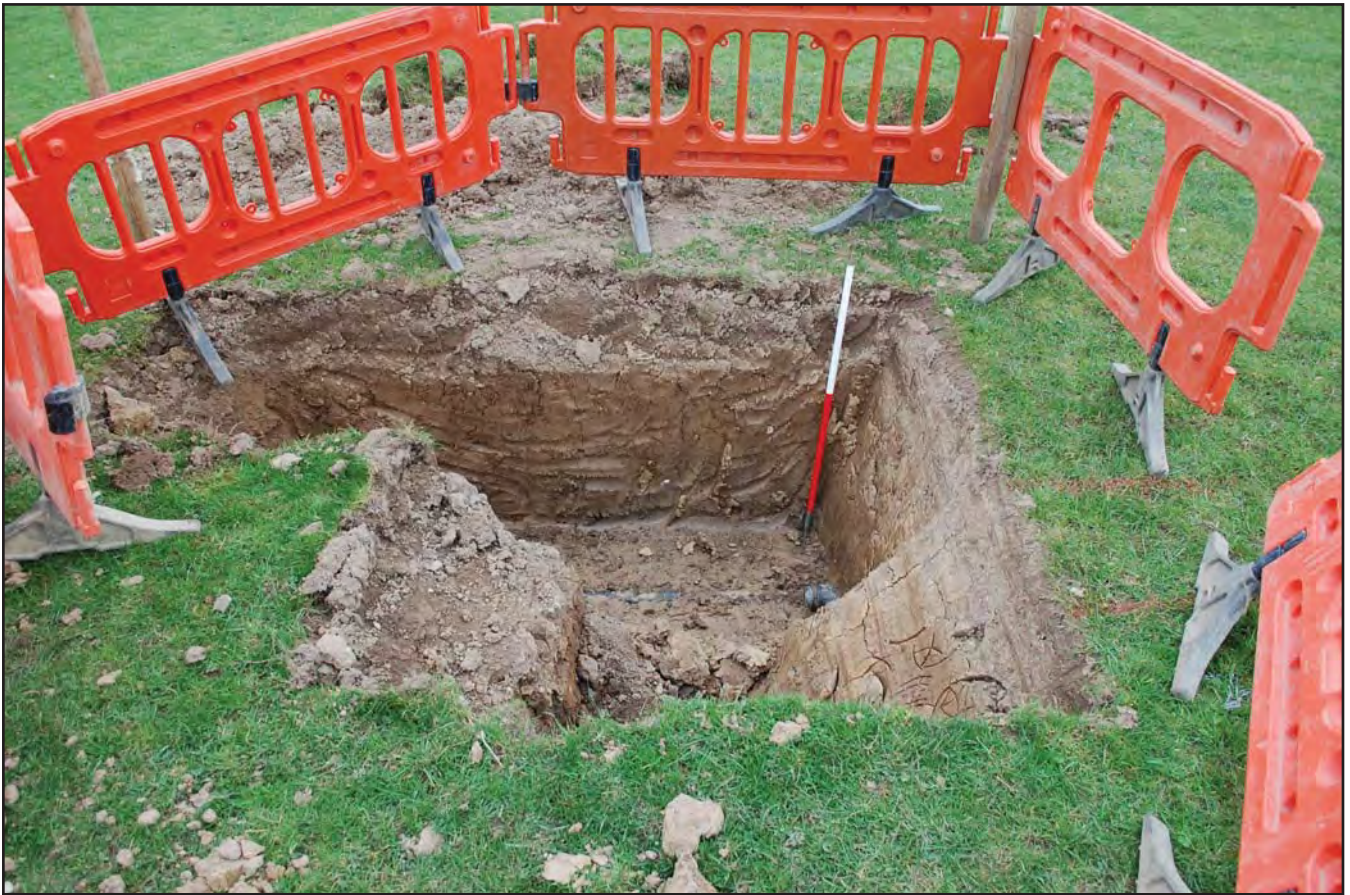
A 'P' Shaped pit measuring 2.5m by 1.5m and 0.92m in depth. The topsoil was a mid yellow brown clay silt with small sub-rounded stone inclusions and measured 0.35m in depth. The glacial horizon was a mid brown yellow silt clay, with occasional sub-angular stone inclusions. No archaeological activity was identified within the confines of the pit.

Plate 07: Pit 02, showing existing pipe in the ground. View from the NE.

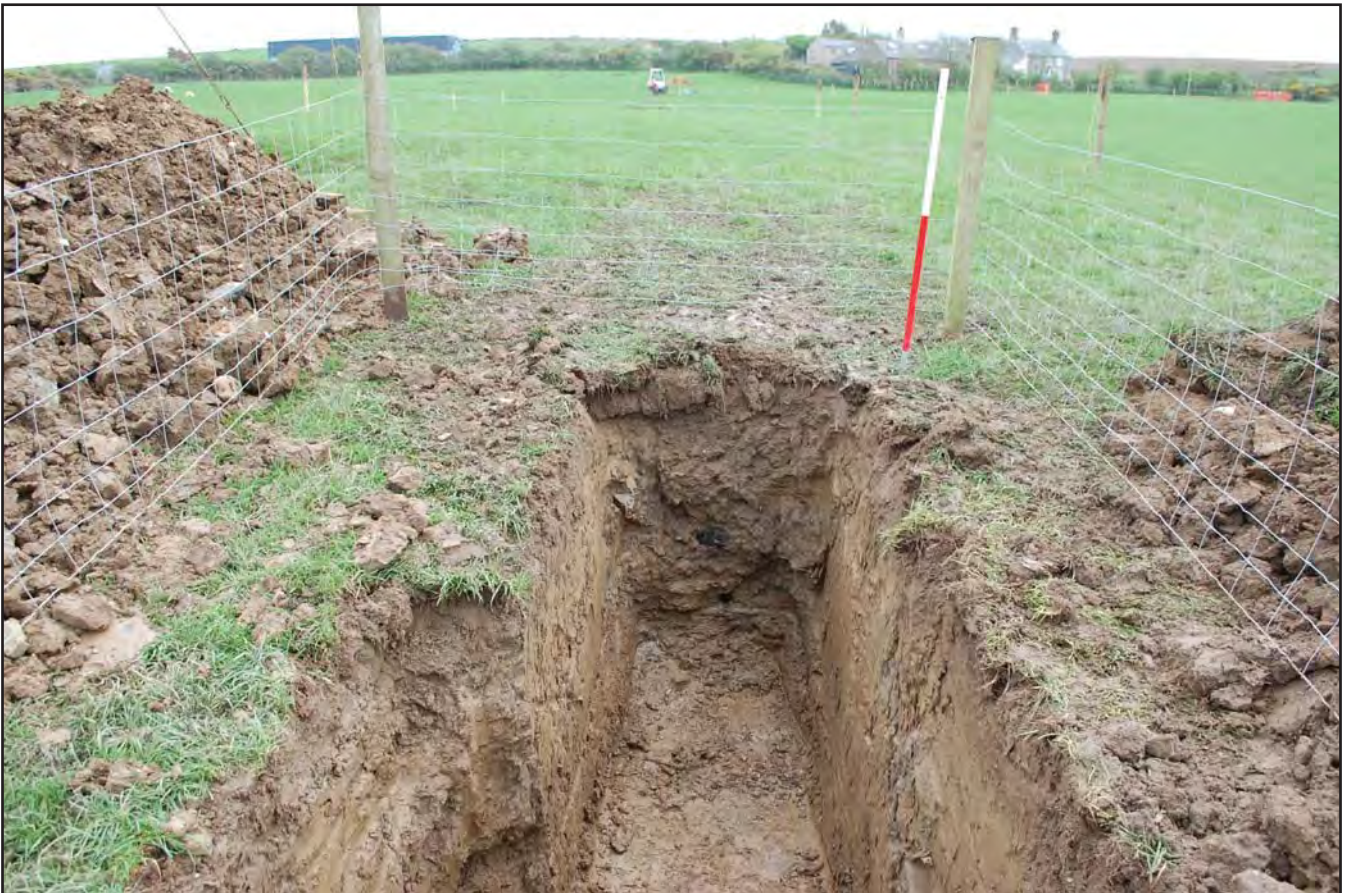
Pit dug to locate the existing pipe. The pit measured 2.5m by 0.90m and 1.30m deep. The topsoil was yellow brown clay silt measuring 0.30m deep. The glacial horizon directly below the topsoil and was a brown yellow clay. Within this pit the cut and fill of the existing pipe trench was identified and consisted of a mixed redeposited natural deposit with mottled brown yellow clay silt/silt clay. No archaeological activity was identified within the confines of the pit.

Plate 08: Pit 03, showing cut and fill of old pipe. View from the NW.

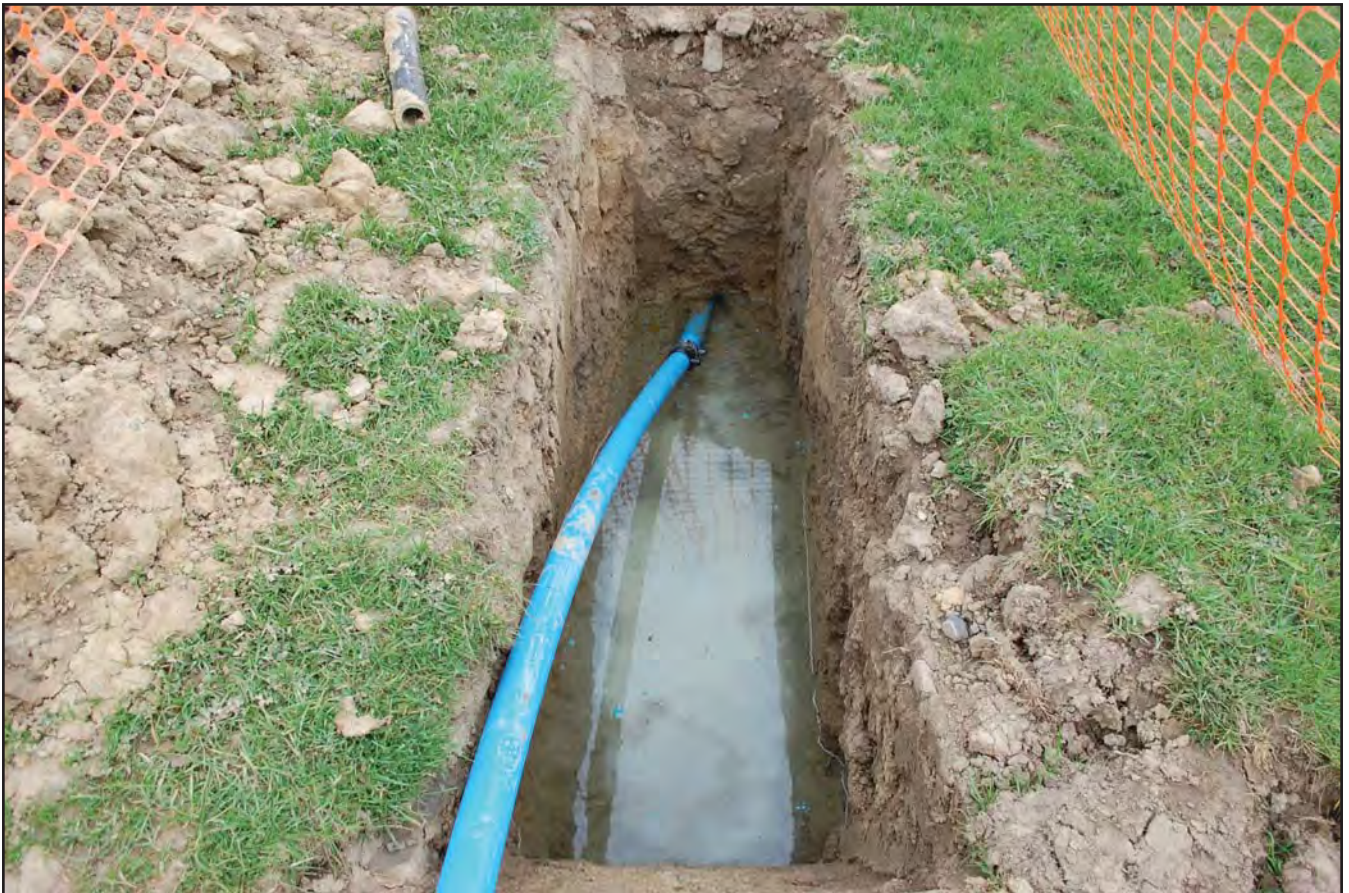
Pit dug to locate the existing pipe. The pit measured 2.0m by 0.90m and 0.85m deep. The topsoil was yellow brown clay silt measuring 0.40m deep. The glacial horizon directly below the topsoil and was a brown yellow clay. Within this pit the cut and fill of the existing pipe trench was identified and consisted of a mixed redeposited natural deposit with mottled brown yellow clay silt/silt clay. No archaeological activity was identified within the confines of the pit.

Plate 09: Pit 04, showing cut and fill of old pipe. View from WNW.

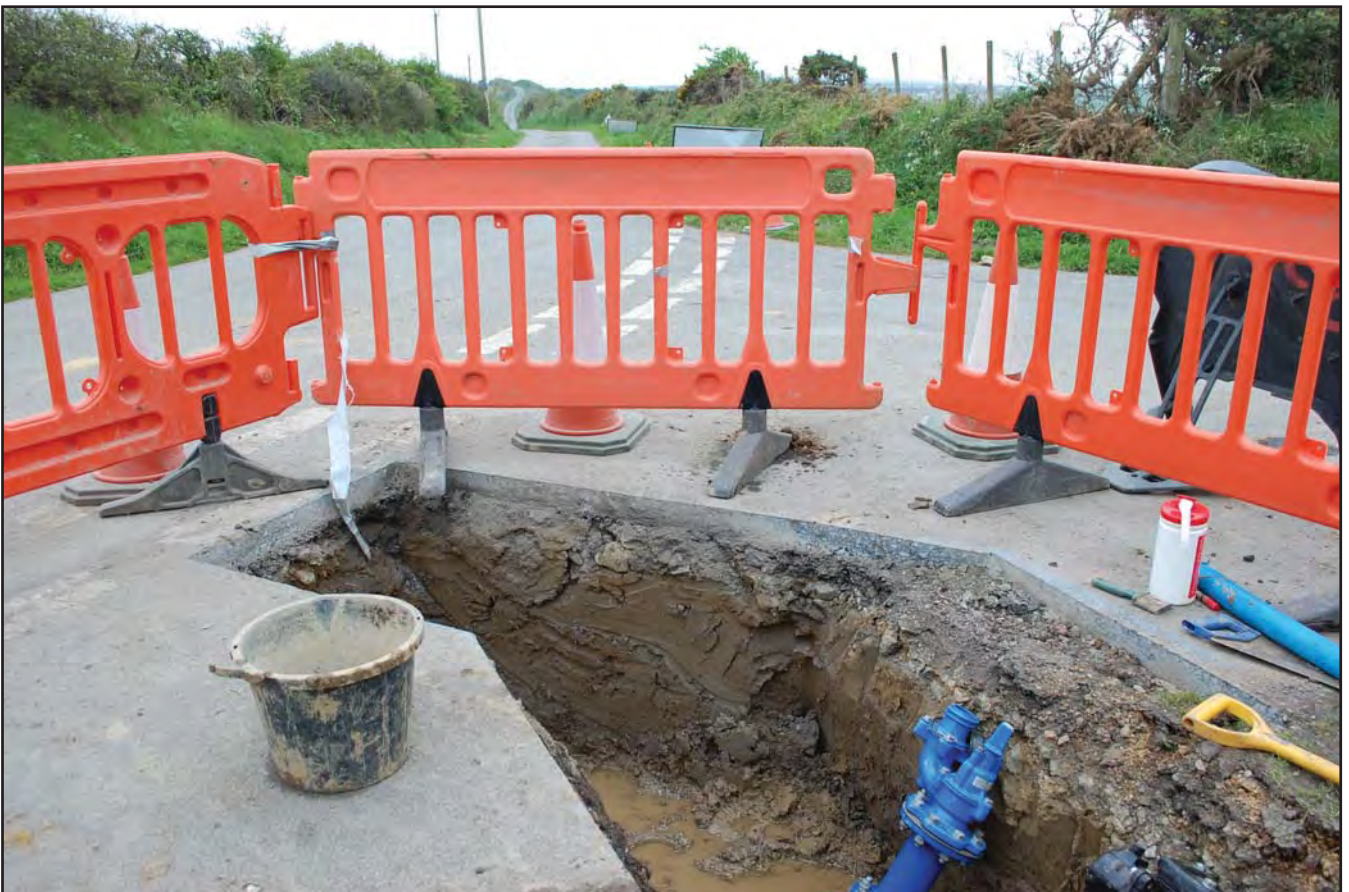
An 'L' shaped pit in the road. The pit measured 2.0m by 0.80m and 0.85m deep. There was 0.10m of road surface, concrete with 0.15m of road and made ground for the road foundation, below that was 0.60m of yellow grey clay. No archaeological activity was identified within the confines of the pit.

Plate 10: Pit 05, within the road. View from the N.
