First World War Military Sites Military Landscapes

Part 1: Report and Gazetteer

Project No. G2180

Report No. 1248

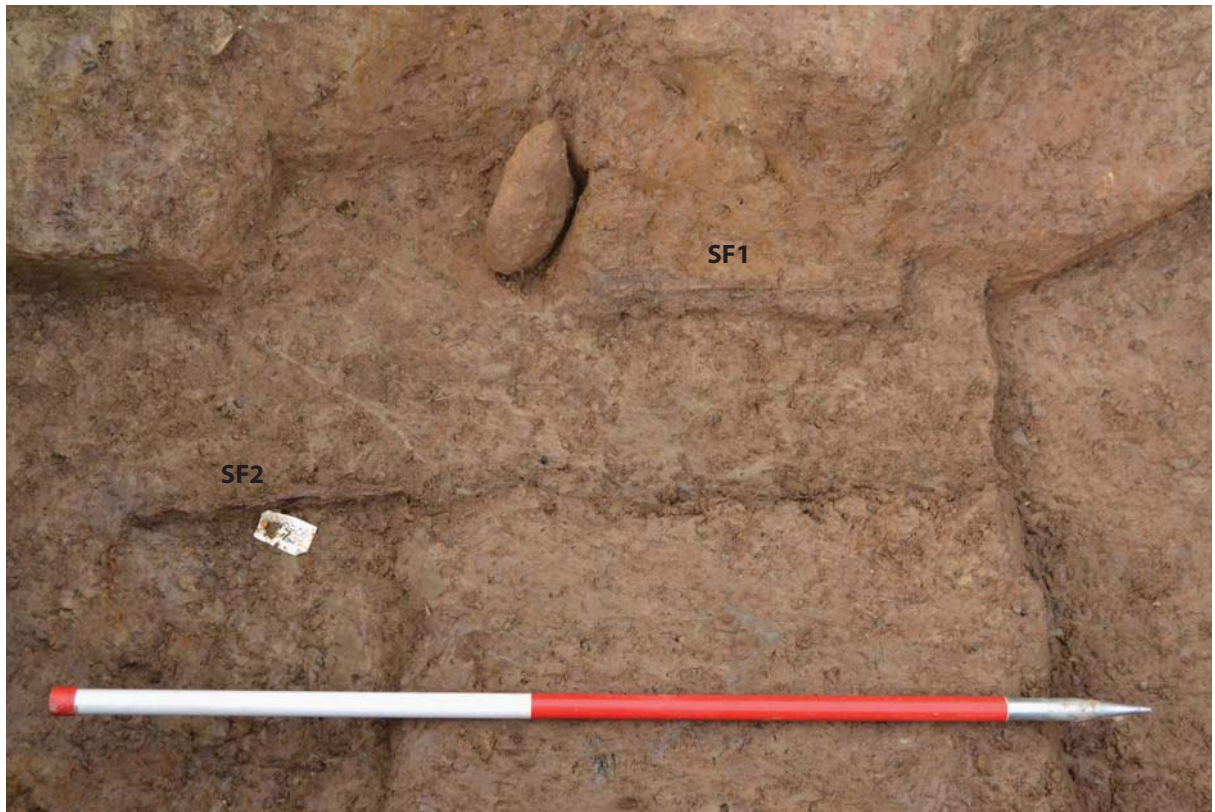
Plate 22. Pieces of wood in trench 1

Traces of timber revetting were found in this trench (plate 22). The decayed remains of one piece of timber (SF1) was found *in situ* against the western side of the trench. This was 0.38m long and 0.05m thick. As it was merely a mud cast of a timber no attempt was made to recover it as it would have been impossible to lift. In the middle of the trench at about the same level was another similar piece of timber (or timber cast) (SF2) with a nail projecting through it. This was clearly not *in situ* but had presumably fallen away from the edge of the trench as it was being backfilled.

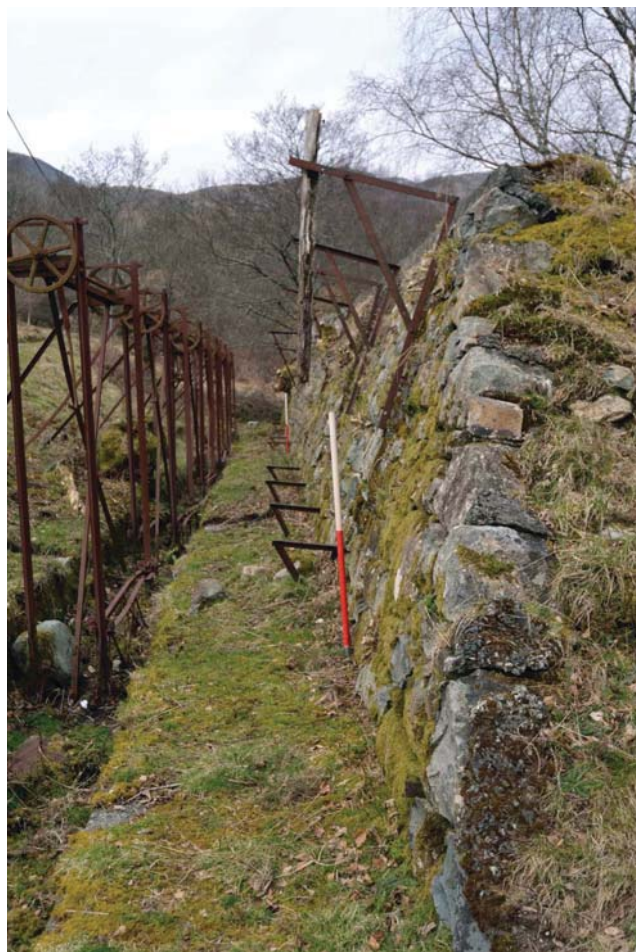
Plate 47. brackets for protective roofing and for seats for the markers

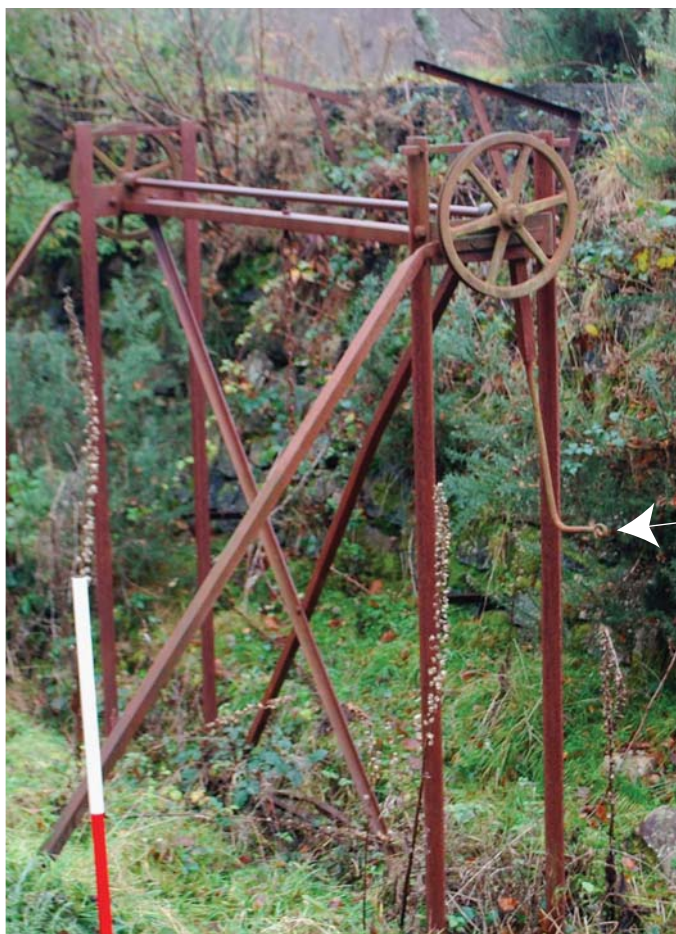
Plate 48. Paste pot hanger on side of target frame with detail of curled end

There are 6 Hythe pattern target frames (plate 49) and by comparing them to the blue-print for a target frame (plate 28) it can be seen that very little is missing from them. All have both target carriages, although in most cases one or both are within the trench at the base of the frame and have been hidden in vegetation. None of the frames have the wire rope that would have raised and lowered the target carriages and in some a chain hanging from the top of the frame is missing. Only frames 3, 5 and 6 retain the metal arm with a curled end, from which was hung the paste pot used when replacing paper targets (plate 48). Otherwise the frames are very complete.

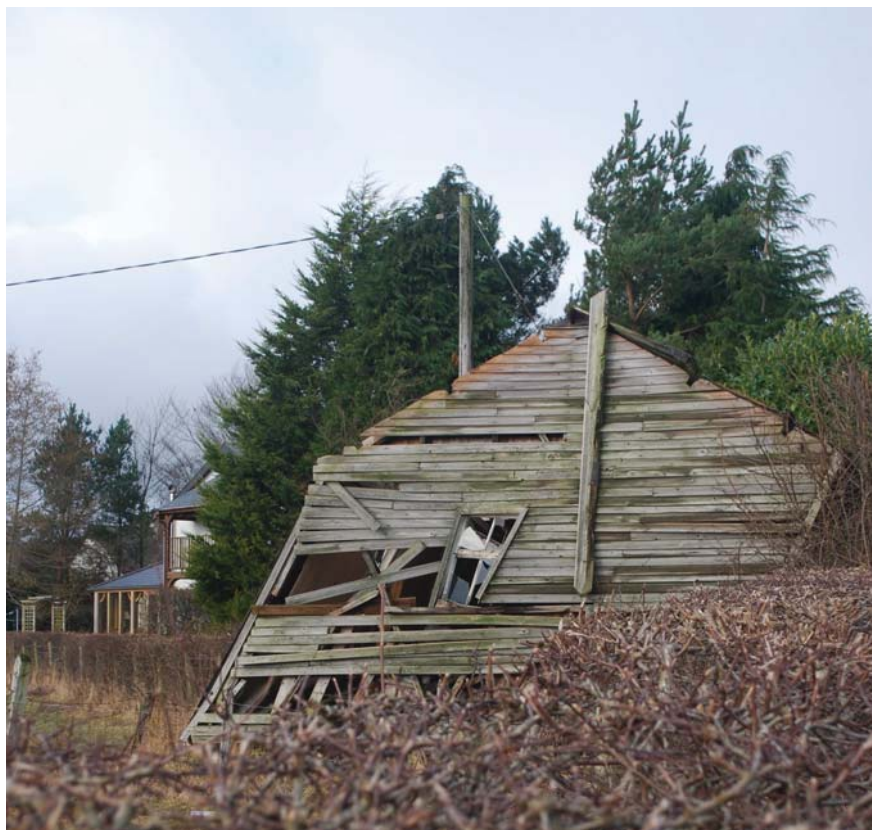
Plate 51. Collapsed hut (PRN 58739) formerly used by Women's Insititute and listed as part of Frongoch Camp

The camp was composed of two parts (figure 30). The southern camp was within a building built as a distillery for Welsh Whiskey in 1889. The northern camp consisted of 27 wooden huts in the adjacent field. The distillery building was demolished in 1934, and a school and houses have been constructed on the site, although foundations and rubble from the original building appear to still survive in places. The north camp site has no surviving identifiable features, and as huts stood on blocks rather than having concrete bases and paths were not surfaced it is likely that very little survives beneath the soil (Huey 2013). A storage hut from the camp still survives, although only one wall is original. This may have originated in the south camp and has been moved away from the site to be used as a garden shed. Another largely collapsed hut (PRN 58739) (plate 51) is grade 2 listed by Cadw as a survival from the camp but Huey (2013, 31-35) believes that it is more likely to have been moved from the flooded village of Capel Celyn in the Tryweryn Valley, demolished in 1965 when a dam was built. This hut was formerly used by the Women's Institute.
