MAENOFFEREN SLATE MINE

Archaeological Assessment Report

Project No. G2417

Report No. 1250

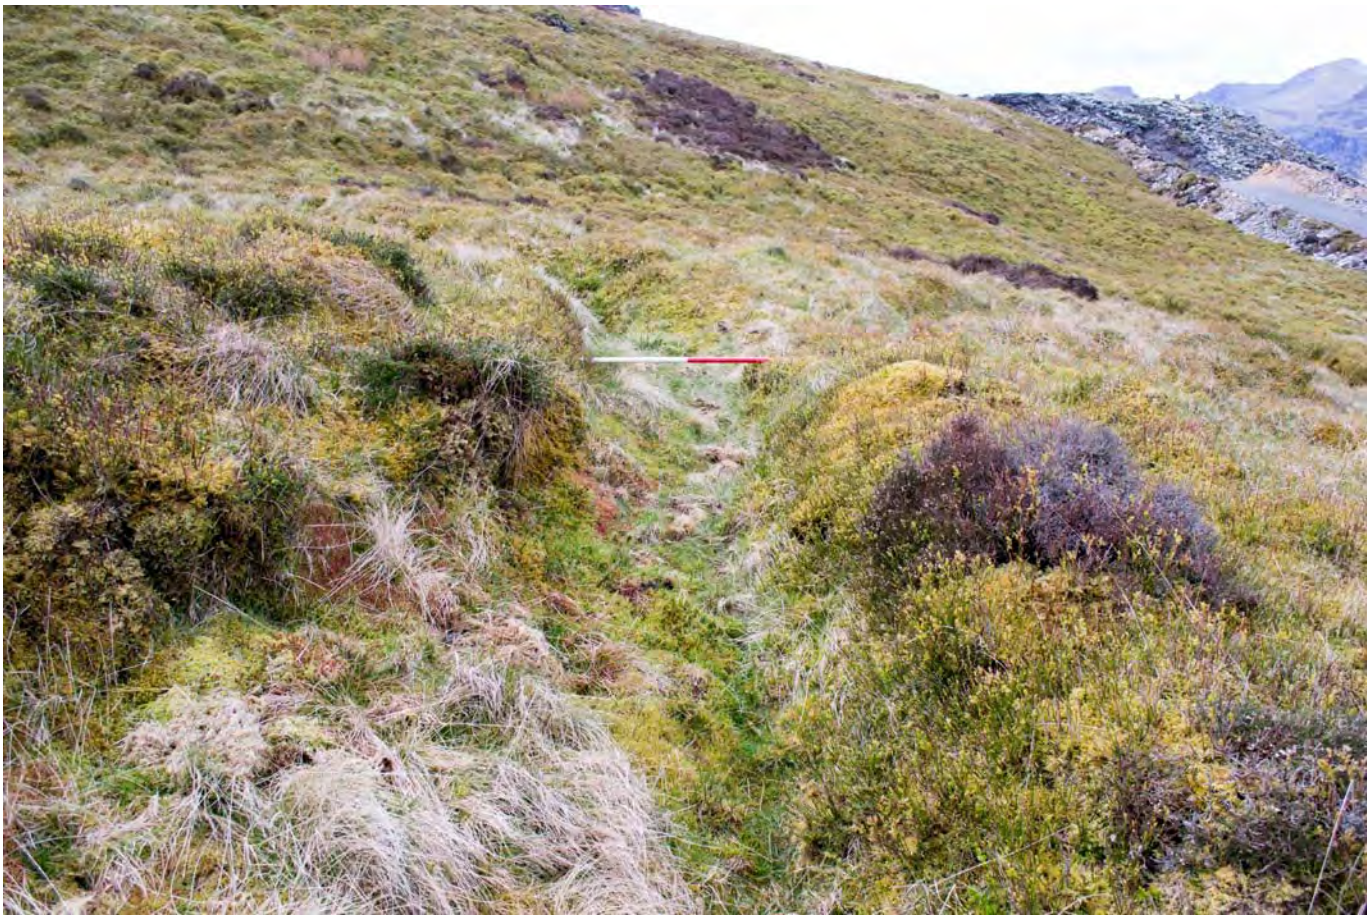
8 and 11: Eroded/ silted drainage ditches which are up to 2m wide and 0.8m deep. Probably dug in the later part of the nineteenth century to divert the flow of surface water into the Maenofferen Quarry workings. The collected water is shed into the Afon Bowyff culvert at the northern boundary of Archaeological Survey Area Two.

The eroded/ silted up drainage ditches (11) are still partially visible on site, however the drainage scoop (15) has fully silted up and is no longer visible. The 19th century dry-stone wall (13) is the same comparable condition as that recorded in the 1998 assessment of the area.

Plate 1: Drainage Ditch (11). View from the Northeast.

The only features recorded within the assessment area date to either the 19th century or current quarry workings. All the features have been recorded photographically and surveyed, and no further work is recommended on them.

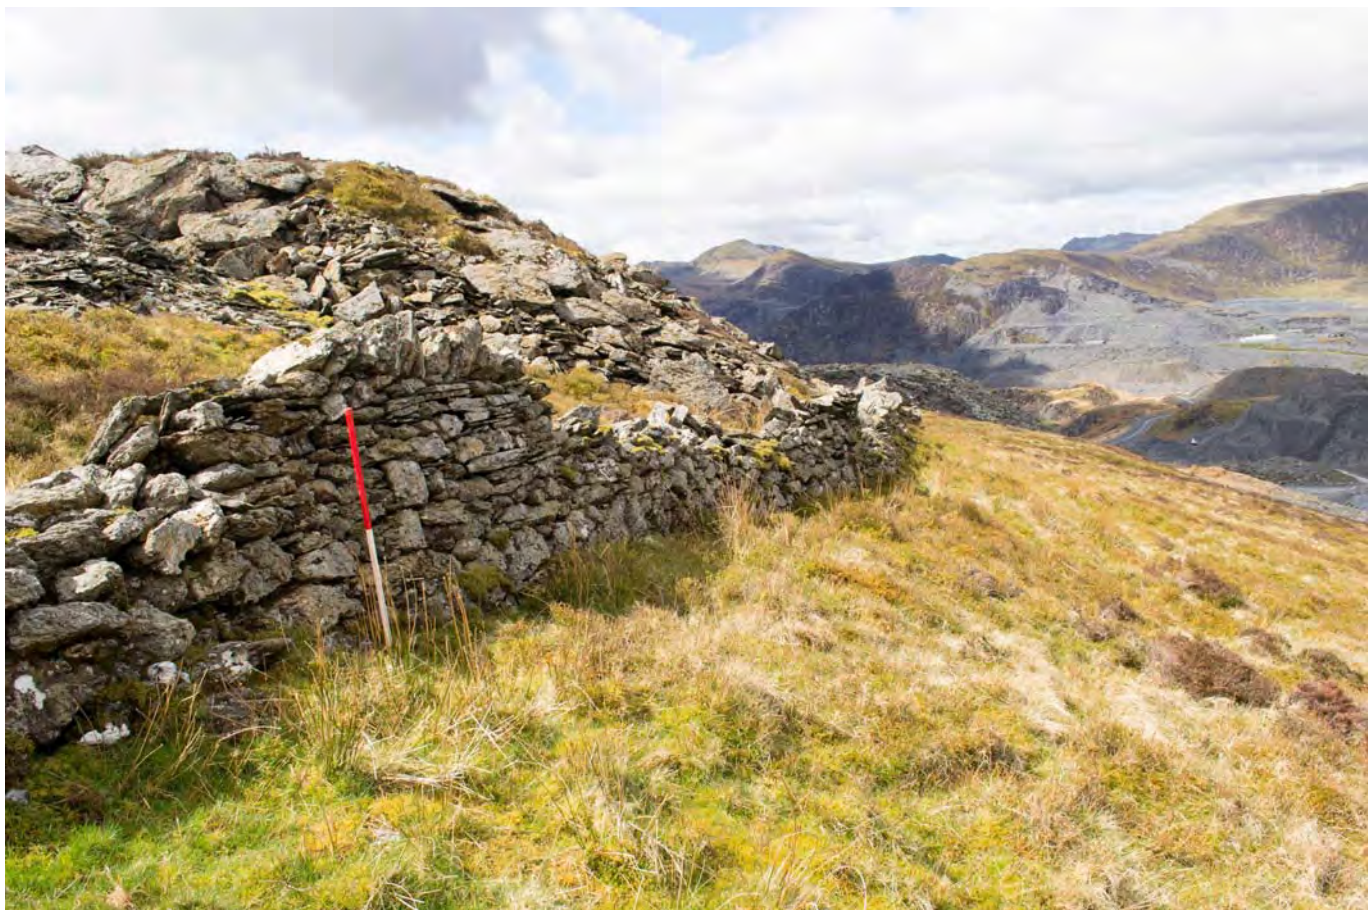
13: Extensive dry-stone wall. 2m maximum height, and 0.5m wide. The wall fabric has both irregularly coursed and uncoursed sections, and comprises a mixture of surface gathered and roughly quarried slate blocks and slabs. The wall is tumbled in places, but survives intact, including its topping of block

cope stones, for most of its length. Probably a nineteenth century wall associated with quarry related ownership boundaries.

Plate 2: Dry-Stone Wall (13). View from the ENE.

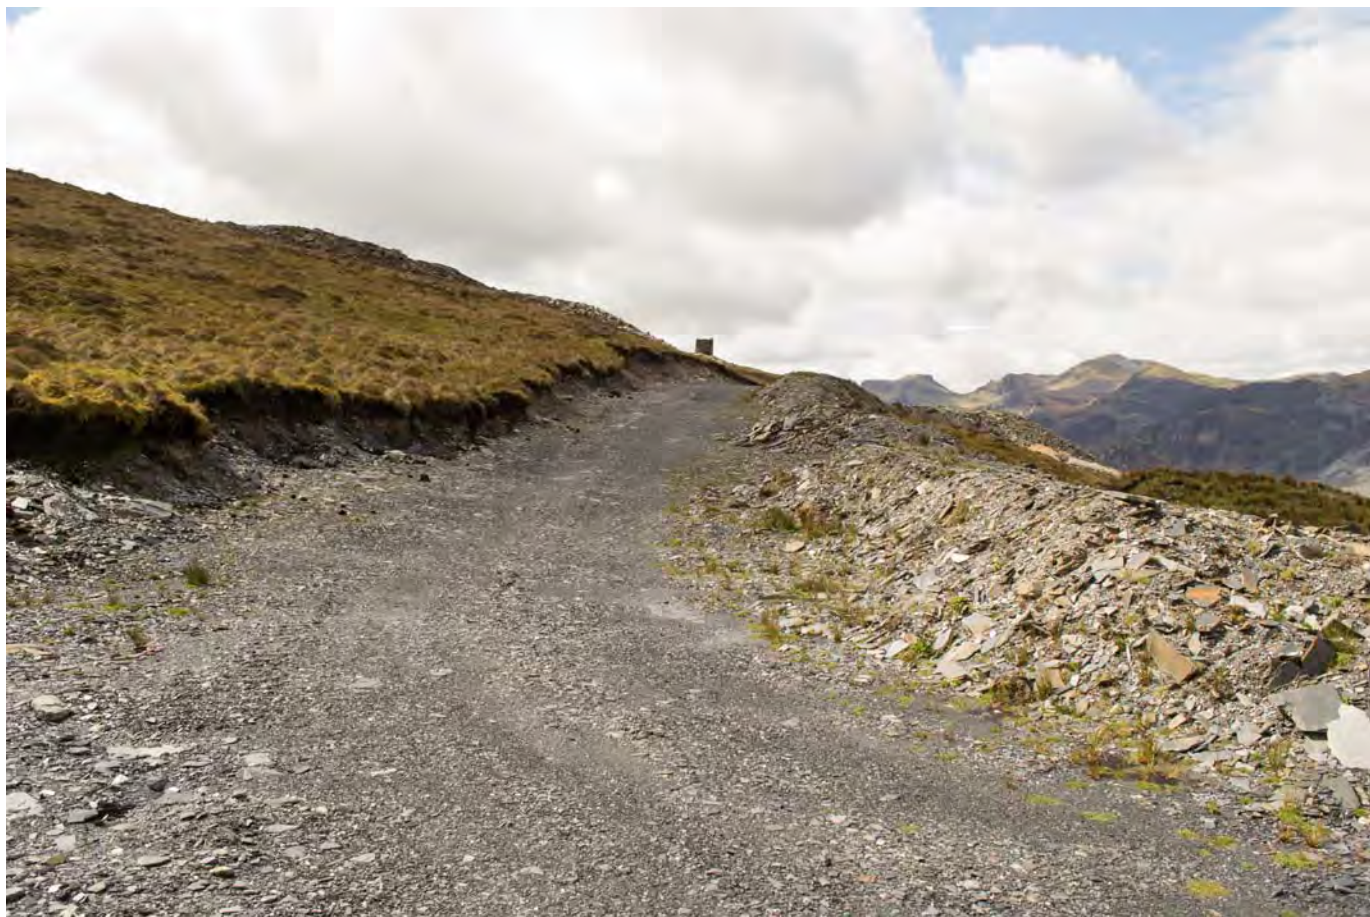
100: a modern rubble stone access trackway approximately 7m wide (Plate 3). The area between this trackway and the existing quarry face to the north and west has been heavily disturbed by surface working. Post-dates the 1998 assessment and is associated with the current quarry works;

The archaeological assessment has shown that a new stone access trackway (100) was constructed at some point after the completion of the 1998 survey of the area. The area to the north and east of this trackway, between the current quarry face and the trackway, and both inside and outside of the current assessment area, has been heavily disturbed. This disturbance, caused by surface working in the area, has removed any evidence of the features recorded by the previous assessment, including the drainage ditches (8), peat cutting (9), and adit (10).

Plate 3: Modern Access Trackway (100). View from the Northeast.

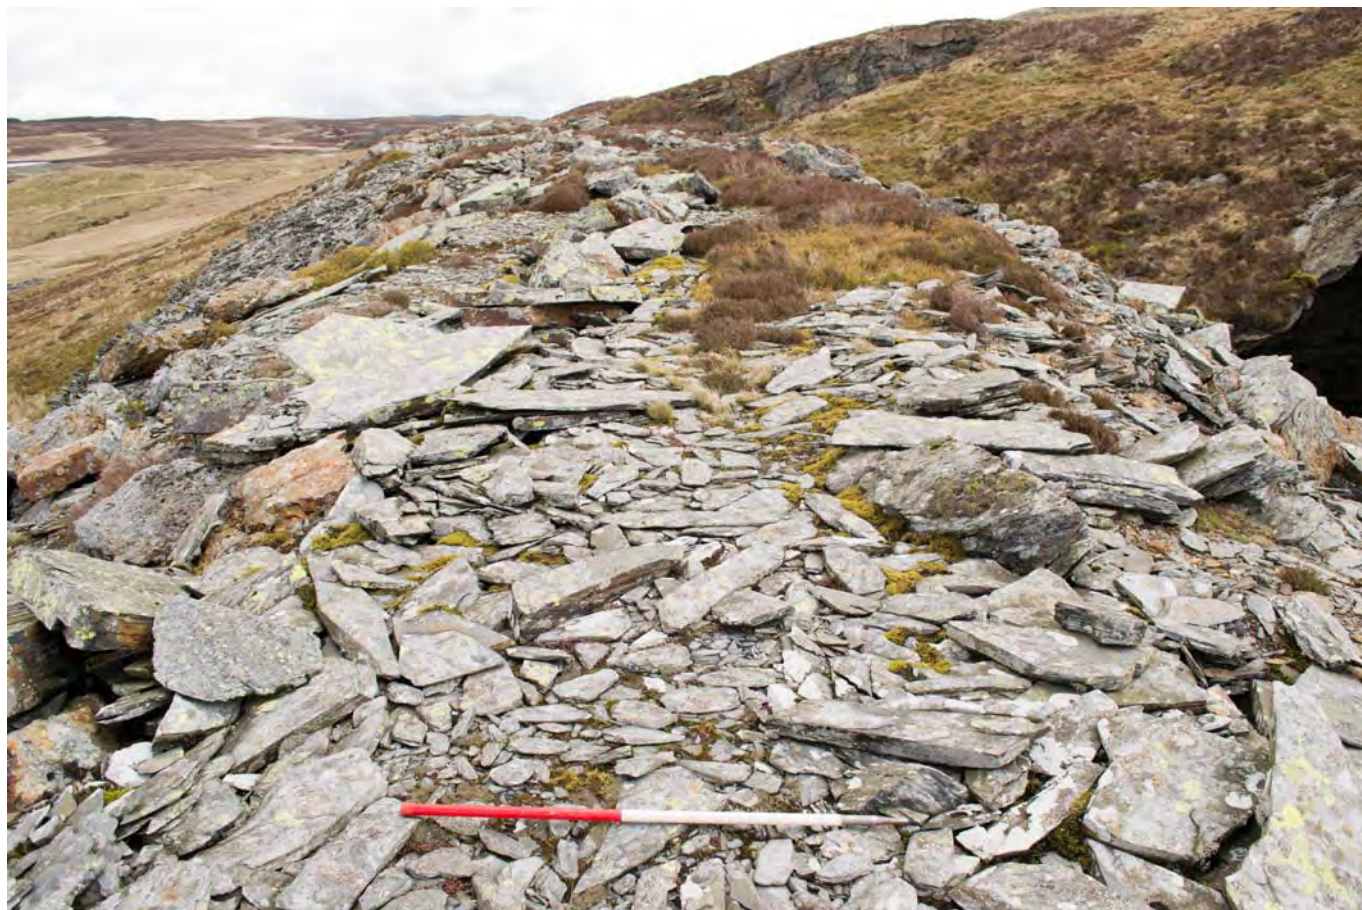
101: a large area of quarried stone, measuring approximately 165m by 40m, and located between the dry-stone wall and the quarry face at the southern end of the assessment area. A rubble trackway, between 2m and 4m wide, was visible running along the top of the stone pile (Plate 4). Associated with the 19th century quarry works;

The southern section of the assessment area, which had not been previously assessed, revealed a large quarried stone pile, with a flattened trackway running along its top (101). A dry-stone sheepfold or store (102) with associated dry-stone wall (103) was located on top of this stone pile, adjacent to the quarry edge. All of these features are associated with the 19th century quarry workings.

Plate 4: Quarried Stone Pile and Trackway (101). View from the WSW.

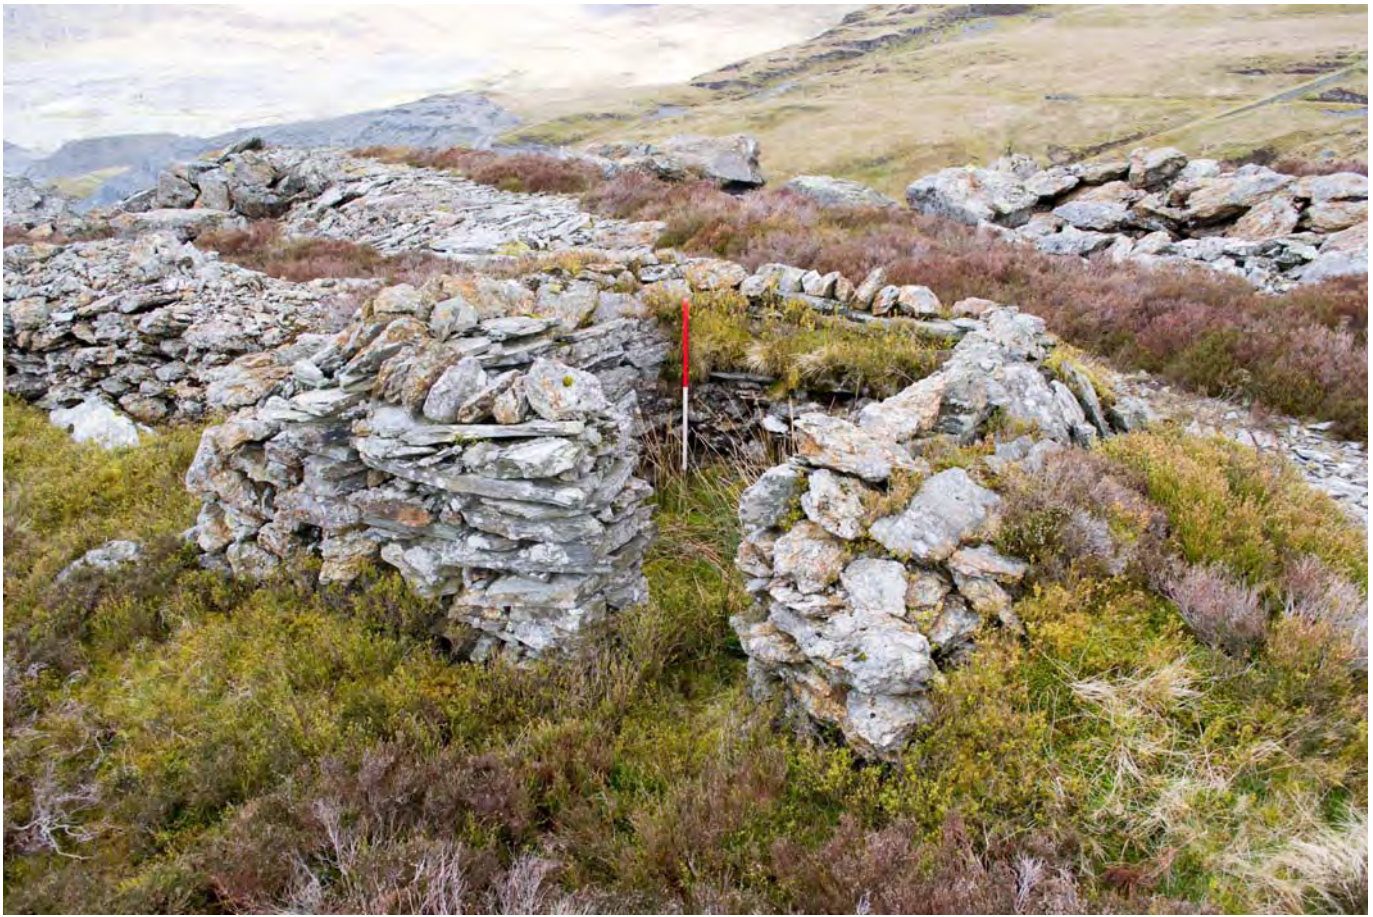
102: a square sheepfold or store (Plate 5) was located on top of the quarried stone pile, measuring 2m by 1.5m internally. Its walls were approximately 1.5m high and 0.6m wide, and were constructed from a mixture of surface gathered and roughly quarried slate blocks and slabs. The topping of block cope stones is mostly intact. An entranceway, 0.5m wide, was located at its southeastern corner. Associated with the 19th century quarry works.

Plate 5: Sheepfold or Store (102). View from the Southeast.

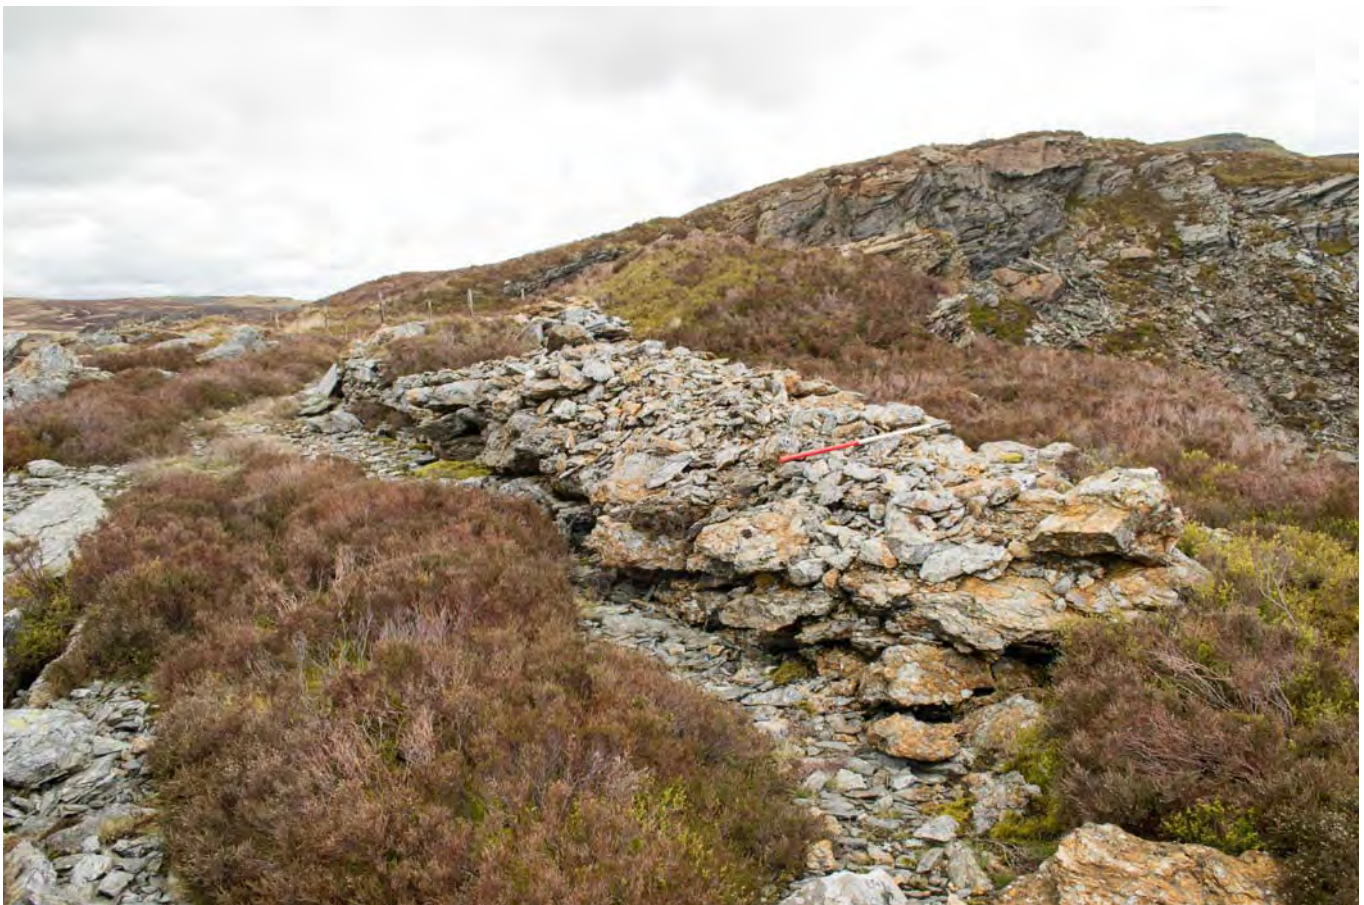
103: A rough stone wall runs west from the northwestern corner of the sheepfold or store along the edge of the stone trackway (**101**) (Plate 6). It ran for approximately 9m and measured 1.7m wide adjacent to the sheepfold or store, and narrowed to 1.3m wide at its western end. It had an average height of 0.6m and was constructed from roughly quarried stone slabs. Associated with the 19th century quarry works.

Plate 6: Stone Wall (103). View from the Northwest.
