Market Street, Holyhead Drainage Scheme

Archaeological Watching Brief

Prosiect Rhif / Project No. G2412

Adroddiad Rhif / Report No.1251

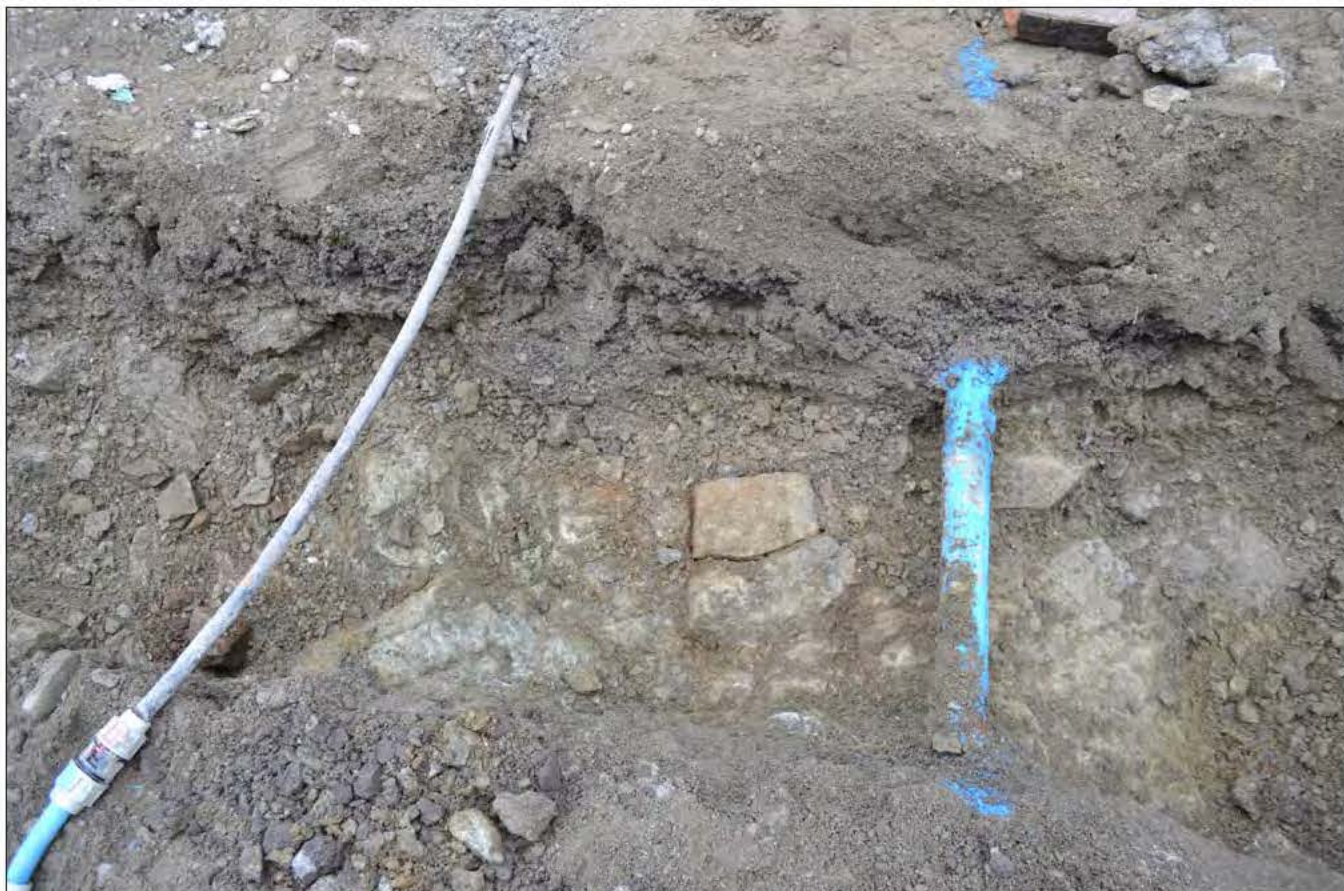
The only archaeology noted during the watching brief was the evidence for two areas containing a metalled surface (between G9-G10, and also after the removal of the lamp-post near St Cybi`s Churchyard wall scheduled monument) (Plates 01 and 05).

Within a service trench between section G9-G10, and during the lamp-post removal a very similar small section of a metalled surface was found directly above the bedrock (Plates 01 and 05). This could be the remnants of a road surface which may date to the Medieval period, or even earlier. The location and depth below the present ground surface was recorded for future reference.

Plate 01: Possible metal surface in open cut trench, with services crossing the trench. Section between G9-G10. No scale. Viewed from the North-West.

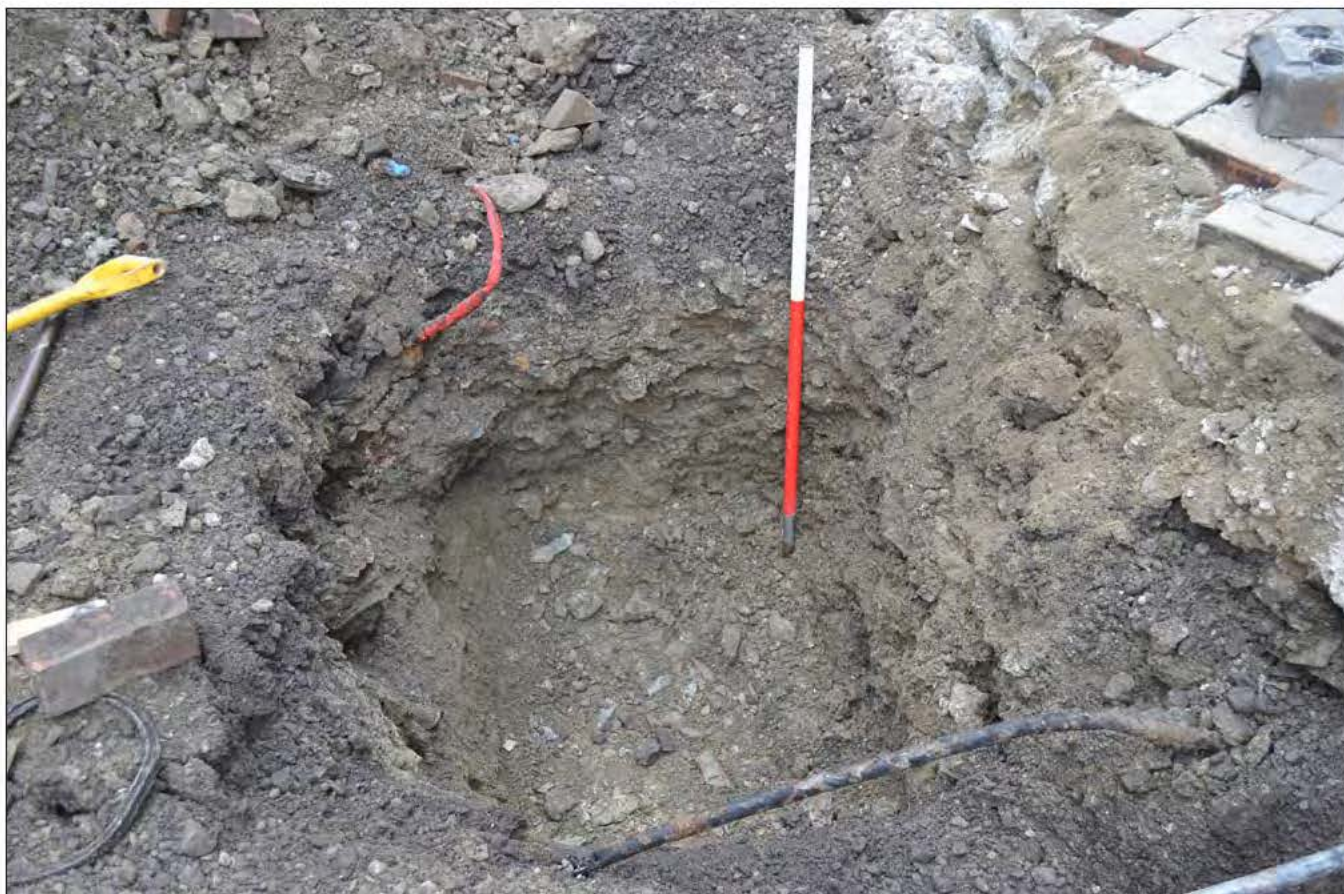
A pit measuring 1.2m x 1.2m, and also 1.2m deep was excavated for a tank/chamber between gully points G9 and G10 (Plate 02); the pit contained grey gravelly clay with sub-angular pebble and cobble inclusions. These deposits within the excavated pit were re-deposited clays excavated from modern made ground connected with previous 20th Century road construction phases, including large amounts of services and drains below street level.

Plate 02: Small pit excavated for gully G9. 1m scale, as seen from the South-West.

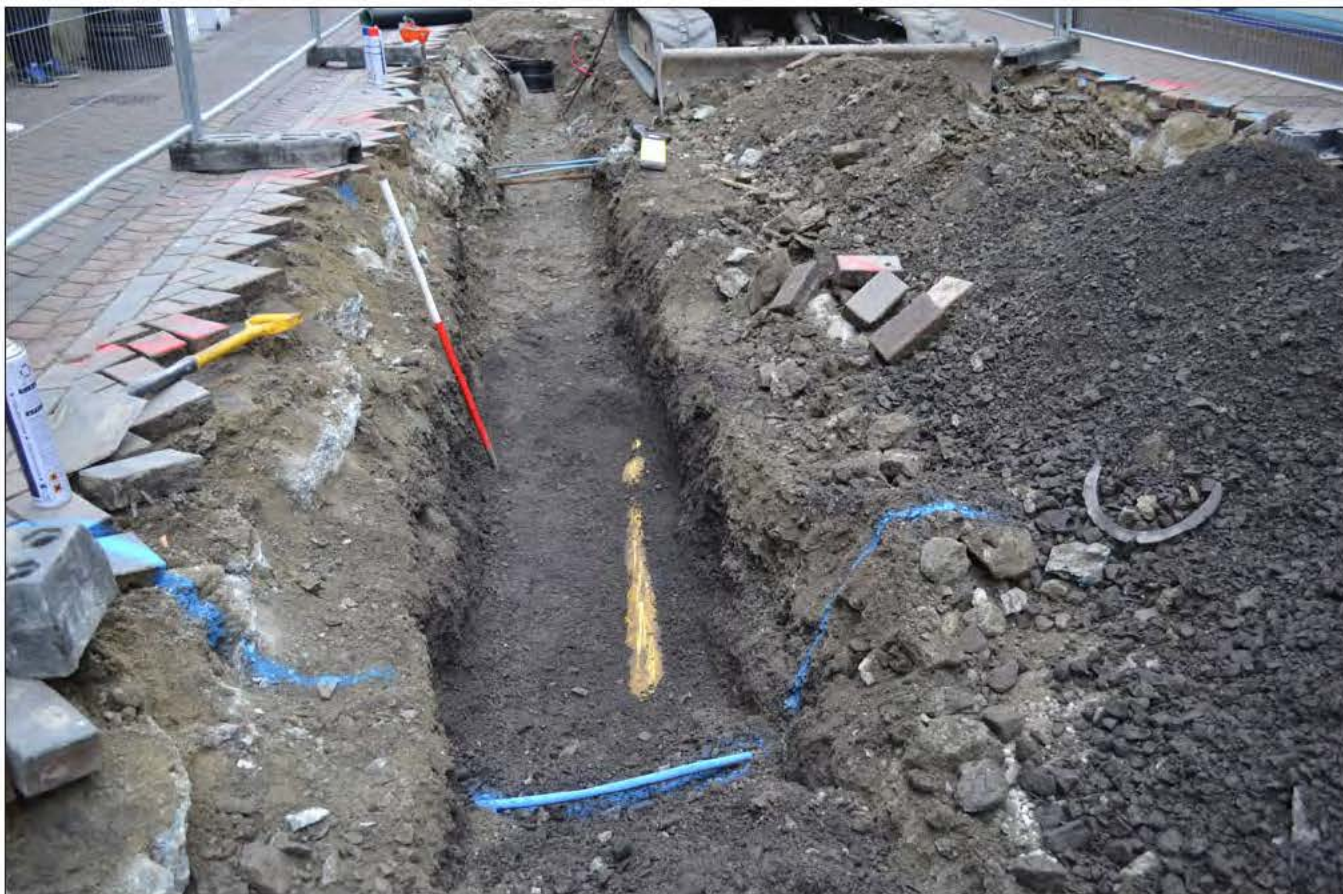
A section of drainage trench by gully point G10 (Figure 02) measured 0.6m wide, 0.75m deep and 30m in length (Plate 03). This exposed section contained a sequence of deposits that included a sub-base for the modern brick road surface above a re-deposited grey gravelly clay containing a moderate amount of sub-angular pebble and cobble sized stone, and also included a few patches of a red brown gravelly clay. These were fairly recent made ground deposits and exceeded the 0.75m depth limit of excavation required by the site contractor. The natural deposits were not reached in this section, except in a short length containing exposed bedrock. These mixed deposits are most likely associated with the modern phases of development in Market Street, possibly during the middle part of the 20th Century.

The next section of the trench was observed between William Hill and Beresford Adams (G10 to G11) (Plate 03) with approximately 30m excavated. The trench was 0.8m wide and 0.6m deep after the removal of the upper street surfaces (paving brick, sand and concrete). The trench contained an orange-grey clayey gravelly silt with occasional angular and sub-angular small and medium stone inclusions. The deposits were very disturbed especially in the areas of the trench where drains and services crossed the trench. Bricks and rubble were observed in this section of the trench.

Plate 03: Length of trench showing gas main and other services. 1m scale, and viewed from the North-West.

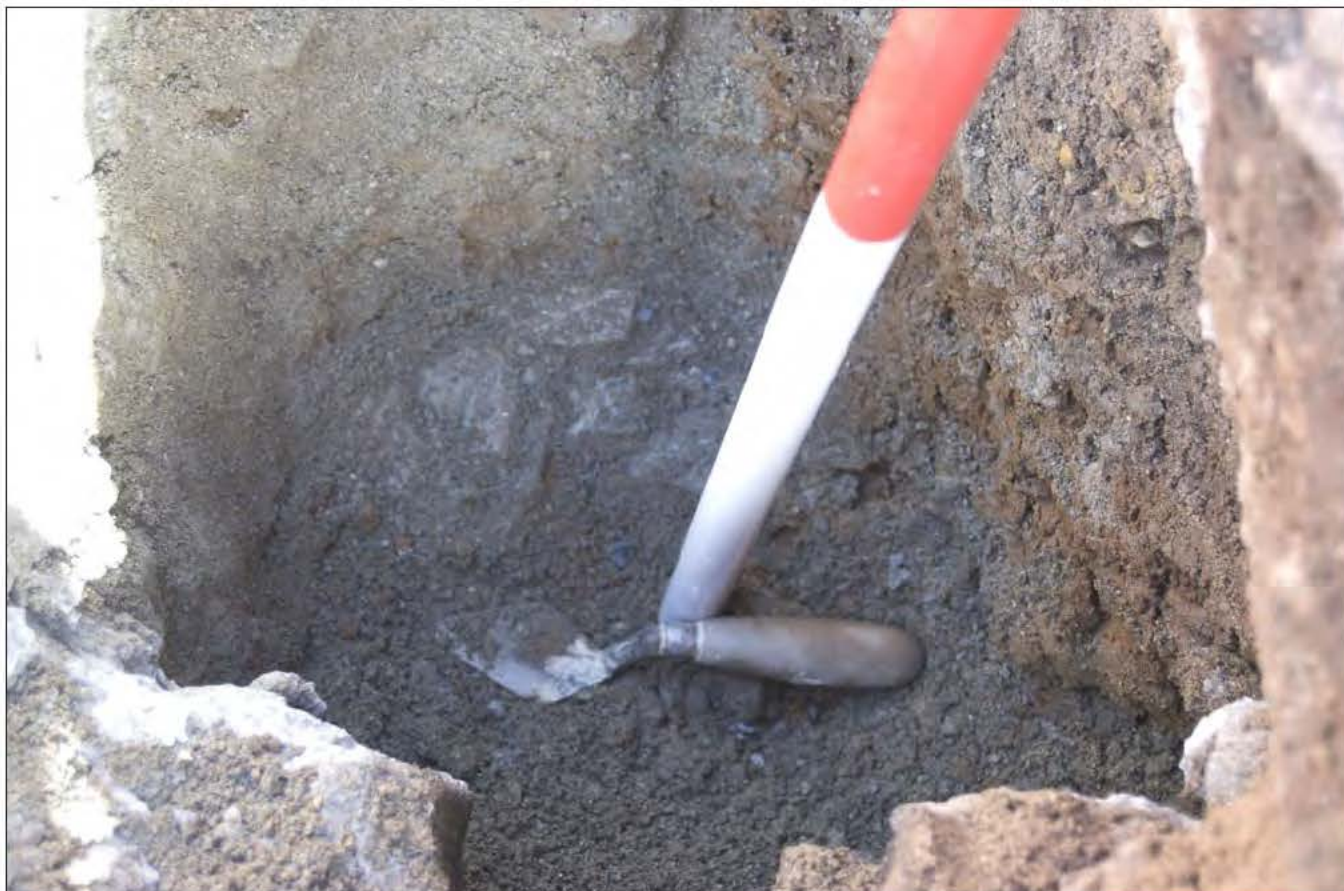
At a depth of 0.6m below the existing ground surface and within the extent of the lamp post post-hole a very small area of possible metalled surface was found (Plate 05). The observed area at the base of the post-hole had a rough diameter of 0.4m, with the metaling only seen in approximately half this area, as the former lamp post had cut the remaining half down to bedrock which was at a depth of 0.7m below ground surface.

The metaling could be fragmented bedrock, although when observed in this very small section the stones lay very flat and were quite level, giving the impression that they were a metalled surface. This metalled area is very similar to another metalled area described above, between section G9 and G10, outside Boots the chemist, and lies directly onto the bedrock with no intervening bedding deposits.

Plate 05: Possible metaling at the base of lamp-post near St Cybi's Churchyard wall after removal. 1m scale, and also trowel for comparison. Viewed from the South-West.

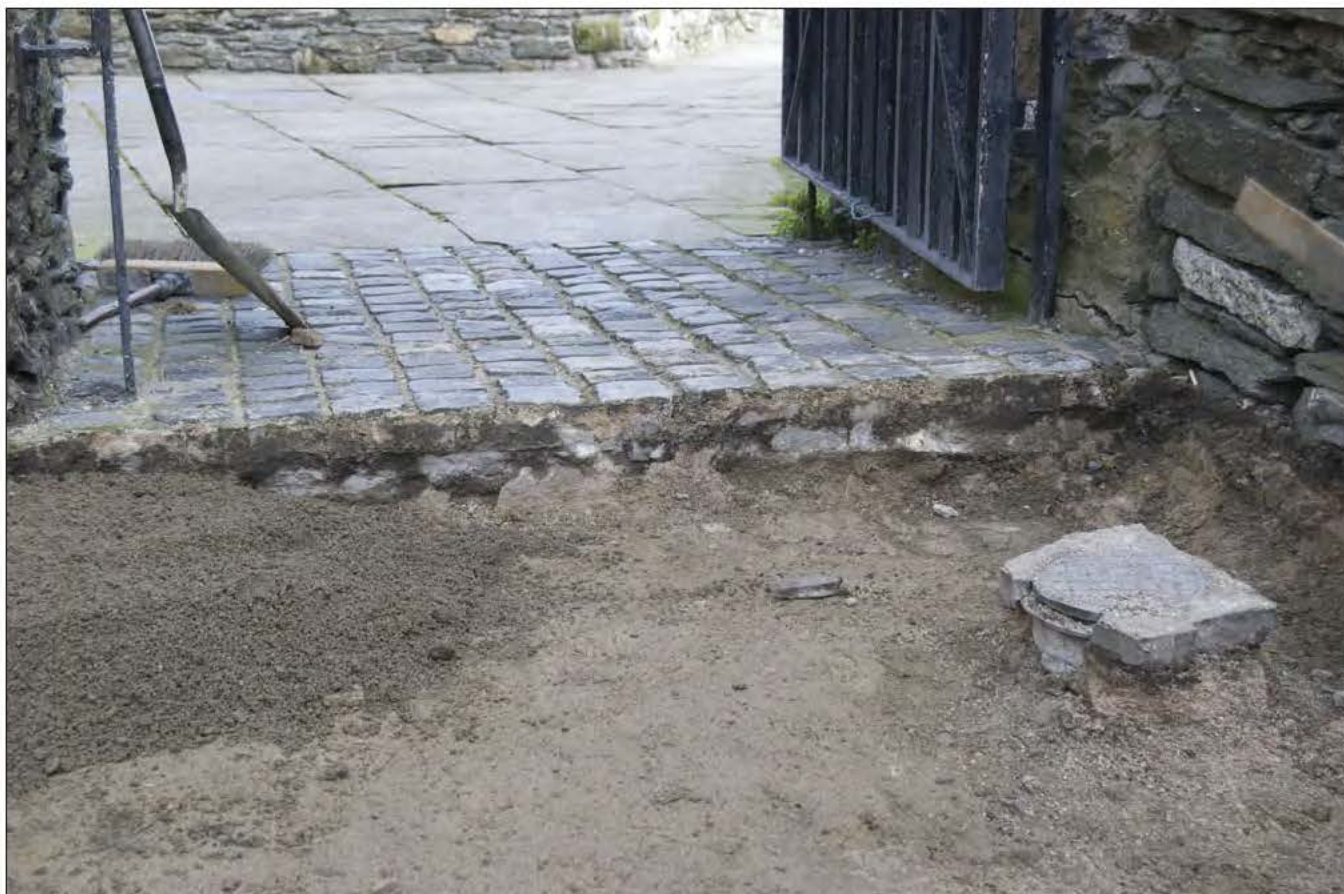
The area underneath the arched churchyard wall/fort entrance is composed of modern stone setts, possibly only 20 years old, bedded into cement and underlain by cobbles (Plate 06). It was not possible to determine in this section of the ground works if the cobbles were set on top of the concrete floor. The stone setts though were laid on top of the cobbles.

Plate 06: Cobbles below modern stone setts within the walled arch at St Cybi's Churchyard wall. No scale and seen from the South-West.
