# MORFA FRIOG EMBANKMENT, FAIRBOURNE

## Archaeological Watching Brief

Prosiect Rhif / Project No. G2440

Adroddiad Rhif / Report No.1279

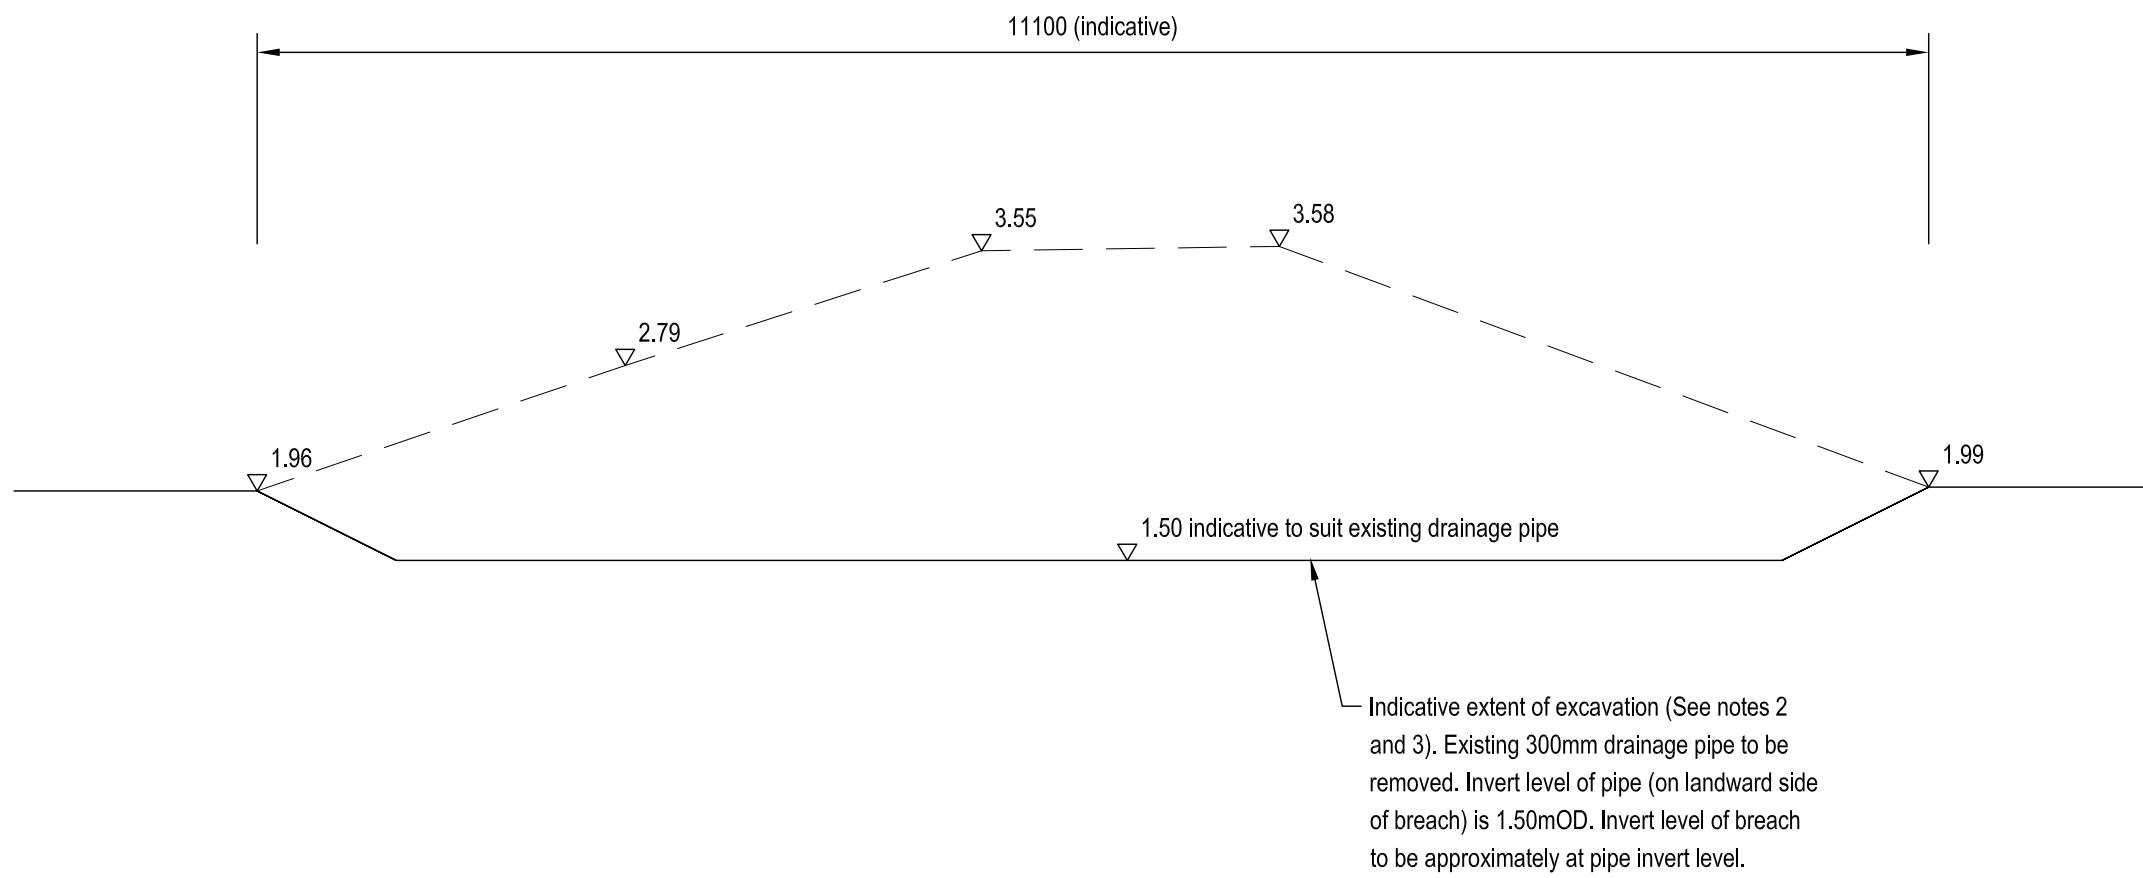
SECTION AA  
SCALE 1:50

The watching brief involved monitoring the breaching of the existing flood alleviation embankment, as indicated on *Black & Veatch* drawing 109448-02 and 109448-03 (Figures 1 and 2 respectively). The embankment measured 560.0m in length and was located along the edge of marshland, connecting to a shingle bank and protecting the Fairbourne railway line to the west. The embankment breach was located at NGR SH61341438 and measured 11.10m in length and 6.20m in width (Figures 3 and 4).
