Great Orme Sewerage Works, Llandudno

Archaeological Watching Brief

Project No. G2439

Report No.1283

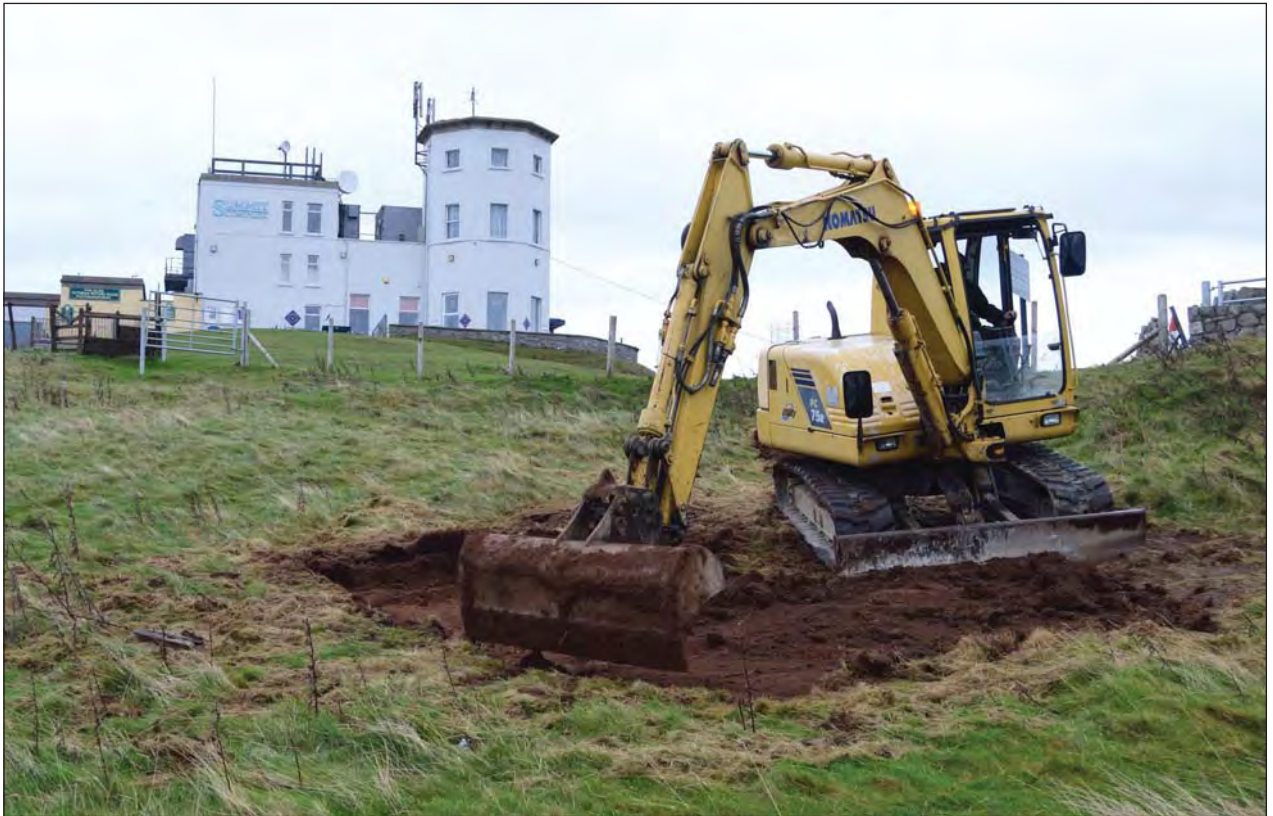
Trench 1 was located to the west of the Summit Complex close to the north-eastern corner of the main visitor carpark (SH 76585 83365). Topsoil was stripped from the access route and around the area of the trench. The main trench (excluding topsoil stripped area) measured 3.3m by 2.7m. This was excavated to a maximum depth of 2.5m.

Plate 1. Location of trench 1 near Summit Complex, taken from the west

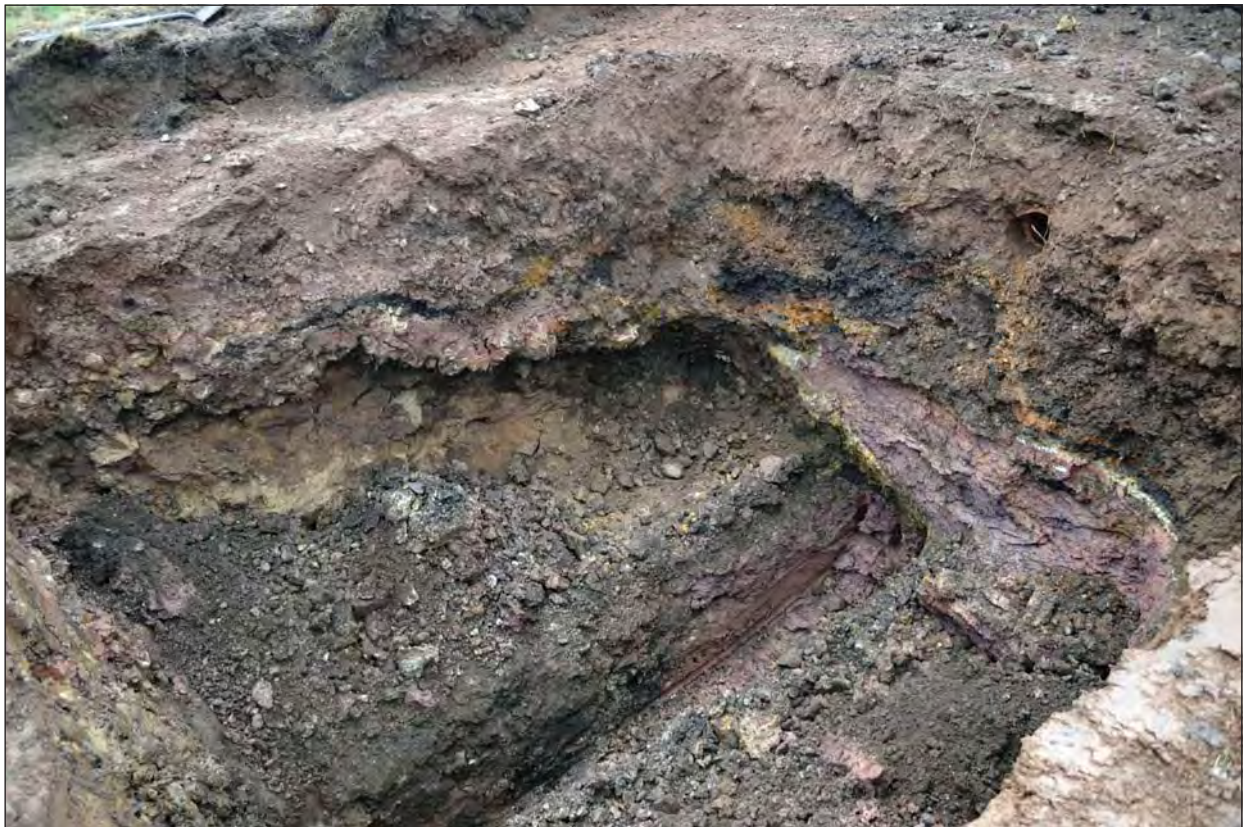
Under up to 0.35m of topsoil (101) and ploughsoil or colluvium (102) was a layer of pale-mid brown silt (103). This resembled the peri-glacial loess (fine wind-blown dust) that is often found as the substrate for soils in north-west Wales, and seemed to be undisturbed.

Below this was a very variable deposit (104) with layers and lenses of different textures and colours; pink clay, orange clayey gravel, very dark grey clayey, pale yellow-brown silt with numerous angular pieces of limestone, and some larger blocks of limestone. The deposit became more consistent with depth, comprising mainly pink clay but still some dark grey clayey gravel. This deposit was initially thought to be spoil from mining, but there is no mining recorded in the immediate area. The fact that it was sealed under the loess layer suggests a glacial origin. A similarly varied layer was seen during the watching brief at St Tudno's Road, where it was interpreted as boulder clay (Kenney 2005, p5). It appears that deposit (104) is the result of boulder clay, containing limestone and other minerals, being deposited over limestone. This has resulted in the varied decay of the rocks and minerals, with some being reduced to gravel.

Plate 2. Trench 1 showing mixed boulder clay (104), taken from the north-west

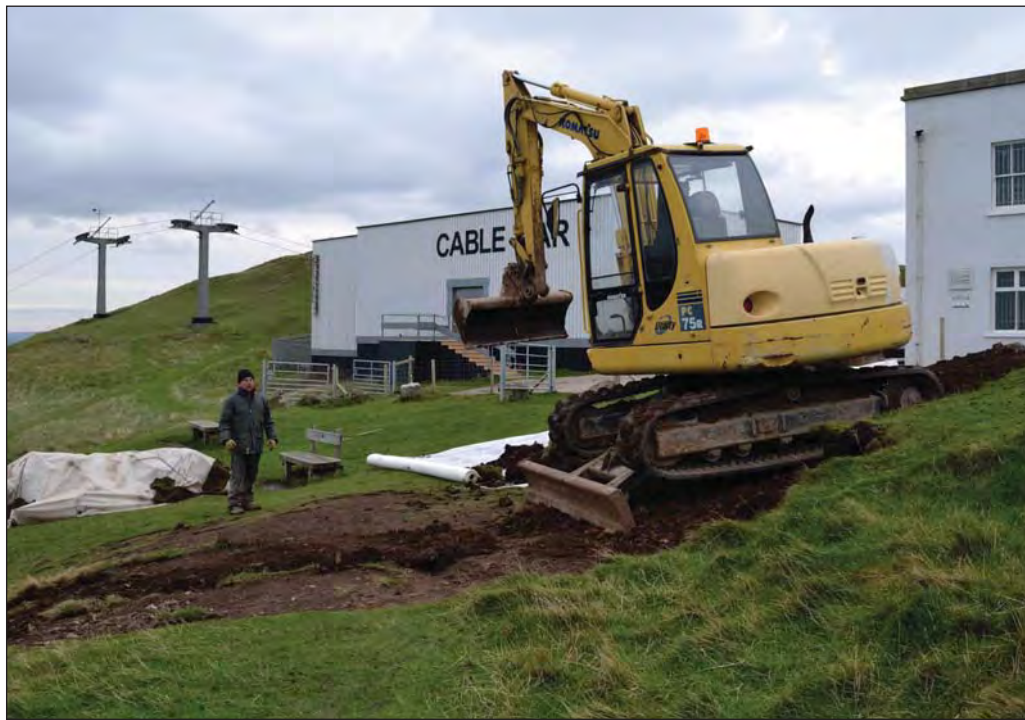
Trench 2 was located to the north of the Summit Complex close to the Cable Car Station (SH 76694 83398). Topsoil was stripped from the access route and around the area of the trench. The main trench (excluding topsoil stripped area) measured 4m by 3m. This was excavated to over 0.9m, but was only watched to that depth.

Plate 3. Location of trench 2 near Cable Car Station, taken from the north-west

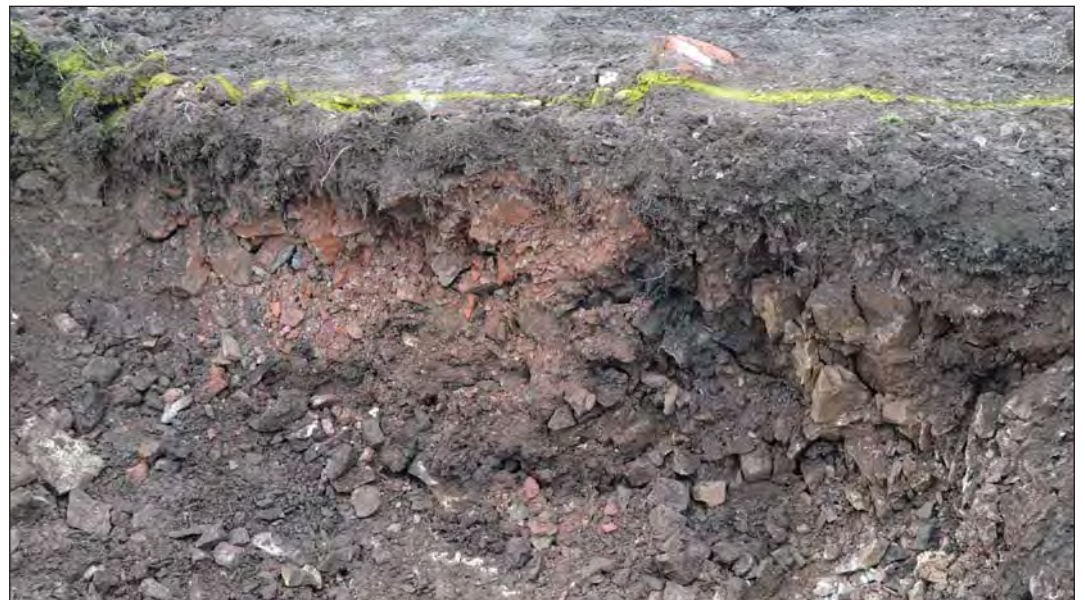
The topsoil (201) and colluvium (202) together were only about 0.2m in depth, and generally directly overlaid shattered bedrock (205). In the south-western side of the current trench it appeared that a previous trench or pit [204] had been dug into this shattered bedrock. This was filled with brick rubble and mortar (203). The rubble

contained electrical wires and was clearly of modern origin. It is likely that the trench had been dug to bury rubble produced by alterations to the Summit Complex buildings at some time.

Plate 4. Brick deposit (203) in trench 2, taken from the south-east

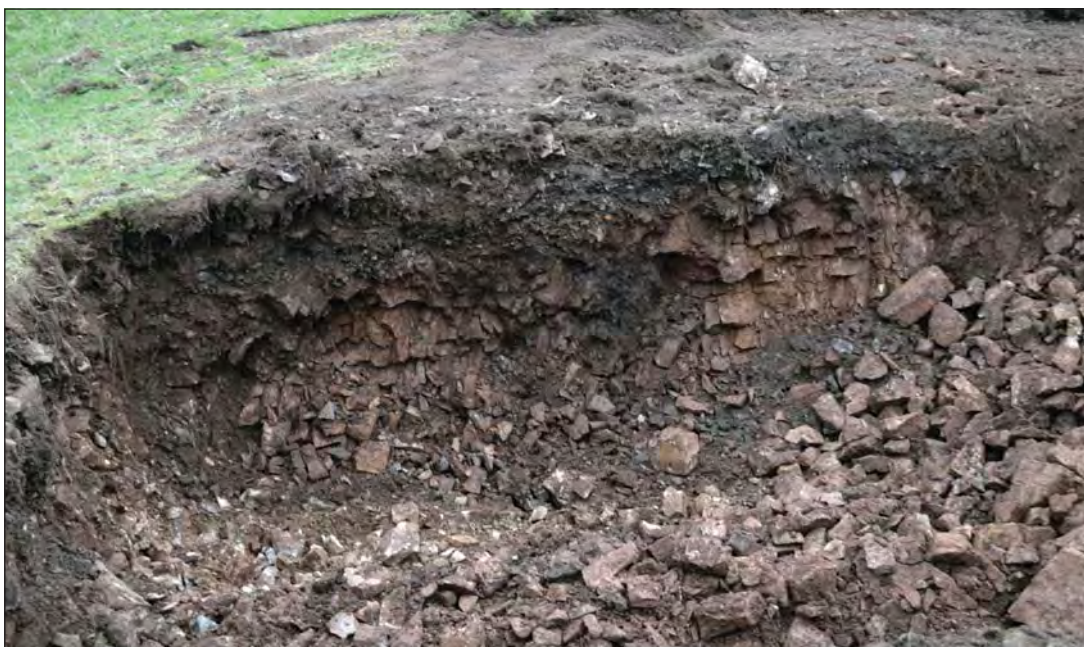
Only shattered bedrock was seen in the rest of the trench. This was loose and composed of small fragments in the top but became more coherent with larger pieces with depth. In section the *in situ* structure of the rock could be seen, with heavily eroded grykes and bedding planes, even where the stone was so eroded that it was loose and easily removed. This shows that the deposit was indeed undisturbed eroded bedrock.

Plate 5. Shattered bedrock (205) in trench 2, taken from the north-west
