Penrhyn Castle Renewable Heating Scheme

Archaeological Assessment

Prosiect Rhif / Project No. G2447

Adroddiad Rhif / Report No.1286

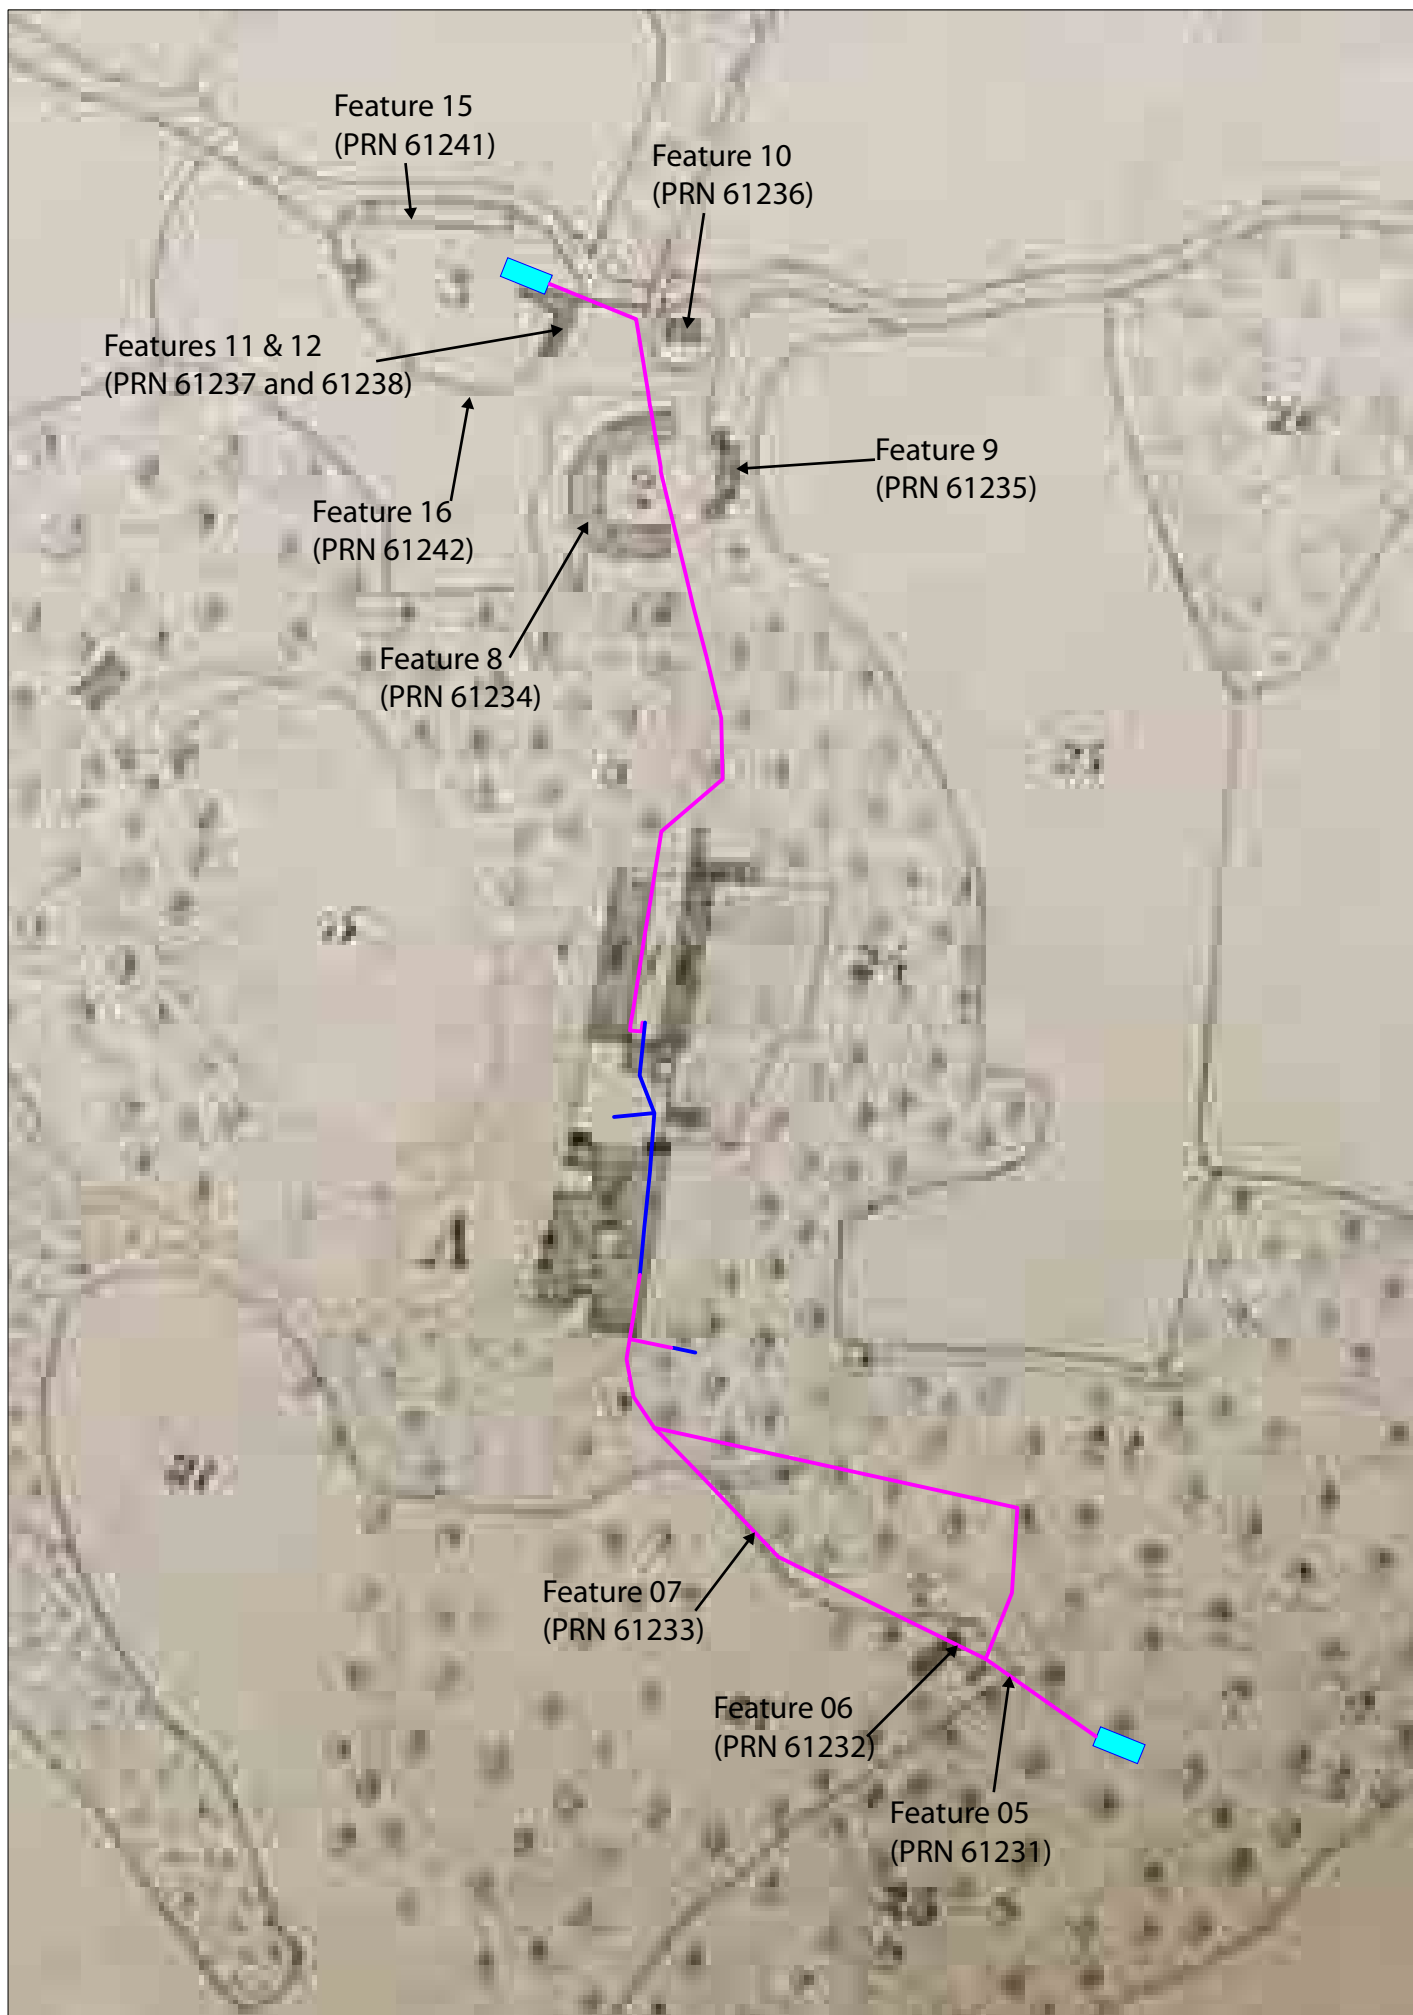
Figure 05: Reproduction of 1803 Penrhyn Estate Map and location of proposed North and South Option routes and information from the Historic Environment Record and National Trust. Scale: 1:2500@A4. (Source: National Trust)

The 1803 map (Fig. 05) shows the Wyatt house, constructed on the same footprint on which the Hopper castle was to be built. The parkland around the estate has now been significantly developed, and woodland surrounds the house, with ornamental features now present. The walled kitchen garden has been constructed to the west and some open areas of lawn created. Nine features appear on the map that lay close to the proposed heat main route. Three features to the south of the house were noted Feature 5 (PRN 61231) and Feature 7 (PRN 61233) appear to have been field boundaries, and Feature 6 (PRN 61232) appears as a building. This is possibly an agricultural building, but its purpose is not clear. To the north, near the proposed northern option Energy Centre location is a collection of buildings. Their purpose is not clear. They include a 'horseshoe shaped' building (Feature 8; PRN 61234) and a small rectangular building with wings to the north and south to the east of it on the east side of the track (Feature 9; PRN 61235). Three structures to the north (Features 11 and 12; PRNs 61237 and 61238) form an 'L' shaped building at this time, and Feature 10 (PRN 61236) is a rectangular building in a small enclosure. Feature 15 (PRN 61241) appears to be an unroofed enclosure by this time. Their purpose is unknown (Gee and Laws 2015, 23-24), however they form a discrete group of structures and may be either a home farm and outbuildings, or an estate yard. The horseshoe shaped building is intriguing, very speculatively it could be stables. Feature 10 is situated within a small sub circular enclosure. It is also of unknown purpose, but could be a former dovecote. At any rate the buildings date from between 1768 and 1803, and form a discrete area of activity, almost certainly associated with the management of the estate.

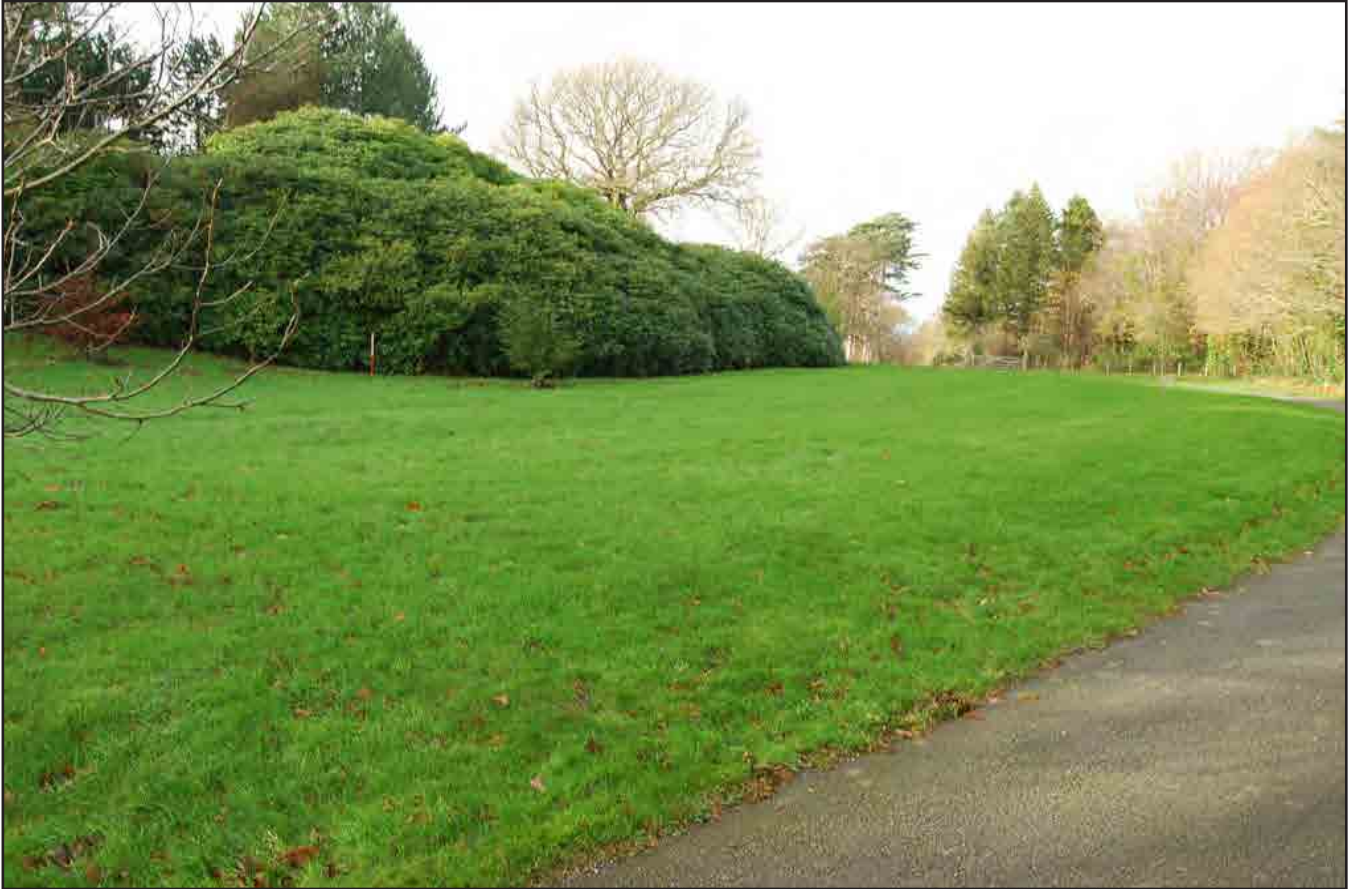
Plate 01: North Option - view north towards location of the energy centre building, which will be screened by existing vegetation.
Scale: 1 x 1m.

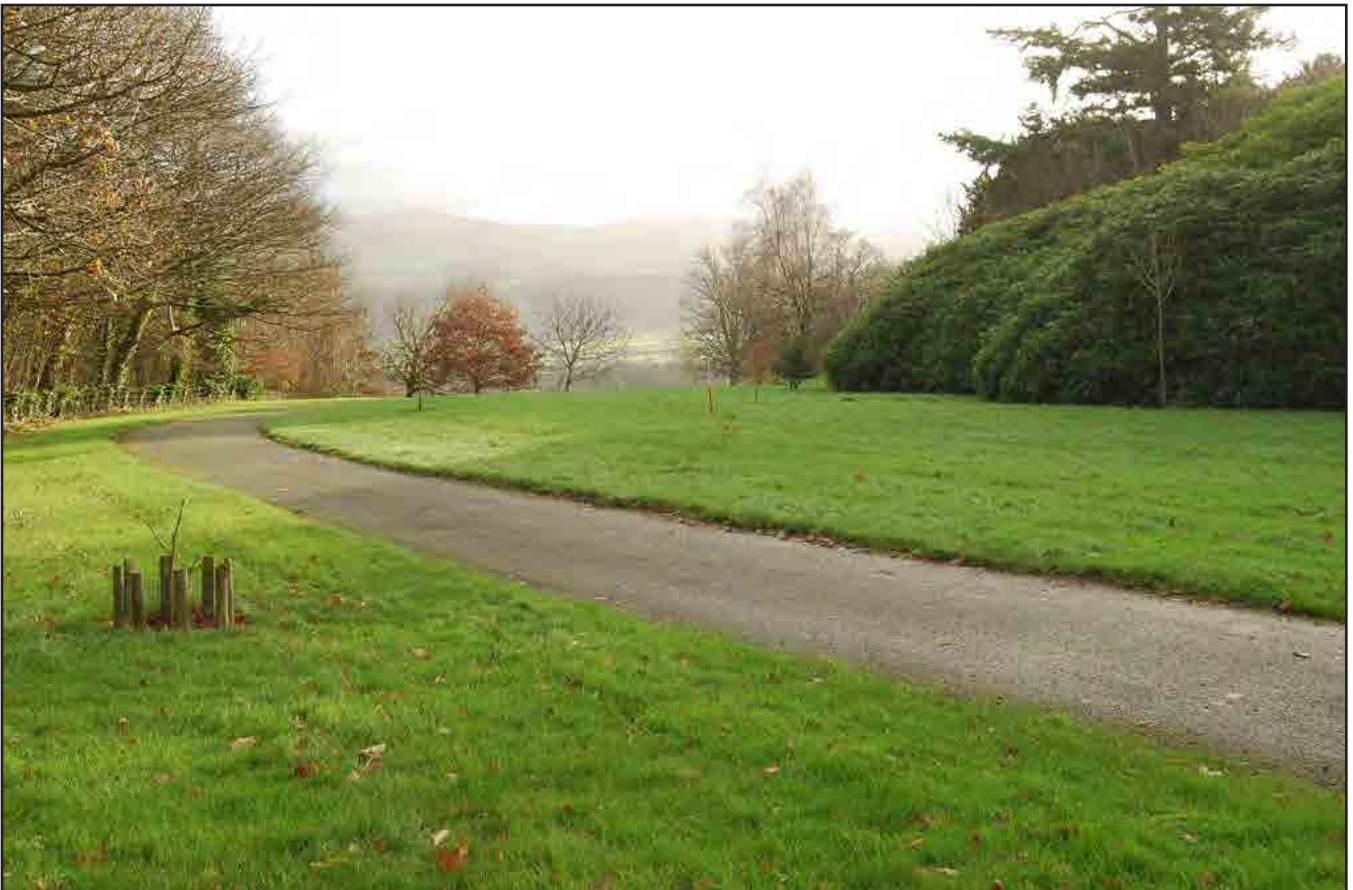
Plate 02: North Option - view south towards location of the energy centre building, which will be screened by existing vegetation.
Scale: 1 x 1m.

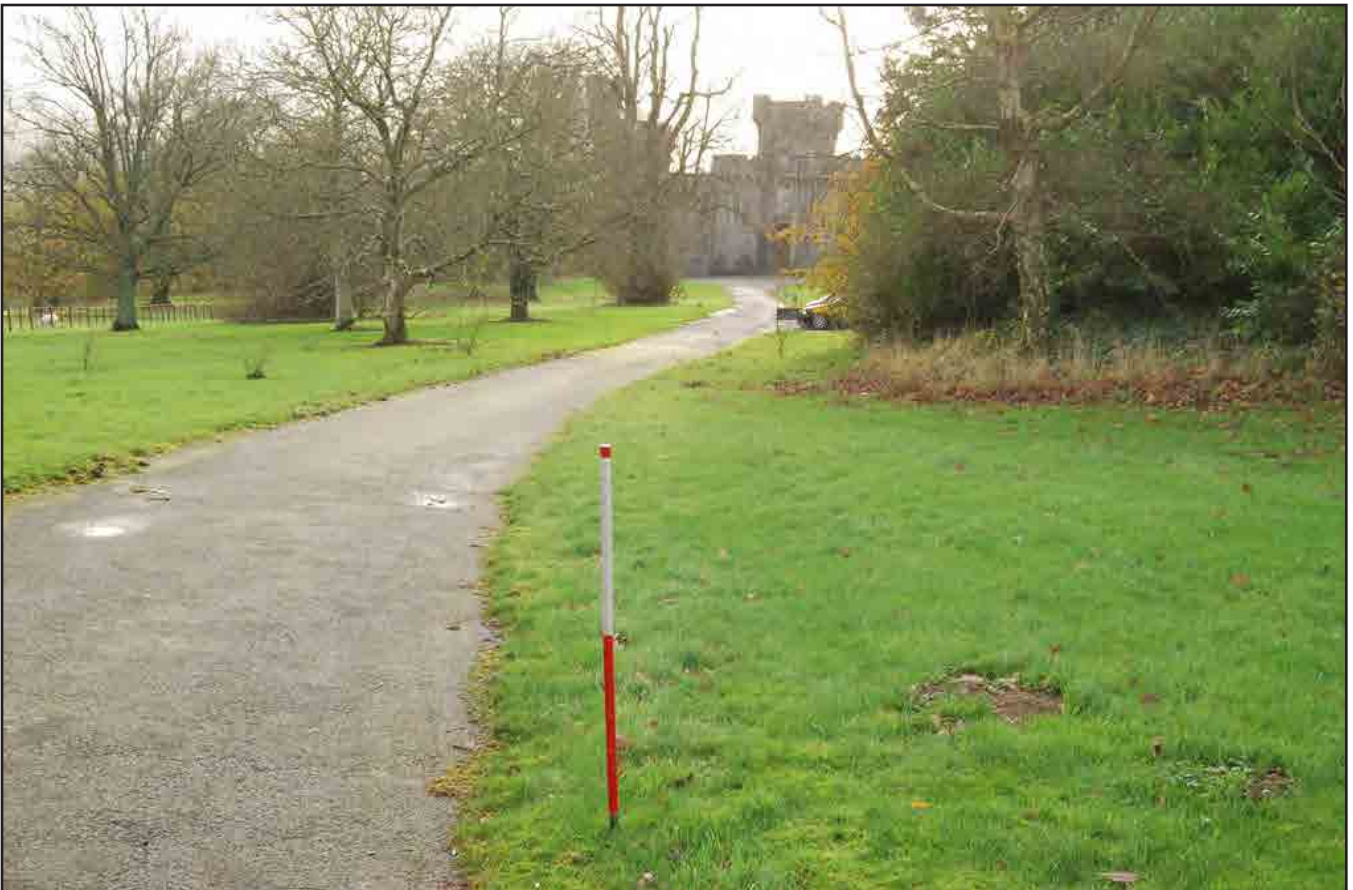
Plate 04: North Option - view south of heat main route which will follow the existing path. Scale: 1 x 1m.

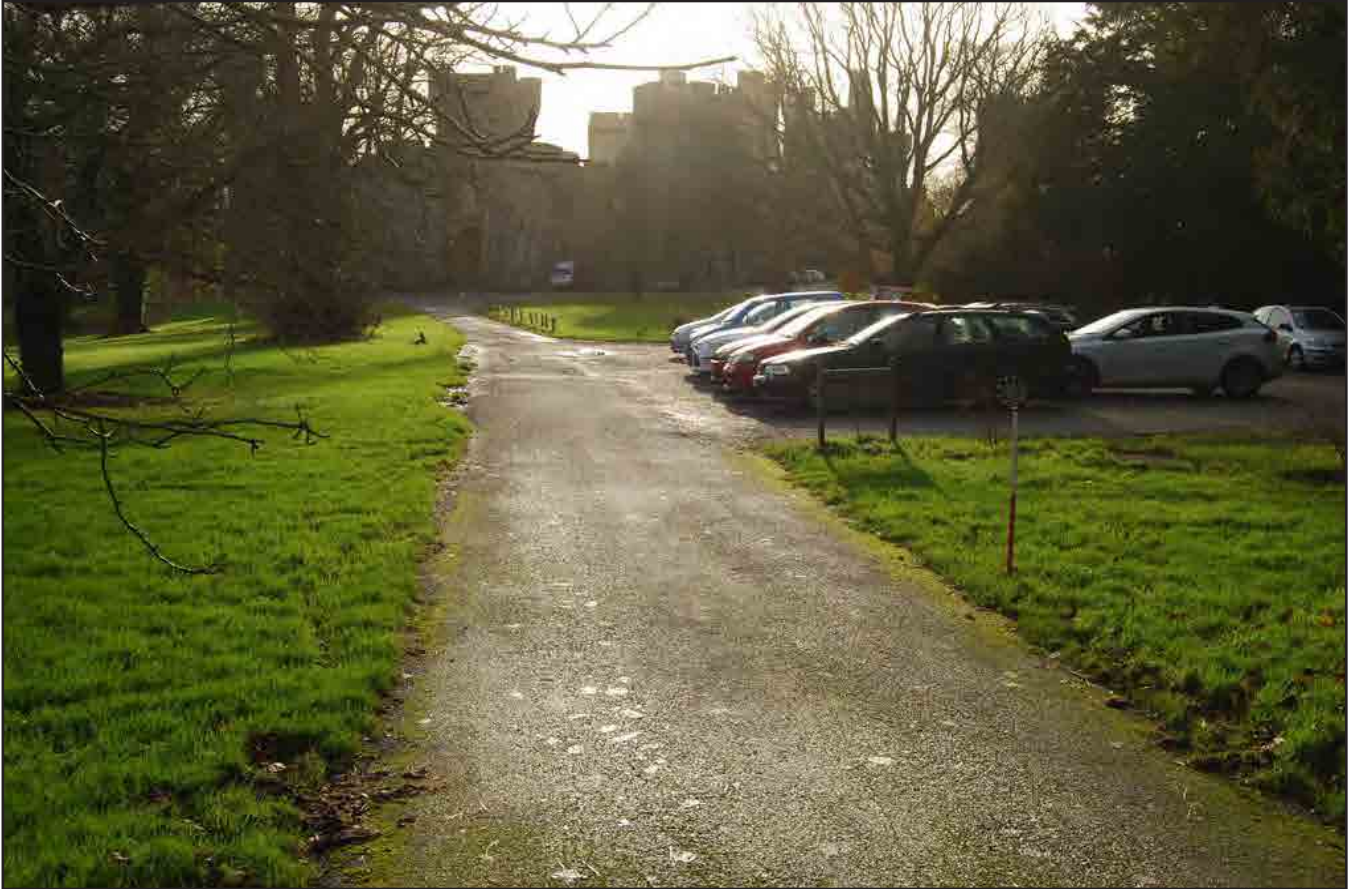
Plate 05: North Option - view south along heat main route, which follows the existing path. Scale: 1 x 1m.

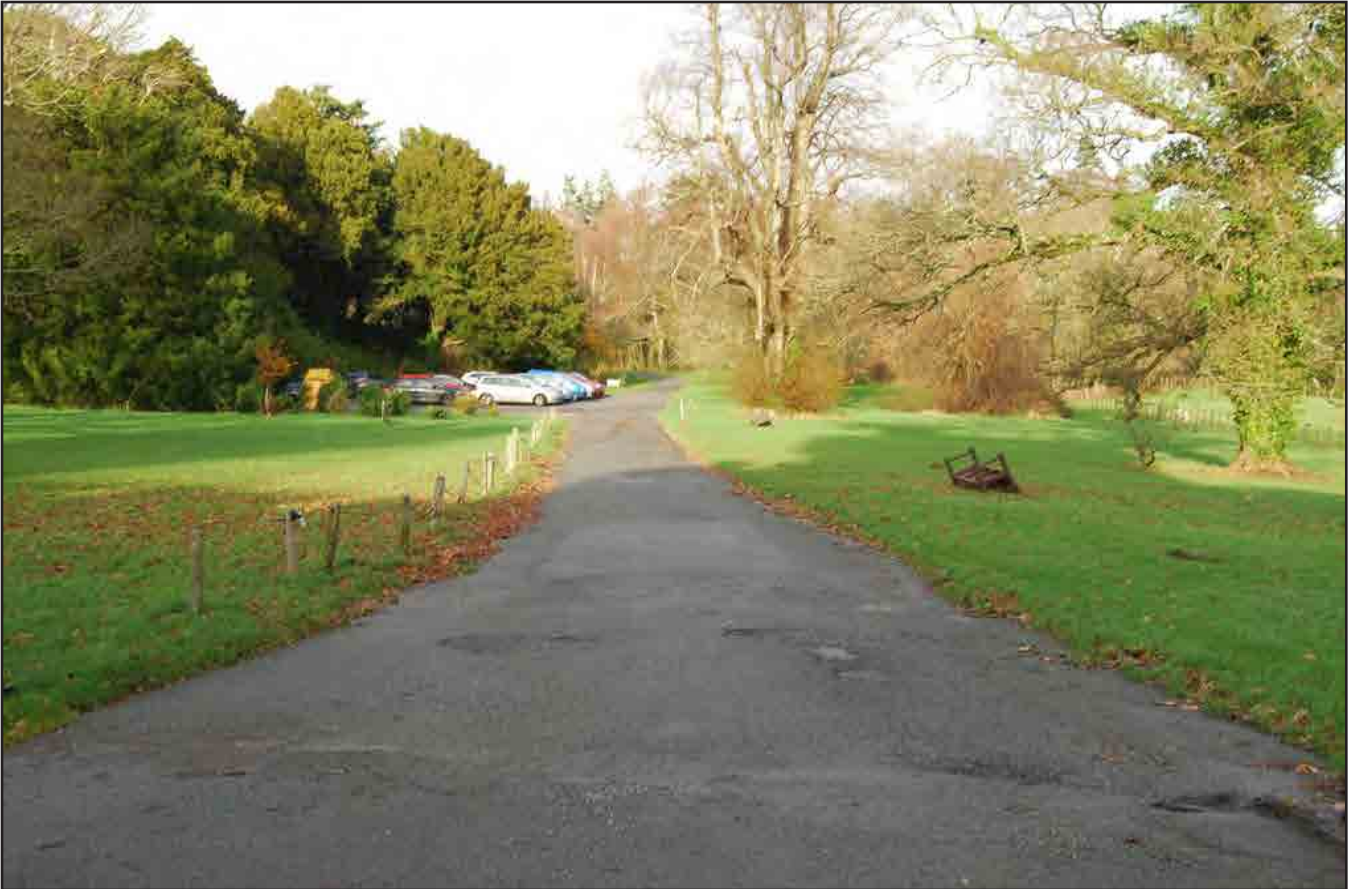
Plate 06: North Option - view north along heat main route, which follows the existing path. Scale: 1 x 1m.

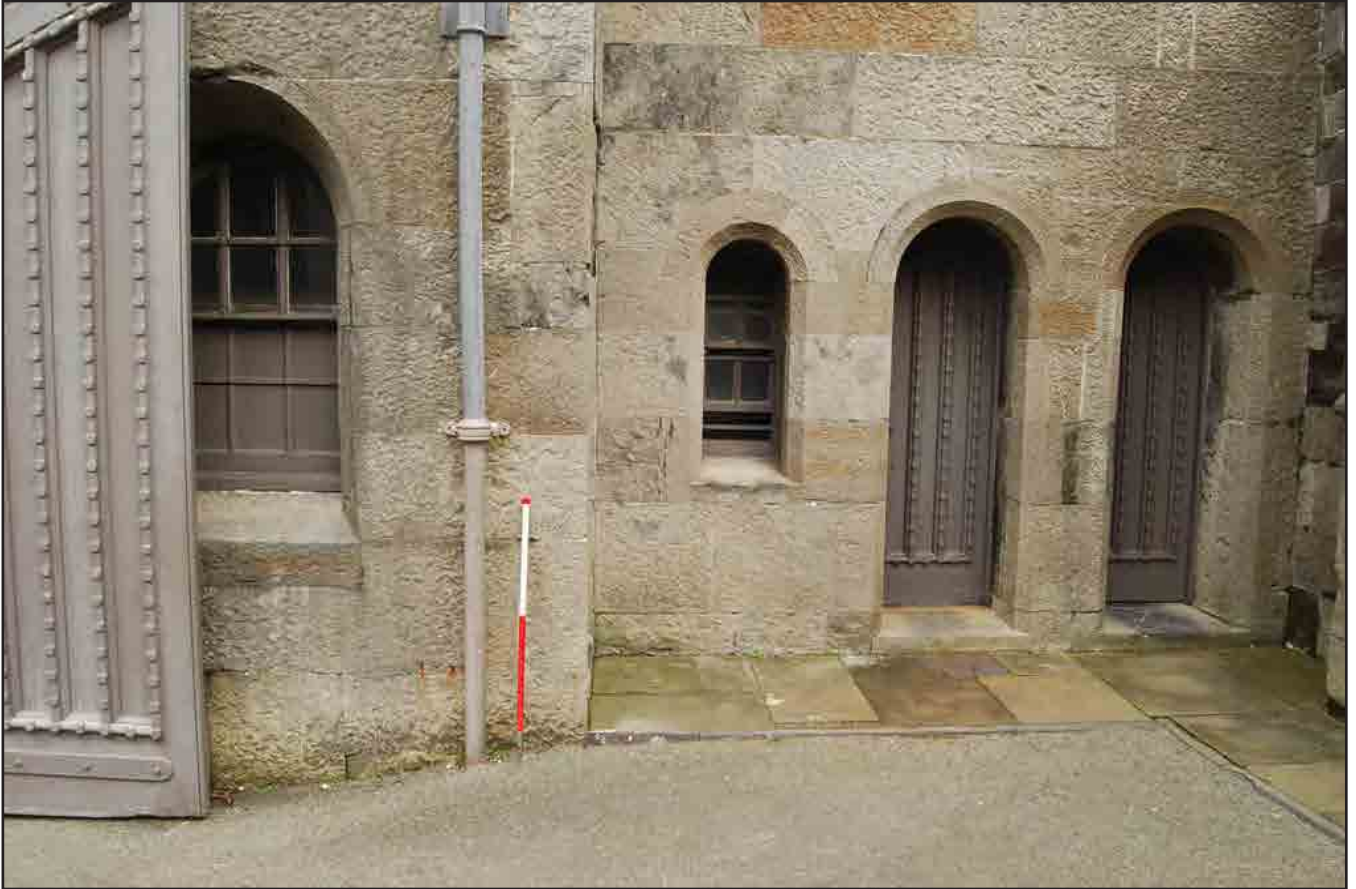
Plate 09: North Option - view north-northwest of heat main route at access point to the cellar. Scale: 1 x 1m.

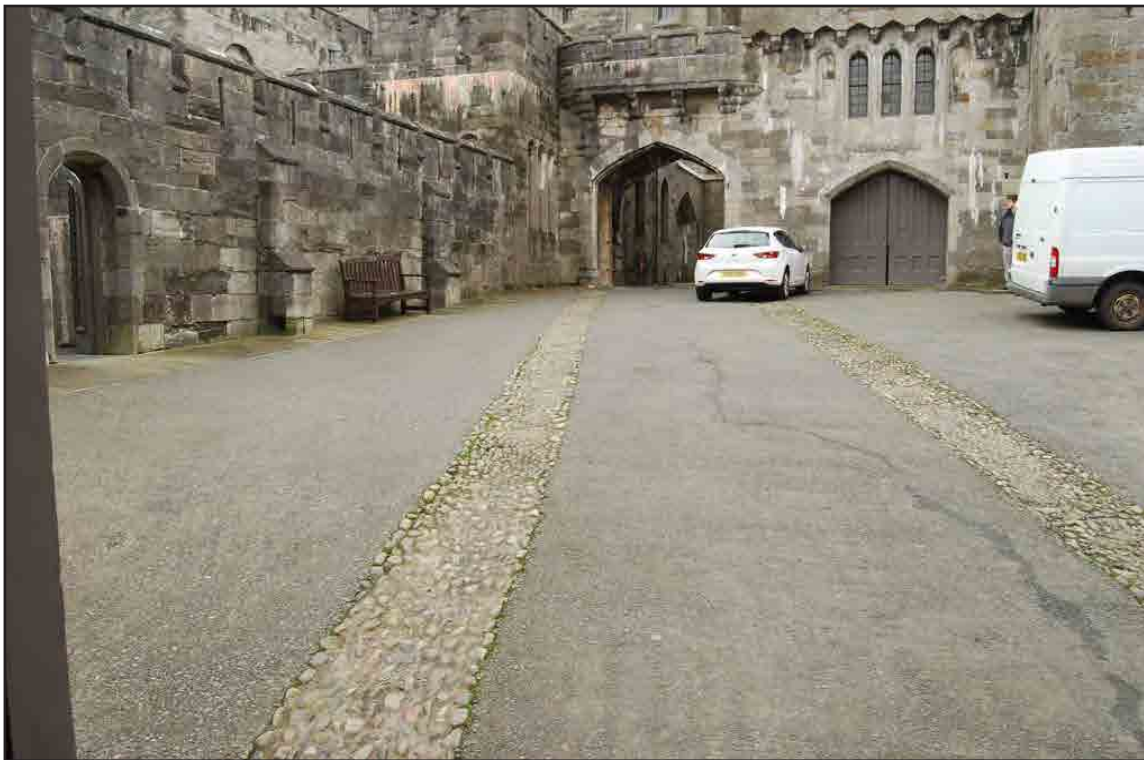
Plate 10: Penrhyn Castle courtyard - view north of courtyard that will be crossed by the heat main.

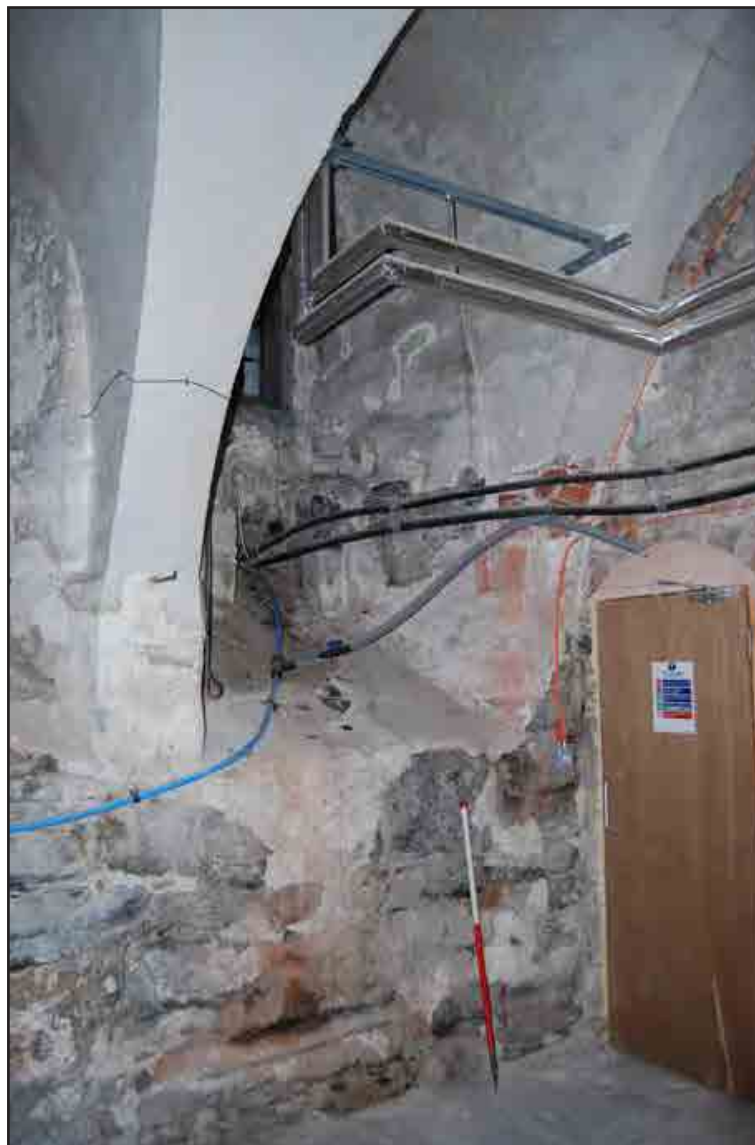
Plate 11: Cellar - view from within cellar of access point for the heat main from the courtyard. The heat main will use the same access point and route as the existing pipes. Scale: 1 x1m.

The cellars observed during the walk-over survey are of brick and stone construction, and are brick vaulted tunnels in places. They appear to be late 18th century or 19th century in date. No medieval fabric was observed, despite potentially being in the area of the former medieval house. This suggests that any medieval structure has been lost under post-medieval cellar construction during the building of both the Wyatt house in 1781 and the 1820s castle.

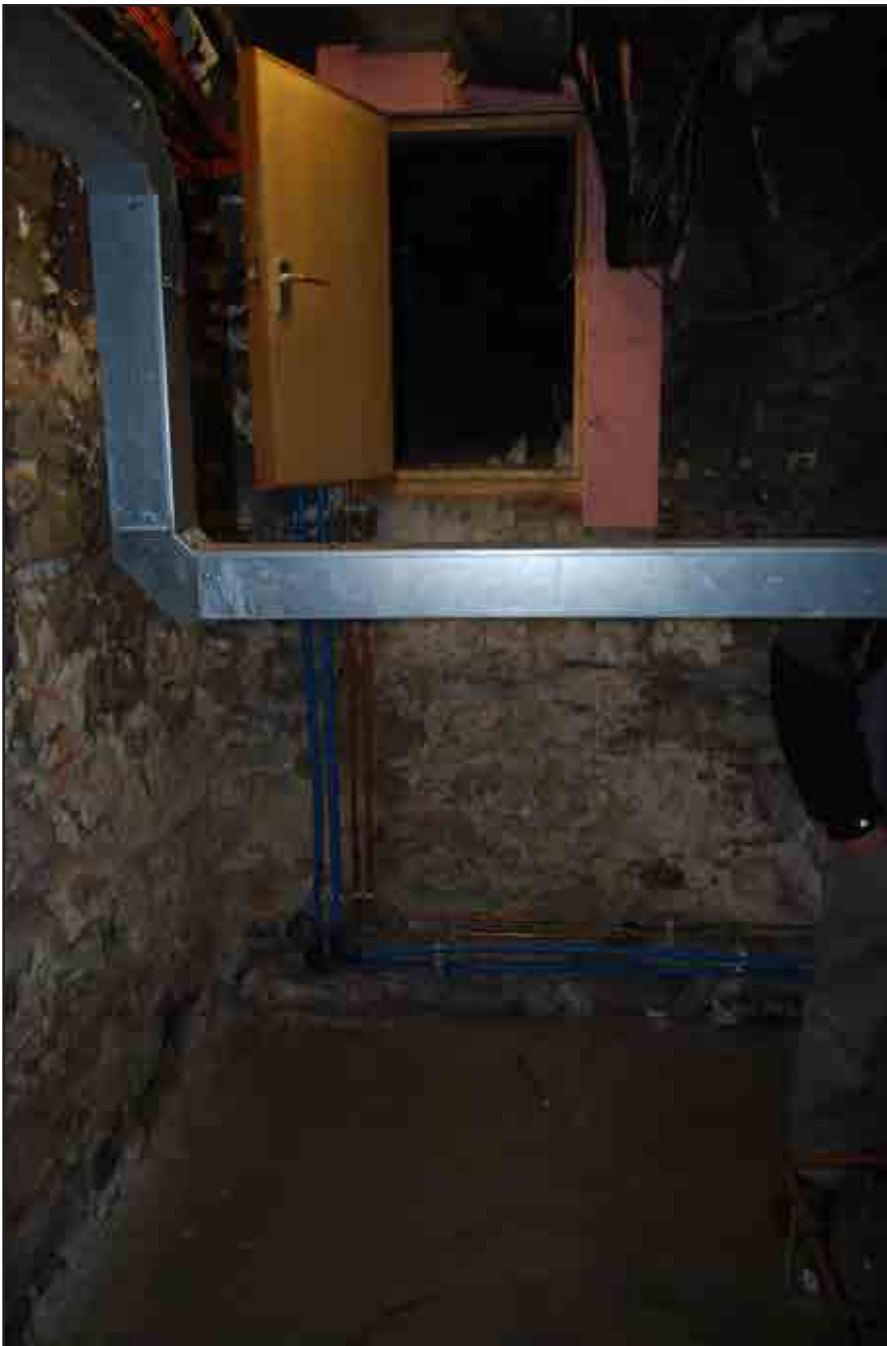
Plate 12: Cellar - view from the south of the proposed route for the heat main which will enter the room through the hatch.

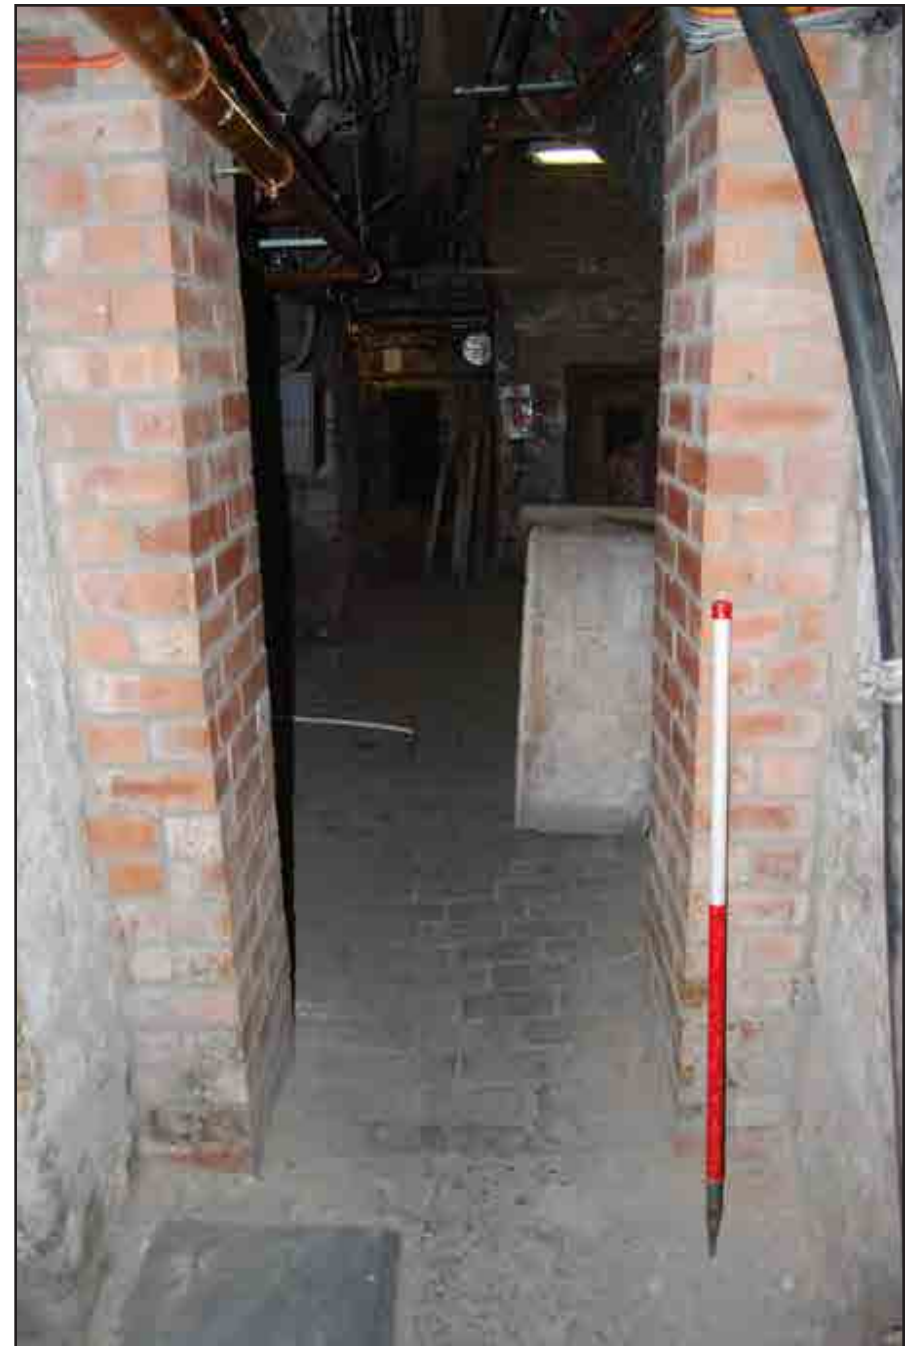
Plate 13: Cellar - view north of cellar within Penrhyn Castle that will incorporate the heat main along the elevated duct line. Scale: 1 x 1m.

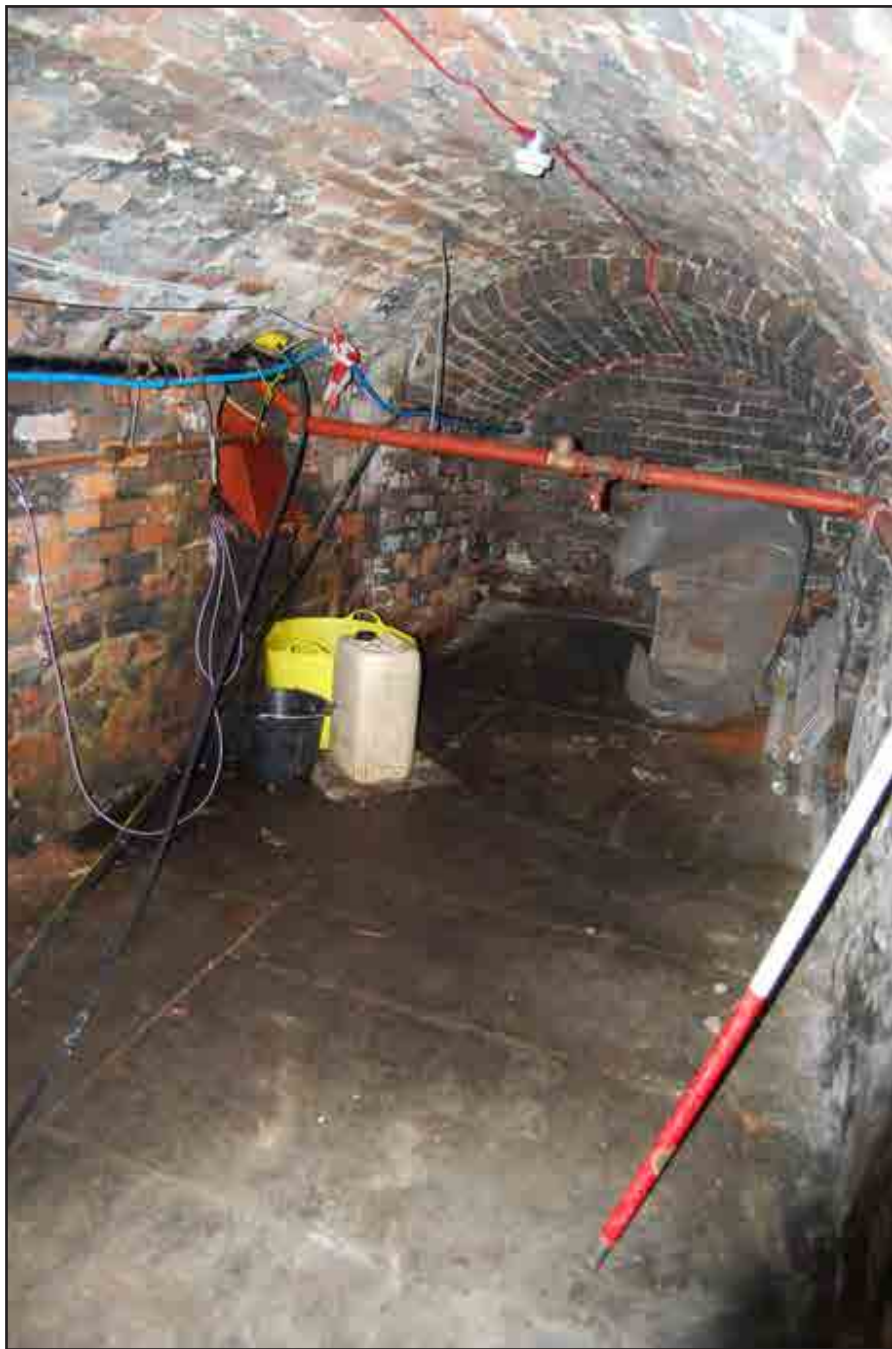
Plate 14: Cellar - view southeast of cellar within Penrhyn Castle that will incorporate the heat main along the elevated duct line.

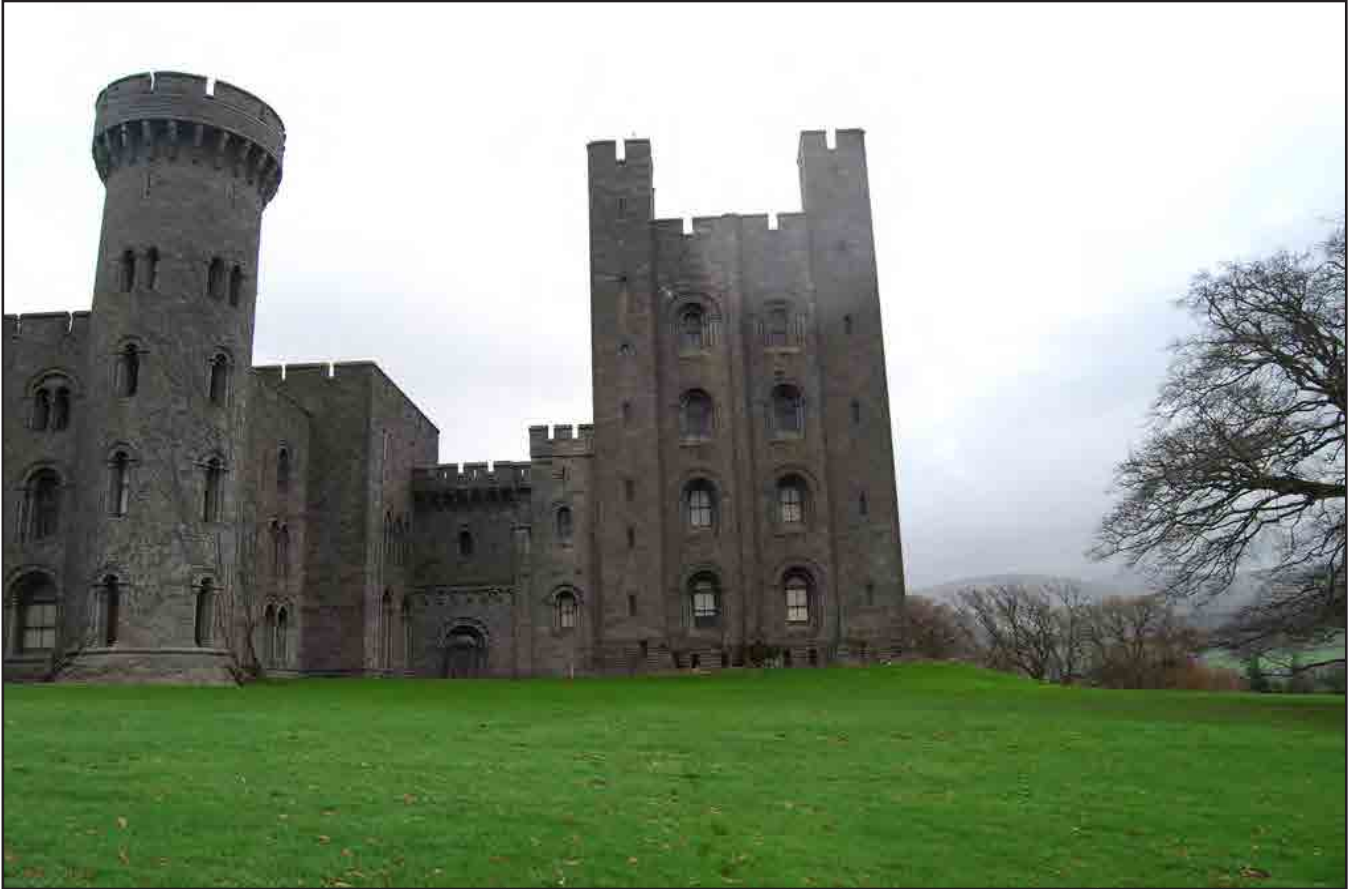
Plate 17: South Option - view north of castle keep along the line of the heat main towards the location of the boiler room within Penrhyn Castle. Scale 1x1m.

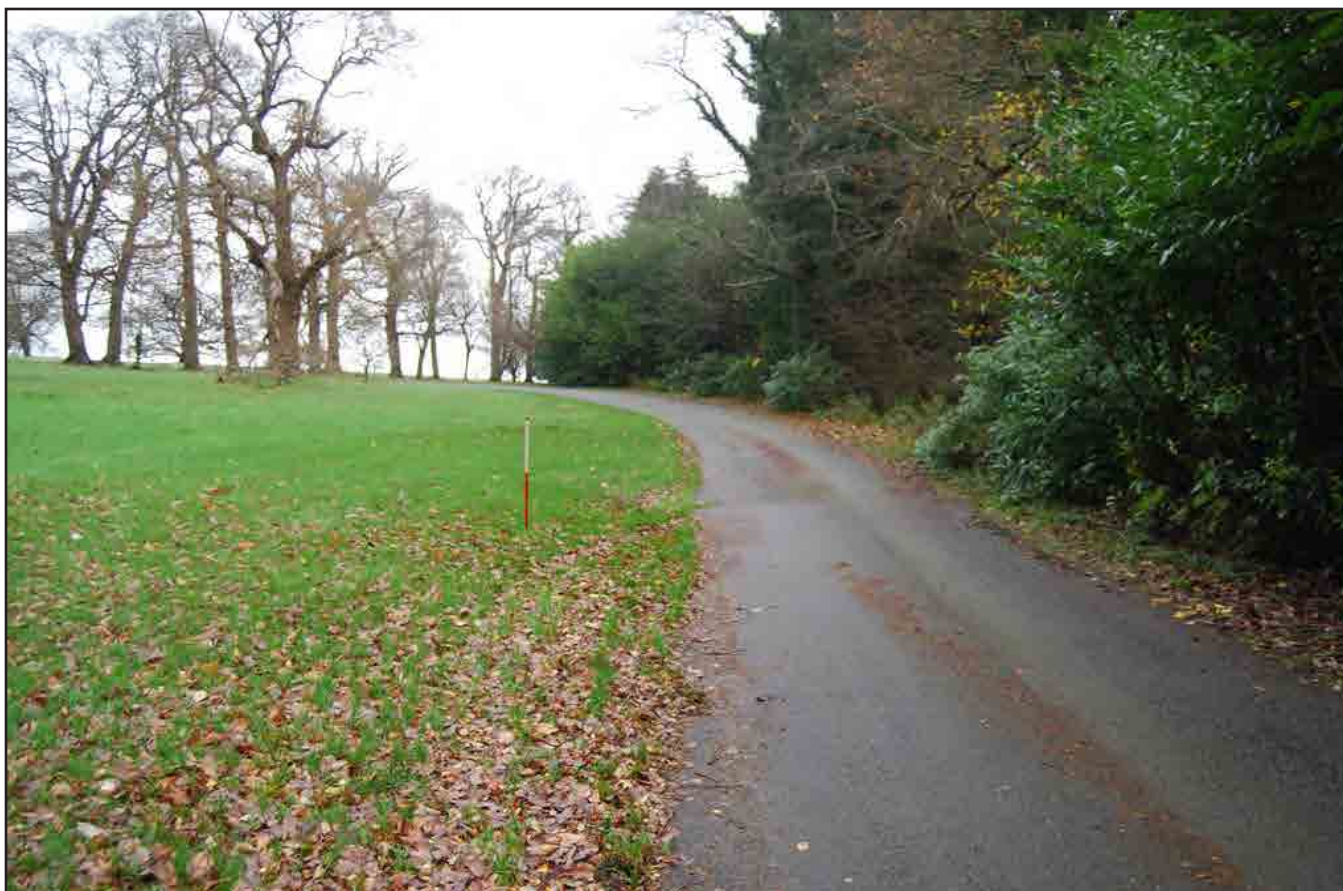
Plate 22: South Option - view north-northeast along access track; the heatmain would be laid along the verge. Scale: 1 x 1m

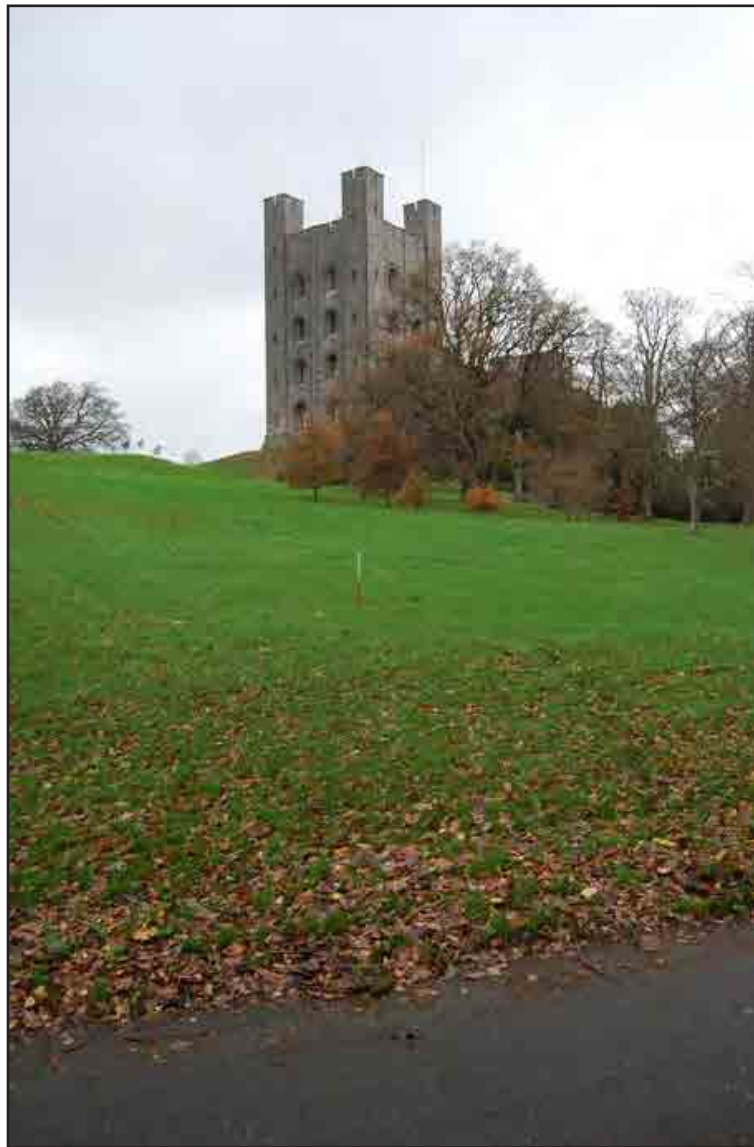
Plate 23: South Option - view northwest of heat main route (i), from Penrhyn Castle to the energy centre building. Route marked by 1 x 1m scale.

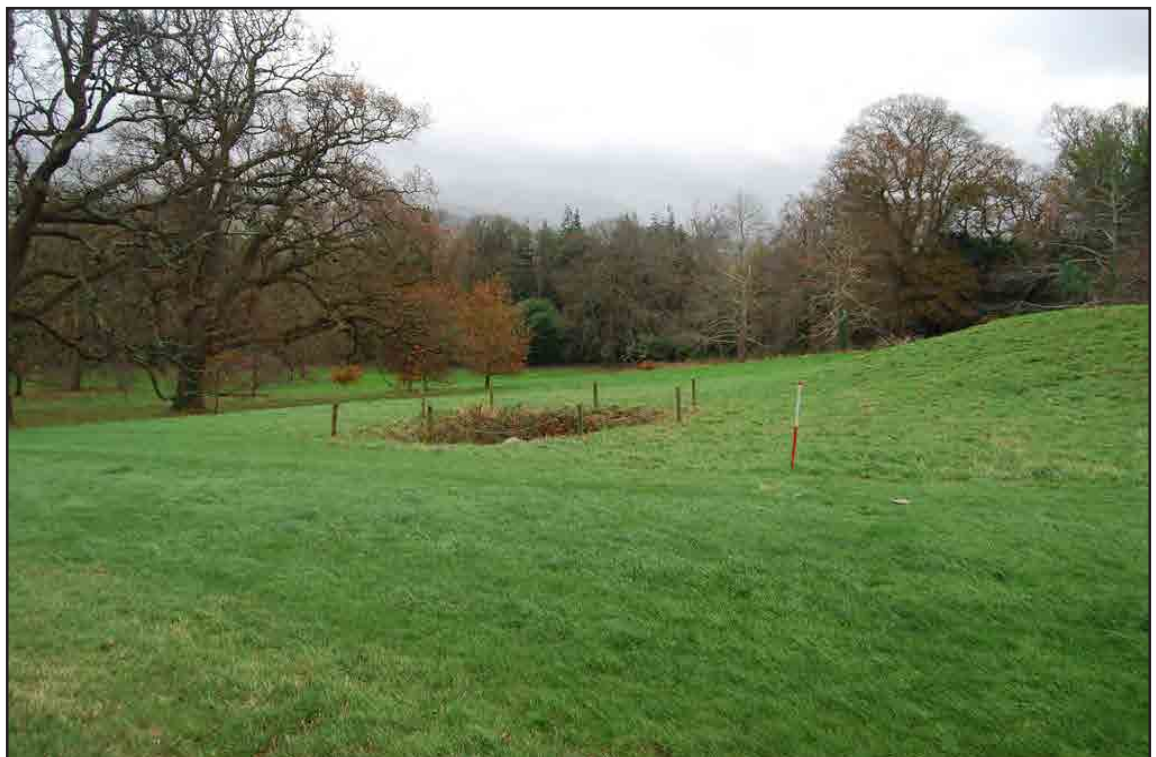
Plate 24: South Option - view southeast of heat main route (i), from Penrhyn Castle to the energy centre building. Route marked by 1 x 1m scale.

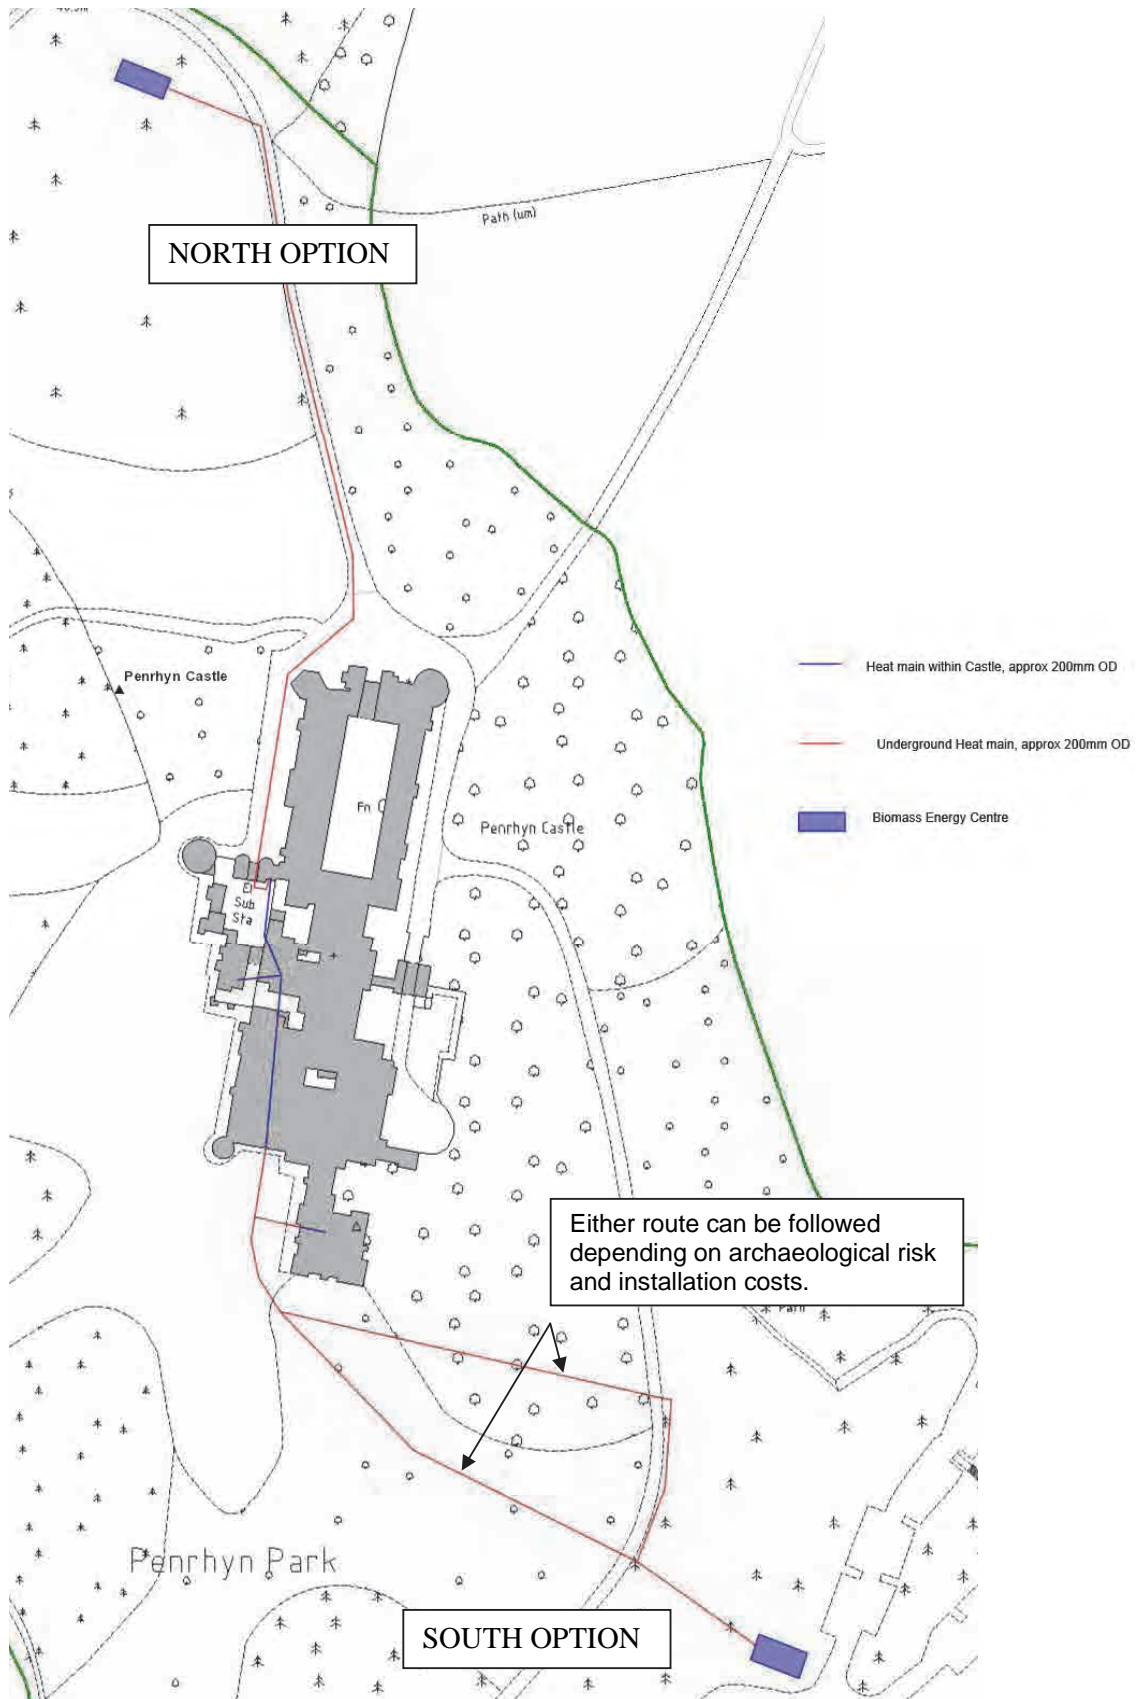
FIGURE 1

Reproduction of Map showing proposed layouts (Source: The National Trust)
