Penrhyn Castle Renewable Heating Scheme

Archaeological Assessment

Prosiect Rhif / Project No. G2447

Adroddiad Rhif / Report No.1286

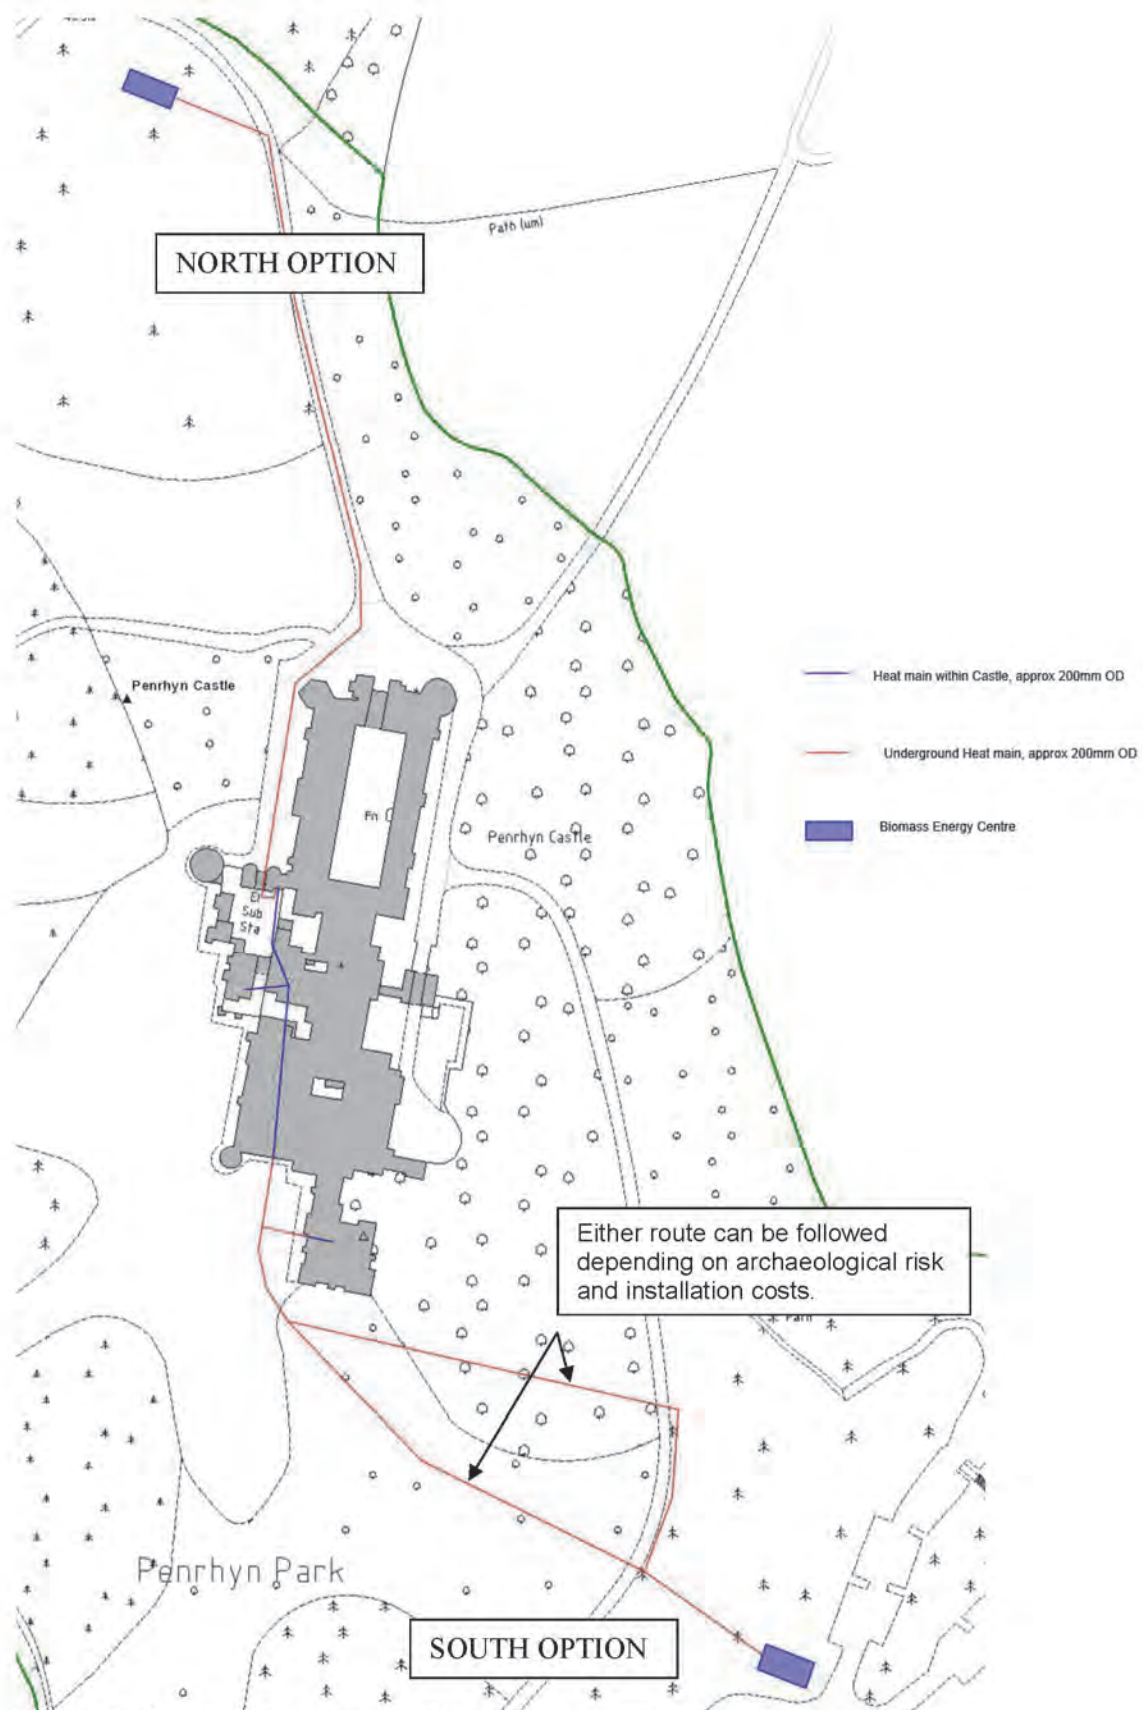
Figure 2 – Map showing proposed layouts for consideration

- 1.1 The proposed Penrhyn Castle Renewable Heating Scheme is located at Penryn Castle, Llandygai, Gwynedd. The scheme is currently at the pre planning stage.
- 1.2 A number of options for the precise location of the scheme are currently being proposed, see map in figure 2, and an archaeological assessment is required to help evaluate these different options.
- 1.3 The proposed scheme consists of an Energy Centre building [approx. 10m(l) x 3m(w) x 3m(h)], a 200mm diameter buried heat main pipe [approx. 250m in length] and pipes within Penrhyn Castle linking up existing boiler rooms. The trench will be excavated to the measurements detailed in the spec in figure 1 for a 200mm diameter pipe. The ground where the Energy Centre will be located will be excavated level and an area of approximately 10m x 6m (0.3m depth) will be concreted as a base and access to the building.

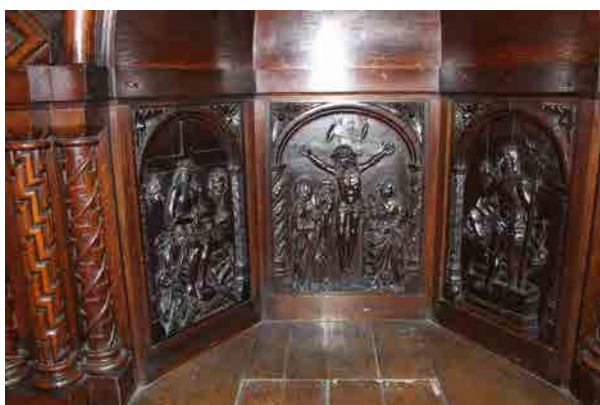
Chapel

The chapel ruin in the garden is a grade II listed feature and has been created as a feature and is not in its original location, however, it is possible that a 1768 estate map depicting the medieval house shows the original location. In the current castle's chapel there is some panelling that may have come from the original chapel although it is possible that it was brought from elsewhere.

The old chapel ruin now stands with no interior features or roof. The ruin has stone facing and medieval stone tracery around the window attached to brick skin and also some concrete supporting one of the windows. The chapel remains one of Penrhyn's biggest mysteries and certainly needs further analysis, as there are so many factors that we're unsure of. For instance, when was the chapel moved to its current location? We know that during the interim period between the medieval house and the current castle that Samuel Wyatt designed a new house that may have redeveloped much that was already there. Therefore when the chapel was moved isn't easy to tell. From plans drawn up by Wyatt it seems that it was intended to be incorporated in his designs. However, it is not seen in an 1803 map so it was probably moved during the construction of the Wyatt house. The chapel needs significant repairs to prevent further damage.

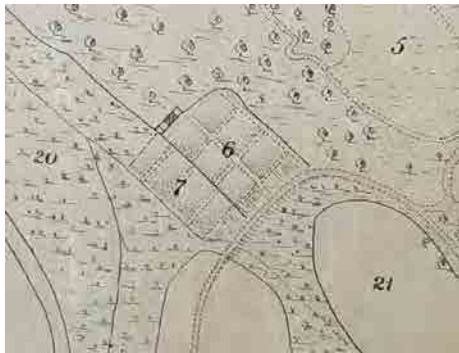
Walled Garden (Flower Garden as opposed to the Kitchen garden)

The walled flower garden is a grade II listed feature and is a key part of the Penrhyn Park and its landscape. Dating from the early nineteenth century it can clearly be seen on an 1803 estate map, however, the extent to which it was a fully formed walled garden is unclear. What is clear though is that this section of the garden has been planned out in a formal structure since 1803, which demonstrates that even before the current castle was built and the estate remodelled there was clear development in the layout of the estate. On some of the estate maps of the nineteenth century there is evidence of buildings around the exterior of the walled garden, which are no longer in existence, however, there is still some evidence of this in the form of an archway at ground level, which needs further investigation as it may relate to the use of glass houses in this area. At the bottom of the walled garden is a bog area, however, talking to some of the gardeners it seems to have once been a water garden where the water was controlled. The build of wall varies considerably with some areas needing immediate attention to prevent further damage.

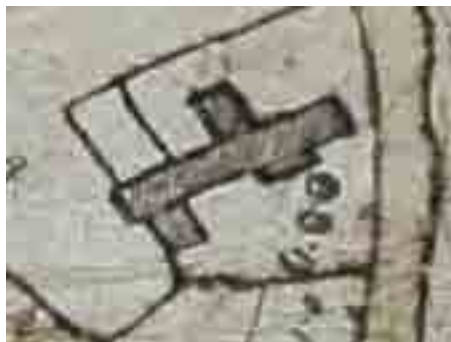
Medieval Structure

To the west of Penrhyn castle is an area of disturbed ground consisting of shallow scoops, which seems consistent with a structure seen on a 1768 estate map. Although it is unclear what this structure is the parching of grass would suggest stone or brick foundations measuring roughly 12m x 12m. The structure relates in some way to the medieval house as in 1803 estate map it is no longer in existence which leads us to believe that under the construction of the Wyatt house there was extensive land development and changes to the structure of the park. Further investigation of this area would undoubtedly lead to a greater understanding of the estate and its history.
