Pandy Farm, Gwynedd

Level 2/3 Building Record

Prosiect Rhif / Project No. G2453

Adroddiad Rhif / Report No. 1292

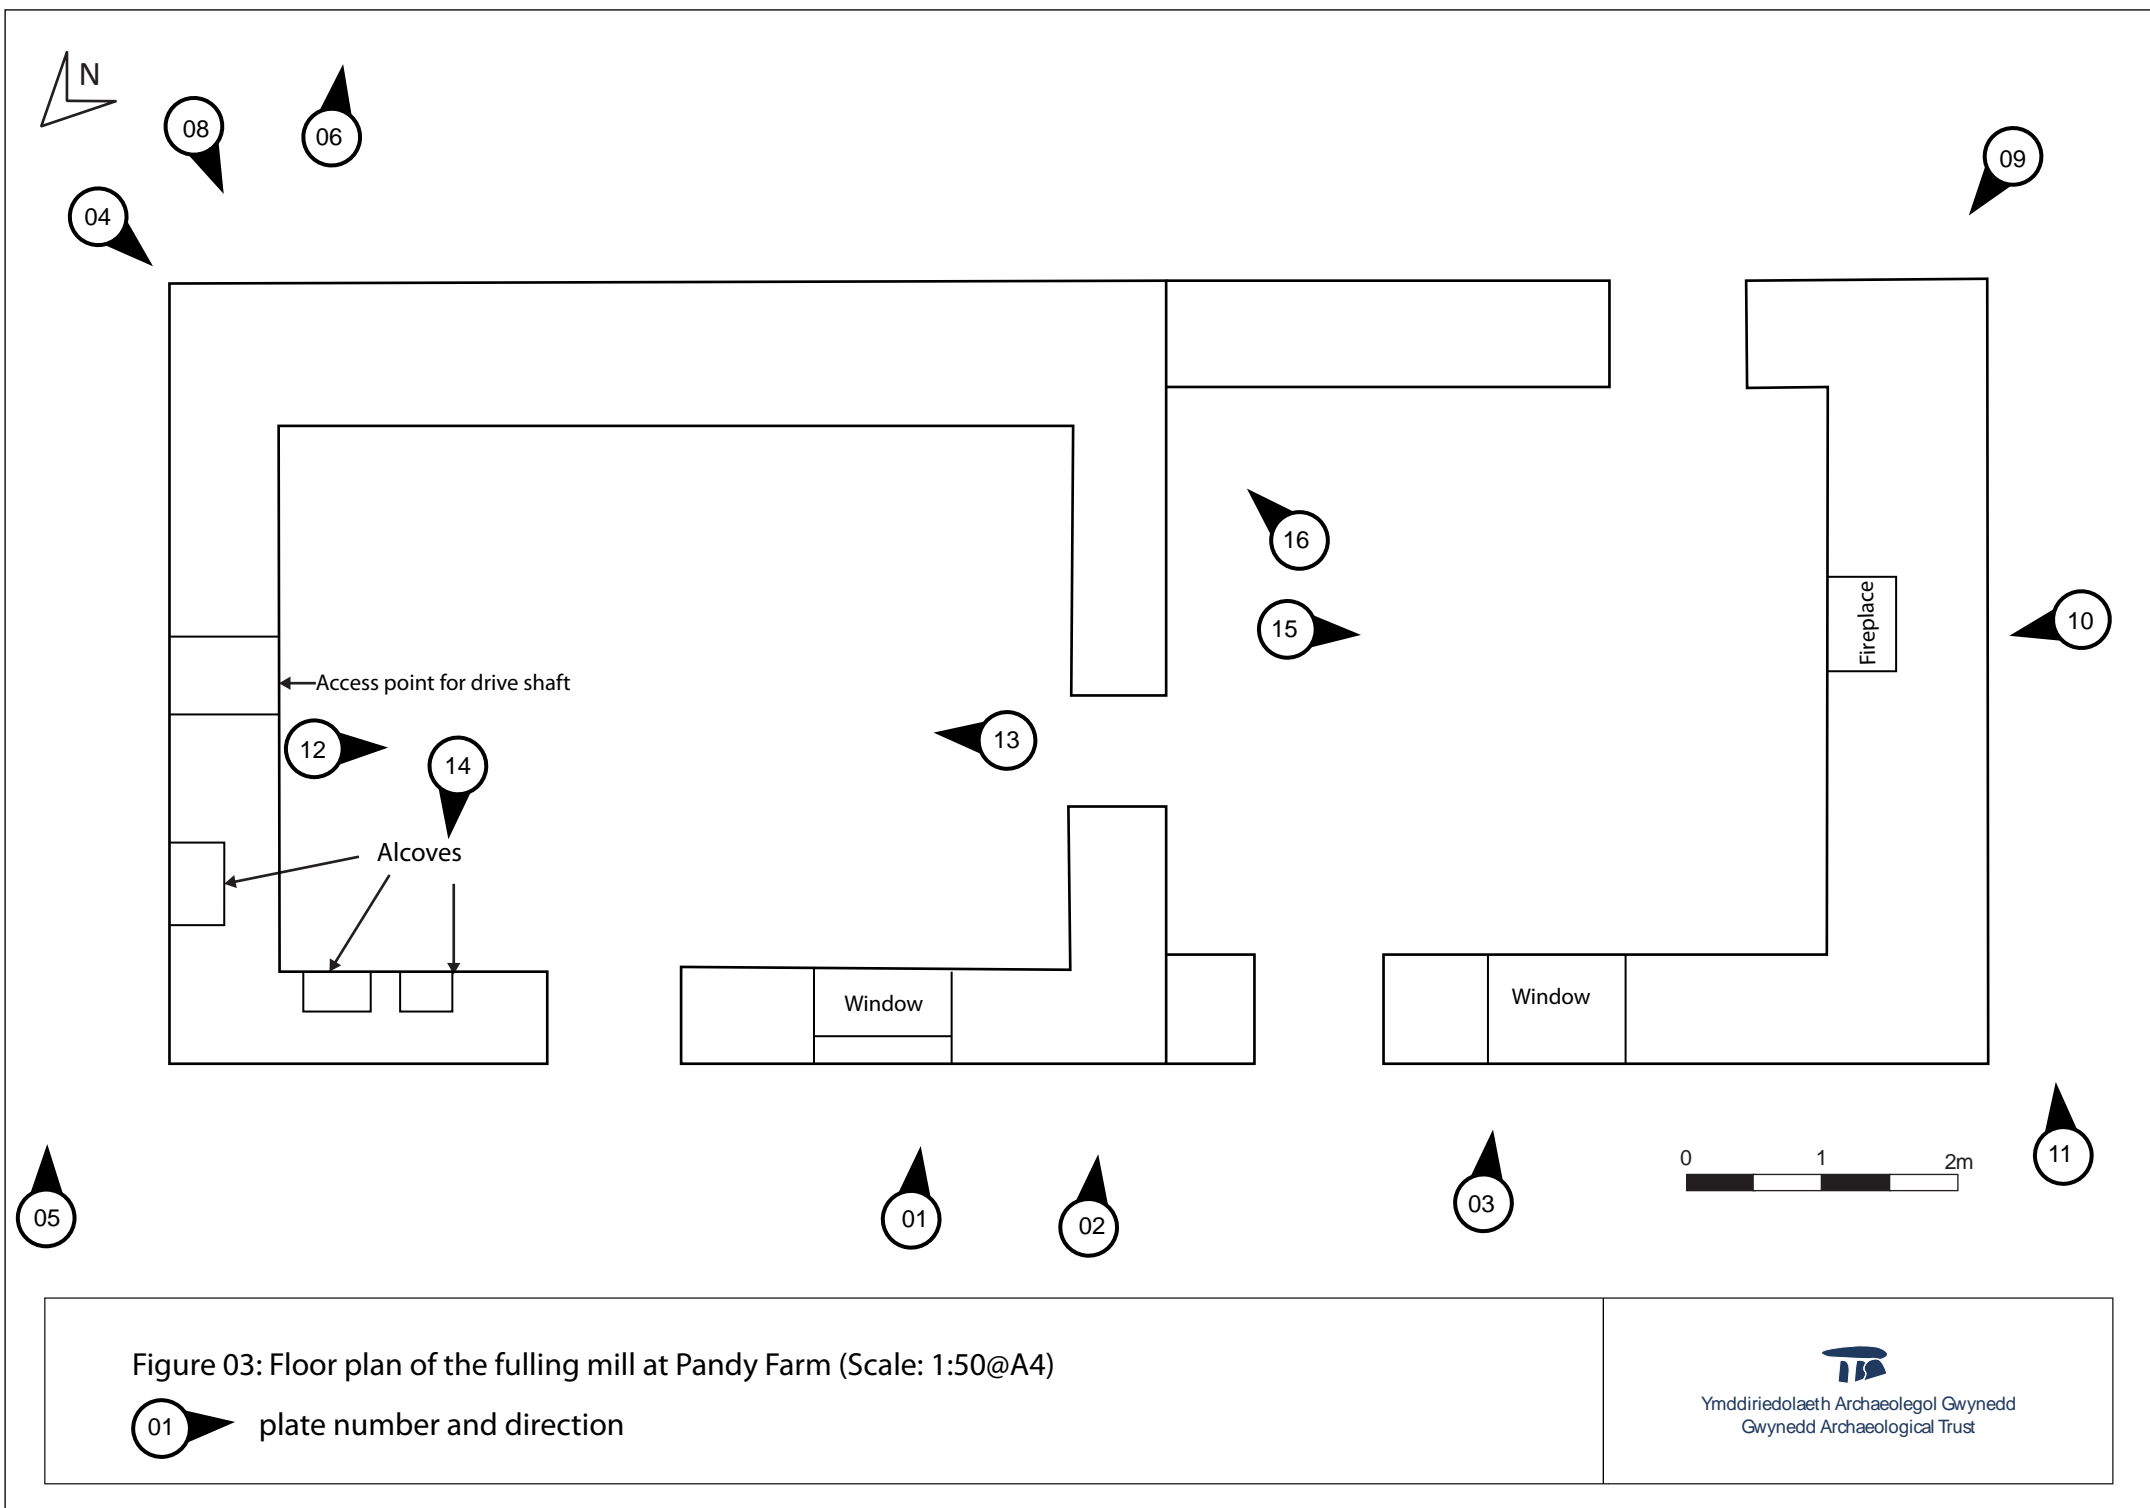
The descriptive record was completed on GAT pro-formas and recorded the exterior and interior of the structure in terms of building fabric, appearance and content. This included the materials used, the location, the composition and appearance of the two rooms and structural remains. Dimensions were taken for the building height, width, length and structural thickness, as well as for openings (doors, windows and apertures) and structural features (including the waterwheel). The existing plan and elevation drawing of the building (WM Design and Architecture Ltd Drawing No. AL(0)01 (Figure 02) was used for general reference. A drawn measured plan was completed by GAT at 1:50 scale (see Figure 03).

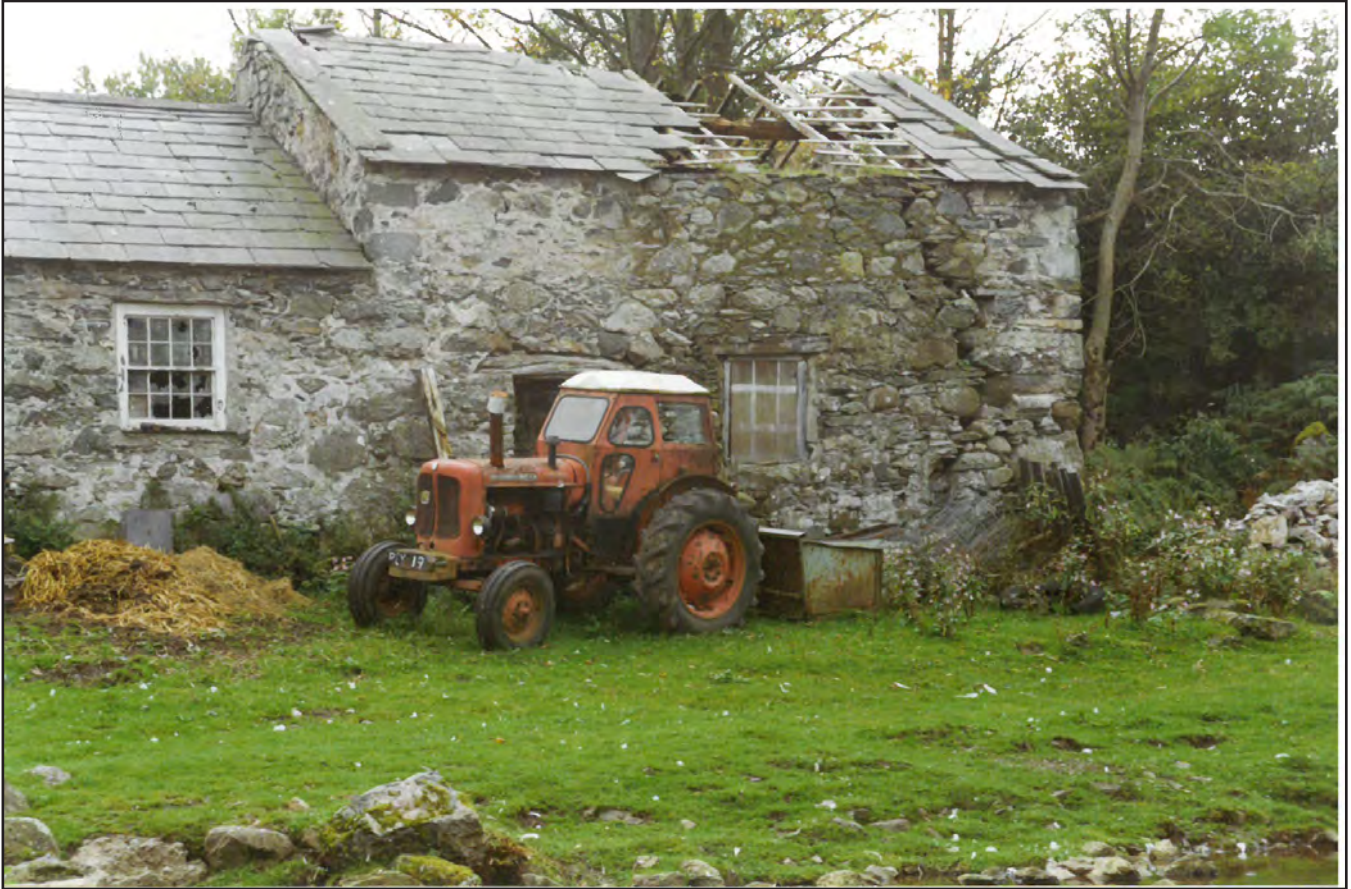
Plate 01: Northwest-facing elevation - photograph taken in 1972 (Source: Mr. Alan Bates)

The principal elevation faces northwest and features two mismatched doorways allowing access to the two internal rooms (see Plates 01, 02 and 03). The doorway to the left (1.0m x 2.2m) features a slate lintel, whilst that to the right (1.0m x 2.0m) has a lintel of badly decayed wood. Two windows, located to the right of the doors, light the interior of the two rooms. The left hand window is set high, the opening is roughly square with a width of c. 1m and it retains the upper portion of an 8 over 8 wooden sash, with a wooden lintel above. The window opening to the right is set somewhat lower, but is of a similar size, though with a stone lintel. The window casement is entirely absent, however a photograph from the late 20th century shows it was of a slightly differing style to the first with only three lights (see Plate 01).

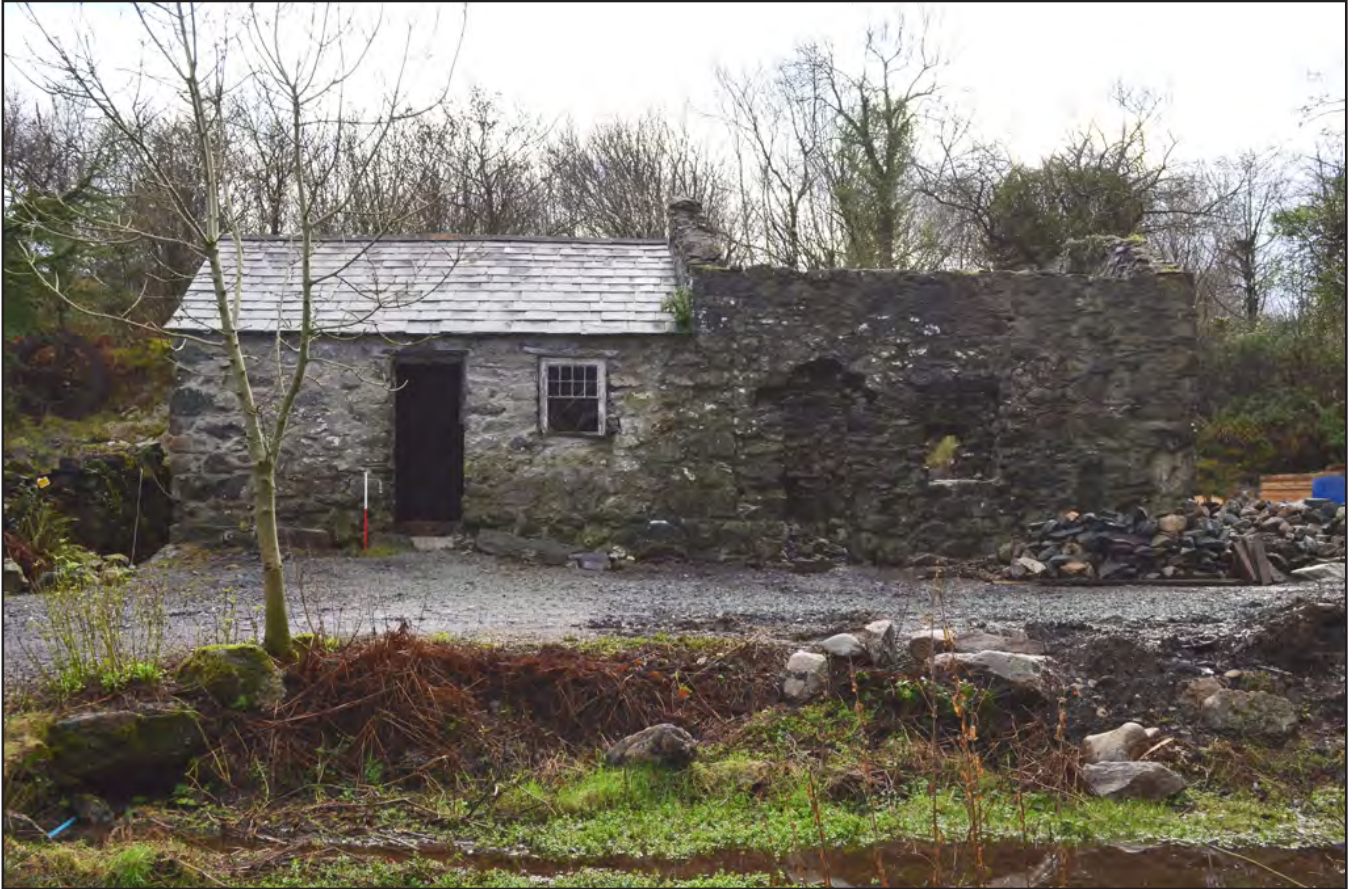
Plate 03: Principle elevation (Scale: 1 x 1.0m).

The former fulling mill at Pandy Farm lies at the southwestern edge of the farmyard facing northwest (see Plate 03). To the northeast stands a substantial farmhouse with a range of single-storey outbuildings facing it. The holding lies on a crossroads, with tracks running in from the northwest, east, south and southwest, linking the site to the roads to the north and south and to the nearby holding of T'yn y Caeau. The mill building is situated at the base of a steep rocky outcrop, from where the ground continues to drop away more gently to the north. The mill stream runs down from the south, a sluice gate once controlled the flow, diverting it to one of two courses which run down the steep face of the rocky outcrop and into two reveted channels at either gable. At present the water follows the southwestern course, though the other remains visible. The two watercourses run below the northeast/southwest running track which runs in front of the building and feed into a small pond, which in turn feeds a stream which continues northwest.

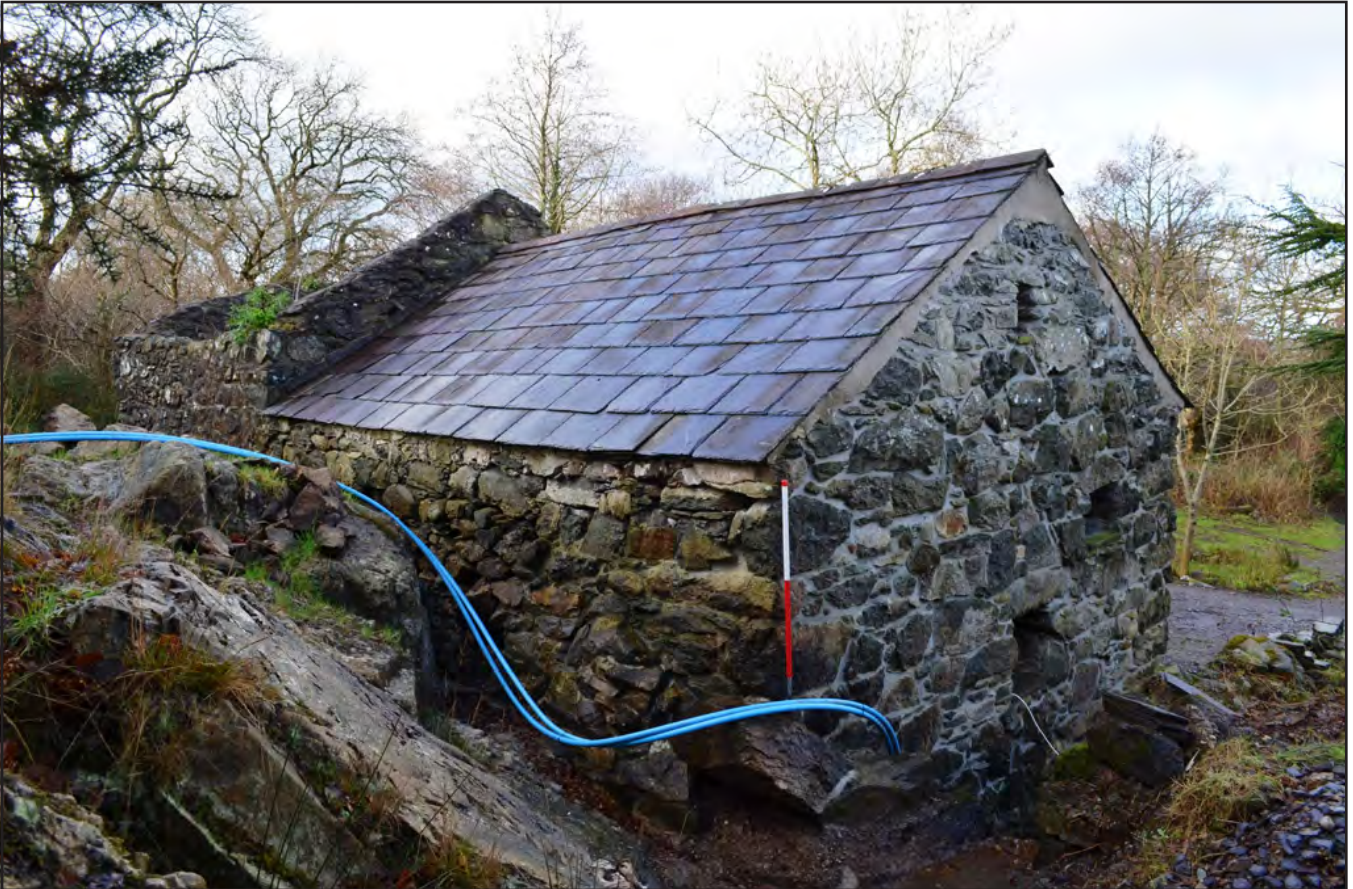
Plate 04: Oblique view of northeast gable (Scale: 1 x 1.0m)

The northeast gable of the structure features a small (approximately 0.3m wide x 0.5m high), central, rectangular window opening at the top, which was likely always left open to aid ventilation and to allow owls access to hunt for rodents (see Plate 04). Below this a square opening (0.6m wide x 0.6m high), set 1.3m above the external ground level which until recently accommodated the drive shaft of the waterwheel. A second opening (0.6m x 0.5m) set higher and right of centre was also noted, but this does not run all the way

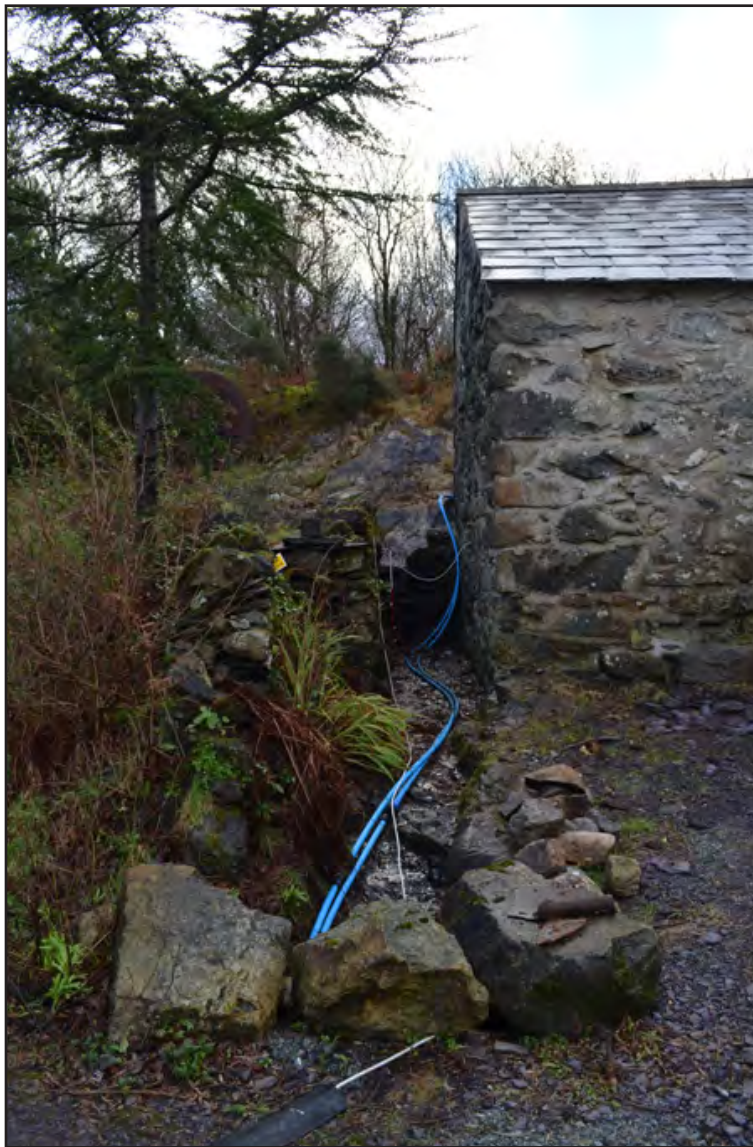
Plate 05: View from the southeast of the former mill stream (now dry)

through the wall and the function is unclear. A reveted stone channel 1.0m wide and a maximum of 1.0m deep runs along the width of the gable (see Plate 05), which is cut into the sloping ground to form a level base, and would have housed the waterwheel (see Plate 02). This channel is now predominantly dry, however its original course may be seen running down the face of the rocky outcrop and along the crest of the hill to the south (see Plate 06).

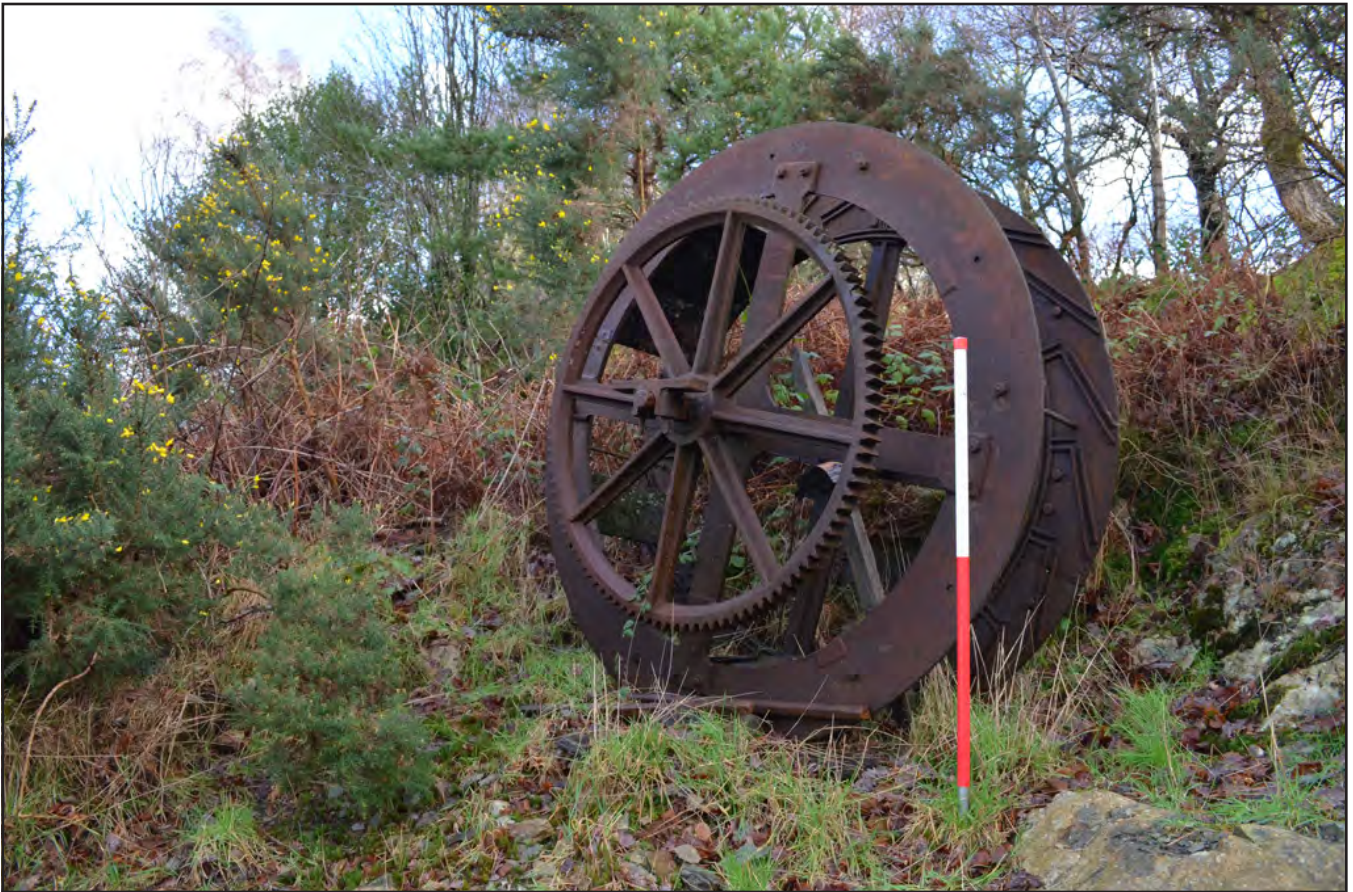
Plate 07: Mill wheel (no longer in situ); (Scale: 1 x 1.0m).

The mill wheel is no longer attached to the building, but remains on site and survives in fair condition (see Plate 07). The wheel is cast entirely of iron, with L-shaped housings for the wooden buckets (not surviving) forming part of the cast. The main wheel is 1.84m in diameter and features four wide spokes; it is formed of two parts set 0.48m apart, separated by cast iron struts. The wheel is set onto a substantial square shaft to which is also affixed two large toothed cogs, 1.81m in diameter, one of which was likely originally housed inside the mill. No makers mark was observed on the wheel and the precise date is unclear.

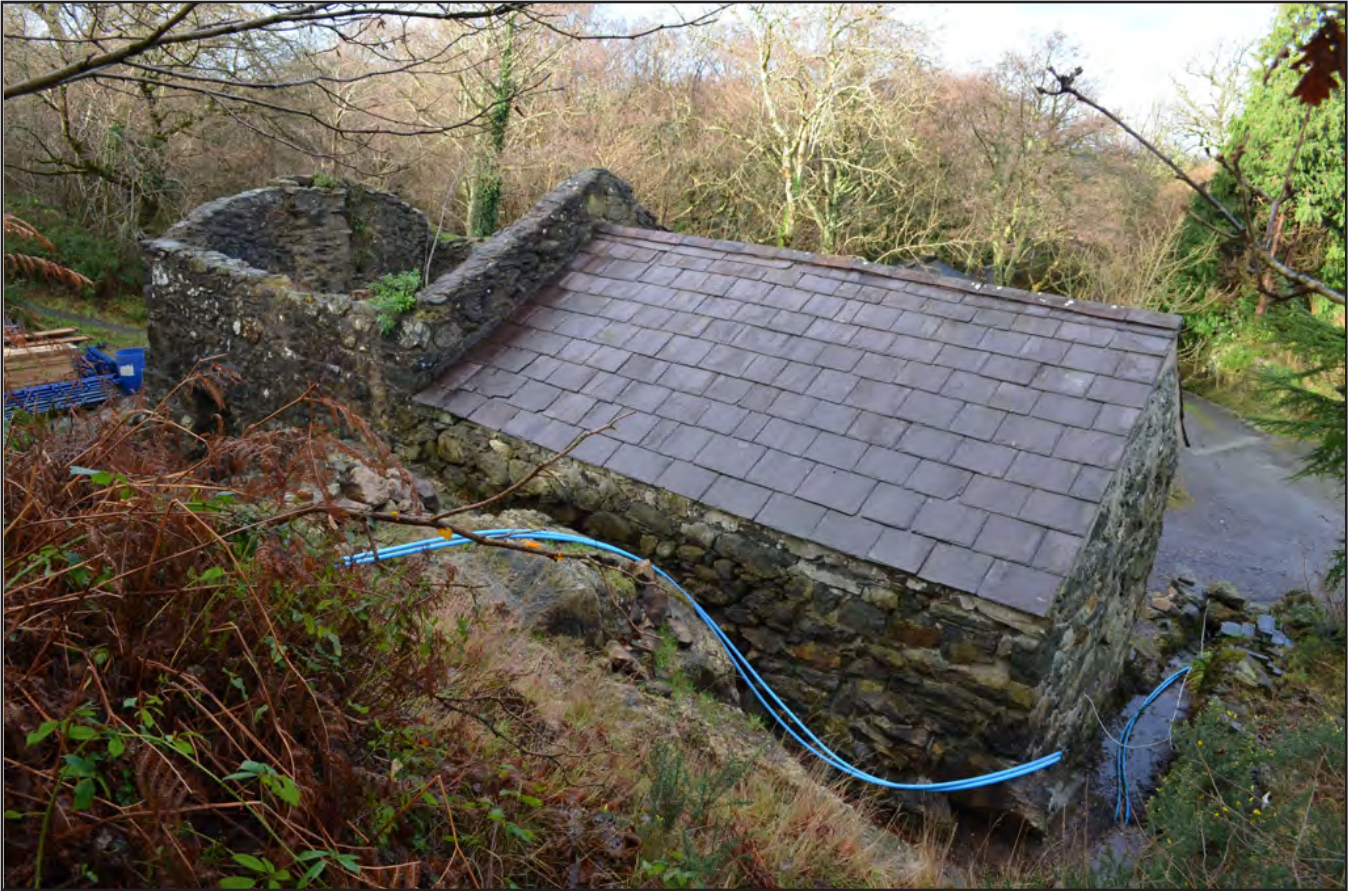
Plate 08: Oblique shot of southeast-facing elevation (Scale: 1 x 1.0m)

The rear, southeastern elevation, is partially built into the hillside, though the ground drops away to the southwest allowing for a second doorway (1.0m x 1.9m) leading into the southwestern room (see Plates 08 and 09). This opening has a narrow slate lintel; no frame or door survive. No additional features were observed within this elevation. The southwest gable has undergone some recent repair; however the lines in the masonry showing the raising of the roof line may just be seen (see Plate 10). A possible blocked opening (c. 1.0m x 1.0m) set right of centre may also be seen, this may indicate a former position of the mill wheel. A second revetted channel runs along this elevation through which the millstream currently runs (see Plate 11).

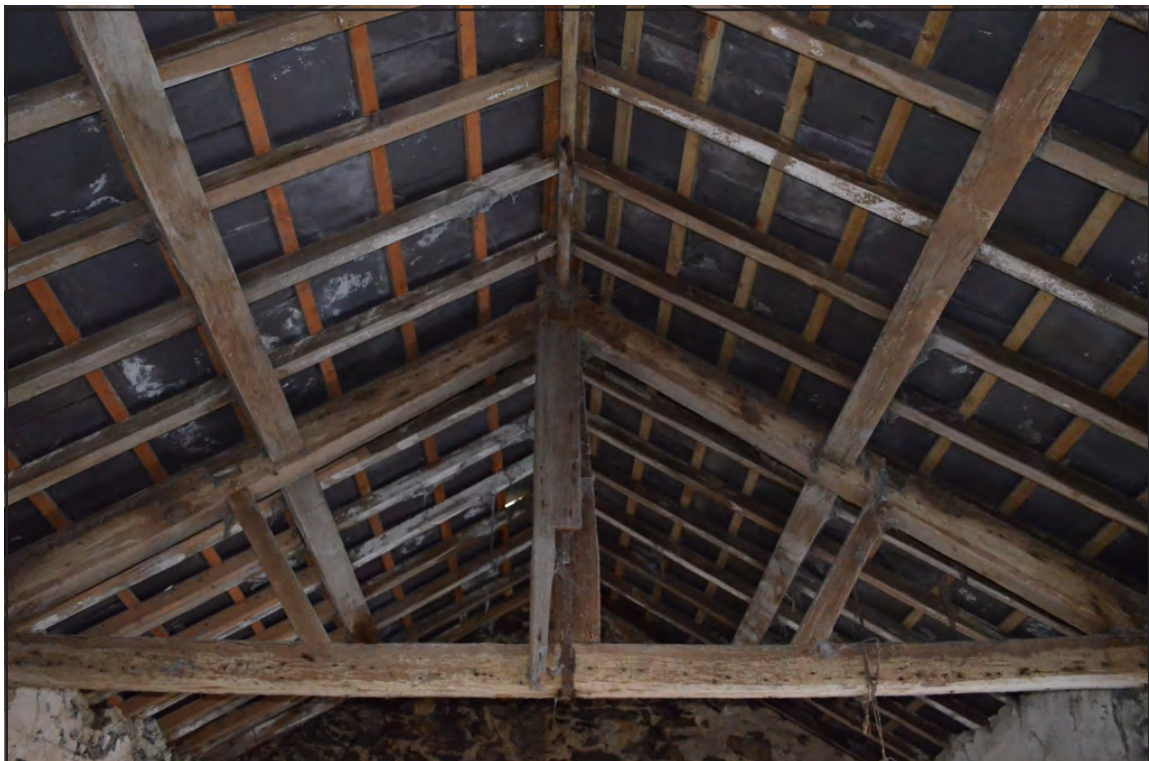
Plate 12: Northeast room - central roof

The northeast room occupies the earliest part of the structure; it is rectangular in plan, measures 5.9m x 4.34m and it is open to the double pitched roof, which stands to a height of 4.16m at the apex. The roof structure comprises a pair of fairly substantial perkins supported by a central tied king post truss (see Plate13). The angled braces of this truss appear to be secured using round wooden pegs indicating a fairly early date, and the timbers generally show signs of age and wear; the central vertical brace has been reinforced using an iron strap. The north-eastern lower edge of the tie beam is chamfered, but this is not seen elsewhere; this beam also features numerous iron nails, which may indicate the location of a former screen or partition. The roof joists are of regular size and spacing and appear relatively early, however the laths to which the slates are fixed are new.

The north-eastern gable features a stone lined opening (0.65m x 0.45m) set approximately centrally, 0.75m above the floor through which the waterwheel drive shaft once passed. Various timbers are set into the masonry around this opening, the purpose of which is unclear, though likely associated with supporting machinery. A second, fairly small doorway (0.85m x 1.75m) in the southwest gable allows access to the adjacent room. This opening has a lintel of rather rotten timber (currently supported by a prop), and the surrounding masonry shows signs of significant repair (see Plate 12).

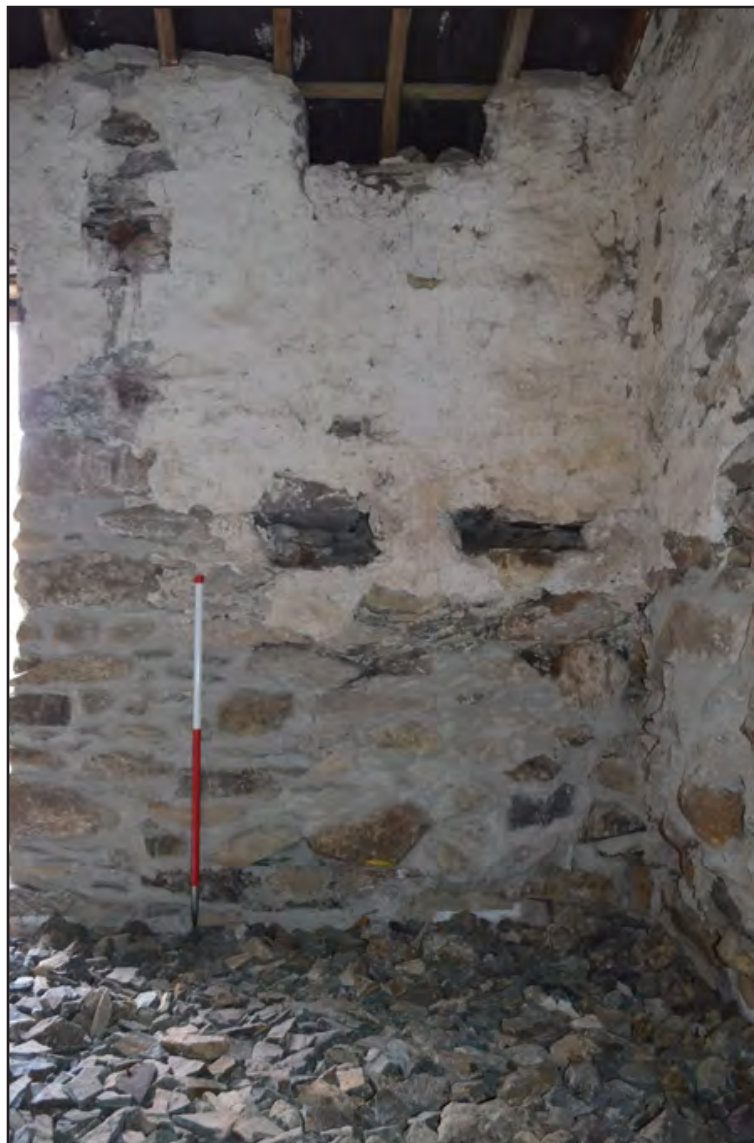
Plate 14: Northeast room - southeast-facing internal elevation (Scale: 1 x 1.0m)

The upper portion of the walls of this room retain rough lime based render and white-wash, however this is absent from the lower sections where recent re-pointing has occurred. The southeastern wall incorporates the natural bedrock within its construction and appears very wet; a reinforcing skin of modern masonry, 0.3m thick and 0.75m high, has been built along its length. The floor is covered by a thick layer of coarse gravel, presumed modern. This room is accessed via a doorway located right of centre in the northwest elevation; the opening has a lintel of roughly hewn slate and timber, and has undergone recent repair to the masonry around the base; remnants of a simple wooden door frame survive but the door is absent. To the left of the doorway a square window is set high in the wall, containing remnants of a four light sash casement. To the right of the door two small (0.40m x 0.10m) somewhat irregular recesses are set 1.10m above the current floor level; these are likely associated with the mounting of internal milling machinery (see Plate 14).

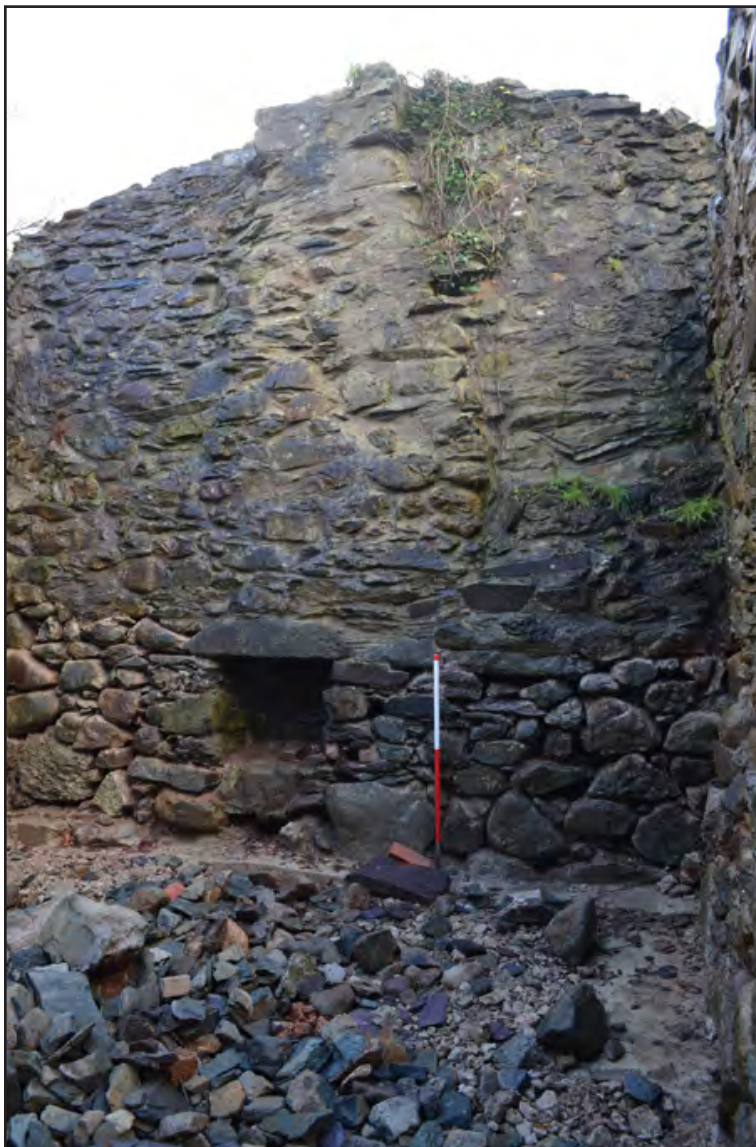
Plate 15: Southwest room - internal elevation: fireplace in the gable wall (Scale: 1 x 1.0m)

The southwest room is rectangular in plan and measures 4.3m wide x 5.1m long and would have been open to the double pitched roof (now entirely absent). The gables stand to an approximate height of 4.8m. The walls of this room are of bare masonry, which has been recently pointed; the rock outcrop against which the building is built has been incorporated into the masonry in the eastern corner (see Plate 16). The floor is covered in a layer of coarse gravel and rubble as before. The room is accessed via doorways in the northwest and southwest elevations, whilst a third doorway in the northeast gable links this with the adjacent room. The room is rather poorly lit by a single window opening set fairly low, left of centre in the northwest elevation, no casement remains. A chimney breast, with a small square fire place (0.65m x 0.65m) has been built into the southwest gable; this may be a later addition to the structure (see Plate 15).
