# Ynys Enlli

## Heritage Management Plan

Project No. G2318

Report No. 1304

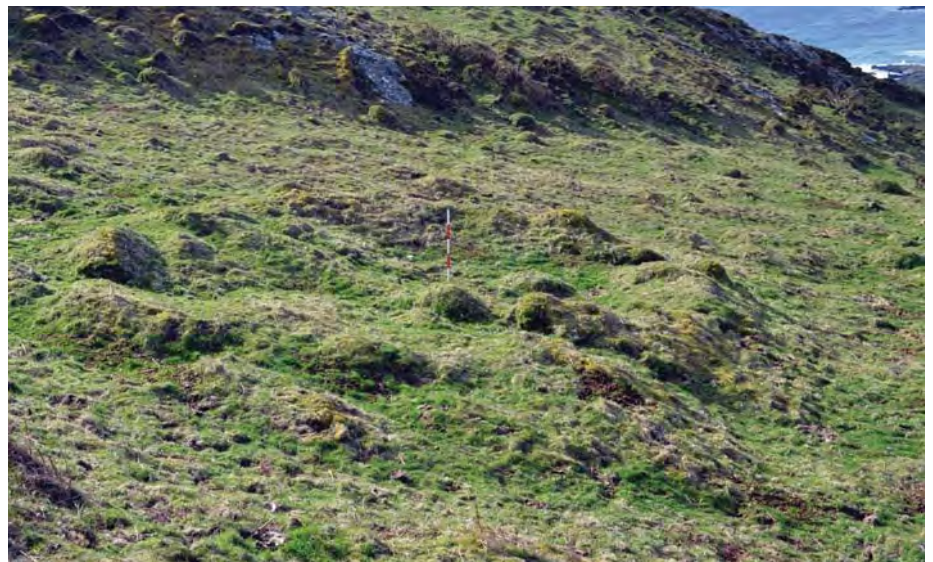
Plate 2. Possible roundhut on Mynydd Enlli (PRN 4535) (photograph taken 20/03/2014)

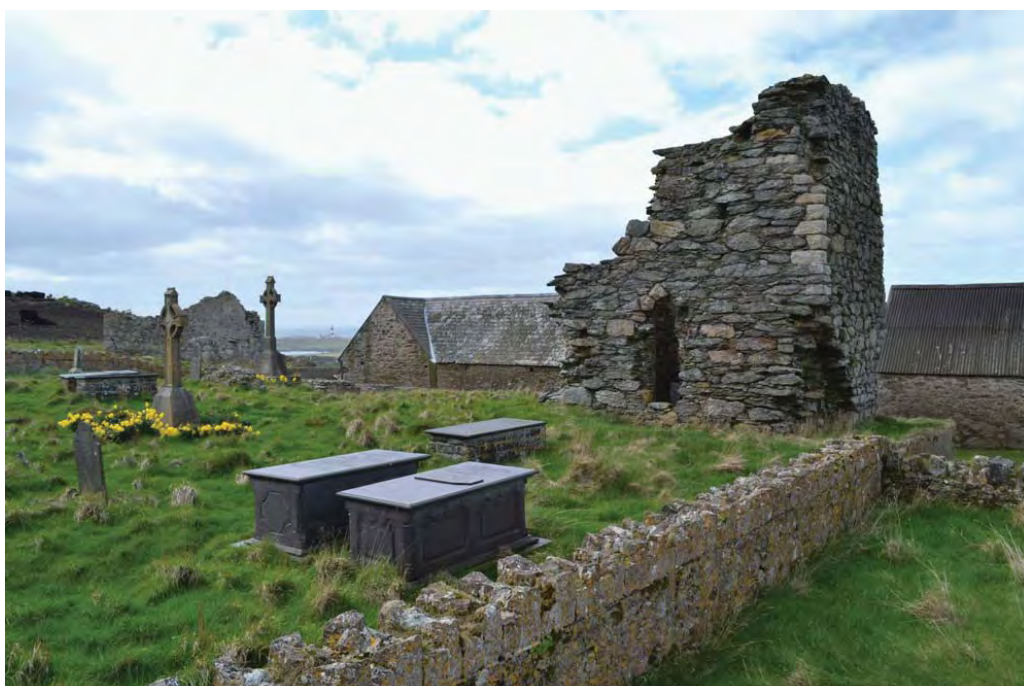
Plate 3. The abbey tower (PRN 781) in the corner of the modern burial ground (PRN 59721) (photograph taken 17/03/2014)

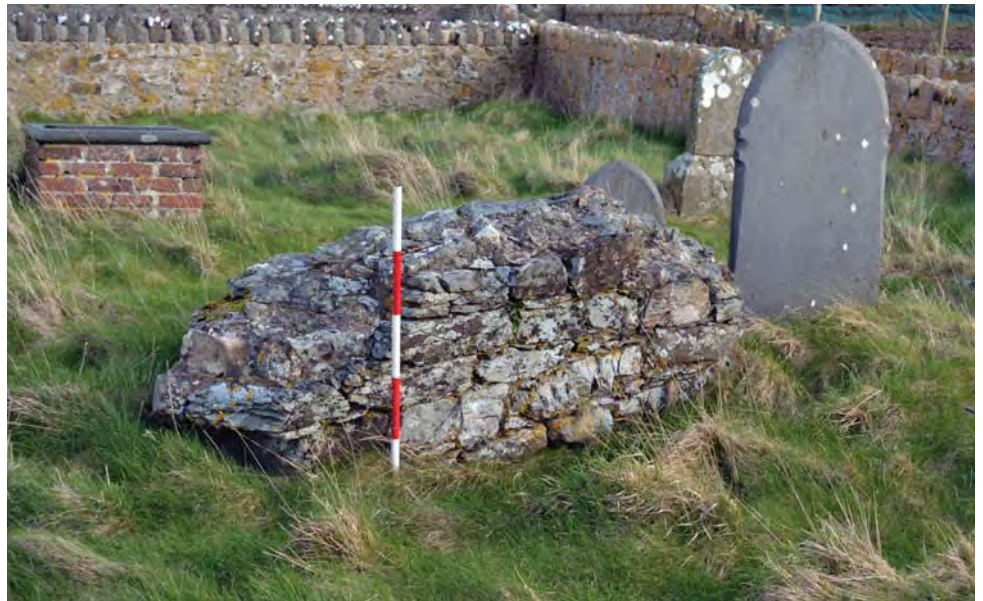
Plate 5. Block of masonry (PRN  
59855) in the burial ground  
(photograph taken 22/03/2014)

Plate 5. Block of masonry (PRN 59855) in the burial ground (photograph taken 22/03/2014)

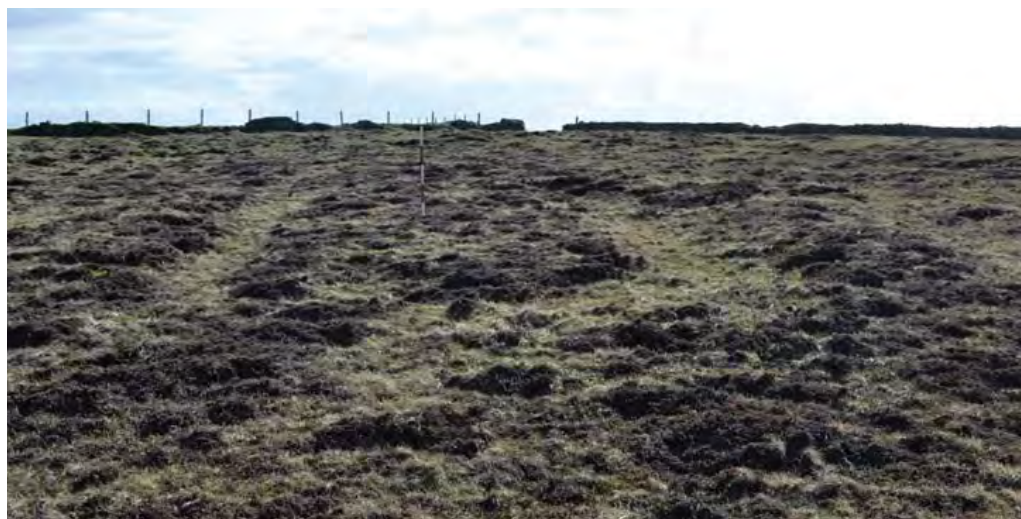
Plate 8. Rectangular feature (PRN 4530) on north end of Island recorded as a long hut and excavated by Hague (photograph taken 17/03/2014)

A group of rectangular features at the north end of the island (PRN 4530) were also planned by Hague and he dug a trench through the larger structure (plate 8). The excavation took place in 1982 but again no evidence of a stone wall was found and the wall of the feature was defined only by turf (CRO XD64/340). Hague concluded that the function of "these primitive structures" "remains a mystery" (CRO XD64/340). He believed that the structures could have been roofed and speculated that they may have been connected with the storage of winter feed (CRO XD64/340). Their slight banked remains, with no trace of stone walls, make their function as roofed

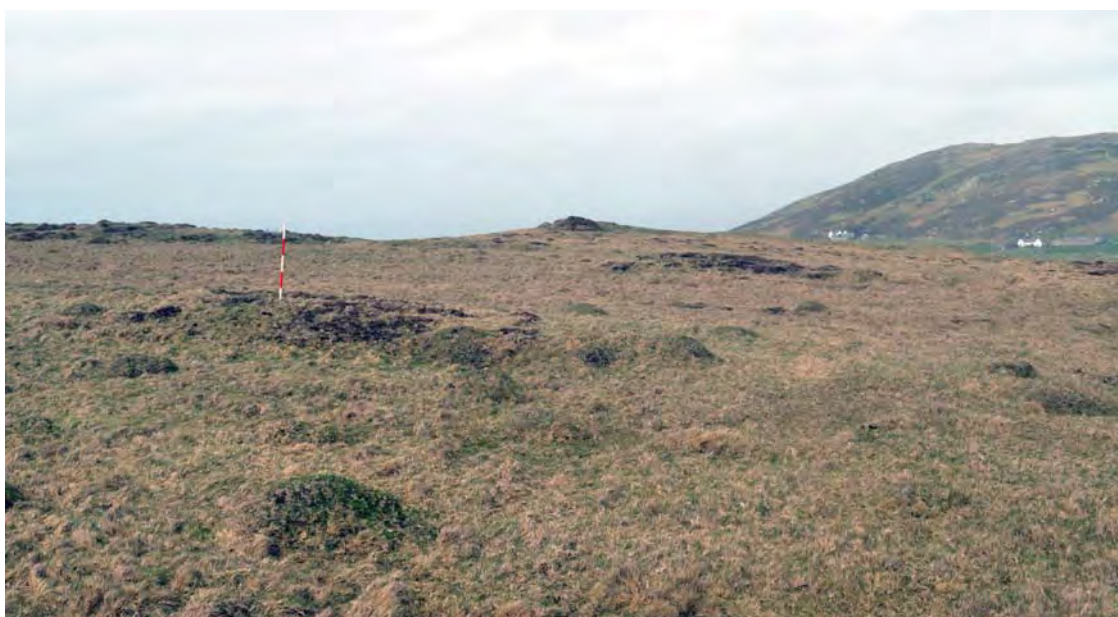
Plate 9. Pillow mounds (PRN 16811) on Pen Diben (photograph taken 18/03/2014)

Plate 9. Pillow mounds (PRN 16811) on Pen Diben (photograph taken 18/03/2014)

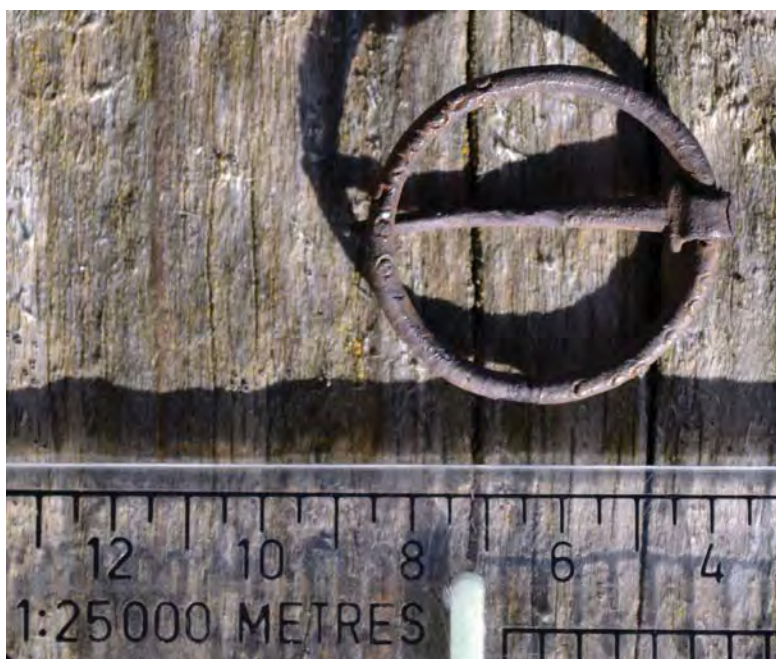
Plate 10. medieval annular  
brooch found on Mynydd Enlli  
(PRN 59986)

Plate 10. medieval annular brooch found on Mynydd Enlli (PRN 59986)

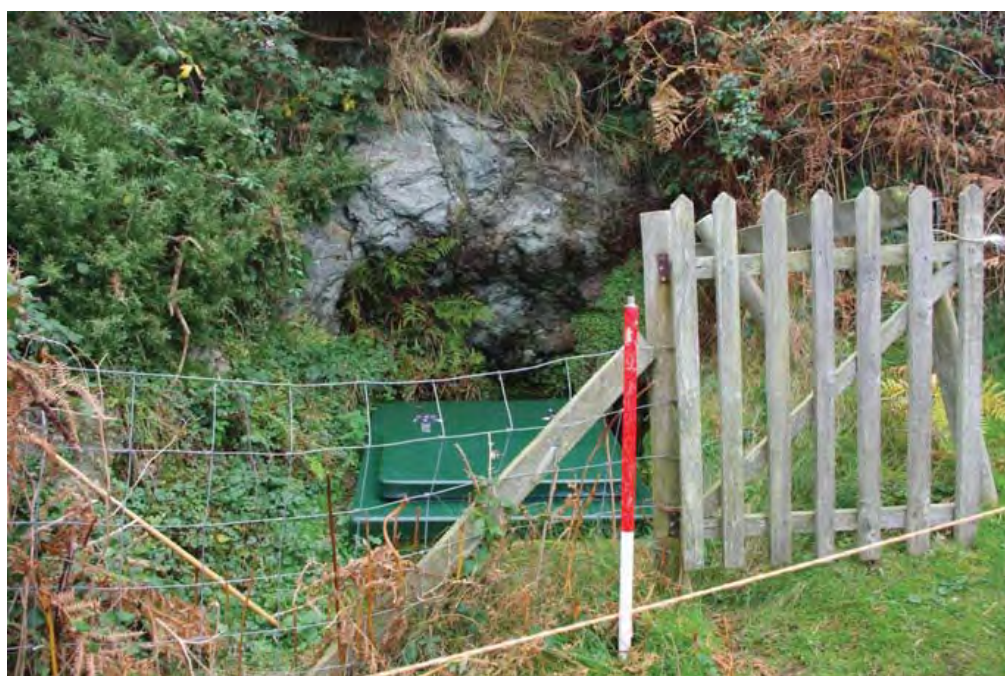
Plate 11. Well/spring (PRN  
1203) with modern cover and  
fence (photograph taken  
01/11/2014)

Plate 11. Well/spring (PRN 1203) with modern cover and fence (photograph taken 01/11/2014)

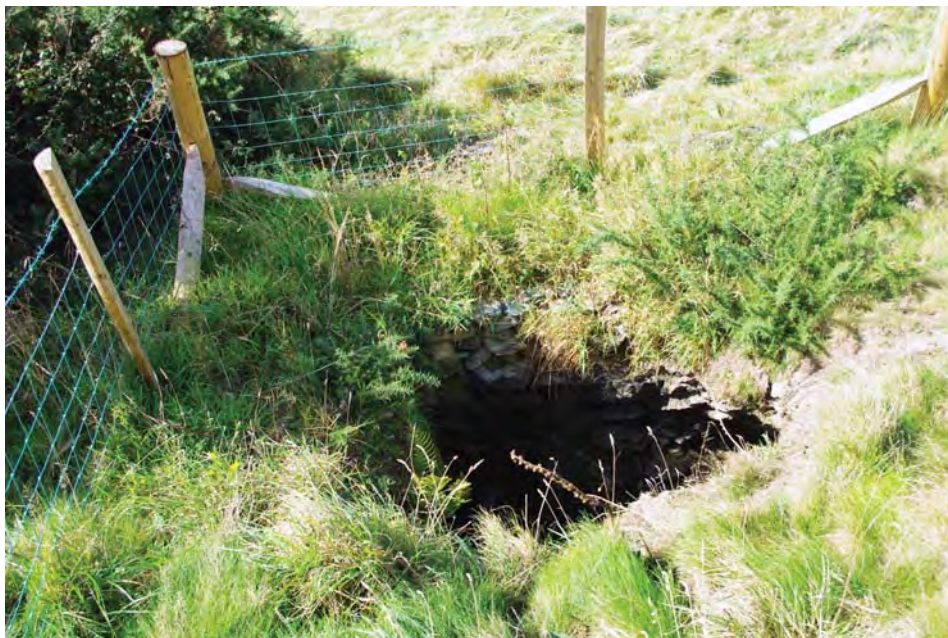
Plate 13. Ffynnon Bryn Baglau (PRN 30819). Photograph taken 24/09/2015 when the well was entirely dry

Plate 13. Ffynnon Bryn Baglau (PRN 30819). Photograph taken 24/09/2015 when the well was entirely dry

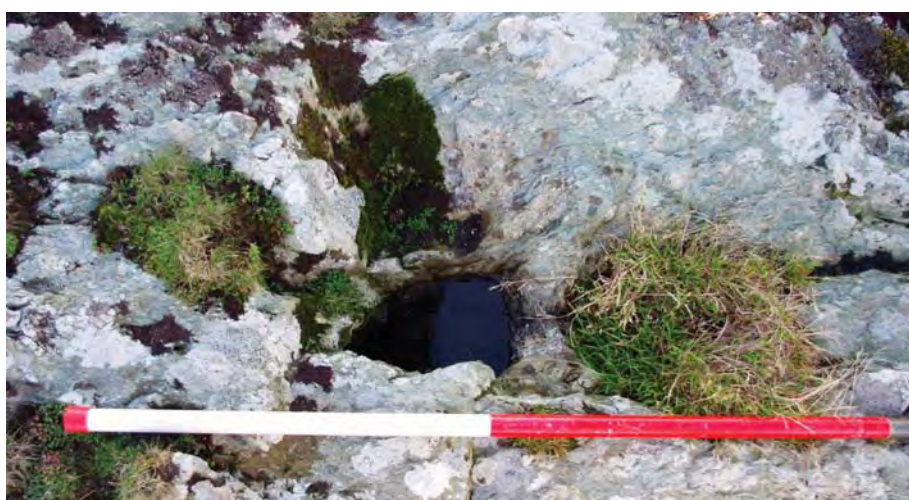
Plate 14. One of the Ffynnonau Barfau (PRN 59985) (photograph taken 22/09/2015)

Plate 14. One of the Ffynnonau Barfau (PRN 59985) (photograph taken 22/09/2015)

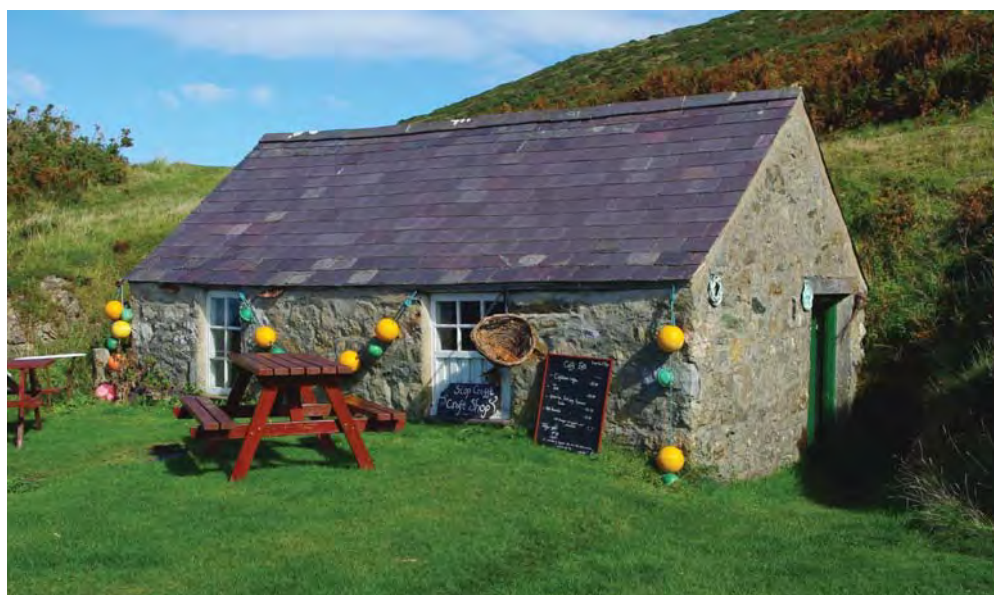
Plate 15. Former Tŷ Pellaf dairy, now the gift shop (PRN 16837) (photograph taken 24/09/2015)

Plate 15. Former Tŷ Pellaf dairy, now the gift shop (PRN 16837) (photograph taken 24/09/2015)

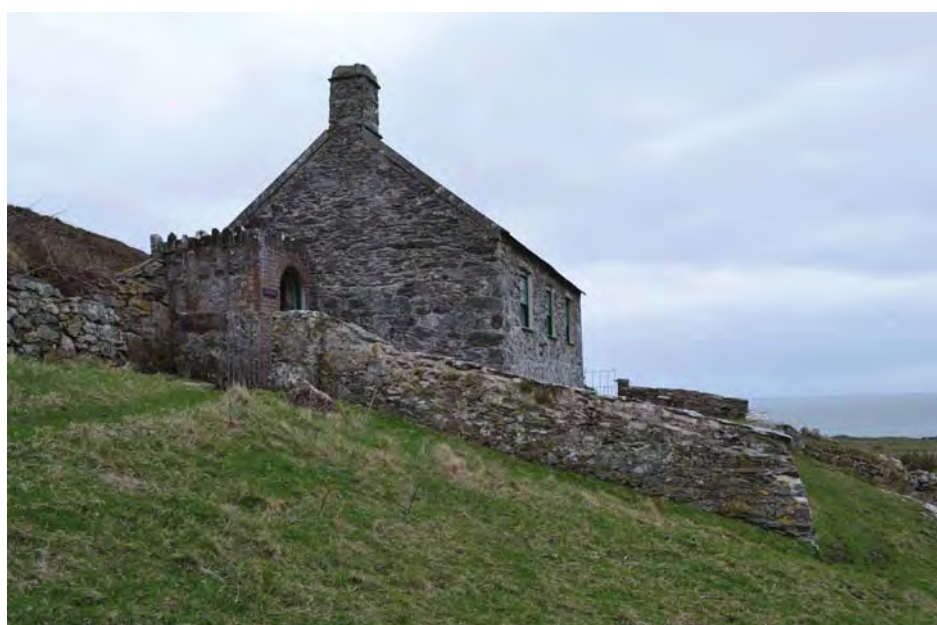
Plate 17. The Schoolhouse (PRN 11657) (photograph taken 16/03/2014)

The school house (PRN 11657) also pre-dates the main rebuilding (plate 17). It was originally a chapel, but was used as a school and meeting place (including for the tenants' "parliament") once the new chapel was built (Arnold 1994). It is now used for a display about the island and for meetings. The boathouse (*storws*) (PRN 16826) (plate 18), near Cafn Enlli, was built during the construction of the lighthouse (Evans and Marloh 2008, 87), so must therefore have been built prior to 1821 when the lighthouse was completed. It is in fairly good condition but some slates are missing from the roof, which could quickly lead to problems if not repaired. The windows are not original as they were replaced by replicas made and fitted by Douglas Hague in 1982, when he also mended the slate roof (CRO XD64/340).

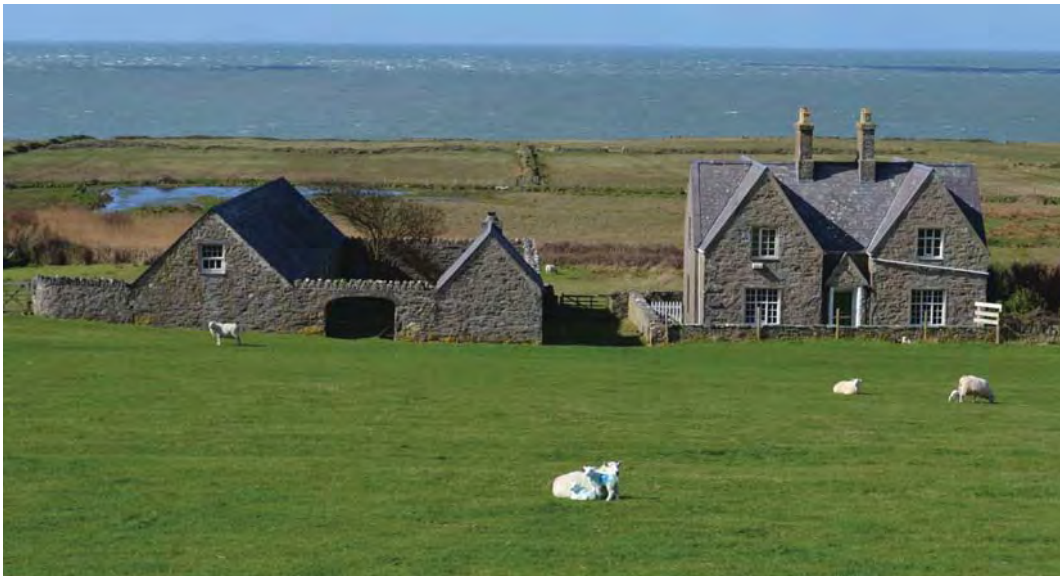
Plate 19. Carreg Fawr (PRN 16785) with its yard (PRN 16784) (photograph taken 22/03/2014)

Plate 19. Carreg Fawr (PRN 16785) with its yard (PRN 16784) (photograph taken 22/03/2014)

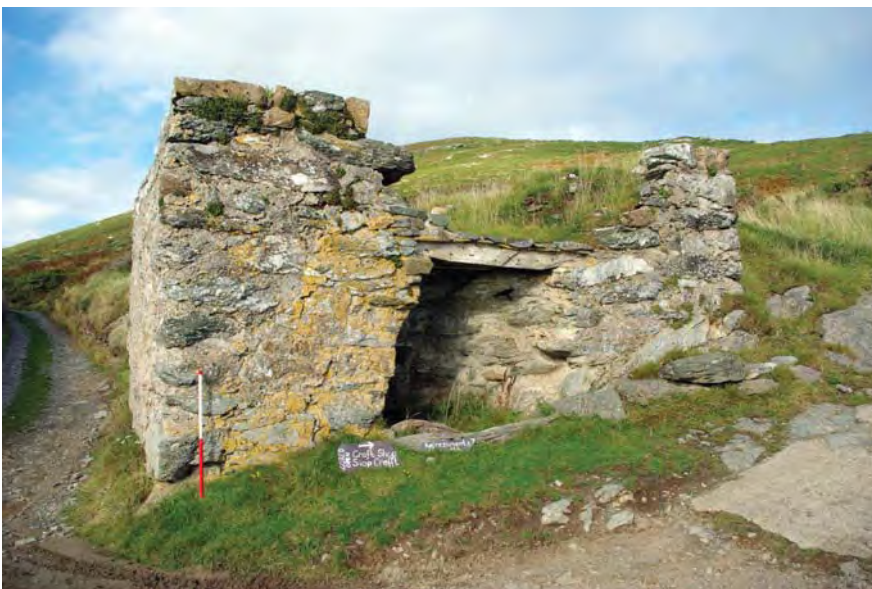
Plate 21. Lime kiln (PRN 16835) (photograph taken 21/09/2015)

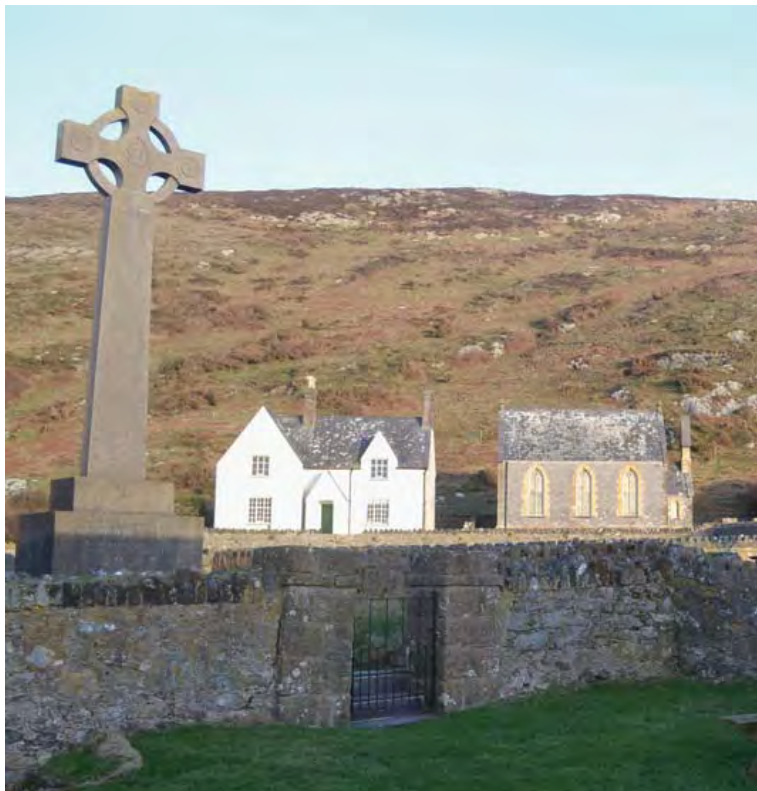
Plate 22. Memorial cross over Lord Newborough's tomb (PRN 59845) (photograph taken 17/03/2014)

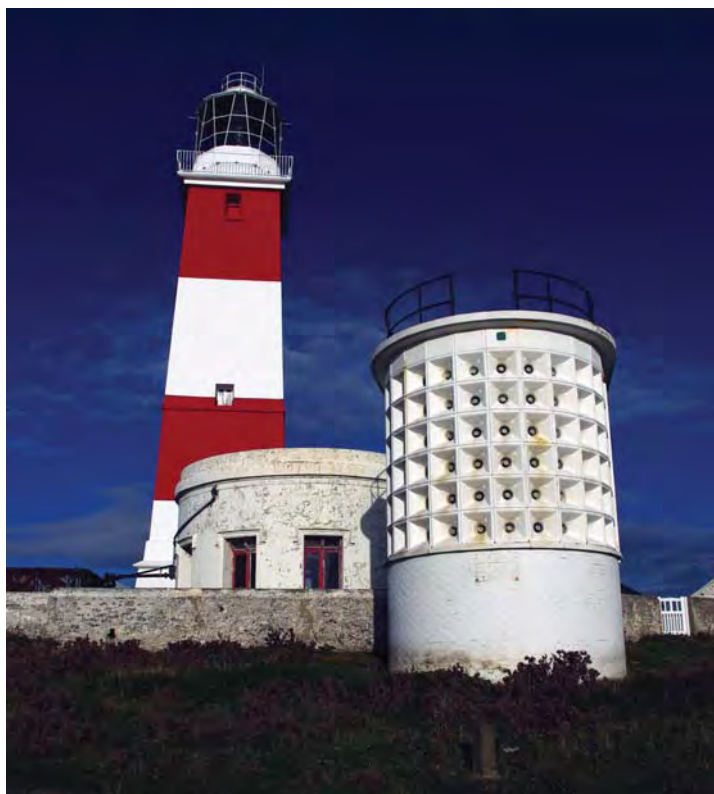
Plate 23. Lighthouse (PRN 3604) and the old (PRN 59851) and new foghorns (PRN 30816) (photograph taken 21/09/2015)

The earliest new construction was a 99ft high lighthouse (PRN 3604) and outbuildings designed by Joseph Nelson and completed in 1821 (RCAHMW 1964, 20). The fog signal tower (PRN 59851) was erected in 1828, now replaced by a modern fog horn outside the boundary wall. There were houses for the keepers with additional accommodation added in 1882, a vaulted paraffin store and in the eastern part of the enclosure a garden with pig sties and privies (Arnold 1994).

Lighthouse (PRN 3604) and associated buildings (plate 23) were designed by Joseph Nelson and completed in 1821. The square tower is the tallest square tower of any lighthouse in the British Isles. The original oil lamp was replaced by electricity in 1973 and the new generators meant that a new electric fog horn (PRN 30816) was installed outside the compound to the west, replacing the previous fog horn (PRN 59851). The installation of the generators resulted in the fog signal changing to the electrical emitters installed in a new building to the west. The lighthouse was automated in 1987 and in 2015 the light was changed for a solar powered red LED.

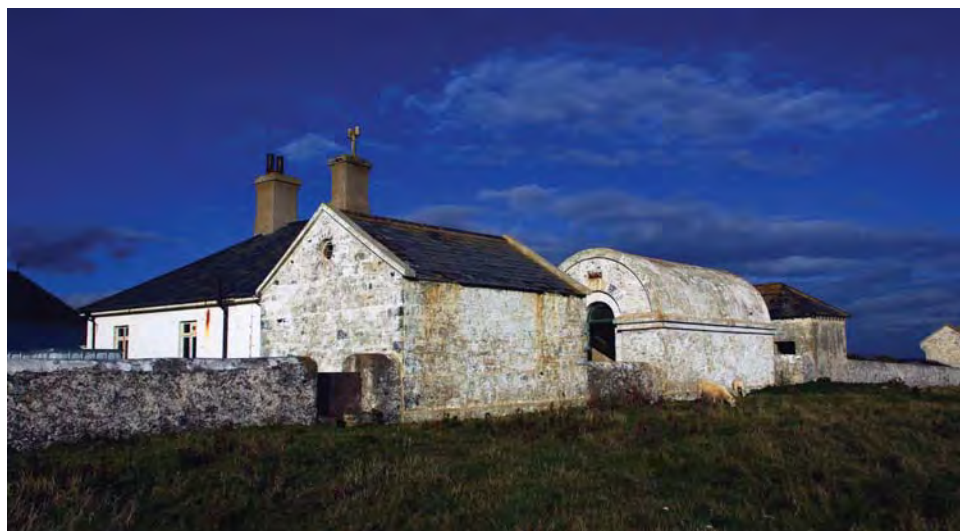
Plate 24. Store houses (PRN 59850) and lighthouse keepers' house (PRN 12267) (photograph taken 21/09/2015)

Plate 24. Store houses (PRN 59850) and lighthouse keepers' house (PRN 12267) (photograph taken 21/09/2015)
