# HIGH STATUS MEDIEVAL SITES CASTELL CARNDOCHAN

Excavation report 2015-16

Project No. G2366

### **CASTELL CARNDOCHAN: CONSERVATION AND ASSESSMENT EXCAVATION**

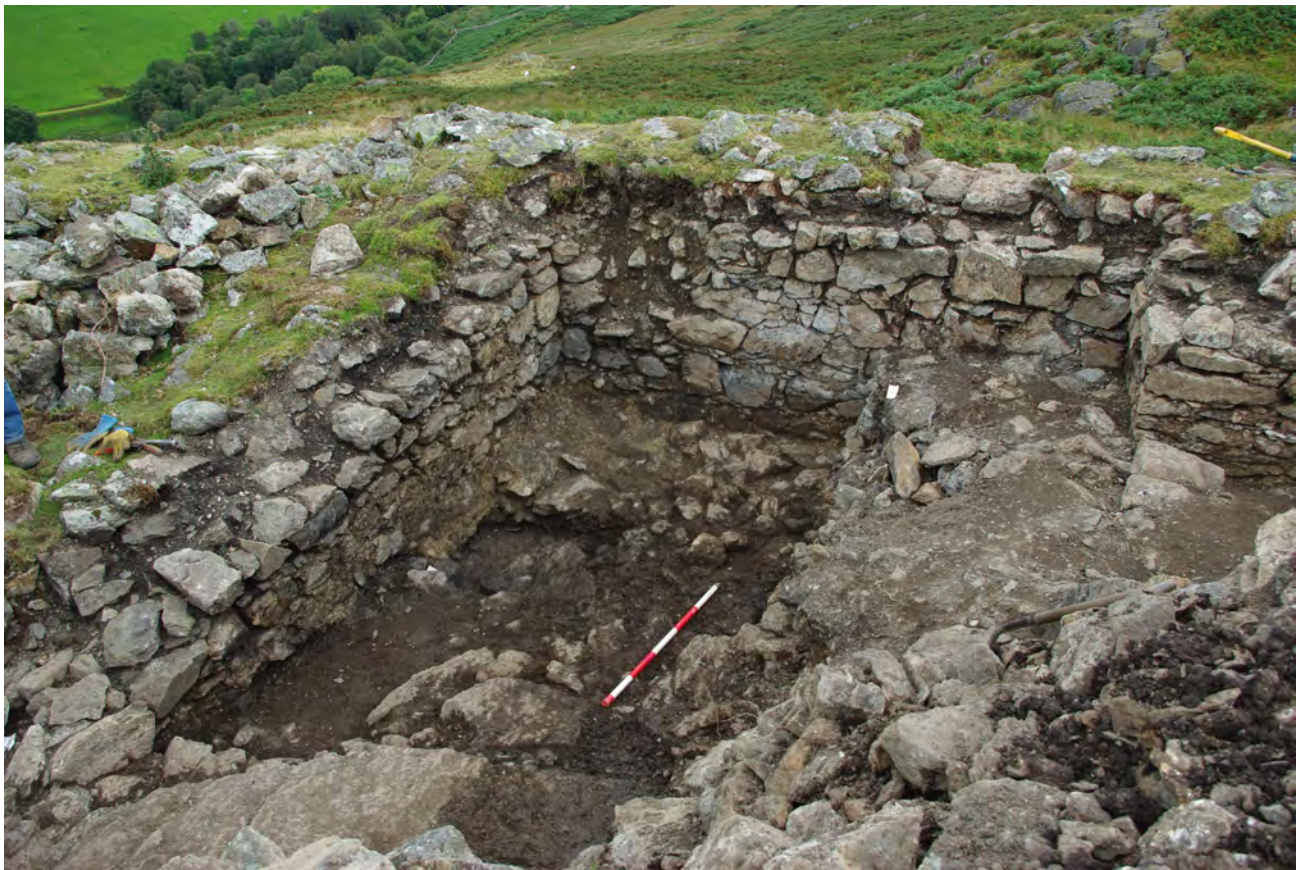
Plate 3 Trench 1 showing mortar (505) at base of wall

Subtrench 1a was excavated down to the wall foundations (Figs 8 and 17). There was no evidence of a foundation trench for the curtain wall or half-round tower. Walls 507 and 508 were found to be standing on bedrock (518), shattered stone (520) or clayey soil. The shattered stone (520) was wedged into the uneven surface of the bedrock beneath the curtain wall (507). This appeared to be a deliberate levelling surface as opposed to being naturally shattered bedrock. Other stones, elsewhere in trench 1, appeared to have been set into the uneven bedrock, most notably a large edge-set stone (marked ES on Fig 8), presumably to infill some of the larger holes. The outer face of the half-round tower was built on bedrock in places but where encountered in trench 1a was built on a thin layer (1 or 2cm) of natural clay (516) which was in turn overlying the bedrock. Some of the hollows were filled with chips of local stone in a matrix of dark grey silt and mixed gravel (515). The chips were sharp-edged and unweathered apart from where they retained a cortex on one side. These did not resemble the stones naturally occurring in the subsoil and appeared to be debris from the shaping of stones during the building process. The deposit also contained a few fragments of medium-sized animal ribs (sheep/pig).

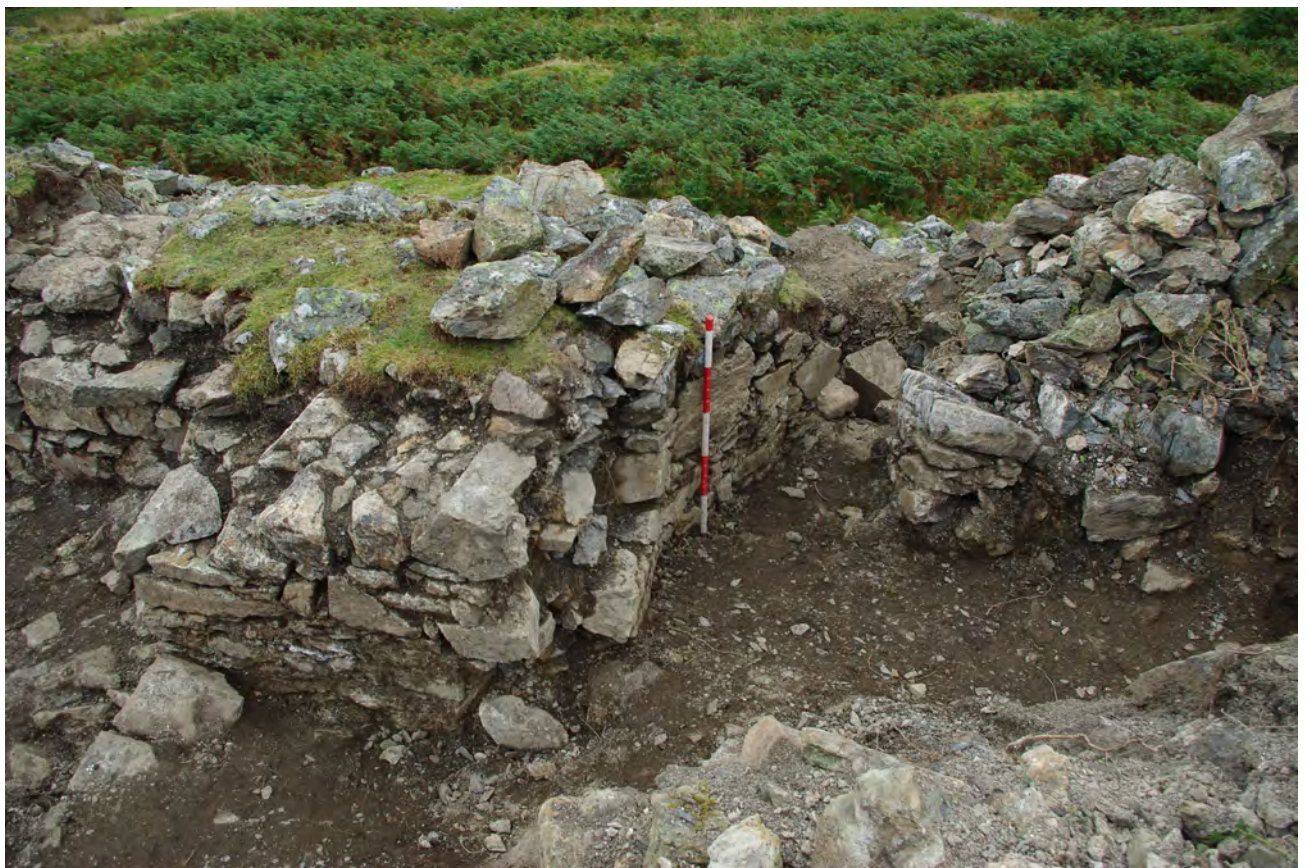
Plate 4 East wall of entrance passage

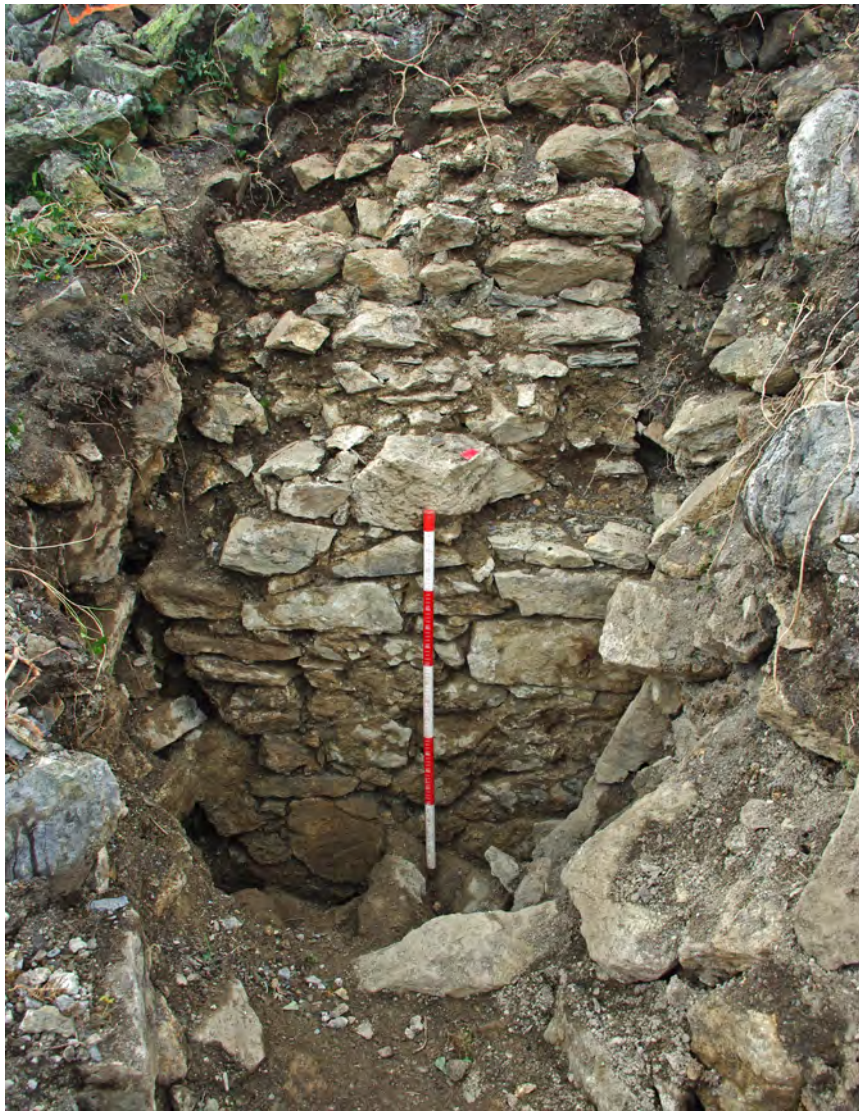
Plate 5 Partly buried facing at the inner W side of the entrance passage

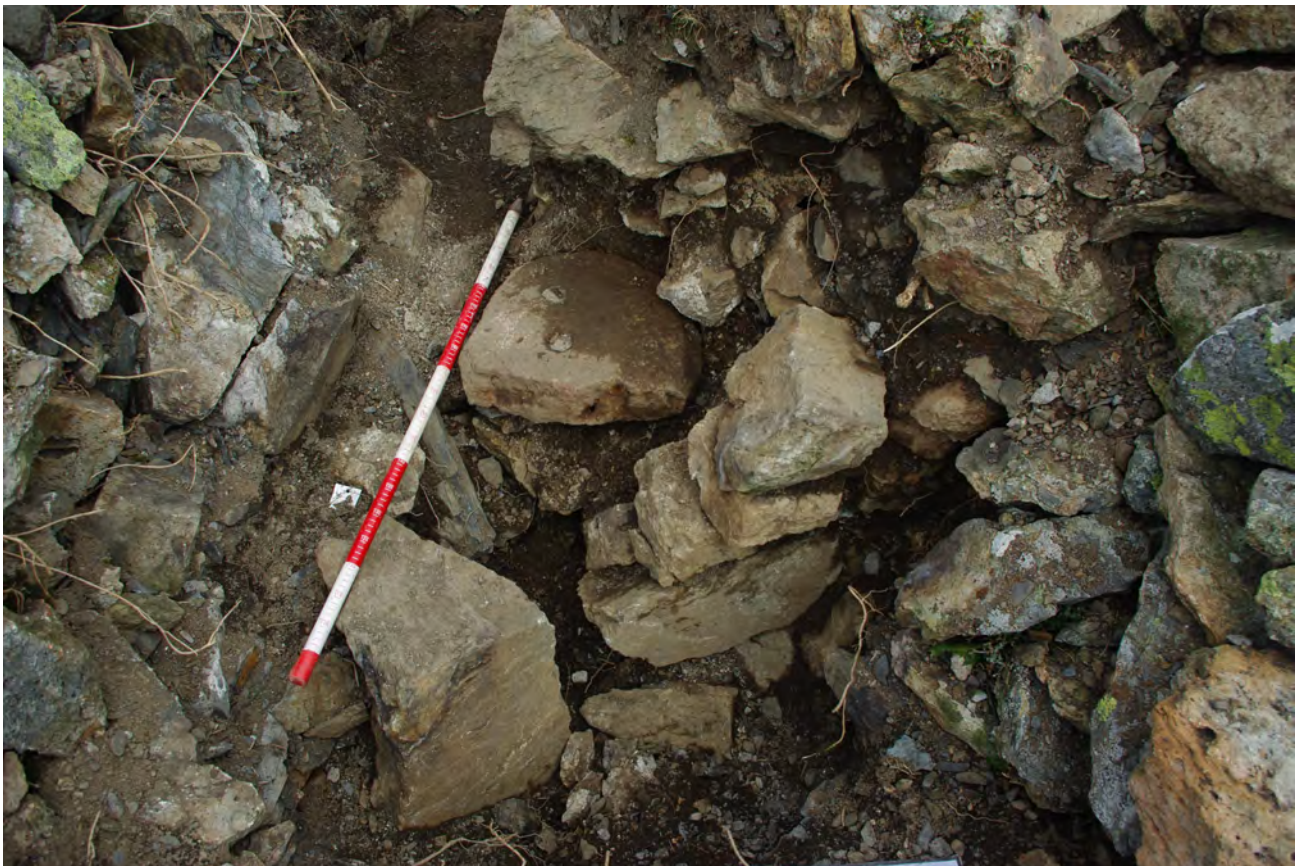
Plate 6 Partly collapsed outer end of the entrance showing possible hinge-mount (521)

presumably to achieve a lower gradient. The inner face and entrance appeared to be one continuous build with no obvious joints. There was a collapse in the upper part of the face on the inner corner of the passage wall and a more serious collapse on the outer corner although only a small amount of masonry appeared to have been lost down to a low level. The latter collapse revealed a thick sandstone slab that had been incorporated into the wall 0.6m from the outer end of the passage. The upper side had two holes drilled in it containing rectangular-section iron mounts set in lead caulking (521, Plate 6). One of the iron mounts had both broken off level with the top of the stone and the other had pulled out of the lead. It is possible these were the remains of a hinge-mount. The twin mounts could indicate that the mount was bifurcated perhaps in order to prevent it from rotating in its socket. There was however no obvious wear on the top of the stone where the mount would have extended from the wall. A heavy door would presumably have exerted a lot of downward pressure on the outer end of the hinge and caused some wear or fracturing of the stone. An alternative interpretation could be that the mount was holding a wooden frame for the gate; the two mounting points could indicate an iron strap.
