RED GABLES, PENMAENMAWR, GWYNEDD

Archaeological Building Record

Prosiect Rhif / Project No. G2474

Prepared for: Berkshire Homes (Northern) Ltd

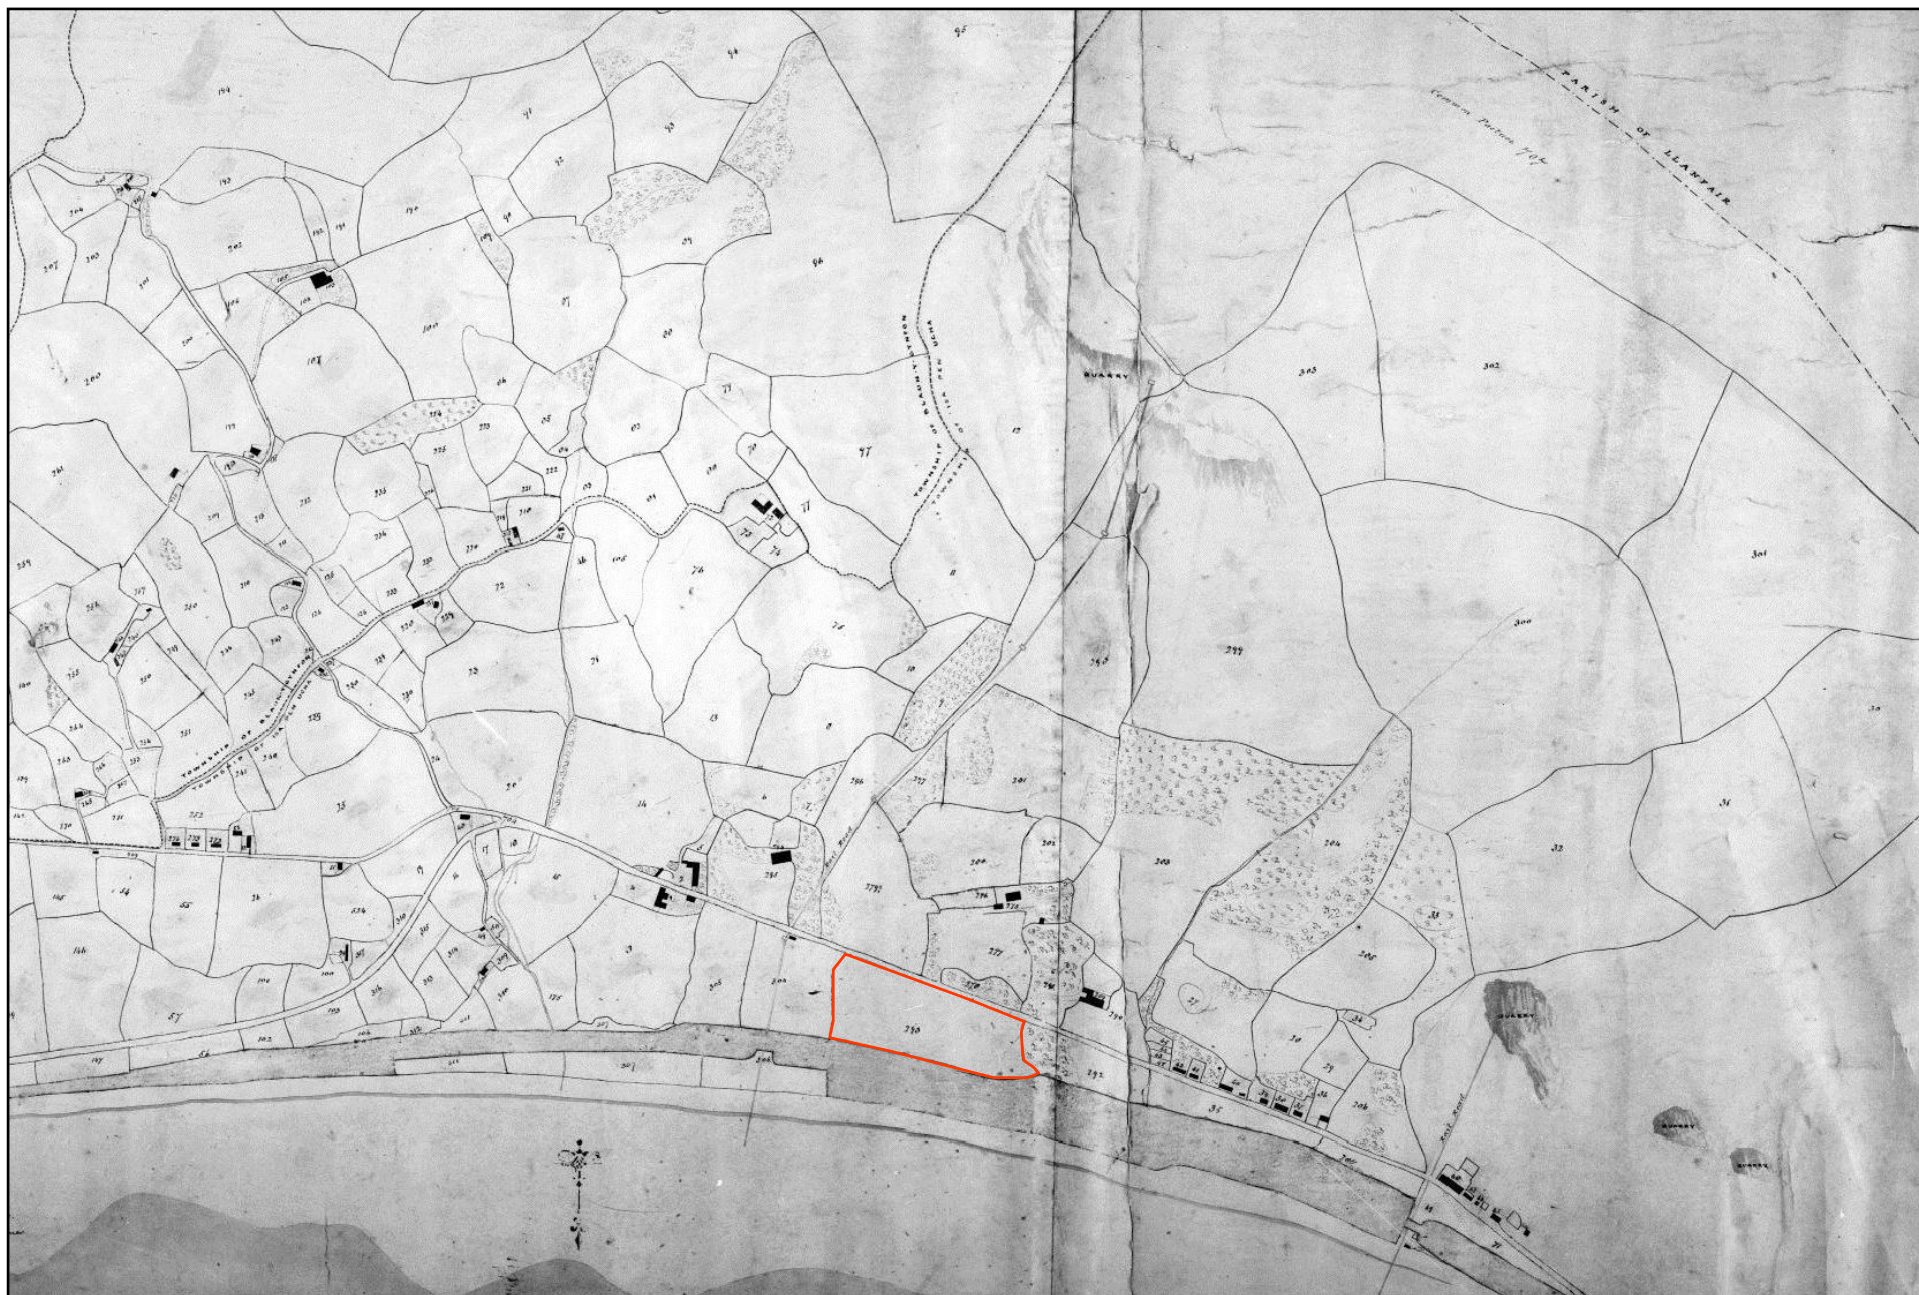
Figure 02: Extract from the Dwygyfylchi Tithe Map of 1842, with the future location of Red Gables outlined in Red. Not to Scale

In 1842 the land on which the Red Gables was subsequently built is described on the Dwygyfylchi tithe map as *Cae Mawr* (Field No. 293; Figure 02) and to be the property of George Thomas Smith Esquire and occupied by William Richard. It consisted of an area of 9 acres 2 roods and 14 perches (Conwy Archives). By 1884 the land had come into the possession of the Darbishire family of Plas Mawr, who had become wealthy from their quarry interests in Penmaenmawr.

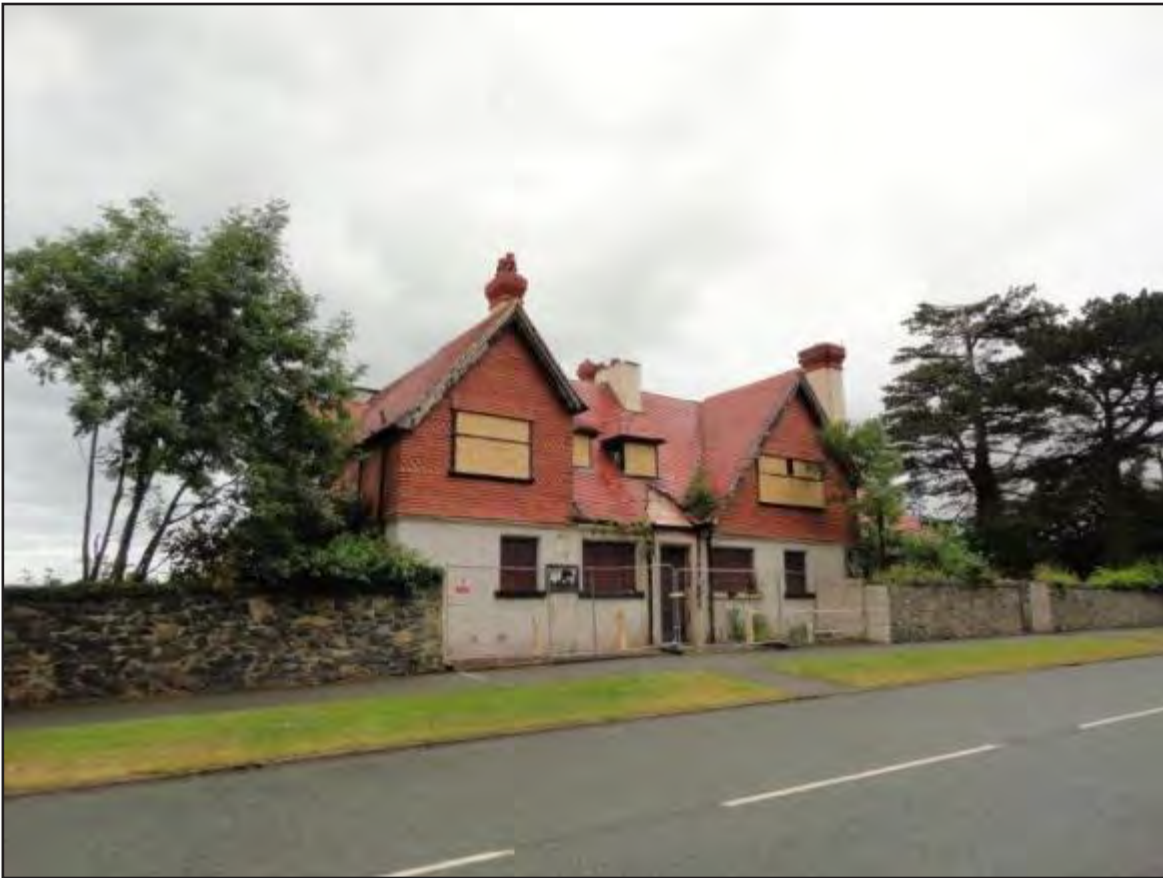
Plate 01: A view of the southern façade of Red Gables

The property of Red Gables has been entirely demolished, so the description of the former property has been taken entirely from historic records and archives photographs (Plates 01-08). The southern façade of the property facing on to Bangor Road consisted of two main floors and a probable cellar and attic level. It consisted of a central block and two cross wings at the east and west ends of the building. These wings were gabled and covered in red pantiles and the roof of the building was covered in red tiles, hence the name 'Red Gables' given to the property (Plate 01). The ground floor was rendered white and a central gabled wooden porch rose to first floor level. There were four windows at ground floor level and two windows in the gable ends at first floor level in the main block and two dormer windows in the central block roof. Four brick chimney stacks were noted on central, on offset to the west and a tall lateral chimney to the east. These were of an elaborate brick construction, with chimney pots of a possibly unique arts and crafts style and made of terracotta. Prominent black barge-boards were noted within the lateral gables of the property. A two storey annex in a similar style was noted at the eastern end.

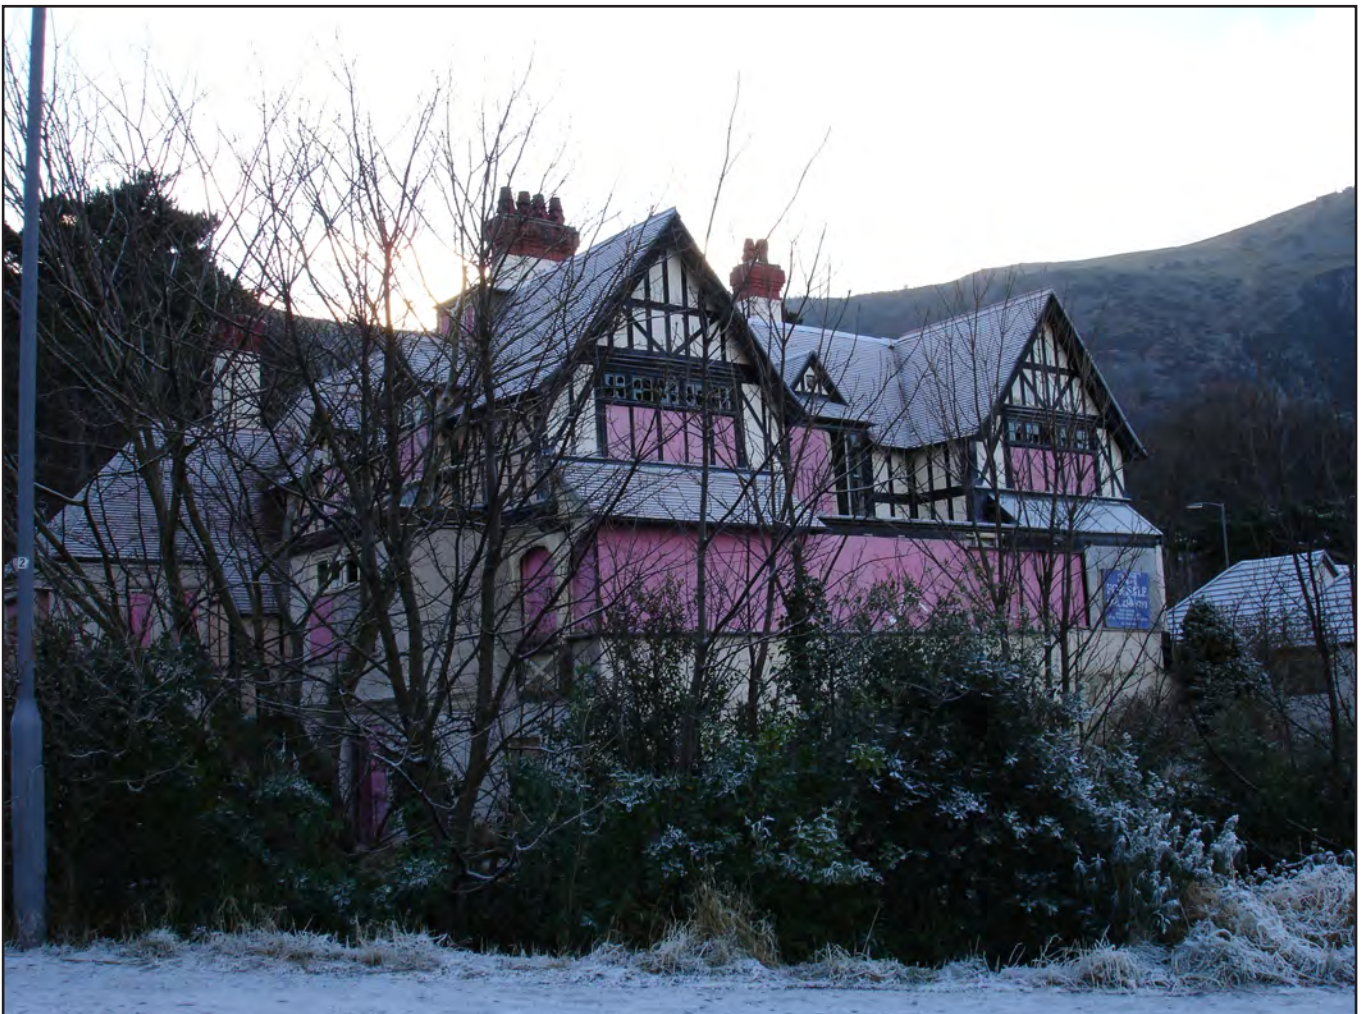
Plate 02: A view of the northern façade of the Red Gables taken in winter in January 2009 © Nina Steele

The northern, seaward elevation of the building had a radically different appearance, of a faux box-framed timber framed character (Plates 02-04). The central block, east and west wings were clad in timber box framing at first floor level. There was a small central gable projecting from the main block, and a projection to the east. A bracketed mono-pitched roof overhung a veranda beneath which was the entrance and windows to the ground floor rooms. The timber supports to the roof were elaborately carved. Two large mullioned and transomed five light windows were located in the gable ends, and a projecting example in the central small gable. Ancillary rooms were to the east of the main block, although it has not been possible to describe these in detail. The garden sloped away to the north of the northern elevation of the building.

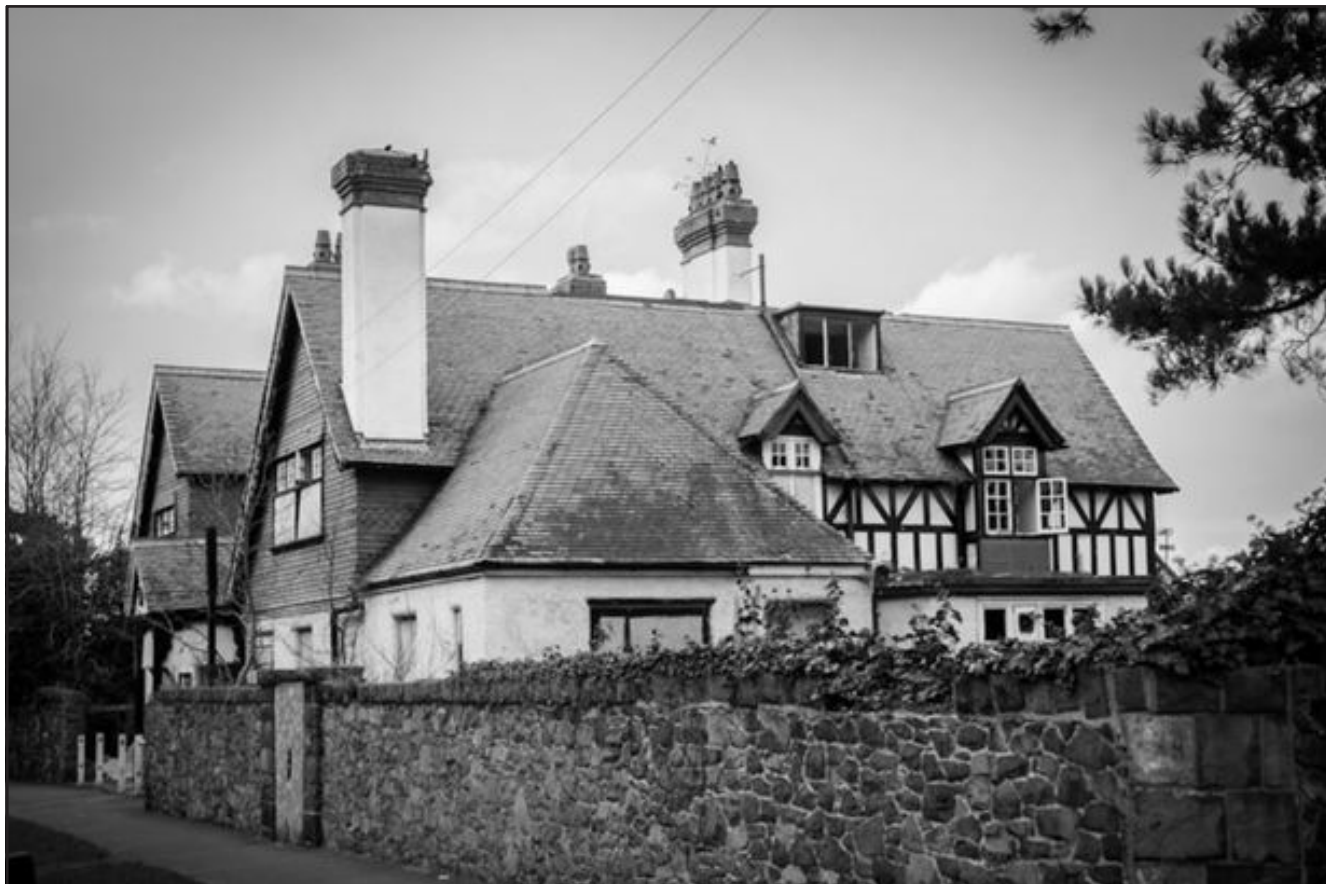
Plate 03: An historic image of Red gables from the south east showing the eastern elevation and part of the southern elevation of the building

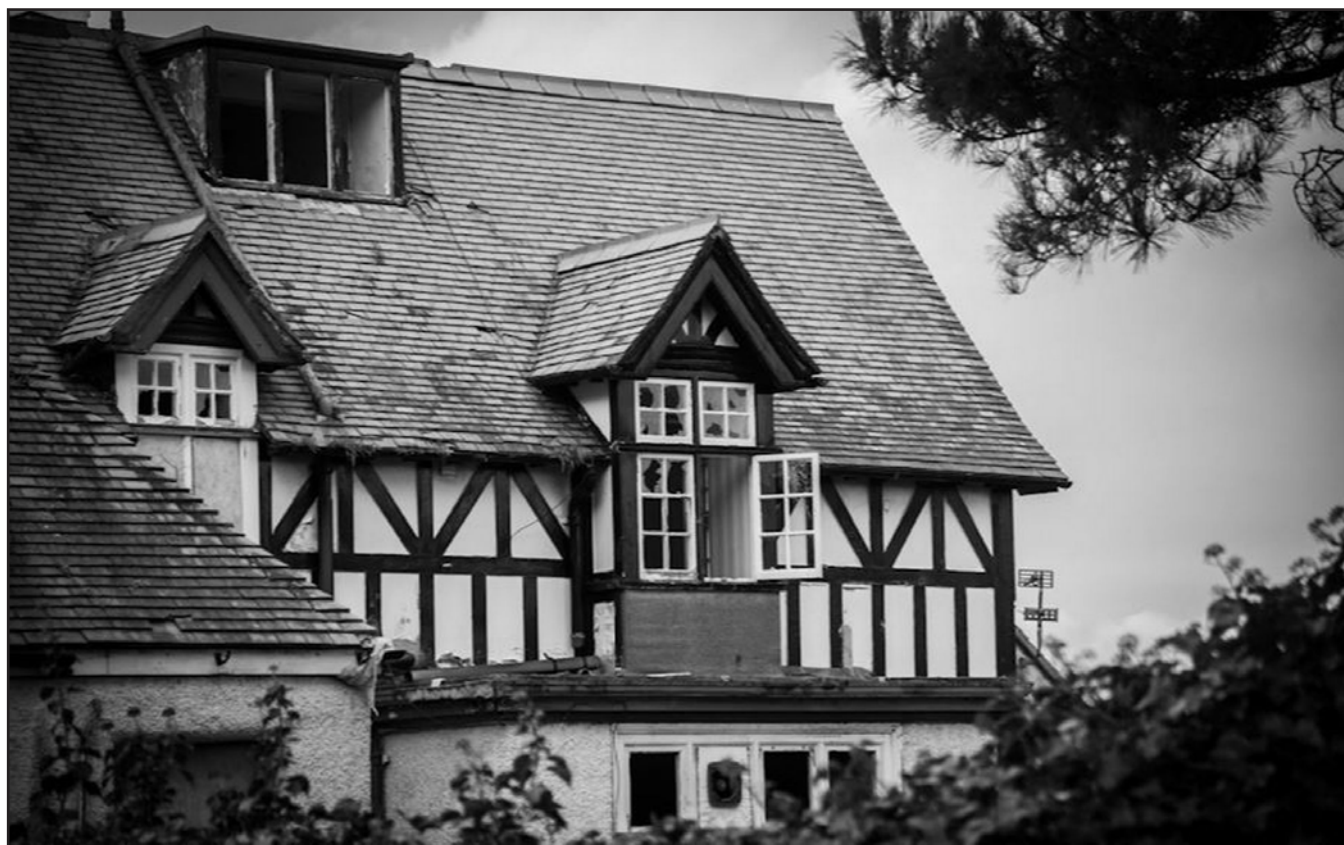
Plate 04: An historic image showing detail of the first floor on the eastern elevation of Red gables showing faux timber framing

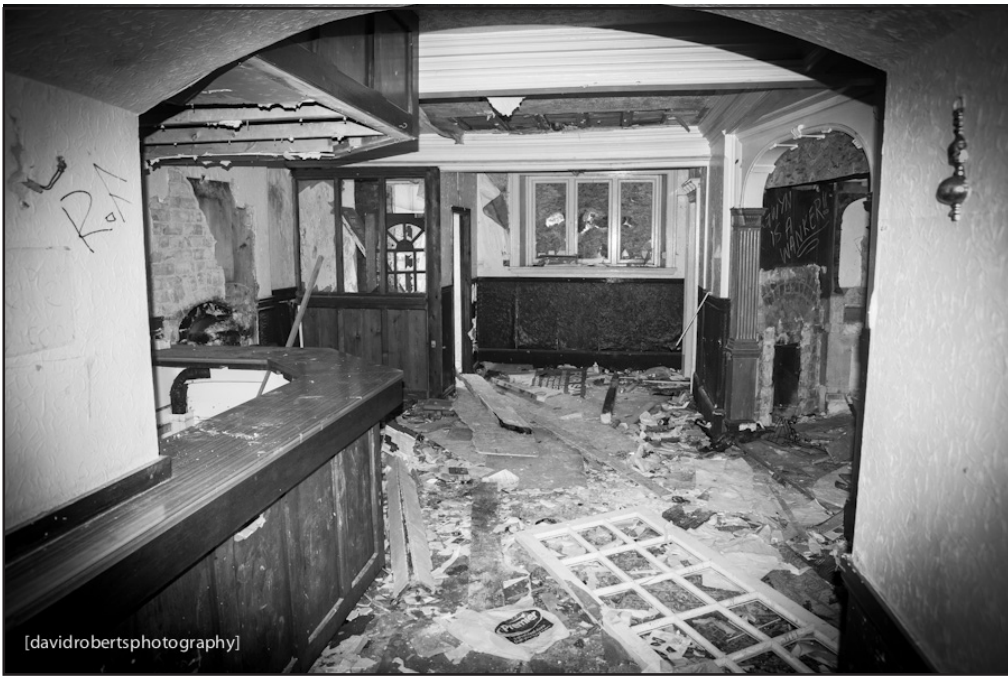
Plate 05: Internal image of the reception area of the Red Gables after the building had fallen derelict.

online, from www.walesonline.co.uk/lifestyle/nostalgia/eerie-look-inside-scene-one-9488907 (Figures 03-08) and www.pugh-auctions.com/lot/manchester/20071206/020 (Figure 01). These show a former reception counter, with an arch leading into the main lounge, and significant amounts of surviving late 19th century fixtures and fittings, an upstairs room within one of the gables to the property and a rear stair well (Figures 05-08).

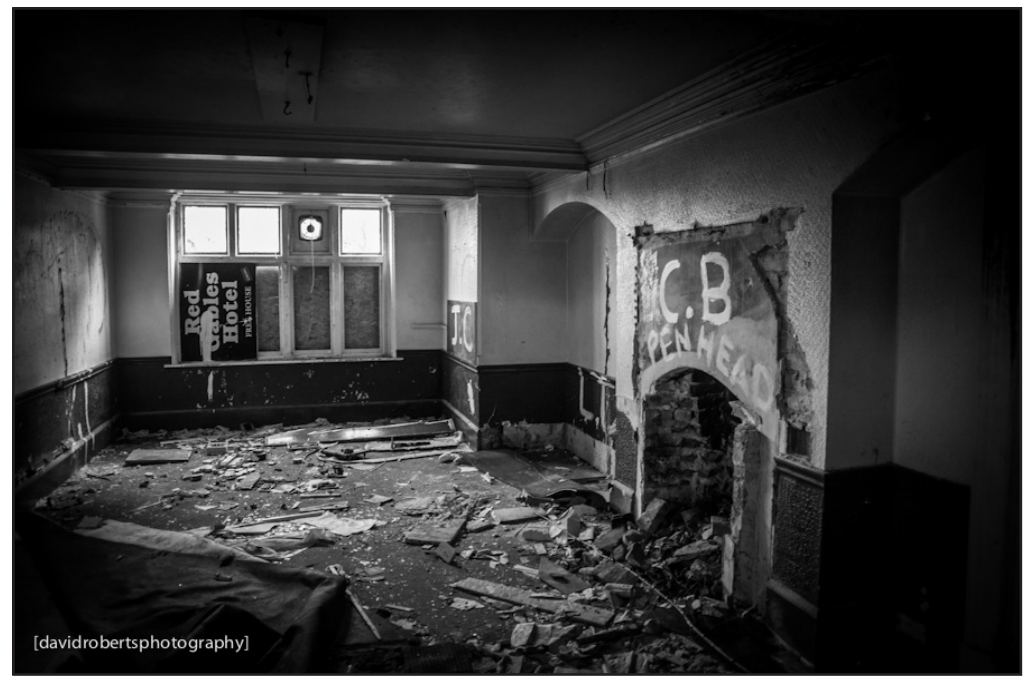
Plate 06: Internal image of the main north facing room of the Red Gables after the building had fallen derelict

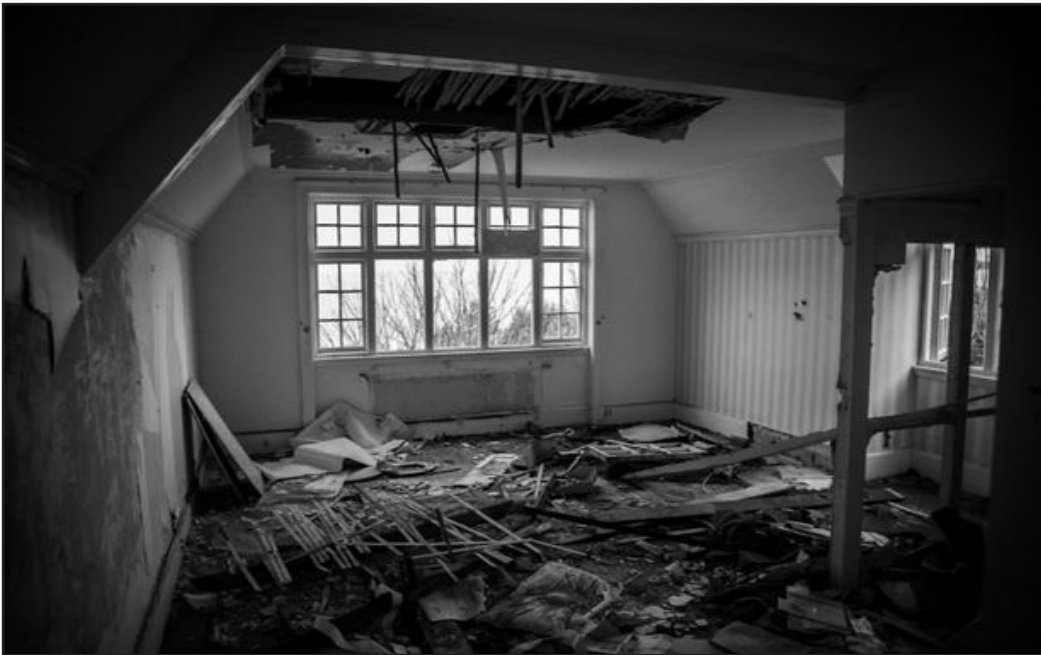
Plate 07: Internal image of the first floor south facing room within the gable of the Red Gables after the building had fallen derelict

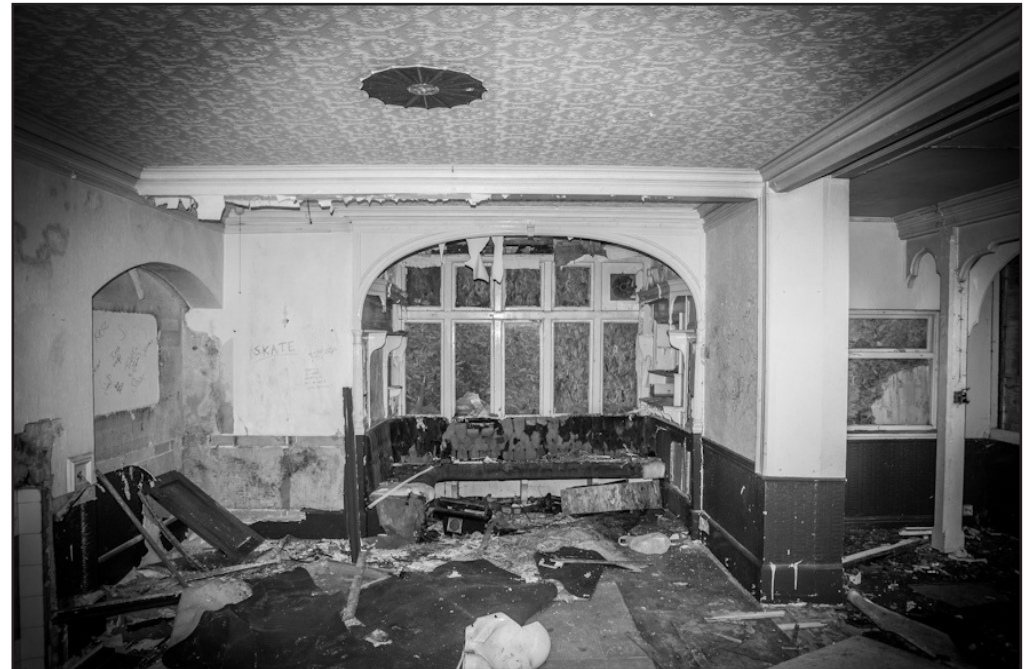
Plate 08: Internal image of the bar area within the property of the Red Gables after the building had fallen derelict

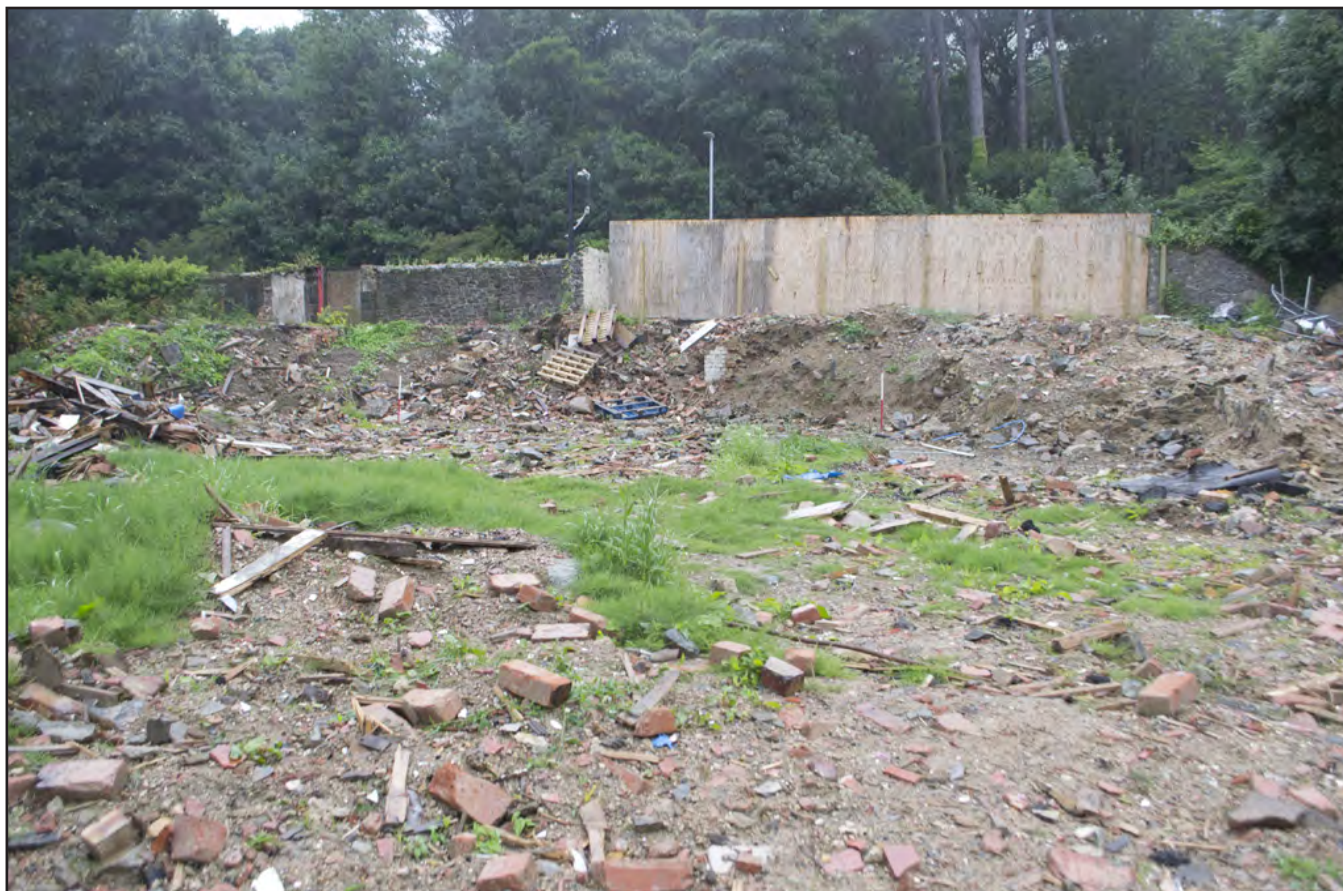
Plate 09: View of the south of the site of the former Red Gables(Scales 2 x 1.0m; archive image: G2474_Red_Gables_001)

The site of the former Red Gables was noted to consist of a former car-park area to the north, with a former path that leads south-east uphill towards the site of the former Red Gables Hotel. The building is now almost entirely demolished (Plates 09-10, 15), with the exception of small fragments of the southern and eastern rear walls to the building (Plate 13). Some remnants of a former garden area to the east (Plates 14) were also noted, and also the southern property boundary wall. Over the central portion of the site rubble from the demolished former hotel building was spread. This has resulted in the raising of the ground level up to 1m across areas of the site (Plate 11), and a difficulty in fully understanding the former topography of the site. The preponderance of brick rubble suggests that construction was mainly of that material, although some rubble stone was noted, along with the surviving small wall fragments. The absence of any architectural detail fragments suggests that any such elements have been removed from the site before the site visit. Fragments of the former garden area were visible (Plate 14).

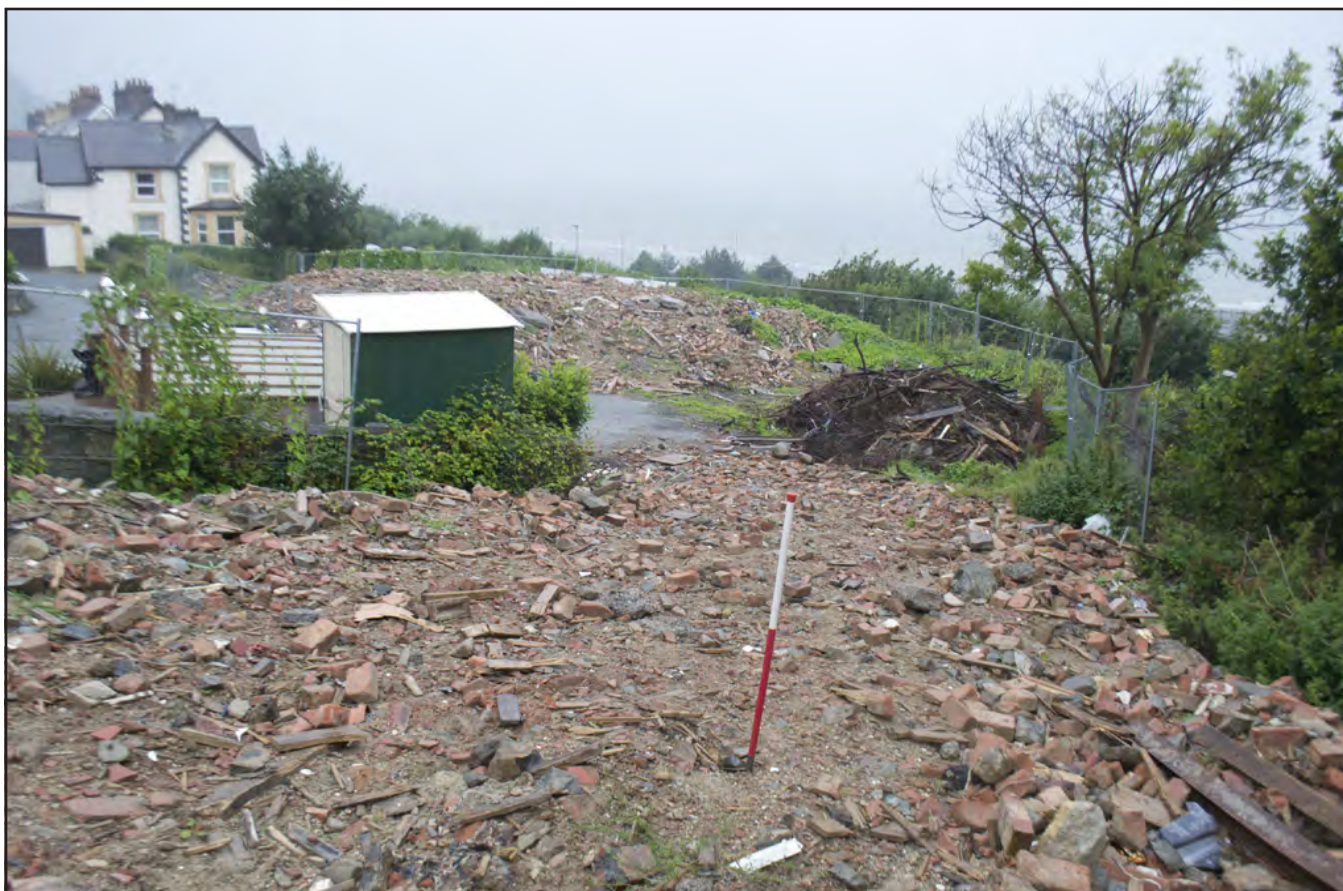
Plate 10: View looking north of the site of the former Red Gables (Scale 1 x 1.0m: archive image: G2474_Red_Gables_009).

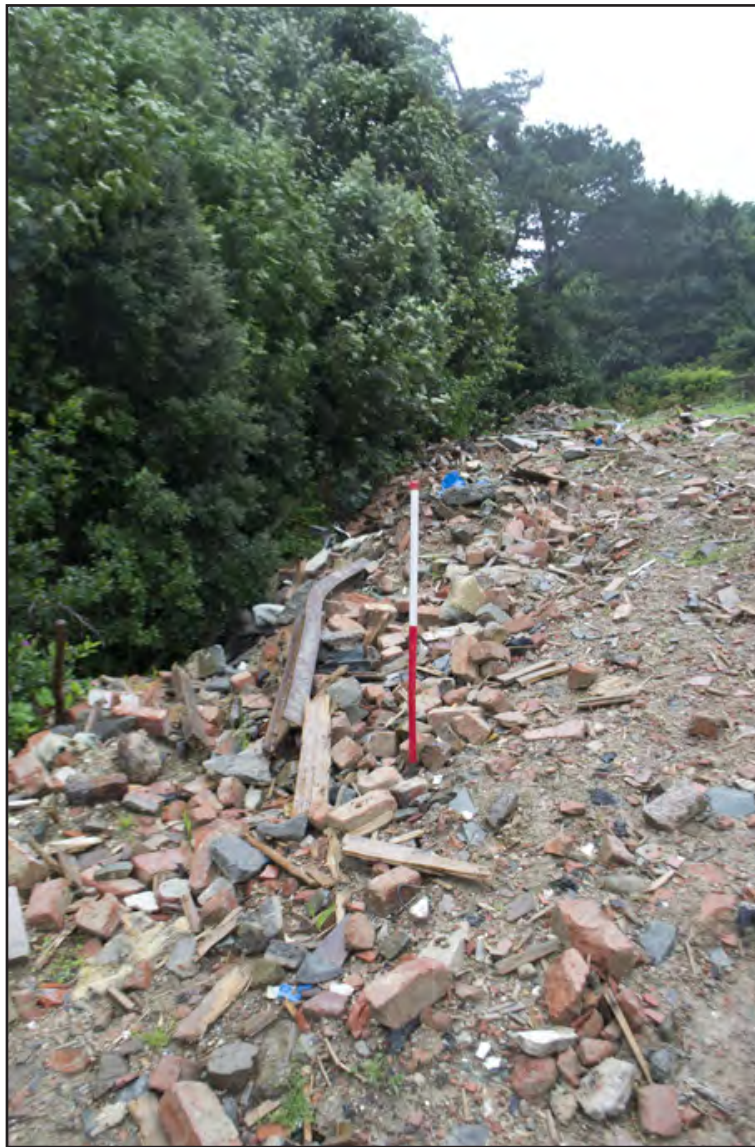
Plate 11: View of eastern side of the side showing the rubble make-up
(Scale 1 x 1.0m: archive image: G2474_Red_Gables_006).

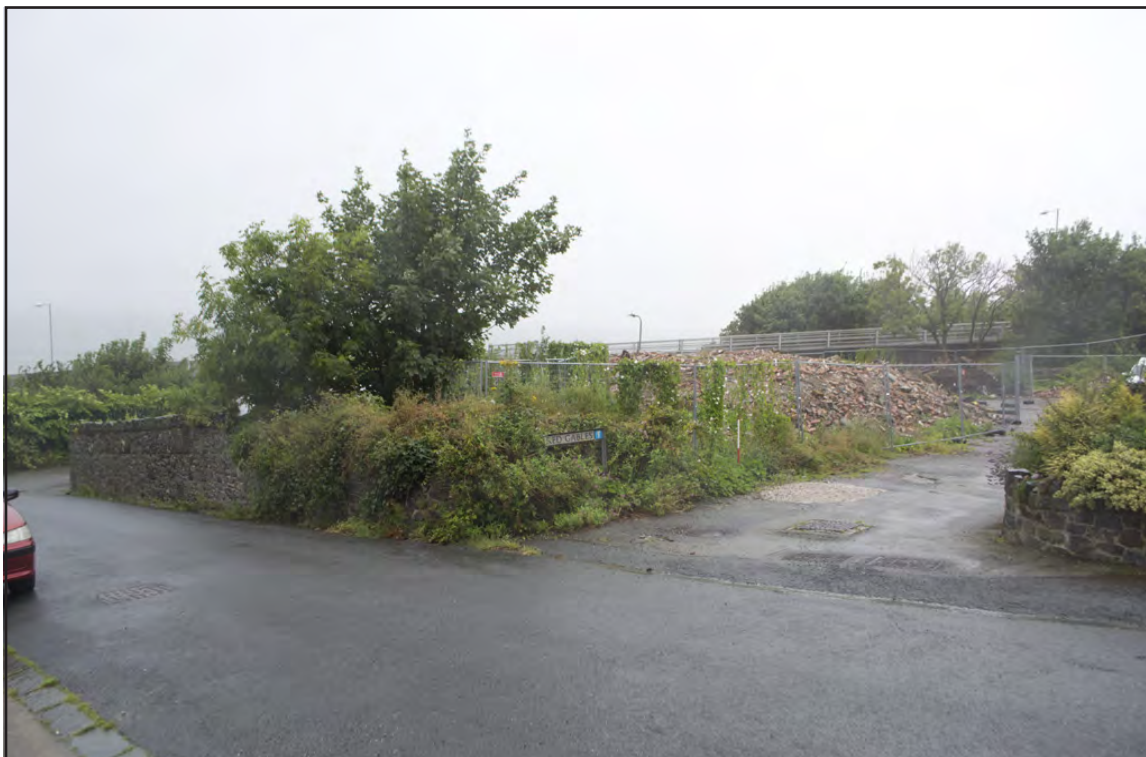
Plate 12: View of the former entrance to Red Gables from St. John's Park East Road
(Scale 1 x 1.0m: archive image: G2474_Red_Gables_014).

The property boundaries (Plate 16) consisted of a rubble stone wall to the south and a heavily overgrown hedgerow to the north-east, associated with a rubble stone wall. Part of the gated entrance to the property survives (Plate 12).

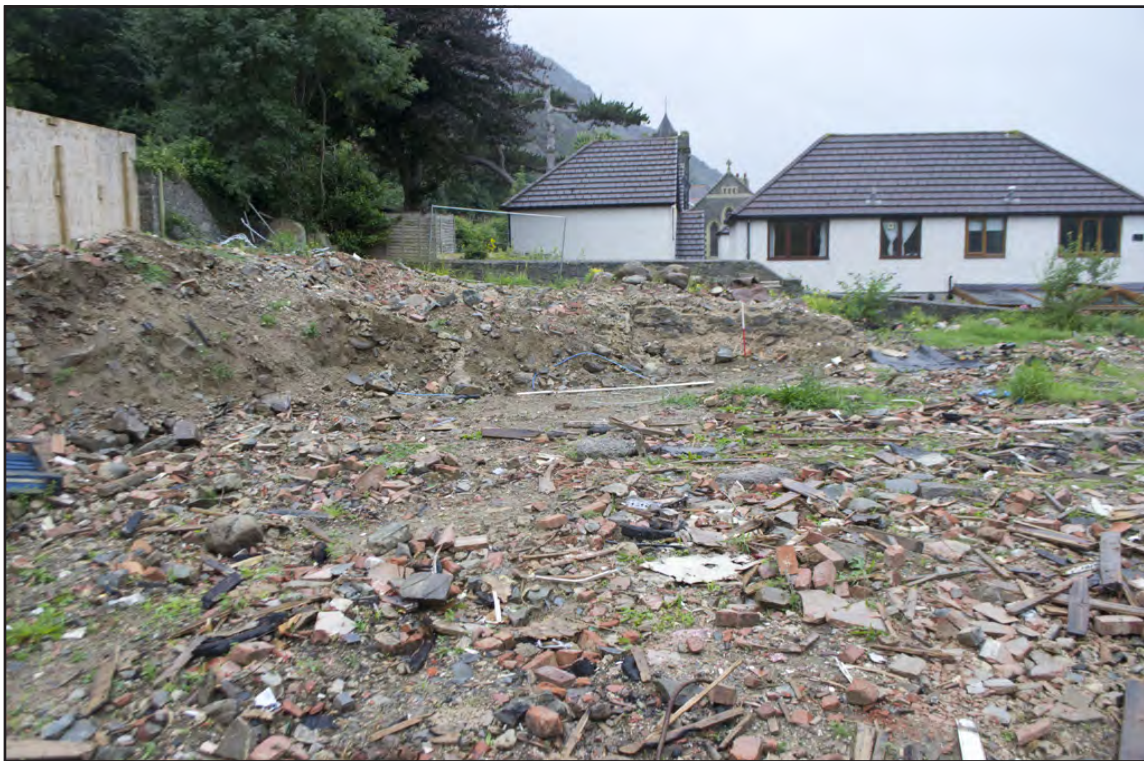
Plate 13: View of the surviving fragment of the west wall of the former Red Gables
(Scale 1 x 1.0m: archive image: G2474_Red_Gables_004).

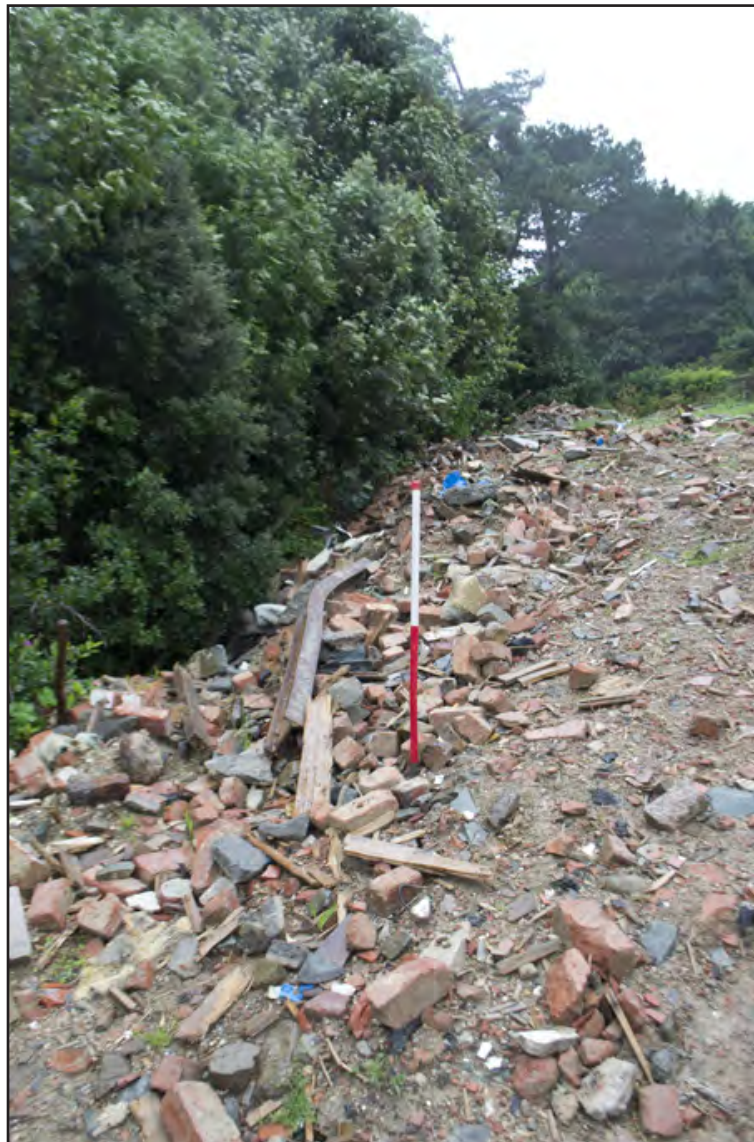
Plate 14: View of the former garden area to the north of the former Red Gables
Hotel from the north-west (Scale 1 x 1.0m: archive image: G2474_Red_Gables_008).

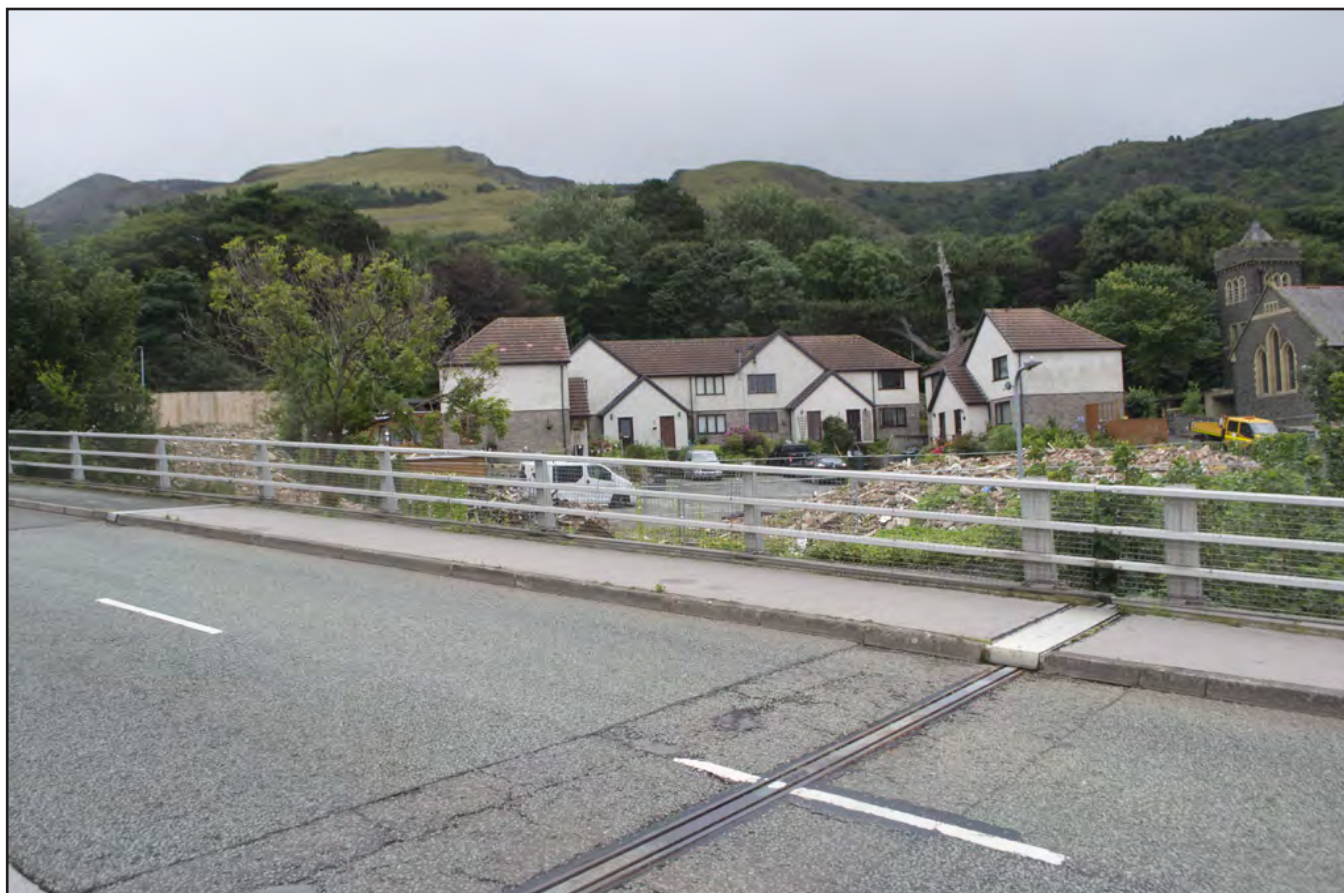
Plate 15: View of the demolition rubble on the former Red Gables site from the Penmaenmawr flyover to the east (G2474_Red_Gables_020).

The lower north and west parts of the site where the former car park was located were also covered in mounds of demolition rubble, but some remains of a Macadamised surface was noted. A set of houses built around a 'U' shape [1-8 Red Gables] to the west of the former Red Gables, was built in recent times on land that was formerly the property of Canon Furneaux, probably the land bought by him in 1888 (Plate 15).

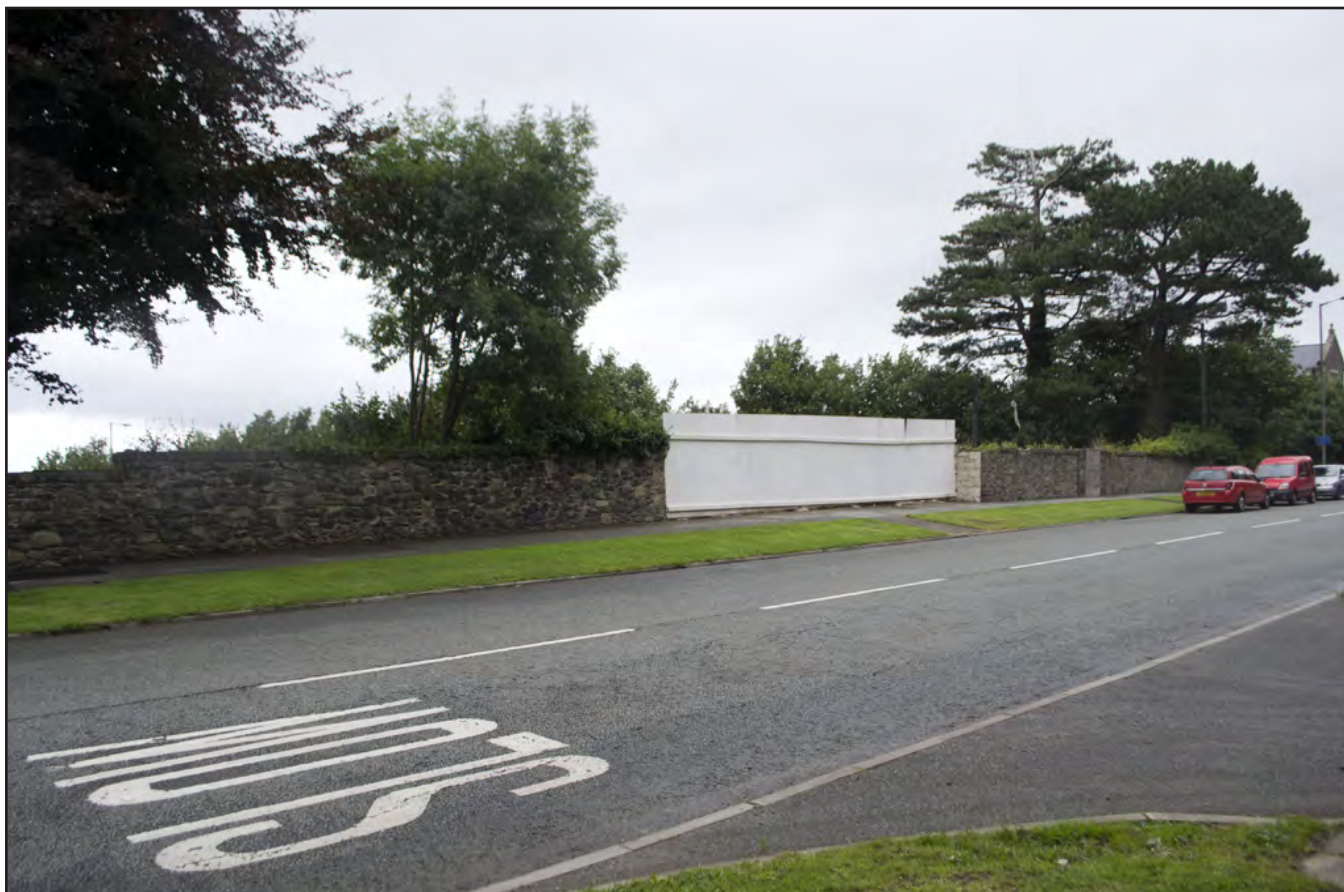
Plate 16: View of the southern property boundary wall from Bangor Road (archive image: G2474_Red_Gables_021).

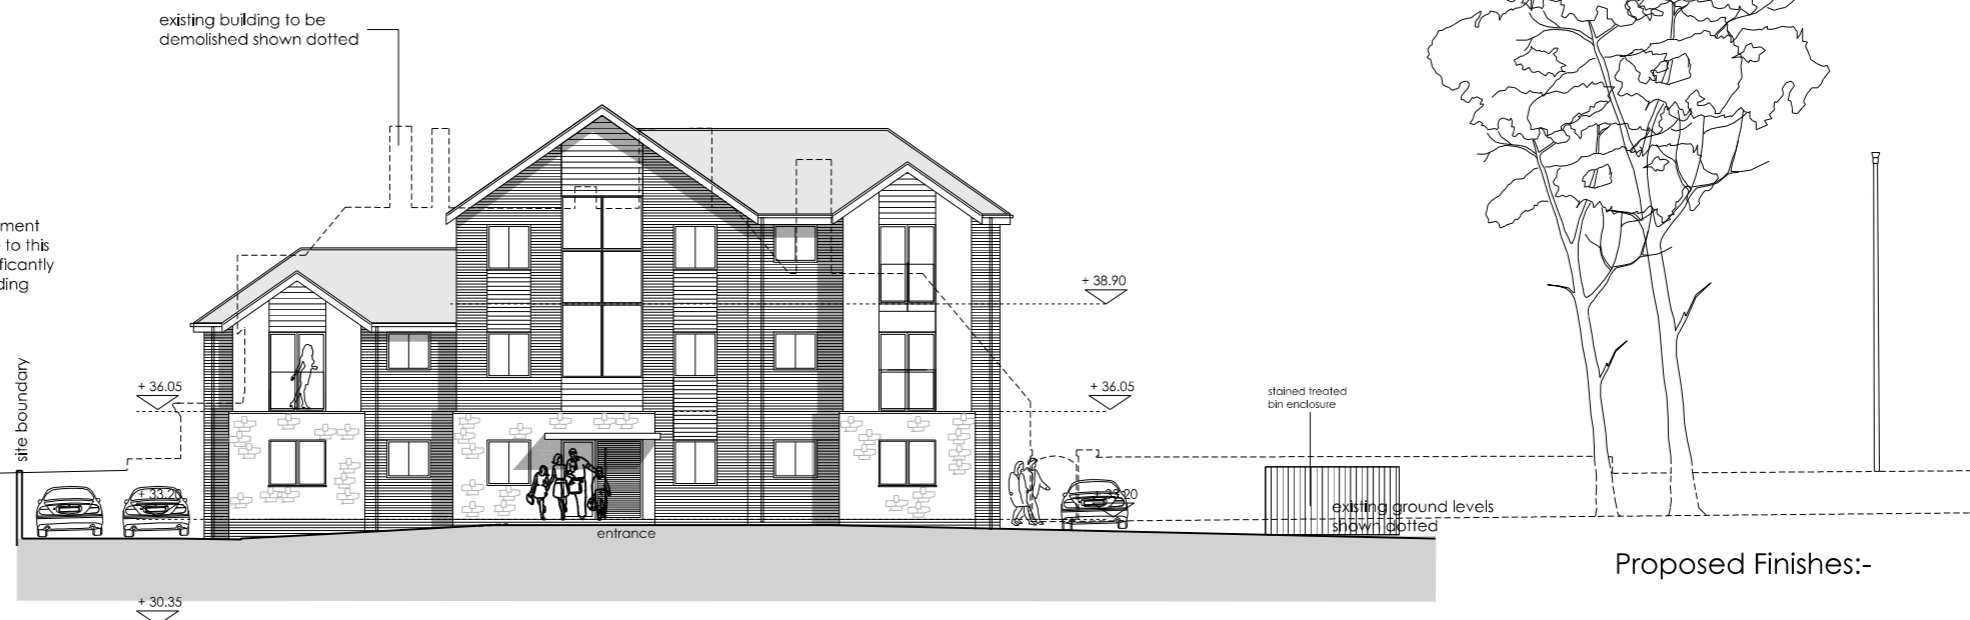
PROPOSED FRONT ELEVATION A (FACING ROAD)

external walls -
white through colour acrylic render/
multi red smooth facing brick/
grey nordic stonepanels by Taylor Maxwell
stained hardwood timber cladding

balconies to be metal frame/
handrail detail with glazed guarding
supported on timber post sections

roof -
natural slate finish/cambrian grey ridges
joinery (fascia,etc.) -
grey upvc

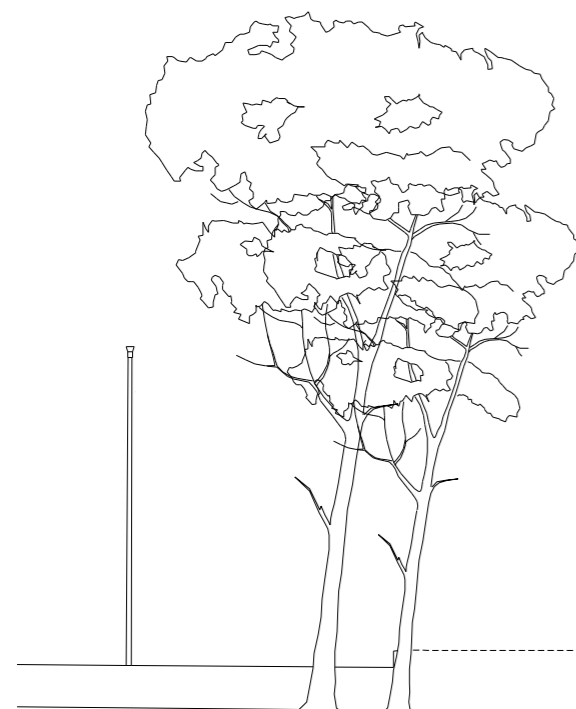
PROPOSED REAR ELEVATION B (FACING SEA)

REV B: LEVELS DROPPED ON WEST SIDE BOUNDARY APRIL 2016
REV A: REAR ELEV EX BUILDING OUTLINE CORRECTED MARCH 2016

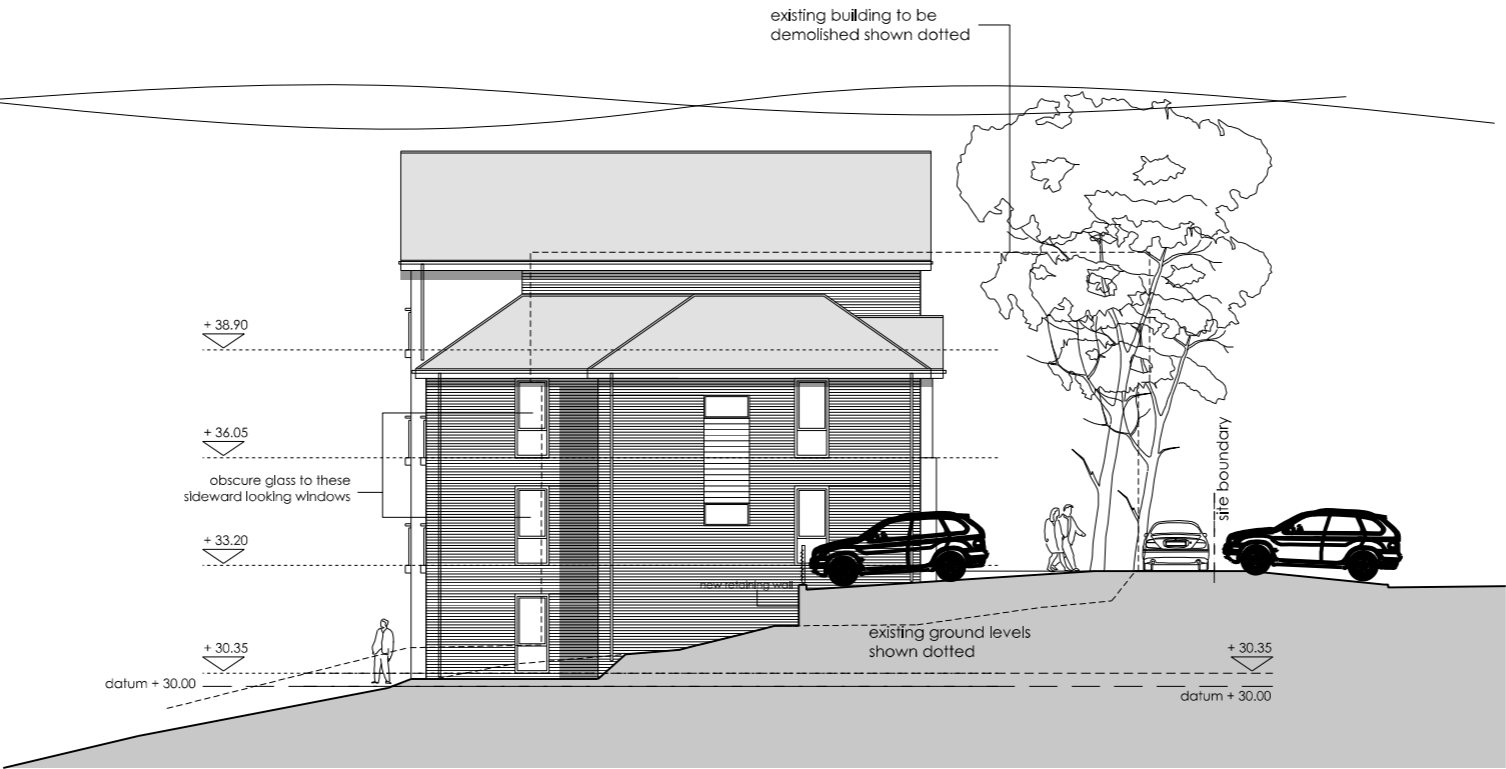
PROPOSED SIDE ELEVATION C (FACING HOUSES)

balconies to be metal frame/
handrail detail with glazed guarding
supported on timber post sections

roof -
natural slate finish/cambrian grey ridges
joinery (fascia,etc.) -
grey upvc
