# Penrhyn Castle Renewable Heating Scheme

## Archaeological Watching Brief

Prosiect Rhif / Project No. G2447

Adroddiad Rhif / Report No. 1341

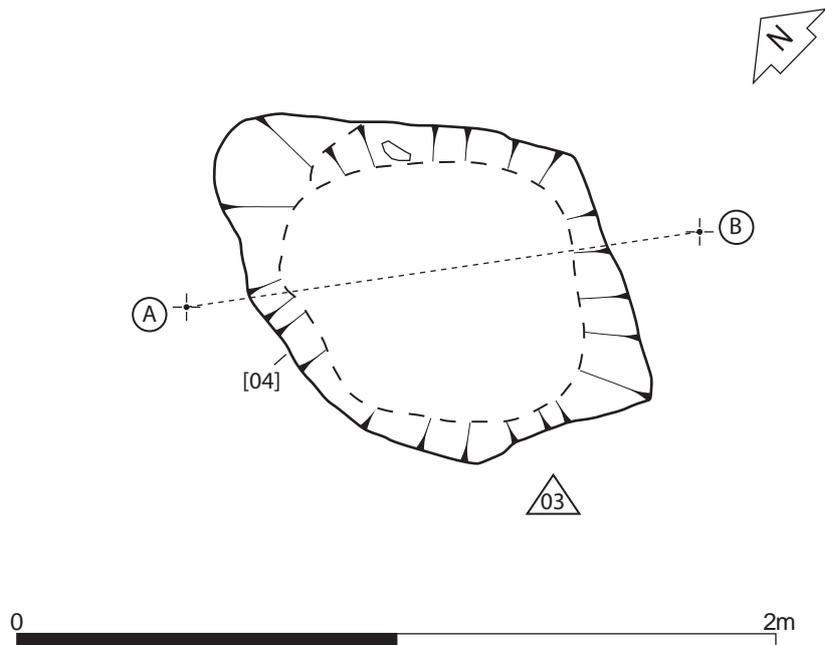
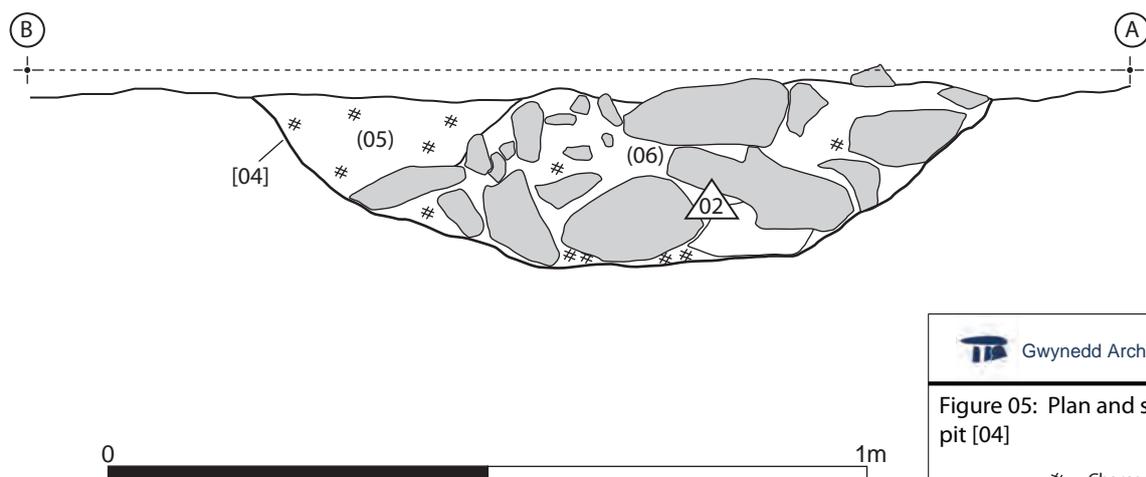
Figure 05: Plan and section through pit [04]

The cut of the possible pit [04] was sub oval, 1.2m by 1m and 0.27m deep, and orientated north-south. The pit contained fire cracked stones within a charcoal rich sandy silt (05) within which a small fragment of worked flint was located (Small Find 02). This deposit was 0.7m long, 0.42m wide and 0.16m deep within the pit. The deposit sealed a dark greyish brown silty clay with small to large rounded cobbles and sub angular stones, as well as about 2% charcoal (06). A possible flint tool (Small Find 03) was found on the south edge of the pit although this was not clearly within a stratified context. It can be suggested that the burnt material was placed in the pit rather than burnt *in situ* as there does not appear to be evidence of burning in the vicinity.

Plan of pit [04]  
Scale 1:20@A4

NE facing section through pit [04]  
Scale 1:10@A4

The pit is similar in character to pits have been found in the excavation carried out at Parc Bryn Cegin nearby and morphologically appears to be a prehistoric feature. The results from further assessment of the ecofacts and artefacts recovered from the pit may help with dating the feature.

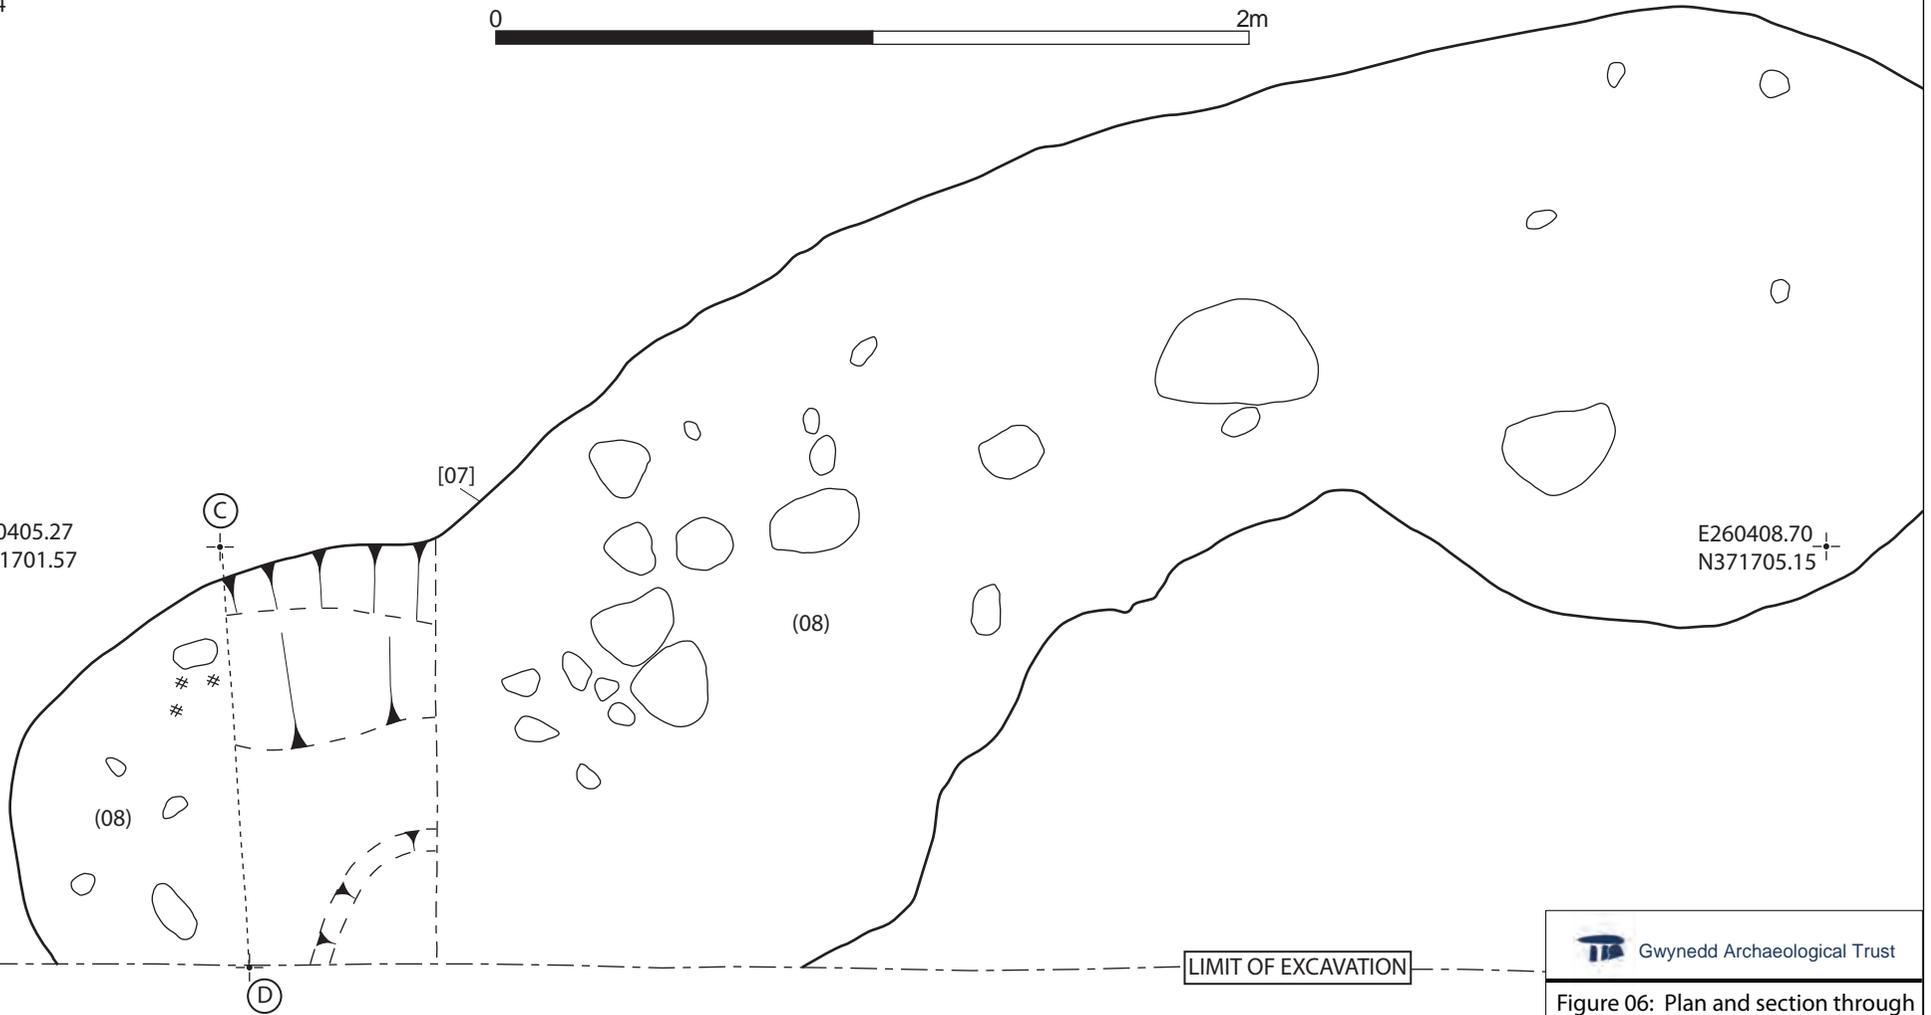
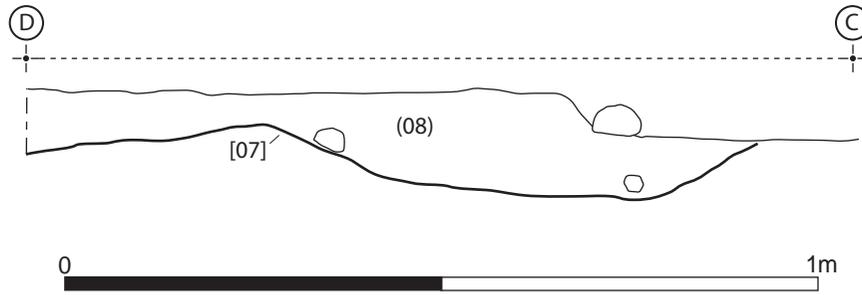
SE facing section through cut feature [07]

The feature measured 5.4m long, 1.6m wide and 0.13m deep [07] and contained a single fill of mid greyish brown sandy silt with clusters of rounded cobbles and occasional charcoal flecks (08). The shallow irregular nature of this feature suggested it may be caused by bioturbation.

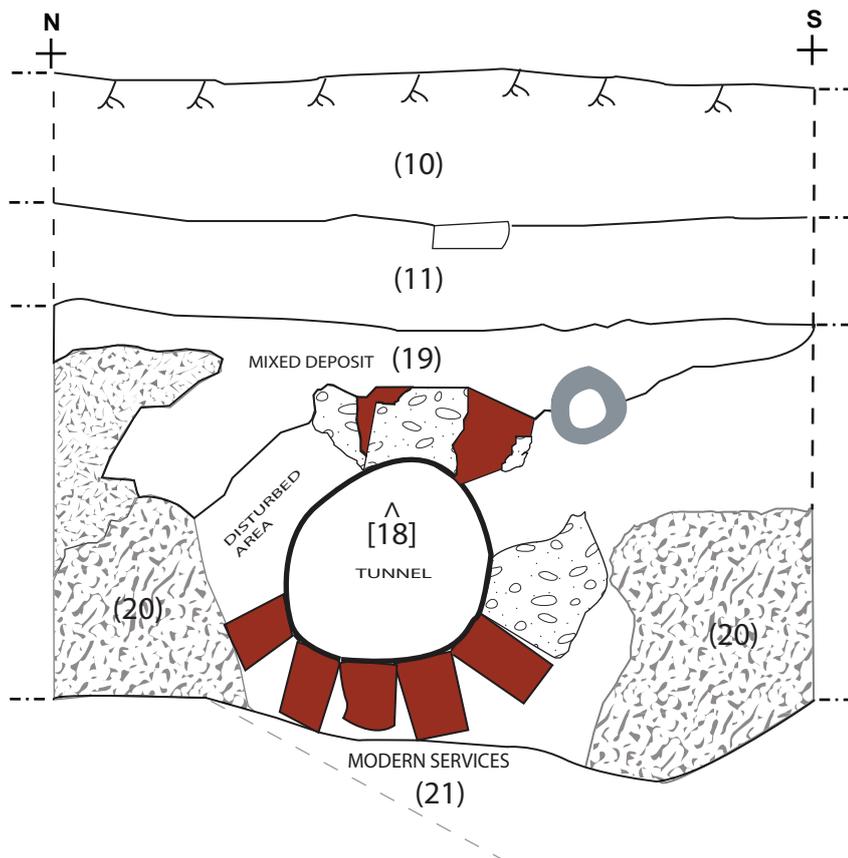
Figure 07: Elevation section drawing of 19th Century lead pipe and brick service tunnel [18]

The tunnel measured 0.36m in diameter and sloped towards the southwest and was cut into dense shale/bedrock (20) and was constructed of gauged/ribbed red brick (Haslam, Orbach & Voelcker. 2009: 178), bonded with lime mortar (Small Find 14). The tunnel was not infilled and was void of silt, suggesting that it may have been in recent use. The appearance of excess mortar within the tunnel interior, suggest that may have been repaired at some point (see Plate 14). Lying directly to the south of the tunnel was a lead pipe with a diameter of 0.07m (see Plate 12 to 14). Both the brick tunnel and lead pipe appear to lead directly into the basement of the castle's keep.

A small inspection of the keep basement was attempted to establish the terminus of the tunnel. In the southwest part of the basement a patch of mortar on the wall with a length and width of c.0.34m was noted along the west wall, with lead pipes similar to that in the heat main trench was identified (Plate 15). It is a possibility that this may have been the terminus of the tunnel. Blocked opening relating to other similar tunnels were also identified within the basement along the western wall. The tunnel was likely a 19<sup>th</sup> century drainage feature associated with the current castle.

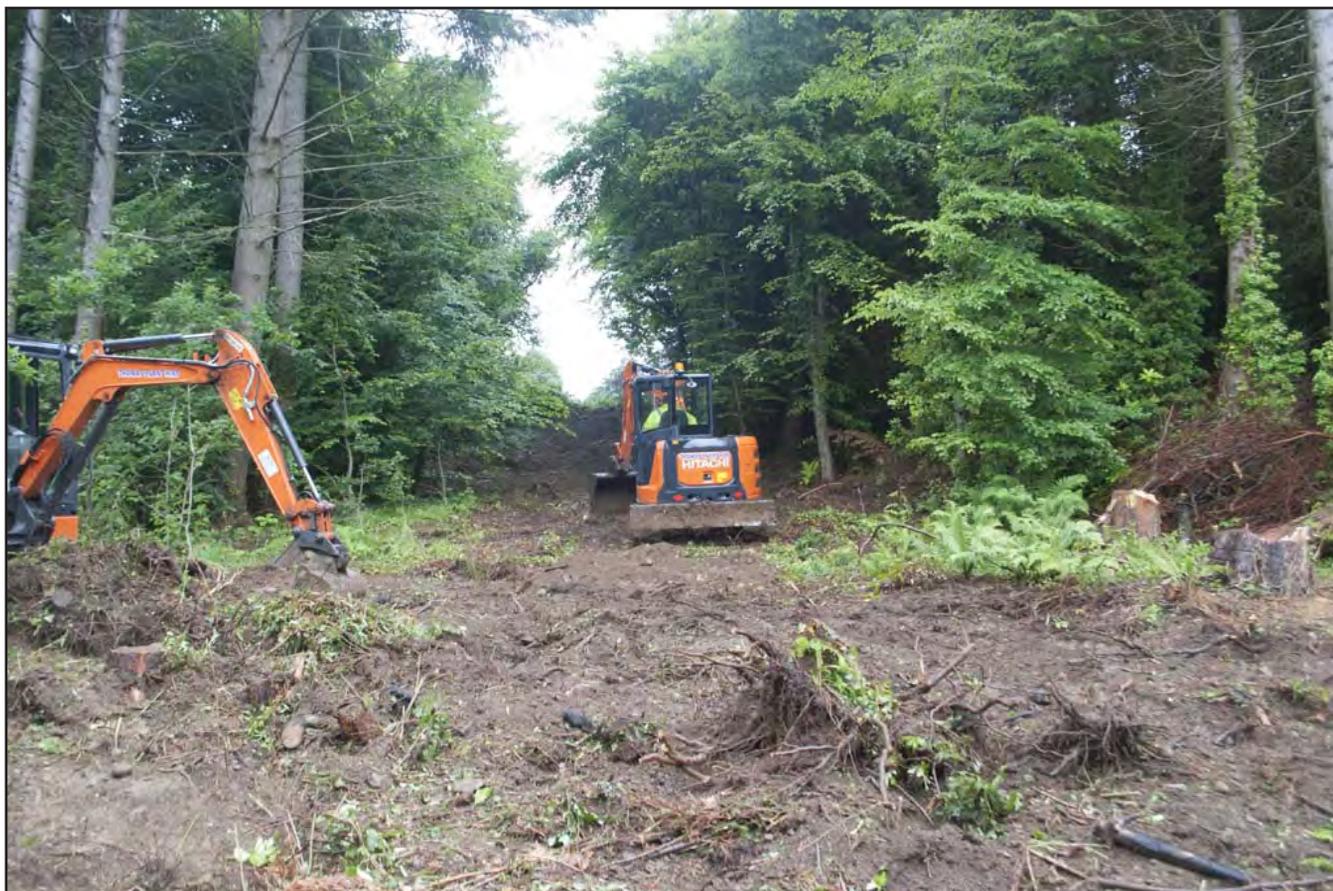
Plate 01: Energy Centre Building: General view of undergrowth removal at the Energy Centre site. View from the west south west (archive image: G2447\_064)

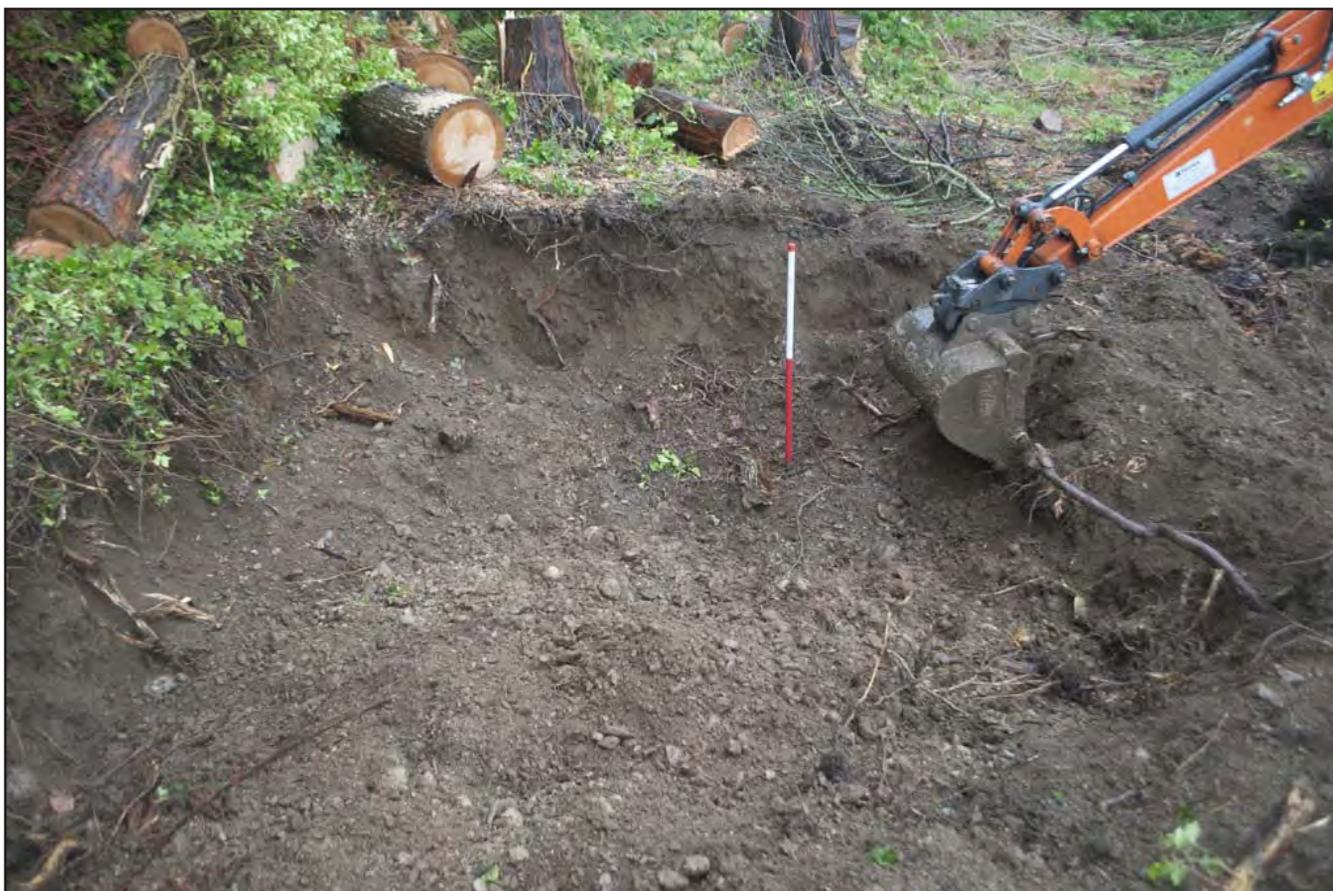
Plate 02: Energy Centre Building: Topsoil stripping at Energy Centre site, viewed from the east; scale 1m (archive image: G2447\_066)

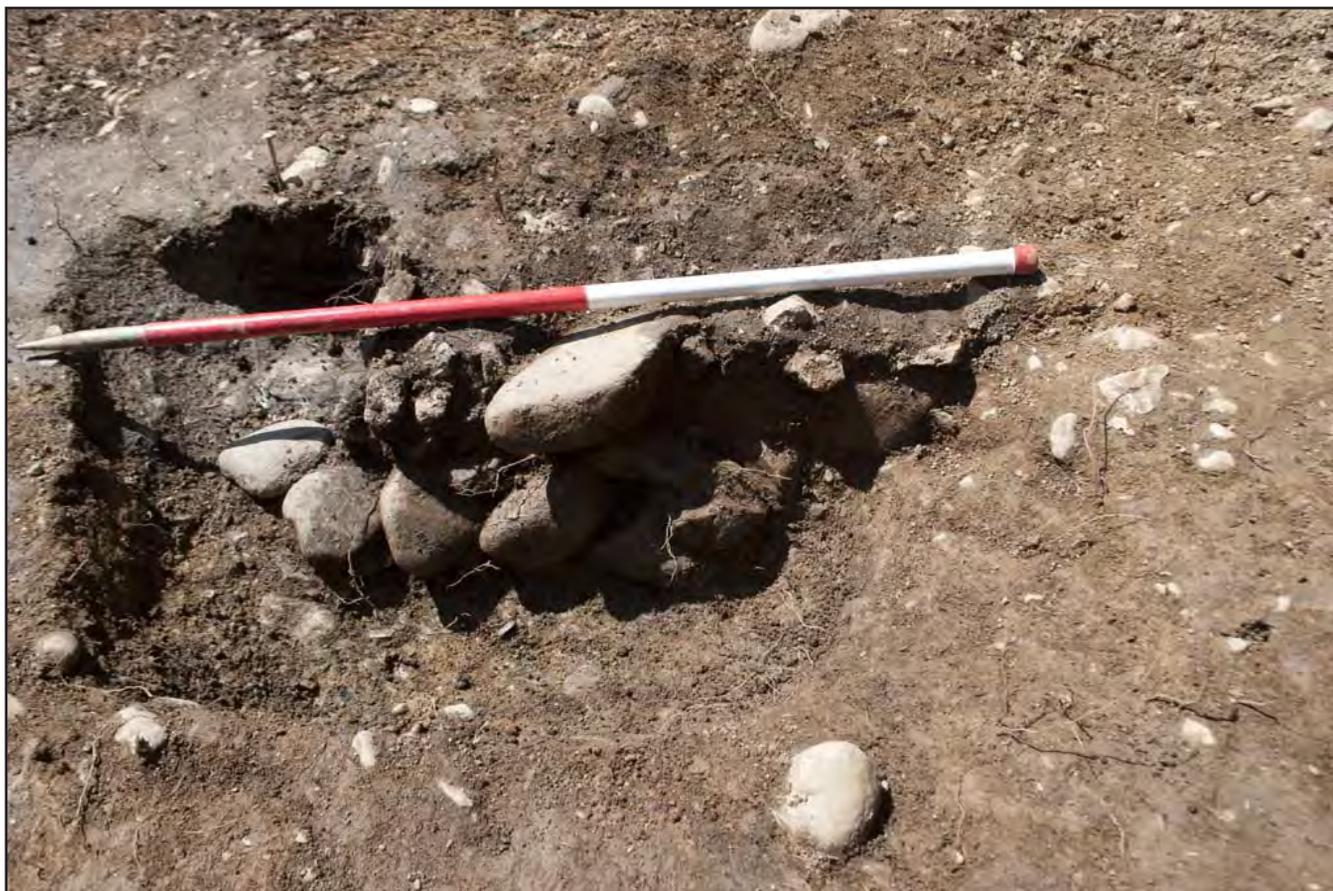
Plate 03: Energy Centre Building: South-west facing section through (05) and (06) in possible prehistoric pit feature [04]; scale 1m (archive image: G2447\_088)

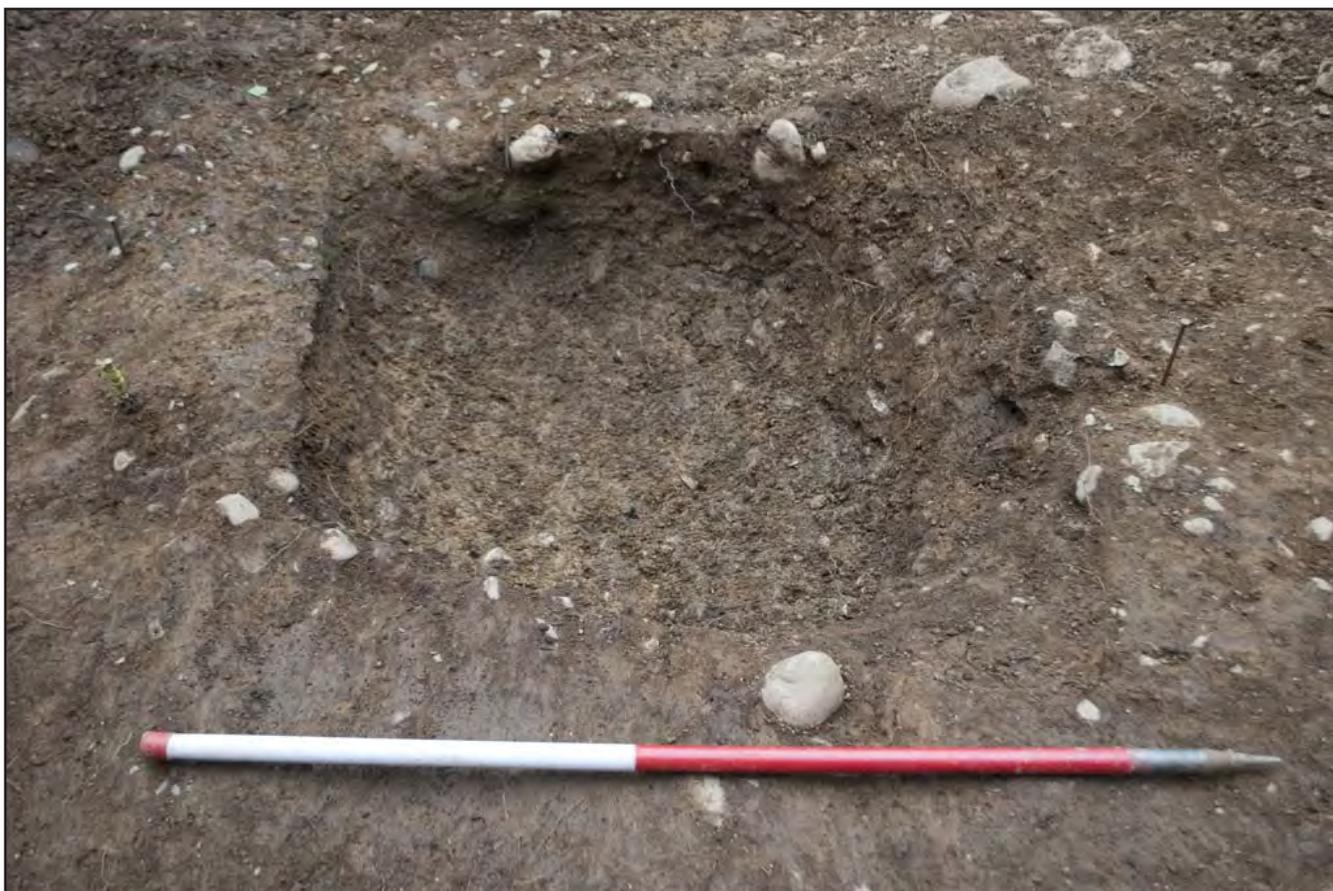
Plate 04: Energy Centre Building: Post-excitation view of pit [04], viewed from the north-east; scale 1m (archive image: G2447\_092)

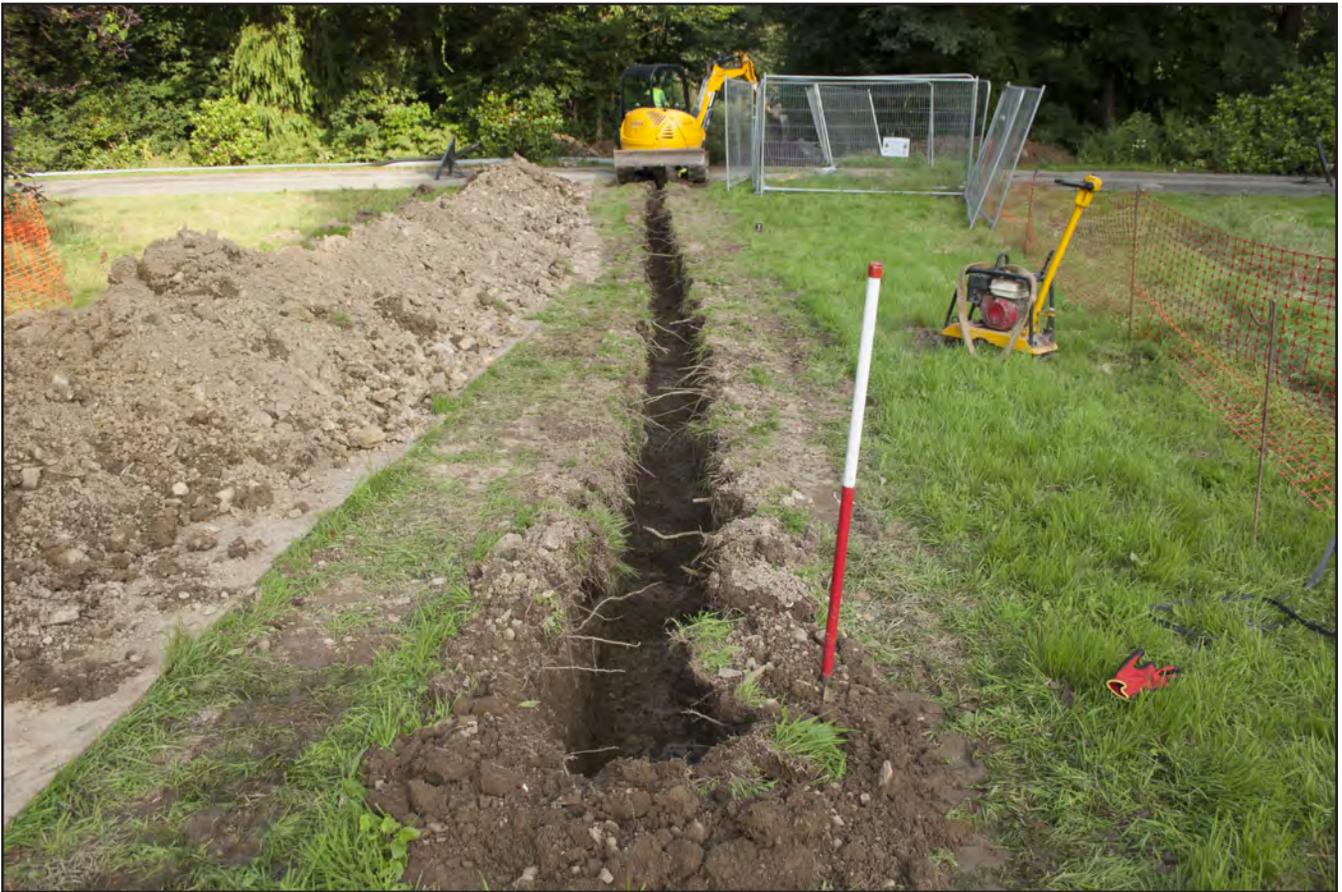
Plate 05: Pipeline 1: end of day shot showing area where ground was cut from woodlands across tarmac; scale: 1m (archive image: G2447\_111)

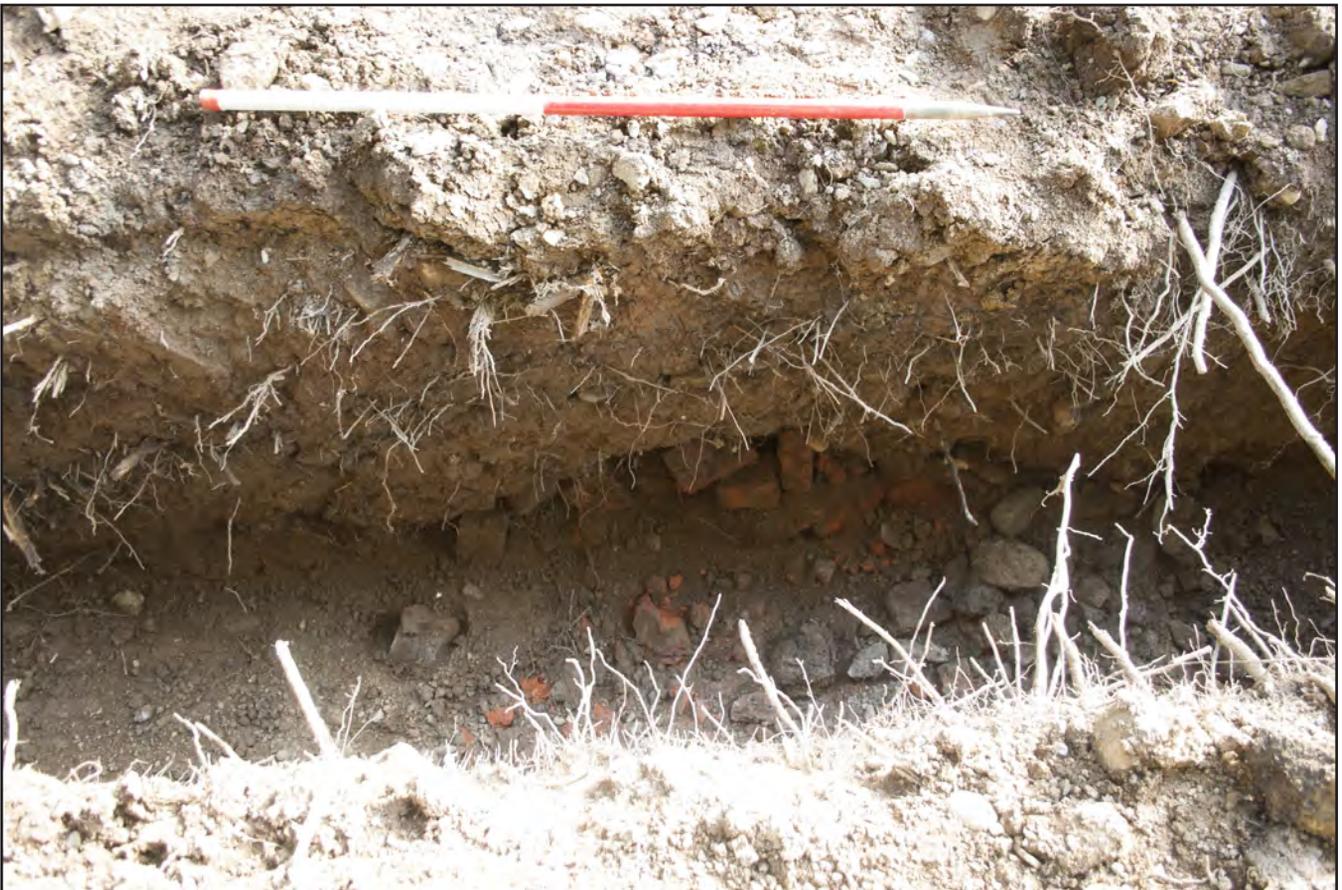
Plate 06: Pipeline 1: Pipe line bricks in section. Possible small enclosure wall of feature 6 in Evaluation. 1m scale (archive image: G2447\_108)

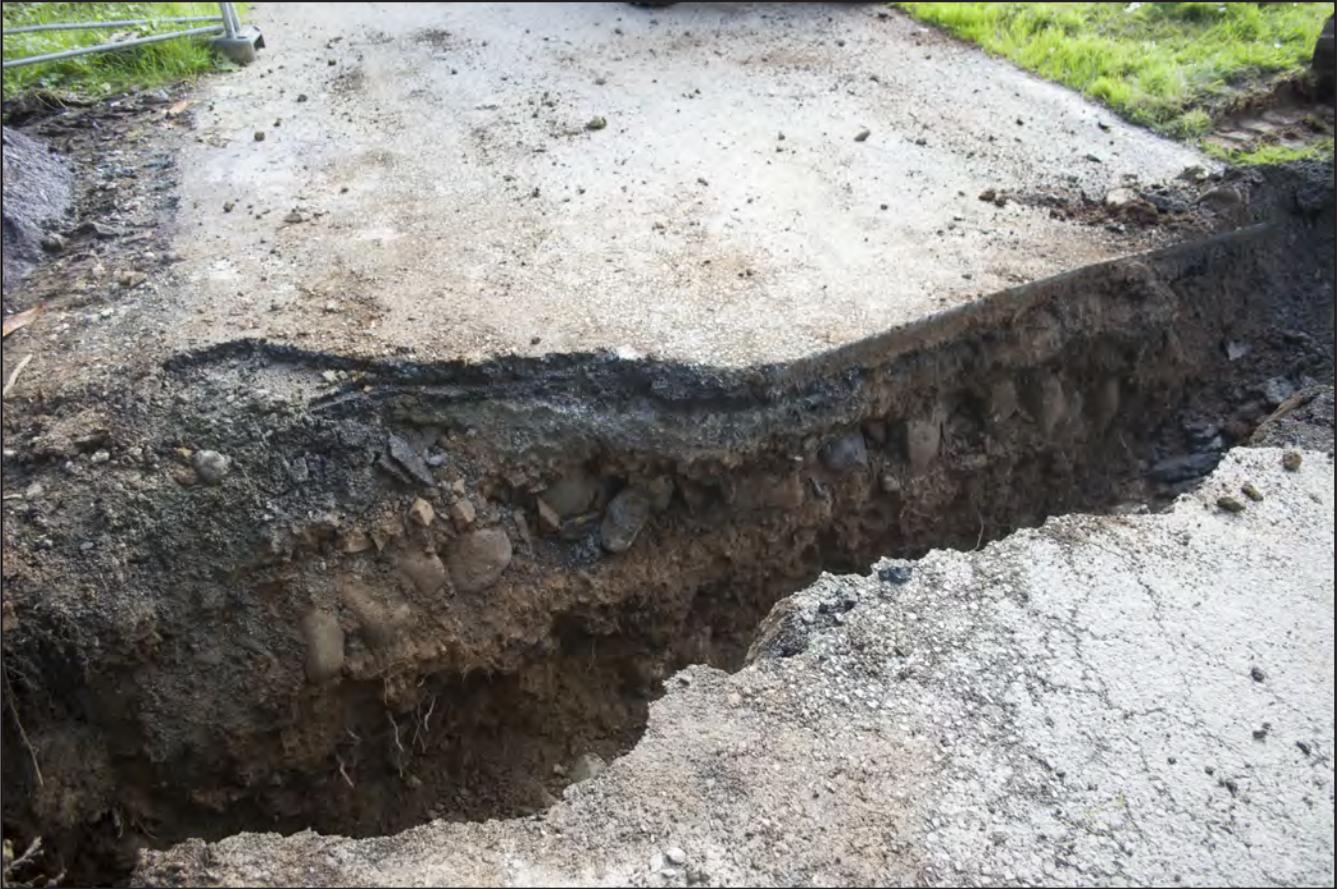
Plate 07: Pipeline 1: Shot of tarmac road showing cobbles in N facing trench section  
(archive image: G2447\_110)

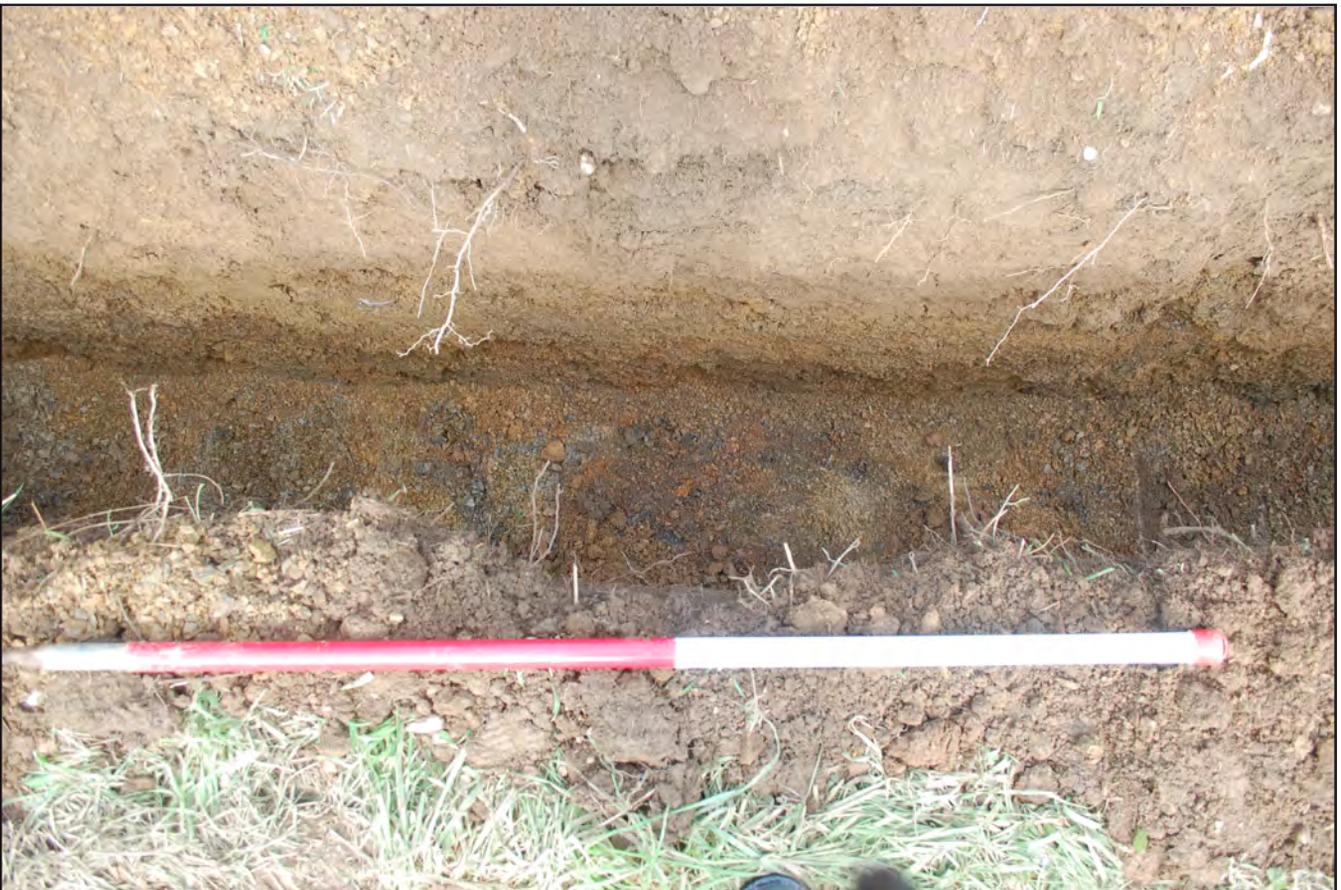
The path was sealed by subsoil (11) and a thin shale deposit (15). Beneath the path were patches of rust (14), c.0.5m in size, which stained the glacial horizon at base of heat main trench, along heavily degraded/non-diagnostic metal item (Plate 08). A small 18<sup>th</sup>/19<sup>th</sup> century white ceramic base sherd (Small Find 10) was recovered atop the path. This path may correspond with Feature 07/PRN 613233 identified in assessment stage (Evans, 2015), identified as a possible field boundary on an 1803 estate map (Figure 02), but as a footpath on the 1890 Caernarvonshire County Series first edition Ordnance survey (Figure 03). This may suggest, that footpath may have succeeded the boundary along this alignment; the degraded metal could be remnants of boundary material.

Plate 08: Pipeline 1: Shot of Iron rust staining below slate chips, where find no. 10 and 11 were recovered; scale 1m  
(archive image: G2447\_120)

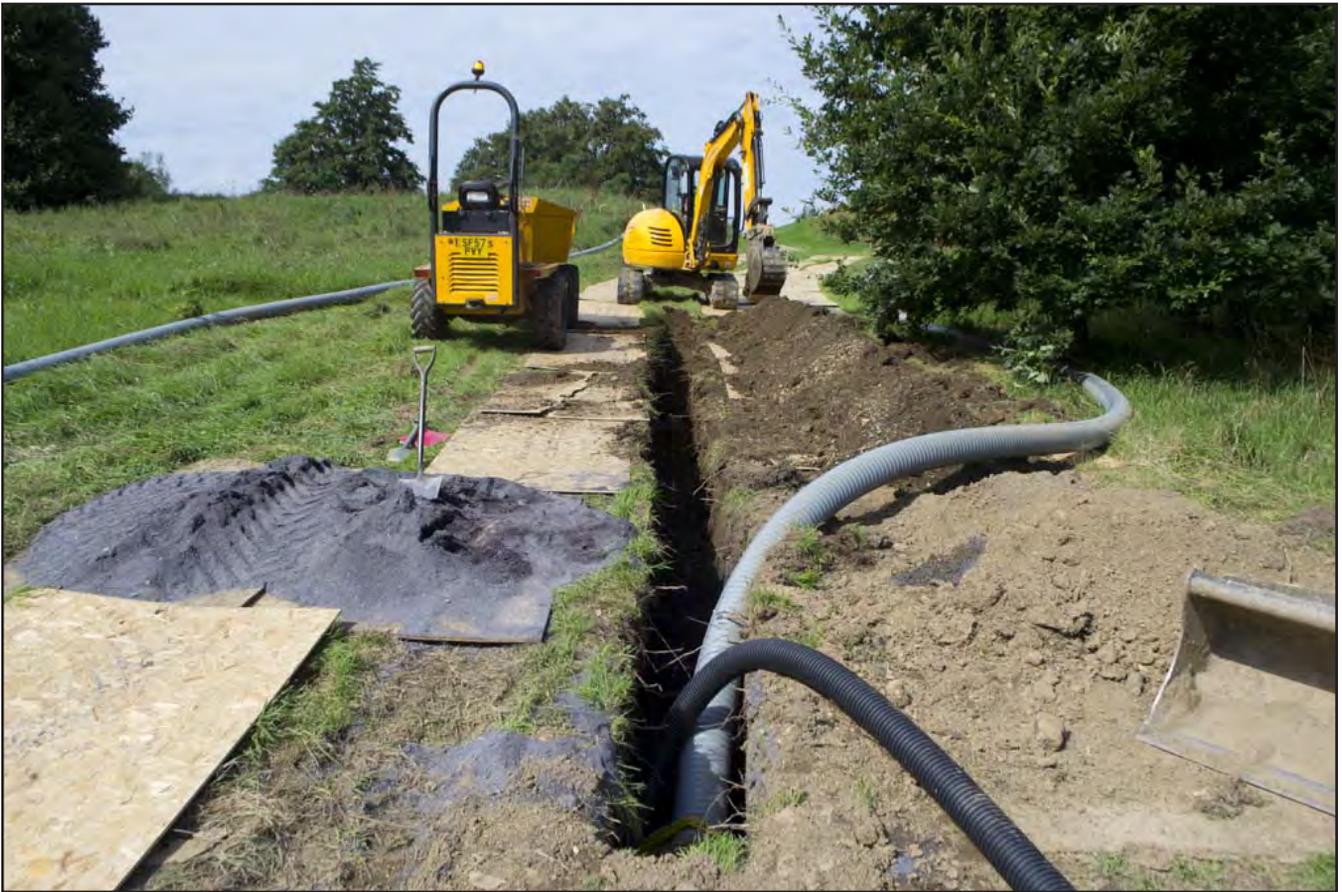
Plate 09: Pipeline 1: Shot along trench during excavation of pipe trench showing previously backfilled area near woodlands (archive image: G2447\_123)

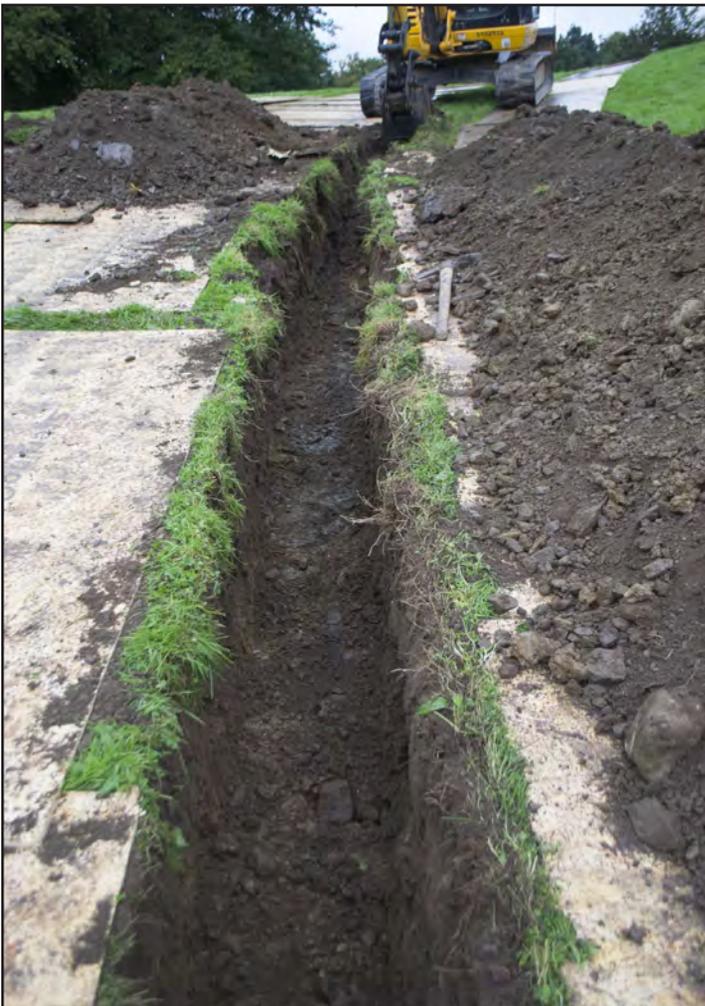
Plate 10: Pipeline 1: Portrait shot showing traces of modern service pipe along with 19th century debris and shale deposit (archive image: G2447\_130)

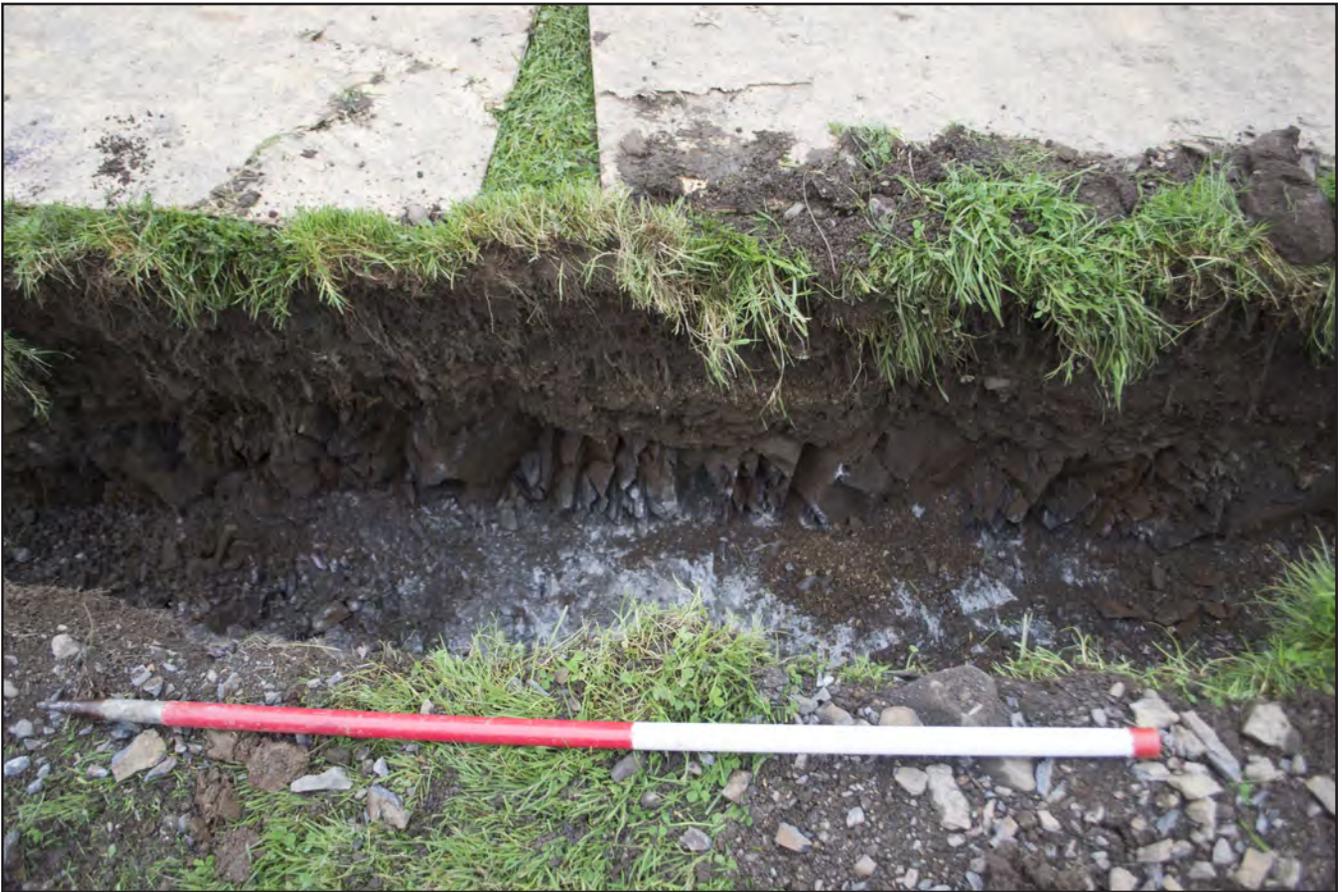
The feature consisted of a 0.16m thick deposit of broken and complete marine shells (16), atop the glacial bedrock (17). The deposit was sealed by the topsoil at a depth of 0.26m and was extant for a length of 1.1m within the heat main trench (Plate 11).

Plate 11: Pipeline 1: Deposit of marine shells (16) in NE facing corner of pipeline 1 trench edge, lying above bedrock (17); scale 1m (archive image: G2447\_131)

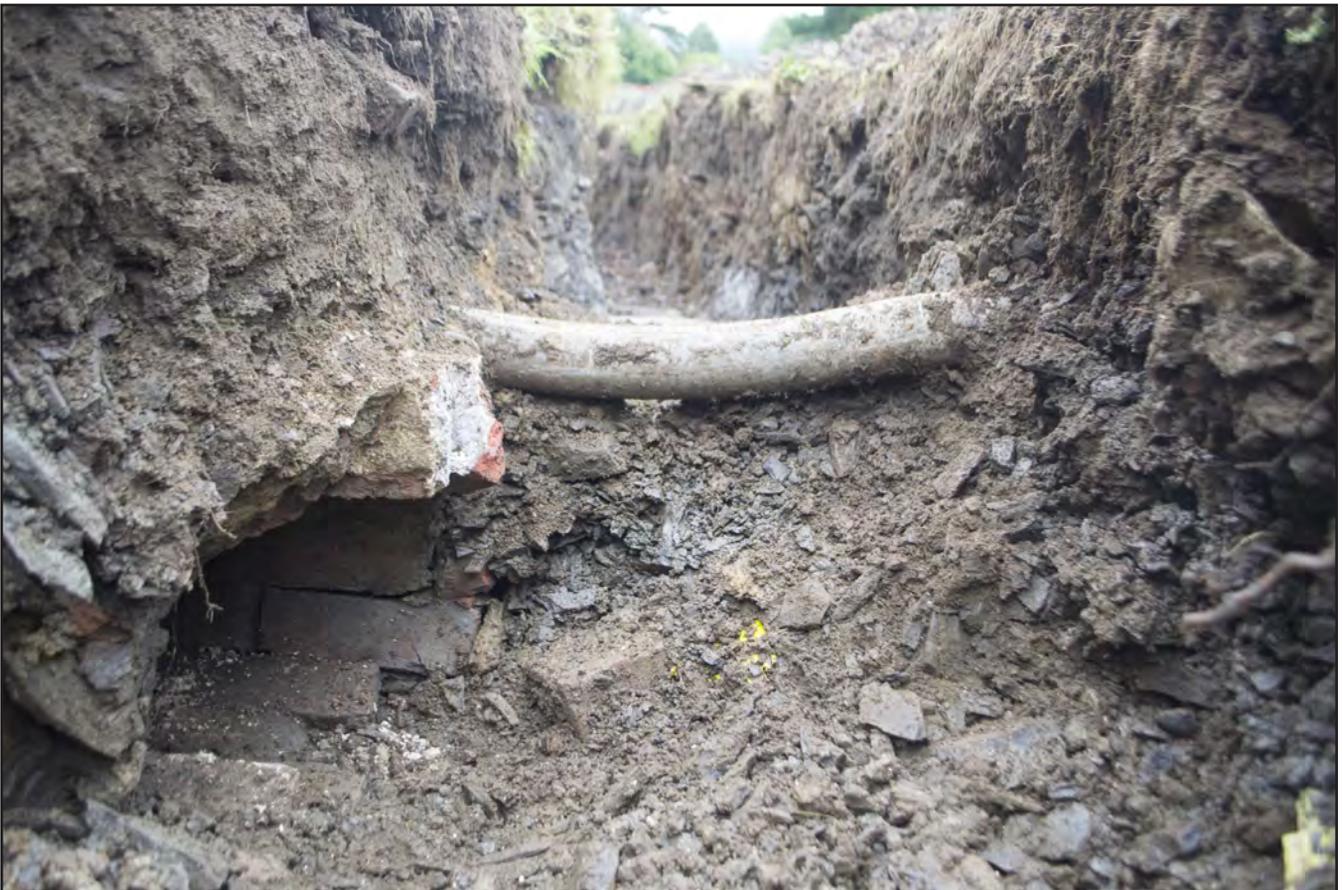
Plate 12: Pipeline 1: Lead pipe and brick tunnel [18^] from within Pipeline 1 as it first appeared at SH 60238 71203 (archive image: G2447\_133)

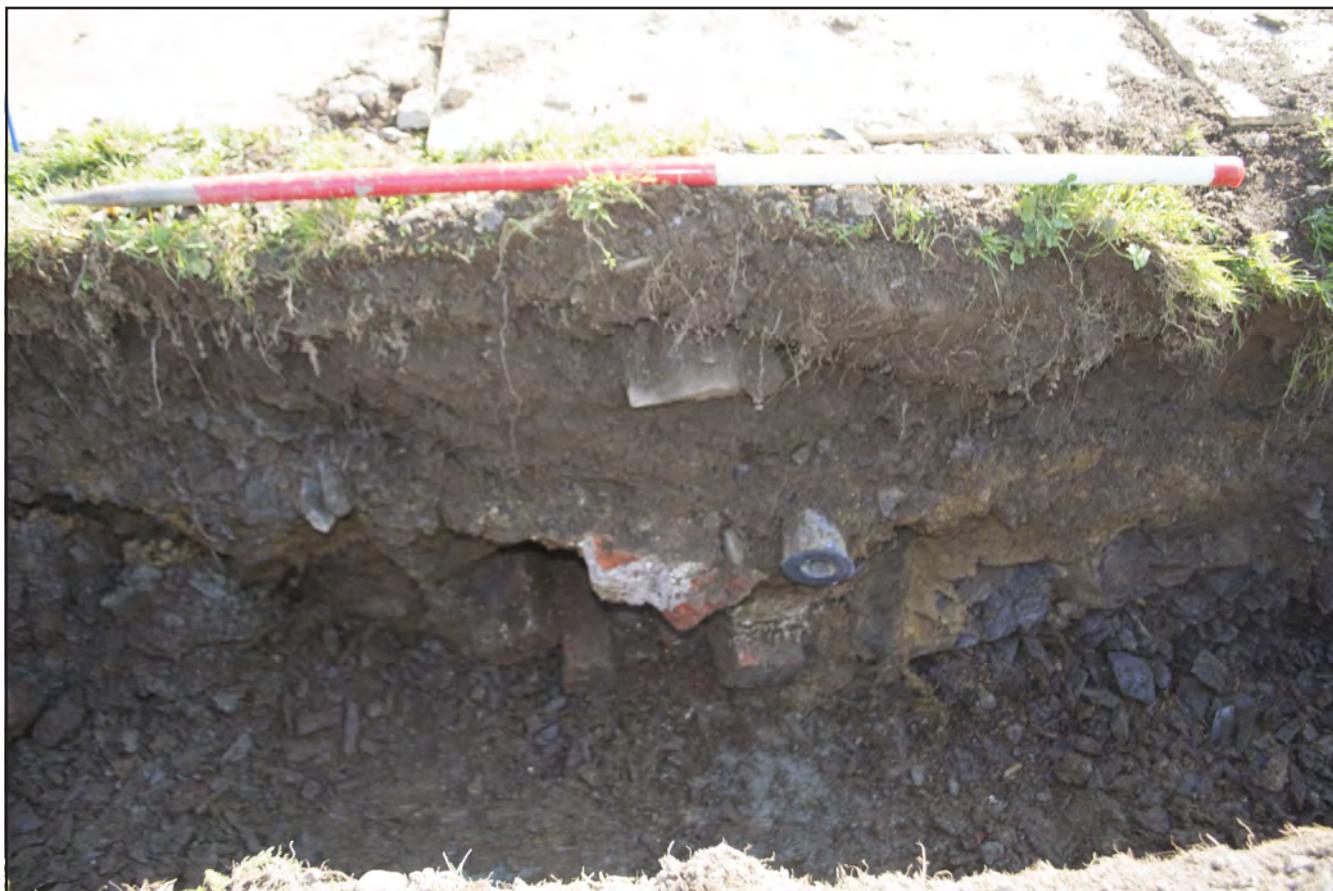
Plate 13: Pipeline 1: Shot of E edge of trench better displaying [18^] tunnel, along with sawn lead pipe; scale 1m  
(archive image: G2447\_ 138)

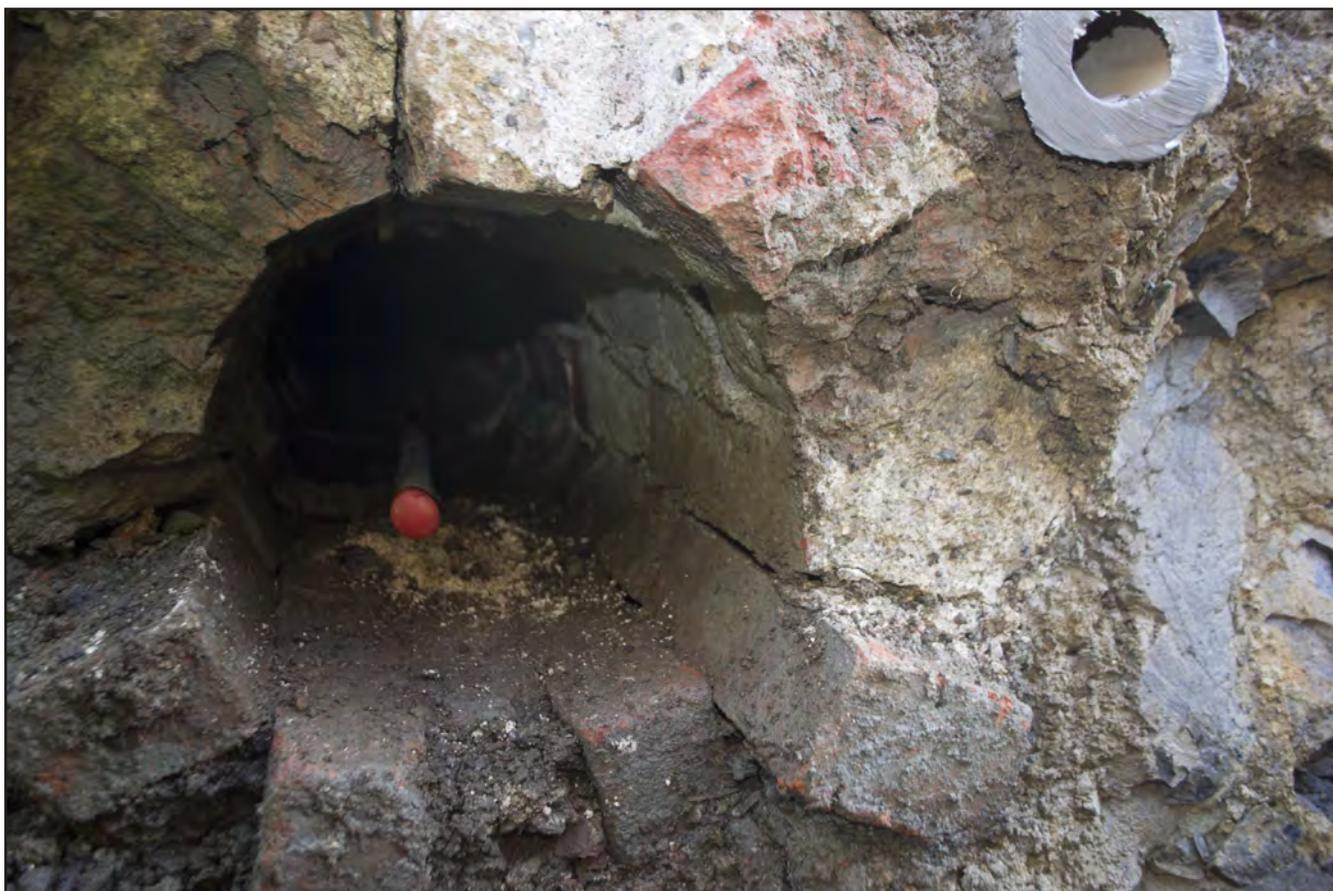
Plate 14: Pipeline 1: Close-up view of E edge of trench better displaying [18^] tunnel, along with sawn lead pipe; scale 1m  
(archive image: G2447\_ 138)

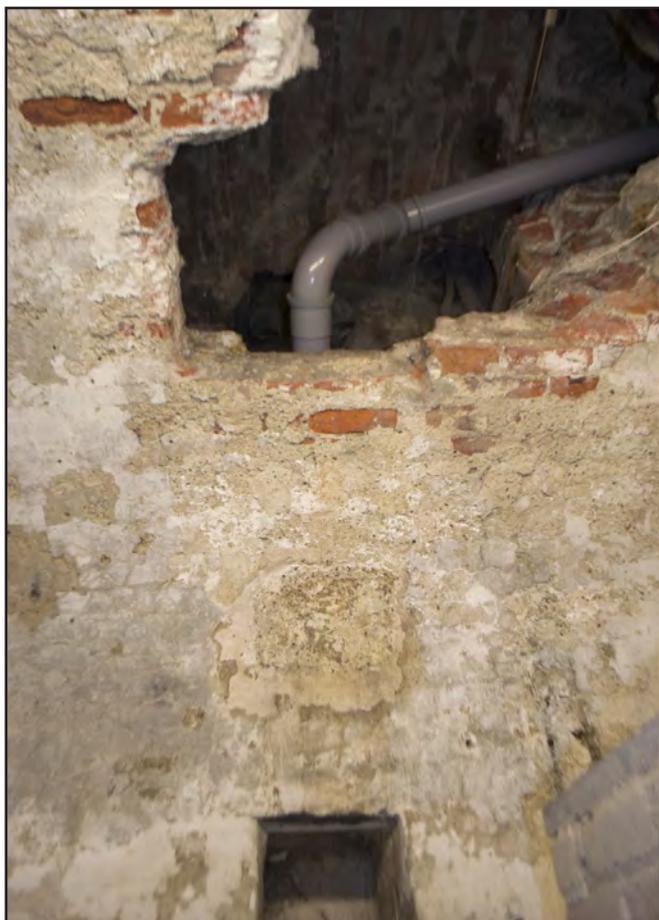
Plate 15: Pipeline 1: Portrait shot of c.30cm x 30cm mortared area - likely to have been [18^] tunnel terminal, along with appearance of lead pipes (archive image: G2447\_144)
