# Penrhyn Castle Renewable Heating Scheme

## Archaeological Watching Brief

Prosiect Rhif / Project No. G2447

Adroddiad Rhif / Report No. 1341

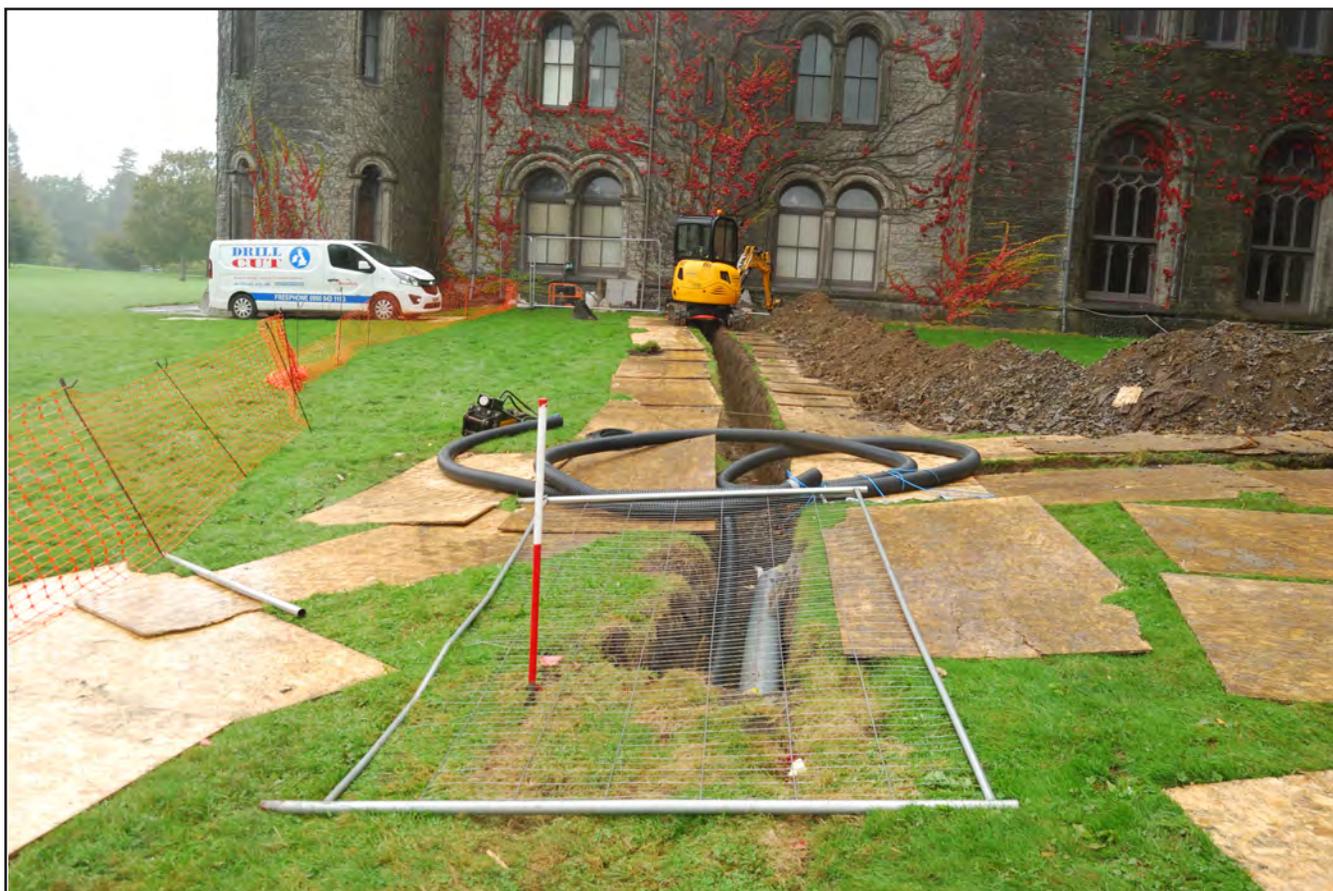
The heat main trench was composed predominantly of topsoil (10) reaching a depth of 0.35m that sealed the glacial horizon (Plates 16 and 17). The main included heavy disturbance from modern services near the castle wall.

Plate 16: Pipeline 3: View of entire length of excavated Pipe 3 trench; scale 1m (archive image: G2447\_167)

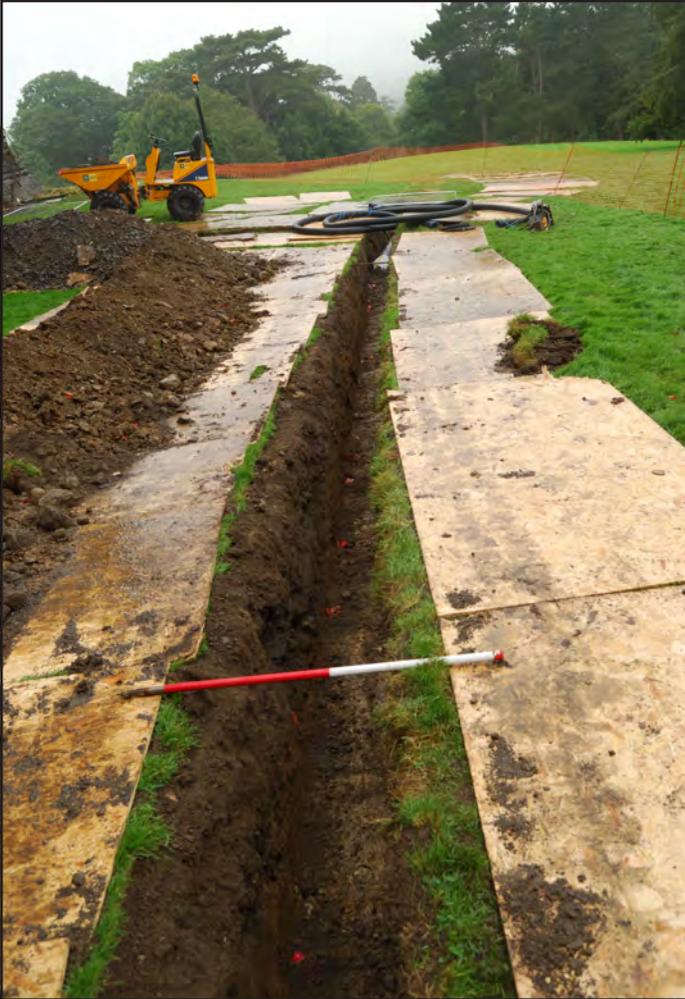
Plate 17: Pipeline 3: View of entire length of excavated Pipe 3 trench; scale 1m (archive image: G2447\_167)

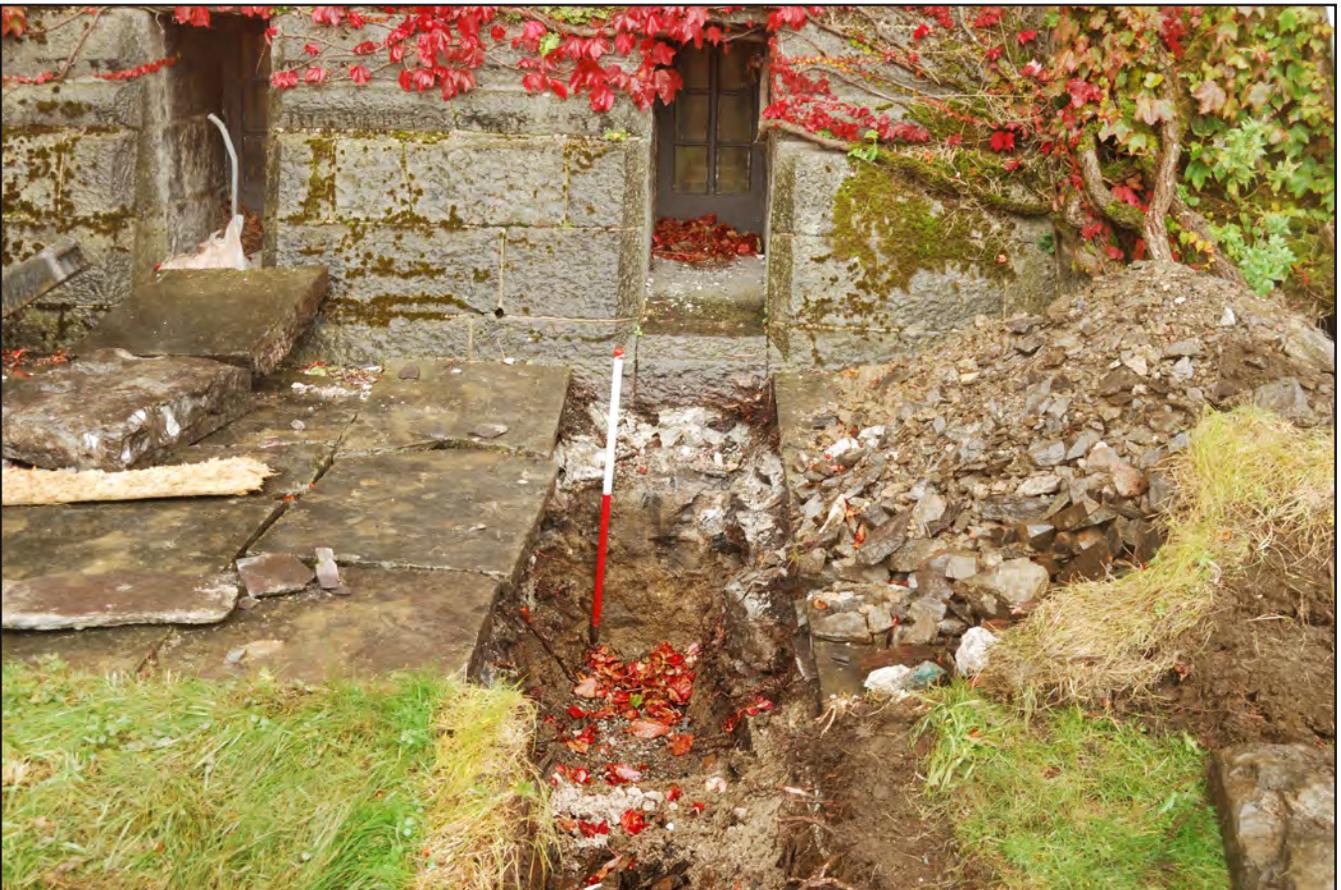
A 2.3m wide slate pavement (28), which ran alongside the keep wall, was uplifted to accommodate the trench (Plate 18). The pavement was built from machined rectangular slabs of blue grey slate, which that ranged from 0.65m x 0.55m to 1.25m x 0.95m in size, with a typical thickness of 0.15m pavement. The slabs sat above a foundation deposit of large angular stones and coarse lime mortar (29), c. 0.35m deep, which sealed the glacial horizon, a coarse light brown gravelly clay and bedrock.

Plate 18: Pipeline 2: Terminal of Pipe 2 trench, beside the tower; scale 1m (archive image: G2447\_163)

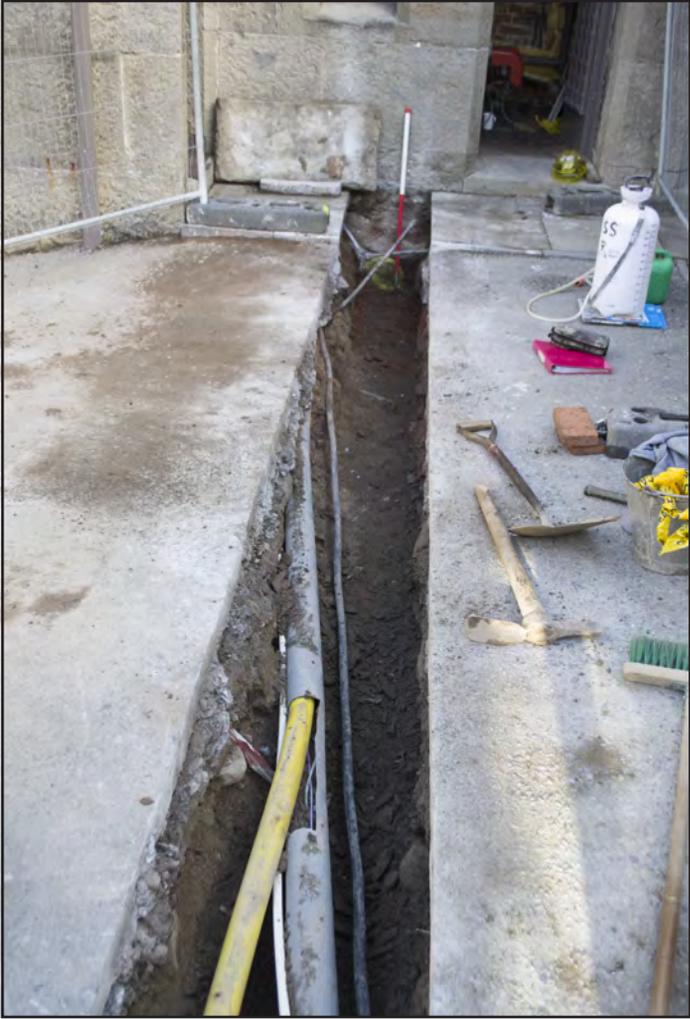
Plate 19: Pipeline 10: Shot of trench leading to N end of castle with damaged bricks and modern services; scale 1m (archive image: G2447\_160)

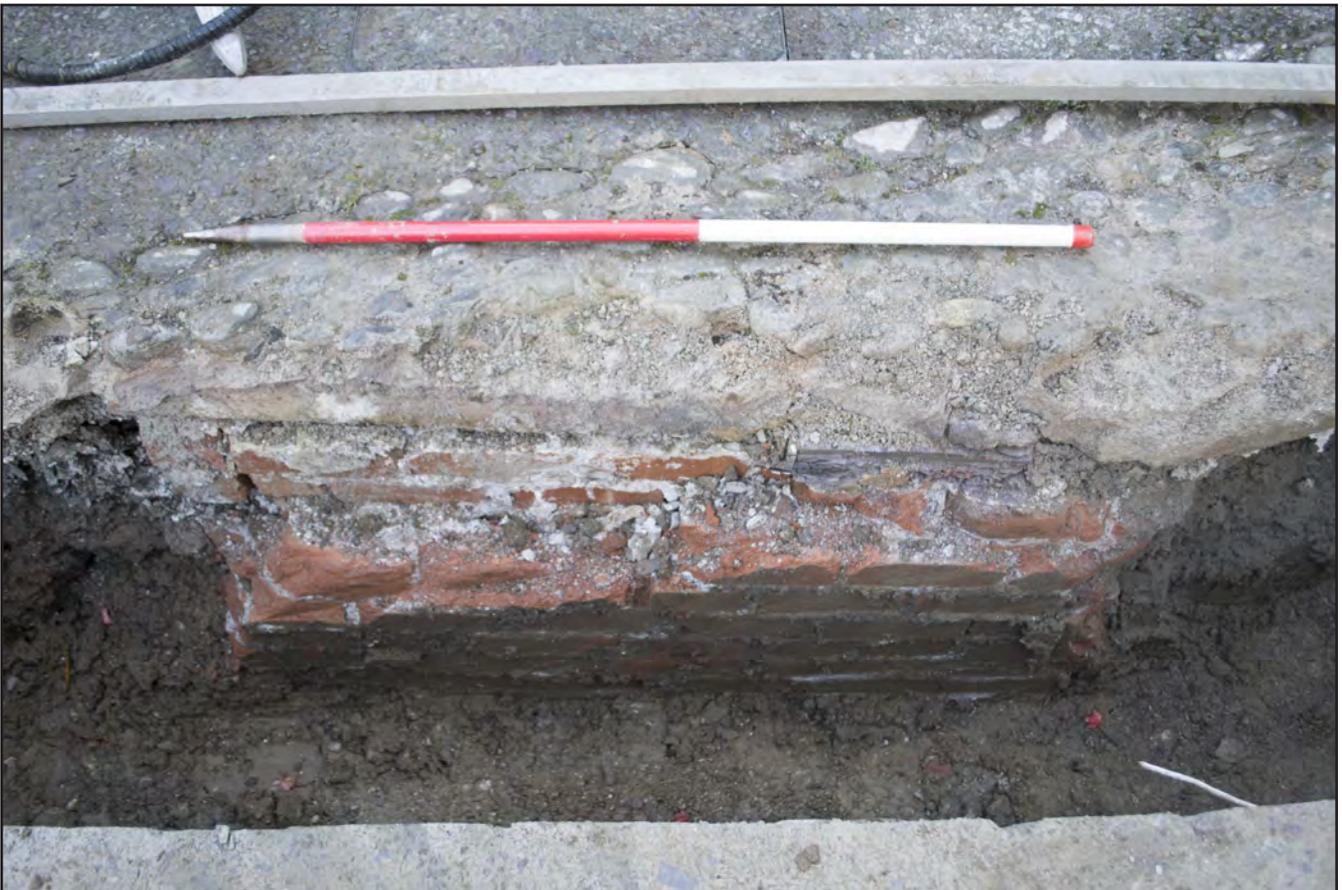
Plate 20: Pipeline 10: Small double-layered brick structure [22^] W facing edge of trench; scale 1m (archive image: G2447\_150)

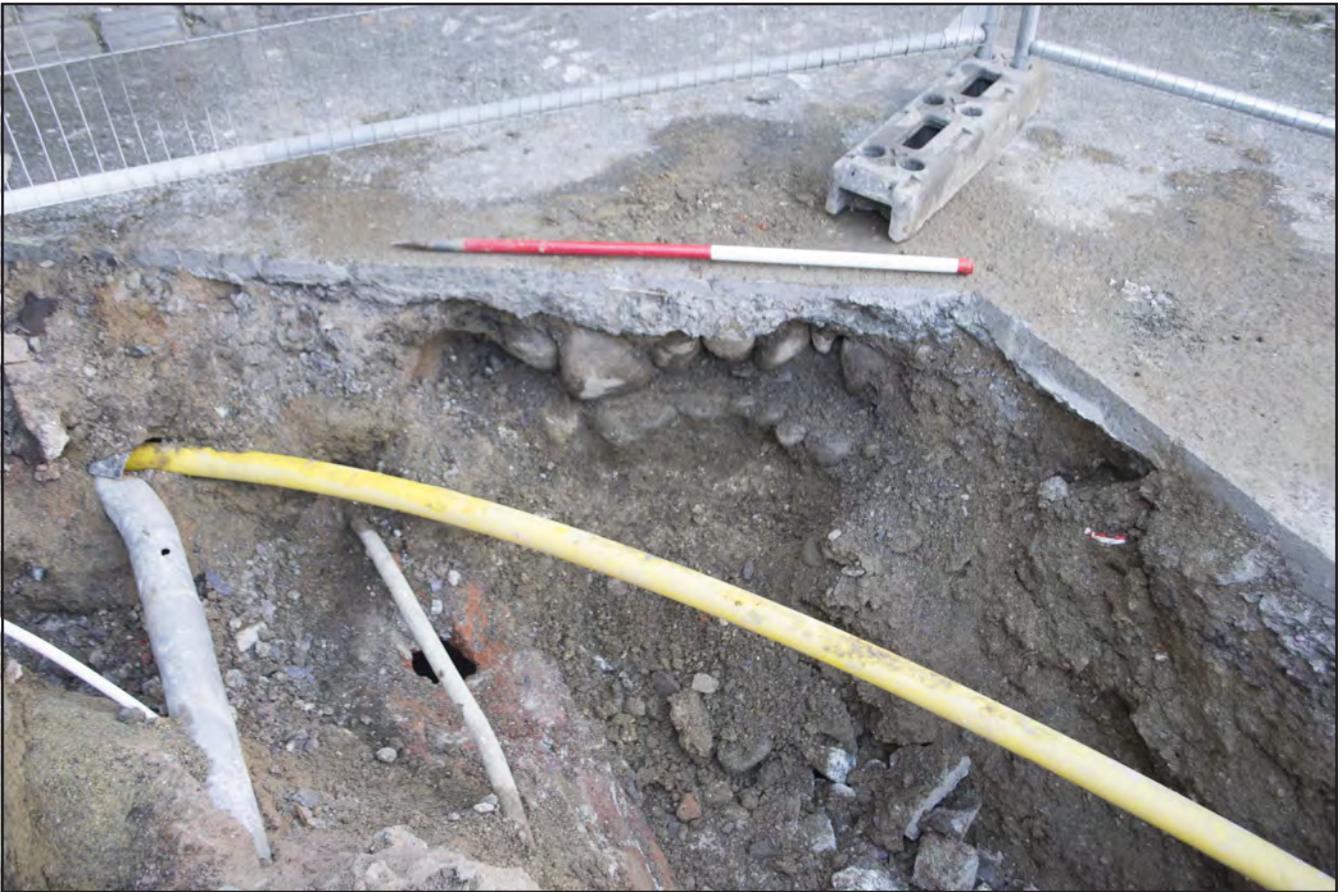
Plate 21: Pipeline 10: Brick service tunnel [23^] with cobbled surface in shot within S end corner of trench; scale 1m  
(archive image: G2447\_155)

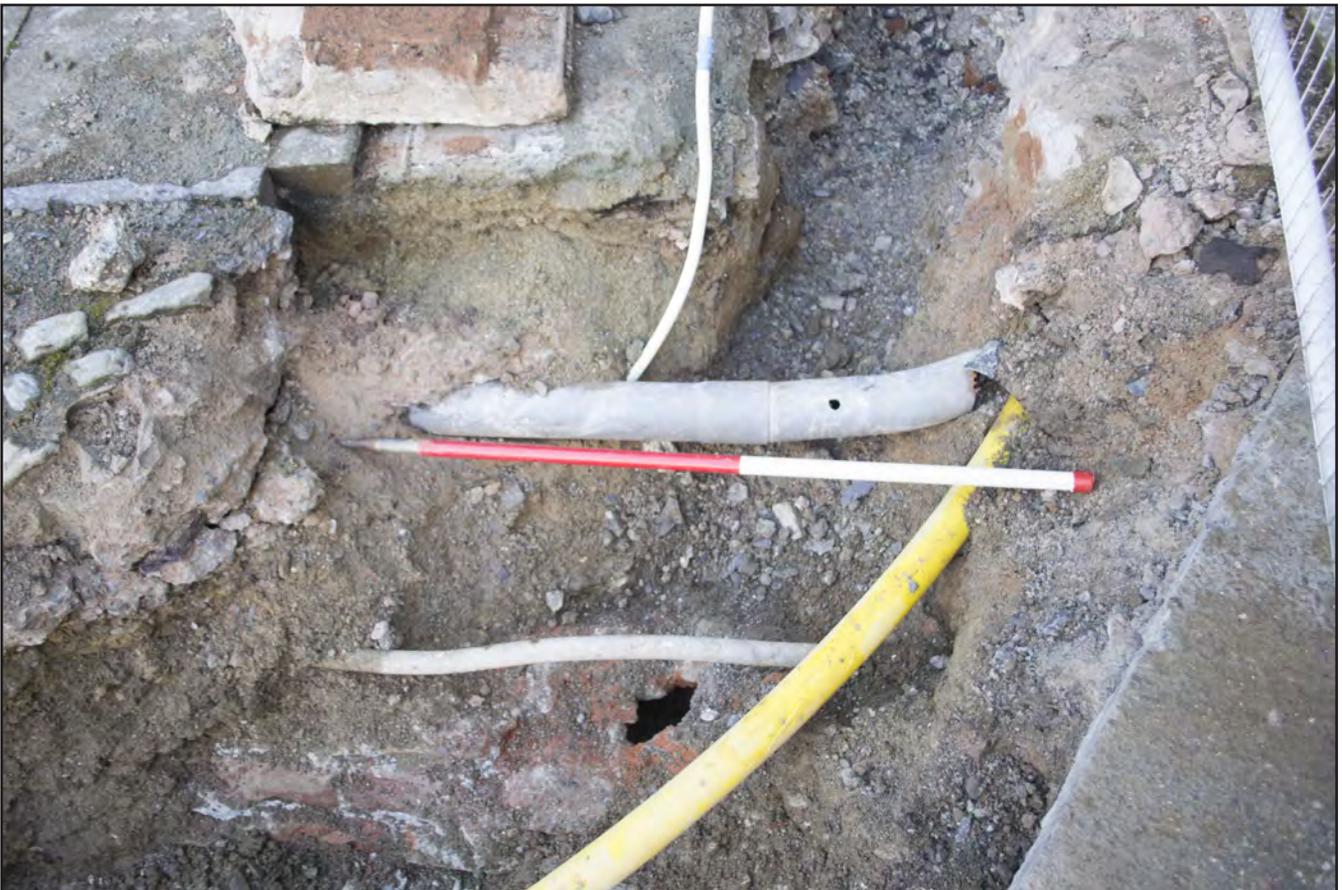
Plate 22: Pipeline 10: Brick service pipe [23^] with lead pipe modern service pipes; 1m scale  
(archive image: G2447\_153)
