# Quirt Farm, Dwyran

LEVEL 3 BUILDING RECORD &  
ARCHAEOLOGICAL WATCHING BRIEF

Project No. G2483

Report No. 1343

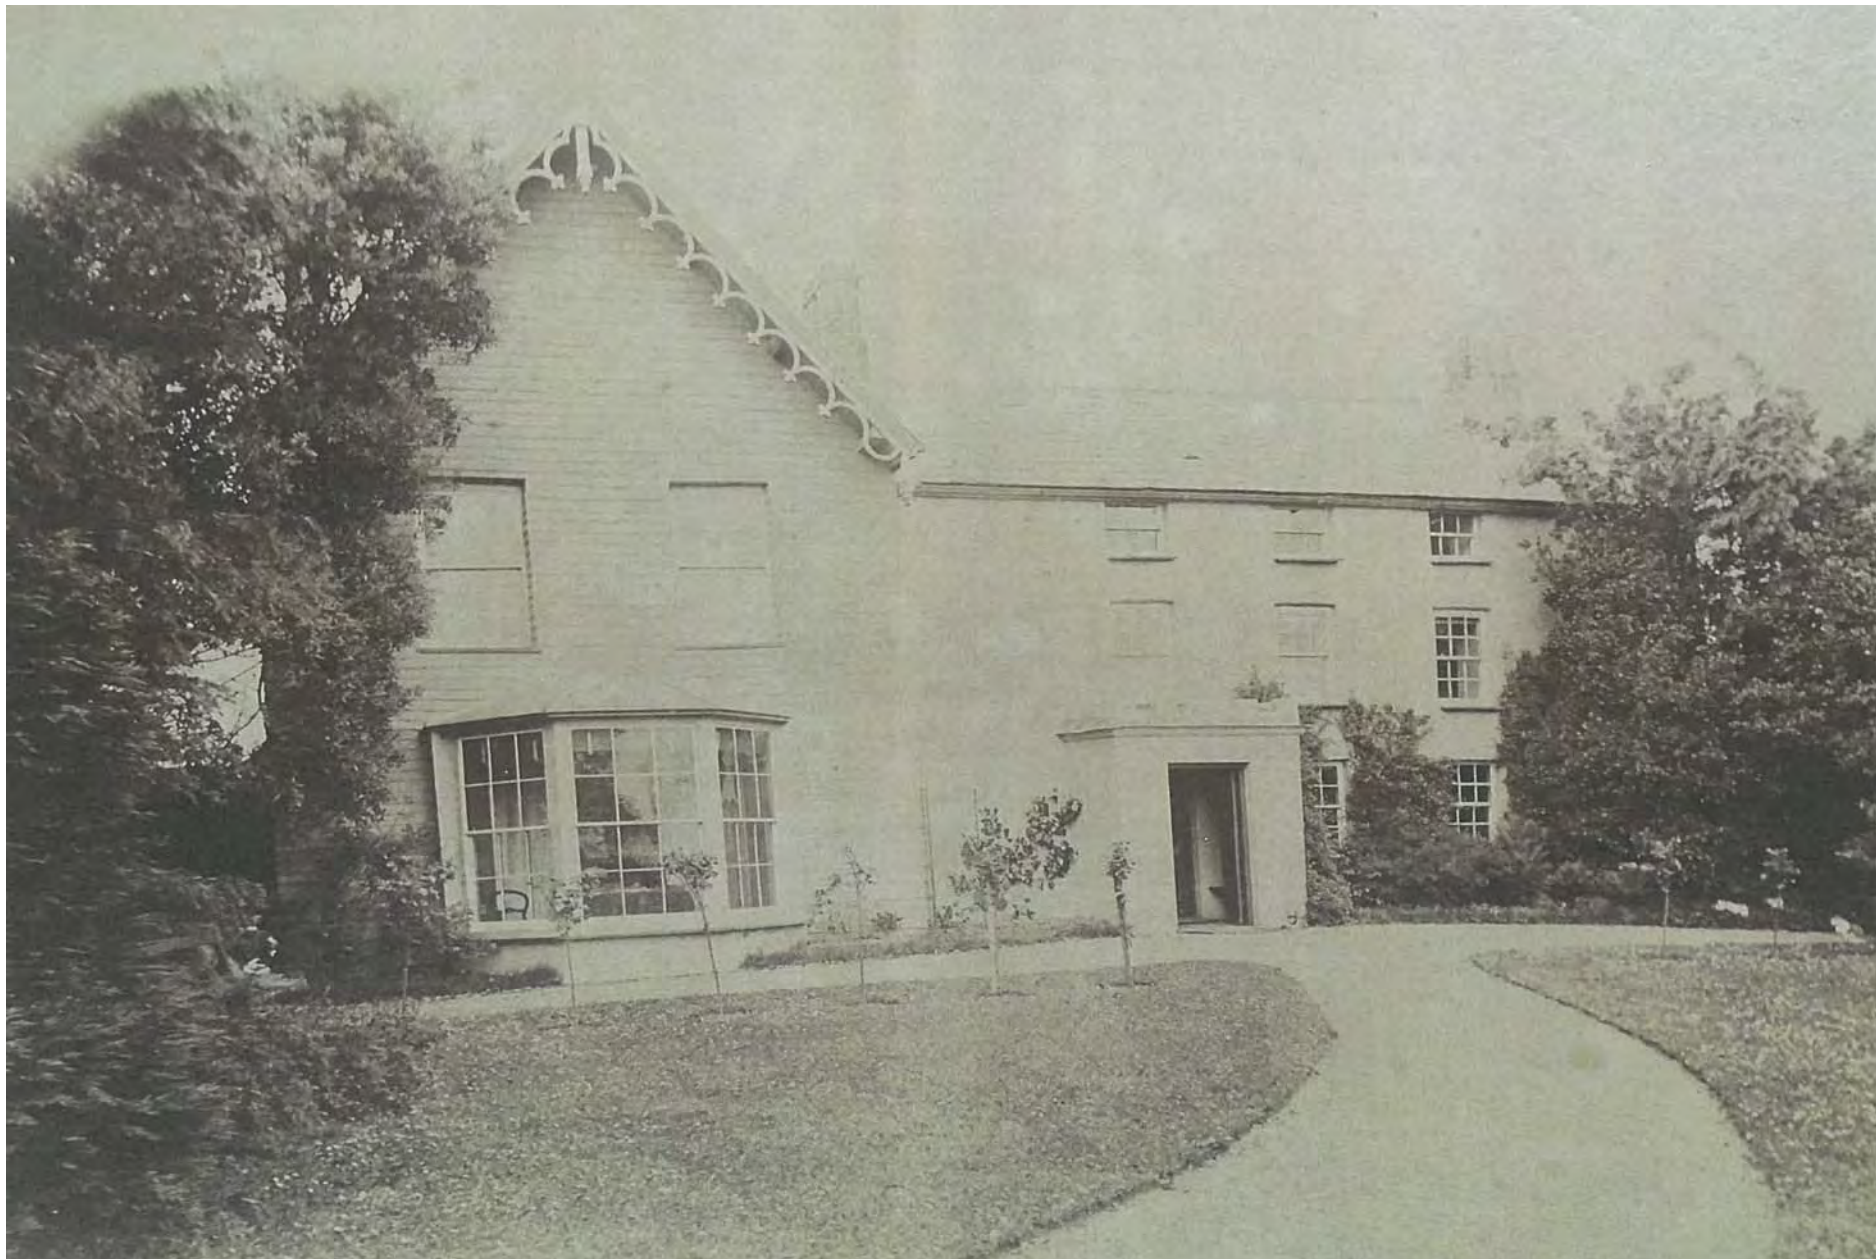
Figure 06 View of the south facing elevation of Quirt Farm in 1919, showing the former porch and western bay window (Anglesey Archives: W/DD/818)

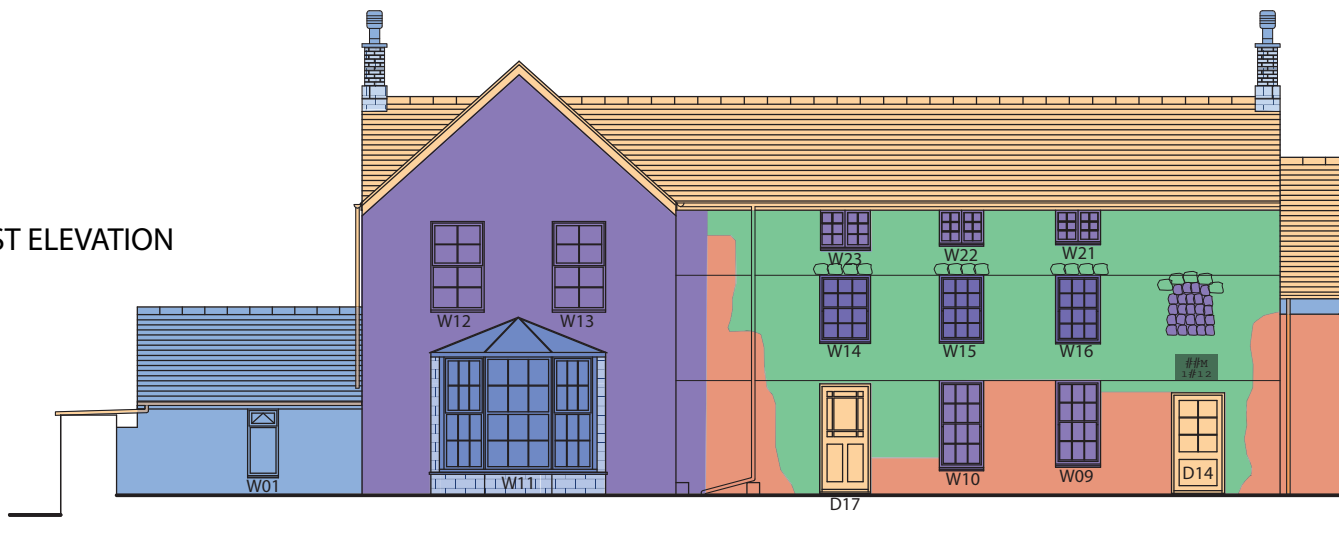
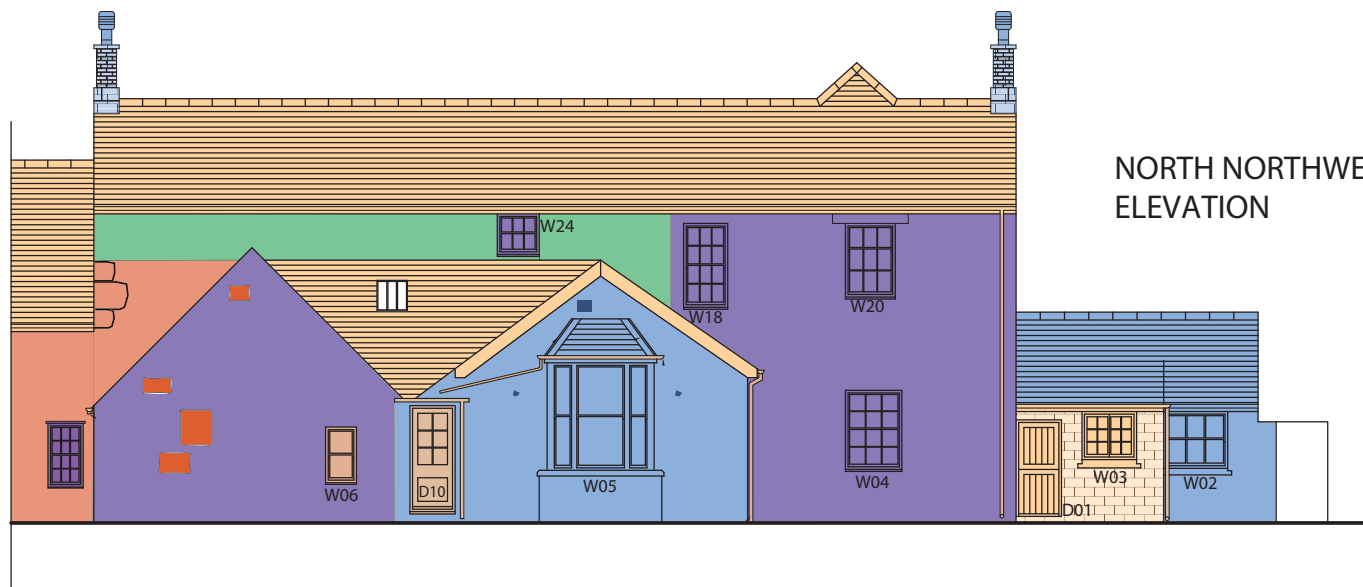
Figure 10: Phased plan of the North and South Elevations of Quirt Farm

SOUTH SOUTHEAST ELEVATION

NORTH NORTHWEST ELEVATION

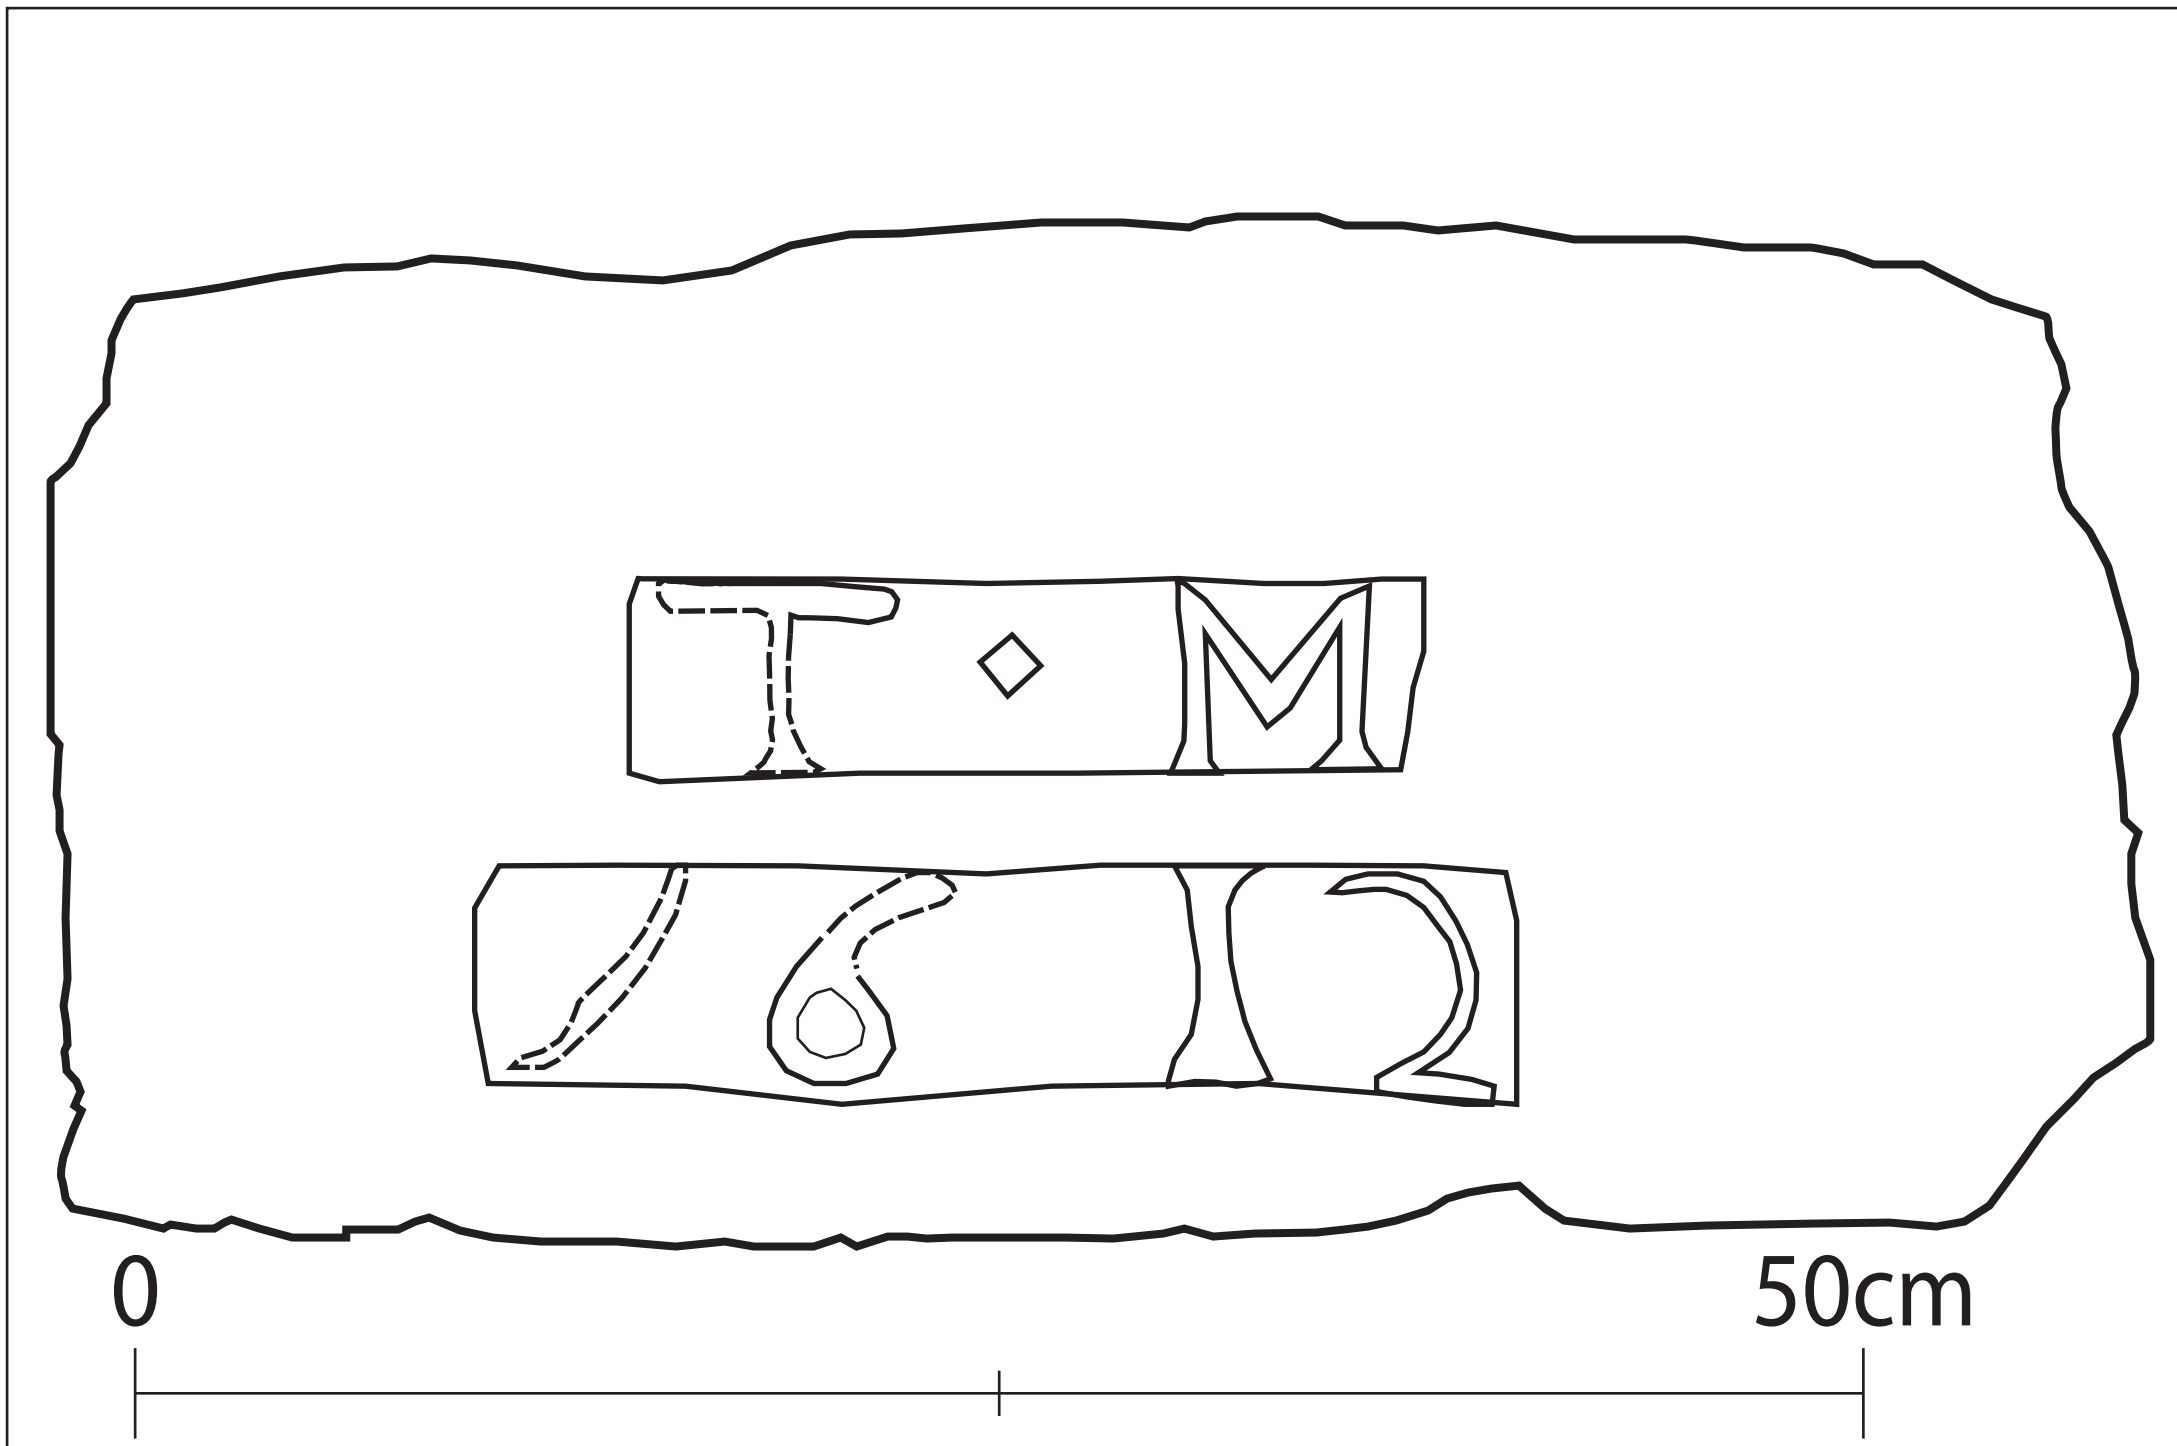
Figure 11: Outline Drawing of False Relief Carved Date Stone on the South Elevation of Quirt above D14 (dashed lines indicate where the original is worn and unclear)

end of the south elevation a plaque, 0.58m wide and 0.27m high, was noted (Figure 11, Plate 84-85). This was carved in false relief into a blue grey limestone, and was of an early 17<sup>th</sup> century type (Figure 11). It was part worn, but the below inscription could be read. The letters in square brackets are uncertain:

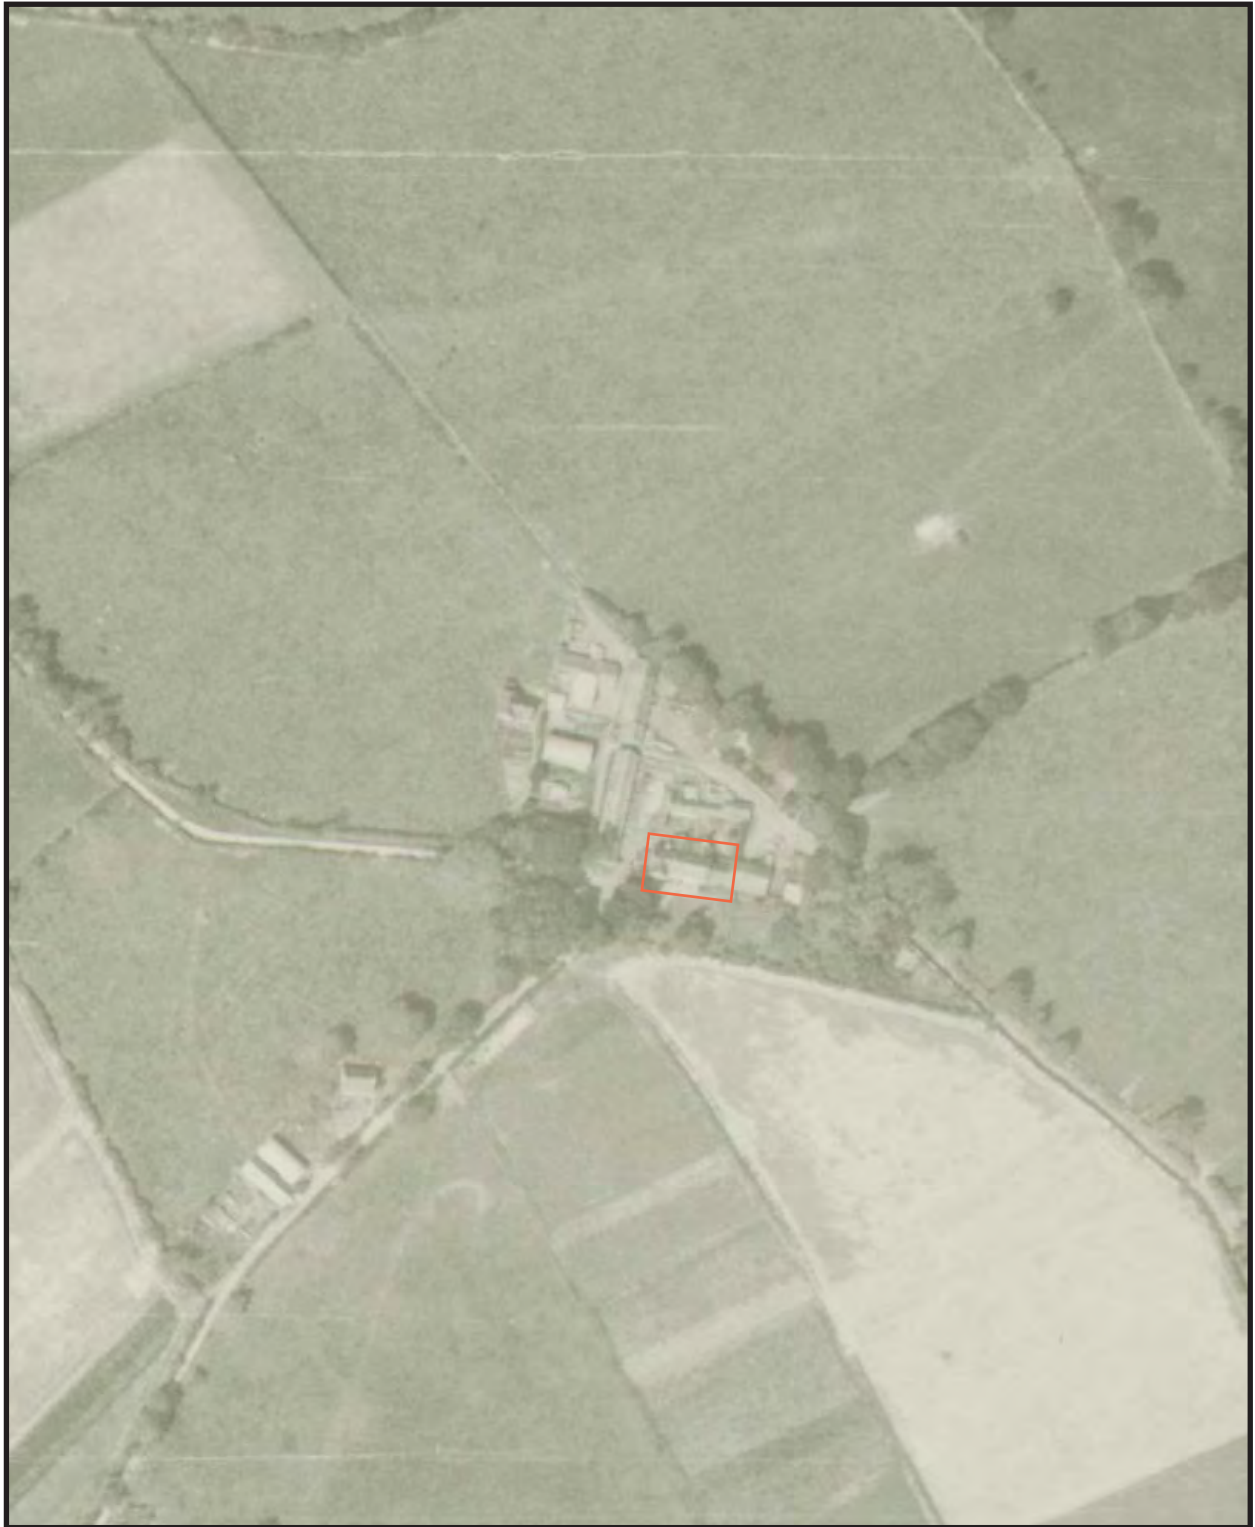
Figure 12: An enlarged extract from RAF Aerial Photograph 106G/UK655 frame 3009, taken 13th August 1945, showing Quirt, with the former Grange Chapel Outlined in Red (Welsh Assembly Government)

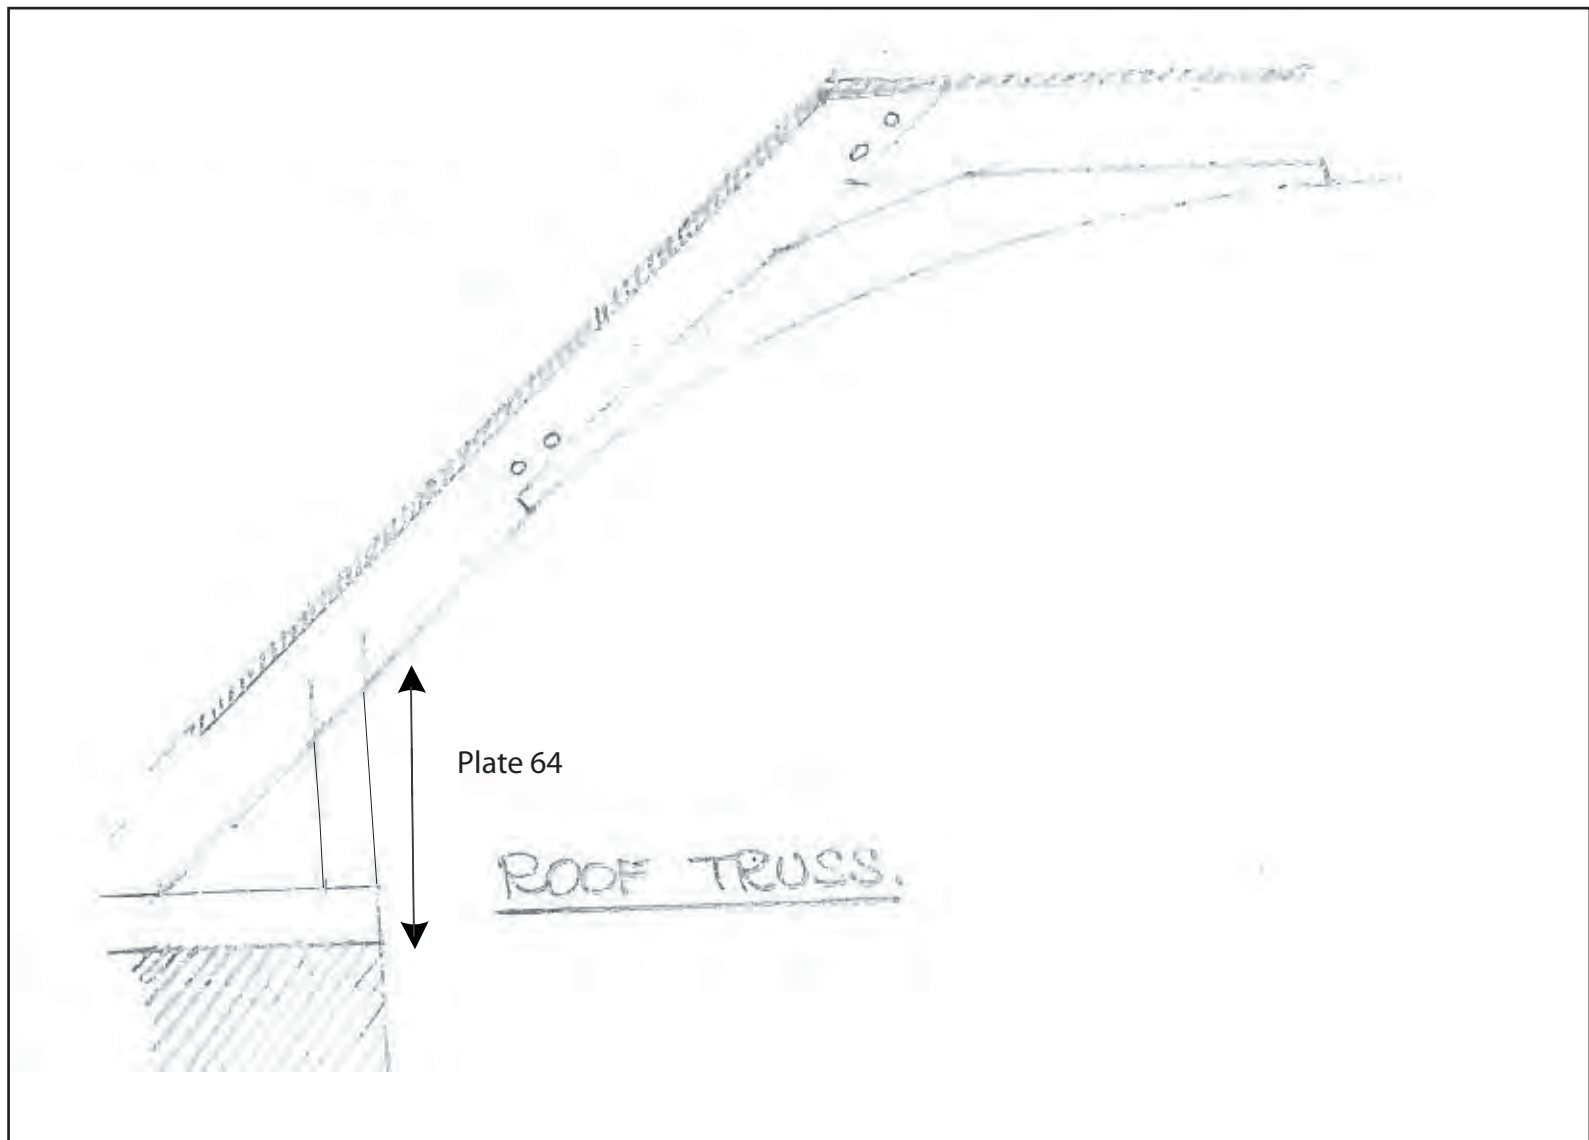
Figure 17: Sketch drawing of the possibly 15th century roof truss in first floor room of the disused chapel made in 1932 (RCAHMW, C42238). The area still visible through later work is indicated.

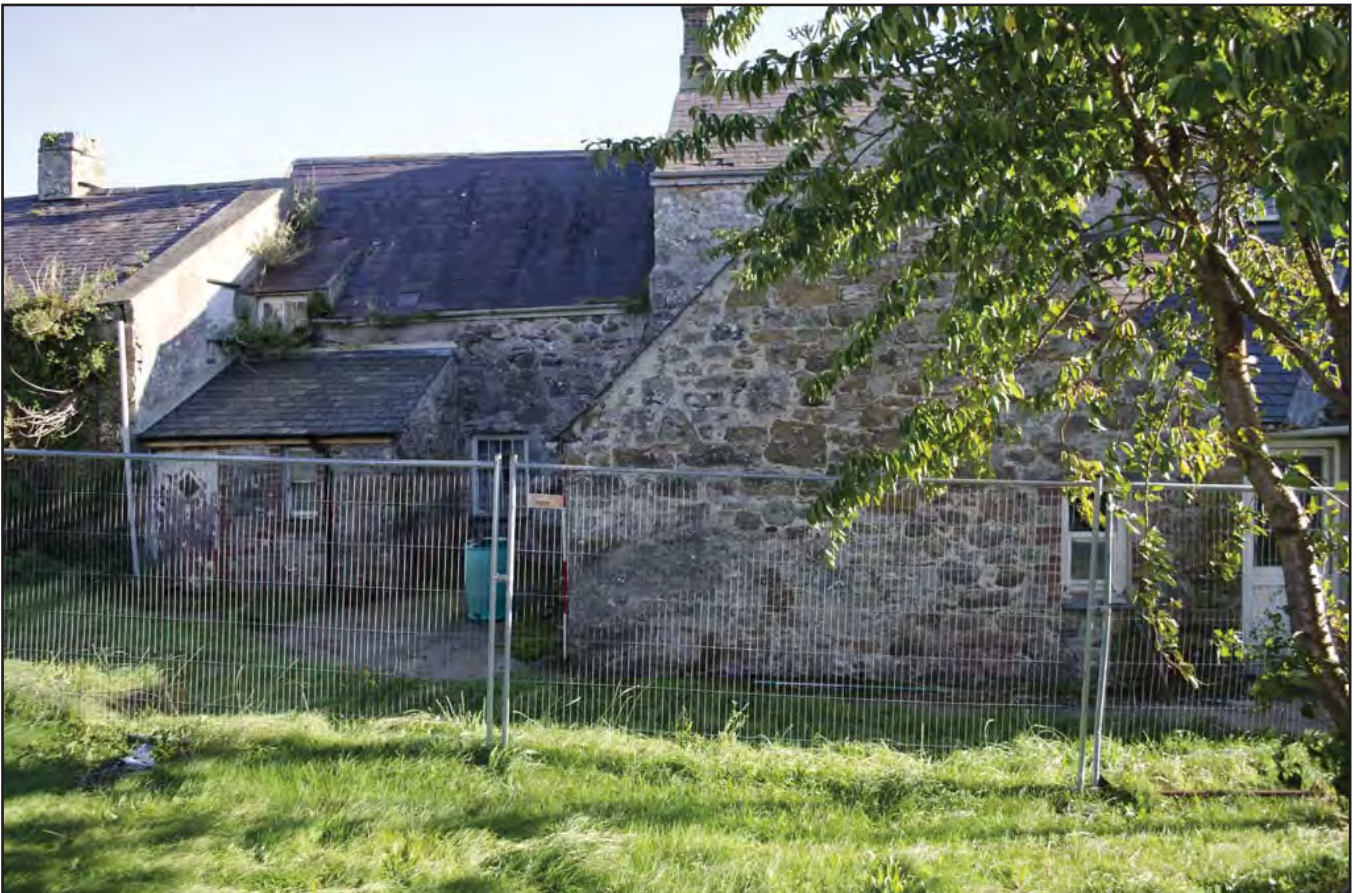
Plate 06: Rear Elevation - view from the north; note the disused chapel at the left of image. Scale: 2 .0m and 1.0m (archive image: G2483\_024).

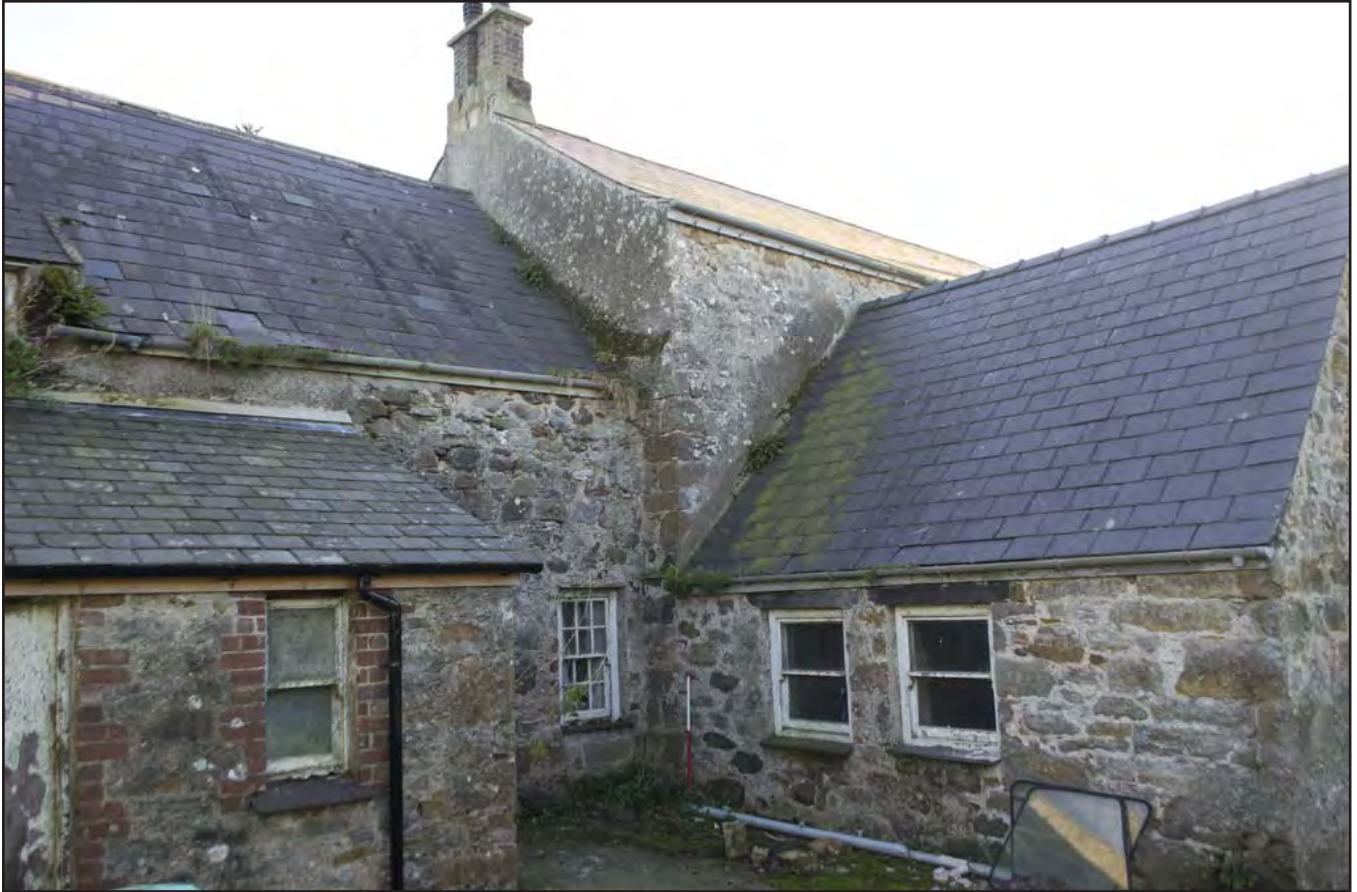
Plate 07: Rear Elevation - view from the northeast detailing disused chapel wall and junction with the nave.  
Scale: 1.0m (archive image: G2483\_187).

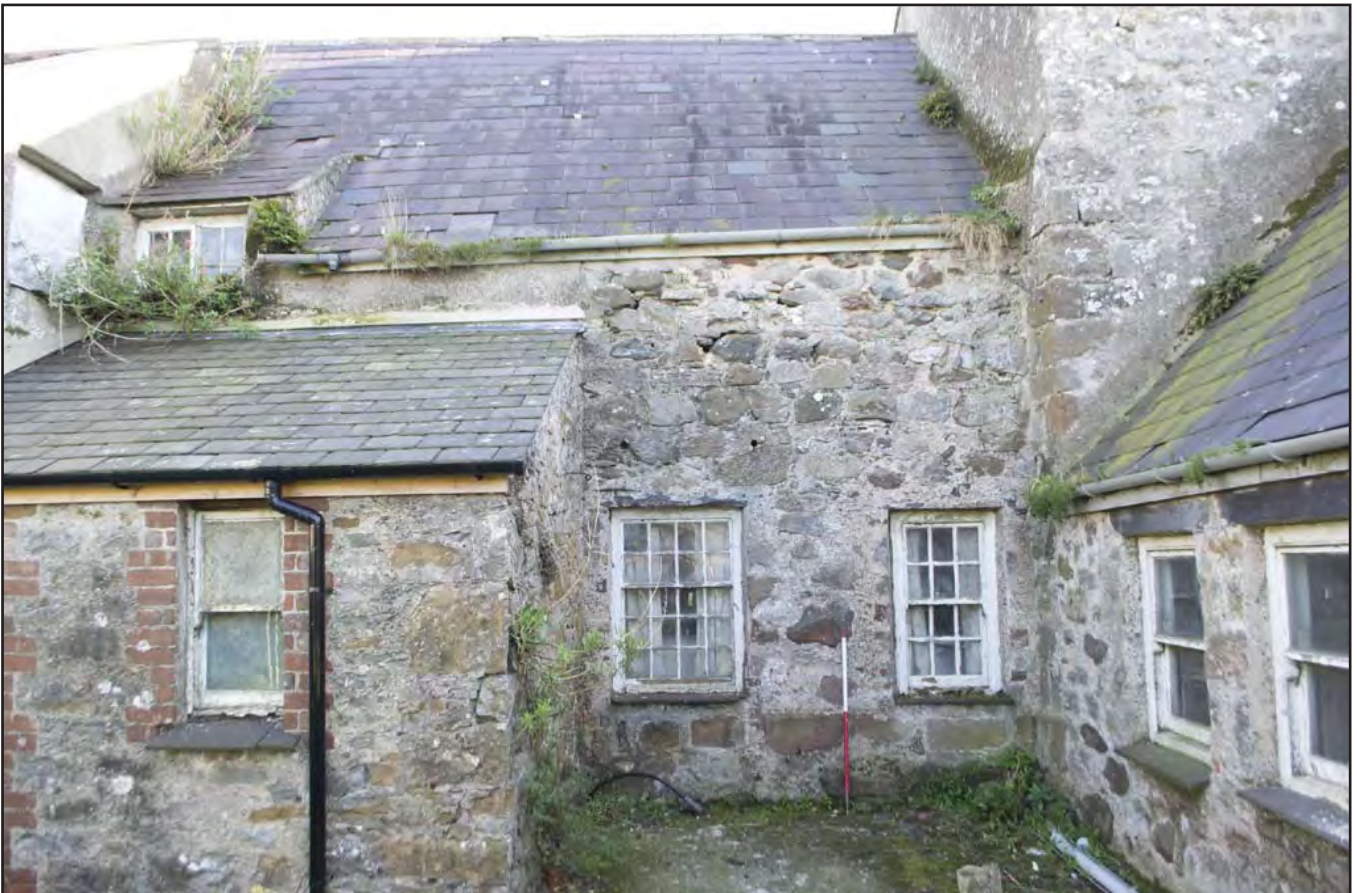
Plate 08: Rear Elevation - view from the northeast detailing disused chapel wall and junction with the nave showing quoins.  
Scale: 1.0m (archive image: G2483\_188).

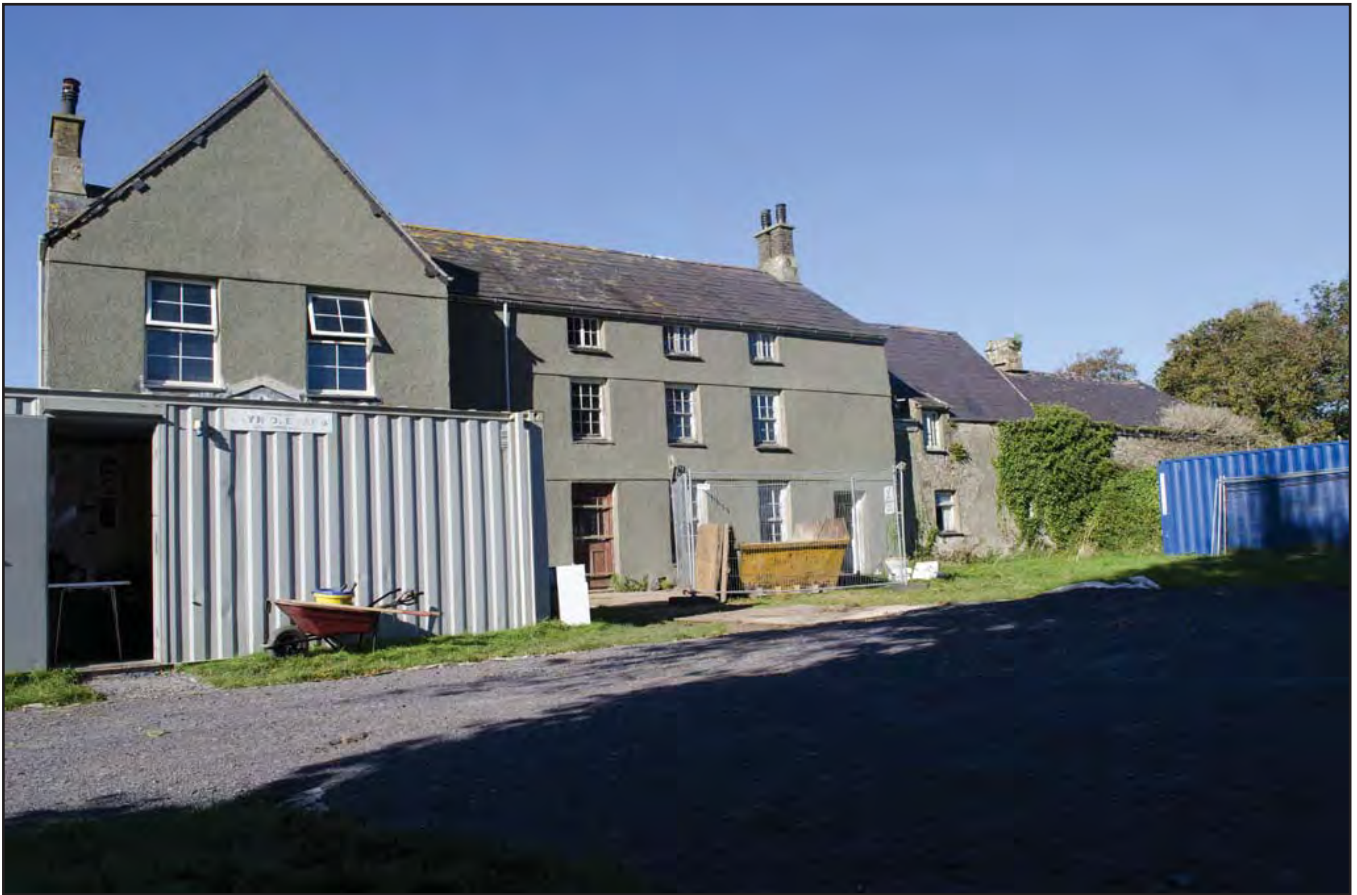
Plate 09: Front Elevation - view from the south; note the disused chapel wall at the right of image (archive image: G2483\_019).

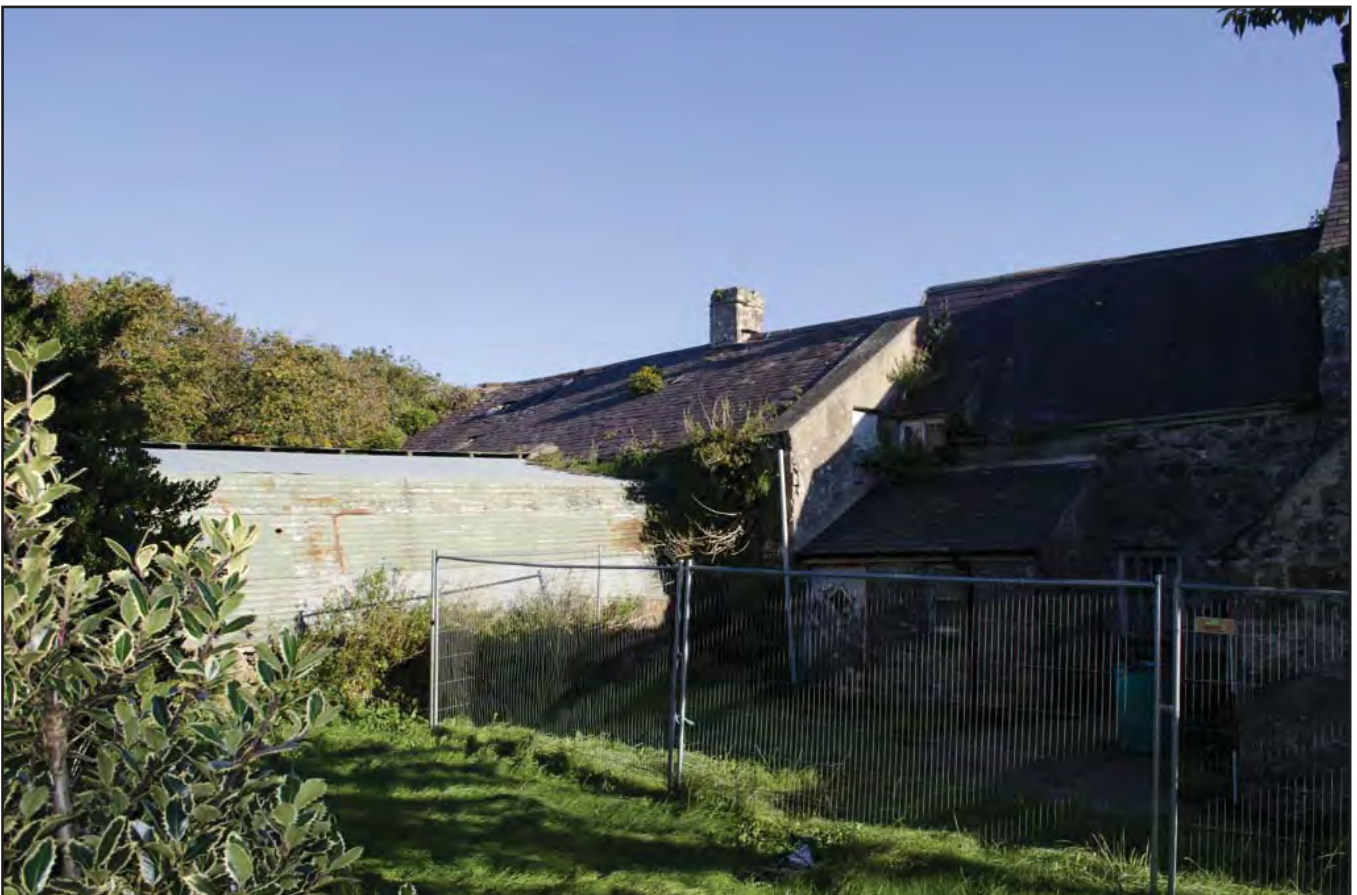
Plate 10: Rear Elevation - view from the northwest detailing disused chapel (archive image: G2483\_025).

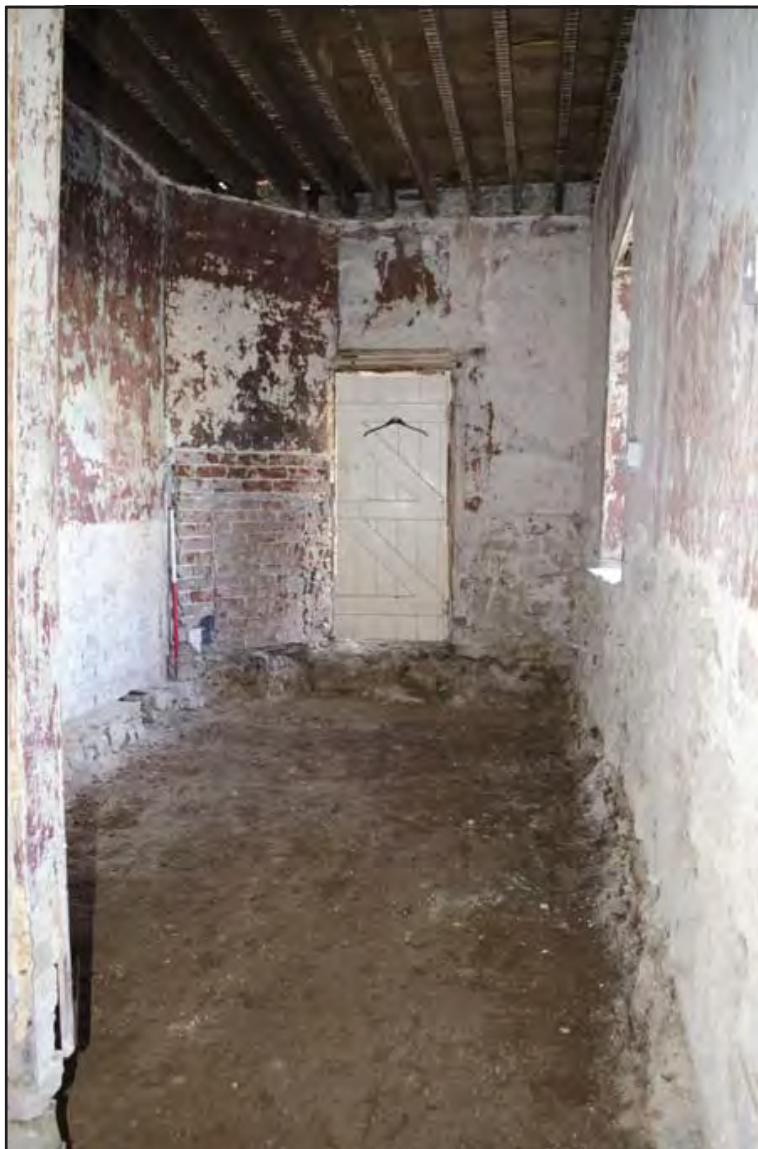
Plate 16: Utility - general interior view along with fireplace F02. Scale: 1.0m (archive image: G2483\_033).

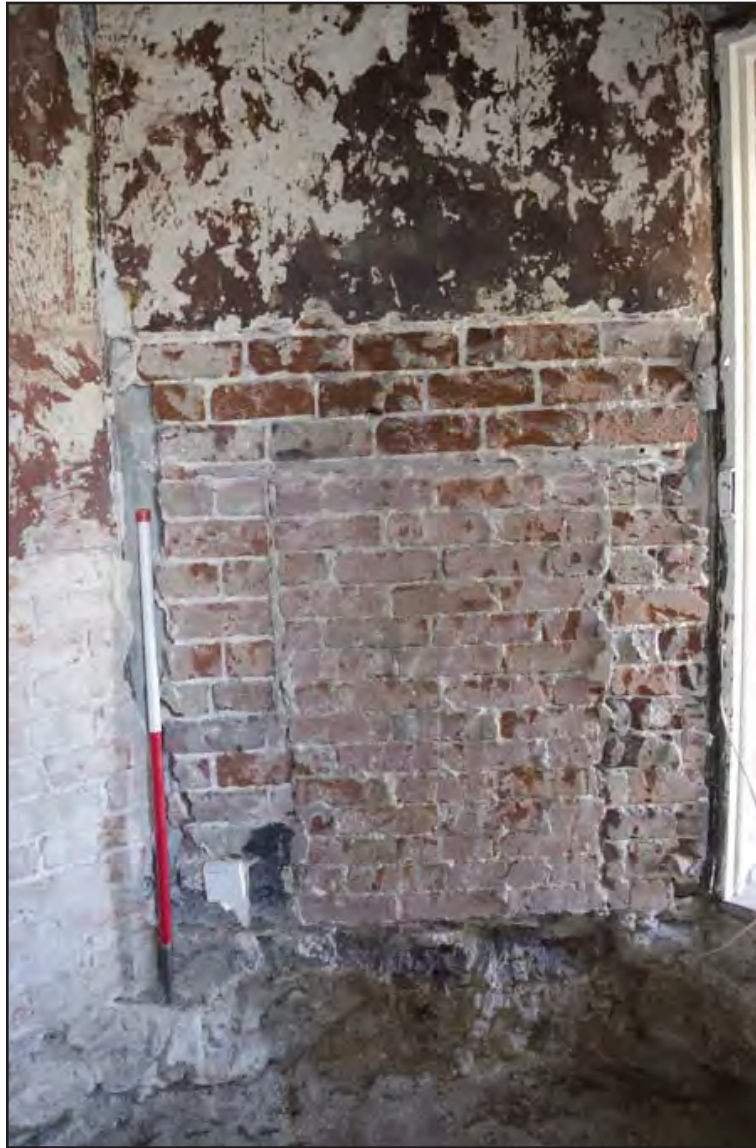
Plate 17: Utility - interior view detailing blocked-up fireplace F02.  
Scale: 1.0m (archive image: G2483\_034).

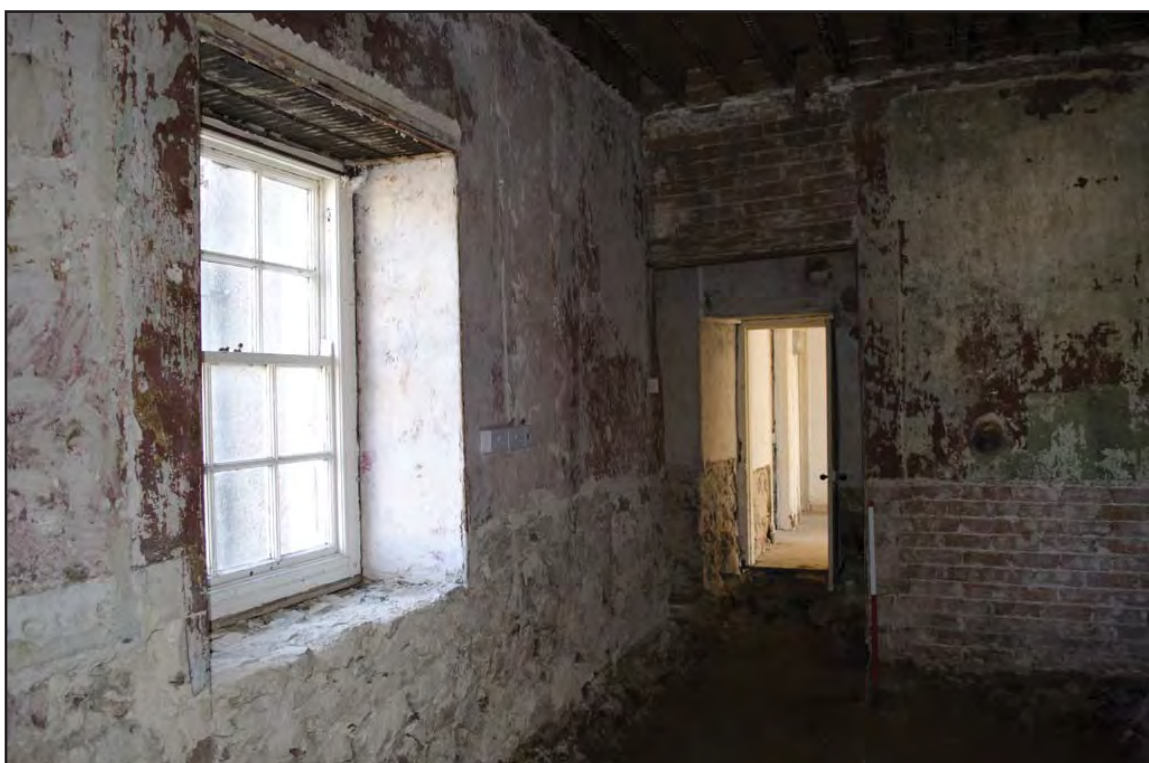
Plate 18: Utility - interior view detailing window W04. Scale: 1.0m (archive image: G2483\_035).

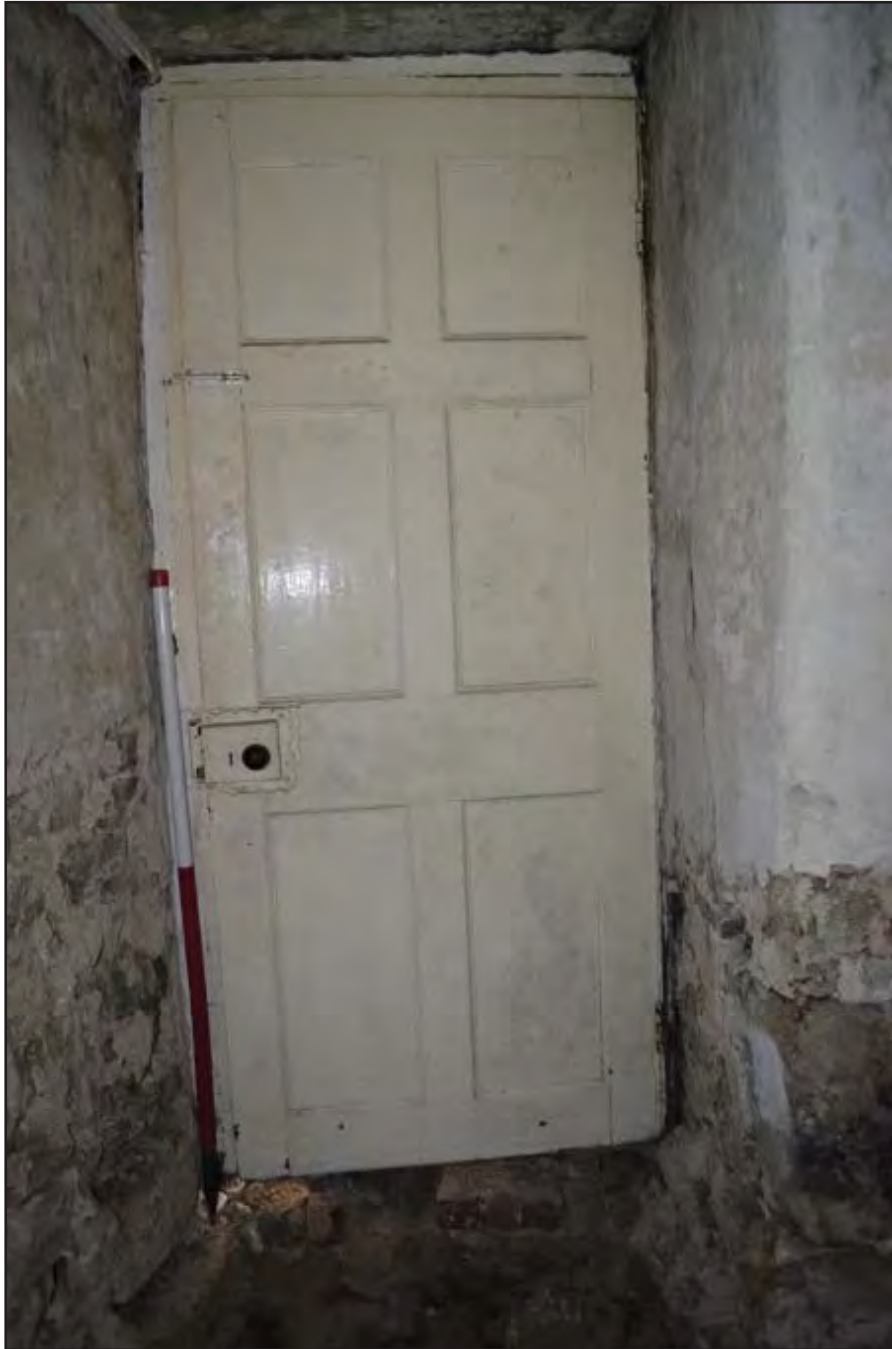
Plate 19: Store - interior view detailing door D06 and showing late Victorian/Edwardian door knob. Scale: 1.0m (archive image: G2483\_036).

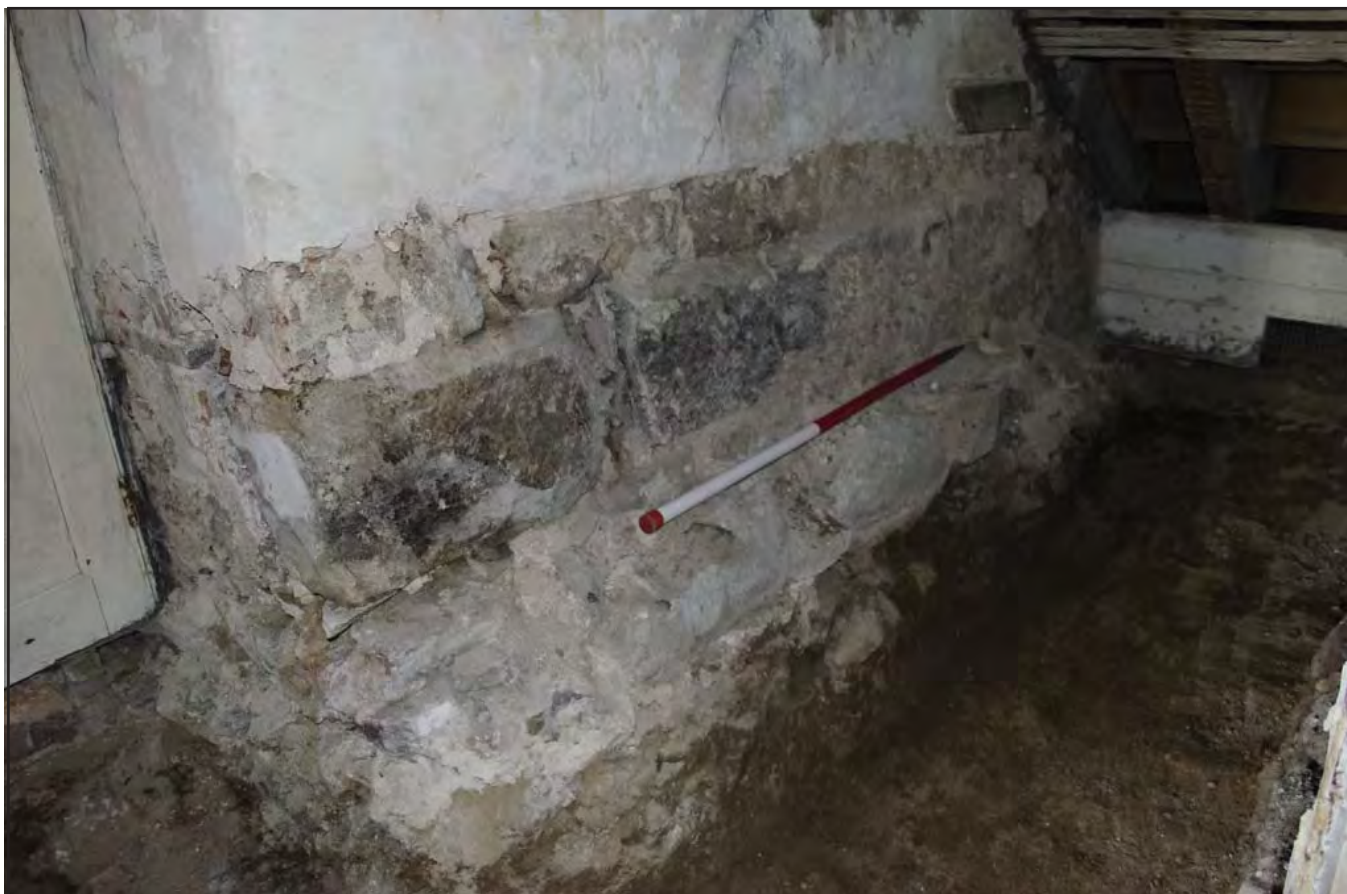
Plate 21: Store - interior view detailing stones possibly belonging to west end nave of chapel. Scale: 1.0m (archive image: G2483\_038).
