# Quirt Farm, Dwyran

LEVEL 3 BUILDING RECORD &  
ARCHAEOLOGICAL WATCHING BRIEF

Project No. G2483

Report No. 1343

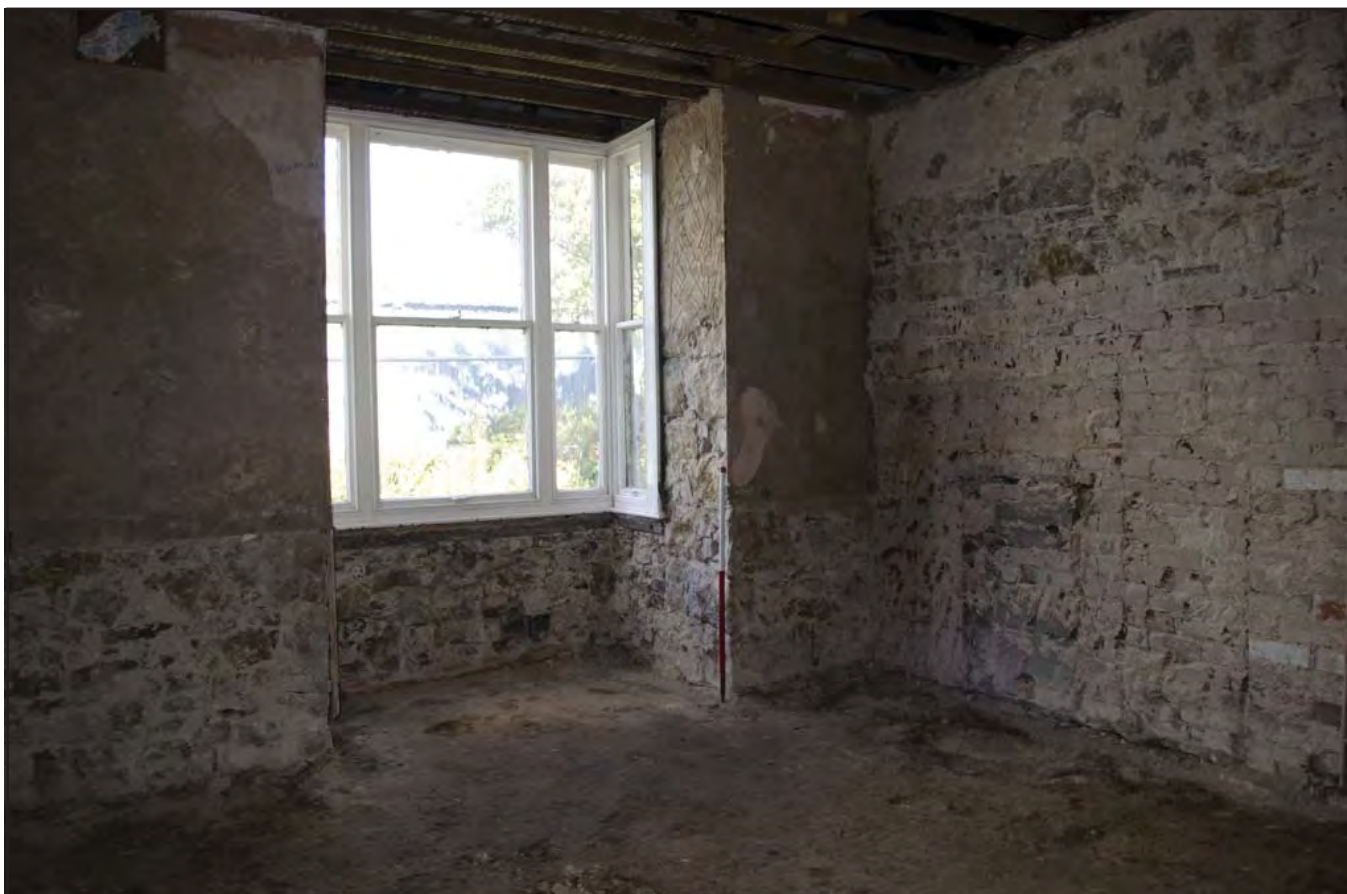
Plate 22: Dining Room - interior view with detail of bay window W05 and blocked fireplace F03. Scale: 1.0m (archive image: G2483\_039).

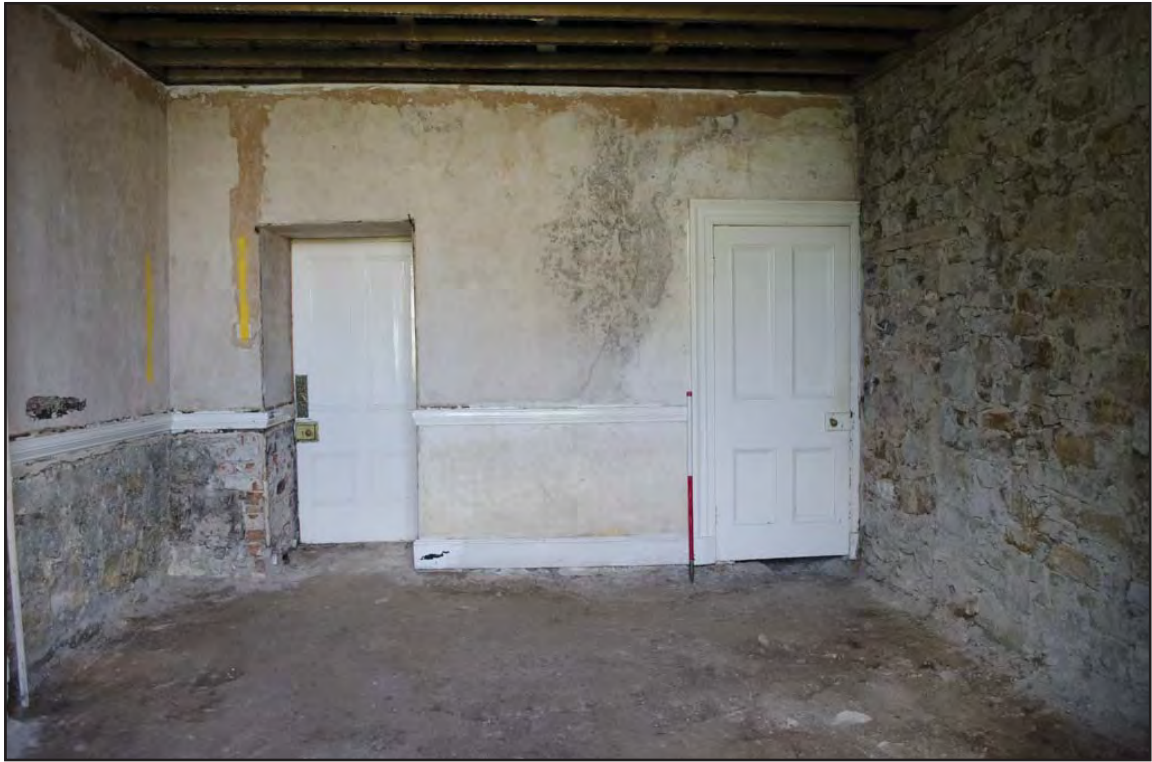
Plate 23: Dining Room - interior view with detail of doors D05 and D07. Scale: 1.0m (archive image: G2483\_041).

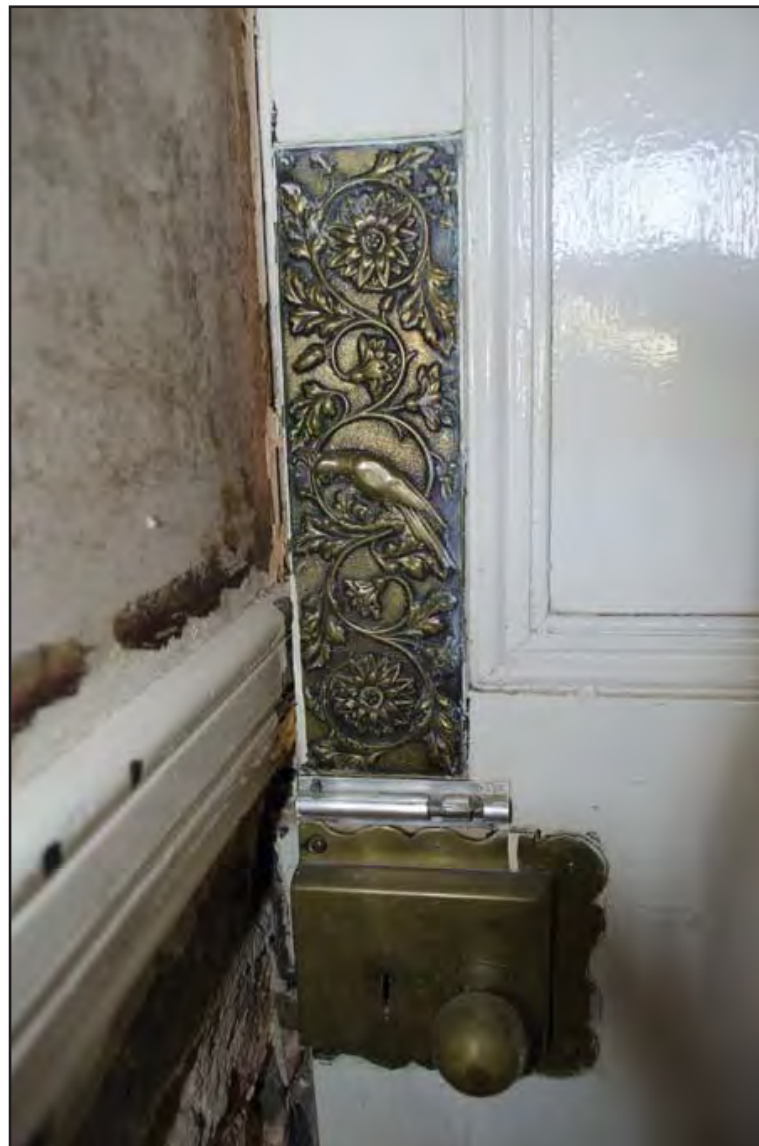
Plate 24: Dining Room - interior view with detail of decorative embellishment on door D07 (archive image: G2483\_043).

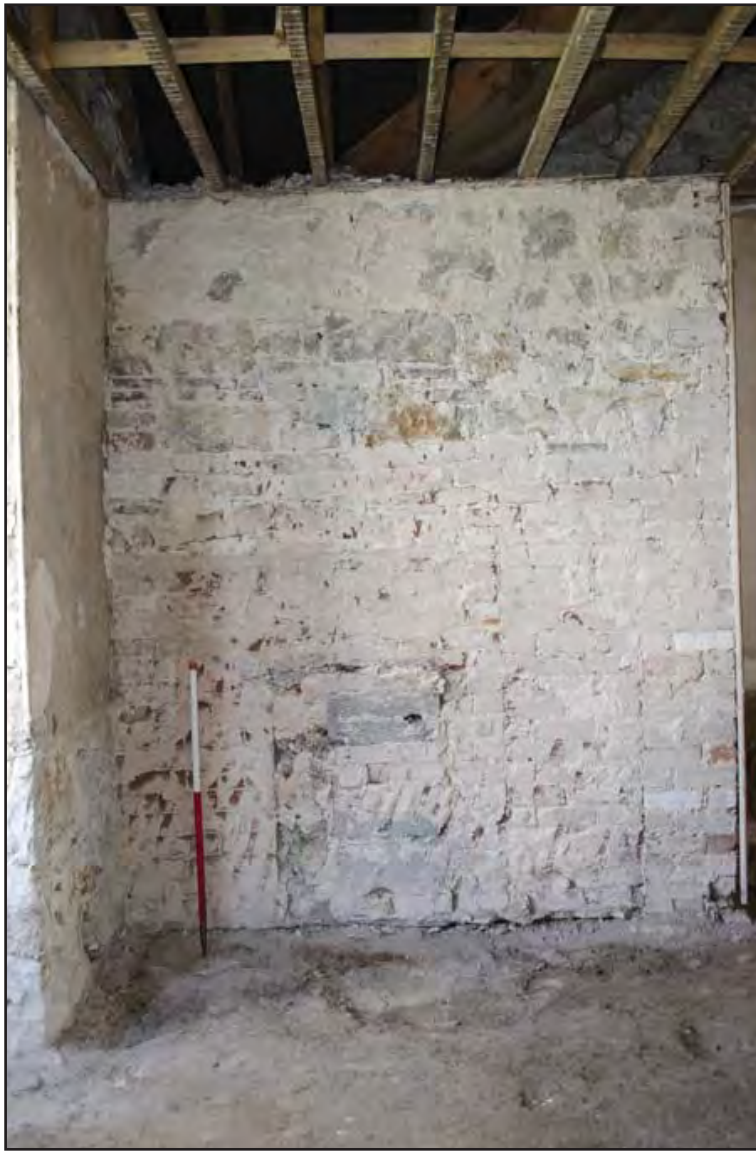
Plate 25: Dining Room - interior view with detail of of blocked-up fireplace F03.  
Scale: 1.0m (archive image: G2483\_046).

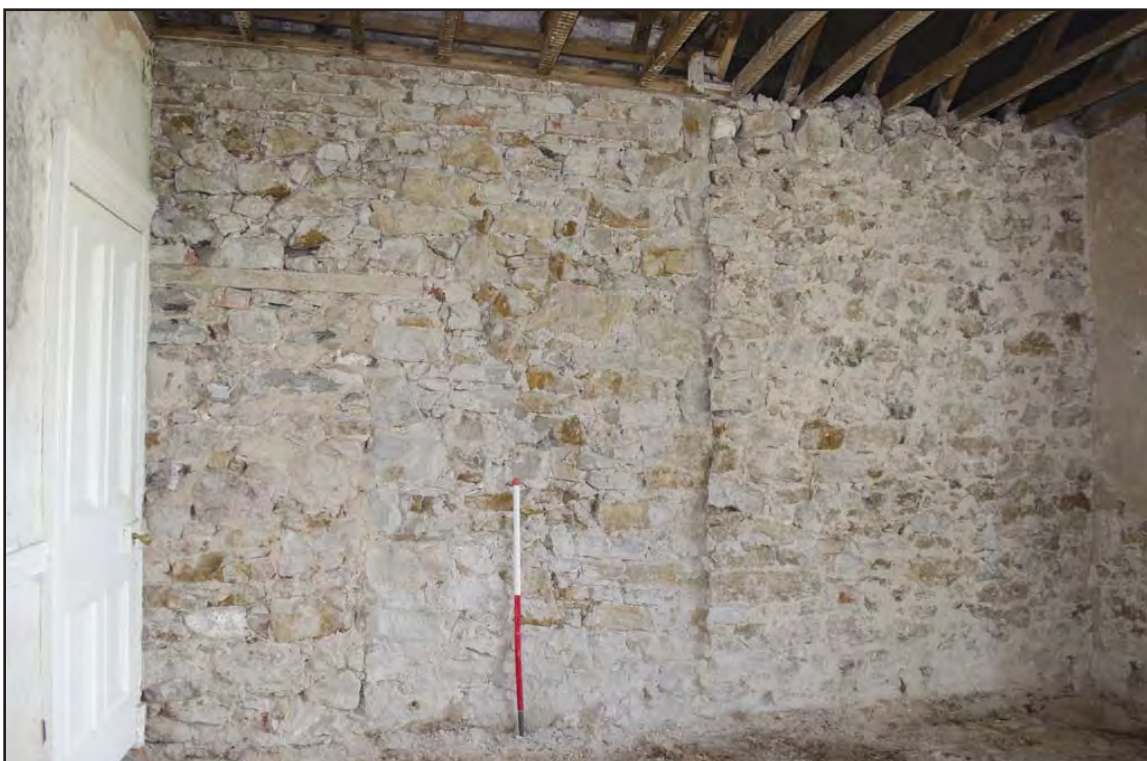
Plate 26: Dining Room - interior view of west wall with detail of blocked door way and later extension walls.  
Scale: 1.0m (archive image: G2483\_181).

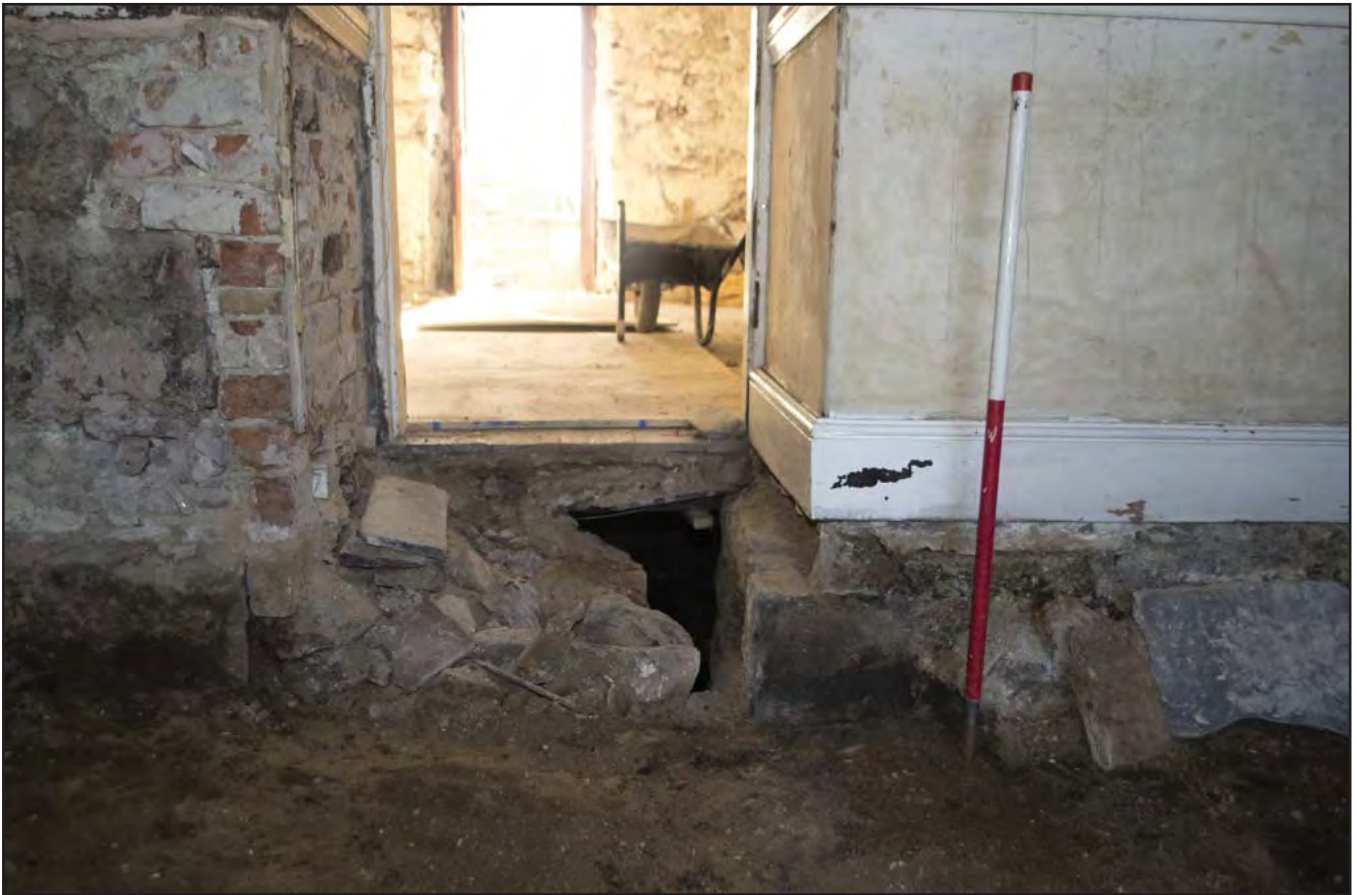
Plate 27: Dining Room - interior view of door D07 showing the decorated door jamb. Scale: 1.0m (archive image: G2483\_181).

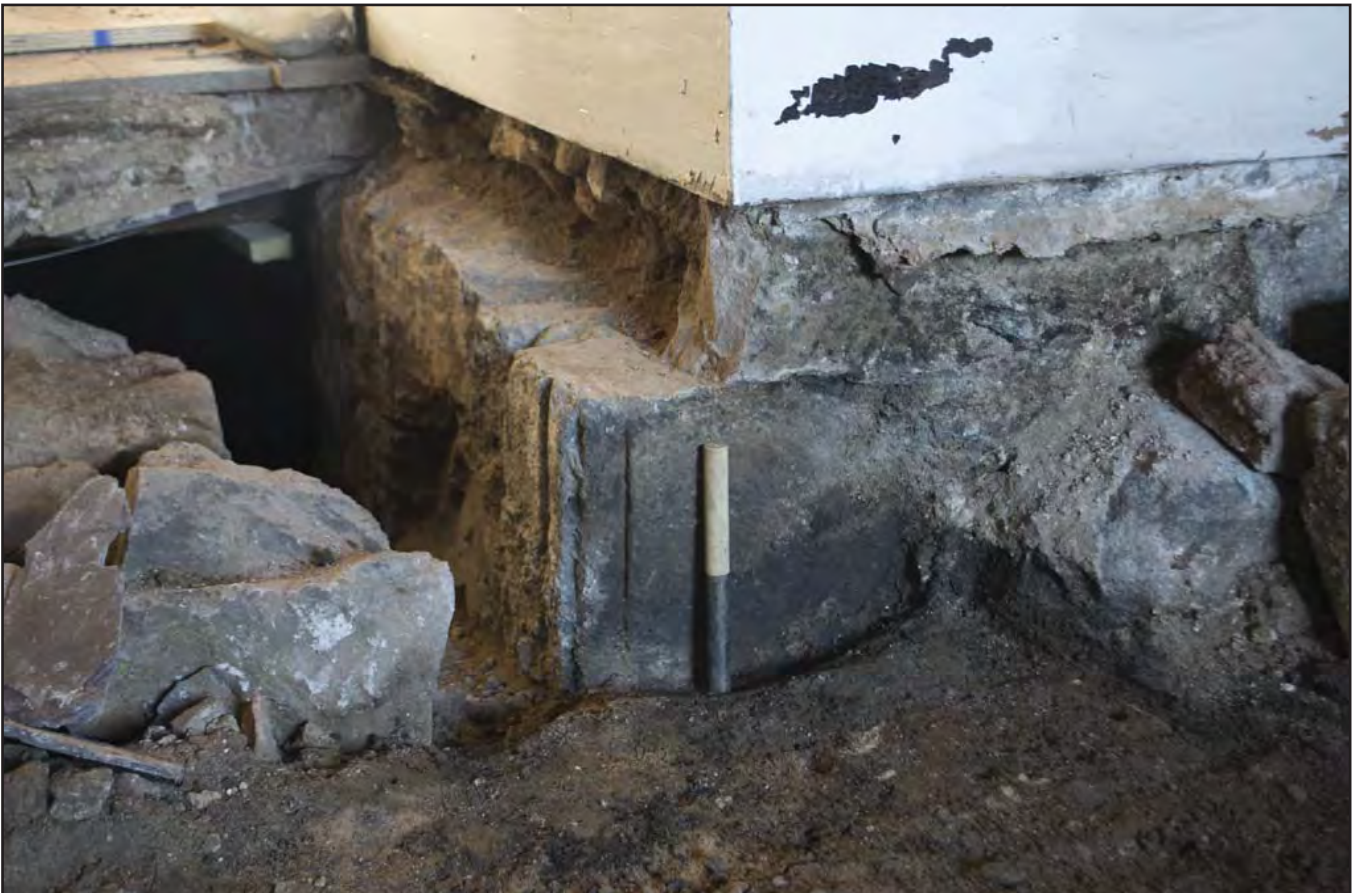
Plate 28: Dining Room - interior view of door D07 showing detail of decorated door jamb. Scale: 0.20m. Scale: 1.0m (archive image: G2483\_181).

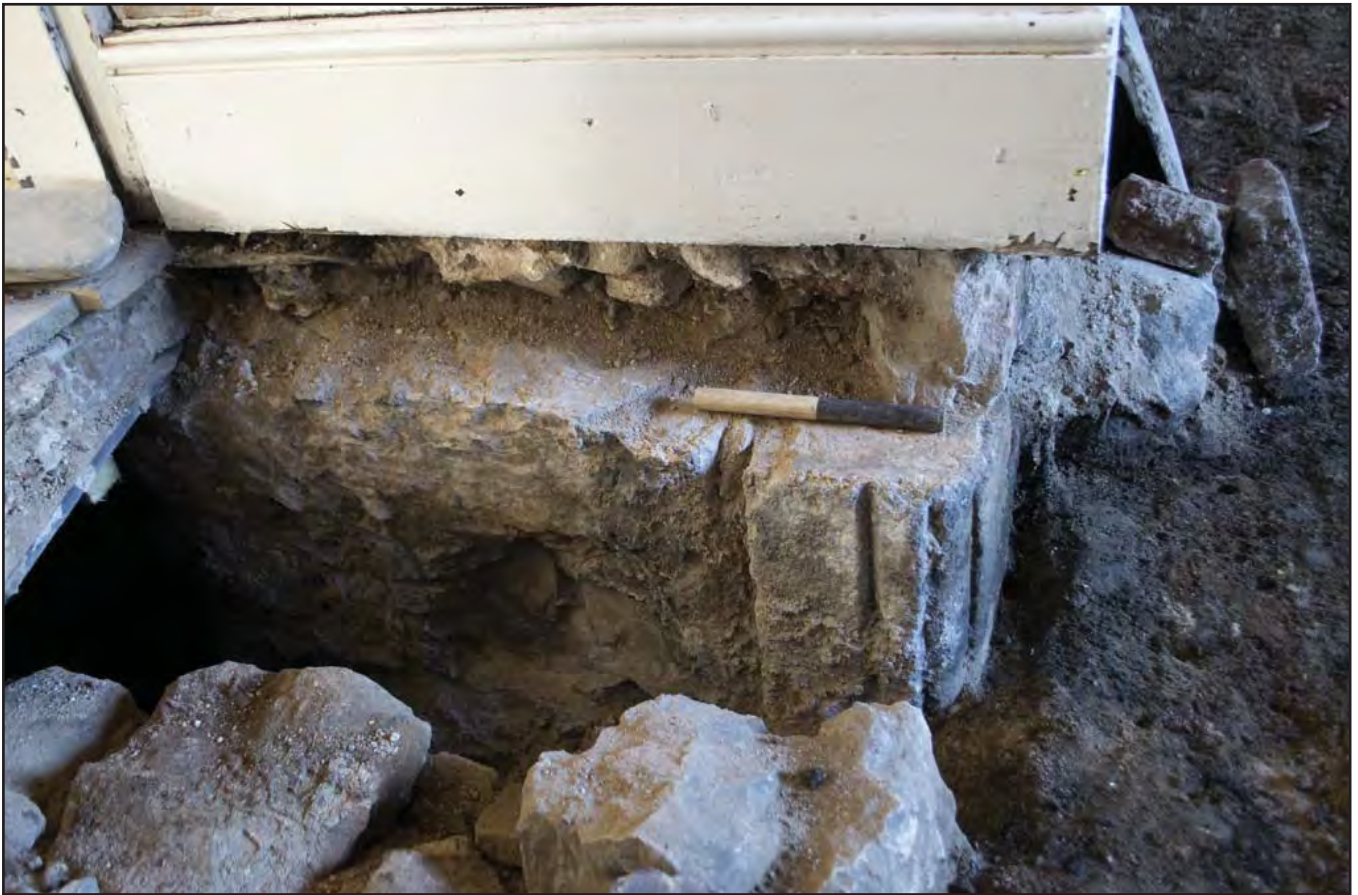
Plate 29: Dining Room - interior view of door D07 with detail of the decorated door jamb. Scale: 0.20m (archive image: G2483\_184).

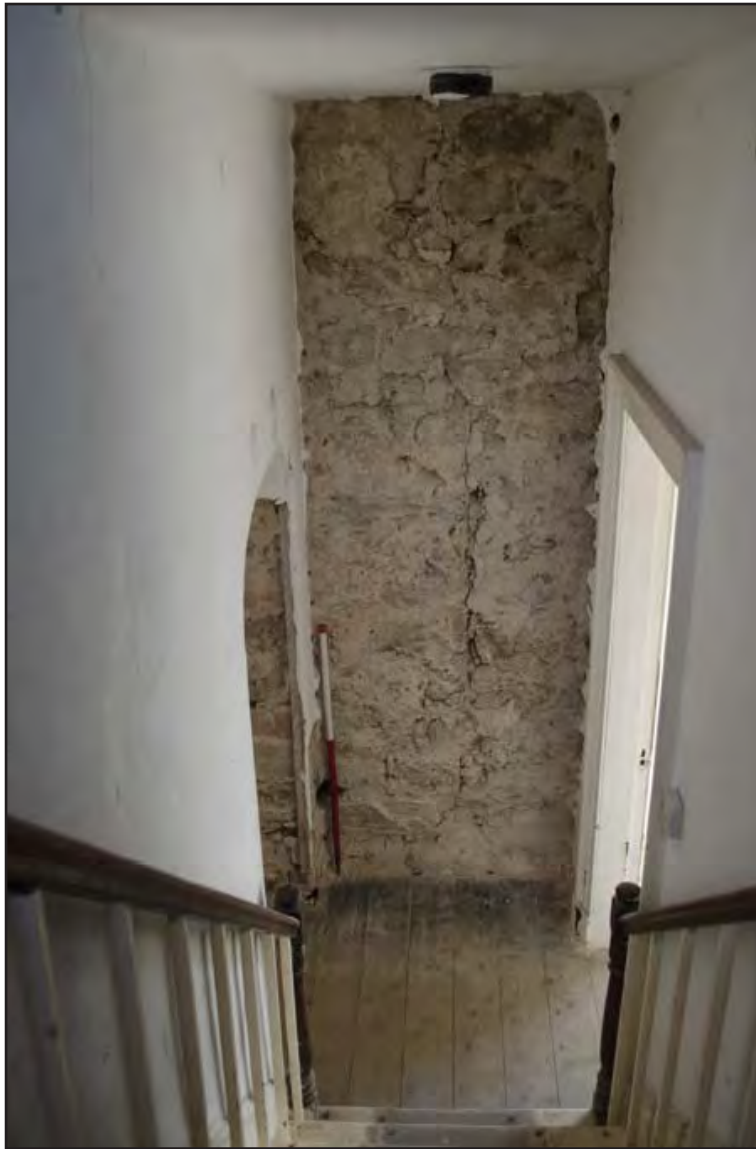
Plate 35: Hall 1 - interior view from main staircase of possible buttress at west end of chapel. Scale: 1.0m (archive image: G2483\_053).

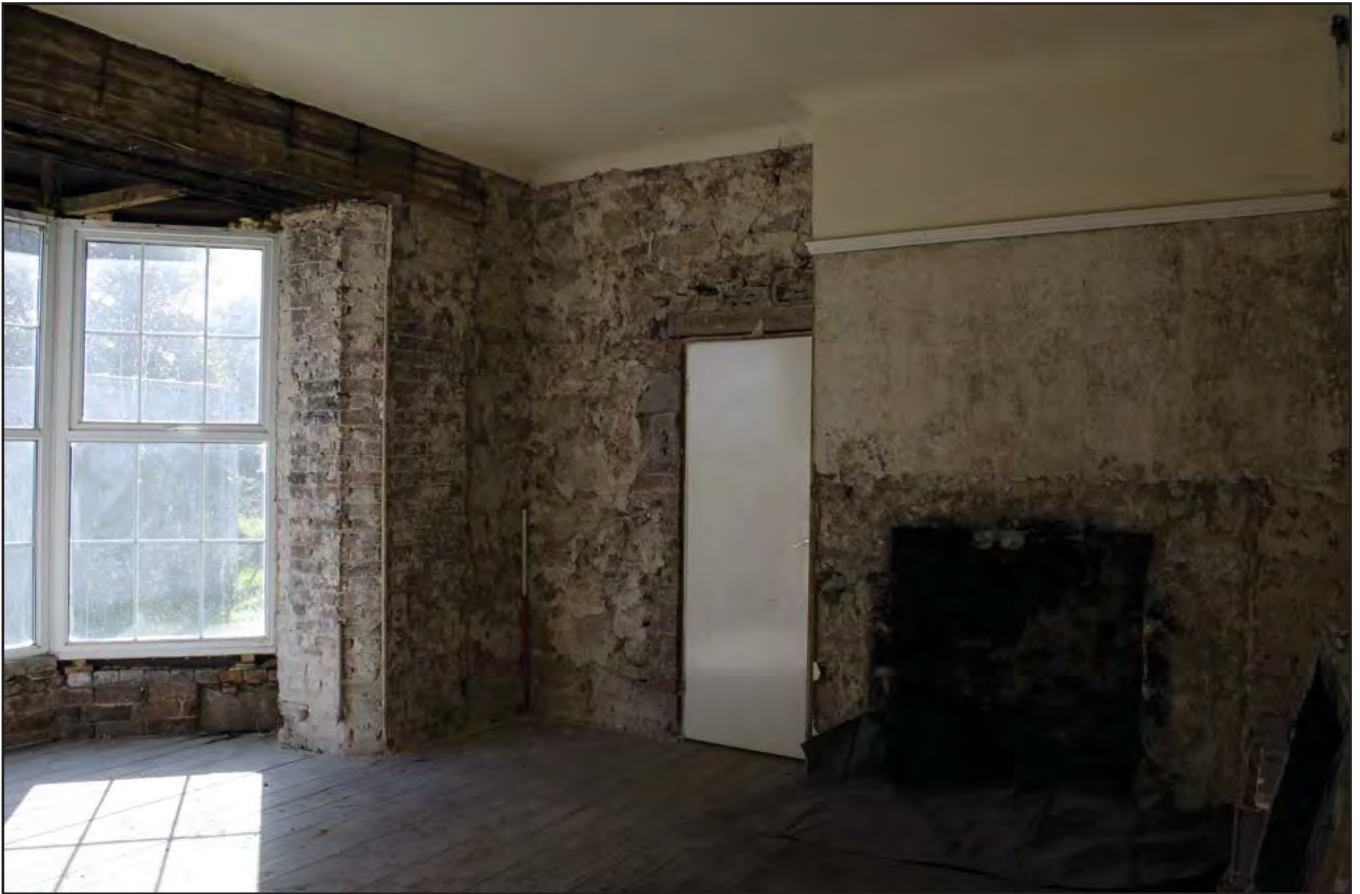
Plate 37: Living Room 1 - interior view with detail of structural phasing including 17th century wall and bay window and door D19 inserted at a later date. Scale: 1.0m (archive image: G2483\_055).

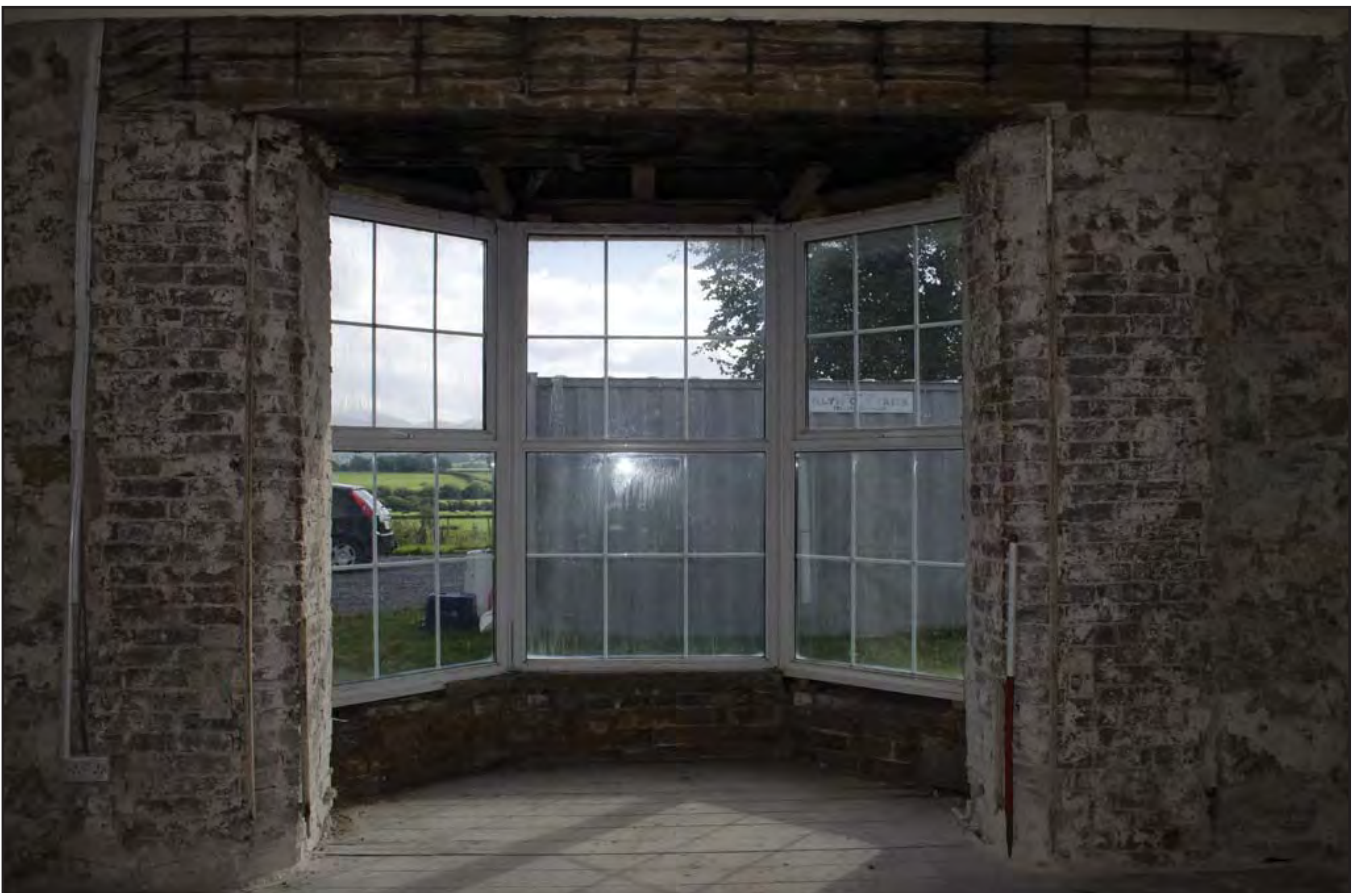
Plate 38: Living Room 1 - interior view with detail of bay window W11 with Victorian brickwork and truss supporting walls above. Scale: 1.0m (archive image: G2483\_055).

In the south wall was a 3.9m wide opening for the bay window, which was clearly a later insertion (Plate 38). Two brick pillars and three angled wall, 0.4m high supported a replacement uPVC bay window with two opening 2.2m high. The two side brick piers were of bricks 0.07m wide and 0.23m long, suggesting an early 19<sup>th</sup> century date, and supported two massive lintel beams, which were necessary as they supported a load bearing external wall. The piers themselves were 0.7m wide and 0.6m deep. They abutted an angled return in the adjacent ashlar masonry on both sides of the window, suggesting that a former grand entrance was located in this area, which would have been 3.9m wide. The south wall of the room was of brickwork and the picture rail still survived here and also above the fireplace (F01) on the western wall which was still in place. A 1930s pre-fabricated mantel piece had been removed from the grate, but was still present *ex situ* in the room. The east wall west of the stairwell with D18 with it was built of 19<sup>th</sup> century brickwork and was 2.8m wide.

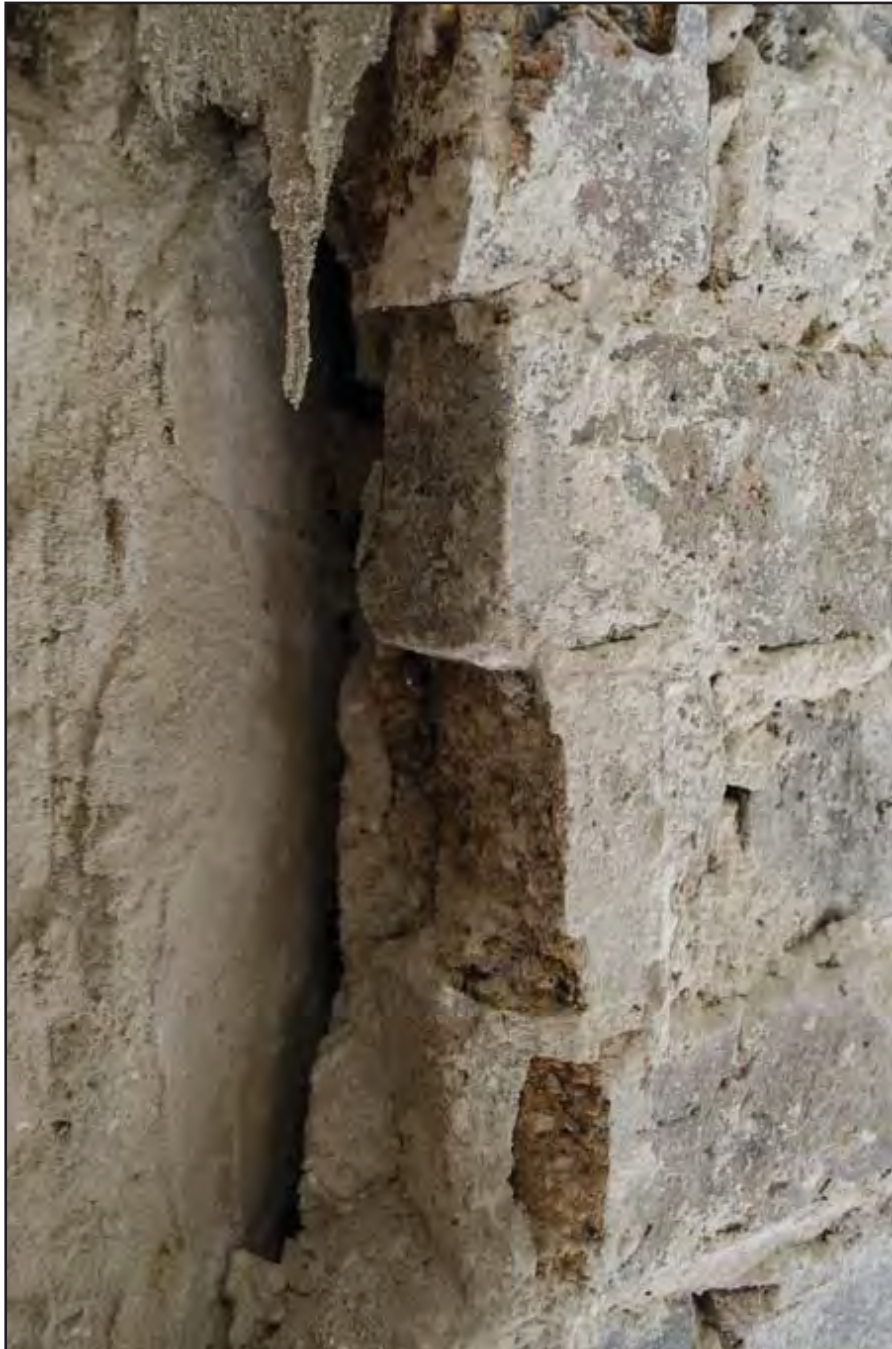
Plate 39: Living Room 1 - interior view with detail of structural phasing associated with bay window W11 (archive image: G2483\_061).

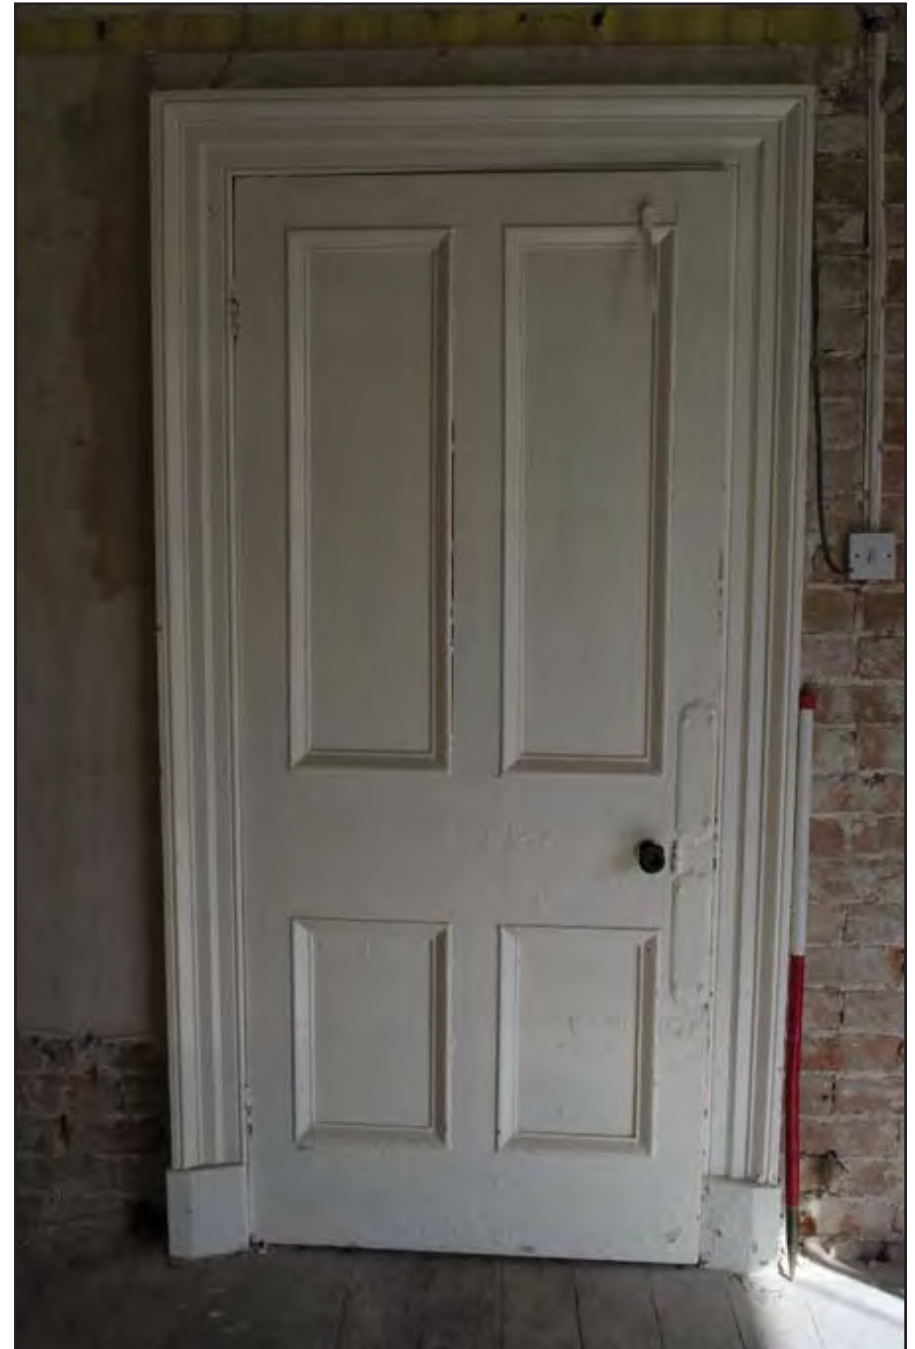
Plate 40: Living Room 1 - interior view with detail of door D18 (leading into Hall). Scale: 1.0m (archive image: G2483\_060).

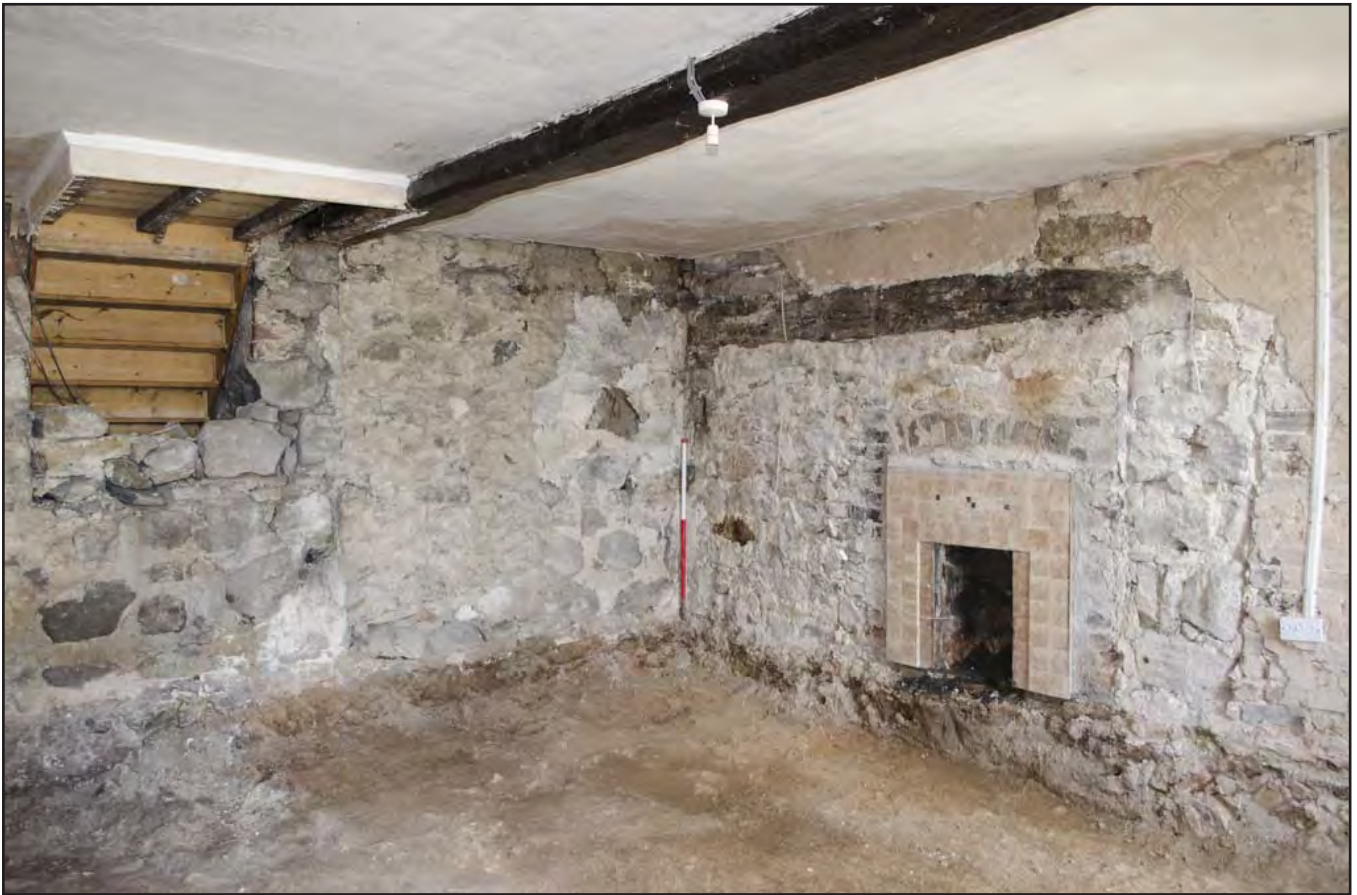
Plate 41: Living Room 2 - general interior view of fireplace F05 and stonework possibly belonging to grange. Scale: 1.0m (archive image: G2483\_064).

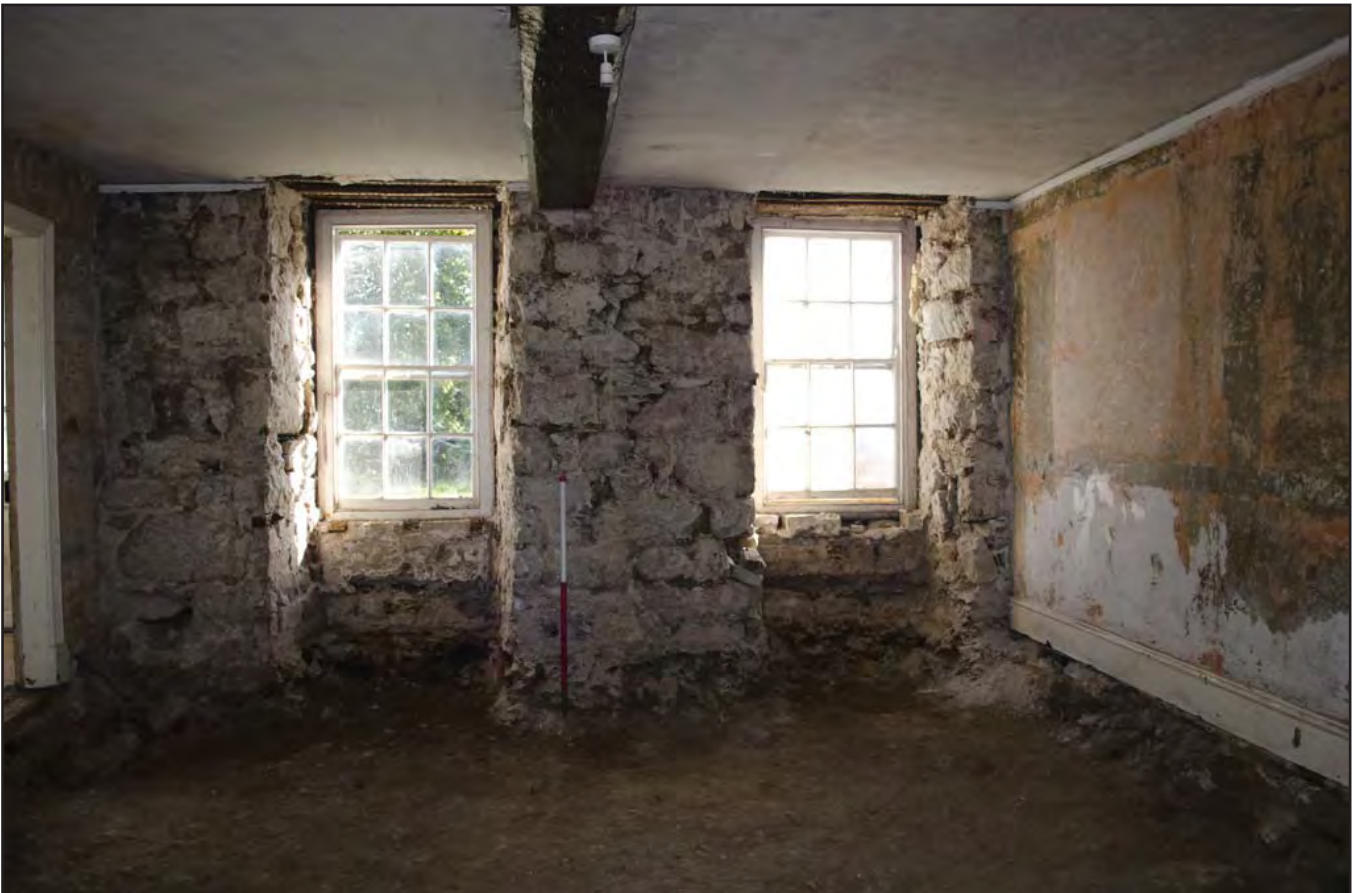
Plate 42: Living Room 2 - interior view with detail of windows of W10 and W09 with central truss. Scale: 1.0m (archive image: G2483\_068).

The south wall has two 12 pane horned-sash windows inserted into the wall of large rubble masonry 0.58m thick (Plate 42). They were 0.9m above the ground (W09 and W10). The windows reveal W10 showed evidence of the masonry having being cut

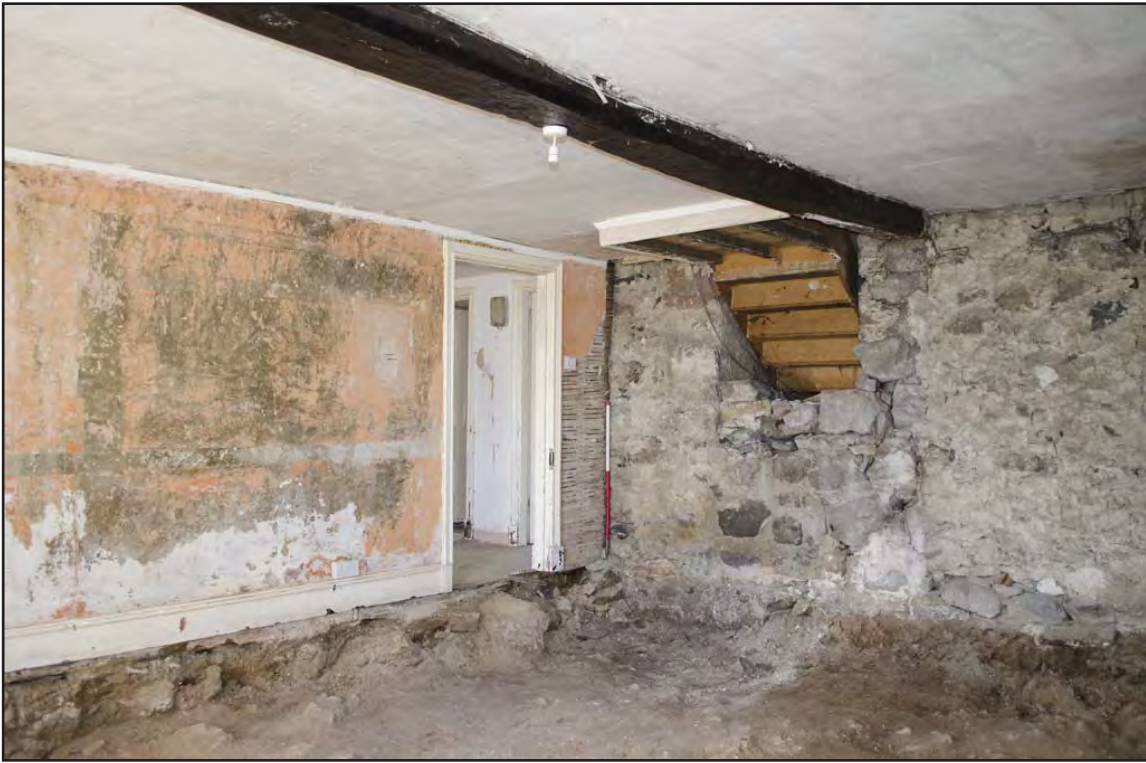
Plate 43: Living Room 2 - interior view showing rear of back stair case, earlier foundations and door D16.  
Scale: 1.0m (archive image: G2483\_066).

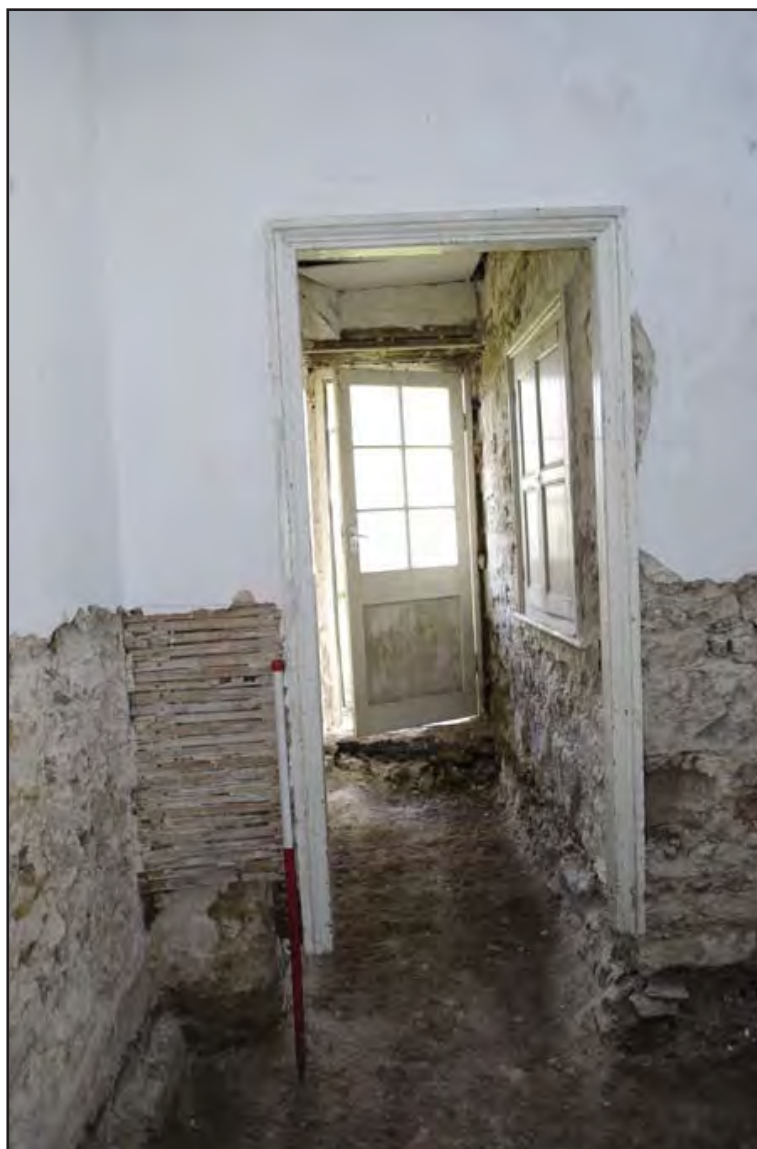
Plate 44: Lobby/Hall - interior view with detail of door D10 and plaster laths .  
Scale: 1.0m (archive image: G2483\_071).

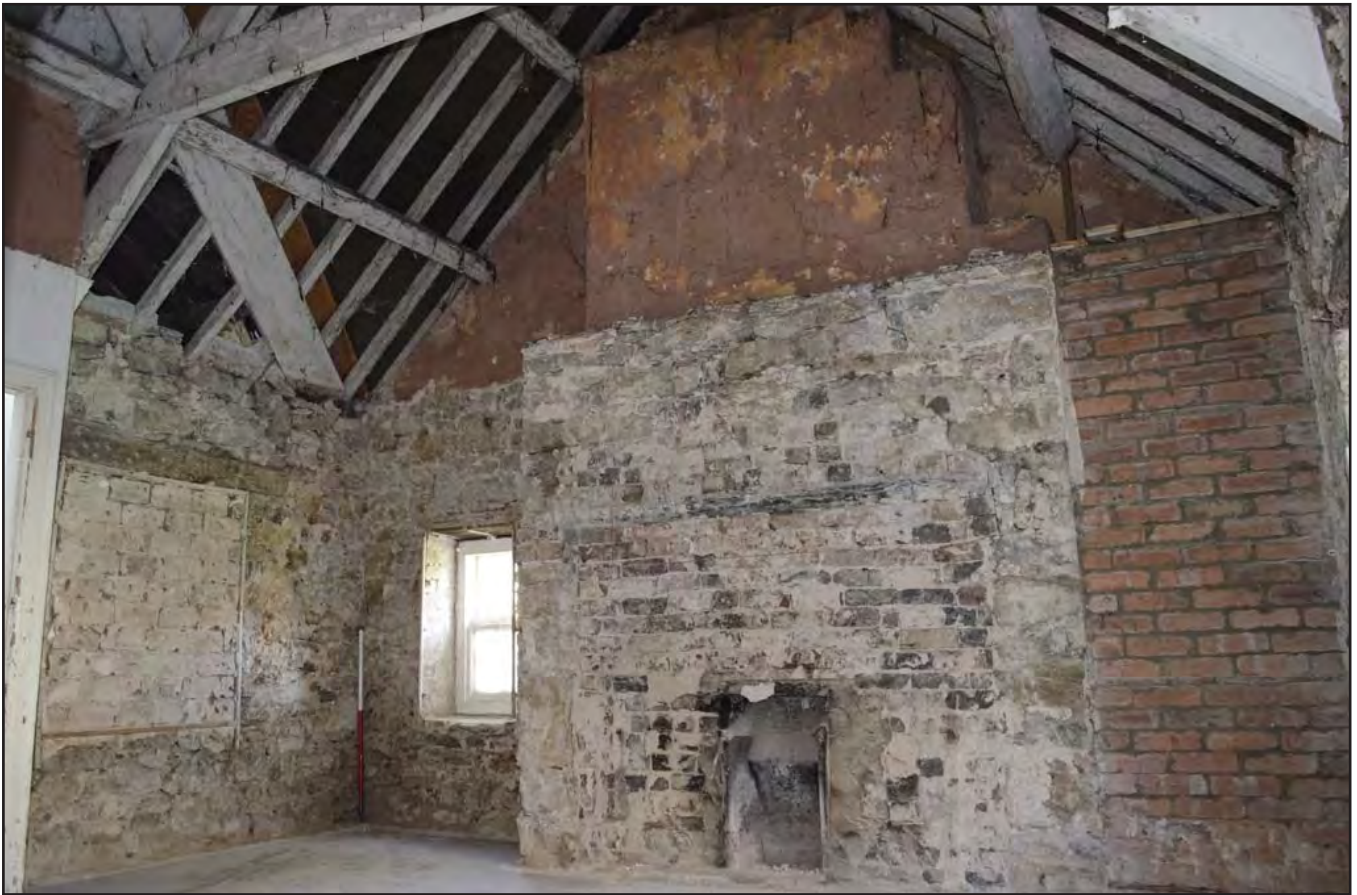
Plate 45: Office - interior view showing fireplace F04, window W06 & blocked window/C01. Scale: 1.0m (archive image: G2483\_077).

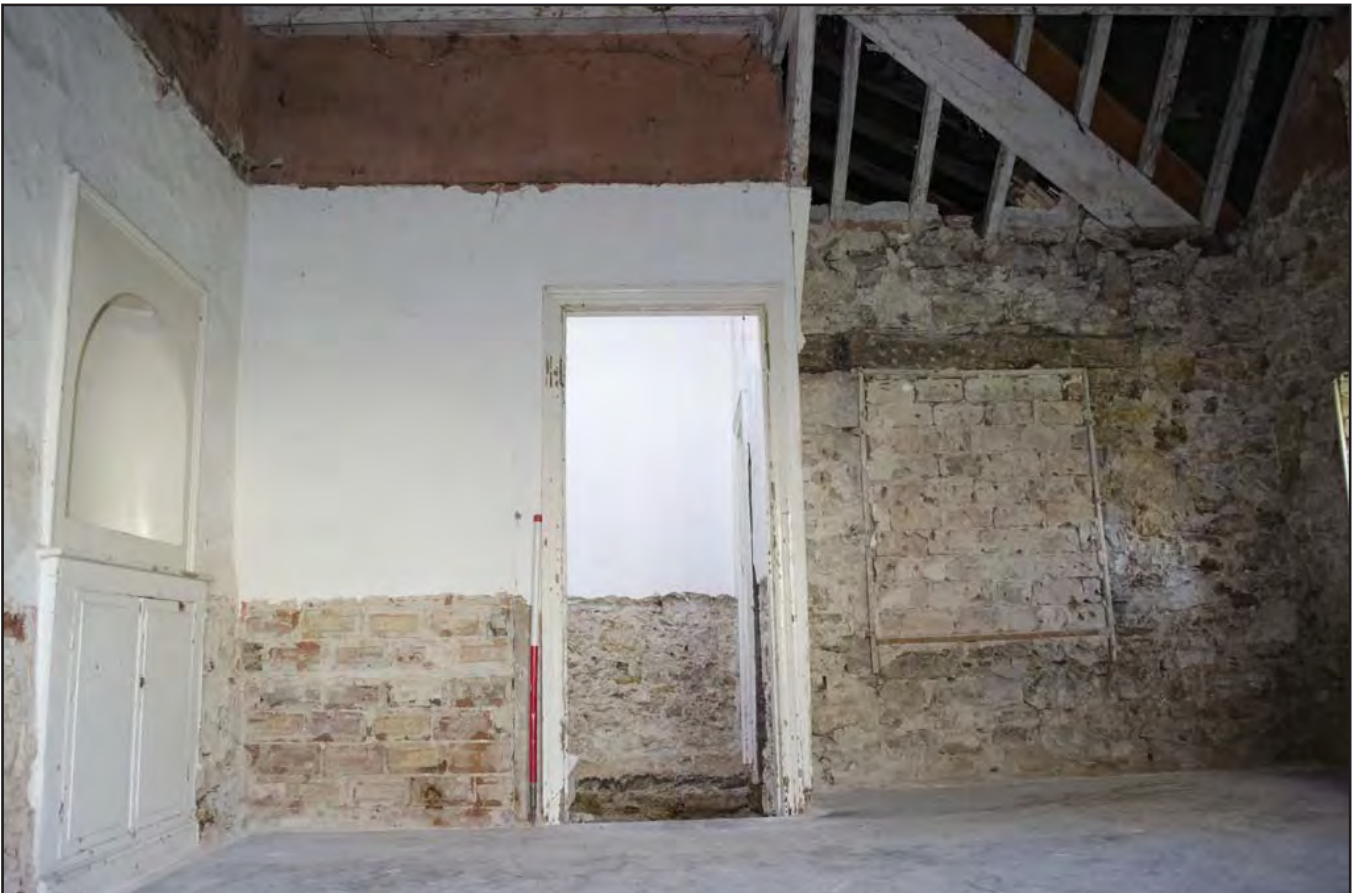
Plate 46: Office - interior view showing door D11 and blocked window. Scale: 1.0m (archive image: G2483\_078).

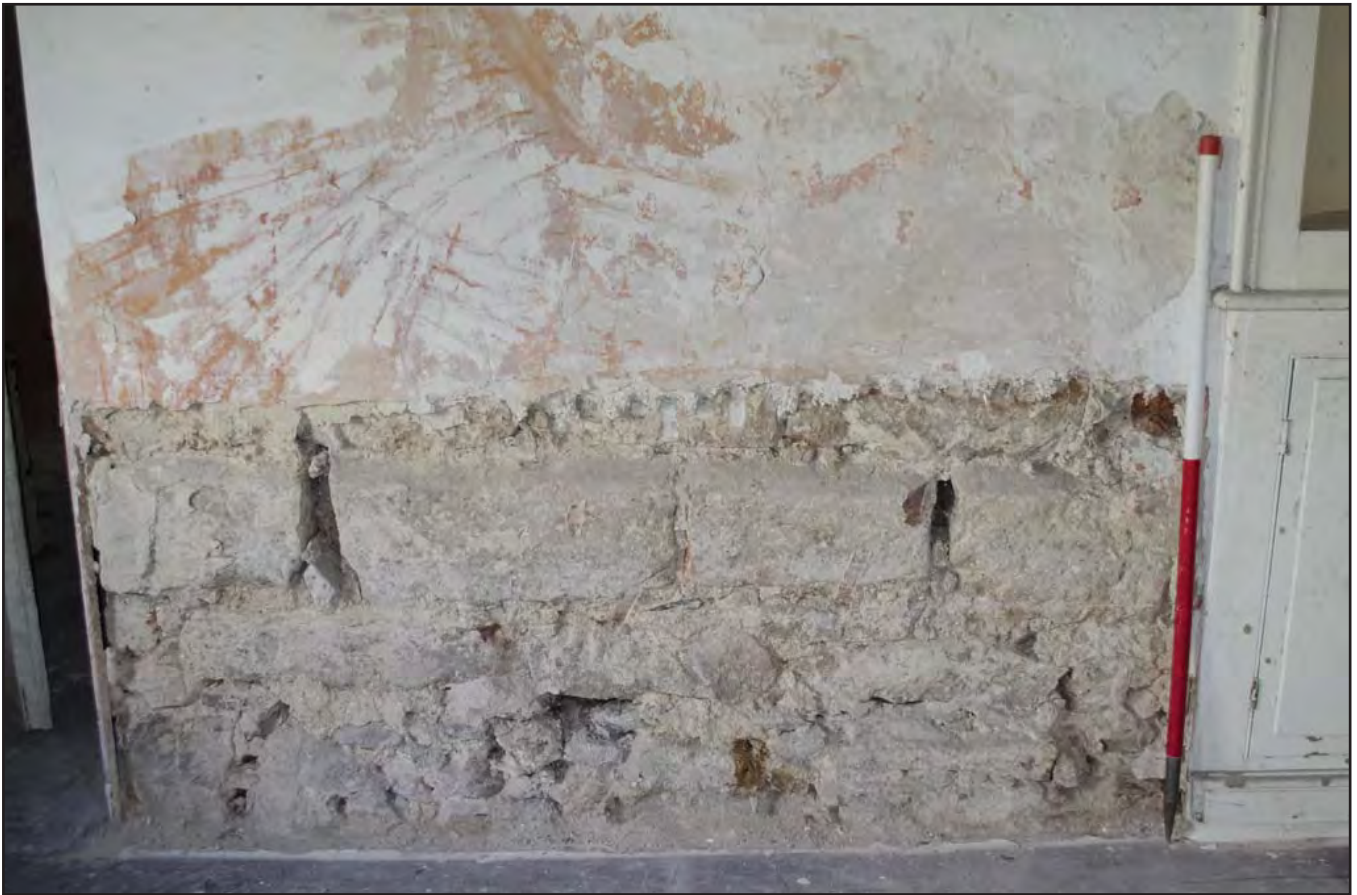
Plate 47: Office - interior view detailing chamfer masonry course, belonging to medieval grange. Scale: 1.0m (archive image: G2483\_080).
