# Quirt Farm, Dwyran

LEVEL 3 BUILDING RECORD &  
ARCHAEOLOGICAL WATCHING BRIEF

Project No. G2483

Report No. 1343

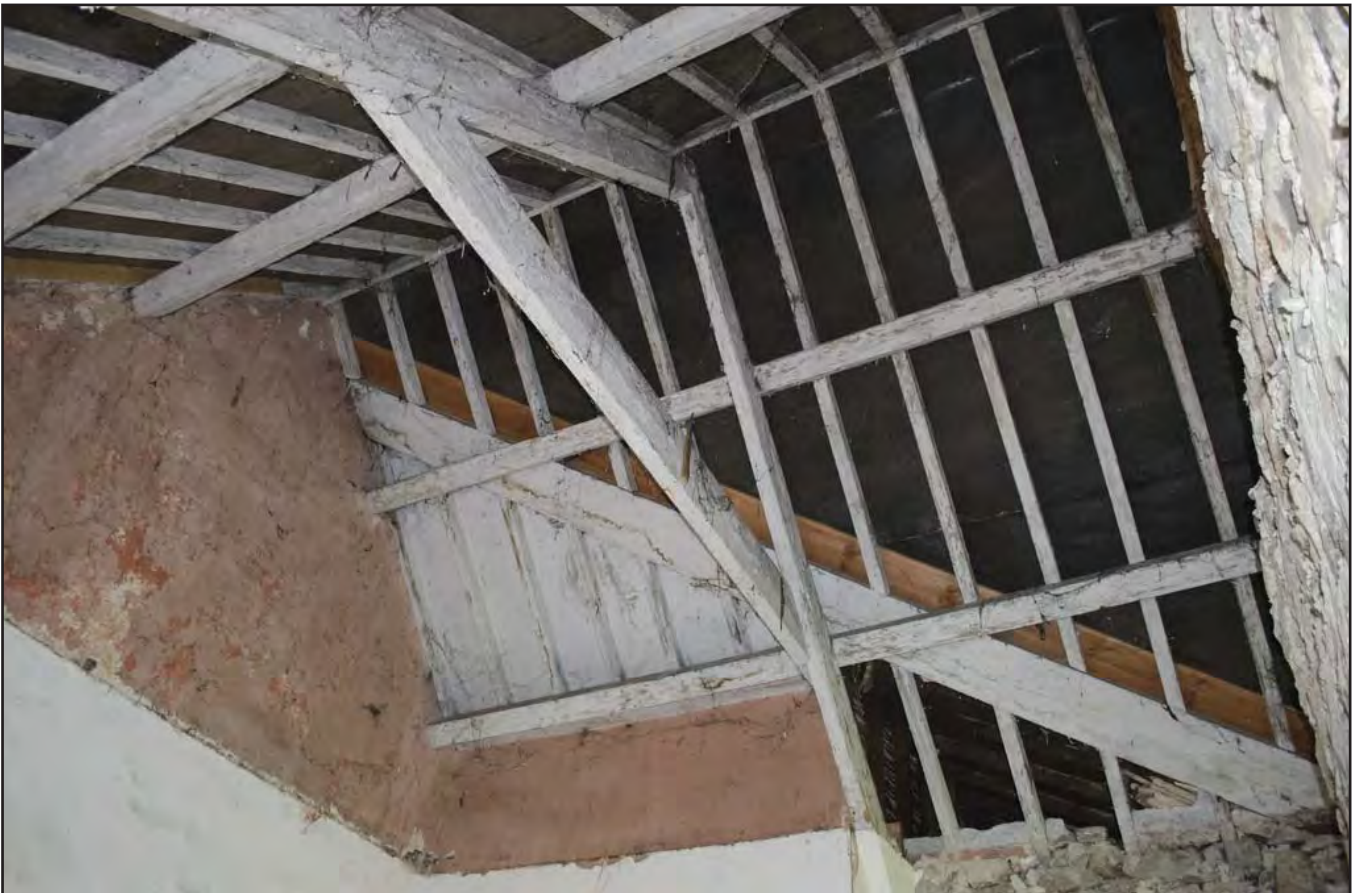
Plate 48: Office - interior view detailing roof beams and A-shaped truss (archive image: G2483\_082).

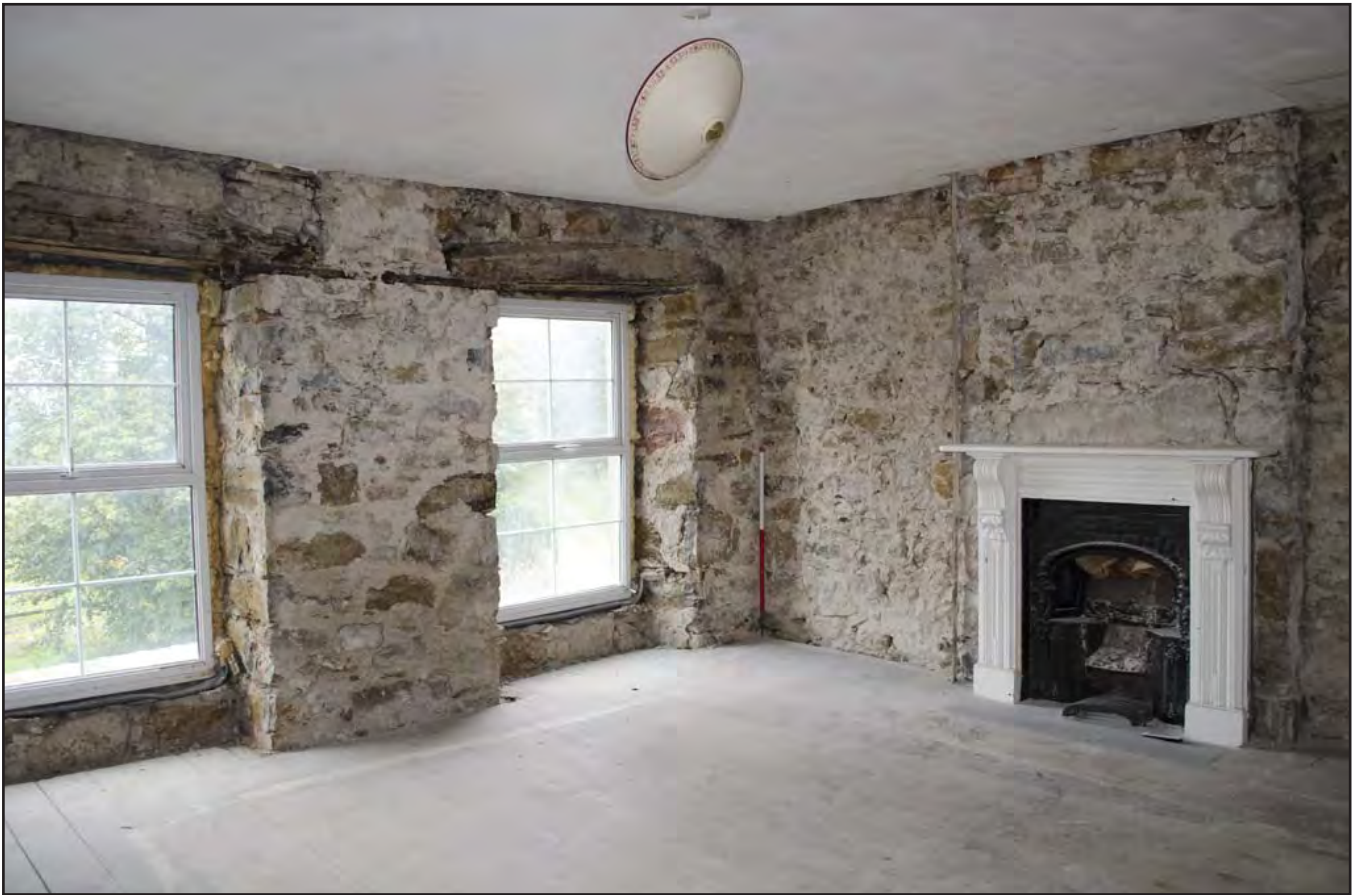
Plate 49: Bedroom 1 - interior view detailing fireplace F06, windows W12 and W13. Scale: 1.0m (archive image: G2483\_085).

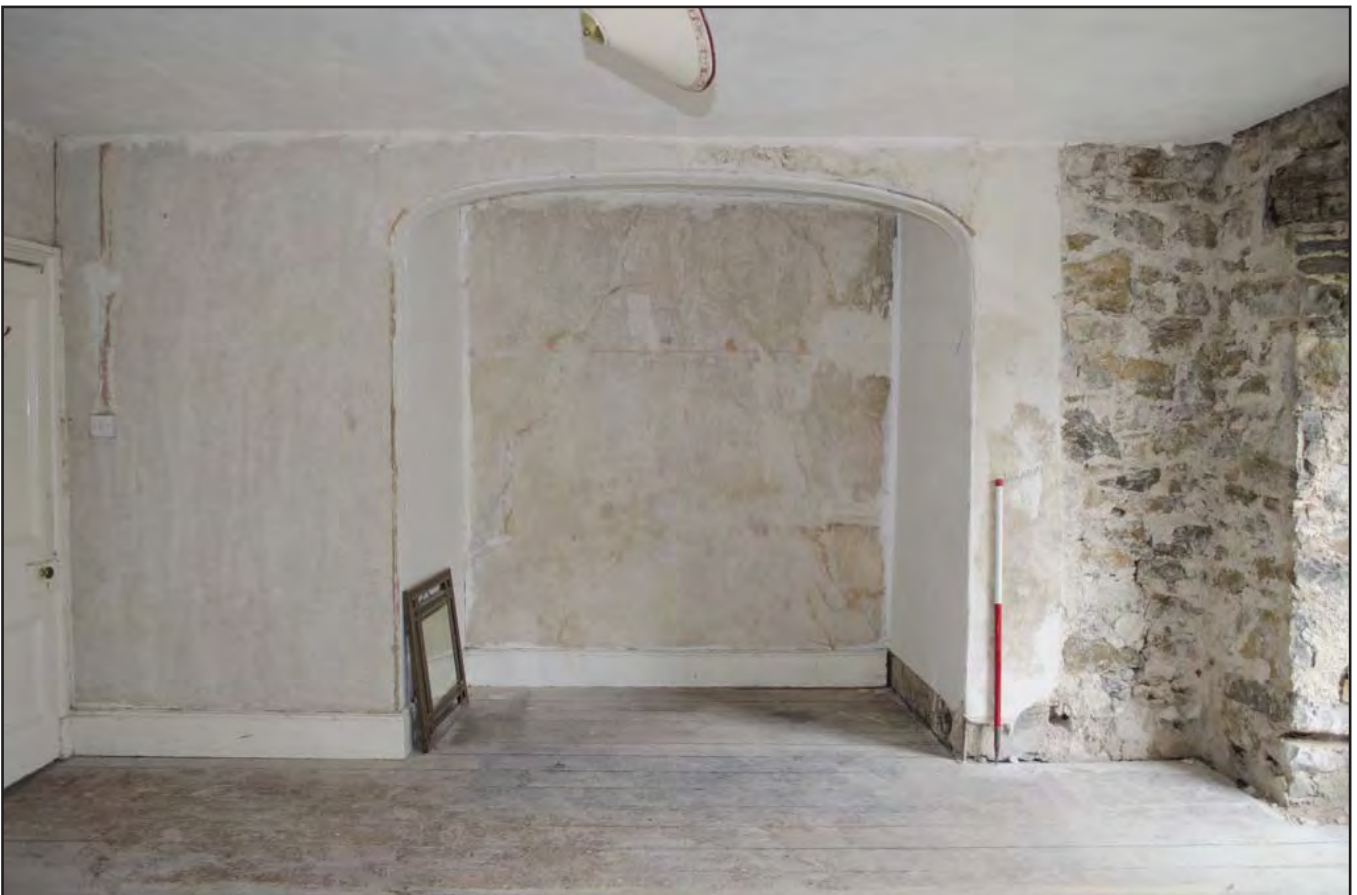
Plate 50: Bedroom 1 - interior view detailing alcove. Scale: 1.0m (archive image: G2483\_082).

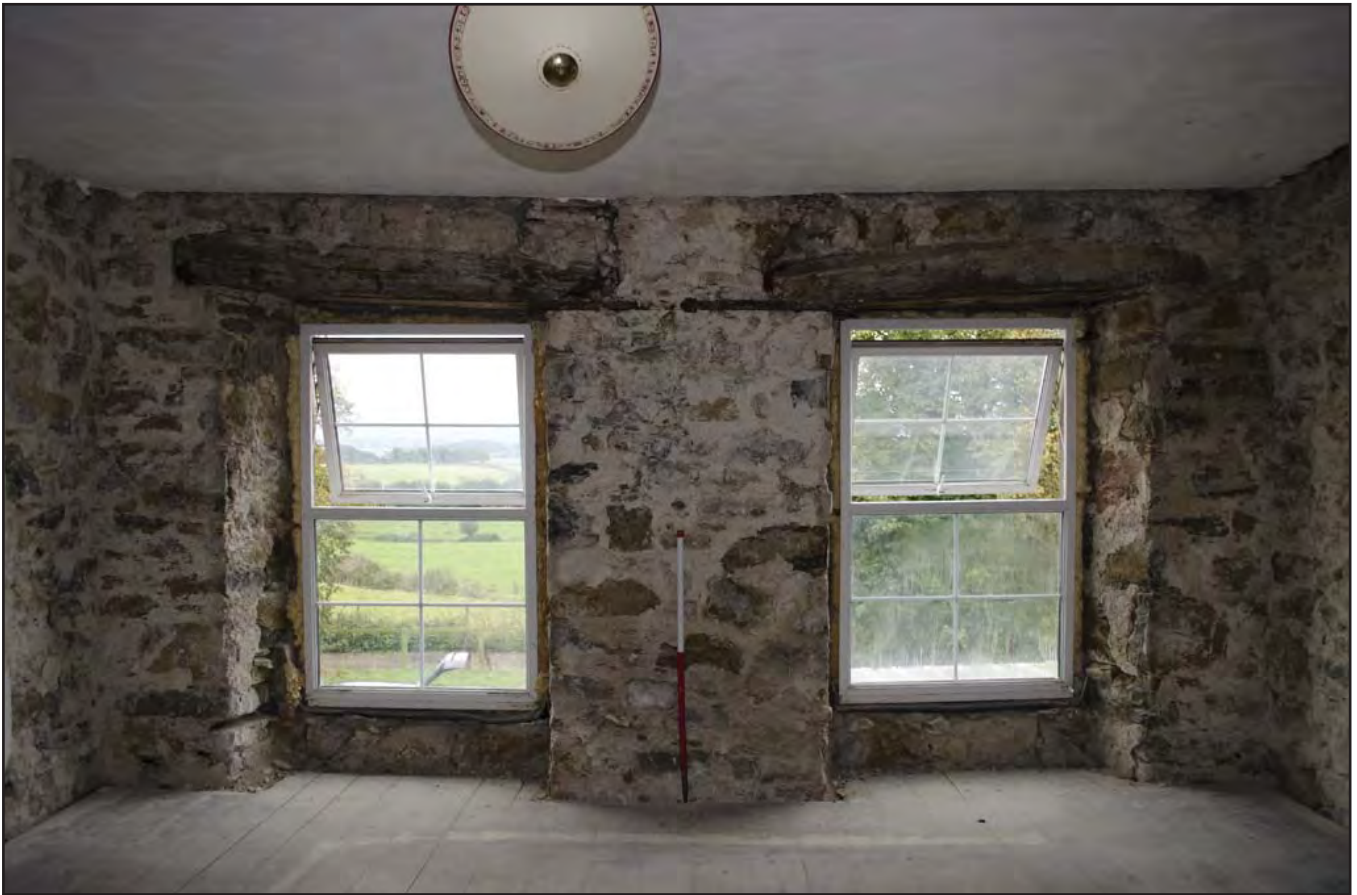
Plate 51: Bedroom 1 - interior view detailing windows W12 and W13, original timber frame above both windows and central iron supports. Scale: 1.0m (archive image: G2483\_091).

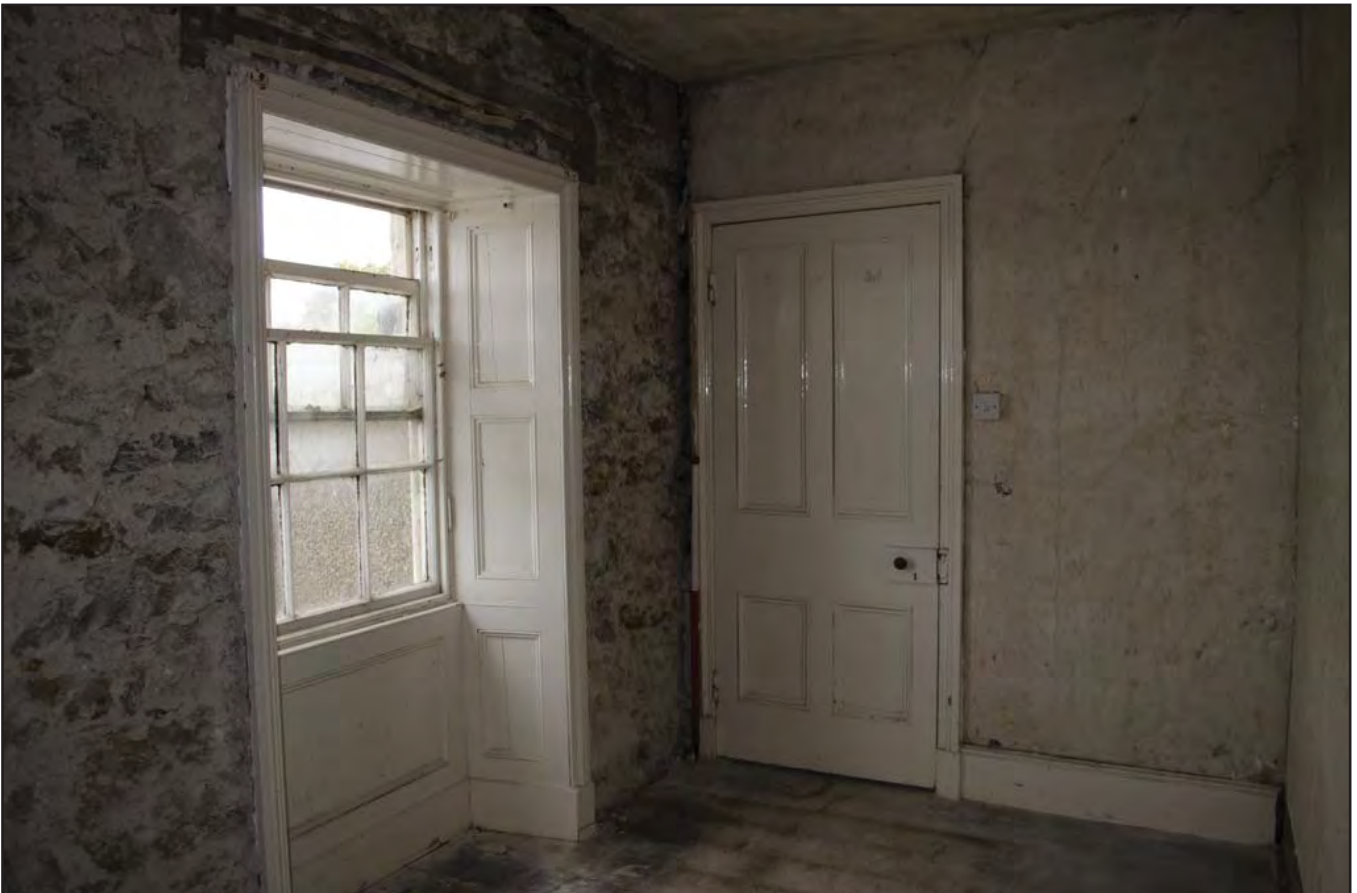
Plate 52: Bathroom - interior view detailing door D20 and window W20. Scale: 1.0m (archive image: G2483\_094).

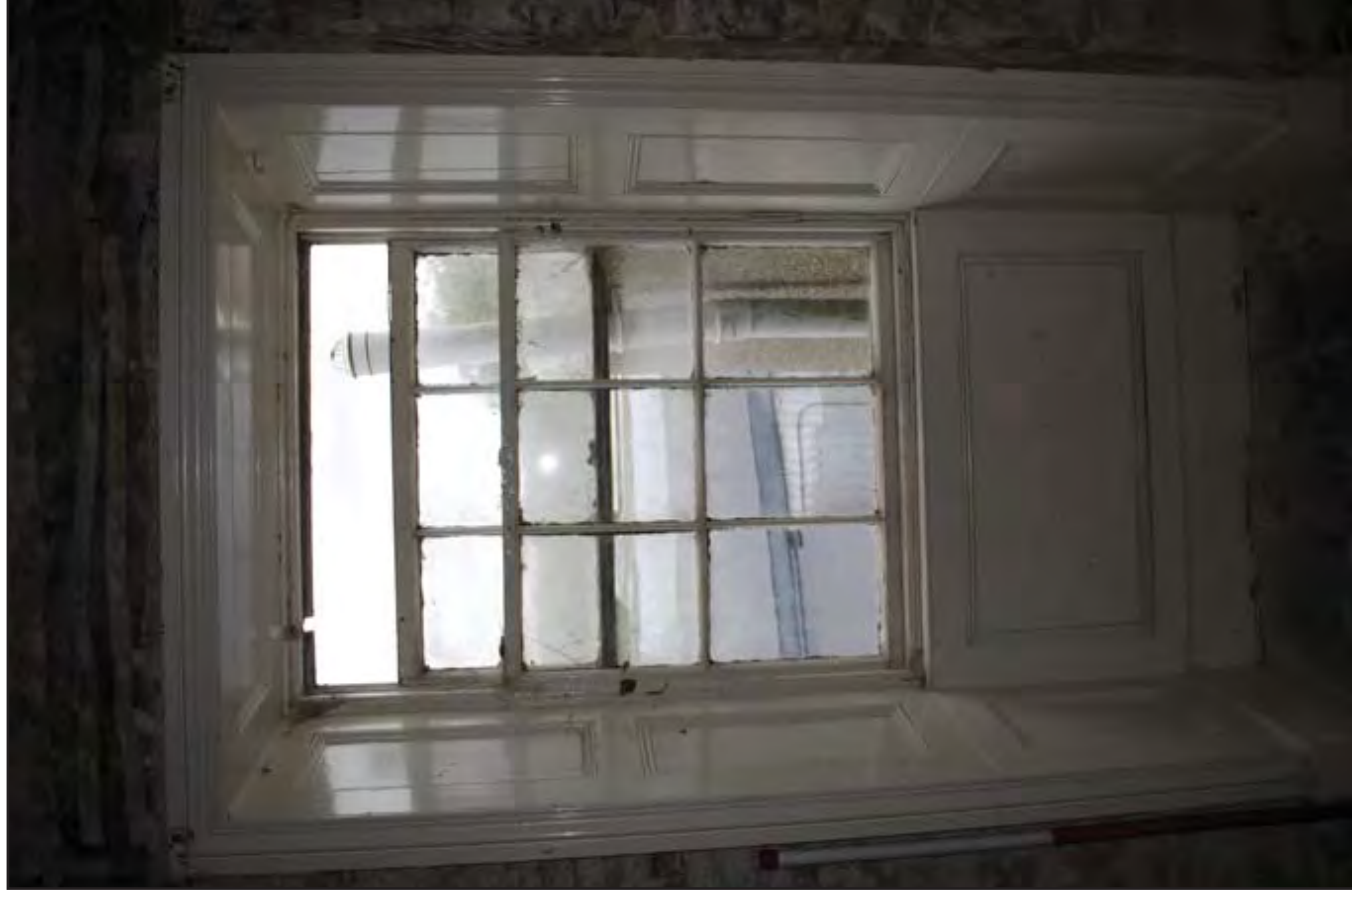
Plate 53: Bedroom 1 - interior view detailing window W20 with Georgian wood panelling. Scale: 1.0m (archive image: G2483\_097).

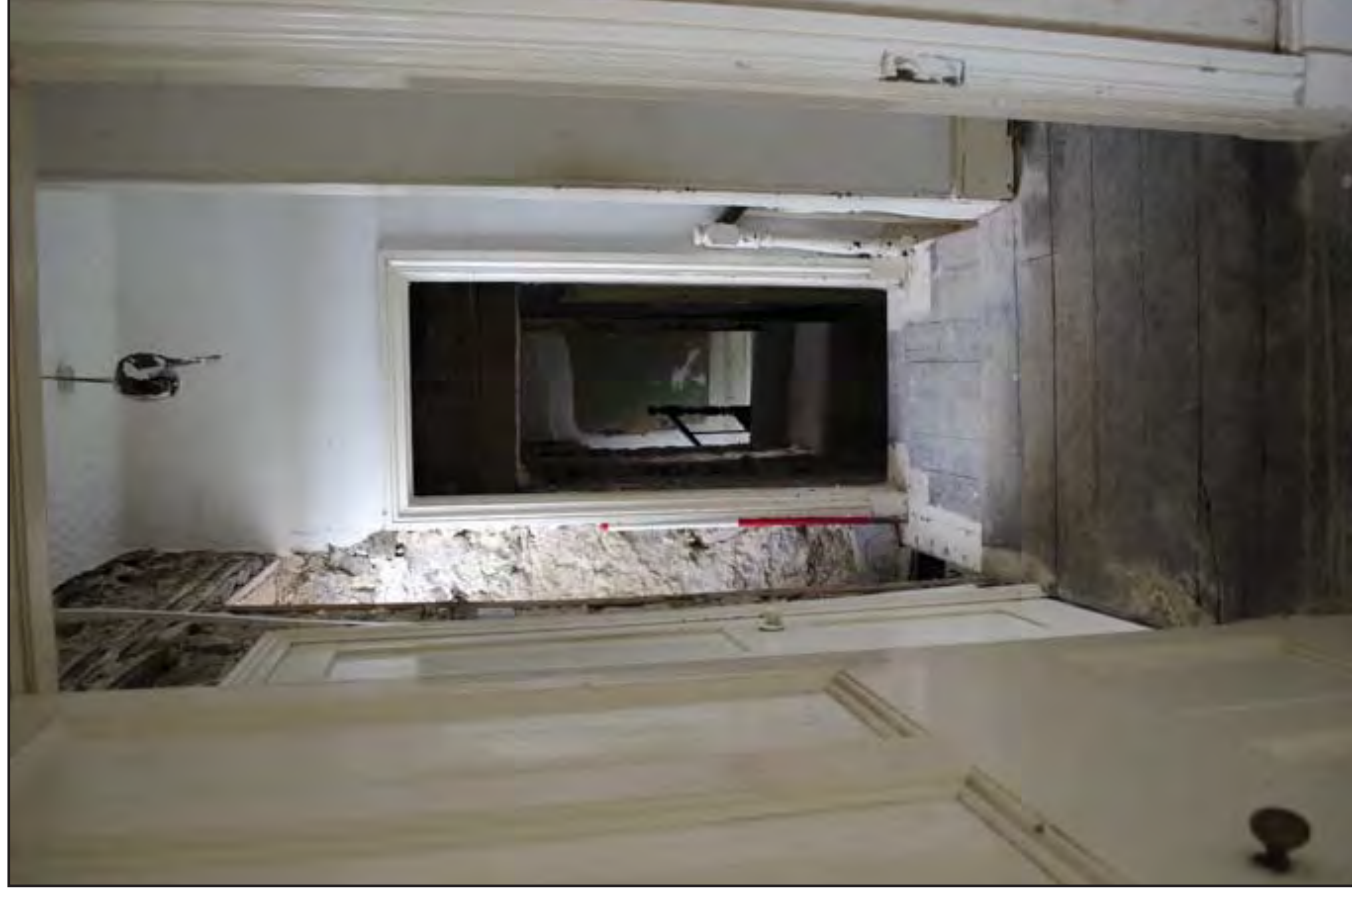
Plate 54: Landing - interior view of landing leading into corridor with main stair case and back staircase. Scale: 1.0m (archive image: G2483\_103).

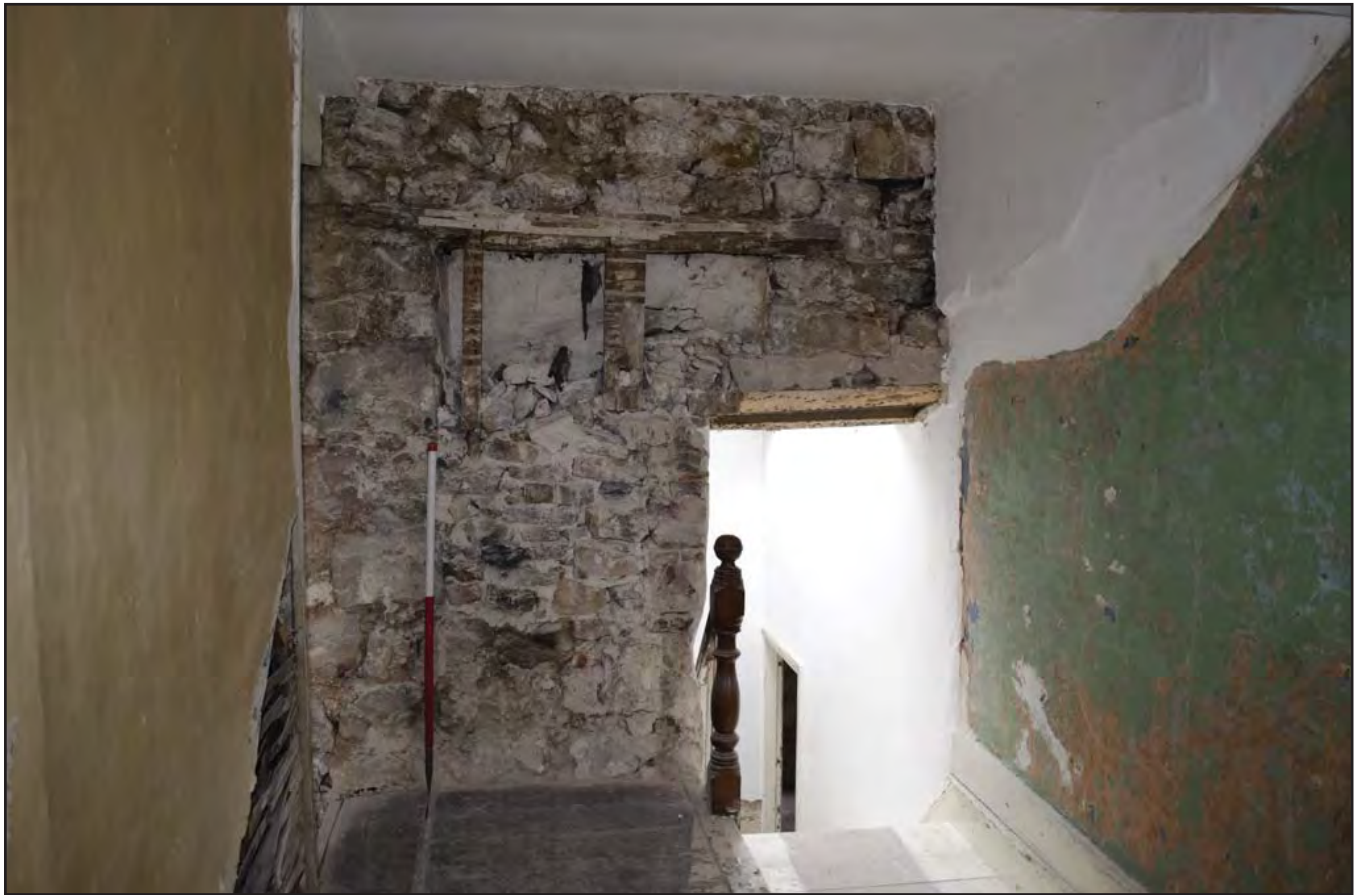
Plate 55: Corridor - interior view detailing stone wall and what appears to have once been a window. Scale: 1.0m (archive image: G2483\_108).

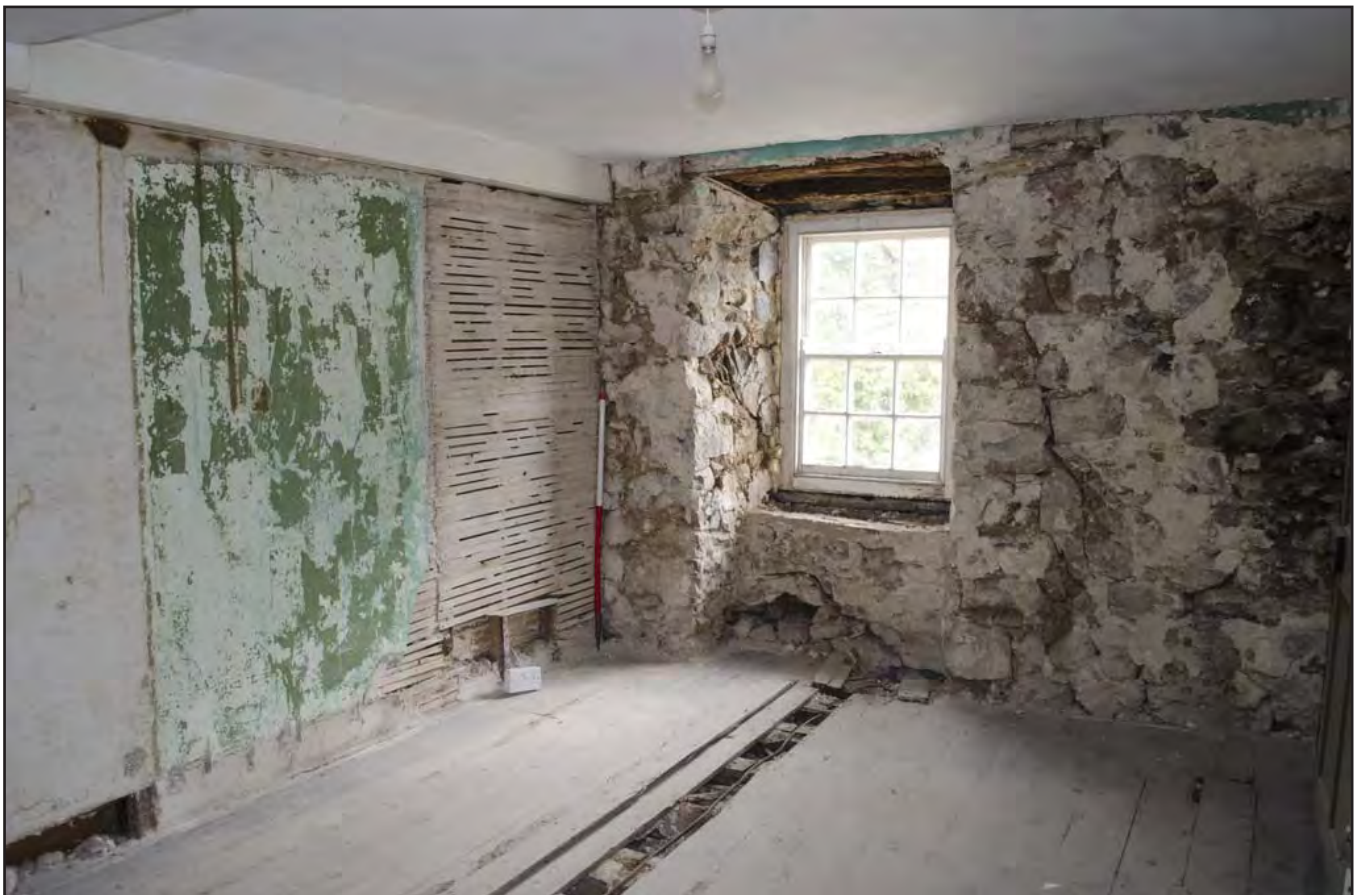
Plate 56: Bedroom 2 - interior view detailing 18th century plaster and original stone wall. Scale: 1.0m (archive image: G2483\_111).

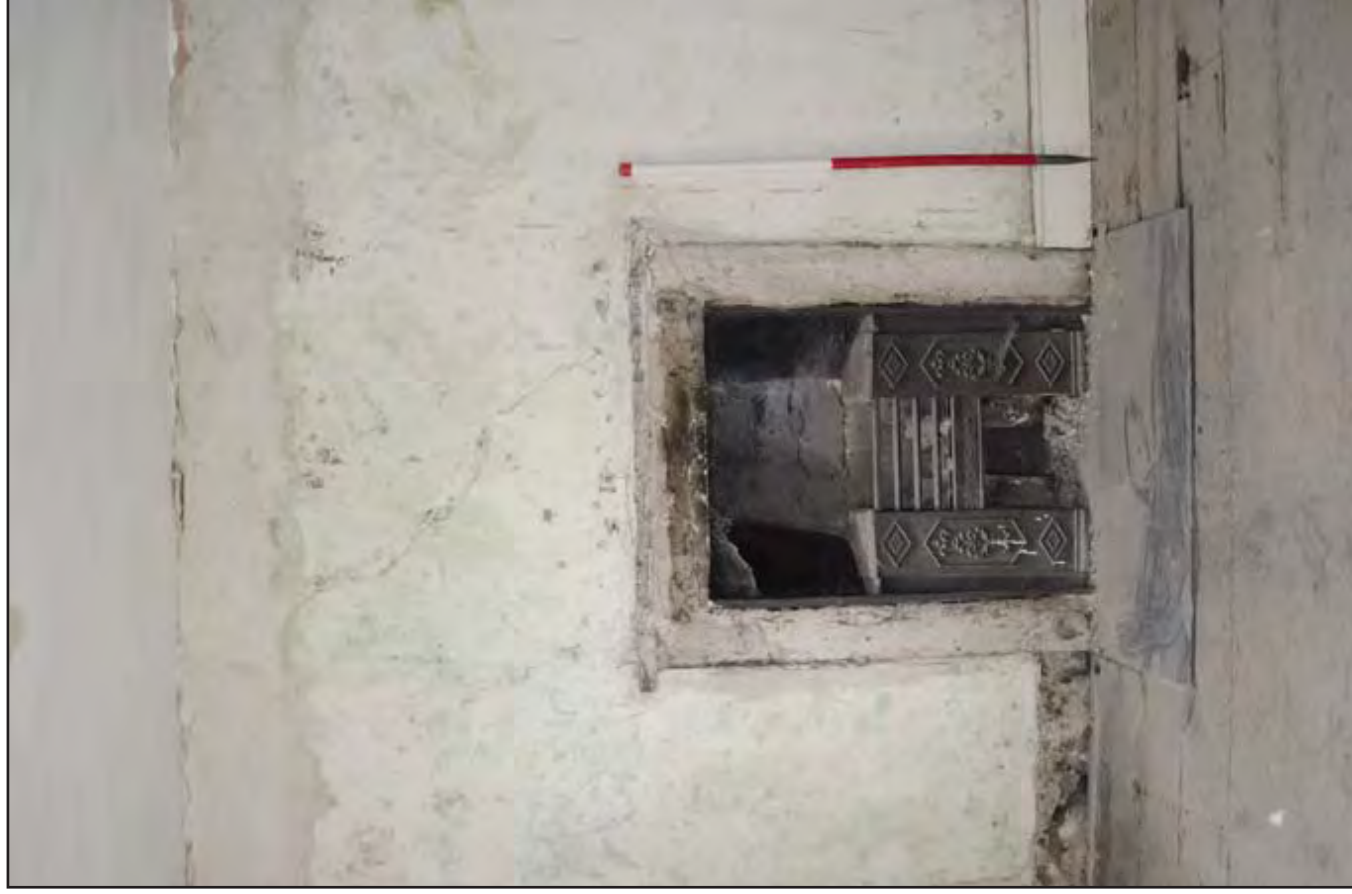
Plate 57: Bedroom 2 - interior view detailing Victorian fireplace F07, surrounded by 18th century plaster. Scale: 1.0m (archive image: G2483\_114).

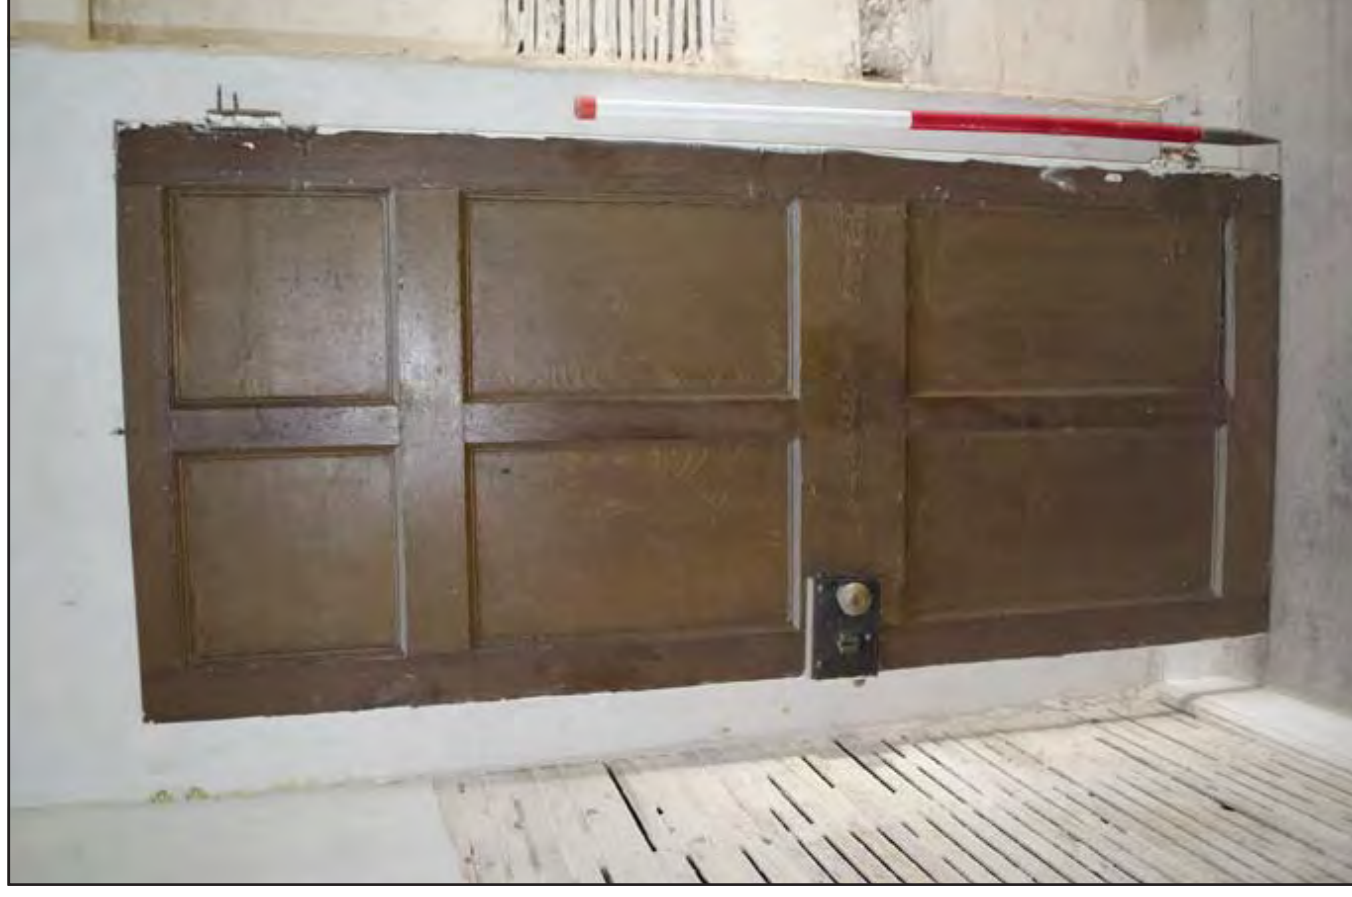
Plate 58: Bedroom 2 - interior view detailing unpainted door. Scale: 1.0m (archive image: G2483\_116).

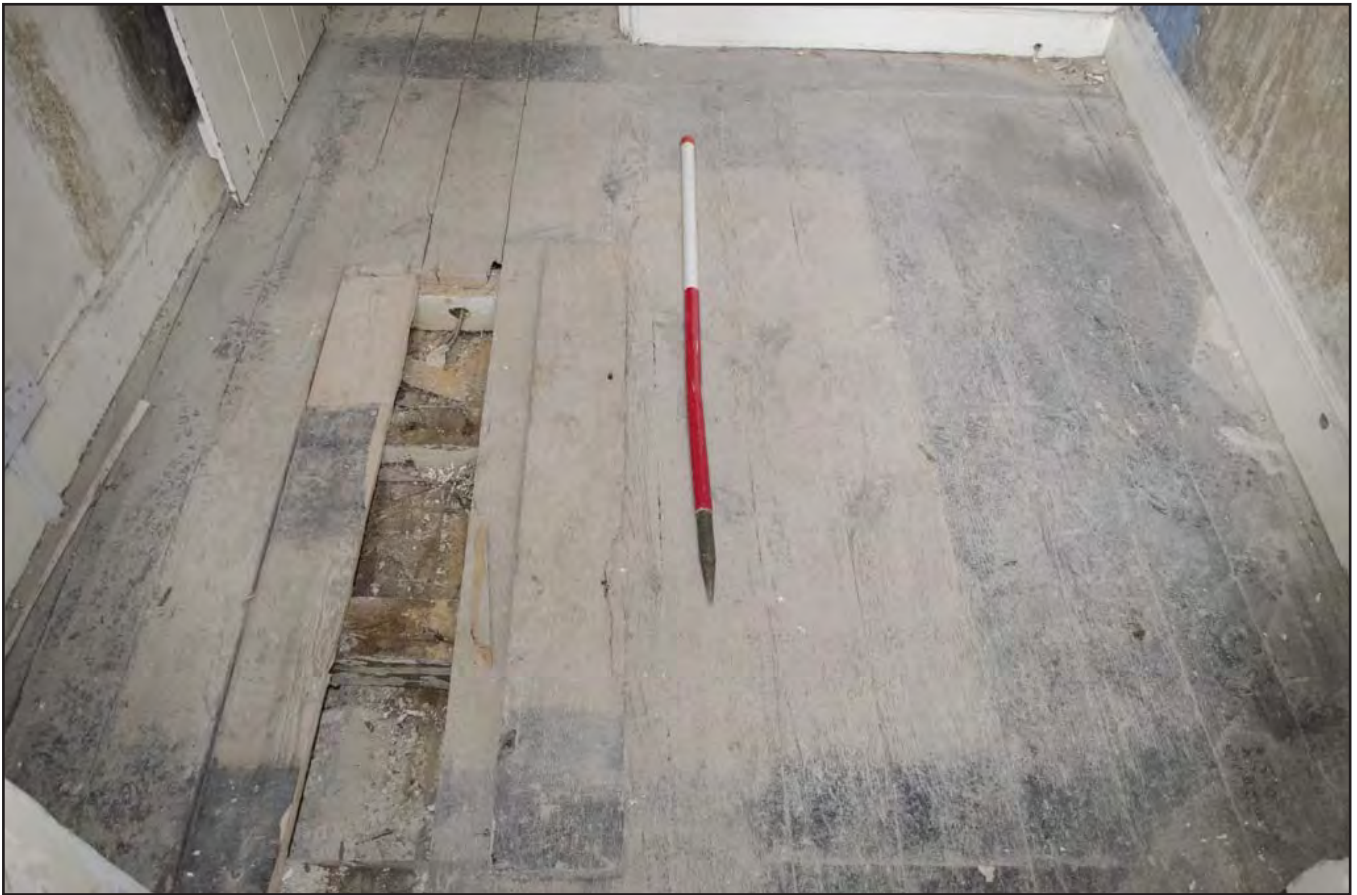
Plate 59: Bedroom 3 - interior view detailing floor timbers. Scale: 1.0m (archive image: G2483\_119).

A small south facing bedroom, roughly square with a planked door (D26), 0.75m wide and 1.83m tall in the northwest corner of it. The central window, 0.4m from east wall and 0.45m from west wall, was 1.45m tall and 1.1m wide, and was 0.7m above ground level. The window was of twelve pane horned sash type (19<sup>th</sup> century), and the sill survived (Plate 60). Apart from the window embrasure the room remained plastered and little information can be detained. The moulded skirting board was 0.13m high. Original brass door knobs survived, along with other door furniture. The floor boards were of a broad oak over wide joists, and may be 18<sup>th</sup> century or even 17<sup>th</sup> century in date (Plate 59). These were subsequently removed as part of the programme of refurbishment.

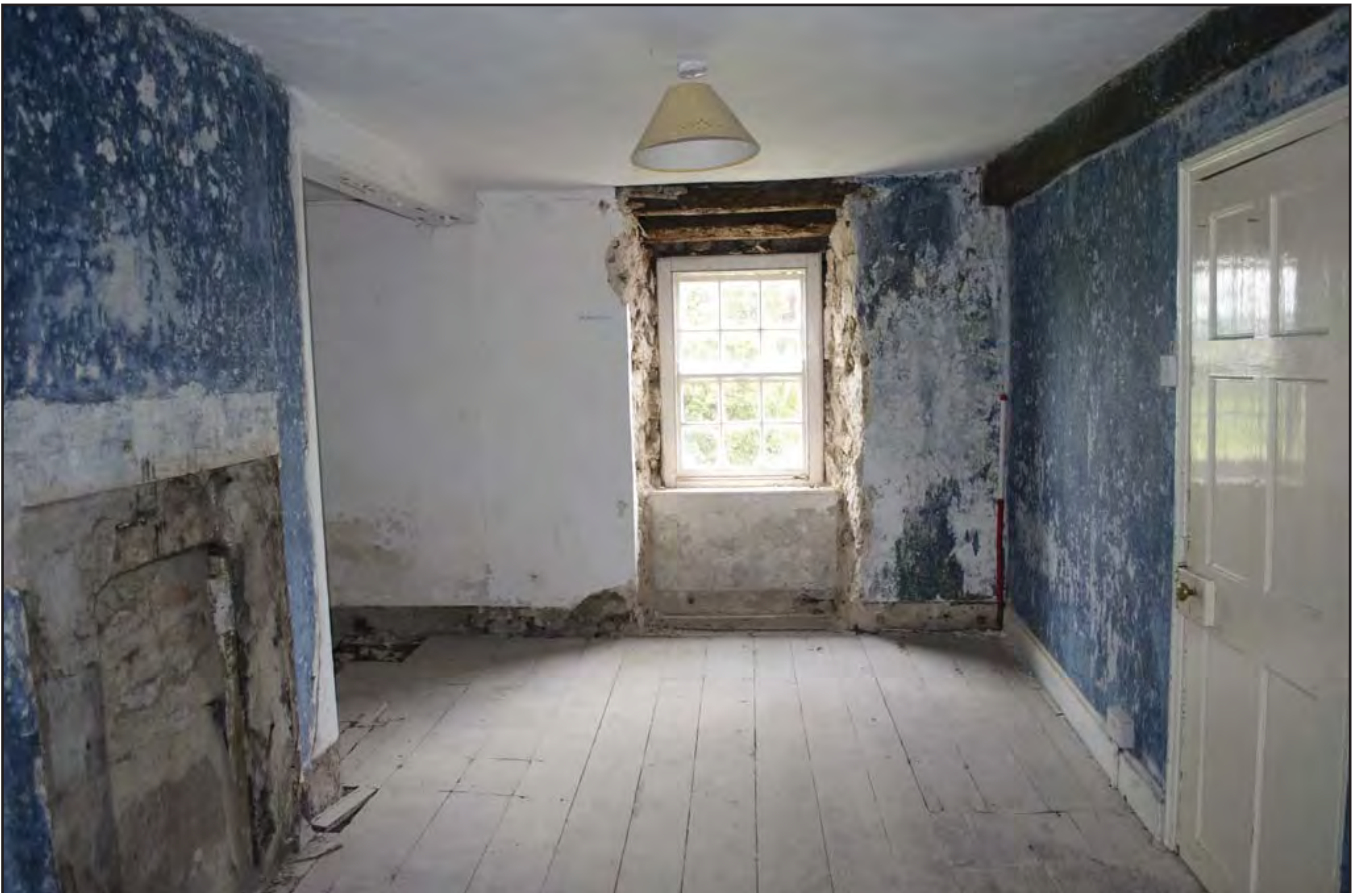
Plate 60: Bedroom 4 - interior view detailing door D27 and window W16. Scale: 1.0m (archive image: G2483\_122).

The window reveal has been stripped of plaster revealing rubble masonry, but no architectural detail could be observed. The sill was still *in situ*. Most of the room was plastered, so the observance of architectural details remained limited. The floor boards were of a broad oak over wide joists, and may be 18<sup>th</sup> century or even late 17<sup>th</sup> century in date (Plate 60). The latter were later removed as part of the refurbishment works.

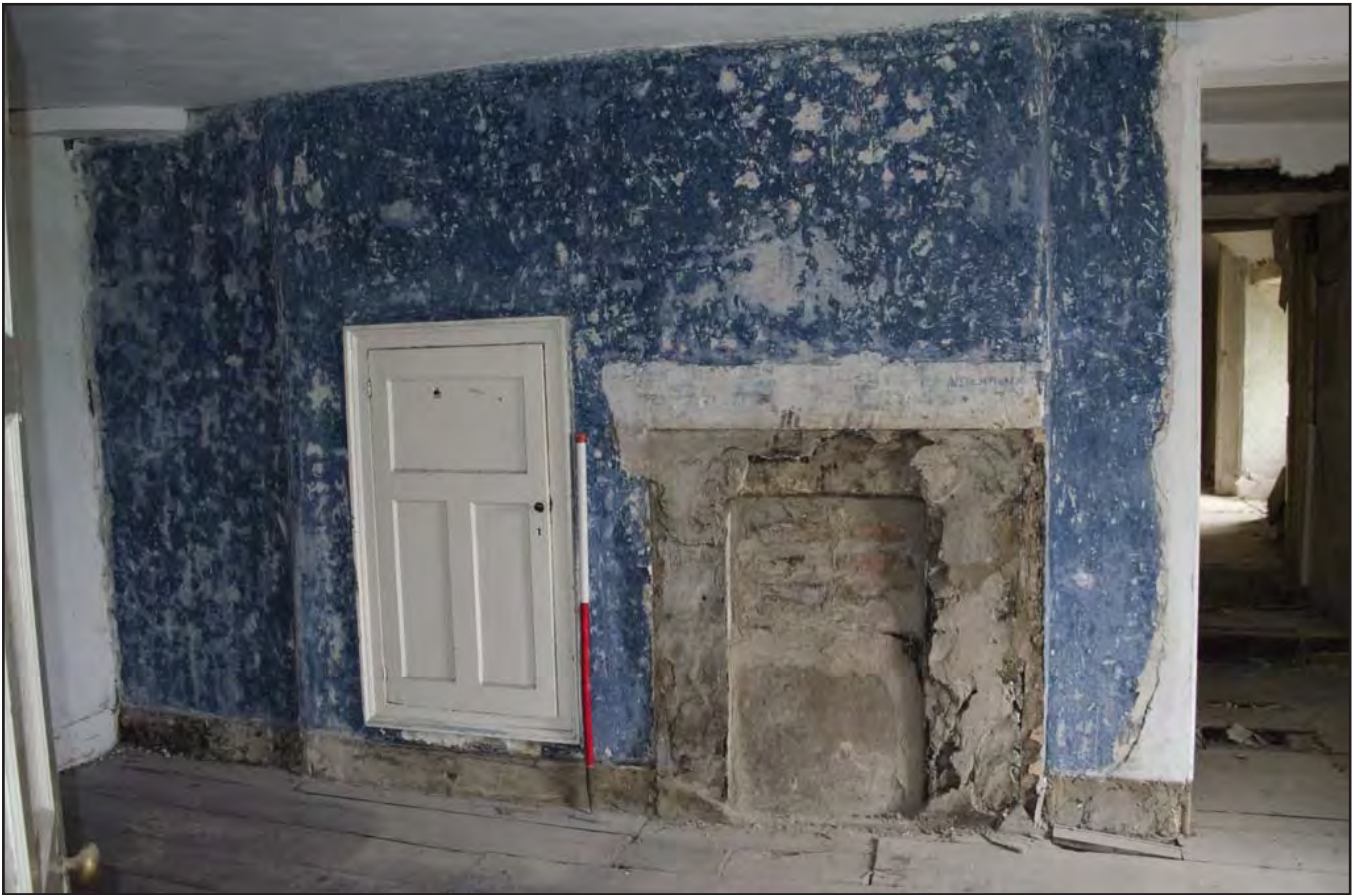
Plate 61: Bedroom 4 - interior view of blocked-up fireplace F09, built in cupboards C03 and chimney breast. Scale: 1.0m (archive image: G2483\_124).

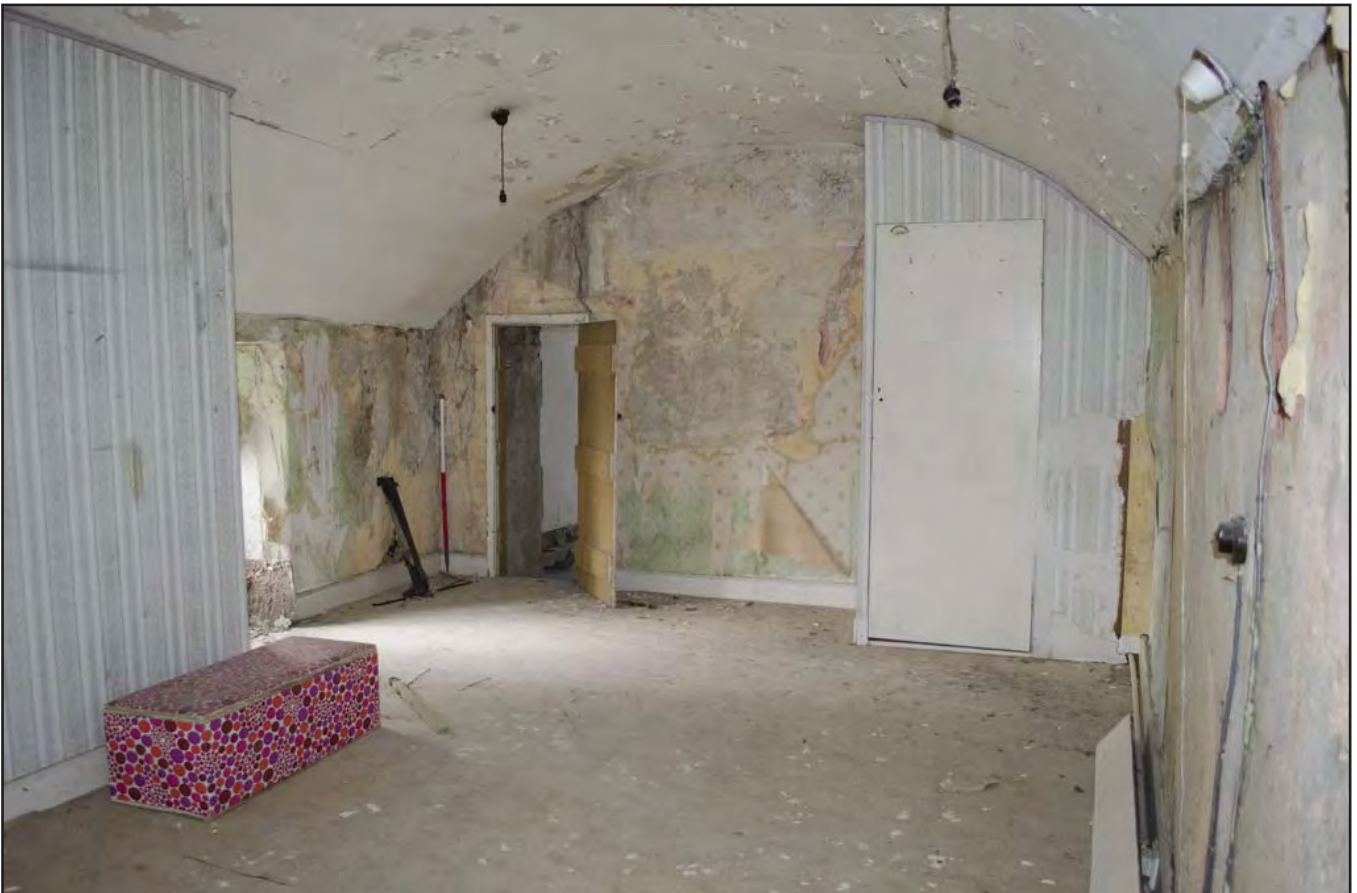
Plate 62: Disused Chapel - interior view looking entrance into Bedroom 4 via door D28, with cupboard C04 in view. Scale: 1.0m (archive image: G2483\_127).

The room had a west wall which was 0.7m thick and had a pointed arch shaped plasterboard ceiling, possibly covering an earlier roof of possible medieval date (Plate 62). On the north side the remnants of three closely spaced (0.5m apart) timbers formed part of possible former roof structure, possibly medieval in date (Plate 64). They were noted 1.55m west of the east wall of the former chancel on the north side wall only. On the south side, inside a boxed stairwell, one timber was noted which mirrored the western most timber on the northern side. The others may have been present but were covered with plaster. The southernmost one was 0.23m x 0.1m and the other was approximately 0.1m x 0.08m, sawn off at the wall face. Given the shape of the roof, it is possible that further original timbers survive below the later work. A date stone 0.26m x 0.23m was set into the eastern gable wall; it was a limestone block with "1706 W TM" on its surface (Plate 63).

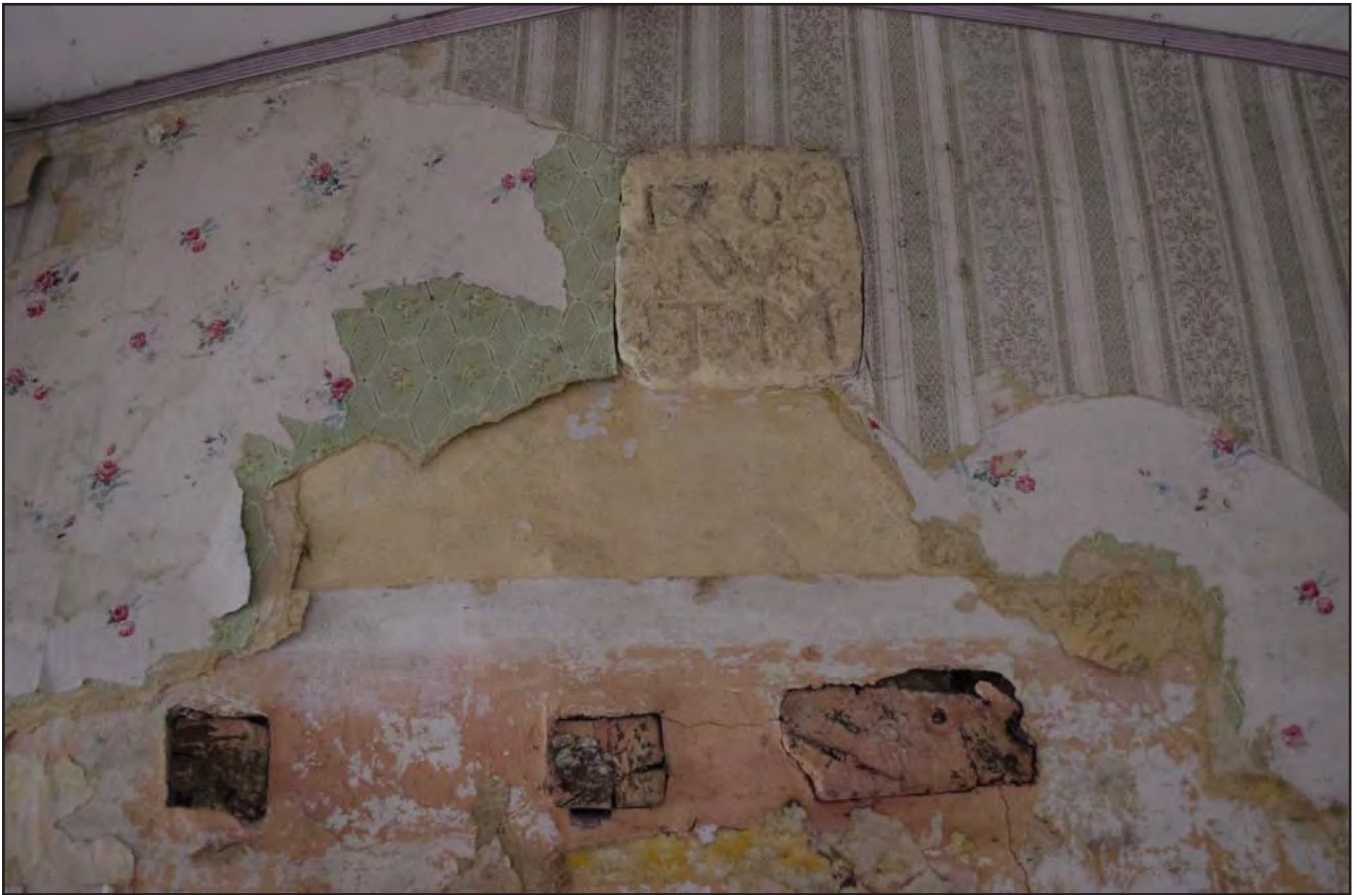
Plate 63: Disused Chapel - interior view detailing plaque reading "1706 W T M" and truncated beams (archive image: G2483\_128).

Two date stones of 1686 and 1706, along with the initials TMW, were noted, the 1706 one in this upper room, and the 1686 one in the external gable wall, which is obscured now by the eastern range of farm buildings (RCAHMW 1937, 92). It was also stated that much of the structure was altered and obscured by later alterations, which is clearly the case. It was also reported in 1932 that 'the present tenant has found graves on the south side of the building' (RCAHMW, C42238).

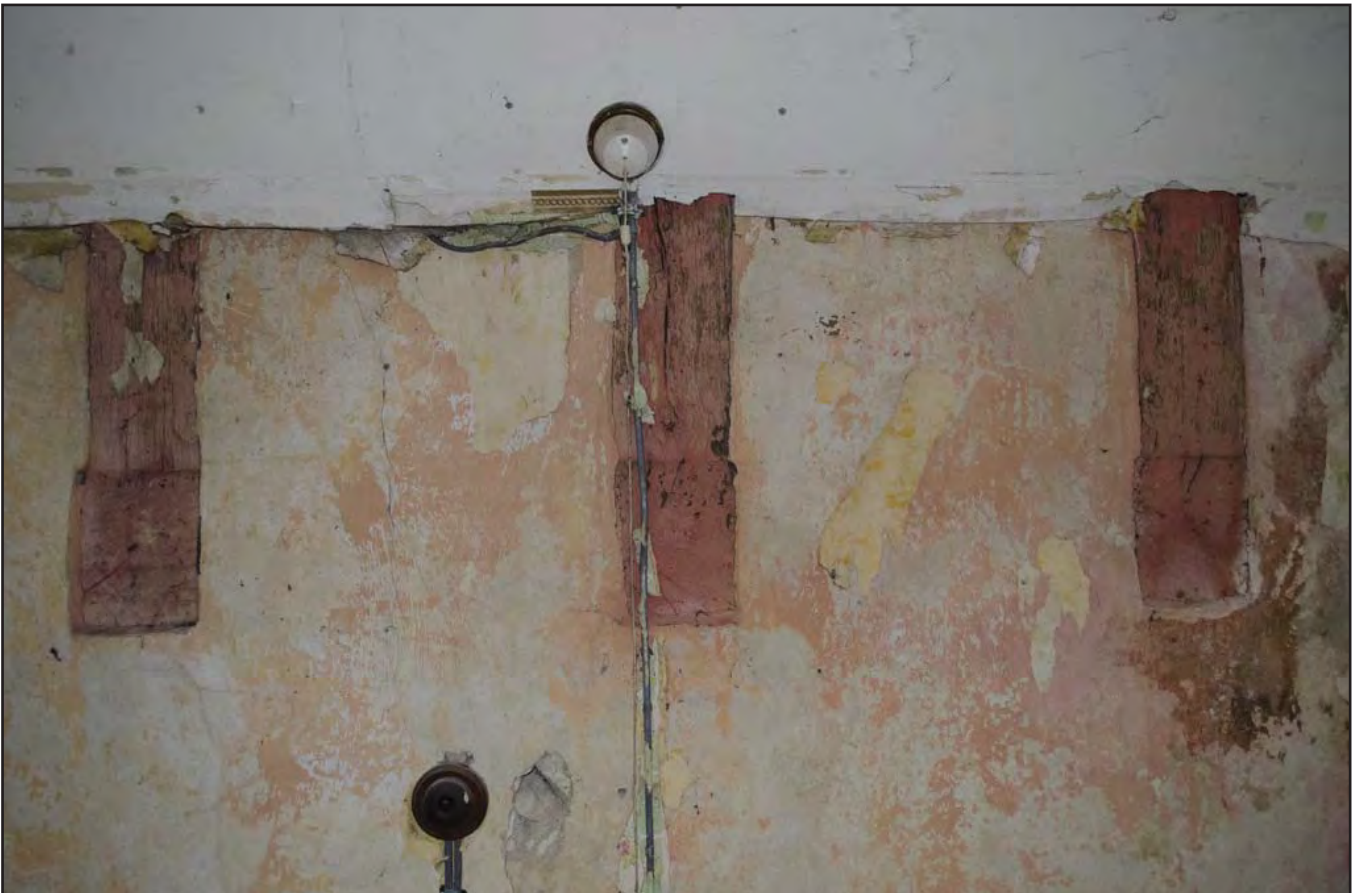
Plate 64: Disused Chapel - interior view detailing truncated beams. Scale: 1.0m (archive image: G2483\_157).
