# Quirt Farm, Dwyran

LEVEL 3 BUILDING RECORD &  
ARCHAEOLOGICAL WATCHING BRIEF

Project No. G2483

Report No. 1343

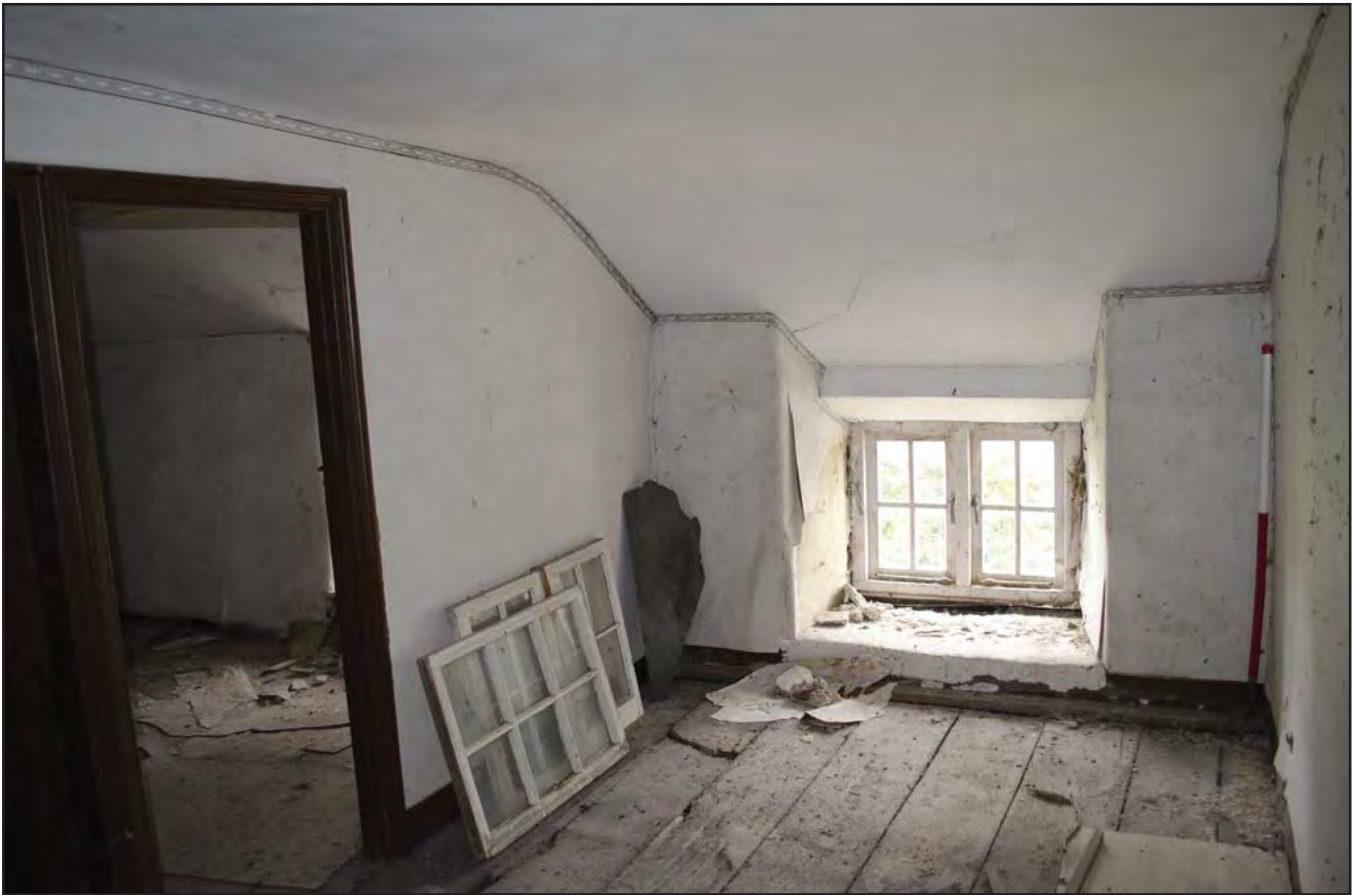
Plate 65: Attic 1: Lobby - interior view detailing door D29 and window W18. Scale: 1.0m (archive image: G2483\_130).

inserted by the current occupiers as a draft excluder (R. O. Davies, *pers. comm.*). An 18<sup>th</sup> to 19<sup>th</sup> century wooden 4 sash window (W22) was still in use (Plate 65). W22 has a height of 0.65m x 0.93m set in a depth of 0.61m. The appearance of the ceiling plasterwork appears to date it to the 19<sup>th</sup> century (Plate 66). The lobby's ceiling was arched, following the shape of the roof beams. The area above lobby ceiling could be accessed via Room A. The late 17<sup>th</sup> to mid-18<sup>th</sup> century oak floorboards were in place, of which each individual plank (5.64m x 0.24m, 0.045m thick) covered the entire breadth of the building on a north to south axis. The planks that ran below Rooms A and B were probably a later 18<sup>th</sup> - 19<sup>th</sup> century feature, though they were truncated by the later staircase addition to the lobby area (measuring a length up to 3.85m). The floorboards were damaged by woodworm and dry rot (Plate 66), and removed as part of the refurbishment works.

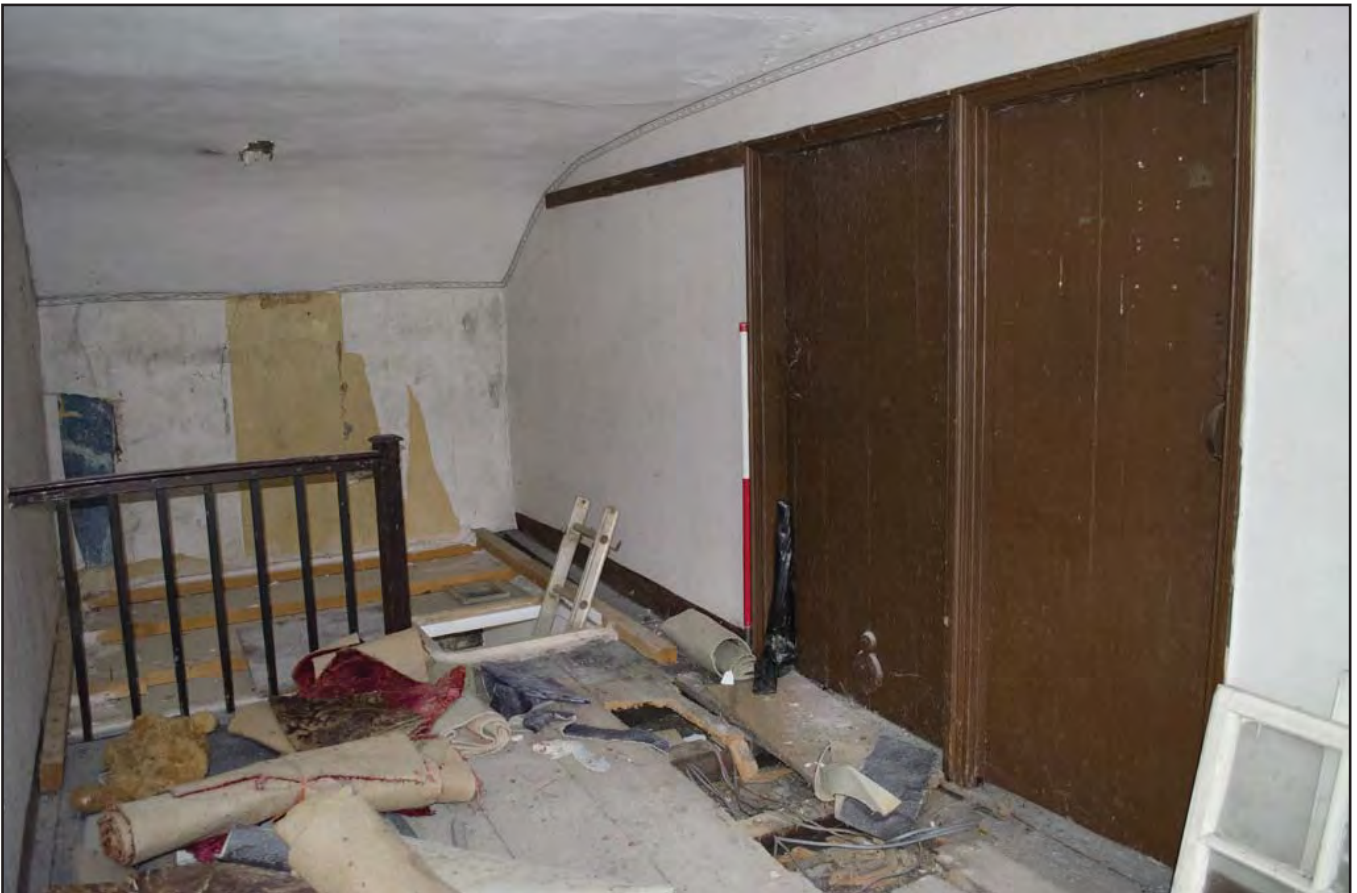
Plate 66: Attic 1: Lobby - interior view detailing bannister and doors D28 and D29 (closed). Scale: 1.0m (archive image: G2483\_131).

The lobby was a small rectangular room which led into Room A and B. An existing bannister of probable Edwardian date suggested that stairs once lead into the lobby (Plate 66). At the northern end of the entrance, modern plaster boards had been

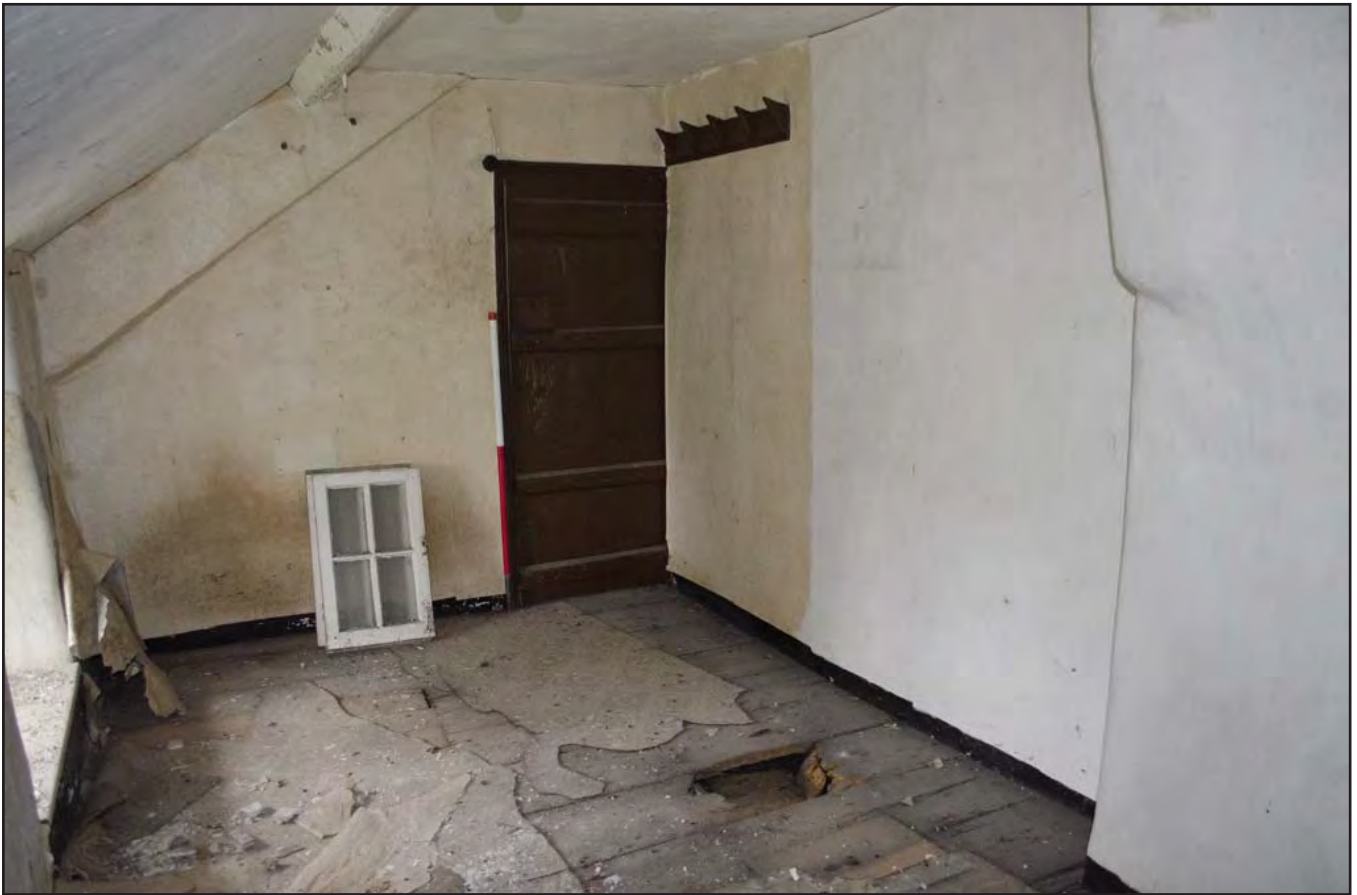
Plate 67: Attic 1: Room B - interior view detailing door D29 and wooden coat rack Scale: 1.0m (archive image: G2483\_133).

A small rectangular room, likely to have once been a farm-hands or servants bedroom, with an exposed roof truss beam a south end (Plate 67). Window W21, was the same as W22, baring height of 0.71m x 0.86m set in a depth of 0.60m. Modern graffiti, dating back to 1981 could be found around the western edge of window. In the northern corner of Room B, the large 17<sup>th</sup> century chimney breast was visible, with evidence of stepping in the southern chimney corner. The possibly 17<sup>th</sup> - 18<sup>th</sup> floorboards ran continuously under the portioned wall into Room A (Plate 67). Room B was accessed via early 19<sup>th</sup> century wooden latch door D29 (1.67m x 0.63m), a built in wooden coat hanger was still present against the north wall by D29.

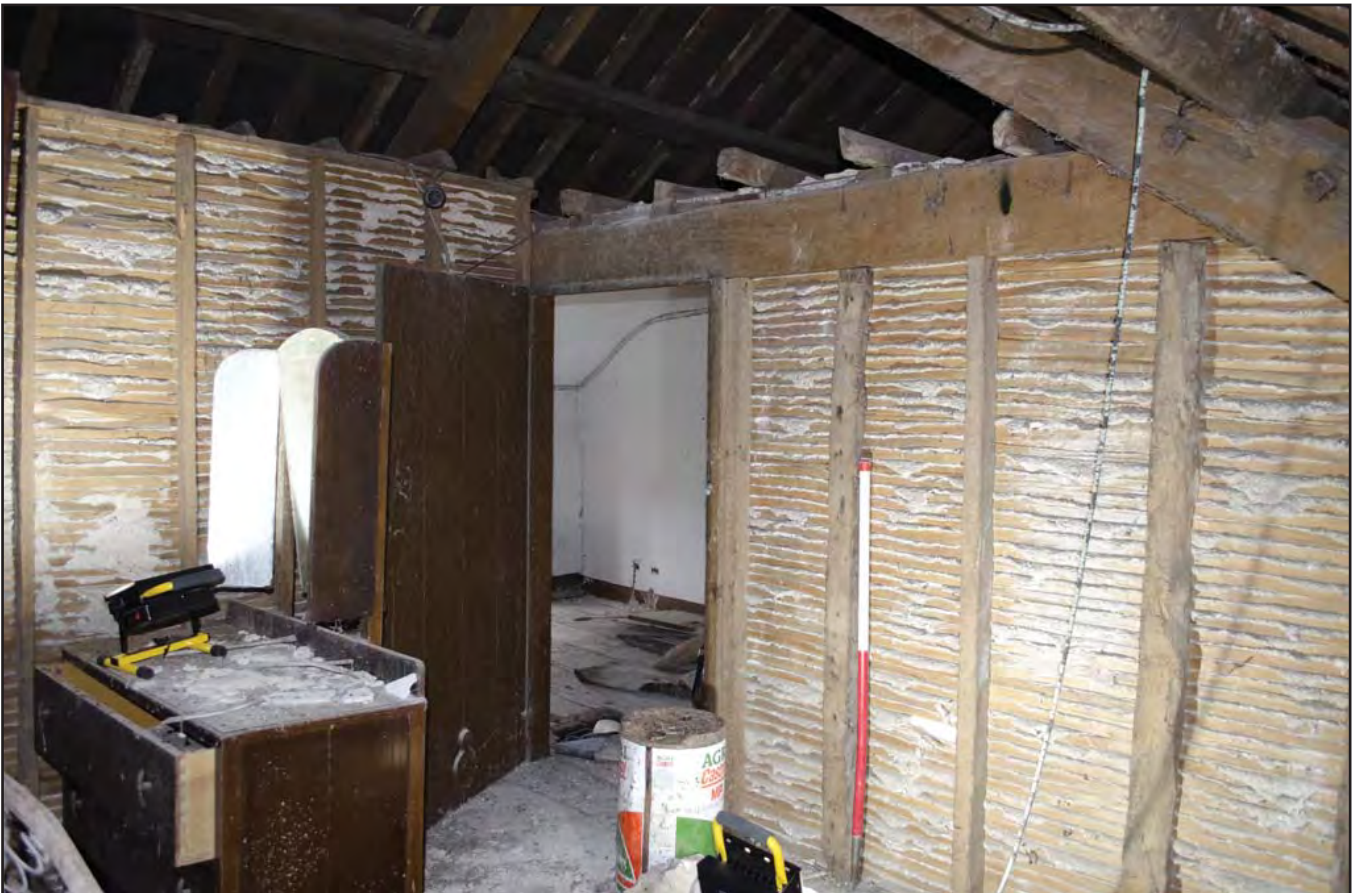
Plate 68: Attic 1: Room A - interior view detailing plaster laths, roof space storage and door D28. Scale: 1.0m (archive image: G2483\_136).

A small room containing disused Edwardian bedroom furniture; wardrobe, dismantled, sprung iron bed with wooden head foot rest, mirrored dressing table, small wooden chair with green upholstery and sub-rectangular wall mirror (Plate 68). The area opened up to a roof space storage areas above Attic 1 Lobby and Room B, alongside roof space over Attic 2. A key feature was the exposed plaster and lattice portioning walls on the west side and at the south end), with the lime plaster work appearing to be late 18<sup>th</sup> – early 19<sup>th</sup> century. Roof beams and tie-beams were relatively modern. The upper portion of the 17<sup>th</sup> century chimney breast was present here, with the exposed roof beams allowing its shape to be seen (Plate 69). Underneath the exposed plaster work of the chimney breast, red-sandstone rubble stone was used for its construction (this was similar material used for blocked up door way of cellar, below Hall 1/Dining Room). The room was accessed via D28 (1.67m x 0.54m) and had 1830s door furniture. At the foot of the door there was an unusual small circular opening (diameter of 0.12m) with a rotating flap.

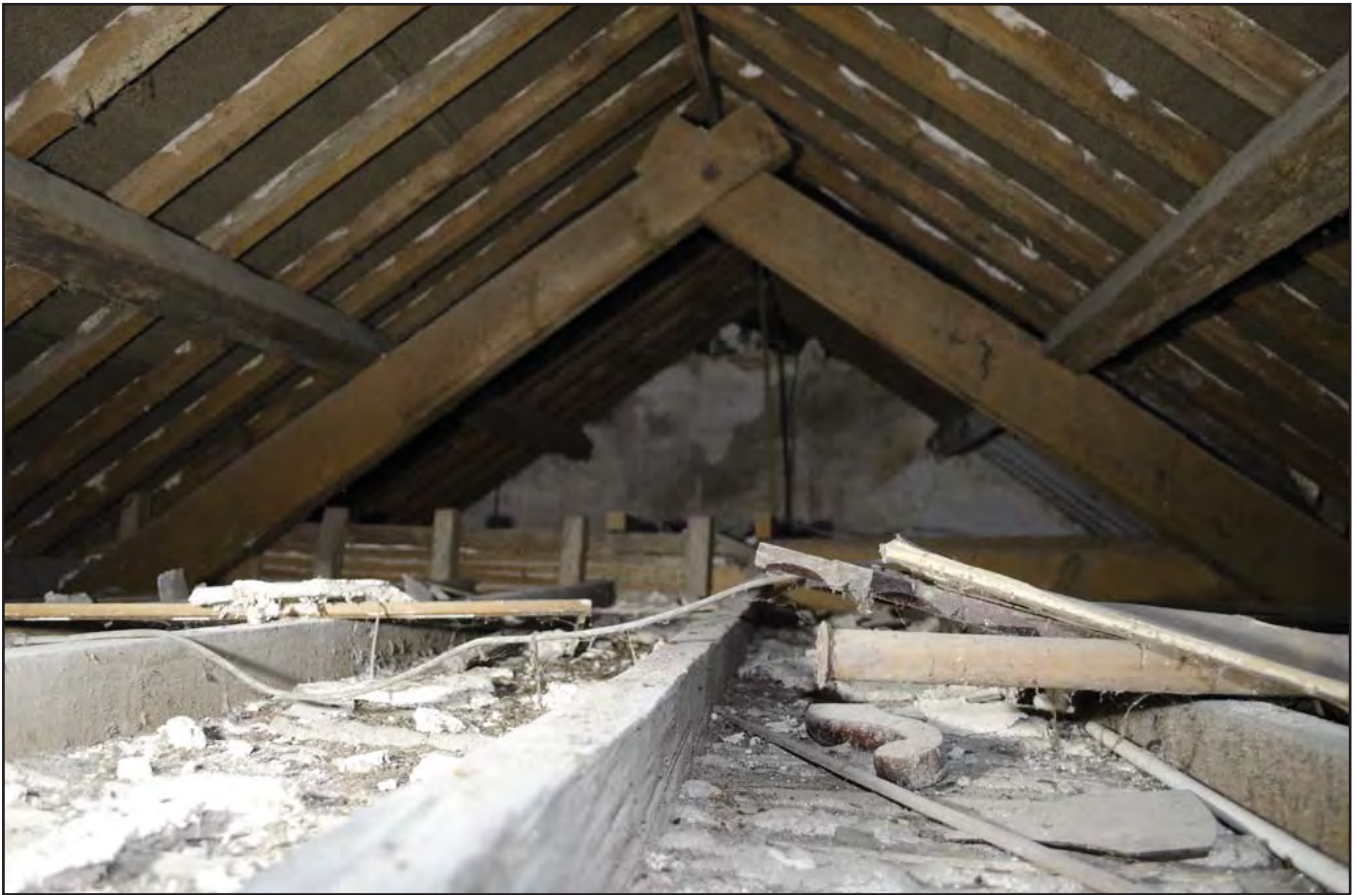
Plate 69: Attic 1: Room A - interior view detailing roof space above lobby and door D28. (archive image: G2483\_139).

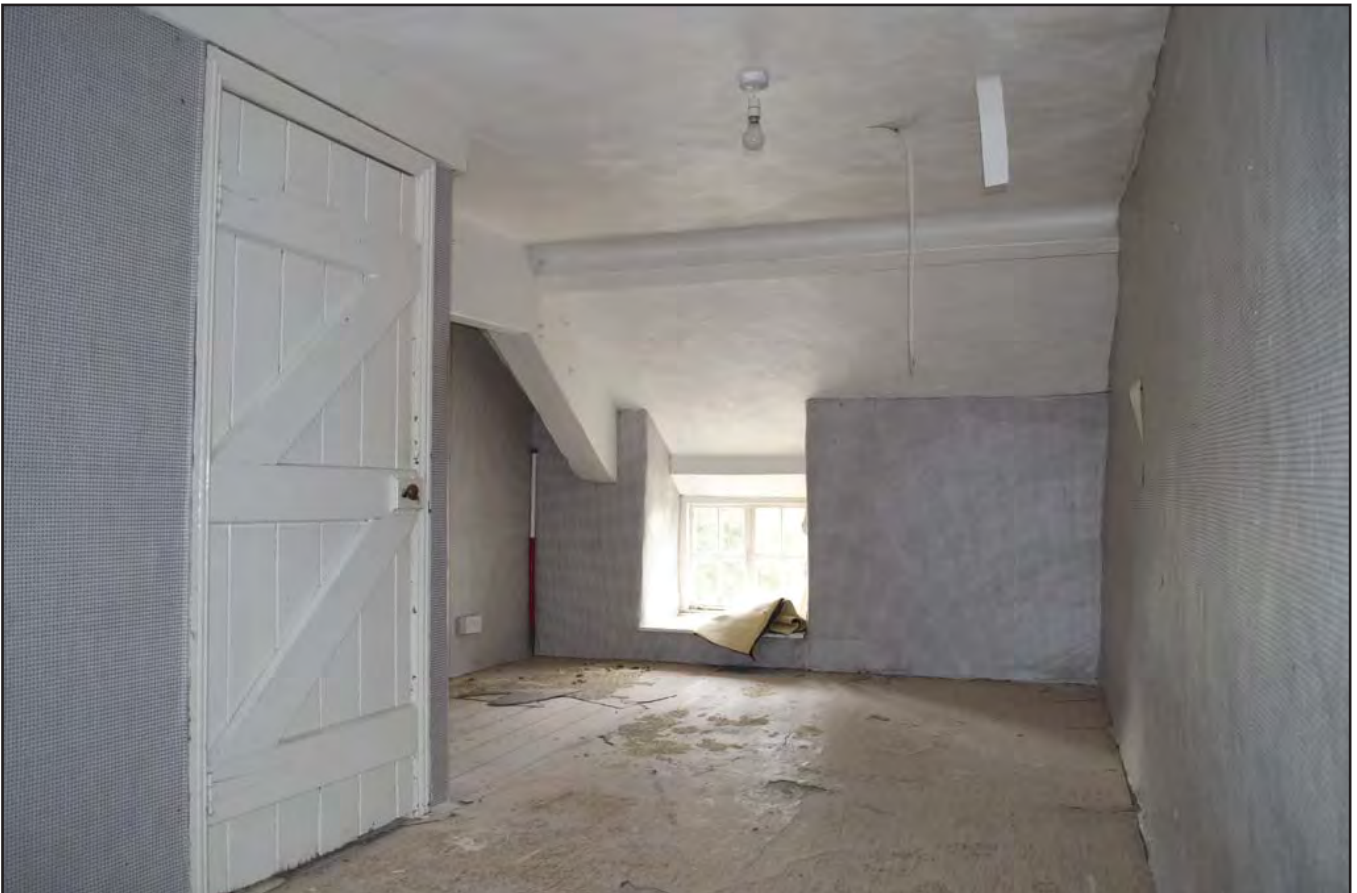
Plate 70: Attic 2: Room C - interior view detailing door D30 and window W19. Scale: 1.0m (archive image: G2483\_143).

The largest of the attic rooms, which was likely to have formerly been a bedroom, was formerly accessed by a small set of stairs which have been removed in advance of the building recording. An 18<sup>th</sup> to 19<sup>th</sup> century tie-beam was visible at east end of the room (Plate 70). Blue chequered 1960s or 70s wall paper decorated the walls of this L-shaped room, with textured wall paper on the ceiling W23 bearing the same resemblance as those in Attic 1's Lobby and Room B (height of 0.68m, width 0.87m and set in at a depth of 0.58m). W24 at northern end of the room (height of 0.64m, width 0.92 set at a depth of 0.44m), appeared to be late 19<sup>th</sup> century in, though partially blocked by partitioned wall separating this space to stairwell and lobby. In the north-west corner (below W24), a "box" has been inserted with wooden panels, possibly to give height to the corridor below or to exclude draft (Plate 71). Modern

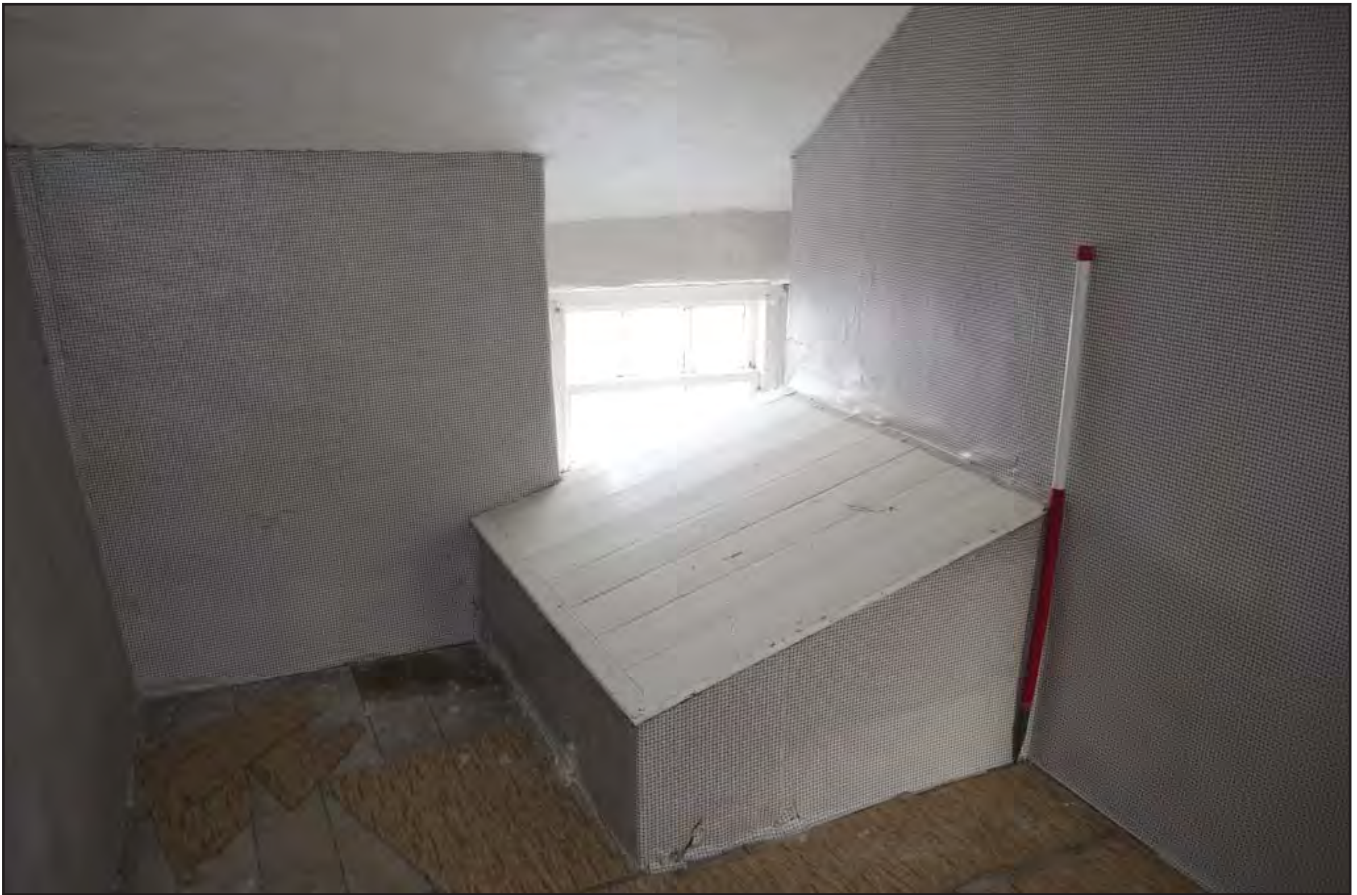
Plate 71: Attic 2: Room C - interior view detailing wooden construction likely used as draft excluder. Scale: 1.0m  
(archive image: G2483\_145).

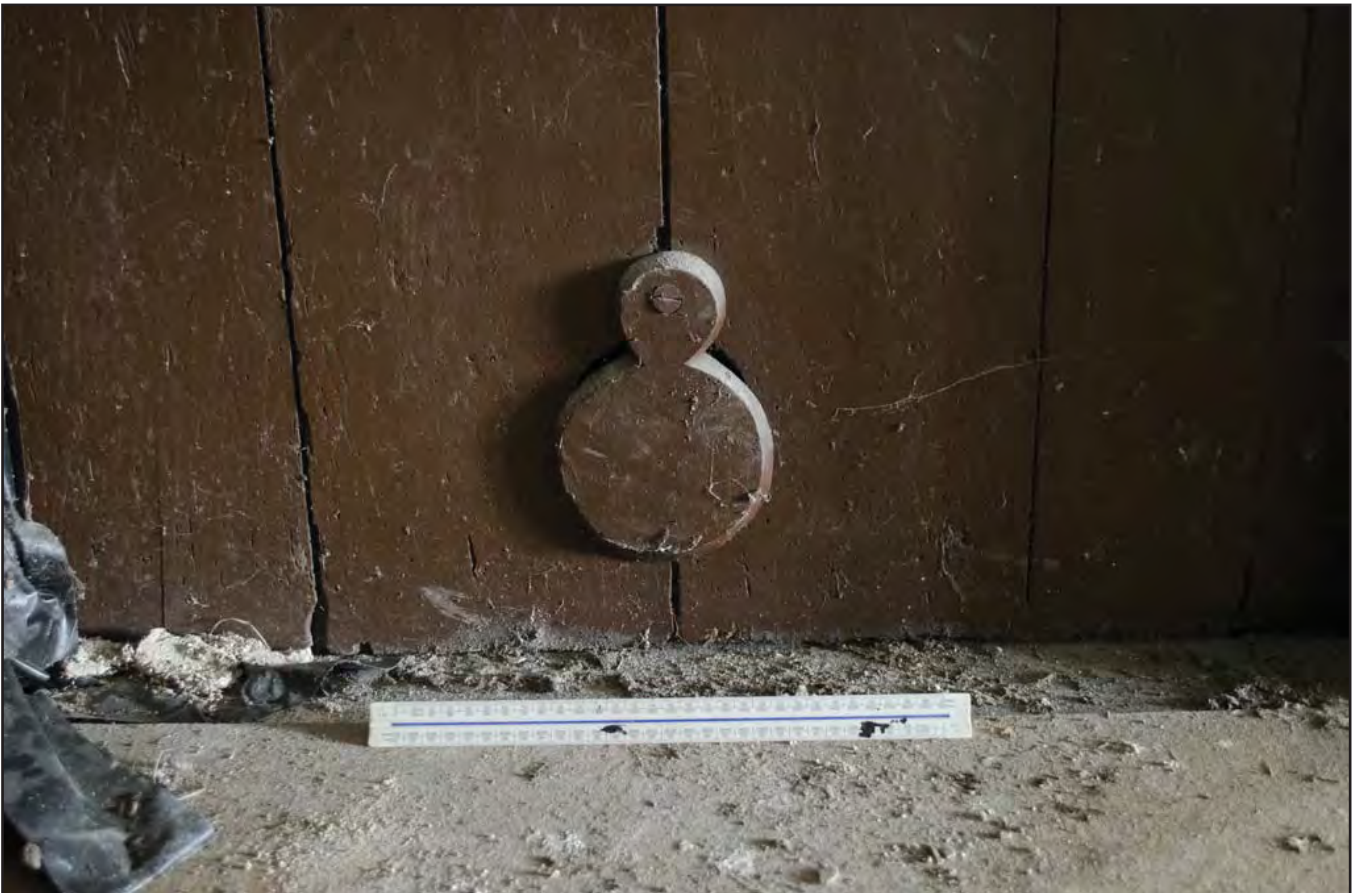
Plate 72: Attic 1: Lobby - interior view detailing circular flap (c.0.24m) at the base of door D28 - closed. Scale: 0.30m  
(archive image: G2483\_151).

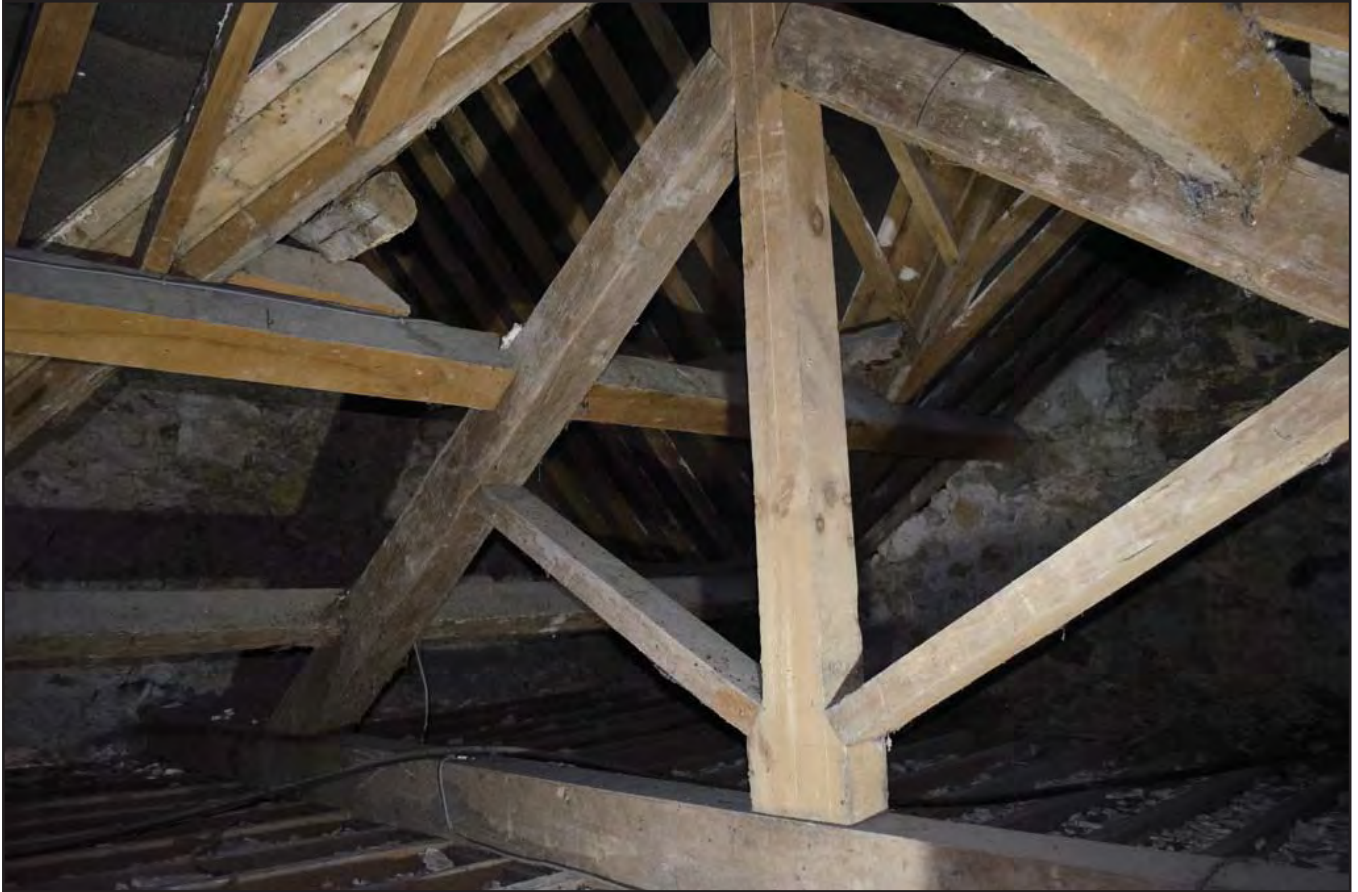
Plate 73: Attic 3 - interior view detailing roof space area with modern beams (archive image: G2483\_153).

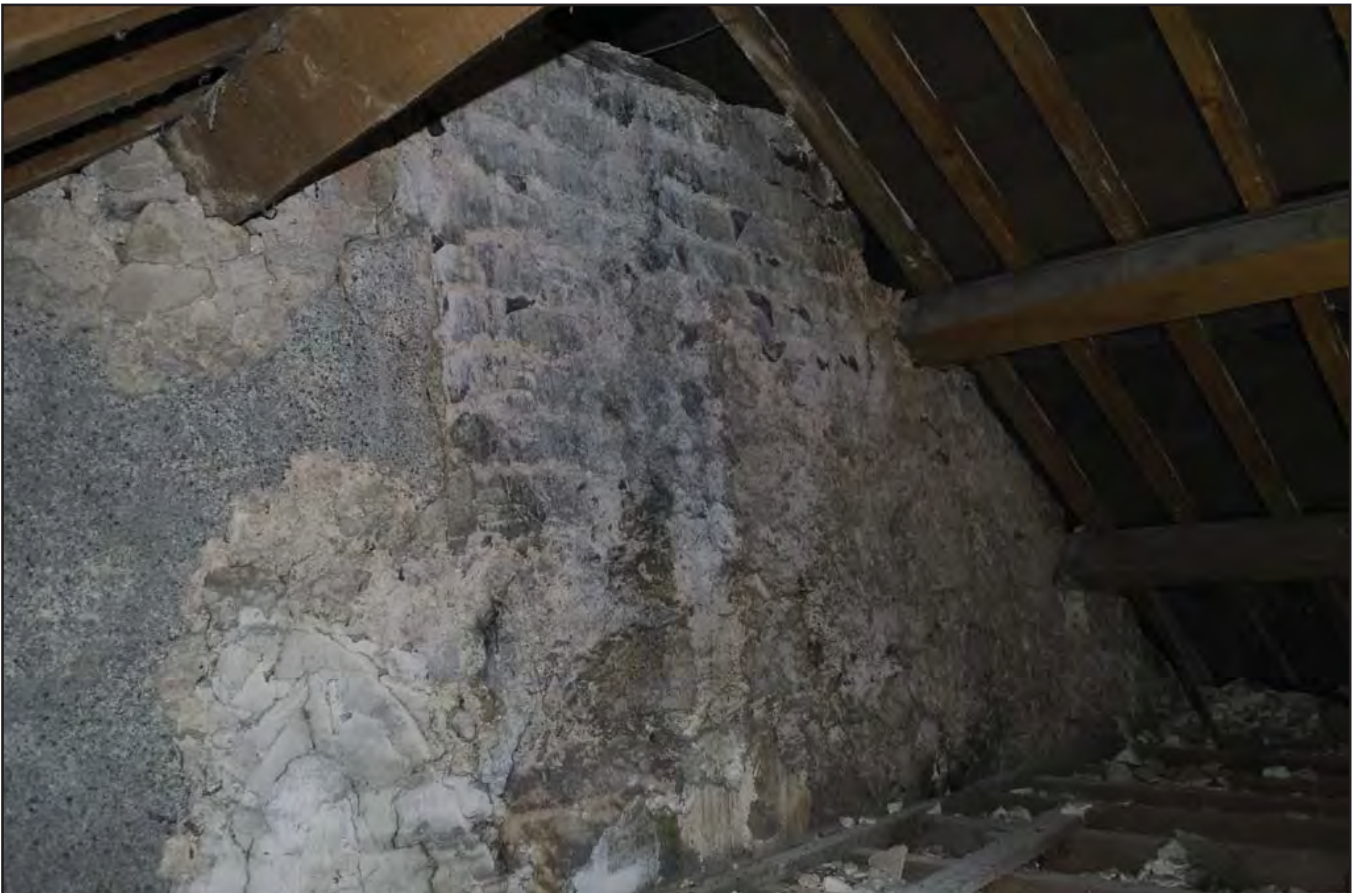
Plate 74: Attic 3 - interior view detailing terminus wall at E-end with 18th century plaster (archive image: G2483\_155).

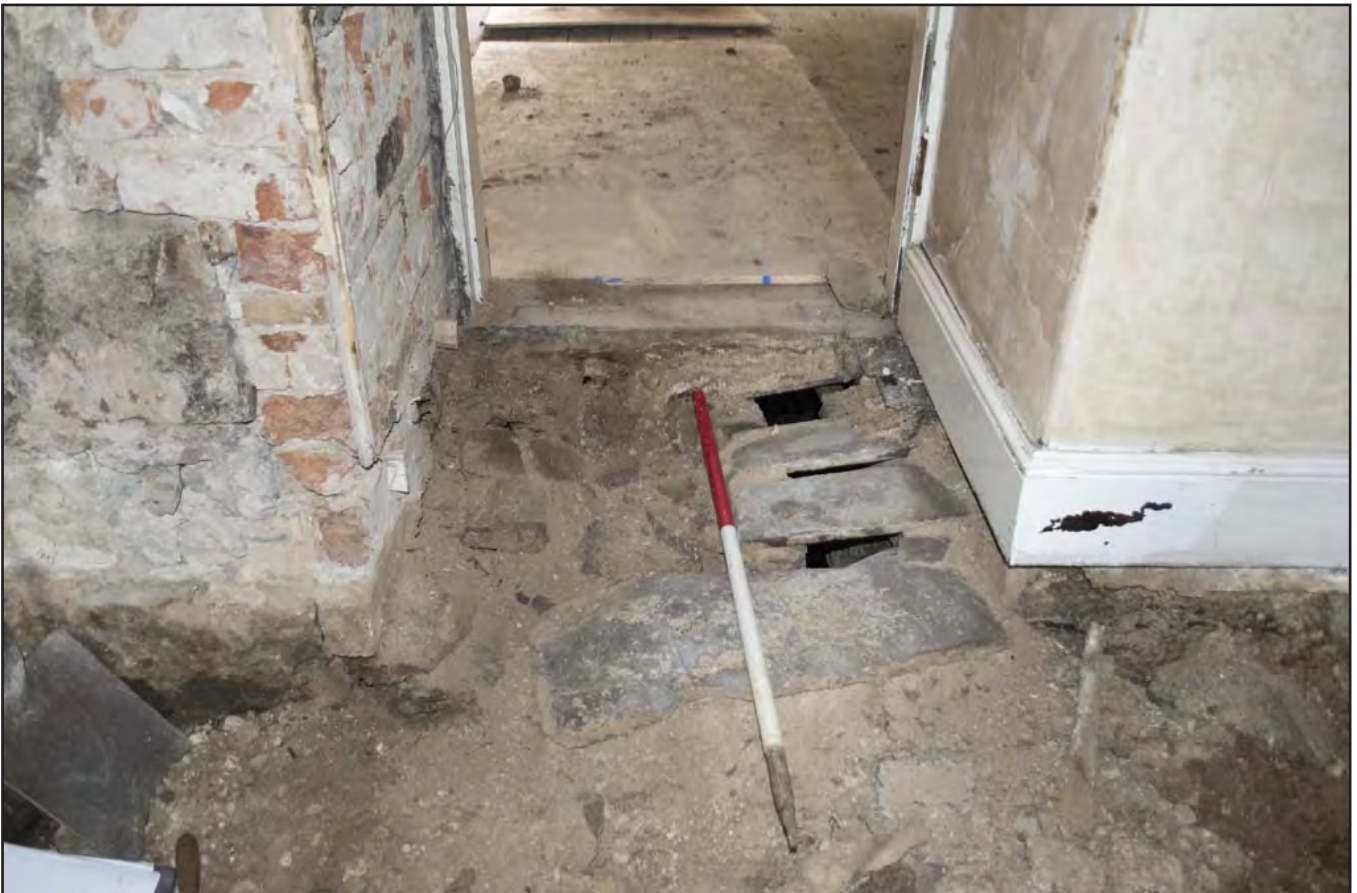
Plate 76: Dining Room - interior view detailing eastern doorway with step partially removed (archive image: G2483\_176).

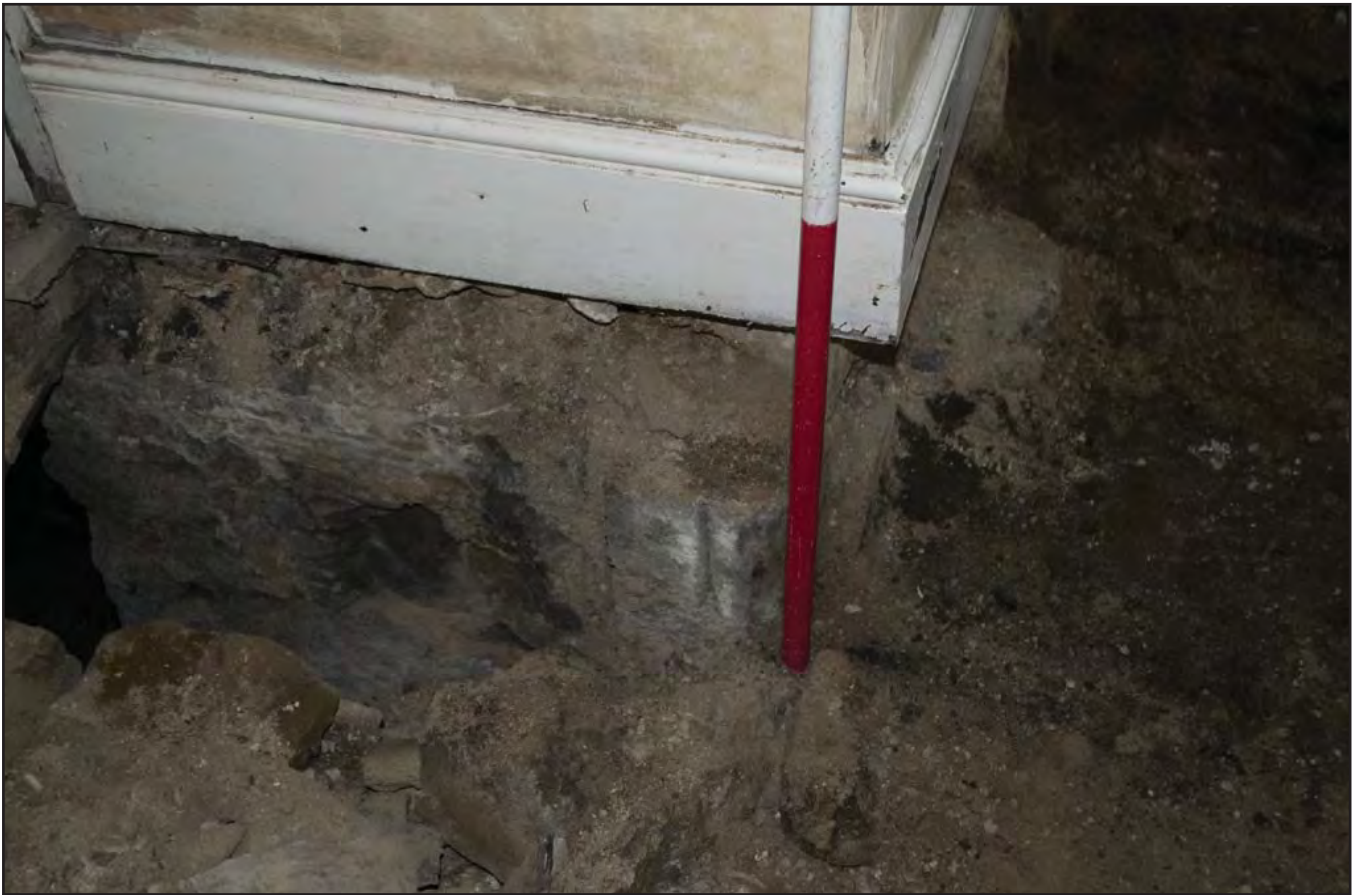
Plate 77: Dining Room - interior view detailing worked stone at base of eastern wall i (archive image: G2483\_178).

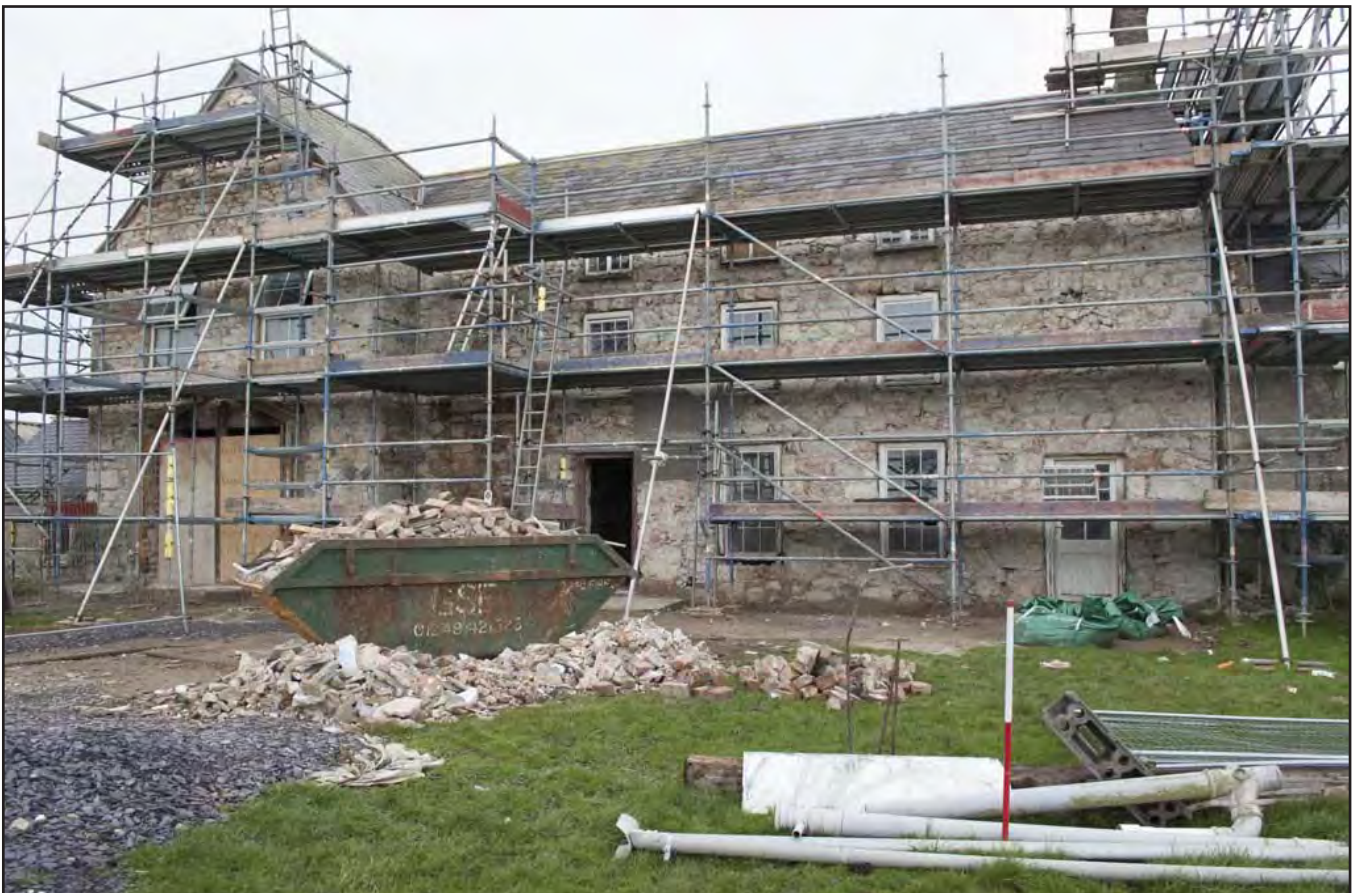
Plate 78: Front elevation - view from the southeast of south facing elevation after removal of render (archive image: G2483\_209).

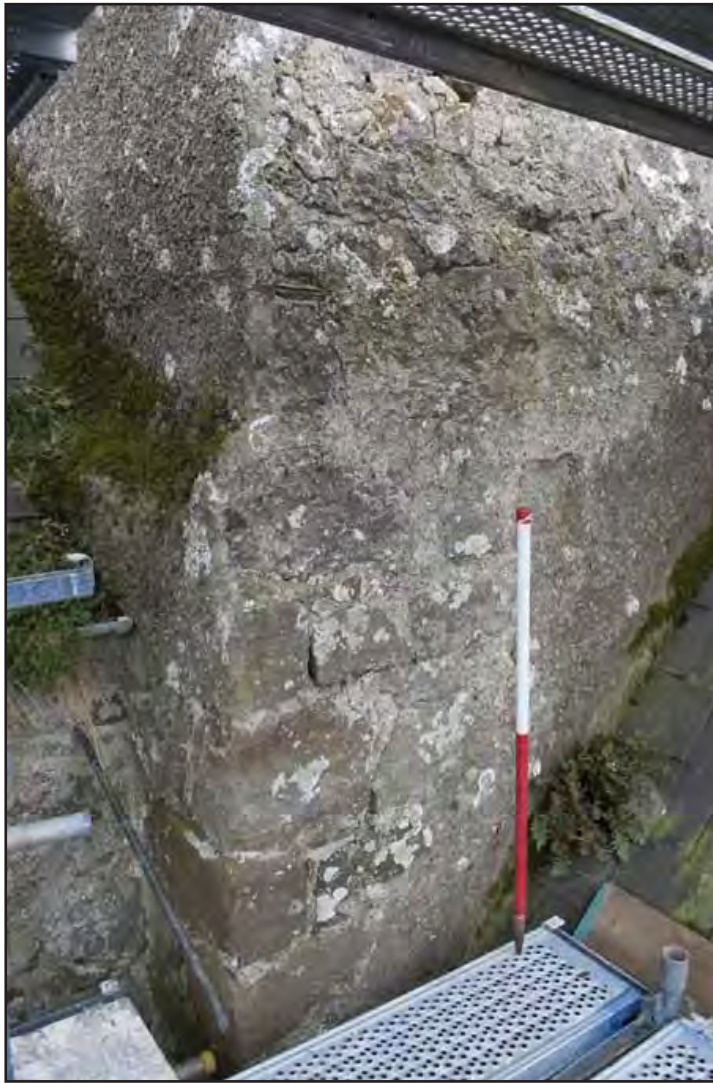
Plate 79: Detail of medieval quoins in northeast corner of former chapel at first floor level; scale: 1.0m (archive image: G2483\_192).

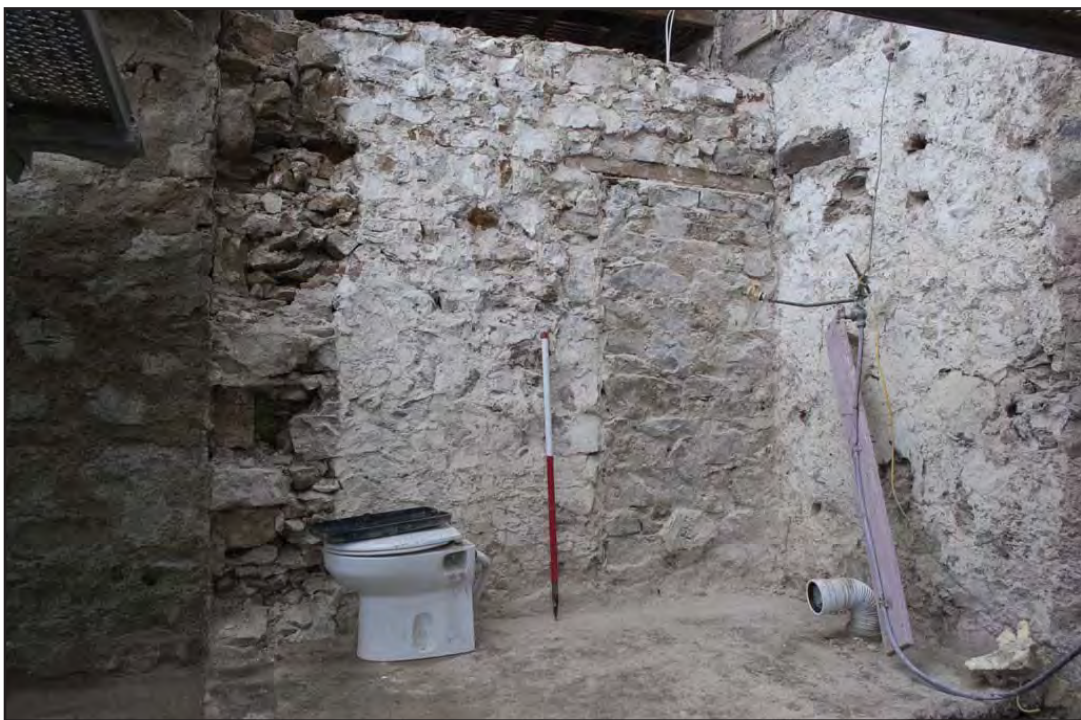
Plate 80: Blocked doorway in northwest rear gable wall; scale: 1.0m (archive image: G2483\_195).

Plate 80: Blocked doorway in northwest rear gable wall; scale: 1.0m (archive image: G2483\_195).

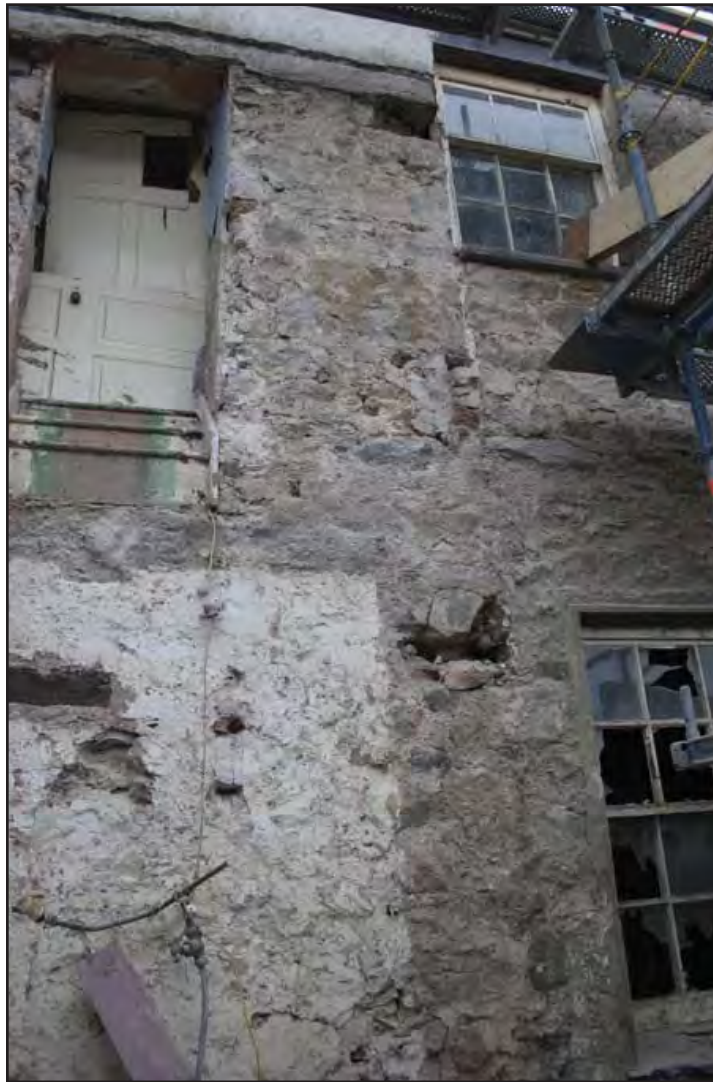
Plate 81: Rear elevation - general view after removal of bathroom extension detailing modifications to the building (archive image: G2483\_199).

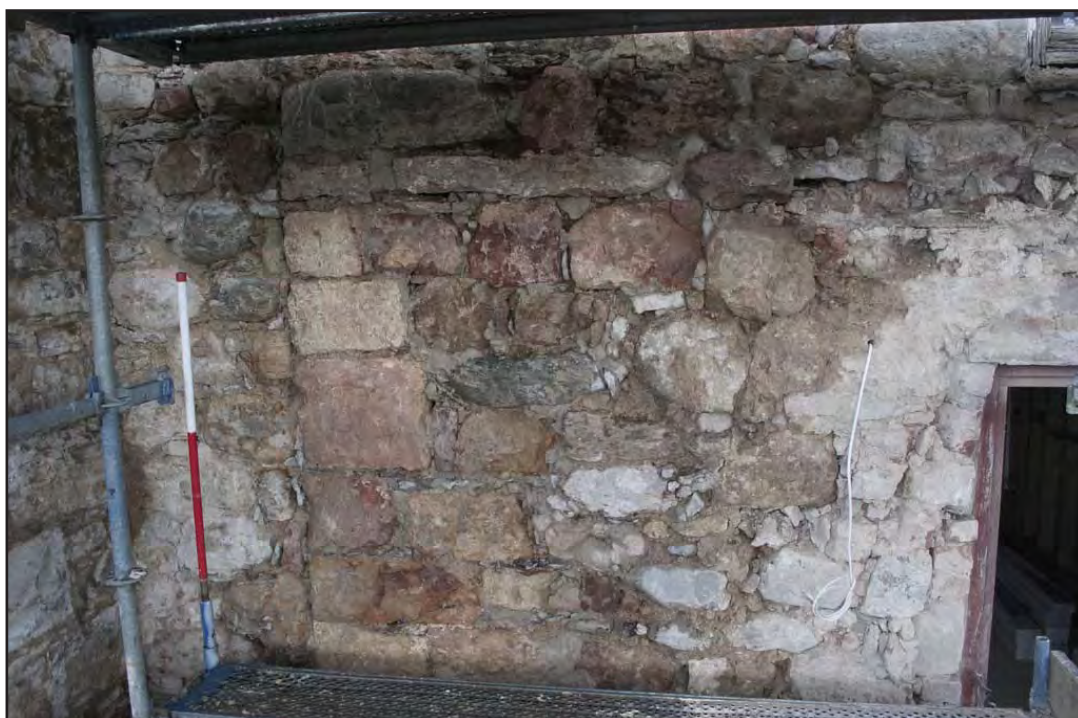
Plate 82: Large quoins and butt joint at the former west end of the grange chapel, with medieval masonry; scale: 1.0m (archive image: G2483\_203).

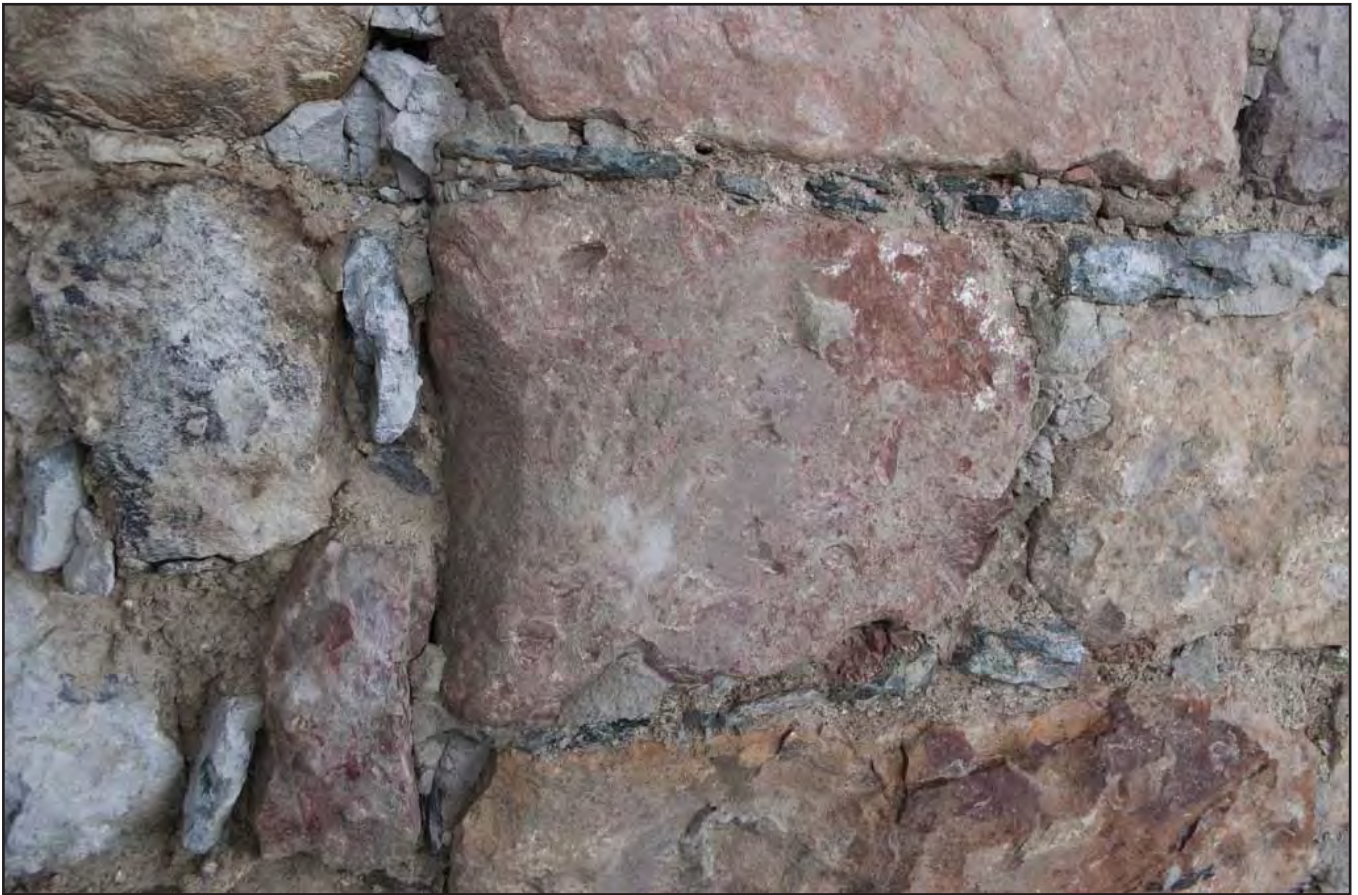
Plate 83: Detail of medieval quoin showing wear created by probable tool sharpening (archive image: G2483\_204).

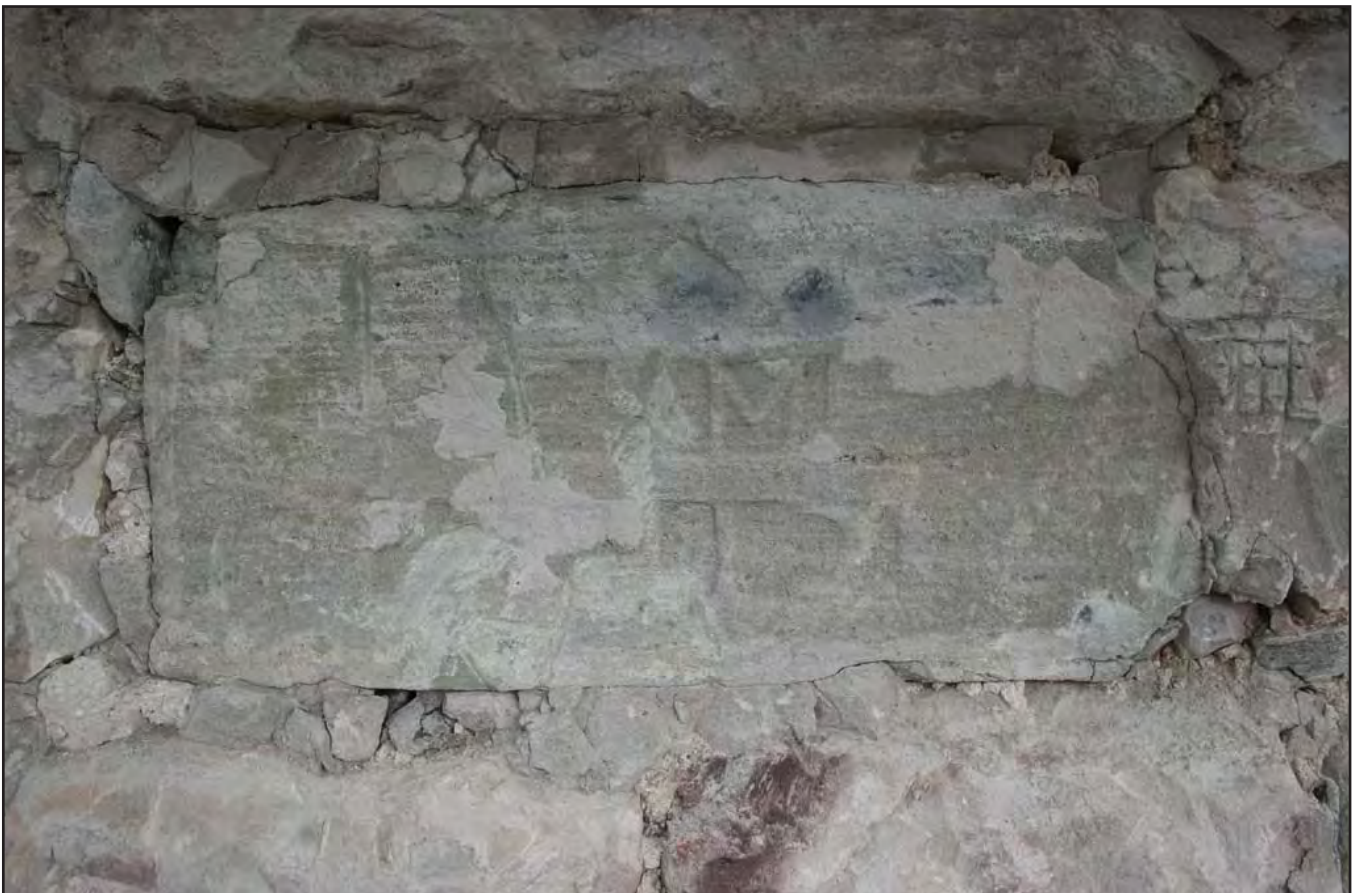
Plate 84: Detail of date plaque reading "1612", positioned above door D14 (archive image: G2483\_207).

end of the south elevation a plaque, 0.58m wide and 0.27m high, was noted (Figure 11, Plate 84-85). This was carved in false relief into a blue grey limestone, and was of an early 17<sup>th</sup> century type (Figure 11). It was part worn, but the below inscription could be read. The letters in square brackets are uncertain:
