# Quirt Farm, Dwyran

LEVEL 3 BUILDING RECORD &  
ARCHAEOLOGICAL WATCHING BRIEF

Project No. G2483

Report No. 1343

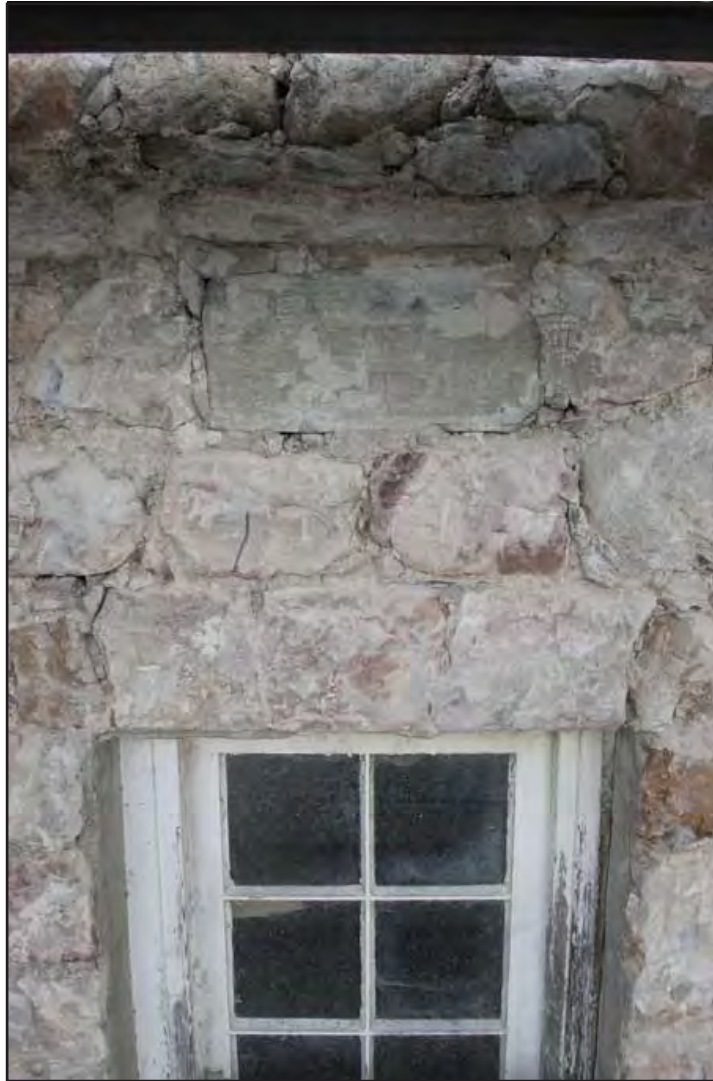
Plate 85: Detail of date plaque reading "1612" and position above door D14 (archive image: G2483\_206).

This is likely to be a date stone, and possibly commemorates the insertion of the fireplace and conversion of the building into a dwelling. It appears to be in its original location, with a flat dripstone above it. It is also likely to have been above the front door of the property, suggesting that D14 was the main entrance to the property at that time, before being superseded by D17 when the house was extended in the late 18<sup>th</sup> or 19<sup>th</sup> century. The large sandstone lintel above this doorway is also suggestive of a 17<sup>th</sup> century date (Plate 85). The entrance would then have faced the south side of the chimney breast, with a small lobby in front of it a style of house known as a 'baffle entry', with the hall to the west and kitchen to the east (in the disused chapel). This was a quite common house layout in the early 17<sup>th</sup> century in northwest Wales (Smith 1975).

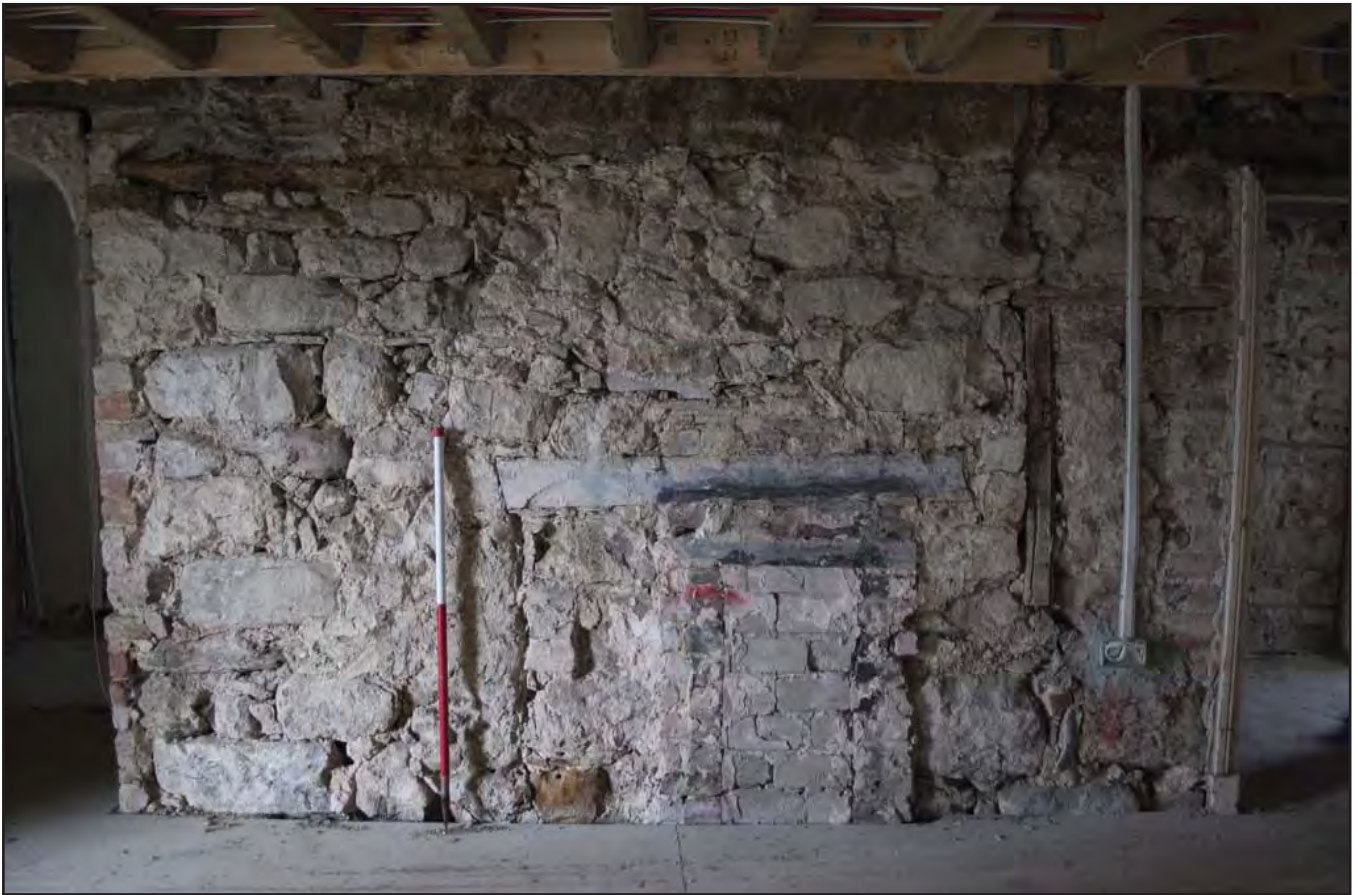
Plate 87: Internal view of east-facing elevation in Hall 1, showing two blocked former fireplaces; scale: 1.0m (archive image: G2483\_214).

The render on the east facing wall elevation, with its two lateral door openings, was removed in early 2017. This elevation was 5.4m wide and 2.15m high. The render removal revealed the presence of two phases of fireplaces, each one with a slate lintel. The larger one was 1.31m by 0.42m, and the smaller one fitted within it and was 0.72m wide. A wooden lintel was noted in the upper rubble adjacent to the south west opening, 0.28m from roof level. Above this was rubble stone, including a possible carved stone 0.29m by 0.19m, although this is a very tentative interpretation (Plate 88). There was some early 19<sup>th</sup> century brickwork forming the edges to the openings (Plate 87), and much rebuilding was noted, including the re-use of timbers, some of which showed former mortice holes. On the south facing elevation of the room a butt joint in the masonry was noted, with a chamfered vertical edge on ashlar masonry, in the north-west corner 0.48m east of the corner, and extending to a height of 0.85m (Plate 89). The chamfered edge was 0.45m west of doorway D07. This appears to have formed part of the Grange Chapel masonry, although its function was hard to interpret.

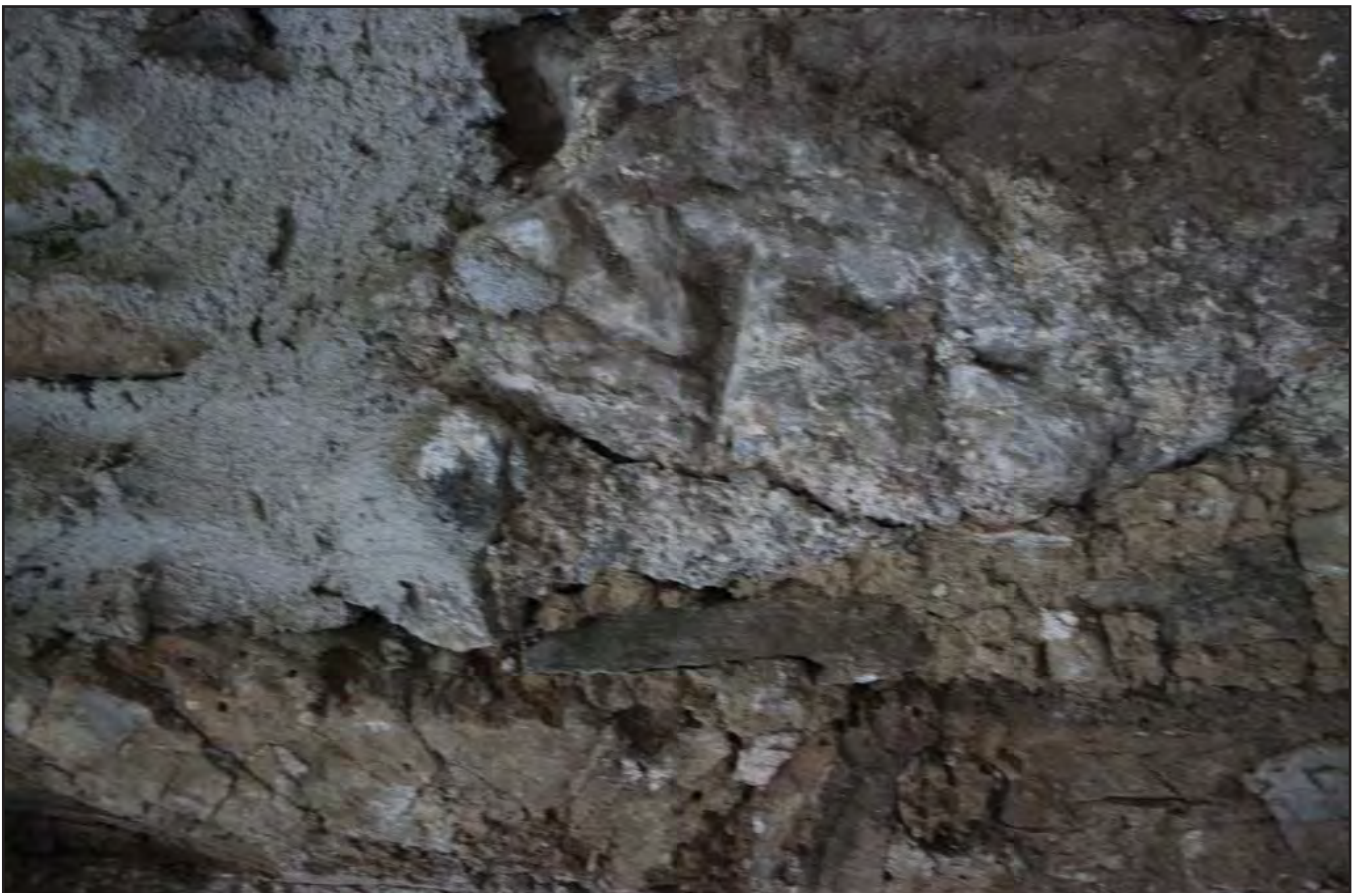
Plate 88: Detail of possible carved stone in east-facing elevation in Hall 1 (archive image: G2483\_215).

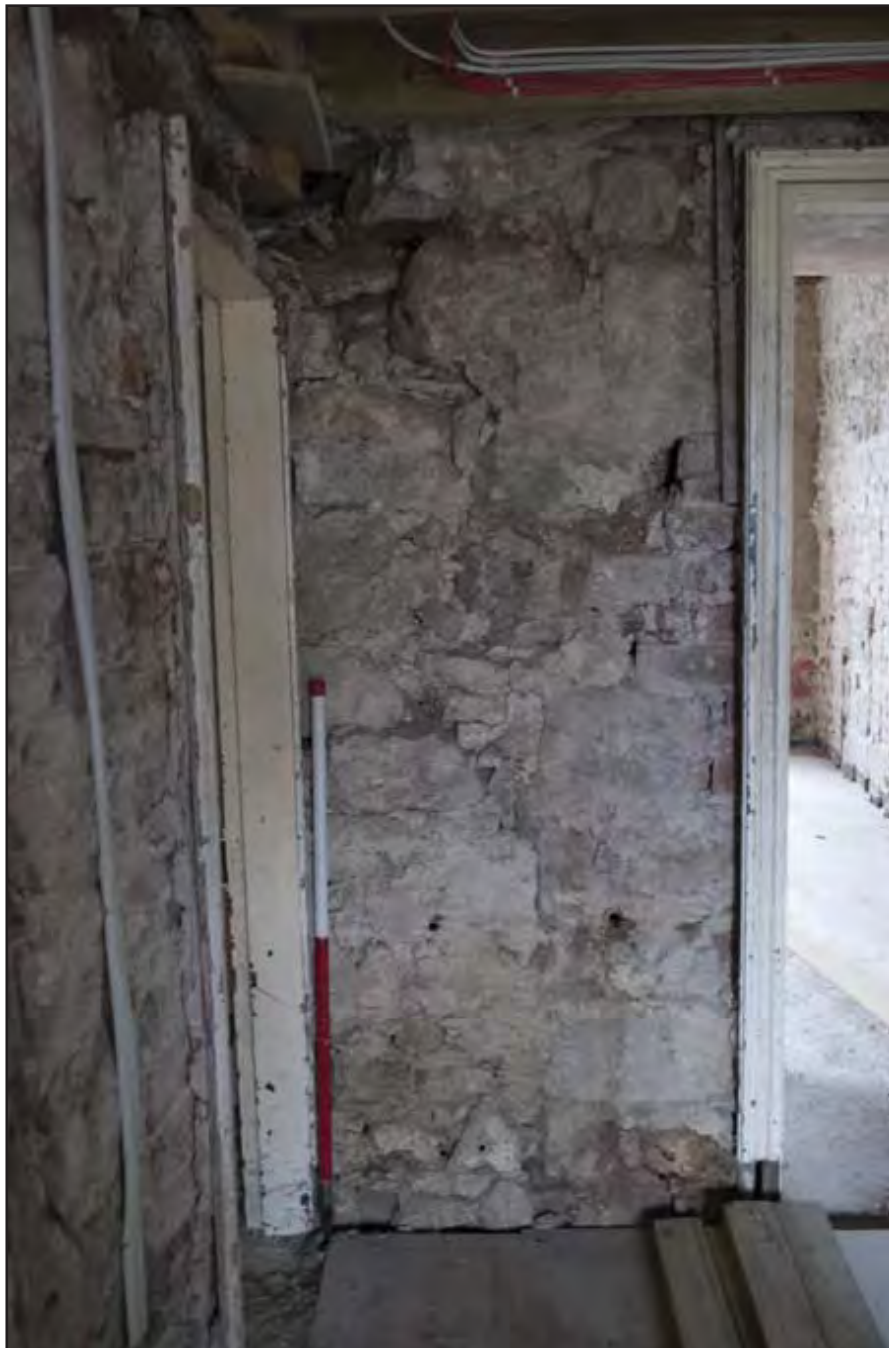
Plate 89: Detail of chamfered stone edge in south-facing internal elevation in Hall 1; scale: 1.0m (archive image: G2483\_217).
