Solar Farm Tyddyn Gwyn Llangybi

Archaeological Watching Brief

Project No. G2460

Report No. 1347

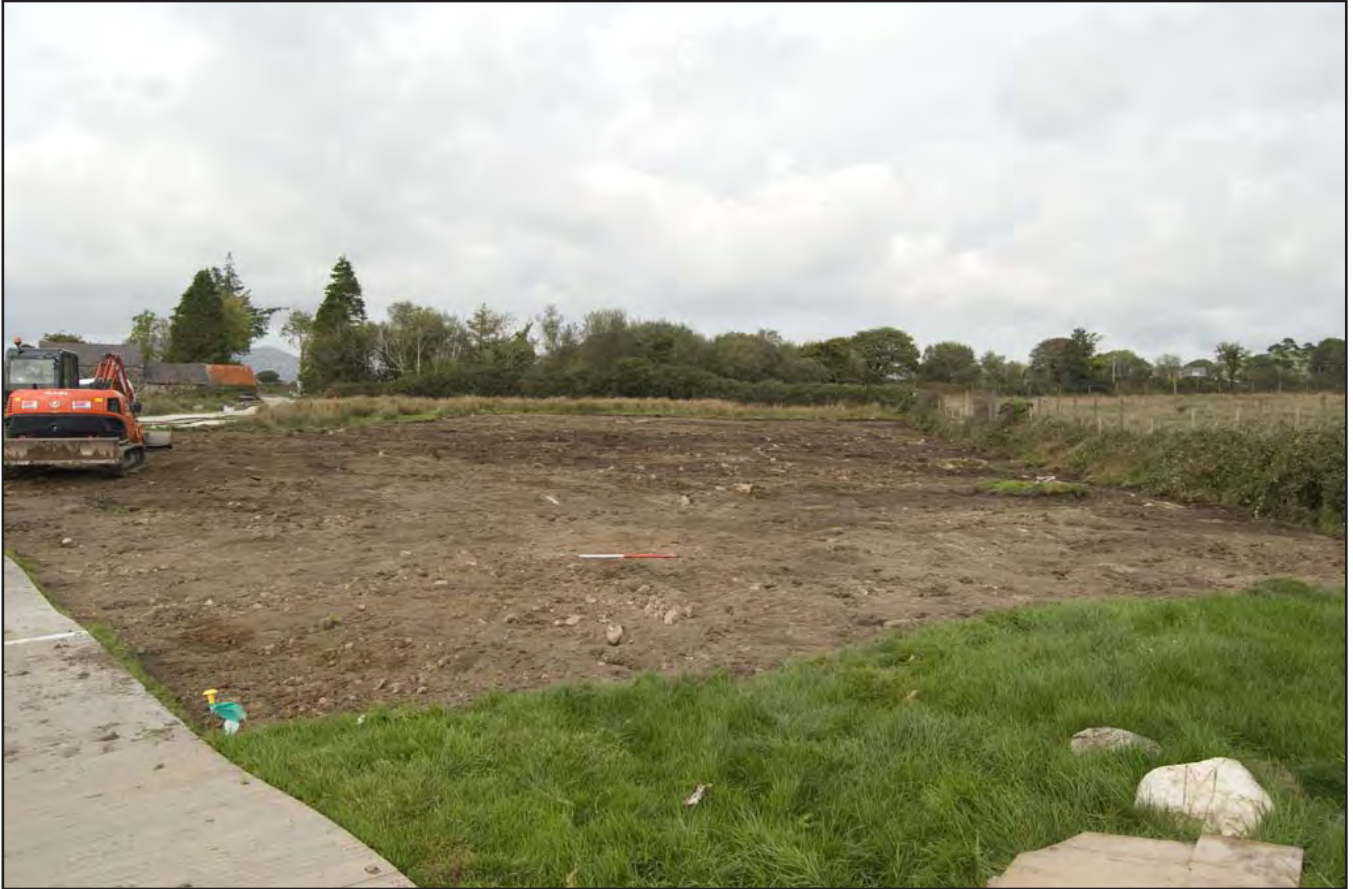
Plate: 01

The site compound was located to the west of the solar panel site and was not targeted by the geophysical programme or the evaluation, consequently an intensive watching brief was maintained throughout the topsoil strip of the area. The compound was situated adjacent to the field boundary with Field A, and covered an area approximately 400 square metres. Some rusted iron bolts were noted in the topsoil but not retained.

The topsoil was found to be shallow, with a depth of between 0.15m and 0.2m, and comprised mid brown clay silt with frequent cobbles and occasional boulders; in places where there were dense reeds, the topsoil was dark blackish brown clay loam. There were occasional patches of gravel. In places the topsoil was removed to the glacial clay which comprised mid greyish yellow sandy clay with gravelly orange patches in places and frequent cobbles and boulders (no subsoil was observed).

No archaeological activity was identified within the compound area.

Plate 01: Topsoil strip for compound area viewed from the south. Scale = 1m.

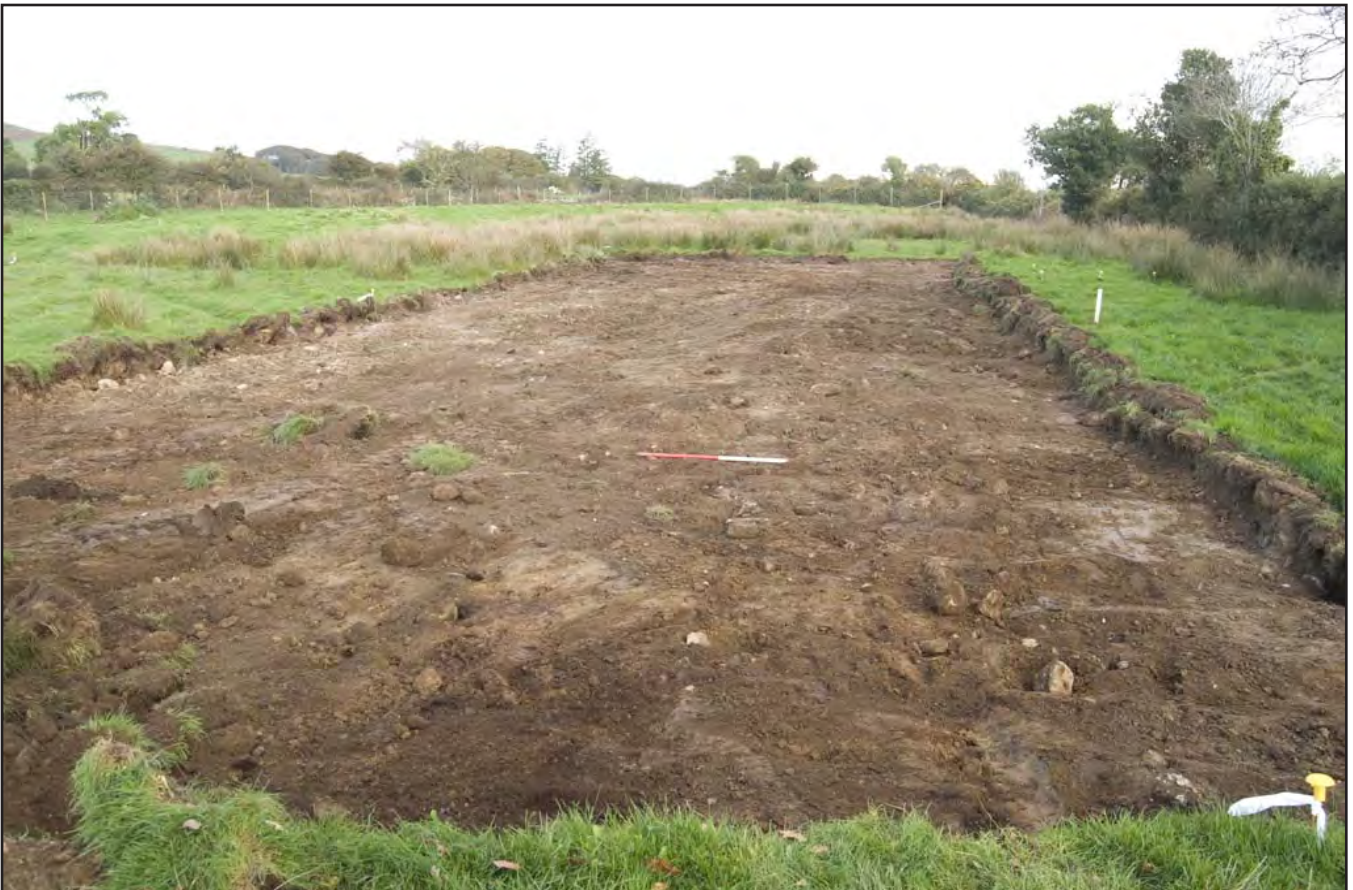
The sub-station area was located at the southern end of Field A, to the south west of the DNO sub-station, adjacent to a watercourse and a dry stone wall which separates Field A and Field B, (Figure 1). The field sloped gently to the north east, and the ground level

was reduced by 0.45m at the north west end and by 0.25m at the north east end of the area.

The topsoil was friable mid grey brown clay silt with frequent sub-angular pebble inclusions with a depth of 0.1m. The glacial comprised brownish orange yellow sandy clay with very frequent inclusions of sub-angular pebbles and cobbles and occasional large boulders.

Plate 02: Topsoil strip for sub-station at southern end of Field A viewed from the south west. Scale = 1m

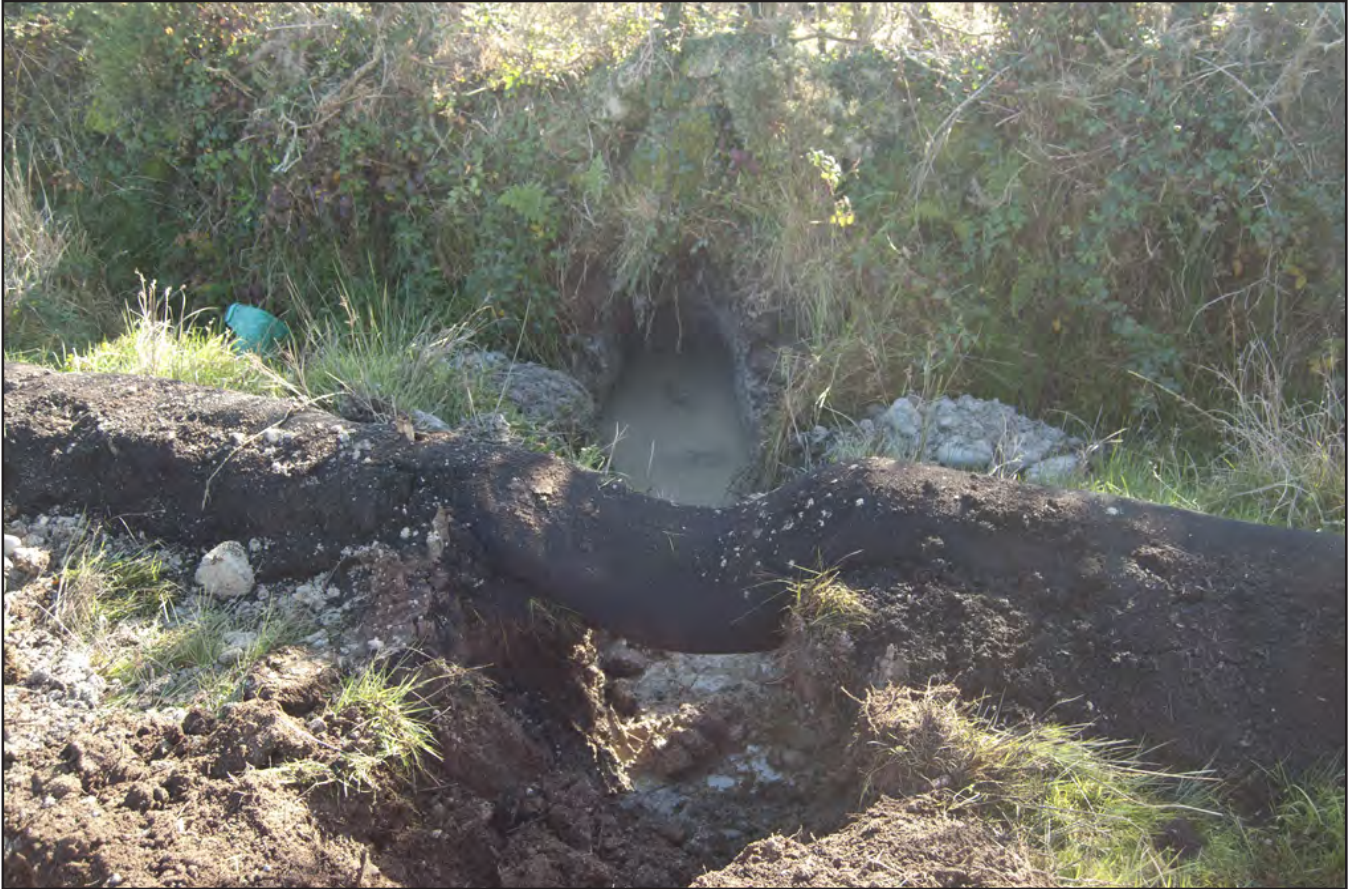
Plate: 03

The cable trench was excavated under the field boundary, which comprised a thin hedge in front of a dry stone wall in Field A. In Field B there was a post and wire fence and a thin hedge in front of the dry stone wall. The trench was 0.5m wide and between 0.5m deep

and 1.2m at its deepest point under the wall. The trench was excavated through the ditch in Field A.

The topsoil was friable dark brown clay loam with frequent sub-angular pebbles and cobbles with a depth of 0.5m deep; the natural was grey gravelly clay with frequent sub-angular cobbles and occasional boulders.

No archaeology was identified within the cable trench.

Plate 03: Cable trench excavated under boundary wall between fields A and B.

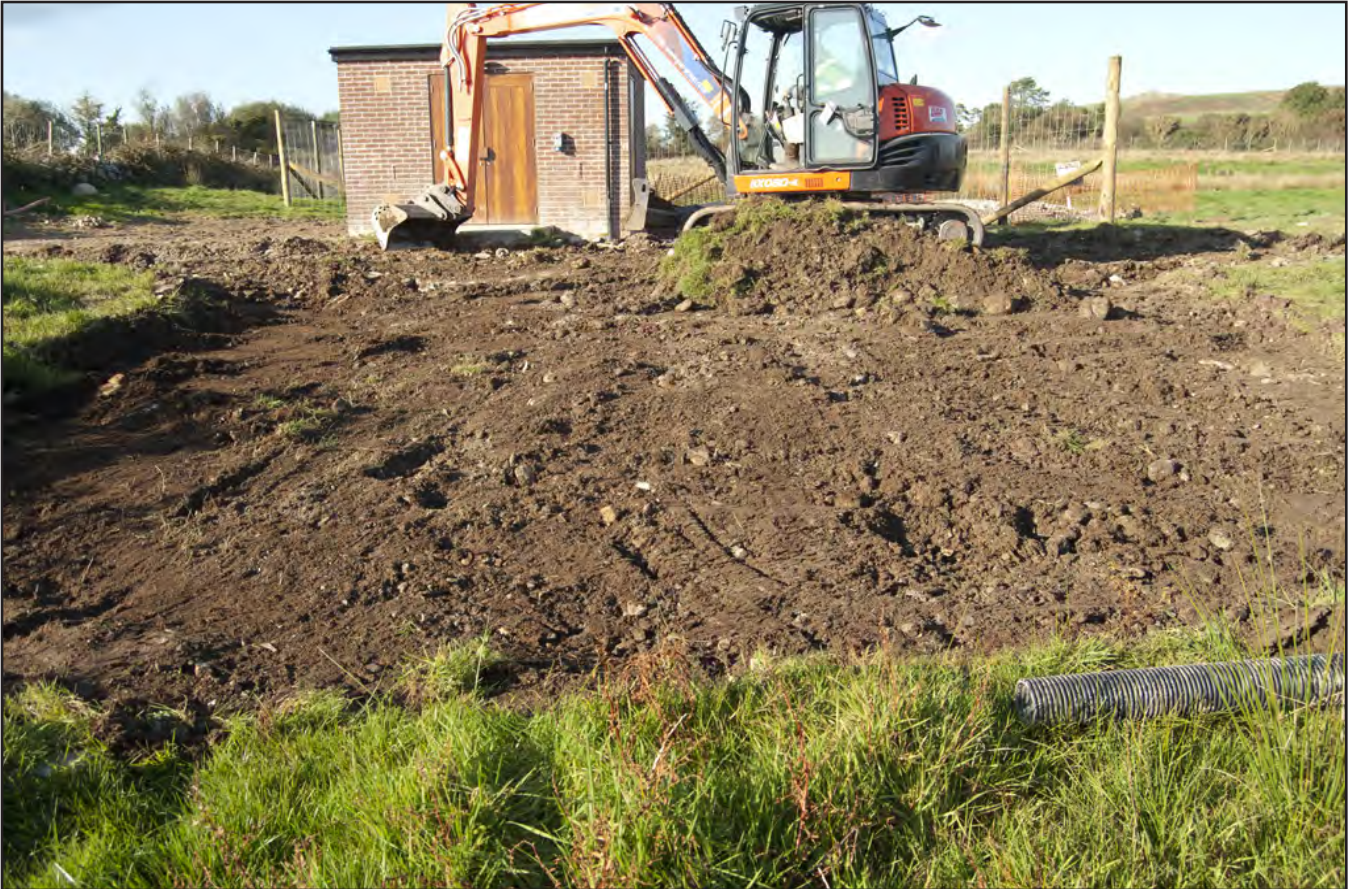
Plate: 04

The turning area was adjacent to the access road and immediately opposite the DNO sub-station, measuring approximately 10m x 10m. The topsoil was removed and the soil descriptions are as for the access road.

No archaeological activity was identified within the turning area.

Plate 04: Topsoil strip for turning area opposite the sub-station at southern end of Field A viewed from the south. Scale = 1m.

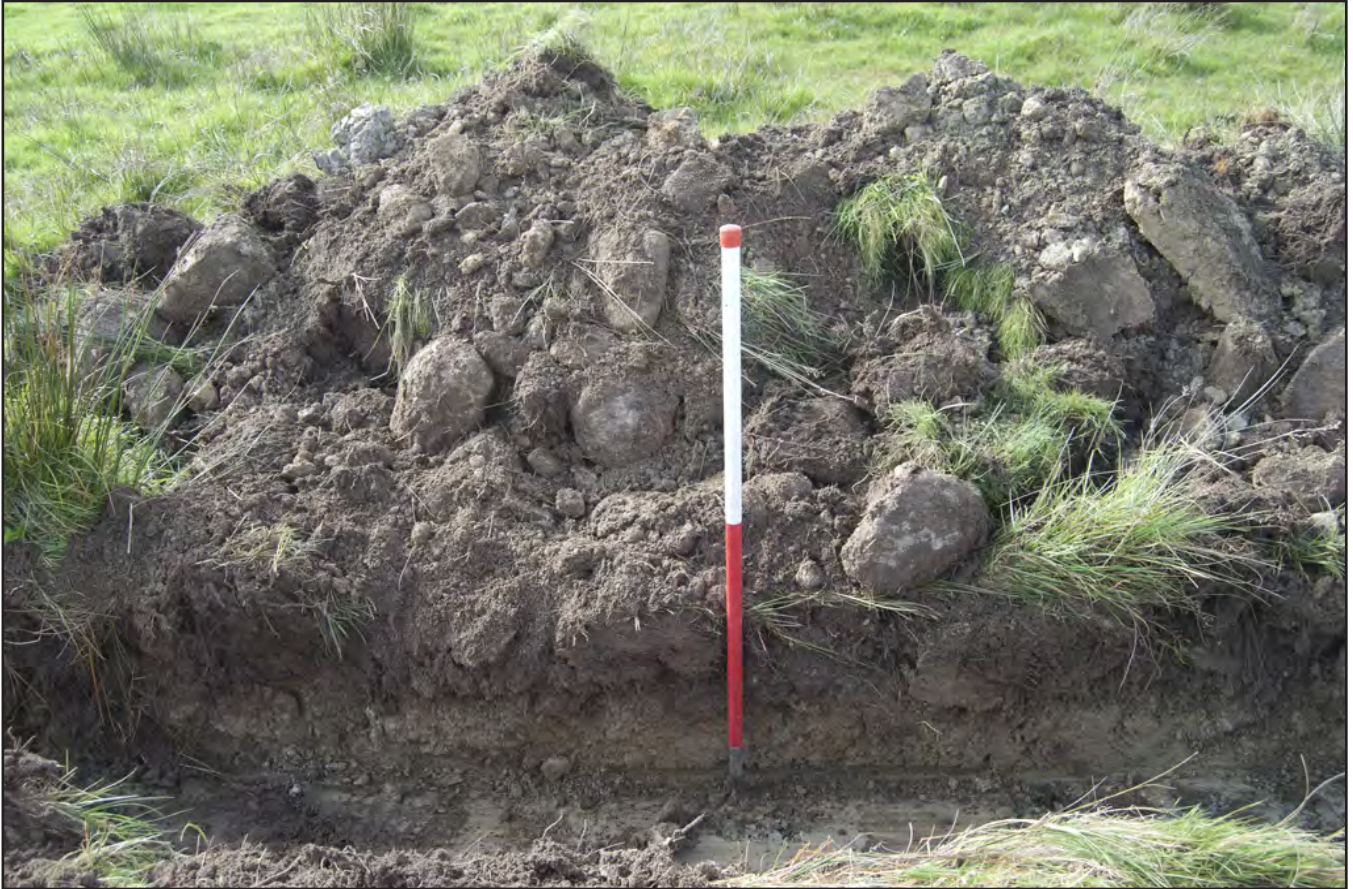
Plate: 05

The earth cable trench was excavated around the perimeter of the field, with a trench also excavated across the middle of the field which was aligned east-west; the trench measured 0.5m wide x 0.5m deep.

The topsoil was friable mid greyish brown clay loam with a depth of 0.15m – 0.2m; the natural was firm mid grey brown sandy clay at the northern end of the field, changing to firm grey blue clay at the south eastern end of the field. There were very frequent sub-angular pebbles, cobbles and some large boulders on the western and southern sides of the field. Stone filled land drains were observed crossing the east-west trench.

No archaeology was identified within the cable trench.

Plate 05: North east facing section of the cable trench in Field B. Scale = 1m.

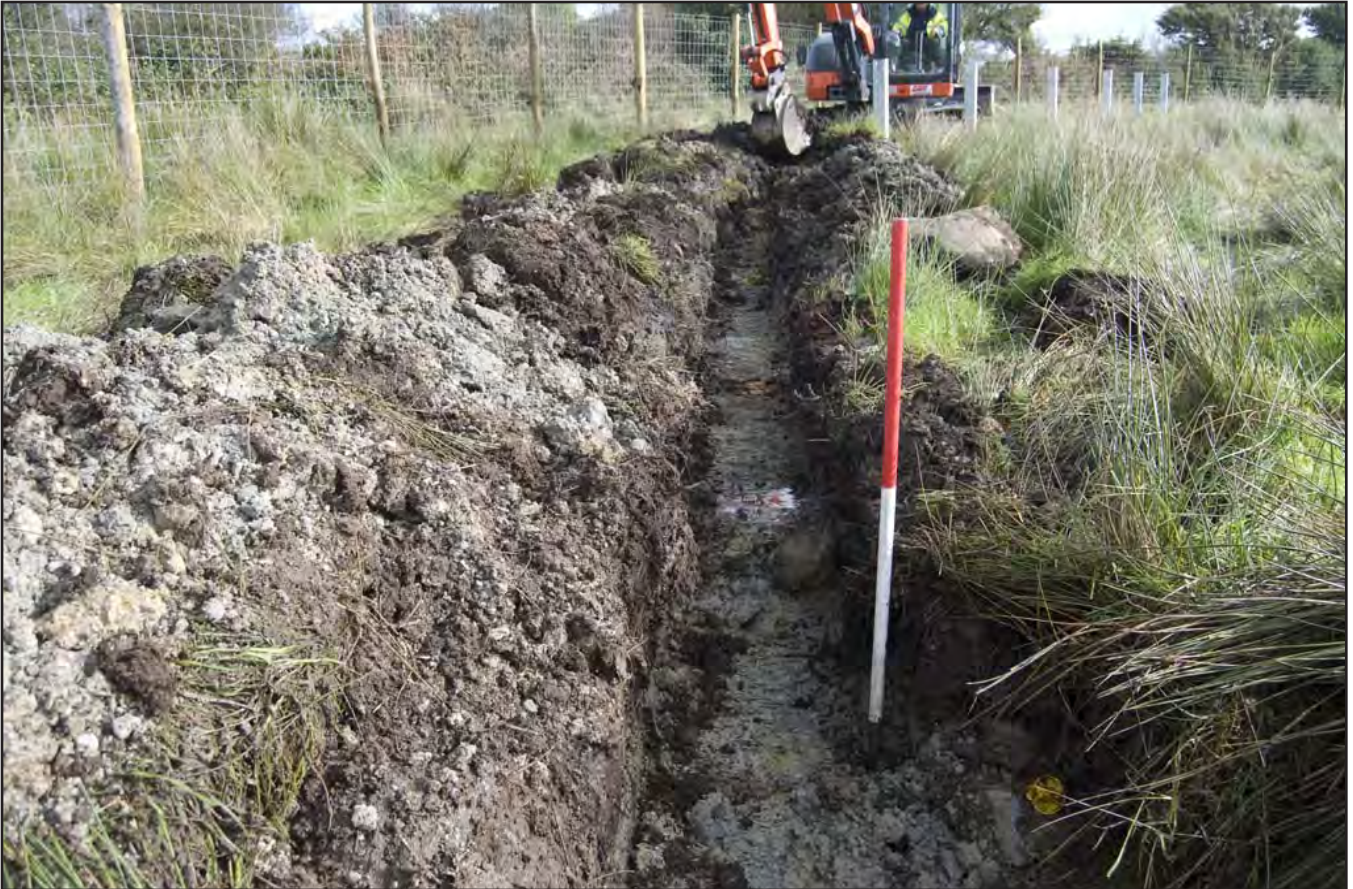
The excavation of the earth cable trench commenced at the north of the field, where the topsoil was friable dark brown silty clay with frequent roots; the natural was greyish yellow clay with frequent sub-angular pebbles, cobbles and boulders. Stone filled land drains were observed in the trench on the east side of the field. Two sherds of Buckley pottery were noted but not retained.

The trench on the north west and the south of the field was 1m - 1.2m deep and 0.5m wide. The topsoil was 0.2m deep and comprised friable dark blackish brown clay loam with frequent sub-angular pebbles and cobbles; the natural was grey gravelly clay with frequent sub-angular cobbles and boulders with occasional large boulders.

No archaeology was identified within the cable trench.

Plate 06: Length of cable trench at north end of Field A viewed from the south west. Scale = 1m.

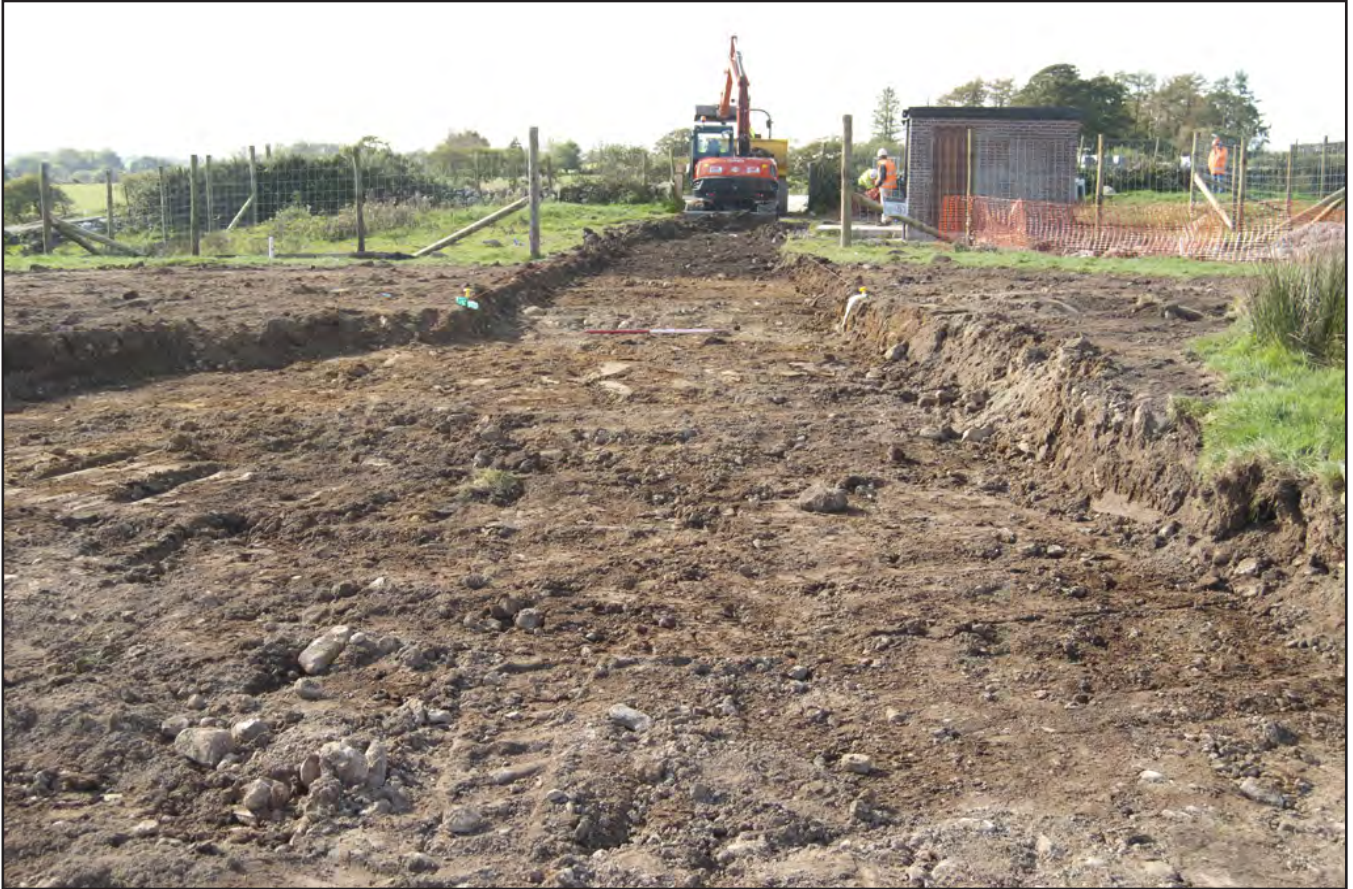
Plate: 07

The topsoil was removed from an area of approximately 30m x 20m for the access road and the sub-station area. The access road was located to the south of the DNO sub-station (Figure 1). The topsoil was removed, terlam laid down and covered with hardcore.

A possible pit was identified in the access road; however, on investigation it was determined to be a natural feature.

No archaeological activity was identified within the access road

Plate 07: Topsoil strip for access road and sub-station area. Scale = 1m.

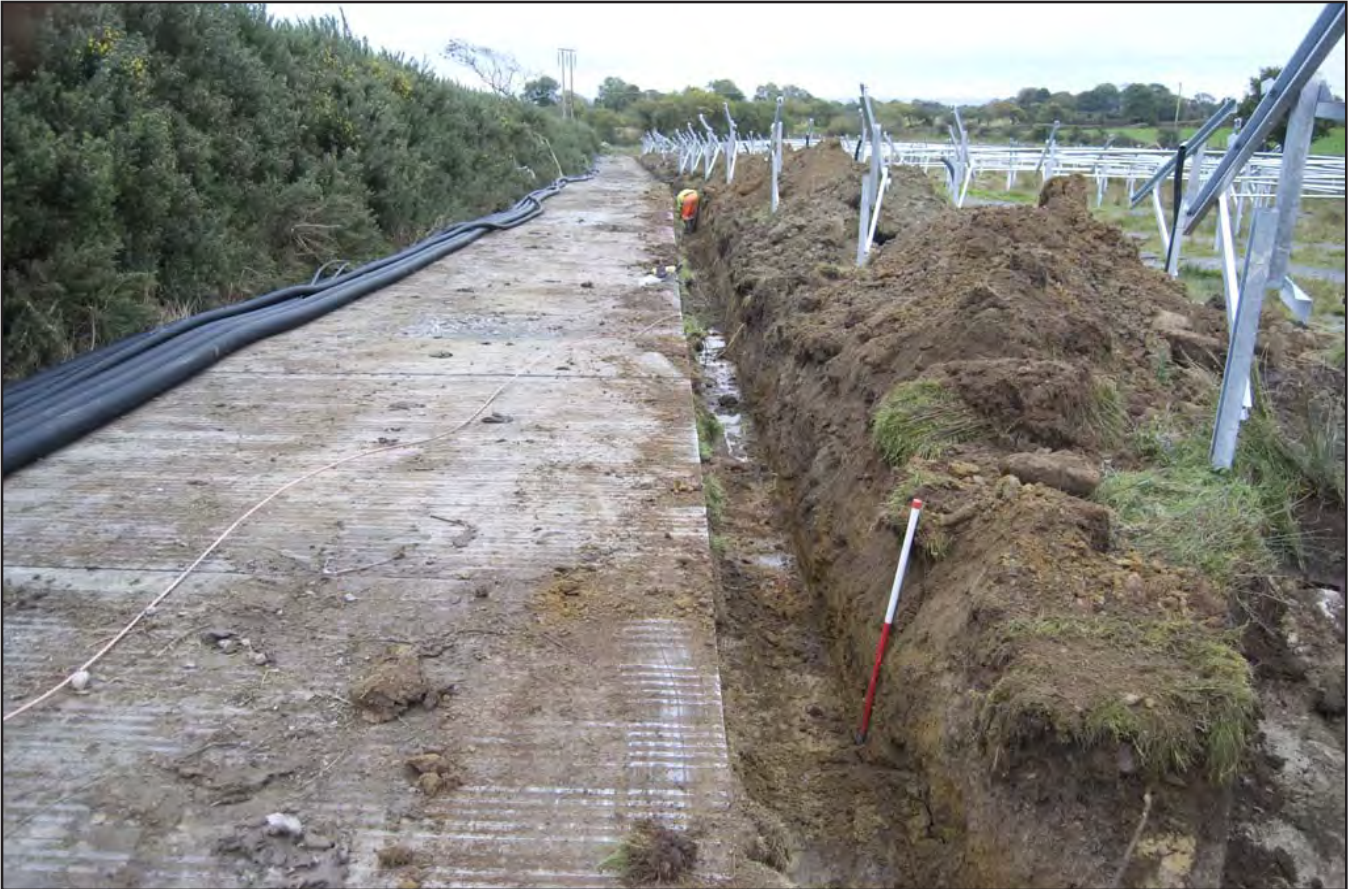
Plate: 08

The watching brief monitored the cable trench on the eastern side of the field; the trench measured 0.5m wide and 1m deep.

The topsoil was firm dark blackish brown clay loam with occasional sub-angular pebbles and cobbles. The natural was grey sandy clay with frequent sub-angular pebbles, cobbles and boulders at the southern end of the trench. Mid-field the natural was orange yellow sandy clay with grey mottling frequent sub-angular pebbles, cobbles and boulders, while at the northern end of the field the natural was grey gravelly clay frequent sub-angular pebbles, cobbles and boulders.

No archaeology was identified within the cable trench.

Plate 08: Length of cable trench in Field C viewed from the north. Scale = 1m.
