EGLWYS LLECHCYNFARWY, CARMEL, YNYS MON

Archaeological Watching Brief of Pipe Trench

Prosiect Rhif / Project No. G2488

Adroddiad Rhif / Report No.1351

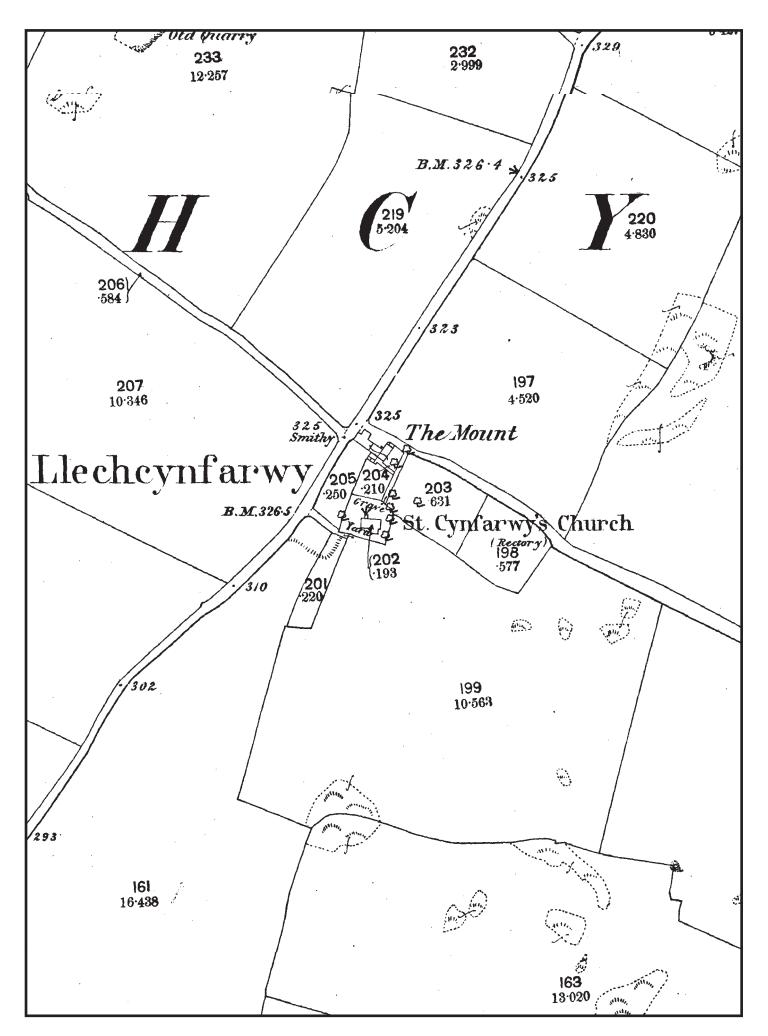
Figure 02: Reproduction of Ordnance Survey County Series First Edition 1" to 25 mile County Series Ordnance Survey Map (1889; Sheet XX.8). Scale: 1:2500@A4.

A brief examination of the first to third edition 1 mile to 25 inch Ordnance Survey maps of the church and environs (map sheet XX.8; 1889, 1900 and 1924 respectively), reveal general information about the historic layout of the area. The overall layout appears little changed during the late 19th to early 20th century, except for the appearance of a property called *Fron* to the southwest on the third edition (cf. Figures 02 to 04).

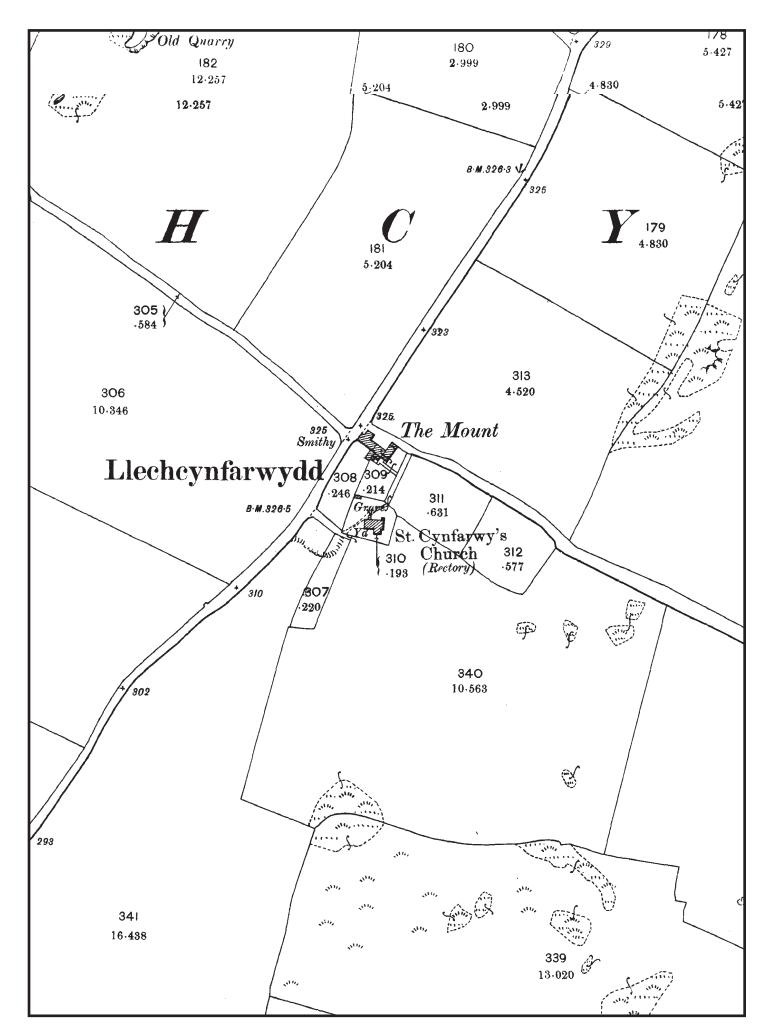
Figure 03: Reproduction of Ordnance Survey County Series Second Edition 1" to 25 mile County Series Ordnance Survey Map (1900; XX.8). Scale: 1:2500@A4.

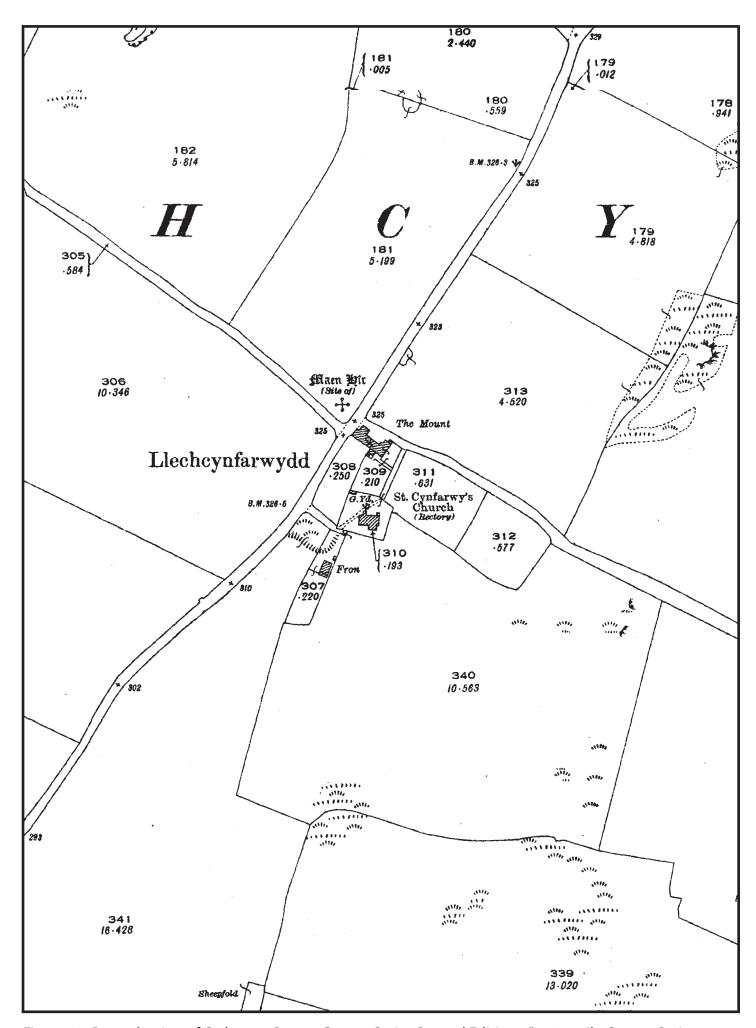
Figure 04: Reproduction of Ordnance Survey County Series Second Edition 1" to 25 mile County Series Ordnance Survey Map (1924; XX.8). Scale: 1:2500@A4

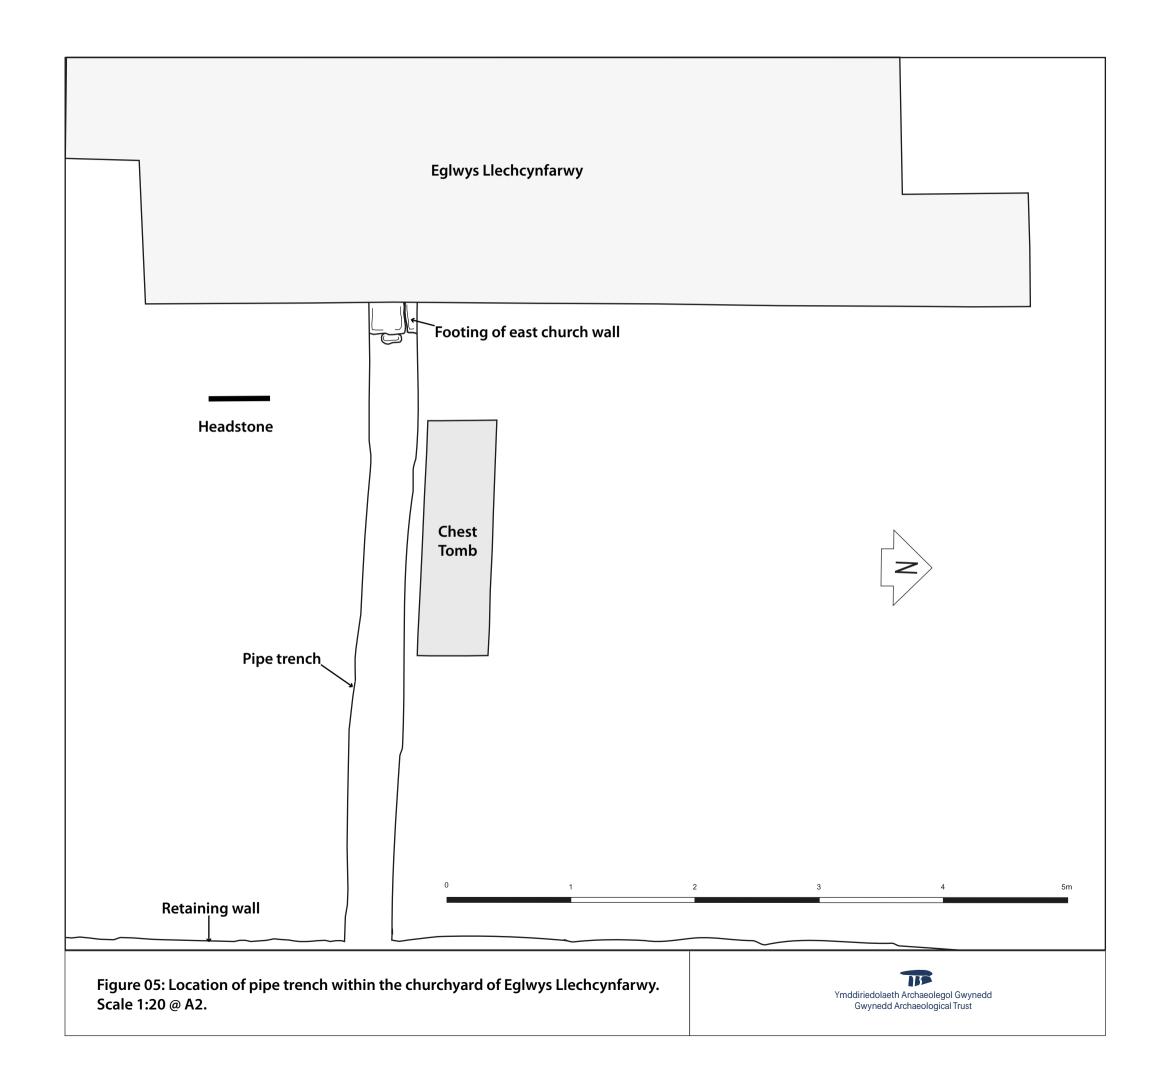
Figure 05: Location of pipe trench within the churchyard of Eglwys Llechcynfarwy. Scale 1:20 @ A2.

- Subsurface remains, in the form of the footing of the east church wall and the base of the box tomb were recorded with scaled photographs and detailed in GAT proformas; and
- A location plan of the drainage trench and adjacent features was drawn at 1:20 scale on GAT A2 pro-forma permatrace (Sheet No. 1, Drawing No. 1; Figure 05).

The pipe trench was excavated from the east face of the church, through the churchyard (Plate 03) and the adjacent retaining wall (Plate 04; Figure 05). The trench had a length of 5.0m, with a variable depth of between 0.50m and 0.65m, and an average width of 0.40m. It was orientated east – west.

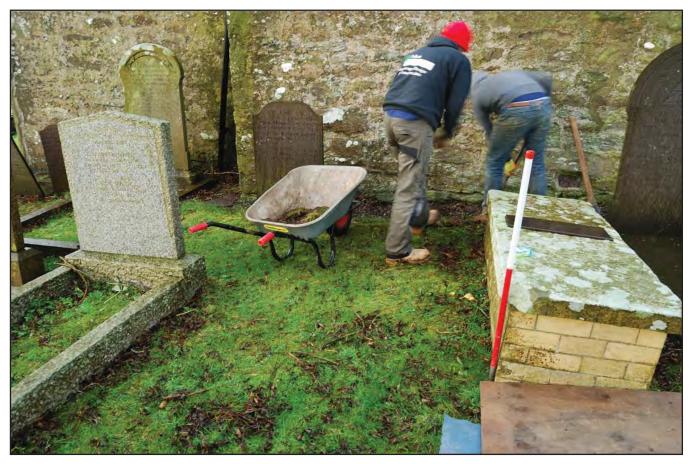
Plate 01: Pre-commencement shot of the eastern end of the churchyard. Scale 1m. (photographic archive ref. G2488_001)

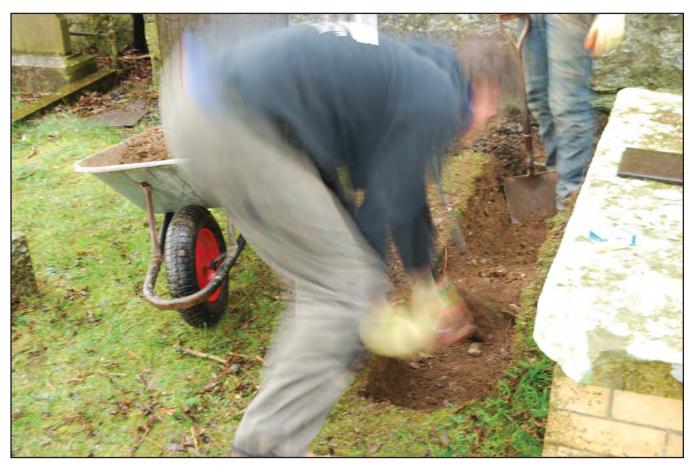
Plate 02: Manual excavation of pipe trench. (photographic archive ref. G2488_003)

The watching brief of the pipe trench was undertaken on Wednesday 23rd November within the grounds of Eglwys Llechcynfarwy, Carmel, Ynys Môn (Primary Reference Number (PRN) 938; NGR SH38118109; Figure 01). The pipe trench was positioned at the eastern end of the churchyard, through a narrow gap (approximately 1.50m wide) between visible grave plots (Plate 01). The pipe trench was manually excavated by the contractor *Eden Landscapes* (Plate 02) and was monitored by a GAT archaeologist.

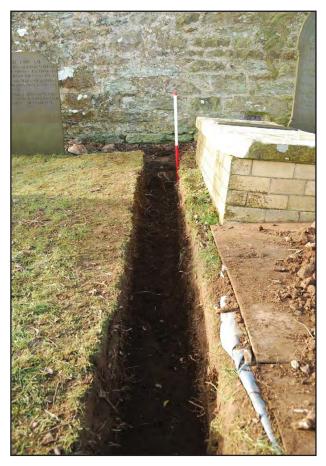
Plate 03: The pipe trench excavated through the churchyard. Scale 1m. (photographic archive ref. G2488_013)

The trench was excavated through one continuous layer of fine, compact mid – dark brown gravelly clay mixed with frequent small angular stones and tree roots. No subsoil or natural deposits were encountered during the excavation of the trench. In addition, no artefacts, cemetery furniture or skeletal remains were identified within the fill of the trench.

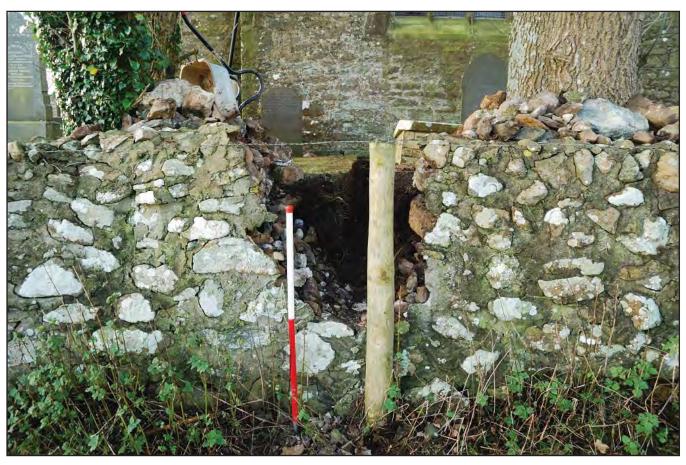
Plate 04: Pipe trench breach through the retaining wall. Scale 1m. (photographic archive ref. G2488_015)

Further to consultation with GAPS along with scaled photographs and documentation prior to disturbance, the pipe trench was extended through the retaining wall of the churchyard. The wall had a maximum height of 1.50m in the field adjacent to the church (Plate 07) and 0.40m within the churchyard (Plate 08), with a width of 0.75m. It consisted of a random assortment of sub-angular and sub-rounded field stones (Plate 09) that may have been originally of drystone build but in recent years it has been capped and faced with concrete.

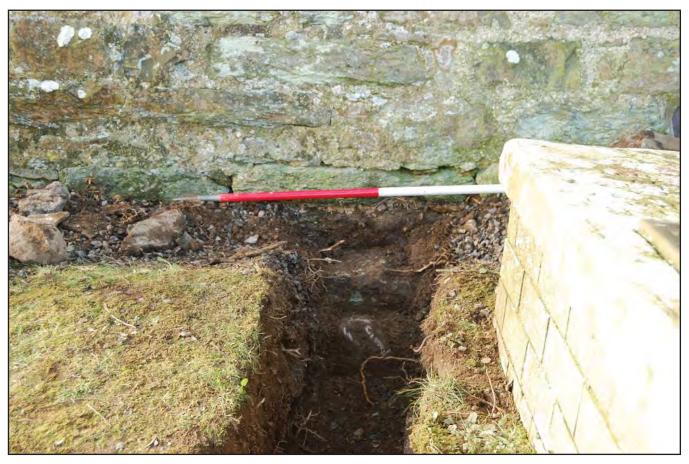
Plate 05: Footing of church wall exposed in the pipe trench. Scale 1m. (photographic archive ref. G2488_009).

The pipe trench though did uncover the footing of the east church wall, which was exposed to a depth of 0.36m (Plate 05). The footing was stepped and consisted of rough schist local stone. The south face of the trench also exposed the base of an adjacent 19th century chest tomb. The base consisted of a narrow strip of stone covered in lime mortar, with a length of 1.90m and depth of 0.07m; it was 0.22m below current ground level (Plate 06). The chest tomb had a maximum length of 1.88m, width of 0.68m and visible height of 0.50m. The body of the tomb consisted of yellow engineering bricks, with five courses visible, and a yellow sandstone lid which had a metal plate with inscribed lettering, positioned close to the centre.

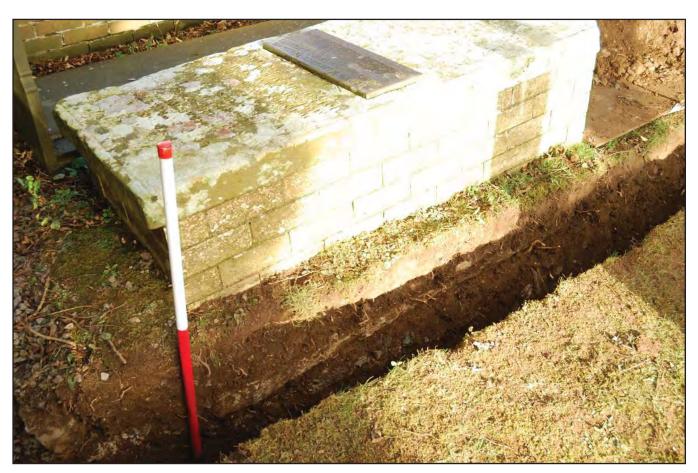
Plate 06: Base of 19th century chest tomb exposed in south face of pipe trench. Scale 1m. (photographic archive ref. G2488_011).

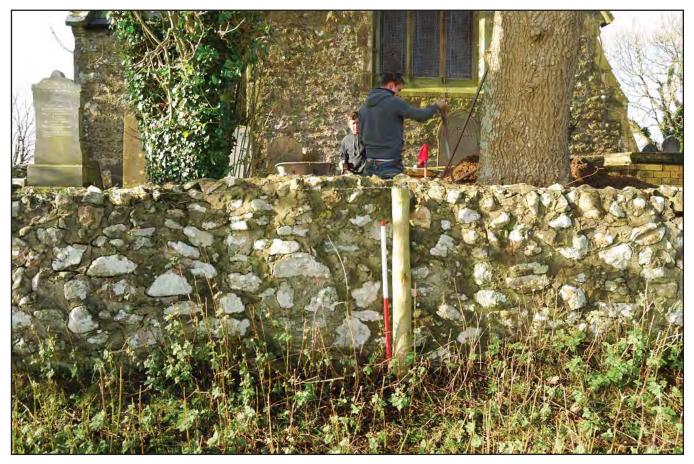
Plate 07: Pre-demolition view of retaining wall from the adjacent field. Scale 1m. (photographic archive ref. G2488_007)

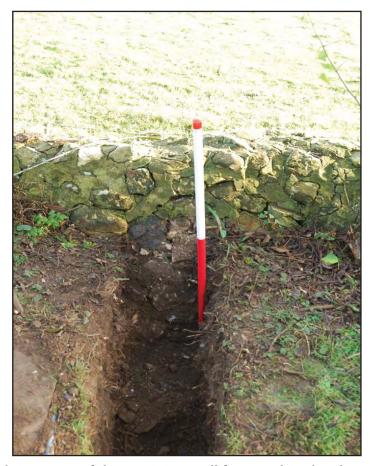
Plate 08: Pre-demolition view of the retaining wall from within the churchyard. Scale 1m. (photographic archive ref. G2488_005)

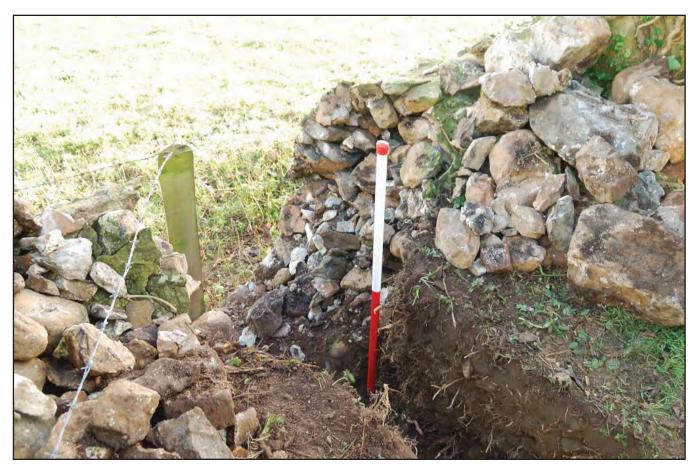
Plate 09: Section through retaining wall. Scale 1m. (photographic archive ref. G2488_014)
